ARCHAEOLOGICAL INVESTIGATION OF THE CONSTRUCTION MATERIALS
OF ROMAN (CARACALLA) BATH IN ANKARA

A THESIS SUBMITTED TO
THE GRADUATE SCHOOL OF NATURAL AND APPLIED SCIENCES
OF
MIDDLE EAST TECHNICAL UNIVERSITY

DECEMBER 2018

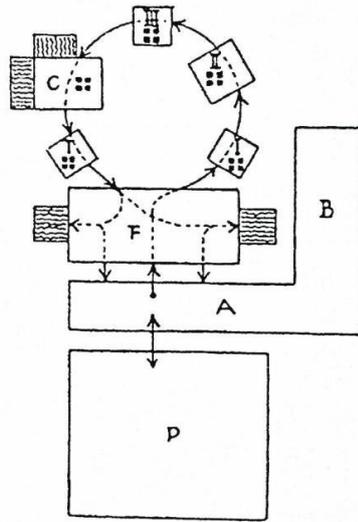
Figure 2.8 Asymmetric Bath Type "Pompeii Type"(Yegül, 2006:163).

Asymmetric Plan: This layout was used mostly in *balneums* (small baths). This important type sometimes is referred to as the "Pompeii Type"(Figure 2.8) emerged in Campania at the beginning of the 19th century BC with the earliest known example being the Stabia Baths in Pompei (Figure 2.9) (Yegül, 2006:163). This plan type could also be found in the houses and villas of the Late Republican period (Yegül, 2006:162).

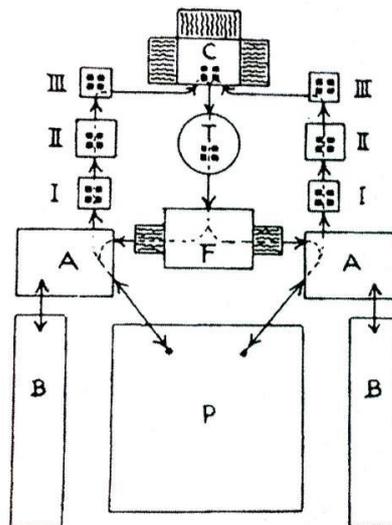
Figure 2.10 Symmetrical Bath Type "Imperial Baths"(Yegül, 2006:163).

The plan layout would feature many rooms and halls on either sides of the symmetrical axis of the bath. The axis was intersected by the *frigidarium* containing a pool called *piscina*. Near the *frigidarium* was the *apoditerium* the changing room, and then there were some smaller rooms of the *tepidarium* for sweating and massage in appropriate places. The *caldarium* which usually lay at the center of the bath was surrounded by a series of hot rooms located to the south or southeast direction to benefit from direct sunlight. The *frigidarium* and *caldarium* were often covered with a cross vault system, but rarely with a barrel vault. In some examples, the round *caldarium* enclosed with a high dome (Figure 2.10) (Kula Say, 2007:14-15).

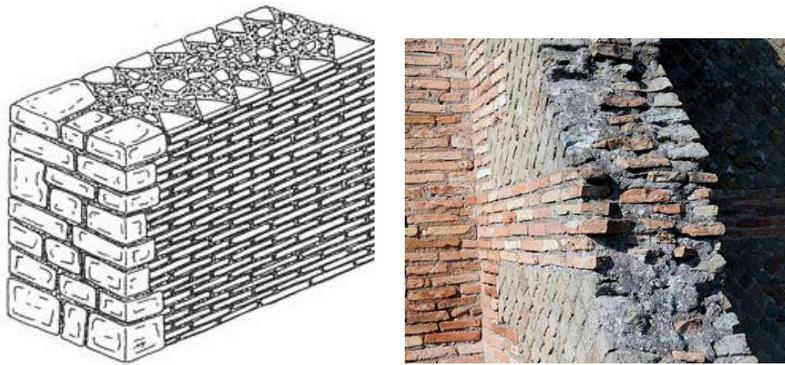
Figure 2.24 *Opus testaceum* -brick and tile faced concrete- (Sharo, 2016; Muench, 2017)

1961) similar to the huge walls of the *frigidarium*, *tepidarium* and *caldarium* sections of the Caracalla Baths, which were constructed in the same way. After that, the inside walls were coated with slabs of marble, glass mosaic and painted *stucco*, while the outside surfaces were coated with white *stucco* (an outdoor plaster) imitating blocks of white marble (DeLaine, 1992:269-270). The walls of the heating rooms were built with hollow areas behind the outer covering to allow the circulation of hot air (DeLaine, 1992:183).

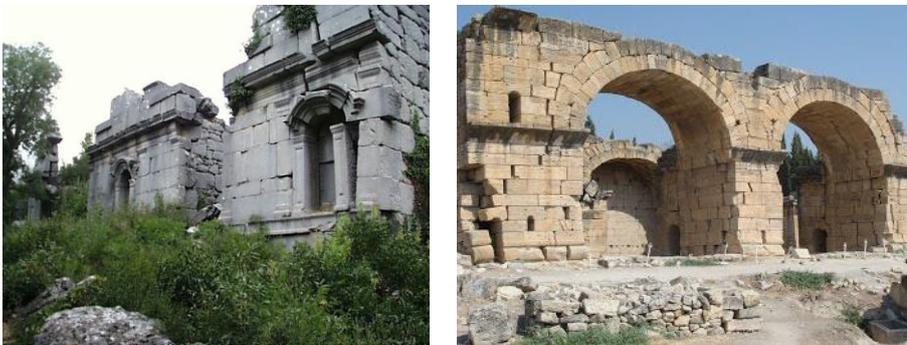
Figure 2.27 Cut stone masonry walls of Termessus and Hierapolis Bath-Gymnasium (Yegül, 2010:185; Daşbacak, 2002:964)

The best examples of the building technique using high-quality rectangular stones can be found in Hierapolis, Laodiceia and Tripolis, located in the eastern Karia highlands. The large, smooth cut stone blocks produced from local limestone were applied in a standard manner to the walls, free standing pillars and barrel vaults of the buildings at these sites (Figure 2.27) (Yegül, 2006:223; Yegül, 2010:183-184). The bath-gymnasium complex of Termessus, one of the leading mountain settlements in Psidia, has carefully-built walls made from rectangular cut stone blocks (Figure 2.27). On the facade of the baths in Oenoanda, which is the mountain settlement of Lycia, the two-story arched walls constructed with rectangular stone blocks are similar to those in Termessus, although the quality of the rectangular stone blocks is lower (Yegül, 2006:223).

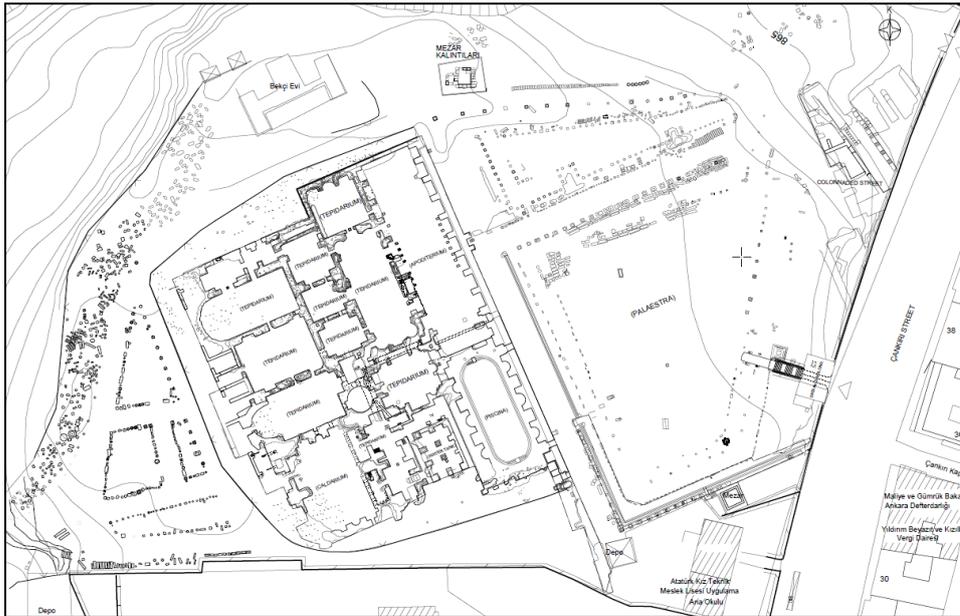
Figure 3.12 Location and plan of the Bath (Keskin, 2012; Nalbant, 2014)

survey project was developed based on the visible architectural remains, being the walls and components of the foundation and the hypocaust system. The remains in the site indicate that the Roman Bath was composed of two parts: bath building and *palaestra* as mentioned previously. The enclosed parts of the Roman Bath building include the *caldarium*, *tepidarium*, and *frigidarium* (*piscina and apoditerium*) (Figure 3.13-3.14). The open building part of the bath is the *palaestra*, although today only parts of the colonnade system can be seen (Figure 3.12-3.14). Although their layout can be assumed from the restitution plan which was drawn by Akok (1955), the east corner of the *palaestra* is not visible today, in that it now lies under the modern Çankırı Street. In the same way, the southern part of the stoa of the *palaestra* is not visible today, as it most probably extends under the garden of the adjacent school (Figure 3.12-3.15) (Drawing B.2 and Drawing B.7 in Appendix B).

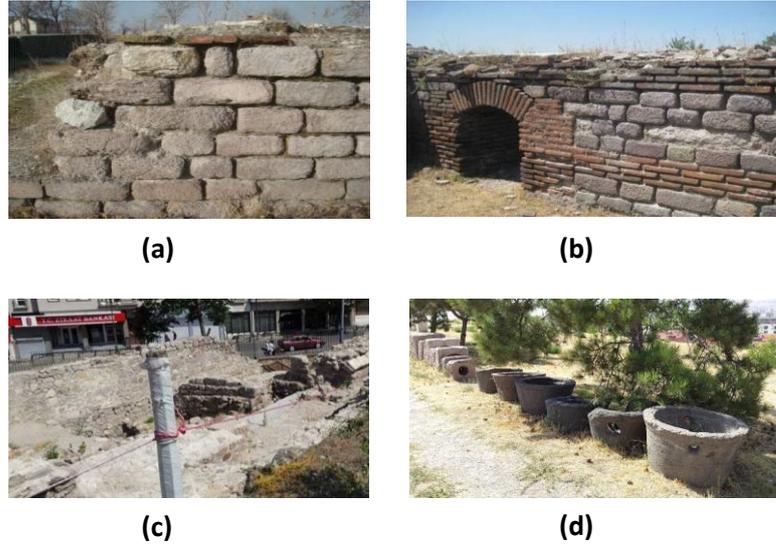
Figure 3.19 (a) The stone masonry wall (b) Masonry wall made from alternating layers stone and brick (c) The rubble stone wall (d) The perforated stone blocks for pipeline (photos: Zeynep Tanriverdi, 2014)

In contrast, the rubble wall remains which were found in the later excavations, where located on the road of the northwest end of the site, were constructed out of undressed stone. The stone material was also used in the channels of water installation system, which brought water to the Bath and distributed it therein (Figure 3.19 (c)-(d)).

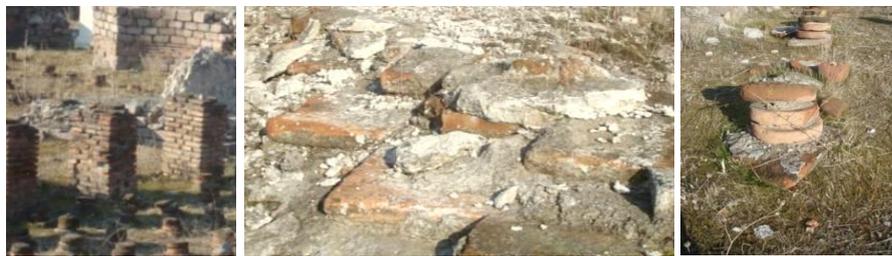
Figure 3.23 Rectangular, square and circular brick examples
(photos: Zeynep Tanrıverdi, 2014)

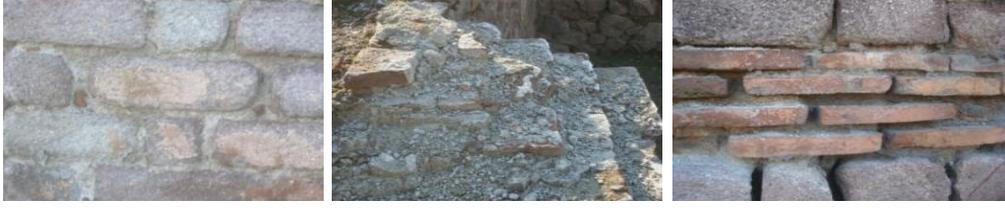
Figure 3.24 Mortar examples in the Bath
(Şener, 2018:251; photos: Zeynep Tanrıverdi, 2014)

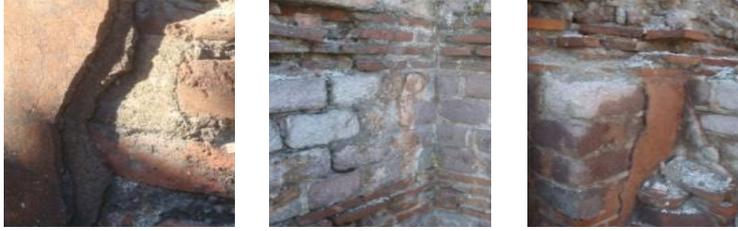
Figure 3.25 Plaster examples in the Bath
(Şener, 2018:250; photos: Zeynep Tanrıverdi, 2014)

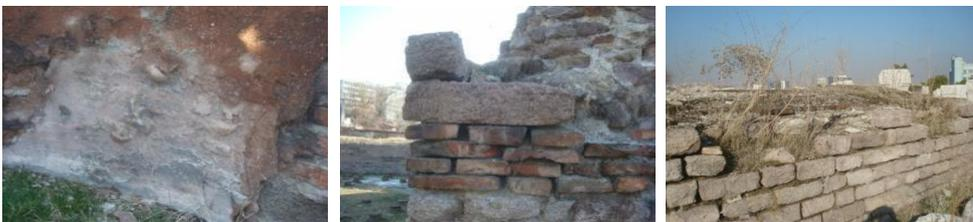
Figure 3.26 Material lost, efflorescence and biological growth on materials of the Bath (photos: Zeynep Tanrıverdi, 2014)

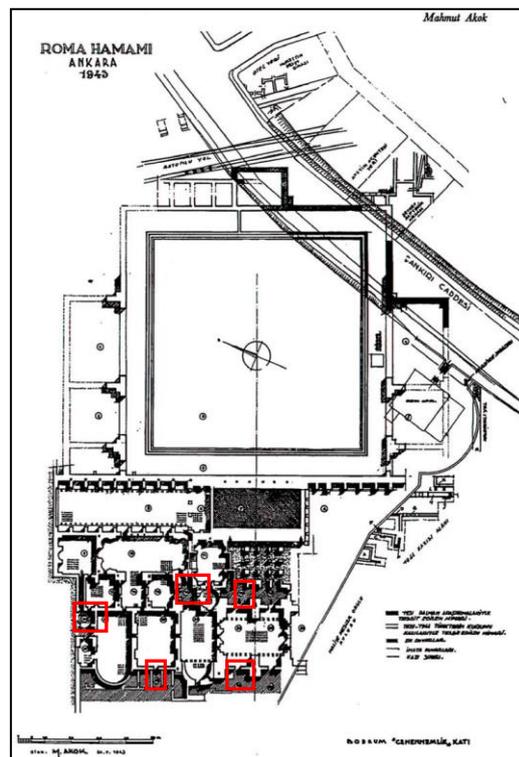
Figure 3.27 Location of the furnaces in foundation plan of the Bath (Akok, 1968:25)

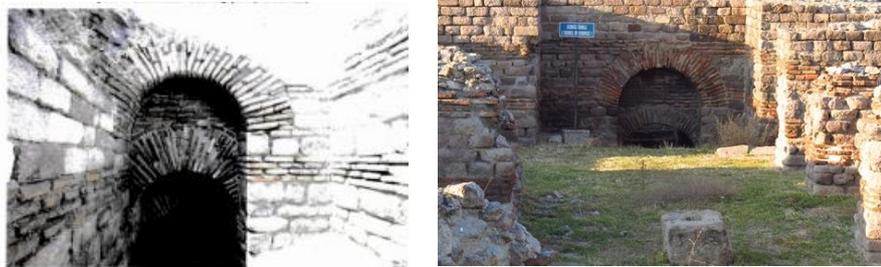
Figure 3.28 The tunnel passage in foundation of the Bath
(Akok, 1968:22; photo: Zeynep Tanrıverdi, 2014)

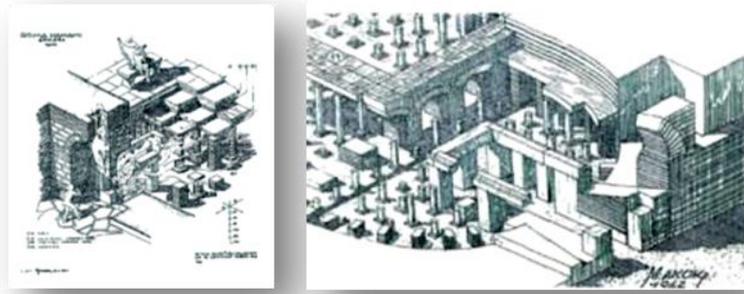
Figure 3.29 Drawings of furnace and *pilae* of the *hypocaust* system (Akok, 1968:19-20)

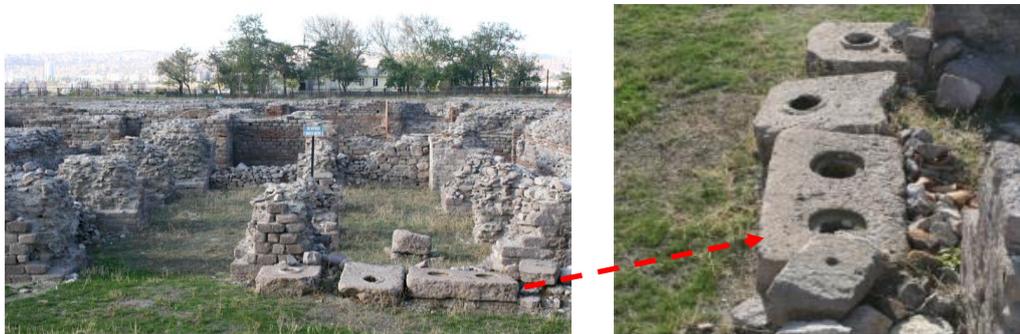
Figure 3.33 The perforated stone near the foundation walls of the water tank reservoir (Kaytan, 2008:30-31)

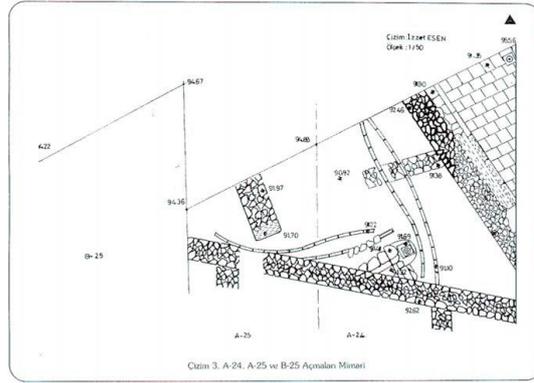
Figure 3.36 Plan of the excavated area and the found *terra-cotta* pipes
(Temizsoy et al., 2002:154)

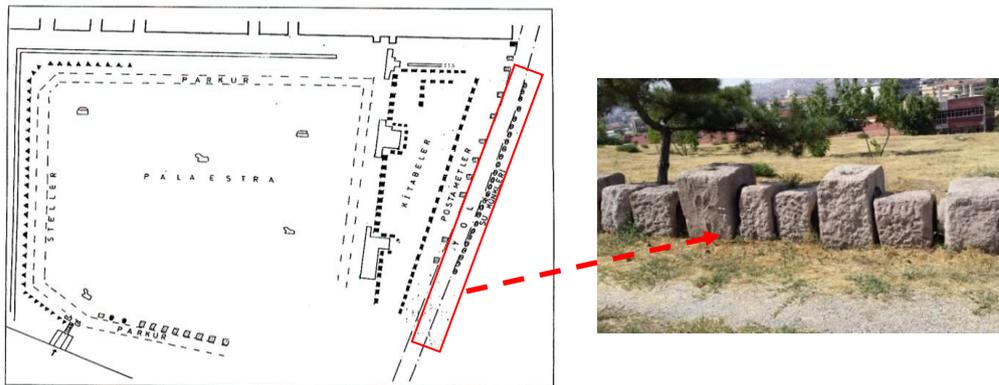
Figure 3.37 Location of the perforated stone blocks re-arranged on the north of the
Open Air Museum (Esen, 2001:289; photo: Zeynep Tanrıverdi, 2014)

Today, the Bath is an open-air museum and some of perforated stone aqueduct components are exhibited in the north of the site (Figure 3.37) (Esen, 2001:286-287; Kaytan, 2008:34-35).

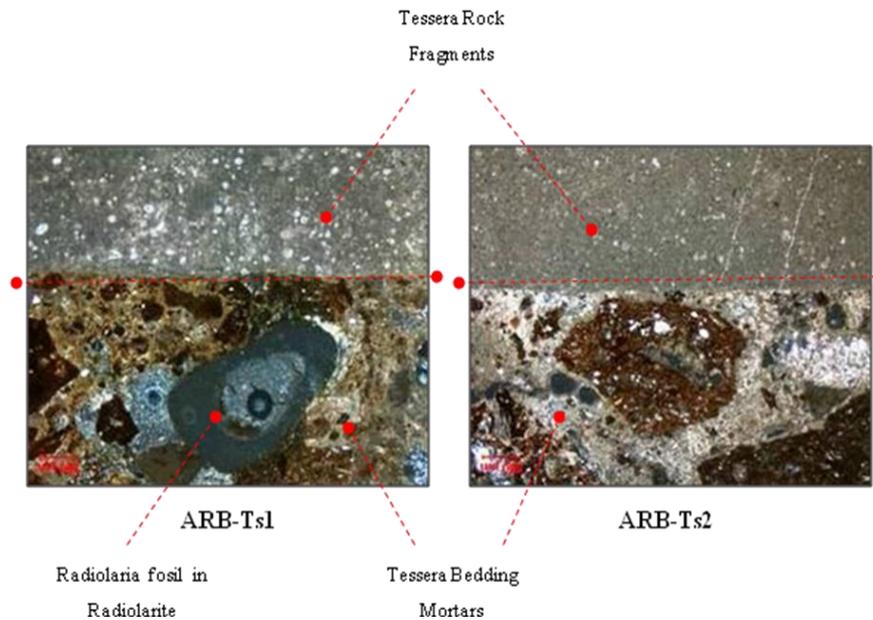
Figure 5.2 Thin section microphotographs of ARB-Ts1- Ts2 samples

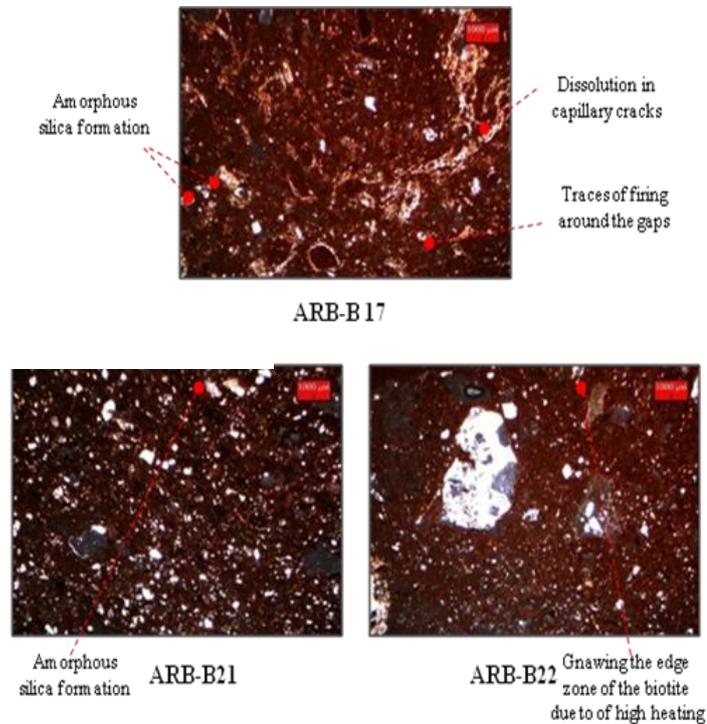
Figure 5.4 Hot water vapor effect on *pilae* type bricks (ARB-B17, ARB-B21, and ARB-B22)

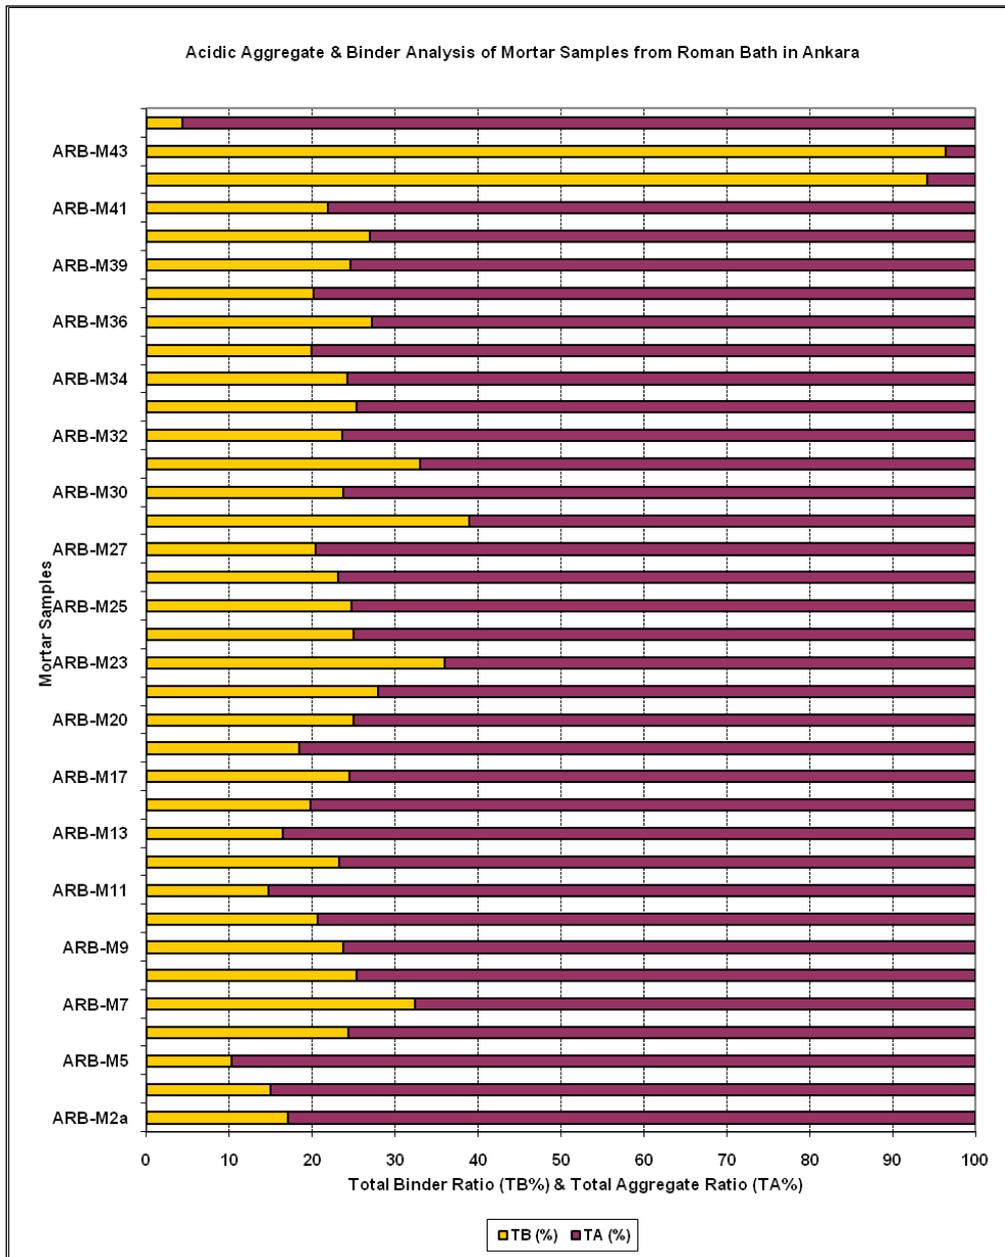
Figure A.11 The Binder-Aggregate Ratio of the mortar and plaster samples

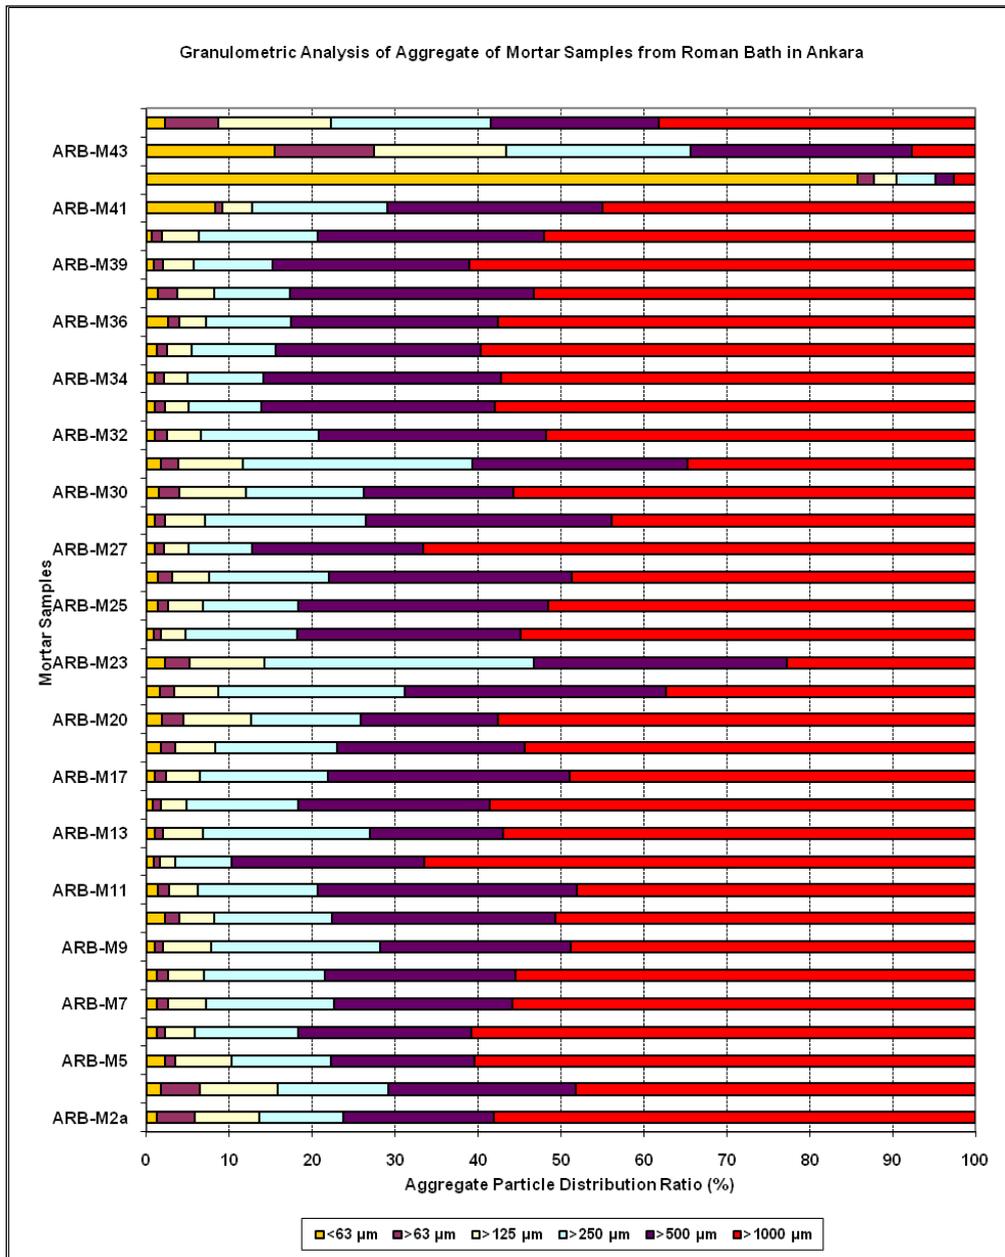
Figure A.12 The Particle Size Distribution of the mortar and plaster samples

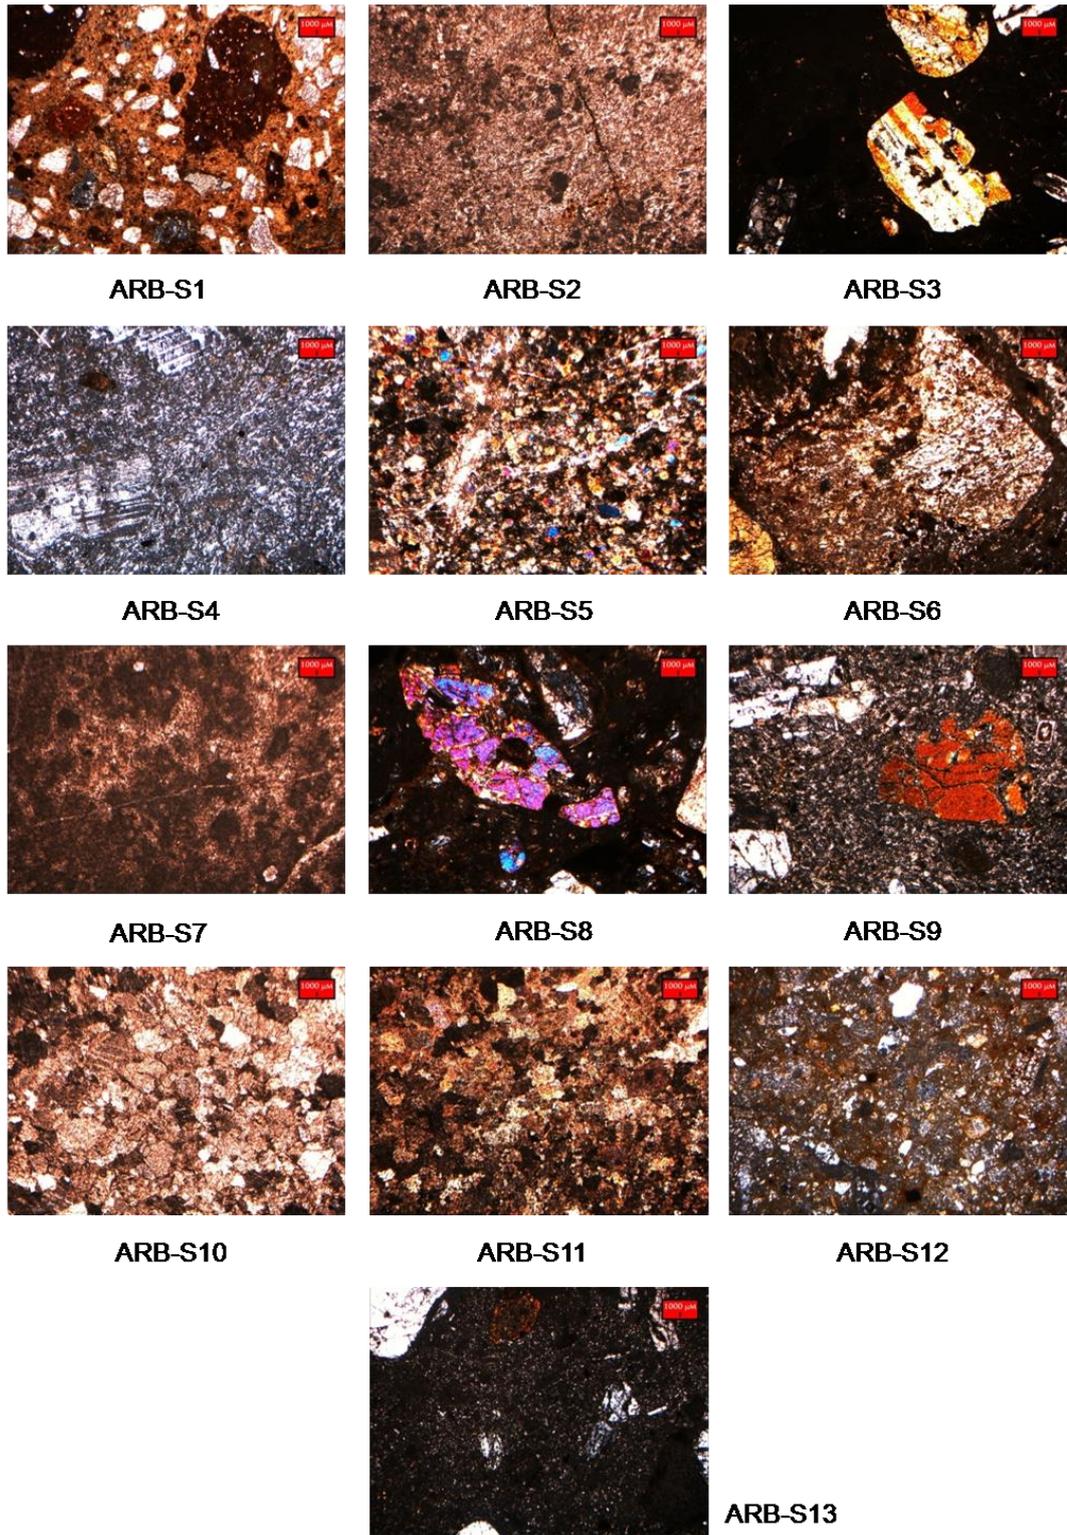
Figure A.14 Thin section microphotographs of stone samples

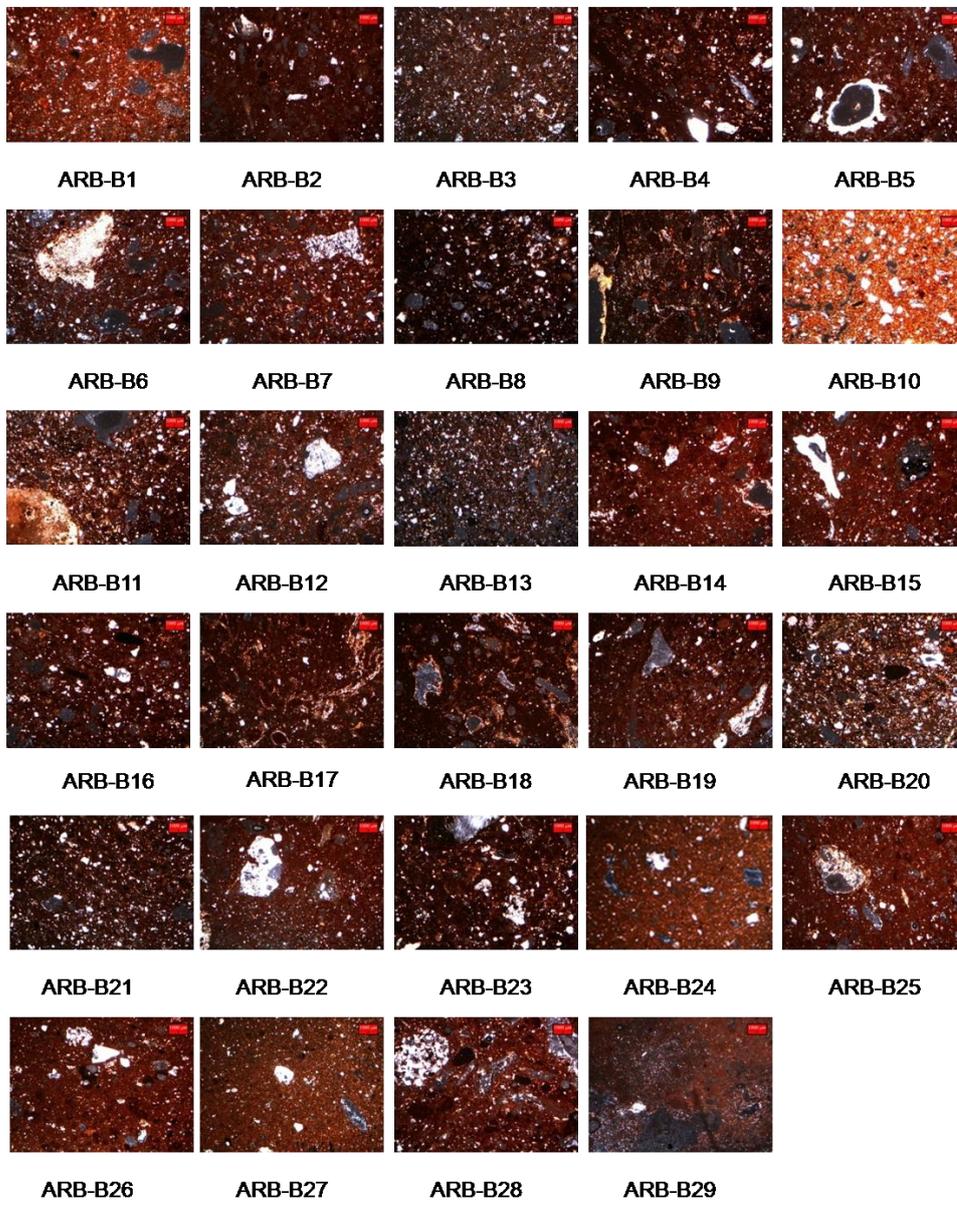
Figure A.16 Thin section microphotographs of brick samples

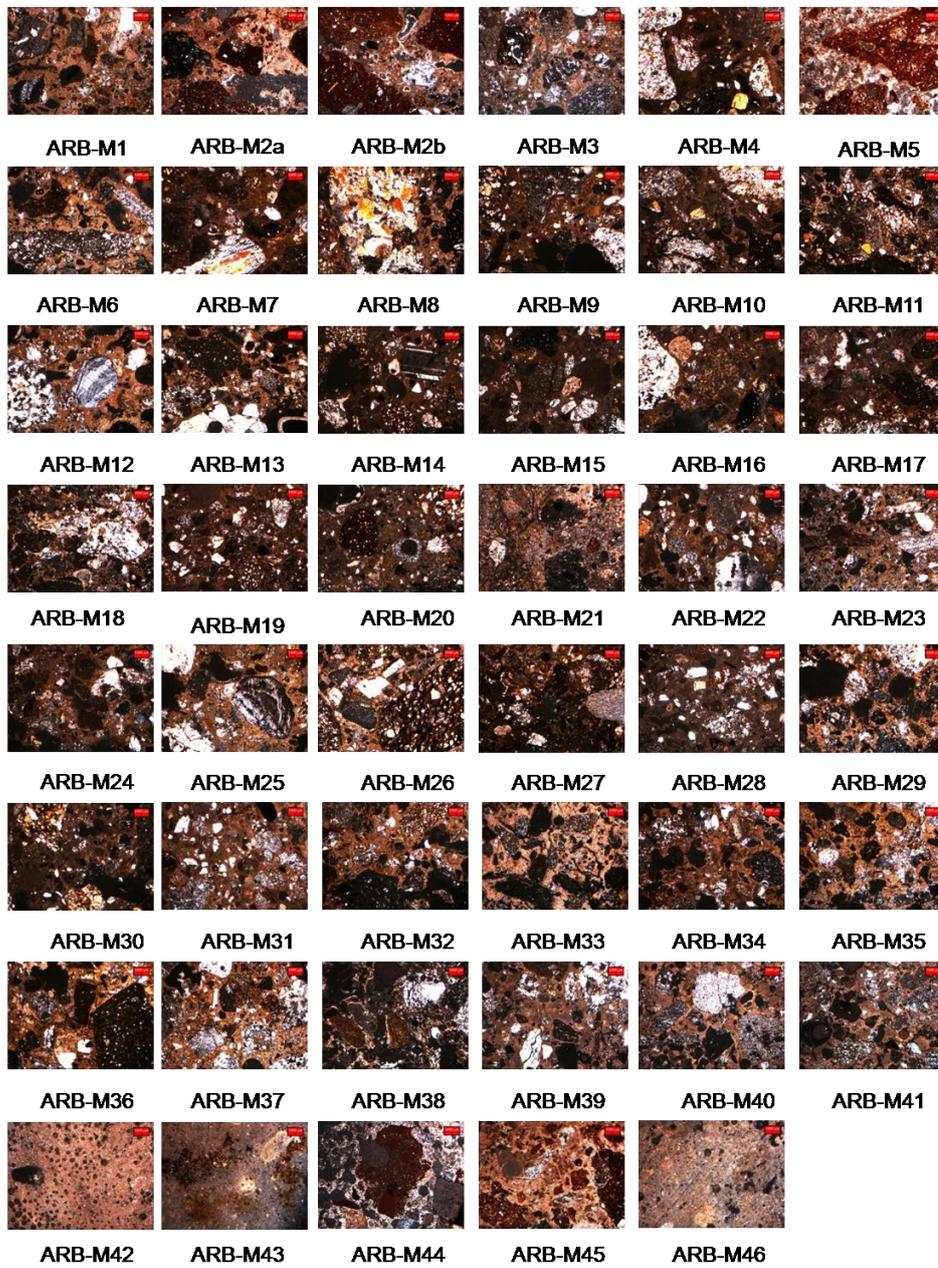
Figure A.17 Thin section microphotographs of mortar samples

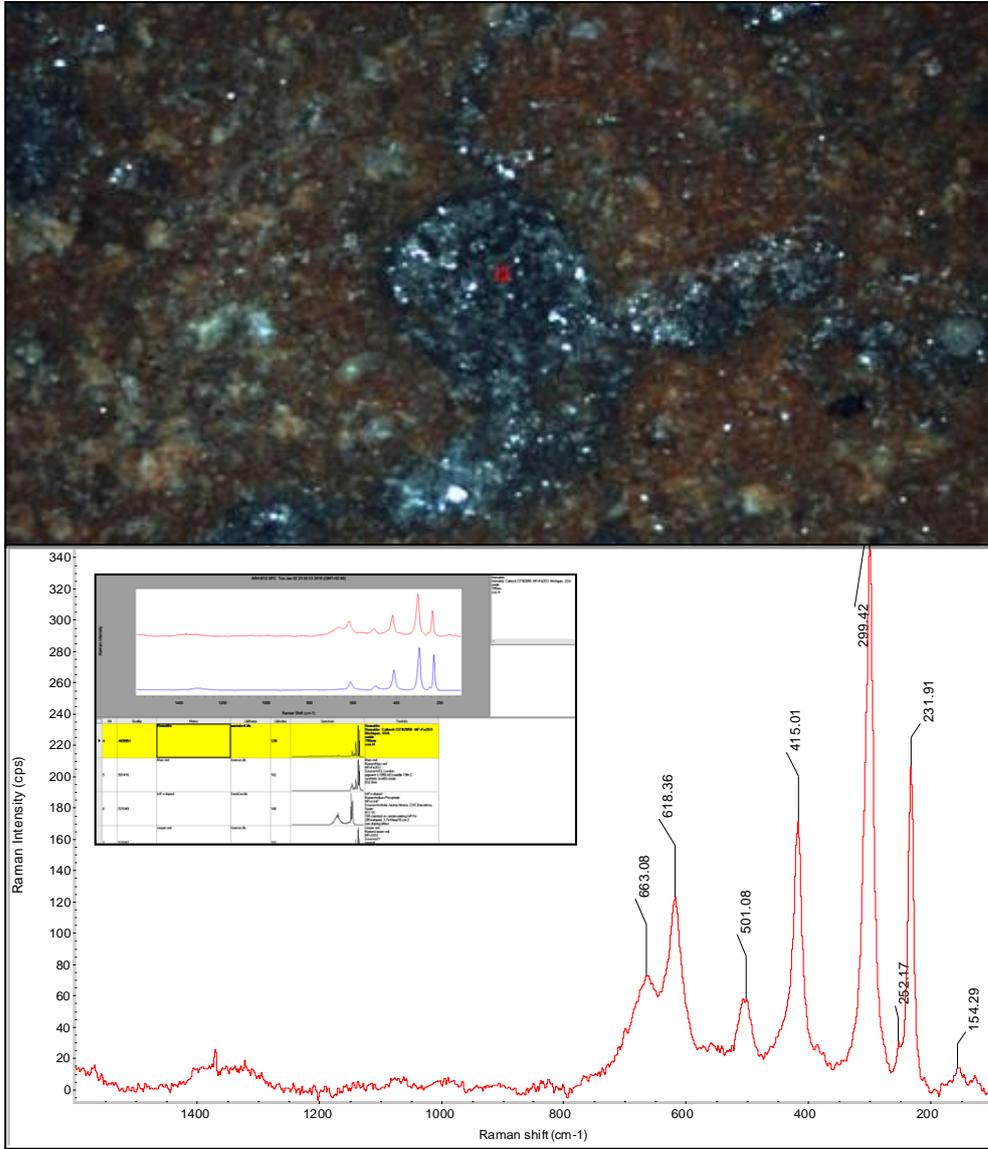
Figure A.19 Raman Analysis Results (sample ARB-B22)

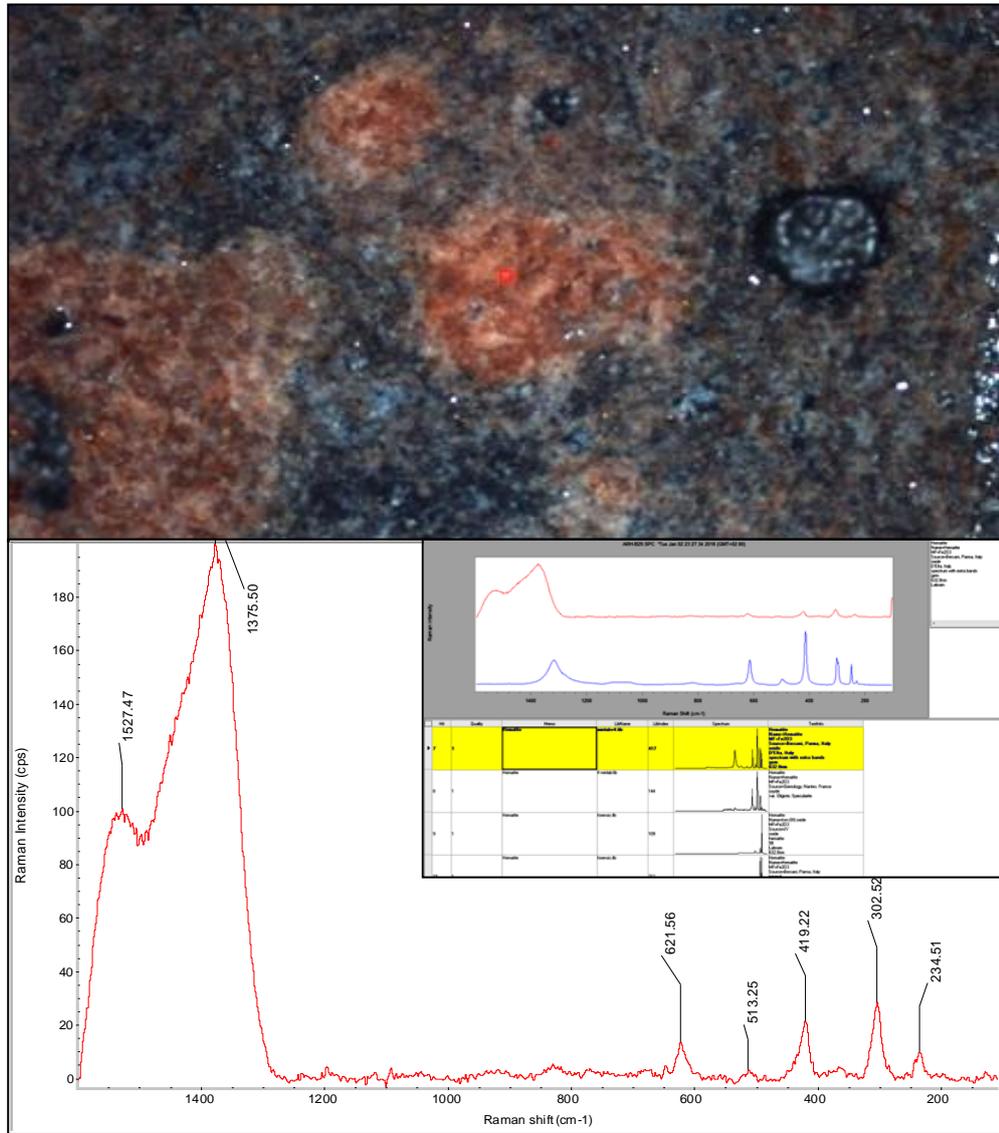
Figure A.20 Raman Analysis Results (Sample ARB-B29)

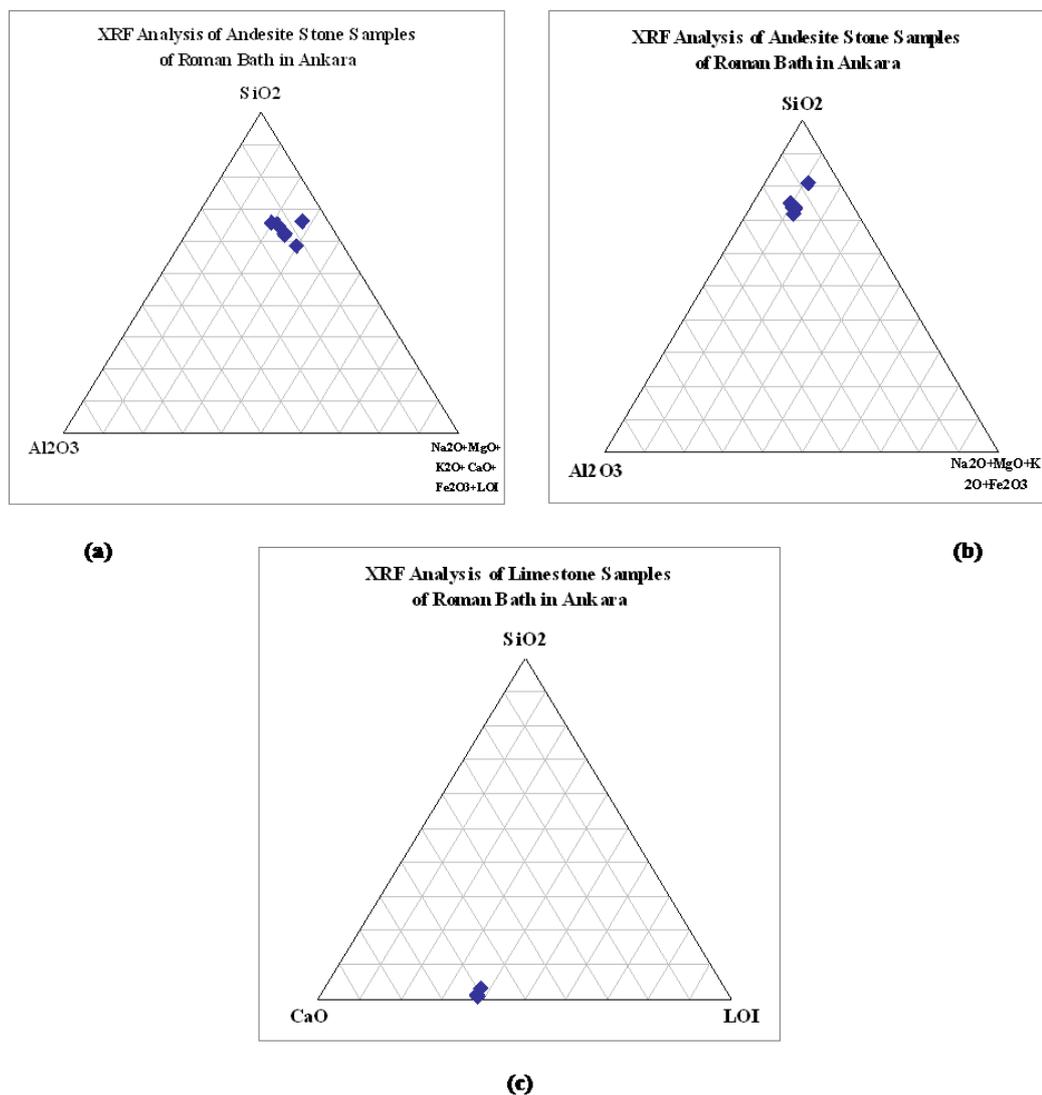
Figure A.22 XRF Analysis – Triangle Plotting of Andesite Stone Samples and Limestone Samples of Roman Bath in Ankara

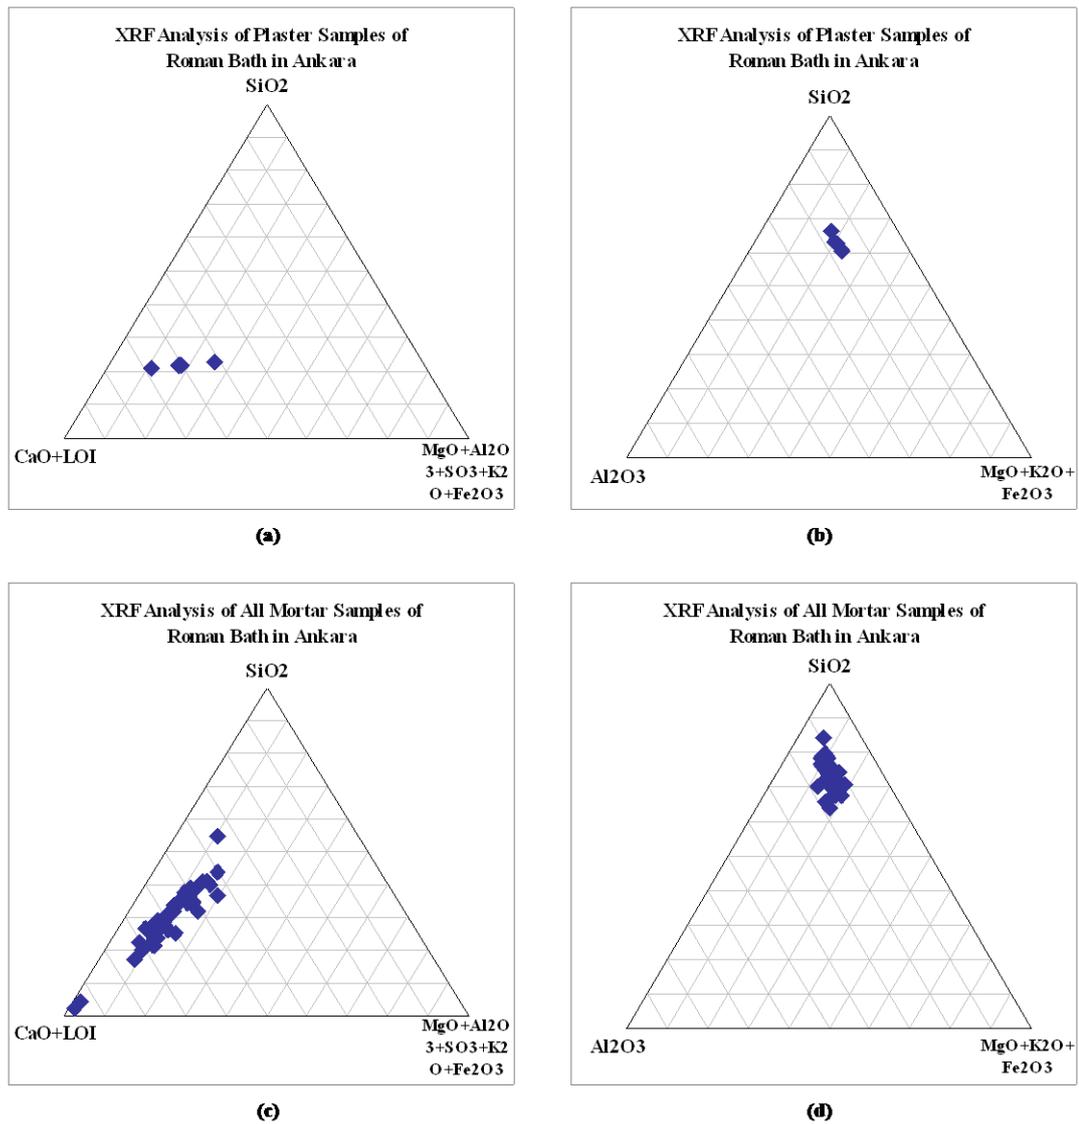
Figure A.24 XRF Analysis – Triangle Plotting of All Types of Plaster and Mortar Samples of Roman Bath in Ankara

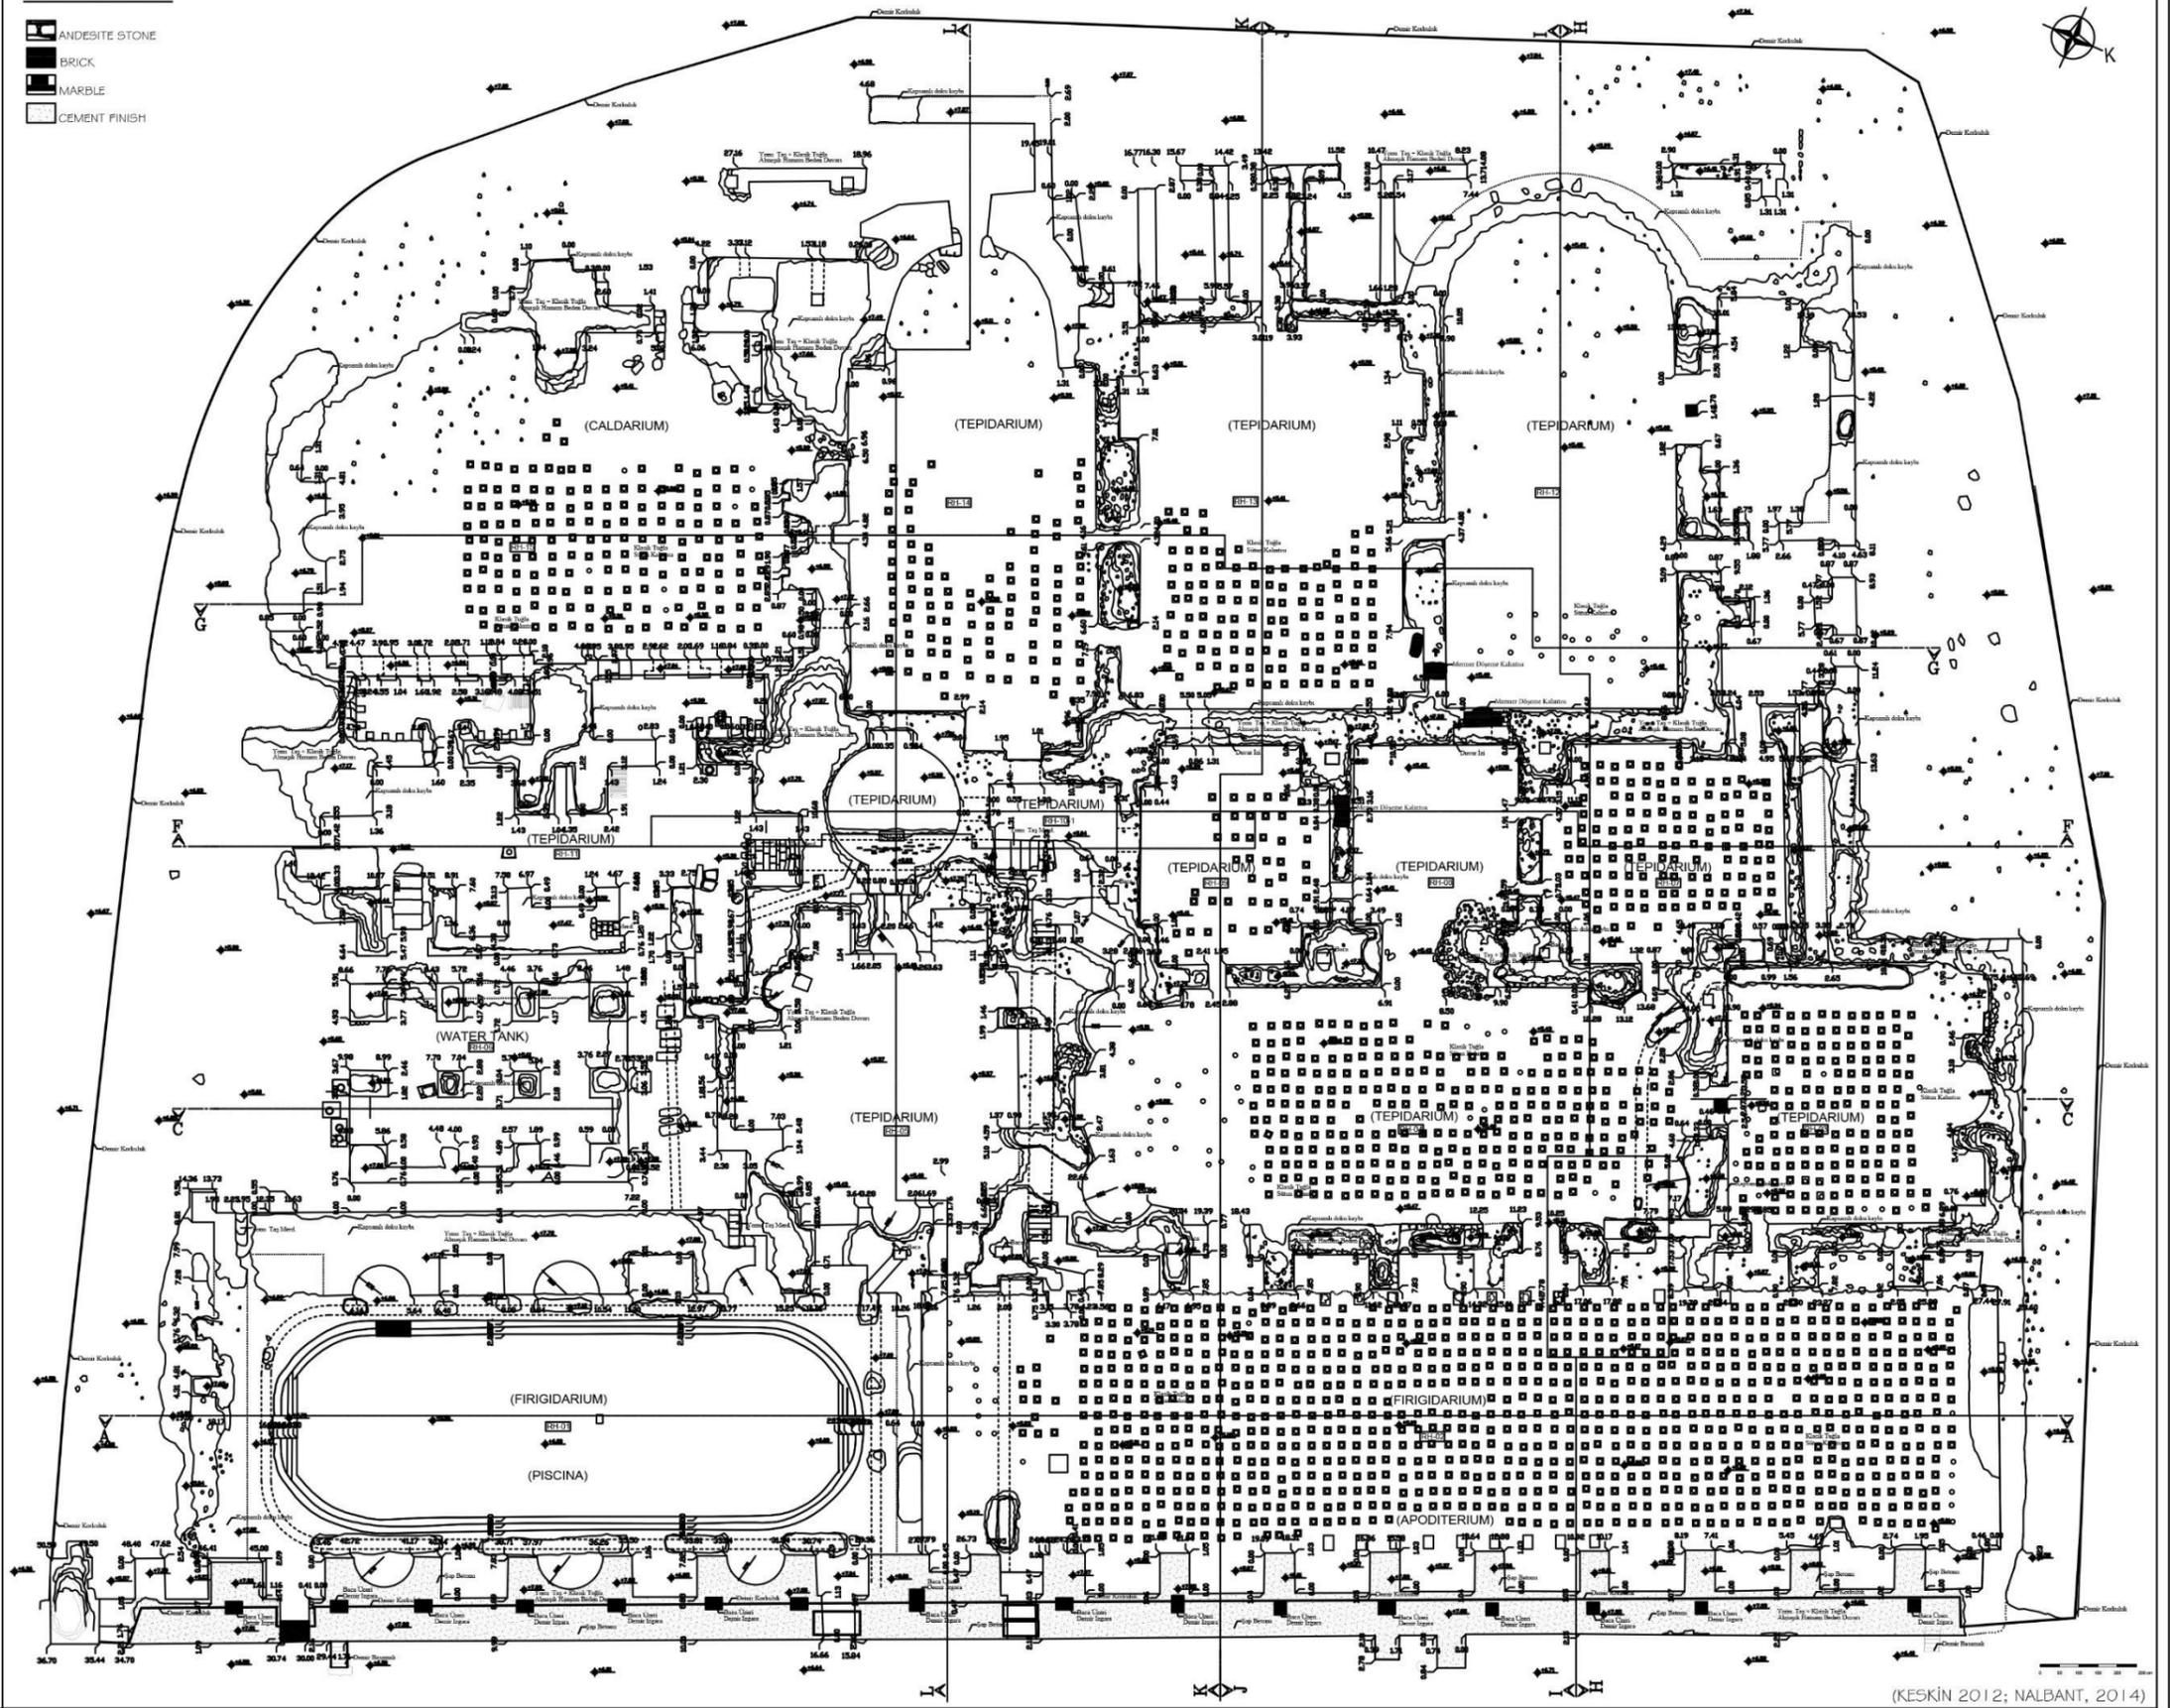
Drawing B.3 Building Survey Drawing of the Bath S: 1/100
