ARCHAEOLOGICAL INVESTIGATION OF THE CONSTRUCTION MATERIALS
OF ROMAN (CARACALLA) BATH IN ANKARA

A THESIS SUBMITTED TO
THE GRADUATE SCHOOL OF NATURAL AND APPLIED SCIENCES
OF
MIDDLE EAST TECHNICAL UNIVERSITY

DECEMBER 2018

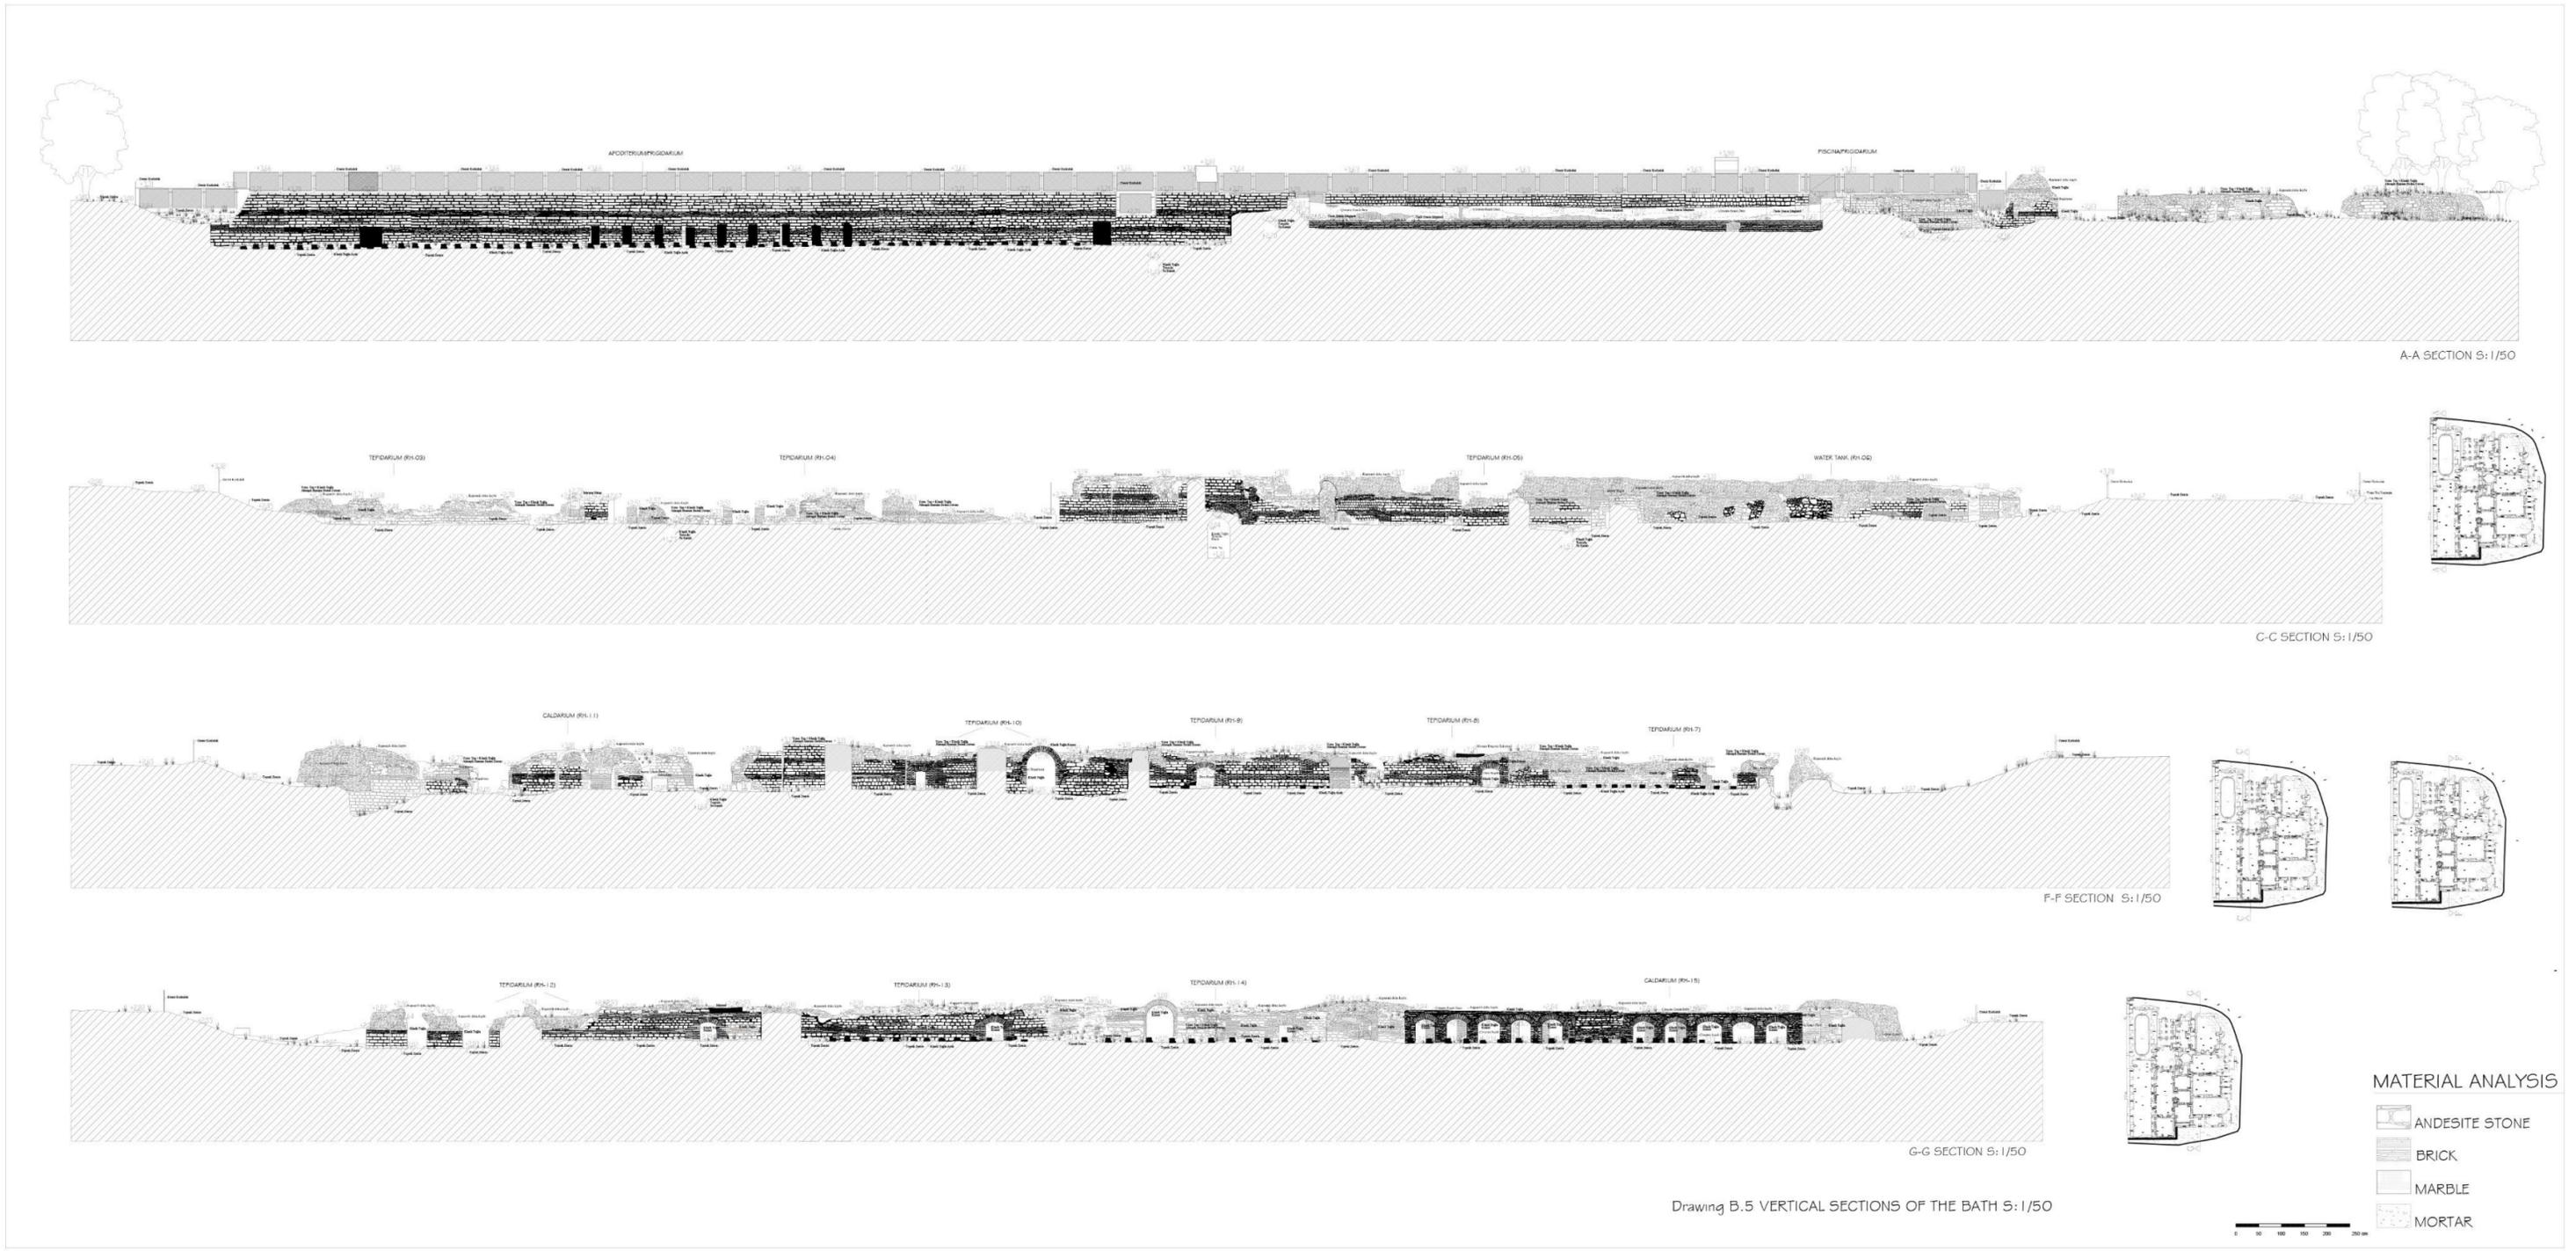
Drawing B.5 VERTICAL SECTIONS OF THE BATH S: 1/50
