ASSESSMENT OF SLOPE STABILITY FOR KM: 109+590-128+630  
SEGMENT OF KIRIKKALE-YERKÖY SECTION (SECTION-2) OF  
ANKARA-SİVAS HIGH-SPEED RAILWAY PROJECT

IN PARTIAL FULFILLMENT OF THE REQUIREMENTS  
FOR  
THE DEGREE OF MASTER OF SCIENCE  
IN  
GEOLOGICAL ENGINEERING

JULY 2019

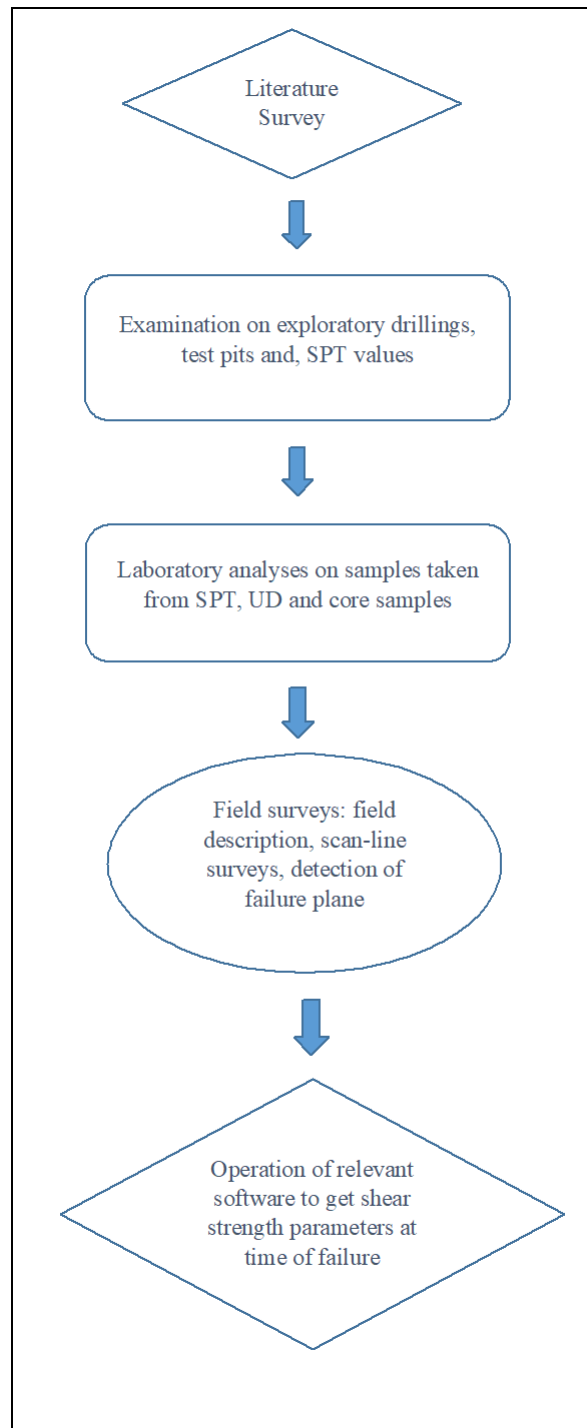
Figure 1.4. Flowchart illustrating the steps on method of study

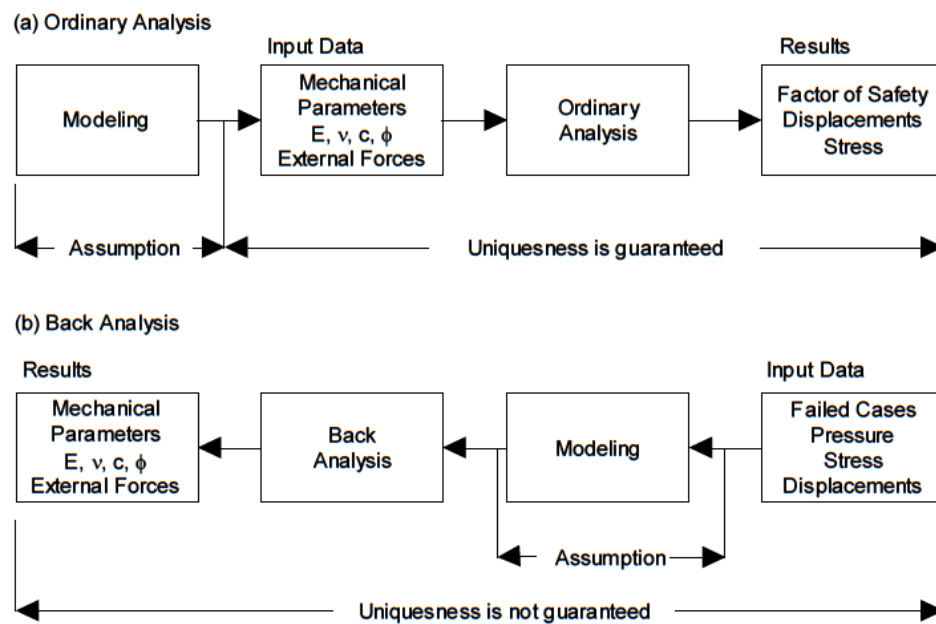
Figure 2.5. Relationship between ordinary analysis and back analysis (after Sakurai, 1981)

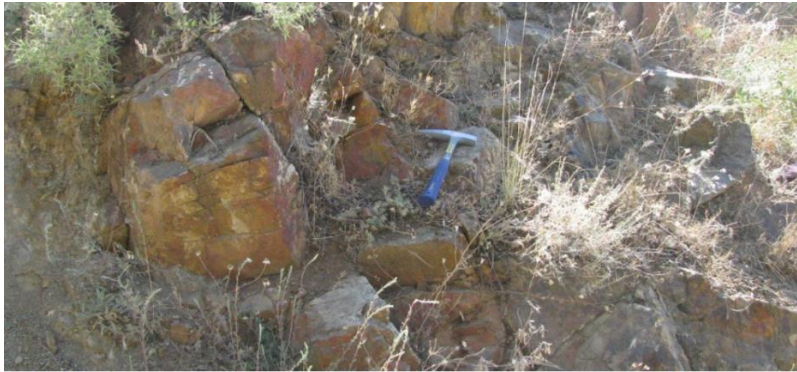
Figure 3.3. General view of Orta Anadolu Granitoid

Orta Anadolu Granitoid is observed at the KM:85+000-88+100 segment of the foreseen high speed railway line (Figure 3.3). At this beginning part of the line, the formation is monitored to be fine-grained and altered. At these parts, feldspars and kaolinized metallic minerals (i.e. pyrite, manganese) are monitored. Towards the end of the railway line (KM:153+725), advanced arenization is monitored locally in the granitic rocks.

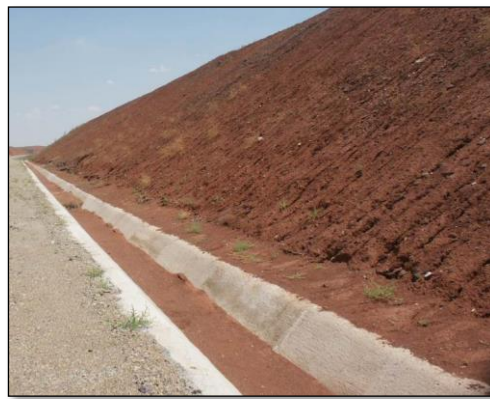
Figure 3.4. General view of the İncik formation around the railway route

In the study area (around Balışeyh), the İncik formation outcrops at places that are not covered by alluvium. In the interval of KM:115+090-115+202 of the railway line, Sekili evaporite (Tois) member of İncik formation is also observed (Figure 3.2 and 3.5). Sekili evaporite (Tois) member was firstly defined by Kara (1991). The member is composed of intercalations of red, brown, gray, white and green colored medium-thick bedded gypsum and mudstone (Kürçer, 2012).

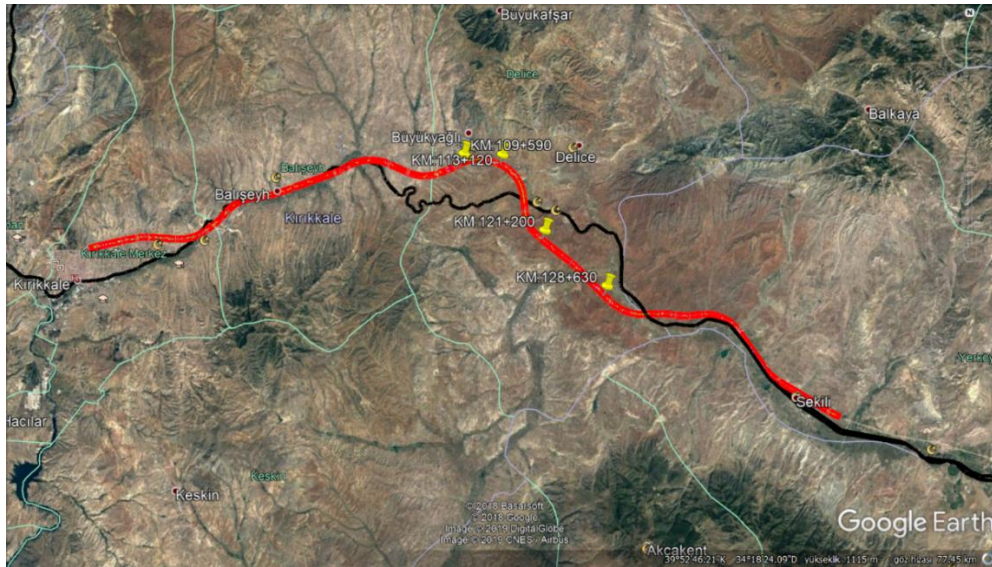
Figure 4.1. Locations of the failed-cut slopes in the study area

field work around July 2015. The failures took place at right slope of the route except for KM:109+590 cut slope in direction of increasing kilometers. Having lower SPT values in the upper 5-7 meters, these parts of the cut slopes are supposed to be weathered (Appendix A). Nevertheless, these differences are assumed to be negligible, not taken into consideration and the formation is supposed to be homogenous throughout the study area. Disturbance due to excavation was estimated to be the main reason for the landslides. On the other hand, effects of groundwater and surface waters were the triggering factors for failures. Rill erosion was also observed at all sections due to surface runoff.

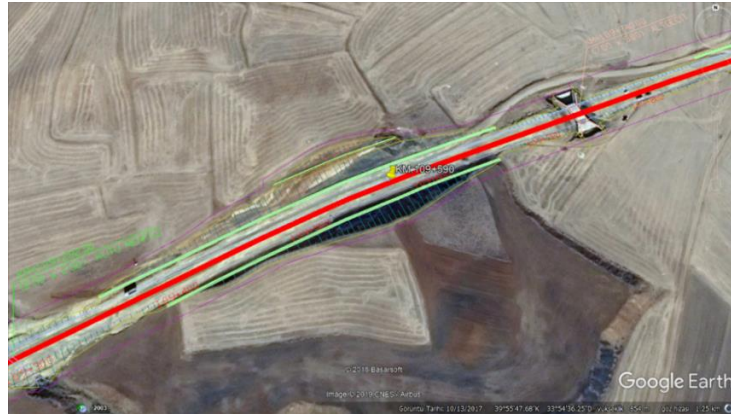
Figure 4.2. Google Earth view of KM:109+590 cut slope

The slope has an inclination of  $H/V=3/2$ . The cut slope is composed of reddish-brown, gray, parallel and cross-bedded, poorly-sorted, partially uncemented continental conglomerate, sandstone, mudstone alternation with evaporates (Figure 4.3). Rill erosion was commonly observed due to surface runoff at durable parts of the cut slope.

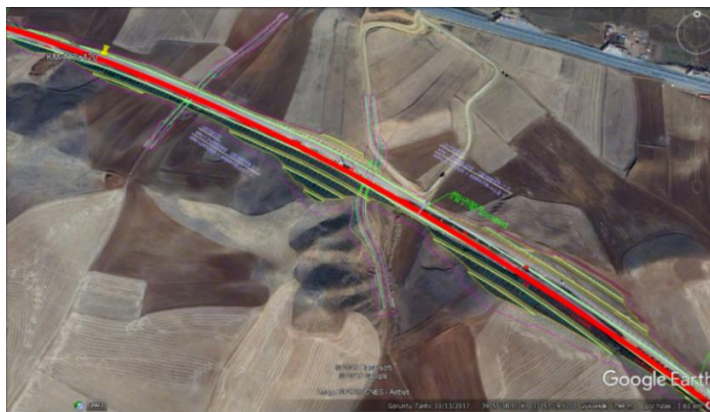
Figure 4.4. Google Earth view of KM:113+120 cut slope

KM: 113+120 cut slope is located around 113<sup>th</sup> kilometer of the railway, at 2,7 km southeast of Fadılobası Village. The cut slope is composed of the İncik formation with a maximum height of 33 meters and length of 1456 meters (Figure 4.4). The slope has an inclination of H/V=3/2. The cut slope is composed of reddish-brown, gray, parallel and cross-bedded, poorly-sorted, partially uncemented continental conglomerate, sandstone, mudstone alternation with evaporates (Figure 4.5). Rill erosion was also observed due to surface runoff at durable parts of the cut slope (Figure 4.6).

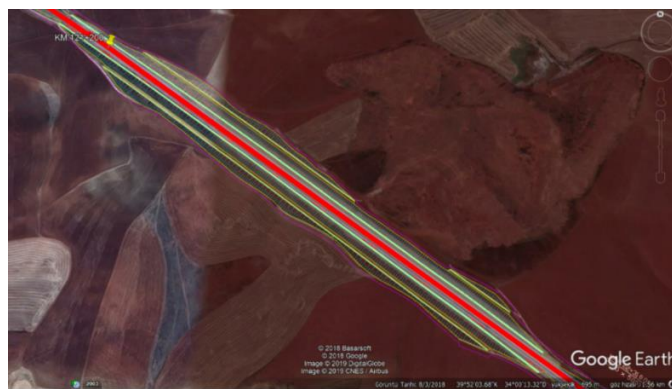
Figure 4.7. Google Earth view of KM:121+200 cut slope

KM: 121+200 cut slope is located around 121<sup>st</sup> kilometer of the railway, at 3,2 km southeast of Fadilobası Village. The cut slope is composed of the İncik formation with a maximum height of 21m and length of 1043 meters (Figure 4.7). The slope has an inclination of  $H/V=3/2$ . The cut slope is composed of reddish-brown, gray, parallel and cross-bedded, poorly-sorted, partially uncemented continental conglomerate, sandstone, mudstone alternation with evaporates (Figure 4.8). Rill erosion was also observed due to surface runoff at durable parts of the cut slope.

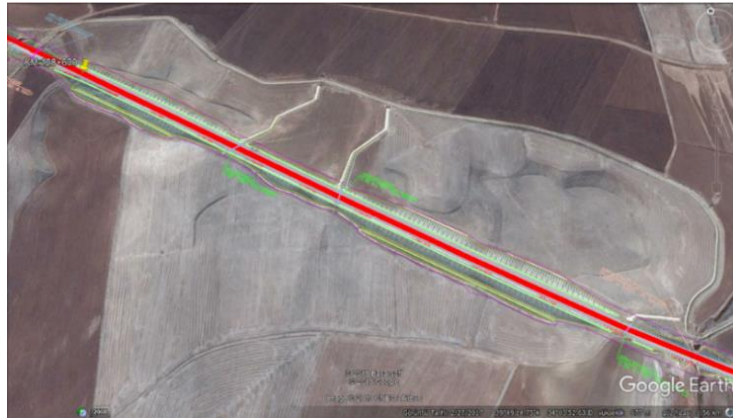
Figure 4.9. Google Earth view of KM:128+630 cut slope

KM: 128+630 cut slope is located around 128<sup>th</sup> kilometer of the railway, at 3,2 km south of Çerikli Village. The cut slope is composed of the İncik formation with a maximum height of 15 meters and length of 1030 meters (Figure 4.9). The slope has an inclination of  $H/V=3/2$ . The cut slope is composed of reddish-brown, gray, parallel and cross-bedded, poorly-sorted, partially uncemented continental conglomerate, sandstone, mudstone alternation with evaporates, formation is characterized by conglomerate dominated bands that can be observed at top levels of this cut slope (Figure 4.10). Sheet erosion was also observed due to surface runoff at durable parts of the cut slope.

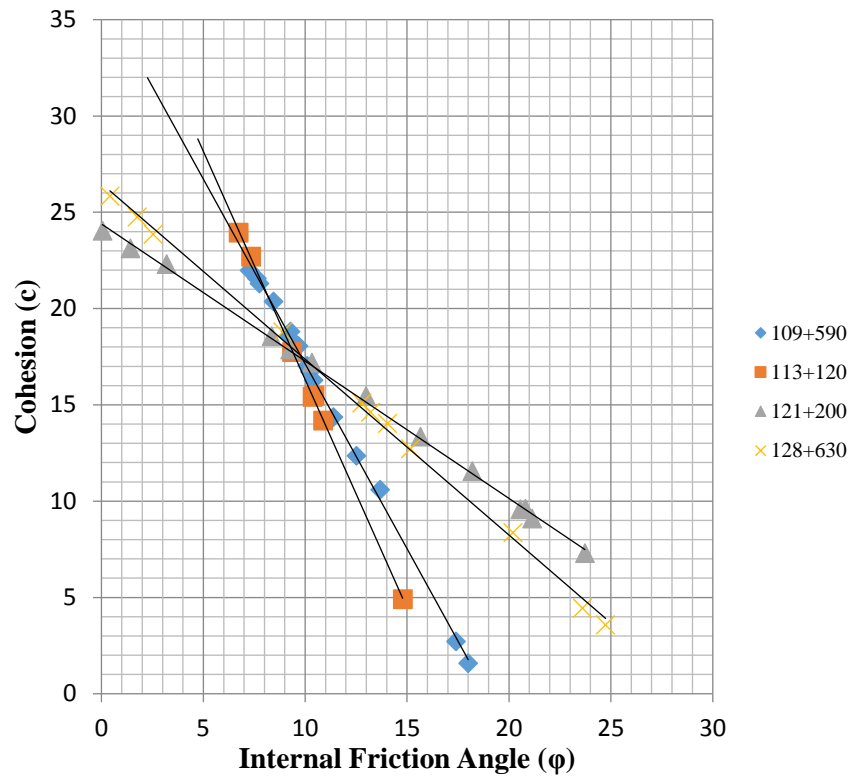
Figure 5.1. c- $\phi$  graph of the cut slopes derived from the back analysis

Each pair of  $c$  and  $\phi$  for the corresponding cut slopes which satisfy the condition of FS equal to 1, is nearly located along a single line. Apparently, intersection of these lines concentrate around a small triangular area indicating  $c=17.5$  kPa and  $\phi=9^\circ$  (Figure 5.1). These values are considered to be representative for the İncik formation.

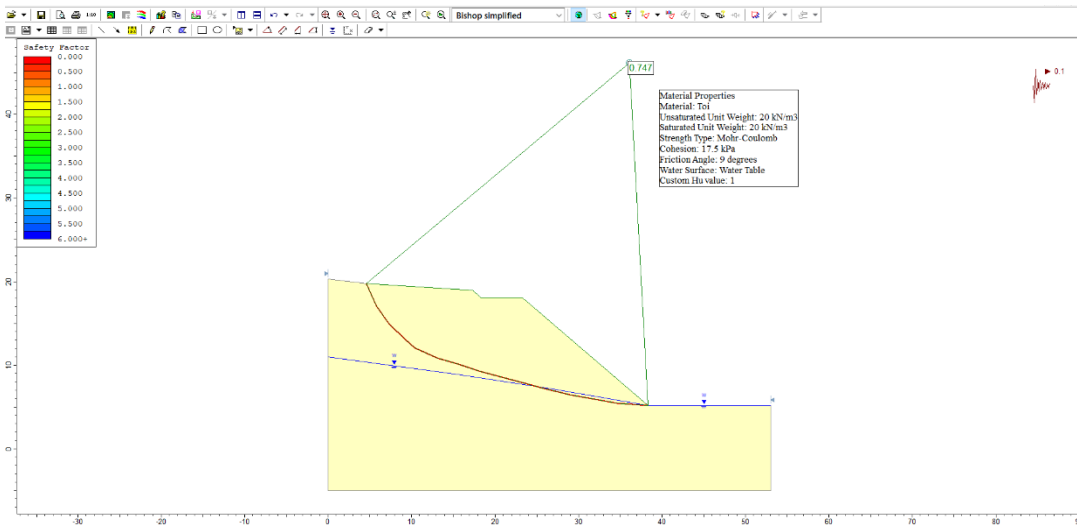
Figure 5.2. Stability analysis of KM: 109+590 cut slope based on the back analysis data via Bishop simplified method

In order to assess the stability of KM:109+590 cut slope, slope stability analyses of the KM:109+590 cut slope were performed in accordance with Bishop (1955), Janbu (1968), Morgenstern and Price (1965) and Spencer (1967) methods (Figures 5.2-5.5).

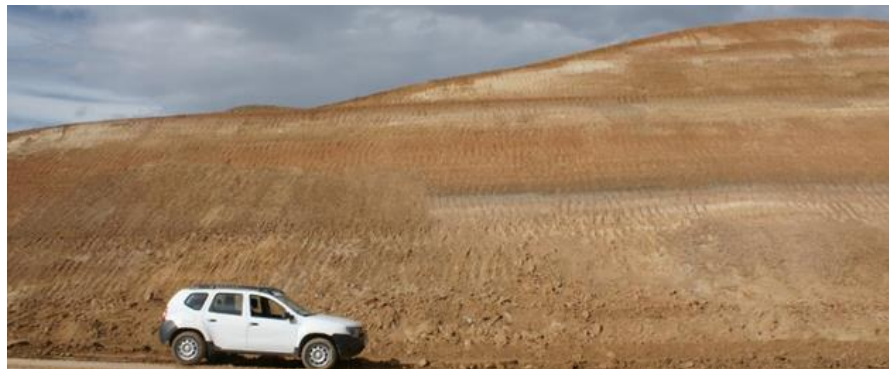
Figure 5.106. General view of KM:107+100 cut slope

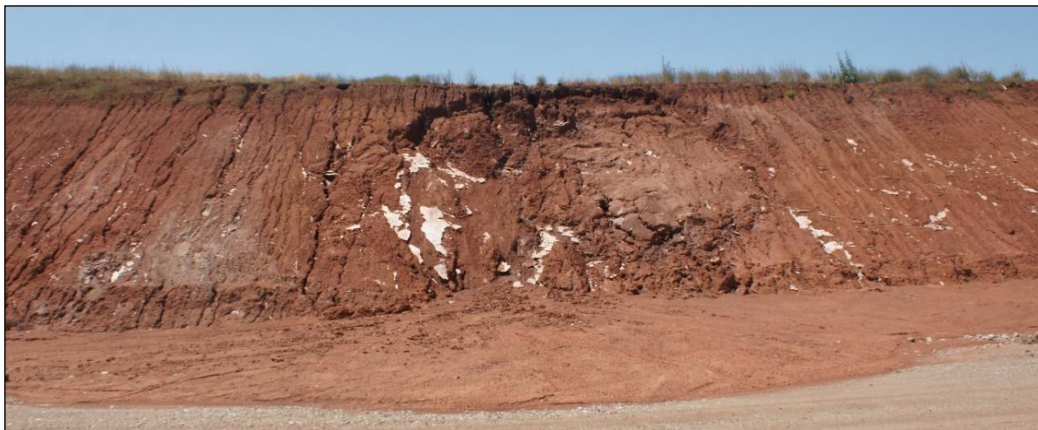
Figure 6.1. Fine evaporite vessels at KM: 121+120 cut slope

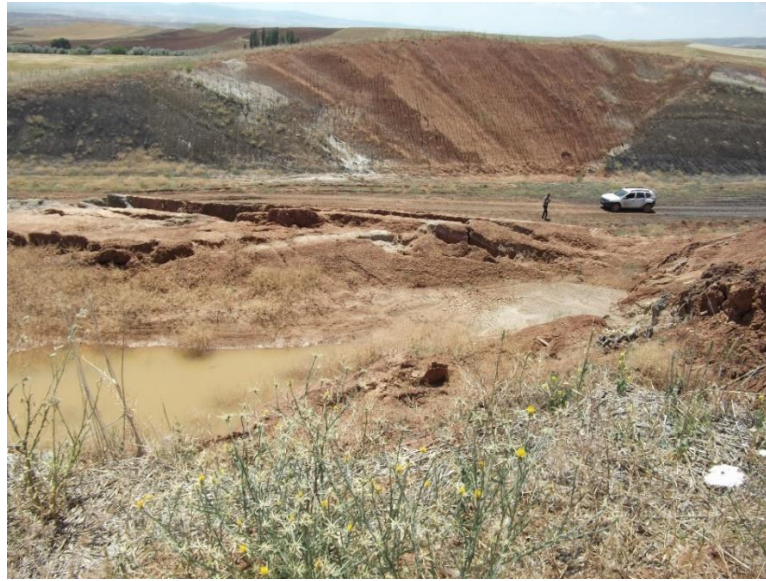
Figure 6.2. Color changes at KM: 109+590 cut slope
