EXPERIMENTAL INVESTIGATION OF PRESSURIZED CONCRETE TUNNEL  
LININGS

A THESIS SUBMITTED TO  
THE GRADUATE SCHOOL OF NATURAL AND APPLIED SCIENCES  
OF  
MIDDLE EAST TECHNICAL UNIVERSITY

JUNE 2019

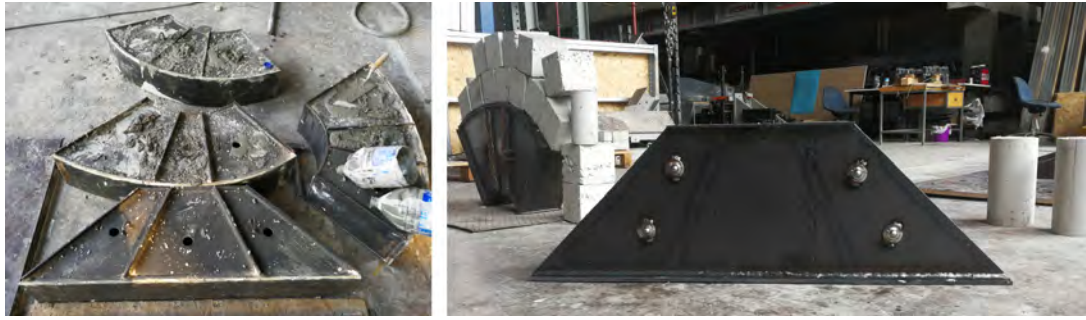
Figure 3.2: Concrete filling process and roller supports of pressure transmitting sections

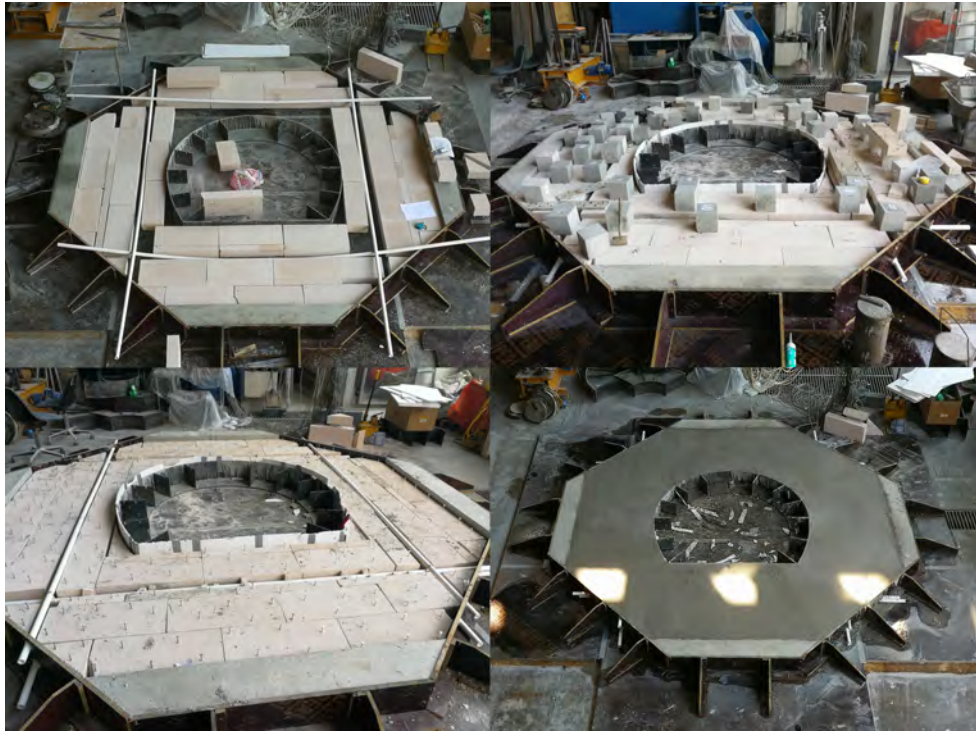
Figure 3.4: Construction stages of three layered rock substitute

Aim of the rock substitute was to obtain an average elastic modulus as 8 GPa. The height of the laboratory model and AAC blocks were 200 mm and 100 mm respectively. Elastic modulus of commercially available AAC blocks were reported and tested to be 2.10 GPa. In order to achieve the target, two symmetrical 50 mm-thick

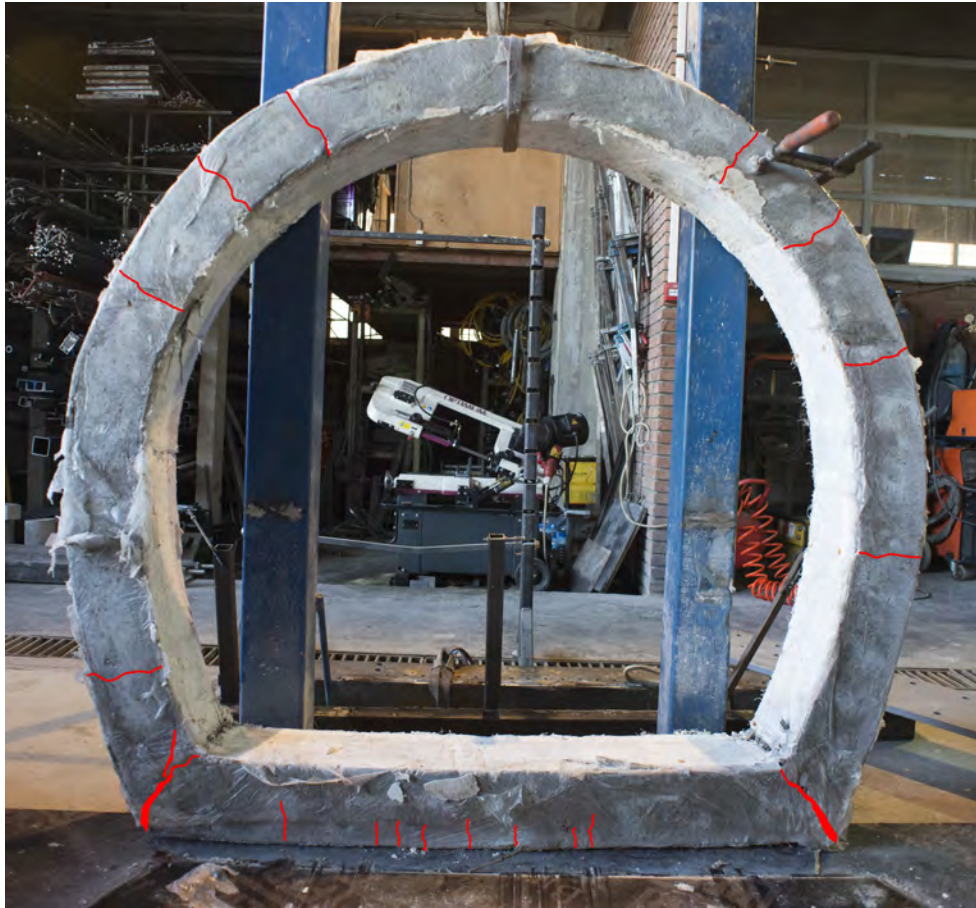
Figure 4.13: Crack map after NCF experiment

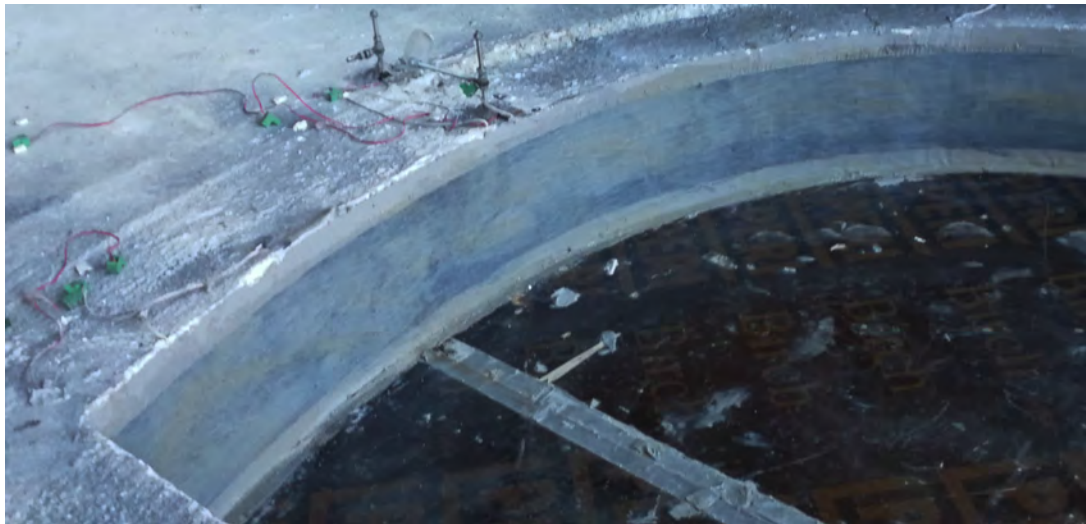
Figure 4.43: FRP application

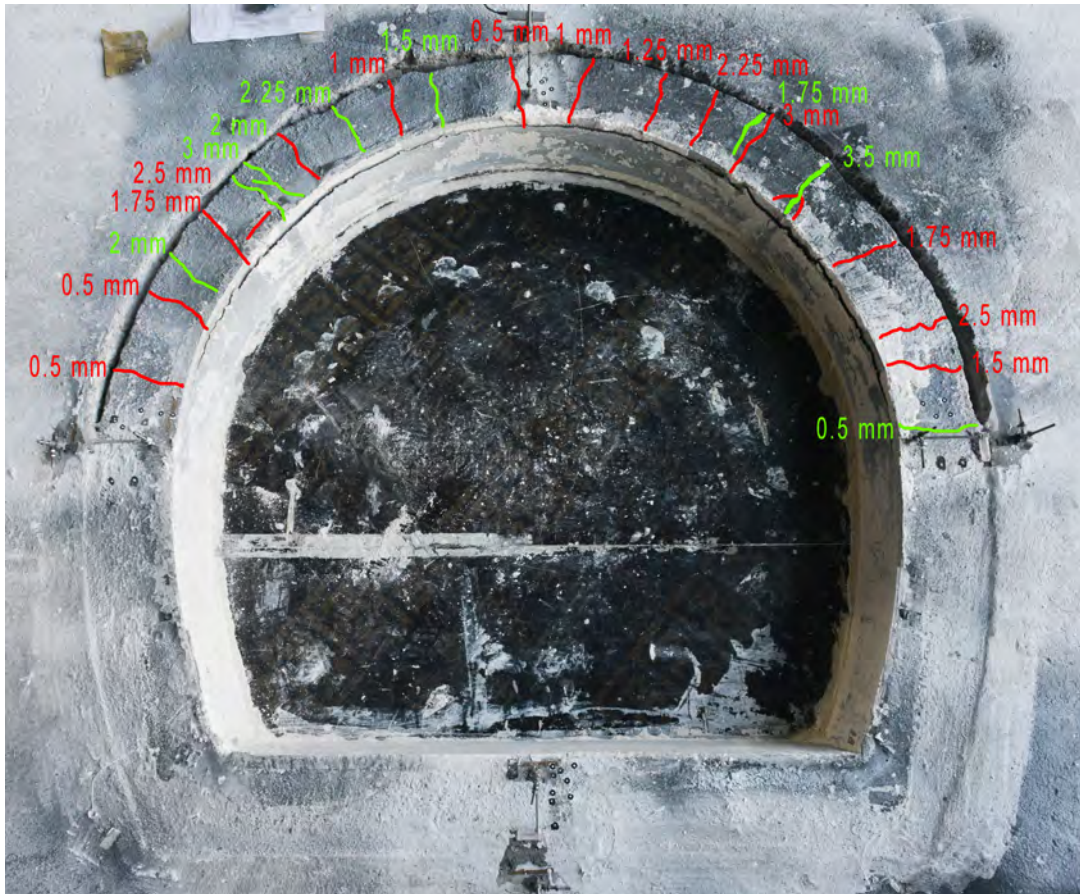
Figure 4.50: Crack map after HCIR experiment (cracks from previous experiment are marked with green)
