ANALYZING THE IMPACTS OF BUILDING FORM ON THE
ENVIRONMENT: A CASE STUDY IN ANKARA WITH A FOCUS ON SOLAR
REFLECTION

A THESIS SUBMITTED TO
THE GRADUATE SCHOOL OF NATURAL AND APPLIED SCIENCES
OF
MIDDLE EAST TECHNICAL UNIVERSITY

SEPTEMBER 2019

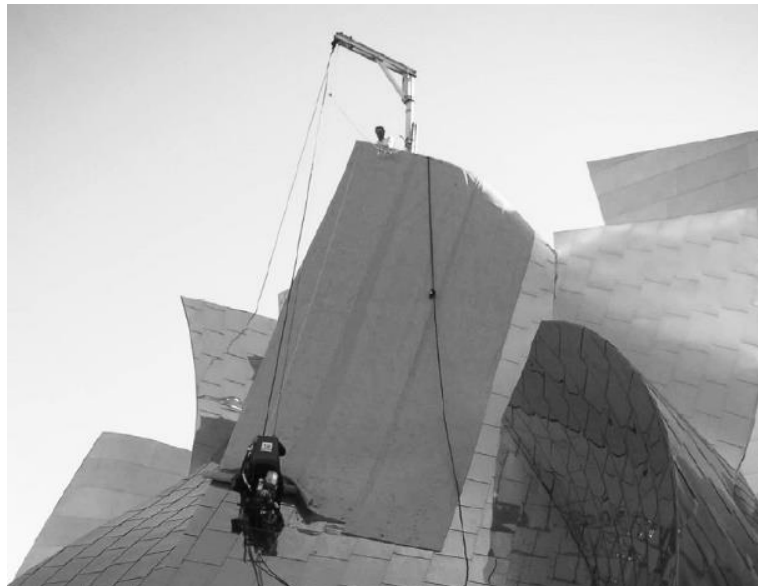
Figure 3. 5. Application of fabric covering to the problematic surfaces. (Source: Schiler and Valmont, 2005)

3. Using Surface films: To lower the specularity rate of stainless steel, using surface films were suggested. Six different surface films were tested and three of them were found acceptable. Yet again, this solution was not applied.
4. Using Fabric: The first applied solution was fabric coating, which was a reasonable solution to diminish the reflectivity, but not in terms of durability. Chong (2004) states that the temporary solution of fabric covering to the most disturbing areas cost 6,000 dollars before the sandblasting solution was applied. Also, this solution provided verification of the problematic areas since further analysis had to be conducted before its application.

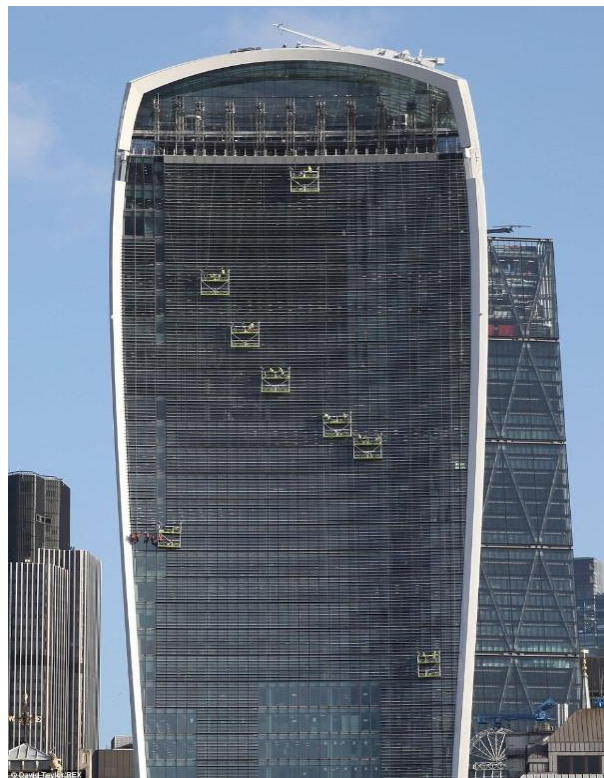
Figure 3. 12. Brise soleil installation on the south façade of 20 Fenchurch Street. (Source: <https://www.dailymail.co.uk/news/article-2786723/London-skyscraper-Walkie-Talkie-melted-cars-reflecting-sunlight-fitted-shading.html>)

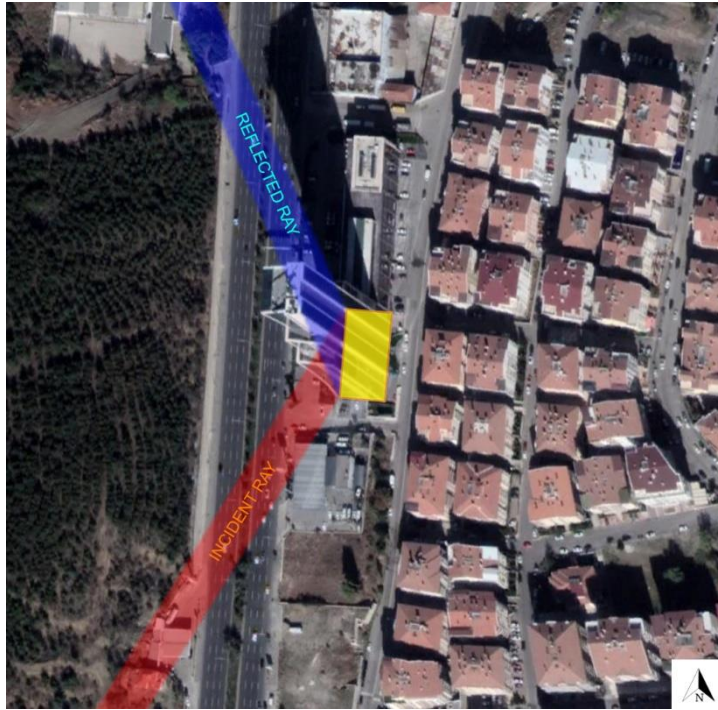
Figure 5. 5. Reflection path at 3:00 pm on August 23rd

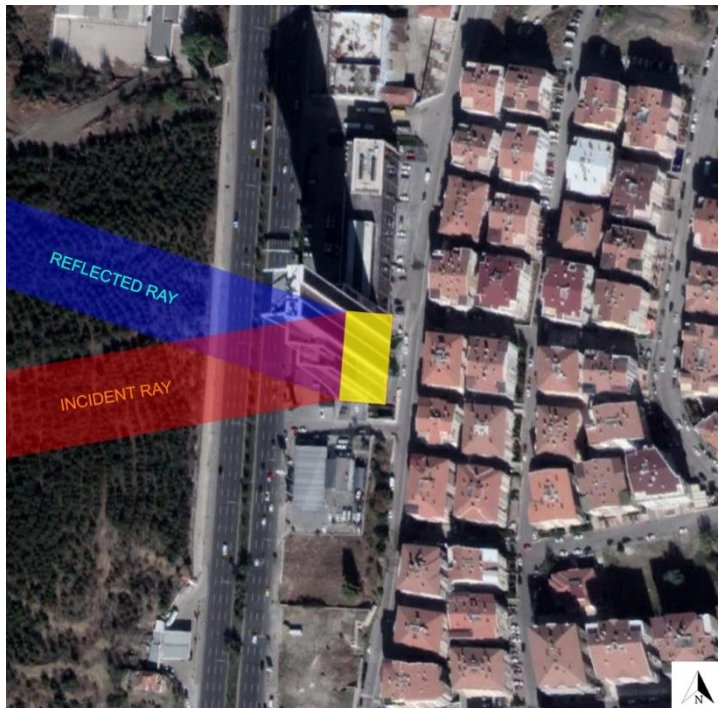
Figure 5. 6. Reflection path at 6:00 pm on August 23rd

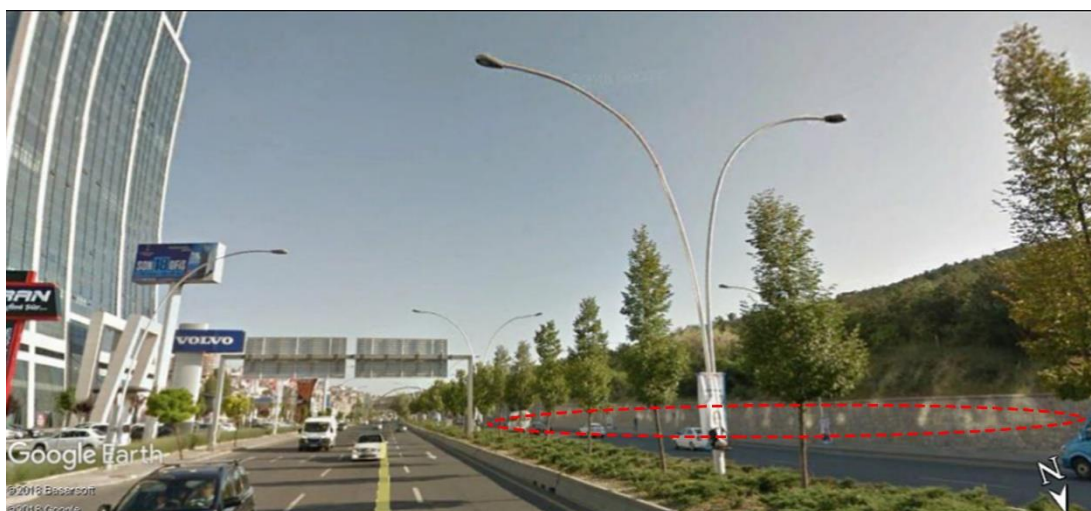
Figure 5. 21. Solar reflection on the retaining wall (encircled in red). (Source: Google Earth Pro, June 2018)

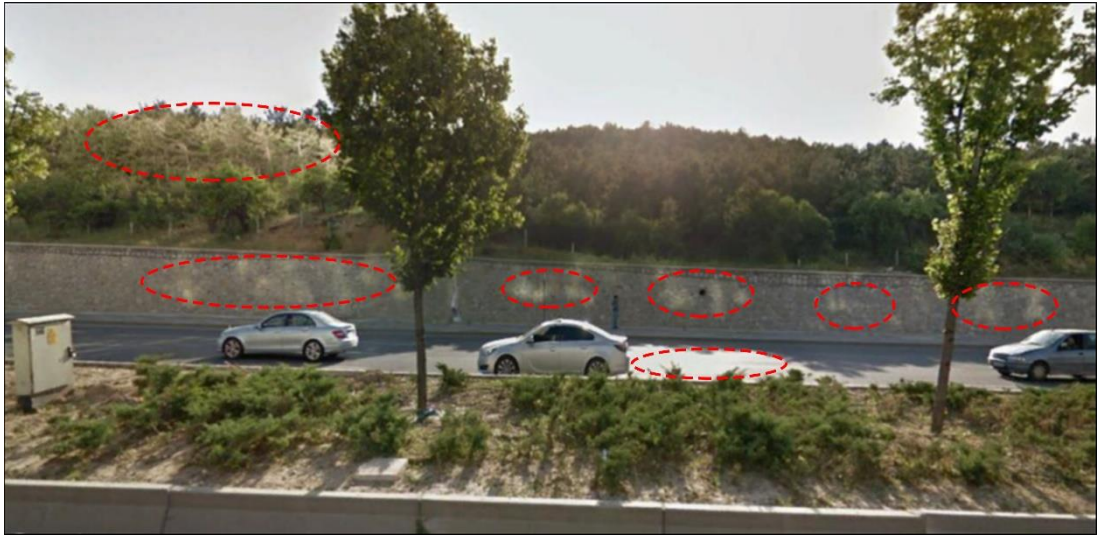
Figure 5. 22. Vegetation damage, solar reflection on retaining wall and a hotspot on the highway. (encircled in red) (Source: Google Earth Pro, June 2018)

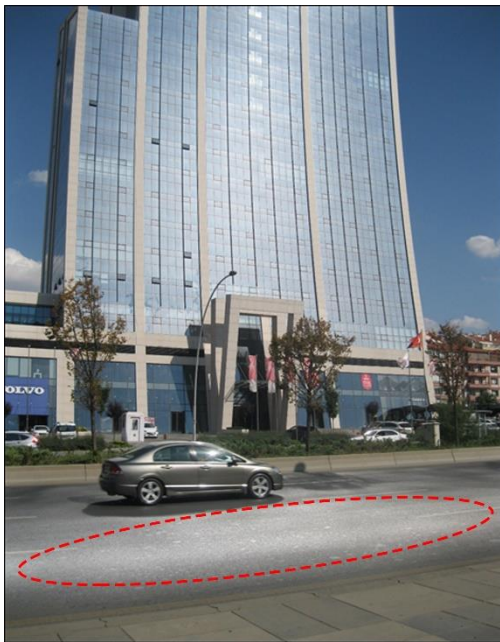
Figure 5. 23. Hotspots (encircled in red) that occurred on Konya Boulevard and photographed around 4:00 pm on August 23rd

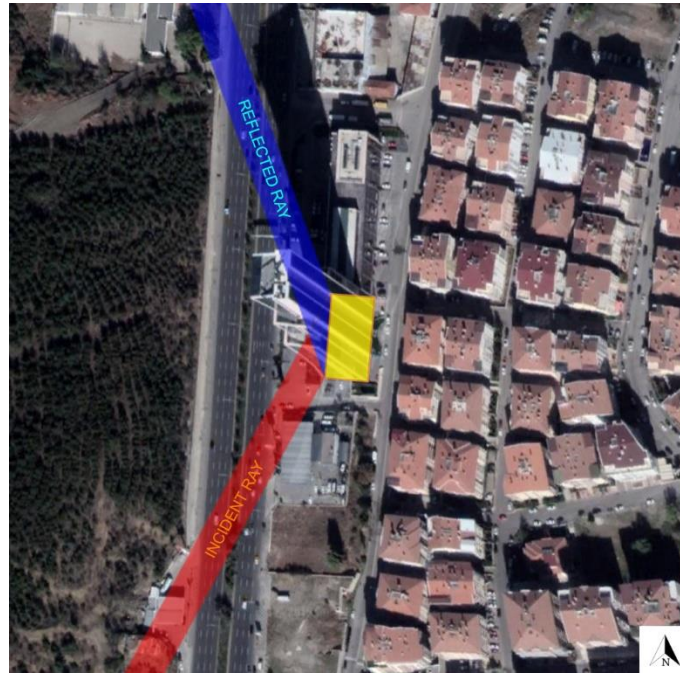
Figure 0. 17. Reflection path at 3:00 pm on September 23rd

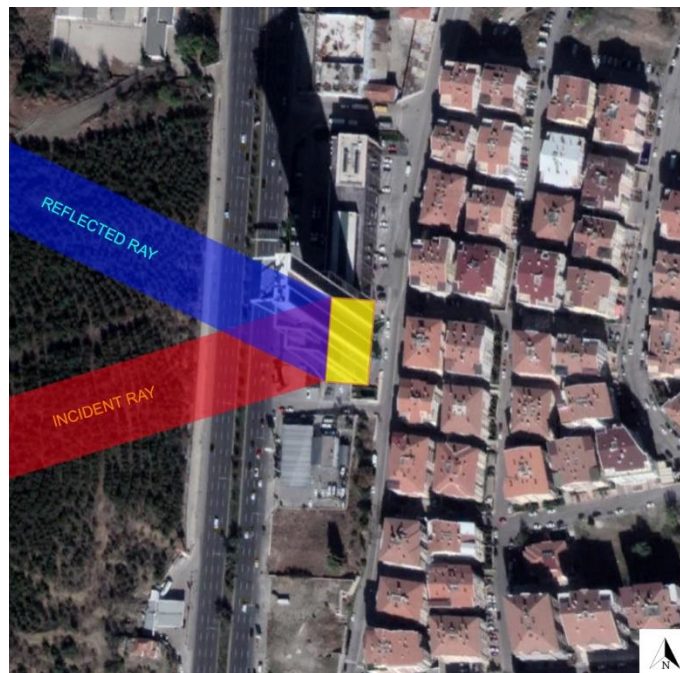
Figure 0. 18. Reflection path at 6:00 pm on September 23rd
