THERMAL TRANSMITTANCE ASSESSMENT OF BUILDING WALLS BY
USING IN-SITU INFRARED THERMOGRAPHY

A THESIS SUBMITTED TO
THE GRADUATE SCHOOL OF NATURAL AND APPLIED SCIENCES
OF
MIDDLE EAST TECHNICAL UNIVERSITY

SEPTEMBER 2019

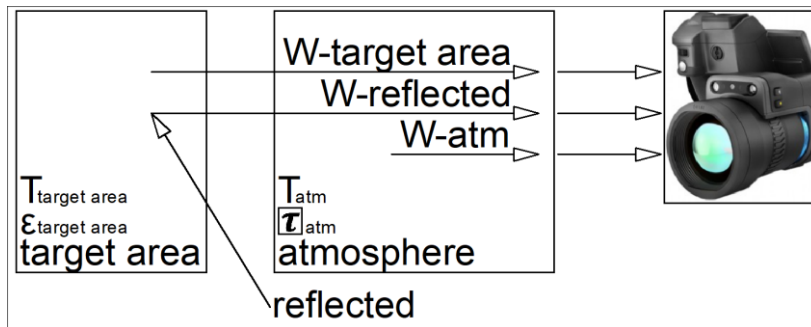
Figure 2.4. Schematic representation of thermographic measurement

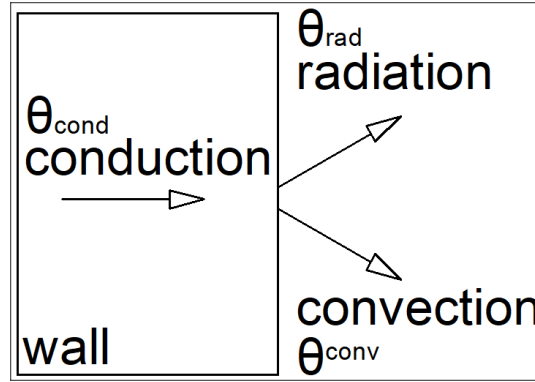
Figure 2.5. Energy interaction at wall surface

Transportation of energy due to a temperature difference between matters is defined as heat transfer, and this energy transfer occurs from more energetic towards less energetic ones. There are three modes of heat transfer: Conduction, Convection and Radiation (Figure 2.5) (Çengel & Ghajar, 2015; Davies, 2004; Modest, 2003).

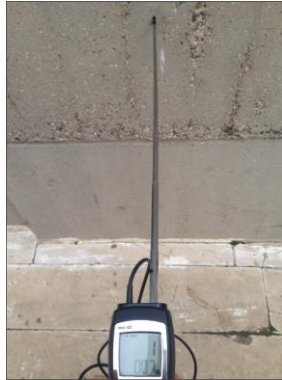
Figure 2.6. Using handheld anemometer to measure wind velocity near wall surface

In that equation, there is necessity of measuring outside surface temperature of exterior walls, inside and outside ambient temperatures and as well, measuring the outside wind/air velocity near wall surface (Figure 2.6) (Albatici & Tonelli, 2010; Albatici et al., 2015).

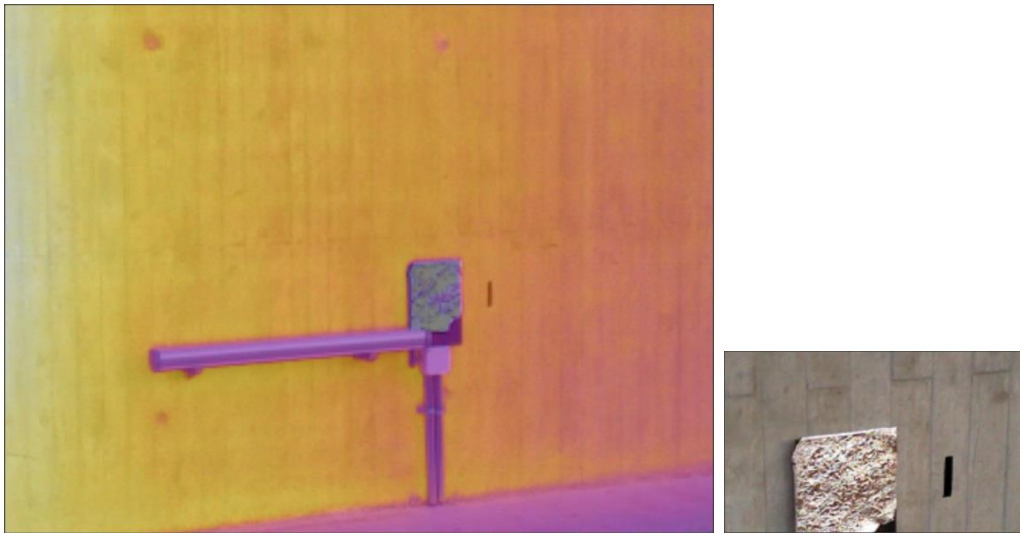
Figure 2.7. Using black electrical tape for surface emissivity measurement and aluminum foil for reflected temperature measurement.

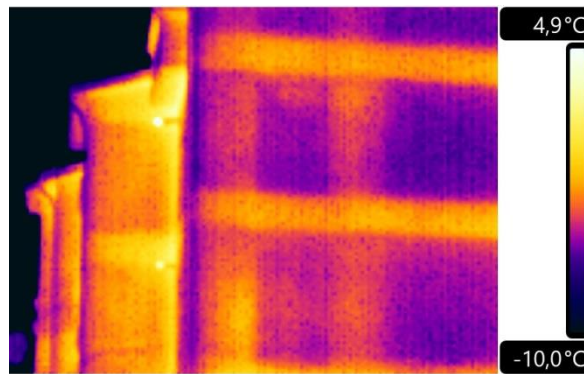
Figure 2.8. Thermal bridges occurring because of non-insulated surfaces at the façade of the building. ($T_{\text{out}} = 1.9^{\circ}\text{C}$ and $\text{RH} = 43\%$)

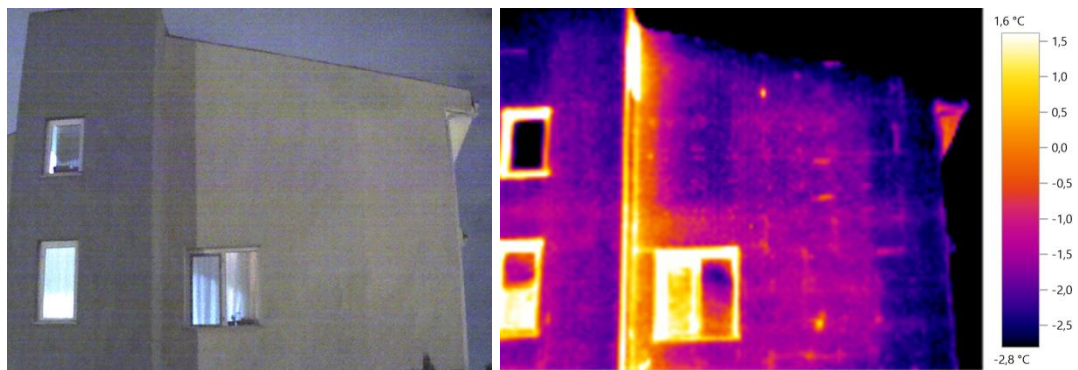
Figure 2.9. Thermal Bridges occurring due to the faults during fastening the thermal insulation boards to the backing wall, ($T_{\text{out}} = -3.9^{\circ}\text{C}$ and $\text{RH} = 60\%$)

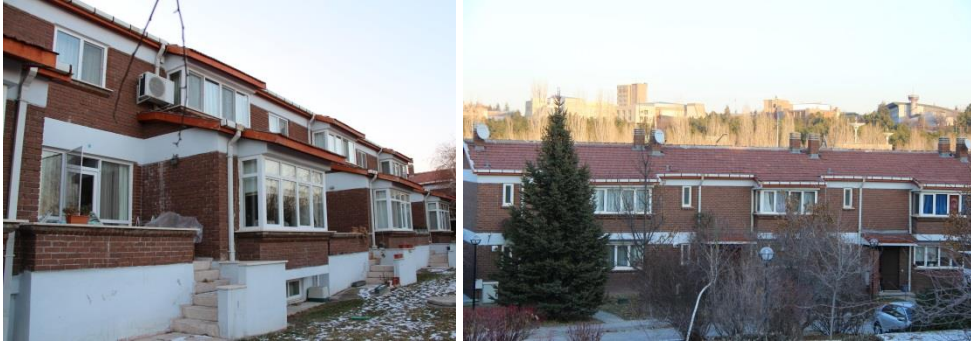
Figure 3.1. Villa type house (B1) under examination in the campus of METU, construction time: 1998 (Ankara, Turkey)

The in-situ IRT examinations involve the thermal performance assessment of two types of residential building and a faculty building in the campus of Middle East Technical University (Ankara, Turkey) (Figure 3.1, Figure 3.2, Figure 3.3, Figure 3.4). Those three buildings are briefly described below:

- One of the residential buildings is a villa type house (B1) composed of one basement, ground floor and first floor. Its exterior façades are composed of fair-faced (exposed reinforced concrete) structural elements, such as shear walls, column and beams, and solid brick cavity wall infill between the fair-faced structural elements (Figure 3.1). Due to the complaints of occupants, the fair-faced reinforced concrete surfaces underwent remedial renovation and externally-insulated with 5cm-thick extruded polystyrene (EPS) boards (Figure 3.2).

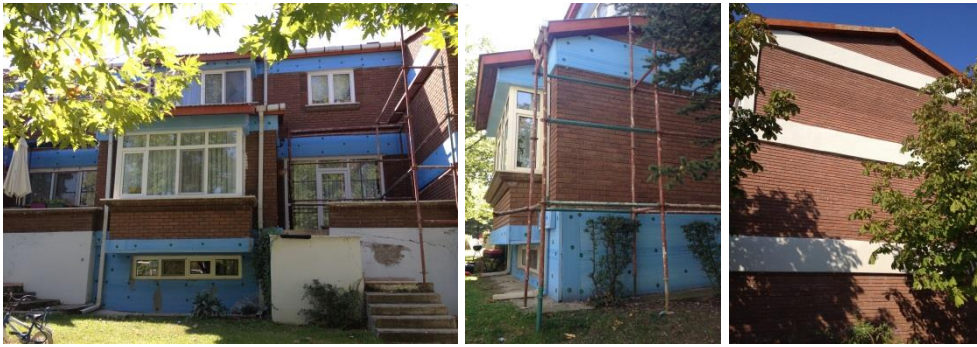
Figure 3.2. Villa type house (B1) during and after externally-insulation of reinforced concrete walls, renovation time: 2014.

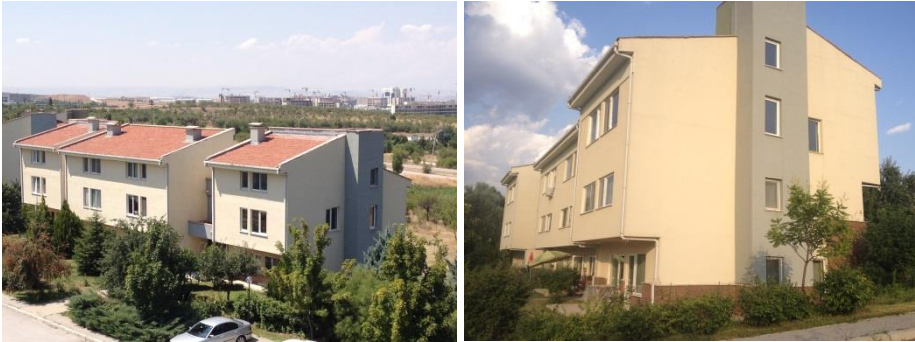
Figure 3.3. Two-storey height residential unit (B2) under examination in the campus of METU, construction time: 2001 (Ankara, Turkey).

- The second residential building is a two-storey height reinforced concrete structure (B2). The infill walls between the reinforced concrete structural elements are made of autoclaved aerated concrete (AAC) masonry units and the whole wall surface is externally-insulated (Figure 3.3).

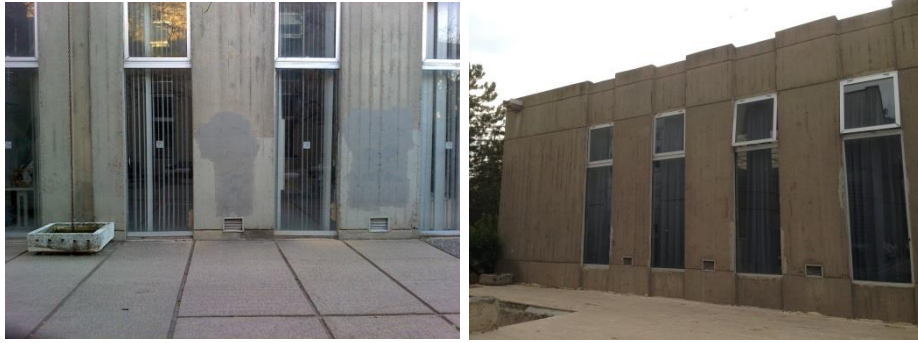
Figure 3.4. Faculty of Architecture Building (B3) under examination in the campus of METU, construction time: 1962 (Ankara, Turkey).

- The third structure is the Faculty of Architecture Building (B3) and its exterior walls are mainly composed of fair-faced shear walls and solid brick masonry infill walls at some parts (Figure 3.4).

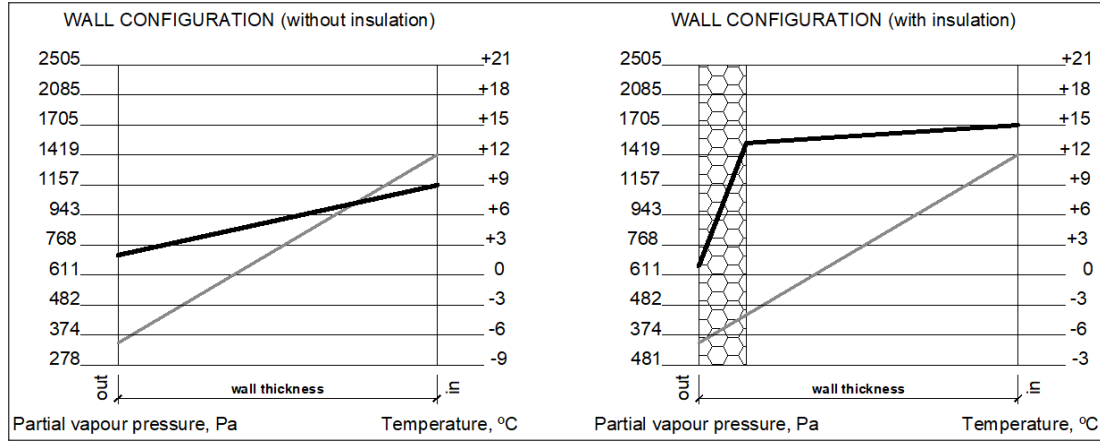
(a) not-insulated reinforced concrete wall

The condensation risk through the wall configuration is assessed by producing the profiles of partial and equilibrium water vapour pressures for each wall cross-section in relation to the temperature gradient and moisture content in the air varying from inside to outside of the wall cross-section (Çengel & Ghajar, 2015; TS 825, 2013). Similar to the vapour pressure analyses, the plot of the as-is temperature gradient through the wall cross-section in reference to the dew point temperature data in a graph is also used for the assessment of condensation risk within the wall section (Çengel & Ghajar, 2015; TS 825, 2013). The Figure 3.7 shows the plot of partial and equilibrium water vapour pressure profiles and the plot of temperature gradient and dew point temperature profile in the same graph produced for an externally-insulated and not-insulated reinforced concrete walls. Vapour pressure data and temperature data exhibit similar profiles for the same wall component as shown in Figure 3.7 since those data are derived from the same microclimatic conditions. The region in the wall section where the equilibrium water vapour pressure is lower than the partial water vapour pressure signals the risk of condensation at that region (Figure 3.7a). In other words, the region where the temperature gradient is below the dew point temperature, that region may suffer from condensation and entrapped moisture problems (Figure 3.7a). In case that equilibrium water vapour pressure is higher than partial water vapour pressure, those parts of the wall is not under risk of condensation at specified microclimatic conditions (Figure 3.7b). In other words, the regions where the temperature gradient is above the dew point temperature are kept away from surface and interstitial condensation problem (Figure 3.7b).

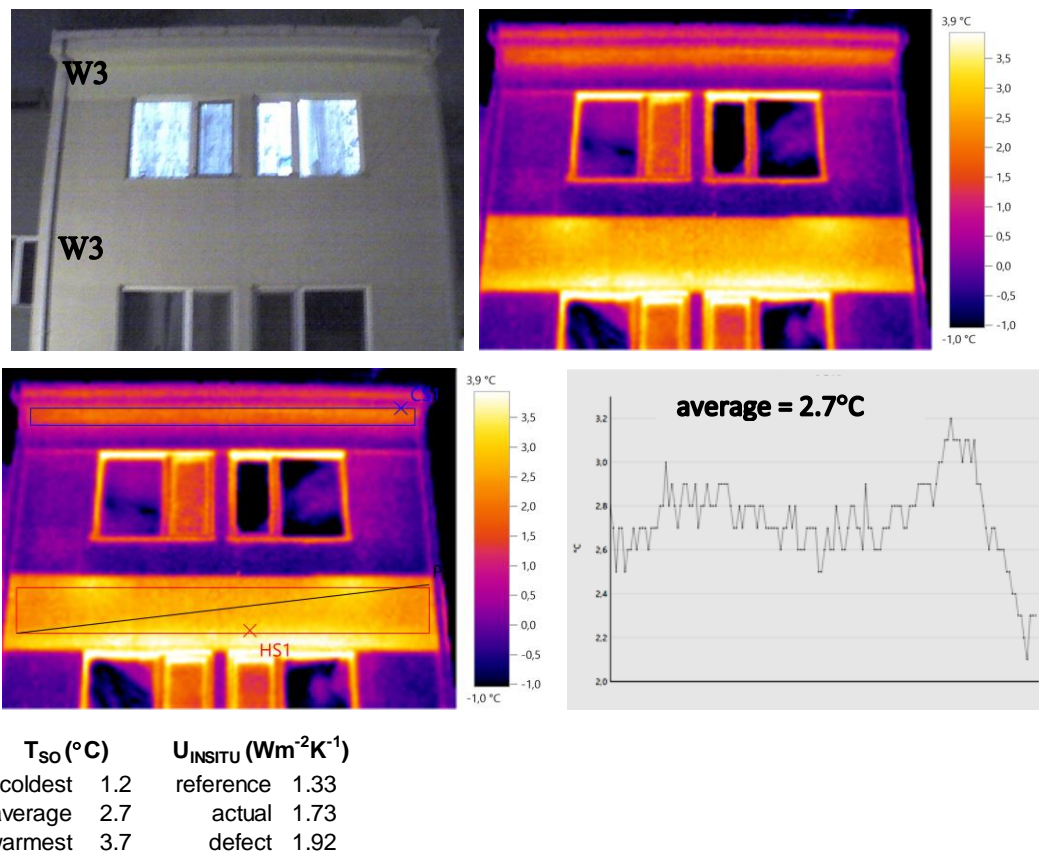
Figure 3.8. Obtaining surface temperature value close to outside air temperature cold spot tool of the software is used and CS1 shows the coldest surface temperature of W3 which represents the reference temperature value and $U_{\text{INSITU-REF}}$ is calculated accordingly. To obtain surface temperature value away from the outside air temperature hot spot tool is used and HS1 shows the warmest surface temperature of W3 which represents the defect temperature value and $U_{\text{INSITU-DEF}}$ is calculated accordingly. Finally, to obtain average surface temperature value temperature profile passing through W3 surface is used and the average surface temperature value is gathered and this value is used for calculation of $U_{\text{INSITU-AVG}}$ value. This method is repeated for eight times and average U values represent the in-situ thermal transmittance values.

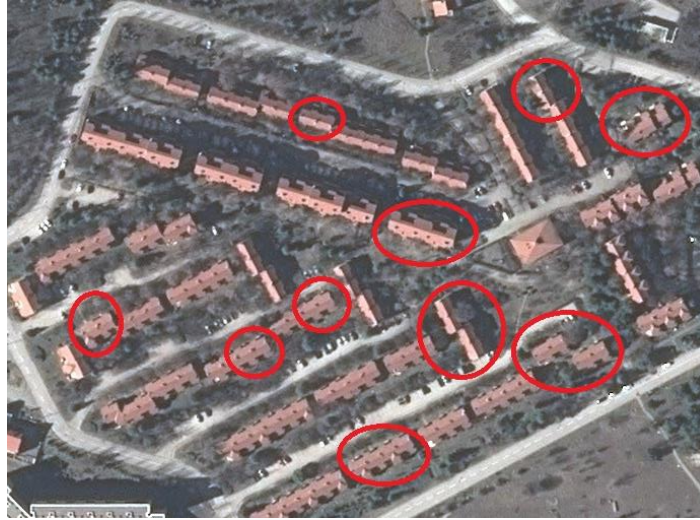
Figure 3.9. Villa Type Houses (B1) that IR images were taken are marked at the site plan

IRT method was used to calculate annual heating energy consumption for villa type houses during cold weather conditions. Heat is transferred in cold weather conditions from warm side to cold side of the wall in other words from inside to outside. In that purpose before renovation and after renovation IR images of different houses were taken at 18.12.2013 and then 26.01.2015 (early in the morning and in late evening: between 06:00-07:30 and 19:00-23:00). The buildings in which IR images were taken are marked in Figure 3.8.

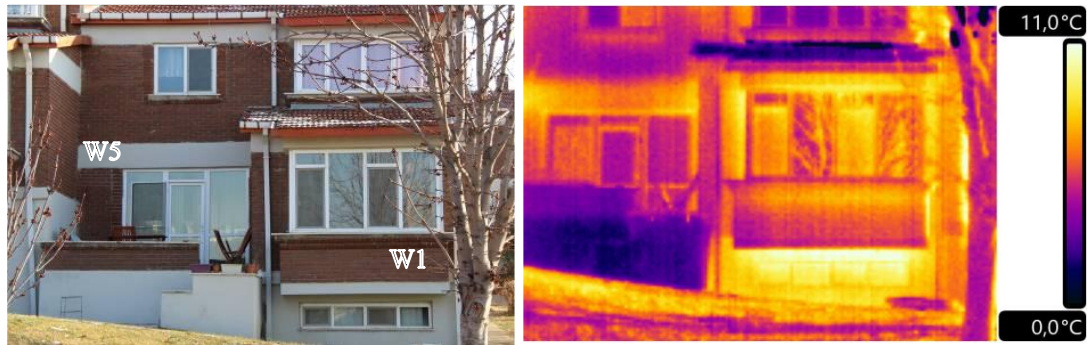
Figure 4.1. Surface temperatures of non-insulated shear wall (W5) and beams are about 4-5°C higher than the insulated cavity brick wall surfaces (W1). W5 surfaces are about 7-8°C higher than the outside air temperature. These temperature differences show that there is serious heat loss through the surfaces of non-insulated reinforced concrete wall and beams (W5). ($T_{out} = -3^{\circ}\text{C}$ and $RH = 43\%$)

The warmer exterior surfaces above the outside air temperature signal the thermal bridge zones where heat loss happens through the warmer inside to the colder outside. For the wall configurations with enough thermal resistance performances, exterior surfaces are expected to have similar surface temperatures with the outside air temperature. Here, Figure 4.1 and Figure 4.2 show that the surface temperature of non-insulated shear wall (W5) is about 7-8°C higher than the outside air temperature as well as about 4-5°C higher than the insulated cavity brick wall (W1). Those temperature differences demonstrate that there is a considerable heat loss through the fair-faced reinforced concrete structural elements (basement walls, columns and beams). Surface temperature of insulated cavity brick wall (W1) is about 4-5°C lower than the non-insulated shear wall (W5) while still above the outside air temperature with a temperature difference in the range of 3-5 °C. This temperature difference shows that W1 has not enough thermal resistance while it has higher thermal resistance performance than W5 because of the thermal insulation infill within the cavity of W1.

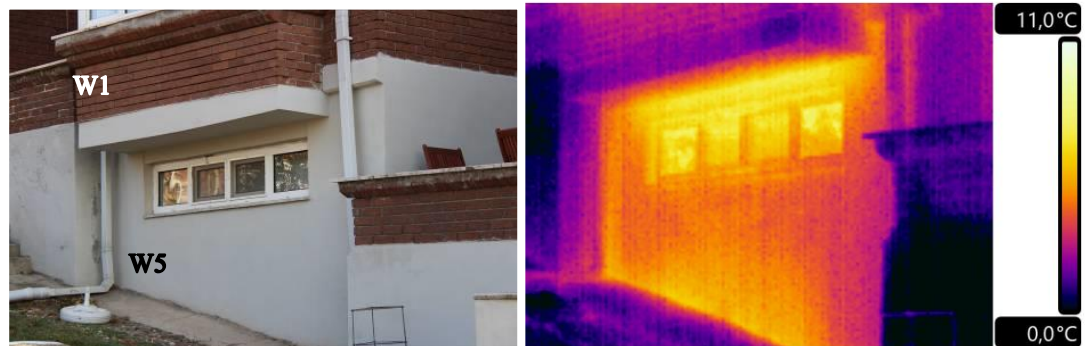
Figure 4.2. Surface temperature of W5 wall is about 7-8°C higher than the outside air temperature. This temperature difference demonstrates that there is a serious heat loss from non-insulated basement shear wall (W5). ($T_{out} = -3^{\circ}\text{C}$ and $RH = 43\%$).

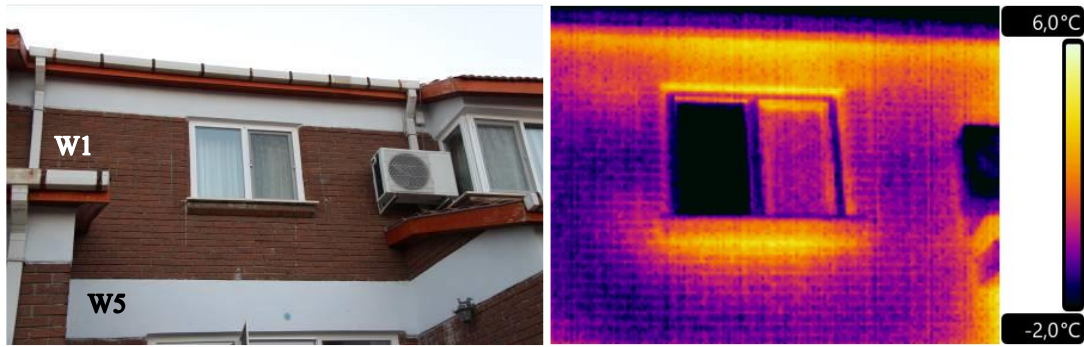
Figure 4.3. IR image showing the warm areas where radiator is positioned behind the insulated cavity walls. Those warm areas have surface temperatures 4-5°C higher than the rest of W1 surfaces. The surface temperatures of W1 being 3-5°C higher than the outside air temperature signal the insufficient thermal resistance of its composition ($T_{out} = 0.3^{\circ}\text{C}$, RH= 60%).

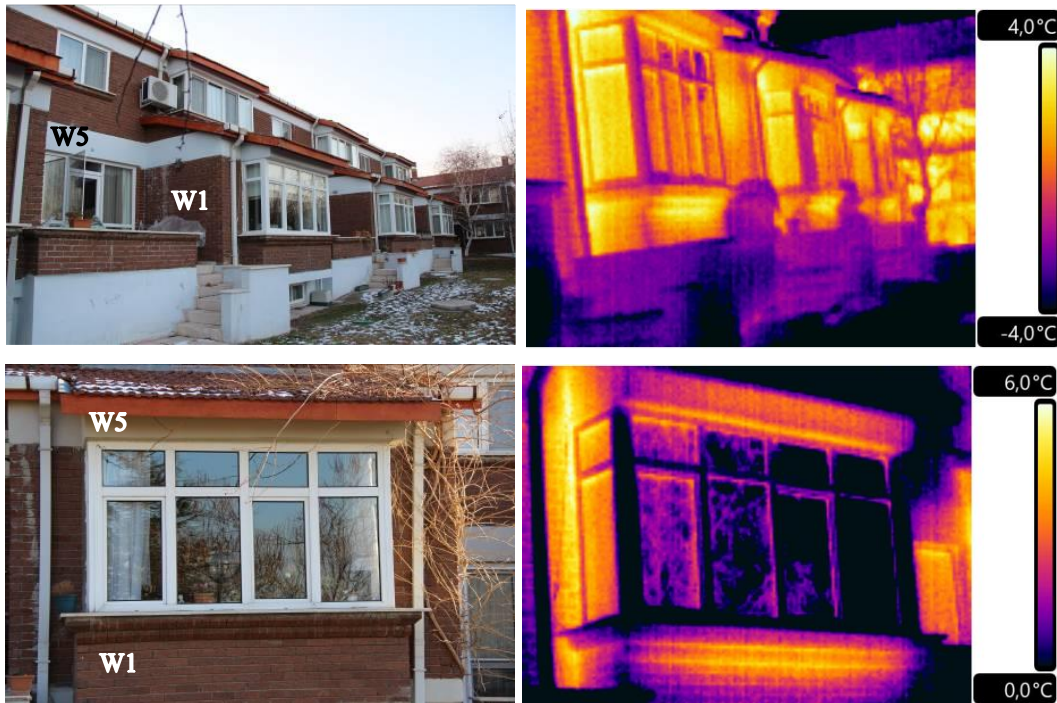
Figure 4.4. The warm edges reaching 6°C difference higher than the outside air temperature exhibit the significant heat loss through the edges where the window frames come together with the structure. The warmer surfaces of the uninsulated reinforced concrete beam (W5) and the insulated cavity brick wall (W1) where the radiator is positioned behind the parapet signal the inadequate thermal resistance of those walls ($T_{out} = 0.3^{\circ}\text{C}$, RH= 60%).

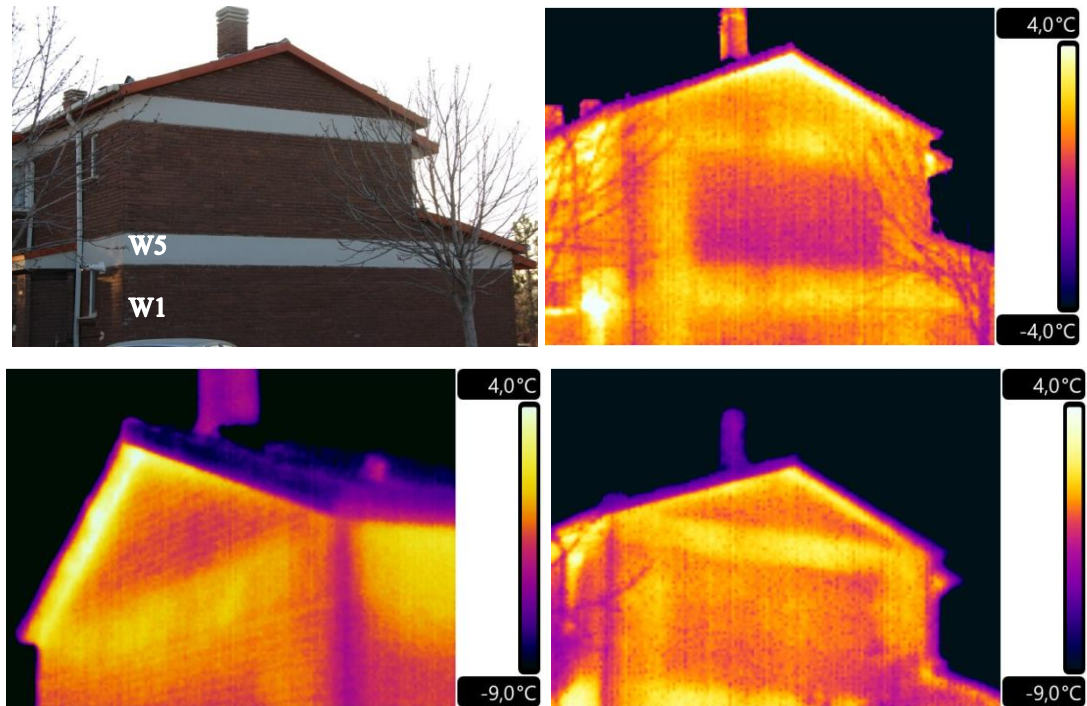
Figure 4.5. The warmest area with surface temperature reaching 8°C higher than the outside air temperature is the edge where roof and gable wall come together. Heat loss through the structural elements of the building (columns and beams) is also visible in IR images. ($T_{\text{out}} = -3^{\circ}\text{C}$, RH= 43%).

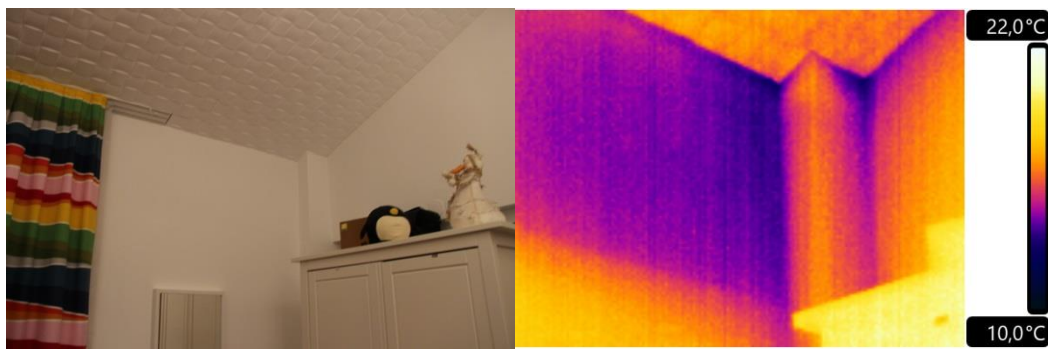
Figure 4.6. The coldest zones having interior surface temperatures almost 10°C colder than indoor air temperature are observed at the corners where building wall and ceiling comes together and those coldest zones are under risk of condensation ($T_{in} = 19.5^{\circ}\text{C}$, $\text{RH} = 45\%$).

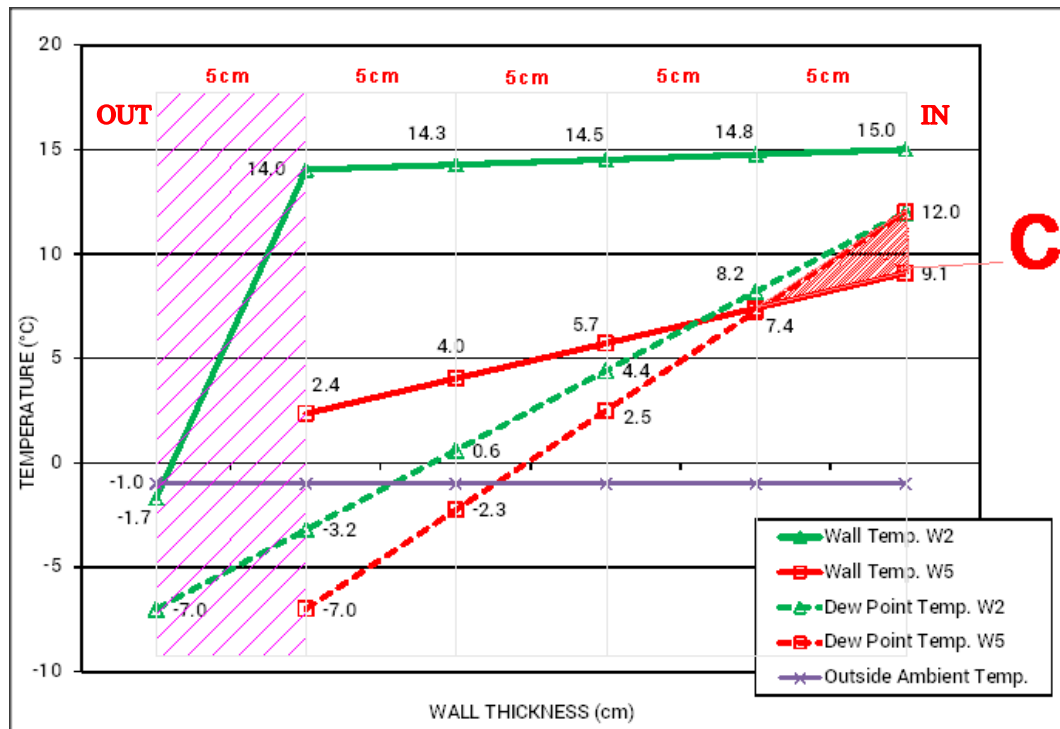
Figure 4.7. Temperature and dew point temperature profiles of non-insulated reinforced concrete surface (W5) and insulated reinforced concrete surface (W2), showing the risk of interstitial condensation (C) in W5, reaching to 5cm depth from interior surface while that risk was eliminated for the same wall after it was externally-insulated (W2) ($TI_{W5-REFERENCE} = 0.75$; $TI_{W5-DEFECT} = 0.58$; $TI_{W2-REFERENCE} = 0.94$; $TI_{W2-DEFECT} = 0.71$) ($T_{in} = 20^{\circ}\text{C}$, $RH_{in} = 45\%$ and $T_{out} = -1^{\circ}\text{C}$, $RH_{out} = 60\%$).

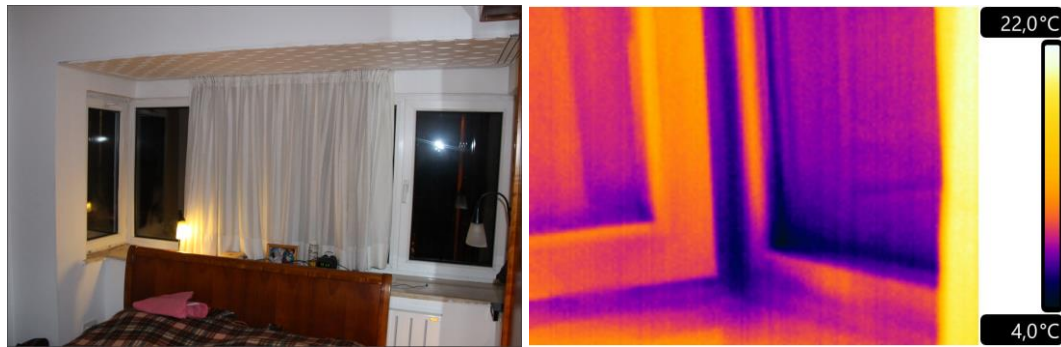
Figure 4.8. The window frames, especially the edges where window frame and building wall come together are the coldest zones with surface temperatures 15°C colder than the indoor air temperature. That temperature difference signals the risk of condensation and air tightness problems occurring at the coldest zones ($T_{in} = 19.5^{\circ}\text{C}$, RH= 45%).

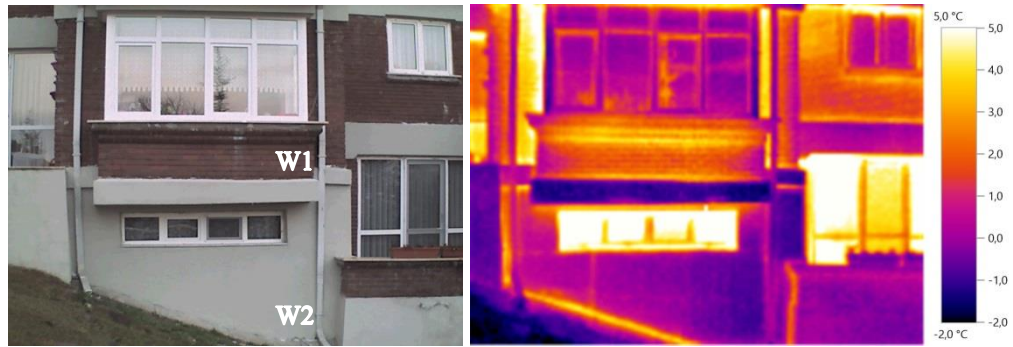
Figure 4.9. Surface temperature of W2 being close to the outside air temperature shows the improvement in thermal resistance while being still 1-2°C higher than the outside air temperature ($T_{\text{out}} = -3.1^{\circ}\text{C}$, RH= 65%).

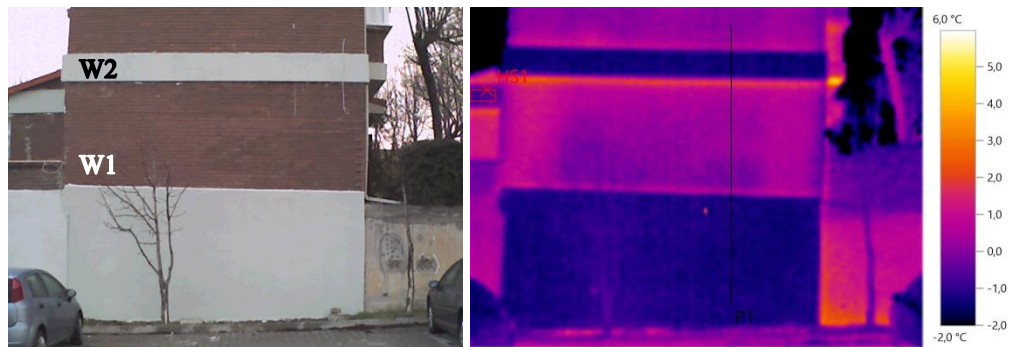
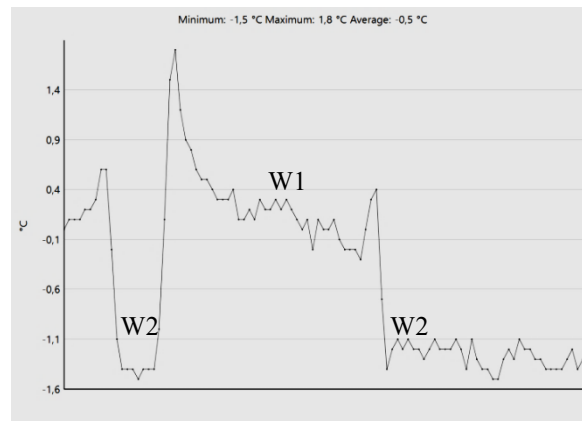
Figure 4.10. The IR image and temperature profile on Line P1 showing the exterior temperature distribution on the insulated cavity brick wall (W1) and insulated reinforced concrete wall (W2). The average surface temperature of W2 is close to the outside air with a temperature difference of 1-2°C. The thermal resistance of W2 seems to be better than the thermal resistance of W1 that is provided by the insulation treatment ($T_{out} = -3.1^{\circ}\text{C}$, RH= 65%).

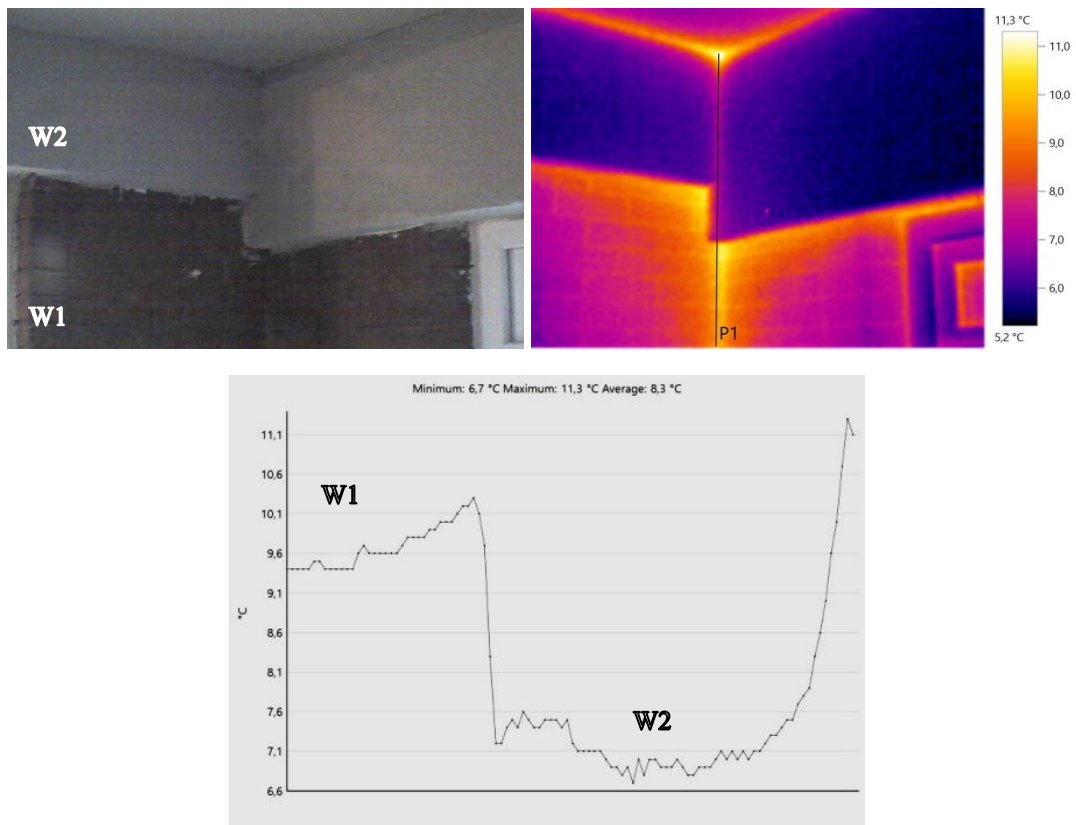
Figure 4.11. IR image taken from the exterior building envelope of villa house and temperature profile on Line P1 showing that thermal bridges occurs because of the discontinuity of insulation material. Thermal bridges are visible in IR images with surface temperatures about 5-6°C warmer than the insulated walls surfaces (non-problem area) as well as about 7°C warmer than outside air temperature. ($T_{\text{out}} = 5.0^{\circ}\text{C}$, RH= 65%).

thermal failure zones occur because of the discontinuity in external insulation, in other words partial insulation of the building envelope during remedial renovation (Figure 4.11 and Figure 4.12).

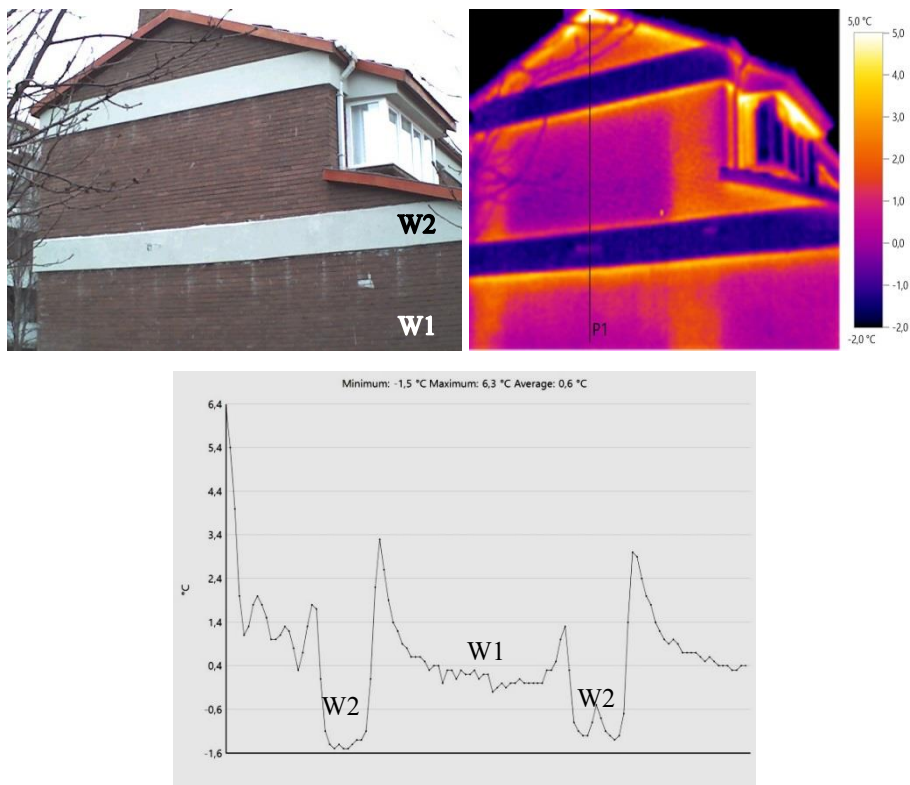
Figure 4.12. The IR image taken from the rear side of the villa house and temperature profile on Line P1 showing that, thermal bridges occur because of the discontinuity of insulation material. Thermal bridges with surface temperatures about 4-5°C higher than the externally-insulated concrete surfaces (non-problem areas) and 6-7°C higher than the outside ambient temperature ($T_{\text{out}} = -3.1^{\circ}\text{C}$, RH= 65%).

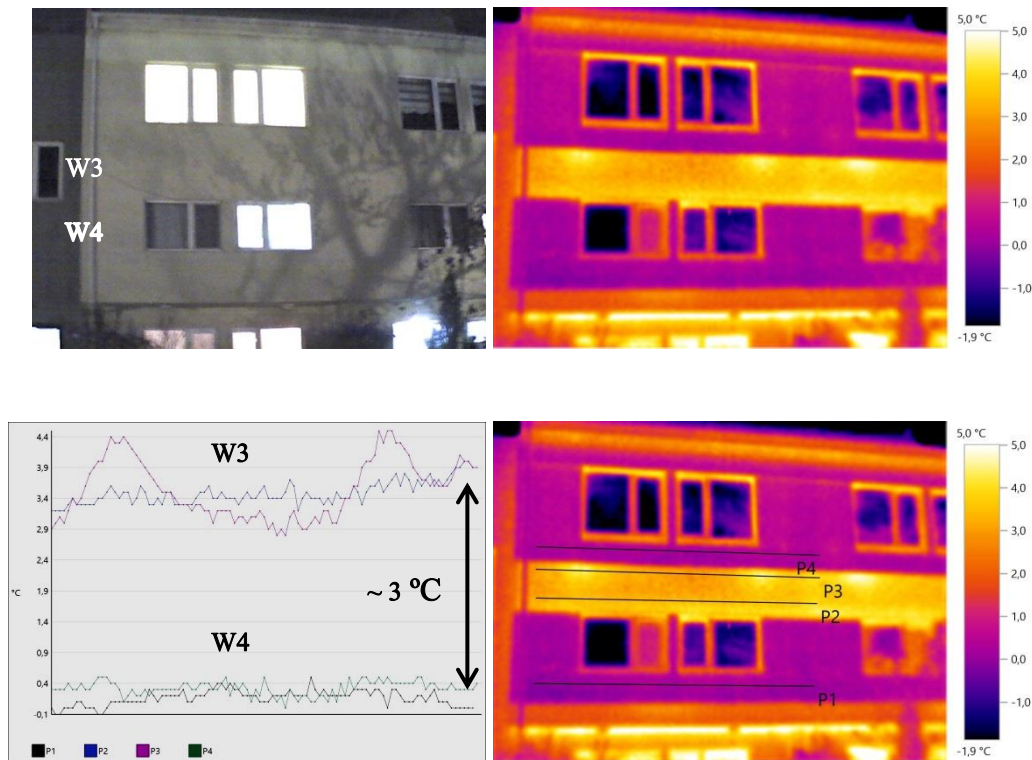
Figure 4.13. Externally-insulated shear wall (W3, P2&P3 profiles) surface temperature is 3,2°C higher than the surface temperature of externally-insulated autoclaved aerated concrete wall (W4, P1&P4 profiles). Heterogeneous temperature distribution visible in the temperature profile (P3) in the form of peak temperature values shows heat source (radiator) behind the wall and this situation signals the insufficiency of the wall's thermal resistance. ($T_{\text{out}} = -3.9^{\circ}\text{C}$, RH= 60%).

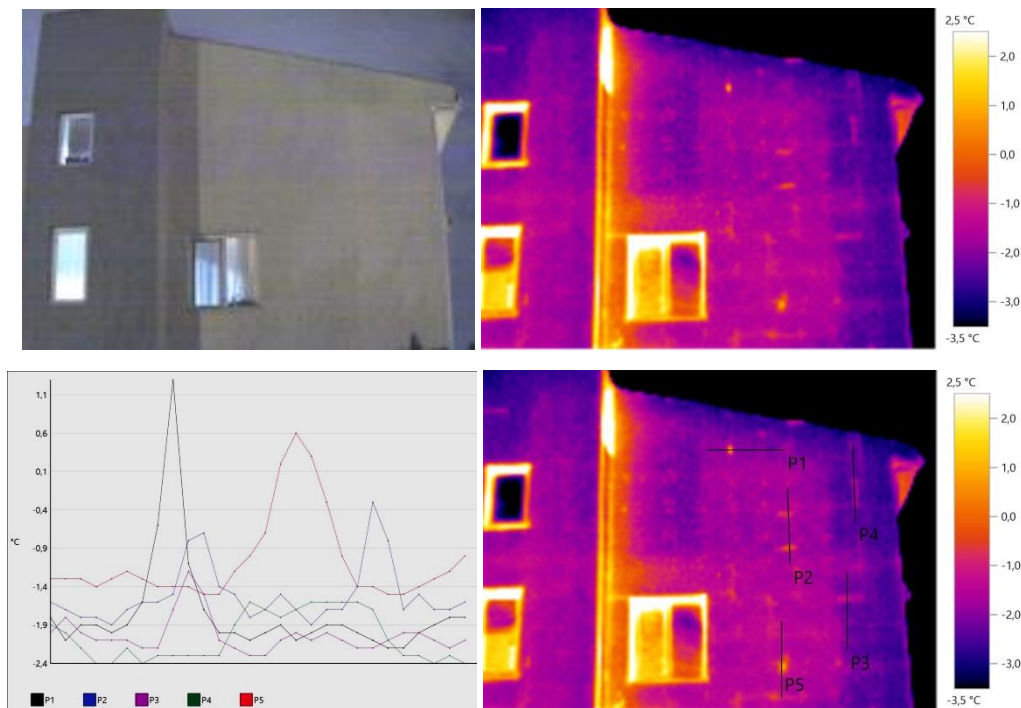
Figure 4.14. Heterogeneous temperature distribution is visible in the IR images in the form of warm patches at the intersection of thermal insulation boards and Temperature profiles passing through these zones shows that, surface temperature at the bridge zones are up to 3-4°C higher than surface temperature without defect ($T_{out} = -3.9^{\circ}\text{C}$, RH= 60%).

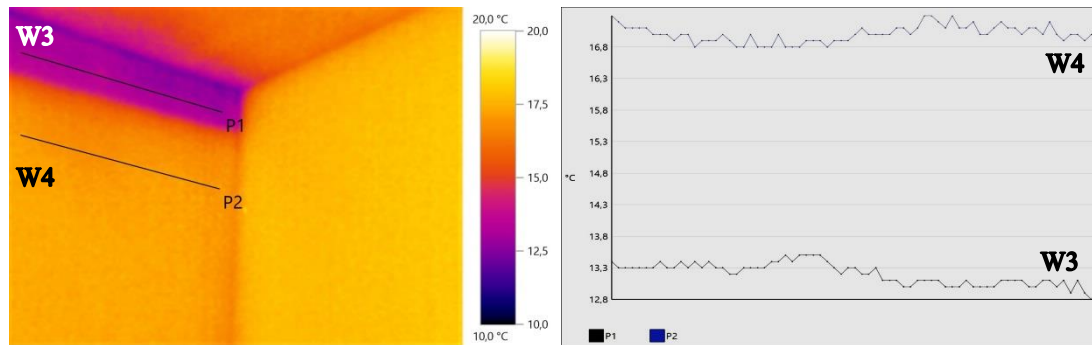
Figure 4.15. IR image and temperature profile taken from inside of the building show the thermal performance difference between W3 and W4 ($T_{in} = 19^{\circ}\text{C}$, RH= 55%).

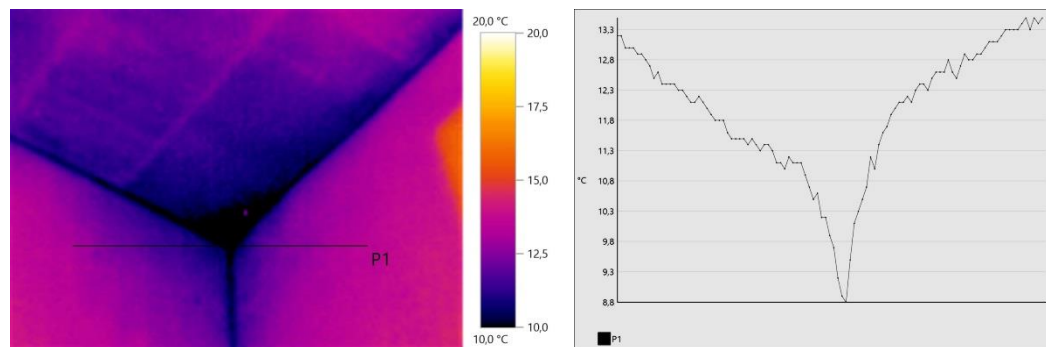
Figure 4.16. Temperature profile of B2 shows the possibility of the surface and interstitial moisture problem ($T_{in} = 19^{\circ}\text{C}$, RH= 55%).

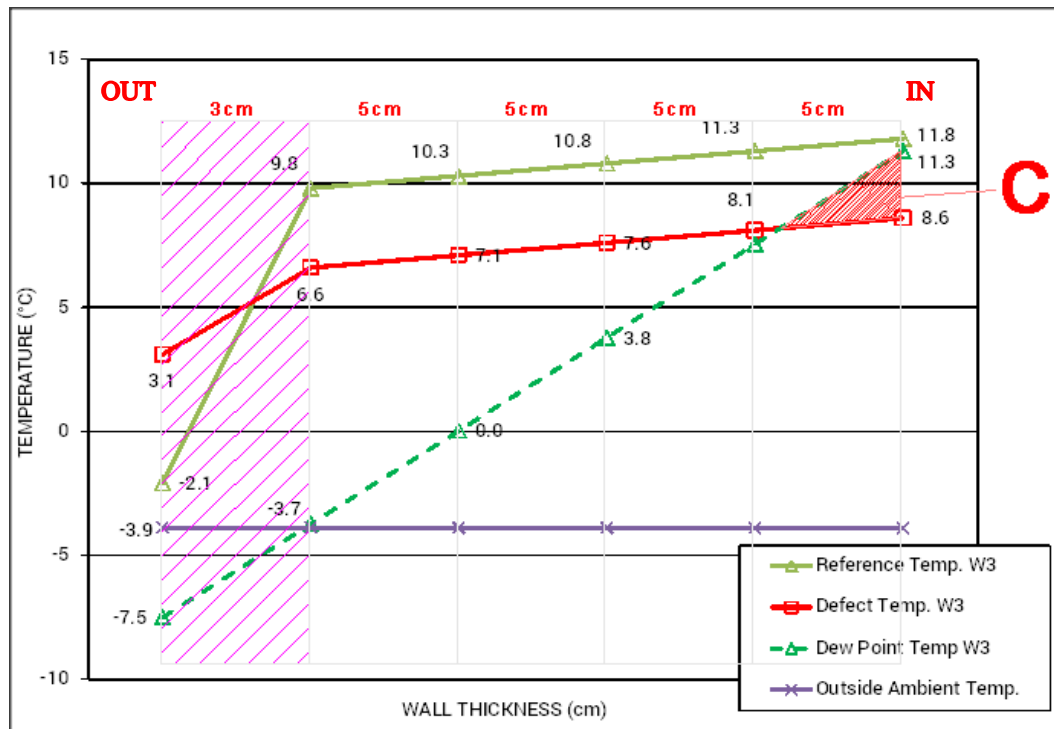
Figure 4.17. Temperature and dew point temperature profiles of insulated reinforced concrete wall (W3) show the risk of interstitial condensation (C) reaching to 4 cm depth from interior surface ($TI_{W3-DEFECT} = 0.71$) ($T_{in} = 20^{\circ}\text{C}$, $RH_{in} = 45\%$ and $T_{out} = -1^{\circ}\text{C}$, $RH_{out} = 60\%$).
REFERENCE = 0.92; $TI_{W3-DEFECT} = 0.71$) ($T_{in} = 20^{\circ}\text{C}$, $RH_{in} = 45\%$ and $T_{out} = -1^{\circ}\text{C}$, $RH_{out} = 60\%$).

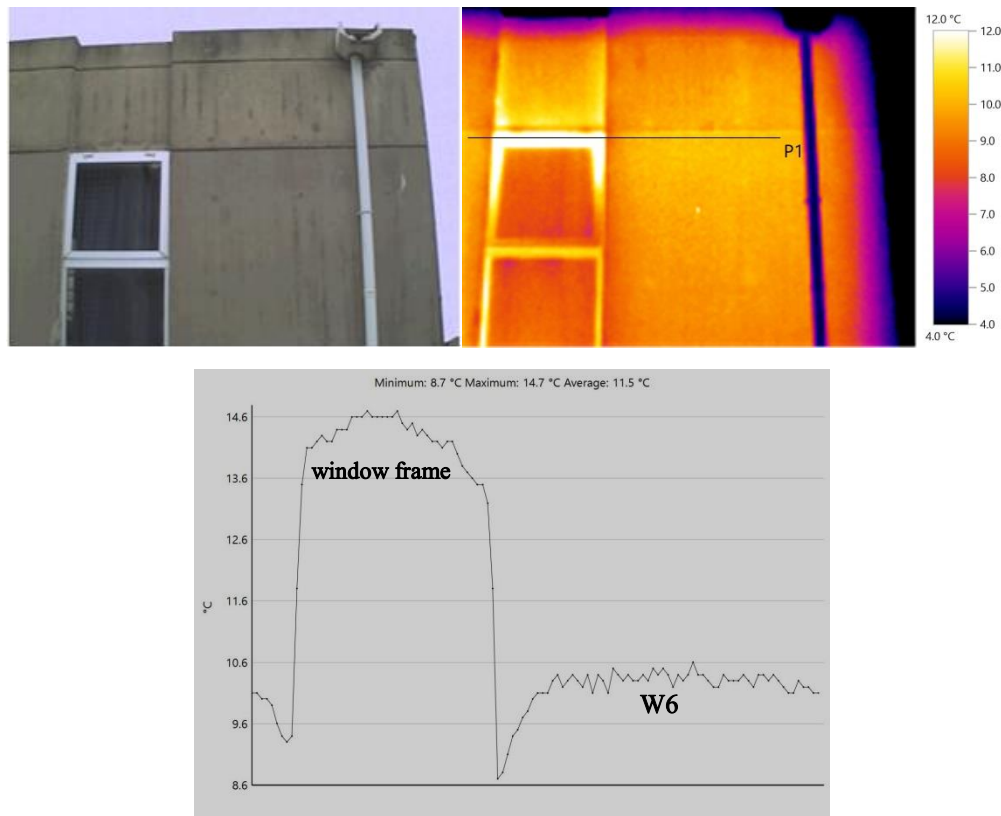
Figure 4.18. Exterior surface temperature of non-insulated shear wall (W6) is about 4°C higher and surface temperature of aluminum window frame is about 8°C higher than the outside air temperature. These temperature differences shows that there are serious heat loss through the wall and aluminum window frame surfaces ($T_{out}=6.4^{\circ}\text{C}$ and $\text{RH}= 65\%$).

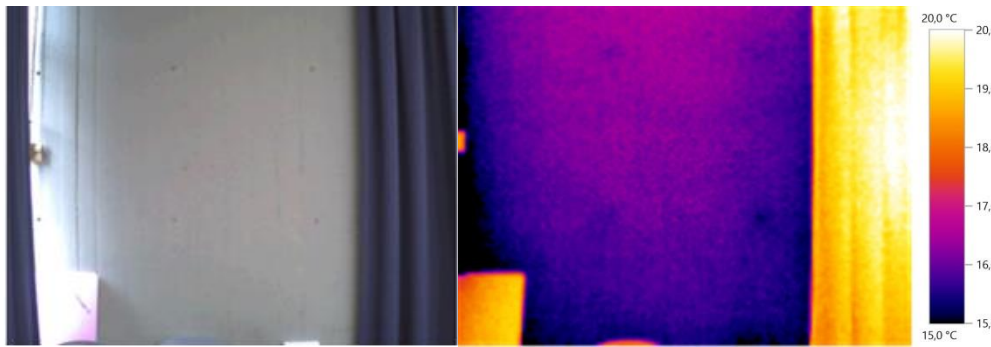
Figure 4.19. IR image shows that surface temperatures of W6 is about 4°C colder than the inside ambient temperature and tie-rod holes can be seen in thermal images in the form of circular colder patches ($T_{\text{out}}=6.4^{\circ}\text{C}$ and RH= 45%).

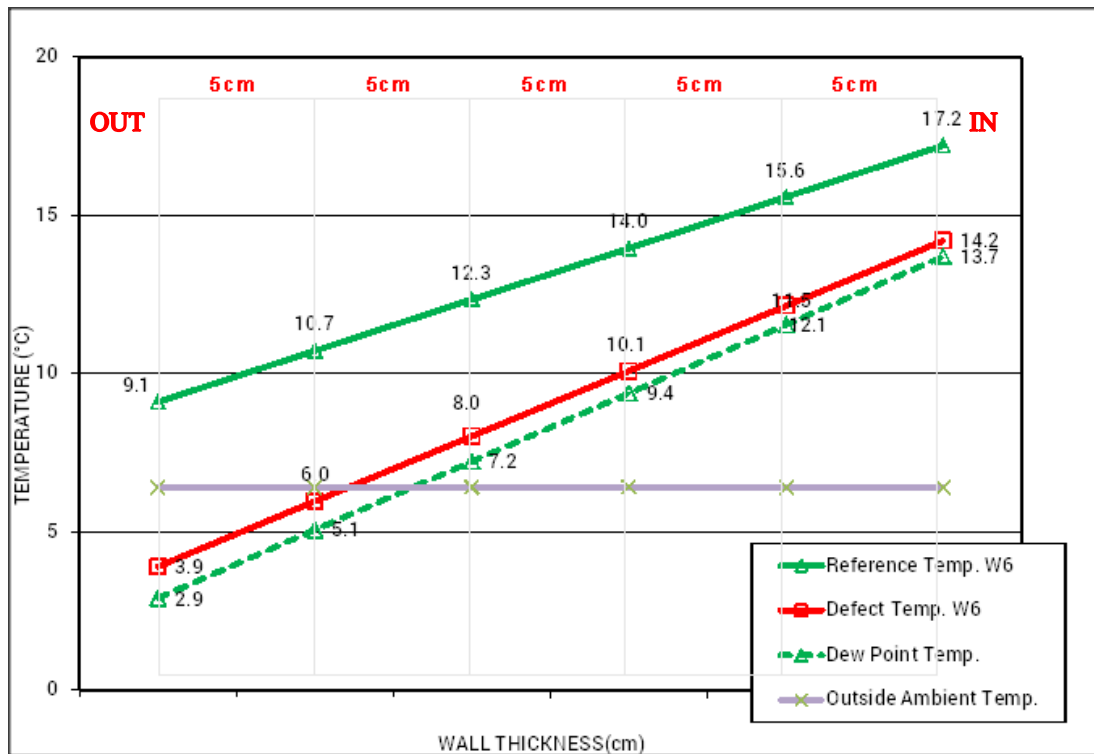
Figure 4.20. Temperature and dew point temperature profiles of W6 showing that temperature gradient throughout the wall section is very close to the dew point temperatures curve, therefore, the wall is under risk of surface and interstitial condensation ($TI_{W6-REFERENCE} = 0.84$; $TI_{W6-DEFECT} = 0.72$) ($T_{in} = 20^{\circ}C$, $RH_{in} = 45\%$ and $T_{out} = -1^{\circ}C$, $RH_{out} = 60\%$).

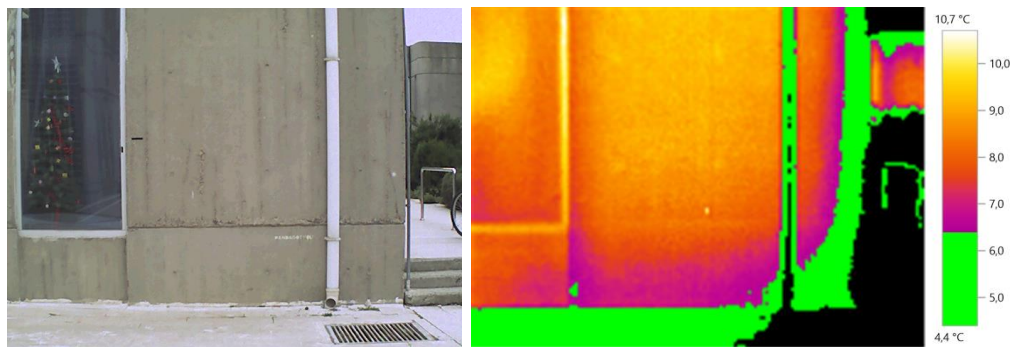
Figure 4.21. Green painted area at IR image shows the surfaces colder than outside air temperature and at the lower corner of W6 there is possibility of evaporative cooling due to damp zones. ($T_{out} = 6.4^{\circ}C$ and $RH = 65\%$).

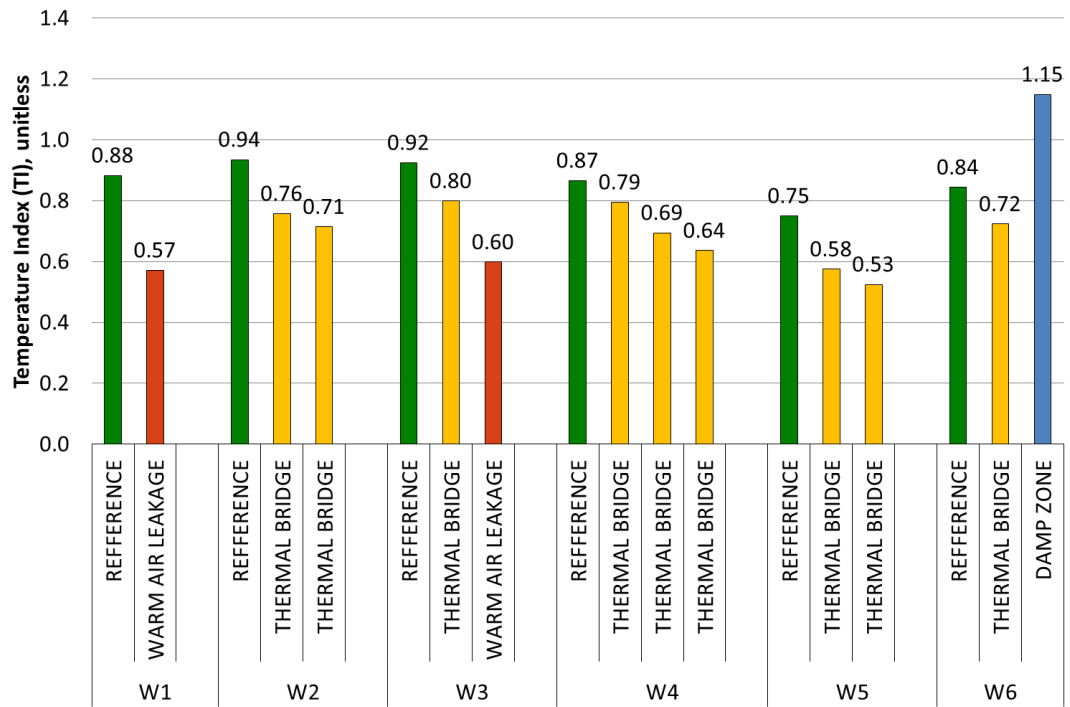
Figure 4.22. Temperature index values calculated for the wall surfaces without any defect and wall surfaces suffering from thermal bridges and air leakages.

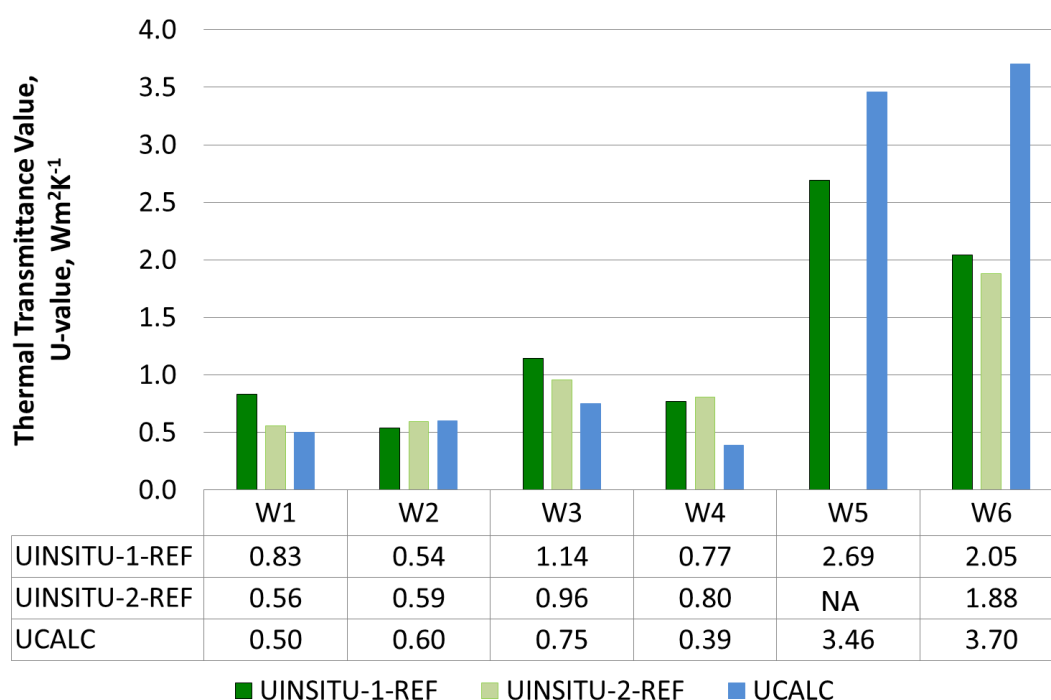
Figure 4.23. Reference in-situ thermal transmittance ($U_{\text{INSITU-1-REF}}$ and $U_{\text{INSITU-2-REF}}$) and the theoretically calculated (U_{CALC}) thermal transmittance values of the walls
