THERMAL TRANSMITTANCE ASSESSMENT OF BUILDING WALLS BY
USING IN-SITU INFRARED THERMOGRAPHY

A THESIS SUBMITTED TO
THE GRADUATE SCHOOL OF NATURAL AND APPLIED SCIENCES
OF
MIDDLE EAST TECHNICAL UNIVERSITY

SEPTEMBER 2019

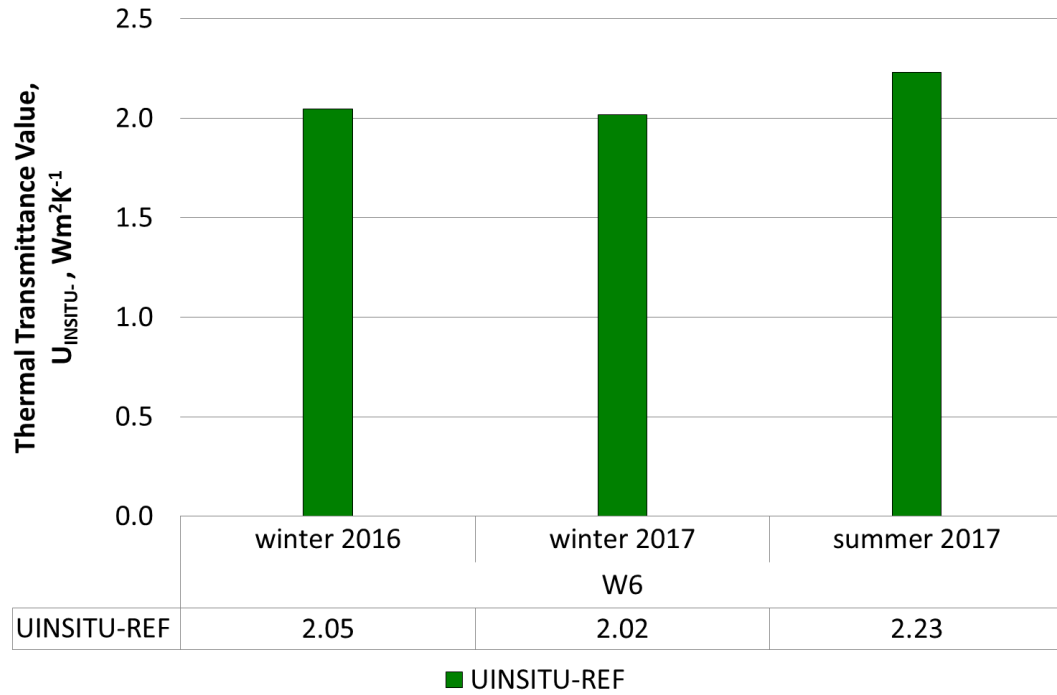
Figure 4.24. In-situ U values of W6, obtained at hot and cold weather conditions

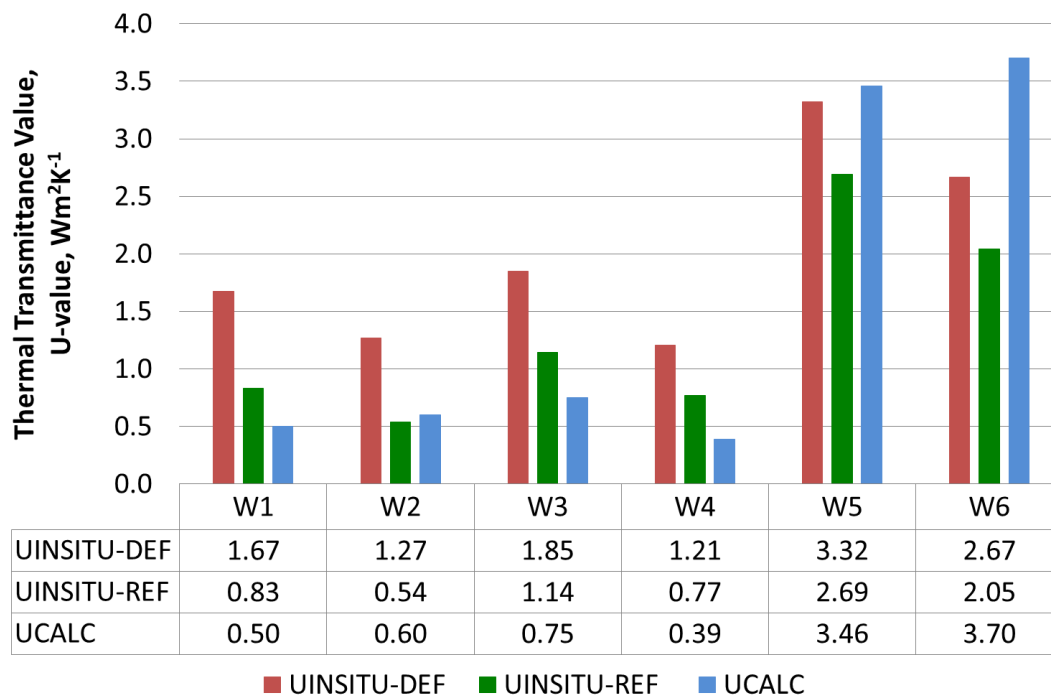
Figure 4.25. The reference value of actual thermal transmittance ($U_{\text{INSITU-REF}}$), the actual thermal transmittance at thermal bridge zones ($U_{\text{INSITU-DEF}}$) and the theoretically calculated thermal transmittance (U_{CALC}) values of the six wall components under examination.

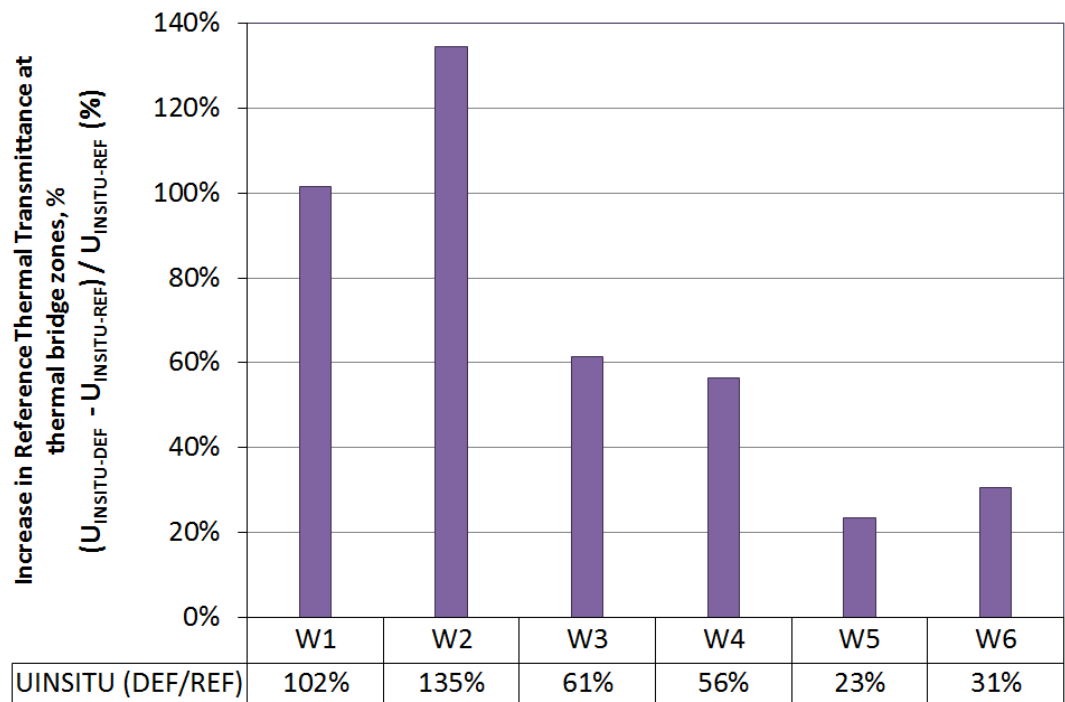
Figure 4.26. The increase in reference values of actual thermal transmittance at thermal bridge zones ($U_{\text{INSITU-REF}}$) in percentages

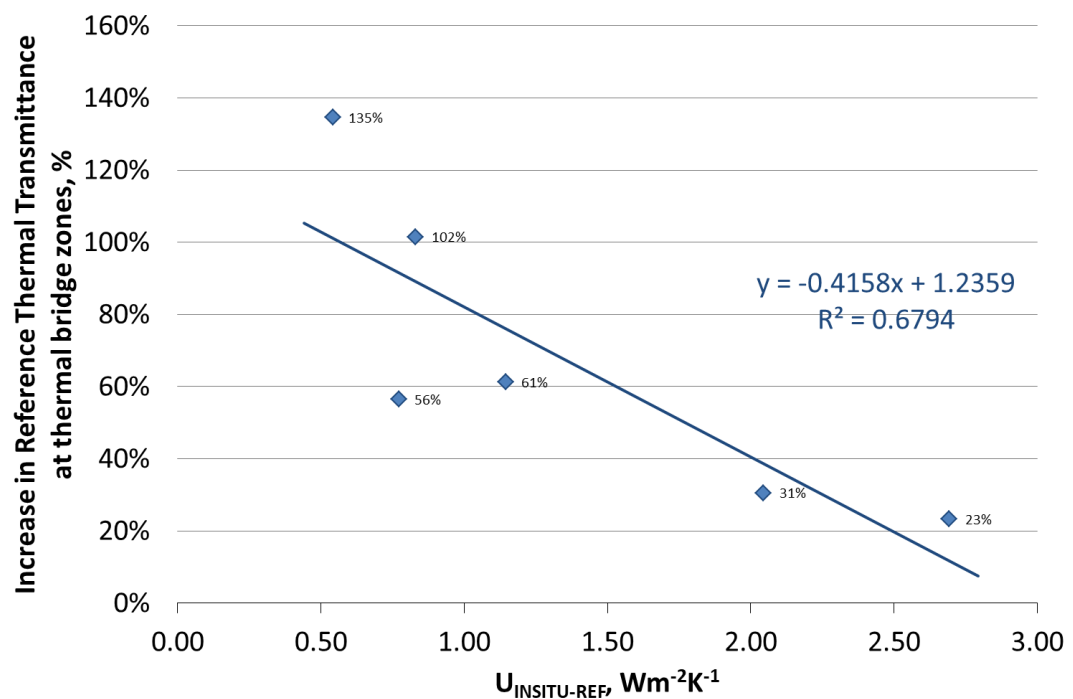
Figure 4.27. The plot of increase in the reference values of actual thermal transmittance values at thermal bridge zones (in percentages) versus $U_{\text{INSITU-REF}}$ values of existing building walls.

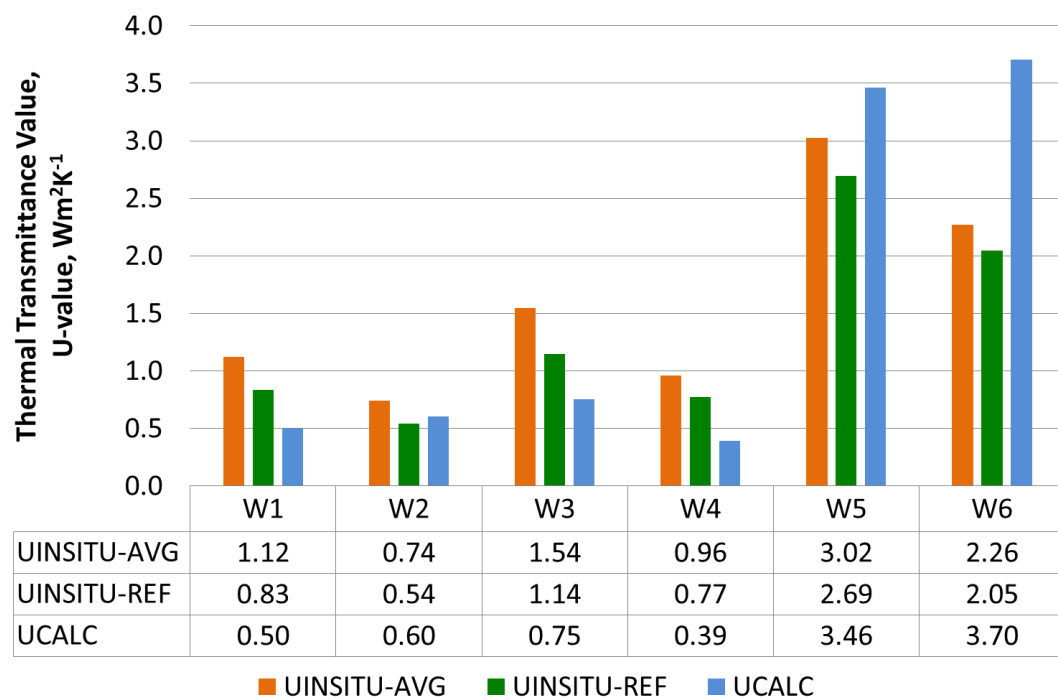
Figure 4.28. The reference value of actual thermal transmittance ($U_{\text{INSITU-REF}}$), the average value of actual thermal transmittance ($U_{\text{INSITU-AVG}}$) and the theoretically calculated thermal transmittance (U_{CALC}) values of the six wall components under examination.

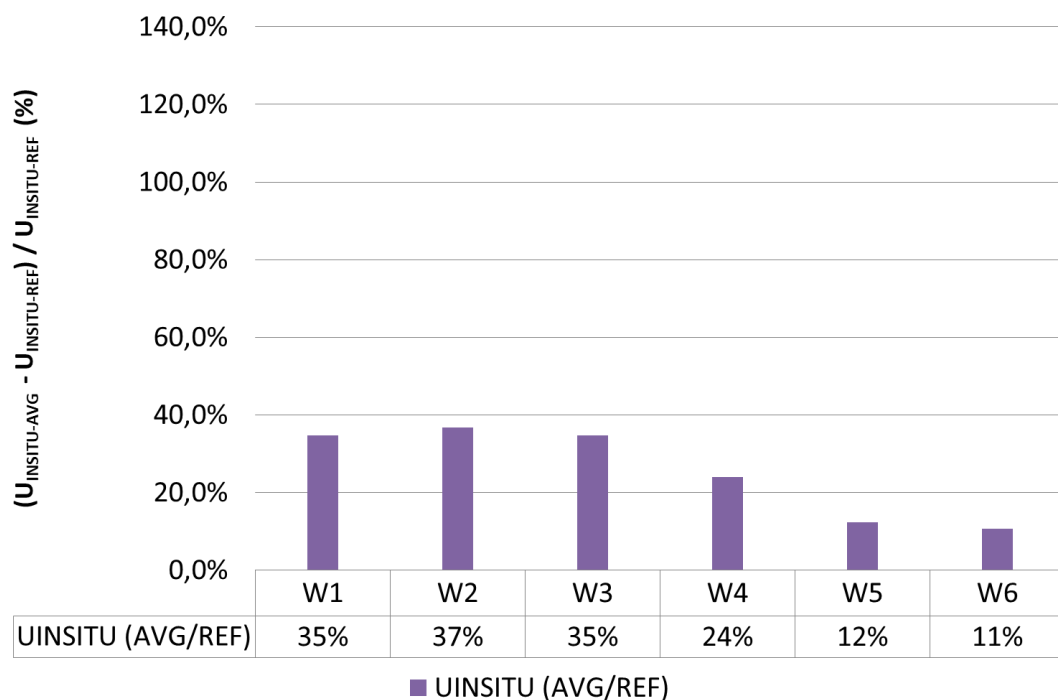
Figure 4.29. The increase in percentages, which were observed in the reference values of actual thermal transmittance ($U_{\text{INSITU-REF}}$) due to the thermal bridges occurred in time in existing building walls

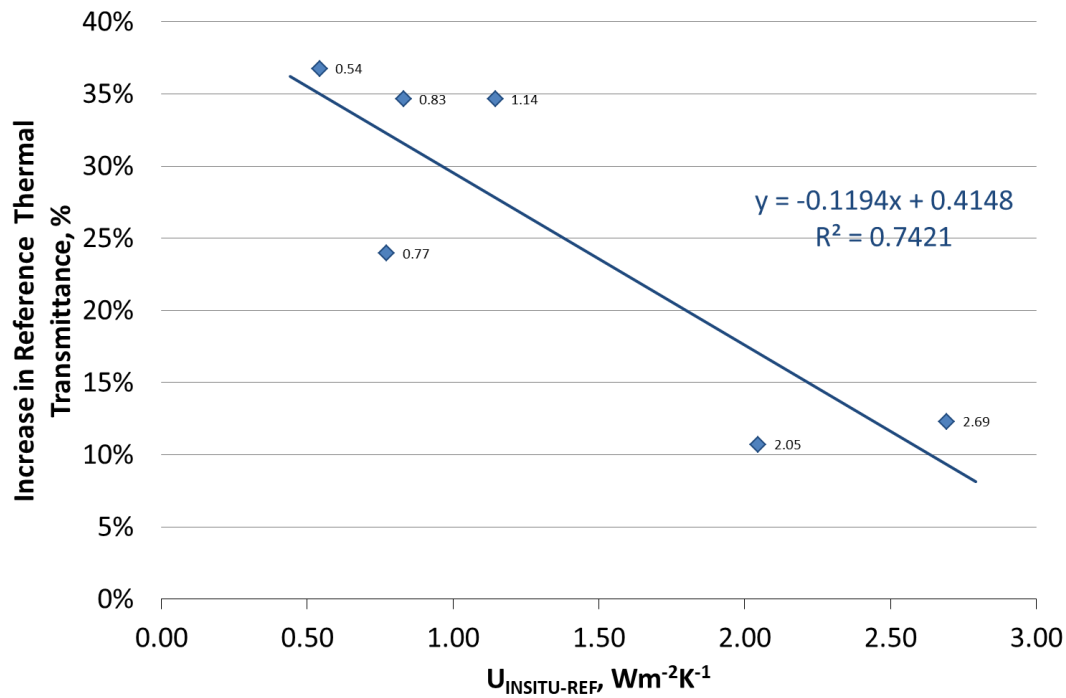
Figure 4.30. The plot of increase in the reference values of actual thermal transmittance values in percentages versus $U_{\text{INSITU-DEF}}$ values of existing building walls

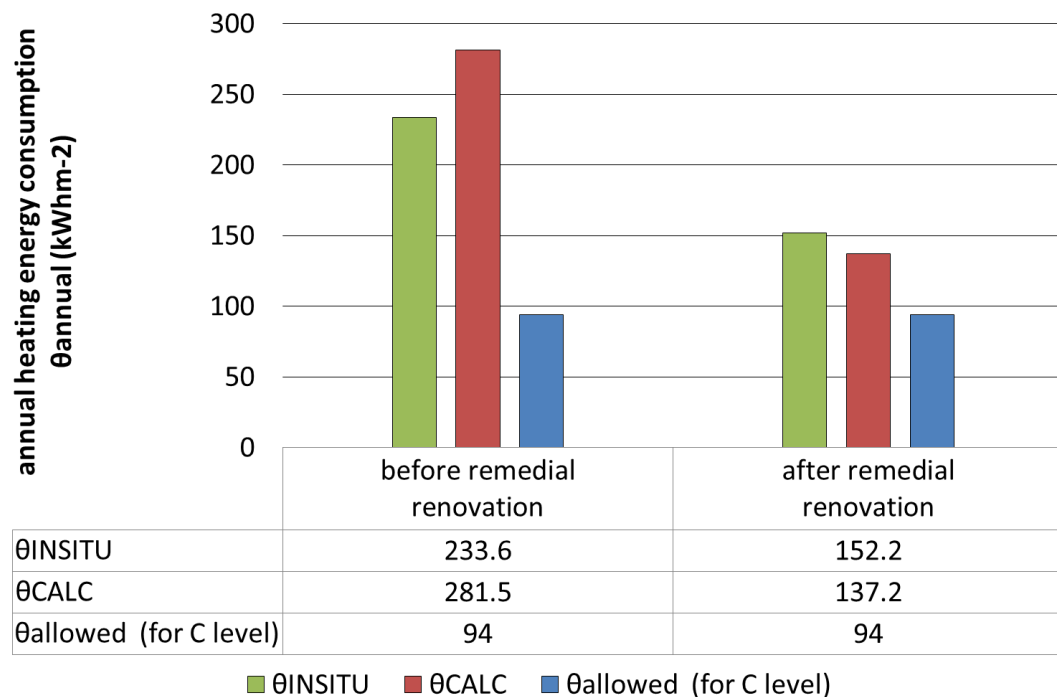
Figure 4.31. Comparison of annual energy consumption for heating purposes for Villa Type Building (B1): theoretically and in-situ θ_{annual} values for both before and after renovation works.
