ASSESSMENT OF CUT SLOPE STABILITY IN WESTERN BLACK SEA
REGION (TURKEY)

A THESIS SUBMITTED TO
THE GRADUATE SCHOOL OF NATURAL AND APPLIED SCIENCES
OF
MIDDLE EAST TECHNICAL UNIVERSITY

IN PARTIAL FULFILLMENT OF THE REQUIREMENTS
FOR
THE DEGREE OF MASTER OF SCIENCE
IN
GEOLOGICAL ENGINEERING

SEPTEMBER 2019

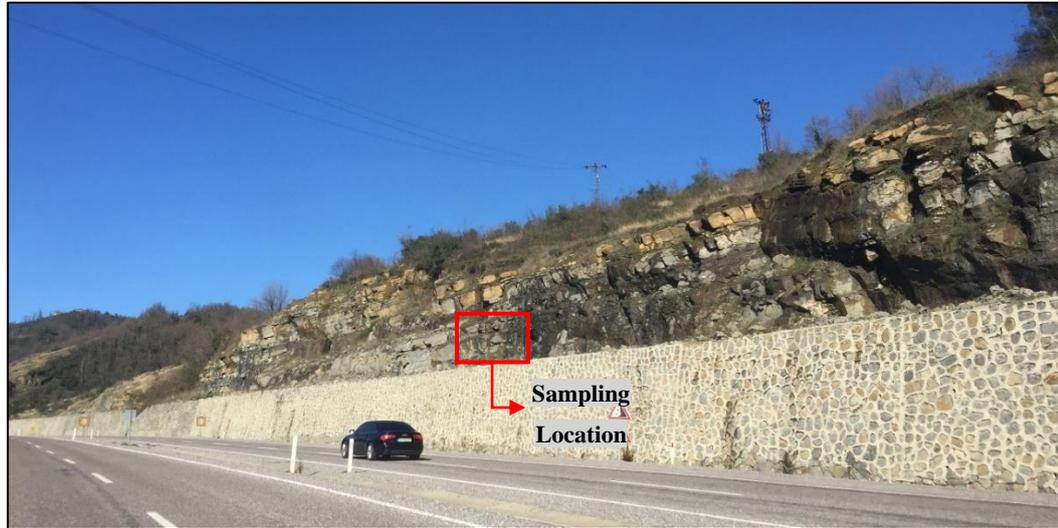
Figure 4.2. View of the road-cut at MS-1

limestone blocks were encountered above the wall, however, none of them was observed at road level. Besides, there was “Landslide Site” caution signboard near the slope. Excavation method for the cut slope is mechanical excavation, therefore disturbance factor (D) can be taken as 0.7.

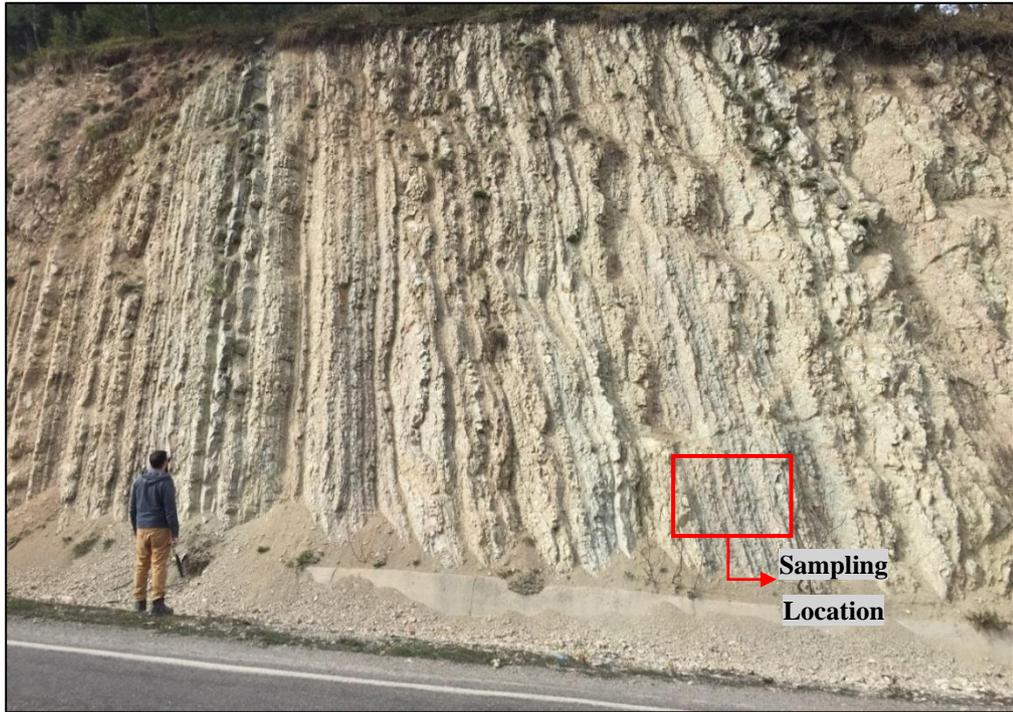
Figure 4.5. View of the road-cut at MS-2.1

The cut slope MS-2.1 is located at nearly 16 km southeast of Zonguldak centrum in the Akveren formation. MS-2.1 is approximately 10 m in height and dip of the cut slope is measured as 55°. The cut slope is comprised of marl-mudstone alternation that is 80 % of white-light colored, nearly 10 to 20 cm thick bedded, fine-grained marl and 20 % of brown-greenish 5 cm thick bedded, fine grained mudstone (Figure 4.5). As field observation, the cut slope MS-2.1 is totally stable however, surficial degradation and surficial failures are encountered and resulted in ravelling of very small sized specimens into the drainage channel in front of the cut slope. Excavation method for the cut slope is mechanical excavation, therefore disturbance factor (D) can be taken as 0.7.

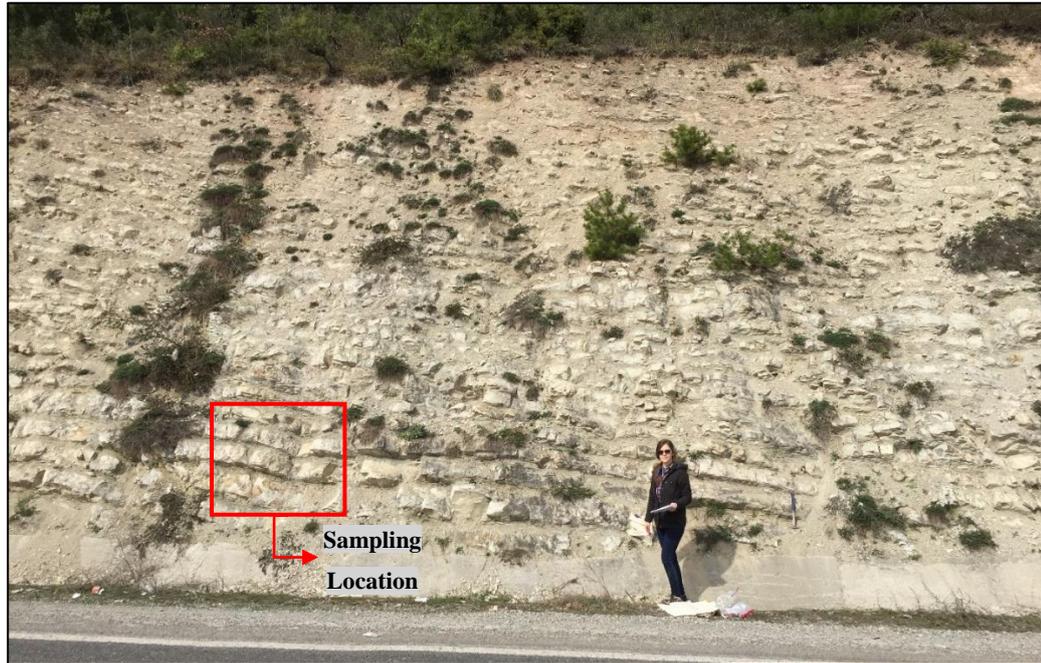
Figure 4.8. View of the road-cut at MS-2.2

Location of the cut slope MS-2.2 is nearly 16 km southeast of Zonguldak centrum, close to the cut slope MS-2.1 and in the Akveren formation. The height of MS-2.2 is approximately 15 m and measured dip of the cut slope is 50°. The cut slope is composed of marl-mudstone alternation that is 75 % of white-light gray colored, nearly 15 to 20 cm thick bedded, fine-medium grained marl and 25 % of gray-dark gray-greenish 5 to 6 cm thick bedded, fine grained mudstone (Figure 4.8). As field observation the cut slope MS-2.2 is totally stable yet, there were rarely surficial failures and rockfalls of small sized specimens into the drainage channel in front of the cut slope. Excavation method for the cut slope is mechanical excavation, therefore disturbance factor (D) can be taken as 0.7.

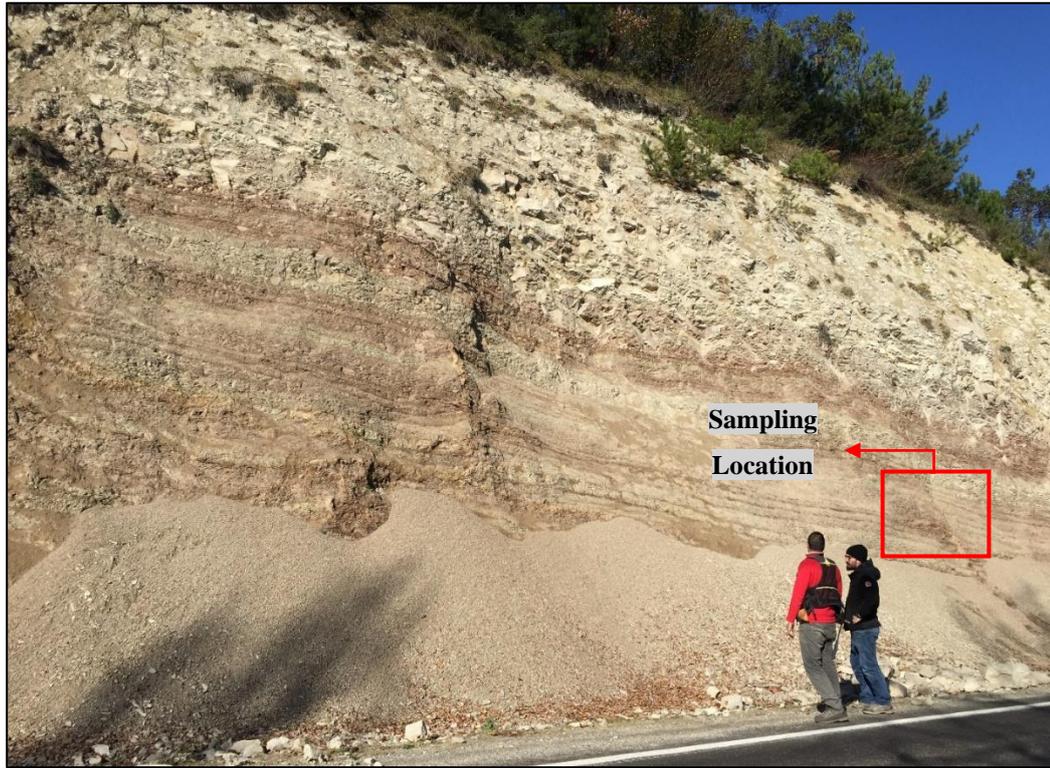
Figure 4.11. View of the road-cut at MS-2.3

Location of the cut slope MS-2.3 is nearly 16 km southeast of Zonguldak centrum, close to the cut slopes MS-2.1 and MS-2.2 in the Akveren formation. The height of MS-2.3 is approximately 20 m and measured dip of the cut slope is 52°. Cut slope MS-2.3 is composed of marl-mudstone alternation that is 70 % of white-light yellow, nearly 5 to 10 cm thick fine grained, thin bedded marl and 30 % of white-reddish approximately 1 cm thick, fine grained mudstone (Figure 4.11). Surficial degradation and surficial failures are encountered and resulted in rockfalls of very small sized specimens into the drainage channel in front of the cut slope into a large extent. Excavation method for the cut slope is mechanical excavation, therefore disturbance factor (D) can be taken as 0.7.

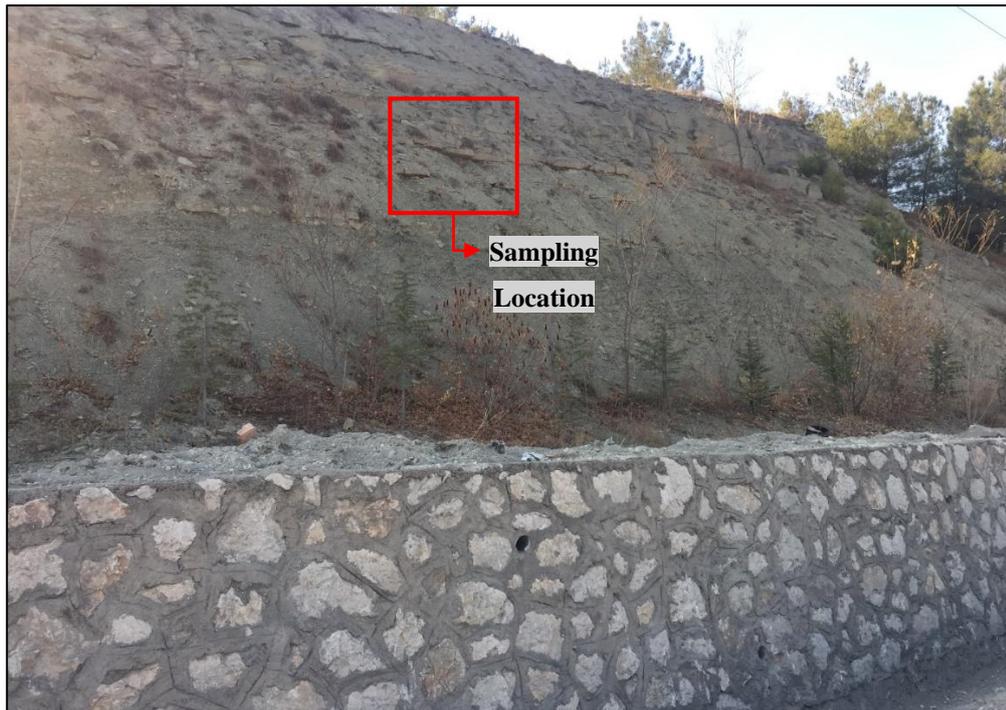
Figure 4.21. View of the road-cut at MS-5

Location of the cut slope MS-5 is nearly 4 km south of Karabük centrum in the Karabük formation. The height of MS-5 is approximately 15 m and measured dip of the cut slope is 50°. The cut slope is composed of marl that shows differential weathering between the layers. The marl of the cut slope MS-5 is gray, locally laminated, rarely 10-20 cm thick bedded (Figure 4.21). As field observation the cut slope MS-5 is totally stable, however; surficial degradation and surficial failures are encountered and resulted in rockfalls of 1 cm, 5 cm and rarely 10 cm rock specimens on the wall and into the drainage channel in front of the cut slope. Excavation method for the cut slope is mechanical excavation, therefore disturbance factor (D) can be taken as 0.7.

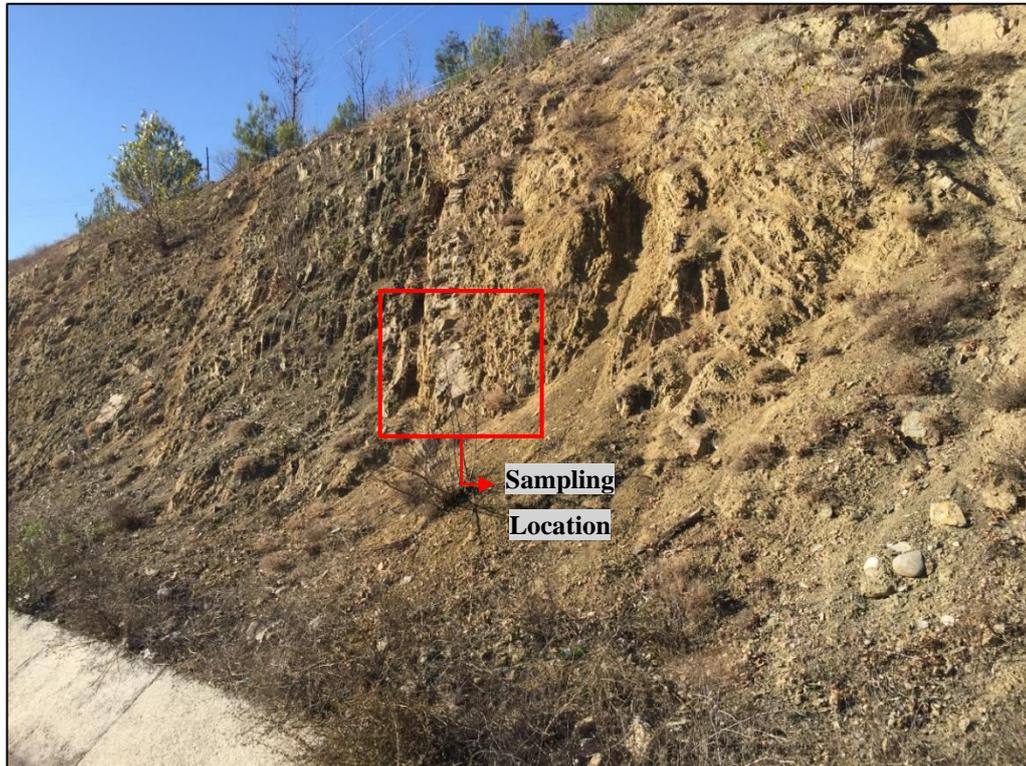
Figure 4.24. View of the road-cut at MS-6

rock specimens into the drainage channel in front of the cut slope. Excavation method for the cut slope is mechanical excavation, thus disturbance factor (D) can be taken as 0.7.

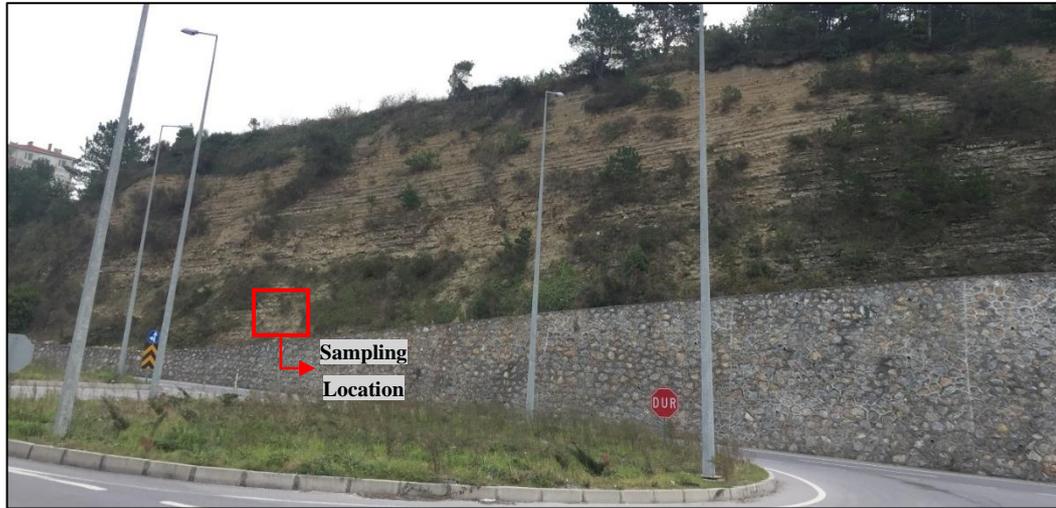
Figure 4.27. View of the road-cut at MS-7.1

Location of the cut slope MS-7.1 is nearly 13 km southwest of Ereğli county town in the Akveren formation. The height of MS-7.1 is approximately 35 m and measured dip of the cut slope is 66°. The cut slope is composed of limestone that is white-rarely yellowish-brownish colored, nearly 10-15 cm thick bedded, fine-medium grained (Figure 4.27). Limestone blocks that were 5 to 10 cm and maximum 20 cm were encountered above the wall however none of them was observed below the wall. Excavation method for the cut slope is mechanical excavation, therefore disturbance factor (D) can be taken as 0.7.

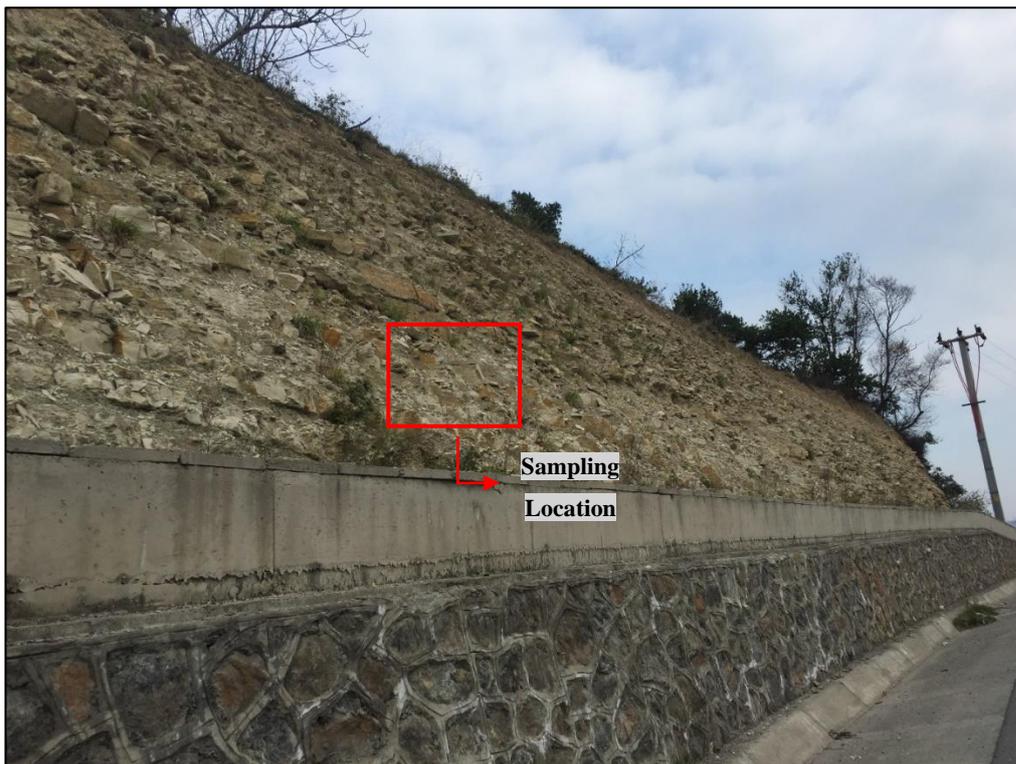
Figure 4.30. View of the road-cut at MS-7.2

Location of the cut slope MS-7.2 is nearly 13 km southwest of Ereğli county town in the Akveren formation, opposite of the cut slope MS-7.1, across the road. The height of MS-7.2 is approximately 8 m and measured dip of the cut slope is 64° . Cut slope MS-7.2 is composed of limestone that is white-rarely yellowish-brownish colored, nearly 10-15 cm thick bedded, fine-medium grained (Figure 4.30). Limestone blocks that were 5 to 10 cm were encountered above the wall however none of them was observed below the wall. Excavation method for the cut slope is mechanical excavation, therefore disturbance factor (D) can be taken as 0.7.

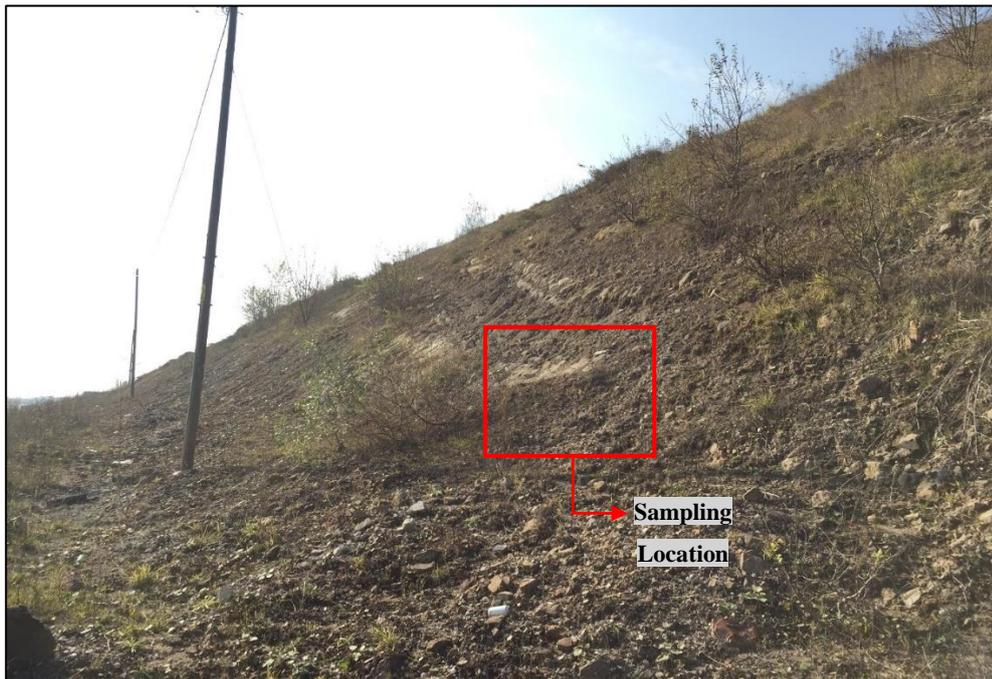
Figure 4.36. View of the road-cut at MS-8.2

Location of the cut slope MS-8.2 is nearly 13 km southeast of Akçakoca county town, adjacent to the cut slope MS-8.1 and in the Çaycuma formation. The height of MS-8.2 is approximately 10 m and measured dip of the cut slope is 30°. Cut slope MS-8.2 is composed of sandstone that is gray and brownish in color, nearly 4 to 15 cm thick fine-medium grained (Figure 4.36). As a field observation, the cut slope MS-8.2 is stable however, surficial degradation and surficial failures and resulted in rockfalls of 4-5 cm blocks on the retaining wall and rarely the drainage channel in front of the cut slope. Surface retaining is observed as color changes into gray and weathered surface color changes into brown. Excavation method for the cut slope is mechanical excavation, therefore disturbance factor (D) can be taken as 0.7.

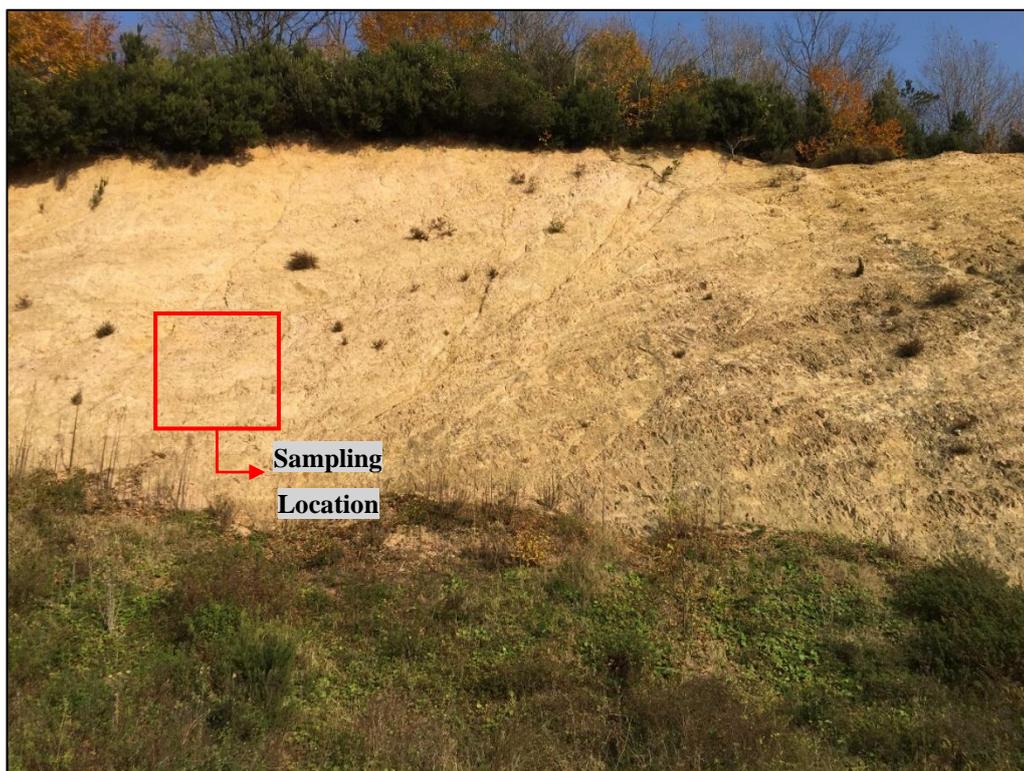
Figure 4.39. View of the road-cut at MS-9

Location of the cut slope MS-9 is nearly 10 km southeast of Akçakoca county town in the Çakraz formation. The height of MS-9 is approximately 8 m and measured dip of the cut slope is 65°. The cut slope is composed of sandstone-marl alternation that is 65 % of yellowish white, nearly 2 cm thick fine-grained sandstone and 35 % of yellowish-light brown, nearly to 1 cm thick, fine grained marl (Figure 4.39). Surficial degradation and surficial failures are encountered and 4 to 5 cm block sized rockfalls are observed. Excavation method for the cut slope is mechanical excavation, therefore disturbance factor (D) can be taken as 0.7.

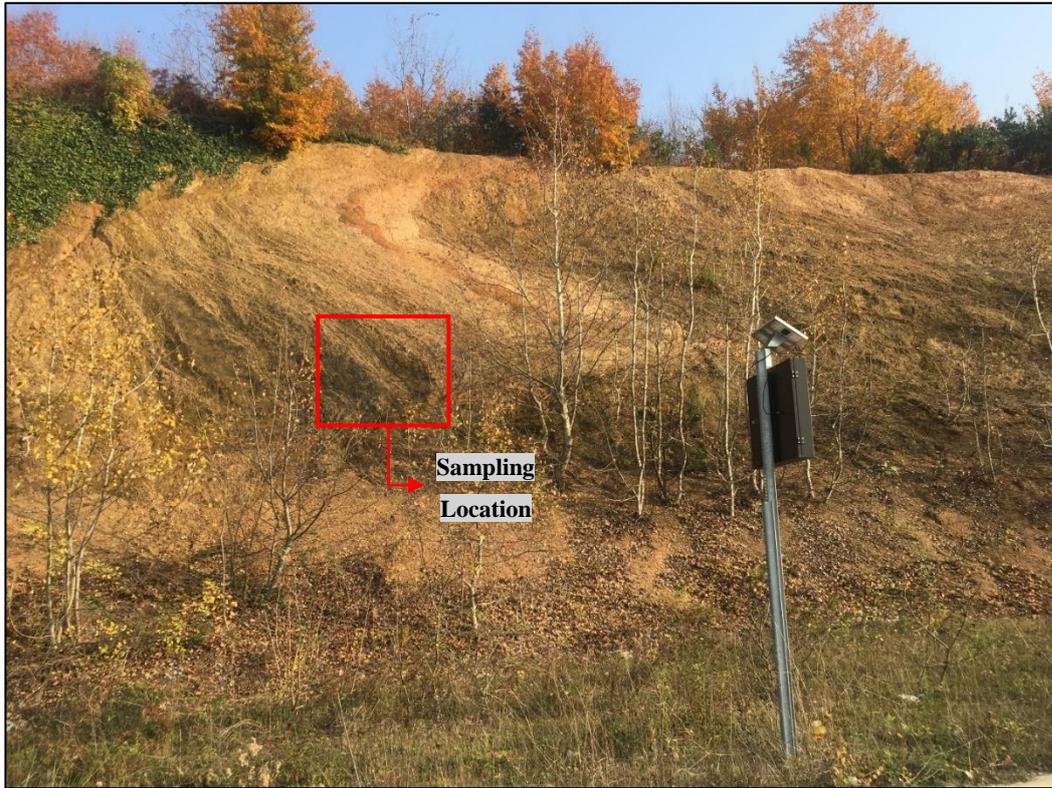
Figure 4.48. View of the road-cut at MS-12

Location of the cut slope MS-12 is nearly 8 km southeast of Akçakoca county town in the Çakraz formation. The height of MS-12 is approximately 15 m and measured dip of the cut slope is 50°. Cut slope MS-12 is composed of sandstone that is brownish-yellowish colored and fine grained (Figure 4.48). Surficial degradation and surficial failures are encountered and also 3 to 5 cm block sized rockfalls are observed. Excavation method for the cut slope is mechanical excavation, therefore disturbance factor (D) can be taken as 0.7.
