DAMAGE IN DUAL PHASE STEELS UNDER INDUSTRIAL FORMING
CONDITIONS

A THESIS SUBMITTED TO
THE GRADUATE SCHOOL OF NATURAL AND APPLIED SCIENCES
OF
MIDDLE EAST TECHNICAL UNIVERSITY

NOVEMBER 2019

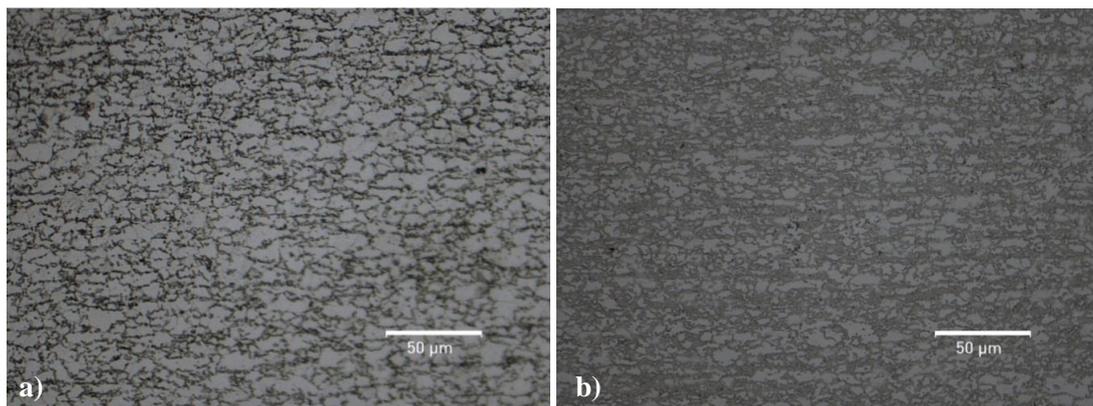
Figure 2.3 Microstructure images of a)DP590, b)DP800 as received condition

The chemical composition and amount of alloying elements of the steels used in this thesis are given in the material section. As received microstructures of DP590 and DP800 given in the figure 2.3.

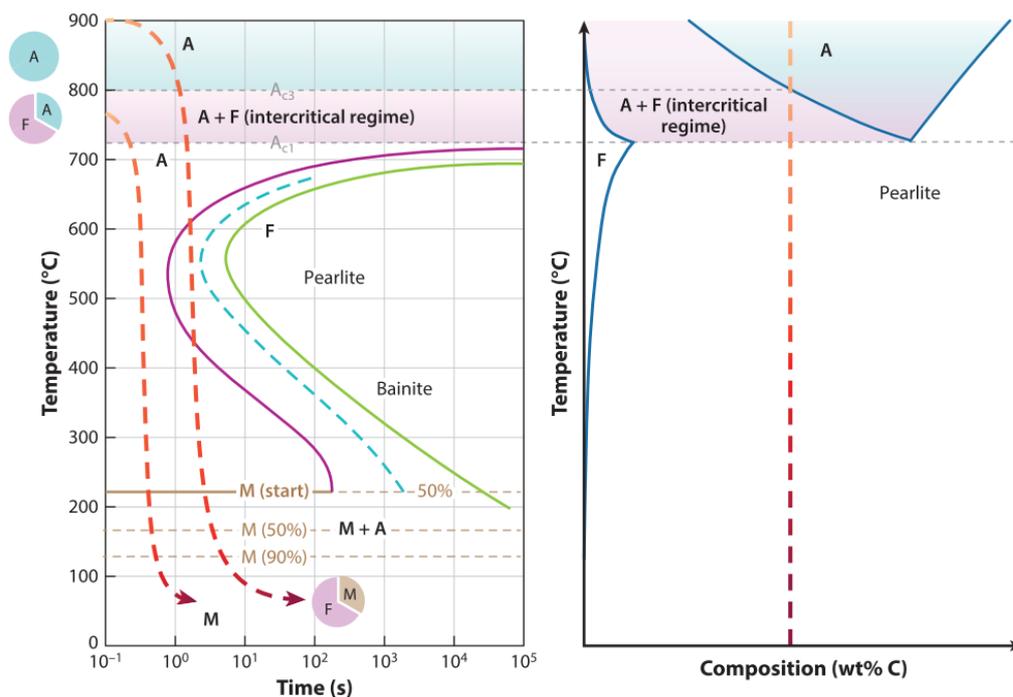
Figure 2.4 Heat treatment processes to observe Dual-Phase steels [14]

For instance, figure 2.4. [14] is explaining the DP steel production with the continuous annealing process from the ferrite – pearlite or ferrite – bainite steels. These steels are heated to the intercritical region or 100 % austenite region. Heating temperature is determined according to the C composition of the steels from the temperature&composition graph. If they are heated to the austenite-ferrite regions (above A_{c1}), all pearlite or bainite phase transforms into the austenite, then with quenching below to the martensite start temperature, austenite phase transform to the martensite. Moreover, if these steels heat to the 100 % austenite region (above A_{c3}), it is essential to arrange the cooling rate as it is necessary to cut the ferrite line to form ferrite phase. After ferrite phase forms, the remaining austenite phase transforms to the martensite below the martensite start temperature. In the end, both heat treatments result in the DP steels.

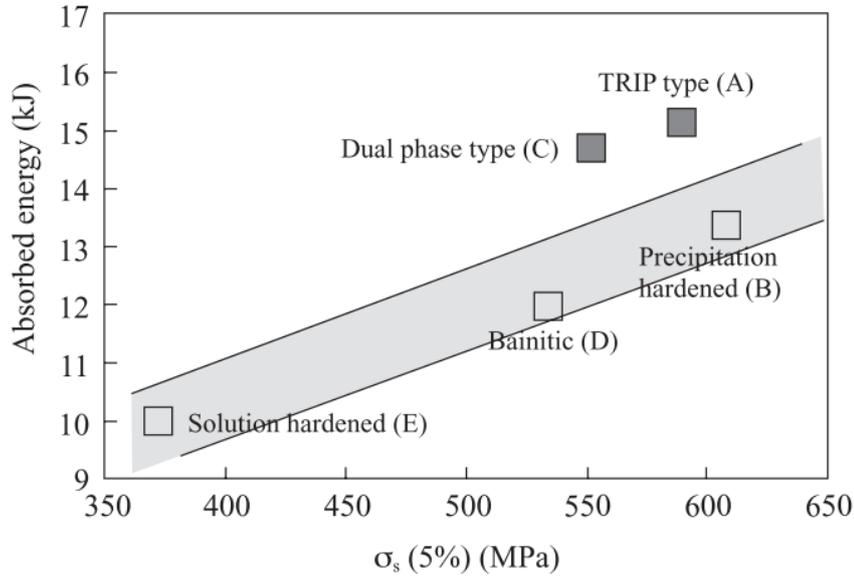
Figure 2.6 Absorbed energy vs. Stress graph of the different types of steels [33]

DP steels have much more uniform elongation compared to the other types of steel which means it has much more formability due to the low yield strength/ultimate tensile strength (YS/UTS) ratio. In sheet metal forming applications, high impact energy absorption is another desired condition for formability. In figure 2.6, absorbed energy at a specific stress level graph of different types of steel is given. As seen from the graph, TRIP and DP steels, which are the prominent members of AHSS, have high energy absorption values at high stresses, compared to the others [33].

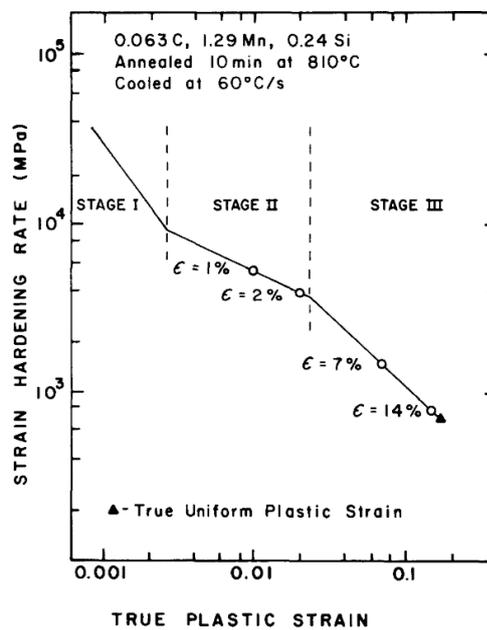
Figure 2.7 Jaoul-Crussard analysis graph of typical DP steel is given with the strain hardening stages [34]

Also, in figure 2.7 [34], Jaoul-Crussard analyse graph of typical DP steel given with the strain hardening stages. This graph shows different level of strains. At those strain values points mark on the graph. At those points TEM studies were performed to get more information.

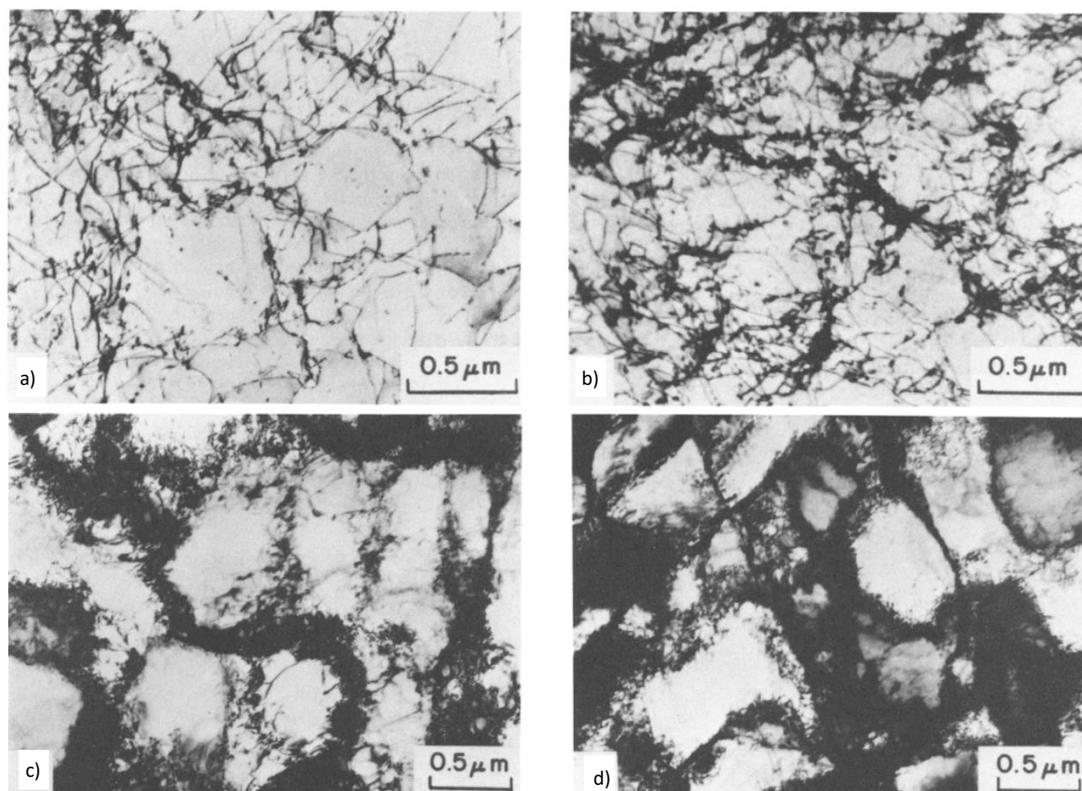
Figure 2.8 TEM images of the DP steel at different stages and strain values; a)1% strain, dislocation tangles, b)2% strain, already formed dislocation cell structure, c)7% strain, dislocation cells in ferrite, d)14% strain, dislocation cells in ferrite [34]

At the beginning of the deformation, while $\epsilon = 1\% - 2\%$, planar dislocation walls and already formed dislocation cells are observed near to the martensite phase. In addition, while $\epsilon = 7\%$, the dislocation cell structure with thicker cell walls was obtained that locates near to the martensite islands with smaller cell size. Furthermore, while $\epsilon = 14\%$, nevertheless, the cell walls got thinner, such thinning was not cause a further

reduction in the cell size (fig 2.8) [34]. As seen from this study, ferrite phase can be examined easily; however, the very high initial dislocation density of the martensite limits the investigation of the steps of plasticity in TEM scale.

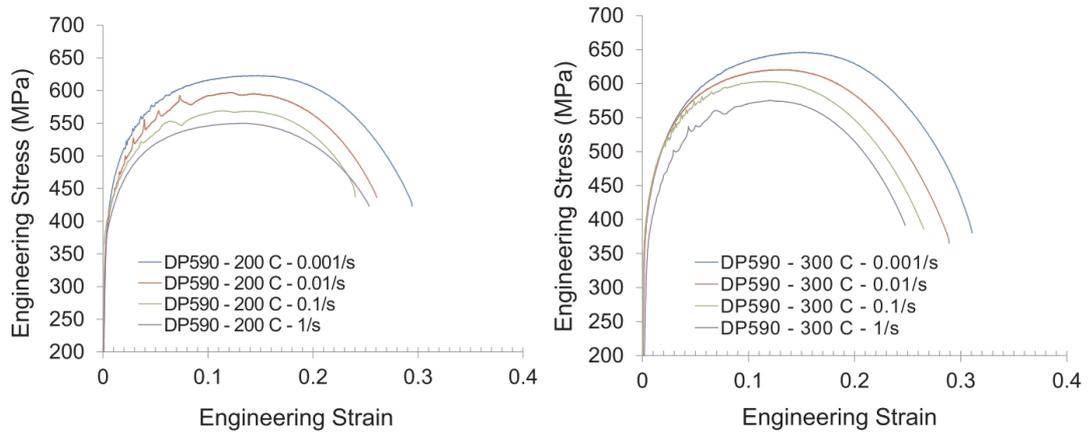
Figure 2.9 Stress strain graph of DP590 observed after tensile tests at different strain rates and temperature (DSA range) [8]

Bayramin et al. [8], [38] studied dynamic strain aging behavior of the DP steels in forming applications. In that study, two different grades of DP steel tensile tested at different strain rates and temperatures. As understood from the figures, DSA is active at 200-300 °C temperatures and relatively high strain rate (Fig. 2.9-10), meanwhile at RT, 100 °C and 400 °C, DP steels showing expected deformation behavior. Furthermore, due to the high amount of ferrite in DP590, DSA mechanism is more effective compared to the DP800. Strain rate sensitivity values of the samples are also calculated and it is observed that at the DSA range strain rate sensitivity has a negative value for both grades. Therefore, it is concluded that during warm forming conditions DP steels can enter DSA range, which is an undesirable condition especially for the massive production in the industry.

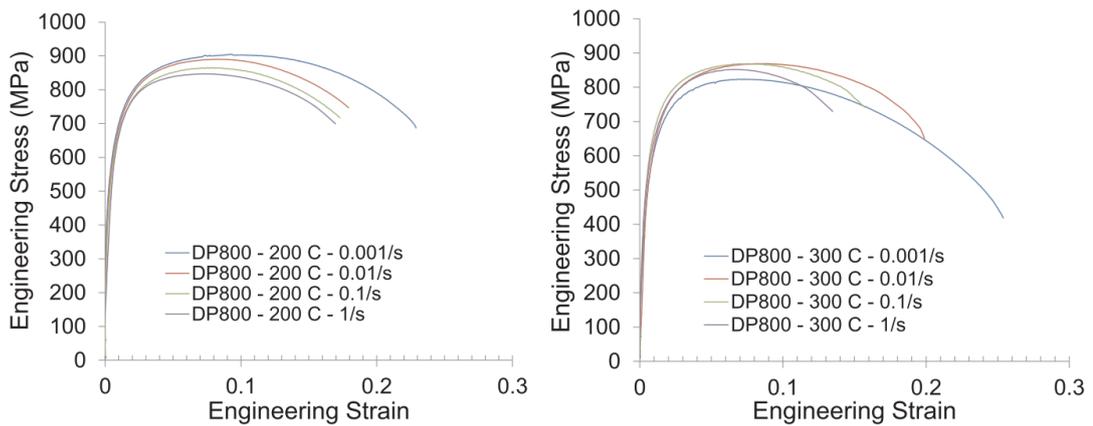
Figure 2.10 Stress strain graph of DP800 observed after tensile tests at different strain rates and temperature (DSA range) [8]

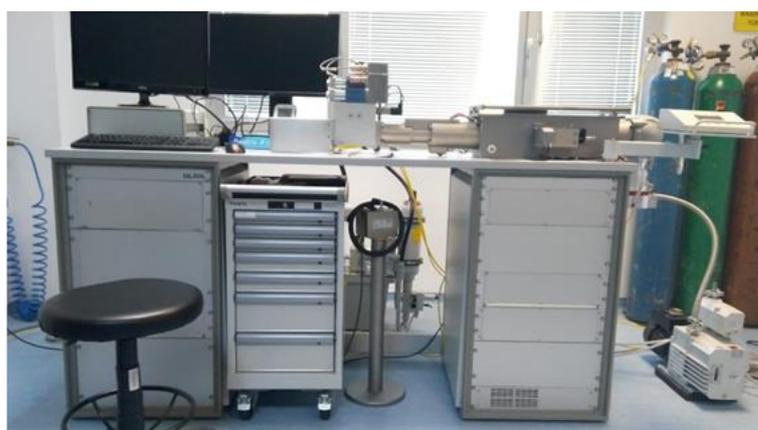
Figure 3.1 TA-BAEHR DIL805A/D-Deformation Dilatomete

DIC tests were operated at the TA-BAEHR DIL805A / D-Deformation Dilatometer (Fig. 3.1.) which is in Metal Forming Center of Excellence in Atılım University.

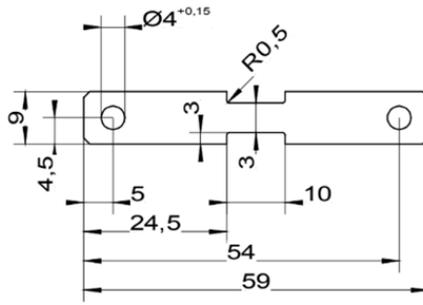
Figure 3.2 Technical drawing of the DIC testing specimen using in TA-BAEHR DIL805A/D-Deformation Dilatometer. Dimensions are in millimeter.

2 mm DP590 and DP800 steel sheets were cut parallel to the rolling direction by electrical discharge machining (EDM) according to the dimensions given in figure 3.2. because the cutting process requires precision. The test matrix determined for DIC experiments is provided in the table 3.2. These tensile tests continued until the samples ruptured.

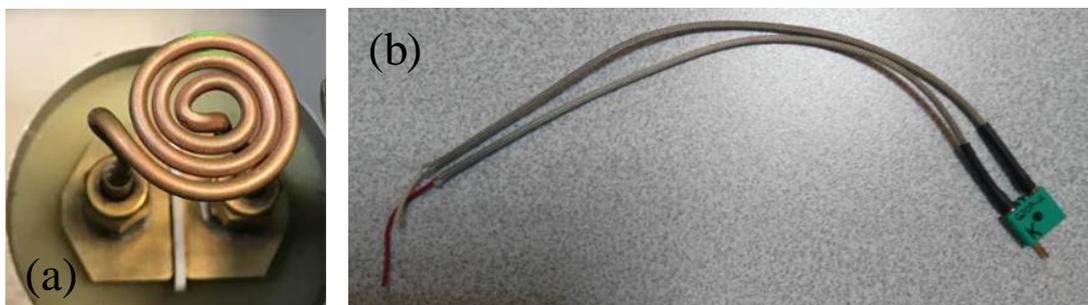
Figure 3.3 a) TA-BAEHR DIL805A/D horizontal induction coil; b) K type thermocouple i.e. suitable for dilatometer

After the room temperature tests were completed, the horizontal induction coil was used in dilatometer for high-temperature tests (Fig. 3.3(a)). Thermocouples are welded to the samples for temperature control in high-temperature tests. The thermocouples used are compatible with the device and differ from the conventional thermocouple (Fig. 3.3 (b)). The thermocouple welding process was carried out with a particular device capable of spot welding (Fig. 3.4). The sample to which thermocouple was welded and ready to be test is given in the figure below (Fig. 3.5).

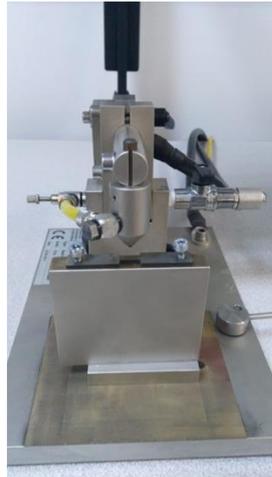
Figure 3.4 Spot welding device for thermocouple welding to sample for temperature control of dilatometer

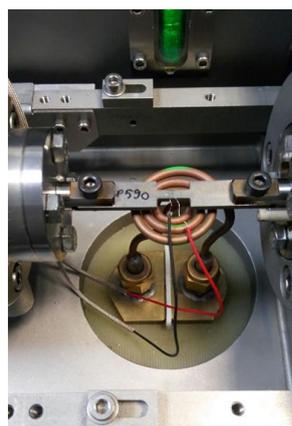
Figure 3.5 Thermocouple welded sample placed in dilatometer

For high-temperature experiments, heating was carried out on the induction coil on the dilatometer. Throughout the experiment temperature was monitored via thermocouple, heating rate was constant and determined as $10^{\circ}\text{C} / \text{s}$. At the end of the experiments, cooling rates was determined as $25^{\circ}\text{C} / \text{s}$.

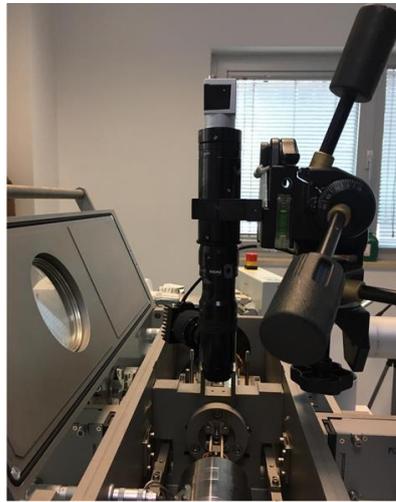
Figure 3.6 Experimental setup (Camera assembly with a tripod placed perpendicular to the sample)

Basler acA2000-165uc- ace model camera was used for optical image recording. This camera is equipped with a continuous magnifying lens i.e. Navitar UltraZoom 6000 brand and model, and the Navitar coaxial light source. This camera equipment was fixed to the TA-BAEHR DIL 805A / D deformation dilatometer with the help of a tripod in a position to view the measuring area of the sample vertically (Fig. 3.6). 1.4X magnification was used for the experiments and the field of view was $7.9 \times 4.2 \text{ mm}^2$. For experiments at a strain rate of 0.001 s^{-1} , the camera was set to receive 1 image per second (1 fps), and 140 images per second (140 fps) for 1 s^{-1} .

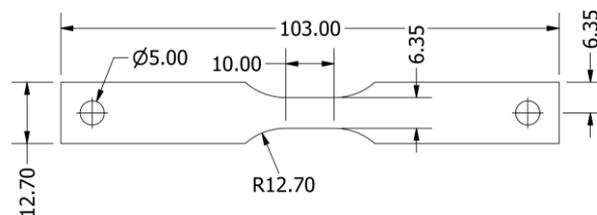
Figure 3.7 Technical drawing of the testing specimen

2 mm thick sheets of DP590 and DP800 grades obtained from Swedish Steel Works, SSAB were used for this study. Firstly, the steel sheets were cut parallel to the rolling direction by EDM according to the dimensions given in Figure 3.7.

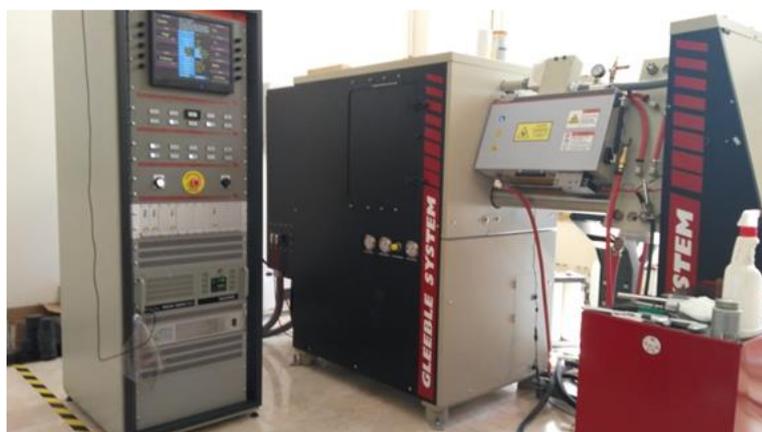
Figure 3.8 Gleeble 3500 device

Transformers (LVDTs) system and also contact-type extensometers [62]. This system was selected because of precise strain/strain rate control and high temperature capability.

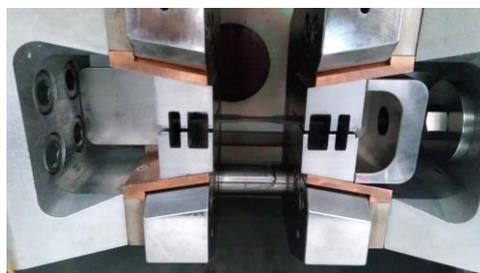
Figure 3.9 Tensile test sample located in the Gleeble the chamber before test

After a K-type thermocouple was welded to the sample to control temperature during the test, it was located chamber of the Gleeble (Fig. 3.9). The heating was performed by direct conduction and the temperature was controlled using the closed-loop thermal control. For high-temperature tensile tests, samples were heated at 10 °C/s up to the desired temperature and soaked for 60 seconds to obtain a homogeneous temperature distribution. The test was conducted with a homogeneous temperature distribution with a temperature difference of 10 °C between the gage and ends of the sample.

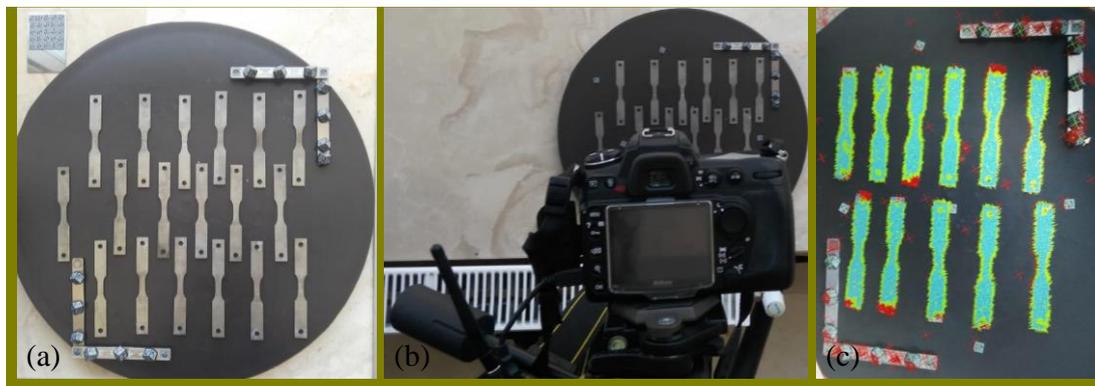
Figure 3.10 Samples a)after tested preparing for the Argus analysis, located with the help of Argus apparatus; b) photos were taken for the analysis; c) Argus analysis started based on the taken photos.

During the strain measurements, a certain speckle pattern was applied to the surface of samples before the tensile tests. The shape and dimensions of the speckles in the original pattern change after the deformation, and a camera records the initial and final patterns. Using the change in patterns, strain values were determined with the help of the Argus software (Fig. 3.10).

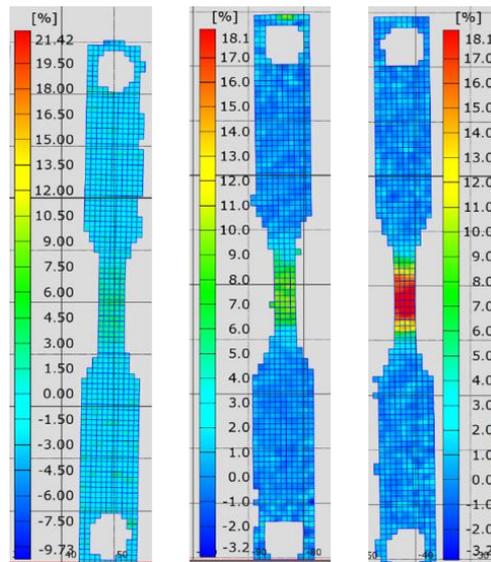
Figure 3.11 Argus analysis results of three different samples (DP590, 10 s-1 strain rate, 300 °C) tested at target strain values of 2%, 8%, 16% (from left to right).

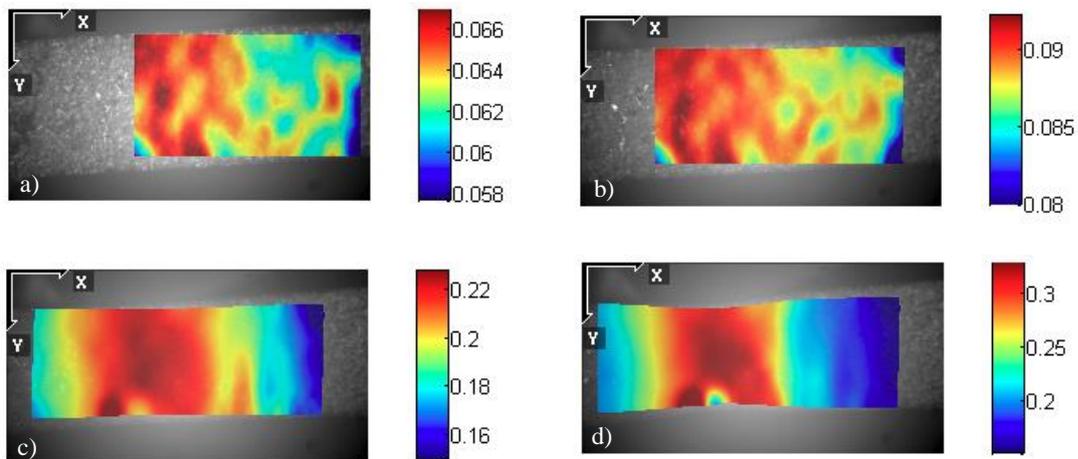
Figure 4.1 DP590 RT 10^{-3} s^{-1} ; a)5%, b)10%, c)20% [before neck], d)23% neck strain, DIC analysis

To compare the samples, the photographs were selected at the same strain values. The scale bars represent the strain amount accumulate in the samples. For some samples more photographs were selected since the DSA phenomenon is an important issue at those parameters.

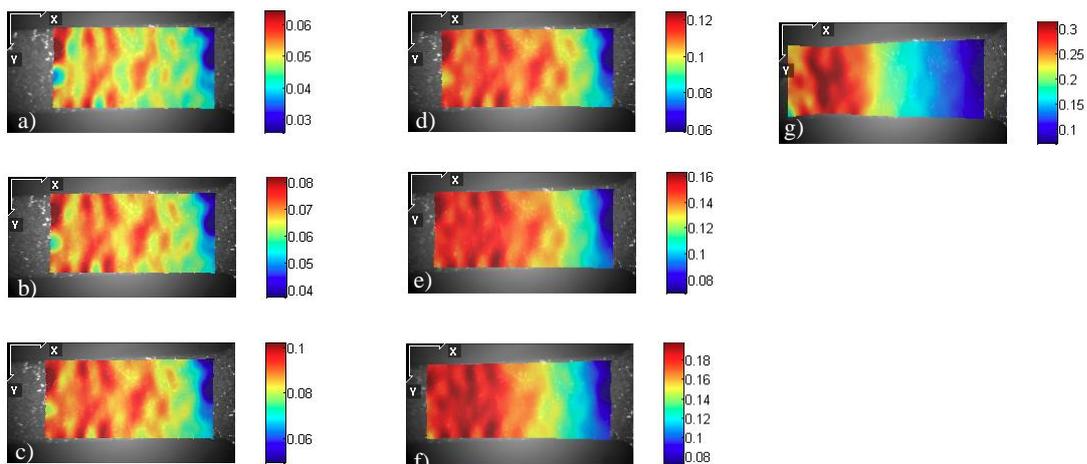
Figure 4.2 DP590 RT s^{-1} ; a)5%, b)6.7%, c)8.65%, d)10.7%, e)14.1%, f)16.4%, g)18.8% (neck) strain, DIC analysis

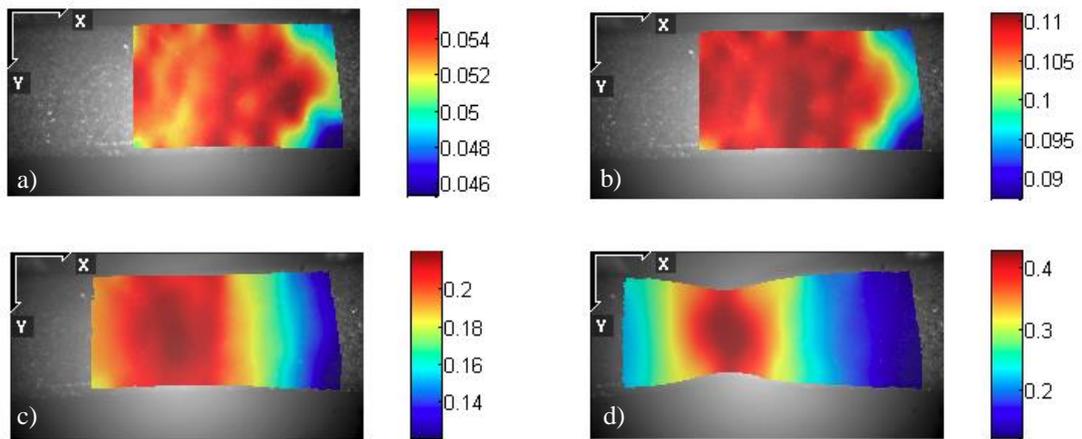
Figure 4.3 DP590 200°C 10^{-3} s^{-1} ; a)5%, b)10%, c)20% [before neck], d)24% neck strain, DIC analysis

Also, when compared to figure 4.3 and figure 4.4, it is seen that high temperature along with the strain rate causes this condition and increases its effect. It can be concluded that the high strain rate affects the flow instabilities and the DSA mechanism more than the temperature.

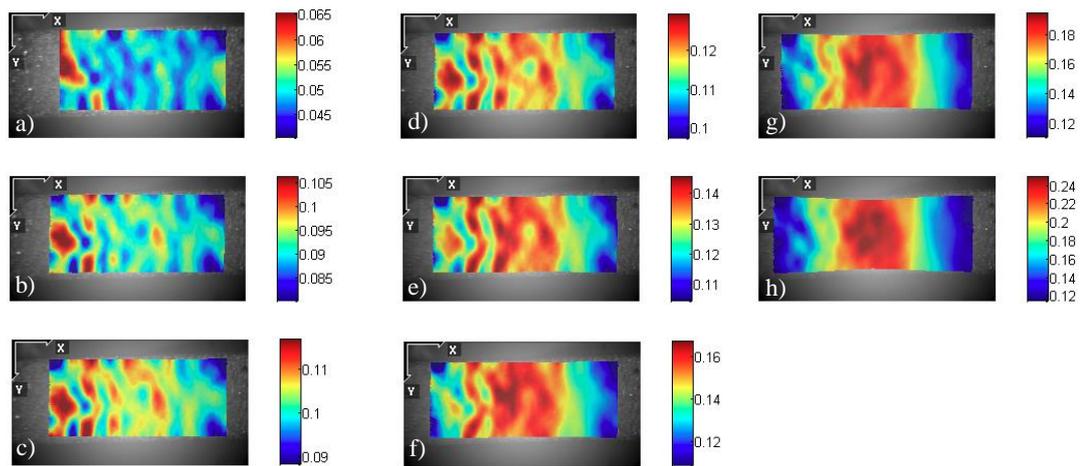
Figure 4.4 DP590 200 °C s^{-1} ; a)5%, b)9.1%, c)10.4%, d)11.6%, e)13.02%, f)14.5%, g)16%, h)18.3%(neck) strain, DIC analysis

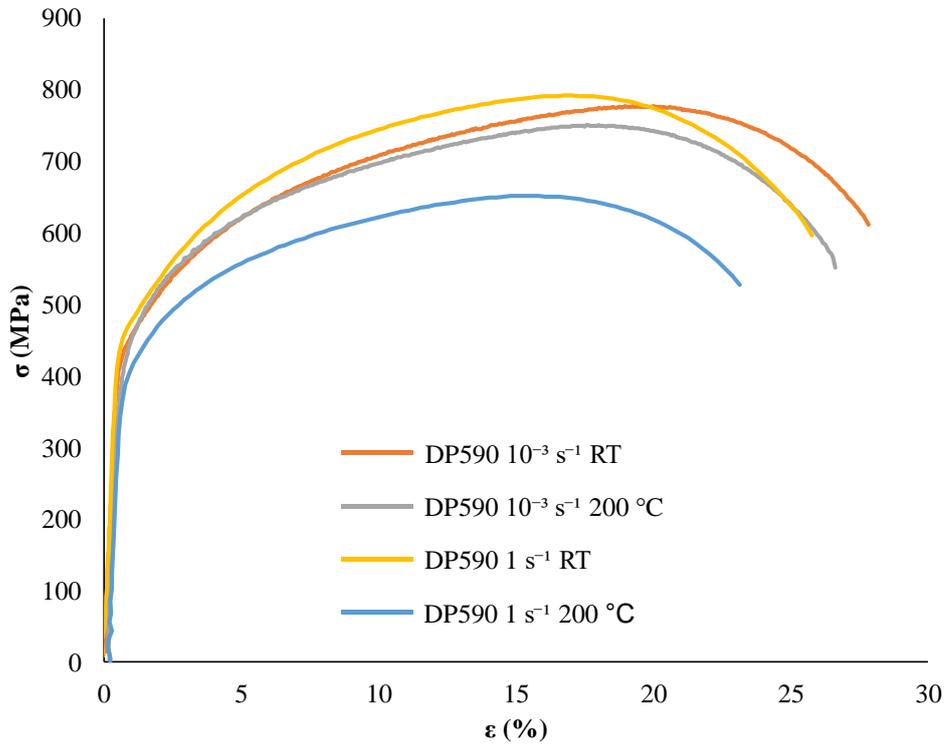
Figure 4.5 Stress&Strain curves of the DIC analyzed DP590 samples observed from tensile tests

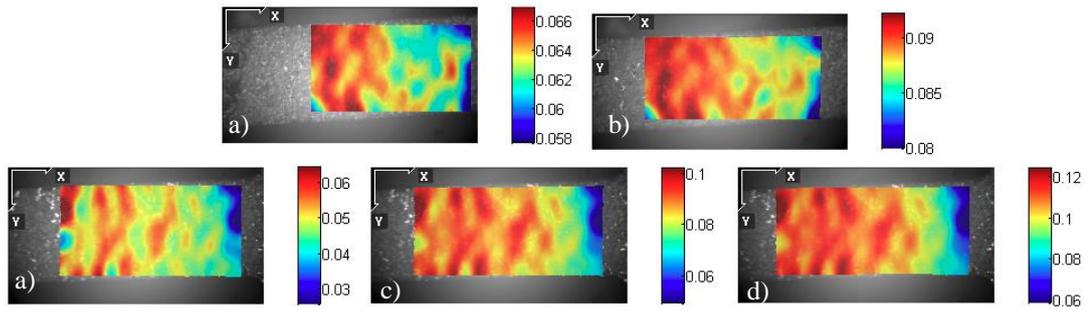
Figure 4.6 DP590 RT 10^{-3} s^{-1} ; a) 5%, b) 10%; DP590 RT 1 s^{-1} ; a) 5%, c) 10%, d) 11% strain DIC analysis

Strain localization is more prominent for the high strain value, so it can be said that the deformation is happening as the strain accumulated in these structures. This behavior is more homogeneous at low strain rates. This result shows the effect of the strain rate by DIC method.

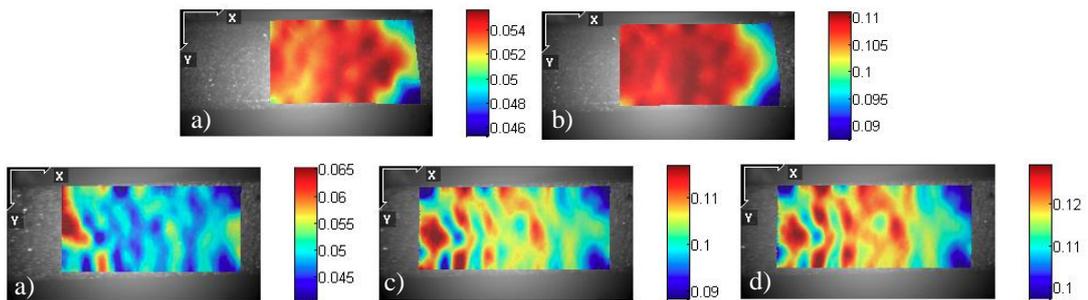
Figure 4.7 DP590 $200 \text{ }^{\circ}\text{C}$ 10^{-3} s^{-1} ; a) 5%, b) 10%; DP590 $200 \text{ }^{\circ}\text{C}$ 1 s^{-1} ; a) 5%, c) 10%, d) 11% strain, DIC analysis

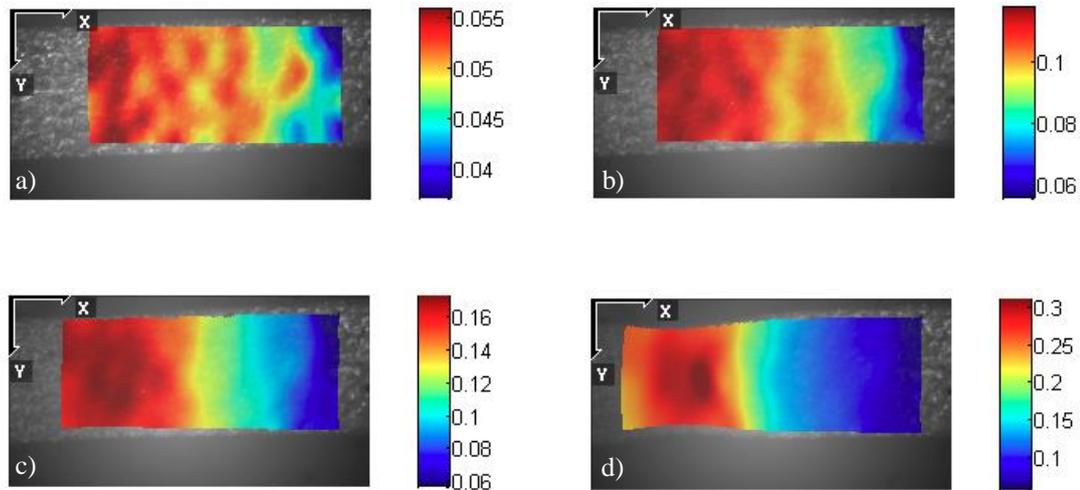
Figure 4.8 DP800 RT 10^{-3} s^{-1} ; a)5%, b)10%, c)13% [before neck], d)14% neck strain, DIC analysis

To compare the samples, the photographs were selected at the same strain values. The scale bars represent the strain amount accumulate in the samples. For some samples more photographs were selected since the DSA phenomenon is an important issue at those parameters.

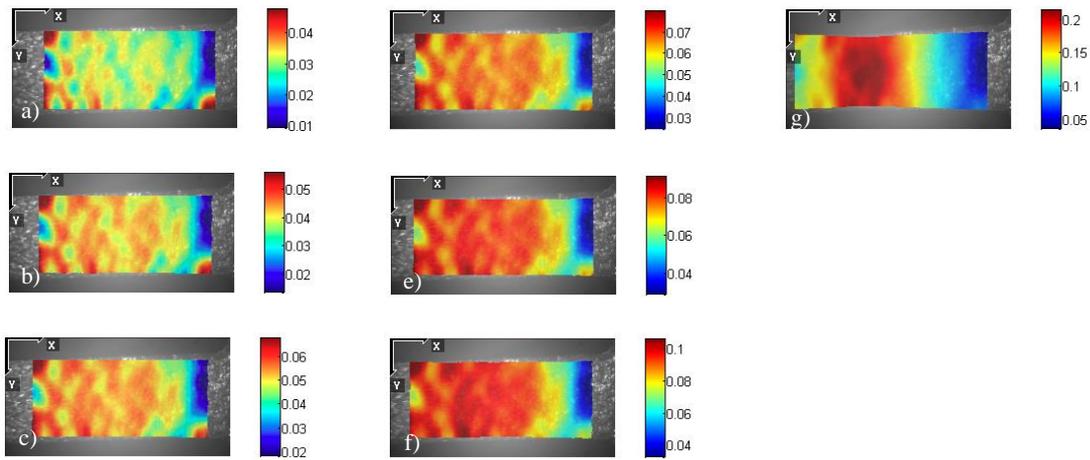
Figure 4.9 DP800 RT 1 s^{-1} ; a)3%, b)4%, c)5.2%, d)6.45%, e)7.8%, f)9.2%, g)14.6% (neck) strain, DIC analysis

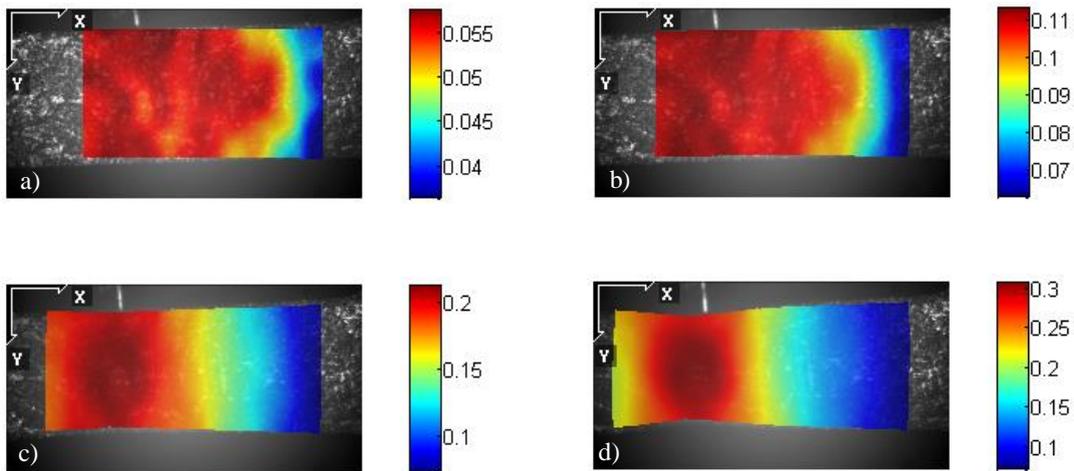
Figure 4.10 DP800 200°C 10^{-3} s^{-1} ; a)5%, b)10%, c) 17%, d)20% strain, DIC analysis

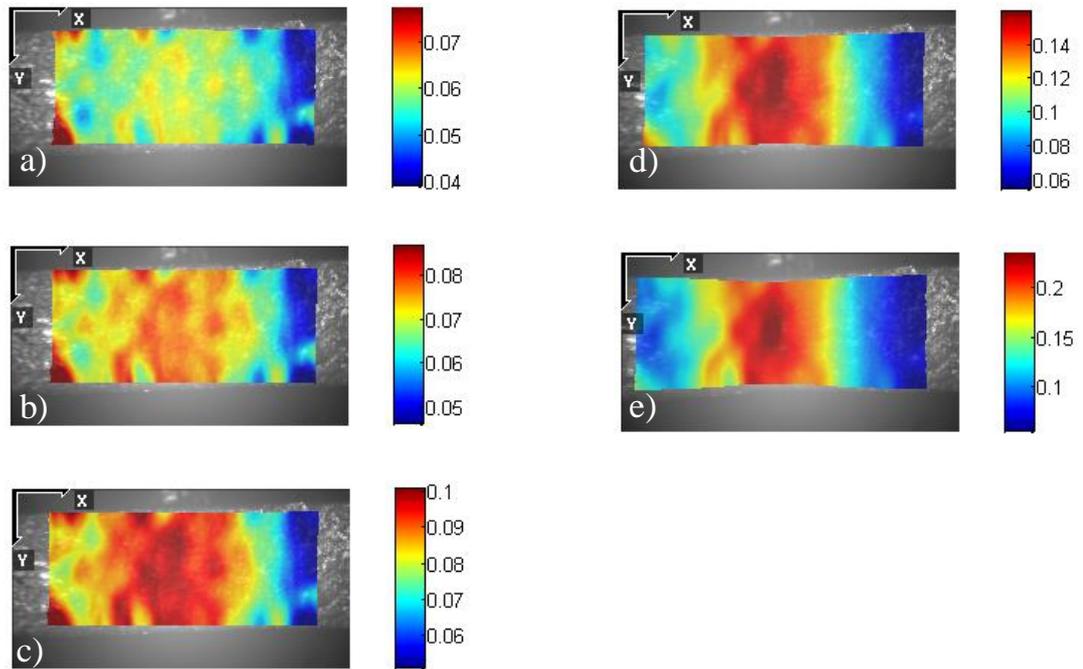
Figure 4.11 DP800 200°C 1 s⁻¹; a)3%, b)4%, c)5.2%, d)6.45%, e)7.8% strain, DIC analysis

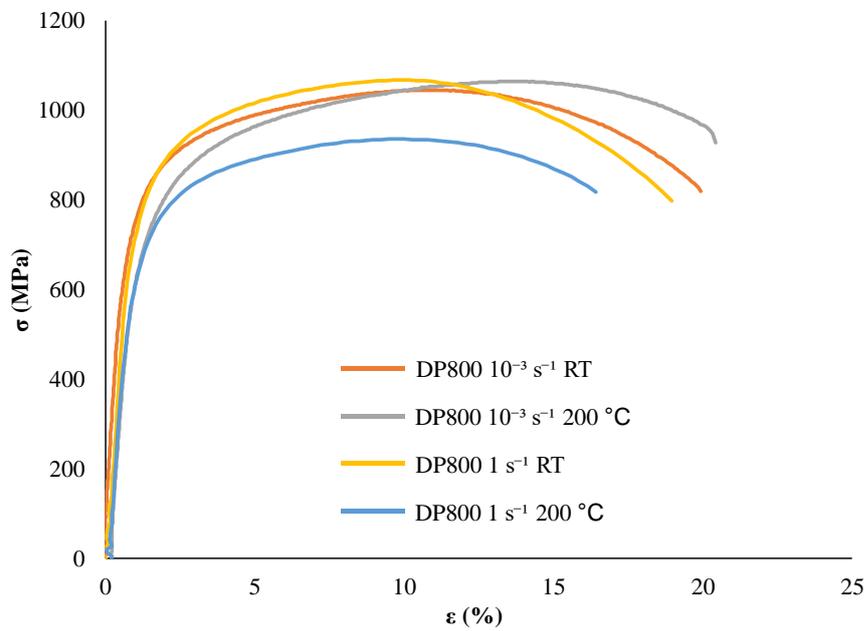
Figure 4.12 Stress&Strain curves of the DIC analyzed DP800 samples observed from tensile tests

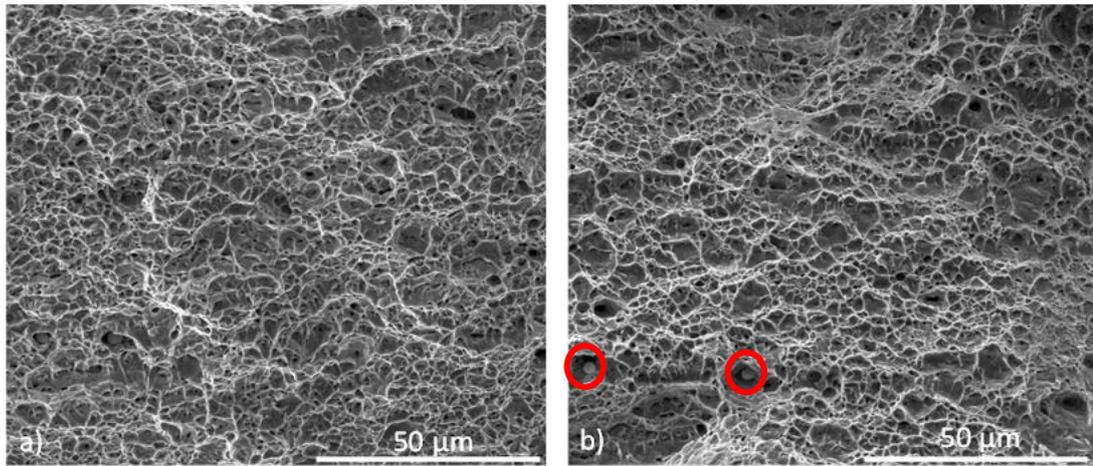
Figure 4.13 Fracture surface of DP590 10^{-3} s^{-1} ; a)RT, b)200 °C (red circles shows the nucleation cites)

Fig. 4.13 (a) is the SEM image of DP590 steel, which was tensile tested at room temperature at a strain rate of 10^{-3} s^{-1} . Figure 4.13 (b) shows the image taken from the fracture surface of DP590 steel, which was tested at 200° C at 10^{-3} s^{-1} .

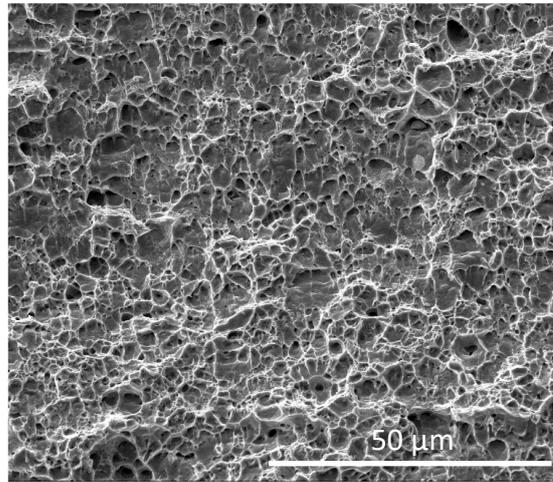
Figure 4.14 Fracture surface of DP590 1 s^{-1} RT

seen the dimples are larger in high temperatures and also since these samples tested at low strain rate no visible DSA effect was observed at the fracture surface images.

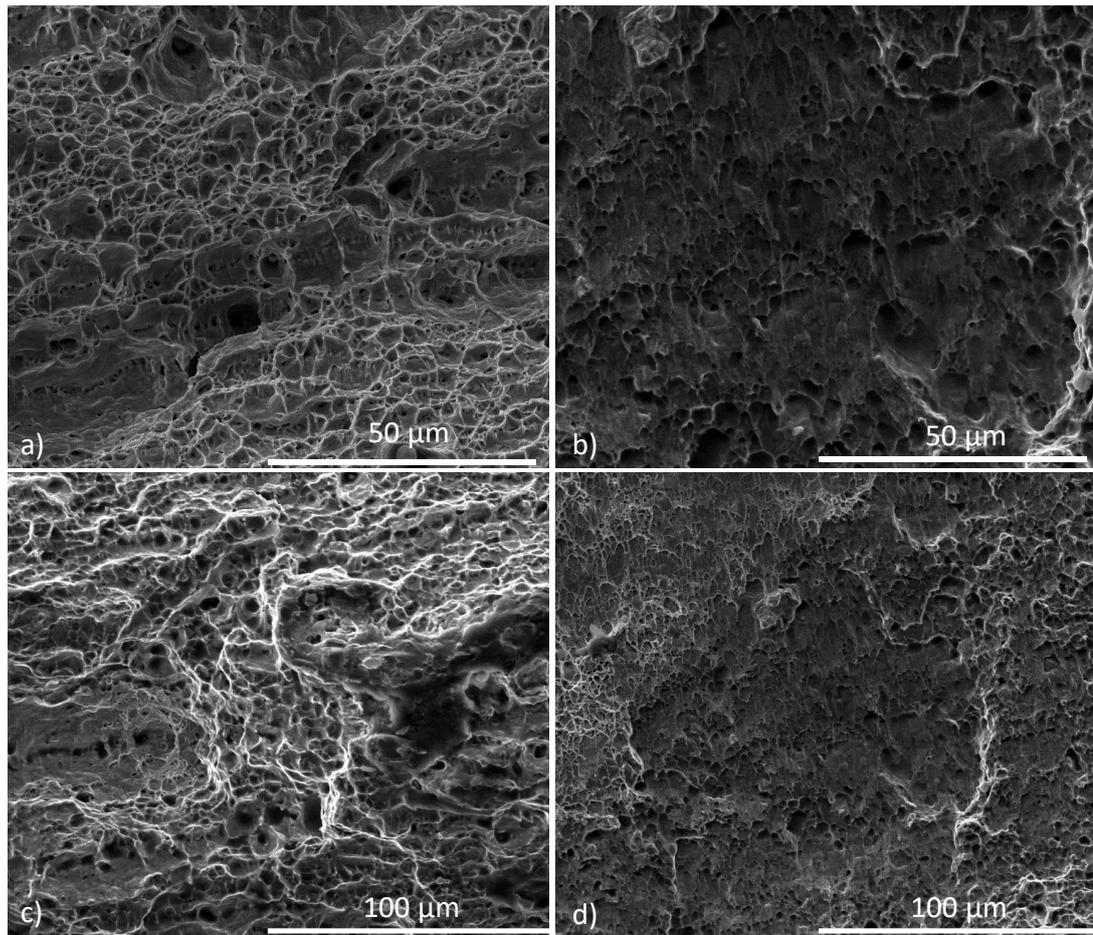
Figure 4.15 Fracture surface of DP590 1 s^{-1} 200 °C; a)3000x, b)3000x, c)1600x, d)1500x

When the images of DP590 obtained from different parameters are analyzed, it is understood from the fracture surfaces the steel is failed in the ductile type of fraction. Dimples are the most characteristic features of this type of fraction.

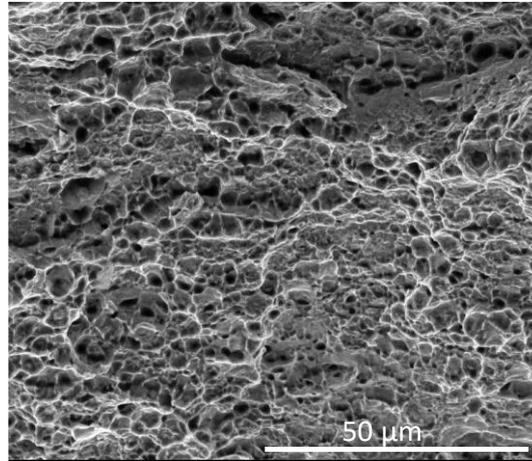
Figure 4.16 Fracture surface of DP800 10^{-3} s^{-1} RT

characteristic features of the ductile type of fracture are seen in the figure 4.16 and figure 4.17.

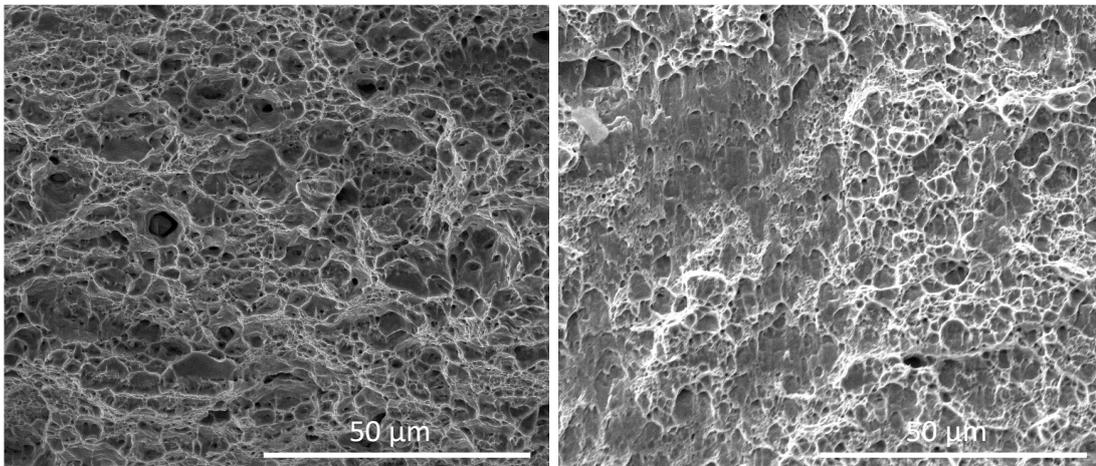
Figure 4.17 Fracture surface of DP800 1 s^{-1} RT

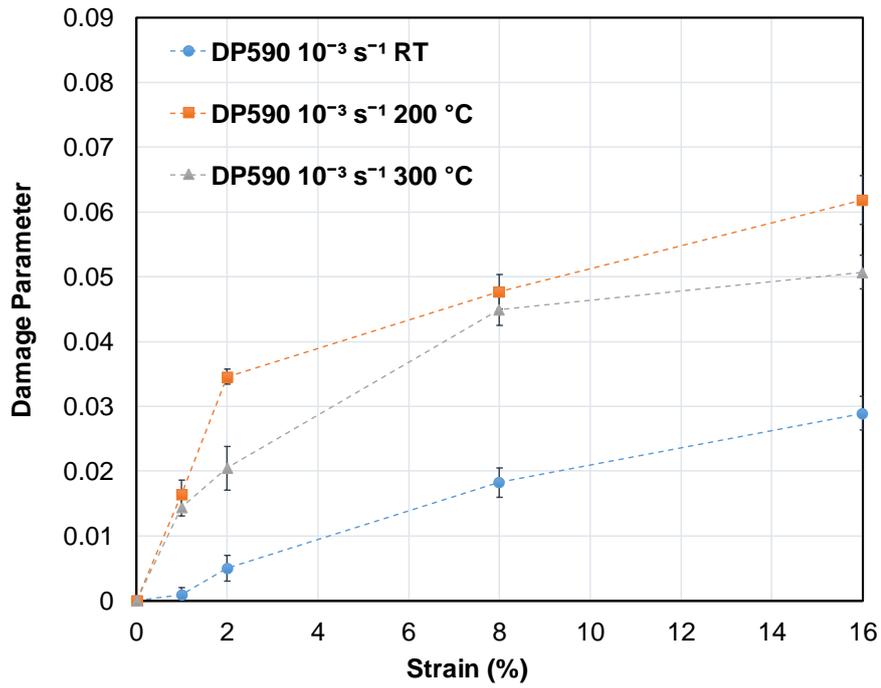
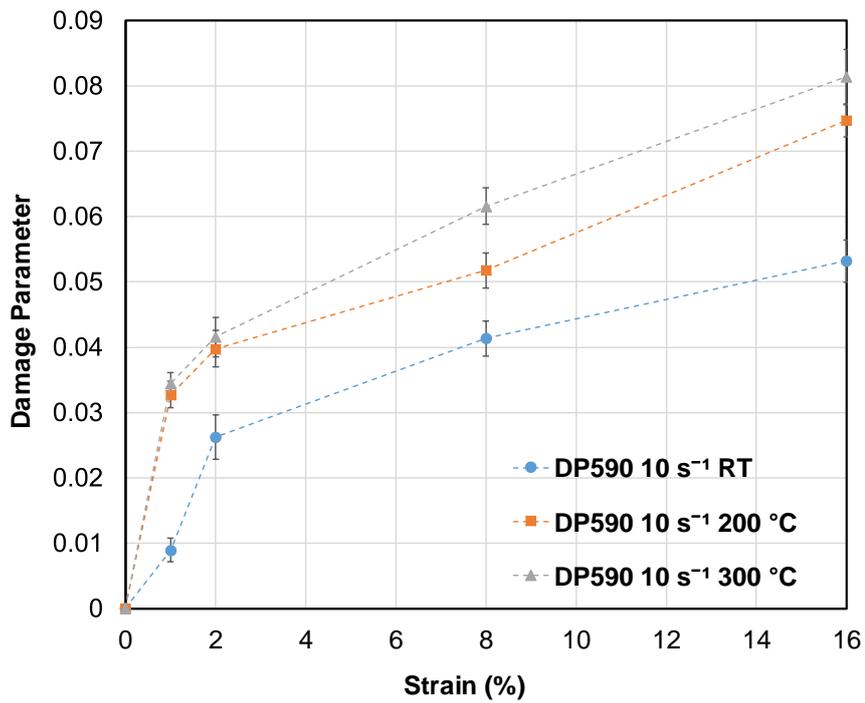
Figure 4.18 Damage parameter vs. strain graphs of DP590 tested at different temperatures; (top) low strain rate, 10⁻³ s⁻¹ vs (bottom) high strain rate, 10 s⁻¹.

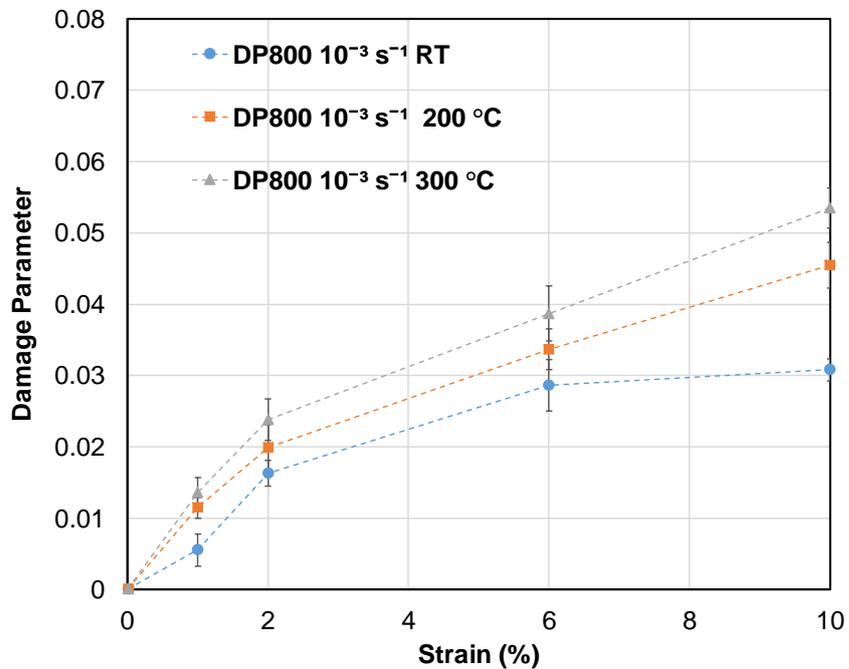
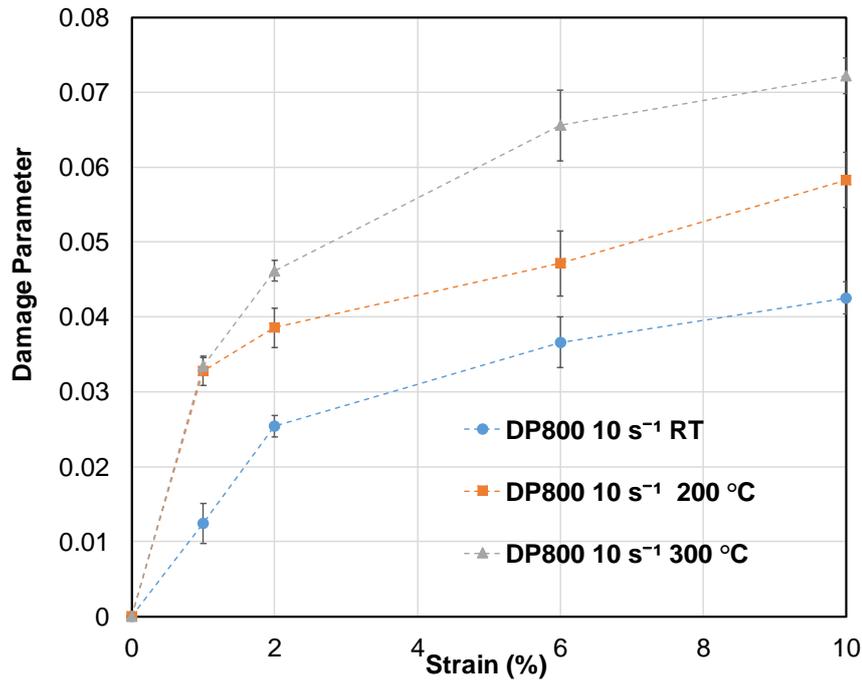
Figure 4.19 Damage parameter vs. strain graphs of DP800 tested at different temperatures; (top) low strain rate, 10⁻³ s⁻¹ vs (bottom) high strain rate, 10 s⁻¹.

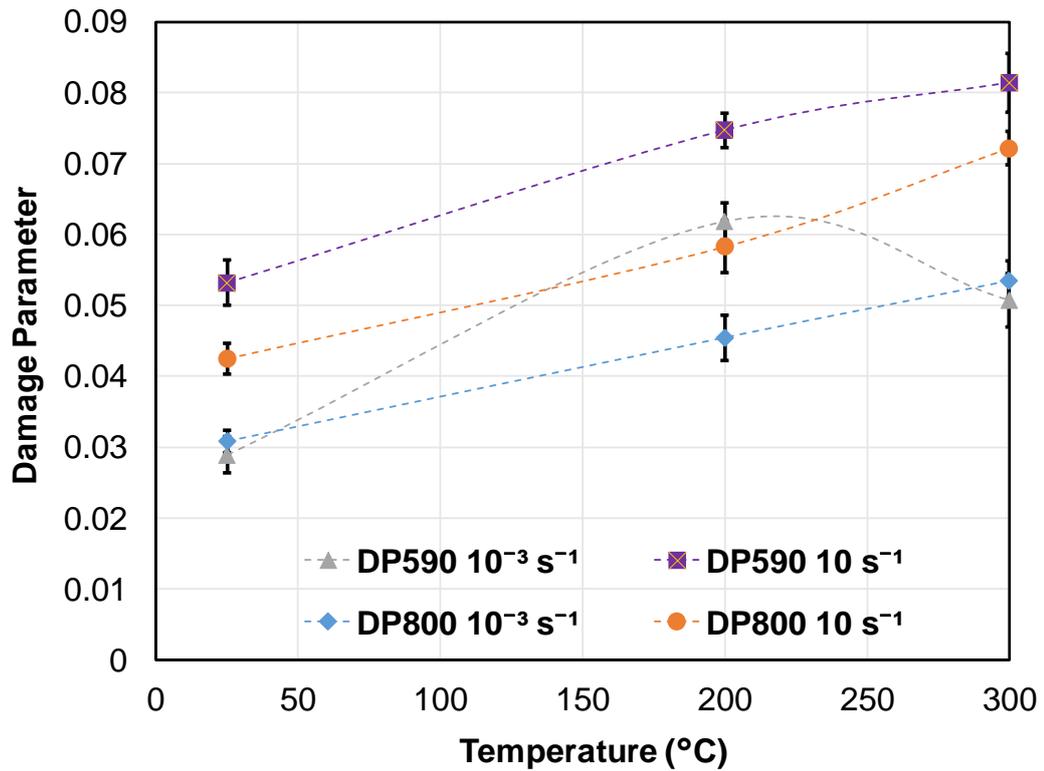
Figure 4.20 Damage parameter vs. temperature graph of DP590 and DP800 at 10^{-3} s^{-1} and 10 s^{-1} strain rates, and at their uniform strains (16% and 10%).

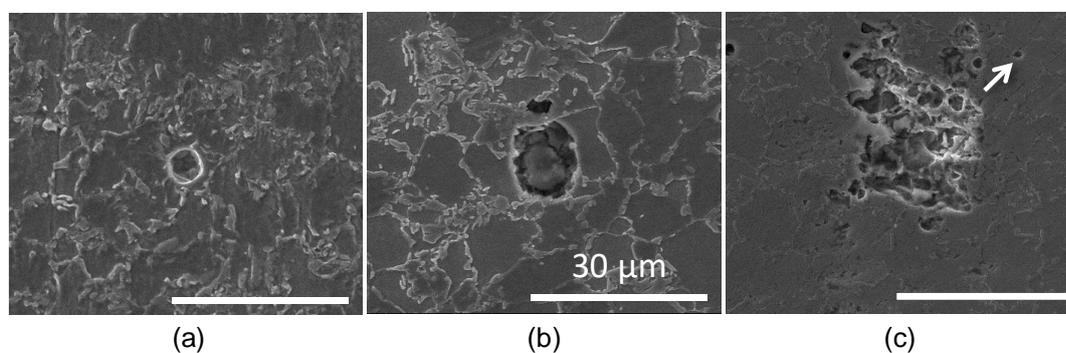
Figure 4.21 SEM pictures of DP590 tested at; a) 10^{-3} s^{-1} - RT, b) 10 s^{-1} - RT, c) 10 s^{-1} - $300 \text{ }^{\circ}\text{C}$, and at same strain of 16 %. Scale bars are $30 \text{ }\mu\text{m}$.

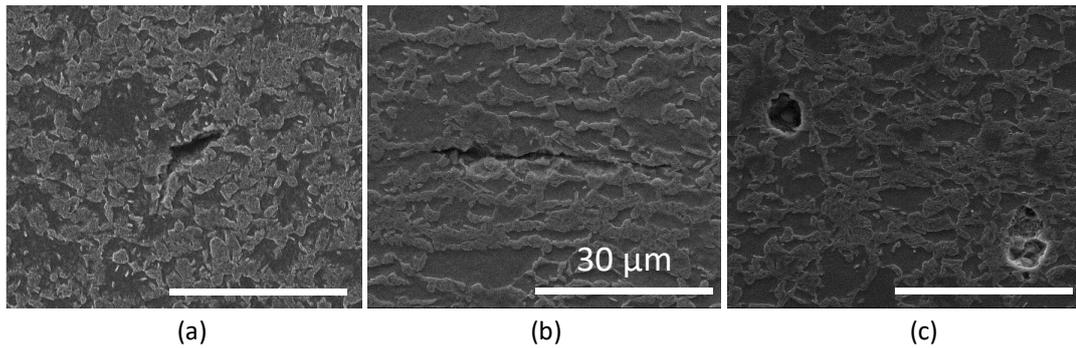
Figure 4.22 SEM pictures of DP800 tested at; a) 10^{-3} s $^{-1}$ - RT, b) 10 s $^{-1}$ - RT, c) 10 s $^{-1}$ - 300 °C, and at same strain of 10 %. Scale bars are 30 μ m.
