AN INFORMED PROCESS FOR NEW BUILDING DESIGN IN HISTORIC  
SETTLEMENT: THE CASE OF İBRAHİMPAŞA VILLAGE, CAPPADOCIA-  
TURKEY

A THESIS SUBMITTED TO  
THE GRADUATE SCHOOL OF NATURAL AND APPLIED SCIENCES  
OF  
MIDDLE EAST TECHNICAL UNIVERSITY

DECEMBER 2019

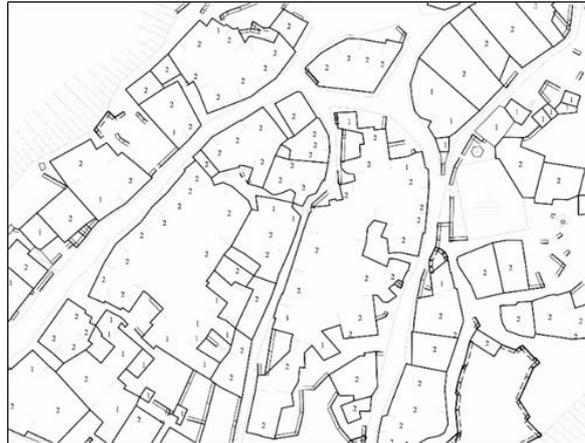
Figure 1.2. Example of the digital basemap provided from Municipality of Ürgüp

The first site survey for gathering above mentioned information and understanding the site, was made in October 2015. The digital basemap provided by the Municipality of Ürgüp didn't provide information about the building-lot relationships, as it only had the outer borders of the building blocks (Figure 1.2). Therefore, a new basemap is prepared during the site survey using the lot borders, regarding the present physical environment. In this site survey, information about open and built-up areas have been collected on the prepared basemap and the village is systematically photographed.

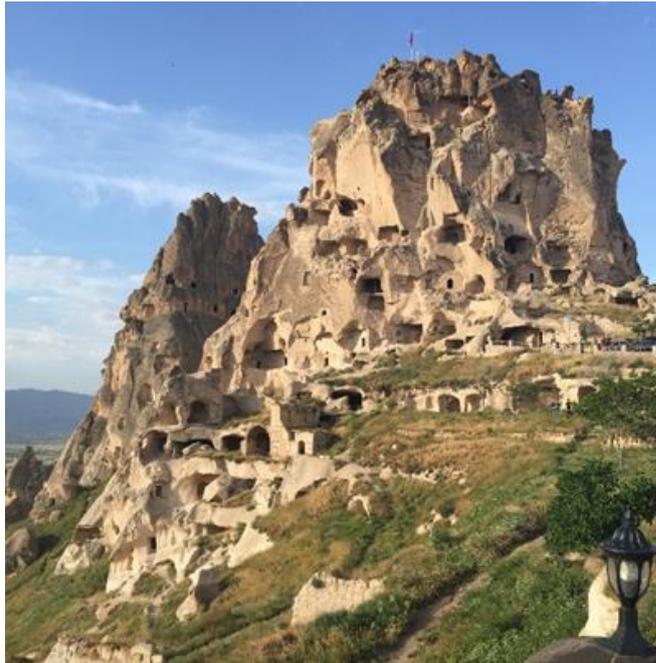
Figure 3.9. Uçhisar, as an example of a settlement placed around a giant tuff rock, with spaces carved into the rock

In addition to the defense reasons, this form of architecture is also a logical response to the local conditions of the area and “carving to dwell” has been a major form of placemaking in Cappadocia during its settlement history (Stea-Turan, 1993, p.165). Extension of carved spaces with exterior masonry structures is also a characteristic of the region and masonry structures as the last stage of this formation. These three types of settlement patterns constitute the variations of traditional houses.

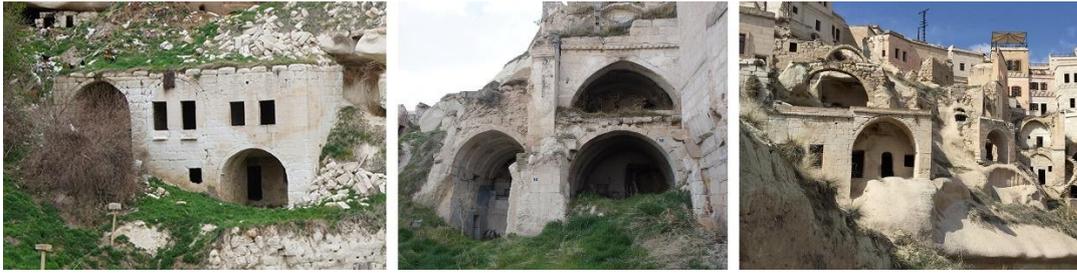
Figure 3.11. Examples of mixed technique, extending from rock-cut spaces with masonry units

Rock-cut houses as the earliest housing type, can be generated vertically or horizontally with spaces within the rock formation and as they grew according to the need, they don’t have any plan typology. In the mixed technique, the carved-out space is extended in the front with masonry structures such as addition of walls, aiwans or room(s) (Figure 3.10). In this process, additional spaces can also be added on the rock or on the masonry part as a second storey. Masonry houses are one, two or sometimes three storeyed buildings which don’t have any relation with rock cut spaces and this

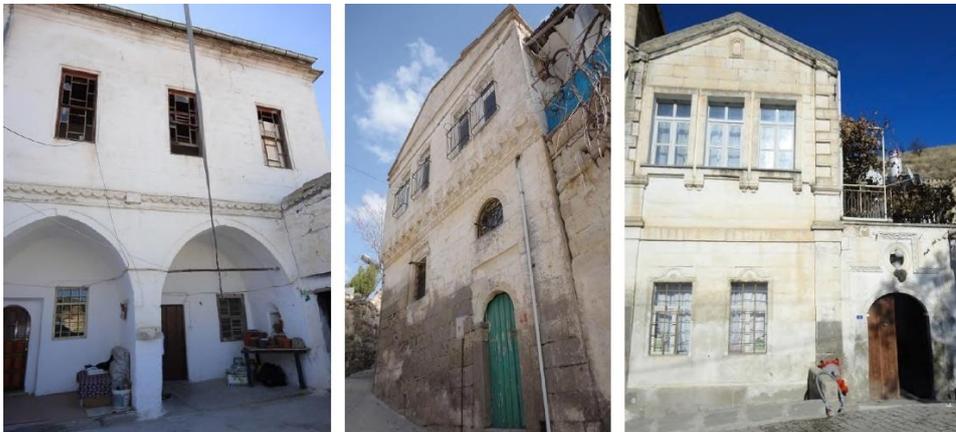
Figure 3.12. Building placed in a courtyard (left - Mustafapaşa), Buildings placed facing the street (middle and right - Mustafapaşa) (Solmaz, 2013)

The settlements in Cappadocia region are shaped according to the geography and natural features. The houses forming these settlement patterns are usually placed either facing the street having an entrance directly from the street or they are drawn back and have a courtyard in the front as a transition space between the street and the building.

There is no systematic production technique of rock-cut houses because new spaces are added according to the needs of the inhabitants. For masonry houses, the buildings are either placed facing the street having a direct entrance, or the building is drawn

back of the parcel and connection is provided by a courtyard in the front (Erençin, 1979, s. 104).

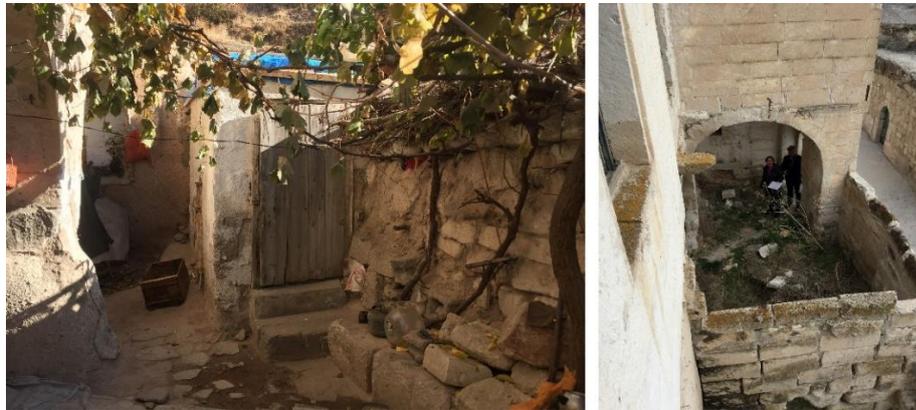
Figure 3.13. Examples of courtyards

Courtyards are places for daily life activities, and they are surrounded with high walls because of privacy reasons. The courtyard walls are above the eye-level and they are made of cut stone or rough-cut stone (Figure 3.14). Courtyards are entered through a double-winged timber door placed on the courtyard walls and the floor is covered with stone or soil (Solmaz, 2013, s. 27). The size of the courtyards can vary and alongside with elements such as *tandır*, toilet etc., spaces such as hayloft, storage, stable, *tandır* room and other living spaces are located in the courtyard (Solmaz, 2013, s. 27).

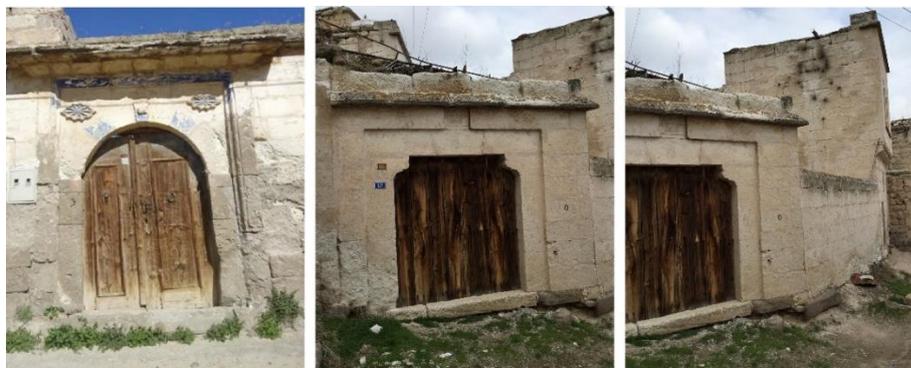
Figure 3.14. Courtyard doors and walls

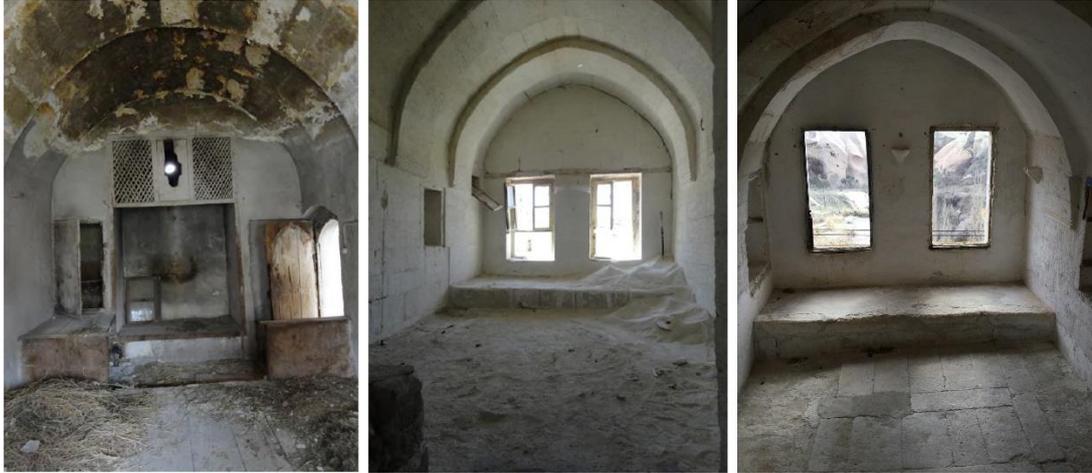
Figure 3.15. Examples of rooms from Ortahisar (left) (Solmaz, 2013), Ulaşlı (middle) (Solmaz, 2013) and İbrahimpaşa (right)

**Room:** Room is the basic unit of the house and it can be placed on any floor either as a whole masonry unit or as a complementary part of a carved-out space. The number of rooms in a house may vary depending on the family living in, their economic condition and the size of the house (Solmaz, 2013, s. 28). The layout of the second floor follows the plan of the first floor, but it can be either set on behind or have projections over the ground floor and the rooms are placed in a way that that all of them can gaze either the street or the courtyard (Binan, 1994, s. 133).

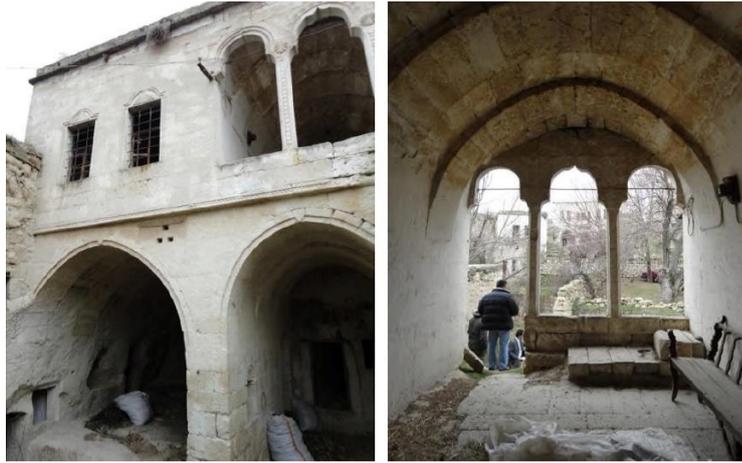
Figure 3.16. Aiwan on the ground floor (left) and upper floor aiwan with triple arch (Solmaz, 2013)

**Aiwan:** Aiwan is another main unit of the house, semi-open in one side and closed in three sides and its covered with a vault (Erençin, 1979, s. 11). It can either be placed on the ground floor or on the first floor and there can be more than one depending on the need and the size of the building. If it is on the ground floor, it may have a *tandır*

The aiwans can sometimes be ended with an arch system on the side that they are open with one, double, triple quarterly arch (Figure 3.16) or a hanging arch (Erençin, 1979, p.114). The aiwans on upper floor are connection areas between room and they face the courtyard sometimes having a direct connection from the courtyard with stairs.

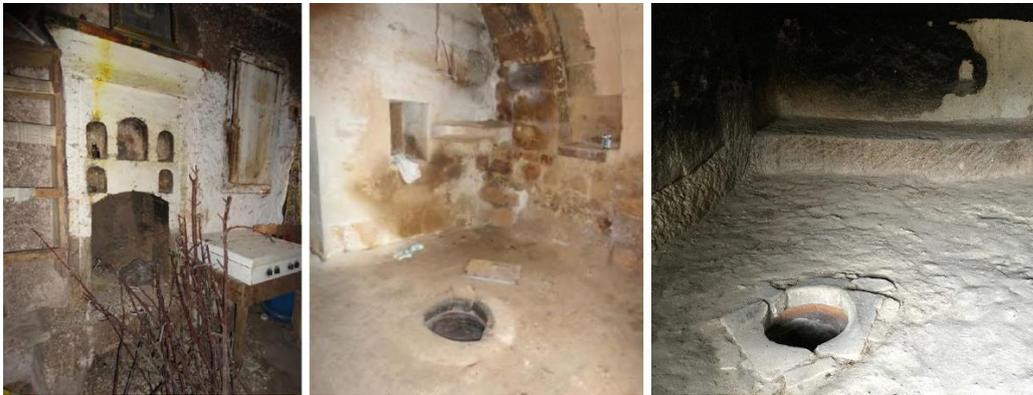
Figure 3.17. Kitchen (left) and tandır rooms (middle and left) (Solmaz, 2013)

**Kitchen:** Kitchen is placed on the ground floor, in relation with the storage rooms either directly or through the courtyard. Fireplace is the main architectural element of this space and it is used in winters (Solmaz, 2013, s. 30).

**Tandır room:** *Tandır* room is a vaulted aiwan with *tandır* on the ground as the main architectural element. It is placed in front of the kitchen and used as a “summer kitchen”. *Tandır* is created by carving the floor and they sometimes have terra-cotta shafts, used for cooking food and bread (Erençin, 1979, p.110).

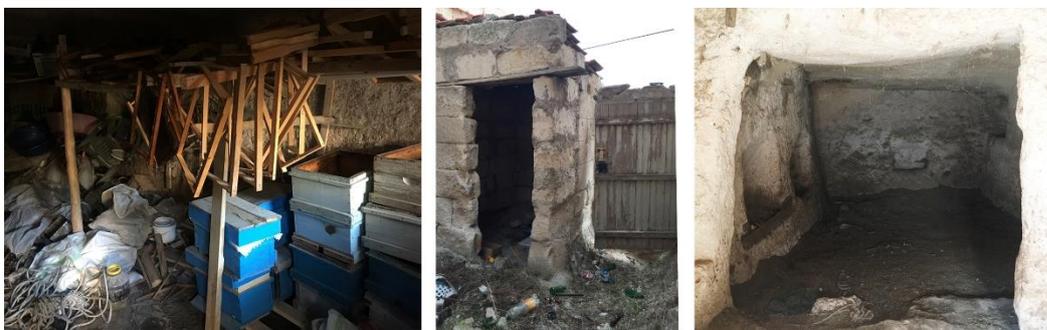
Figure 3.18. Storage (left), toilet (middle) and stable (right)

**Storage:** These spaces are to store foods and other things and they are in connection with the kitchen either directly or through the courtyard. Storage spaces are mostly rock cut spaces with lots of niches and shelves (Solmaz, 2013, s. 31).

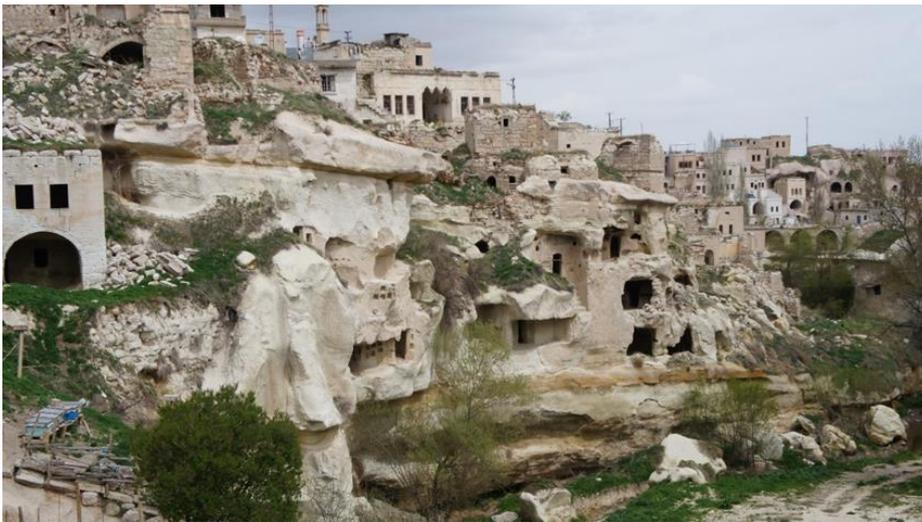
Figure 3.36. Carved-out spaces along the streambed

Topography of the area affected the settlement characteristics of the village. The former living units were carved into rocks along the streambed as seen in Figure 3.36. The buildings are placed on the slopes in a way that they don't close the view of the others (Figure 3.37) on both sides of the streambed and the higher parts of the village are denser in terms of buildings intensity, gradually decreasing to the sides in harmony with the slopes (Figure 3.35).

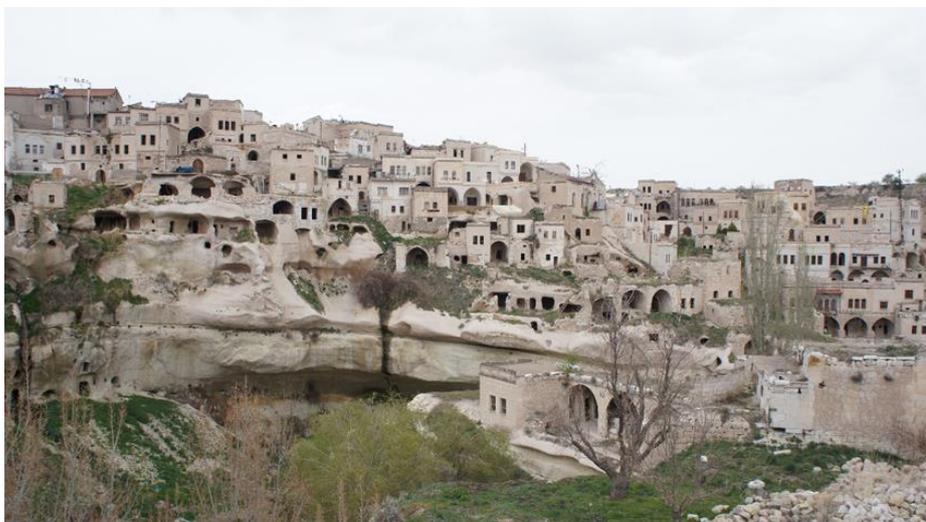
Figure 3.37. Buildings on the slopes

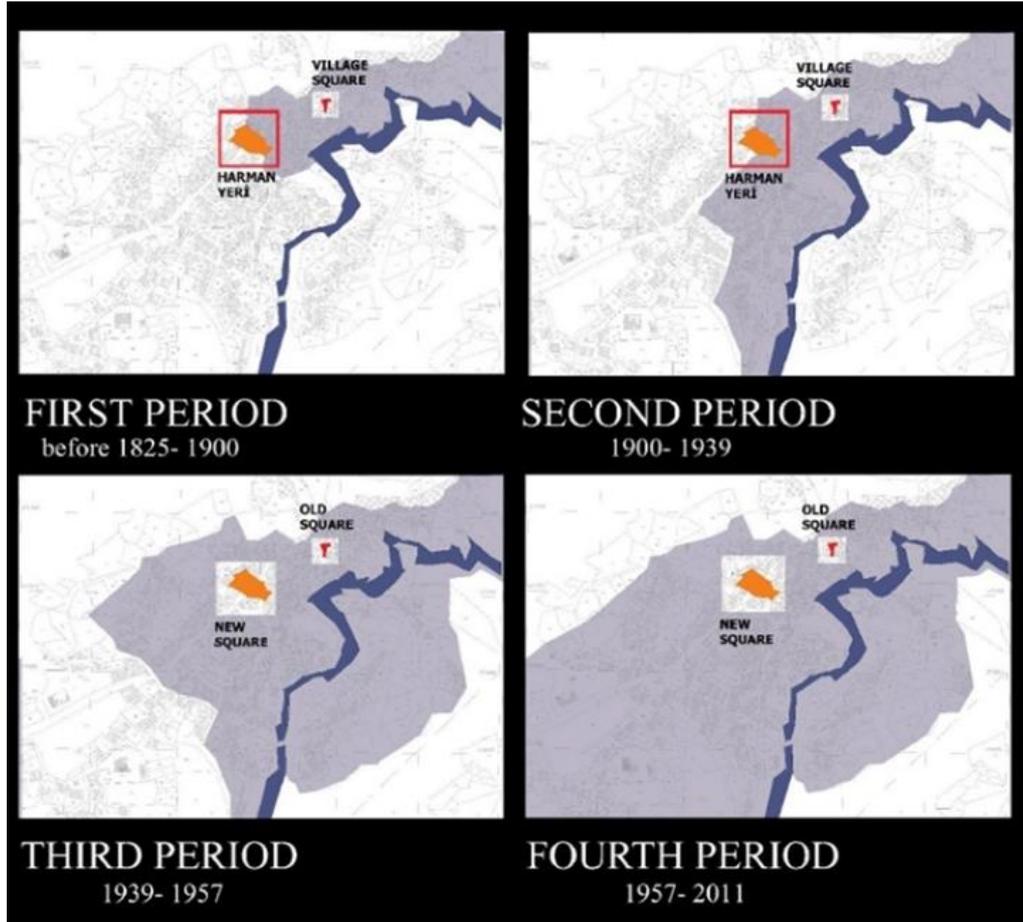
Figure 3.40. Transformation process of the village settlement (Karakul, 2011, s. 162)

The following analysis of the village will concentrate on the building inventory which belongs to the third and fourth periods as the study area, and the borders of the third period will be mentioned as “primary study area”.

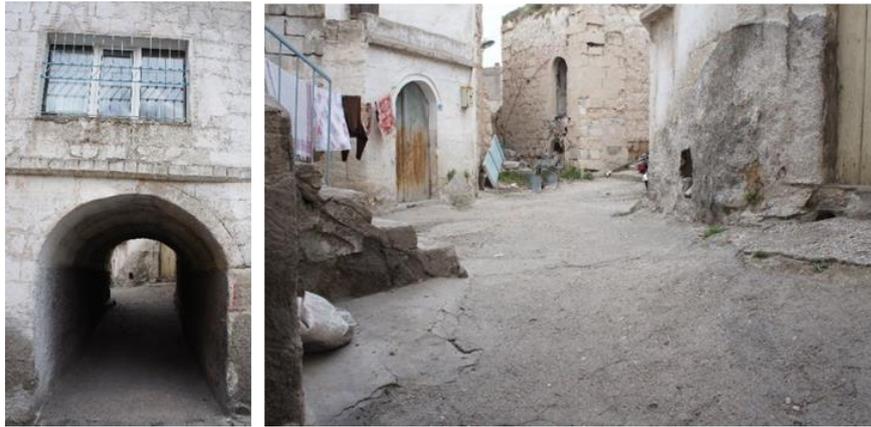
Figure 3.48. Archway and Courtyard through an archway

Courtyards are generally paved, sometimes having some land for planting. There are also some courtyards which are used by several buildings which do not have their own private open areas and entered through an archway from the street which are called “*Aralık*” or “*Kemeraltı*” (Figure 3.48).

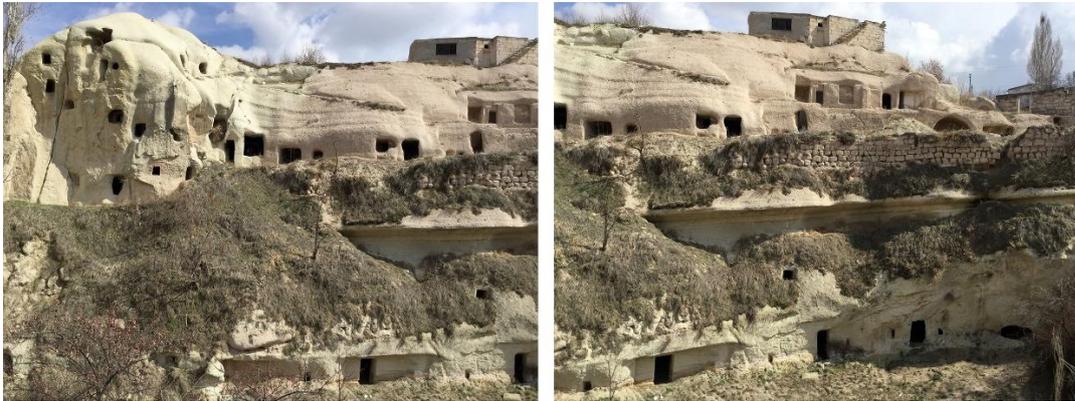
Figure 3.53. Carved-out spaces

The public open areas which are located along the streambed consist of rock formations, some of them comprising of carved-out spaces (Figure 3.53) and there are also some lots which the borders are not perceived (Figure 3.54) and became a part of the street. The dead-end streets are also defined by lot boundaries and they are used by public as continuation of streets.

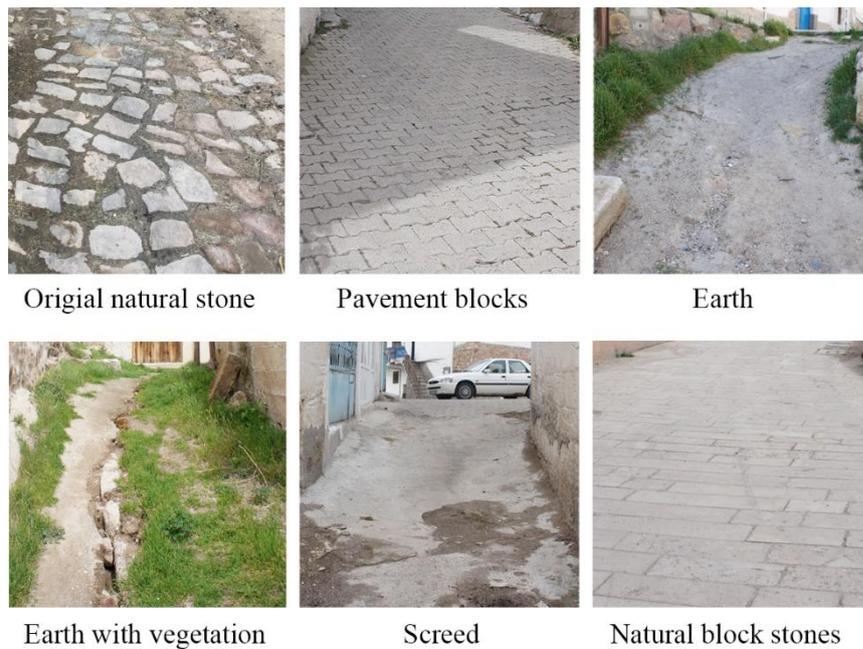
Figure 3.62. Different types of pavements in the study area

There are different types of pavements in the study area. The traditional natural stone is only seen in western part of *Aşağı Mahalle* and a small part of *Yukarı Mahalle*. The main road and the village square, which have both vehicular and pedestrian circulation, is paved with pavement blocks. It is seen that the streets which are located on areas with steep slopes are covered with earth and sometimes with vegetation on them. Remaining streets are paved with screed and the İbrahimpaşa Bridge is paved with natural block stones.

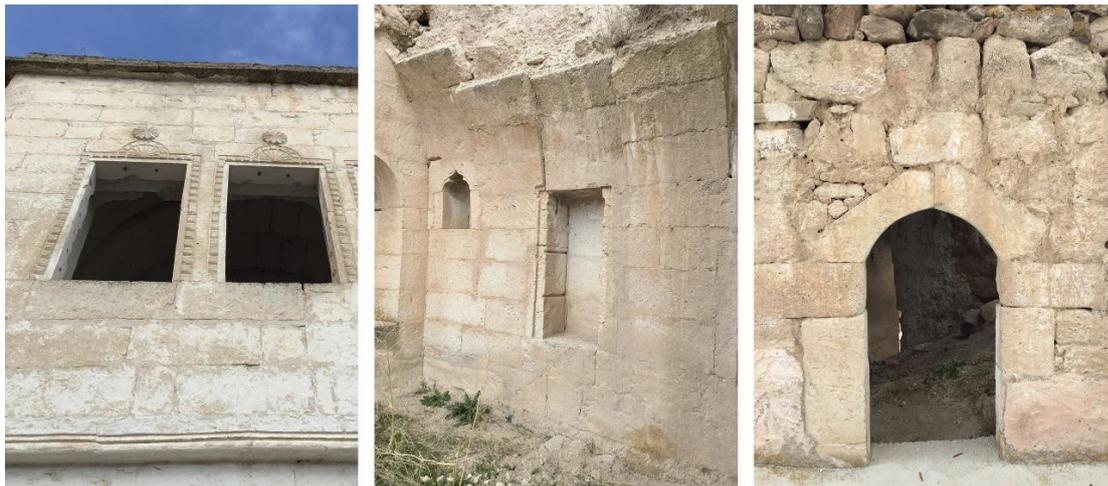
Figure 3.73. The local “white” stone used for buildings

Nearly all buildings in the primary study area are constructed with local stone, “white stone” which was carved from a quarry near the village. This stone was used on street facades and main walls whereas tuff was used for secondary walls and in rock cut units by being carved out (Karakul, 2011, s. 76). Traditional buildings are built with stone masonry as additions to a rock carved space or as a single building. In the main

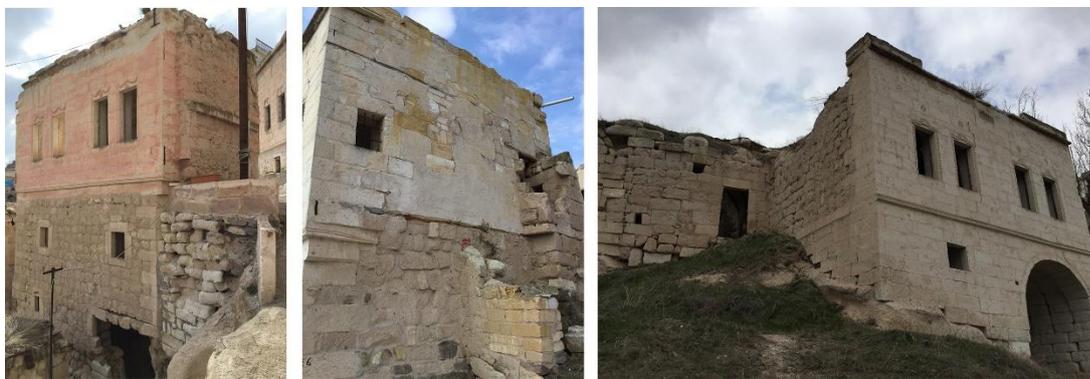
Figure 3.74. Buildings with serious structural problems but are still standing

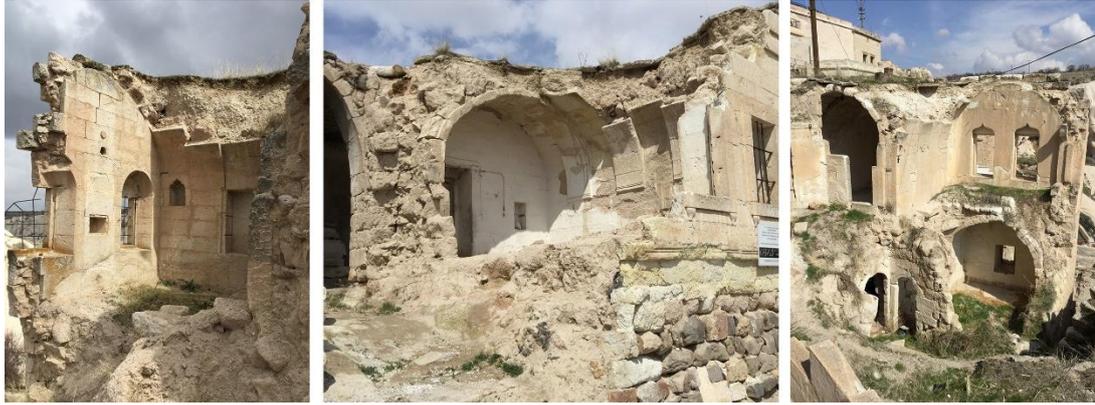
Figure 3.75. Buildings which are partially collapsed

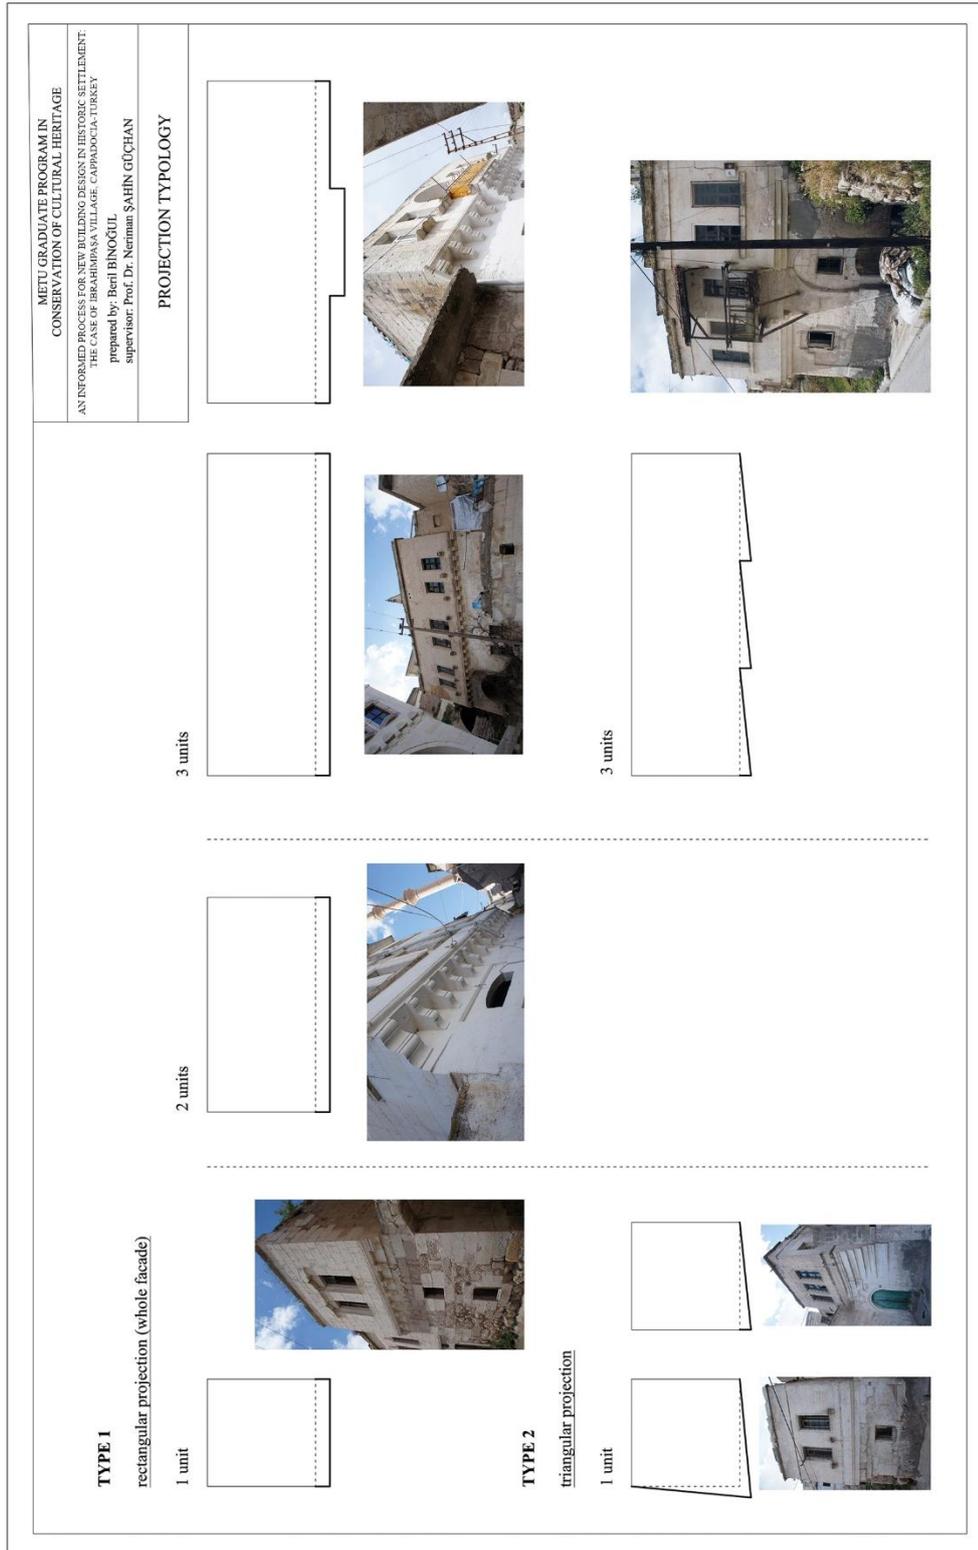
Figure 3.77. Projection typology

There are 2 main types of closed projections in the village (Figure 3.77). Type 1 consist of rectangular projections generated by pulling out the whole second floor. In this case, the enlarged first floor is supported by stone brackets varying in size depending on the size of the projection. Type 2 consist of triangular projections (beveled projections) constructed by placing the stones upon each other extruding a certain distance to the street. The buildings which doesn't have projections, have cornices. They don't have any structural function, but they emphasize visually the distinction between first and the second floors. Buildings with cornices build out the simplest form of a facade in the village.

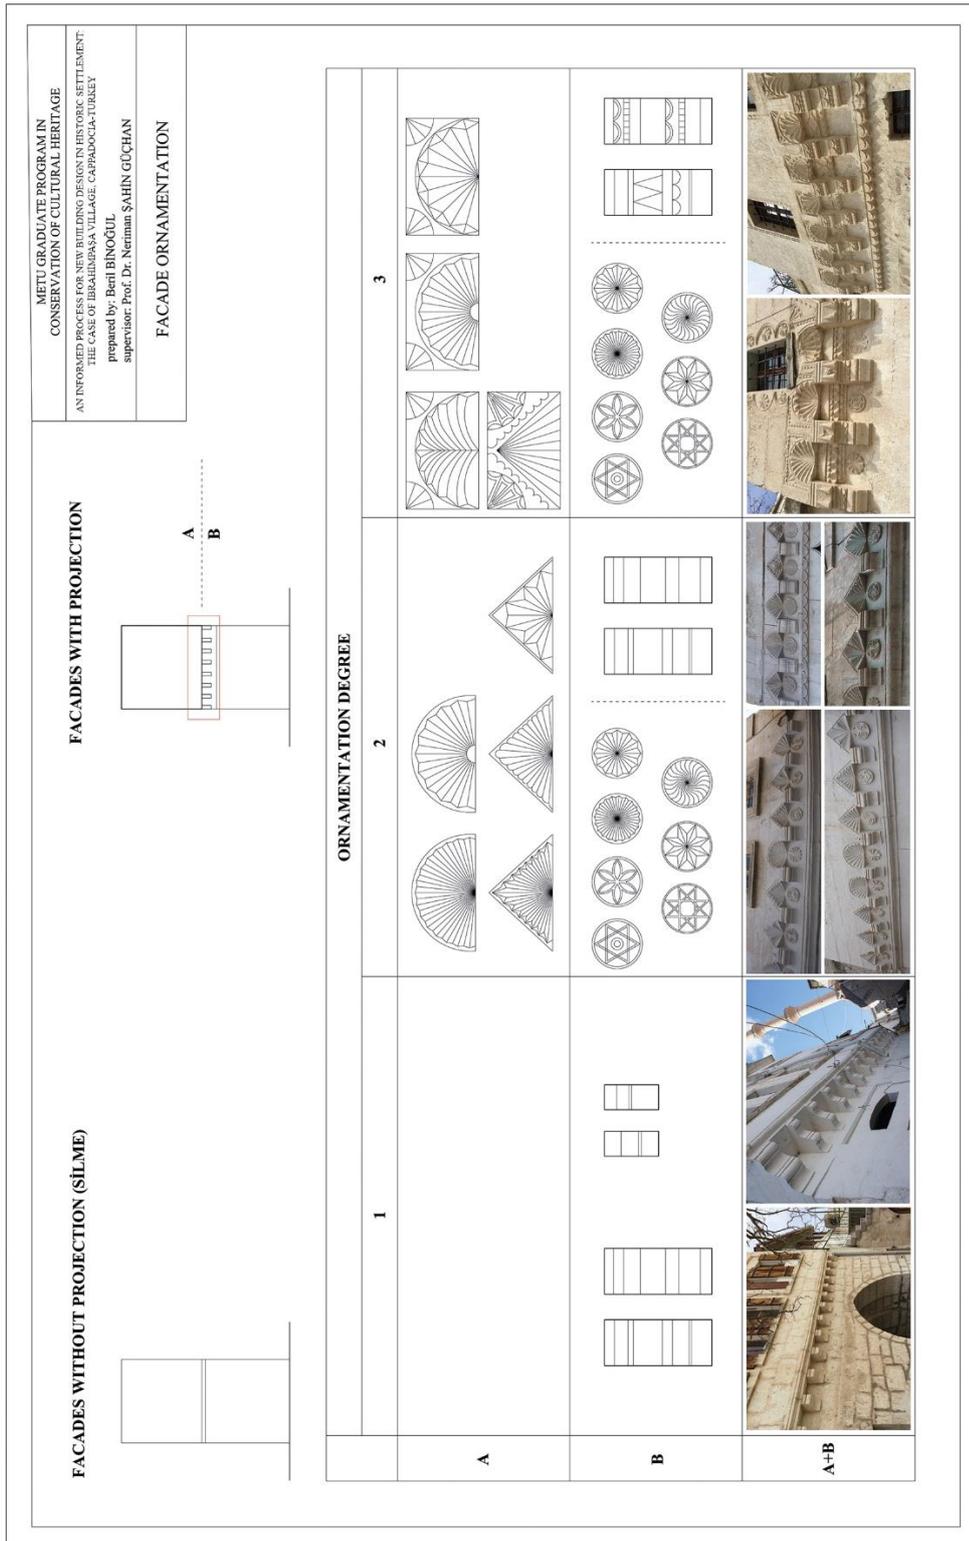
Figure 3.79. Facade ornamentation

Facades with projection have mouldings as the most ornate part of the facade, having three different degrees of ornamentation (Figure 3.79). As mentioned above, the stone projections are supported by stone brackets which have various details in their section.

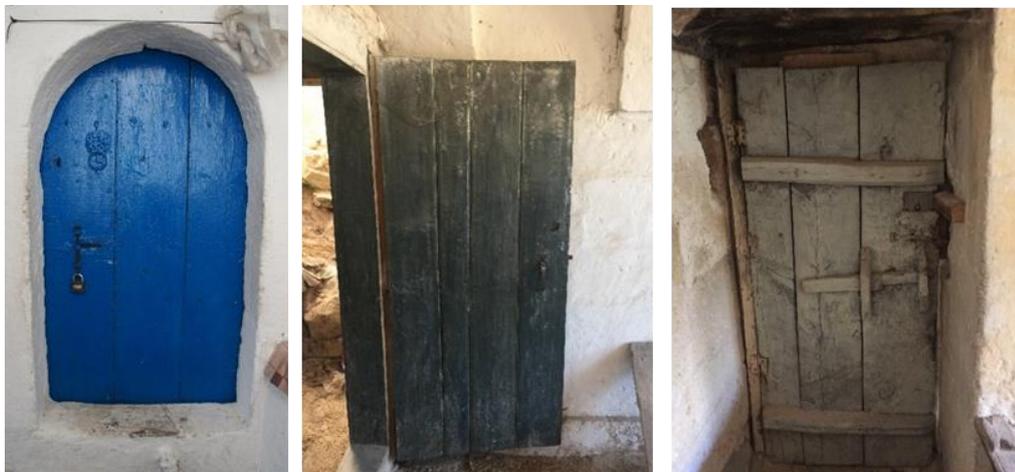
Figure 3.81. Examples of interior doors

Interior doors are also built with timber having one wing. Doors of vaulted rooms are placed between two cover arches and they have metal components such as hinge, lock and handle (Solmaz, 2013, sf. 93). The simplest type is assembled with three, four or five pieces of wood placed vertically and fixed with horizontally nailed thinner timber pieces on the back (Figure 3.81).

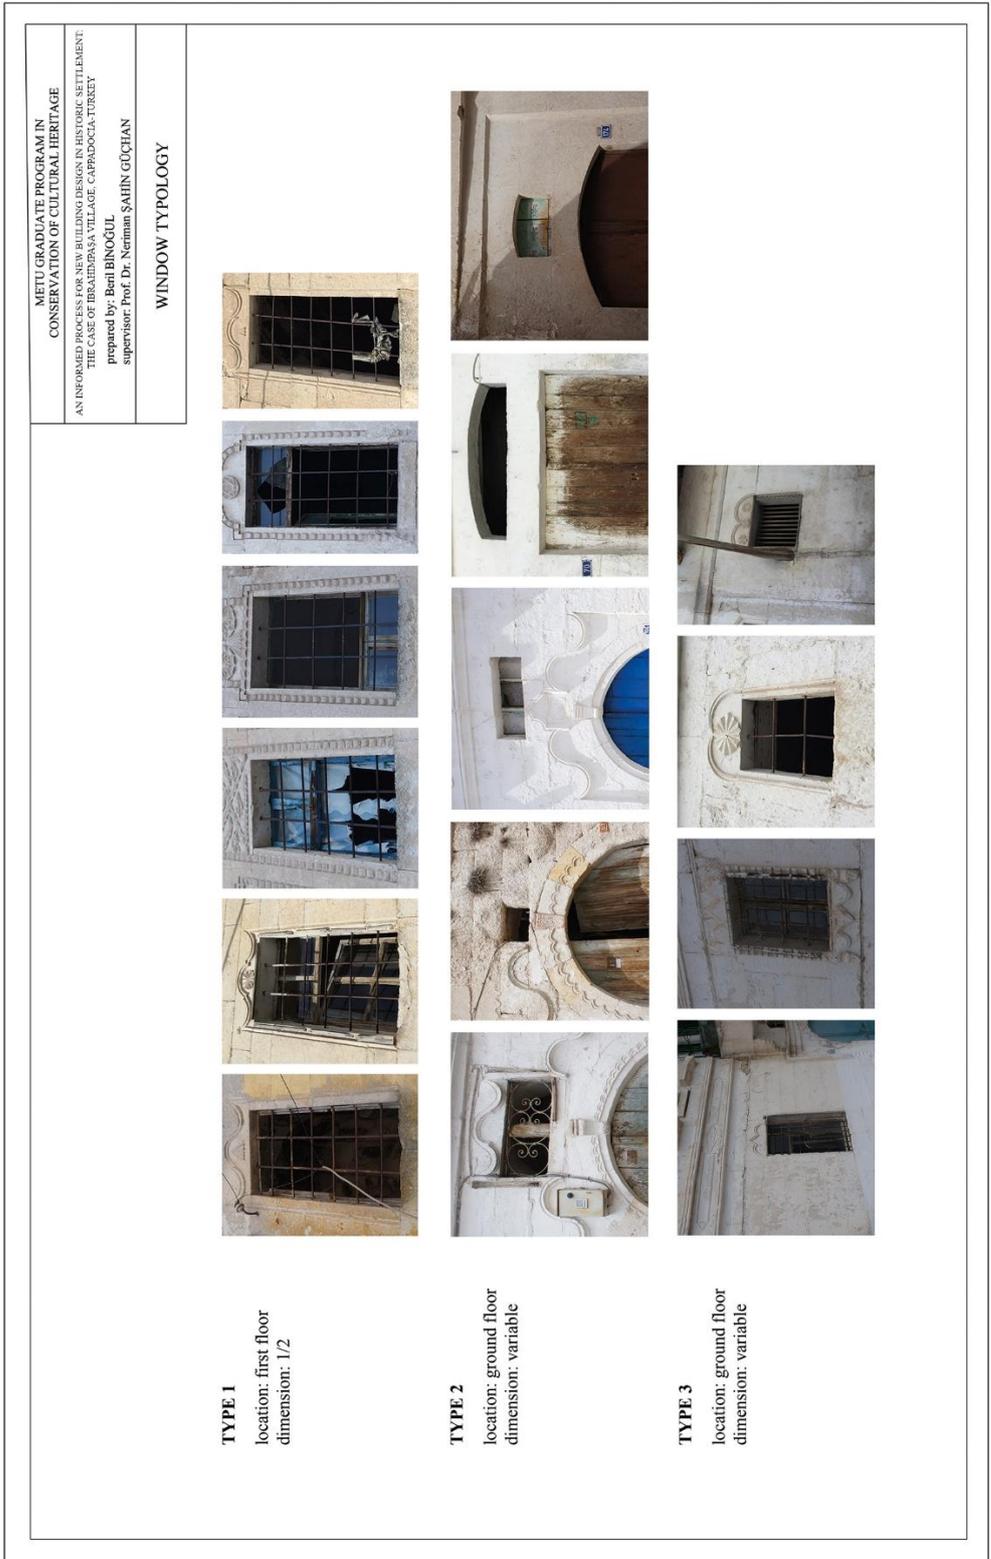
Figure 3.83. Window typology - 1

**Windows:** Windows in the study area can be categorized into three main groups (Figure 3.83). First group consists of room windows which are to be found only on upper floors of the traditional buildings having a ratio of nearly ½. Second group is top windows which are also a part of the door enlightening the entrance hall. Their size and shape vary independently of the type of the door underneath. Third group consists of room windows which are to be found on ground floors and are placed above the eye level because of privacy concerns.

The windows which constitute the first group are placed in rooms of the upper floors and a categorization was made by their profiles and opening types (Figure 3.83). The window profiles in the study area were damaged or replaced with PVC profiles, so this typology was made among the authentic windows which still existed. The windows are mostly winged opening from the midline and the most common profile type was the one which is divided into three parts vertically and into two horizontally. The vertical three parts have two wings, one part having two sections and the other one only one. Two-sectioned part can be placed below or above the other part but if it is placed above, the upper part of the window is fixed and can't be opened. Another type of the winged windows is very similar with it, only having two sections with the proportions of three. In this type, the upper part is fixed having two longer wings underneath. Aside from the winged windows, a rare type is guillotine windows having two main parts vertically sliding, each divided into four pieces.

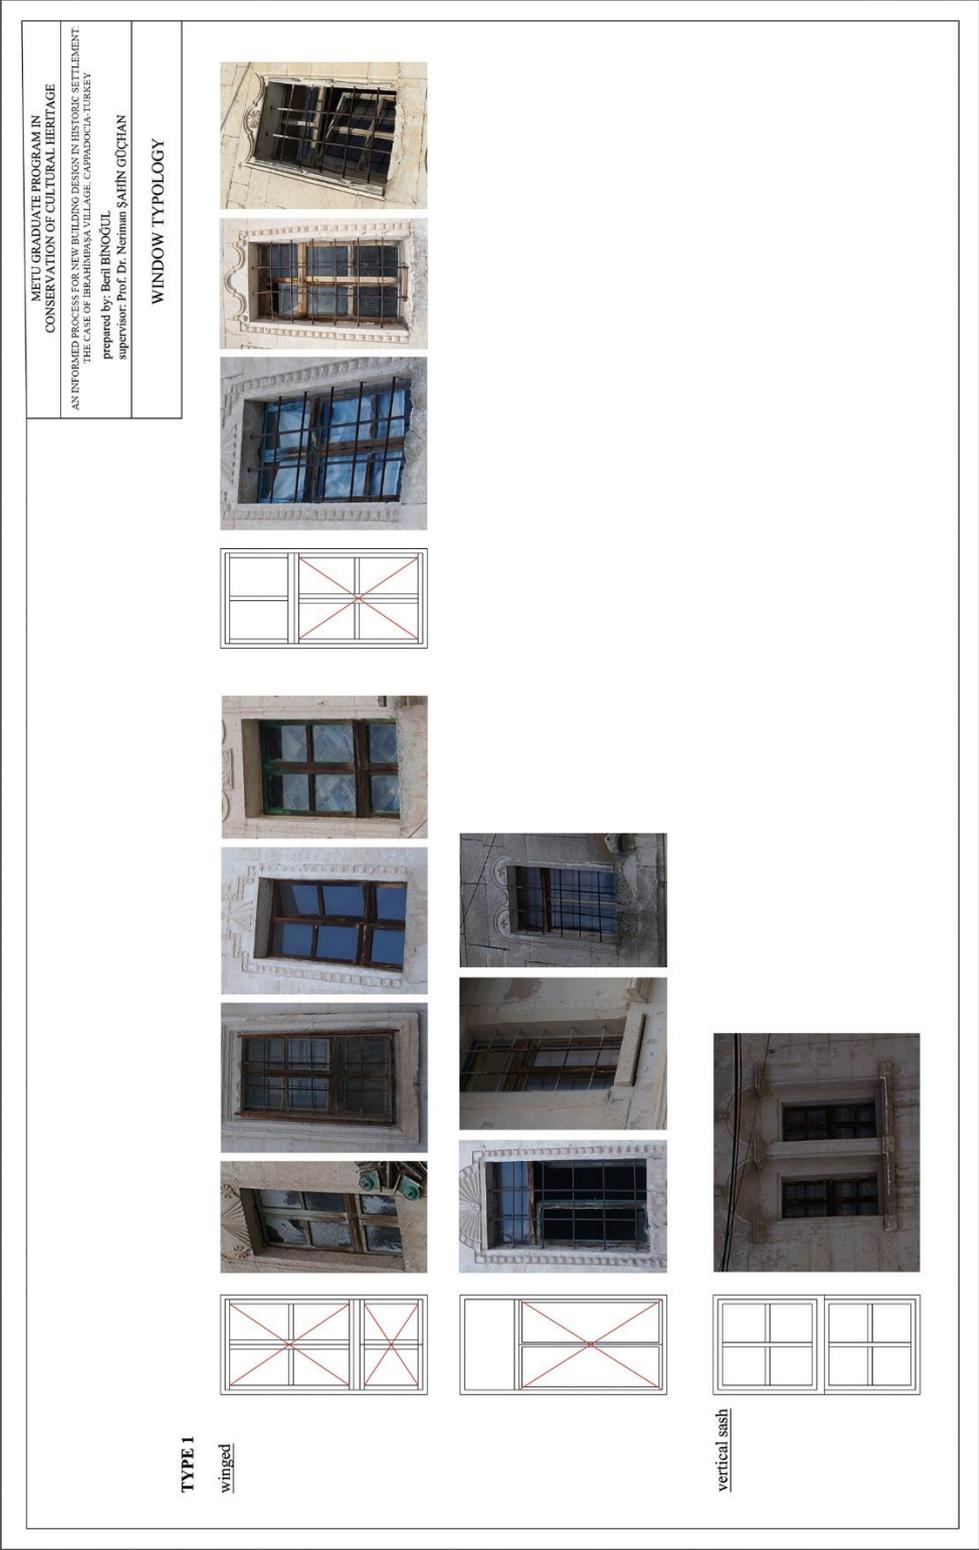
Figure 3.84. Window typology - 2

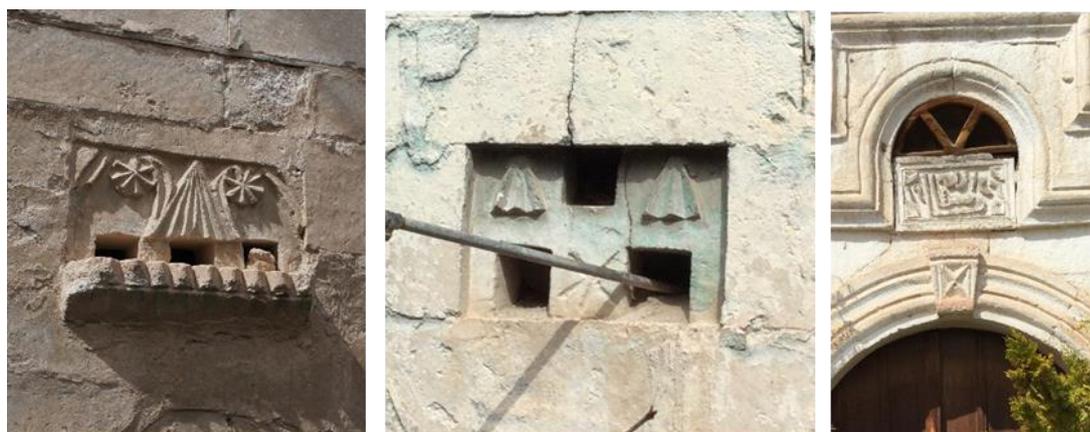
Figure 3.85. Examples of pigeon houses and inscription (right)

**Pigeon Houses:** In the region, pigeon excrement are used fed for fertilizing the soil and for killing insects. There are lots of pigeon houses carved along the rock valley and also on the facades of the dwellings as a common architectural element (Figure 3.85). They are sometimes ornamented in harmony with the façade of the building.

**Inscriptions:** Inscriptions are mostly placed on the entrance doors, some of them written in Arabic, some of them in Turkish letters and they contain information about the construction date of the dwellings (Figure 3.85).

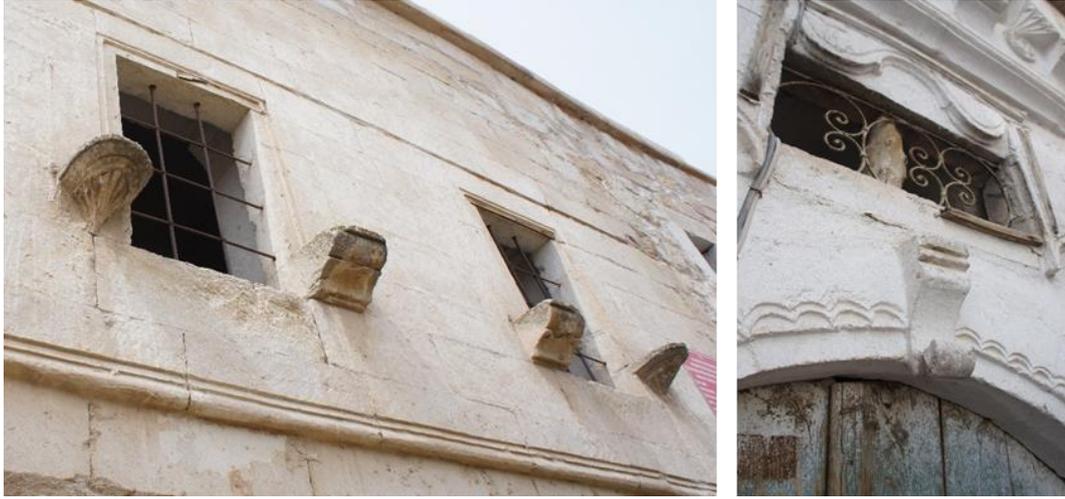
Figure 3.86. Examples of flower shelves and stone for keys

**Flower shelves / *Saksılık*:** The flower shelves are made of stone, projecting from the facade of the dwelling. Their shapes vary throughout the village, but they are only big enough to carry one pot and they are placed on the sides of the first floor windows.

**Stones for keys / *Anahtarlık Taşı*:** It is a specially shaped stone placed above the entrance door for keeping the keys (Figure 3.86). Besides its function, it has a connotative meaning showing the trust among villagers (Karakul, 2011, s. 155).

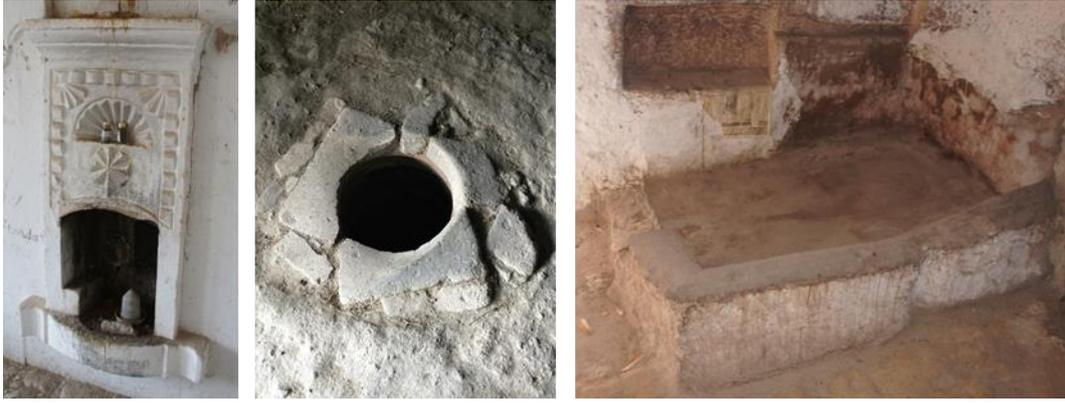
Figure 3.87. Fireplace (left), tandır (middle), şıralık (right)

**Şıvalık:** It is generally located in kitchens, 15-20cm lower than the floor and used for preparing grape molasses (Figure 3.87).

**Tandır:** It is a hole on the ground, which is made of stone or terra-cotta, used for cooking food and bread. It can be located either in a closed room or in the courtyard (Figure 3.87).

**Fireplace:** Fireplaces are located either in rooms for heating or kitchens as a main architectural element (Figure 3.87). It is usually placed between two arches in a room and it is ornated and even sometimes painted. In carved-out places, fireplaces are located in a rock.

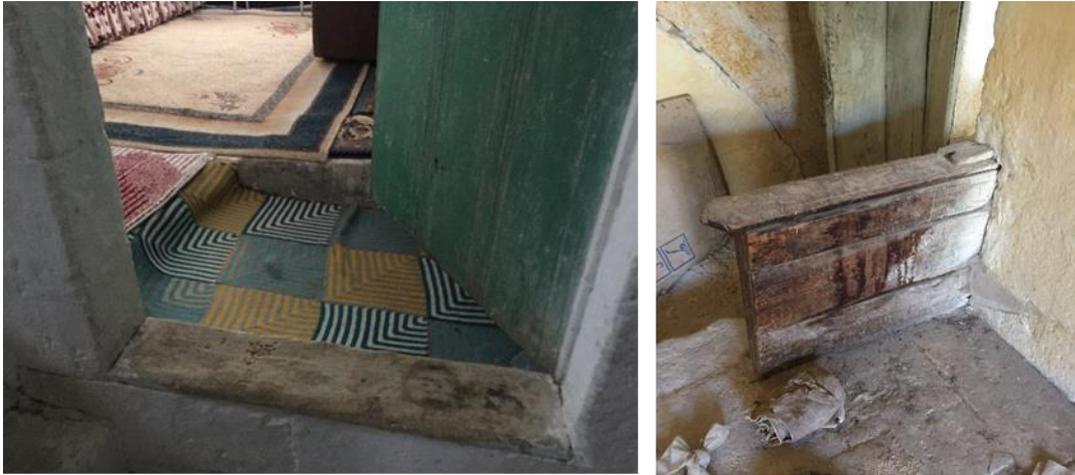
Figure 3.88. Seki, Pabuçluk and Musandra

**Seki / Pabuçluk / Musandra:** In some of the houses, there is a space when you enter the door and an elevated area which is called ‘Seki’ continuing inwards. It is either made of stone or timber in the area creating a hierarchical order in the room. The area which is lower is called ‘Pabuçluk’ as it is a place to take the shoes of and there is a timber balustrade between these two areas, which is called ‘Musandra’ (Figure 3.87).

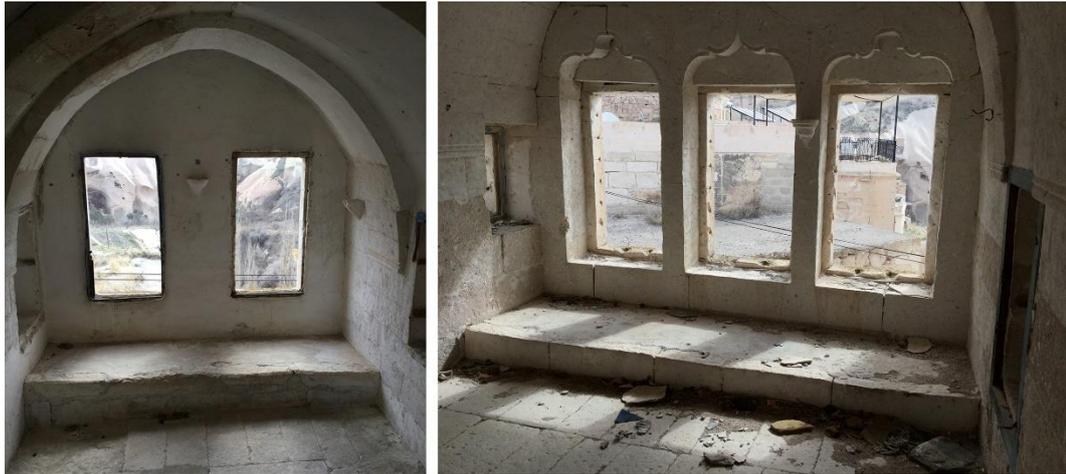
Figure 3.89. Examples of *sedir*

**Sedir:** ‘Sedir’ is an architectural element which is either constructed with timber or stone and located along the front façade of the room in front of the windows. Its height is around 30-40 cm. used for sitting or sleeping (Figure 3.89).

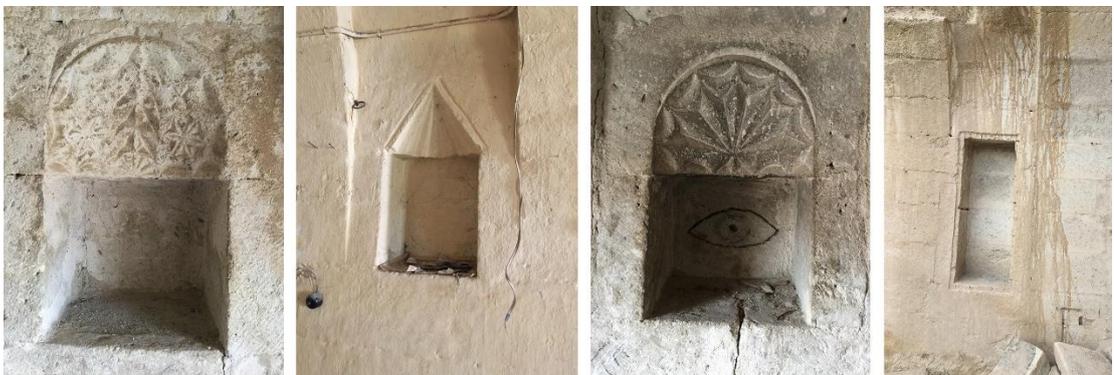
Figure 3.90. Examples of different types of niches

**Niche / Taka:** Niches are called ‘Taka’ by the locals and they are placed either in the rock or in the stone walls. There are various shapes, sizes and decorations of niches located in the rooms (Figure 3.90).

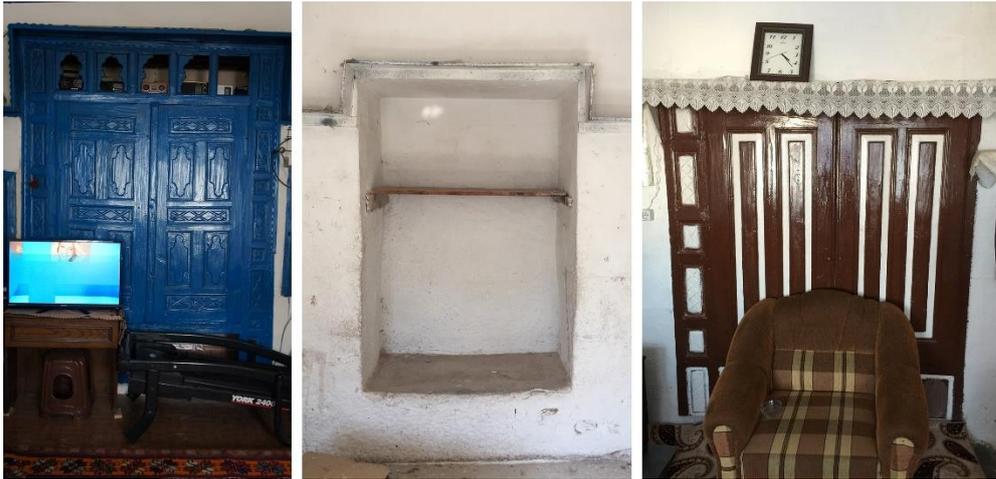
Figure 3.91. Examples of cupboards

**Cupboards / *Yüklük*:** Cupboards are either carved-out from the rock or they are placed in a stone wall having wooden doors, mostly used for storing quilts and pillows. The wings might be simple or decorated with geometrical motifs (Figure 3.91).

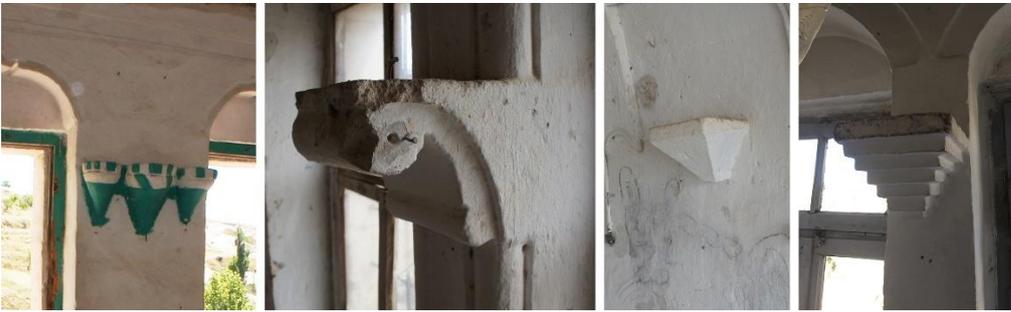
Figure 3.92. Different types of *lambalik*

***Lambalık*:** *Lambalık* is a cantilevered stone element placed on the walls, creating a space to put lighting equipment (Figure 3.92).
