AN INFORMED PROCESS FOR NEW BUILDING DESIGN IN HISTORIC  
SETTLEMENT: THE CASE OF İBRAHİMPAŞA VILLAGE, CAPPADOCIA-  
TURKEY

A THESIS SUBMITTED TO  
THE GRADUATE SCHOOL OF NATURAL AND APPLIED SCIENCES  
OF  
MIDDLE EAST TECHNICAL UNIVERSITY

DECEMBER 2019

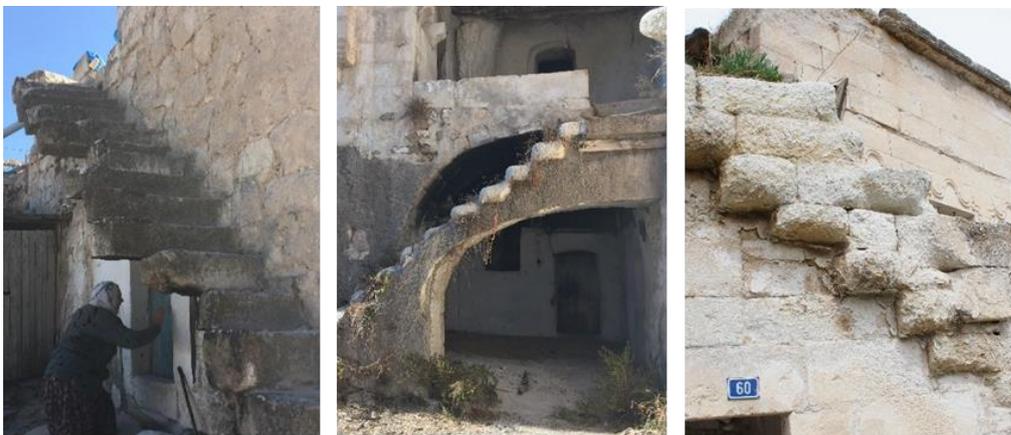
Figure 3.93. Examples of staircases

**Staircase:** The stairs are very important architectural elements contributing the circulation through the building. The staircases in the study area are either rock carved or they are built with stone and sometimes they are used together. There are two different types of stone staircases. The stairs are either supported by a wall, arch or a rock, or the stone steps fits in the wall sitting on each other working as a console.

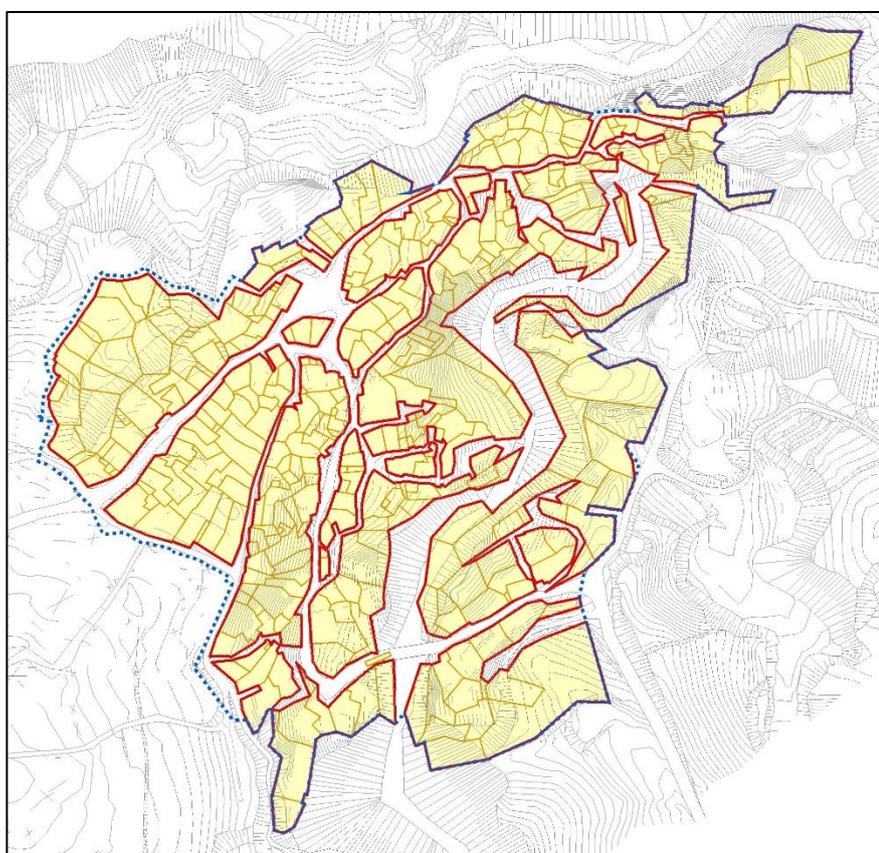
Figure 4.1. Building blocks of the primary study area

The building blocks in the study area are formed according to the topography. As seen in Figure 4.1, they are more fragmental and amorphous on the slopes around the streambed. In parallel with this, the building lots which constitute those building blocks on the slopes, are becoming smaller. In order to analyze the settlement fabric, the building lots will be analyzed according to their nearby relations, form, size and location of buildings within the lots as they form the fabric.

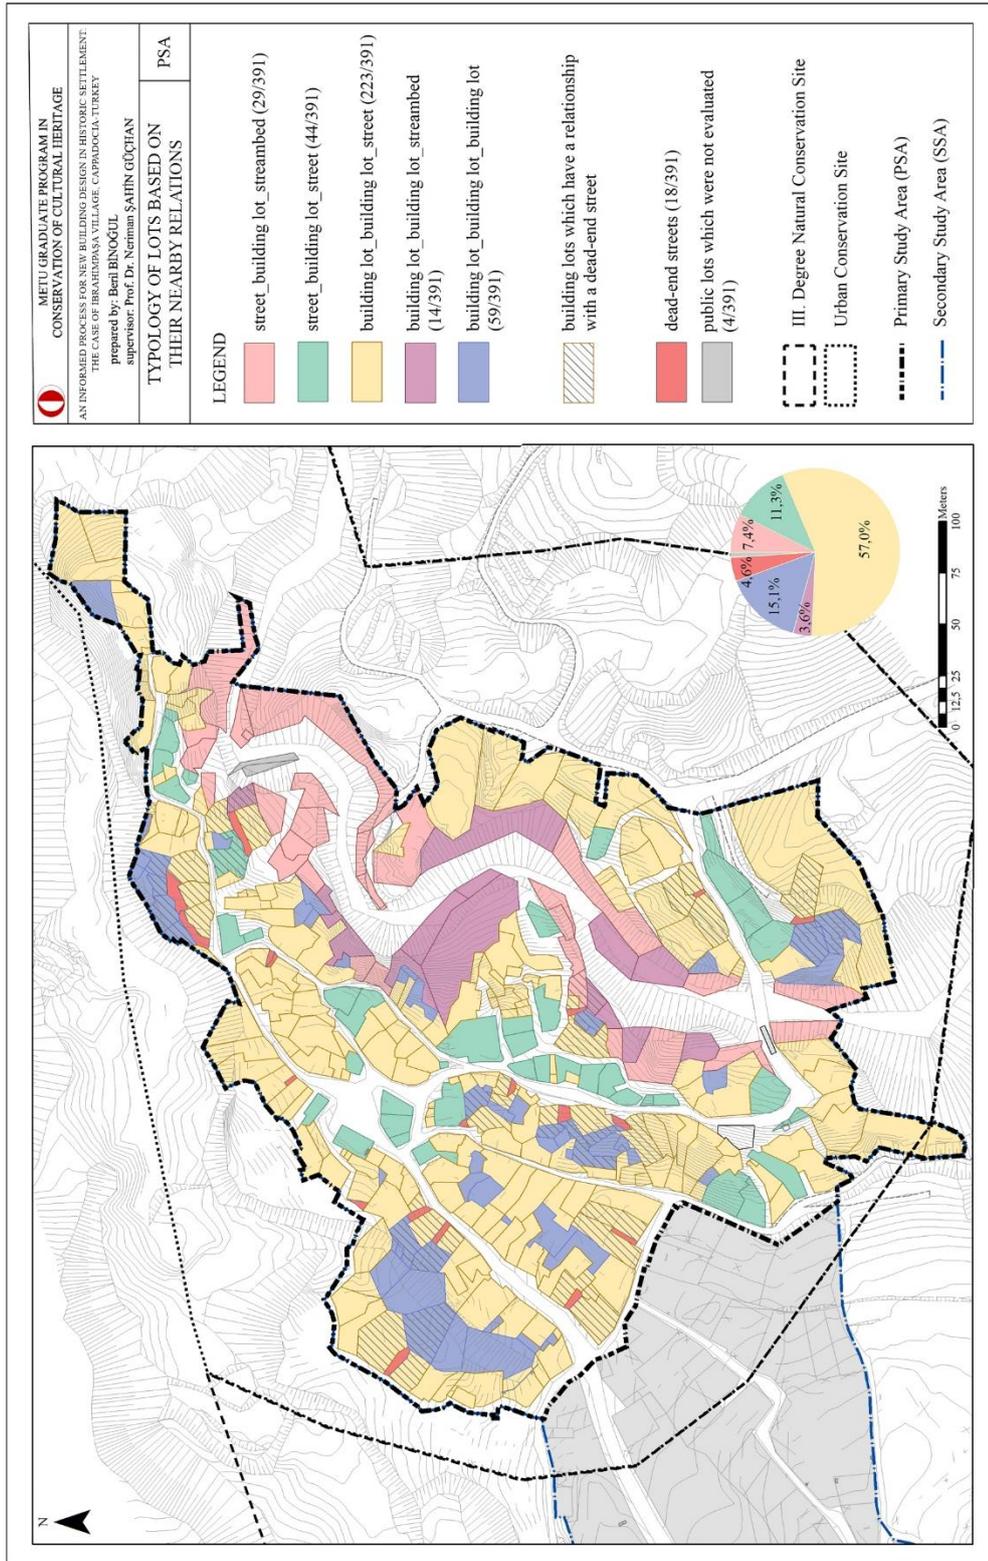
Figure 4.2. Typology of lots based on their nearby relations

**Nearby Relations of Building Lots:** The settlement fabric of the village is formed by various nearby relations of three components: streets, streambed and the building lots (Figure 4.2). More than half of the building lots in the primary study area have a nearby relation which they have a building lot on the backside and street in the front. Depending on the size of the building block and the slope, some of the building lots have streets on both sides and these two varieties can also be seen if the street component is replaced with the streambed. 15% of the building lots have building lots all around them and it can be seen that either they have a connection with a dead-end street or that they belong to the same owner with one of the surrounding building lots.

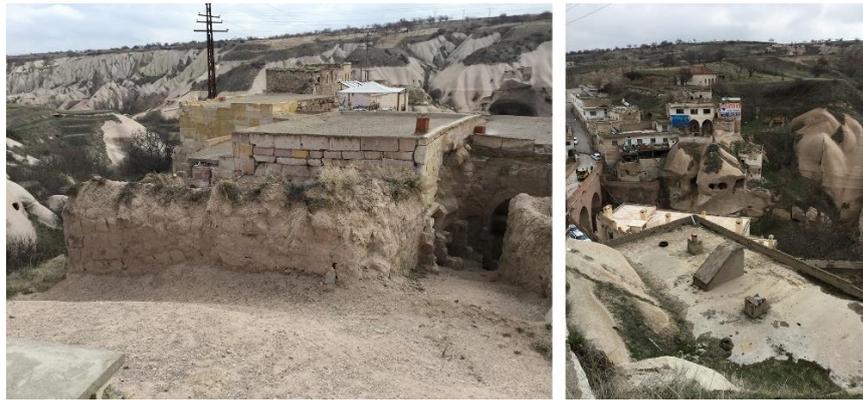
Figure 4.6. Buildings with rock formations at their back as examples for Group B

According to Group A, the building is located on the whole site. This type is mostly seen where the topography is flatter, and the buildings are denser. As no building has a courtyard at the back, Group B consist of buildings which have rock formations at their back within the borders of their building lots. Group C is also a similar case with a rock formation but which also has a courtyard in the front. Group D and E are both cases which the building has a courtyard and they are mostly placed on flat lands without any interaction with a rock formation.

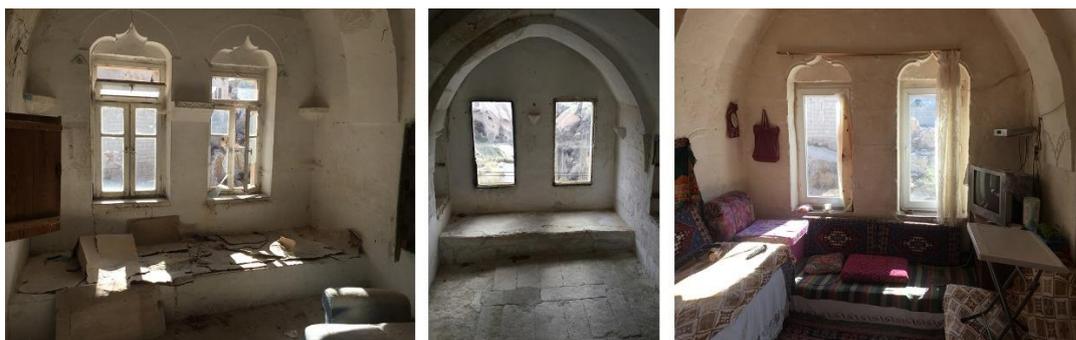
Figure 4.7. Room as the main living space

cupboard, shelves and *lambalık*. A room can either have all these elements or some of them and its always placed on the front side of the building having two or three windows. It is either placed as a whole masonry unit or as a complementary part of a carved-out space. According to the size of the building, there are more than one room. The rooms have stone floor coverings and the masonry walls are spanned with rib vaults which is a system that the structure is created by set of arches.

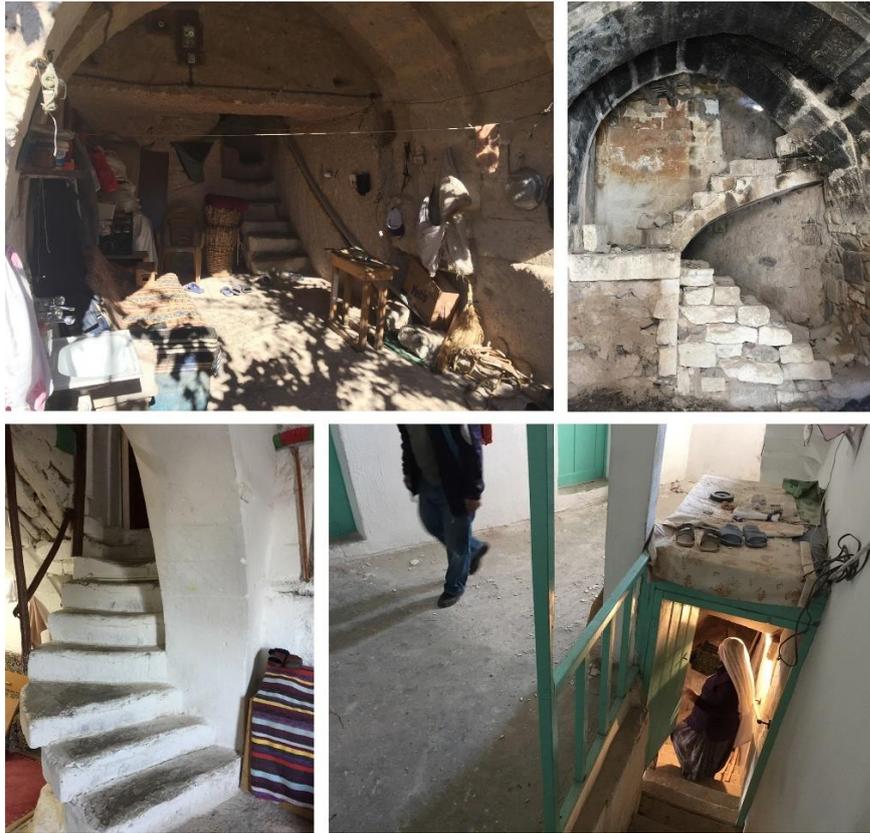
Figure 4.8. Circulation spaces

Circulation spaces are either stairs, corridors or aiwans in some cases if the building is located in a courtyard. The corridors are located at the back side of the building whereas the aiwans are located such as rooms. The stairs can be located inside the building or outside (if the building has a courtyard) combining the units of the building.

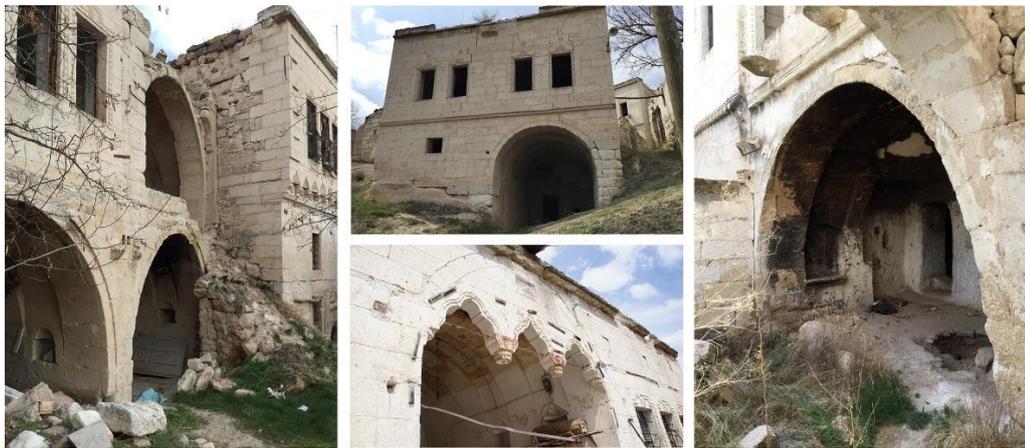
Figure 4.9. Examples of aiwans

Aiwans are semi-open spaces which are covered with vault and they can be placed either on the ground floor or the first floor. . If it is on the ground floor, it may have a *tandır* on the floor and it is named as “summer kitchen” or “*yazlık*” by the inhabitants. The aiwans on the first floor connect the rooms, sometimes having a direct connection from the courtyard with stairs and they can sometimes have an arch system on the side that they are open. If they are only located on the ground floor, their depth varies according to the size of the building and the building lot.

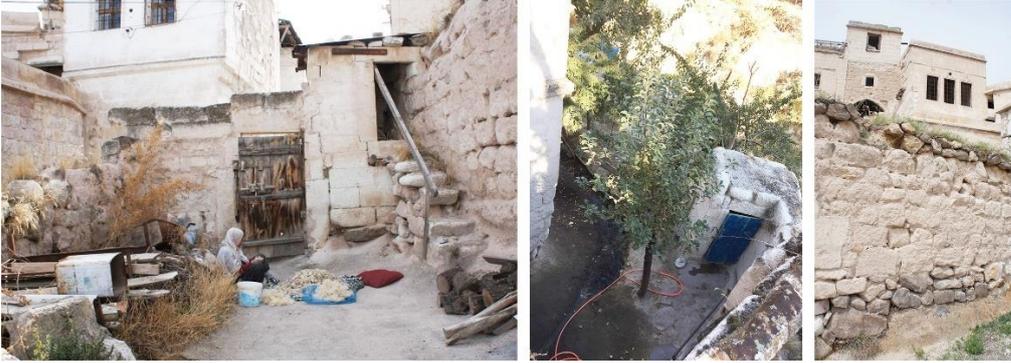
Figure 4.10. Views from inside of courtyards including a WC (left and middle) and courtyard wall (right)

Courtyards are open spaces of traditional buildings, surrounded by stone masonry walls above the eye level where the daily life activities occur in. The spaces on the ground floor such as kitchen, stable, *şirahane* and storage spaces are connected with the courtyard and the size of the courtyard might vary.

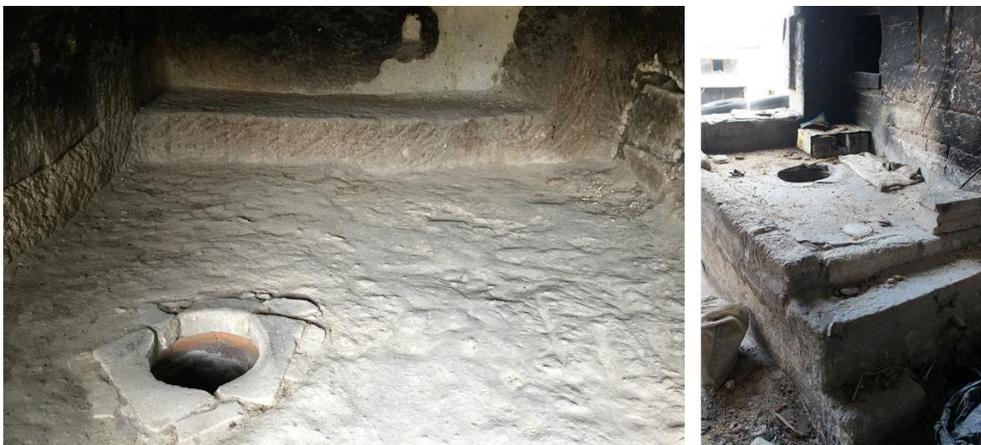
Figure 4.11. Kitchen (left) and *tandır evi* (right) with a *tandır* placed in an aiwan

Kitchen is placed on the ground floor, in relation with the storage rooms either directly or through the courtyard. There are no examples in the studies buildings of a masonry kitchen space and they are usually carved out spaces with *tandır* inside. The *tandır evi* is an aiwan with a *tandır*, placed in front of the kitchen and used in summer times.

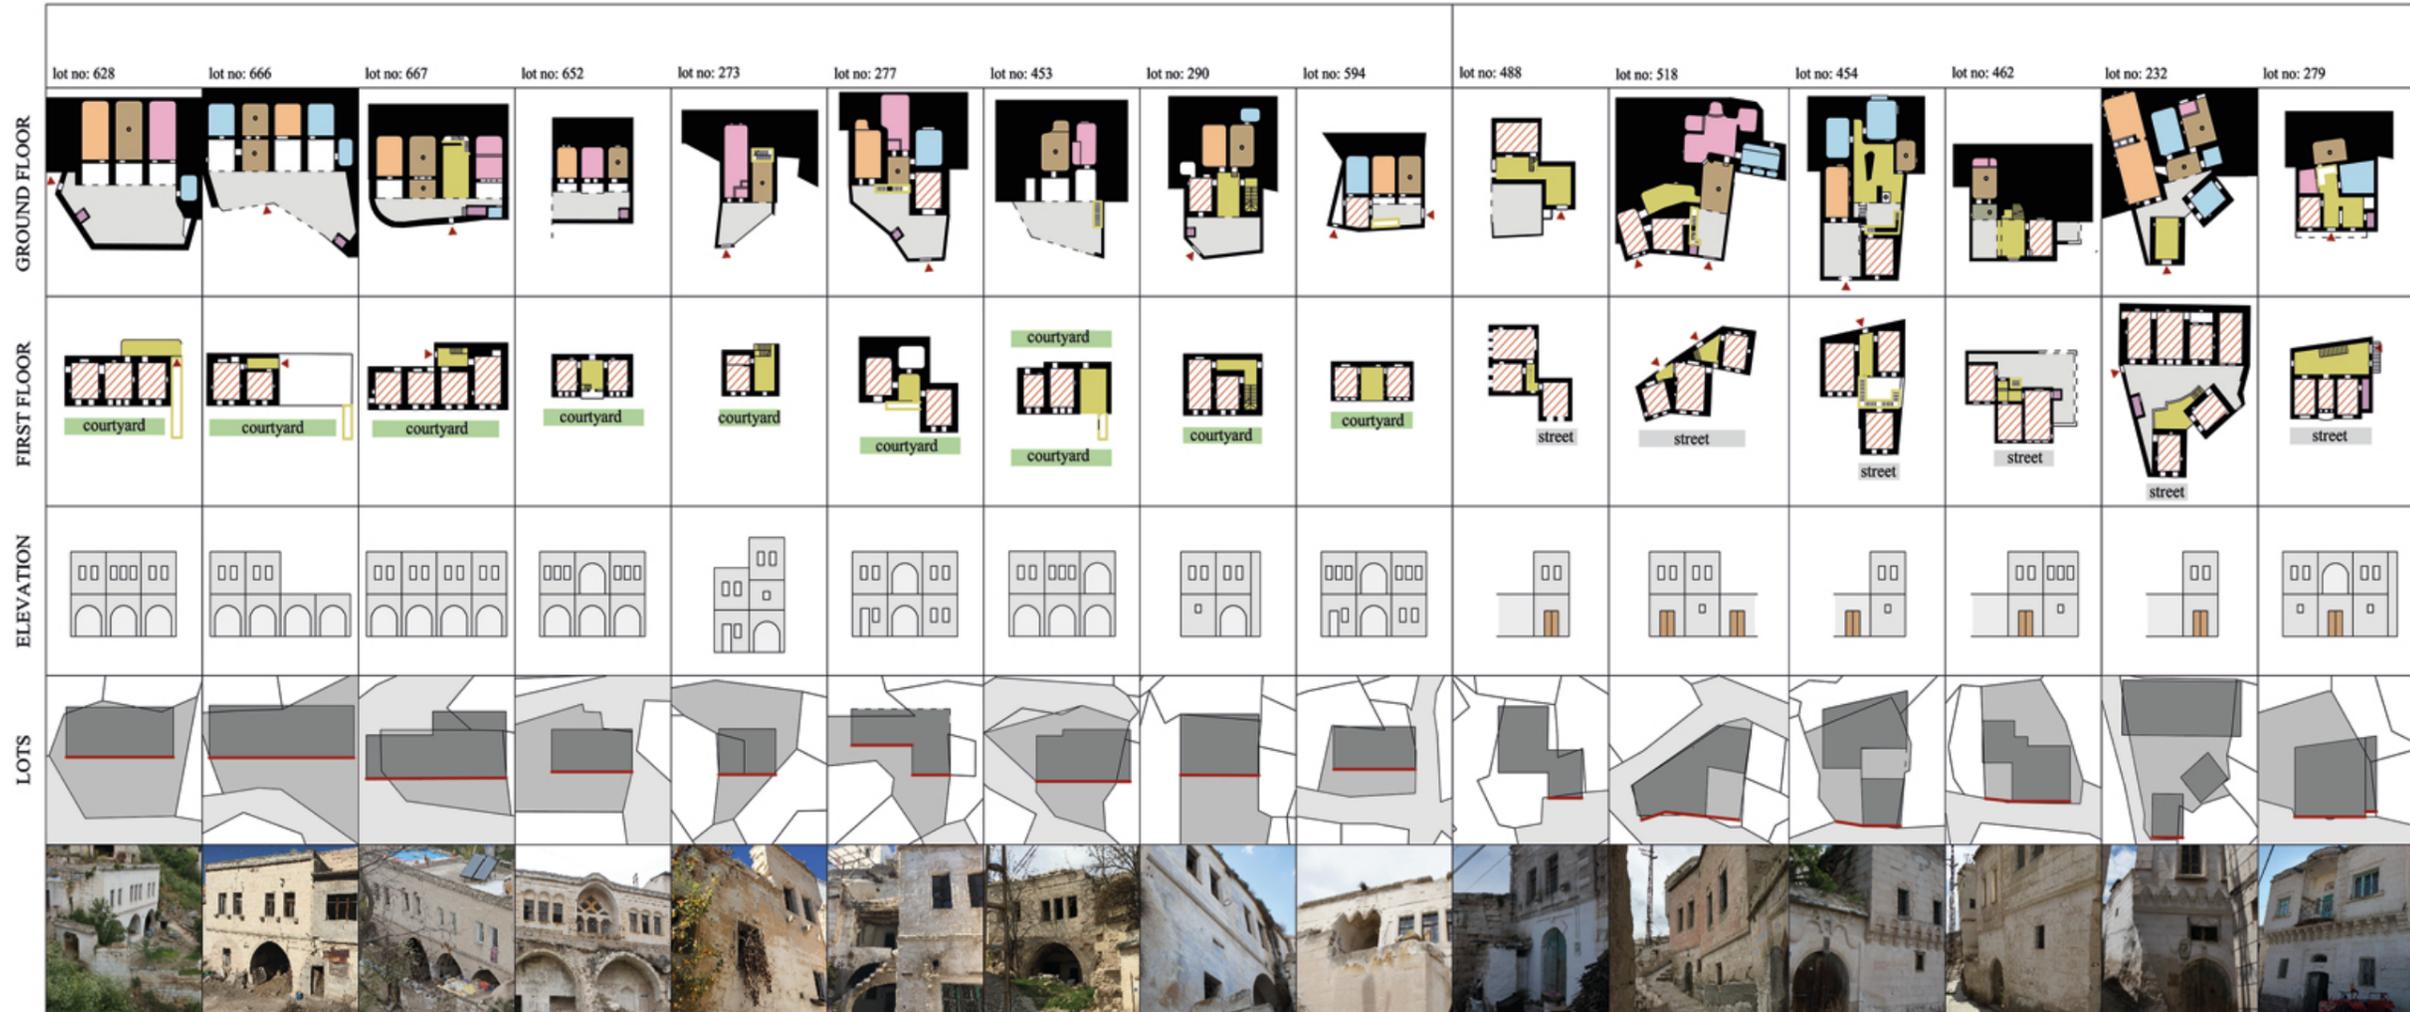
Figure 4.12. Studied Buildings

For the study of plan typology, 15 buildings were surveyed in the primary study area (Figure 4.12) and there are two main types of buildings which effects the plan typology in the village: the building is either placed in a courtyard (Type 1) or have a street facade (Type 2) (Figure 4.18). The plan schemes which belong to the buildings placed in a courtyard (Type 1) have two different variations for their ground floor. In the first one, they have their units arranged side by side, one after another all facing the open space in the front (Type 1.G.a). These types of buildings have their circulation with stairs at the back or going up through an aiwan (Figure 4.14).

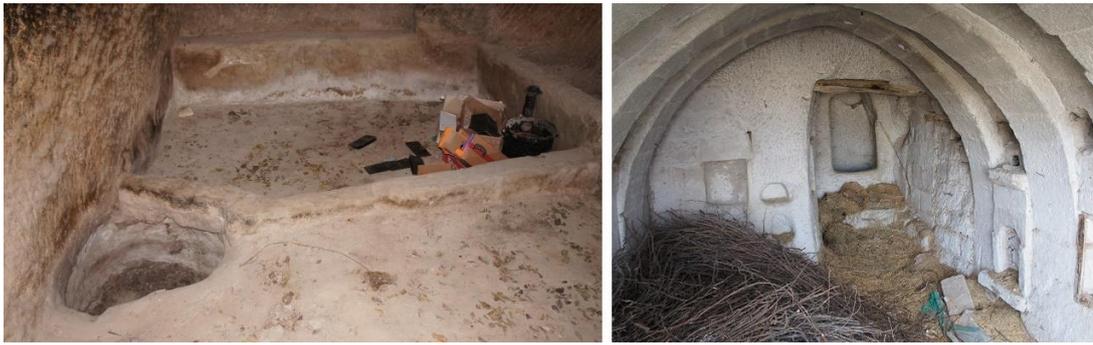
Figure 4.13. *Şirahane* (left) and hayloft (right)

Storages are carved-out spaces to store foods and other things and they are located on the ground floor in connection with the kitchen either directly or through the courtyard. They have lots of niches on their walls for the stored goods. Stables are also carved-out spaces located on the ground floor and in relationship with the courtyard. They have larger niches on the walls to put animal feed and sometimes they have fireplaces. As another part of the plan, *şirahanes* are spaces for preparing grape molasses in the buildings which has special pools in order to trample the grapes by feet and obtain grape juice.

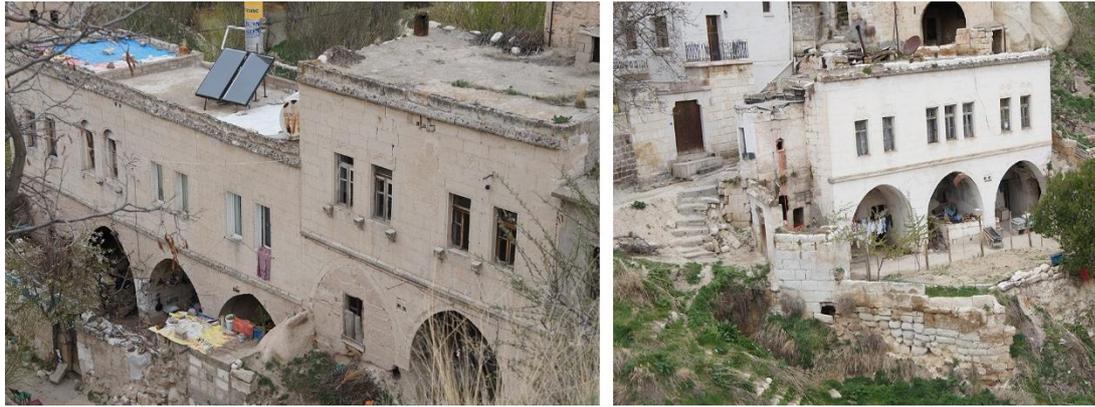
Figure 4.14. Buildings having their ground floor units arranged side by side (Type 1.G.a seen in Figure 4.18)

The main characteristic of the ground floor units is that they always have a semi open space in the front of which the depth can vary. The first floors of this type of ground floor plan schemes are also very ordered and the walls are aligned with the ground floor. So, the units are placed side by side having their circulation on the back side. The units are either have the same size, or one can be bigger depending on the circulation area. In Type 1, there are no buildings which have more than four units placed next to each other either on the ground floor or on the first floor.

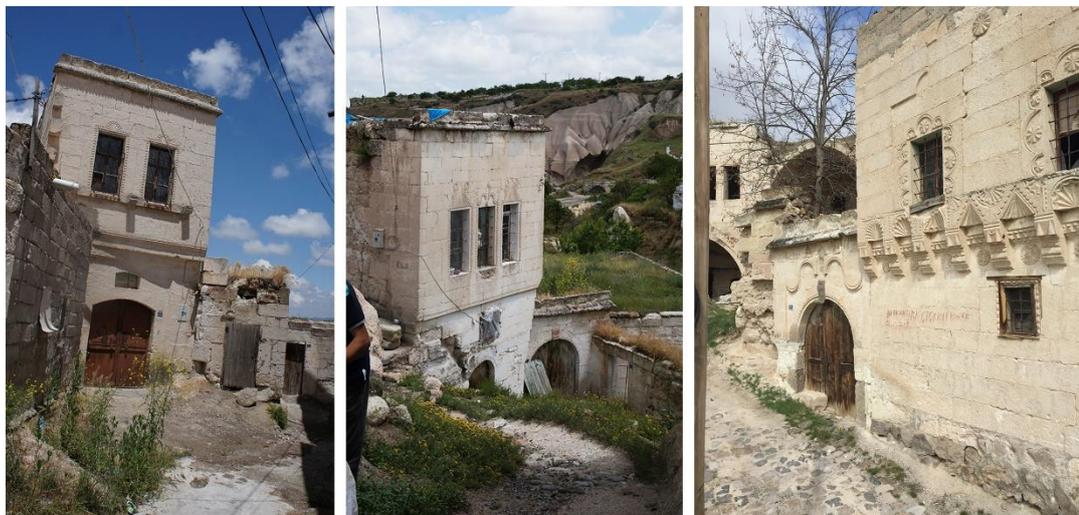
Figure 4.16. Buildings which have units placed irregularly having a street facade and a courtyard

In the first one, units are placed irregularly, but also depending on the ground floor, placed around a circulation area which has access to all of the units (Type 2.F.a). With

this type of plan schemes, the building has a street facade but also has a courtyard. The second one, which is also very similar with the buildings placed within a courtyard, has its units placed side by side with a circulation area at the back. In Type 2, there are no buildings which have more than three units placed next to each other either on the ground floor or on the first floor.

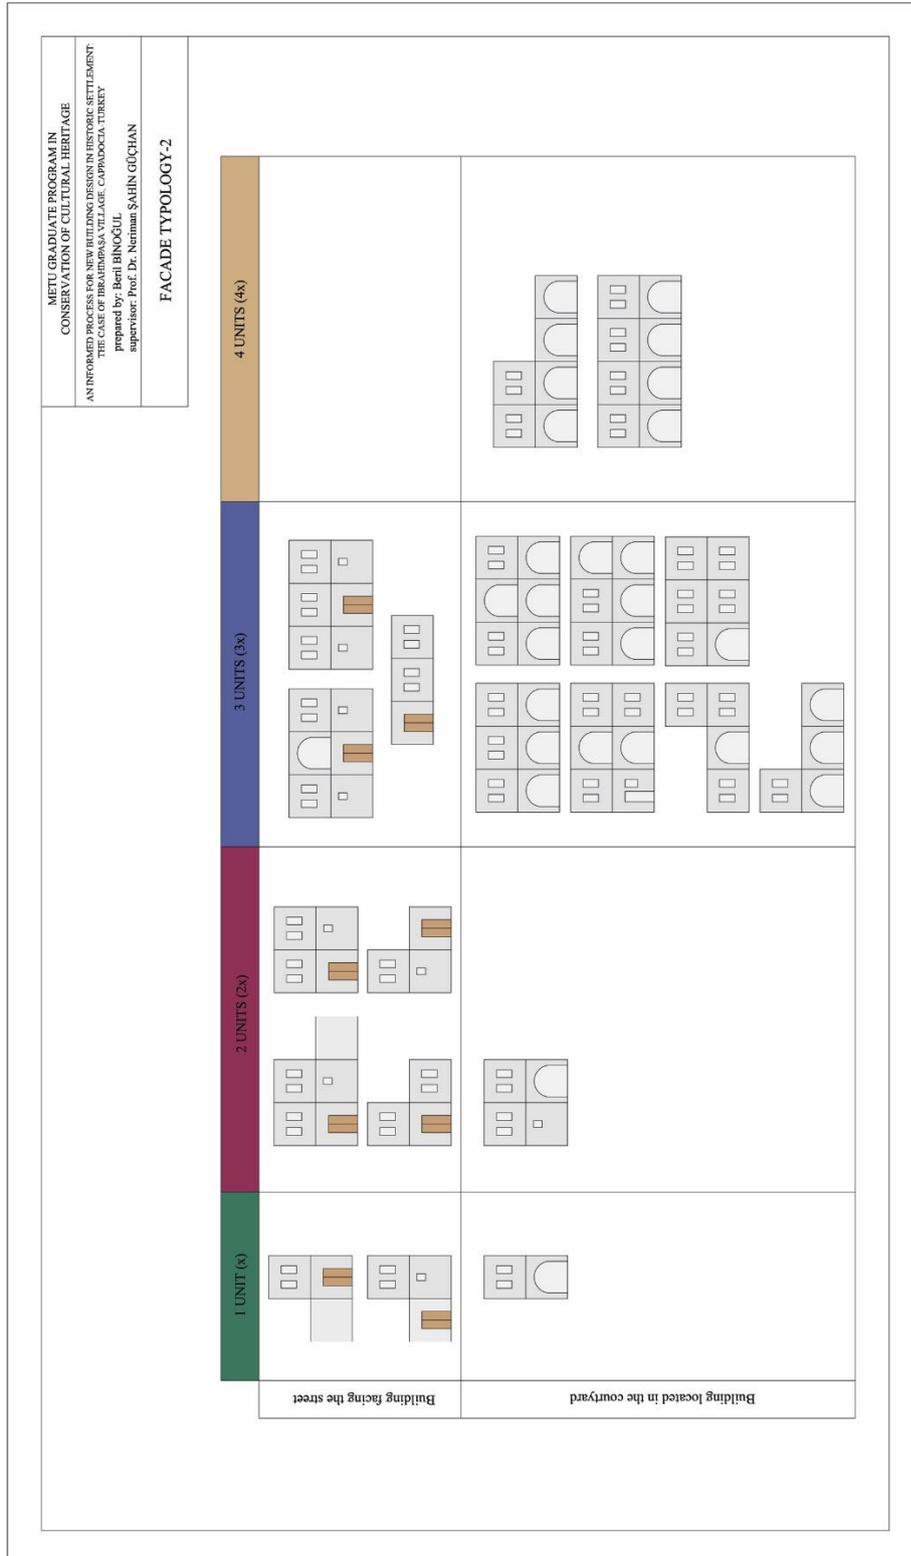
Figure 4.21. Facade type created by the units

The different combinations of A, B, C units defined above in the primary study area can be seen in Figure 4.21. The facades are divided into groups based on their number of units counted horizontally, either facing the street or the courtyard. If the building has one unit facing the street, that means it has a courtyard on the side<sup>32</sup>. This courtyard is either entered directly from the street or only from the building. If the building has two units facing the street, building is certainly entered only from the street and these types have no courtyard door if they have a courtyard. Second unit of the building can have one or two floors either having the entrance or a room. If the two-unit building is located in a courtyard, it has two floors on both units and an aiwan on the ground floor. The most common type in the primary study are the buildings with three units. It is also the only type having only one floor for the whole building with only one example. If the building is facing the street and the units have two floors, this type of facades are symmetrical having the entrance in the middle. The unit in the middle on

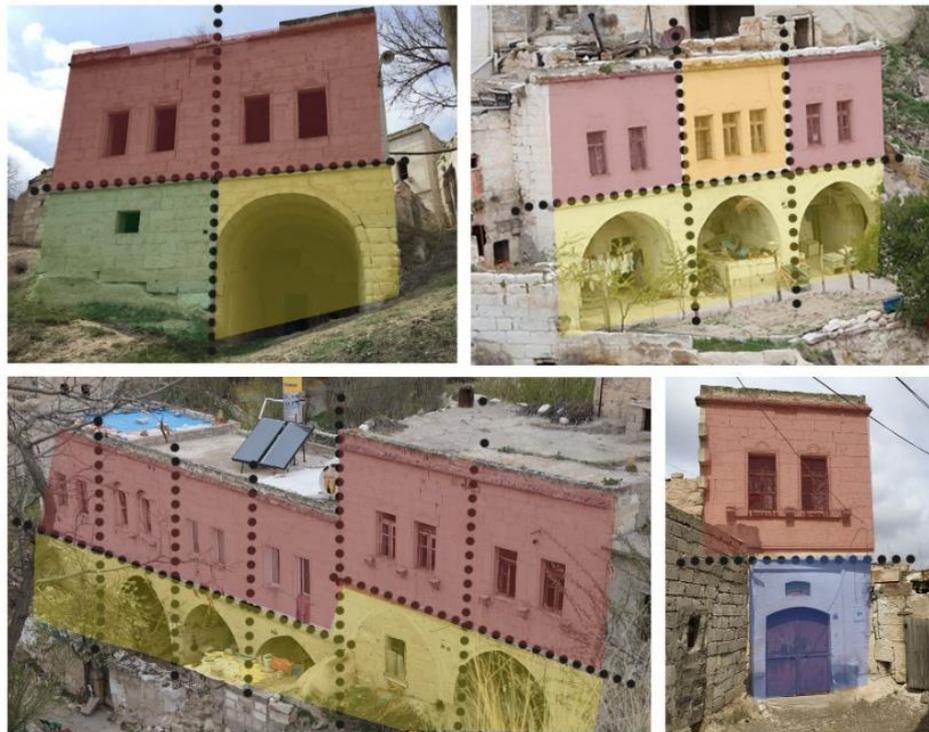
Figure 4.23. Different combinations of units

the second floor is either an upper floor aiwan with triple arches or a balcony or it is a room unit. If the building is located in a courtyard, there are various combinations also depending on the plan. There are no buildings in the study area which has four units facing the street. They are located in courtyards having either one or two floors on some of the units.

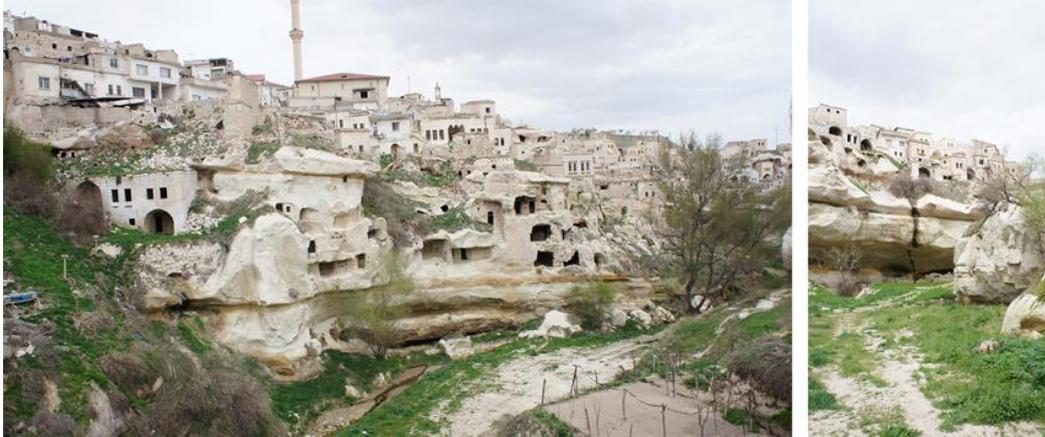
Figure 4.25. The streambed, dividing the village into two parts

The village is laid down on a land which is formed by a stream dividing the village into two parts. As a main natural feature of the village, there are rock formations mostly around the stream, which are not suitable for building on them (Figure 4.25). The earliest dwellings of the village were all rock cut spaces along the stream which dates back to 10<sup>th</sup> century<sup>34</sup>. Those rock cut spaces expanded to the slopes starting from the northeast of the village and as they had suitable land when the angle of the slope decreased, they built masonry extensions in the front. The first extensions were

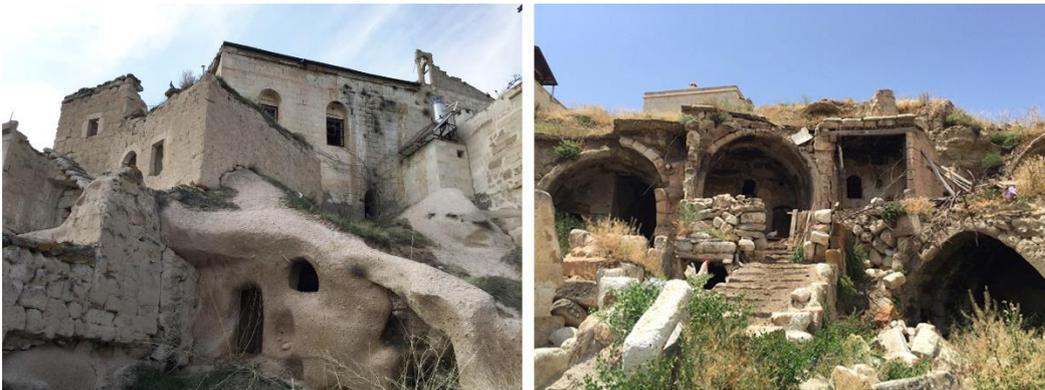
Figure 4.26. Earliest dwellings as extensions of the rock cut spaces

in form of aiwans and as the built-out units started to be constructed, spatial organization of the buildings started to develop.

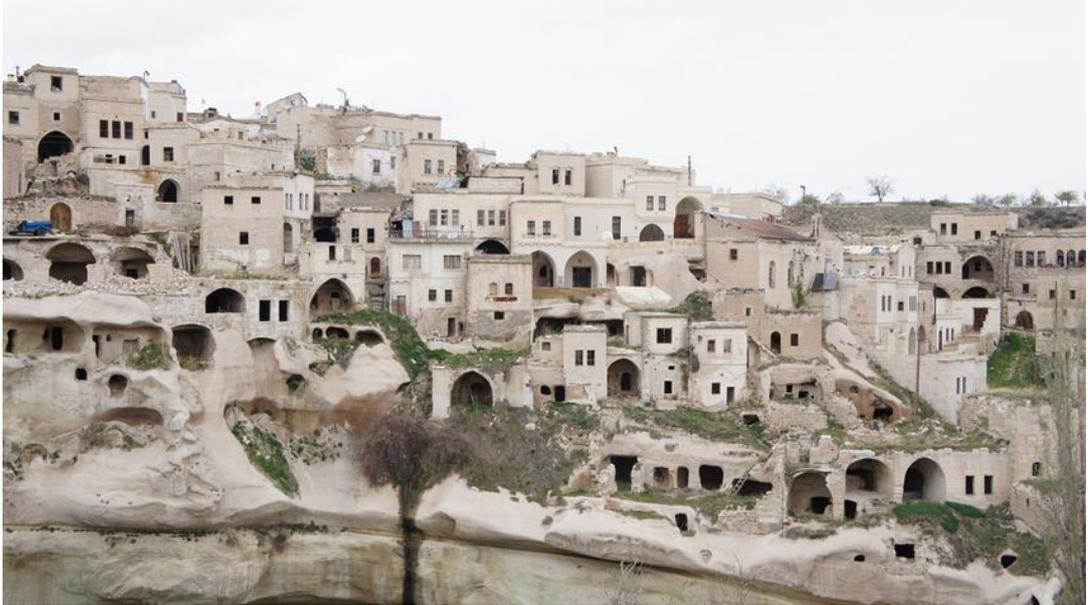
Figure 4.27. View from the village which the evolution process can be followed from bottom to top

In the first period of the development process of the village (see Figure 3.40 on s. 61), the building lots were smaller in size and the dwellings were in a direct relationship with the street having a street facade. The sizes of the dwellings varied according to the size of the buildable area of the lots either covering the whole lot or having a courtyard on the side. The plan schemes of the buildings were shaped according to the

form of the lot and the landscape without a certain typology. The ones which had a suitable rock formation at the back, carved according to their needs, always in a relationship with the courtyard on the side. If they didn't have an open area, they had a bigger carved-out unit which operated as a circulation area between the service units. All service units such as *tandır evi*, kitchen, storage, *şirahane*, stable and wc are located on the ground floor in a relationship with a carved-out circulation area or the courtyard. There might also be a living unit on the ground floor which is always placed on the street side of the building but the whole first floor consists of living units and circulation spaces.

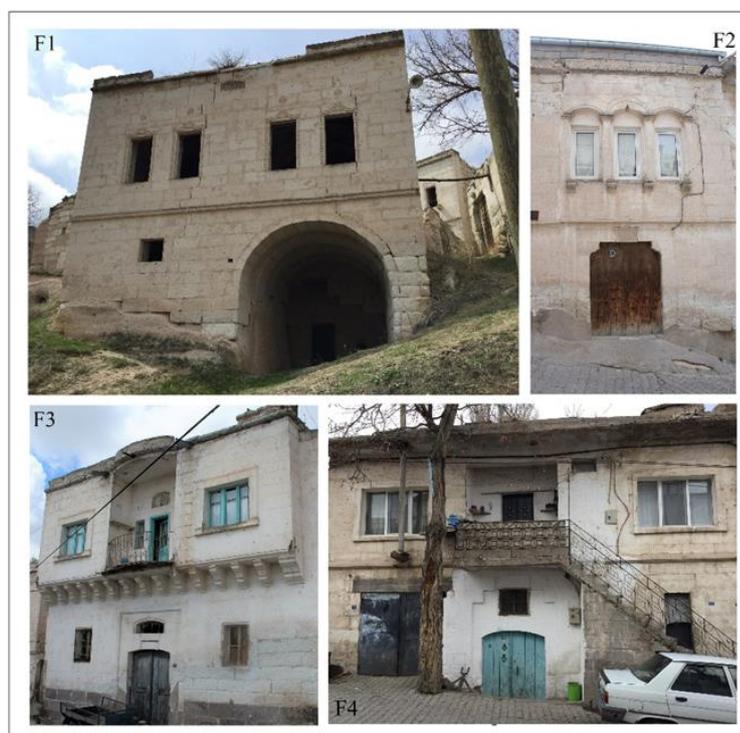
Figure 4.29. Examples of facade changes in the village in reference to Figure 4.32

The vast majority of the buildings in the primary study area have no or minor changes on their facades. The most common change in the facades are due to the change of original architectural elements with new ones, but their proportions and facade organizations are conserved. The reason is that they are more affordable, easy to find and do not need regular maintenance. In some of the buildings, the openings are combined as one large opening in order to have more light inside the rooms. In a few buildings, the facade became illegible because of the changes and additional architectural elements due to the functional changes of the plan units by the users.

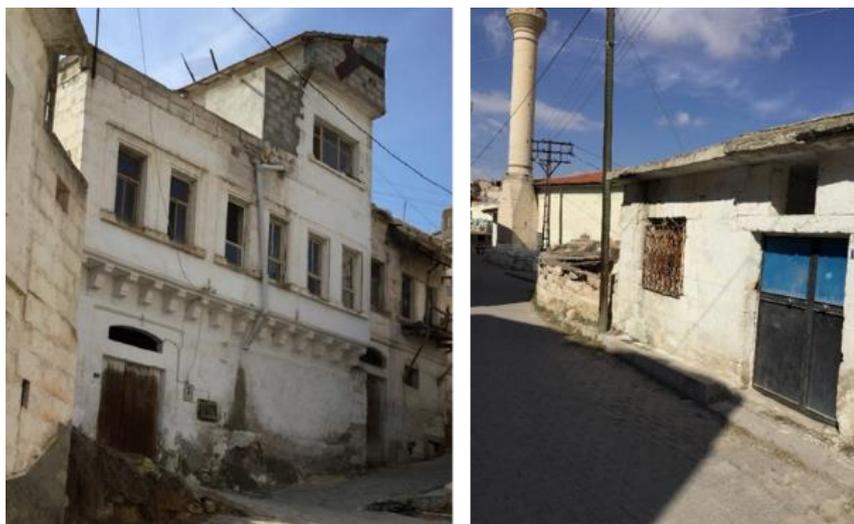
Figure 4.30. Facade elevations of the same building from two different streets

If the building is located between two streets, a third floor is built, which is perceived as a one floor building from the other side of the street (Figure 4.30). Change in vertical dimension in most cases occurs as a result of enclosure of the courtyard where the courtyard becomes a closed space having a direct entrance from the street. In these cases, also a horizontal addition can be added as a second floor to the closed area (Figure 4.31).

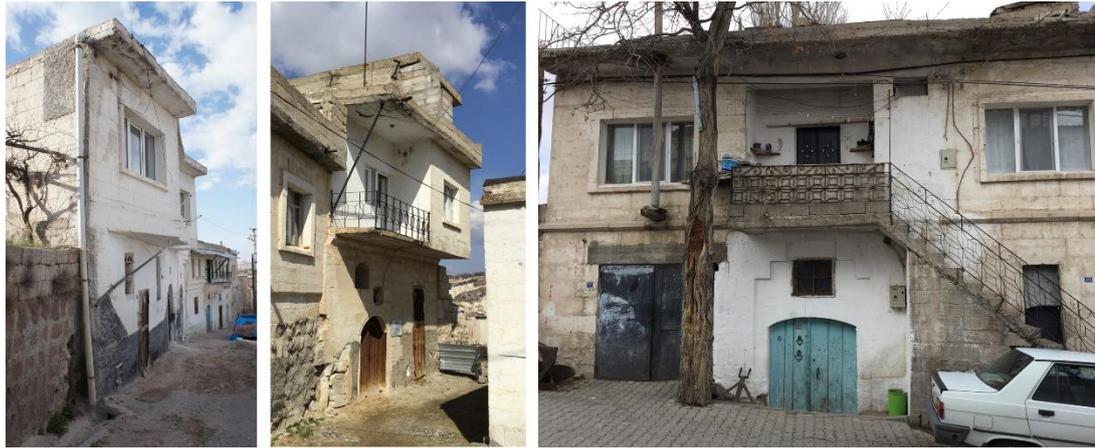
Figure 4.36. The buildings which have lost their authenticity

As seen from Figure 4.35, there are only three buildings in the primary study area which have lost their authenticity and it is not possible to turn them to their original status. Other buildings conserve their architectural and spatial characteristics with minor changes which don't affect their legibility and can be turned to their original status with necessary interventions.

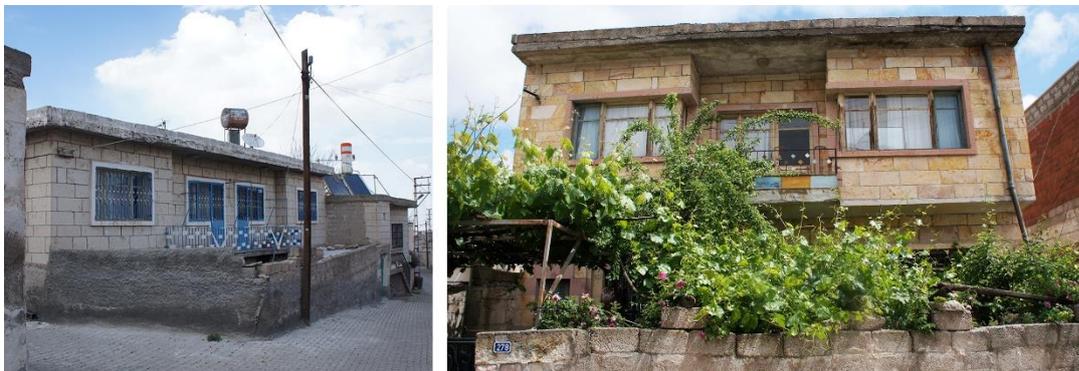
Figure 4.38. Examples for masonry walls with RC Frame slabs of new buildings

**Evaluation of new buildings:** This study aims to understand the tendencies of new building constructions in the study area and how it affects the settlement fabric. New buildings in the primary are mostly built after the second half of the 20<sup>th</sup> century with different materials and construction system. They are mostly located around the village square and the northwest side of the village, where the village tends to grow. As mentioned previously in Figure 3.72, they are either built with stone masonry walls having RC Frame slabs or totally built with RC Frame. The traditional techniques of arches and vaults were not used in new buildings. To evaluate their harmony with the traditional settlement fabric, a table is prepared according to the general criteria (Table 4.6).

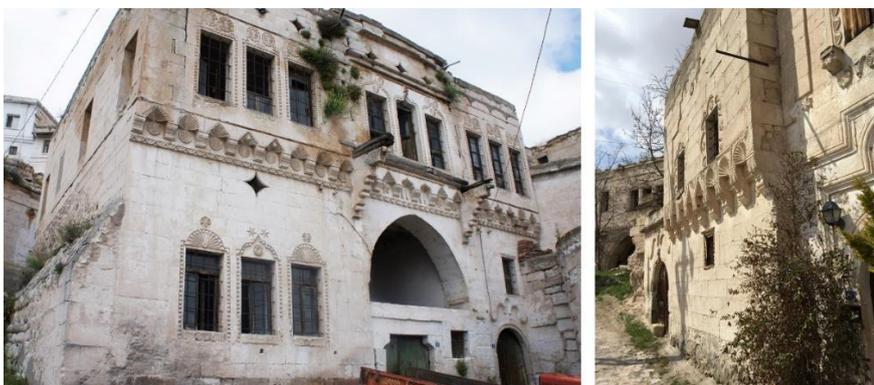
Figure 4.41. Buildings which belong to group V1 and rich in terms of facade ornamentation and architectural elements

Value group V1 consist of buildings which have the typological features of a traditional İbrahimpaşa house and preserving their authenticity. V1 has another sub-group for the buildings which have ornamented facades and are rich in terms of architectural elements.

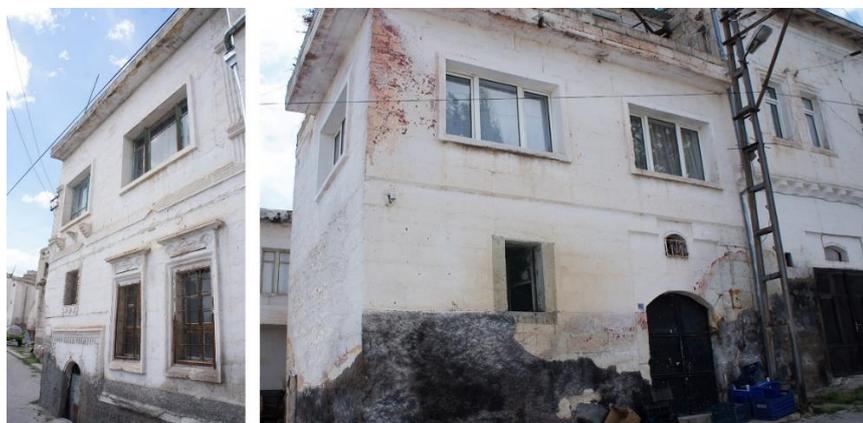
Figure 4.42. Buildings belonging to value group V2

Value group V2 consist of buildings which have the typological features of a traditional İbrahimpaşa house, have changes in terms of authenticity but which are still legible whereas the value group V3 consist of buildings which don't have any architectural elements, no typological features and are illegible.

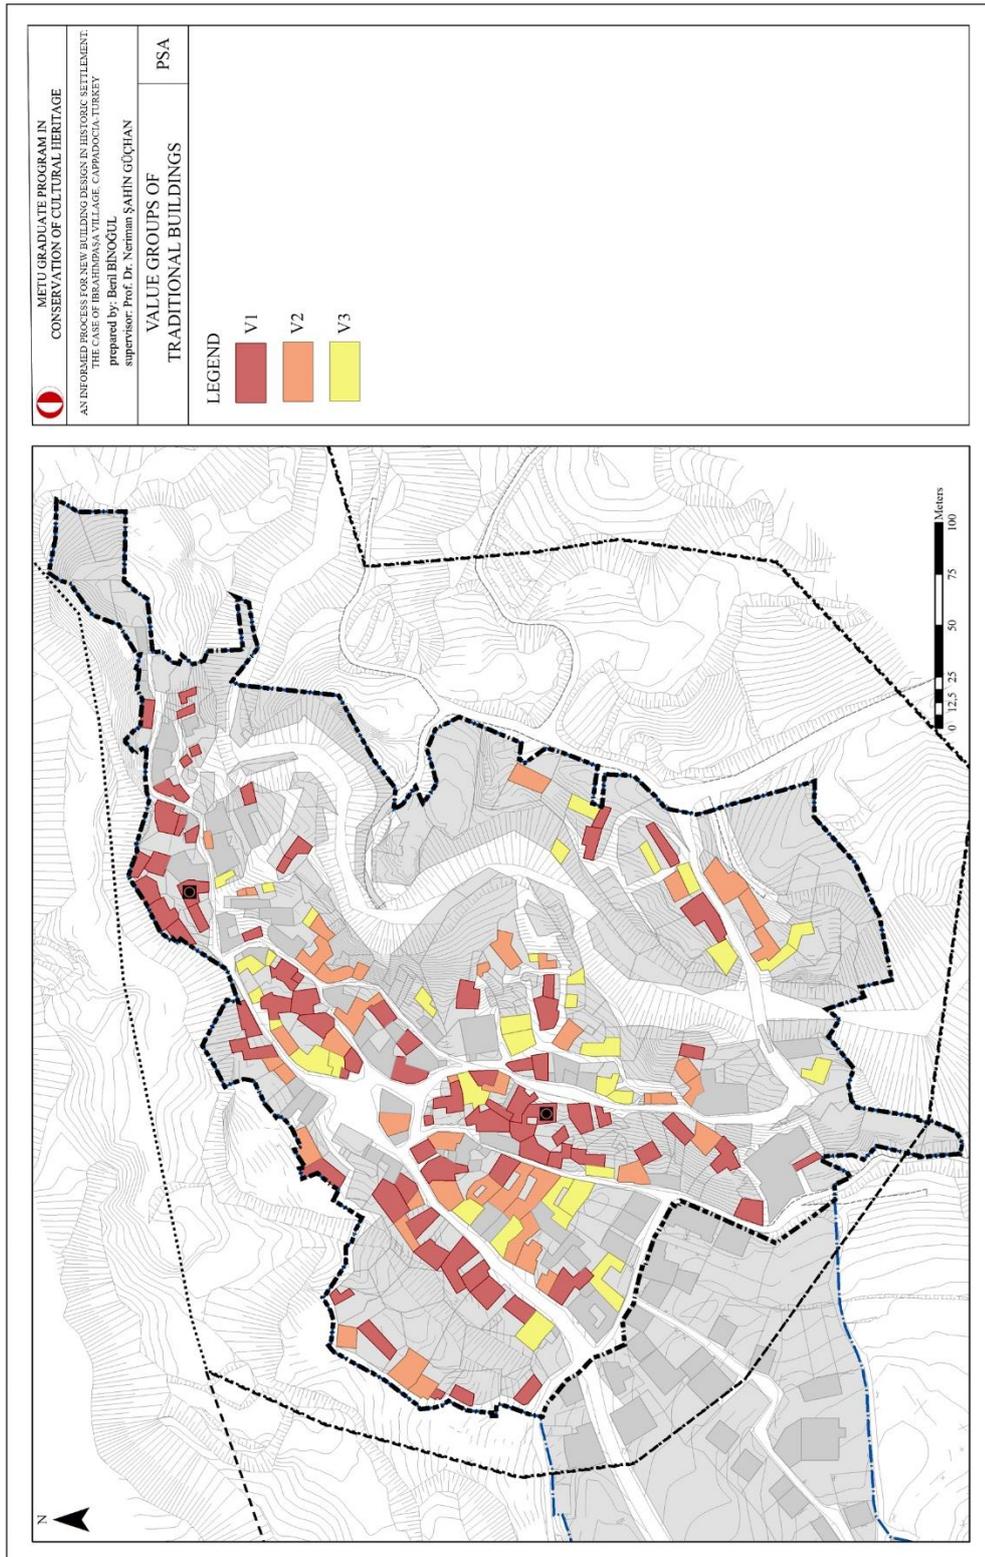
Figure 4.43. Value groups of traditional buildings

Assessment of the traditional settlement fabric and buildings of the village requires determination of value groups of traditional buildings. It is essential both to understand the existing building inventory and to decide interventions which are necessary for the continuity of the historical settlement fabric. In order to determine the value groups the following parameters were used: the structural condition of the buildings, their architectural elements including their ornamentation degree, typological features and their authenticity degree (Table 4.7).

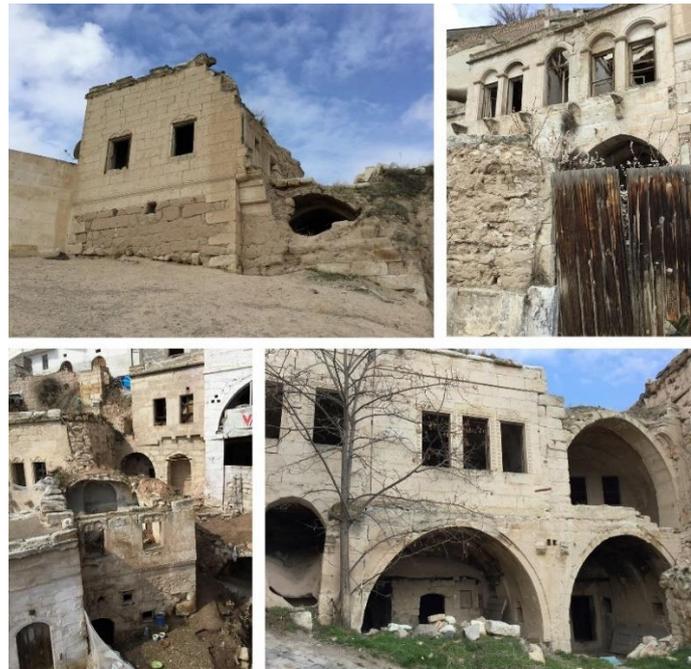
Figure 4.47. Unused and ruined buildings

In terms of built-up environment, most of the buildings in the first study area are in a good condition in terms of structure and material but there are also lots of unused buildings in the study area which have already turned to **ruins** or which will if the preventive precautions are not taken (). In these cases, architects may use the information given in this study in order to construct a building from its footprints.
