“THE CITADEL OF ANKARA”: ASPECTS OF VISUAL DOCUMENTATION
AND ANALYSIS REGARDING MATERIAL USE

A THESIS SUBMITTED TO
THE GRADUATE SCHOOL OF NATURAL AND APPLIED SCIENCES
OF
MIDDLE EAST TECHNICAL UNIVERSITY

IN PARTIAL FULFILLMENT OF THE REQUIREMENTS
FOR
THE DEGREE OF DOCTOR OF PHILOSOPHY IN BUILDING SCIENCE
IN
ARCHITECTURE

SEPTEMBER 2005

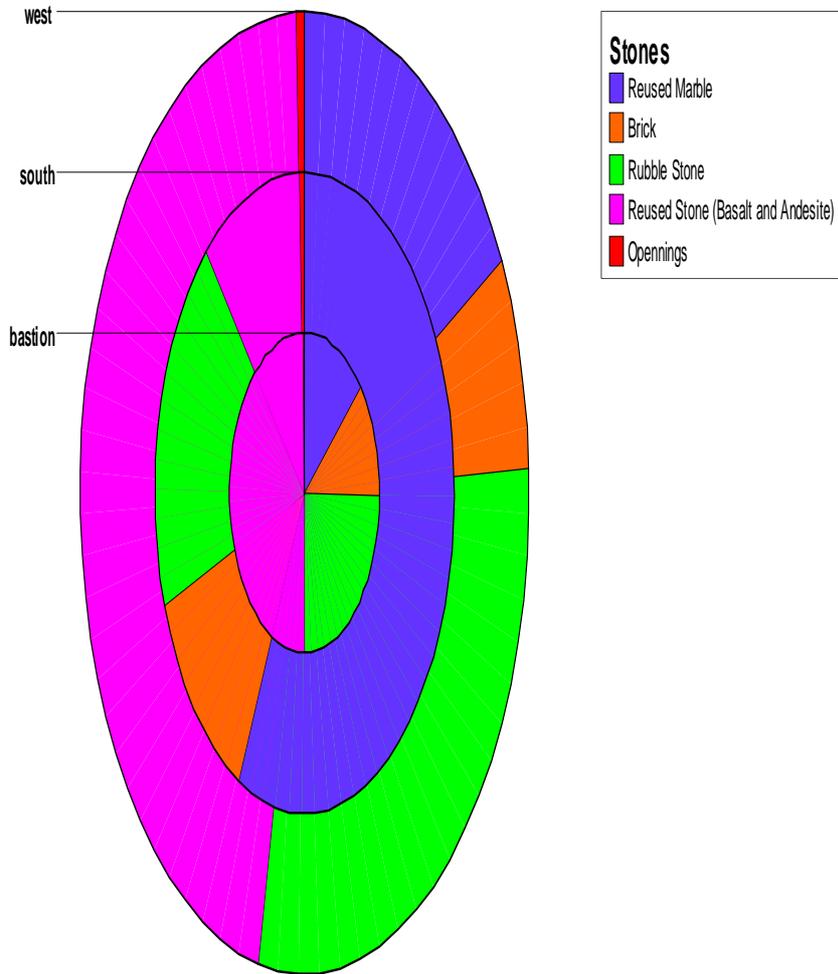
Chart 8

The comparison of the west side , south side and the bastion with respect to the distribution of the building materials.

The results obtained from the sampling of % 29 of the Bastion:

Stones.....	Surface m²
Reused marble.....	31, 390871
Reused andesite/basalt.....	114,232130
Rubble stone.....	56,803369
Brick.....	26,794170
Openings.....	0,418401

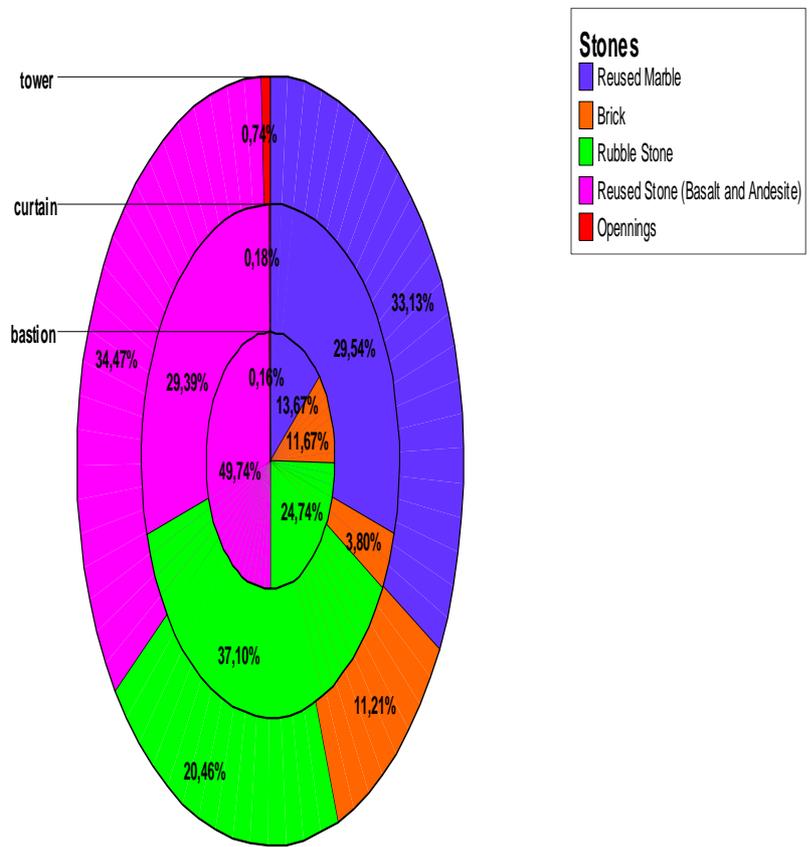
Chart 9

The comparison of the towers, curtains and the bastion with respect to the distribution of the building materials.

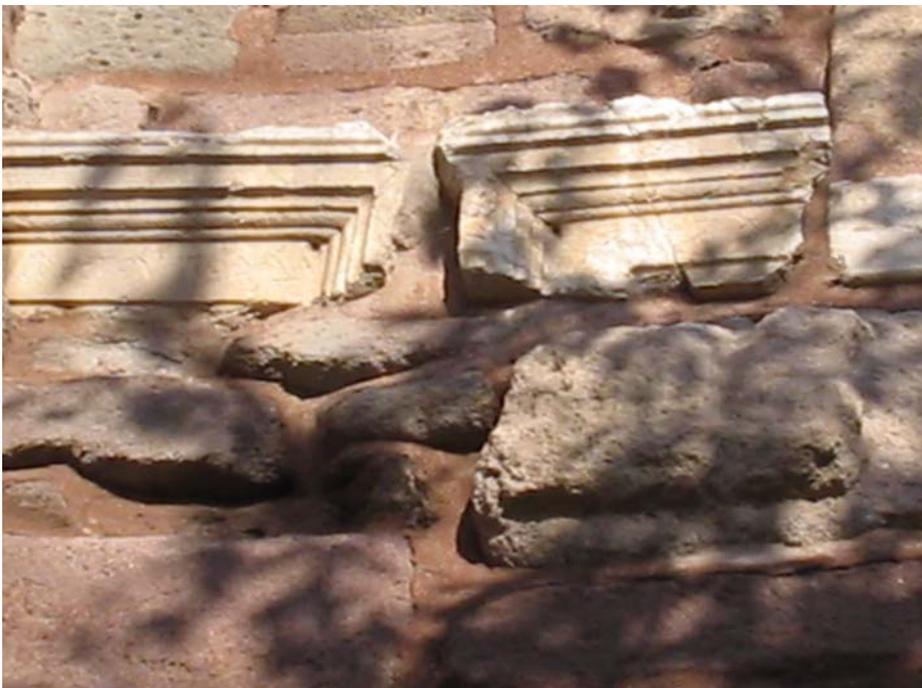
Figure 12. West Curtain 9 (inscription/Greek?)

WC9: (West Curtain 9): 2 frames in marble. The sections remaining within the frames bear inscriptions in Greek. 1 block in marble with an inscription in Greek (Figures 12, 13).

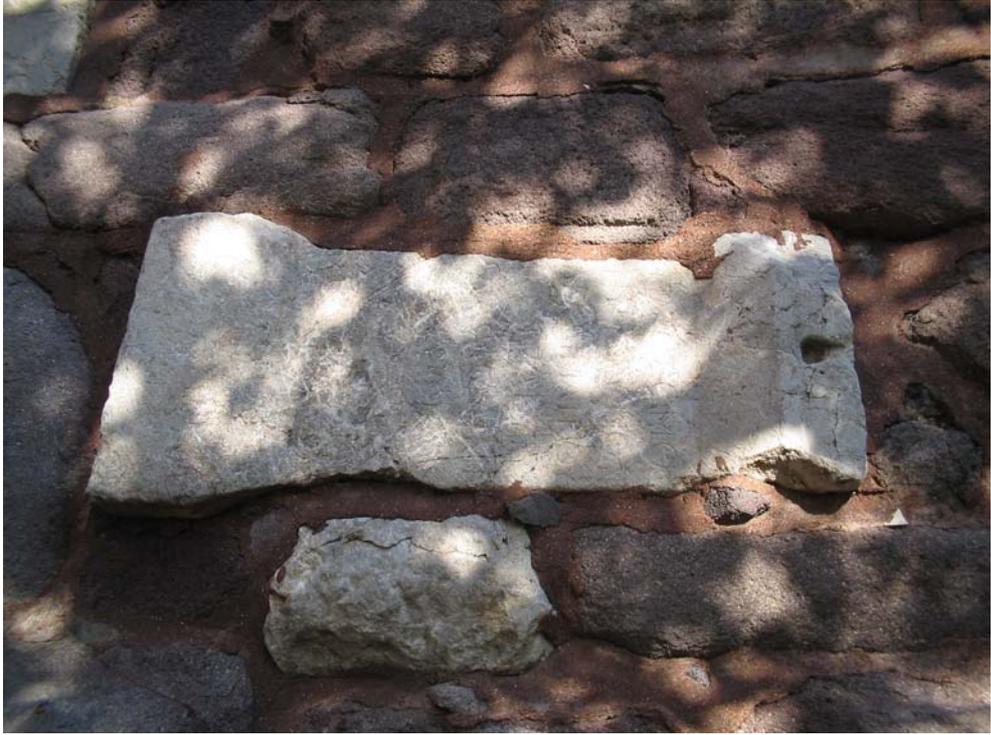
Figure 13. West Curtain 9 (inscription/Greek)

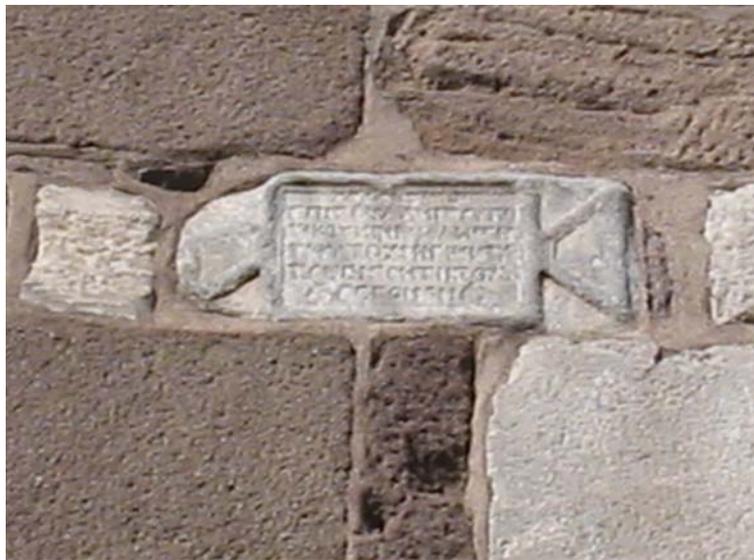
Figure 14. West Tower 5, Face 3 (inscription in tabula ansata/Greek)

WT 5 F 3 (West Tower 5, Face 3): 1 inscription in Tabula Ansata (in Greek) on a marble block, 1 mason's mark (in Greek) on a block of andesite (Figures 14, 15).

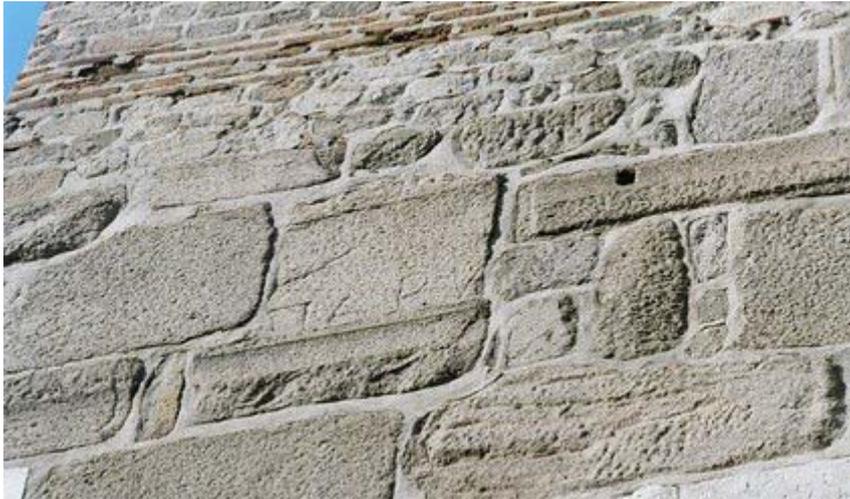
Figure 15. West Tower 5, Face 3 (mason's mark/Greek)

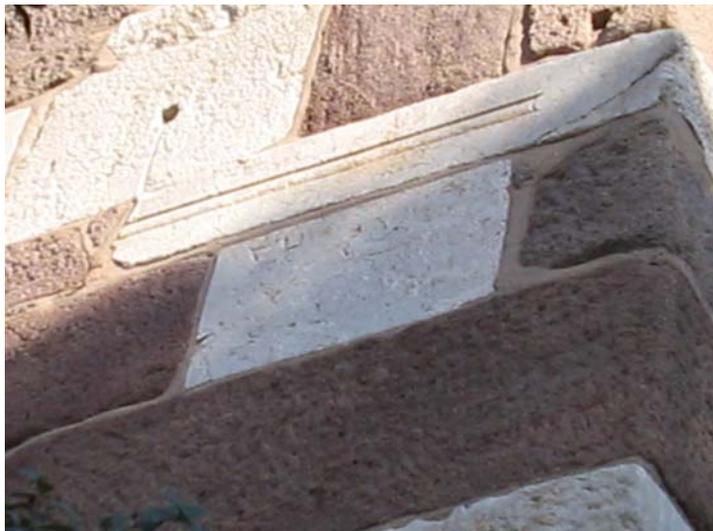
Figure 16. West Tower 4, Face 2 (inscription/Greek)

WT4 F2 (West Tower 4 Face 2): A marble block bearing an inscription in Greek (Figure 16).

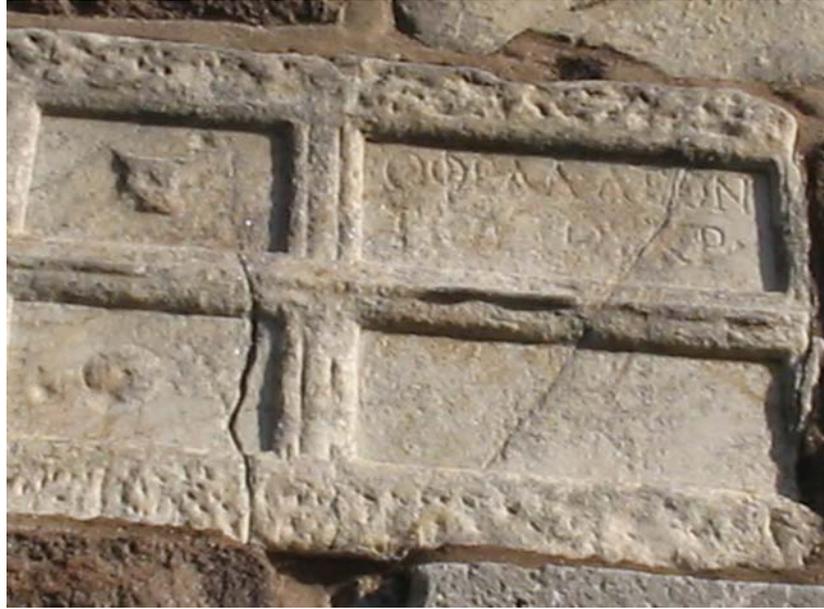
Figure 17, West Tower 3, Face 2 (inscription/Greek)

WT3 F2 (West Tower 3 Face 2): A grave stele bearing an inscription in Greek (Figure 17).

The pagan and Christian elements can be observed at the same tower or curtain with crosses engraved on blocks that surmount the loopholes (Figures 17, 81-84) or by the architectural elements and sculpture like priapus, bucranium, medusa and rain-water spout (Figures 93, 97-101, 108, 138). The marble columns are mostly used to anchor the facing to the rubble core (Figures) and at times for decorative purposes (Figures 124, 139).

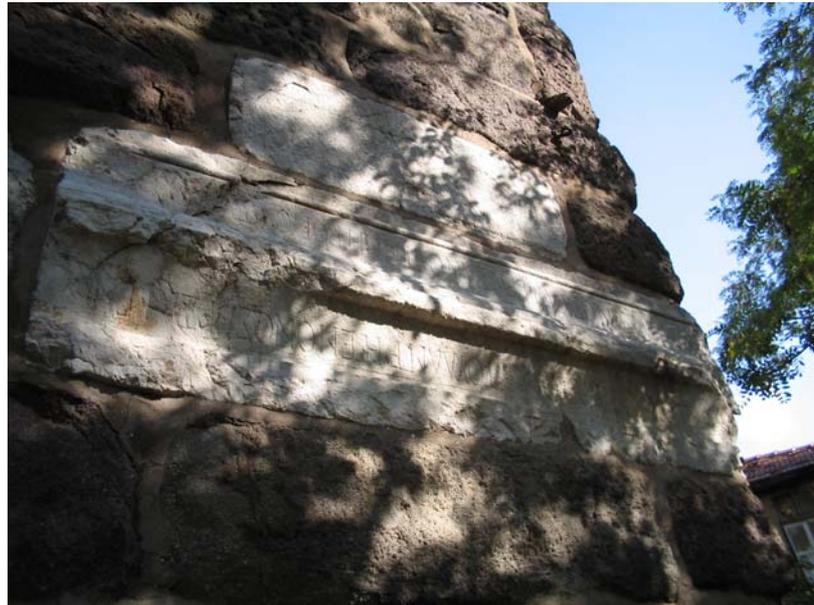
Figure 18. West Tower 2, Face 2 (inscription/Greek)

WT 2 F2 (West Tower 2, Face 2): 1 inscription in Greek engraved on a marble architrave, the block is broken at the ends and the inscription incomplete, upsidedown (Figures 18,19).

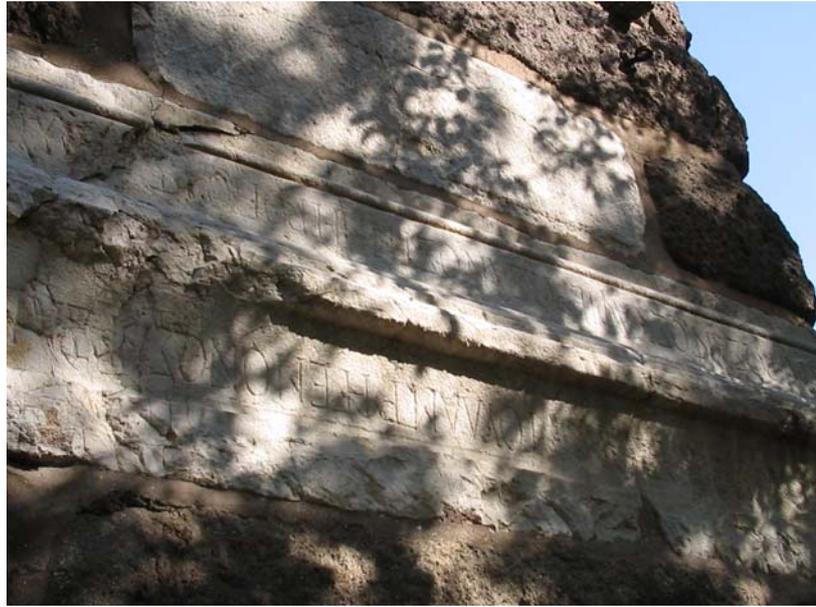
Figure 19. West Tower 2, Face 2 (inscription/Greek)

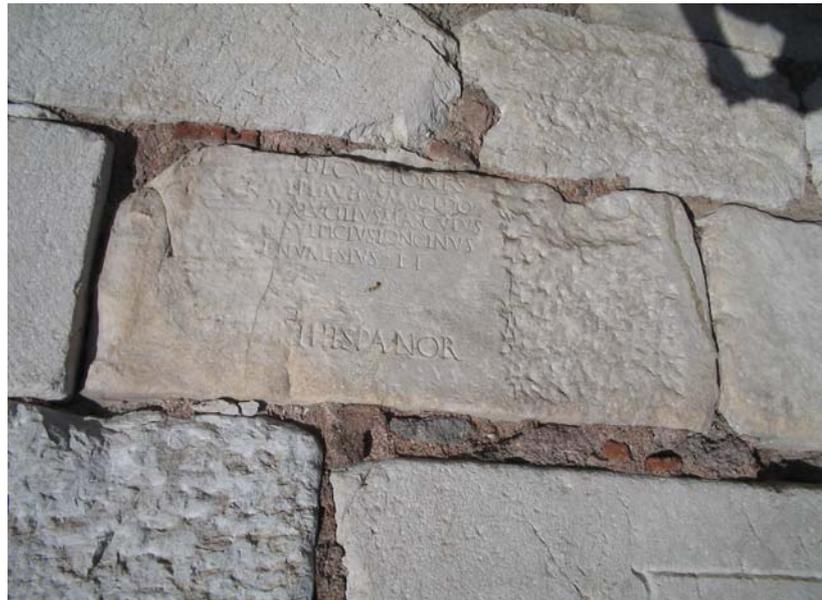
Figure 20. South West Tower 1, Face 2 (inscription/Latin)

SWT1 F2 (South West Tower 1, Face 2): 1 inscription in Latin on a marble block, upsidedown, incomplete, the surface of the half of the block is broken⁵⁶ (Figures 20,21).

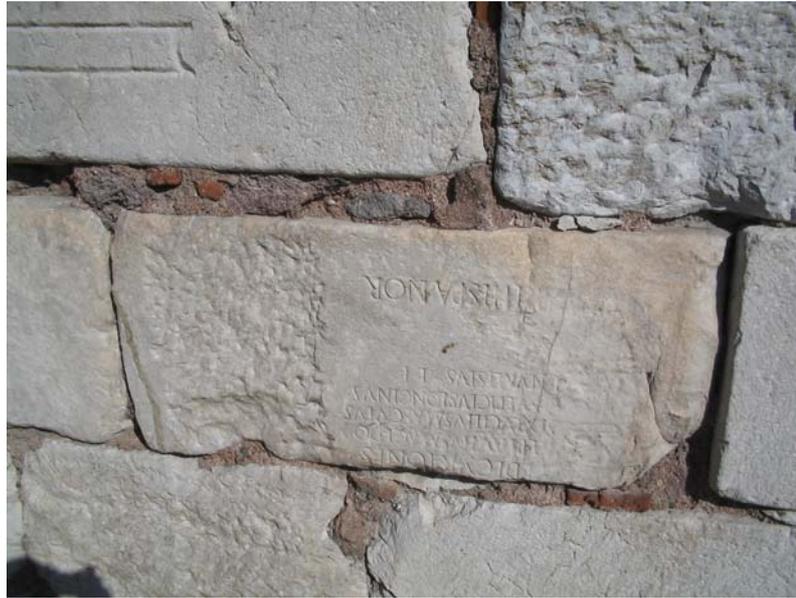
Figure 21. South West Tower 1, Face 2 (inscription/Latin)

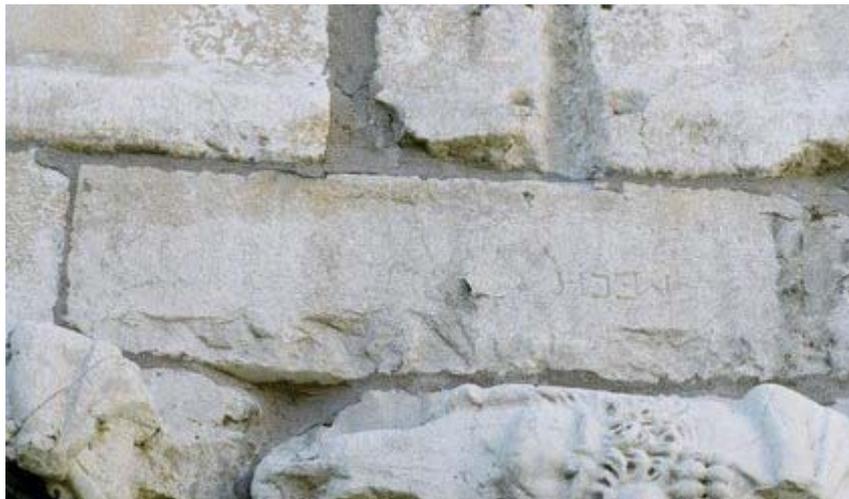
Figure 22. South Curtain 4 (mason's mark/Greek?)

SC4 (South Curtain 4): mason's mark in Greek on a marble block, upsidedown., (Figure 22).

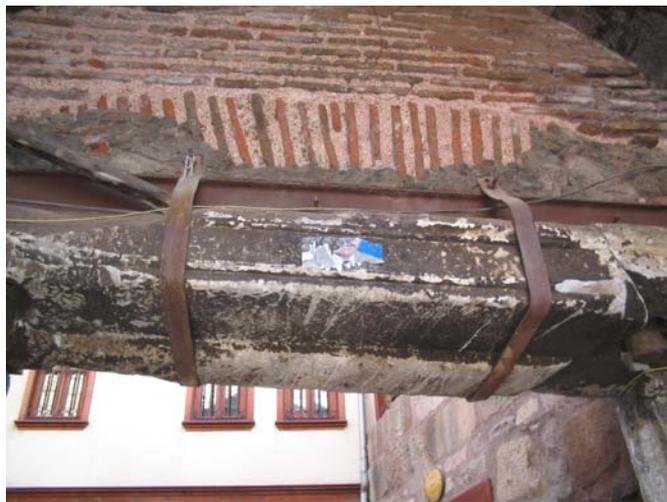
Figure 28. Zindan Kapı, interior (inscription/Greek?)

Zindan Kapı (interior): 1 inscription on the lintel of the gate, in Greek? (Figure 28).

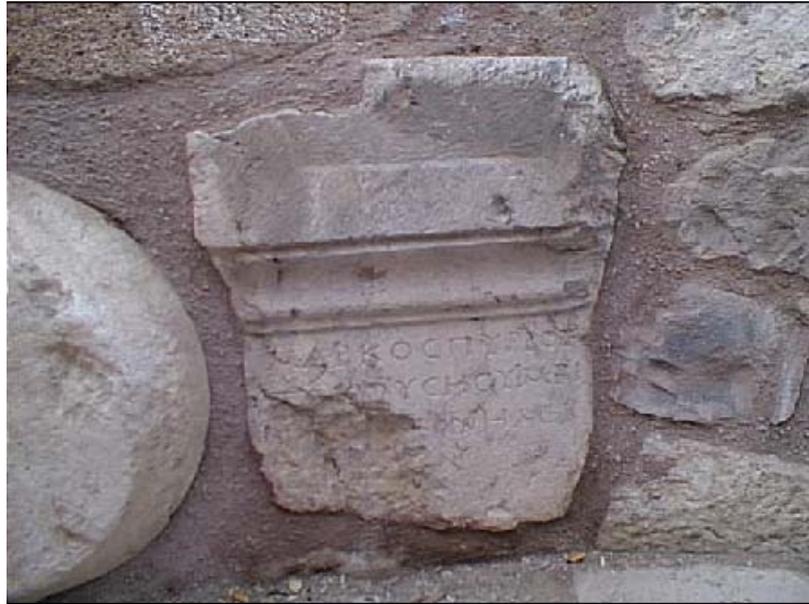
Figure 33. Bastion, interior (inscription/Greek)

B (Bastion), Interior: 1 inscription in Greek, marble architrave, marble broken, incomplete, (Figure 33).

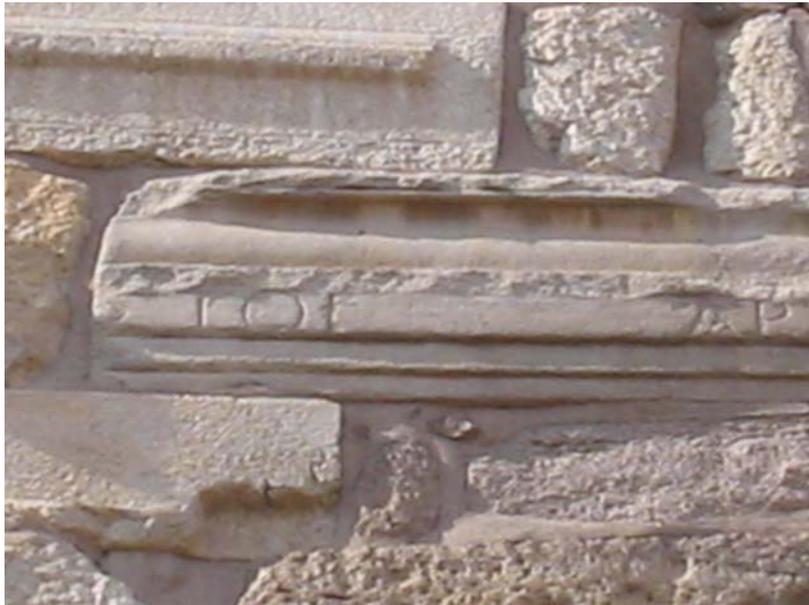
Figure 34. Bastion Face 3 (inscription/Greek)

BF2 (Bastion Face 3): 1 inscription on a broken marble architrave, incomplete, in Greek (Figures 34, 35).

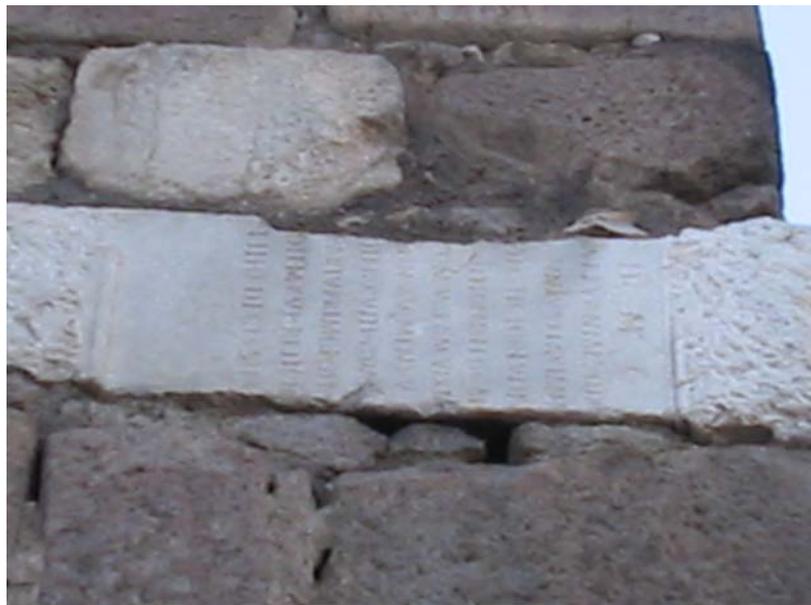
Figure 36. East Tower 9, Face 2 (inscription/Latin? Greek?)

ET9 F2 (East Tower 9 Face 2): A marble block bearing an inscription in Greek? (Figures 36,37)

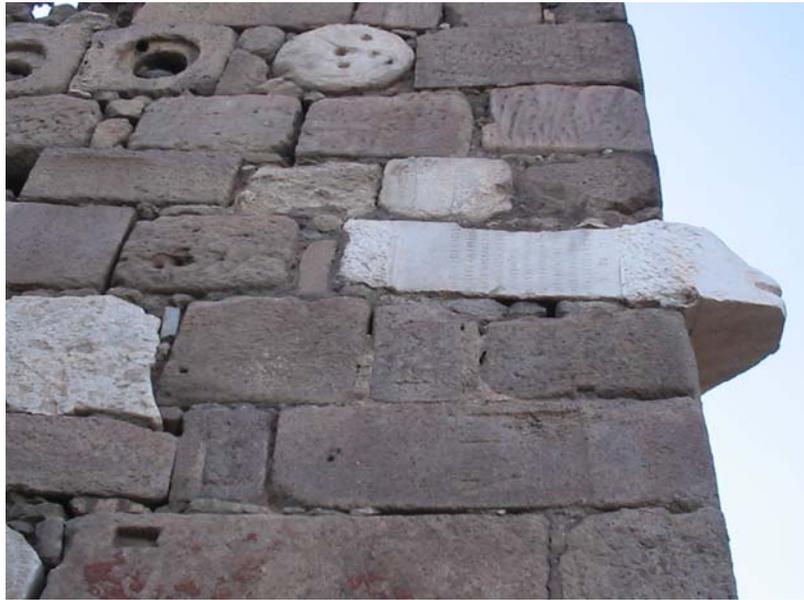
Figure 37. East Tower 9, Face 2 (inscription/Latin? Greek?)

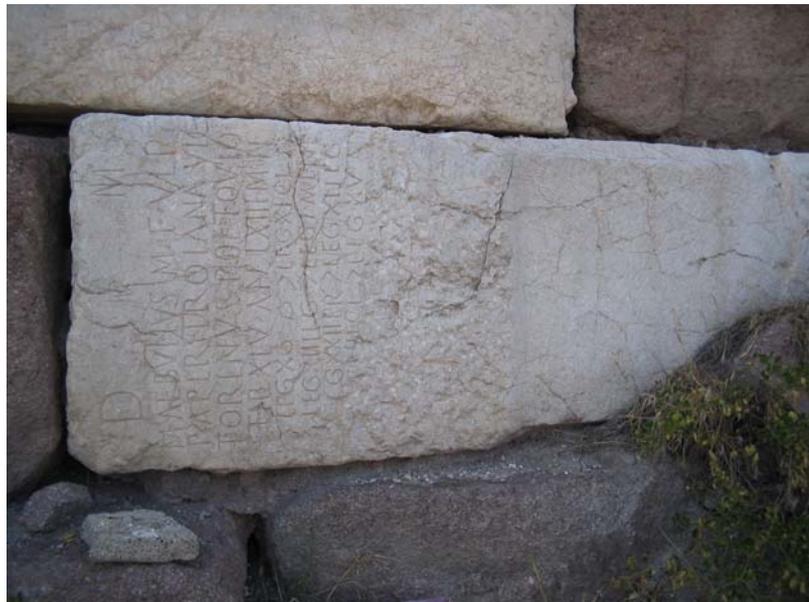
Figure 38. East Tower 13, Face 2 (inscription/Greek)

ET13 F2 (East Tower 13 Face 2): 1 inscription in Greek on a marble block. 1 marble block carrying mason's mark (Figures 38,39).

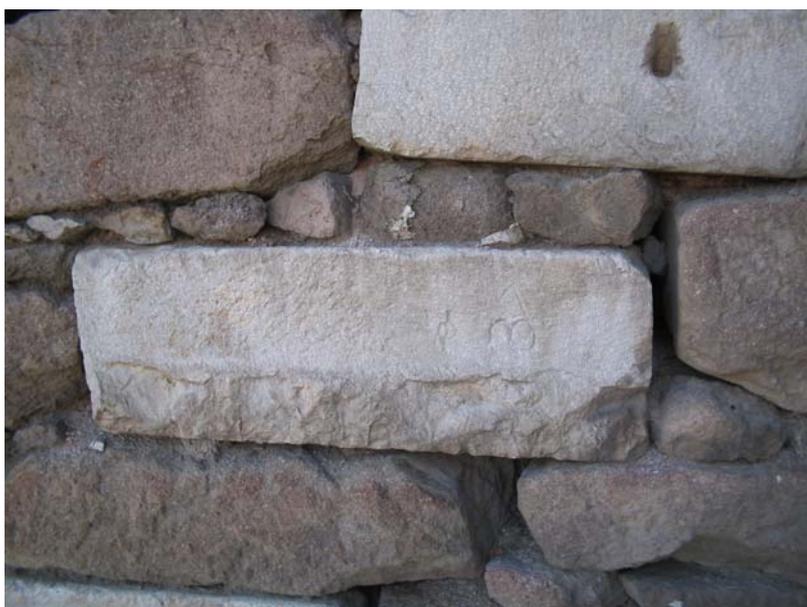
Figure 39. East Tower 13, Face 2 (mason's mark/Greek)

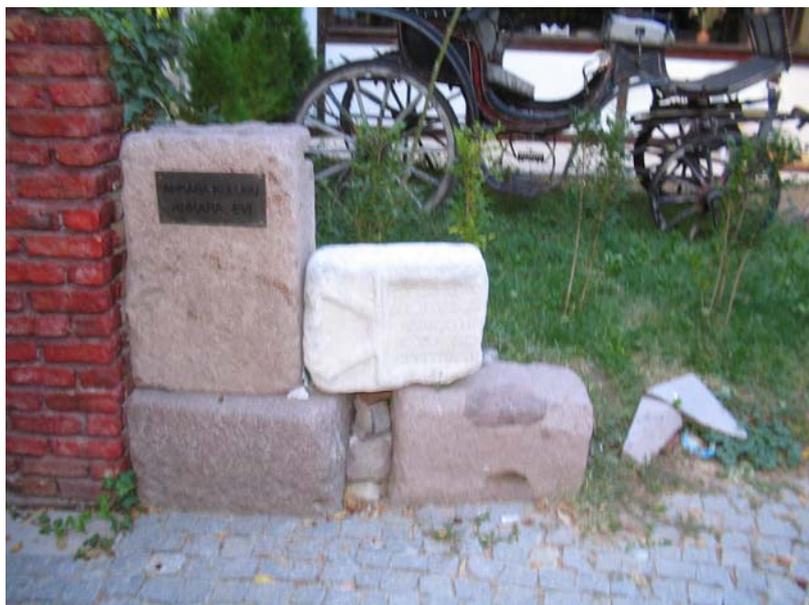
Figure 40. Ankara Evi Parkı (inscription in tabula ansata/Greek?)

Ankara Evi Parkı: 1 inscription in tabula ansata, fragmentary marble block (Figure 40).

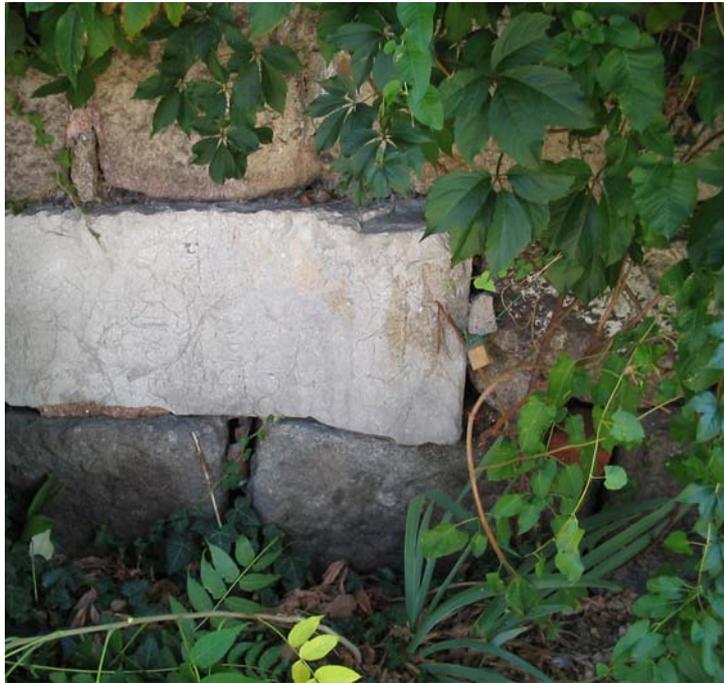
Figure 41. Inscribed stone built into the wall across the Museum of the Anatolian Civilizations (Greek)

The wall across the Museum of Anatolian Civilizations: 1 inscription in Greek engraved on a marble block (Figure 41).

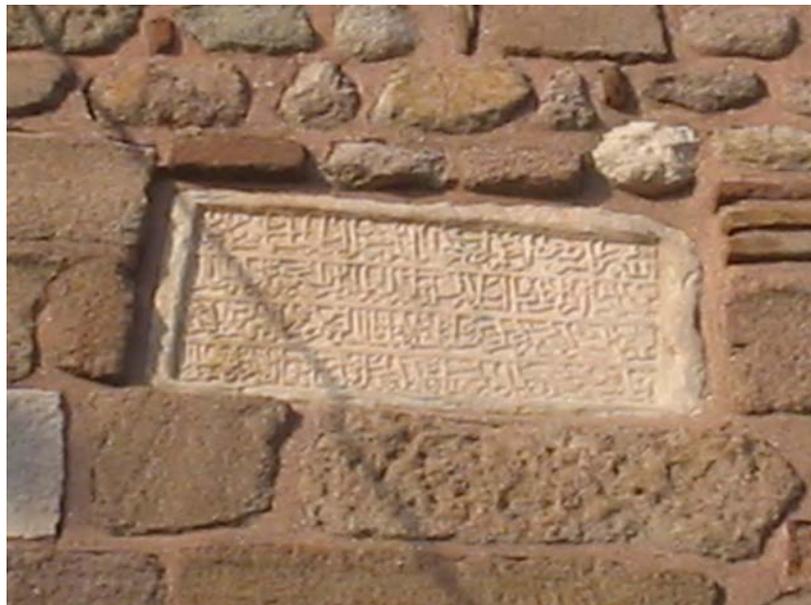
Figure 42. Hisar Kapı, exterior (inscription/Persian)

Hisar Gate, Exterior: 1 inscription in Persian on a marble block (Figure 42).

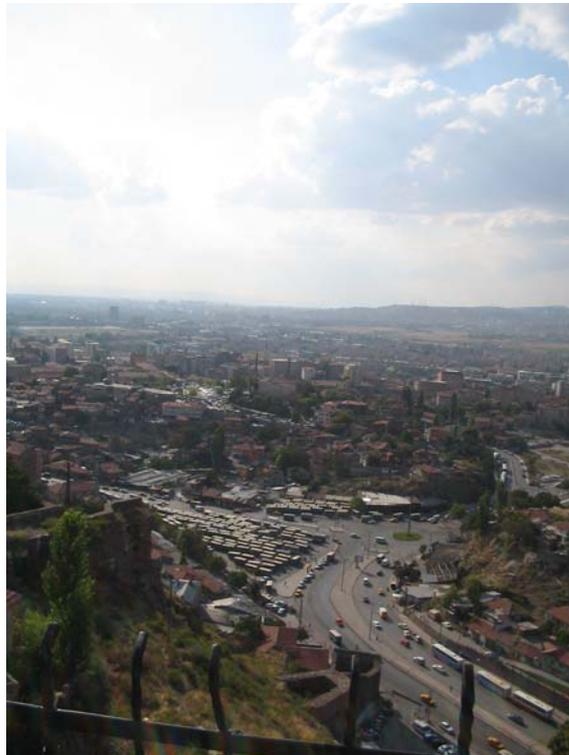
Figure 44. Hacı Bayram Mosque and the Temple of Augustus

The north-west corner of the citadel overlooks to the valley below; Bend Deresi street (Figure 44) and Hıdırlık Hill (Figure 50) on the north and Hacı Bayram mosque and the Temple Augustus on the west (Figure 44). The east of the citadel commands the valley below which is now the continuation of the Kale district and further down is the district of Cebeci (Figure 57). The view from this side extends as far as “Elmadağ”, the ancient mountain of “Megaba” which lays beyond the city limits. The water system would have been installed between this mountain and the east side of the citadel which explains the accumulation of water pipes on this side of the citadel⁷⁴ (Figures 131, 151, 165). Although the majority of the antique fragments were built into the the west and south sides of the citadel, spolia belonging to ancient monuments are also found on the south-east and east sides of the circuit (Figures 145, 146, 150, 151).

The citadel was not only protected by high cliffs or a second circuit. The steep hill was once surrounded by streams on the north and south. The Bend Deresi street is constructed over the “Hatip Çayı”, “Bend Deresi” and follows its path (See Map), (Figure 44). The city was also surrounded from the south by another stream called İncesu. These two streams would have joined on the north-west and the city would have been surrounded by water or swamp from the north, north-west and south. Consequently the fortress was not only protected by a steep hill and a double circuit but also by streams.

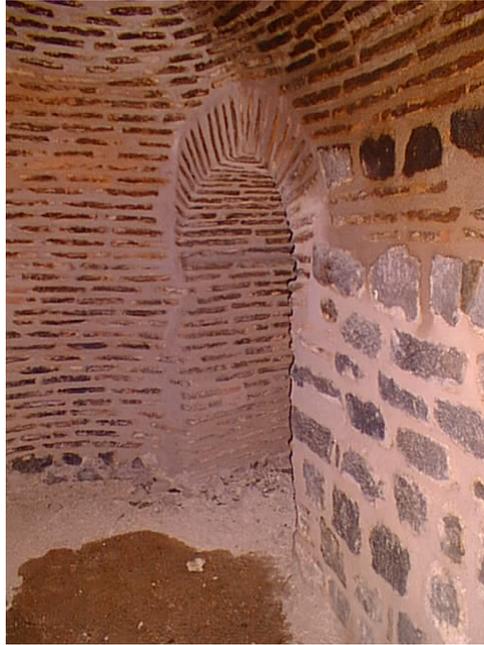
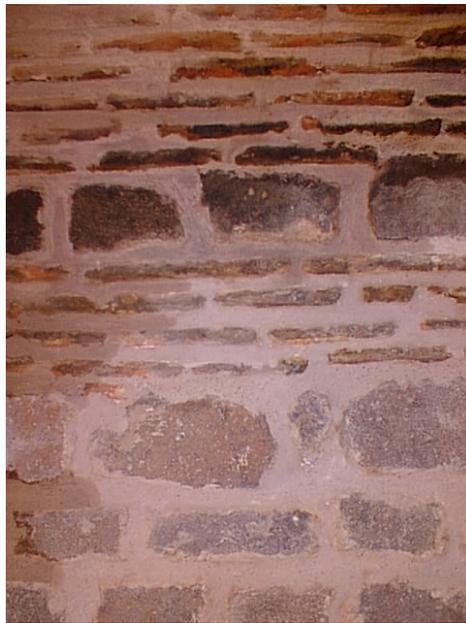
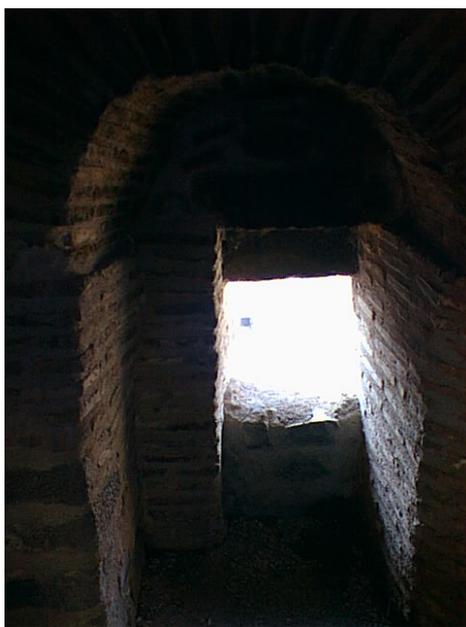
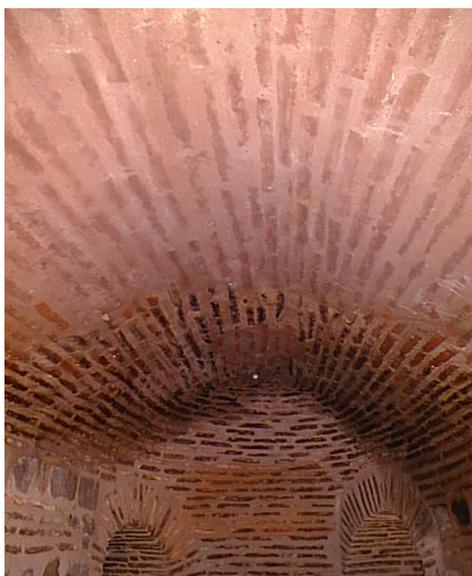
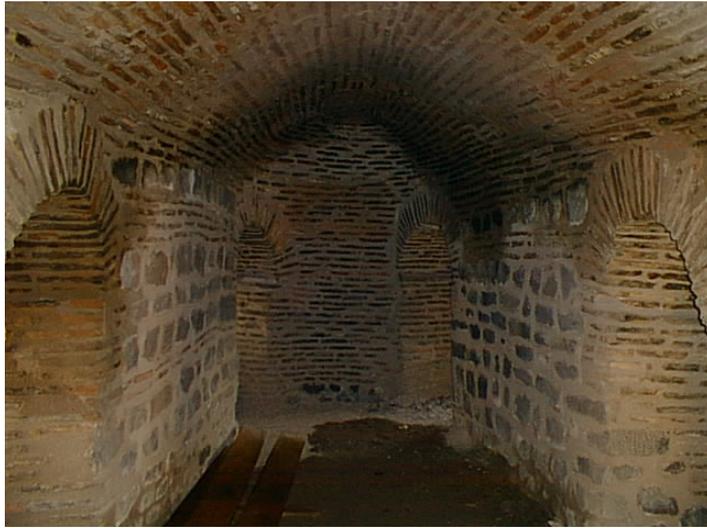
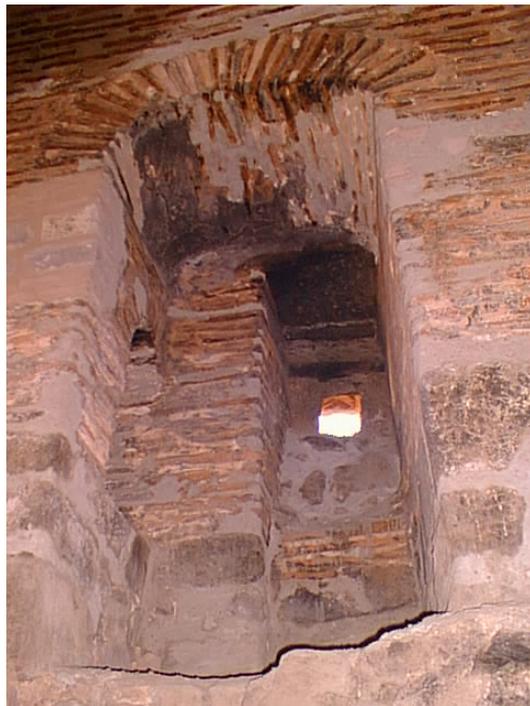
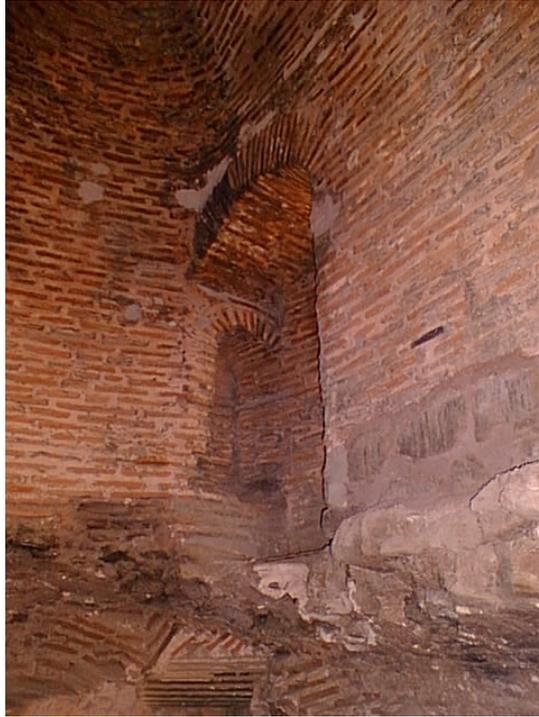
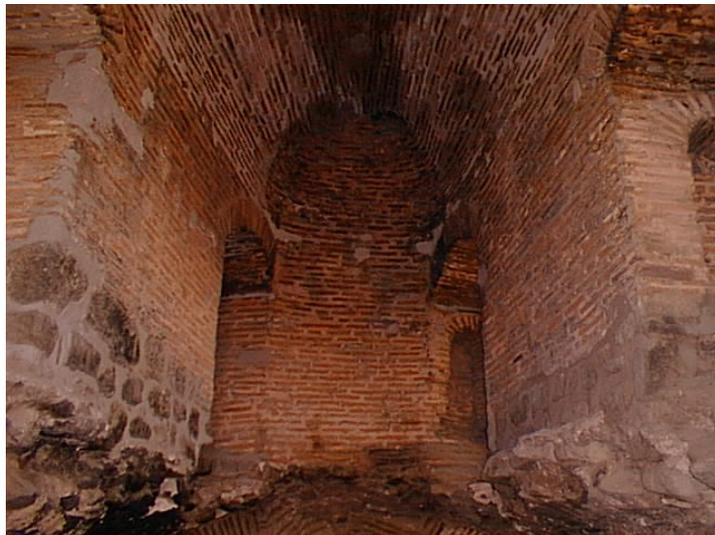
ST2 and ST3 (Figures 187-194) has not yet reconstructed and considerably in good condition. The windows at the upper storey of ST2 have brick arches (Figures 192, 193). Its ceiling is vaulted and faced with brick. The bricks are laid longitudinally conforming to the curve of the vault (Figures 190, 191, 194). The sides of the lower structure are faced with shapeless rubble stones in thick mortar (Figures 187, 188, 191, 194). The mortar is pink and would have been Byzantine. The masonry of ST3 is similar but its lower room is left beneath the present ground level. These rooms are very small compared with the rooms in the towers of Heraclius at the land walls of İstanbul.

The masonry of the interior of the circuit can only be observed from this side as the interiors of the west and east sides are completely obstructed by houses. The sizes of the rooms are very small as compared with the rooms in the towers of the wall of Heraclius. The masonry of ST 2 consists almost entirely of brick (Figures 193, 194). The interior at present is a fairly large room extending vertically and ending with a barrel vault. The masonry of the lower section consists of irregularly

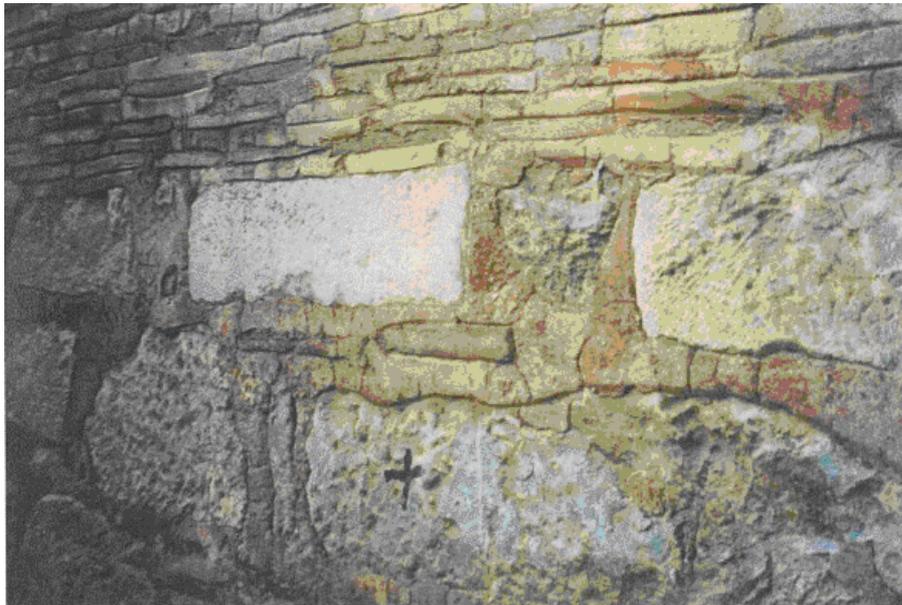
Figure 214. Detail of masonry between Towers 95-96, south

between the South Lake and Yenişehir gates are quite similar to the towers at Ankara; large irregularly shaped marble spolia laid in regular rows with wide mortar joints (Figures 214, 215, 217-219). This type of masonry indicates that the lower sections of these towers were reconstructed as mortar was used to cover large gaps between the blocks. The mortar joints are even larger on the west side of the citadel at Ankara which conceals the irregularity of the blocks.

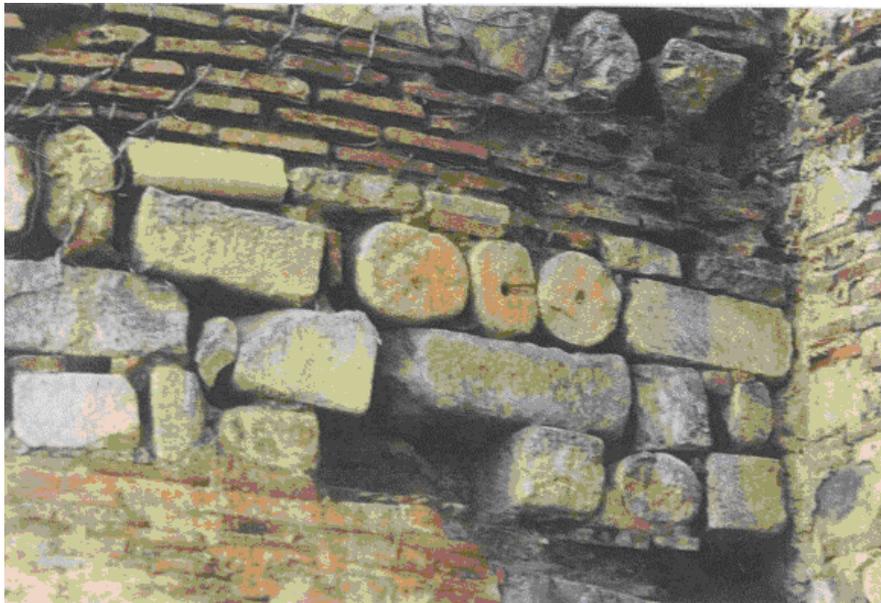
Figure 216. Detail of masonry, Tower 100

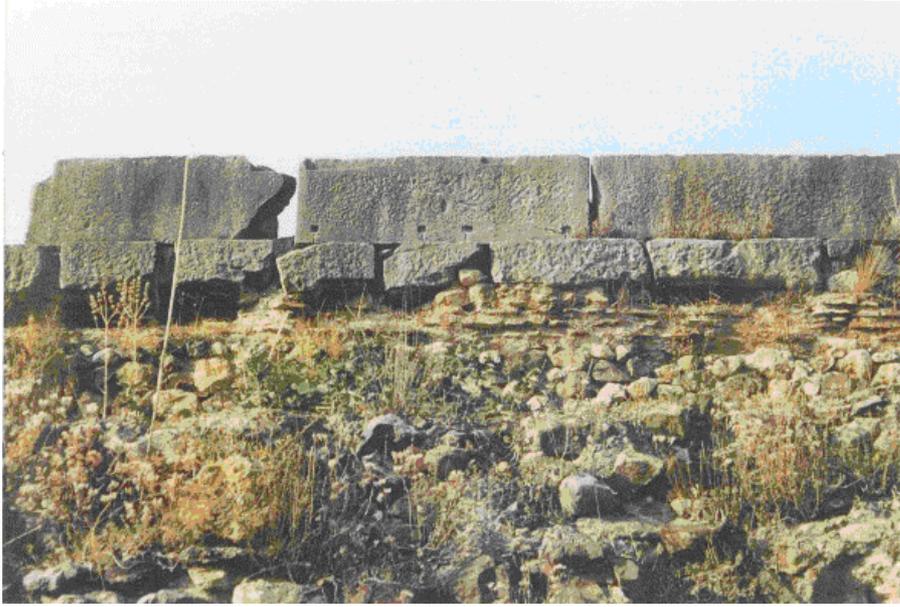
Figure 225. Wall between Towers 106-108

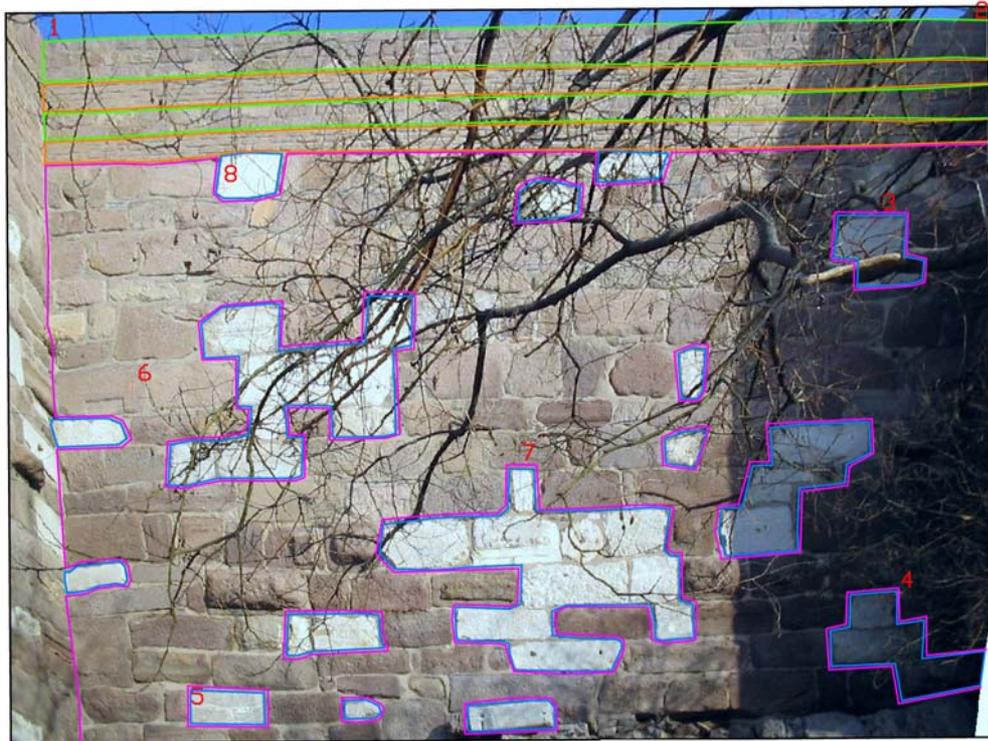
Figure 226. West Curtain 17

Building Materials Legend

- Reused Marble
- Reused stones (basalt/andesite)
- Rubble stone
- Brick

In the second stage the walls were chosen from the west side of the inner citadel. Kemal Gülçen conducted the survey with Sinan Sülüner. Kemal Gülçen read the control points using total station equipment. In this stage of the survey total station read the points without the control point papers stuck on the walls. The photographs were taken by Sinan Sülüner. The rectifications of the photographs were done in Arcview Desktop 9.0 software. Polynominal transformation method was used for the rectification with an error margin of approximately 10cm. The error was caused by the difficulties encountered in the site due to the steepness of the slope which started from the foot of the towers and curtains (Figures 3-5) as it was very difficult to take photographs by standing parallel to the walls. Consequently some of the walls which were included in the random selection for statistical evaluation were not drawn as they were not suitable for rectification⁶. The difficulty was not only the slope of the terrain but some of the towers and curtains were obstructed by trees. In this stage the photographs were rectified in colour. The rectified photographs were put in Autocad program by Nurdan Atalan and the distribution of the building materials in areas was digitized by Sinan Sülüner (Figures 226-234).

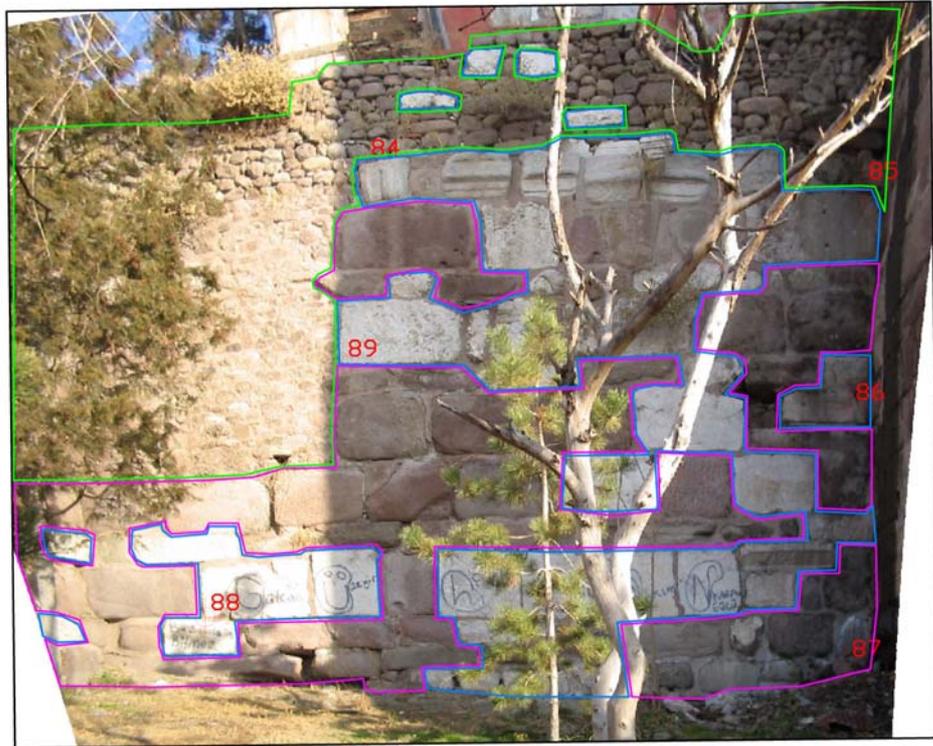
Figure 233. West Curtain 7

Building Materials Legend

- Reused Marble
- Reused stones (basalt/andesite)
- Rubble stone
- Brick

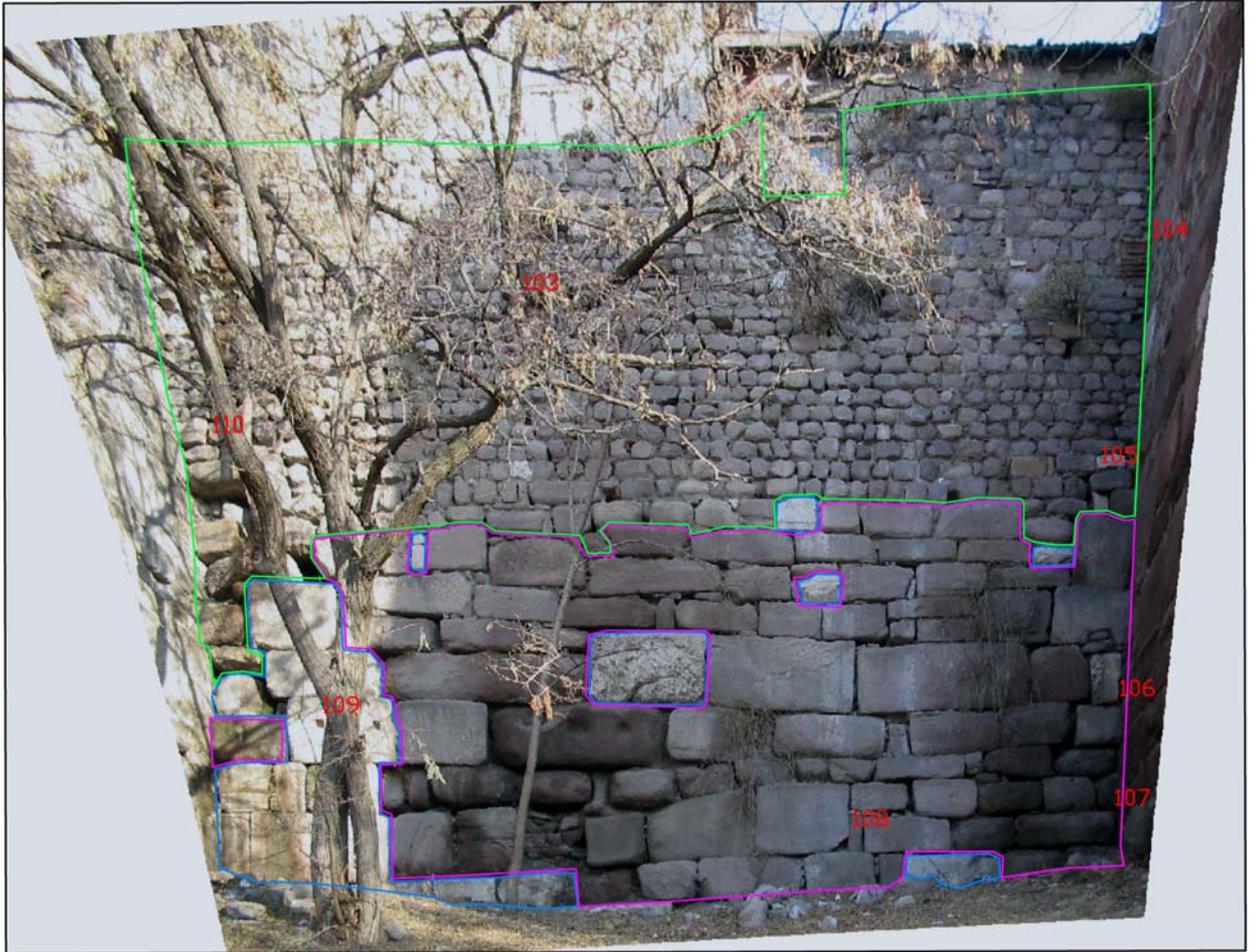
Figure 234. West Curtain 2

Building Materials Legend

- Reused Marble
- Reused stones (basalt/andesite)
- Rubble stone
- Brick

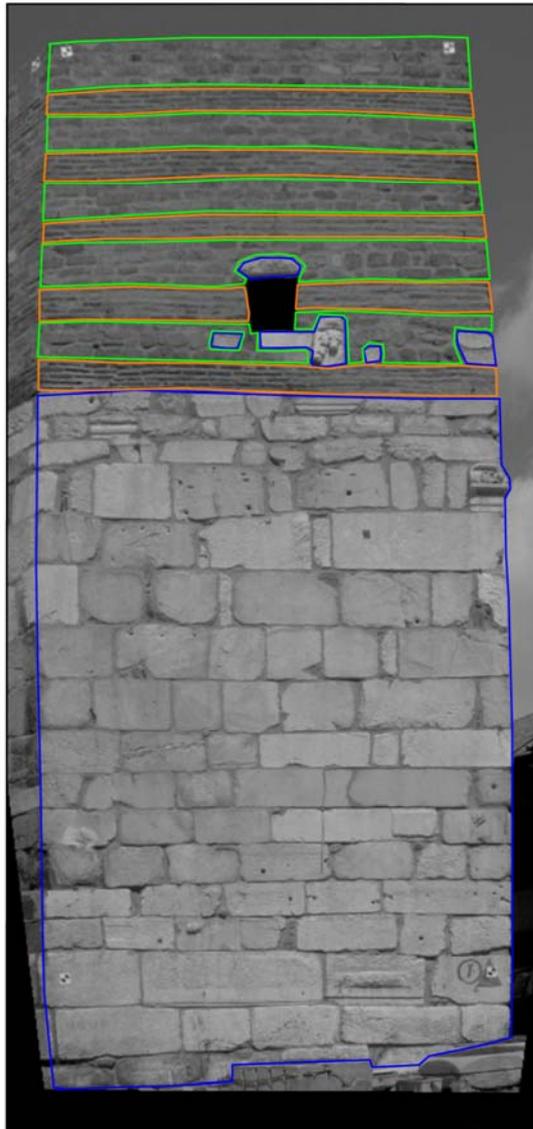
Figure 239. South Tower 5 Face 1

- Reused Marble
- Reused stones (basalt/andesite)
- Rubble stone
- Brick

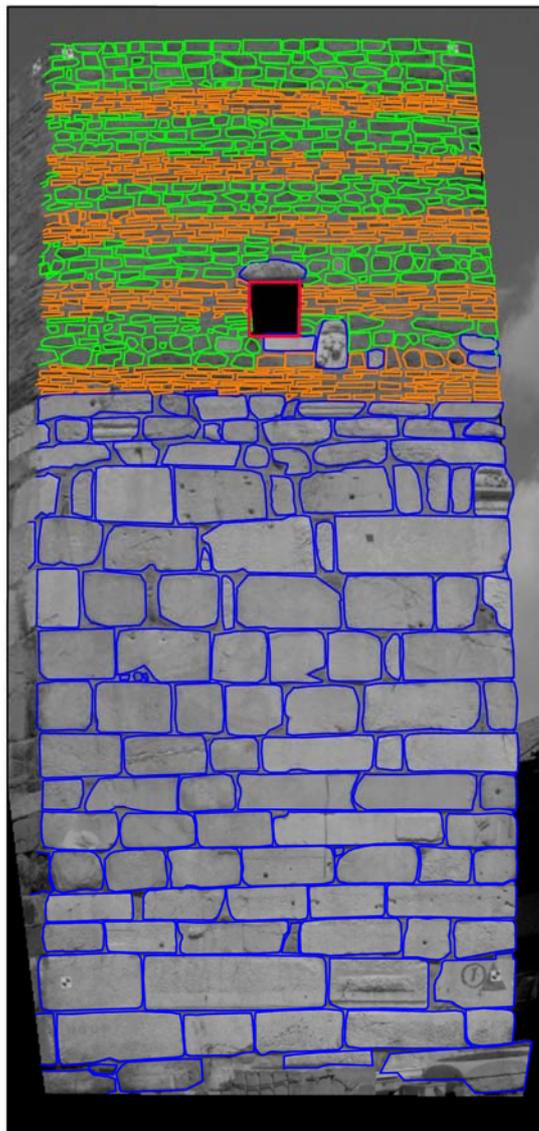
Figure 250. South Tower 5 Face 1

—	Reused Marble
—	Reused stones (basalt/andesite)
—	Rubble stone
—	Brick
—	Window/Door
