“THE CITADEL OF ANKARA”: ASPECTS OF VISUAL DOCUMENTATION
AND ANALYSIS REGARDING MATERIAL USE

A THESIS SUBMITTED TO
THE GRADUATE SCHOOL OF NATURAL AND APPLIED SCIENCES
OF
MIDDLE EAST TECHNICAL UNIVERSITY

IN PARTIAL FULFILLMENT OF THE REQUIREMENTS
FOR
THE DEGREE OF DOCTOR OF PHILOSOPHY IN BUILDING SCIENCE
IN
ARCHITECTURE

SEPTEMBER 2005

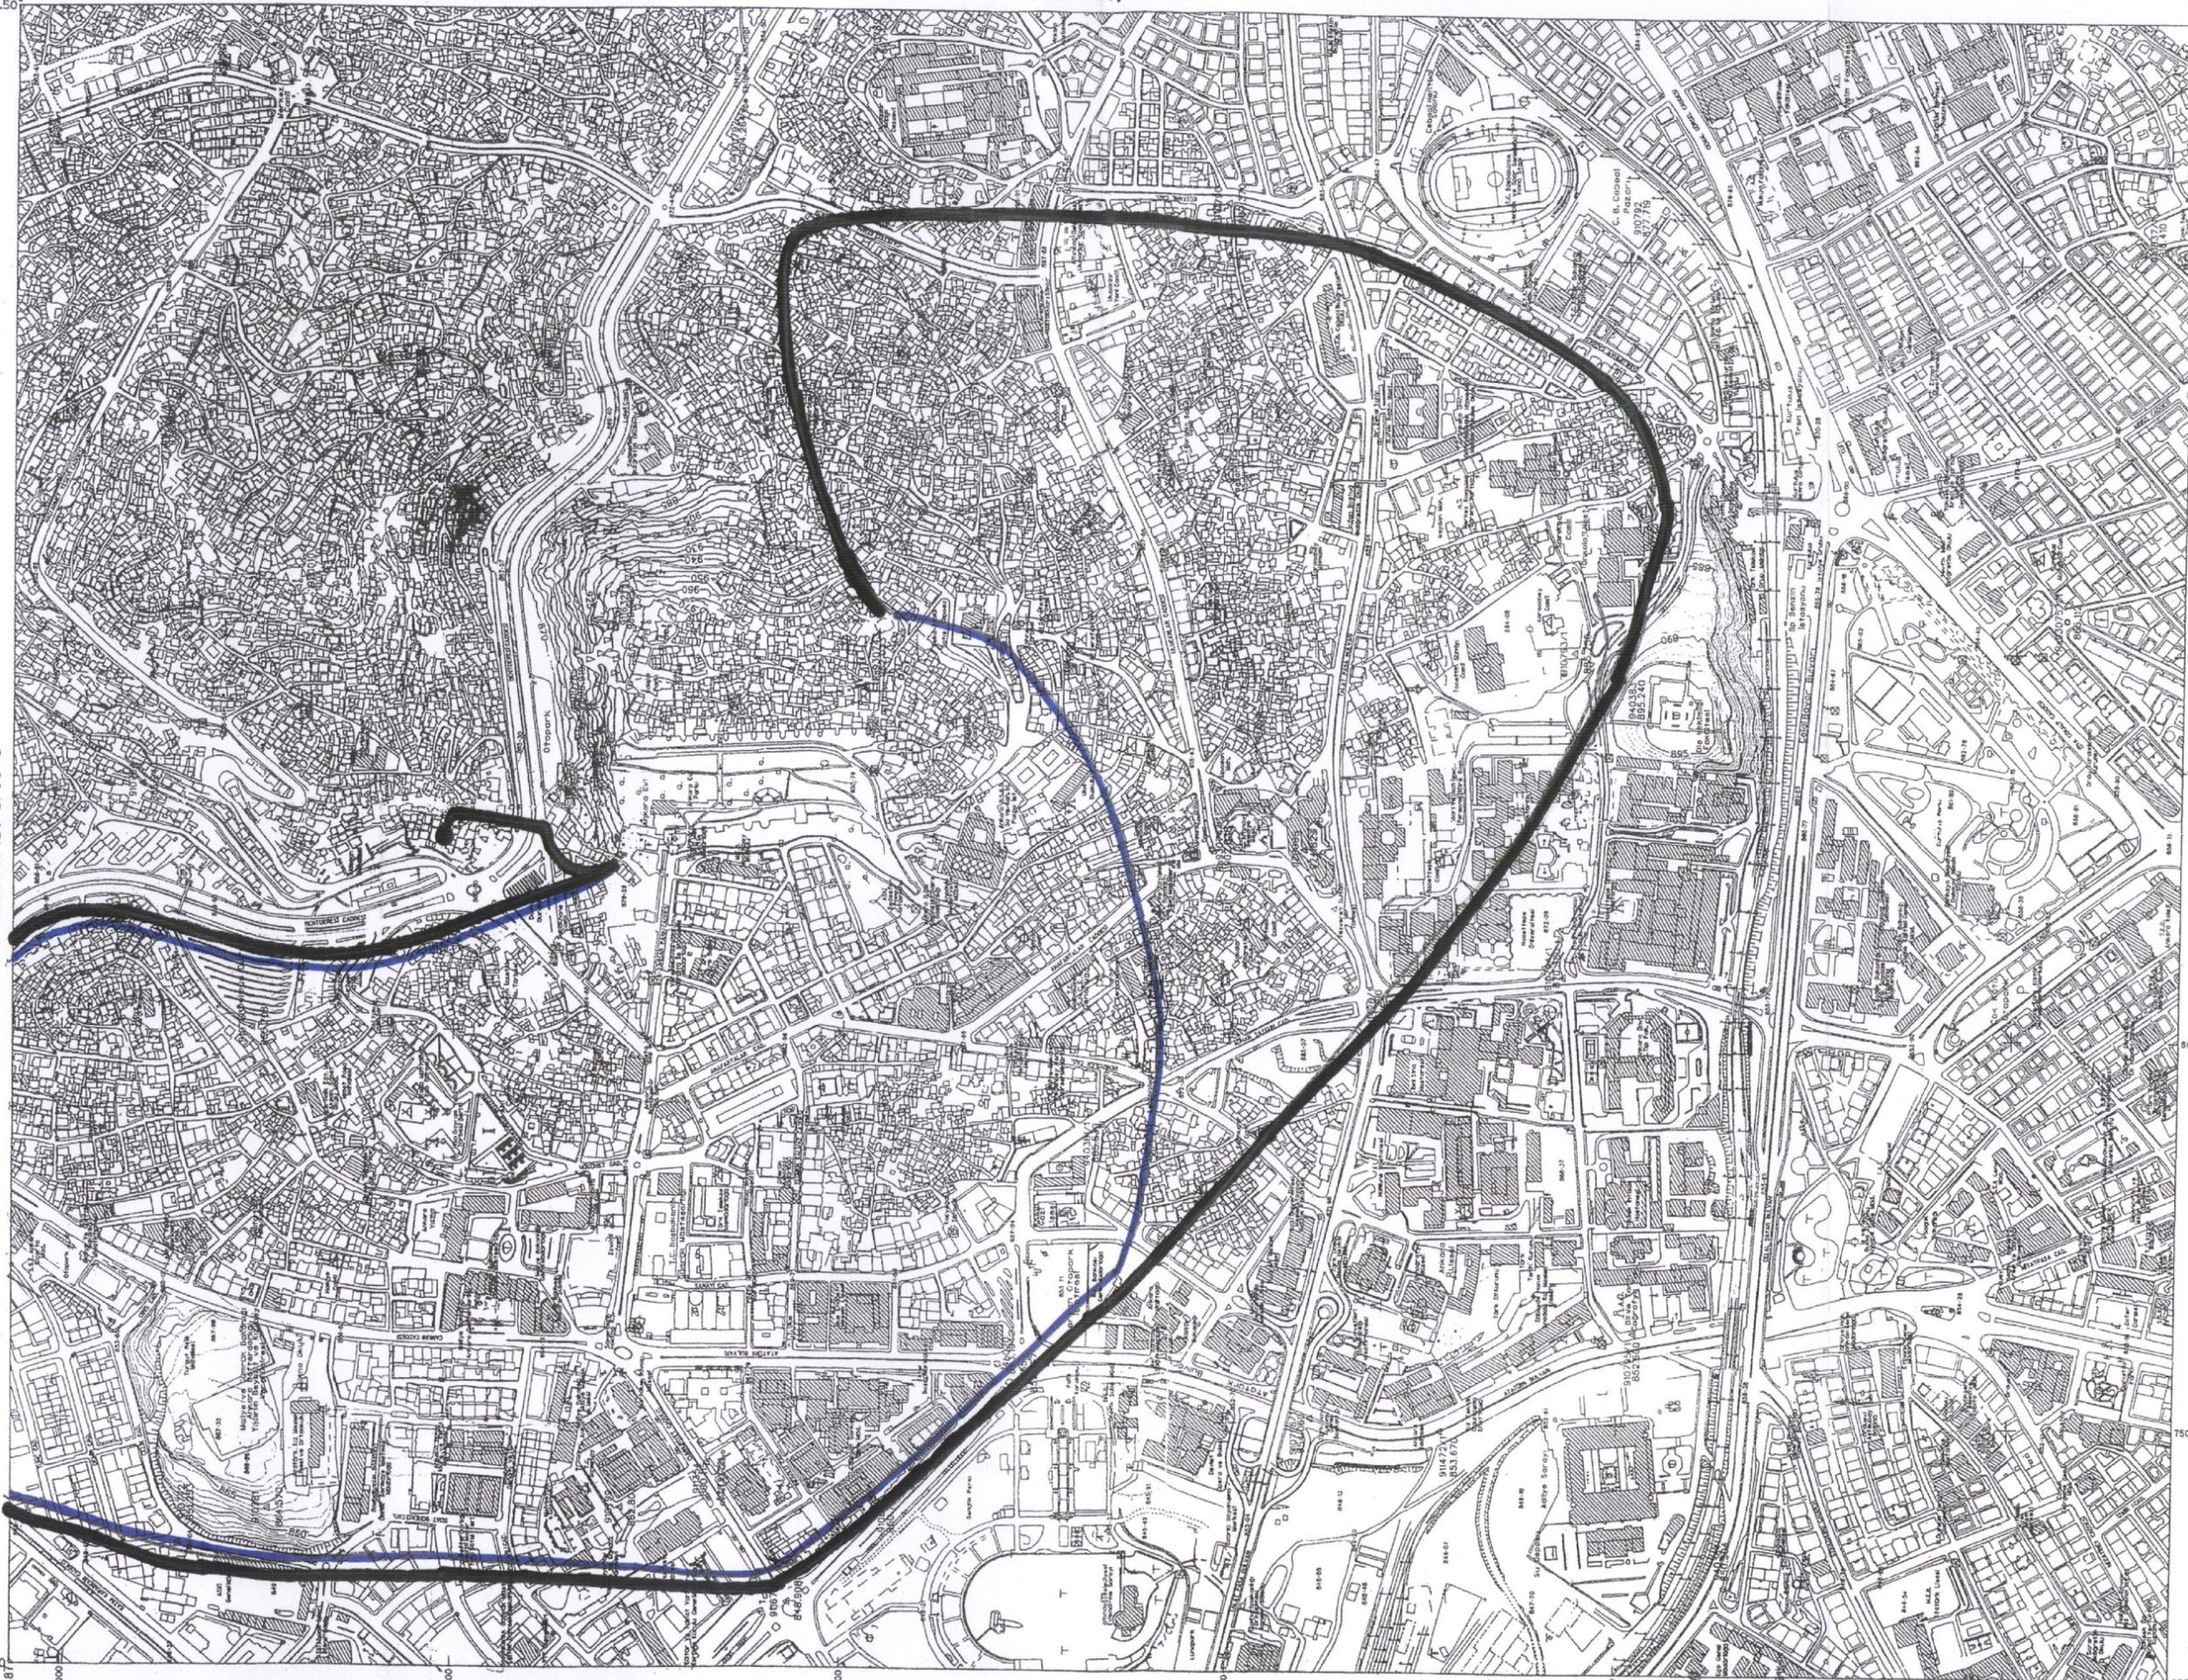
Map 4. Conjectural course of the Roman and Ottoman walls

Blue: Roman Period
