**BIOLOGICAL DECAY AND ITS CONTROL BY BIOMINERALISATION
IN CALCAREOUS STONES**

**A THESIS SUBMITTED TO
THE GRADUATE SCHOOL OF NATURAL AND APPLIED SCIENCES
OF
MIDDLE EAST TECHNICAL UNIVERSITY**

MELTEM CEMRE ÜSTÜNKAYA

DECEMBER 2008

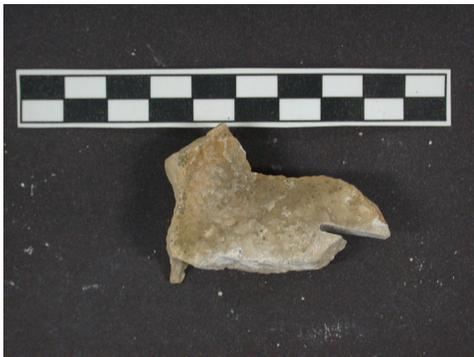
Sample	Photograph	Type of Analysis
NEL1U

Table 2. 1 Nemrut Untreated Limestone Samples.

Thin/Cross Section XRD SEM-EDX FDA Colorimetric Data (L*a*b)
NEL2U

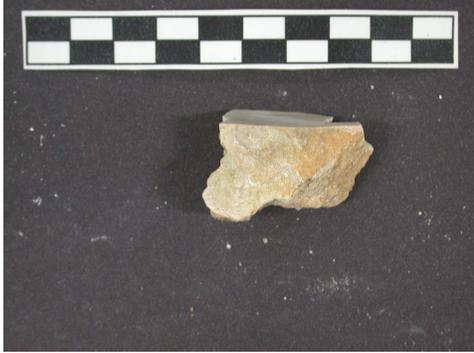
Thin/Cross Section Colorimetric Data (L*a*b)

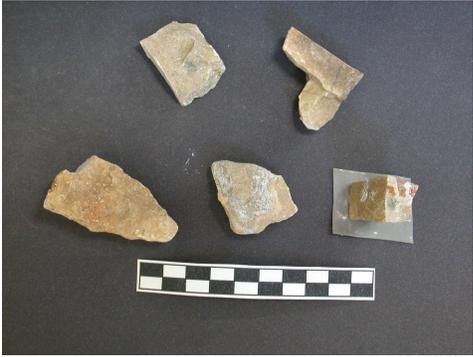
Sample	Photograph	Type of Analysis
NEL2L

Table 2. 2 Nemrut Lyophilized Bacteria Treated Limestone Samples.

SEM-EDX Colorimetric Data (L*a*b)
NEL3L		XRD Colorimetric Data (L*a*b)
NEL4L		FDA Colorimetric Data (L*a*b)
NEL5L		FDA Colorimetric Data (L*a*b)

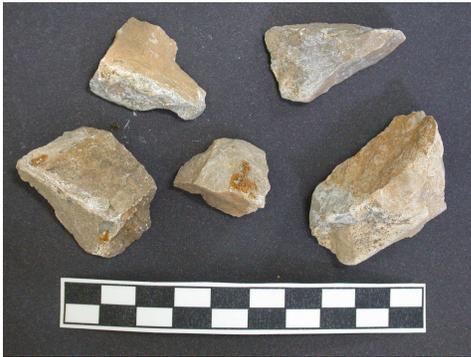
Sample	Photograph	Type of Analysis
NEL2F

Table 2. 3 Nemrut Fresh Bacteria Treated Limestone Samples.

SEM-EDX Colorimetric Data (L*a*b)
NEL3F		XRD Colorimetric Data (L*a*b)
NEL4F		FDA Colorimetric Data (L*a*b)
NEL5F		FDA Colorimetric Data (L*a*b)

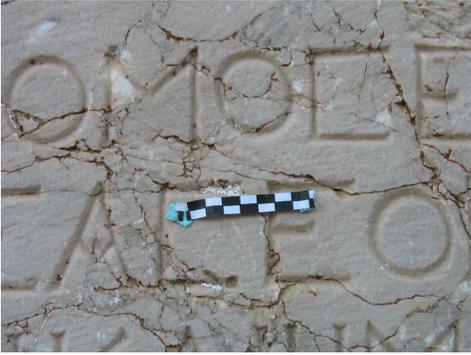
Sample	Photograph	Type of Analysis
NEL1P _w

Table 2. 4 Nemrut Limestone Samples with Patina.

XRD
NEL2P _w

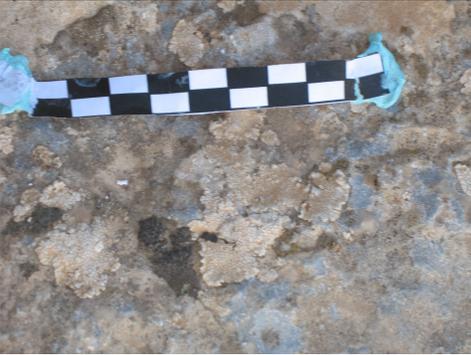
XRD FDA SEM-EDX
NEL3P _{nc}

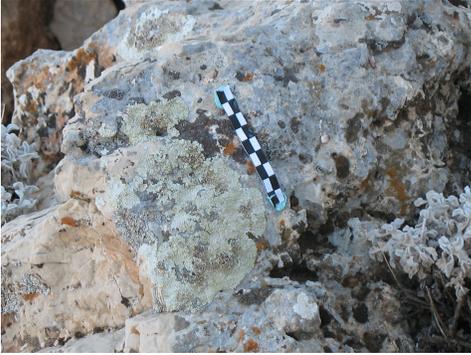
XRD FDA

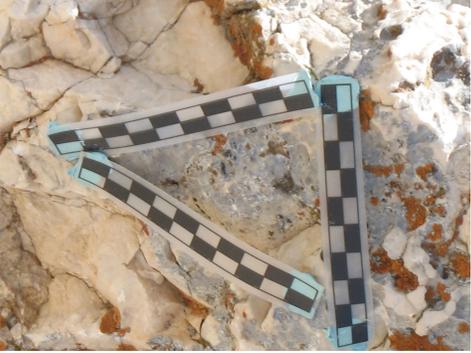
NEL4P _{gr}

A photograph showing a close-up of a light-colored, textured rock surface. A black and white checkered scale bar is placed on the rock for size reference. The rock appears to have some small, reddish-brown spots or inclusions.	XRD
NEL5P _o

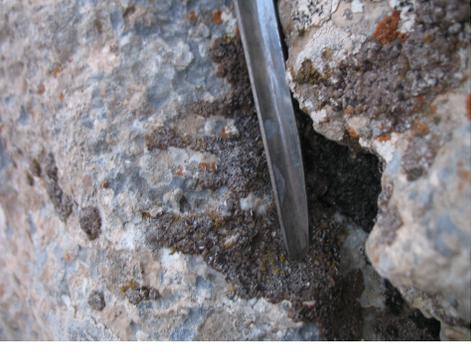
A photograph showing a close-up of a rock surface. A metal tool, possibly a hammer or a probe, is inserted into a hole or crevice in the rock. A black and white checkered scale bar is also visible, providing a sense of scale. The rock surface is dark and appears to have some mineral deposits or staining.	XRD FDA

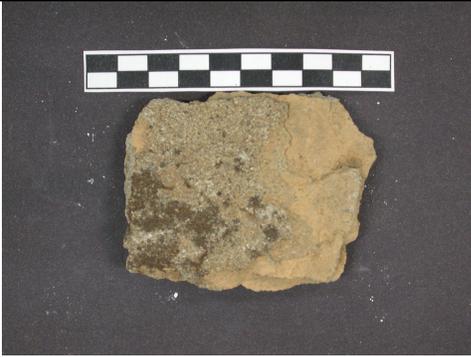
Sample	Photograph	Type of Analysis
NES1U

Table 2. 5 Nemrut Sandstone Samples.

<p>XRD</p> <p>FDA</p> <p>Colorimetric Data (L*a*b)</p>
NES1L

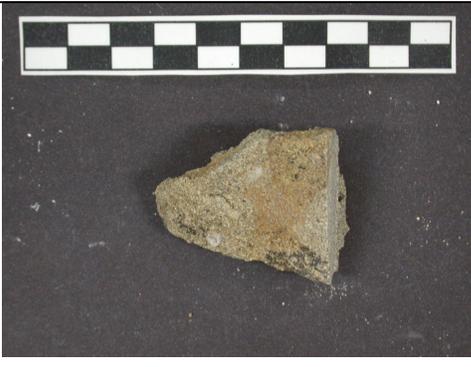
<p>SEM-EDX</p> <p>FDA</p> <p>Colorimetric Data (L*a*b)</p>

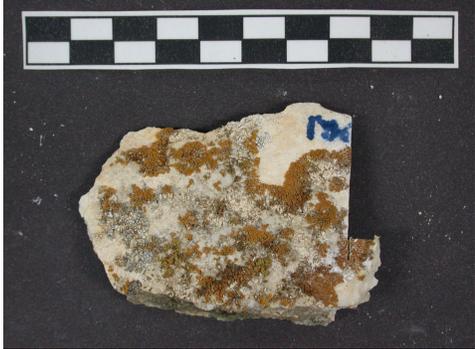
Sample	Photograph	Type of Analysis
PM1U

Table 2. 6 Pessinous Marble Samples.

Thin Section XRD FDA Colorimetric Data (L*a*b)
PM2U

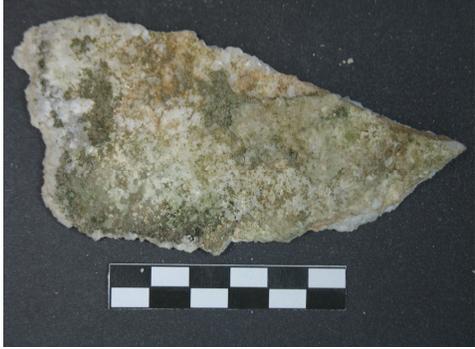
FDA XRD Colorimetric Data (L*a*b)

Figure 3. 9 Deteriorated marble sample from Pessinous Archaeological Site (PM2U) and marble samples from ancient Pessinous quarry (PM1U,PM3U), C: Calcite, D: Dolomite, We: Wedellite.

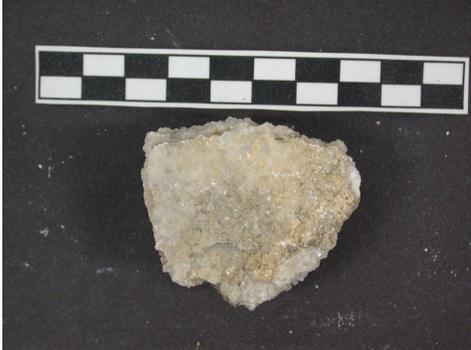
PM3U

Thin Section XRD FDA SEM-EDX Colorimetric Data (L*a*b)
------	--	--

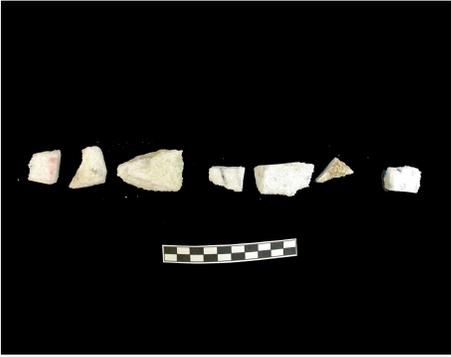
Sample	Photograph	Type of Analysis
PM2L

Table 2. 7 Pessinous Lyophilized Bacteria Treated Marble Samples.

XRD Colorimetric Data (L*a*b)
PM3L		FDA Colorimetric Data (L*a*b)
PM4L		FDA Colorimetric Data (L*a*b)

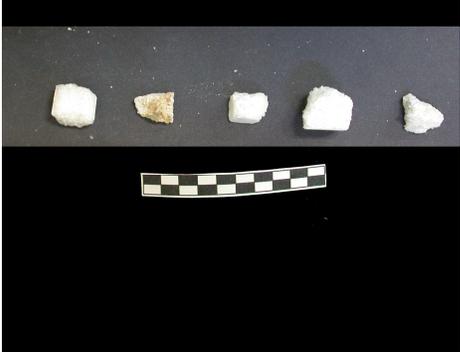
Sample	Photograph	Type of Analysis
PM2F

Table 2. 8 Pessinous Fresh Bacteria Treated Marble Samples.

XRD Colorimetric Data (L*a*b)
PM3F		FDA Colorimetric Data (L*a*b)
PM4F		FDA Colorimetric Data (L*a*b)

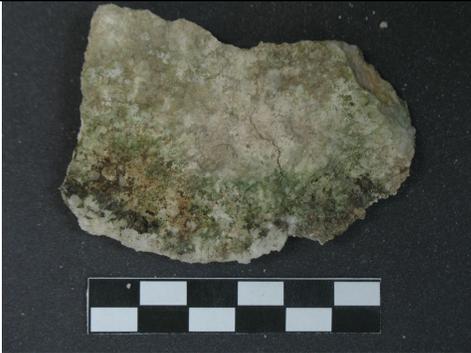
Sample	Photograph	Type of Analysis
PM1P _{bk}

Table 2. 9 Pessinous Marble Samples with Patina.

XRD
PM2P _{bk}

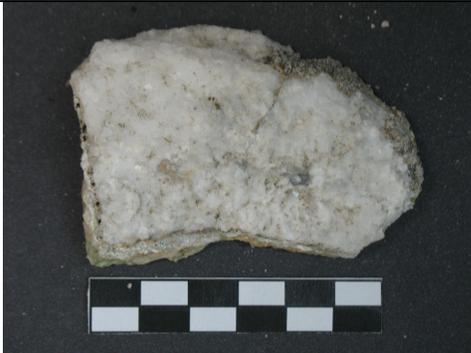
XRD

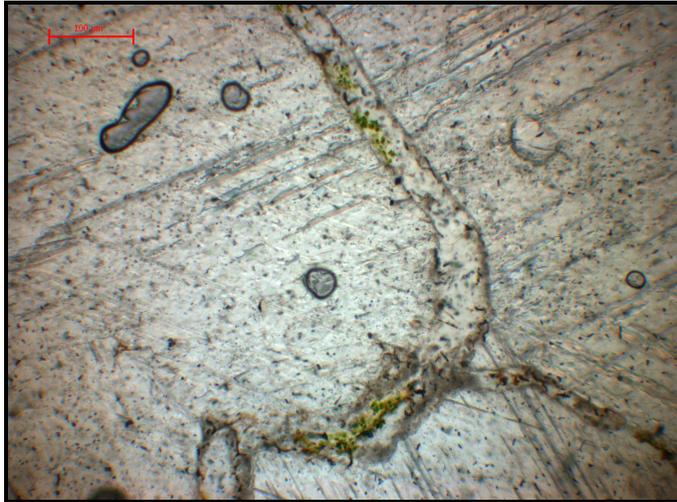
Figure 3. 18 Thin section view of Pessinous quarry marble (PM3U) showing biological activity in intergranular and intragranular zones of calcite grains, (20X, single nicol).
