**IMPACTS OF PLANNING DECISIONS IN AN EARTHQUAKE VULNERABLE
CITY:THE CASE OF ADAPAZARI**

**A THESIS SUBMITTED TO
THE GRADUATE SCHOOL OF NATURAL AND APPLIED SCIENCES
OF
MIDDLE EAST TECHNICAL UNIVERSITY**

**IN PARTIAL FULFILLMENT OF THE REQUIREMENTS
FOR
THE DEGREE OF MASTER OF SCIENCE
IN
CITY PLANNING
IN
CITY AND REGIONAL PLANNING**

JUNE 2010

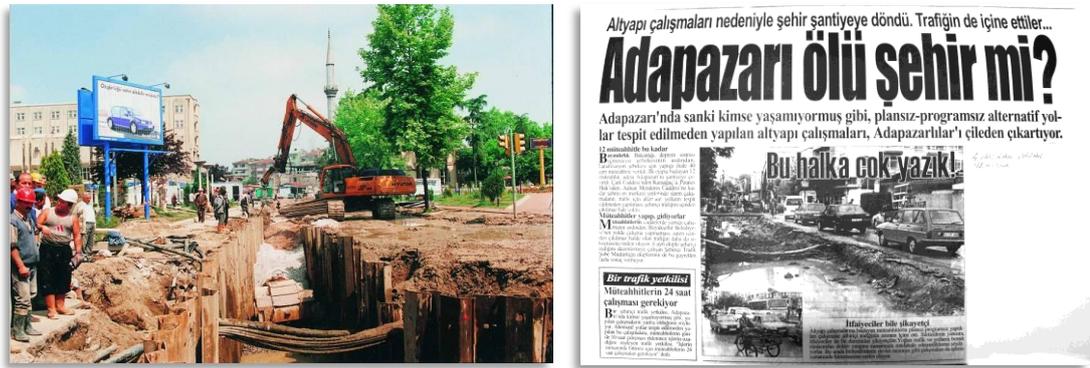
Picture 3.5 Infrastructure Works Caused the Destruction Of 1000 Km Of Asphalt Surfaced Roads And Pavement Surfaces

The other result of the earthquake was that 90% of the city infrastructure fell completely into disuse. Within the scope of sewage system operations, 1478 km of the sewage network was reconstructed, with a total cost of \$ 584 millions. The potable water system was renewed with its total length of 2356 km. costing \$ 93 millions. In the case of drainage constructions, 131 km rain water canals were renewed at a cost of \$ 29 millions. Total loss of infrastructural systems of Adapazarı amounted to \$ 706 millions (ADASU, 2009).

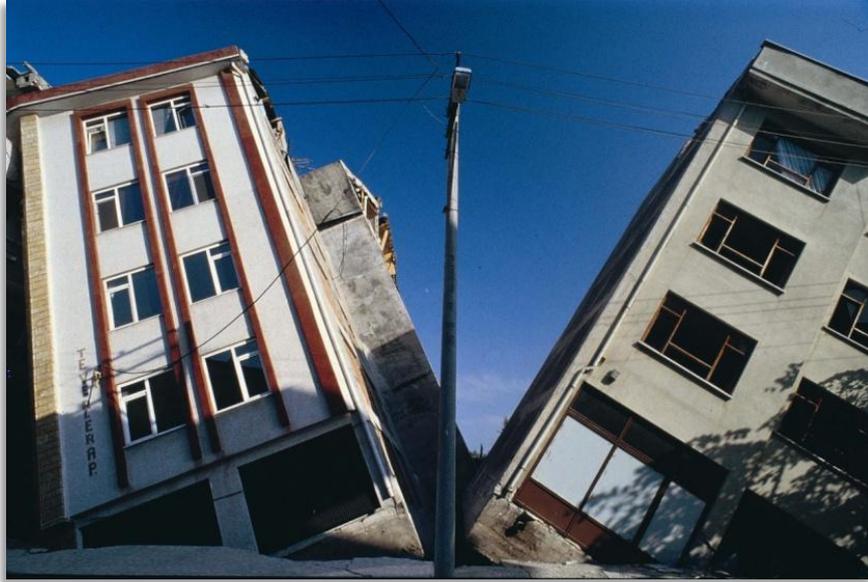
Picture 5.2 Damages in High-Rise Structures of Çark Street, Central Adapazarı (SMM, Archive)

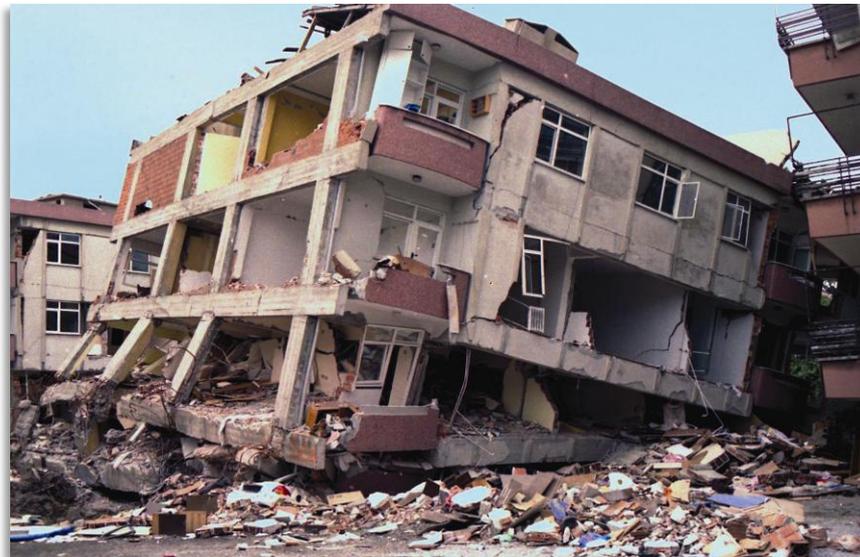
Picture 5.3 Damages in High-Rise Structures of Adnan Menderes Street, Central Adapazarı (SMM, Archive)
