**SEISMIC STRENGTHENING OF MASONRY INFILLED  
REINFORCED CONCRETE FRAMES WITH  
PRECAST CONCRETE PANELS**

**A THESIS SUBMITTED TO  
THE GRADUATE SCHOOL OF NATURAL AND APPLIED SCIENCES  
OF  
MIDDLE EAST TECHNICAL UNIVERSITY**

**IN PARTIAL FULFILLMENT OF THE REQUIREMENTS FOR THE DEGREE OF  
MASTER OF SCIENCE  
IN  
CIVIL ENGINEERING**

**DECEMBER 2004**

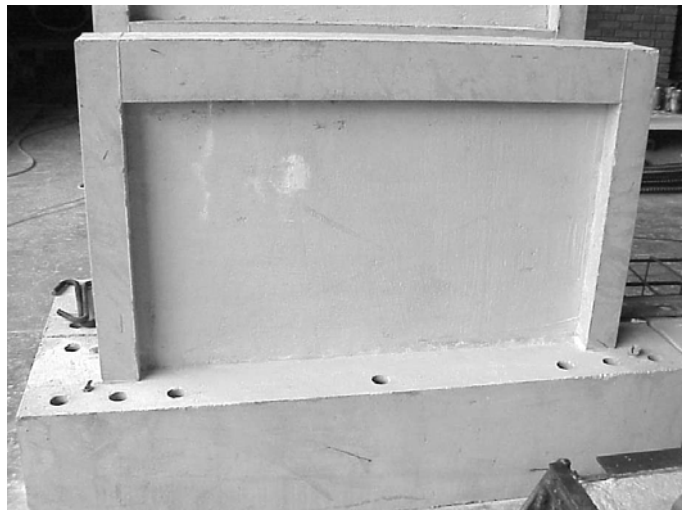
Figure 3.1 – General View of the Test Specimen

The test specimens used in this experimental study are one-third scale, single-story single-bay reinforced concrete frames with hollow brick masonry infills. **Figure 3.1** shows a general view of the frames. These frames resemble typical characteristics and common deficiencies of the structural frames of reinforced concrete buildings in Turkey. These weaknesses include low concrete strength, using plain bars, short lap length, insufficient anchorages, poor confinement and beams stronger than columns. The frames were divided into two groups according to their detailing type of reinforcement. Continuous reinforcement was used in some specimens, whereas, some had lap-spliced reinforcement.

All frames were infilled with hollow brick masonry walls. Masonry infill and plaster were made by ordinary workers the same way as in the standard practice. All specimens were white washed for better observation in the tests.

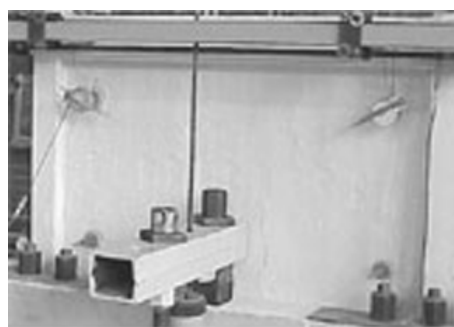
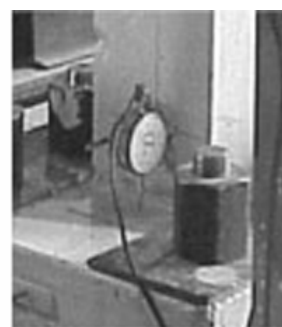
Two dial gauges were arranged to measure the diagonal displacement between the opposite corners of the infill (gauges 1 and 2). These 20-mm gauges took measurements on the cable attached to thin bars fixed on the infill wall surface. Two 50-mm gauges were placed at the lower ends of the columns (gauges 3 and 4) in order to measure the variations in the column-base rotations, and also cracking under tension and crushing under compression.

Figure 4.10 – Dial Gauge Positions

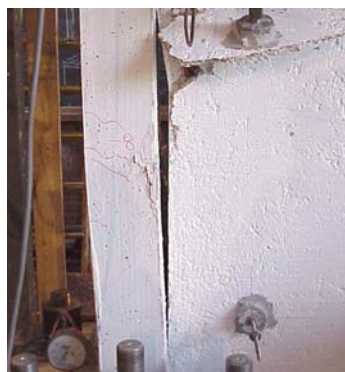
Figure 5.9 – Damage in the South Column in the Ninth Cycle, Specimen CR

- In the ninth forward half cycle, the separation of the infill and the frame increased so much that it was possible to see the other side of the frame. Crushing started at the mid-span of the south column due to bending (Figure 5.9). The plaster was completely wiped off from the column faces. Dial gauges on the infill dropped down. The load-displacement curve also progressed with very small slope in this cycle.

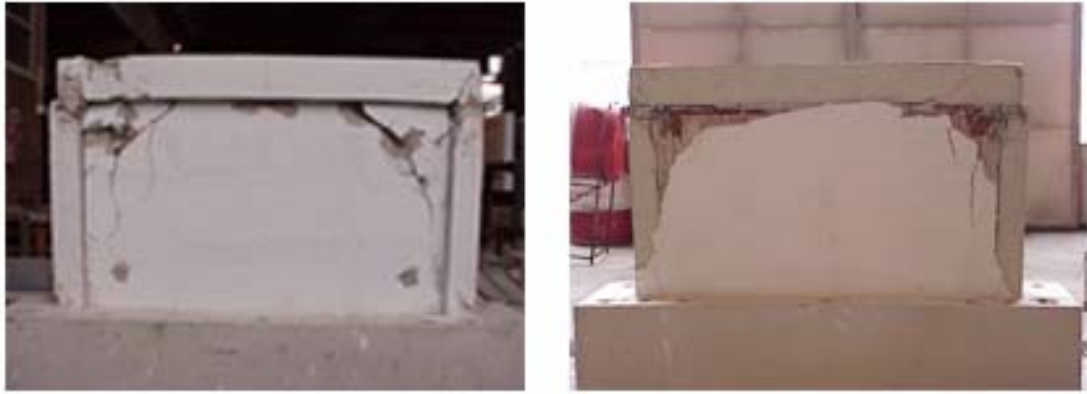
Figure 5.20 – Specimen CIA4 at the End of the Test

- Since the frame members were damaged and the specimen lost its load carrying capacity, the experiment was discontinued after the nineteenth cycle. The final view of the specimen from front and back is given in Figure 5.20.

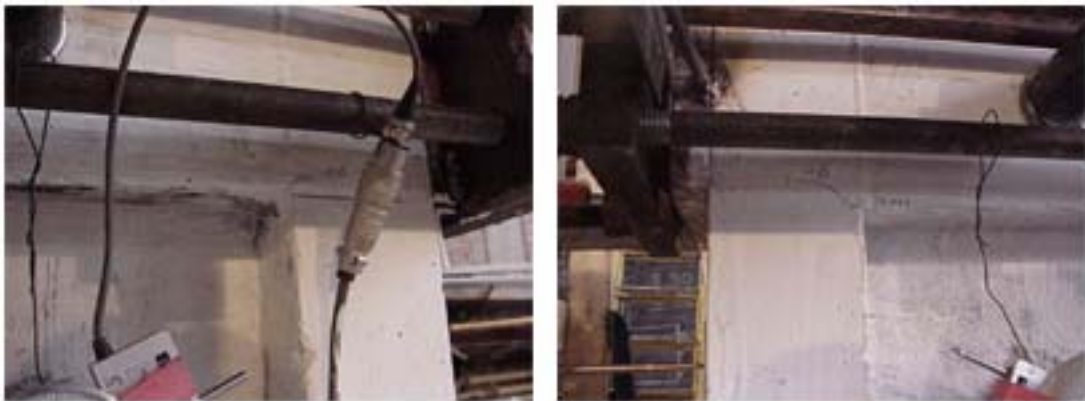
Figure 5.25 – Joint Cracks in the Sixth Cycle, Specimen CIB4

- North beam-column joint cracked in the sixth forward half cycle. In the backward loading of the same cycle, south beam-column joint cracked. Joint crack shapes may be seen in Figure 5.25. Another diagonal crack appeared at the north beam-column joint just below the first crack in the eighth forward half cycle.

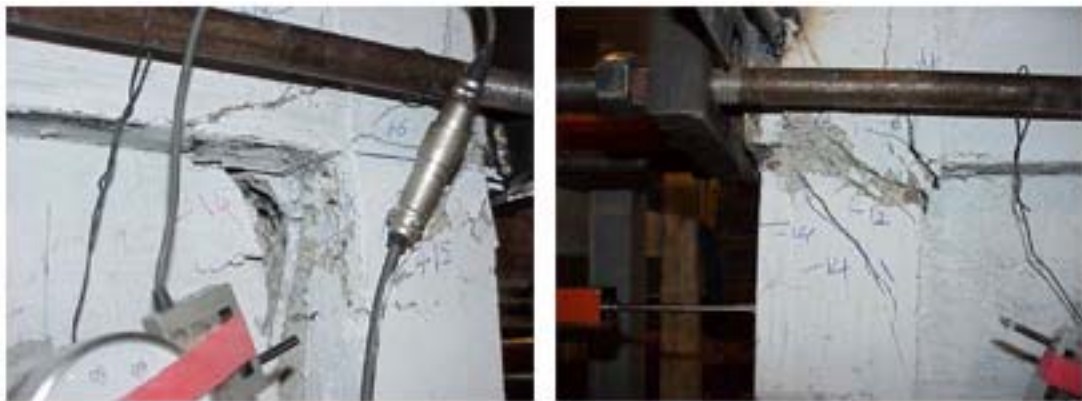
Figure 5.27 – Damage at the Joints, Specimen CIB4

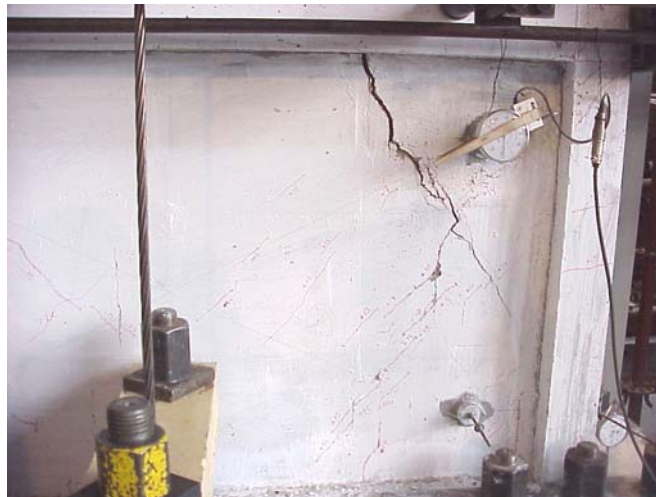
Figure 5.35 – Infill Cracks in the Seventeenth Cycle, Specimen CIC4

- From the thirteenth cycle to the sixteenth cycle, diagonal cracks on the panels increased in number and length. Some diagonal cracks grew as wide as 3 to 4 mm and as long as 250 mm. Infill cracks in this stage of the experiment are shown in Figure 5.35. Also, many cracks were observed on the columns in the fifteenth and the sixteenth cycles. Load-displacement curves started to shift from the elastic action, but not significantly. Increasing lateral load in the thirteenth to fifteenth cycles was carried by the specimen without much loss in stiffness. Load-column deformation at the base and load-shear displacement diagrams were showing slight indications of softening.

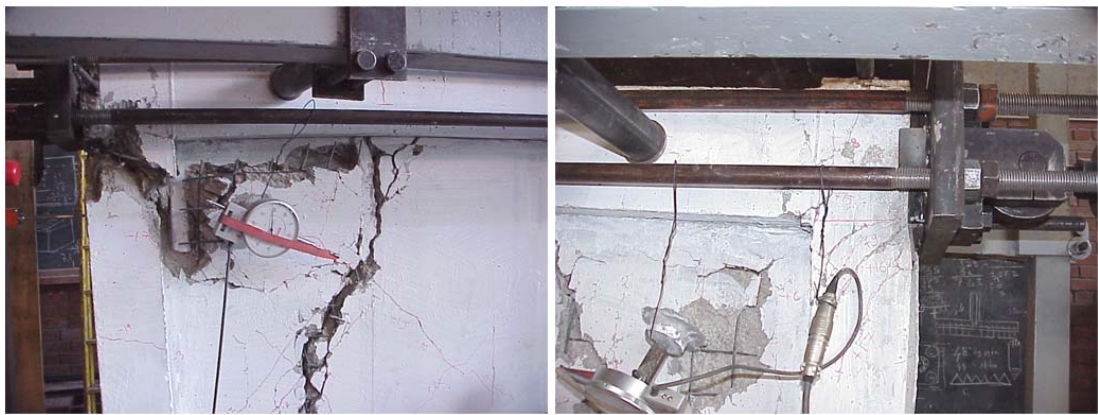
Figure 5.37 – Damage in the Beam-Column Joints after the Test, Specimen CIC4

- In the eighteenth backward cycle, the south column completely crushed a little below the joint at 11.3-mm top displacement. Due to crushing, the column was torn apart from the beam and the frame lost its stiffness abruptly, making the load-displacement curve make a sharp turn and jump to 19 mm displacement with load dropping to zero suddenly. Together with crushing, column reinforcement bars buckled. The top panel at the south corner was also completely crushed. Many panels suffered damage due to severe cracking. Views of the frame at the end of the test are shown in Figure 5.36 and Figure 5.37.

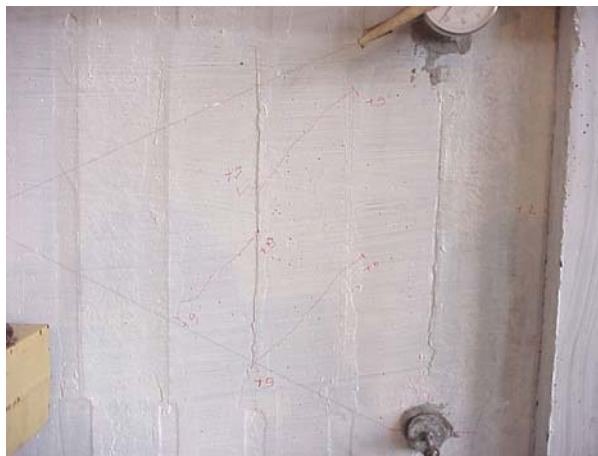
Figure 5.42 – Panel Cracks in the Ninth Cycle, Specimen CID4

- A few thin diagonal cracks were formed on the panels close to the north side in the ninth forward half cycle. These diagonal cracks had a direction from the top north corner towards the bottom south corner of the infill (Figure 5.42). In the next half cycle, some thin cracks perpendicular to the previous diagonal cracks were formed on the panels close to the south side. A bending crack was observed at the bottom end of the south column and another small crack was noted at the joint of the south column with the beam.

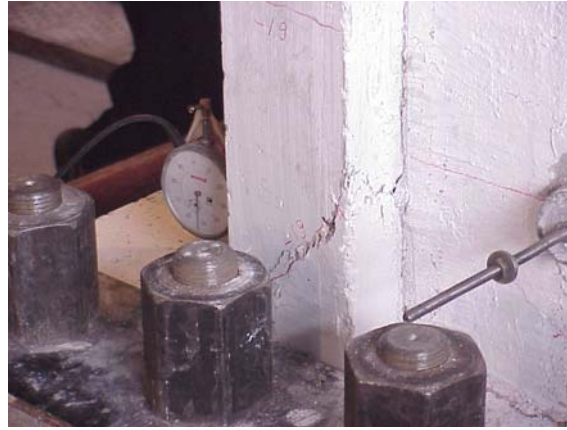
Figure 5.44 – Column Base Damage in the Nineteenth Cycle, Specimen CID4

- In the nineteenth forward and backward half cycles, significant cracks were formed on the north column and south column, respectively. Especially, the diagonal crack at the bottom of the south column, which is shown in Figure 5.44, seemed to be critical.

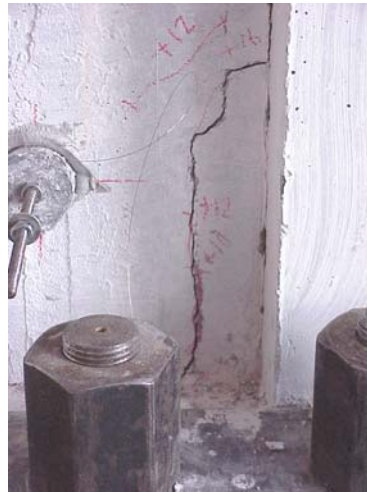
Figure 5.45 – Separation of the Column from the Infill, Specimen CID4

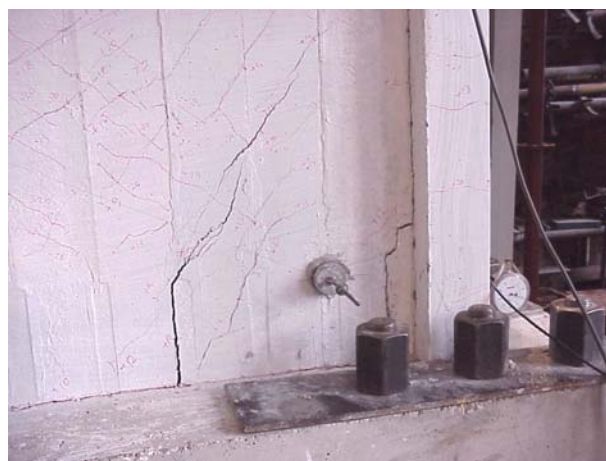
Figure 5.46 – Infill Cracking, Specimen CID4

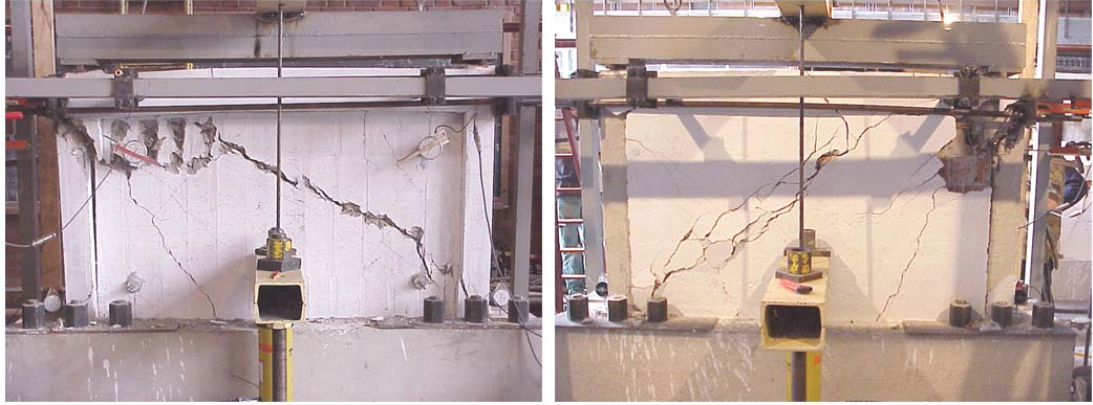
Figure 5.47 – General View of Specimen CID4 after the Test

- In the twenty-first half cycle, excessive deformation took place and the loading was stopped at 250.6 kN with 10.3 mm top deformation. After the loading was stopped, the deformation still continued increasing and diagonal cracks kept on progressing until the south beam-column joint failed suddenly. Column reinforcement bars buckled, panels at the corner crushed. Since the load carrying capacity of the specimen deteriorated, the test was terminated. The final view of the frame is given in Figure 5.47.

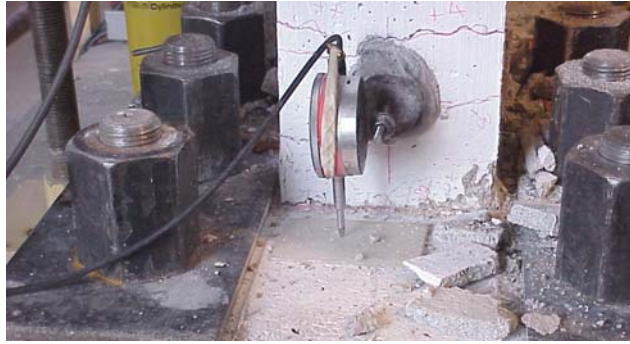
Figure 5.52 – Cracking at the Column Base and Lap-Splice Level in the Fourth Cycle, Specimen LR

- Another bending crack was formed at the outer surface of the north column 100 mm above the base, in the fourth forward half cycle. This crack appeared like a bending crack and close to the lap-splice end where stress concentration was expected (Figure 5.52). In the fourth backward half cycle, top south corner of the infill started crushing. Crushing was seen at the opposite corner in the fifth forward half cycle. A sudden jump was seen in the load-shear displacement graph related with infill crushing. In the backward loading of the fifth cycle, multiple bending cracks were seen at the south column. In the fifth forward half cycle, the maximum lateral load of the test was recorded as 65.5 kN. Joint cracks progressed. After this cycle, the experiment was continued on a displacement controlled basis. The next cycle was carried out until 10-mm top deformation and the following cycles were continued with 5-mm increments. In the next cycles, significant loss of lateral strength and stiffness was observed from the load-displacement graph.

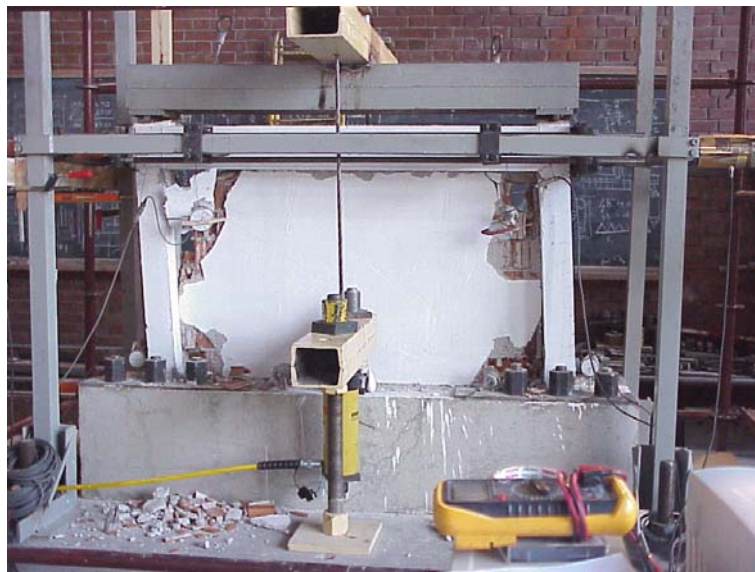
Figure 5.53 – Deformation in the Frame during the Test, Specimen LR

- In the later cycles, severe damage of frame members was observed. Both columns developed many cracks and their deformation was noticeable (Figure 5.53). Joint cracks extended to the outer surface with large widths. Infill crushed completely at the corners. Due to excessive damage, the experiment was ended at the end of the fifteenth forward half cycle. The final view of the frame from the front and back can be seen in Figure 5.54.

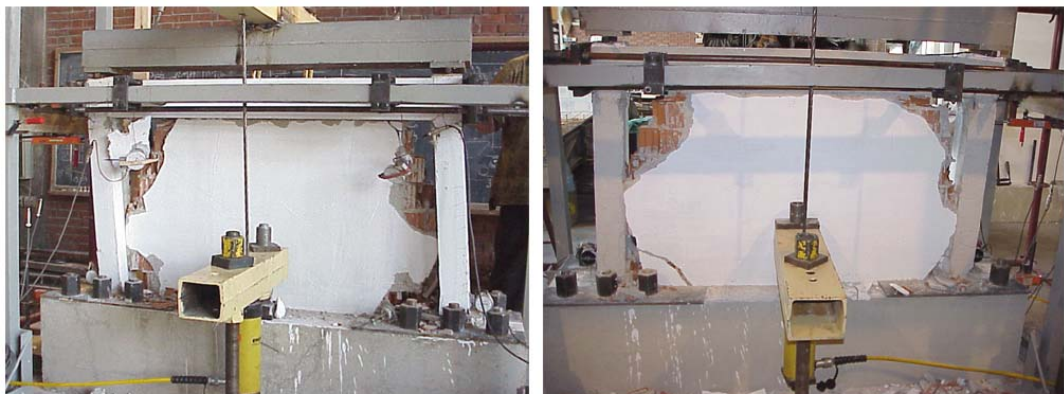
Figure 5.54 – General View of Specimen LR after the Test

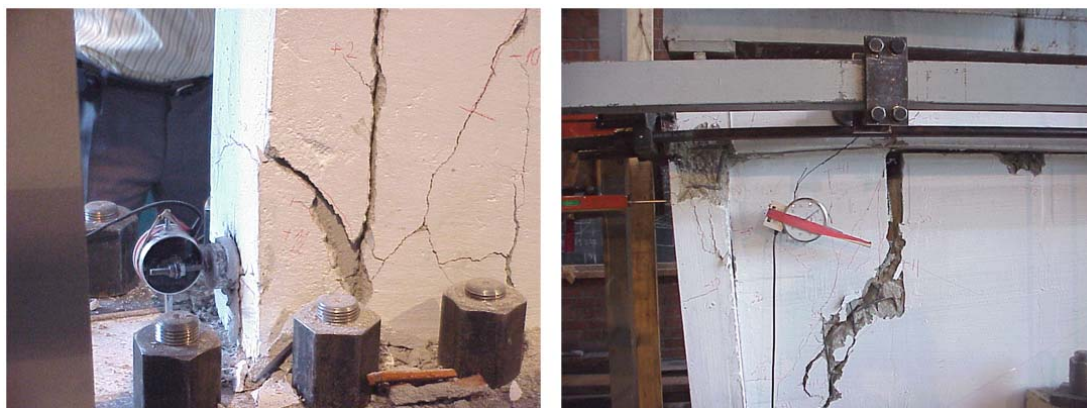
Figure 5.62 – Column Base Crack (left) and Joint Cracks (right), Specimen LIC4

- Column base deformations increased to more than 4 mm, and indication of bar slip at the lap-splice region was observed for the tension sides (Figure 5.62). Large tensile deformations at column end dial gauges also support the evidence of bar slipping. The experiment was ended after the fifteenth cycle, in which  $\pm 30$  mm top displacement was given to the specimen. The final views of the specimen from the front and back are given in Figure 5.63.

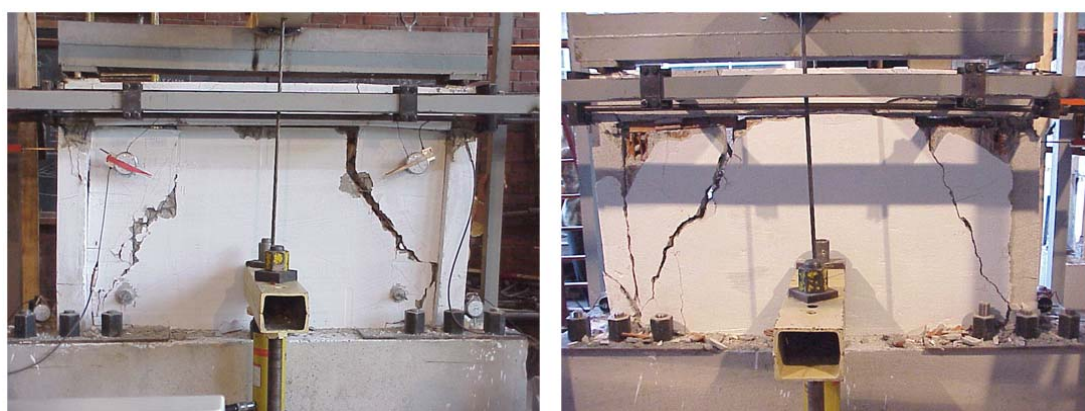
Figure 5.63 – General View of Specimen LIC4 after the Test

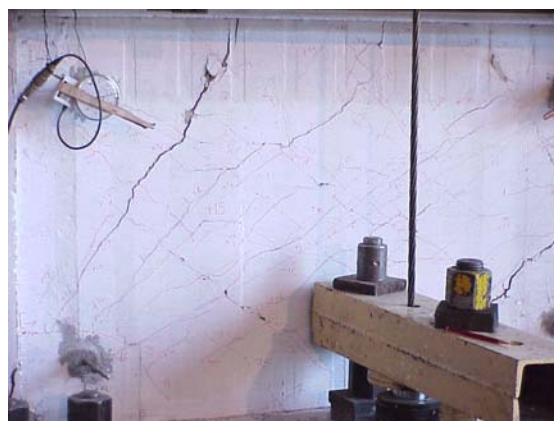
Figure 5.68 – Infill Cracking Pattern, Specimen LID4

- Some cracks on the infill joined to form major diagonal cracks starting from the fifteenth cycle. Column bases and beam-column joints suffered heavy cracking in the sixteenth cycle. Column base cover concrete has crushed and reinforcement became visible.

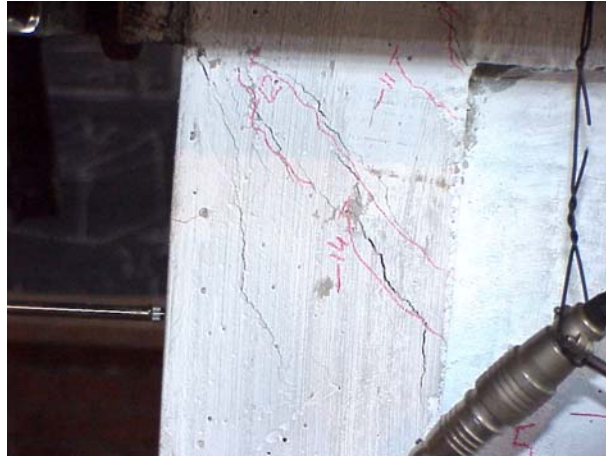
Figure 5.69 – Damage in the South Beam-Column Joint, Specimen LID4

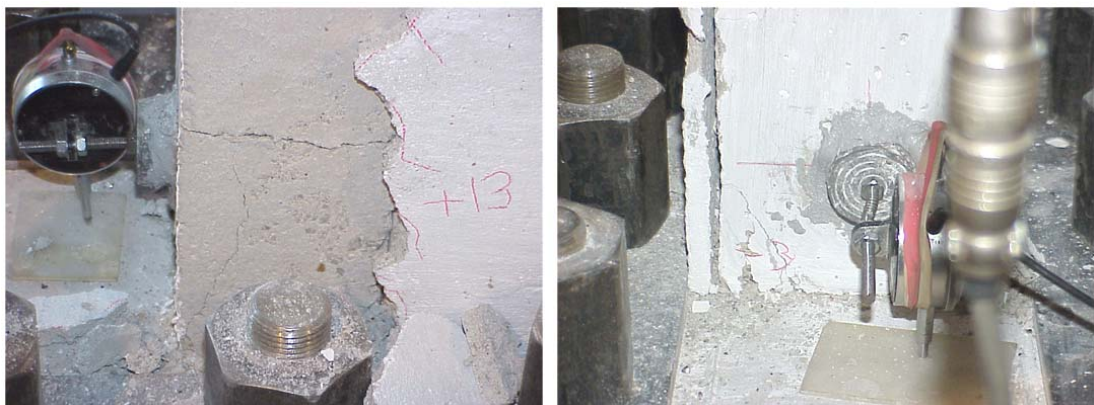
Figure 5.71 – Cracking at the Column Base and Lap-Splice Region, Specimen LID4

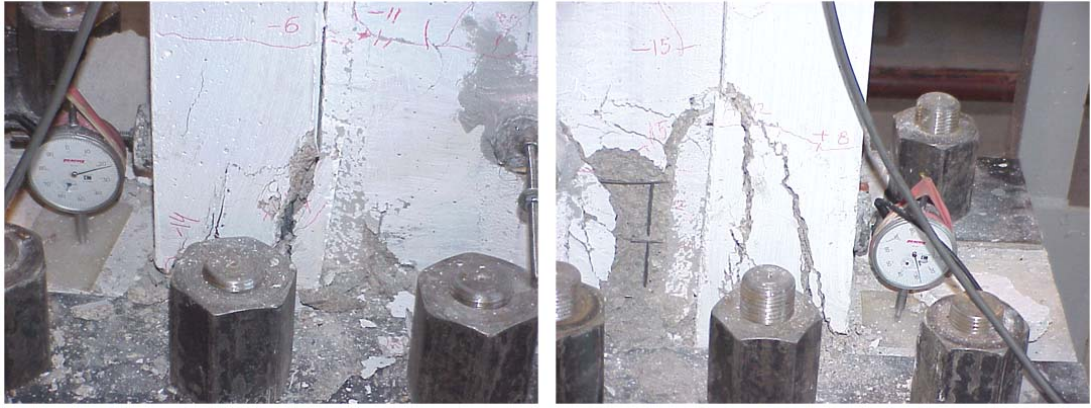
Figure 5.72 – Damage in the Lap-Splice Region of the Column, Specimen LID4

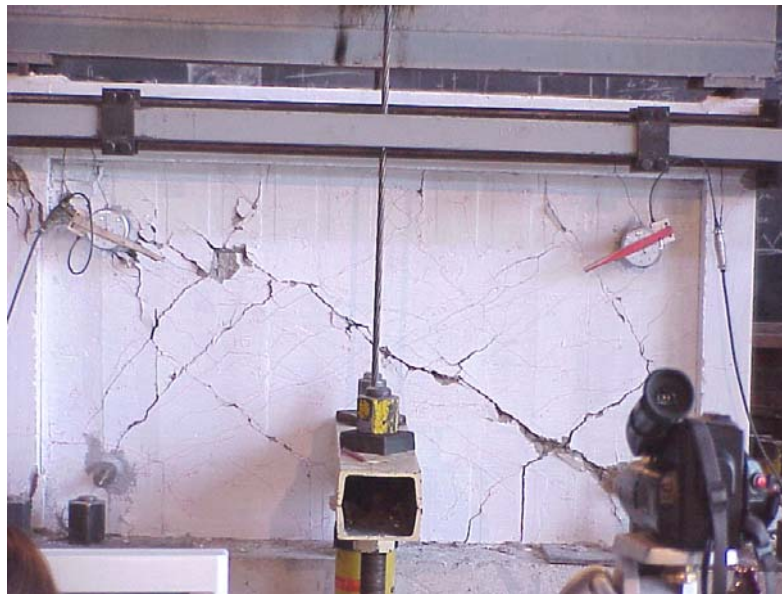
Figure 5.73 – General View of Specimen LID4 after the Test
