TECHNOLOGICAL CHARACTERISTICS OF A BRICK MASONRY
STRUCTURE AND THEIR RELATIONSHIP WITH THE STRUCTURAL
BEHAVIOUR

A THESIS SUBMITTED TO
THE GRADUATE SCHOOL OF NATURAL AND APPLIED SCIENCES
OF
MIDDLE EAST TECHNICAL UNIVERSITY

YASEMİN DİDEM AKTAŞ

SEPTEMBER 2006

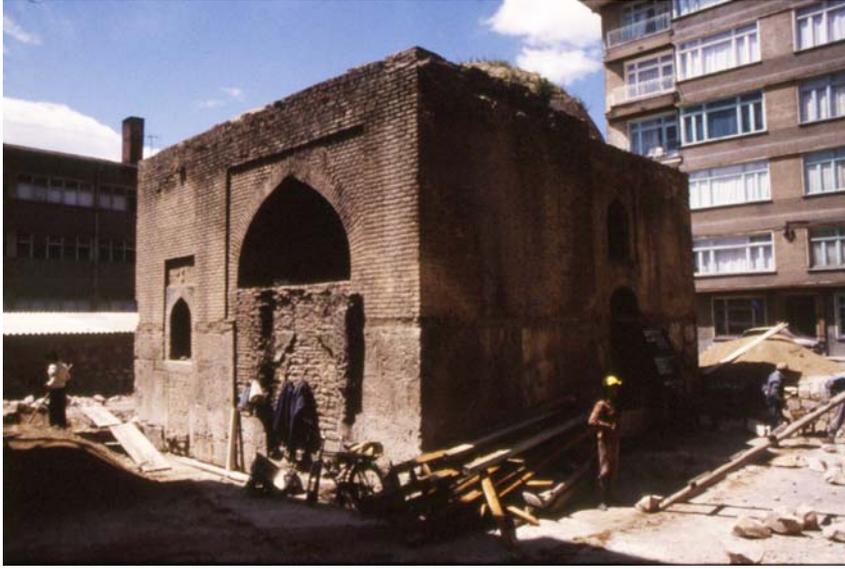
Figure 1 A general view of Tahir ile Zühre Mescidi

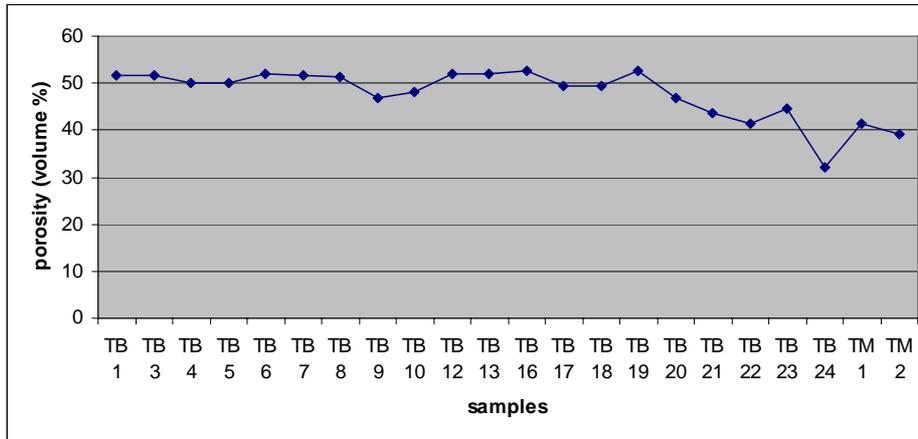
Figure 2 Variation in porosity values (% volume) of the samples

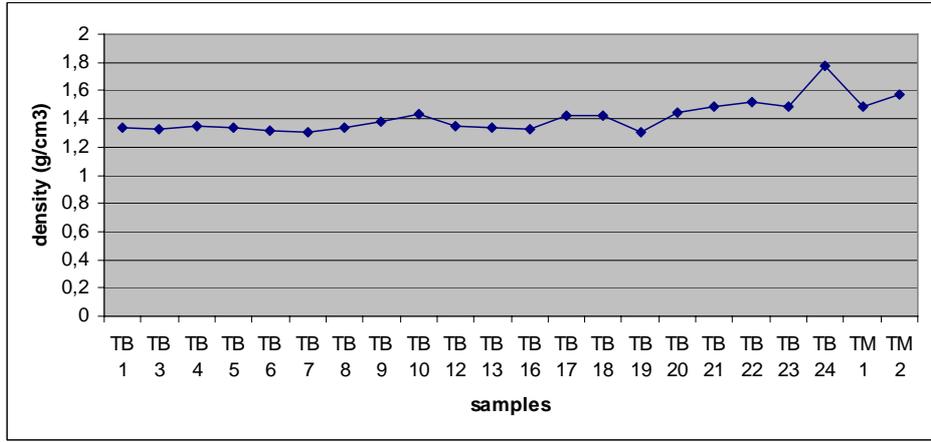
Figure 3 Variation in bulk density values (g/cm³) of the samples

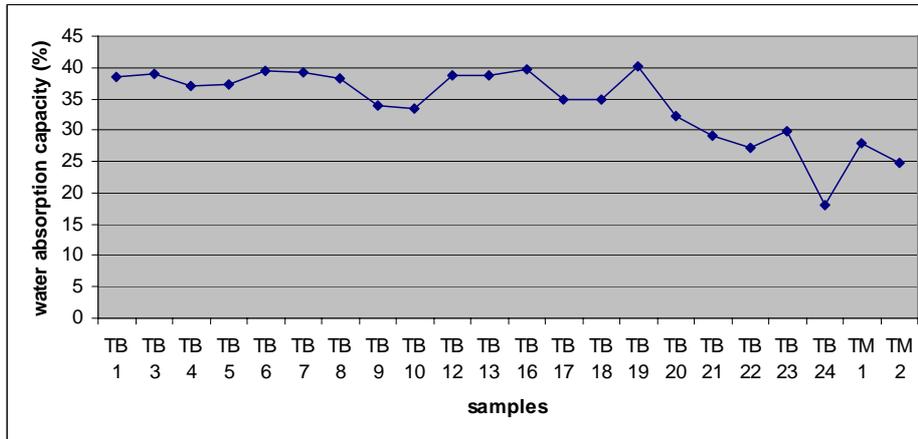
Figure 4 Variation in water absorption capacity values (% weight) of the samples

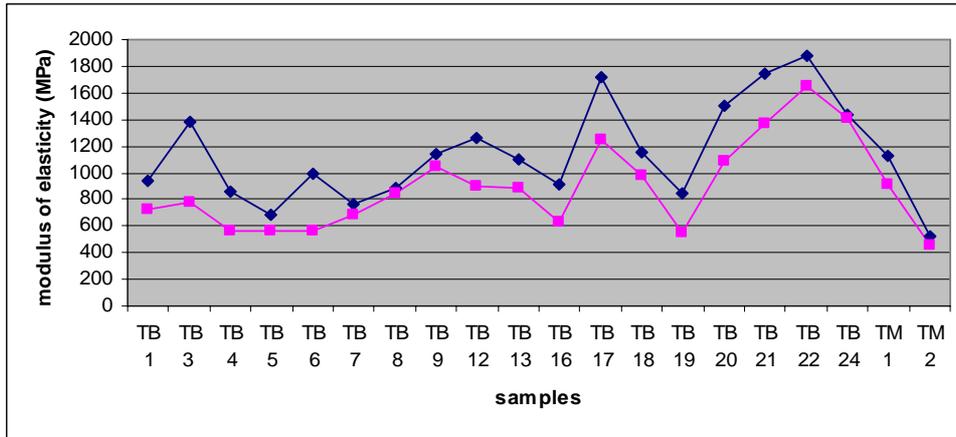
Figure 5 Variation in modulus of elasticity (Young’s Modulus) values (MPa) of the samples in dry and wet state (dry and wet states are shown by blue and pink lines, respectively).

In this study, the *modulus of elasticity* values were determined by ultrasonic velocity testing. It was observed that, moduli of elasticity of tested bricks appeared to change within the range of 1878 MPa-554 MPa and those of mortars within 457 MPa-1124 MPa (Table 5 and Figure 5). These values are comparable with those found by Tuncoku (2001) at his study carried out for a series of Seljuk period structures, and the values reported here can be positioned close to the lower bound of the interval reported by him. However, the values are much lower than the Young's Modulus values of Hagia Sophia bricks, which are in the order of 3100 MPa as estimated by Çakmak *et al.* in 1995. On the other hand, the moduli of elasticity values determined by Çakmak *et al.* (1995) for the mortars of Hagia Sophia fall within the range of the results obtained in this study. The modulus of elasticity values obtained for the Byzantine monuments in Kiev (Moropoulou *et al.*, 2000: 606) are also consistent with the results obtained here. At the latter, the moduli of elasticity were estimated for the bricks and mortars, as 1000-3000 MPa and 600-700 MPa, respectively. In that study, the Young's Modulus of brick and mortar composite were given as 2200 and 2500 MPa for Hagia Sophia (Moropoulou *et al.*, 2002: 544).

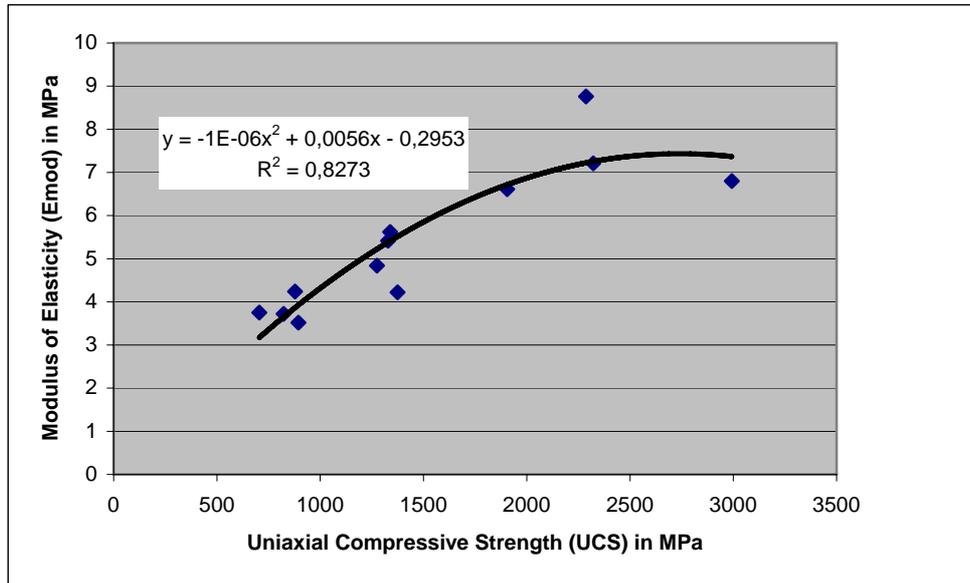
In this study, in addition to the laboratory analyses explained above, the results of a previous study carried out by Tuncoku (Tuncoku, 2001) were used as well to obtain the uniaxial compressive strength values of the samples studied here. The mentioned study included the uniaxial compressive strength investigation carried out by point load testing, as well as the determination of modulus of elasticity values through ultrasonic velocity measurements for a wide range of mortar samples taken from 22 different Seljuk Period structures. Therefore, utilizing these values, a search for any correlation between uniaxial compressive strength versus modulus of elasticity was made (Figure 6).

Figure 6 Correlation Developed Between Emod and UCS values Reported in Tuncoku, 2001

The best second degree equation representing the relation between the modulus of elasticity and uniaxial compressive strength values was tried to be found. The reason for this is that the value in such an equation for concrete is two, as seen below:

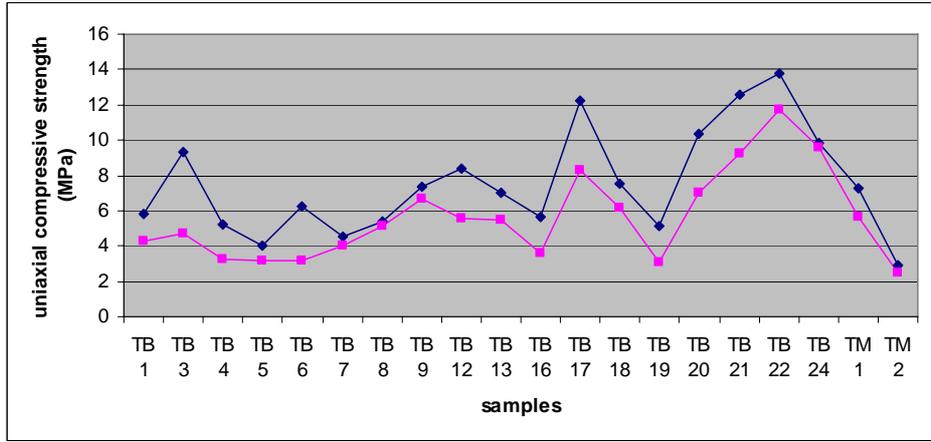
Figure 7 Variation in uniaxial compressive strength values (MPa) of the samples in dry and wet state (dry and wet states are shown by blue and pink lines, respectively).

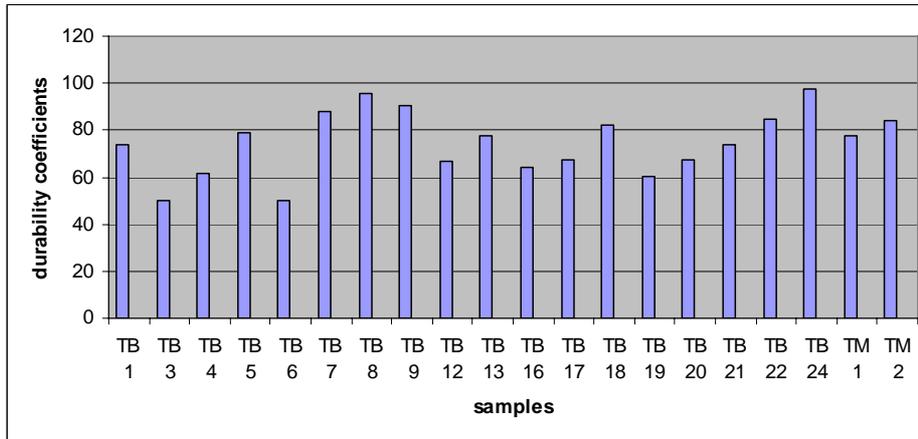
Figure 8 Variation in durability features of the samples

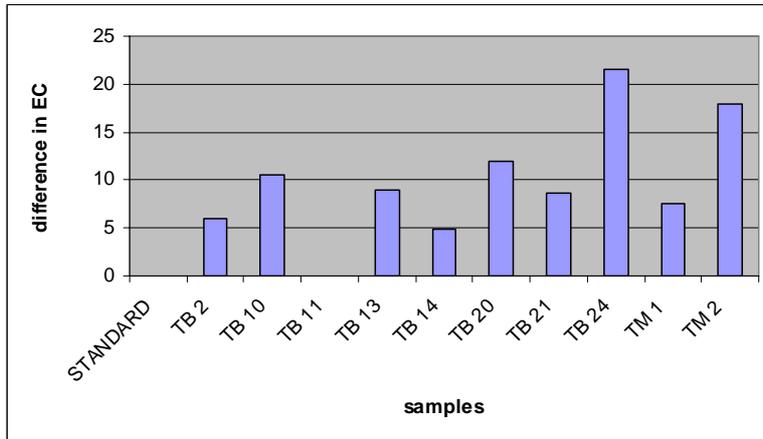
Figure 9 Variation in pozzolanic activity values (ΔEC) of the samples

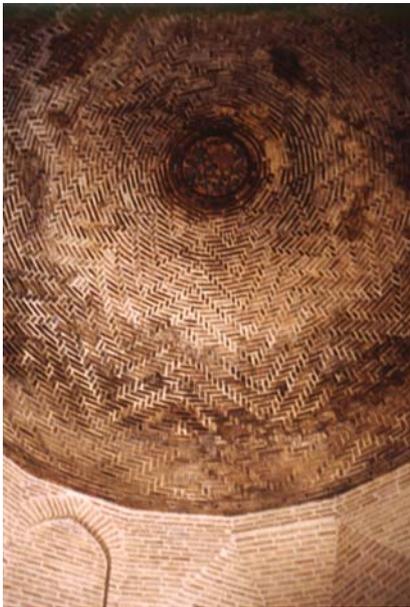
Figura 10 Dome of Tahir ile Zühre Mescidi

Tuncoku (1993) described the state of the dome. There were few minor cracks at the east and west of the dome, internally, caused by water penetration. There were some losses in bricks and mortars, however, the dome has no any important structural problems that could be seen visually (Tuncoku, 1993: 30).

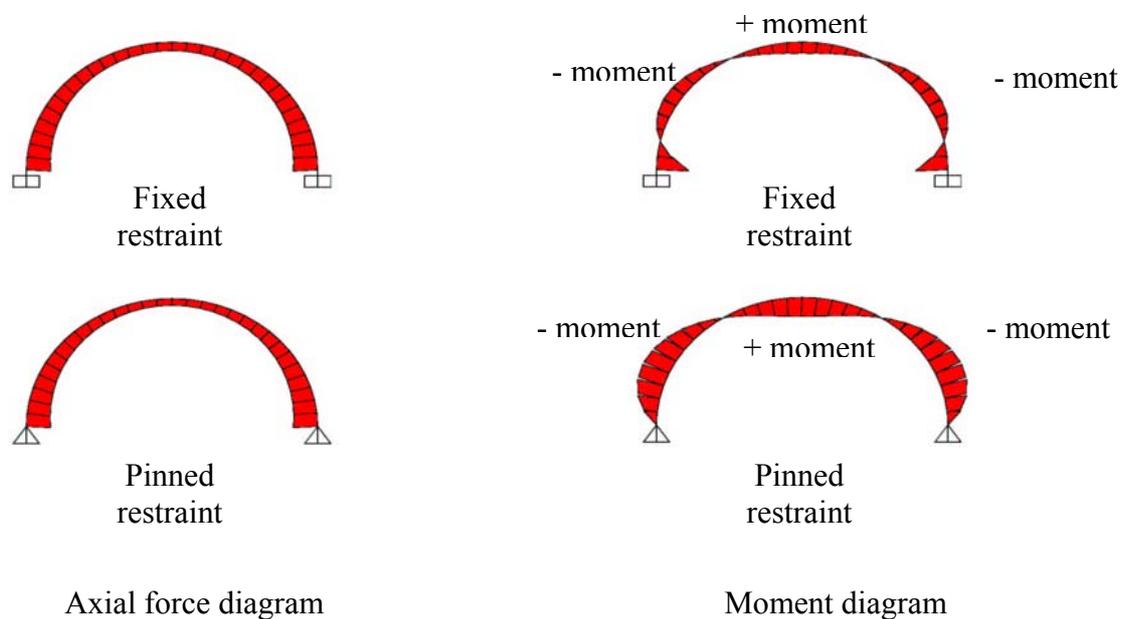
To understand the behaviour of the dome under its self-load, this simplified two dimensional semicircular arch example seen in Figure 11 can be utilized.

Figure 11 Axial stress and moment diagrams of semicircular arches in pinned and fixed restraint conditions, above and below, respectively.

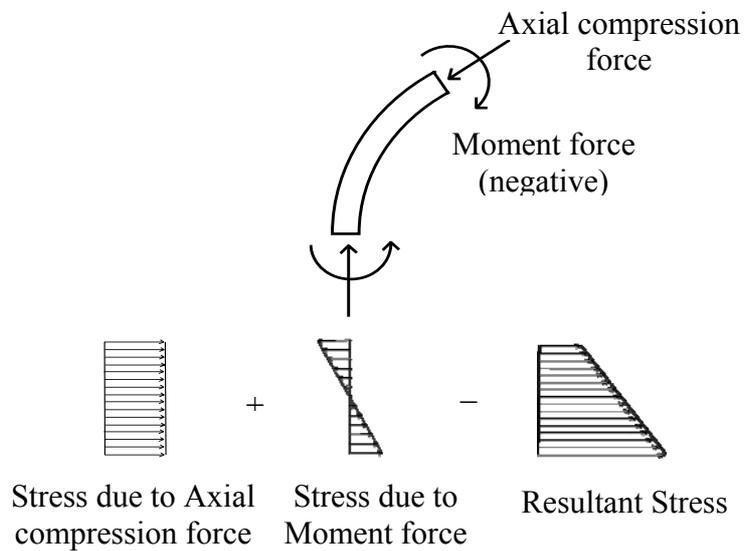
Figure 12 Resultant stress due to axial and moment forces

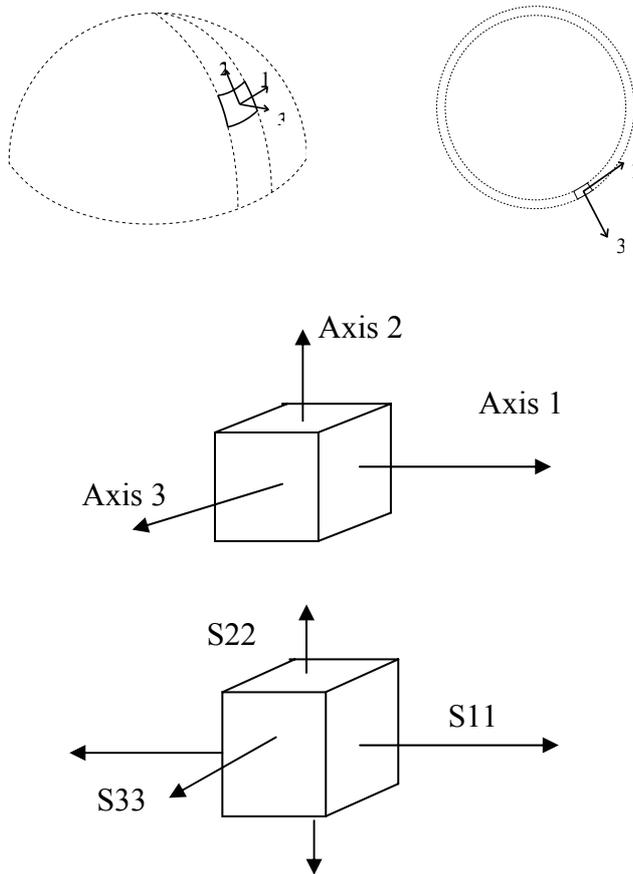
Figure 13 shows the local axes' sign convention followed all throughout this study.

Figure 13 Local axes directions and corresponding stress directions used in this study

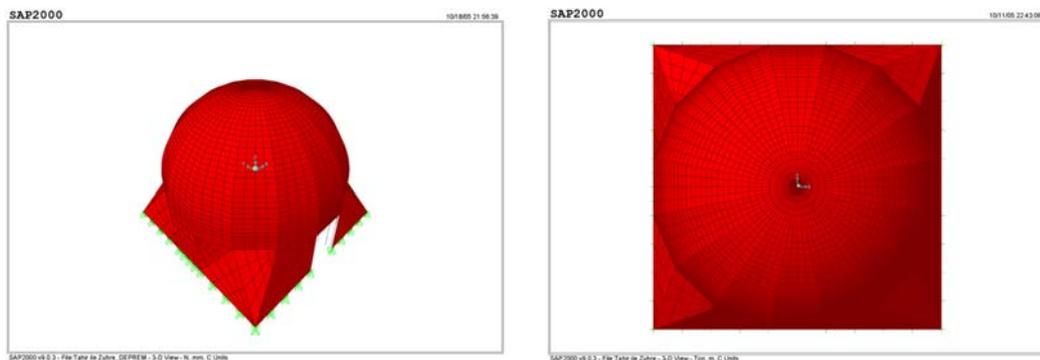
Figure 14 3D view and top view of the model of the upper structure of Tahir ile Zühre Mescidi

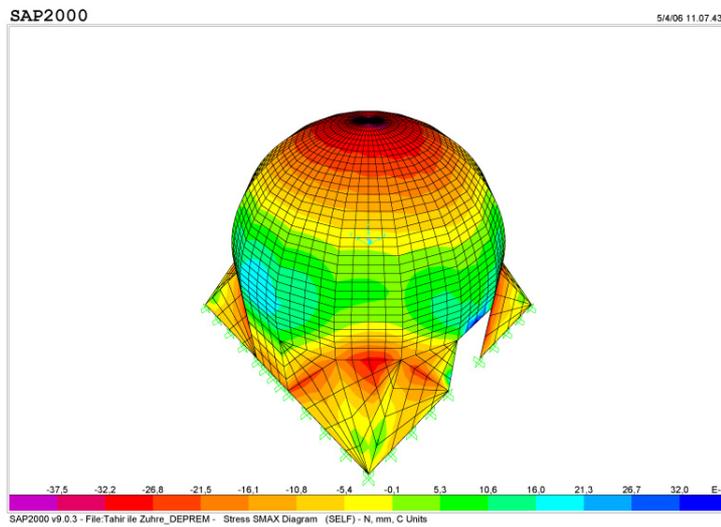
Figure 15 3D view of SMAX diagram of the upper structure of the monument under dead load

The developing stresses are in the order of 0.030 MPa in compression and in tension. These are the values far less than 4.4 MPa and 0.4 MPa, the compressive and tensile strength of the material, respectively.

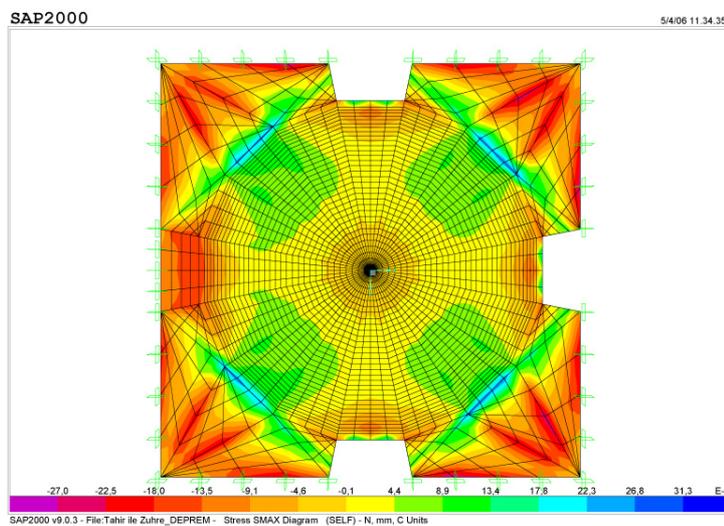
Figure 16 Bottom view of SMAX diagram of the upper structure of the monument under dead load

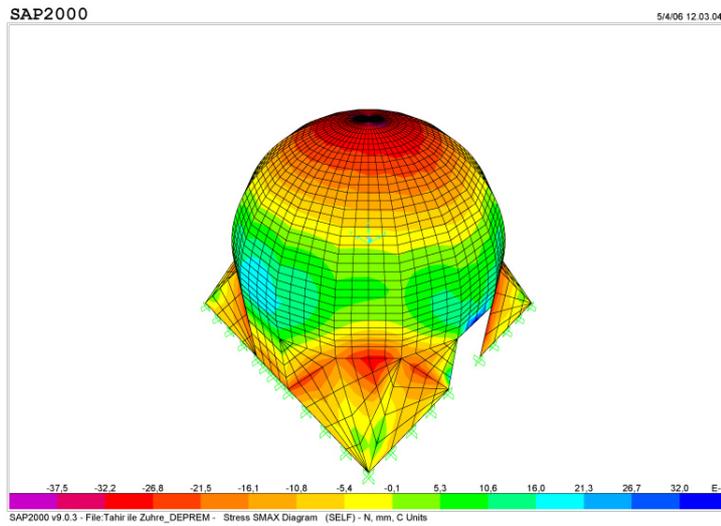
Figure 17 3D SMAX diagram of the upper structure of the monument under the combination of its dead load, snow load and wind load

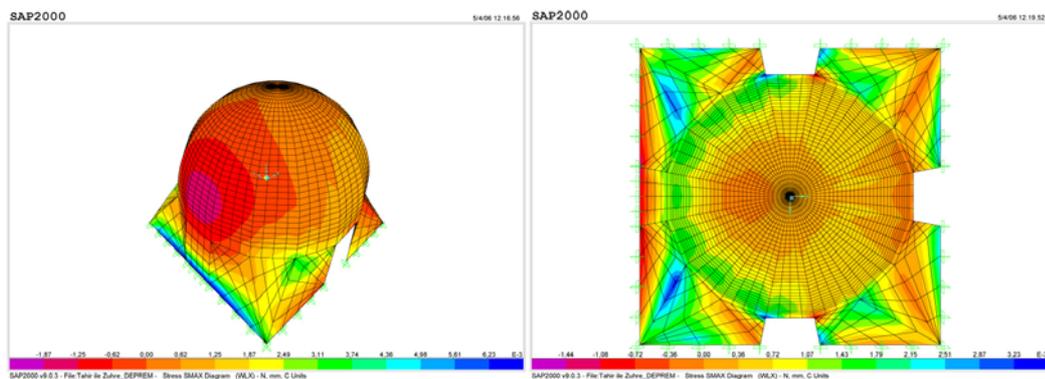
Figure 18 3D deformed and bottom view SMAX diagram of the upper structure of the monument under wind load

The effects of wind and snow load were tried to be seen separately as well (Figure 18 and Figure 19).

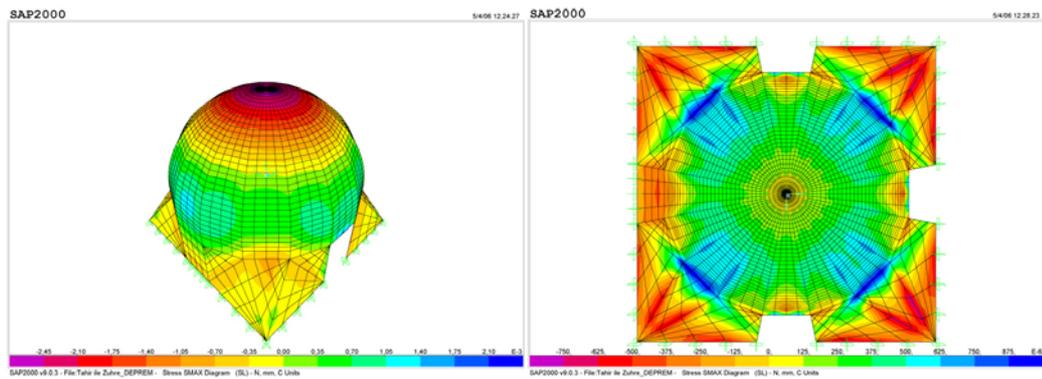
Figure 19 3D and bottom views SMAX diagram of the upper structure of the monument under snow load

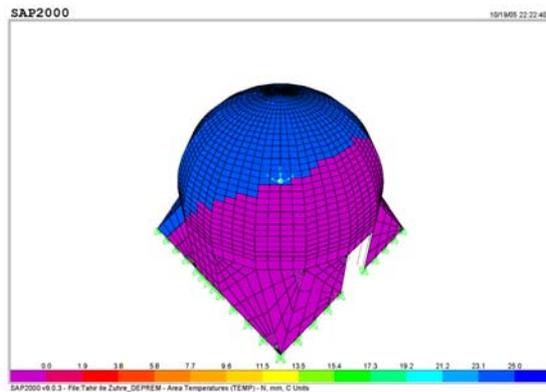
Figure 20 Applied temperature load of 25°C. Dark blue indicates the part warmer.

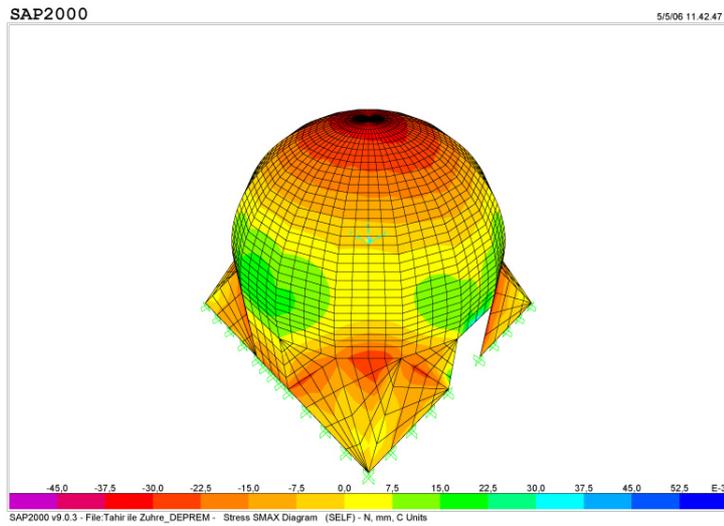
Figure 21 3D SMAX diagram of the upper structure of the monument under the combination of dead load and temperature load

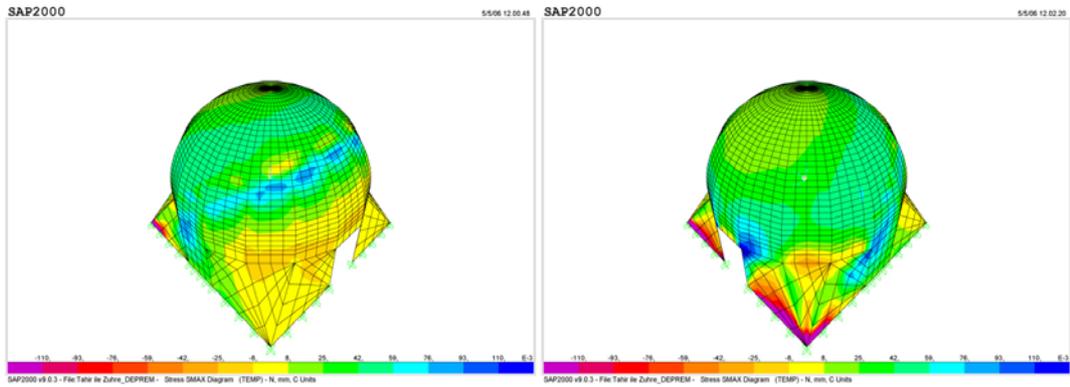
Figure 22 3D SMAX diagrams of the upper structure of the monument under temperature load

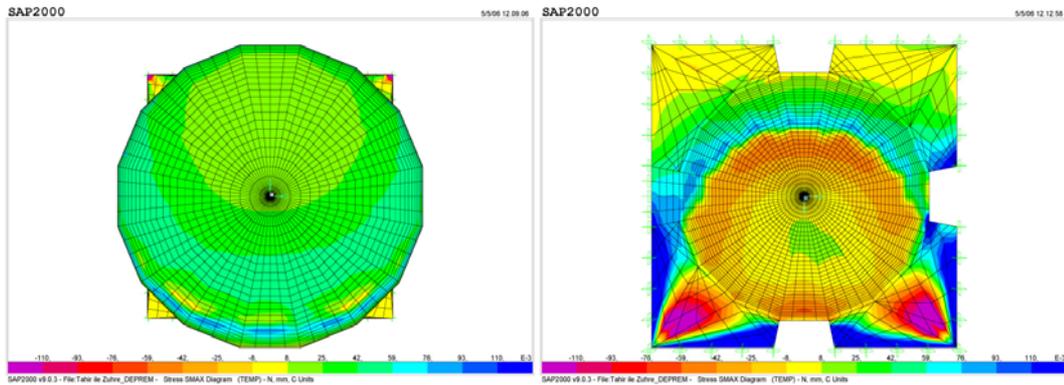
Figure 23 Top and bottom views of SMAX diagram of the upper structure of the monument under temperature load

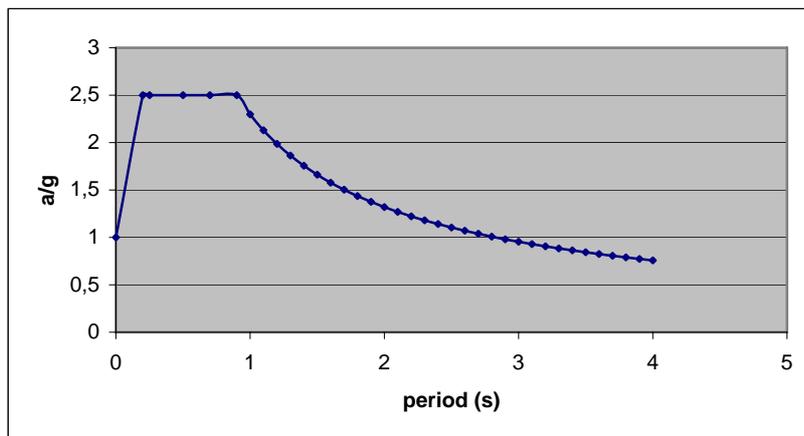
Figure 24 Response spectrum according to ABYYHY 98 (Turkish Earthquake Resistant Design Code 1998) for the soil type Z4

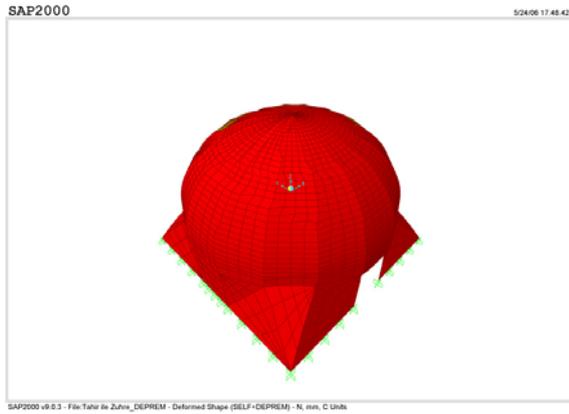
Figure 25 3D deformed shape of the upper structure of the monument under the combination of earthquake load and dead load

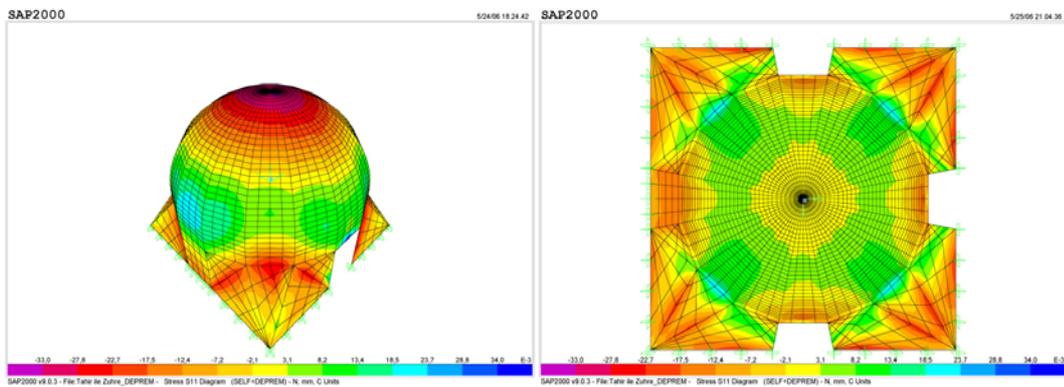
Figure 26 3D and bottom views of S11 diagram of the upper structure of the monument under earthquake load

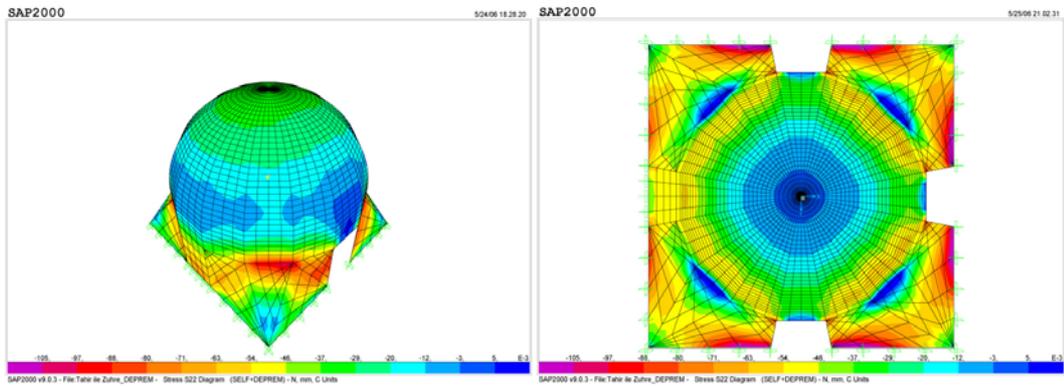
Figure 27 3D and bottom views of S22 diagram of the upper structure of the monument under earthquake load

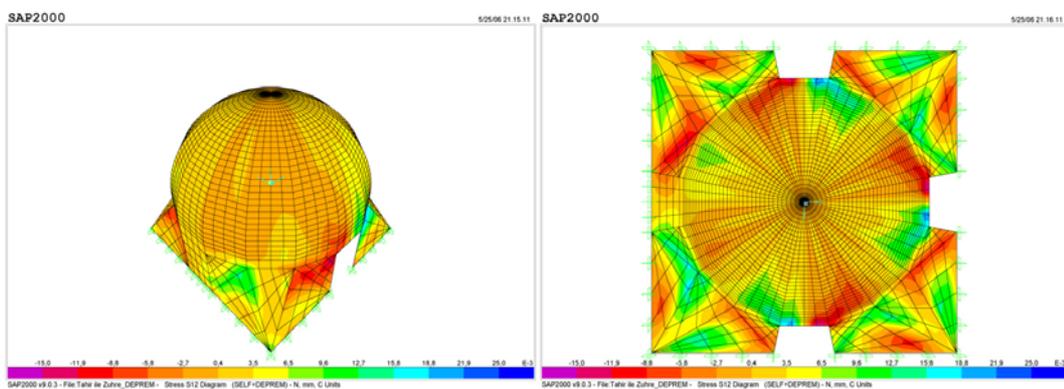
Figure 28 3D and bottom views of S12 diagram of the upper structure of the monument under earthquake load

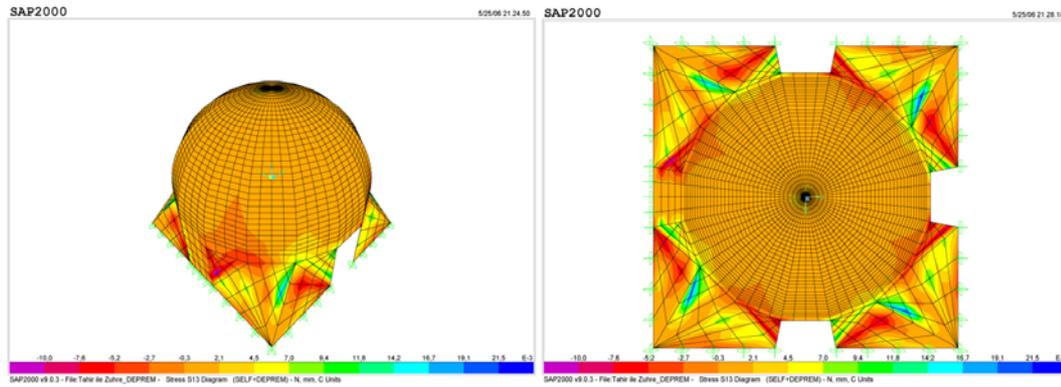
Figure 29 3D and bottom views of S13 diagram of the upper structure of the monument under earthquake load

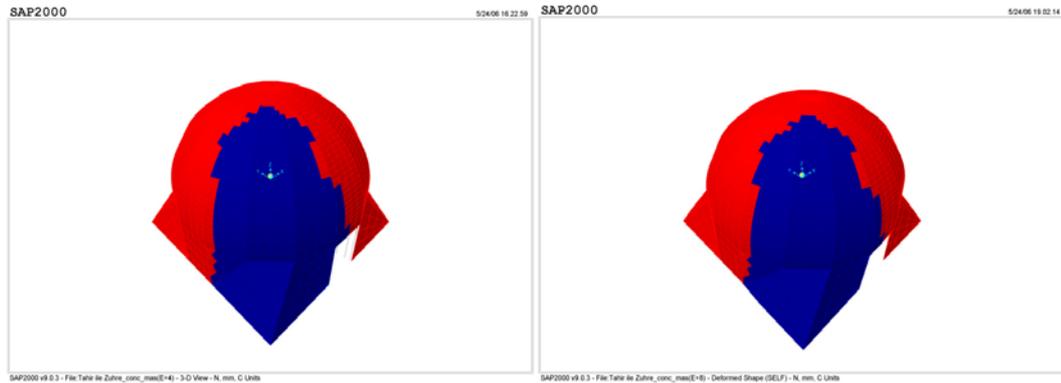
Figure 30 3D undeformed and deformed views of the upper structure of the monument, partially collapsed and completed using concrete, under dead load (red and blue demonstrate masonry and concrete materials, respectively)

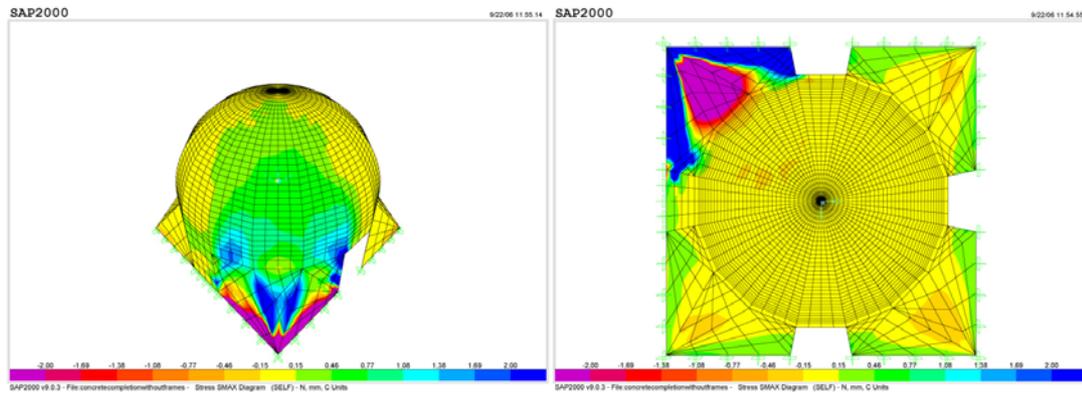
Figure 31 3D and bottom SMAX diagrams of the upper structure of the monument, partially collapsed and completed using concrete, under dead load

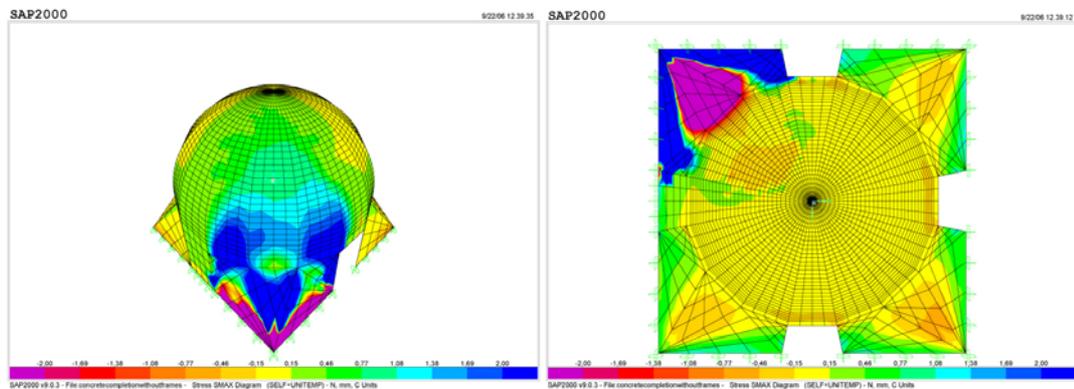
Figure 32 3D and bottom SMAX diagrams of the upper structure of the monument, partially collapsed and completed using concrete, under dead load and 40°C uniform temperature load

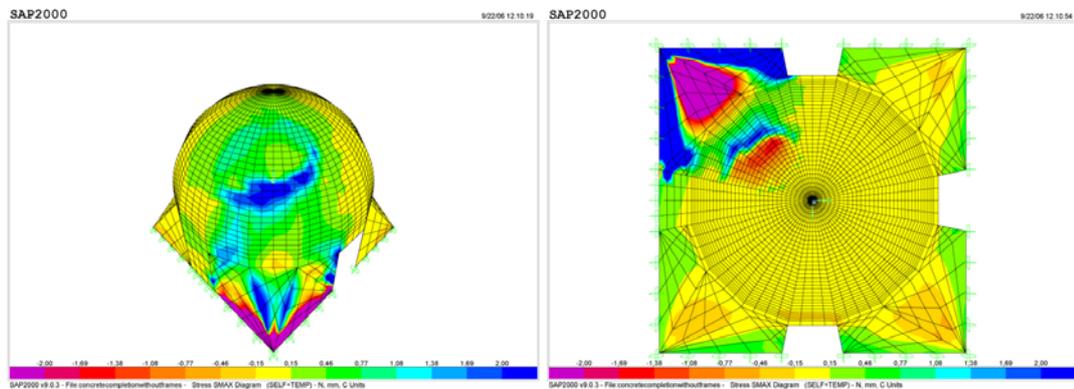
Figure 33 3D and bottom SMAX diagrams of the upper structure of the monument, partially collapsed and completed using concrete, under dead load and 25°C randomly distributed temperature load

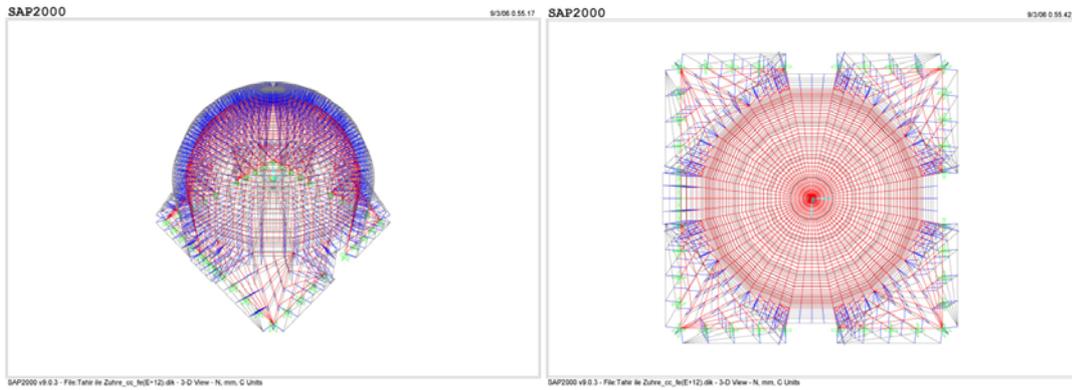
Figure 34 3D and bottom views of the upper structure of the monument composed of two layers connected with rigid links

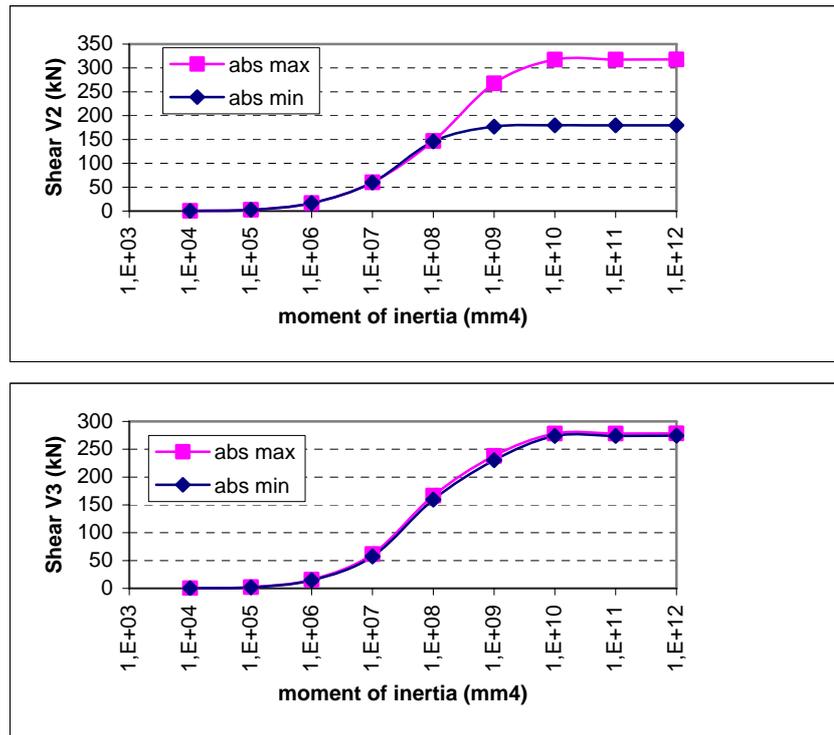
Figure 35 Graphs of minimum and maximum V2 and V3 values (i.e. shear forces in the 1-3 and 1-2 planes respectively) as a function of moment of inertia.

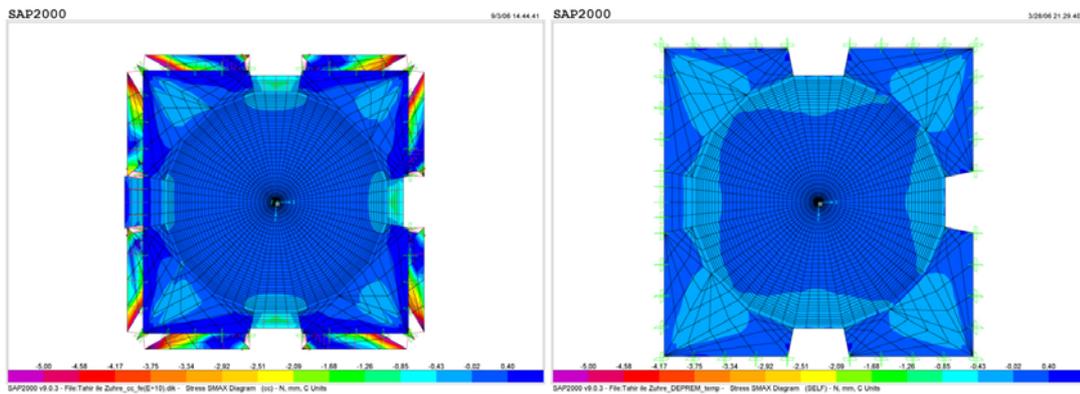
Figure 36 Bottom view of resulting SMAX diagrams of the upper structure of the monument with and without concrete cover, respectively, under dead load and uniformly distributed temperature load of 40°C for $I=10^{10} \text{ mm}^4$

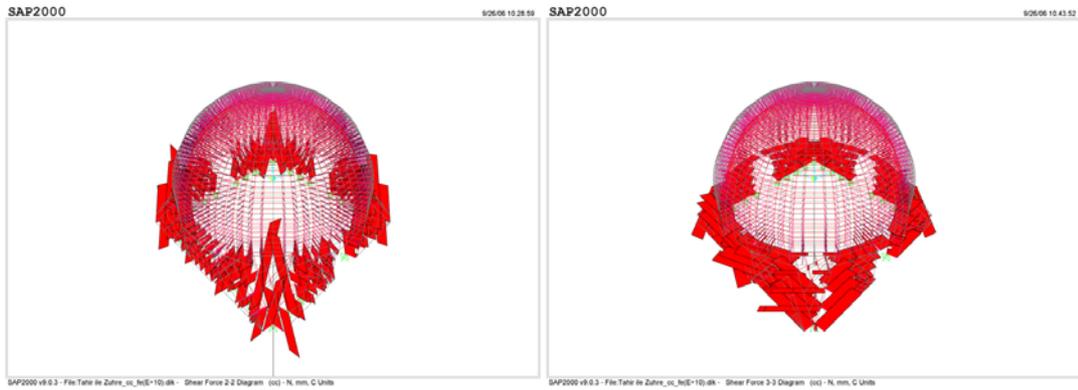
Figure 37 Graphs of resulting V2 and V3 values (i.e. shear forces in the 1-3 and 1-2 planes respectively) under dead load and uniformly distributed temperature load of 40°C for $I=10^{10} \text{ mm}^4$

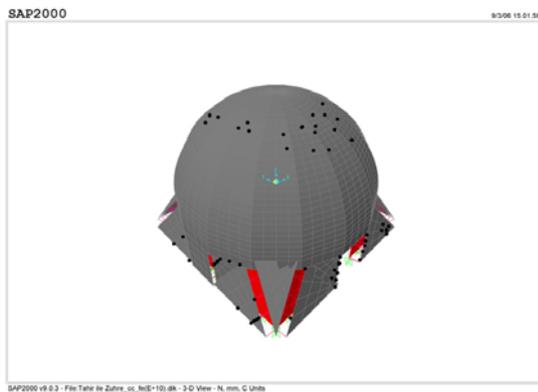
Figure 38 Critical frame elements indicated on the upper structure of the monument, covered with concrete coating, under dead load and uniformly distributed temperature load of 40°C for $I=10^{10} \text{ mm}^4$

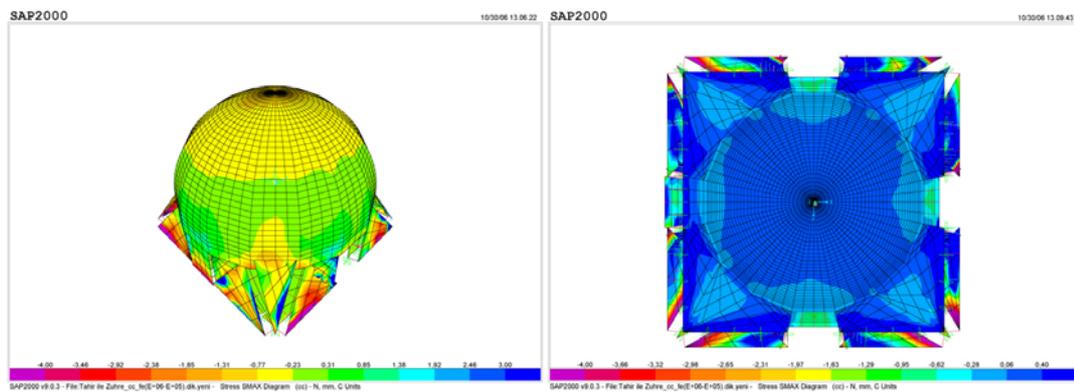
Figure 39 3D and bottom views of the SMAX diagram the upper structure of the monument covered with concrete coating, under dead load and uniformly distributed temperature load of 40°C for $I=10^5 \text{ mm}^4$

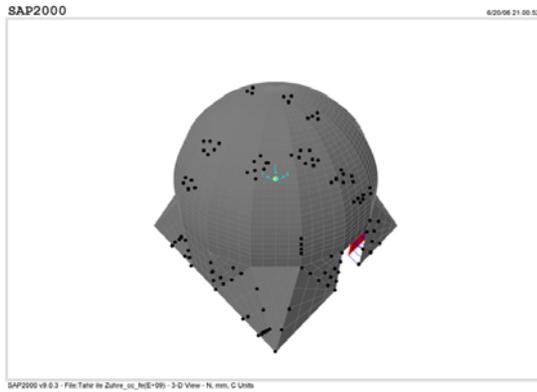
Figure 40 Critical frame elements indicated on the upper structure of the monument, covered with concrete coating, under dead load and uniformly distributed temperature load of 40°C for $I=10^5 \text{ mm}^4$

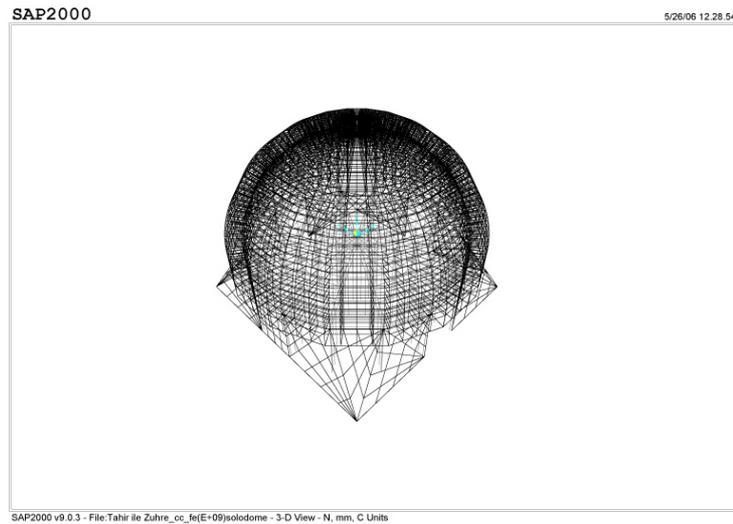
Figure 41 A 3D view of the upper structure of the monument composed of two layers connected only at the dome part with rigid links

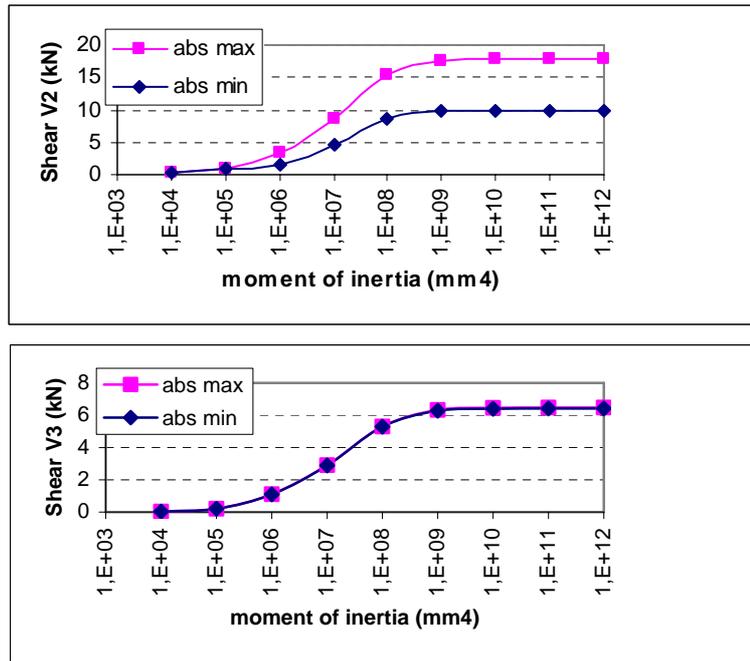
Figure 42 Graphs of minimum and maximum V2 and V3 values (i.e. shear forces in the 1-3 and 1-2 planes, respectively) as a function of moment of inertia.

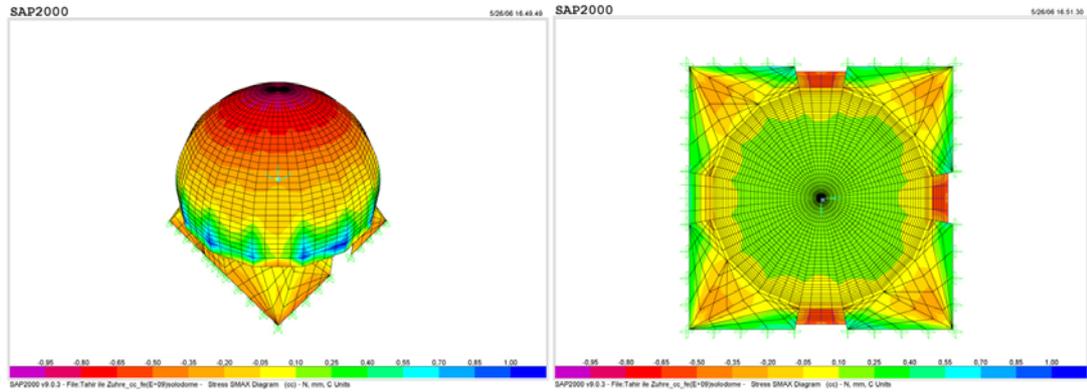
Figure 43 3D and bottom views of the SMAX diagram the upper structure of the monument, whose dome covered with concrete coating, under dead load and uniformly distributed temperature load of 40°C for $I=10^9 \text{ mm}^4$

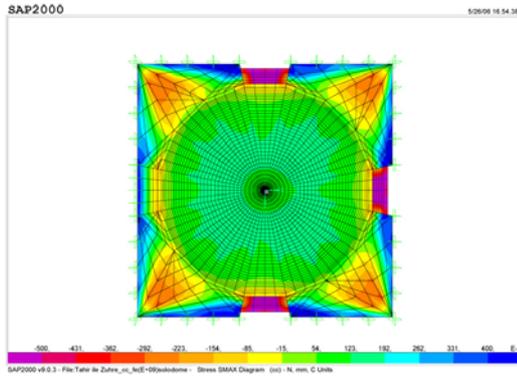
Figure 44 Bottom view of the SMAX diagram of the upper structure of the monument covered with concrete coating, under dead load and uniformly distributed temperature load of 40°C for $I=10^9 \text{ mm}^4$

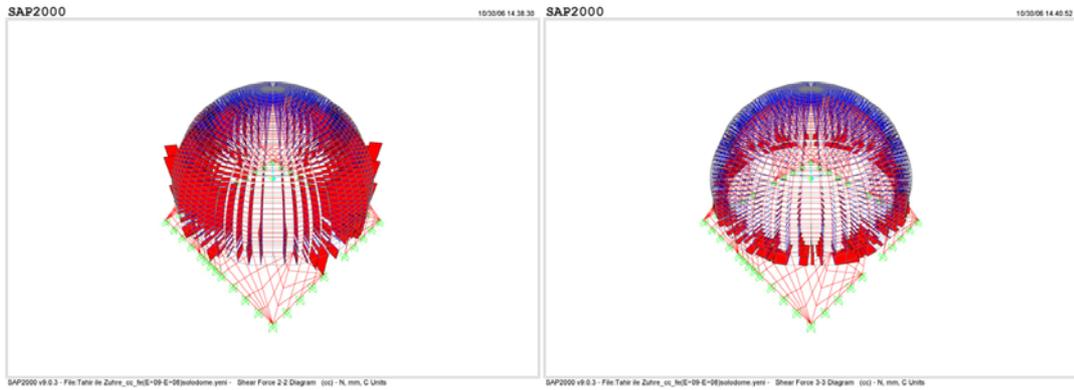
Figure 45 Graphs of resulting V2 and V3 values (i.e. shear forces in the 1-3 and 1-2 planes respectively) under dead load and uniformly distributed temperature load of 40°C for $I=10^9 \text{ mm}^4$

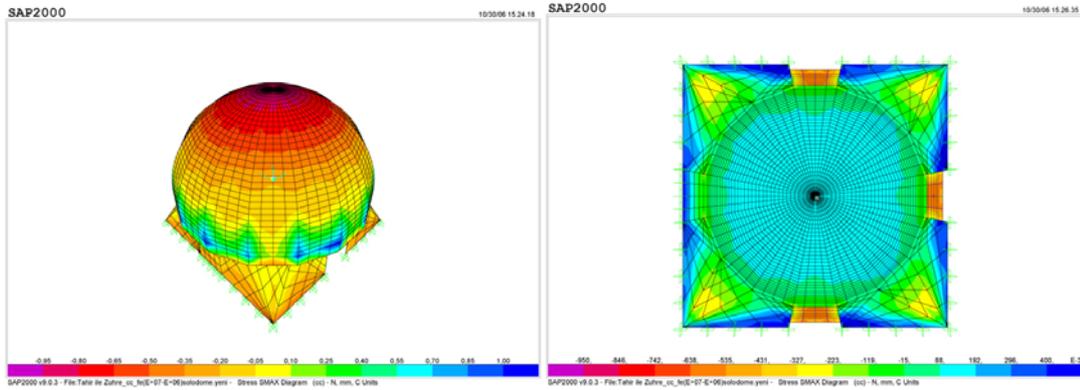
Figure 46 3D bottom views of the SMAX diagram the upper structure of the monument, whose dome covered with concrete coating, under dead load and uniformly distributed temperature load of 40°C for $I=10^5 \text{ mm}^4$

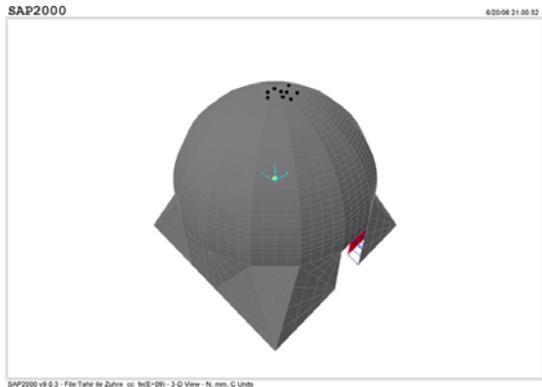
Figure 47 Critical frame elements indicated on the upper structure of the monument, whose dome covered with concrete coating, under dead load and uniformly distributed temperature load of 40°C for $I=10^5 \text{ mm}^4$

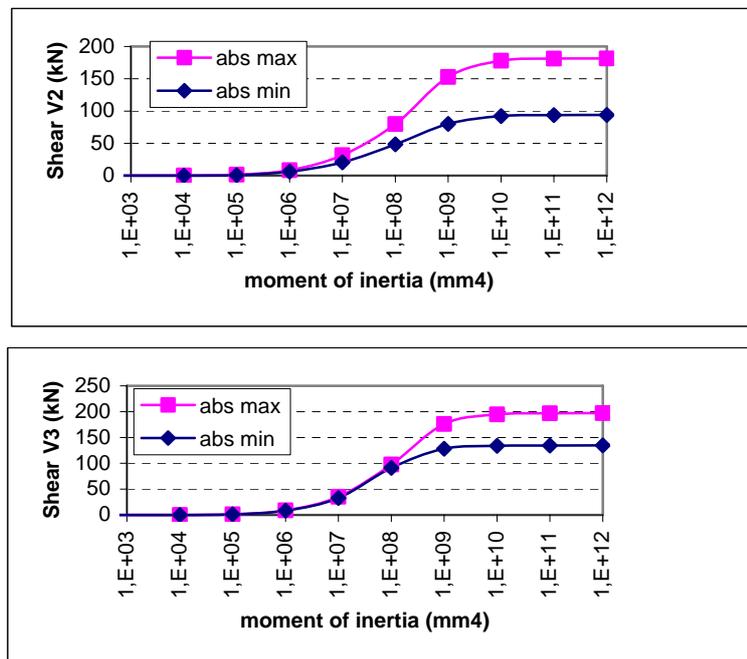
Figure 48 Graphs of minimum and maximum V2 and V3 values (i.e. shear forces in the 1-3 and 1-2 planes with square and diamond markers, respectively) as a function of moment of inertia

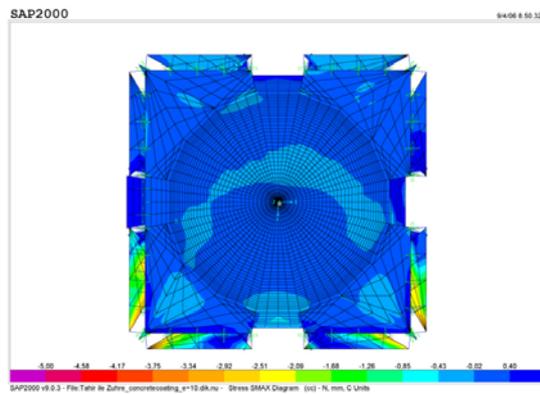
Figure 49 Bottom view of the SMAX diagram of the upper structure of the monument covered with concrete coating, under dead load and randomly distributed temperature load of 25°C for $I=10^{10} \text{ mm}^4$

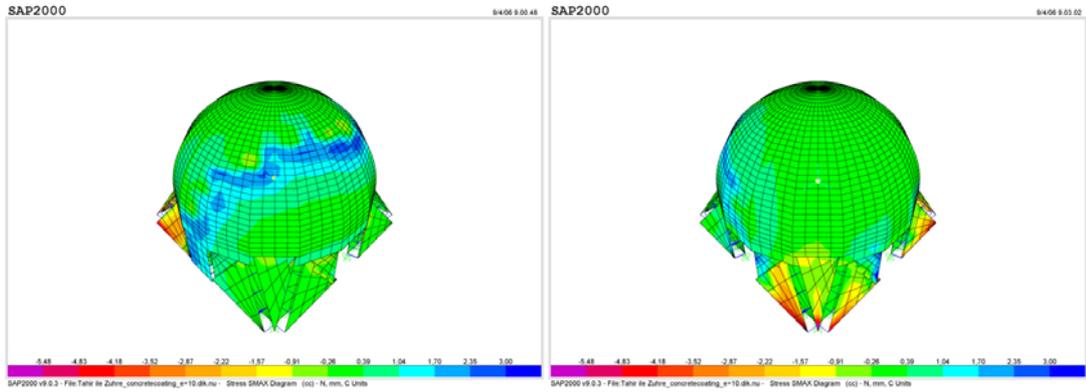
Figure 50 3D SMAX diagrams of the upper structure of the monument covered with concrete coating, under dead load and randomly distributed temperature load of 25°C for $I=10^{10} \text{ mm}^4$

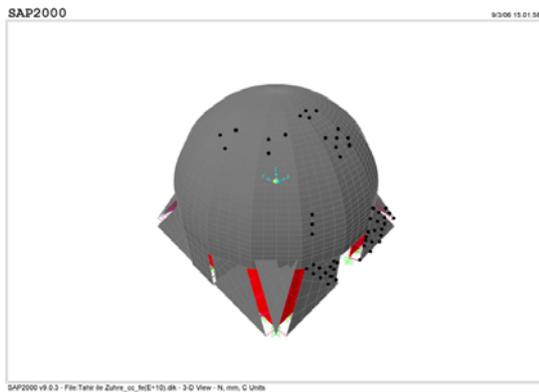
Figure 51 Critical frame elements indicated on the of the upper structure of the monument, covered with concrete coating, under dead load and randomly distributed temperature load of 25°C for $I=10^{10} \text{ mm}^4$
