TECHNOLOGICAL CHARACTERISTICS OF A BRICK MASONRY
STRUCTURE AND THEIR RELATIONSHIP WITH THE STRUCTURAL
BEHAVIOUR

A THESIS SUBMITTED TO
THE GRADUATE SCHOOL OF NATURAL AND APPLIED SCIENCES
OF
MIDDLE EAST TECHNICAL UNIVERSITY

YASEMİN DİDEM AKTAŞ

SEPTEMBER 2006

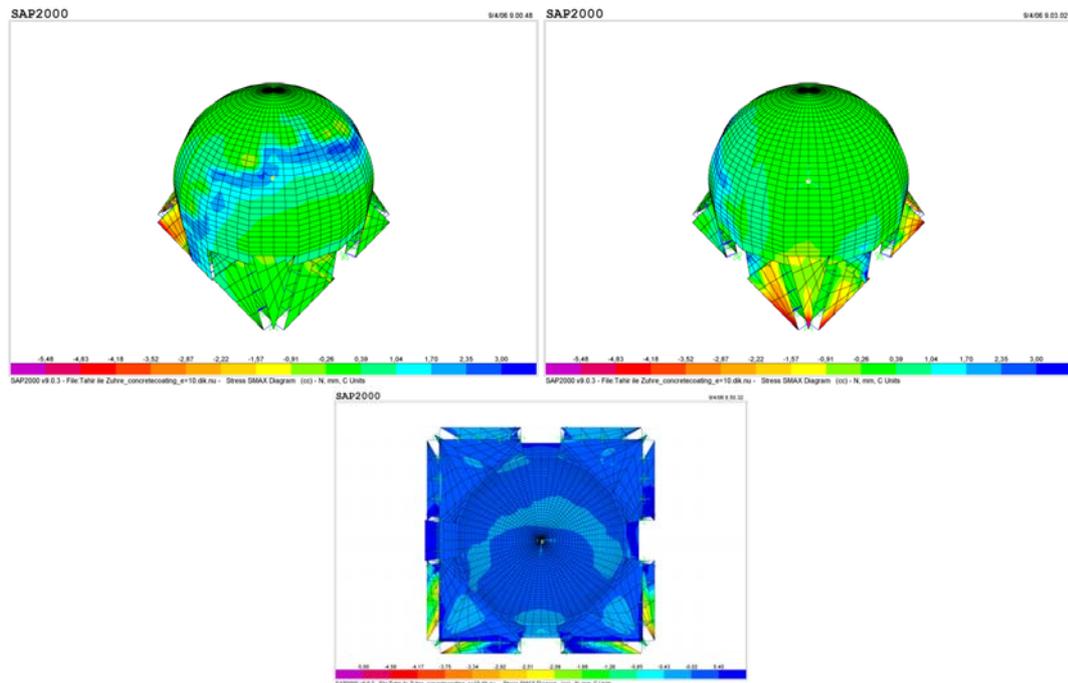
Figure 52 3D and bottom views of resulting SMAX diagrams of the superstructure covered with concrete coating, under dead load and randomly distributed temperature load of 25°C for $I_{\text{sys}}=10^7 \text{ mm}^4$ and $I_{\text{cr.frames}}=10^6 \text{ mm}^4$
