**CONSERVATION OF CULTURAL HERITAGE ON ALAEDDIN HILL IN KONYA
FROM THE 19TH CENTURY TO PRESENT DAY**

**A THESIS SUBMITTED TO
THE GRADUATE SCHOOL OF NATURAL AND APPLIED SCIENCES
OF
MIDDLE EAST TECHNICAL UNIVERSITY**

**IN PARTIAL FULFILLMENT OF THE REQUIREMENTS
FOR
THE DEGREE OF DOCTOR OF PHILOSOPHY IN RESTORATION
IN
ARCHITECTURE**

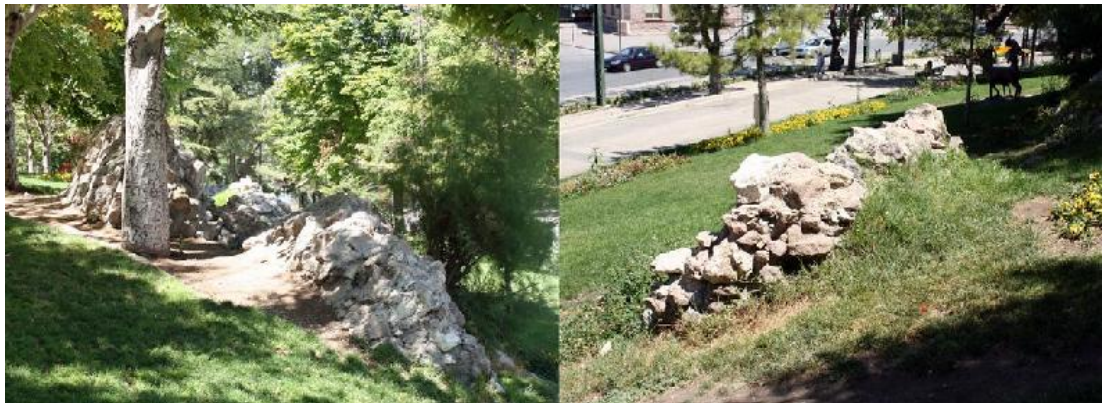
Fig. 2.29. The ruins of inner citadel walls as of 2007 (photo by the author)

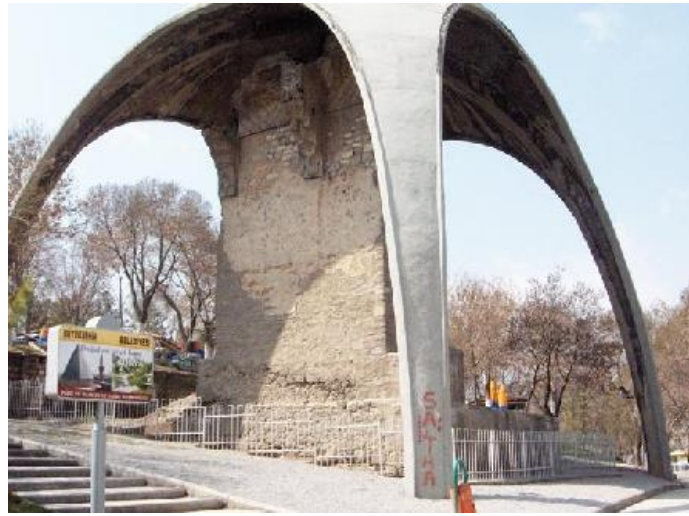
Fig. 2.30. The ruins of Kılıçarslan kiosk as of 2007 (photo by the author)

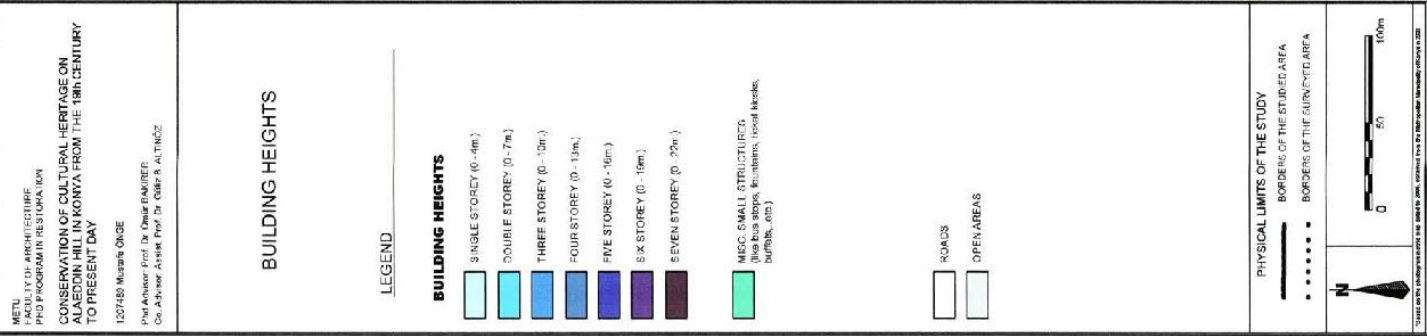
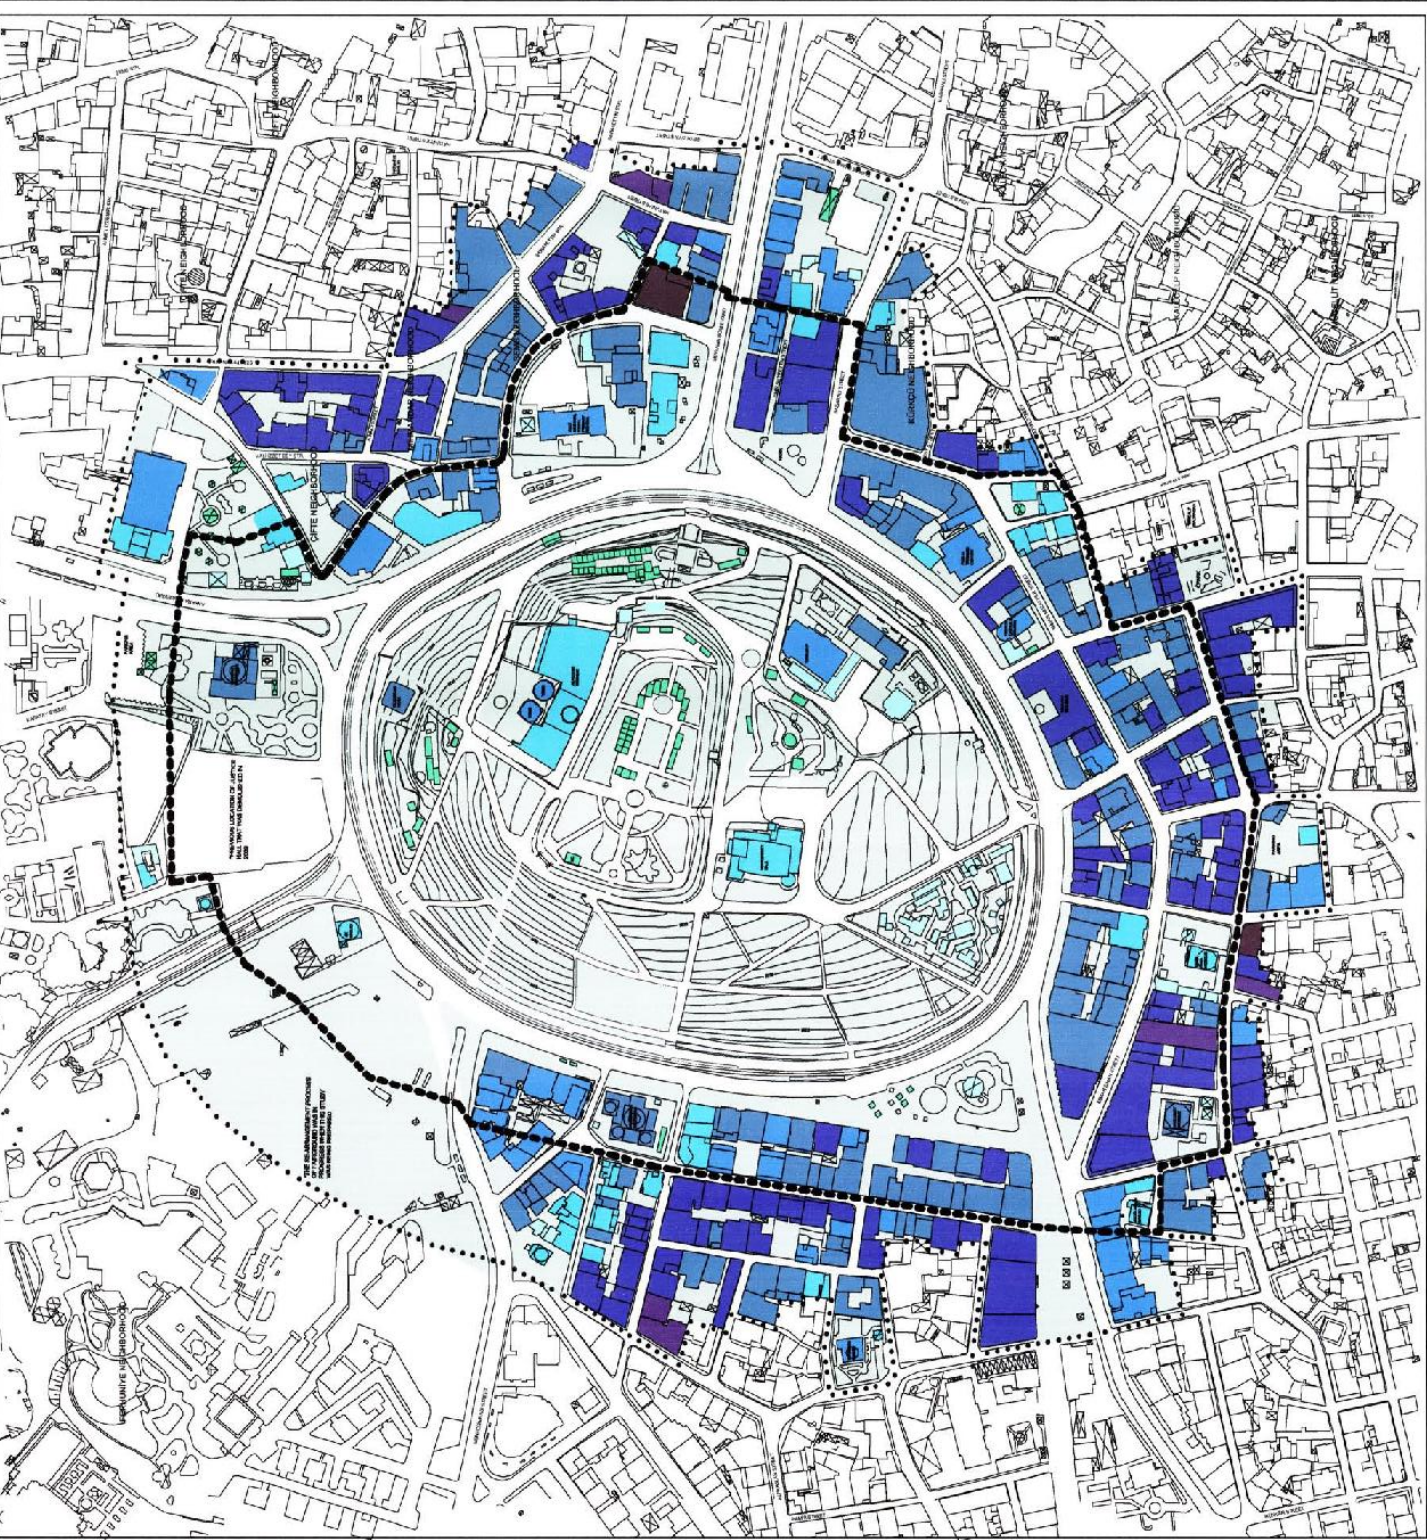
Fig. 2.36 Analysis of Building Heights

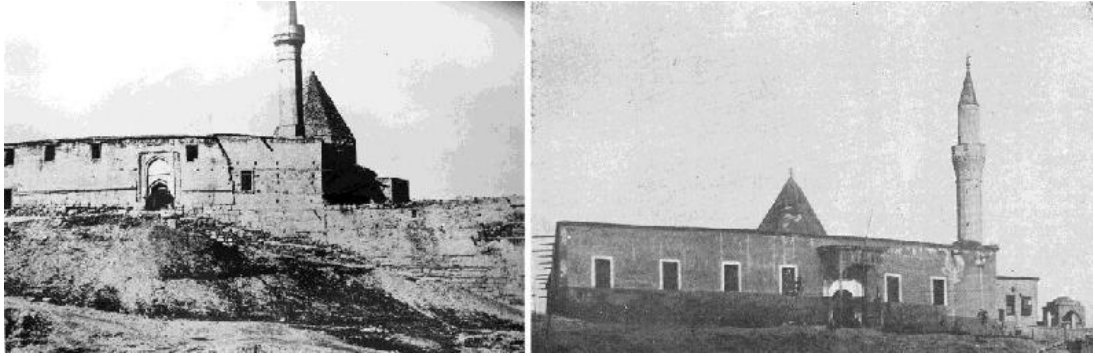
Fig. 3.4 Views of Alaeddin Mosque before and after 1889 dated repair (Sarre photo from Koyunoğlu Museum Archives, Konya ve Rehberi, 1921)

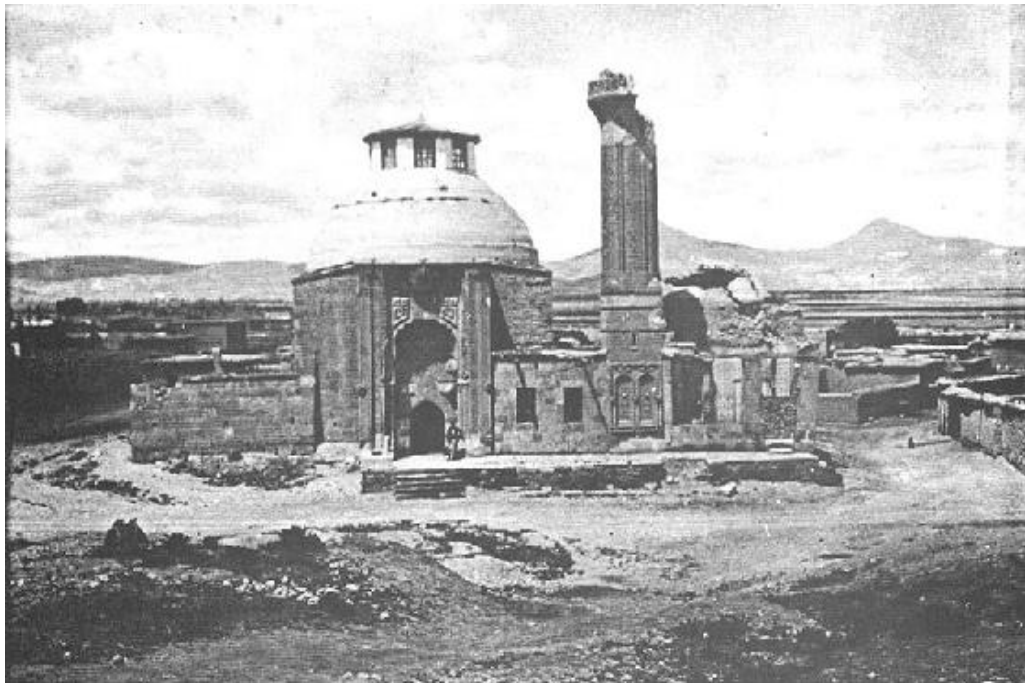
Fig. 3.10 A photograph taken by G. Bell in 1907, showing the status of İnceminare Madrasah and Mosque after thunderstrike (Eravşar, 2004, p.126).

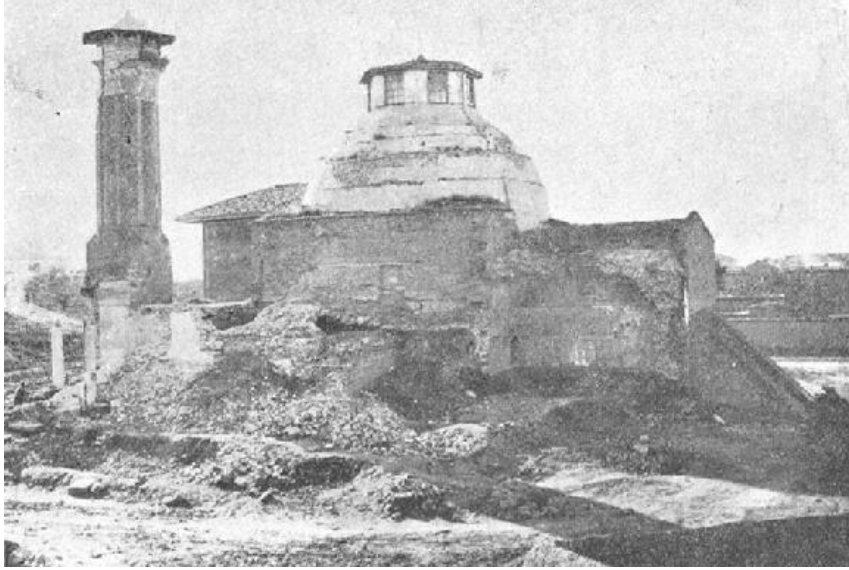
Fig. 3.15 A view from İnceminare Madrasah, showing the masjid and student cells on the north, after the demolition attempt in 1929 (Tarihi Abidelerimizi, 1933, np.).

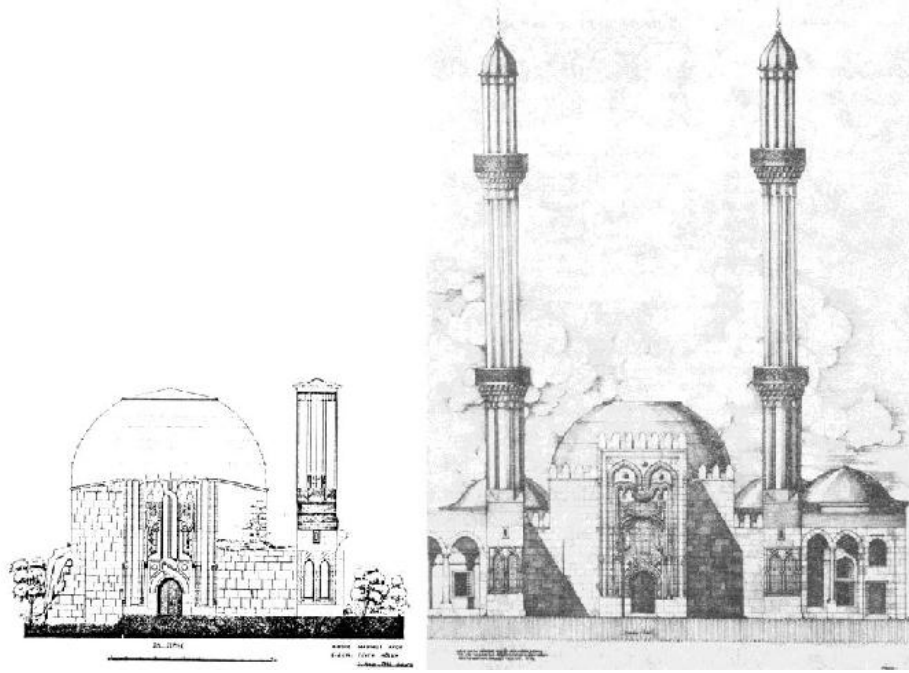
Fig. 3.28 Comparison of the 1961 dated survey and 1974 dated restoration drawings of İnceminare Madrasah entrance façade (Akok, 1977, p.69, Akok, 1970, p.19)

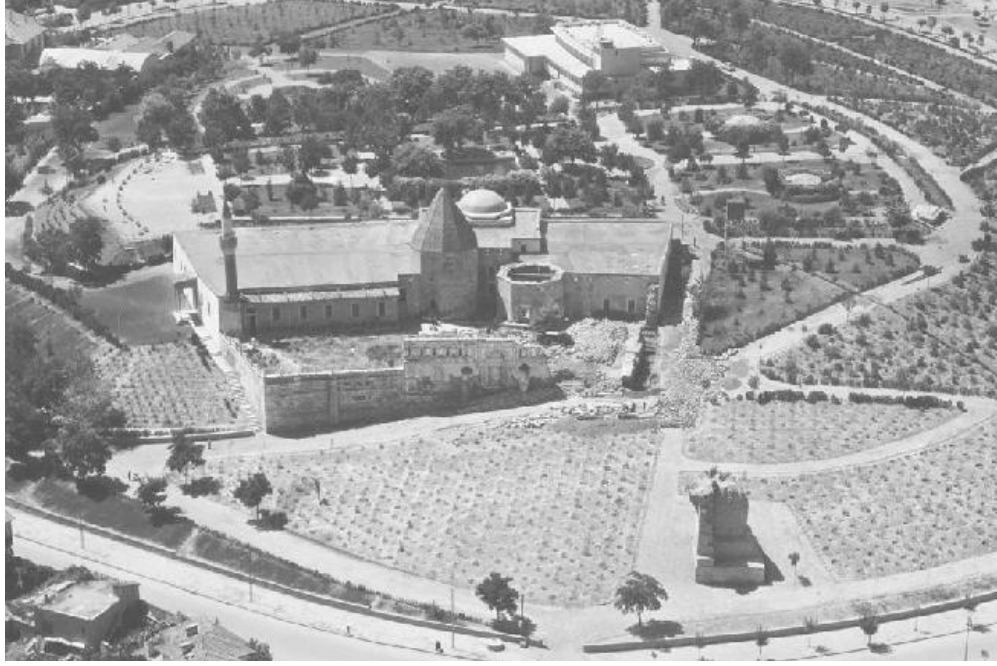
Fig. 3.30 Aerial view of Alaeddin Mosque during the repairs in 1959 (Y. Önge photo archive)

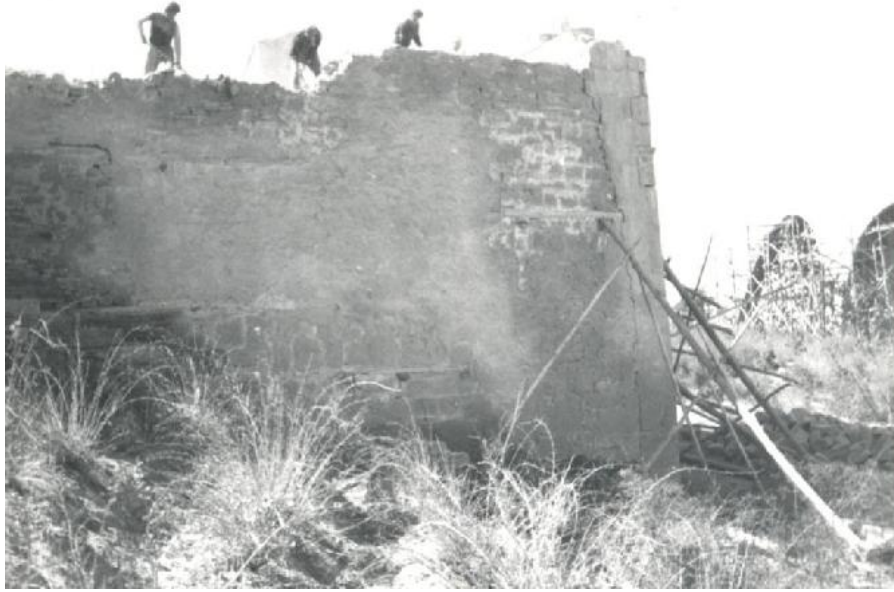
Fig.3.31 Dismantling of the courtyard walls on the eastern section in 1962. The edifice with scaffolding on the background is the shelter for the remains of Kılıçarslan Kiosk (Y. Önge photo archive).

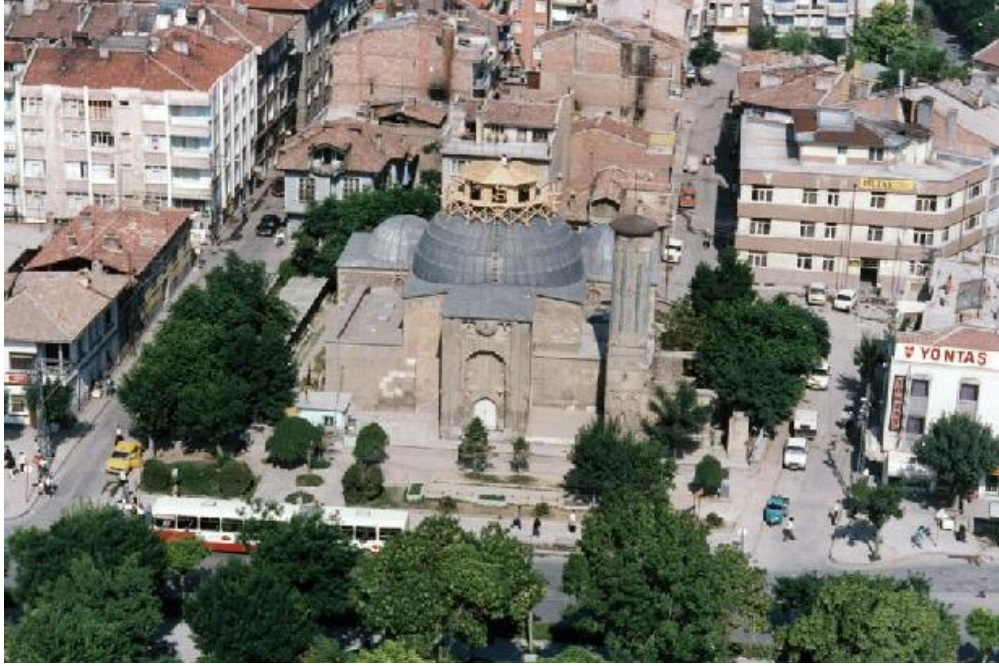
Fig. 3.34 Inceminare Madrasah, reconstruction of skylight structure in the summer of 1990 (Y. Önge photo archive)

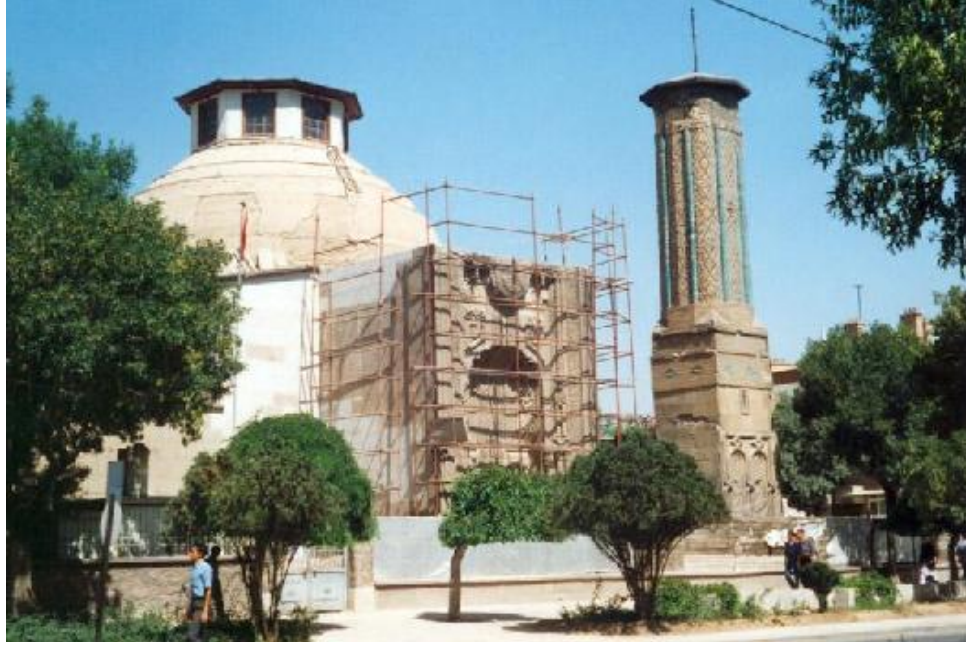
Fig. 3.39. İnceminare Madrasah, during the repairs in 2000 (M. Önge photo archive)

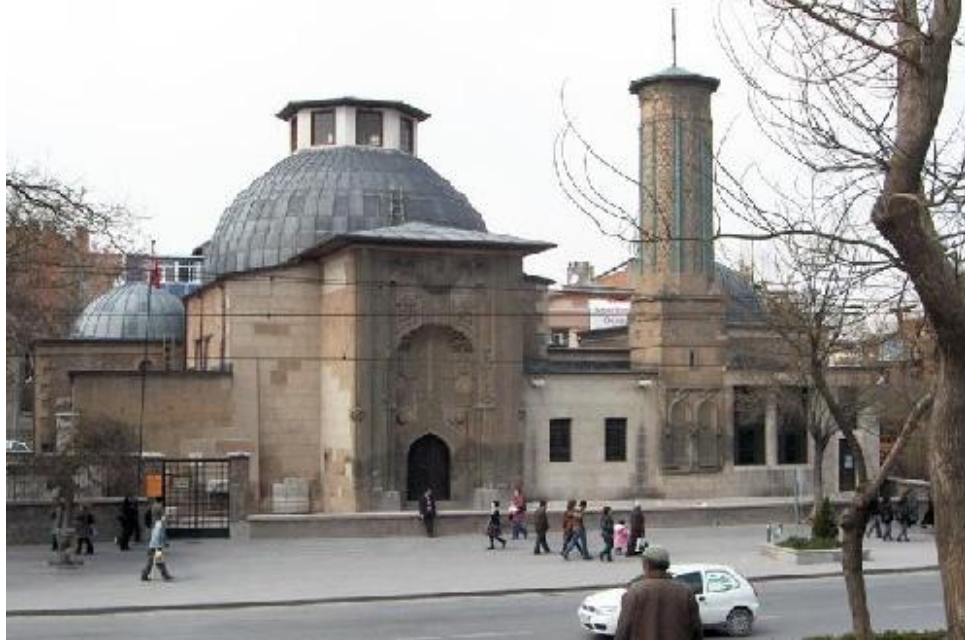
Fig. 3.40 İnceminare Madrasah, before the latest repair period, in 2007 (M. Önge photo archive)

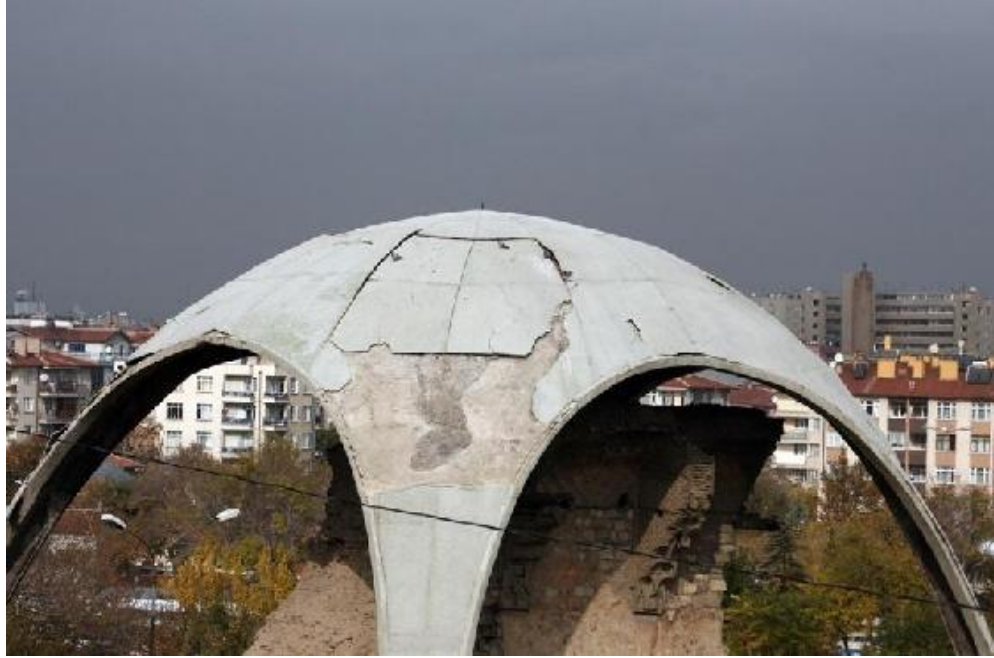
Fig.3.41 The shelter of Kılıçarslan Kiosk, view from Alaeddin Mosque as of September 2009 (M. Önge photo archive)
