TECHNOLOGICAL PROPERTIES AND CONSERVATION PROBLEMS OF
SOME MEDIEVAL BRICKS AND TILES

A THESIS SUBMITTED TO
THE GRADUATE SCHOOL OF NATURAL AND APPLIED SCIENCES
OF
MIDDLE EAST TECHNICAL UNIVERSITY

The aim of this study is to examine the technology of the relatively deteriorated historic tile, brick and mortar samples of Sivas Gök Medrese and Tokat Gök Medrese. Their main deterioration factors were analyzed mainly as salt weathering. It was examined in detail, and the possible desalination methods were discussed.

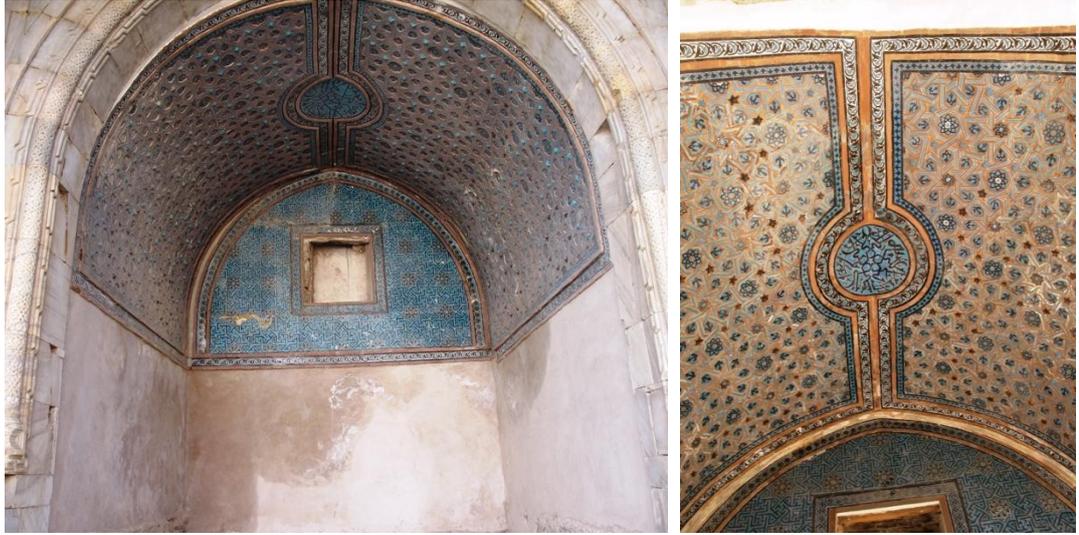
Figure 2.3 General view of South Eyvan; Sivas Gök Medrese (2011)

The empty spaces of the lost tiles on the domes were filled and painted reminiscent to tile revetment. The roof system was not finished, so the eyvan walls were moisturized because of rain penetration. Darker color noticed on the eyvan walls was accepted to be evidence for this (Figure 2.3).

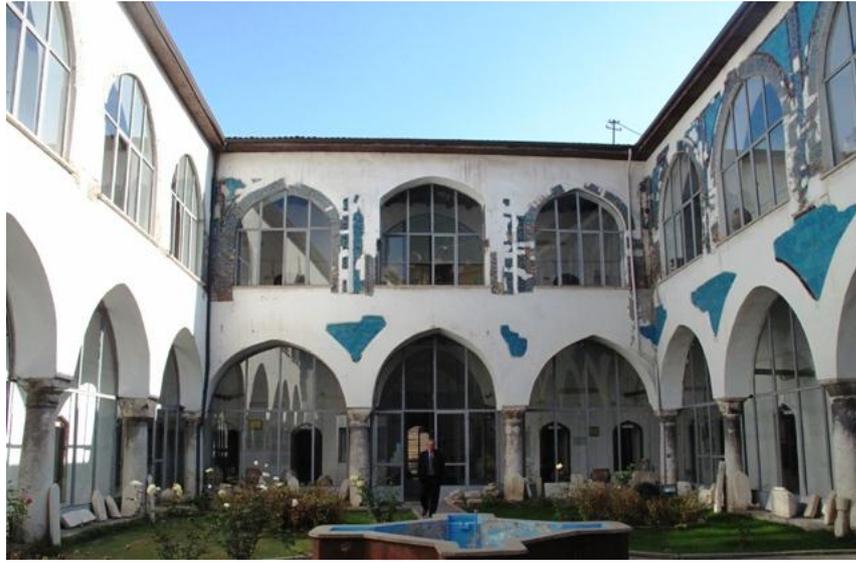
Figure 2.5 General view of Tokat Gök Medrese (2011)

Today, the medrese is used as a museum for the exhibition of archaeological and ethnographic pieces and coins. The main eyvan walls were covered with cement and limewash (Figure 2.5). The plain tiles of the facades are mainly lost. Although the in situ tiles of the front façade were partially lost, most of them are on the wall. The repairs applied locally on certain spots that were in need of immediate care were not successful.

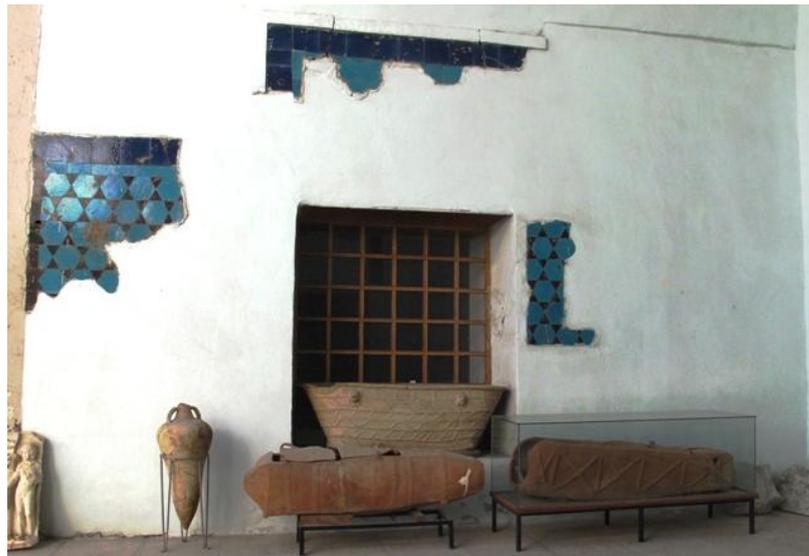
Figure 2.6 Left wall of main eyvan. Plain ceramic tiles were mostly lost (2011).

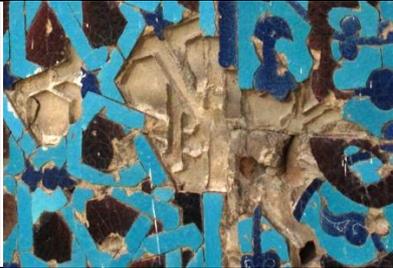
Materials	Deterioration Forms	Definitions	Photographs
Tiles	Deteriorations of tile, glaze and mortar	Detachment of tiles from adhesive tile mortar

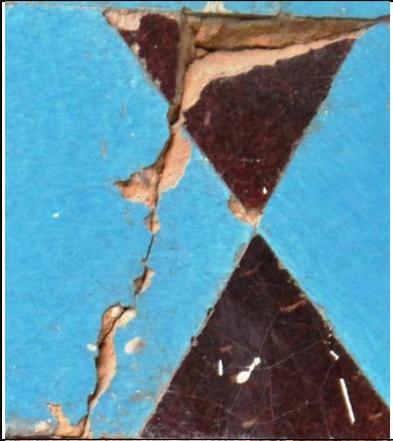
Structural Materials	<p>Deterioration of brick and mortar behind the tiles</p> <p>Loss of bricks could be detected in TGM together with crumbling bricks, but it could not be detected in SGM.</p>	Loss of bricks behind tiles

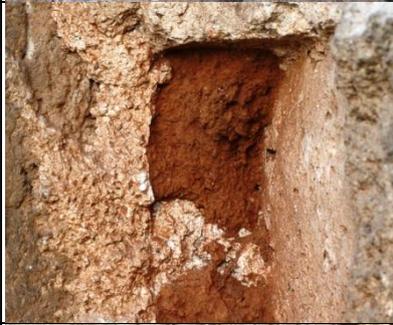
<p>Crumbling bricks together with its loss could be observed in window frame of SGM. They could also be observed in eyvan walls of TGM.</p>	Crumbling and loss of bricks

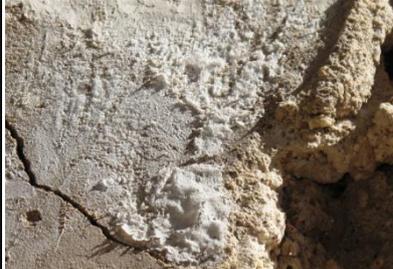
<p>Efflorescence was clearly seen on the walls of SGM.</p>	Efflorescence

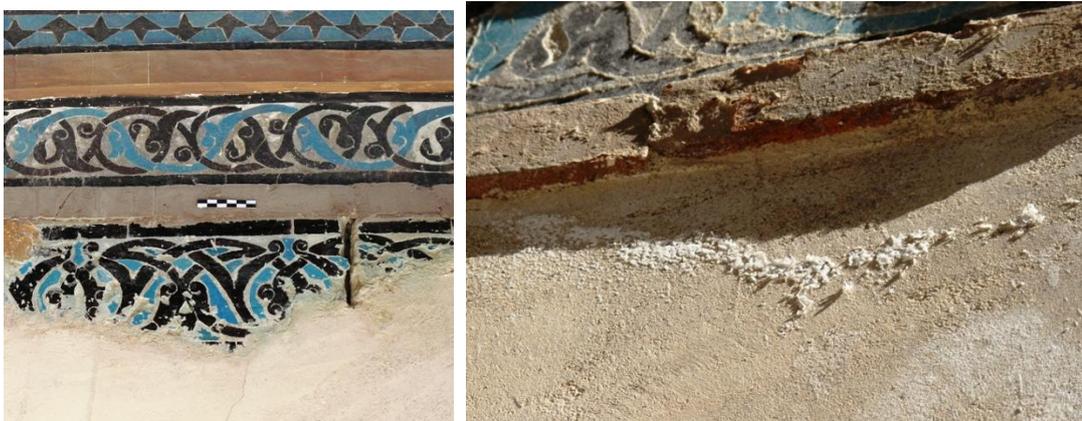
Figure 3.1 North Eyvan wall and dome. New restoration material was in contact with the original tiles and florescence was seen

It has been under restoration, but the studies were given up because of the winter (Figure 2.2 and Figure 2.3). Only some site conservation studies around the monument were still going on. In the medrese, the missing parts next to the original in-situ tiles were covered with imitation tiles as new restoration materials. Therefore, it was difficult to observe the deteriorations on the original tiles. The original tiles were surrounded with new restoration materials and imitation tiles are shown in the figures. The new restoration materials were in contact with the original tiles in Figure 3.1. Figure 3.2 showed the painted imitation tiles which were detached. The painted imitation tiles and the original ones were difficult to differentiate by eye. Although they were new, their deterioration has started.

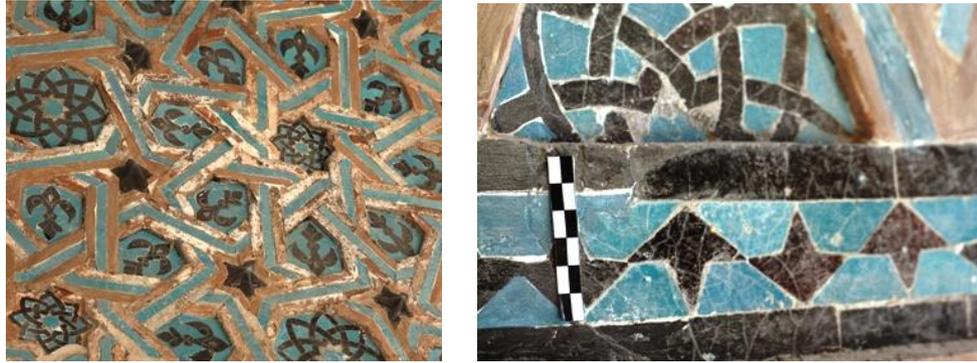
Figure 3.2 North Eyvan wall and dome. Painted imitation tiles were detached and the original ones were not differentiated by eye.

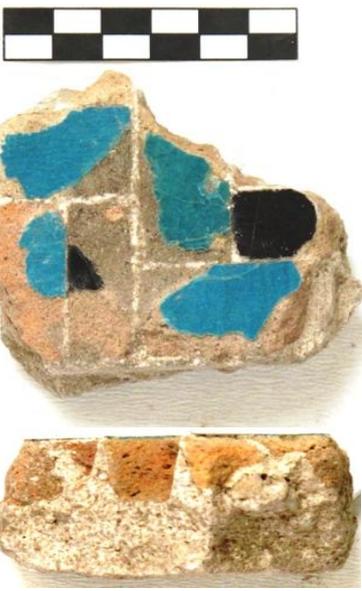
STM1	The thickness of the tile body was between 1-1.5 cm and the thickness of the mortar was between 1.7-2.1 cm.

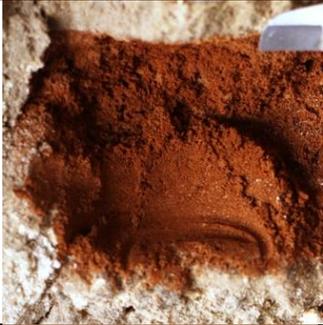
Salt	SS5	South Eyvan, 1 st Wall, Height: 125-140cm	
	SS6	South Eyvan, 1 st Wall, Height: 110-125cm	
	SS7	South Eyvan, 1 st Wall, Height: 200-215cm	
	SS8	South Eyvan, 1 st Wall, Height: 150-200 cm	
Brick	SBr2	South Eyvan, 1 st Wall, Interior side of window frame. It was in powdered form.

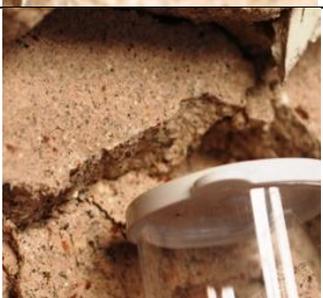
SRM2	North Eyvan, 1 st Wall, Interior side of window frame. It was behind the SRM1.

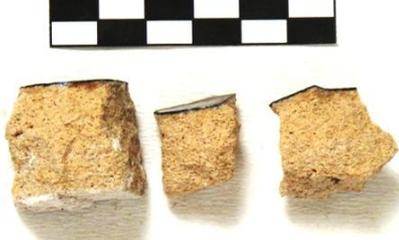
TB3	Eggplant purple colored tile body fragments having the thickness were between 1,9-2,3 cm

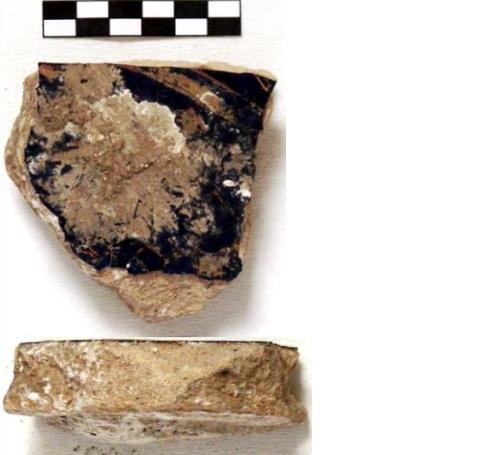
<p>TB6 TTM1</p>	<p>Black colored tile fragment and its mortar. The thickness of tile body was between 1.5-1.6 cm. Also the thickness of mortar was between 1.6-1.8 cm. There were glaze cracks on the surface.</p>

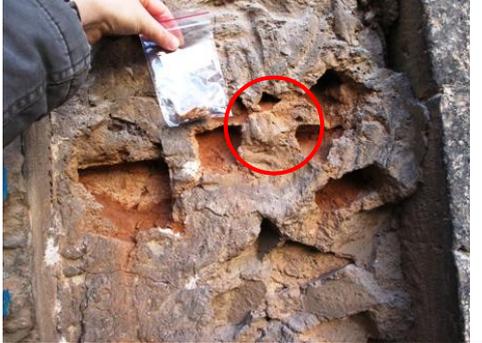
Sample Codes	Description	Photographs
TM1	Mortar sample from the left side of the façade of the main eyvan. It was taken at the height of 130 cm. There were powdered bricks behind the mortar.

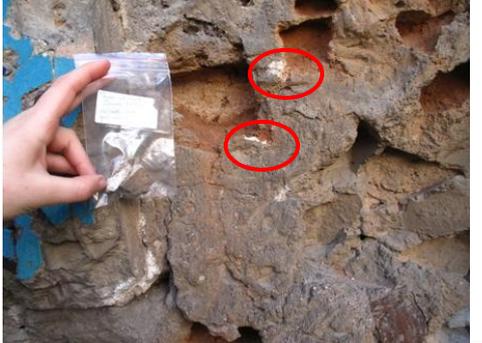
TM2	Mortar sample from the left side of the façade of the main eyvan. It was taken at the height of ~120-125 cm. There were powdered bricks behind the mortar.

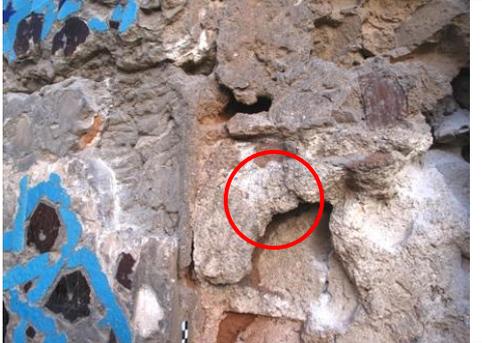
TM3	Mortar sample from the left side of the façade of the main eyvan. It was taken at the height of ~100 cm. There were powdered bricks behind the mortar.

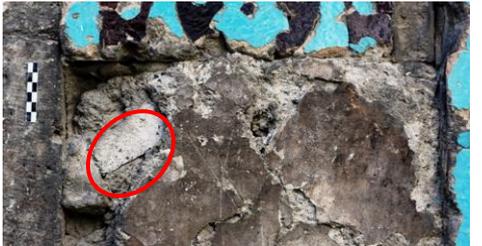
TM4	Mortar with a thin layer of plaster sample from the right side of the façade of the main eyvan. It was taken at the height of ~100 cm. It was applied to the bed of lost tile block.

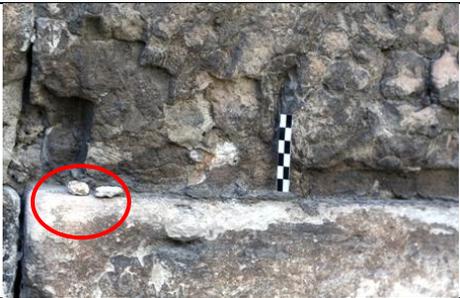
<p>TBr1</p>	<p>Brick sample from the left side of the façade of the main eyvan. It was taken at the height of ~105 cm. It was on TM3.</p>

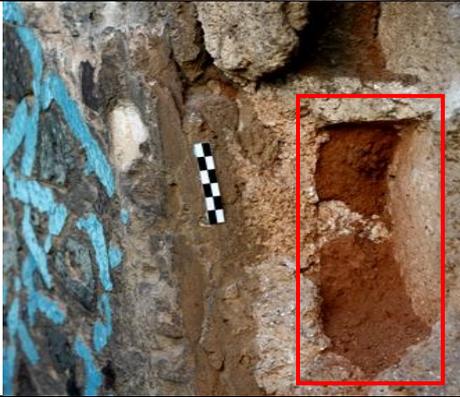
<p>TBr2</p>	<p>Powdered brick sample from the left side of the façade of the main eyvan. It was taken at the height of ~95 cm. It was behind TM3.</p>

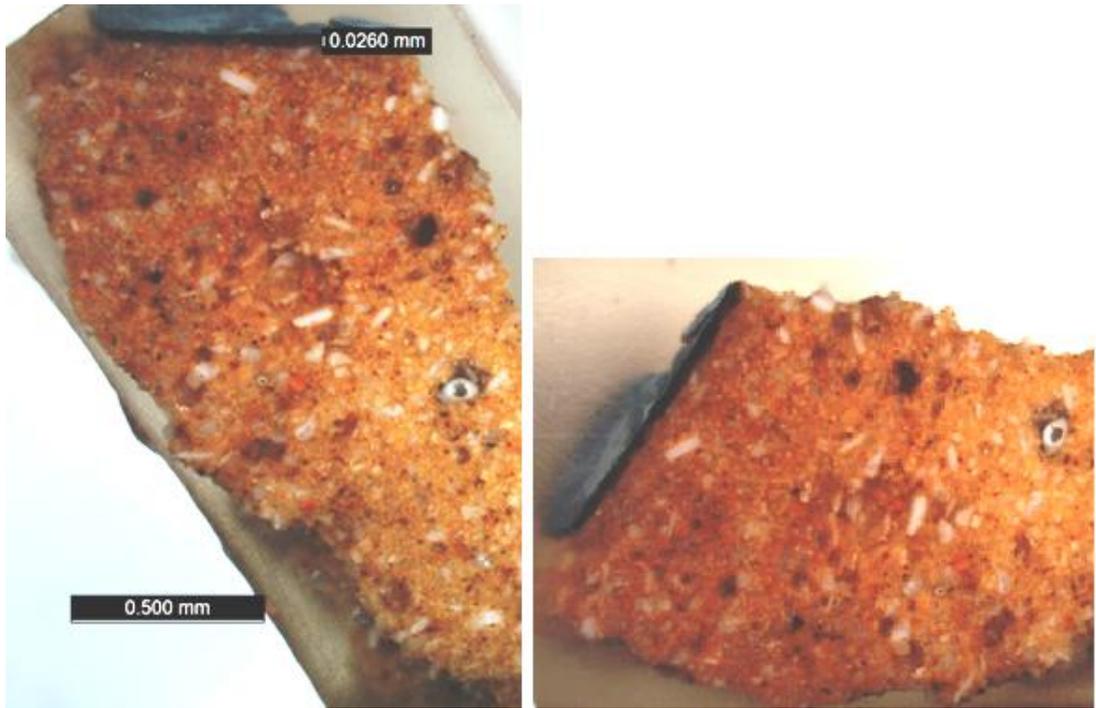
Figure 4.14 Tokat Gök Medrese tile body and its eggplant purple glaze. The thickness was 0.026 mm
