CONSERVATION OF RURAL ARCHITECTURAL HERITAGE AS PART OF
HISTORIC RURAL LANDSCAPES: PRINCIPLES AND STRATEGIES FOR
ZEYTİNLİKÖY-AGIOS THEODOROS (GÖKÇEADA)

A THESIS SUBMITTED TO
THE GRADUATE SCHOOL OF NATURAL AND APPLIED SCIENCES
OF
MIDDLE EAST TECHNICAL UNIVERSITY

NOVEMBER 2019

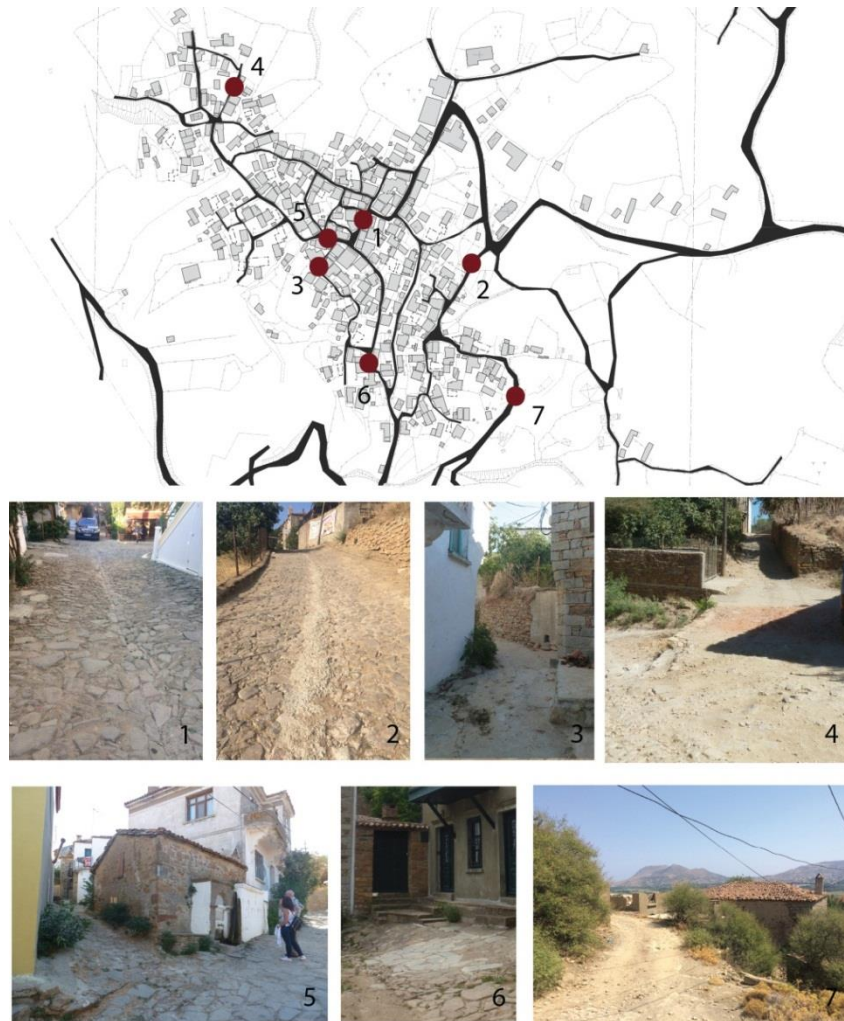
Figure 47: Zeytinliköy, street pavements: (1) original stone street pavement; (2 and 3) cement-based interventions to the original pavement; (4) destructions; (5 and 6) later, additional stone pavements; (7) an earth pathway

The original street pavement used stone and those streets usually have a slight incline towards the center for water drainage. Today such pavements can still be seen, despite much destruction and interventions, such as the addition of new unsuitable stone pavements and cement-based repairs.

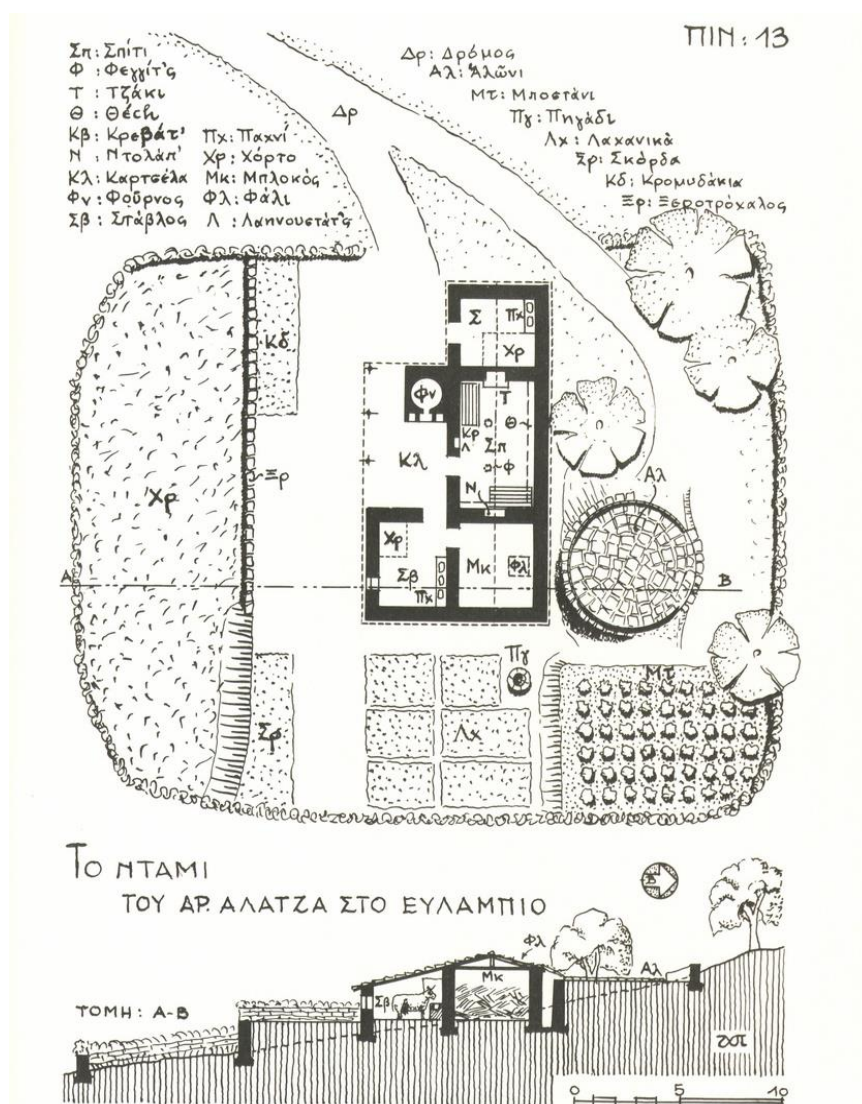
Figure 73: Zeytinliköy, space organization of a *dam* (Pasadeos 1973, appendix ΠΙΝ:13)

with stone and the area surrounded by vertically placed stones to retain the crop being processed.¹⁵⁴ The *dams* commonly have courtyards surrounded by stone walls where the small cattle are kept. An oven in the area is also common. Today, as a result of the change in economic activities, they are no longer used and the majority of these structures are in ruin, and not easily accessible.

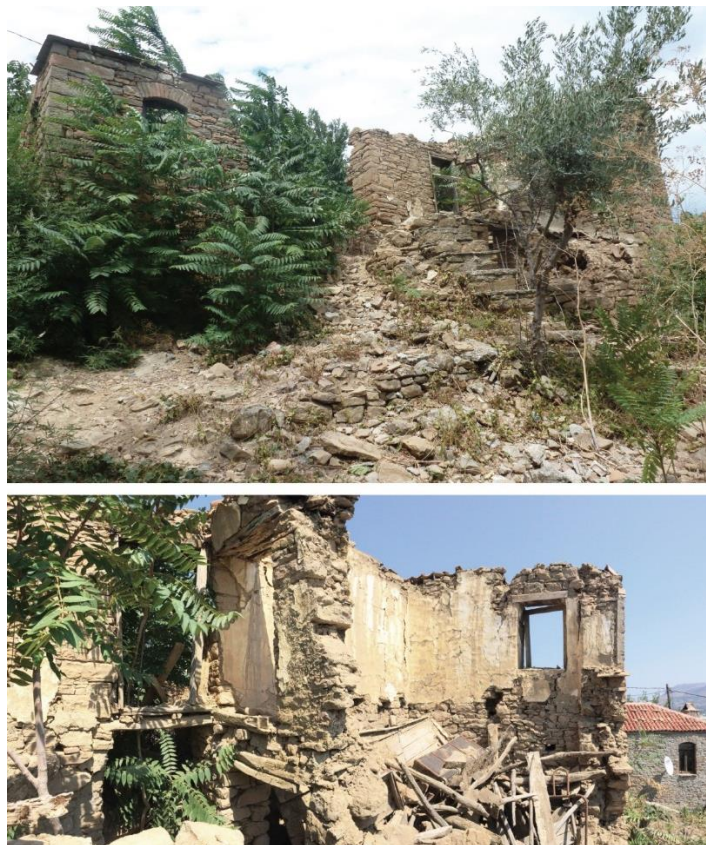
Figure 81: Zeytinliköy, example of a double-house now in ruins

The first building category, made of stone and their variations, are today difficult to find. They are either in ruins, slowly waiting to disappear, or have undergone significant interventions and are no longer distinguishable (**Figure 81**).

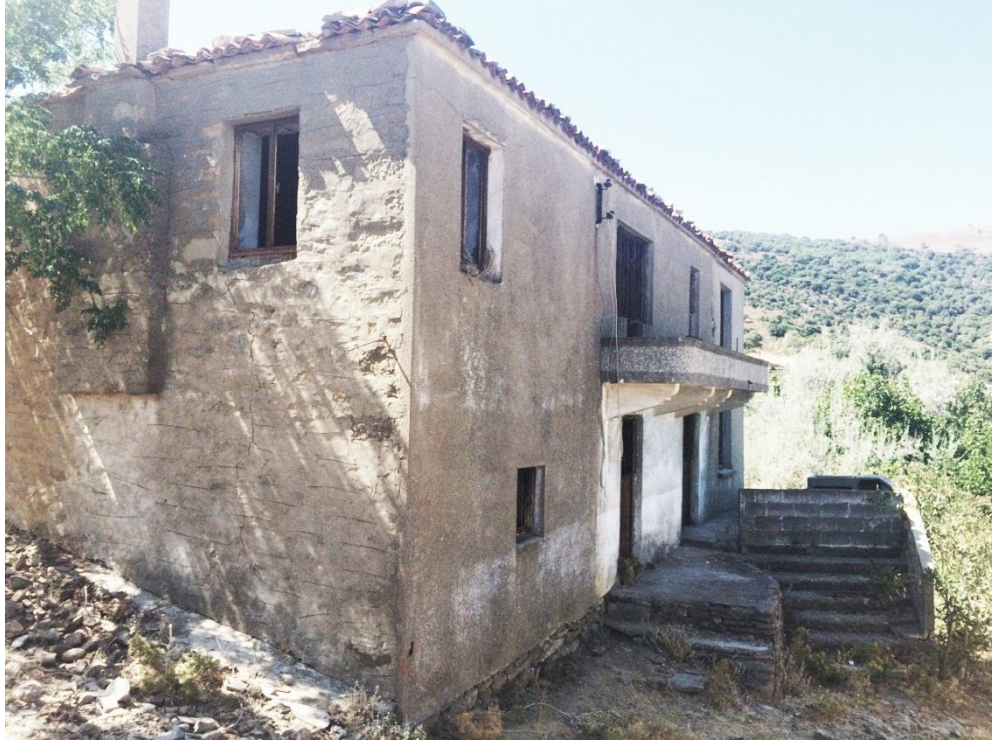
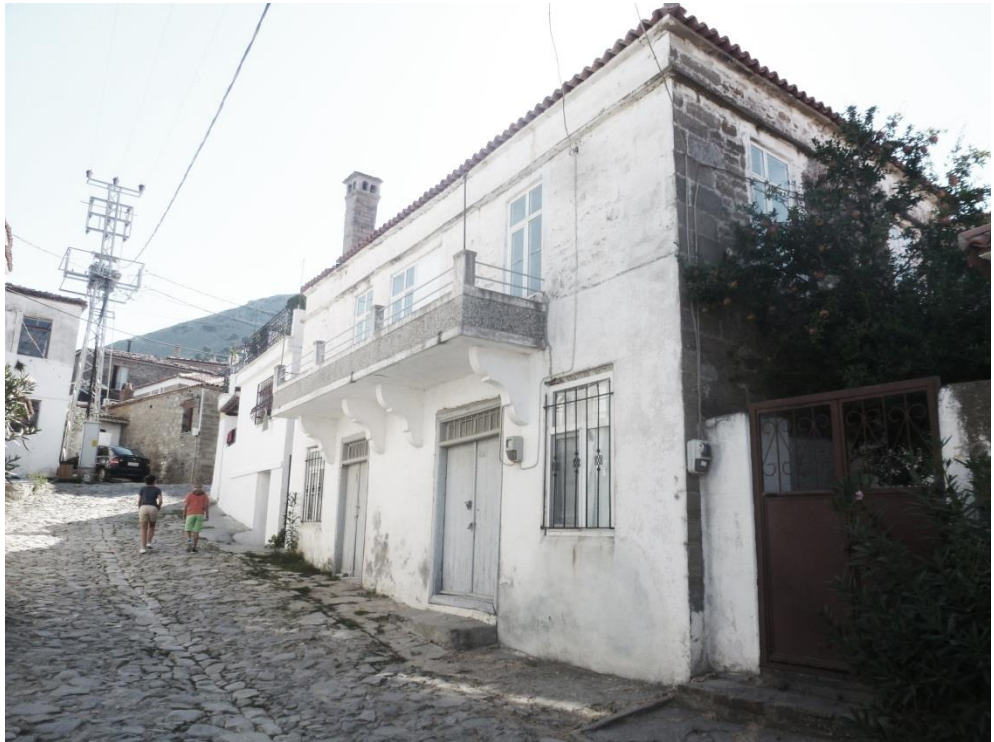
Figure 88: Zeytinliköy, double hybrid-type examples

mostly seen with this house type, there are also variations, i.e. the double-house shown in THS 17 and 18, where the two dwelling units share the same balcony, divided by a party wall (**Figure 88**).

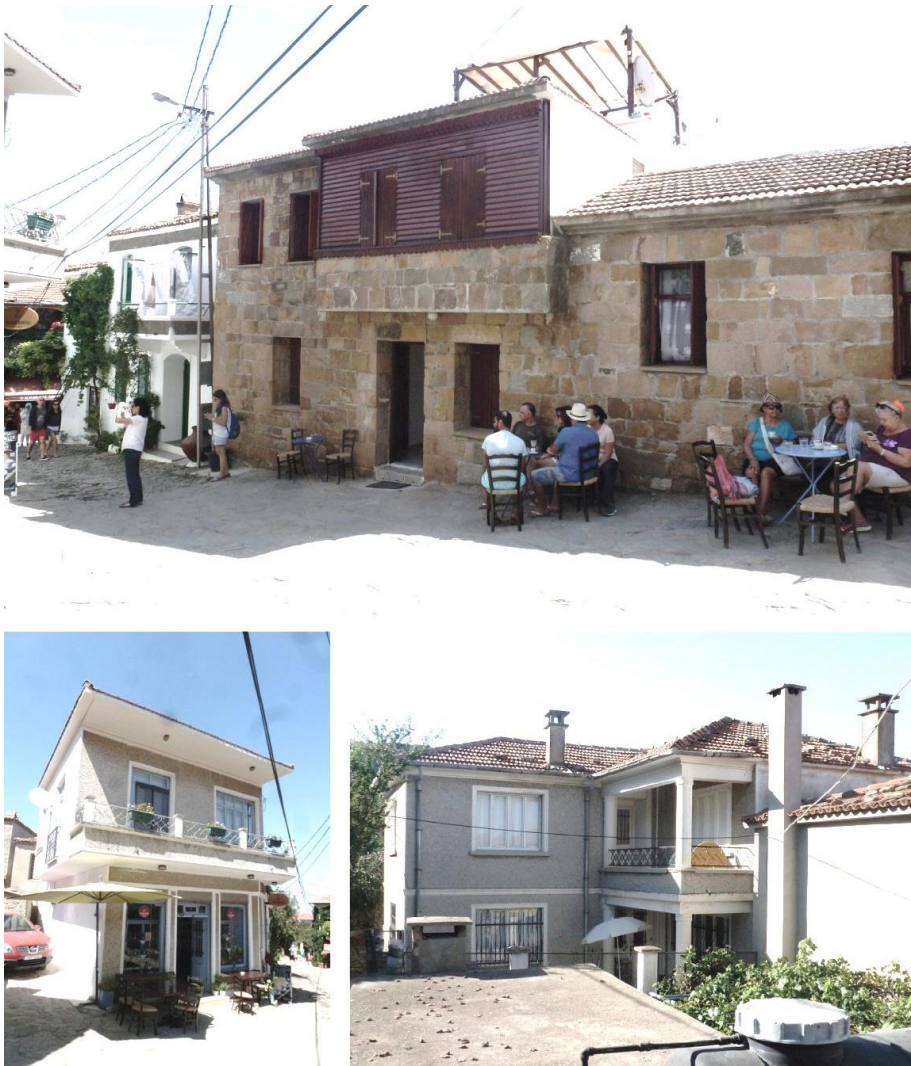
Figure 92: Zeytinliköy, ill-conceived reconstructions (above) and new buildings (below)

Although they differ in number, and it is difficult to notice former examples, Pasadeos' first four types can still be seen today. However, it is important to record the hybrid-type continuously built by local inhabitants around the 1950s. In addition to the types mentioned above, there are also new examples that differ from the local architecture. These also be divided into two groups: various stone reconstructions that are hard to classify in any type; and new constructions with totally reinforced concrete systems (Figure 92).

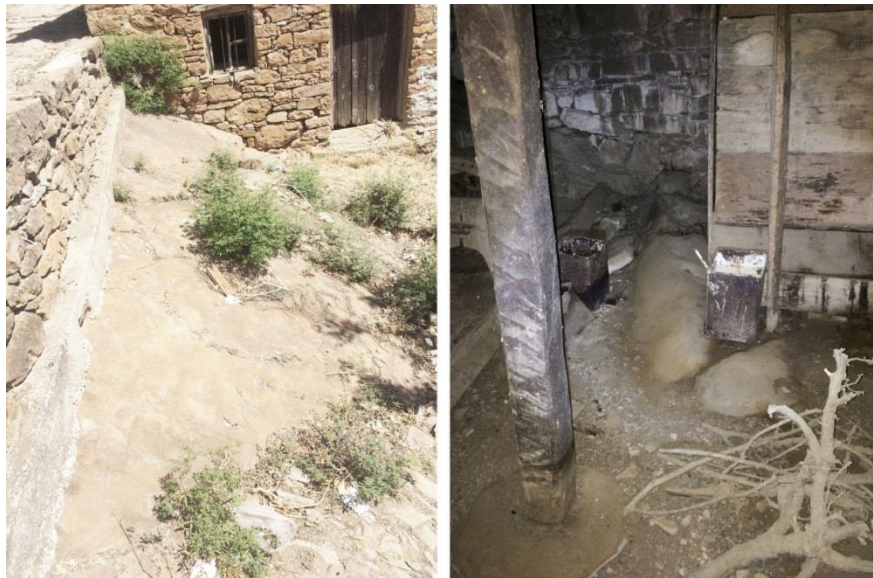
Figure 93: Zeytinliköy, the bedrock of TH9

The traditional buildings of Gökçeada are built on earth foundations and (mostly) bedrock. The island has suffered two serious earthquakes (magnitude 6 in 1917 and 6.5 in 2014), but as the settlements are on the slopes of rocky hills and the buildings placed on appropriate foundations, most of the traditional houses were rescued without serious damage. As noted by SP3, the foundations of the houses are usually 70-80 cm thick, down through the solid earth or bedrock. Below some earth-covered ground floors it is still possible to see actual bedrock (**Figure 93**).

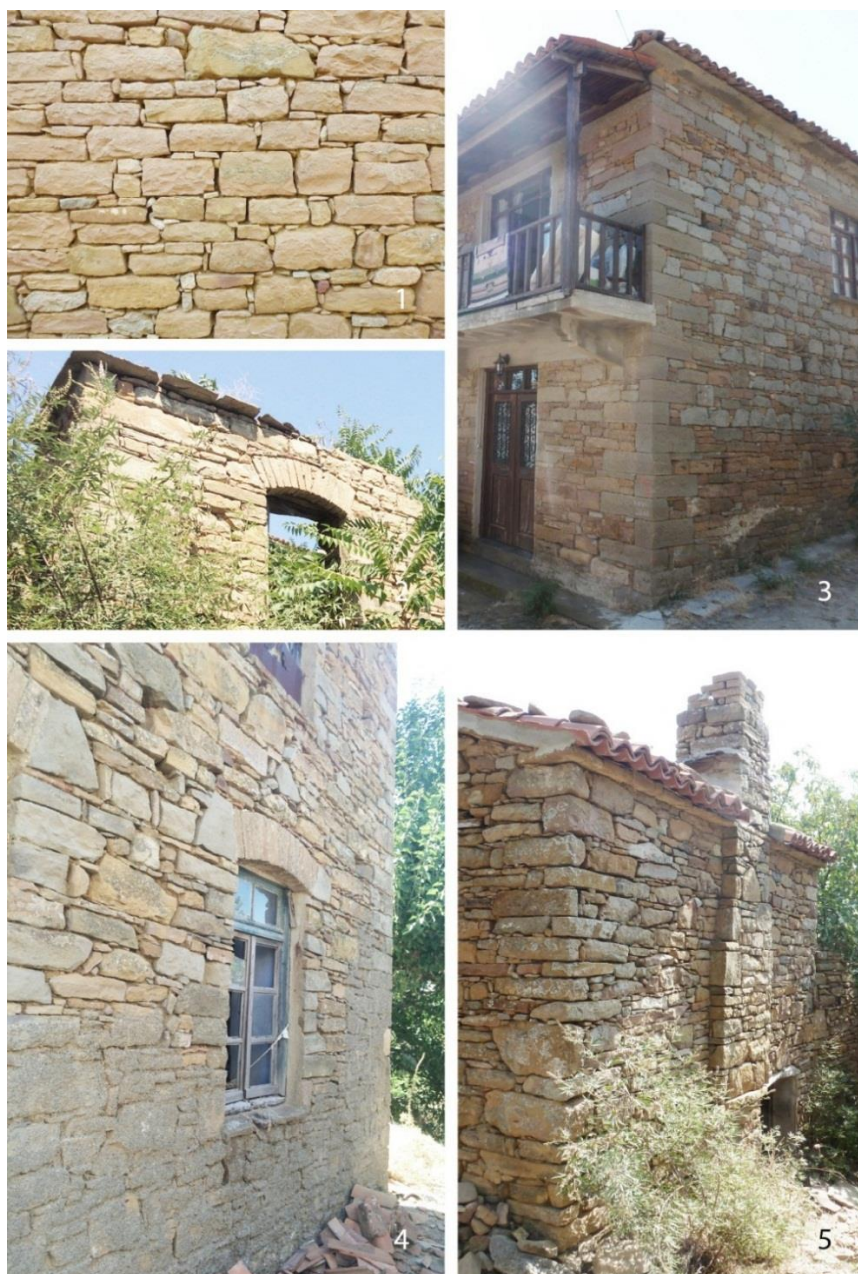
Figure 94: Zeytinliköy, stone masonry details: (1) masonry technique; (2) wall and window end details; (3) cornerstones; (4) stone masonry and window opening; (5) chimney detail – *kremasti*

walls are constructed using the dry wall technique – the positioning of the small (header) and larger (stretcher) stones together plays a key role in the final resilience of the building and reveals the skills of the masons.

The stone masonry technique that can be seen in the village can be defined as ‘irregular’ rectangular stone masonry mixed with rubble (**Figure 94**). Larger and longer cornerstones, which are cut stones of basalt, are used to provide extra stability. Moreover, the stability of the wall is provided by headers placed repeatedly 1 m apart.¹⁸²
