SEISMIC STRENGTHENING OF MASONRY INFILLED R/C FRAMES WITH  
STEEL FIBER REINFORCEMENT

A THESIS SUBMITTED TO  
THE GRADUATE SCHOOL OF NATURAL AND APPLIED SCIENCES  
OF  
MIDDLE EAST TECHNICAL UNIVERSITY

IN PARTIAL FULFILLMENT OF THE REQUIREMENTS  
FOR  
THE DEGREE OF DOCTOR OF PHILOSOPHY  
IN  
CIVIL ENGINEERING

FEBRUARY 2010

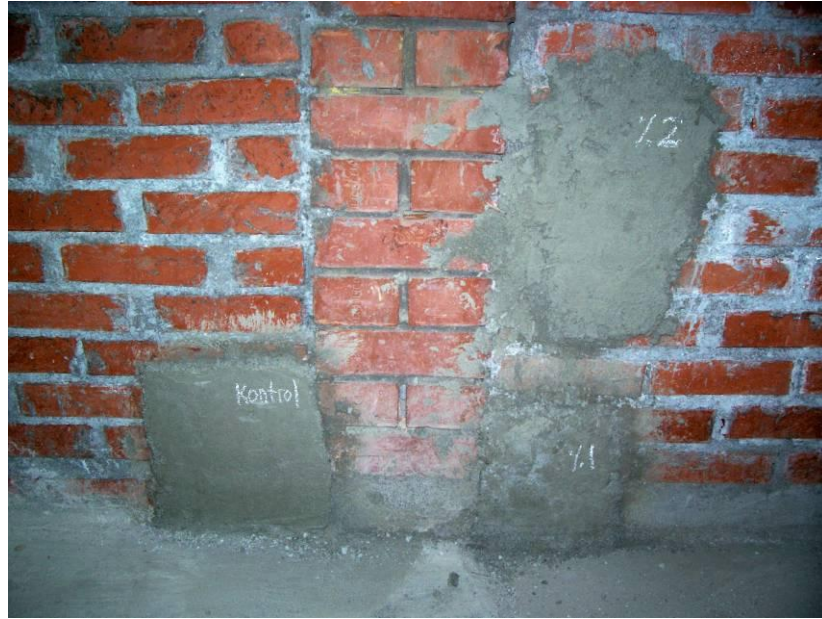
Mortar having 20 mm thickness was applied on a wall with no steel fibers as reference and mortars having 1%, 2%, and 4% volume contents of steel fibers (**Figure 3.1**). The mortar should stick to the wall when it is thrown to the wall by using a trowel. The reference mortar stuck to the wall easily. However, in the 4% volume content case the mortar did not stick to the wall, and in the 1% and 2% volume contents cases the mortar could hardly be fixed to the wall. Consequently; reference, 1%, and 2% steel fiber contents were selected to be used for the tests.

**Figure 3.1** Applications of Mortars on Wall

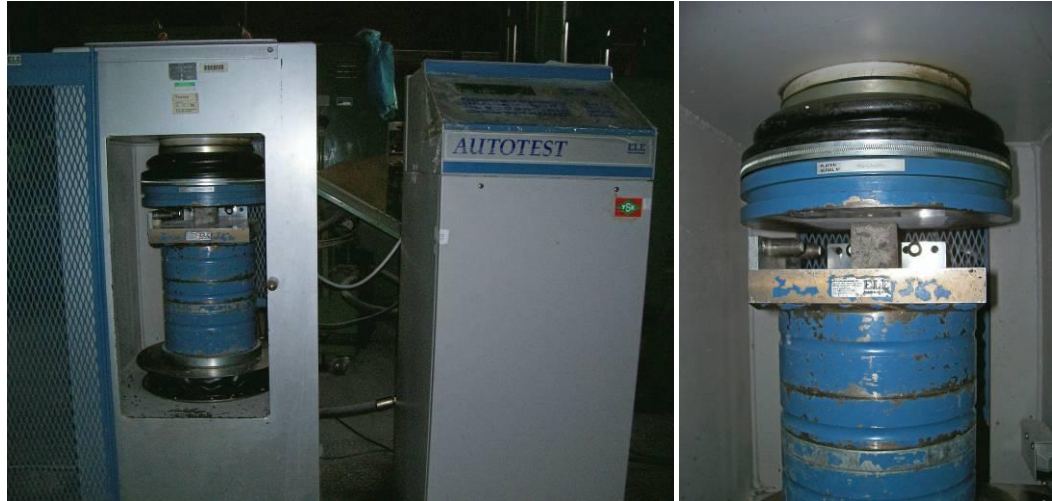
Specimens were taken out from steel forms the next day and were put in saturated lime water at  $23.0 \pm 2.0$  °C. Compressive strength of the cubical mortars were measured at 7 and 28 days. Tests were conducted in accordance with ASTM C 109. A universal testing machine shown in **Figure 3.2** is used for tests.

**Figure 3.2** Views of Compressive Strength Testing

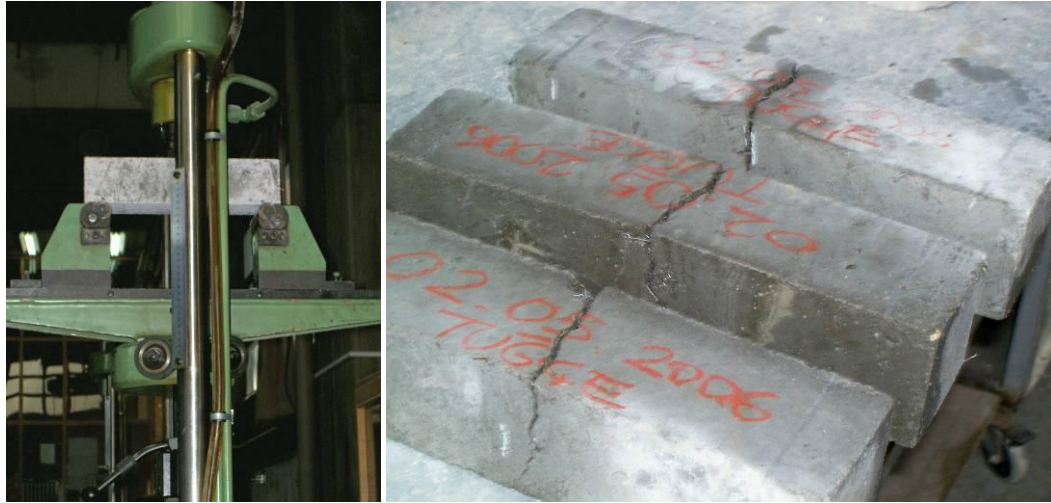
Flexural tensile strength of prismatic specimens having dimensions of 70×70×320mm was measured using a simple beam test with center-point loading at 7 and 28 days. The distance between supports was 260 mm. Although cross-sectional dimensions of the prism should be 70 mm, actually it was measured as 75 mm. Tests were performed according to TS EN 196-1. Views of flexural tensile strength testing are shown in **Figure 3.3**.

**Figure 3.3** Views of Flexural Tensile Strength Testing

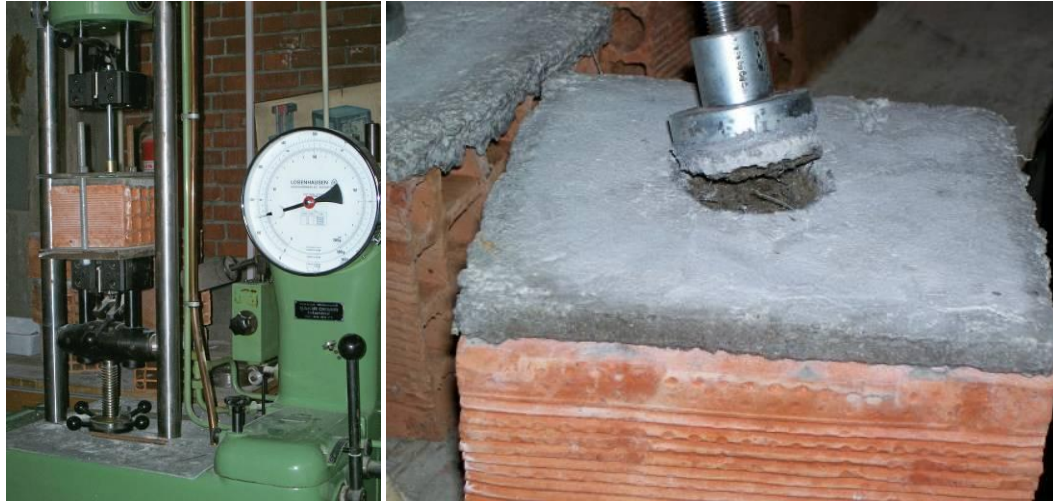
Adhesion strength of the mortars were determined at 28 days. Tests were conducted according to TS EN 1015-12. Views of testing are shown in **Figure 3.4**.

**Figure 3.4** Views of Adhesion Strength Testing

Adhesion strength was calculated by dividing the maximum tensile load to the corresponding loading area. Average adhesion strength is calculated by taking average of adhesion strengths of five specimens for each mortar and rounding this number to the closest 0.1 MPa.

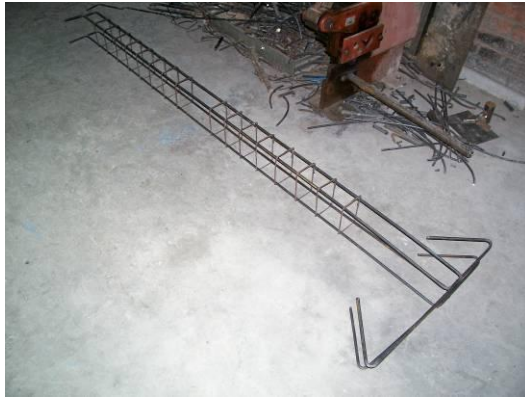
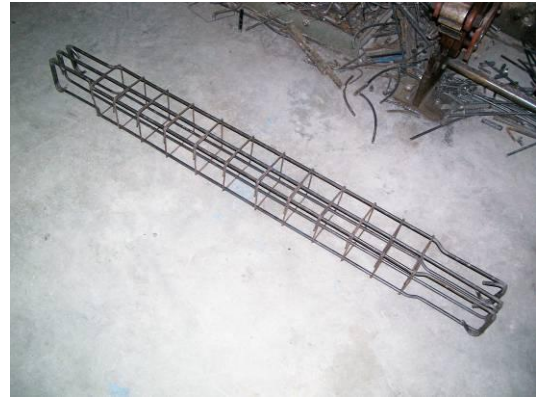
Reinforcement details of the columns and beams are given in **Figure 3.7**. Same reinforcement details were used for all of the test specimens. Reinforcement views of columns and beams are shown in **Figure 3.8**.

View of Column Reinforcement

View of Beam Reinforcement

**Figure 3.8** Reinforcement Views of the Columns and Beams

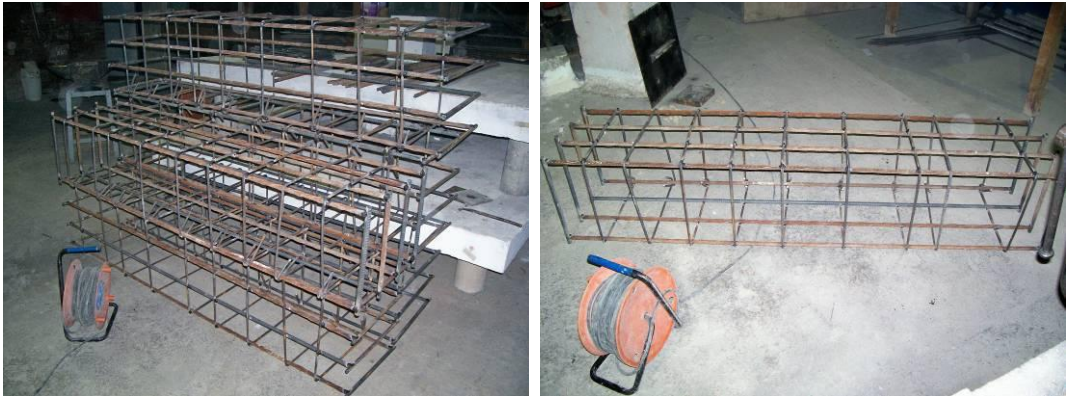
General View of Reinforcements      View of Foundation Beam Reinforcement

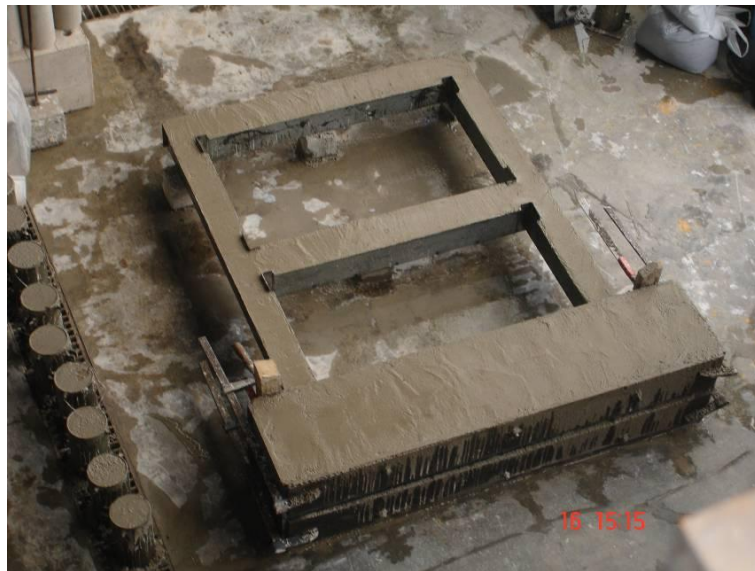
**Figure 3.12** View of Frame Specimen after Concrete Casting

with wet burlap in order to maintain moisture [25]. View after concrete casting is presented in **Figure 3.12**.

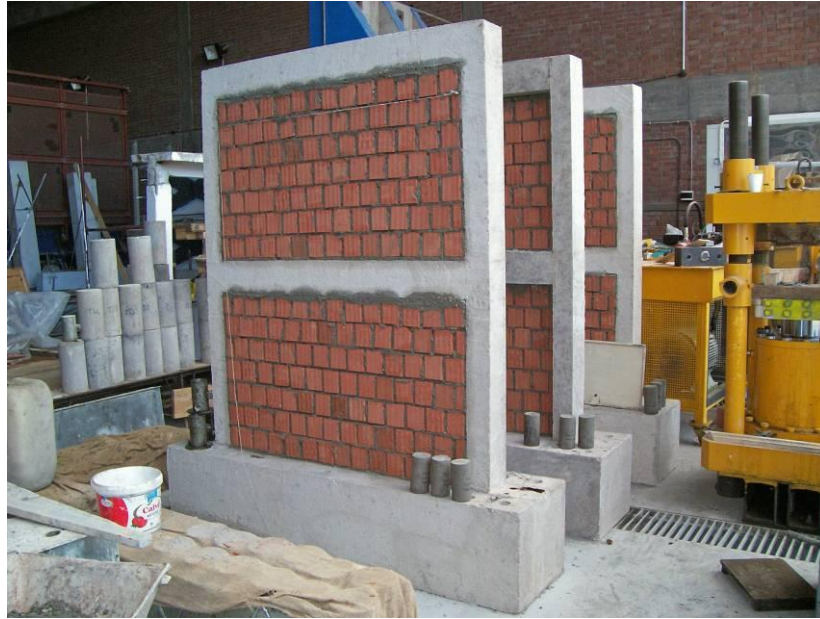
After minimum 7 days of curing, forms were removed and specimens were hold up in vertical position. After preparation of the frame specimens, brick laying operations were completed. On the brick walls, plaster having 6 mm thickness was applied. Brick laying and plastering applications are illustrated in **Figures 3.13** and **3.14**, respectively.

**Figure 3.13** View of Brick Laying Application

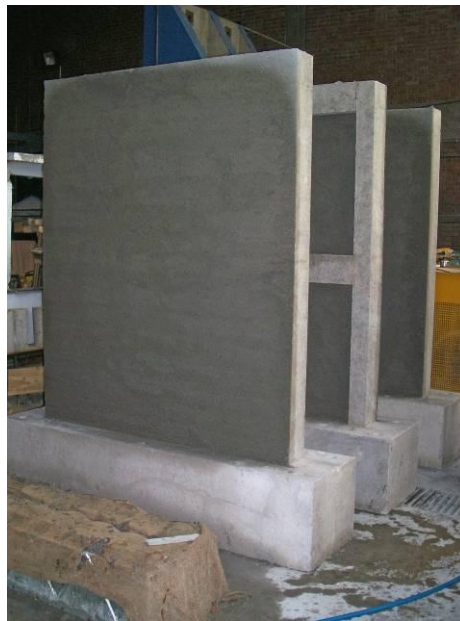
**Figure 3.14** View of Plastering Application

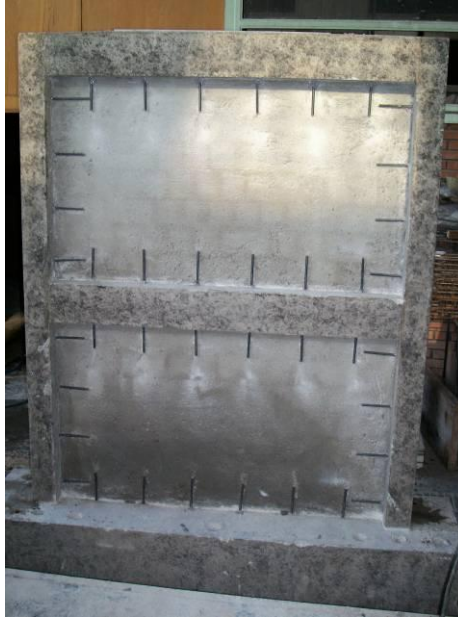
To ensure force transfer between frame and strengthened masonry infill wall, anchorage bars were fixed to the surrounding frame. As anchorage, deformed bars having 180 mm length and 8 mm diameter were used. Bars were placed at 200 mm intervals with 60 mm embedded in to the frame and 120 mm remained outside. Totally 80 anchorage bars were used for one frame.

**Figure 3.15** View of Anchoring Operation

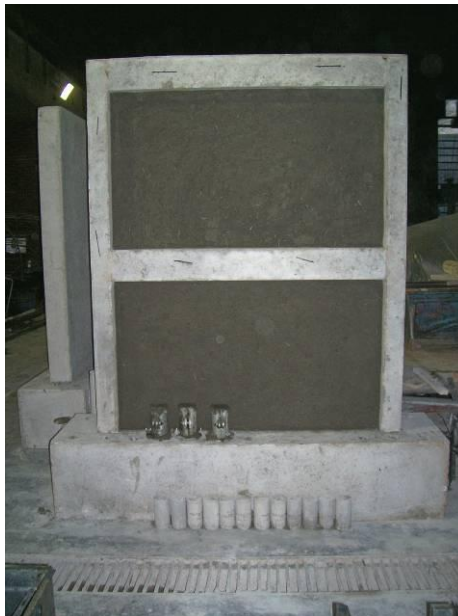
Anchoring of a frame specimen is shown in **Figure 3.15**. Strengthening using mortar with or without fibers is presented in **Figure 3.16**.

**Figure 3.16** View of Strengthening Operation

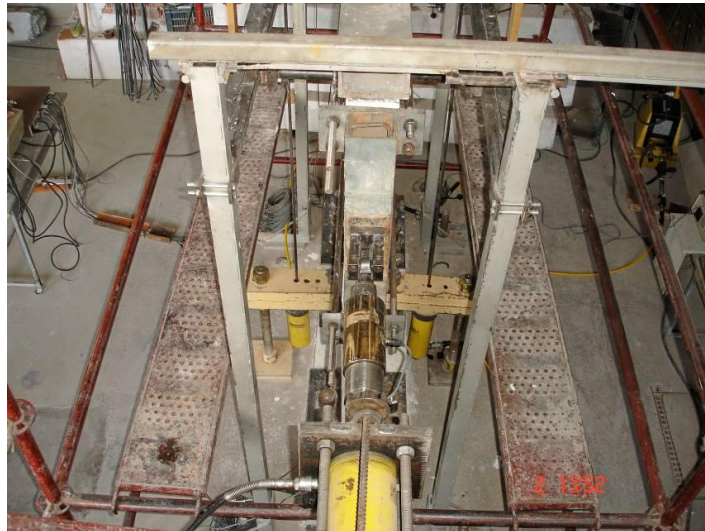
plane movement of the specimen. Four rollers were attached to the box sections, and they touched the test frame beam. For rollers, ball bearings were used since the test frame had to make vertical as well as horizontal displacement [18]. Guide frame and ball bearings are shown in **Figures 3.19** and **3.20**, respectively.

**Figure 3.19** Appearance of Guide Frame

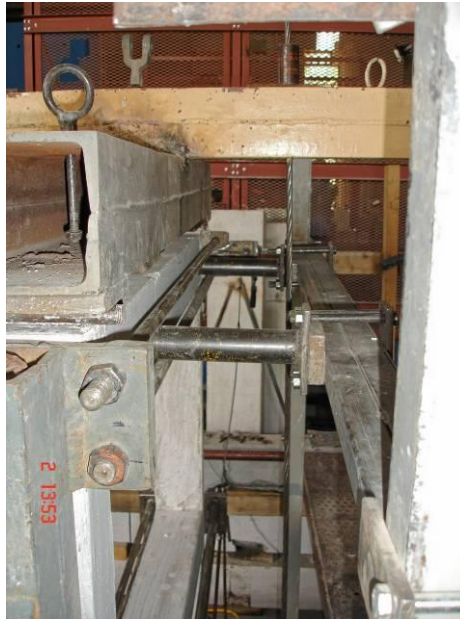
**Figure 3.20** Ball Bearings

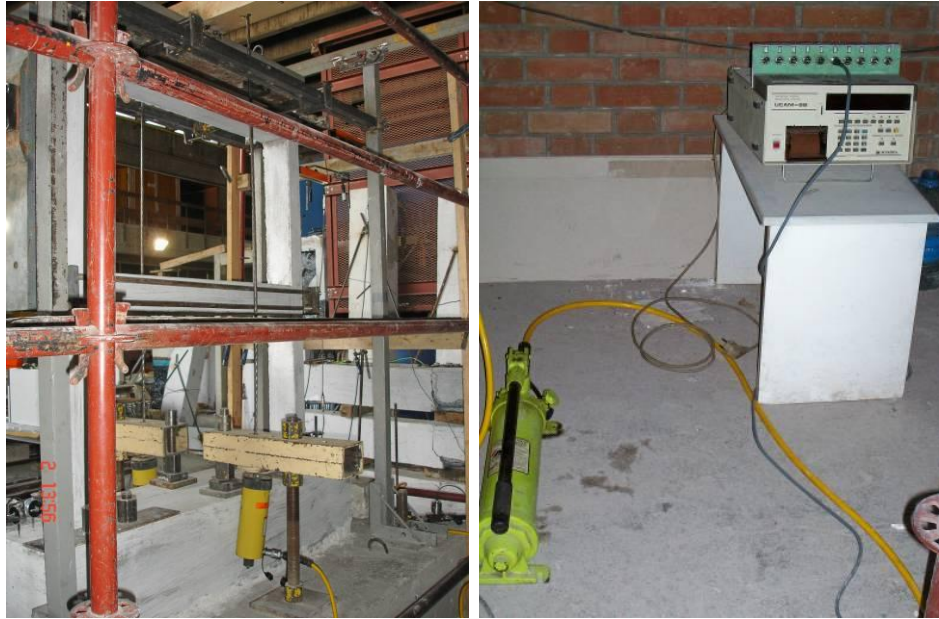
jacks which were placed under the box sections. The other ends of the steel cables were connected to a cross beam which was welded to another spreader steel beam simply supported at the top story columns of the specimens. When the load was applied, the spreader beam divided the load developing in the hydraulic jacks and the steel cables into two equal components and transferred it to the two columns. The load was continuously monitored and readjusted during the test [25].

**Figure 3.22** Application of Axial Load

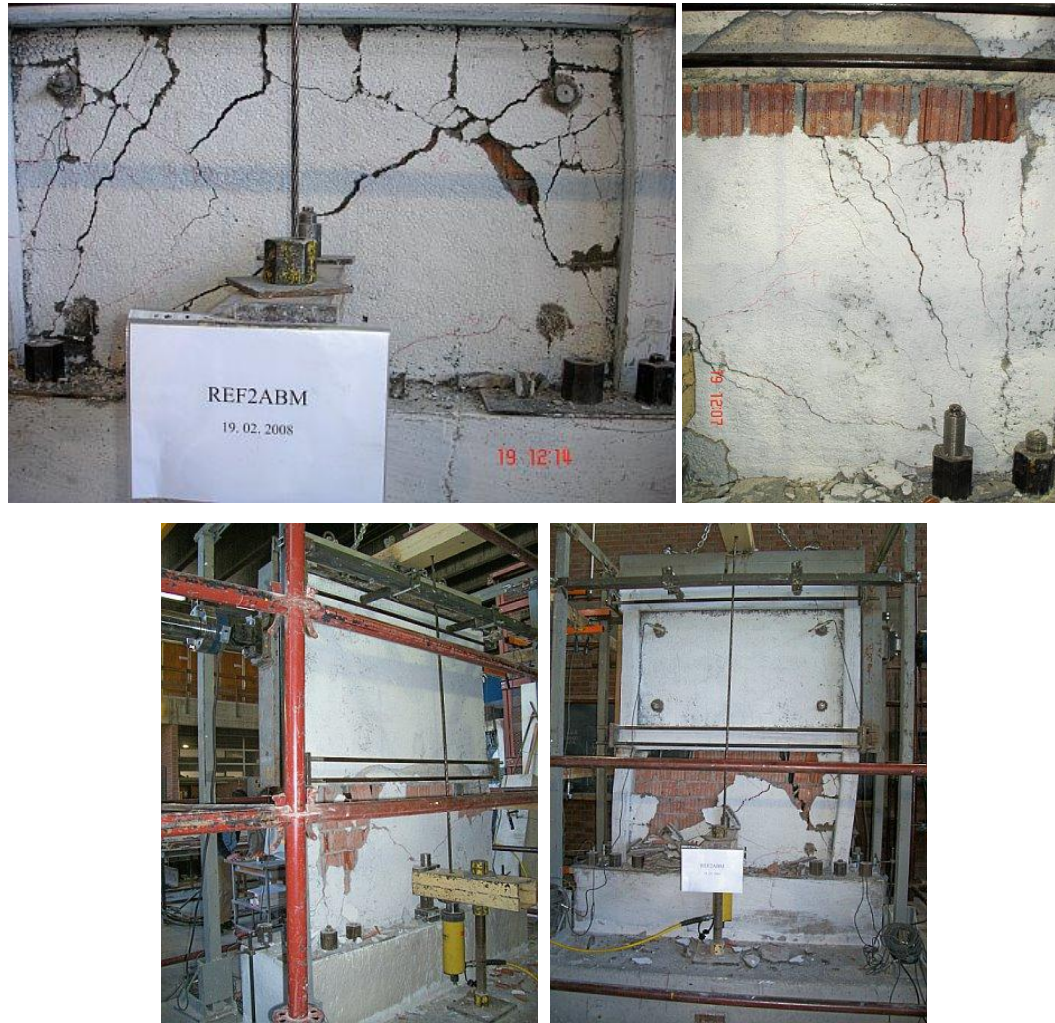
**Figure 4.30** Views of TS7 (REF2ABM) Specimen during the Test

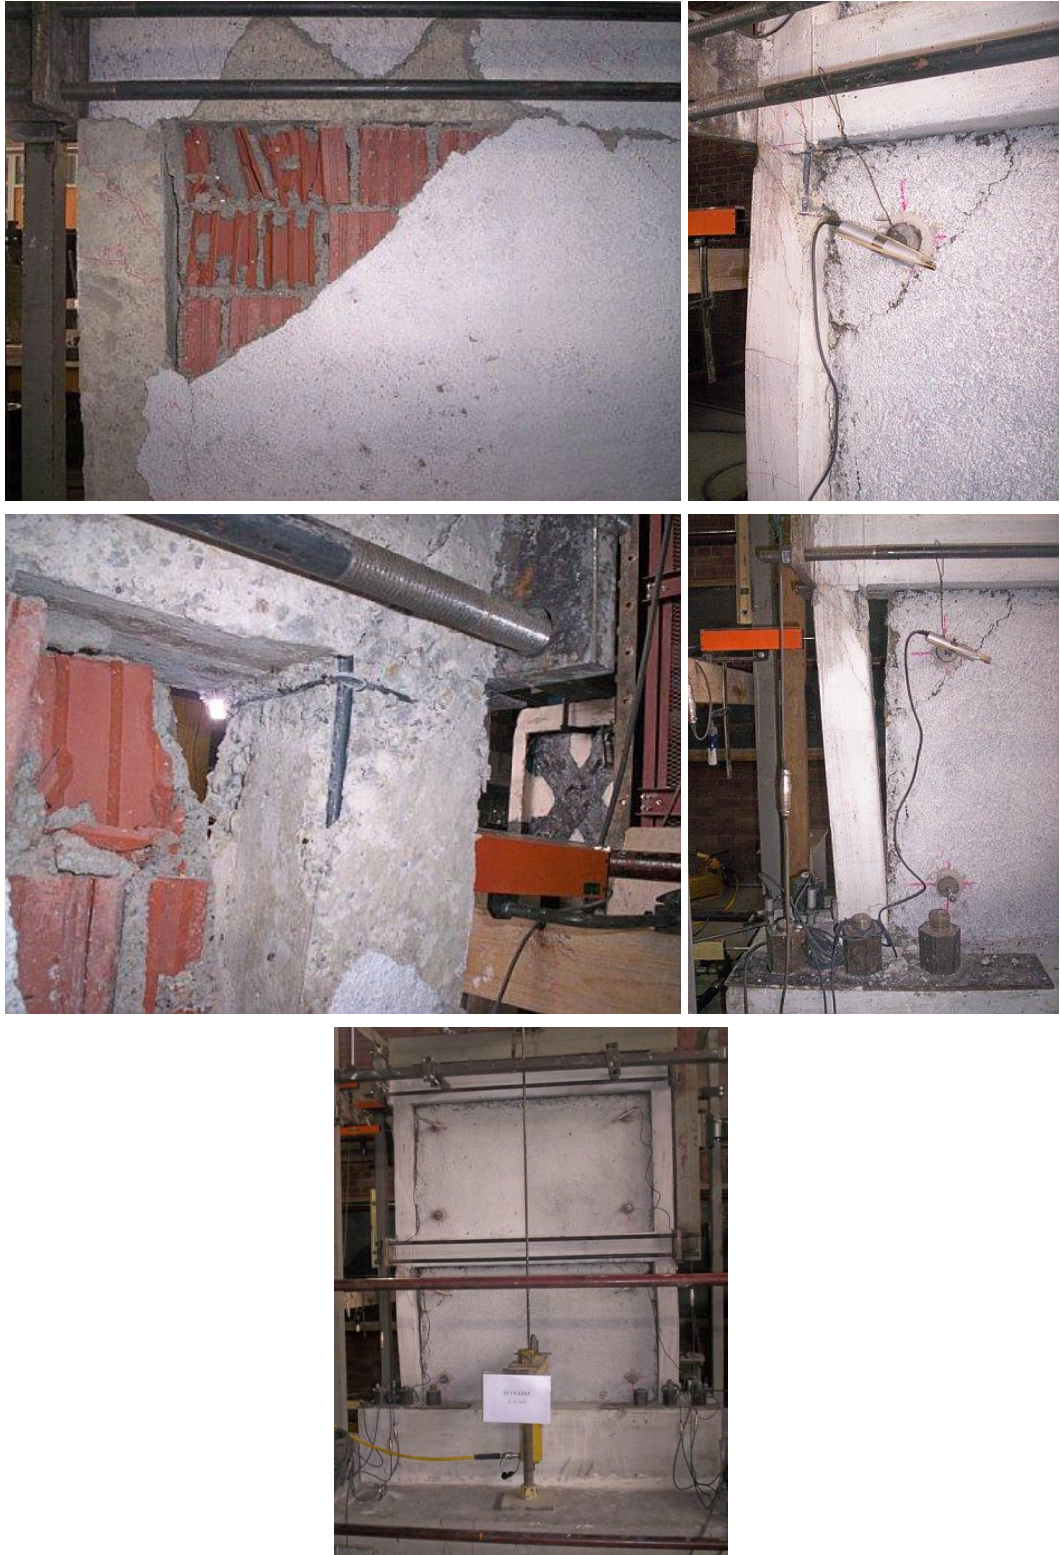
**Figure 4.38** Views of TS9 (SF1NABM) Specimen during the Test

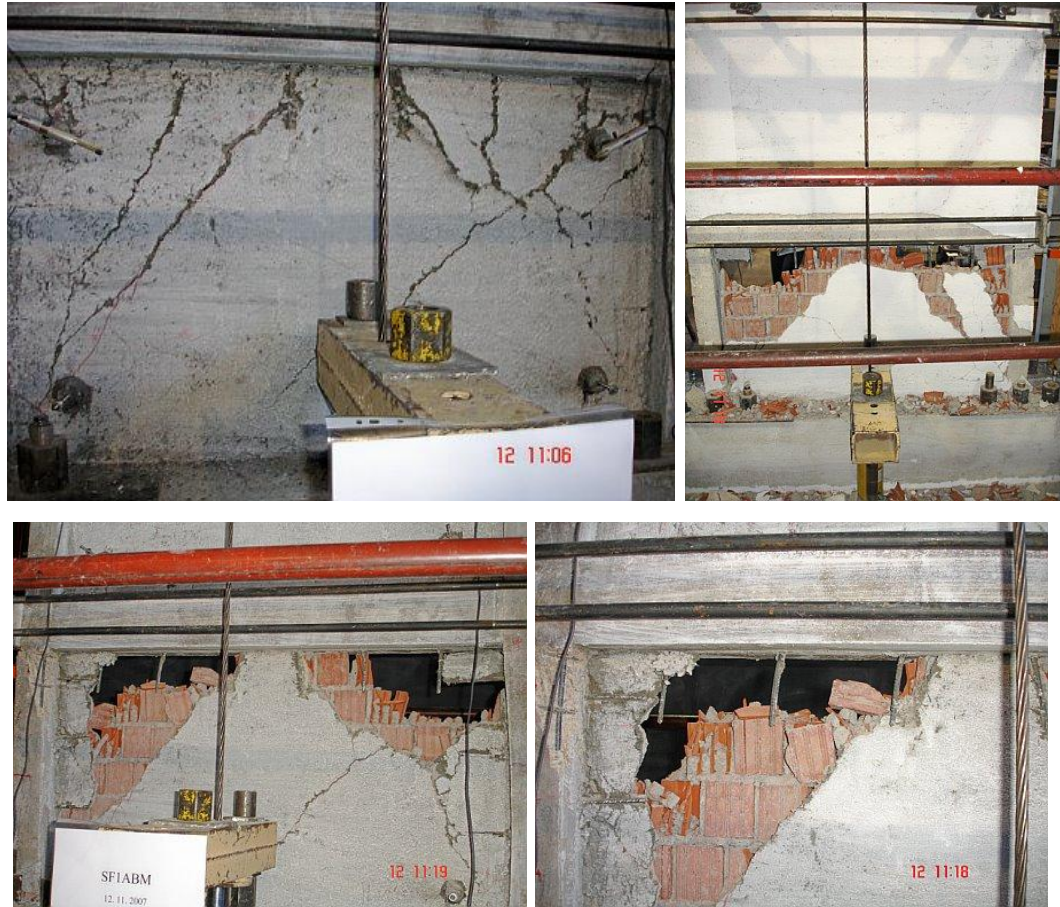
**Figure 4.54** Views of TS3 (SF1ABM) Specimen during the Test

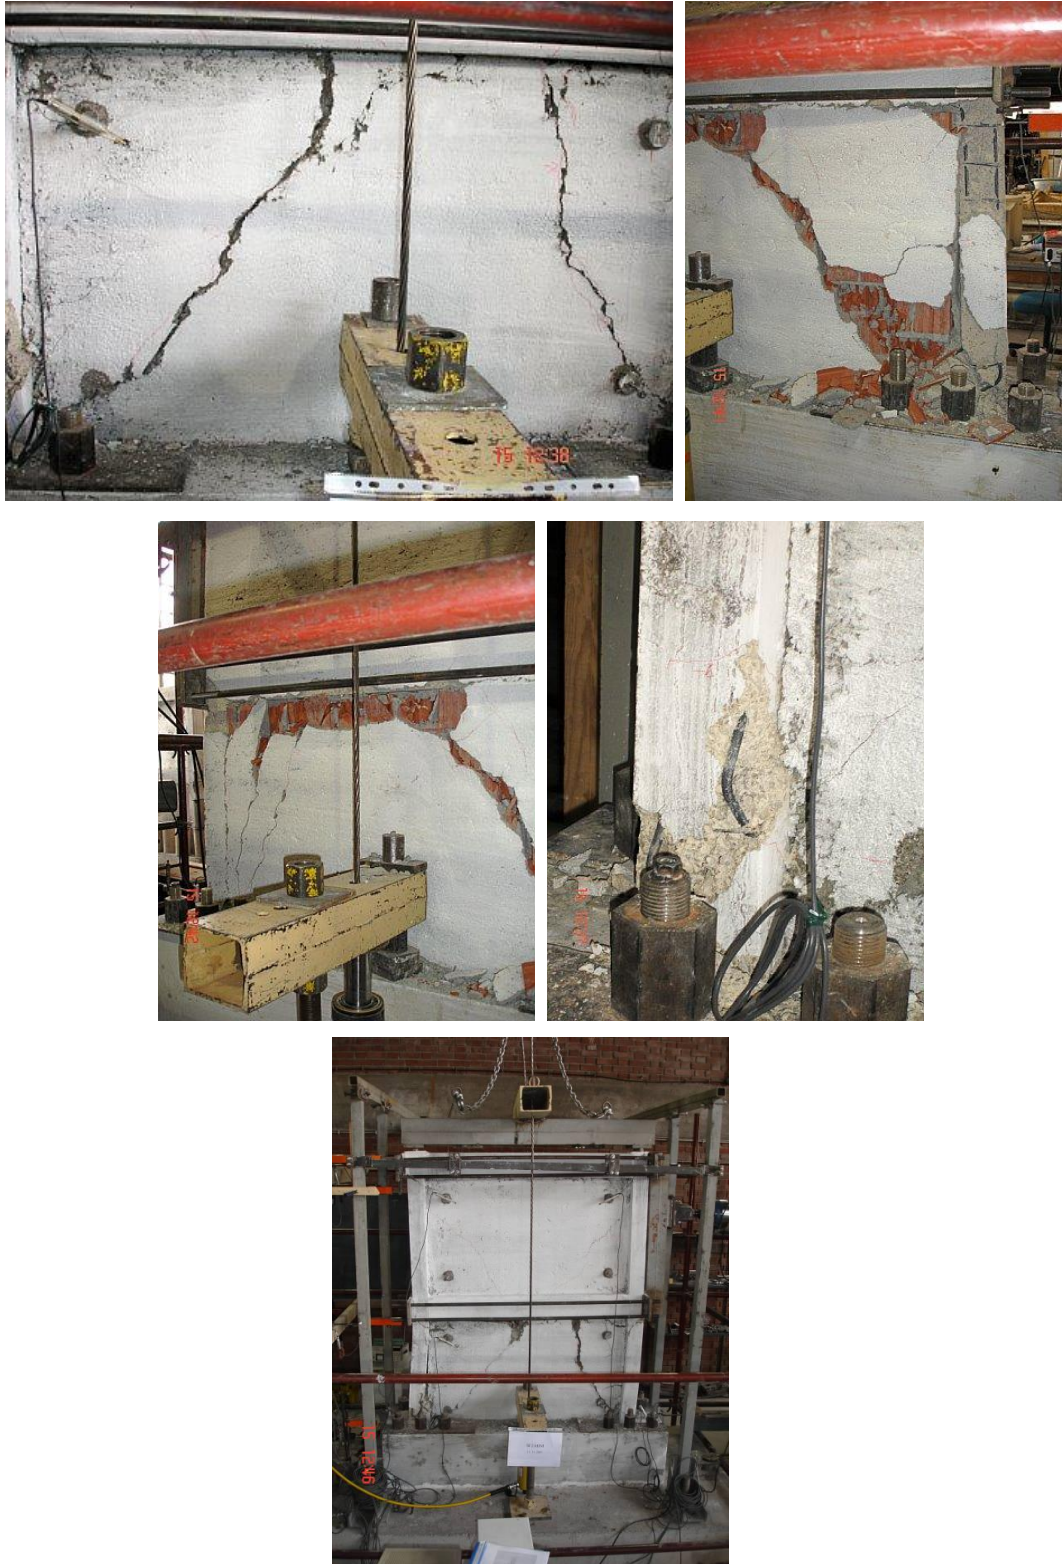
**Figure 4.62** Views of TS4 (SF2ABM) Specimen during the Test

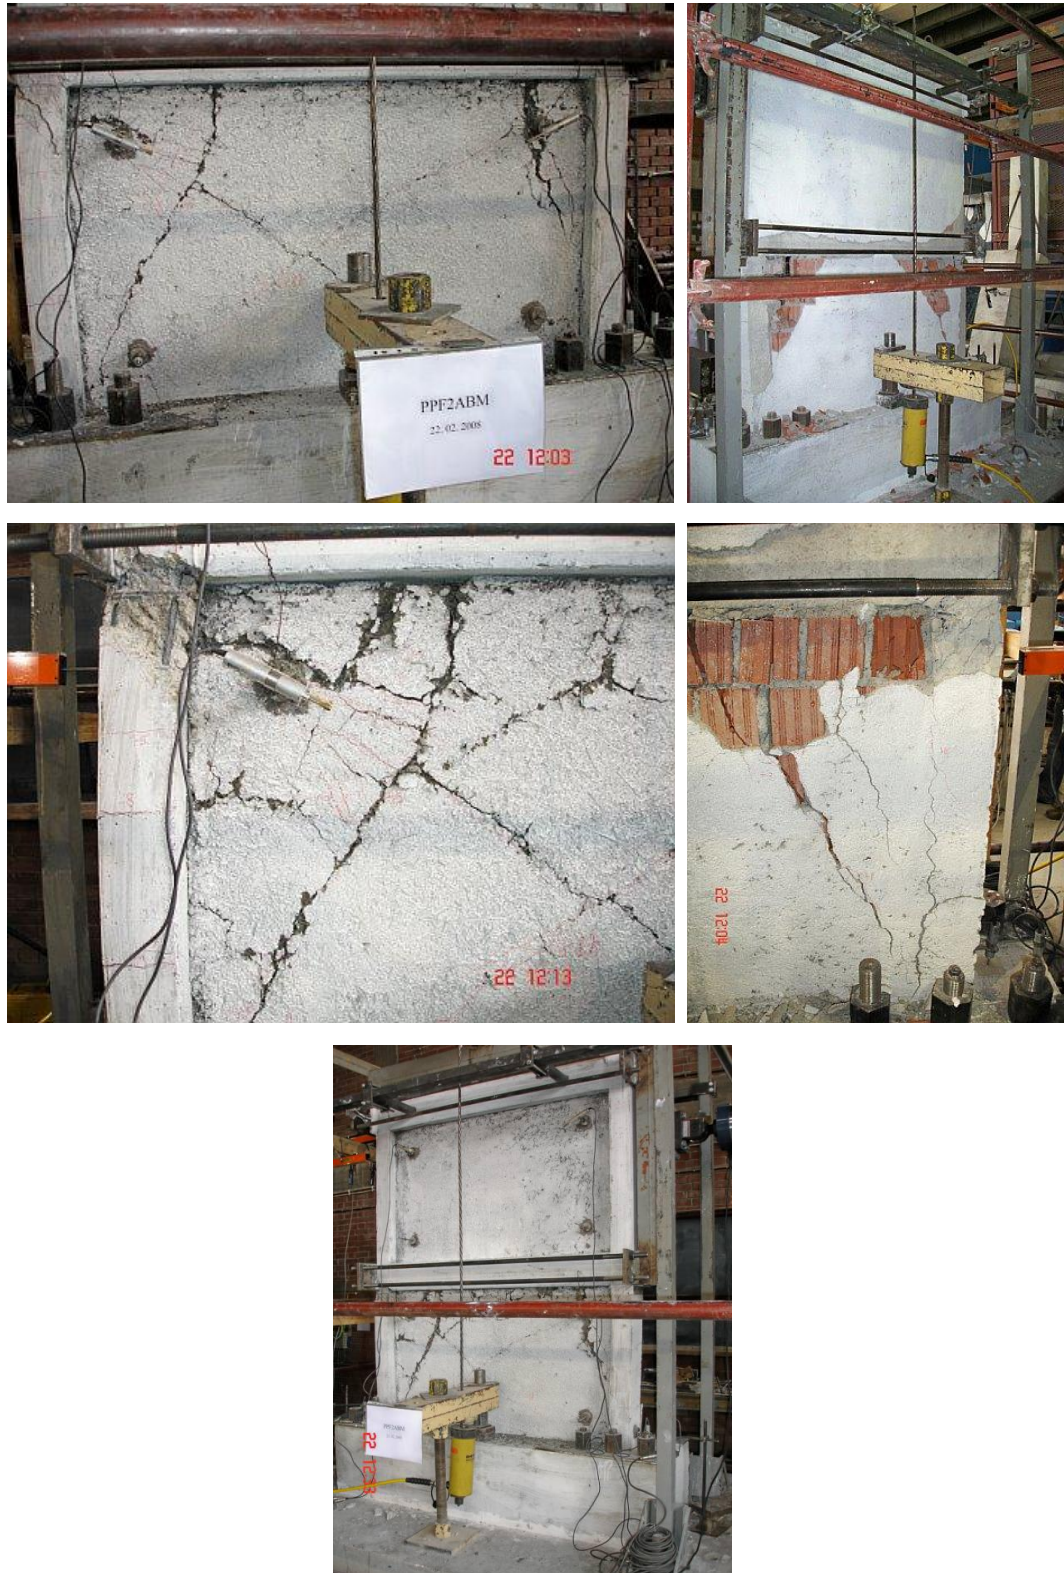
**Figure 4.70** Views of TS8 (PPF2ABM) Specimen during the Test

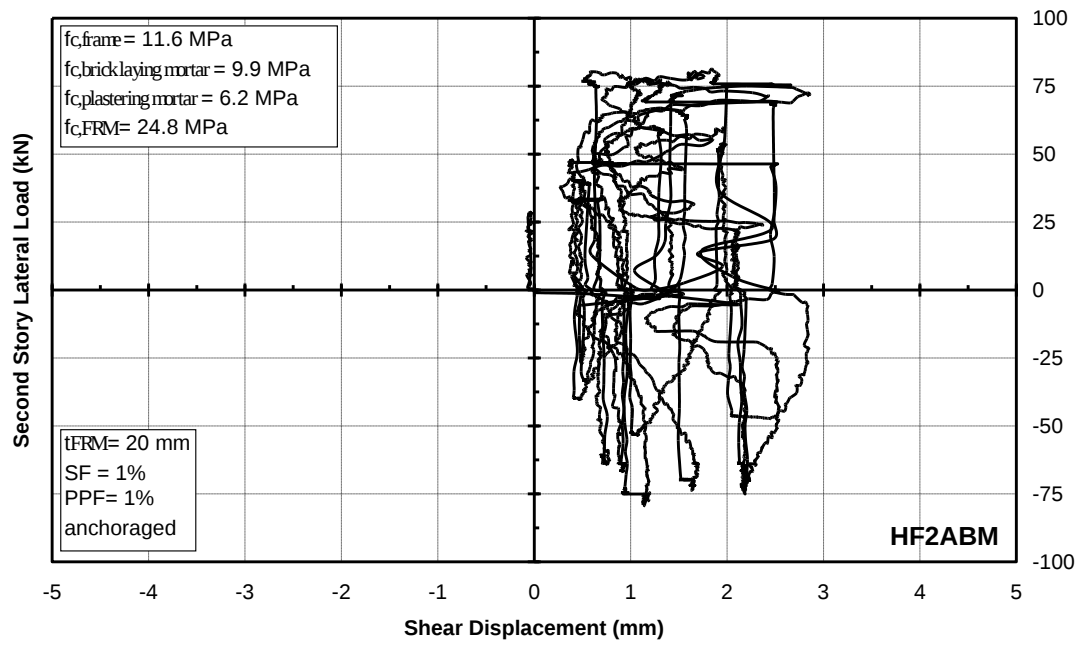
**Figure 4.76** Load-Second Story Shear Displacement Graph of TS10 (HF2ABM) Specimen

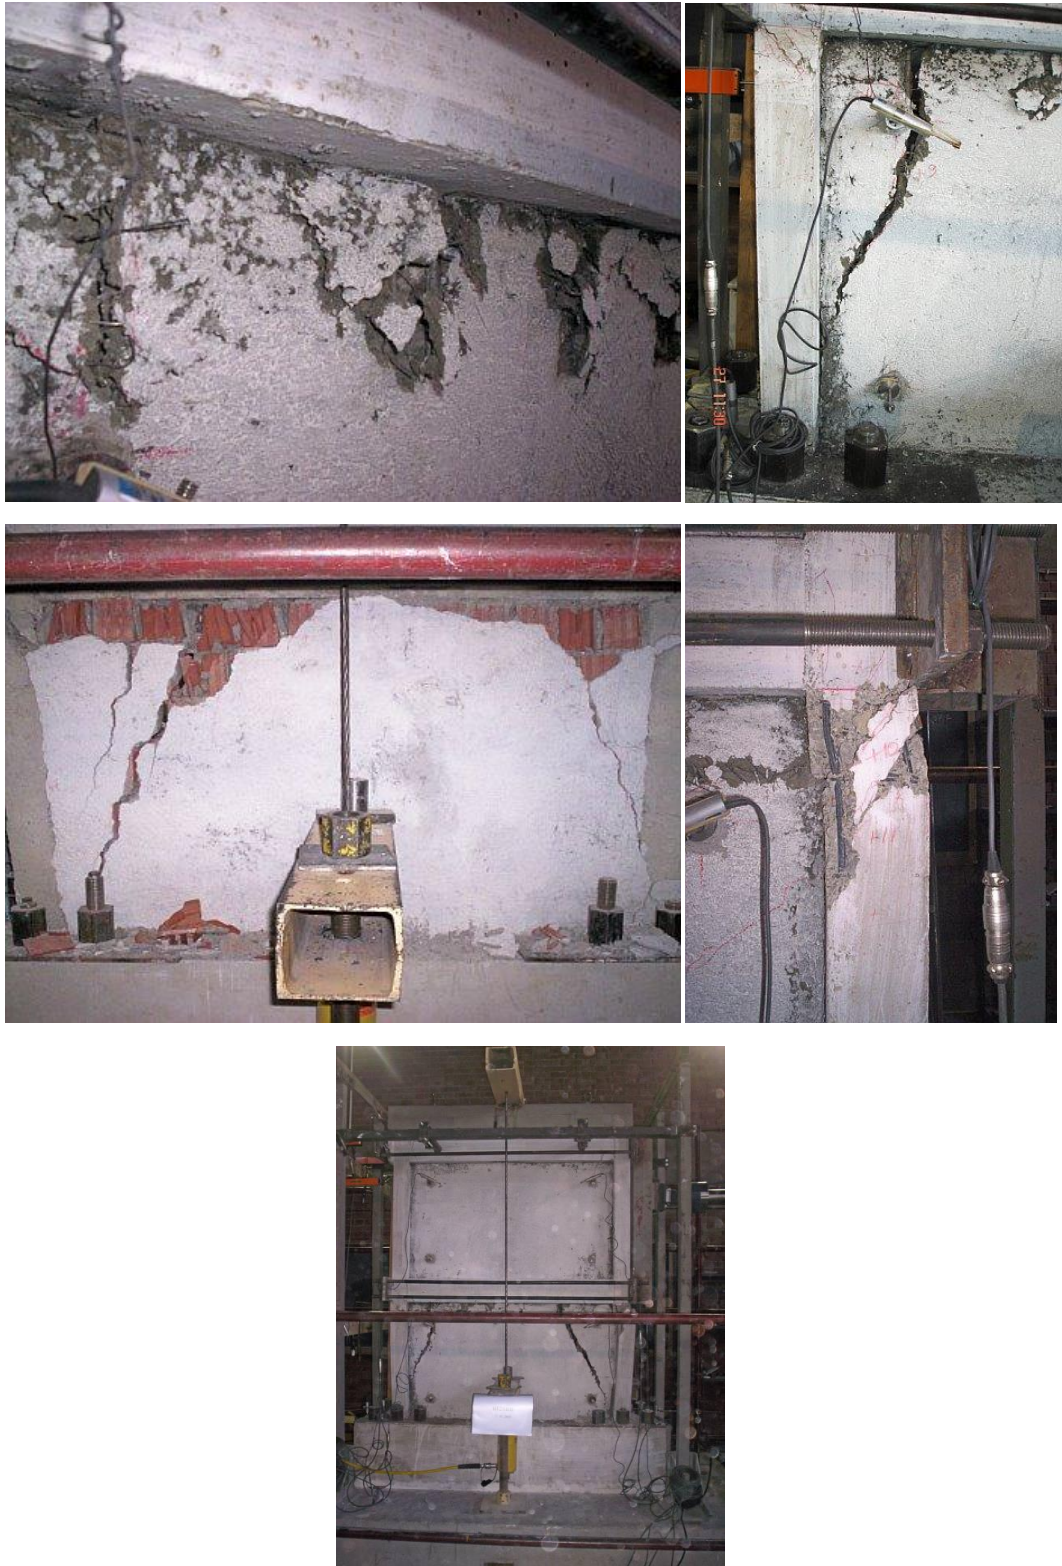
**Figure 4.78** Views of TS10 (HF2ABM) Specimen during the Test

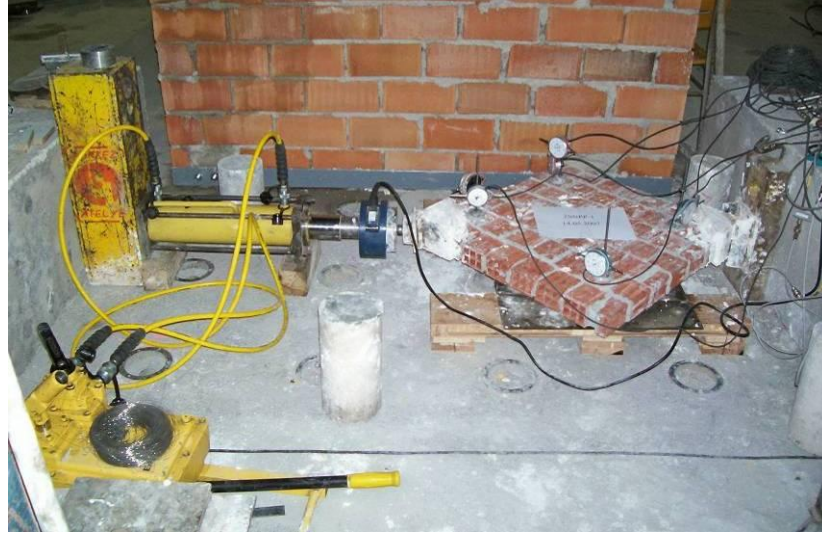
Test set-up was prepared between two heavy concrete support blocks. Test specimen was placed on thin metal plates parallel to floor. Steel plate was oiled and sat on ball roller supports to ensure friction free movement of panel specimens. Steel heads were placed to corners of the wall specimen in the diagonal direction and were attached with gypsum. Dial gages were placed in six directions to measure displacements on the wall. Test set-up is illustrated in **Figures 6.1** and **6.2**.

**Figure 6.2** General View of Panel Tests

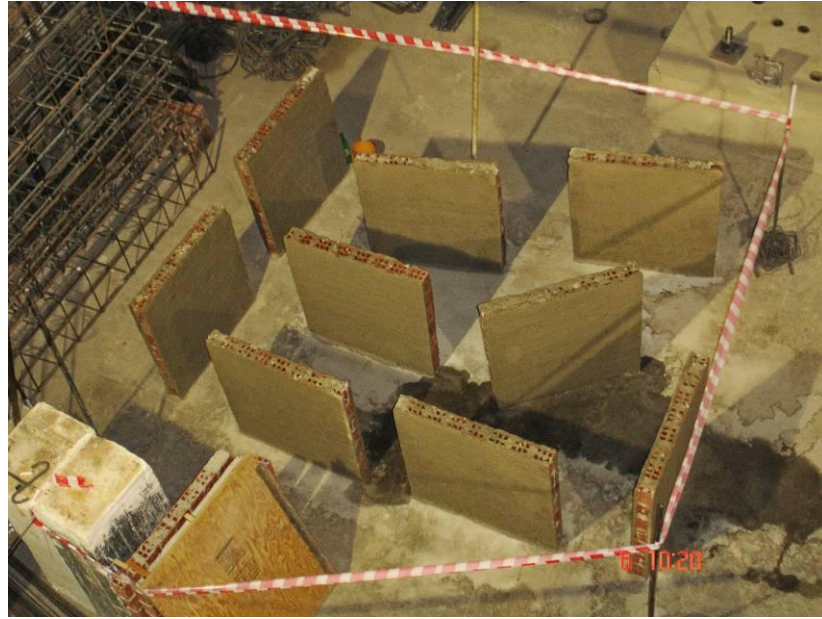
**Figure 6.3** General View of First Series Panel Specimens

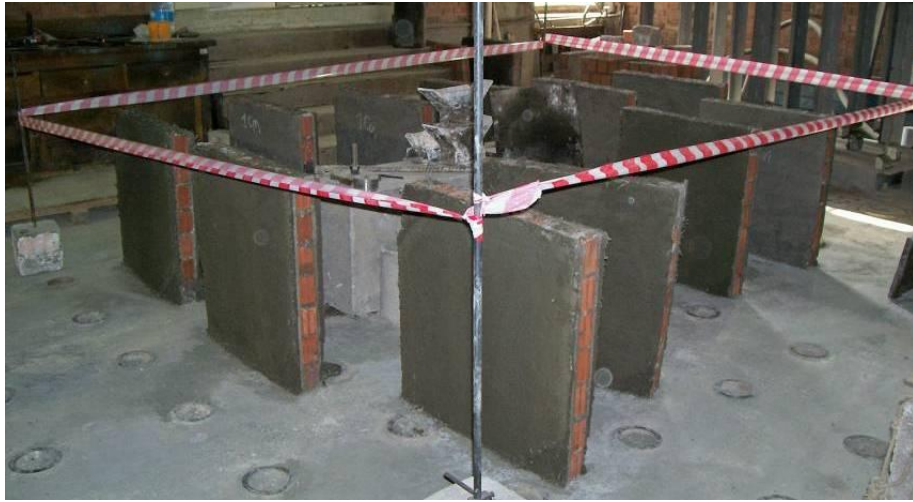
**Figure 6.4** General View of Second Series Panel Specimens

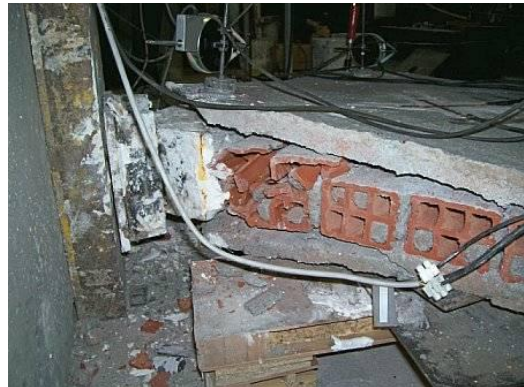
**Figure 6.47** View of 2SSF1PD-1

| <b>Panel</b> | <b>Observed Damage</b> |
|---|---|
| 2SSF1PD-1 | No cracking occurred at the top and bottom. Only, there was a slight crushing of the bricks at the region of one cap. |

2SSF1PD specimens were strengthened by steel fiber reinforced mortar application on both sides. These panels behaved very stiff up to ultimate load of 132.06 kN in average. The average diagonal compressive force capacity of 2SSF2PD specimens was 128.53 kN. Besides, it should be noted that capacities of 2SSF1PD and 2SSF2PD specimens varied a lot in each sub-group. Application of reinforced mortar on both sides of the panel results in a considerable amount of increase in ultimate diagonal compression capacity with respect to the one side application. Double side application provided very stiff behavior but high variation in ultimate strength as well [46]. In **Figure 6.54**, one test data from each sub-group is presented.

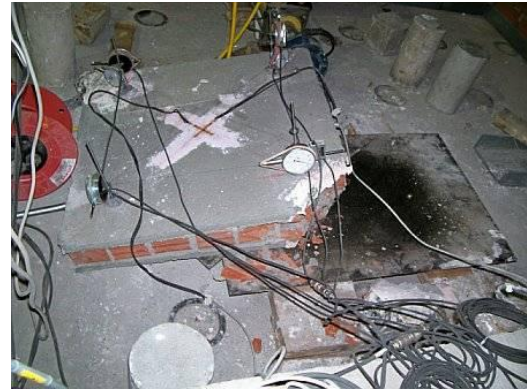
**Figure 6.51** View of 2SSF2PD-2

| <b>Panel</b> | <b>Observed Damage</b> |
|---|---|
| 2SSF2PD-2 | Clamps were used as in 2SSF1PD-2. Separation of the plaster at the bottom at one of the caps' region was identified. The brick layer was divided into two parts due to diagonal cracking. |
