STRUCTURAL ANALYSIS, EVALUATION AND RECOMMENDATIONS FOR CONSERVATION OF THE LAHORE MUSEUM

A THESIS SUBMITTED TO
THE GRADUATE SCHOOL OF NATURAL AND APPLIED SCIENCES
OF
THE MIDDLE EAST TECHNICAL UNIVERSITY

JULY 2018

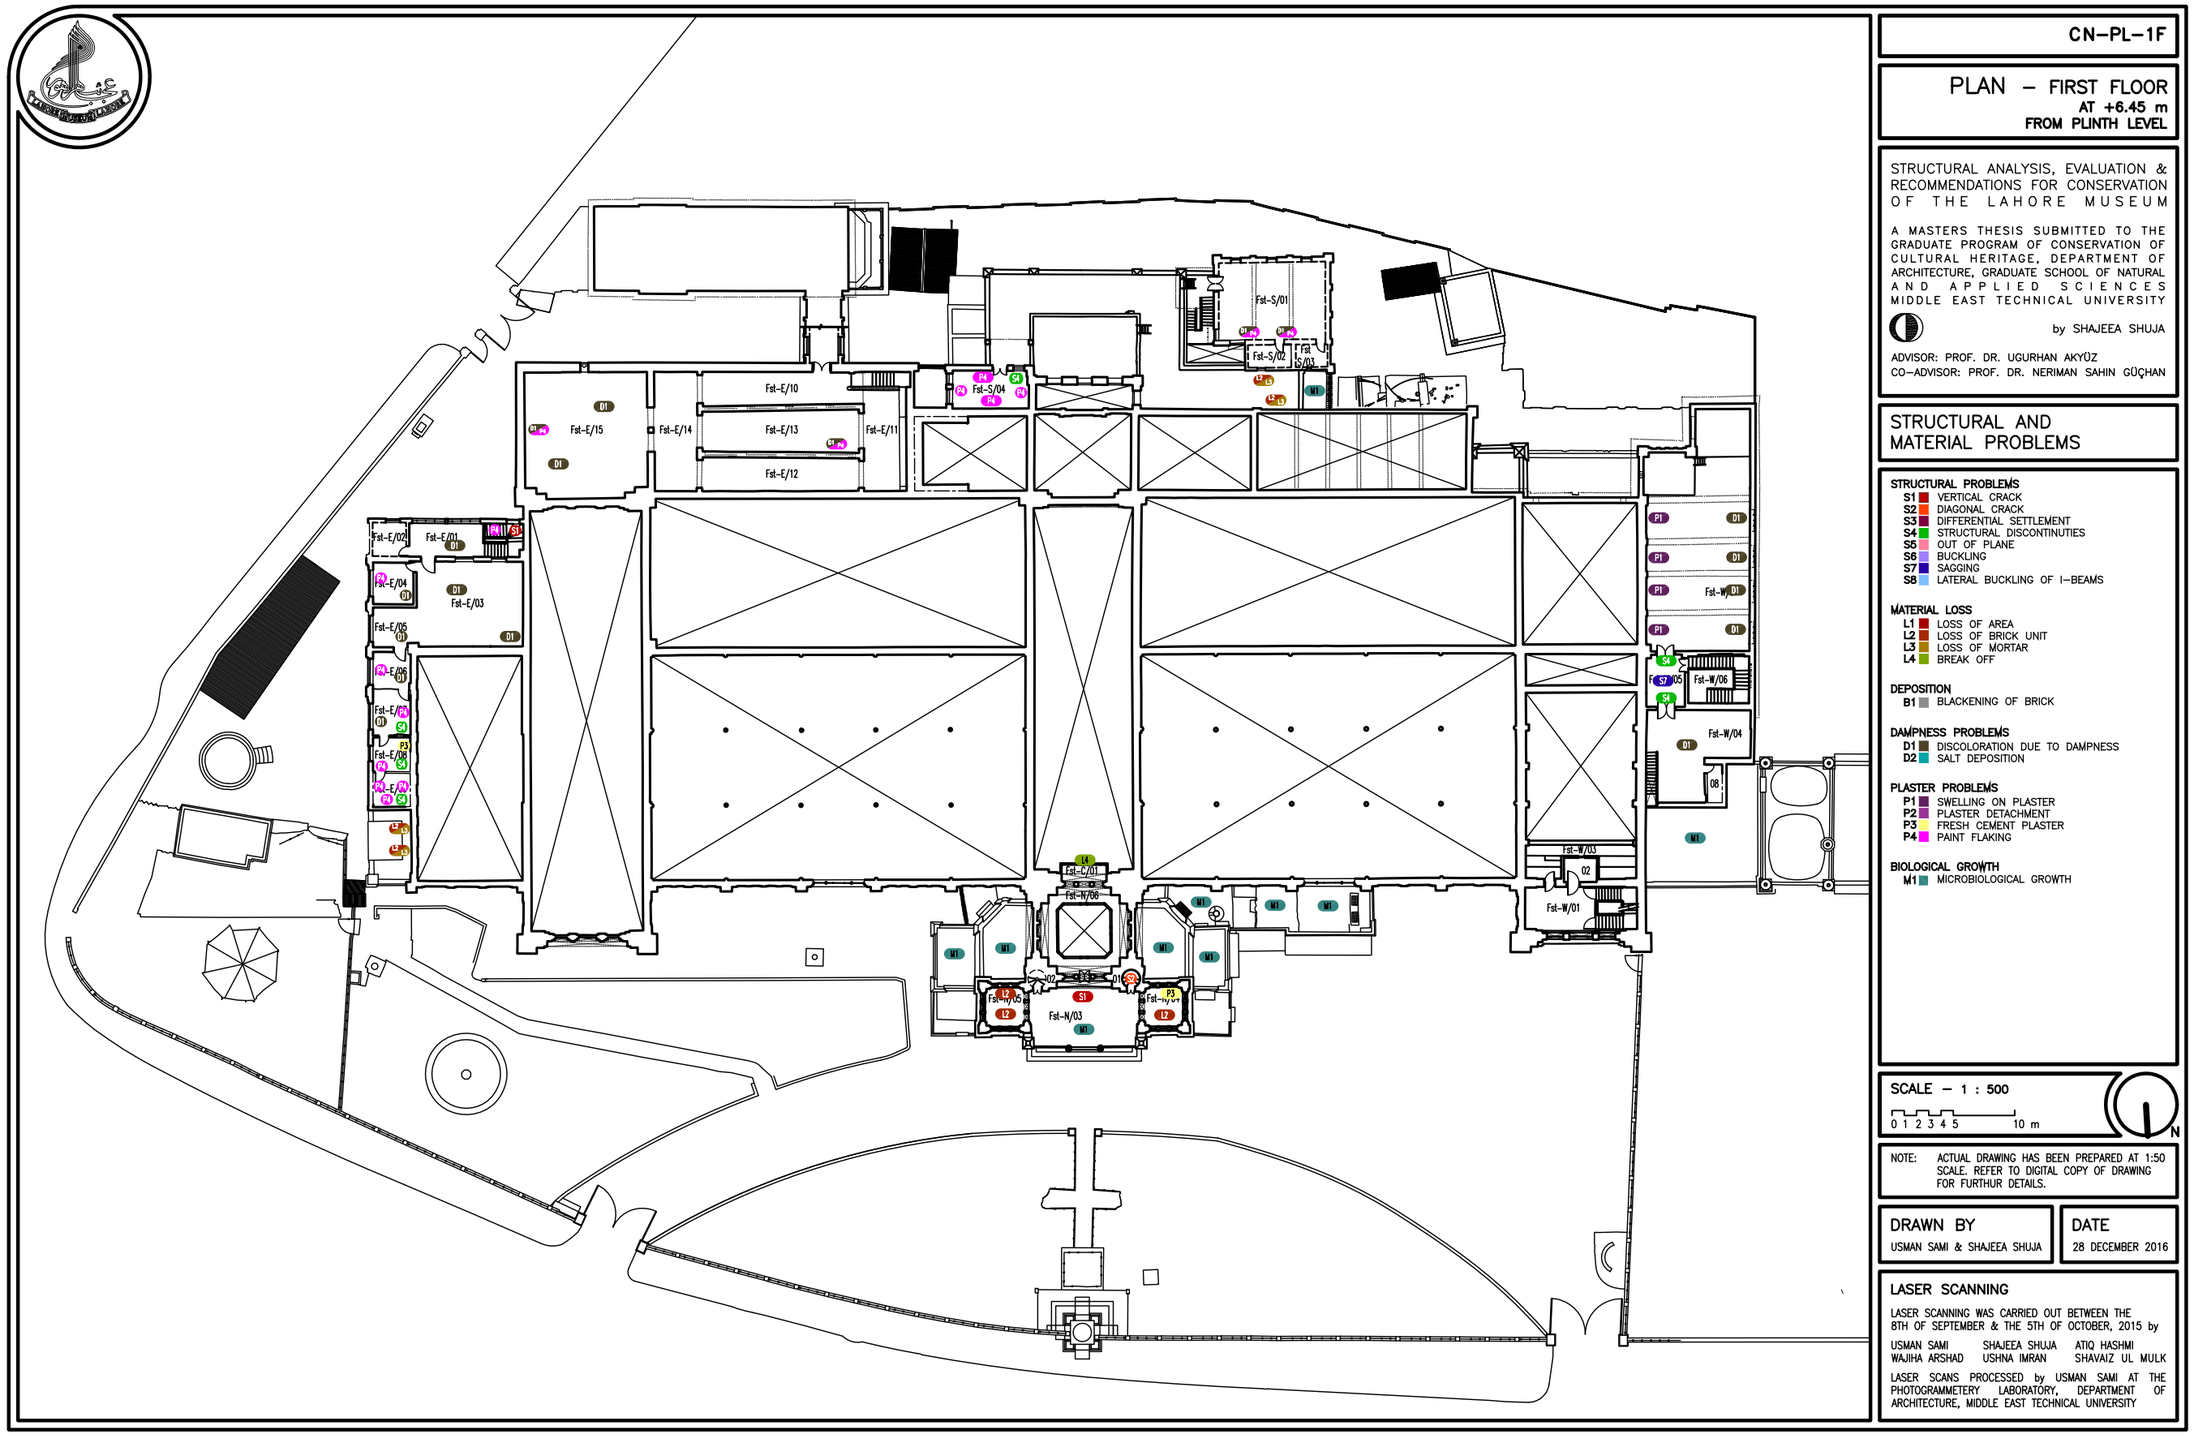
CN–PL–1F

STRUCTURAL PROBLEMS
- S1 VERTICAL CRACK
- S2 DIAGONAL CRACK
- S3 DIFFERENTIAL SETTLEMENT
- S4 STRUCTURAL DISCONTINUTIES
- S5 OUT OF PLANE
- S6 BUCKLING
- S7 SAGGING
- S8 LATERAL BUCKLING OF I–BEAMS

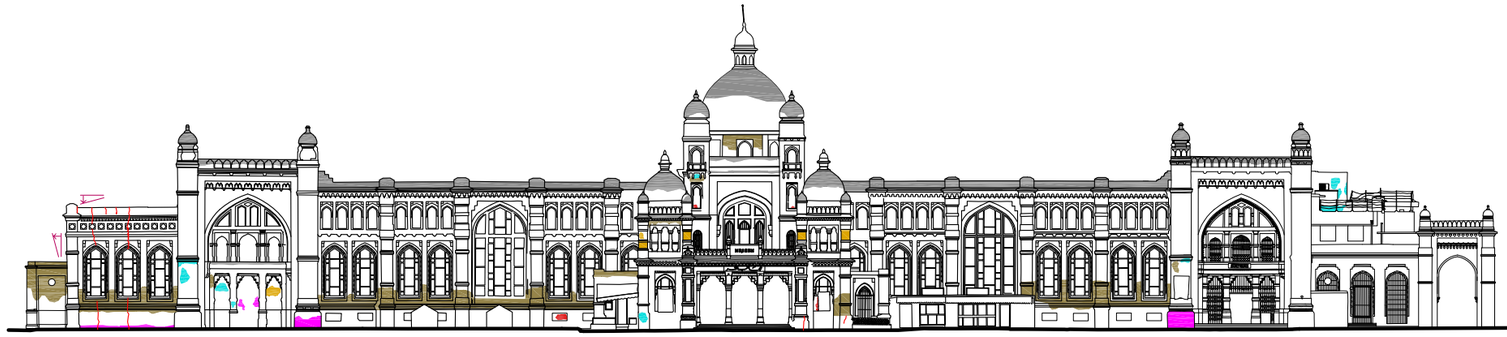
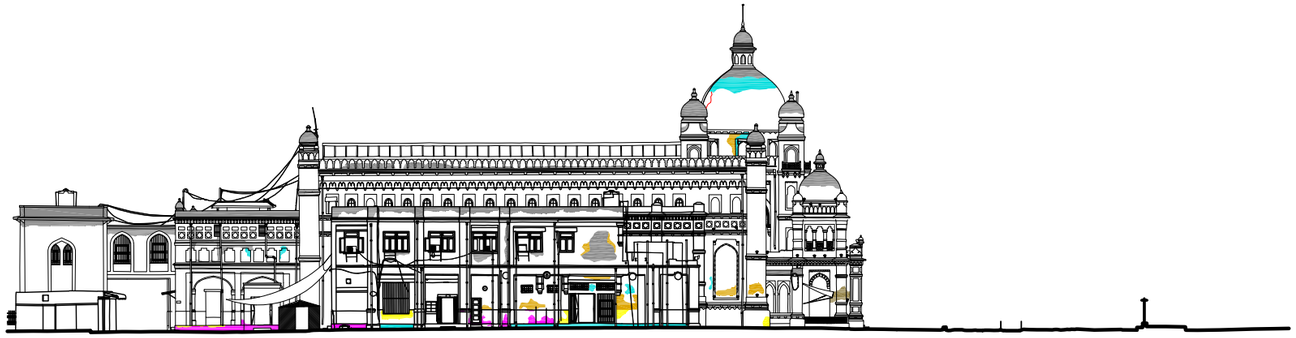
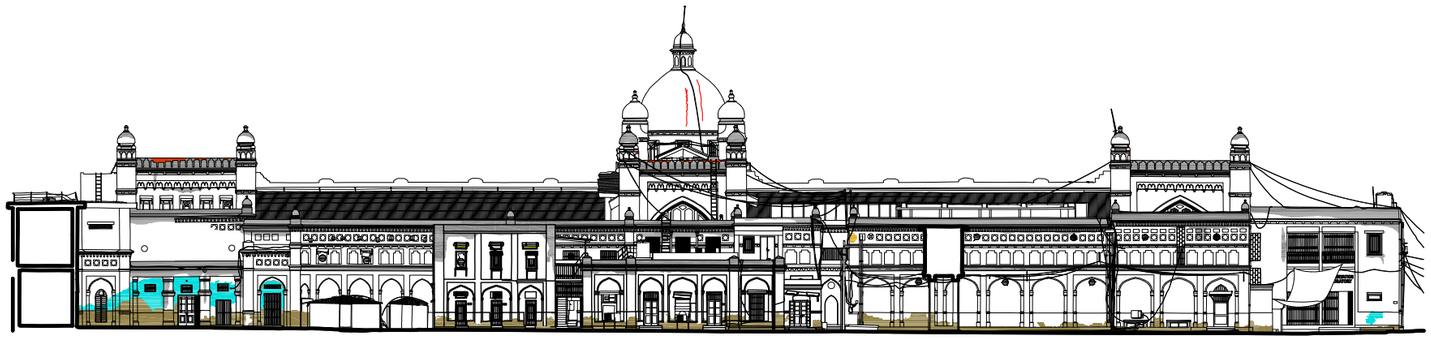
CN–EL–N/E/S

STRUCTURAL CRACKS AND DEFORMATION
- STRUCTURAL CRACK
- DIFFERENTIAL SETTLEMENT
- STRUCTURAL DISCONTINUTIES
- OUT OF PLANE
- BUCKLING
- SAGGING
- LATERAL TORSIONAL BUCKLING

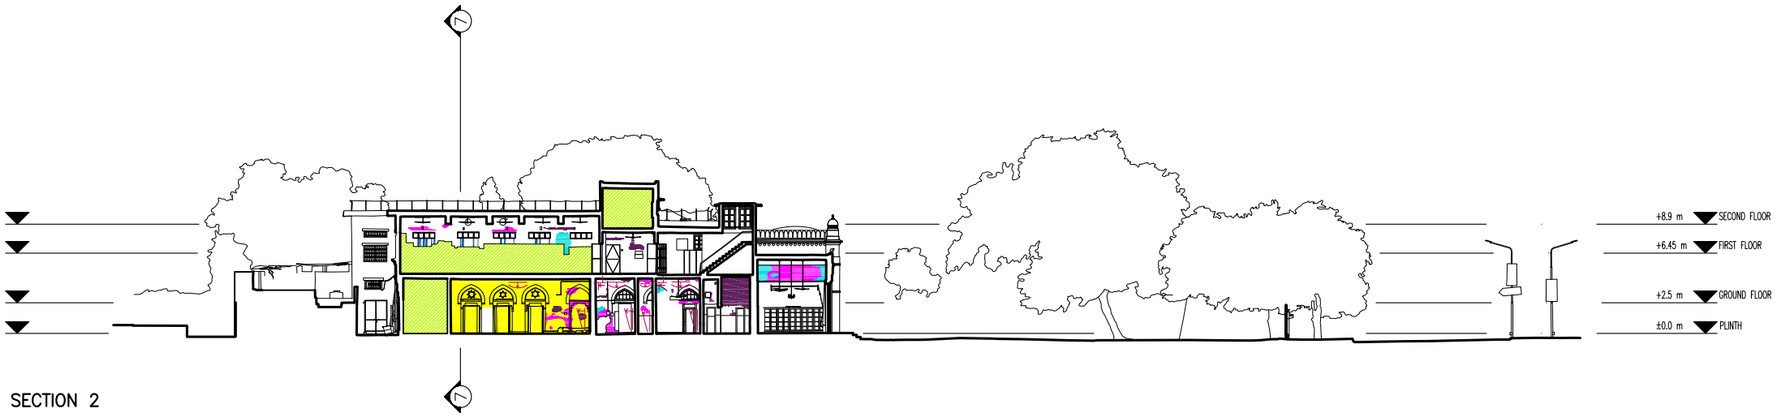
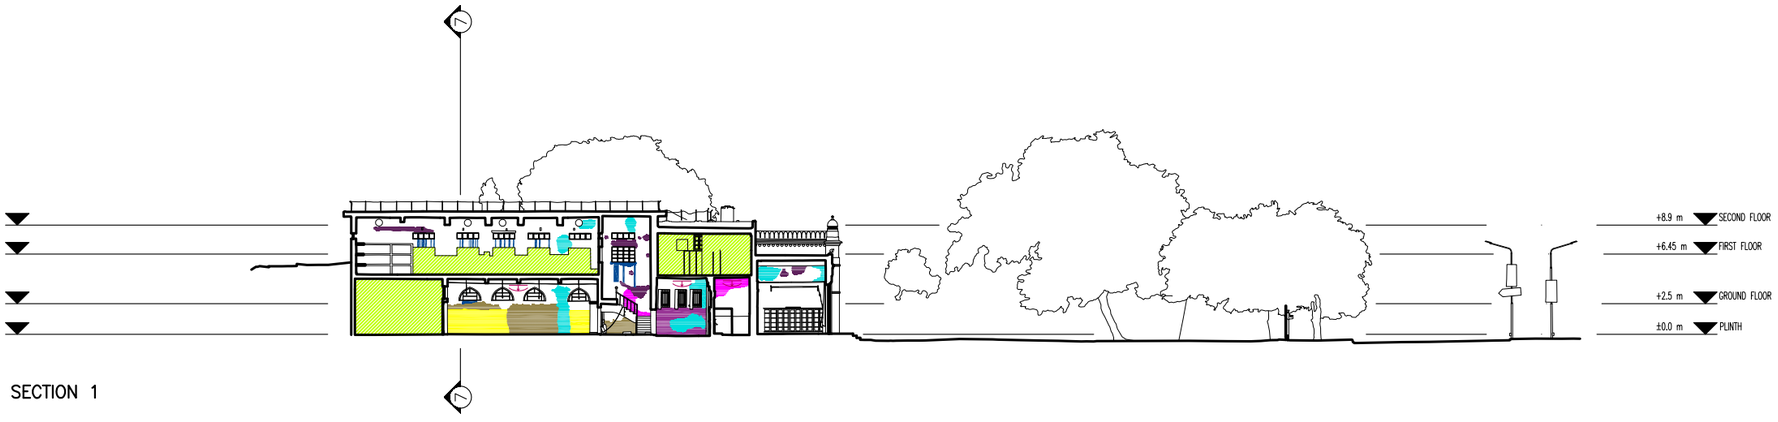
CN–SE–1/2/3

STRUCTURAL CRACKS AND DEFORMATION
- STRUCTURAL CRACK
- DIFFERENTIAL SETTLEMENT
- STRUCTURAL DISCONTINUTIES
- OUT OF PLANE
- BUCKLING
- SAGGING
- LATERAL TORSIONAL BUCKLING

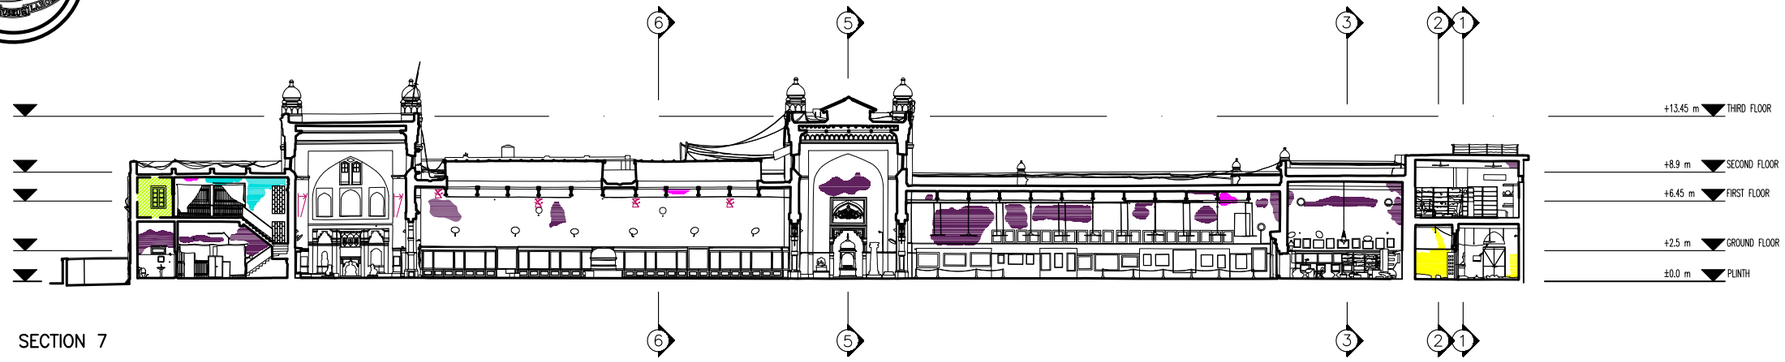
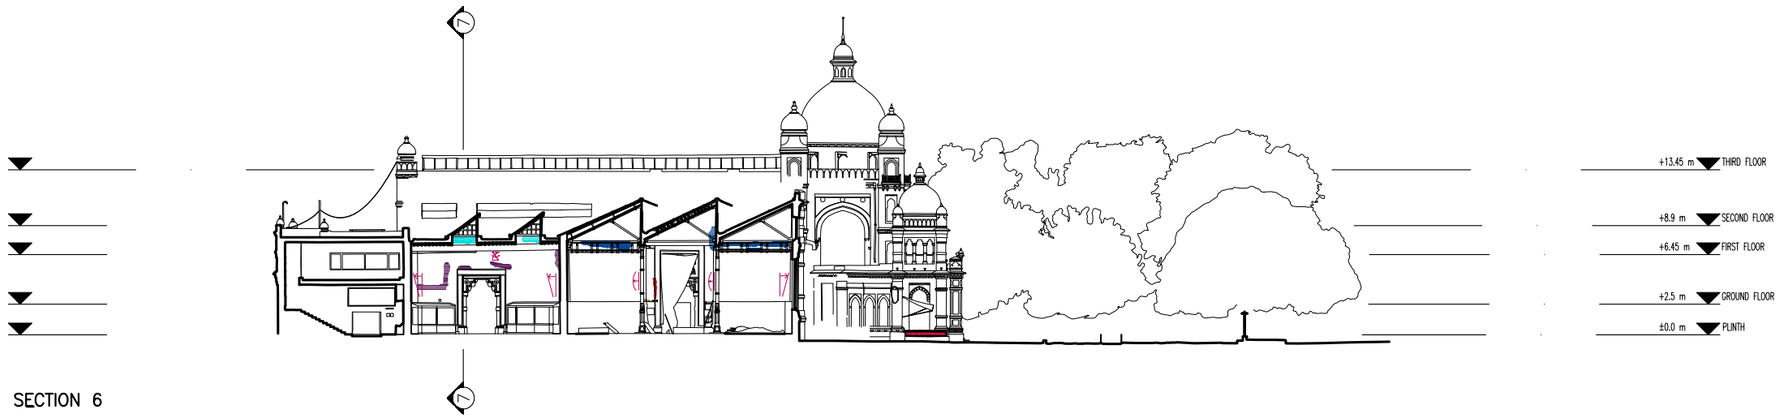
Figure 2.68: CN-SE-5/6/7 – Structural and Material Problems – Sections – 5 / 6 / 7 (2016)

STRUCTURAL CRACKS AND DEFORMATION
- STRUCTURAL CRACK
- DIFFERENTIAL SETTLEMENT
- STRUCTURAL DISCONTINUTIES
- OUT OF PLANE
- BUCKLING
- SAGGING
- LATERAL TORSIONAL BUCKLING

base in the Northern direction. Similarly the wall Gnd-E/01-S-W is also seen to exhibit Out of Plane behavior (S5) and is tilting away from the base in the Southern direction. Lastly, the CI columns are showing signs of slight deformation of shape i.e. Local Buckling (S6) (Figure 2.68).

In case of the wall Gnd-E/02-S-W it was observed that the wall titled from its base in the southern direction. This was cross checked with the help of a plumb line and was also confirmed through the documentation drawings (Figure 2.68). This behavior can be attributed to the construction of the adjacent space Gnd-E/18, south of space Gnd-E/02 in 1972, and later in 1974 the addition of gallery spaces above Gnd-E/18. Additionally, the roofing system of space Gnd-E/02 was frequently changed due to the persisting roof leakage. Thus the increased gravity load due to the new constructions and the addition of slab approximately at mid-height of the wall Gnd-E/02-S-W coupled with recurring changes in the loading pattern due to roof changes could have resulted in the Out of Plane Behavior (S5) observed in wall Gnd-E/02-S-W .

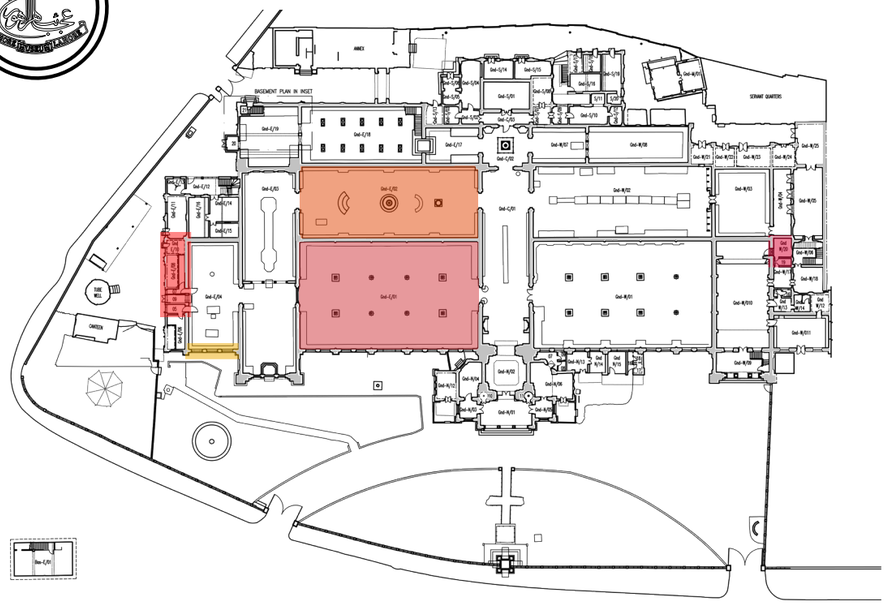
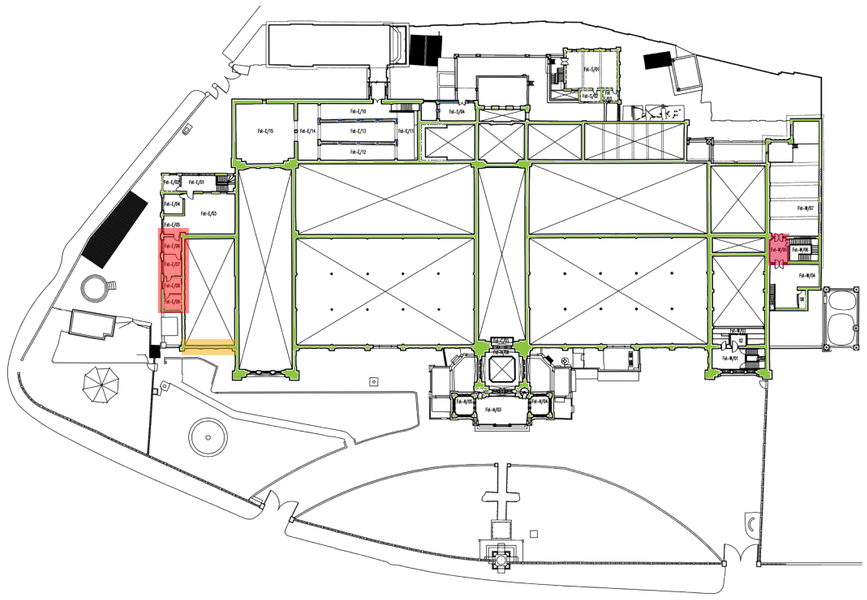
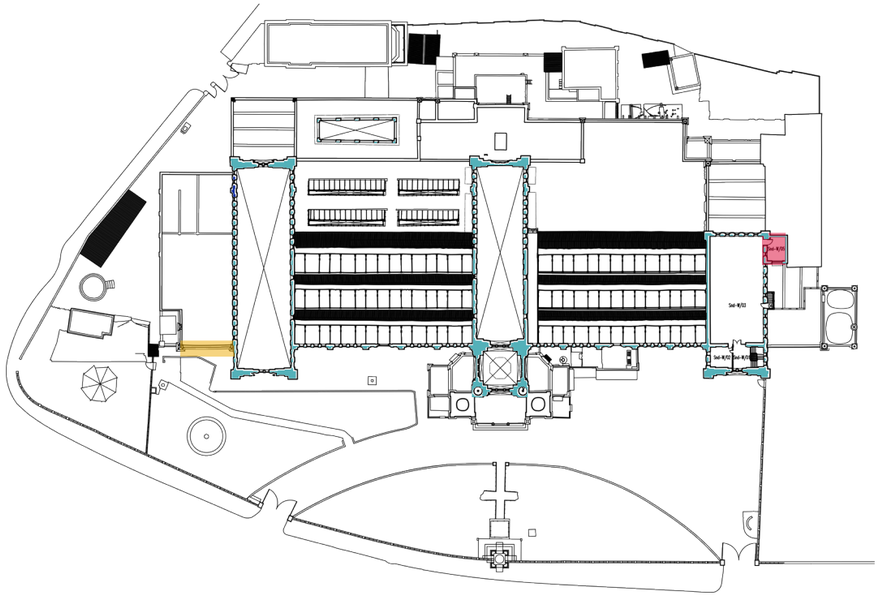
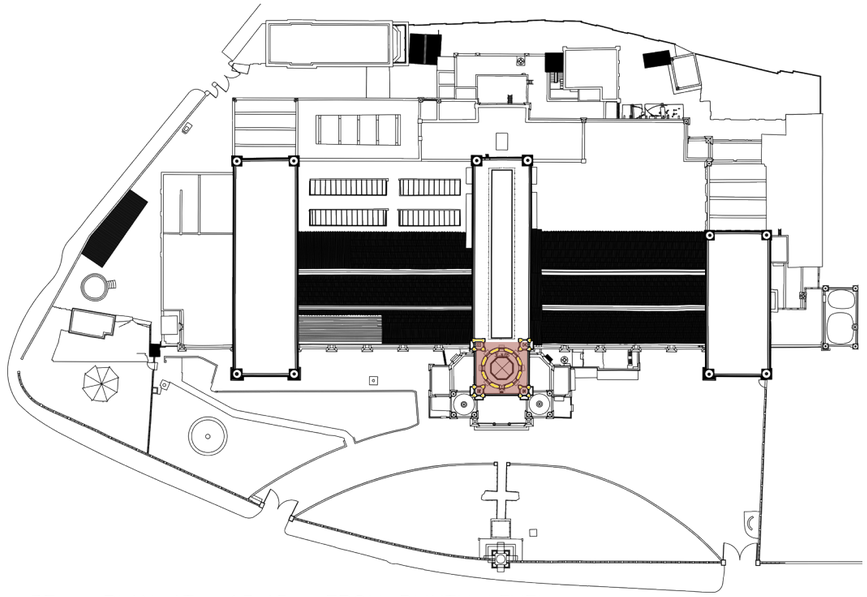
ZI–PL–GF/1F/2F/3F

STRUCTURAL DAMAGES ZONES IDENTIFICATION

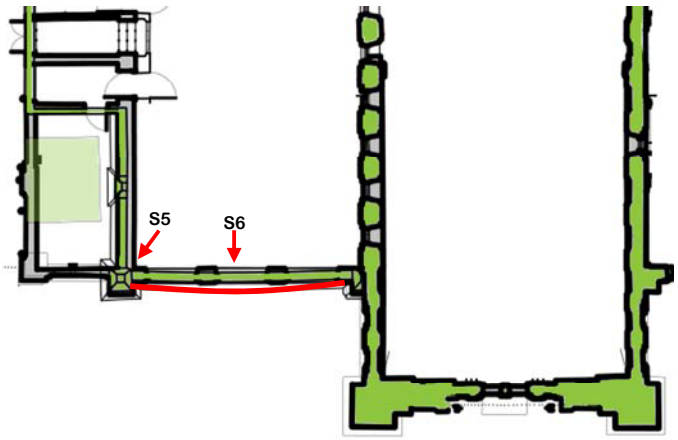
Figure 2.73: Out of Plane behavior (S5) and Buckling (S6) in Zone 01
Seen through the overlapping of Plans
Plan at +2.5m Plan at +6.45m

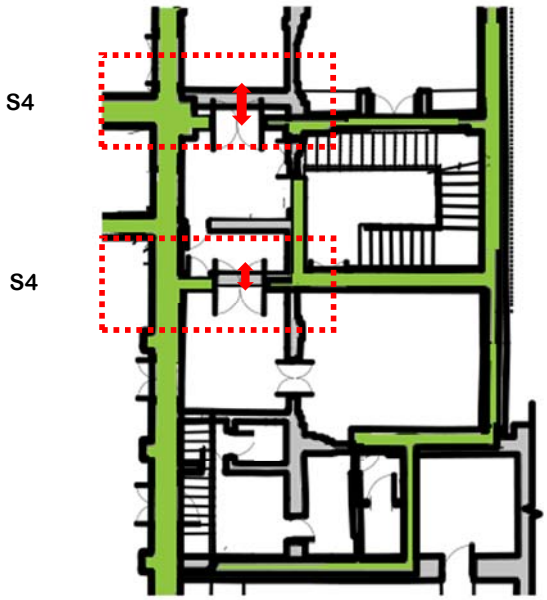
Figure 2.75: Structural Discontinuities in Zone 03 seen by overlapping of Plans
Plan at +2.5m Plan at +6.45m

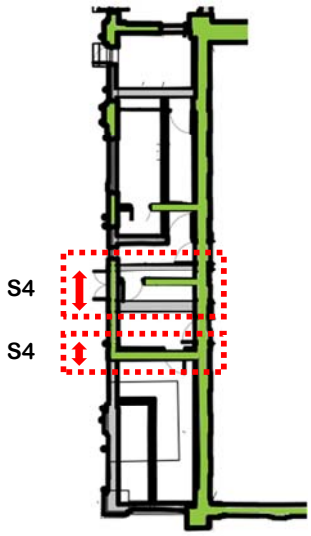
Figure 2.78: Structural Discontinuities in Zone 06 seen through the overlapping of Plans
Plan at +2.5m Plan at +6.45m

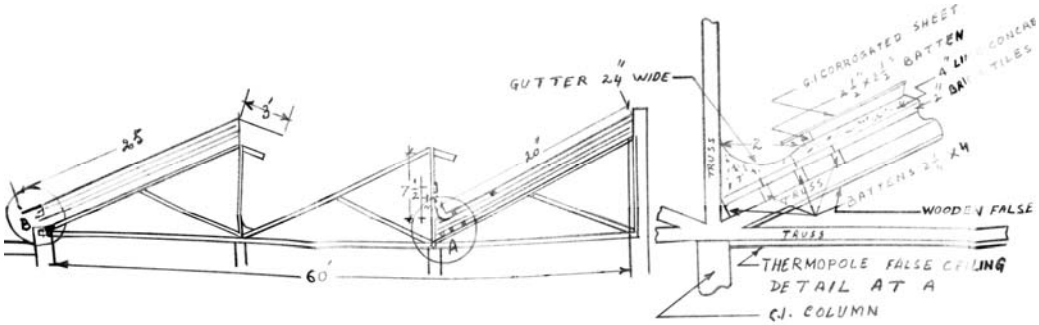
This problem is best exemplified in the case of the two galleries with trusses i.e. Gnd-E/01 (Islamic Arts Gallery and Gnd-W/01 (General Gallery). The design of the roof in these spaces is inherently flawed as the trusses, oriented in the east-west direction, abut much higher building blocks on either side. Catchment channels in the middle of the roof collect rainwater from the two drainage valleys (Figure 2.80) and evacuates it into drain pipes. The pipes then drop below the soffit into the gallery spaces from there they run along the eastern wall of Gnd-W/01 and western wall of Gnd-E/01 concealed behind the plaster of Paris cornices that slope towards the north. The water is finally channeled out of the building through spouts on the upper levels of the northern façade of the building.

The badly designed roof drainage has caused discoloration and blackening of the exposed brickwork and opening of masonry joints especially at the upper part of the walls on the building exterior. It has also resulted in microbiological growth on various flat roofs of the building.

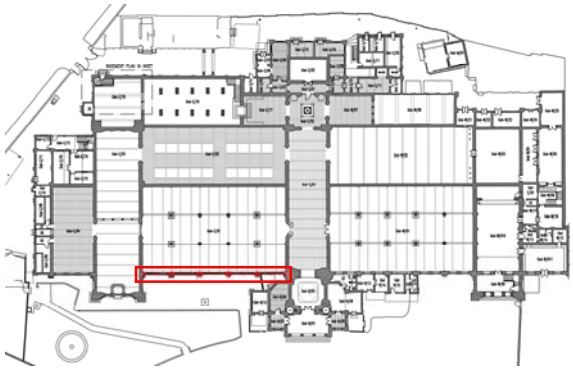
Figure 3.22: Key Plan showing wall Gnd-E/01-N-W

The critical location in the wall Gnd-E/01-N-W is observed near the top western corner of the wall.

In Stage 1, the S11 results for the selected location show high values of compression on both faces, while the overall wall exhibits in plane bending with tension in the top zone and compression in the bottom zone for both faces (Figure 3.20-c). This could be credited to the settling of the wall at the ends due to the adjacent heavier load bearing galleries Gnd-E/03 and Gnd-C/01 on the eastern and the western end respectively as well as due to the settling of the truss roofing system which ties the wall at the top and causes it to sway towards the northern direction. In the next two stages stress values tend to lower which can be attributed to the addition of space Gnd-N/04, that arrests the neighboring wall to relieve and redistribute the stresses observed in Stage 1. Moreover, a marked reduction is observed in the stress values in Stage 4 which could have resulted due to the change in roof loads in this stage of the building life.

In case of the S22 results for Stage 1 we observe difference in the nature of stresses, with the north (top) face in tension and the south (bottom) face in compression, indicating that the segment of the wall is undergoing bending (Figure 3.21-c). The stress values tend to lower in the subsequent stages for the area element. This behavior is reflected in the overall behavior of the wall as well and can also be ascribed to the construction of space Gnd-N/04 and change in the roof loading.

The behavior of the wall observed in the analytical model corresponds with the behavior observed for the actual wall in the documentation stage of the building. As the actual wall exhibits out of plane behavior and is titling towards north (Figure 2.68).

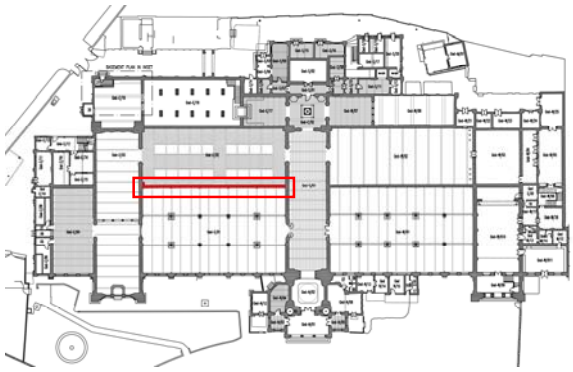
Figure 3.24: Key Plan showing wall Gnd-E/01-S-W

The critical location in the wall Gnd-E/01-S-W is observed in the middle of the wall near the top.

In Stage 1, the S11 results for the selected location exhibits tensile stresses on both faces, while the overall wall exhibits tension in the top zone and compression in the bottom for both faces (Figure 3.20-c). This could be credited to the settling of the wall at the ends due to the adjacent heavier load bearing galleries Gnd-E/03 and Gnd-C/01 on the eastern and the western end respectively as well as due to the settling of the truss roofing system which ties the wall at the top and causes it to sway. In Stage 2 the

nature of stresses for the south (bottom) face is reversed from tension to compression while the north (top) face retains tension. The results of the overall wall also show that the entire wall is exhibiting similar behavior which indicates that the wall is exhibiting out of plane behavior (Figure 3.20-d). This could be attributed to the construction of space Gnd-E/02 on the southern side of the wall. As the roofing system of the new space settles it causes the wall to bulge towards north. Moreover, in Stage 3 an increase in tension is observed on the north (top) face while the behavior is reversed for the south (bottom) face this could be due to the construction of spaces Gnd-E/18 and Fst-E/10-14. The roofing systems of all the additions in Stage 2 and Stage 3 play a vital role in the behavior of the wall Gnd-E/01-S-W, for as the horizontal diaphragms settle and attain equilibrium they cause the wall to experience bending due to the shear forces at the interface. In Stage 4, a decrease in tension is observed on the north (top) face whereas the south (bottom) face experiences an increase in compression. This could have resulted due to the change in roof loads in Stage 4.

The behavior of the wall observed in the analytical model corresponds with the behavior observed for the actual wall in the documentation stage of the building (Figure 2.68).

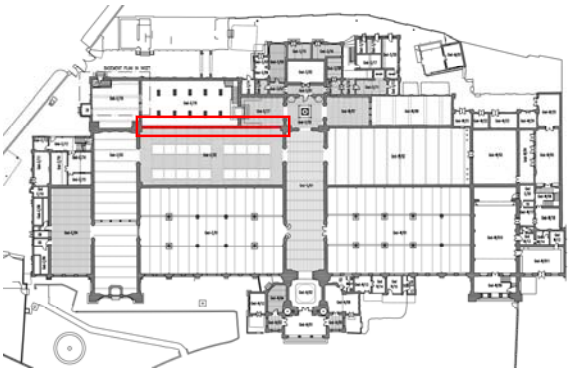
Figure 3.26: Key Plan showing wall Gnd-E/02-S-W

The critical location in the wall Gnd-E/02-S-W, constructed in Stage 2, is observed near the middle of the wall at the top.

In Stage 2, the S11 results for the selected location exhibits that the nature of the stresses varies with the north (top) face in compression and the south (bottom) face in tension. Similar behavior is observed in the entire wall which indicates out of plane bending (Figure 3.20-d). This can be the result of the roofing system settling and causing the wall to sway towards north. In the subsequent stages the nature of stresses remains the same for the area element, with minute changes in the magnitude of the stresses. However, in case of the entire wall stress reversal is observed in the lower part of the wall in Stage 3, with the north (top) face in tension and the south (bottom) face in compression. This behavior is sustained in Stage 4. The observed behavior can be ascribed to the construction of Spaces Gnd-E/18 and Fst-E/10-14, towards the south of the wall, in Stage 3. The increased gravity load and the addition of slab approximately at mid height of the wall, causes it to sway towards the south.

The behavior of the wall observed in Stage 4 of the analytical model corresponds with the behavior observed for the actual wall in the documentation stage of the building (Figure 2.68).

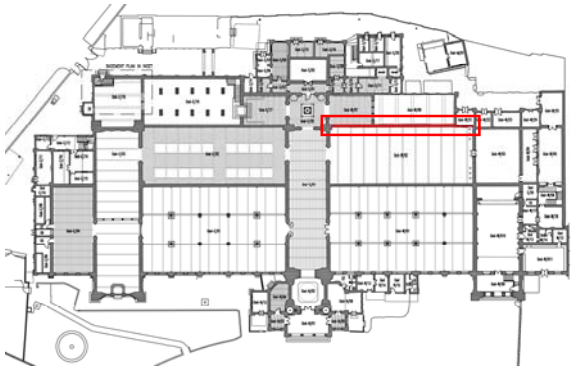
Figure 3.27: Key Plan showing wall Gnd-W/02-S-W

The critical location in the wall Gnd-W/02-S-W, constructed in Stage 2, is observed near the middle of the wall.

In Stage 2, the S11 results for the selected location exhibits that the nature of the stresses is different; with the north (top) face in tension and the south (bottom) face in compression which indicates out of plane bending (Figure 3.20-d). In Stage 3 the stress values increase, implying more out of plane bending, under increased gravity loads due to the addition of space Gnd-W/08 south of the wall. A further increase in stress is observed in Stage 4 and can be attributed to the construction of a double storey structure south of space Gnd-W/08 which consequently results in the stiffening of the walls Gnd-W/08-E-W and Gnd-W/08-W-W, which are perpendicular to the discussed wall.

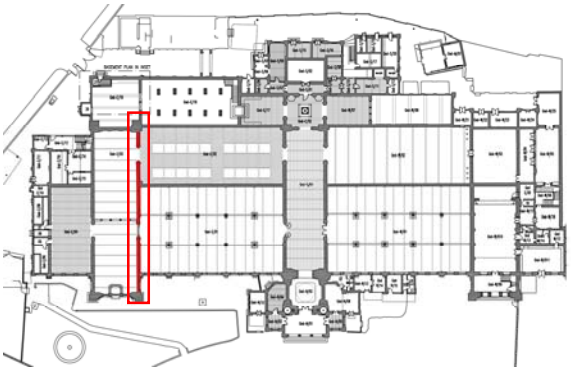
Figure 3.28: Key Plan showing wall Gnd-E/03-W-W

Two critical locations were observed in wall Gnd-E/03-W-W. One of the observed segment is located near the top of the wall close to the junction with wall Gnd-E/01-N-W at the northern end of the wall. The other is located near the top of the wall towards the southern end of the wall.

For the area element at the northern end, S11 results for Stage 1 exhibit very high magnitude of stress values. The nature of stresses is different on the opposite faces with the west (top) face exhibiting tension while the east (bottom) face is in compression. This points to out of plane bending with the tilt towards east. With each subsequent stage magnitude of the stresses reduce although the nature of stresses remains the same. Similar behavior is observed in the entire northern part of the wall. The S22 results, of the same area element, for Stage 1 also show that the west (top) face is in tension while the east (bottom) face is in compression, thus depicting out of plane bending (Figure 3.21-c). In Stage 2, magnitude of stress values reduce while the nature of stresses on opposite faces remains the same. However, in Stage 3 a reversal of stresses is observed, with both faces now experiencing compression, this behavior is retained in Stage 4. These results dictate that addition of galleries, such as Gnd-E/02 (south-west) in Stage 2 and Gnd-E/19 (south) and Gnd-E/11-16 (south-east) in Stage 3, around space Gnd-E/03 have been favorable in redistributing and relieving stresses.

the nature of stresses remains the same and though slight variation in magnitude is observed none of the values exceed the threshold. Similar behavior is observed in the entire northern part of the wall as well. The S22 results, for the same area element, for Stage 1 also show that the west (top) face is in compression while the east (bottom) face is in tension which indicates out of plane bending (Figure 3.21-c). For all stages the stress values for tension exceed the threshold; however the values sustain for Stage 1 and 2 but in Stage 3 a sudden increase in tension is observed which is then sustained in Stage 4. This could be attributed to the change in the roofing system of space Gnd-E/03 in Stage 3; the added structural weight could have resulted in increase in tensile stresses. Also the addition of spaces Gnd-E/19 (south) and Gnd-E/11-16 (south-east) in Stage 3, could have contributed to the observed behavior through redistribution of loads.

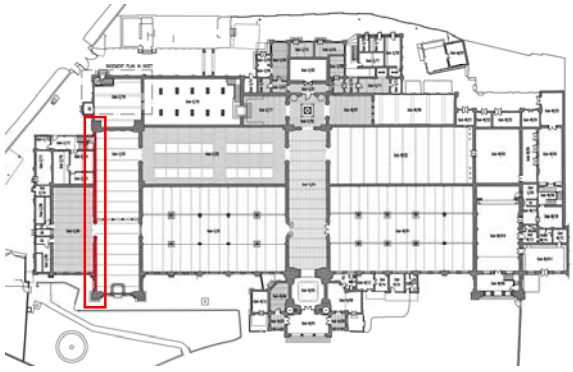
Figure 3.29: Key Plan showing wall Gnd-E/03-E-W

Two critical locations were observed in wall Gnd-E/03-W-W. One of the observed segment is located near the top of the wall close to the junction with wall Gnd-E/04-N-W at the northern end of the wall. The other is located near the top of the wall, above the opening leading to space Gnd-E/04, towards the middle of the wall.

The results for both the area element are very similar. The S11 results, of both area elements, for Stage 1 exhibit compression on the west (top) face while the east (bottom) face is in tension indicating out of plane bending with the tilt in the western direction. In case of the entire wall in Stage 1, the wall from the northern end till the transverse wall Gnd-E/04-S-W exhibits compression on the west (top) face and tension on the east (bottom) face. While in the remaining wall stress reversal is observed with the west (top) face in tension and east (bottom) face in compression. In the subsequent stages for the area element and the entire wall, nature of stresses remain the same while the magnitudes gradually reduce. This could be attributed to the construction of space Gnd-E/02 (south-west) in Stage 2 and spaces Gnd-E/19 (south) and Gnd-E/11-16 (south-east) in Stage 3, which help relieve and redistribute the stresses.

For both area element the S22 results of Stage 1 show that the west (top) face is in compression while the east (bottom) face is in tension depicting out of plane bending (Figure 3.21-c). In the subsequent stages the nature of stresses remains the same while the magnitude gradually reduces. In context of the entire wall, in Stage 1 bending deformations are observed in the top zone which could be caused by the roof of space Gnd-E/03 pulling the wall towards west. While in the mid-section of the wall a reversal of stress is observed which could be due to the roof of space Gnd-E/04, located east of the wall, pulling the wall eastwards. Whereas in the bottom zone the tensile stresses are being eliminated by compression due to the self-weight of the overlying wall matrix. This behavior is sustained in Stage 2 but in Stage 3, an increase in tension is observed in the top zone which could be the result of roof change of space Gnd-E/03 in this stage. The tensile stresses are relieved in the mid-section of the wall which could be due to redistribution of loads due to the addition of spaces Gnd-E/19 (south) and Gnd-E/11-16 (south-east).

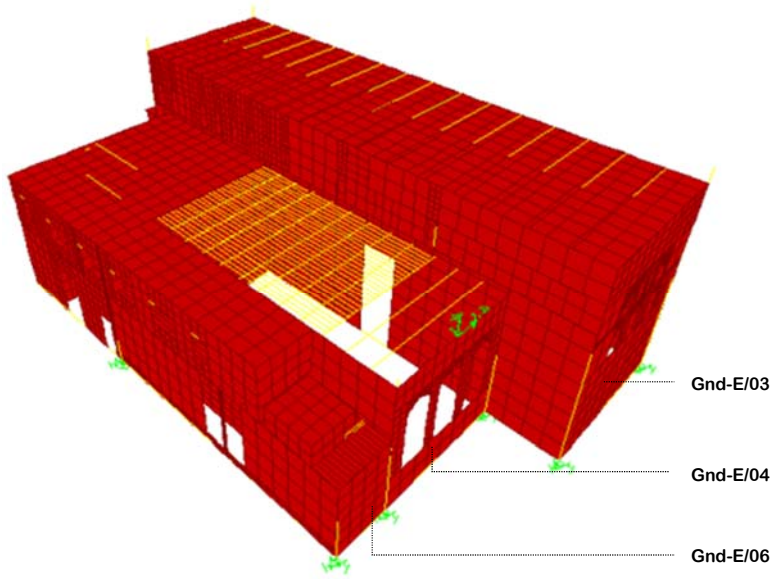
Figure 3.33: Part-Model of Space Gnd-E/04
For testing out probable causes of damage observed in wall Gnd-E/04-N-W

In order to simulate the hypothesis that localized sub-strata performance might be poor, due to rupturing of water pipes in the adjacent space Gnd-E/06, the subgrade values applied in the form of line springs under the walls Gnd-E/04-N-W and Gnd-E/04-E-W were reduced by 30%. The second hypothesis that the structural alteration triggered by the temporary removal of roof structure of space Gnd-E/04, may have caused the wall to lose its top tie action was simulated through the removal of the roof. Furthermore, the hoisting equipment mounted at the top of the wall during the reworking of the roof was simulated through the application of point load in the part model.

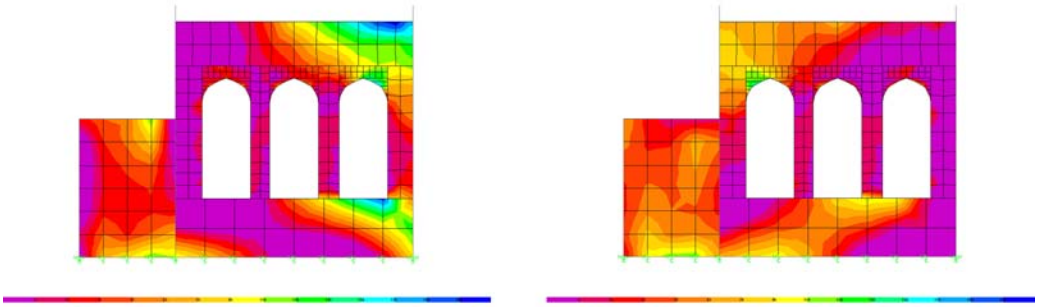
Figure 3.34: Maximum Principal Stresses (kPa) for wall Gnd-E/04-N-W
Left: North (exterior) Face; Right: South (interior) Face

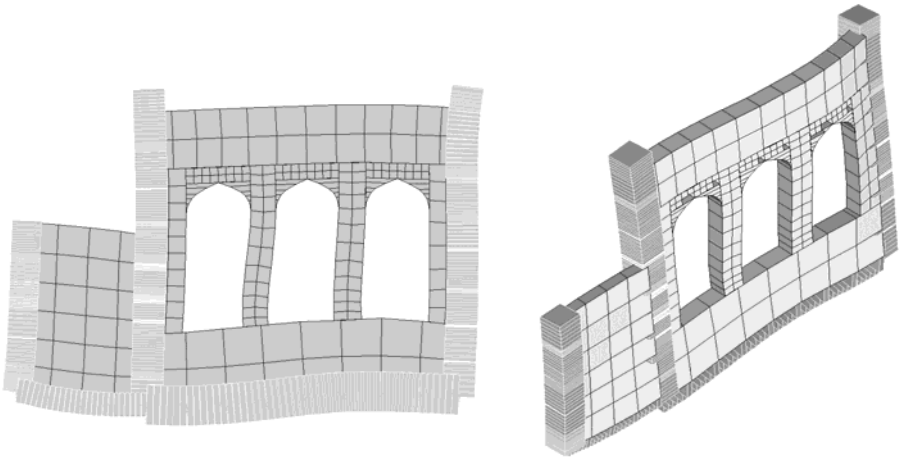
Figure 3.35: Deformed shape of wall Gnd-E/04-N-W
Left: North (exterior) face elevation showing differential settlement
Right: North (exterior) face 3D showing lateral buckling

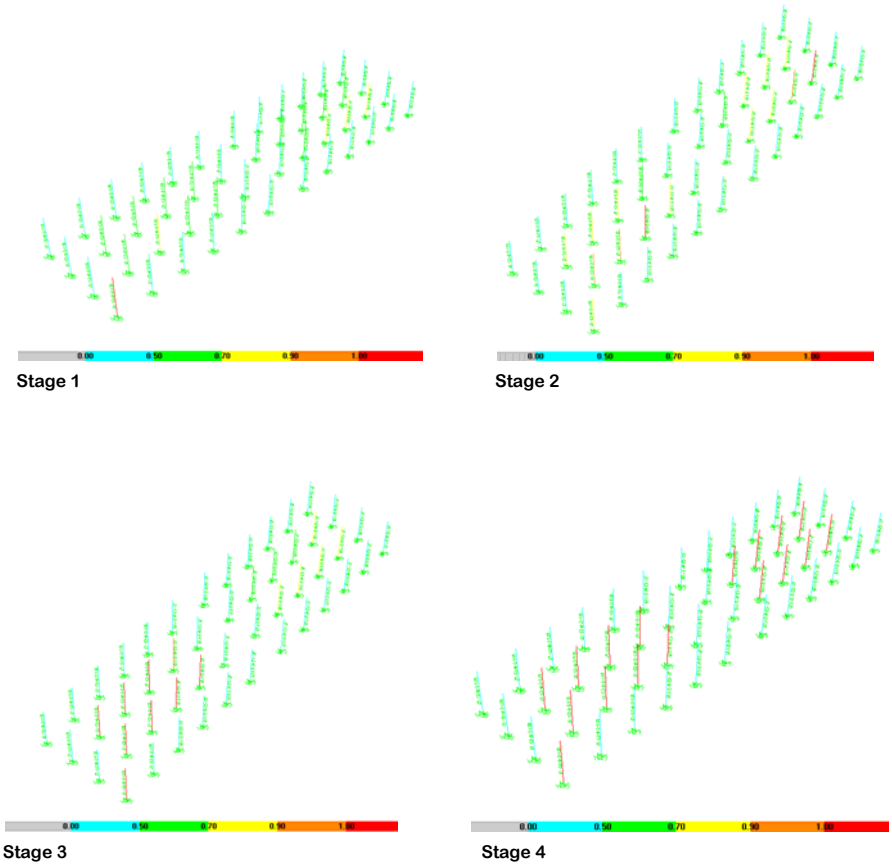
The CI columns were also evaluated as per UBC code. It was observed that although the utilization ratio remain under 1.0 for the gravity load combinations but the ratio exceeds 1.0 for seismic load combinations (Figure 3.36).

Figure 3.36: Evaluation Results of Cast Iron columns for all four stages.
Stage 1 (Top Left), Stage 2 (Top Right), Stage 3 (Bottom Left) and Stage 4 (Bottom Right)

Although, deformations in the CI columns have also been observed during the documentation stage of the study. But bearing in mind that the material aging and degradation of CI is based on the simplified approach of reduction of MoE of material it cannot be definitively stated whether the problem originates due to inaccuracies of casting or because the material is fatigued. Hence, for any conclusive safety evaluation apropos the structural performance of the CI columns detailed material testing is required.

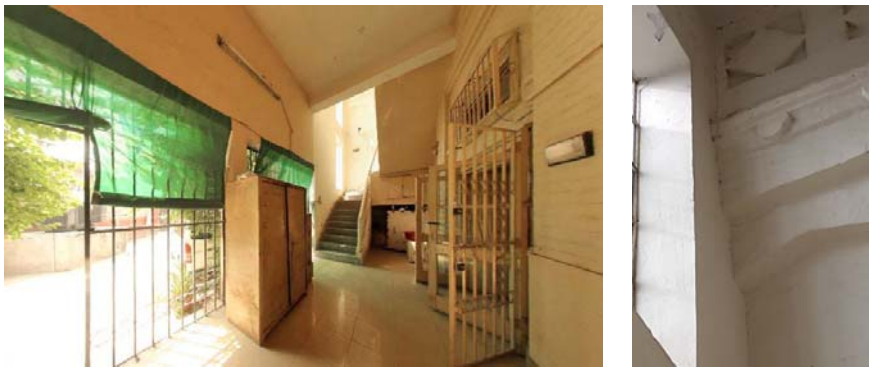
Figure B.49: Gnd-E/12 – Verandah/ Stair hall for Conservation Laboratory (2015)
Looking West (left) Separation Crack (right)

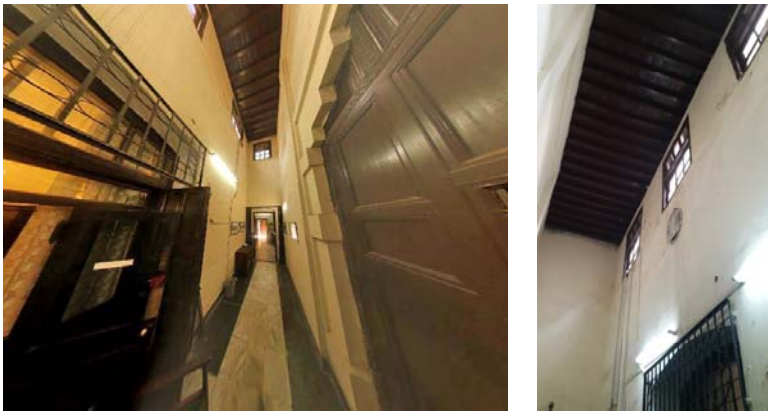
Figure B.55: Gnd-C/03 – Corridor connecting administrative areas to display areas (2015)
Looking West (left) Looking East (Right)

Drip marks flowing down the ventilators are observed on both the southern and the eastern walls (Figure B.55).

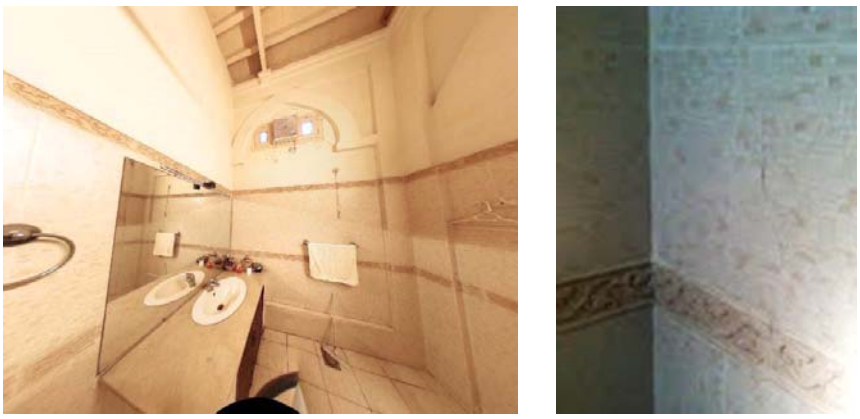
Figure B.58: Gnd-S/03 – Toilet for Director's Office (2015)
Looking South (left) Diagonal crack on the Northern wall (right)

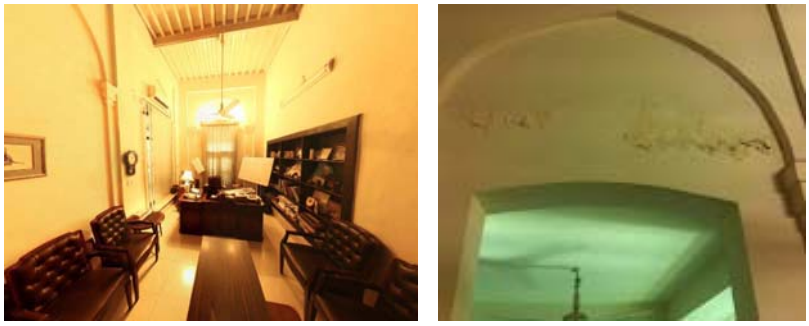
Figure B.59: Gnd-S/04 – Office for Director of the Museum (2015)
Looking South (left) Flaking of Paint on the eastern wall (right)

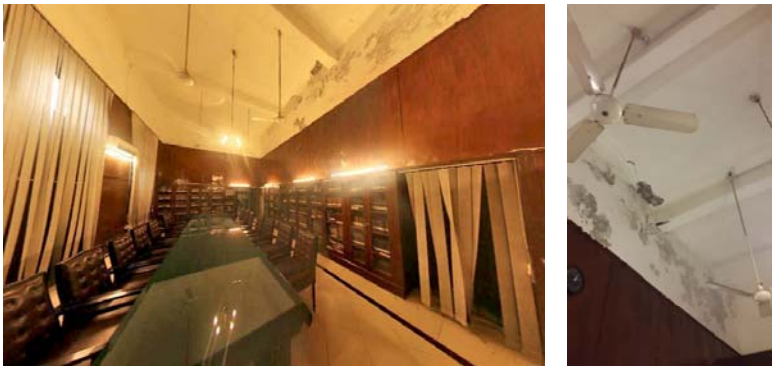
Figure B.74: Gnd-W/11 – Conference Room (2015)
Looking East (left) Flaking of paint on the southern wall & detachment of concrete (right)

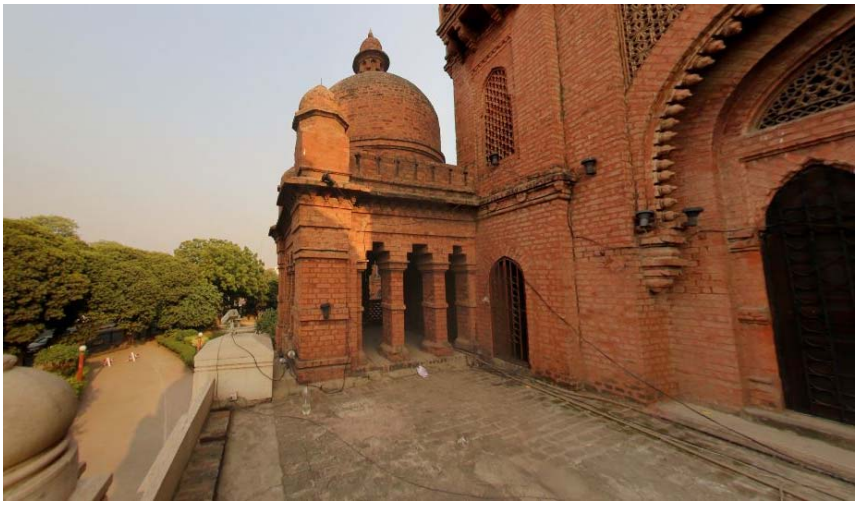
Figure B.85: Fst-N/03 – Terrace (2015)
Looking East

The space is accessed through the door leading from space Fst-N/01, in the southern wall. East of the door on the same wall is an arch, vertically divided into two sections. The upper section is horizontally divided into three sections and each section is fitted with terracotta *jalis* while the lower section is divided into three arch openings. The middle arch is fitted with a door leading onto space Fst-N/06 while the arches on either side have floor length windows. Further east of the arch is a door which leads onto space Fst-N/02. On the western side there are three corbelled brick openings leading onto space Fst-N/04. The eastern side has identical openings leading onto space Fst-N/05. The bounding surface on the northern side is a solid marble parapet which is 80cm (31.5in.) high in the middle and 36.5cm (14in.) on either sides. Microbiological growth is observed on the floor of the terrace.

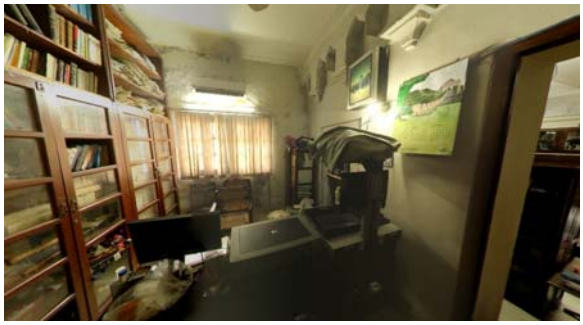
Figure B.118: Snd-W/05 – Digitizing Room (2015)
Looking North

The space is accessed through a door in the eastern wall. There is a window in the northern wall. There are no architectural features of importance on the western and the southern walls. The space has an RC slab roof. Flaking of paint due to dampness is observed on the northern wall.
