RESTORATION PROJECT OF ÇARBOĞA AND YENİGÜN HOUSES IN
ŞİRİNCE, İZMİR

A THESIS SUBMITTED TO
THE GRADUATE SCHOOL OF APPLIED AND NATURAL SCIENCES
OF
THE MIDDLE EAST TECHNICAL UNIVERSITY

JANUARY 2004

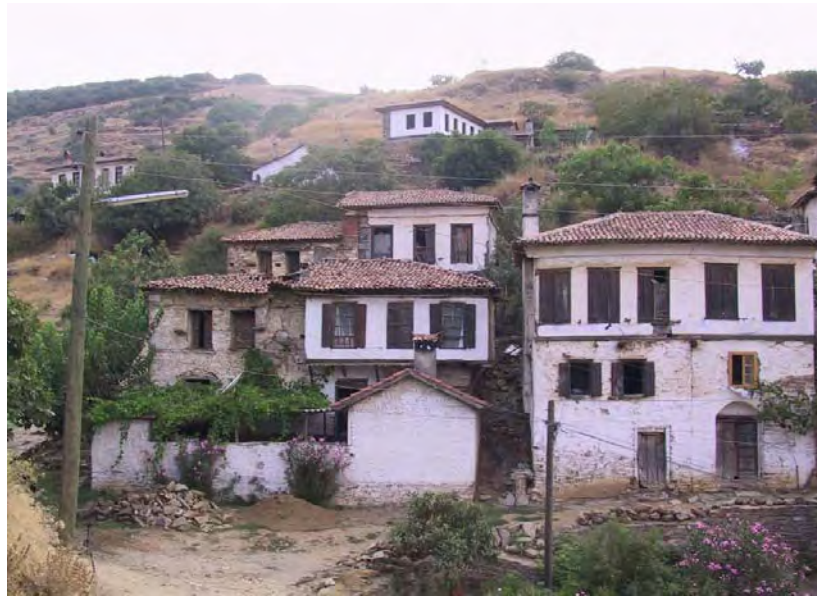
Figure 3.6 East elevation of Yenigün House

On both eaves there are missing boards and tiles.

The northern part of the roof of the south mass has partially collapsed. There are cracks and deformations on the northern part of the wall of the south mass.

On the timber elements insect holes can be observed, and they have changed colour due to radiation from the sun.

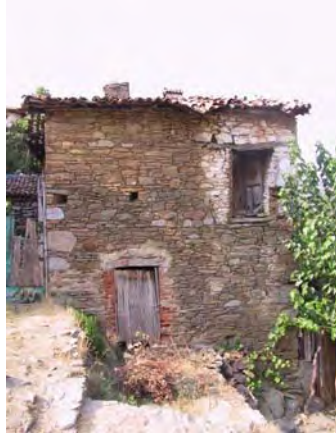
Figure 3.7 South elevation of Yenigün House

On the north side of the vertical joint, the wall of the fireplace in F01 space projects 17cm from the elevation. On the south part of the joint there are two holes 15cm by 15cm approx. 1.5m above ground level and placed with 1.30m distance. In the fabric of the wall there are two timber lintels one

of them 1m the other 1.5m long. They are not continuous, and are randomly placed; they do not refer to any architectural element on the elevation. There are traces of plaster on the wall of the fireplace and near the north corner.

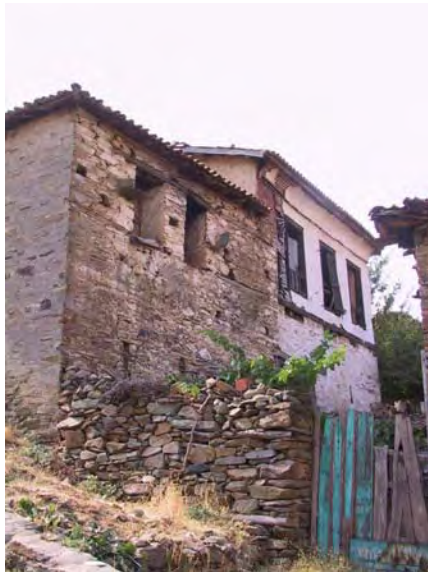
Figure 3.10 East elevation of Çarboğa House

On the first floor wall of south mass there are 3 windows with timber shutters and balustrades. Many of the shutters and parts of the balustrades are missing. On the first floor of the south mass, similar to Yenigün House there are two windows with timber shutters and there are stone shelves on sides of them and two tie beams below and above the windows extending throughout the elevation.

On the elevation of the south mass there are three rows of holes measuring 12cm by 12cm. There are 3 holes on lowest row, 2 and 4 in the remaining two respectively. The elevation is without plaster but there are traces of plaster below the windows.

On the elevation of the north mass, the ground floor is plastered and white washed. The plaster on the southern part of the wall is removed, the wood lath beneath is in a bad condition, and some of the pieces are broken or missing.

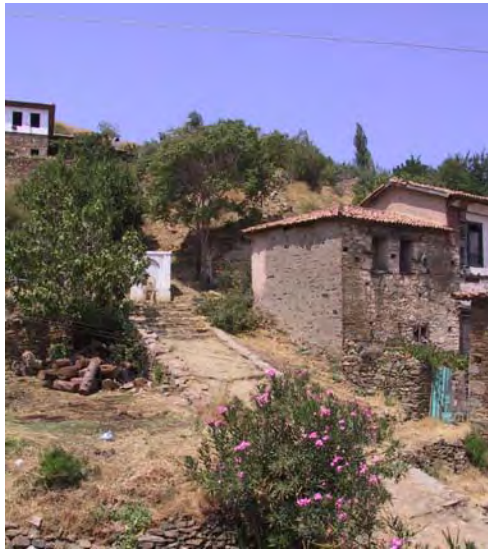
Figure 3.11 South elevation of Çarboğa House

The Courtyard wall of Çarboğa House is constructed with rubble stone masonry without mortar. There are tie beams in the fabric of the wall. The upper part of the wall is irregular it is approx. 1.5m high and is roughly parallel to slope. (See figure 3.11, 3.15).

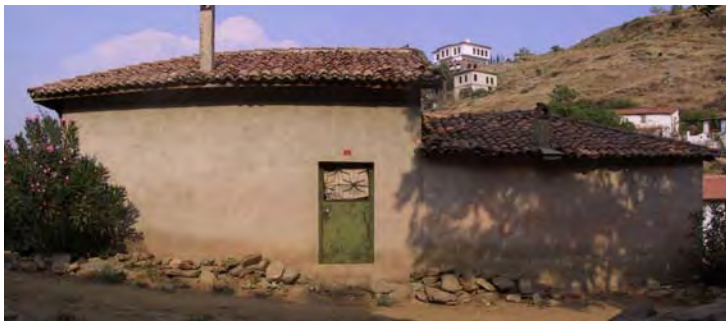
Figure 3.12 West elevation of Çarboğa House

The eaves project 38 cm at the north mass and 25 cm at the south mass. (See figure 3.12, 3.14)

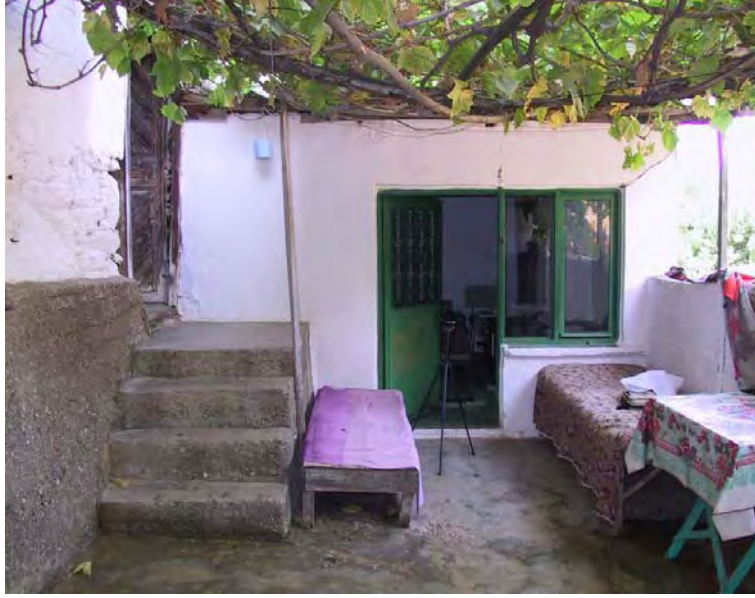
Figure 3.16 Courtyard of Yenigün House

The floor of the courtyard is covered with levelling concrete below which traces of slate stone covering is visible. (See figure 3.16)

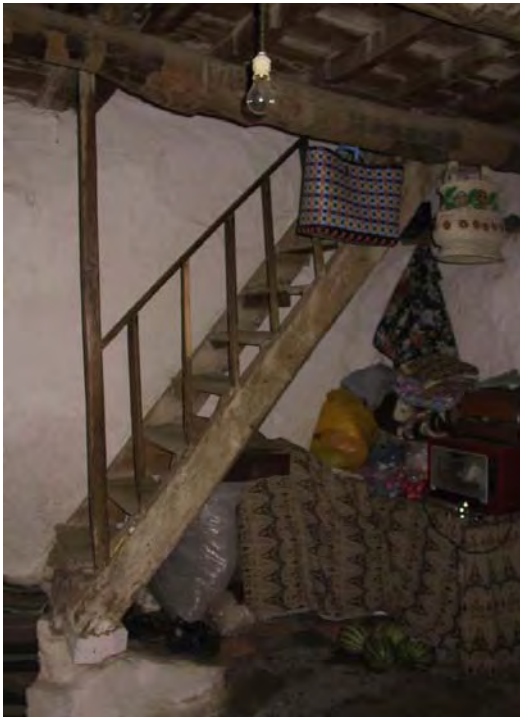
Figure 3.17 G01 space of Yenigün House

It is a rectangular space measuring 3.99m by 4.69m at north and west walls and it can be entered from the courtyard through D1-b door. In it there is the staircase leading to F01 space at first floor. The staircase is adjacent to the south wall. The first 3 steps are stone; the remaining steps are in timber. (See figure 3.17).

The floor is covered with levelling concrete. Traces of slate stone covering are visible beneath the concrete.

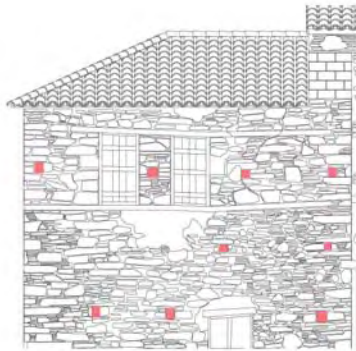
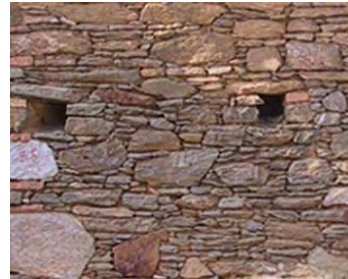
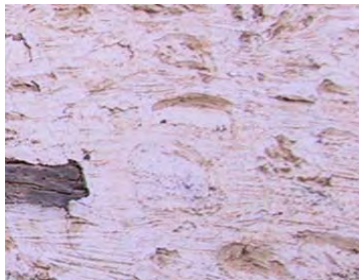
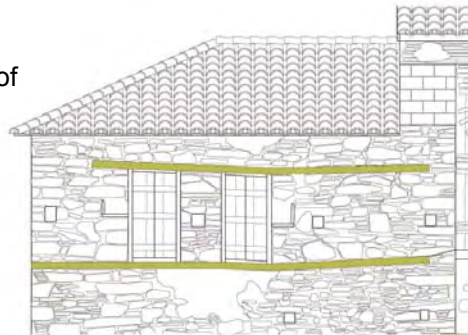
Figure 4.5 Material and construction system, stone masonry walls type 3 (continued)

Rubble stone masonry wall with lime mortar, with lime plaster.

Observed at ground floor and first floor walls of Çarboğa and Yenigün Houses.

Larger stones are used and the fabric is rigid at the corners. The order diminishes towards the center of the wall. App. 10cm by 10cm holes are located with app. 1m distance on the facades

Below and above openings bands of timber lintels are used.

Texture was observed on the plaster on exterior walls.

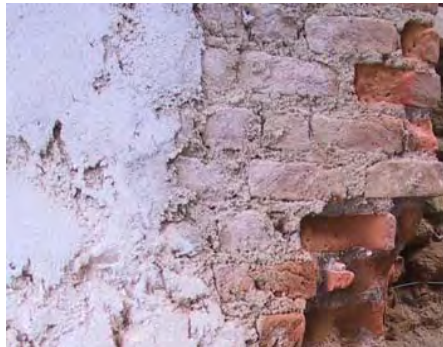
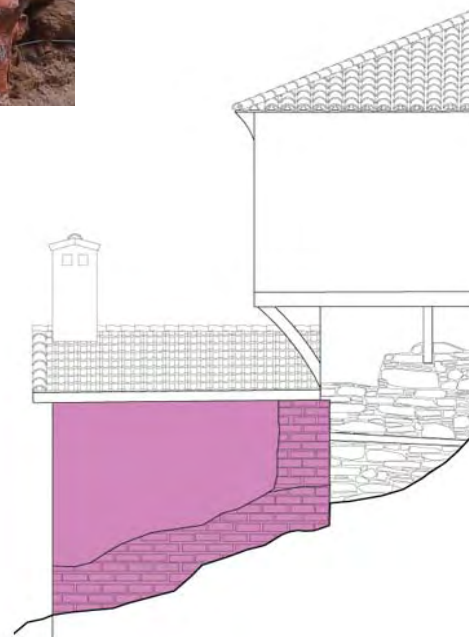
Figure 4.6 Material and construction system, brick masonry walls type1

There are two types of brick masonry walls observed in the houses. The first type (B1) is constructed with solid bricks measuring 8cm by 10cm by 20cm. It is observed on the walls of G03 and G04 spaces in the courtyard of Yenigün House. It is also observed in the jambs of altered doors in Yenigün House. (See figure 4.6)

Solid brick masonry wall with lime mortar, with lime plaster.

Observed at walls of G03 and G04 spaces, courtyard wall, jambs of altered doors of Yenigün House

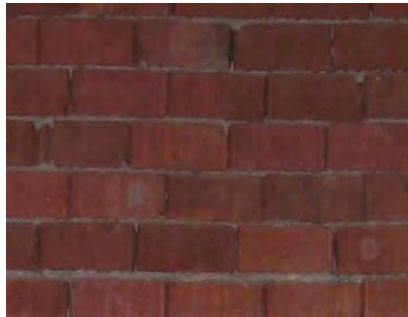
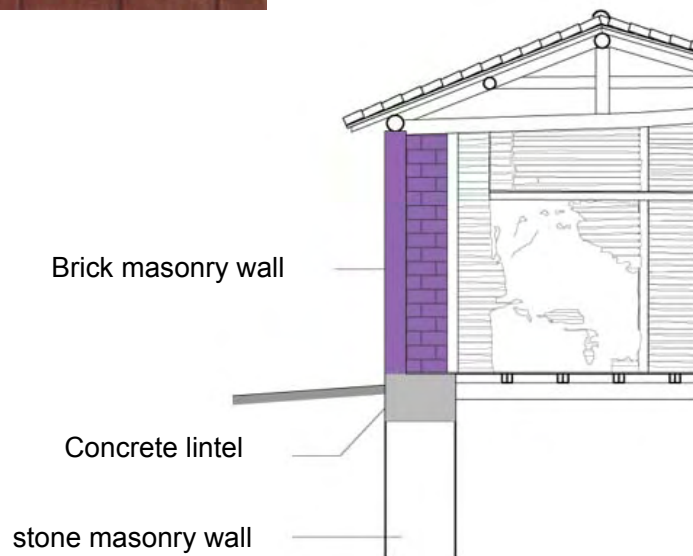
Figure 4.7 Material and construction system, brick masonry walls type 2

The second type (B2) is observed in first floor walls of Çarboğa House. Between the stone masonry ground floor walls and the brick walls, cement lintels are placed. The binding material is cement mortar. The exterior faces of the west wall and the west corner of the south wall are covered with cement plaster. The interior faces and the other walls are left bare without finishing. (See figure 4.7)

Hollow brick masonry walls with cement mortar, with cement plaster.

Observed at first floor walls of Çarboğa House

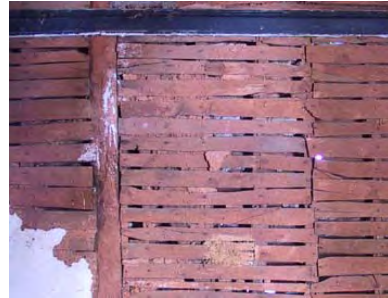
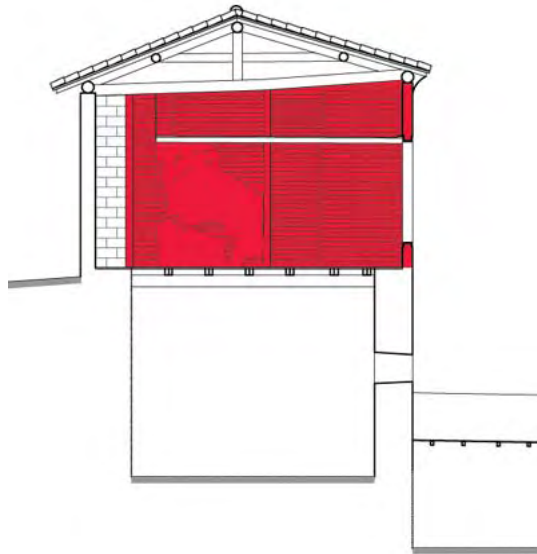
Figure 4.8 Material and construction system, timber frame walls type 1

sections of approx. 10cm by 15-cm. The wood lath has a rectangular cross-section of approx. 2cm by 6cm. (See figure 4.8)

Observed at first floor walls of Yenigün and Çarboğa Houses

Woodlath has rectangular cross section. (app. 1cm by 4cm)

woodlath and plaster is applied on both sides of the wall.

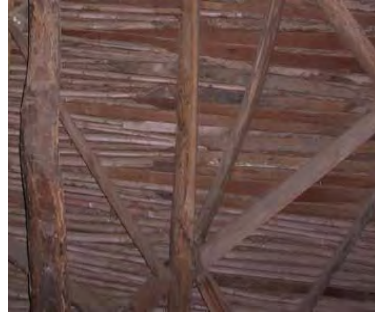
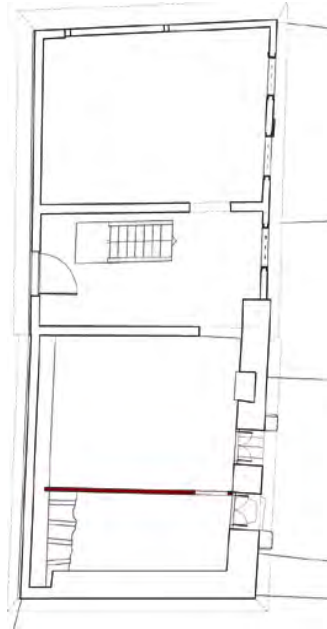
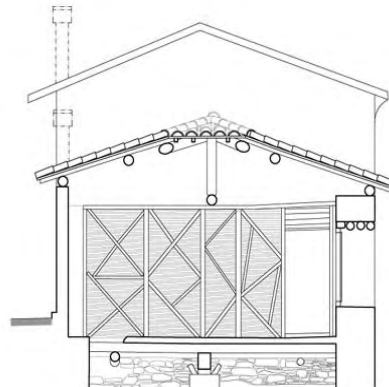
Figure 4.9 Material and construction system, timber frame walls type 2

Instead of wood lath and they are covered with reed and lime plaster. The south face of the construction is left bare without wood lath or plaster. (See figure 4.9)

Observed at the wall between F03 and F04 spaces of Çarboğa House.

Reed sticks with circular cross section are utilized for woodlath.

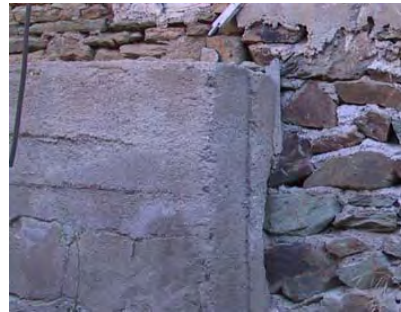
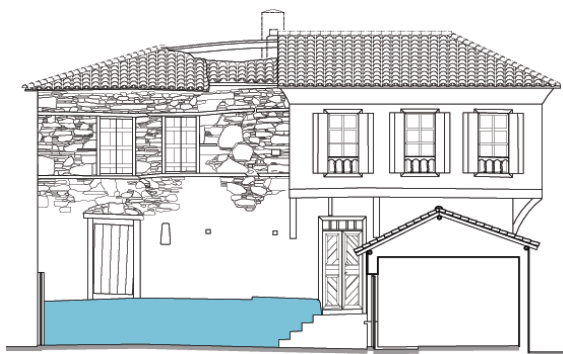
Figure 4.10 Material and construction system, timber frame walls type 3 and concrete walls

At east elevation of both houses, a 20cm thick and approx. 1m high concrete wall is built in front of the stone masonry wall. (See figure 4.10)

At the east elevation of Çarboğa and Yenigün Houses a 20cm thick and 1m high concrete wall is attached to the stone masonry wall at ground level.

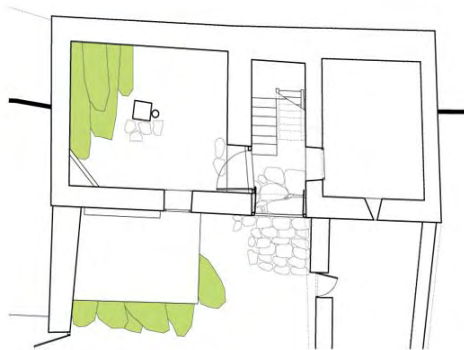
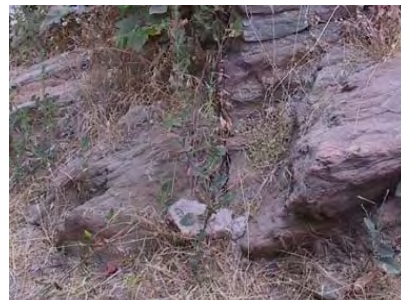
Figure 4.11 Material and construction system, floors resting on ground A1 – A2

Observed at courtyard of Çarboğa House and ground floor of both houses. At ground floors the rocks alternate with slate stone paving. Especially the west walls (which also serve as foundation walls) rest on rocks.

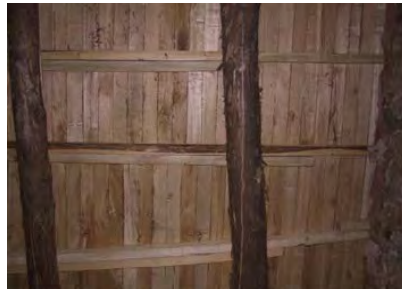
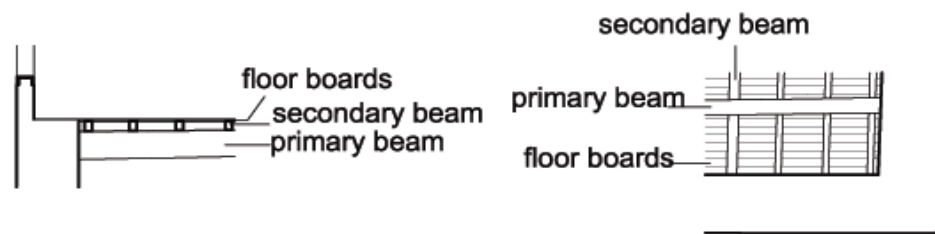
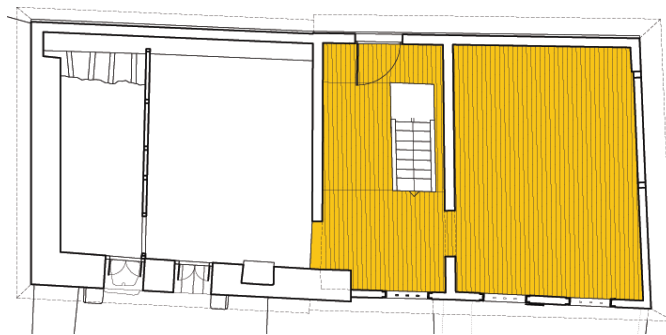
Figure 4.14 Material and construction system, first floor floors type2

The second type (B2) is observed on the floor of F01 and F02 spaces of Çarboğa House. These floors are recently altered. Finely shaped secondary beams of approx. 6cm by 10cm cross sections are supported over circular cross-sectioned primary beams. The floorboards have 10cm by 2cm cross-section. (See figure 4.14).

Observed at floors of F01 and F02 spaces of Çarboğa House.

The floors are recently altered. There are circular sectioned primary beams and finely shaped secondary beams with rectangular cross section of app. 6 x 10 cm. The floor boards are app. 10 cm wide.

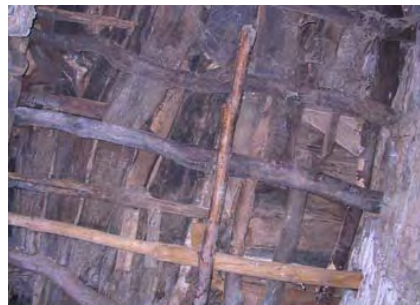
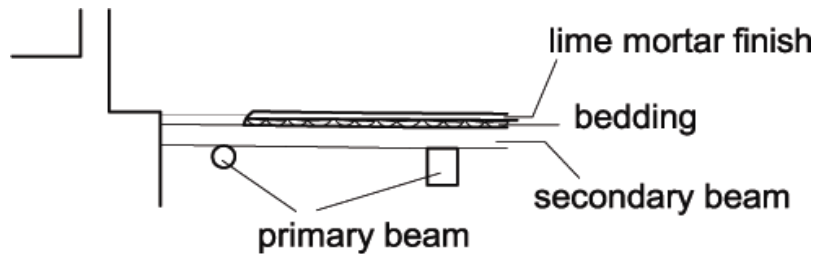
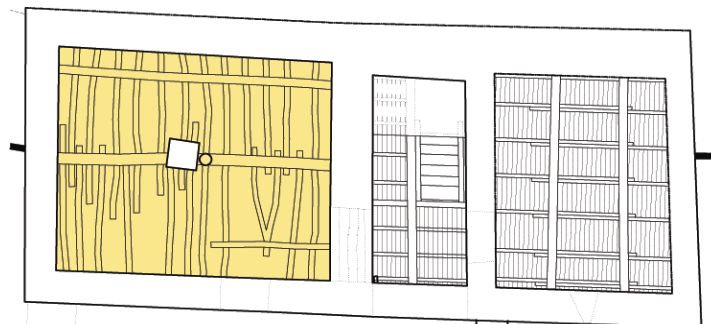
Figure 4.15 Material and construction system, first floor floors type3

The third type (B3) is observed on the floors of F03 and F04 of Çarboğa House. The primary beams and secondary beams are similar to those of G02 space of Yenigün House. Roughly shaped secondary beams are placed with approx. 15-cm distance over a single primary beam. The primary beam is supported by the stone masonry pillar in the centre of the room. Over the secondary beams a bedding of timber pieces are placed over which a lime mortar finish is applied. (See figure 4.15)

Observed at floors of F03 and F04 spaces of Çarboğa House.

There are roughly shaped primary and secondary beams with circular cross sections. Above the secondary beams a bedding of timber pieces is placed, over which lime mortar is applied as floor finish.

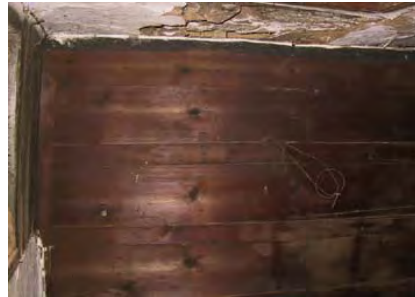
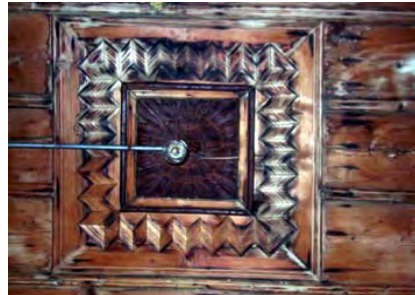
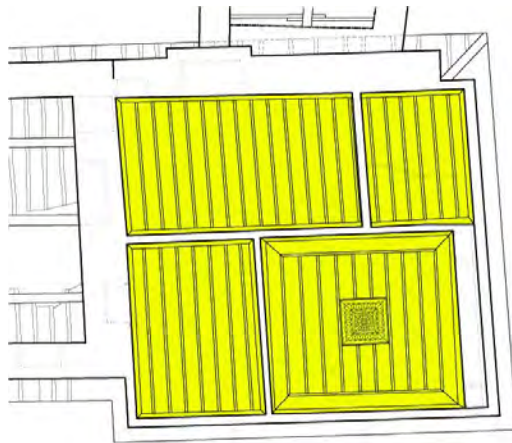
Figure 4.16 Material and construction system, ceilings below roof construction type1

A centrally located decorative panel can be observed at the ceiling of F02 in Yenigün House. (See figure 4.16)

Observed at ceilings of F01, F02, F03 F04 of Yenigün House and F03 of Çarboğa House. Roof construction above these ceilings could not be observed.

Ceiling boards are app. 25cm x 2cm. The laths between the boards are 4cm wide at Yenigün House, 9 cm at Çarboga House

A centrally located decorative panel can be observed at ceiling of F02 of Yenigün House

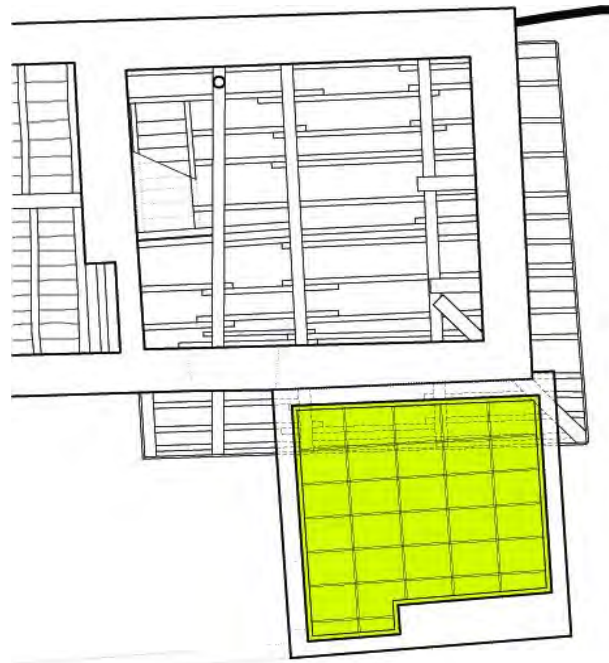
Figure 4.17 Material and construction system, ceilings below roof construction type 2

The second type (C2) is observed at the ceiling of G03 at Yenigün House. It is formed with plywood panels over which 2.5cm thick narrow strips of wood are nailed. (see figure 4.17)

Observed at ceiling of G03 space of Yenigün house

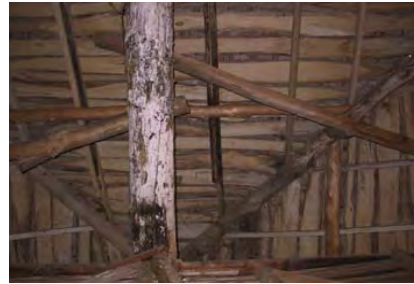
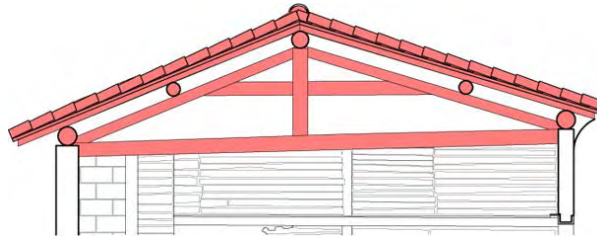
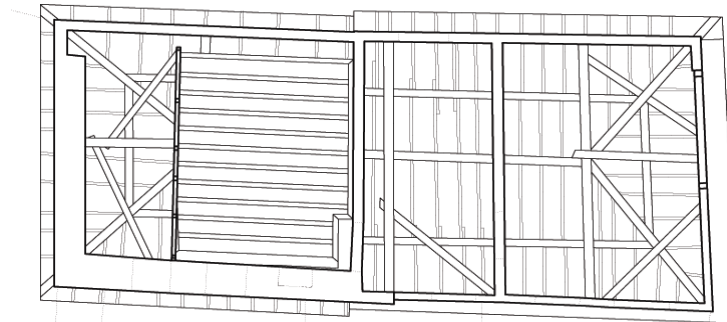
Figure 4.18 Material and construction system, roof type 1

The roof is covered with over and under tiles. (See figure 4.18)

Observed at roof of Çarboğa House.

The roof has been recently repaired. The Beams are roughly shaped circular sectioned timber. The rafters are finely shaped timber with app. 6cm x 10cm rectangular section.

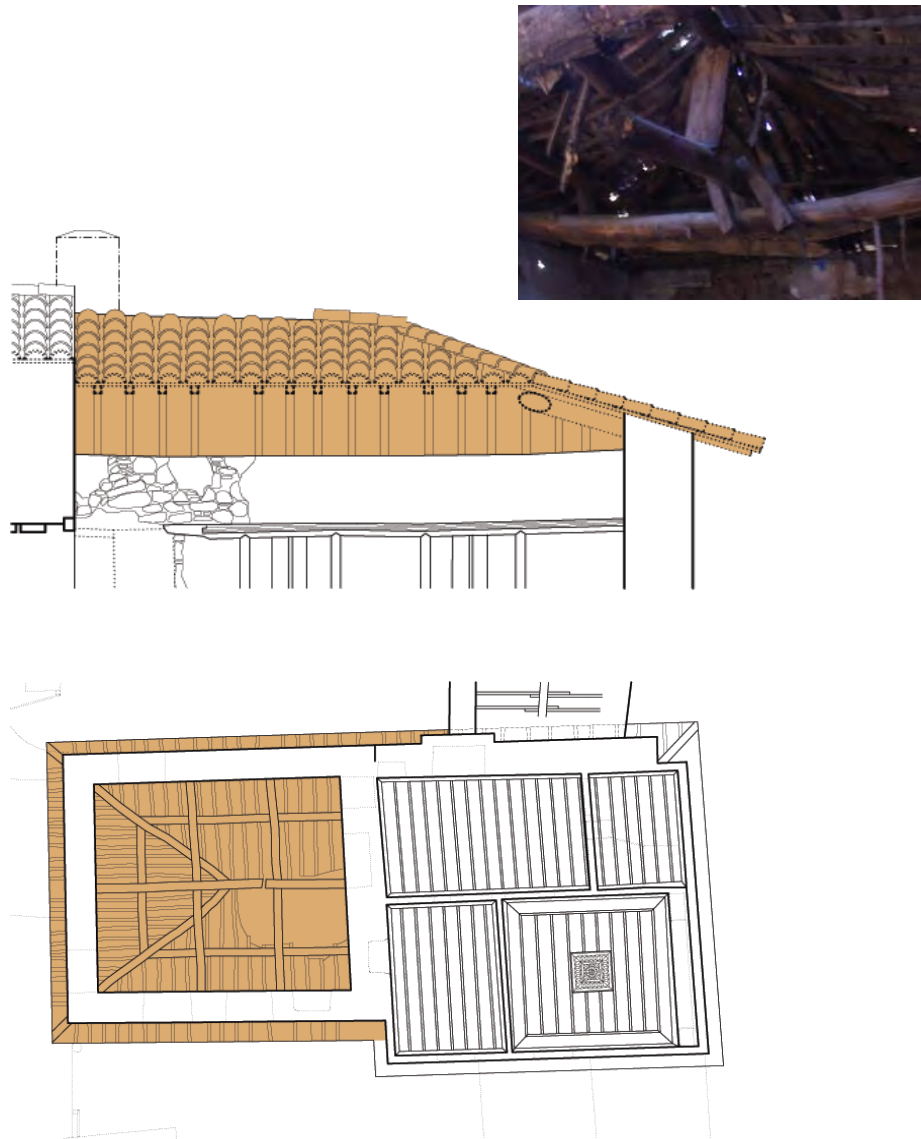
Figure 4.19 Material and construction system, roof type 2

The roof of Yenigün House can only be observed in F05 space where the ceiling is missing and the roof itself has partially collapsed. It has a gable roof with roughly shaped beams and rafters. (See Figure 4.19)

Observed at roof of Yenigün House over G05 space.

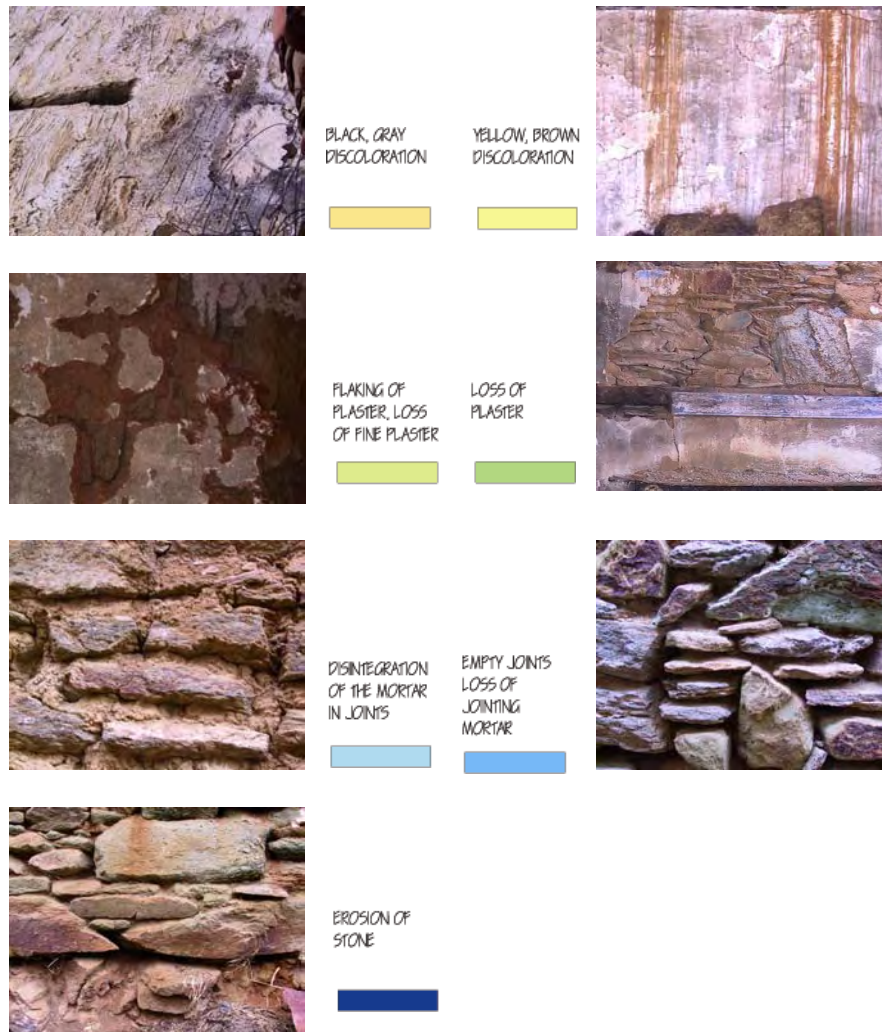
Problems in stone masonry walls type 3

The problems in stone masonry walls Type 3 were observed in 4 stages.

The first stage is the problems observed on the plaster. The second stage is the disintegration of the mortars in the joints; the third is the loss of jointing mortar (empty joints); and the fourth is the erosion of the stones. (See figure 4.31).

On east facades of both houses disintegration of mortar is observed on south mass, between the eave and the windows. At Çarboğa House the same problem is seen also near the ground level, over the concrete platform. At Yenigün House, on the part of the eave where the roof has partially collapsed empty joints can be observed together with cracks on the wall surface.

On the south elevation of Yenigün House the plaster is totally missing and there is disintegration of the mortar on the whole façade. On the higher east corner of the façade between the eave and the window there are empty joints. To the east of the window there is erosion of stones and missing stones on the wall.

On the north elevations, starting from the ground level deterioration is seen in stages. Lower parts are more deteriorated and empty joints can be seen. On Yenigün House near the ground level erosion of stone can also be seen. On the upper parts of the masonry walls the plaster still remains.

As a result the problems on masonry walls are seen near the ground level and near the eaves especially where the eaves are damaged and therefore they are probably caused by humidity problems like rainwater penetration and rising dampness.

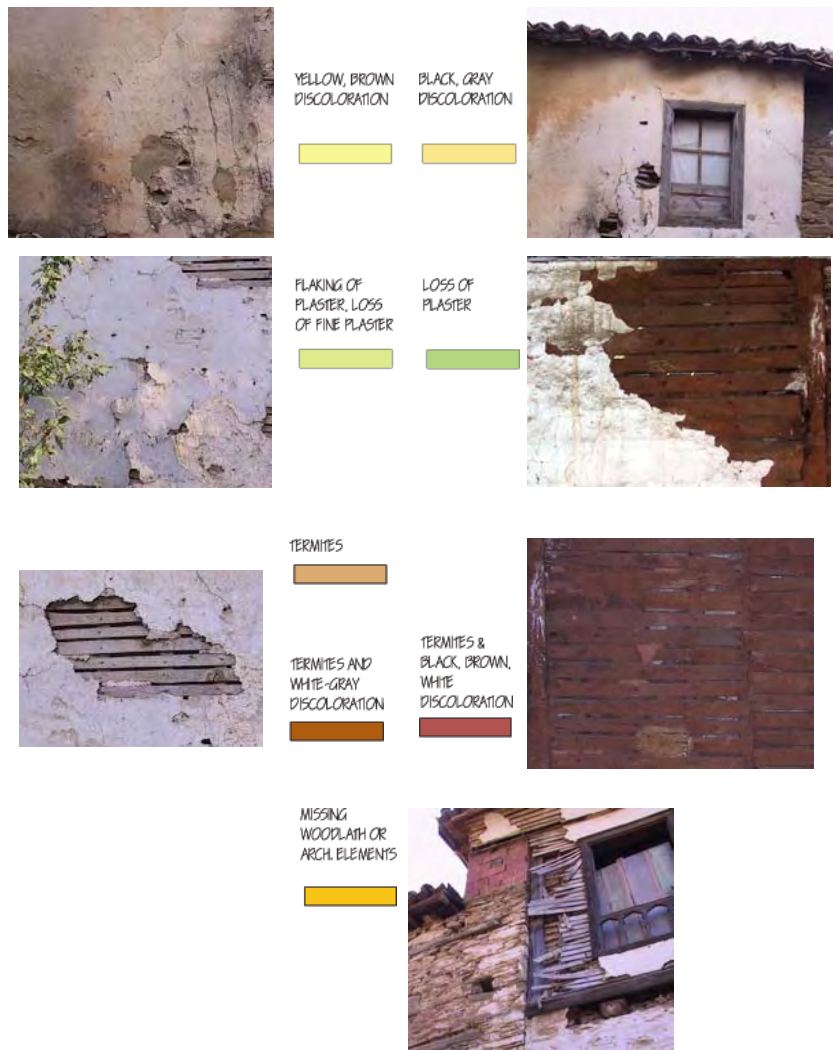
Figure 4.33 Material problems on timber frame walls

The problems on timber frame walls Type 1 are seen in 4 stages. The first stage is the problems with plaster. (see below). The second stage is the presence of termites. The third stage is the presence of termites together with white / grey or brown discoloration on timber elements. The fourth stage is missing wood-lath on wall construction. (See figure 4.33).

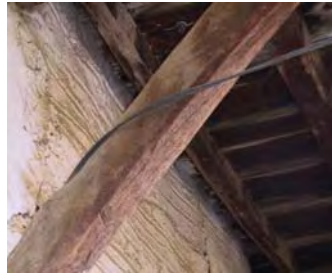
TERMITES

The deterioration in the first floor floor type 1 is seen in four stages. The first is the presence of termites. The second is the presence of termites together with white-grey discoloration, the third is termites together with black brown and white discoloration and the fourth is termites together with black, white brown discoloration and spongy appearance. (See figure 4.34).

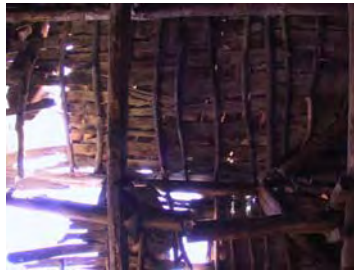
TERMITES &
BLACK, BROWN,
WHITE
DISCOLORATION

Roof type 1 can be observed above F05 space in Yenigün House where the ceiling cover is missing. On this construction the presence of termites together with black, brown and white discoloration and spongy appearance can be observed. These problems are accompanied with serious structural problems as the north east corner of the roof has collapsed. (See figure 4.35)

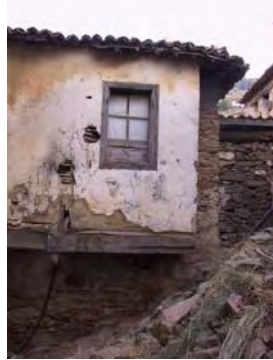
Crack on Masonry
Wall

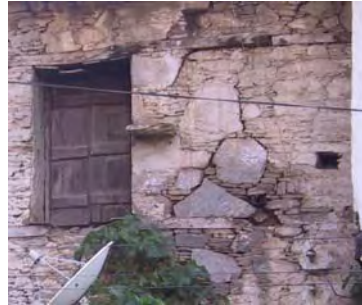
Sagging of Floors
/ Ceilings / Roof

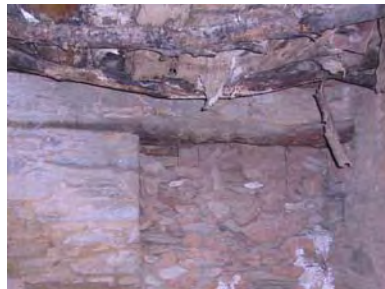
Disjointing of Walls / Walls
and Ceiling and Floors

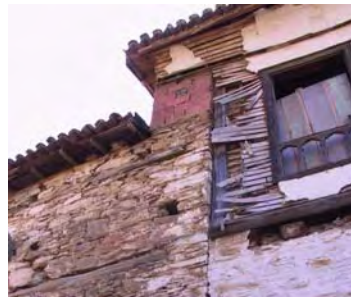
Partial Collapse

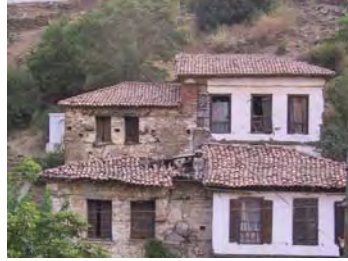
1 - Roofs of north and south masses are constructed separately

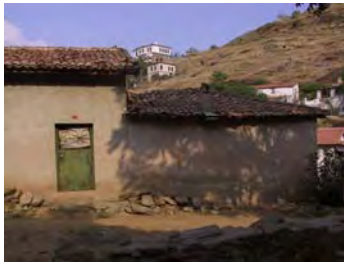
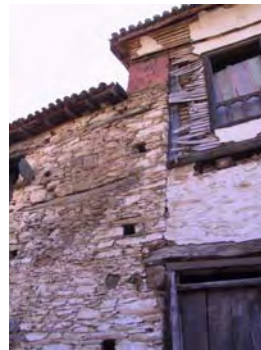
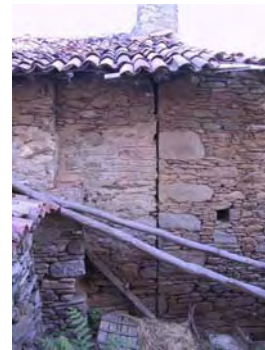
2 - There is a vertical joint on east and west façade of the houses between the north and south masses.

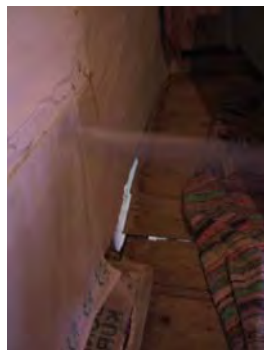
3 - There is a gap of 1-2 cm between the floor construction and west wall of F01 space of Yenigün House

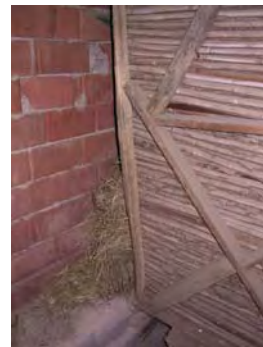
In Çarboğa House In F03 and F04 spaces the floor construction is 48cm away from the west wall, indicating the original thickness of the stone masonry wall. (See figure 4.45).

4 - There is a gap between the floor and ceiling construction and west wall of F03 and F04 spaces of Çarboğa House

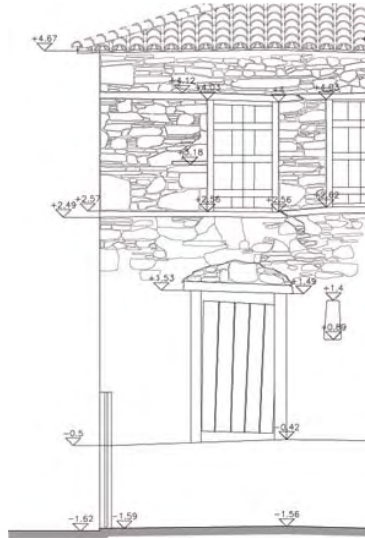
4 - Door of F02 space of Yenigün House is 1m above courtyard level

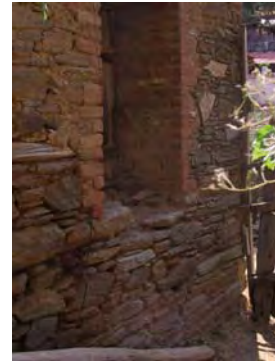
5 - Aborted opening between F01 and F05 spaces of Yenigün House.

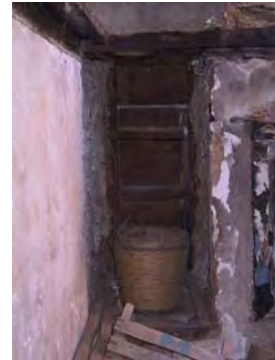
Figure 4.49 Indicators of alterations, peculiarities in architectural elements

Between the floor of F01 space and F03 space in Çarboğa House there is a level difference of 70-cm and there are no steps between the two spaces. On the wall surface 20cm below the wall surface there are traces of floorboards. (See figure 4.49)

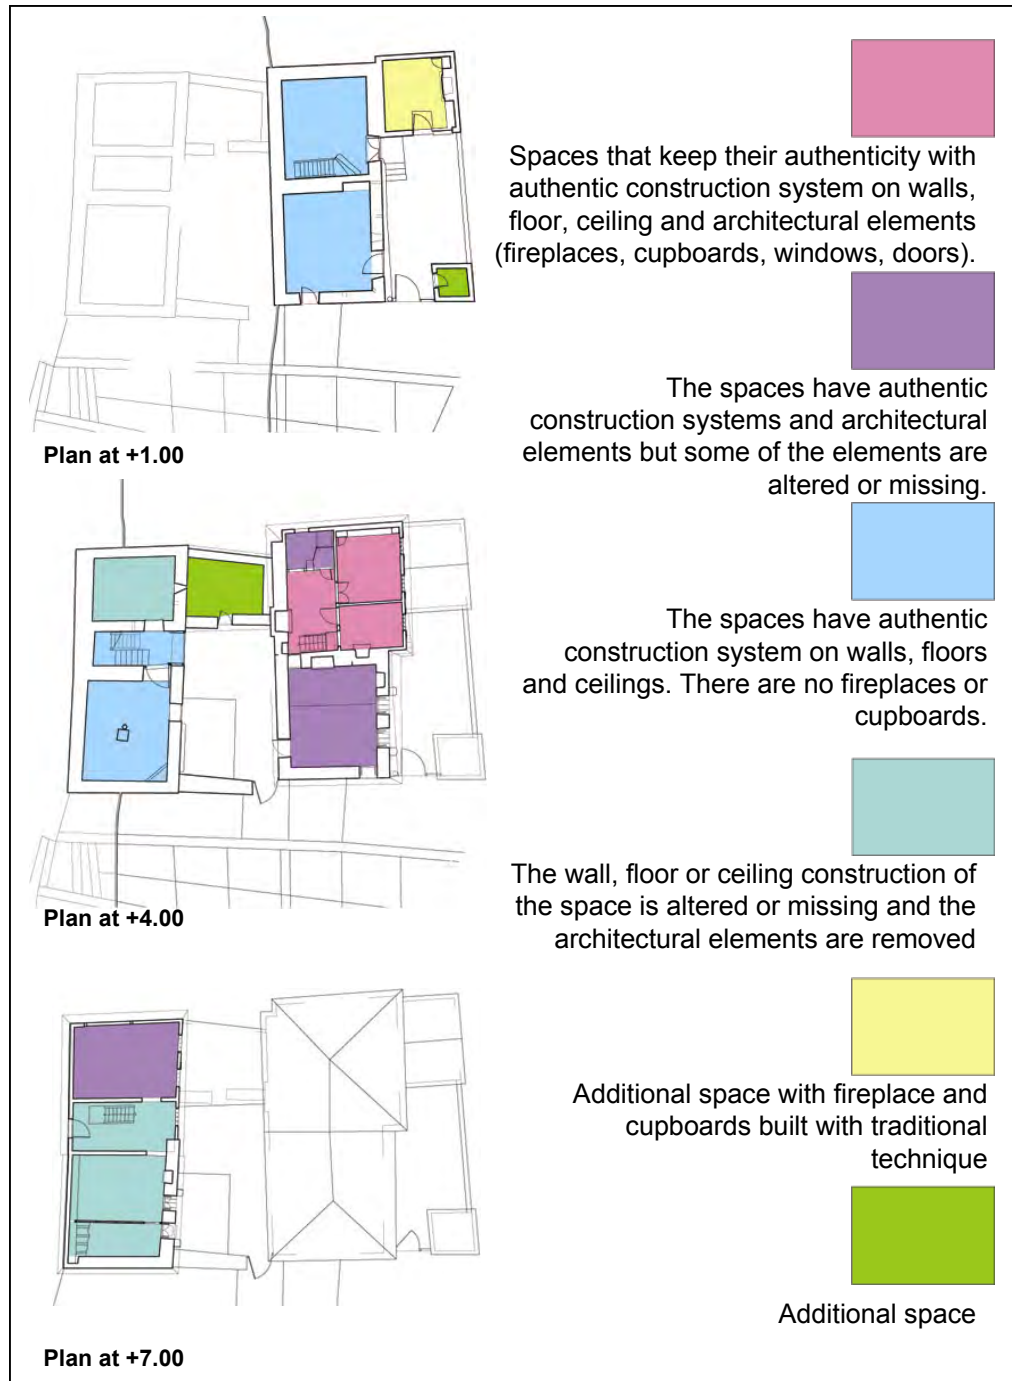
Figure 7.4. Evaluation of the spaces in the building – Authenticity of the spaces

Çarboğa House has undergone some alterations in recent years and lost some of its architectural elements but conserves the authentic plan layout.

In the courtyard the slate stone steps are missing and the concrete platform is added. In G01 space the concrete staircase is added but the trace of the original staircase is left on the south wall. The door wings of G02 and G03 spaces are missing and screed is applied over slate stone paving of G02 space. In the first floor the authenticity of the spaces is destroyed with the alteration of the stone masonry walls on west façade and interior walls with brick masonry walls. This alteration has generated problems with the joining of walls and floors and ceilings since the dimensions are set according to stone masonry walls. Furthermore some of the authentic architectural elements like the door and cupboard of F02 space, door and fireplace of F03 space are removed during this alteration. Another important alteration in Çarboğa House is the removal of the ceilings

of F01, F02 and F04 spaces. The authentic ceiling decoration of F02 space is removed during this alteration.
