RESTORATION AND REVITALIZATION PROJECT OF HOUSE NO 1 in  
ZENGINLER DISTRICT BUYUK CIKMAZ - ANTAKYA

A THESIS SUBMITTED TO  
THE GRADUATE SCHOOL OF NATURAL AND APPLIED SCIENCES  
OF  
MIDDLE EAST TECHNICAL UNIVERSITY

MAY 2008

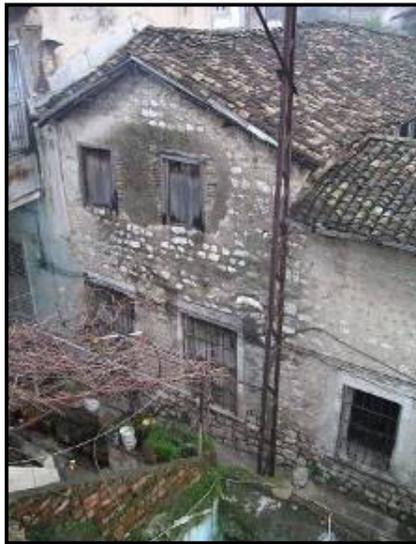
**Figure 3:** North-east Façade (author April, 2003)

openings are made of cut and fine cut stone blocks. At the left corner of the façade, right behind the projection, the stone wall has been combined with almost 45 degrees about 42cm long fine cut stones. From -0.10cm level to +0.03cm level, this surface has been attached the corner with a curvilinear carved stone block.

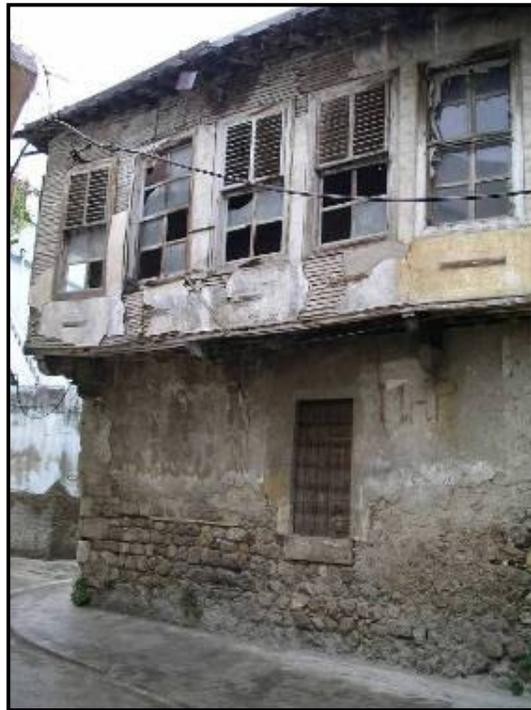
**Figure 4:** North-west Façade (author April, 2003)

Timber skeletal first floor is lime plastered but almost the half of the plasters has been lost. At those parts, the wood-laths can easily be seen. The left hand side of the first floor - from the second window to the left corner – has rubble stone infill with lime mortar binding. There is a flue 2.70m far from the right side at 4.40m level. Each window has a timber framing piece which is located almost 30cm below and these framings are 35cm long.

The eaves project 90 cm from the roof. Like the other parts of the roof, the facial boards at edges of the eaves stand back. The roof tiles have been lost at those parts.

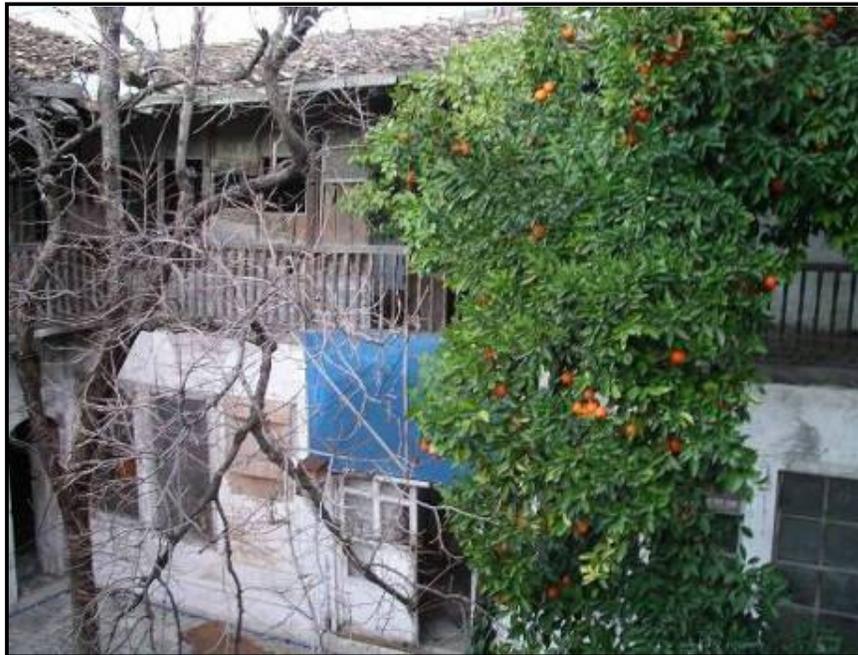
**Figure 8:** North-east Façade of the Courtyard (author April, 2003)

There are six windows and three of them are on GF03 space's wall and the other three is on GF05 space's wall. All of the windows are sash and they have the same feature. The first window at the left side has iron balusters which have been fixed horizontally. Some of the elements of the baluster have been lost and the others have leaned. The second window at the left side also has iron balusters. It is forged and inappropriate with the dimensions of the window. The

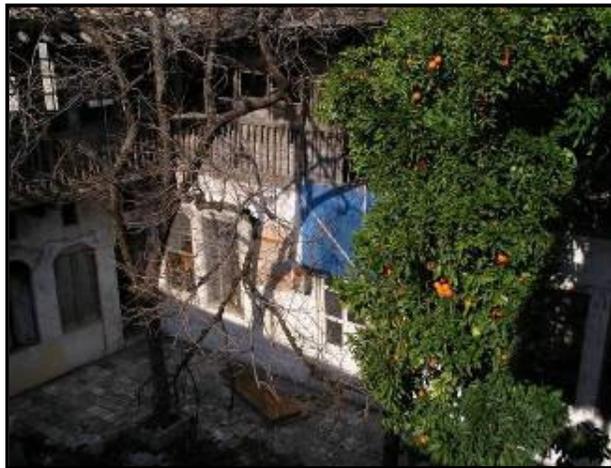
**Figure 9:** Courtyard (author April, 2003)

The floor covering of the courtyard is of cut stone. There is a well located near the entrance door of GF07 space and there are two trees in the middle of the courtyard. There are also a fountain and a washbasin on the courtyard wall underneath of the stair which goes to north-west mass' first floor.

The courtyard wall is stone masonry. However, baked brick masonry can be observed at some parts of it.

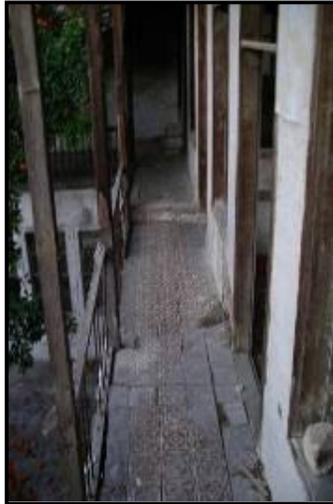
**Figure 19:** Circulation Space at South-east mass (author April, 2003)

The floor cover is of mosaic tiles. There is a row consisting single colour tiles and the others are figured mosaic tiles. The floor has been divided into two and has a level difference as one step. The level of the floor at stair side is +1.97m and 2.11m at left hand side. The step is of fine cut stone but a half of it has been lost. A timber piece has been used instead of this lost element.

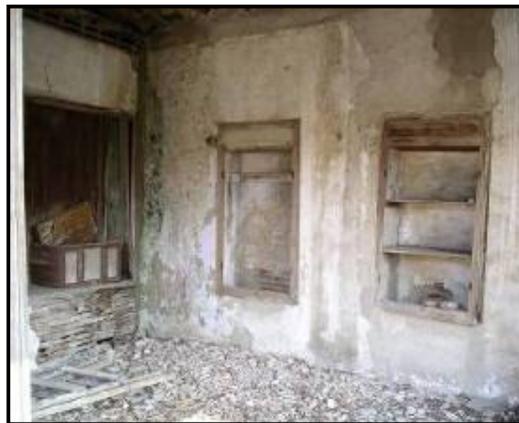
**Figure 20:** Space FF01 (author April, 2003)

The north-east wall has the entrance door and two windows open out circulation corridor. It finishes at +5.27m level with a profiled timber cornice. The rest of the wall is lime plastered and lime-washed. The plaster has been lost at some parts and the wood-laths have come out.

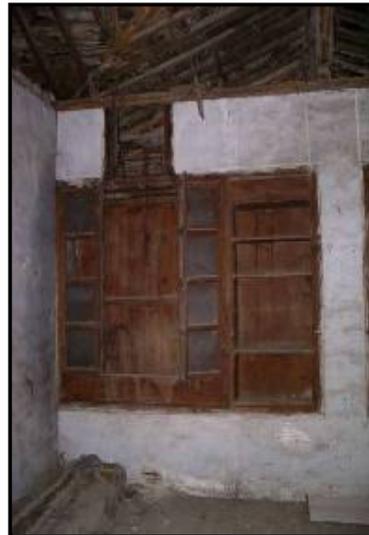
**Figure 21** : Space FF02 (author April, 2003)

The south-west façade has been organised like a mirror of neighbour wall of space FF01. The cupboard (CPV) at the left corner has the door which includes three wings. The timber cornice does not exist but the supporting beam of it still at its place. The surface is lime-washed on lime plaster.

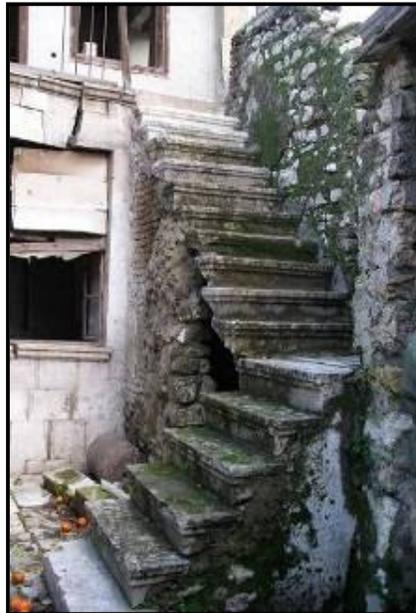
**Figure 29:** Stone Stair at the South-east Side of the Courtyard (author April, 2003)

The stone stair which is located at the right hand side of the courtyard entrance is "L" shaped and goes up to first floor of south-east mass. It has double flights and consists of sixteen steps. Ten of the steps are at second flight and the six of them are at first flight. The first step of the stair is just like the steps at other stone stair but the others are more detailed in comparison to the one flight stone stair's steps. Unlike the other stair, the steps do not get inside to the courtyard wall. Each step carry the one above and also a jerry-built composite wall built up with bricks and rubble stone pieces supports the steps of second flight. The width of the stair is 95cm. The height of the steps is 17cm and the landings are 25cm.

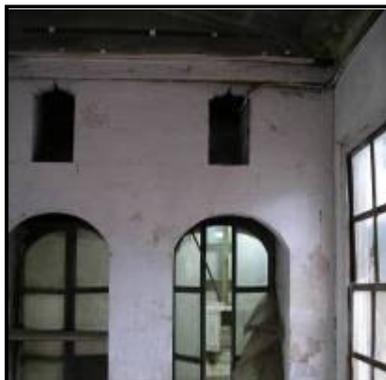
**Change:** The top windows between GF02 and GF03 spaces have been altered.

**Evidence:** The top windows have been closed from the GF03 space.

**Figure 36:** Top Windows between Space GF02 and GF03 (author April, 2003)

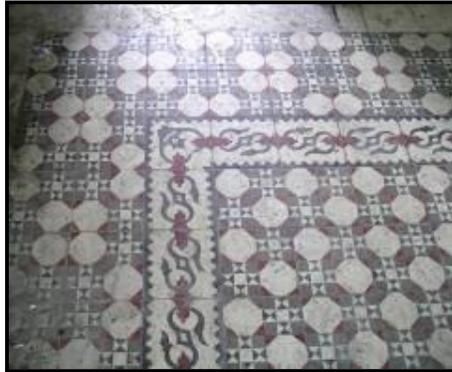
**Change:** The mosaic tile floor covering of the GF02 space is an alteration.

**Evidence:** This kind of floor covering materials started to be used with French Mandate period.

**Figure 37:** Mosaic Tile Floor Covering of Space GF02 (author April, 2003)

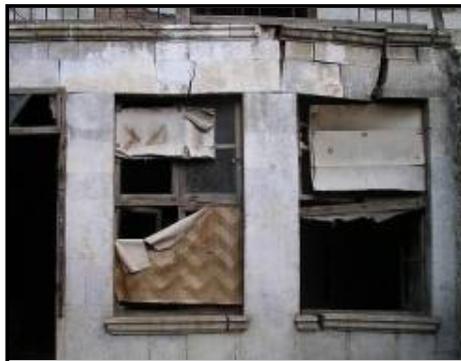
**Change:** The two windows of the space GF01 have been altered.

**Evidence:** Use of fine cut stone pieces on inner side of the surfaces and brick depressed arches at the top are the indicators of alteration. Furthermore, the flat arches of the outer surface and the dimensions of the openings are peculiar.

**Figure 38:** The Windows of Space GF01 (author April, 2003)

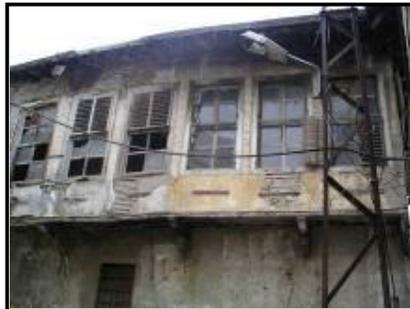
**Change:** The shutters of the windows located on the first floor of north-west mass have been altered.

**Evidence:** The wooden laths placed under each window are the indicators of different type of shutters. Besides, the shutters of FF06 are stable at the top even if they seem like folding. There is not any hinges or traces of hinges at those parts, either.

**Figure 40:** The Shutters on First Floor (author April, 2003)

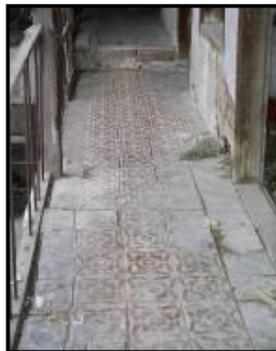
**Change:** The mosaic tile floor covering of the circulation corridor on first floor of south-east mass is an alteration.

**Evidence:** This type of materials started to be used with the French Mandate Period.

**Figure 42:** The Mosaic Tile Floor Covering of the Circulation Corridor (author April, 2003)

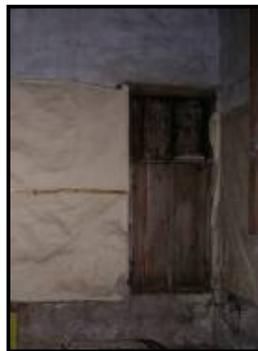
**Change:** The bed-light in-between the space GF06 and GF07 has been altered.

**Evidence:** The window has been closed with timber pieces.

**Figure 44:** The Bed-light between GF06 and GF07 Spaces (author April, 2003)

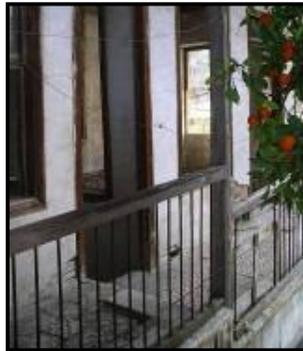
**Change:** The iron balustrades of the circulation corridor of south-east mass are the alterations.

**Evidence:** Use of different materials from the other balustrades indicates the alteration.

**Figure 49:** The Iron Balustrades of South-east Mass (author April, 2003)

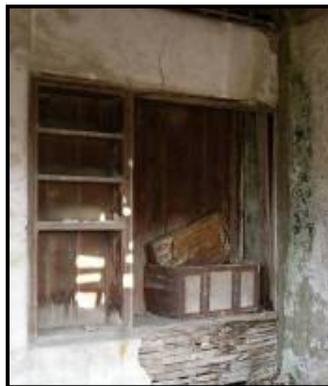
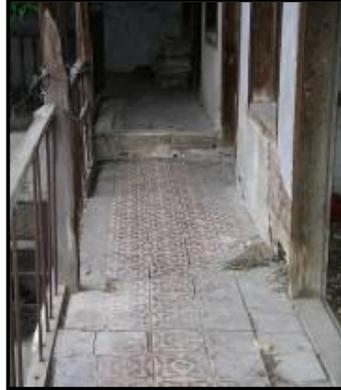
**Change:** The entire first floor of south-east mass is a later addition.

**Evidence:** Differences in details and architectural elements indicate that the floor is an addition built up in a later period. The connections of the cupboards with walls in FF01 and FF02 spaces, the openings directly open out to the streets, the dimensions and the details of the openings on the courtyard façade, fine cut profiled stone works around the openings, the stair which goes up to this floor with different detailed steps and the peculiar step on the floor of circulation space are some of the indicators of the change.

**Figure 54:** The Cupboard in FF01 Space (author April, 2003)

**Figure 55:** The Level Difference on the First Floor of South-east Mass (author April, 2003)

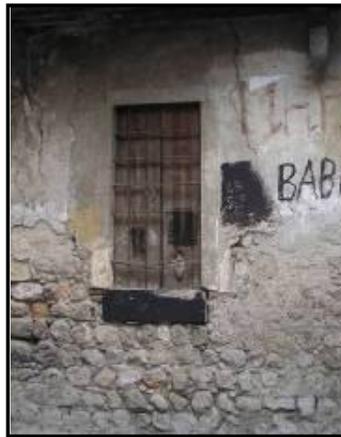
**Change:** The window in GF06 which opens out to the street is an addition.

**Evidence:** The details and the design of the window wing at inner side are different from the others. An opening which gives face to the street is not typical in earlier times.

**Figure 59:** The Window of Space GF06 on North-west Façade (author April, 2003)

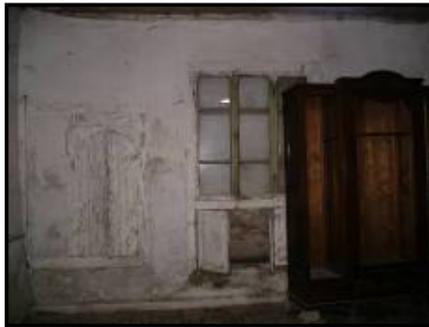
**Change:** The cupboard located in the middle of the south-east façade of GF02 space is a later addition.

**Evidence:** The details and the arrangement of the cupboard differentiate from the others. It is also transverse to the arrangement of the inner façade which it has been located on.

**Figure 62:** The Cupboard in Space GF02 (author April, 2003)

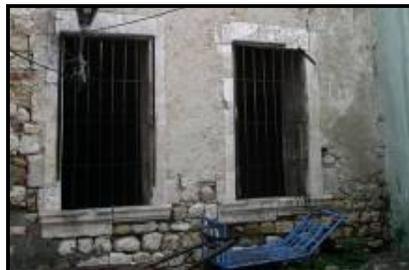
**Change:** The windows of GF01 space on north-west façade are later additions.

**Evidence:** The details of the fine cut stone cases and profiled fine cut stone sills of the windows show the change on the façade. An opening which gives face to the street is not typical in earlier times.

**Figure 63:** The Windows of GF01 Space on North-west Façade (author April, 2003)

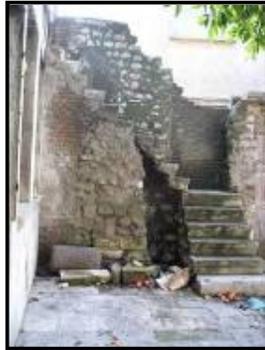
**Change:** The stone staircase which goes up to the first floor of south-east mass and the wall underneath of the stair are the additions.

**Evidence:** The details of the profiled fine cut stone steps indicate the change. Use of re-used fine cut profiled stone blocks and the jerry-built brick and stone composite work of the wall are peculiar. In addition, this stair does not exist in the French Map prepared in 1928 which has been obtained from the municipality.

**Figure 64:** The Staircase in the Courtyard and the Wall under the Stair (author April, 2003)

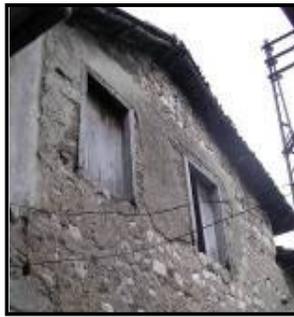
**Change:** The windows located on the north-east façade which belong to FF02 are additions.

**Evidence:** The window openings have been defined with brick works in the stone masonry. The dimensions and the details of the windows are different from the others.

**Figure 65:** The Windows of FF02 on North-east Façade (author April, 2003)

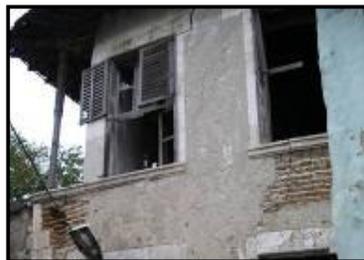
**Figure 66:** The Windows of FF01 on South-east Façade (author April, 2003)

**Change:** The windows located on the south-east façade which belong to FF01 are additions.

**Evidence:** The details of the window sills, the brick work under the windows and fine cut stone works above the windows are some of the indicators of the change.

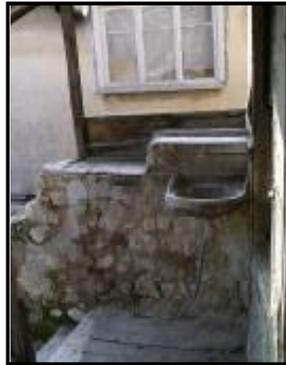
**Figure 67:** The Wash Basin in the Circulatin Coridor (author April, 2003)

**Change:** The wash basin in the circulation corridor of north-west mass and the wall behind this element are later additions.

**Evidence:** Use of modern material with peculiar place of the basin and the jerry-built construction of the wall indicate the changes.

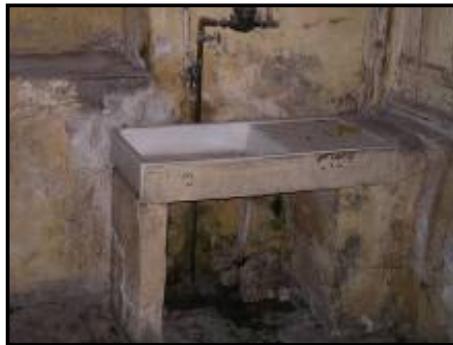
**Figure 69:** The Wash Basin in GF07 Space (author April, 2003)

**Change:** The wash basin in GF07 space is an addition.

**Evidence:** Use of modern material indicates the change.

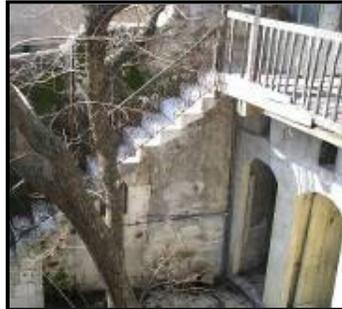
**Figure 73:** The Trace under the Staircase (author April, 2003)

**Change:** A space located in the courtyard under the one flight stair has been removed.

**Evidence:** The clear difference of construction technique between the two parts of the wall and plastered area indicate the removal.

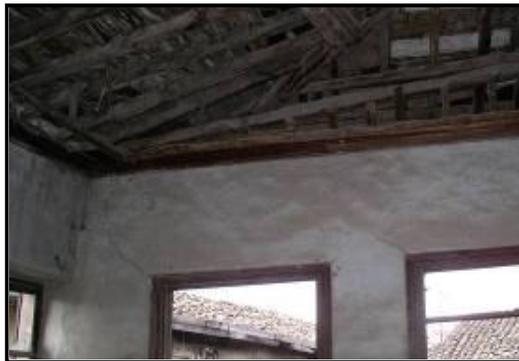
**Figure 74:** The Remains of the Ceiling Cover in FF01 Space (author April, 2003)

**Change:** The ceiling cover of Space FF01 has been lost.

**Evidence:** The remains of the ceiling cover and the timber cornice at the top of the walls indicate the removal.

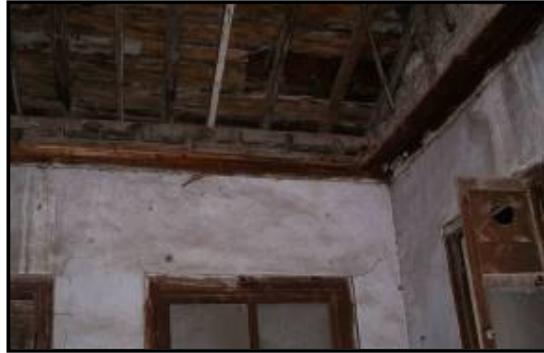
**Figure 75:** The Remains of the Ceiling Cover in FF02 Space (author April, 2003)

**Change:** The ceiling cover of Space FF02 has been lost.

**Evidence:** The remains of the ceiling cover and the timber cornice at the top of the walls indicate the removal.

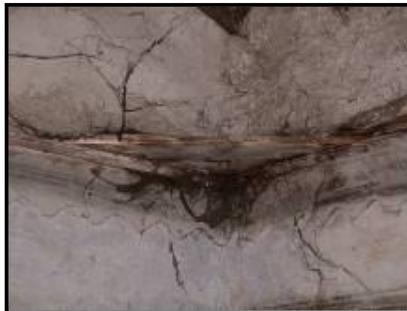
**Figure 76:** The Remains of the Ceiling Cover in FF06 Space (author April, 2003)

**Change:** The ceiling cover of Space FF06 has been lost.

**Evidence:** The remains of the ceiling cover and the timber cornice at the top of the walls indicate the removal.

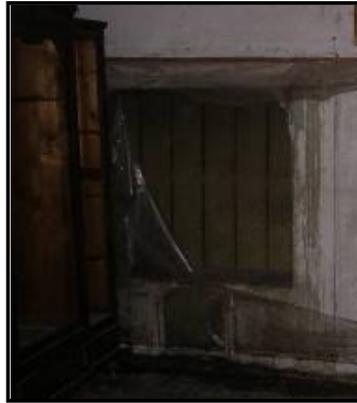
**Figure 77:** The Cupboards in Space GF02 (author April, 2003)

**Change:** Some of the doors of the cupboards in GF02 space have been lost.

**Evidence:** The hinges on the frames indicate the changes.

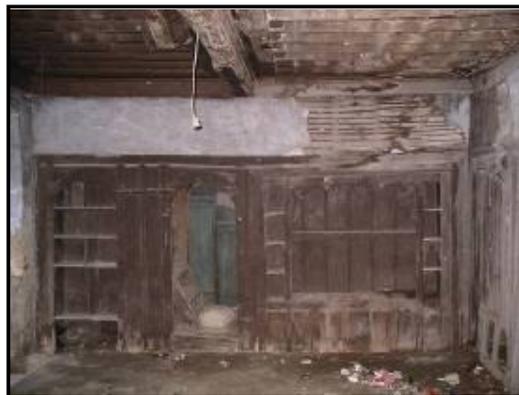
**Figure 78:** The Cupboards in Space GF01 (author April, 2003)

**Change:** Some of the doors of the cupboards and the door wings of “mabein” in GF01 space have been lost.

**Evidence:** The hinges on the frames indicate the changes.

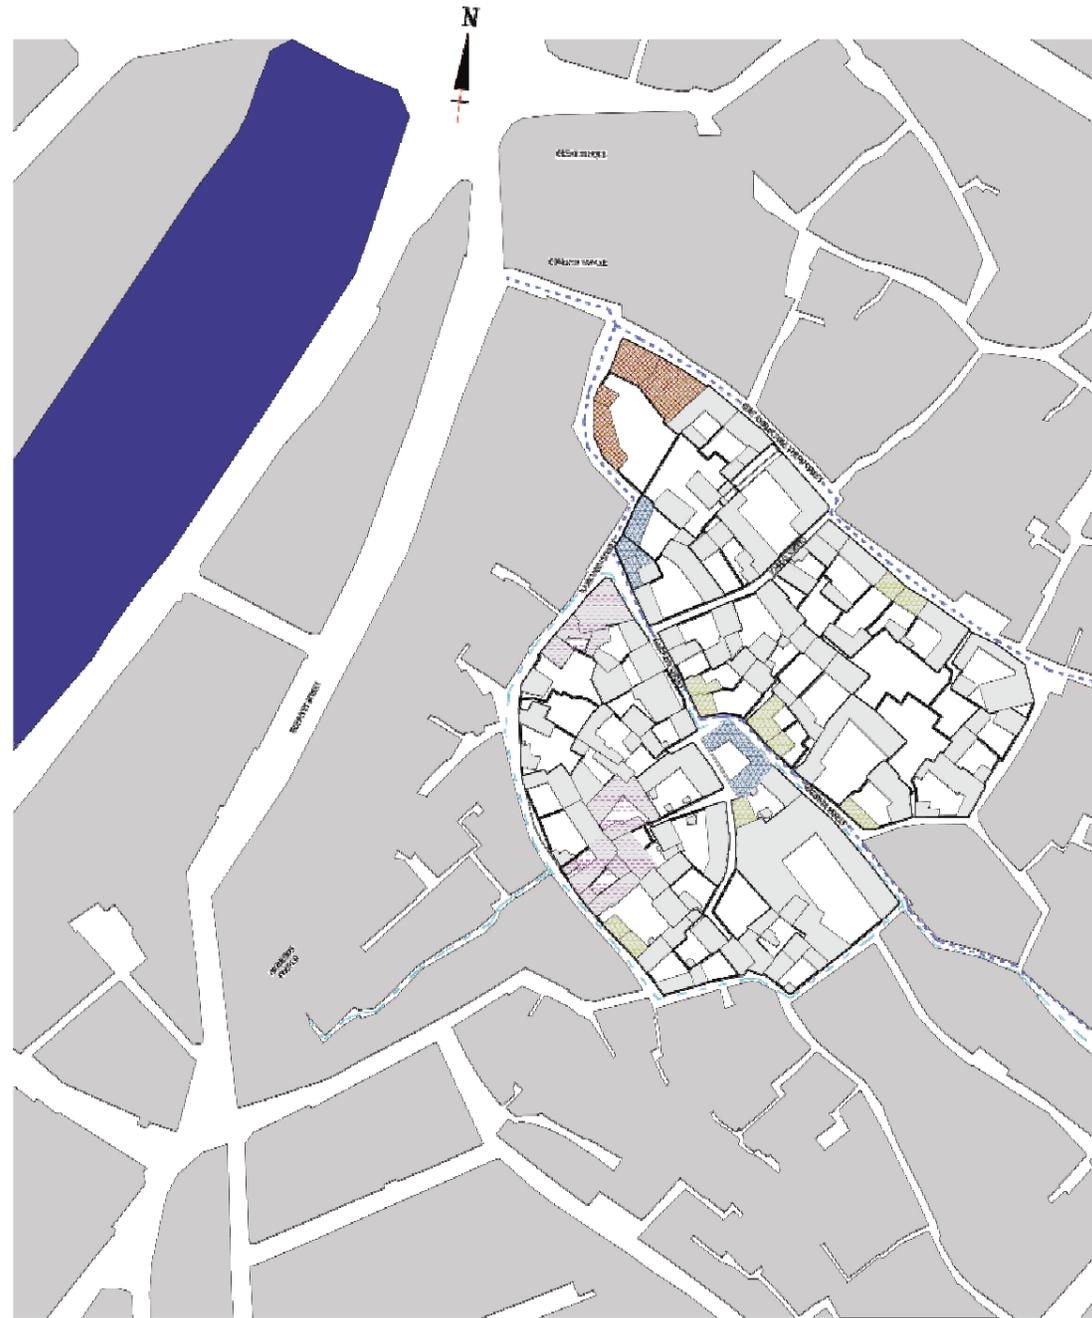
problems 1/500

The aerial lines of electricity and communication not only cause to visual pollution but also expose danger especially in the hot temperature by bending. The places of posts of these systems are problematic for the visual concerns as well as the pedestrian movement. The electric boxes have been fixed by haphazard. Another drawback, the streets are lack of lighting fixtures.

Replacement of original stone pavement with asphalt and concrete and the small channels called "arık" in the middle of the streets cause flood in rainy weathers. This intervention also damages on the building façades and stone masonries. It affects all authenticity of the streets, as well.

The interventions done especially with cement based materials cause damages on the traditional buildings in terms of both structural and in material scale. The altered concrete slabs which are supported by iron I-beams, cement plasters, screed floor covers and cement based jointing are some of these interventions. The additional service spaces also blemish the perception of the courtyards and break the relationship of it with masses. Painted fine cut stone surfaces of the courtyard façades have been visually polluted.

The new buildings can be accepted another problematic issue for the site. The vast majority of the buildings' heights are inharmonious with the traditional fabric. They damage the silhouette of the historical urban site. However, their façade organisations are inharmonious with the rest to a large extent. Built B up/open area relationships of the new buildings are remarkably dense in comparison to the traditional ones. They almost sit on their lots by covering whole area.
