A PROPOSAL FOR PRESERVATION AND REHABILITATION OF
YENİ GALLE PAZARI HANI (FORMER ALİ PAŞA KERVANSARAYI)
AND ITS IMMEDIATE SURROUNDING
IN BURSA

A THESIS SUBMITTED TO
THE GRADUATE SCHOOL OF NATURAL AND APPLIED SCIENCES
OF
MIDDLE EAST TECHNICAL UNIVERSITY

MAY 2008

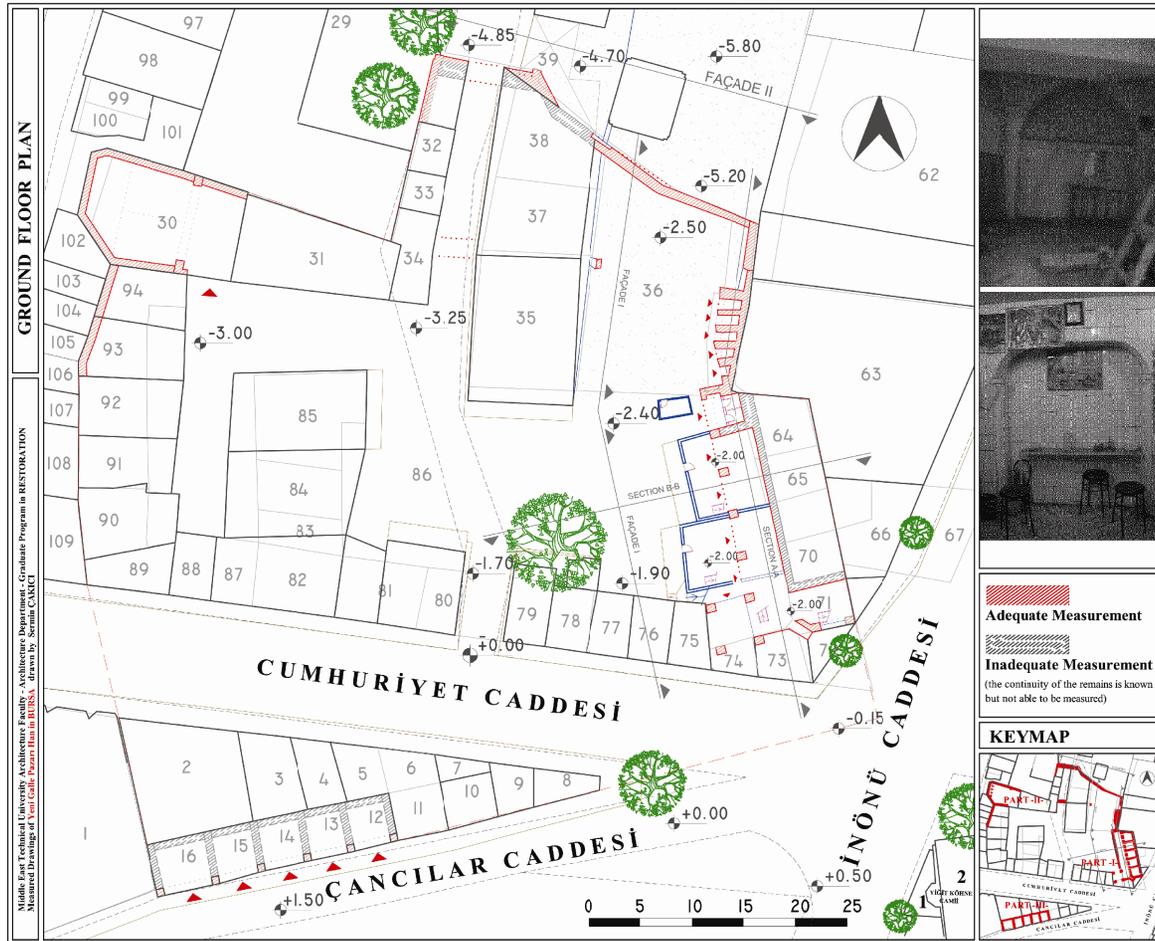
Figure 2. 42 : Ground Floor Plan of Yeni Galle Pazarı Hamı (2007)

Yeni Galle Pazarı Hanı is known as a 16th century Ottoman Han which was partially destroyed at the beginning of the 20th century. But the walls of the Han still exist. The north wall still stands in its location while including the remains of the two gates of the Han in approximately 7.00 metres height (Facade II). In addition, there are remains, partially existing at the north-east corner of the Han, which also include the rest of five small cells or rooms on the ground. The rooms, in around 2.50-3.00 metres height, are not clearly read however their structure is displayed in the drawing of (Section A-A).

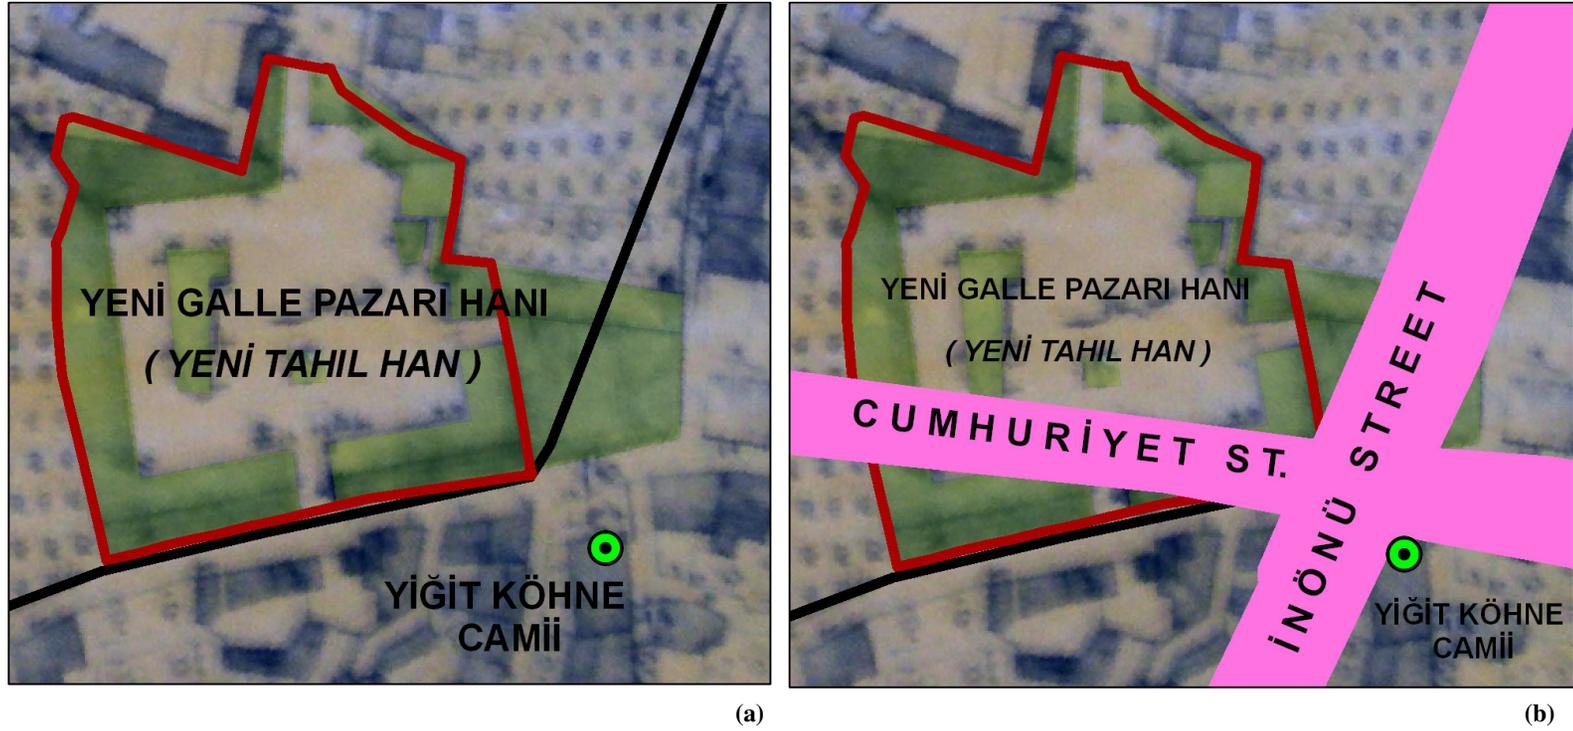
Figure 2. 55 : (a) Status of Y.G.P.H. before 'Tanzimat Movements' (b) Status of Y.G.P.H. after 'Tanzimat Movements'

Yeni Galle Pazarı Hanı can be perceived completely in Suphi Bey Map of Bursa (1862) before innovations by ‘Tanzimat Movements’ in Bursa (Figure 2.55a). Therefore, the map of Suphi Bey can be accepted as a significant document revealing the original locations of Yeni Galle Pazarı Hanı together with other commercial buildings within the H.C.C. just before the modernization movements by Tanzimat Movements. According to the written documents by Kepecioğlu and Baykal, there are many repairs and interventions within the Han since the 17th century. Kepecioğlu mentioned that (KEPECİOĞLU, 1935: 21-22) Yeni Galle Pazarı Hanı (Yeni Tahıl Han) was partially repaired after the decays due to the harmful results of ‘*Celali İsyamları*’ and harmful uses within the inner spaces of the Han. It is informed that after the effects of ‘*Celali İsyamları*’ in Bursa; nine shops attached to Yeni Galle Pazarı Hanı, the roof covering the gates and the barn locating at the east sides of the Han were repaired in 1608. It is also added that there are thirty-two rooms within the boundary of the Han some of which were used inappropriately and these inharmonious ones were repaired in 1610 by the aid of financial profit taken from the foundation (*vakıf*) operated inside the Han. On the other hand, Baykal mentioned that (BAYKAL, 1950: 110) after a fundamental repair on Yeni Galle Pazarı Hanı in 1690; the timber door of the Han was also repaired in 1844. However, the integrity of the Han has already been destroyed by the opening of two main streets, called as Cumhuriyet Street and İnönü Street, as a result of ‘Tanzimat Movements’. Yeni Galle Pazarı Hanı was divided into pieces at the south and the east sections (Figure 2.55b).

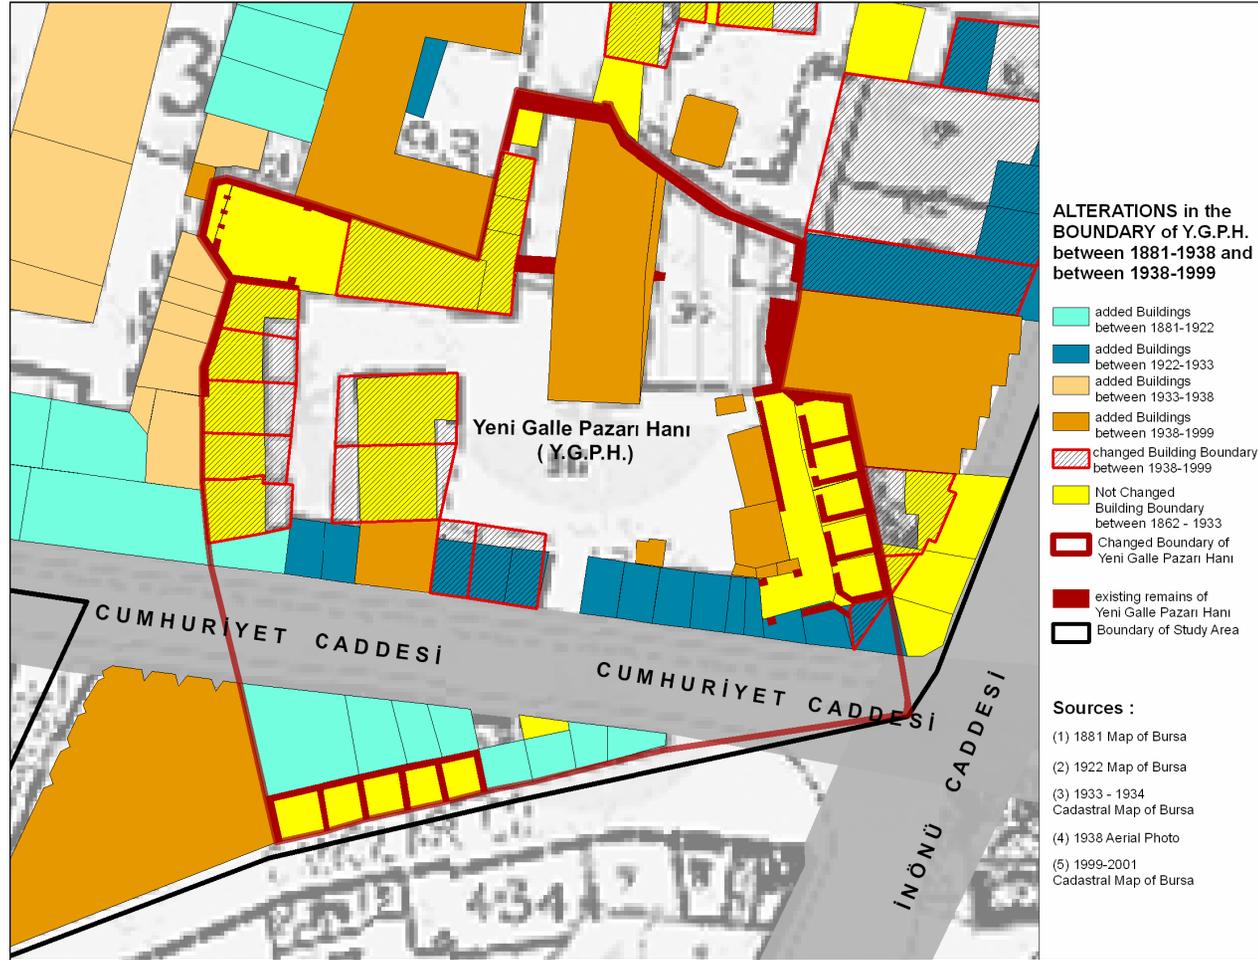
Figure 2. 56 : Alterations in the Boundary of Y.G.P.H. between 1881-1938 and 1938-1938-1999

Accordingly, the illegal constructions of new shops and office buildings, existing within the courtyard of Yeni Galle Pazarı Hanı, were mentioned at first in 1966 by Celalettin Unseli, who was the governor of Bursa. In addition to these reports, concerning the physical changes in Yeni Galle Pazarı Hanı as a result of the interventions, Kaplanoğlu mentioned that (1994: 54) the plane-tree within the courtyard and the fountain at the corner of the Han, which was constructed after the opening of the streets and ornamented with tile, were removed by the illegal new constructions surrounding the Han until 1980s.

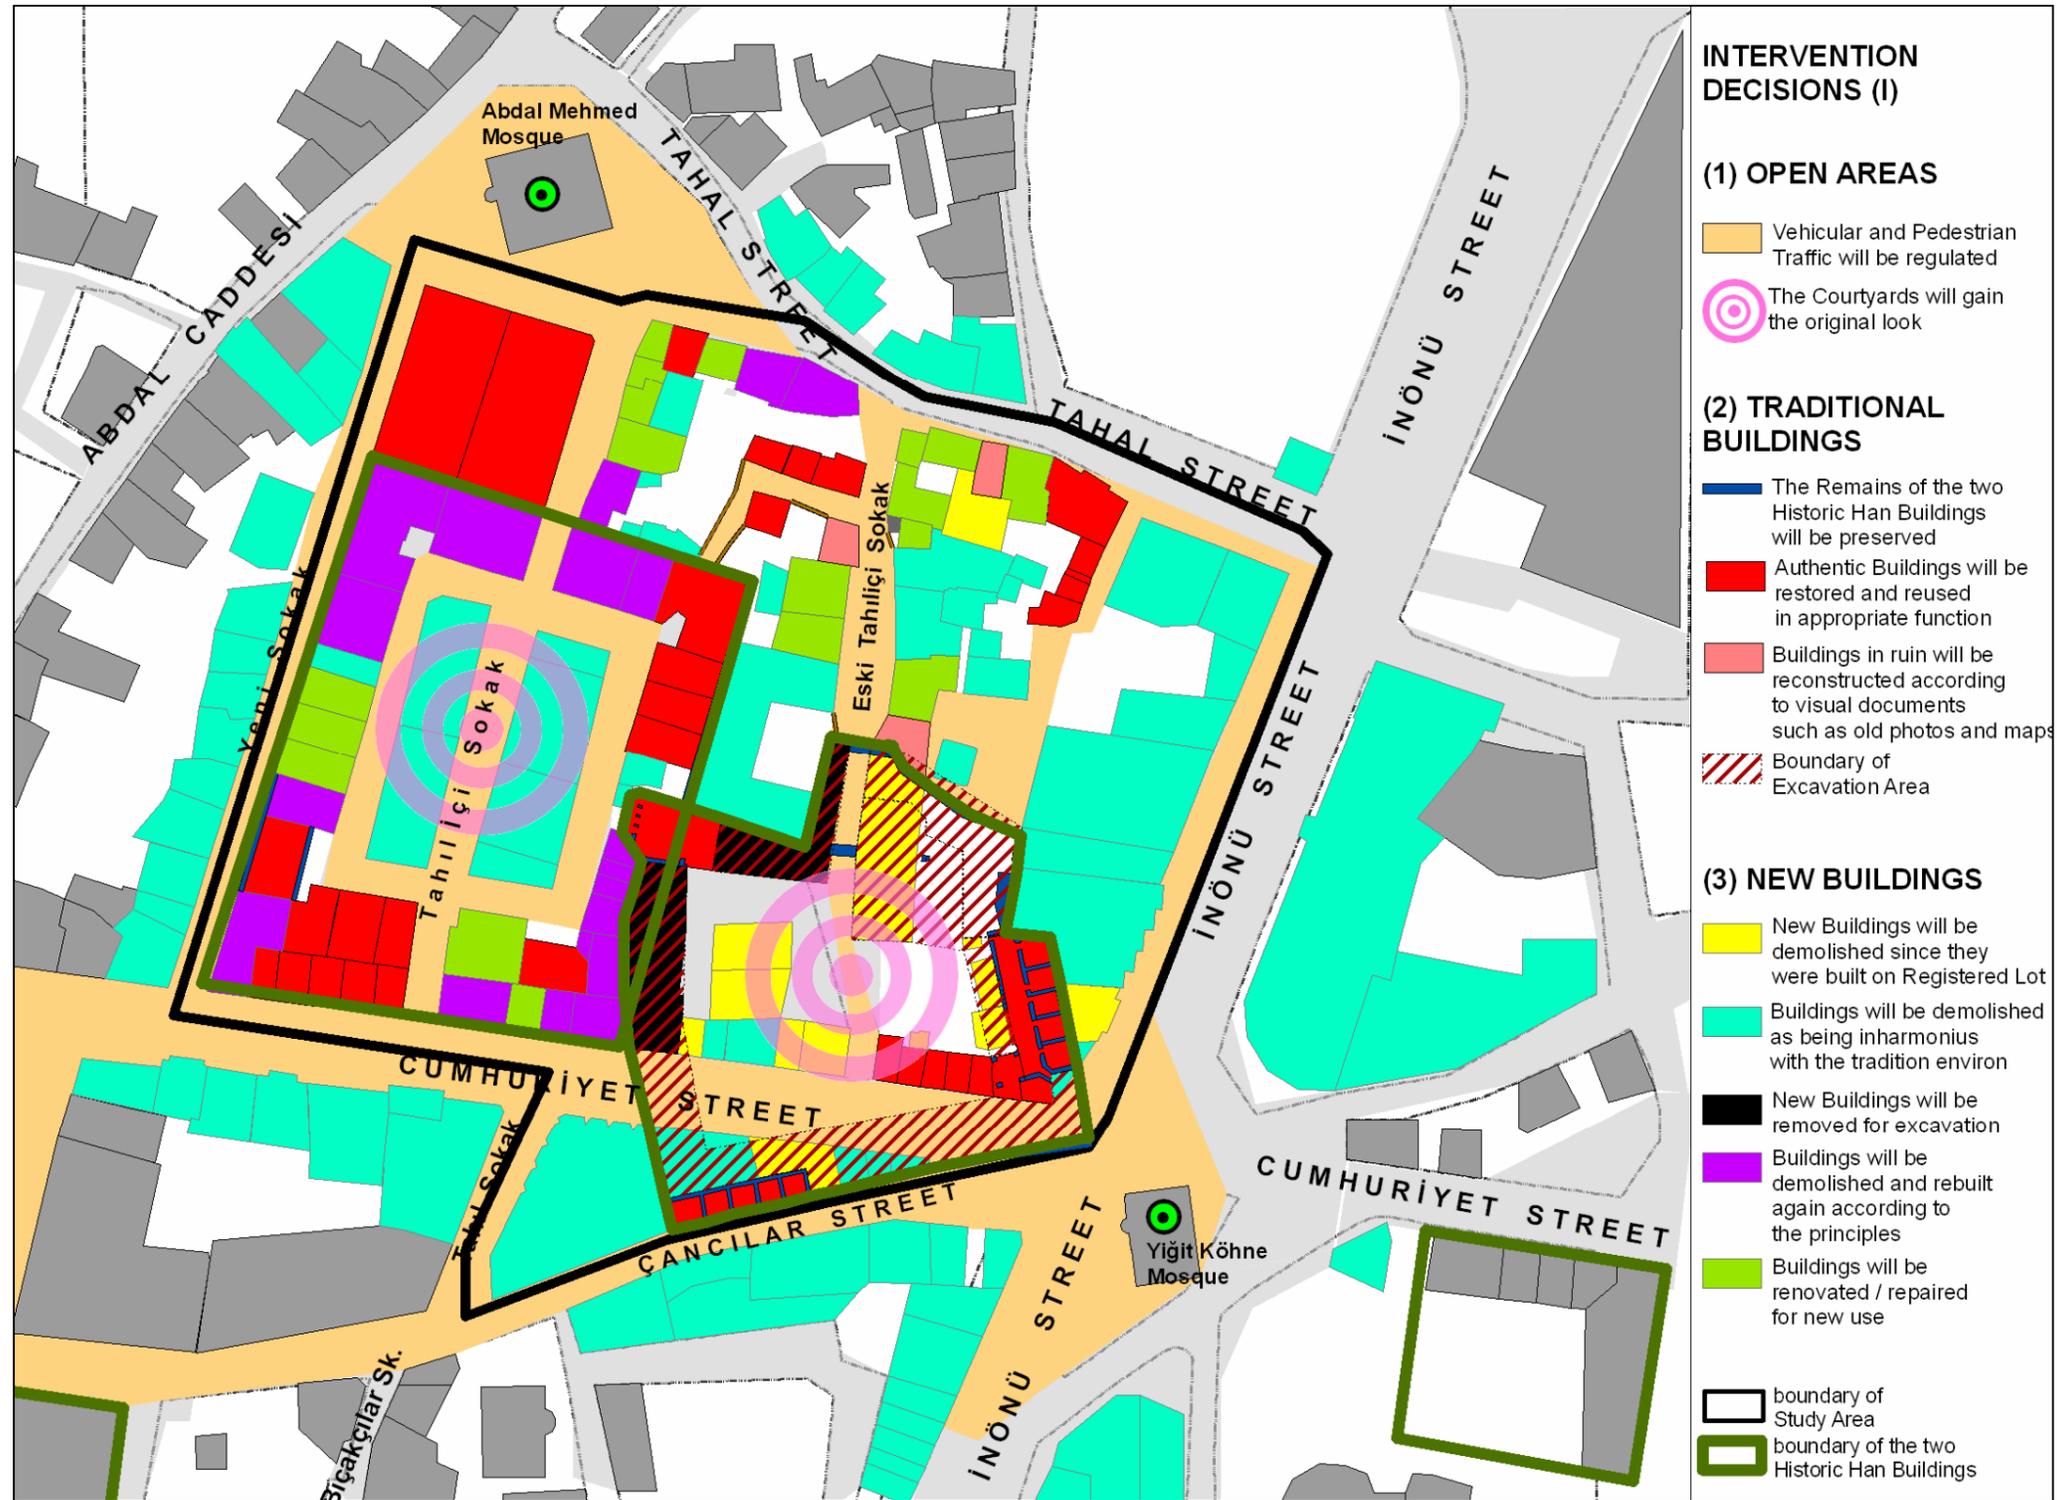
Figure 4. 2 : Intervention Decisions at Site Scale (I)

While being located at the intersection of two main streets, 'Cumhuriyet Street' and 'İnönü Street', the study area is subjected to heavy vehicular and pedestrian traffic. Therefore, it is necessary to redefine the places allocated for vehicular and pedestrian traffic, by taking following measures:

- The vehicular traffic surrounding the study area should be controlled in order to slow down the traffic flow.
- The current traffic axis cuts the study area into two pieces and also destroys the integrity of the study area. In order to avoid this handicap, turning from İnönü Street to Cumhuriyet Street should be cancelled and a new connection should be provided to Cumhuriyet Street via Abdal Street, which will pass through the western side of the study area.

- A part of Cumhuriyet Street, within the boundary of the study area, should be closed to vehicular traffic and regulated only for pedestrian circulation together with compatible pavement and street furnitures.
- The vehicular traffic passing inside the courtyards of the Hans should be limited and should be regulated for the pedestrian use in order to strengthen the pedestrian transportation in south-north direction.
- The cars which will serve for the commercial units should enter the study area at limited hours.
- The dead-end streets within the study area should be closed to the vehicular traffic and should be used for only pedestrians.
