NON-DESTRUCTIVE EXAMINATION OF STONE MASONRY HISTORIC  
STRUCTURES – QUANTITATIVE IR THERMOGRAPHY AND  
ULTRASONIC TESTING

A THESIS SUBMITTED TO  
THE GRADUATE SCHOOL OF NATURAL AND APPLIED SCIENCES  
OF  
MIDDLE EAST TECHNICAL UNIVERSITY

SELEN AKEVREN

FEBRUARY 2010

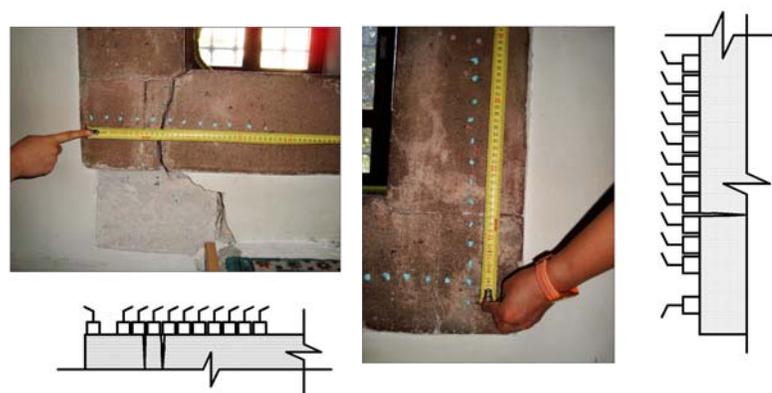
Figure 3.7 The arrangement of transducers on red tuff surfaces when placed at the opposite sides of a deep crack (at the left) and at the opposite sides of jointing between two red tuff blocks (at the right).

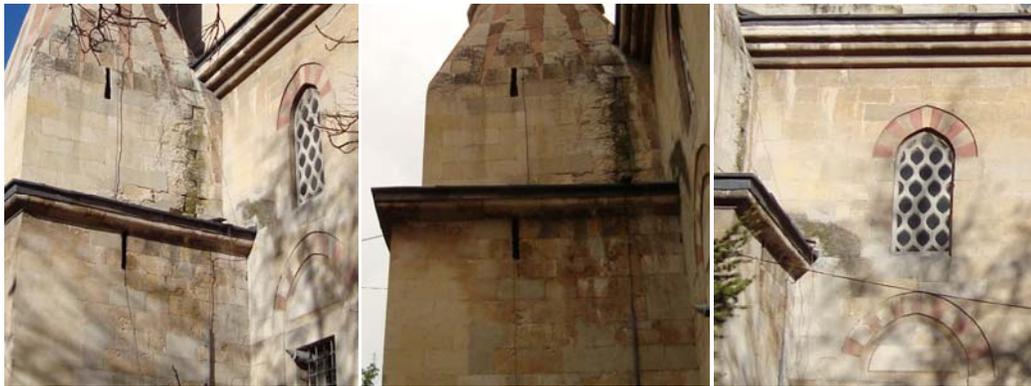
Material loss of the structure was categorized in three types; slight, moderate and severe material loss. Lack of roof drainage system caused material loss in different damage categories both on the south elevation of minaret and west elevation of the building, as it was shown in Figures 4.2 and 4.3. Severe material loss, on the route of water coming from the dome at south side of minaret, was surrounded with moderate material loss and cement based repair coats. Slight material loss was observed on the first layer of minaret wall surface under the eave. Additionally, cement based repairs on the west wall of building was seen mostly around the moderate material loss.

The same wall surfaces were also mapped from the discoloration and deposit positioning at the locations of biological growths, yellow and black staining (Figure 4.3). Biological growths were encountered on the minaret wall surface and on the west wall surface of building where severe and moderate material losses were occurred on the route of water. Yellow staining was common under the eaves and location of slight material loss on south side of minaret wall was overlapped with the yellow and black staining.

Figure 4.2 Partial view of exterior wall surfaces; south elevation of minaret wall and west elevation of building wall; taken from different directions.

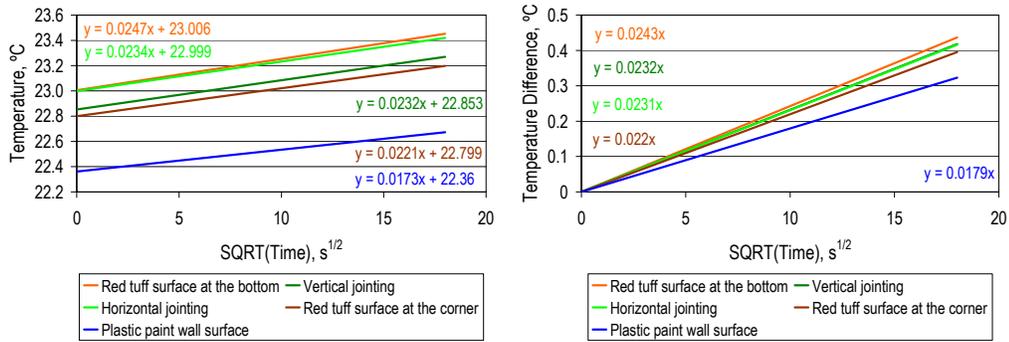
- The results of thermal monitoring for visually-sound masonry surfaces, such as fair faced red tuff blocks, vertical and horizontal jointings in between those blocks and wall surface coated with cement-lime based plaster and plastic paint, during the heating and cooling periods were summarized in Figures 4.8-4.10. IR sequences were taken at the ambient conditions of 23.7°C and 46%RH during the heating period of 856s when the wall surface was uniformly heated with halogen lamp and then during the cooling period of 342s after the halogen lamp was turned off. The linear fitting of surface temperatures versus square root of time and temperature differences versus square root of time during the first 360s of heating period and during the first 324s of cooling period were given in Figures 4.9 and 4.10. The results showed that the red tuff surfaces at the bottom, vertical jointing mortar surfaces, horizontal jointing mortar surfaces and red tuff surfaces at the corner exhibited similar thermal response to the warming up conditions with the rates of 0.0243, 0.0232, 0.0231 and 0.022, respectively. They also exhibited similar thermal response to the cooling down conditions with the rates of -0.025, -0.0241, -0.0235 and -0.0234, respectively. These results signalled that tuff and its jointing mortar had similar thermo-physical properties establishing similar thermal inertia characteristics. The wall surfaces coated with cement-lime based plaster and plastic paint had the coldest surfaces with the slowest rates of warming up and cooling down among fair-faced red tuff and jointing mortar surfaces. These plaster surfaces were colder than the fair faced tuff surface with a temperature difference of -0.64°C and had the warming up and cooling down rates of 0.0179 and -0.0193, respectively.

Figure 4.9 The linear fitting of surface temperatures and temperature differences versus square root of time during the heating period for the case defined in Figure 4.8: The visually-sound red tuff and jointing mortar surfaces exhibited similar warming up rates while the plastered masonry wall coated with plastic paint had the coldest surface temperature with the lowest rate of warming up.

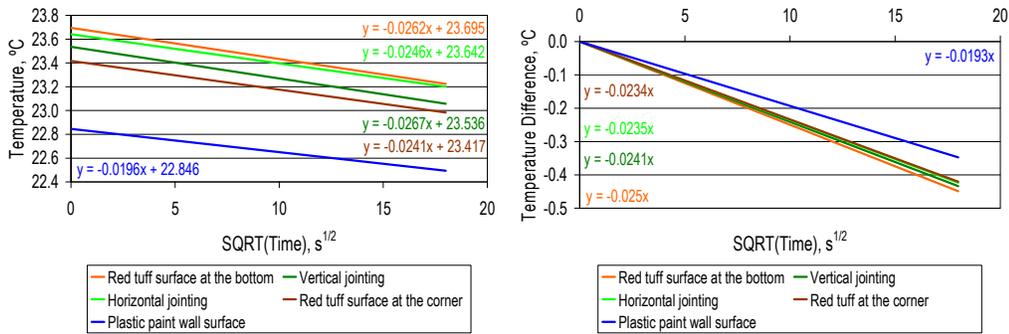
Figure 4.10 The linear fitting of surface temperatures and temperature differences versus square root of time during the cooling period for the case defined in Figure 4.8: The visually-sound red tuff and jointing mortar surfaces exhibited similar cooling down rates while the plastered masonry wall coated with plastic paint had the coldest surface temperature with the lowest rate of cooling down.

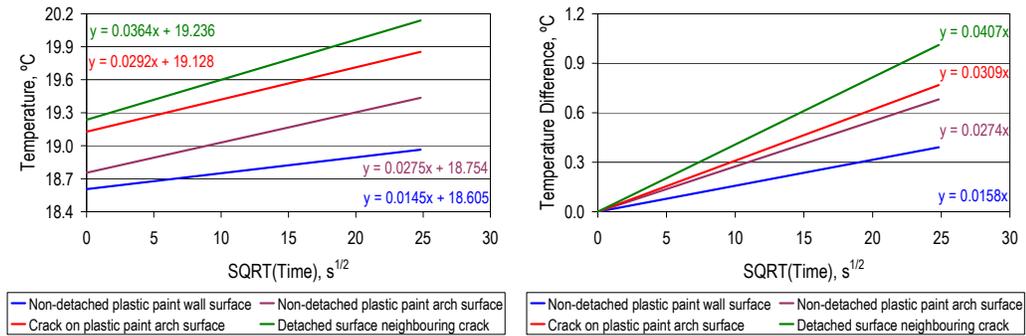
- Sequential IR imaging of the superficial crack, detached and non-detached surfaces on the south wall of the structure were taken during the heating and cooling conditions and the results were summarized in Figures 4.11-4.13. IR sequences were taken at the ambient conditions of 20.1°C and 49%RH during the heating period of 616s when the wall surface was uniformly heated with halogen lamp and then during the cooling period of 580s after the halogen lamp was turned off. The linear fitting of surface temperatures versus square root of time and temperature differences versus square root of time during the 616s of heating

period and during the 580s of cooling period were given in Figures 4.12 and 4.13. It was found that the detached plaster surfaces associating with/neighbouring the crack and superficial crack were both warmed up and cooled down faster than the sound surfaces. The warming up rates of the detached plaster surface neighbouring the crack, superficial crack, non-detached plastic paint arch surface and non-detached plastic paint wall surface were 0.0407, 0.0309, 0.0274 and 0.0158, respectively while the cooling down rates of the detached plaster surface neighbouring the crack, superficial crack, non-detached plastic paint arch surface and non-detached plastic paint wall surface were -0.0359, -0.0272, -0.0207 and -0.0119, respectively. Superficial crack and detachment could be differentiated by slightly slower warming up and cooling down rates of superficial crack during the heating and cooling periods.

Figure 4.12 The linear fitting of surface temperatures and temperature difference versus square root of time during the heating period for the case defined in Figure 4.11: The detached surfaces warmed up the fastest while the non-detached wall surface coated with plastic paint had the coldest surface temperature with the lowest rate of warming up.

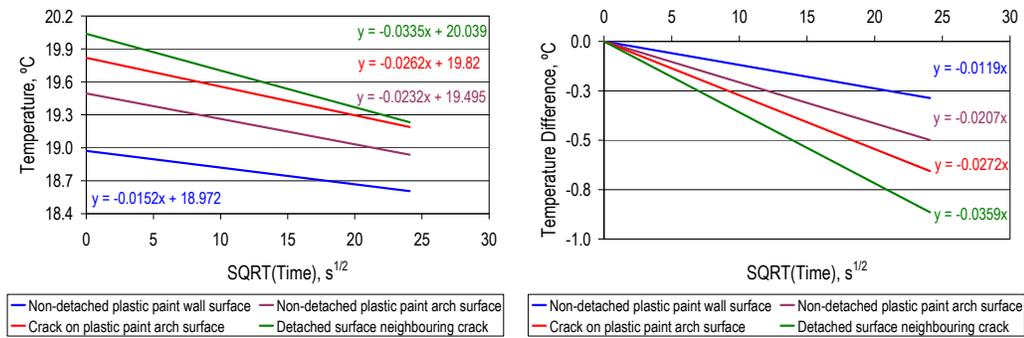
Figure 4.13 The linear fitting of surface temperatures and temperature difference versus square root of time during the cooling period for the case defined in Figure 4.11: The detached surfaces cooled down the fastest while the non-detached wall surface coated with plastic paint had the coldest surface temperature with the lowest rate of cooling down.

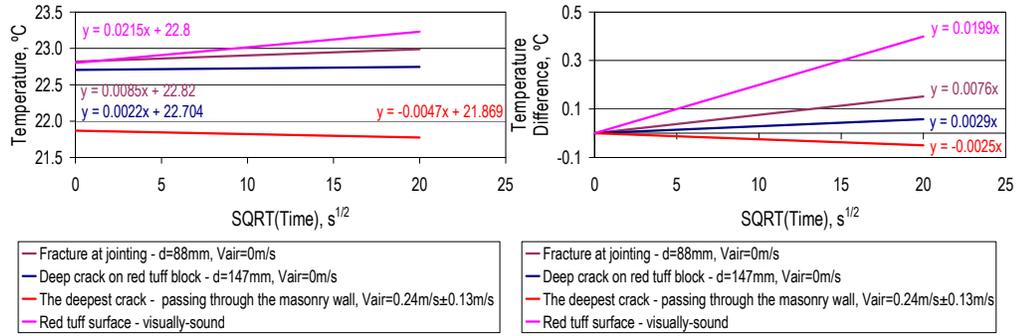
- The deepest crack, deep cracks, visually sound red tuff surfaces, detached and non-detached surfaces were monitored during the heating and cooling conditions. IR sequences were taken at the ambient conditions of 23.7°C and 46%RH during the heating period of 886s when the wall surface was uniformly heated with halogen lamp and then during the cooling period of 430s after the halogen lamp was turned off. The linear fitting of surface temperatures versus square root of time and temperature differences versus square root of time during the first 400s and 282s of heating period, and during the first 120s of cooling period were given in Figures 4.15-4.18. The results showed that the deep cracks at masonry wall with the depths of 147mm and 88mm, presented noticeably slower warming up and cooling down rates than the sound surfaces (Figures 4.14-4.16). The deeper crack had also warmed up and cooled slower than the less deep one. The warming up rates of deep crack in 147mm depth, deep crack in 88mm depth and visually-sound tuff surfaces were 0.0029, 0.0076 and 0.0199, respectively while the cooling down rates of deep crack in 147mm depth, deep crack in 88mm depth and visually-sound tuff surfaces were -0.0109, -0.0119 and -0.0314, respectively. The deepest crack had the coldest surface temperature, being colder than the visually-sound tuff surface with a temperature difference of -0.93°C and cooled down during the heating period with the rates of -0.0025 and -0.0035 for the cases defined in Figures 4.15 and 4.17, respectively. That signalled the presence

Figure 4.15 The linear fitting of surface temperatures and temperature difference versus square root of time during the heating period for the case defined in Figure 4.14: The deep cracks had noticeably slower rate of warming up than the sound red tuff while the deepest crack allowing air leakage through its cavity had the coldest surface temperature and cooled down under the exposure of heating process.

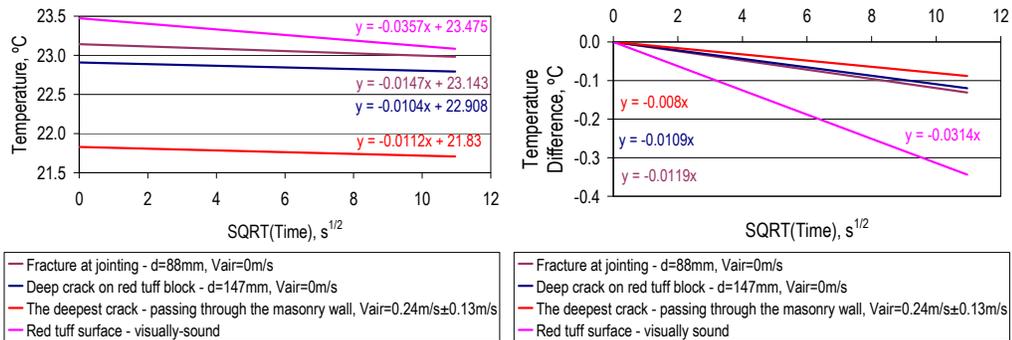
of entrapped moisture in the masonry and air flow through its gap/cavity, both encouraging evaporative cooling there. The deepest crack also presented the slowest rate of cooling down during the cooling period with the rate of  $-0.008$  (Figures 4.14, 4.16 and 4.18). The deepest crack, even neighbouring detachments, had noticeably colder surface temperature than the deep cracks and sound surfaces.

Figure 4.16 The linear fitting of surface temperatures and temperature difference versus square root of time during the cooling period for the case defined in Figure 4.14: The deep cracks had noticeably slower rate of cooling down than the sound red tuff while the deepest crack allowing air leakage through its cavity had the coldest surface temperature and the slowest rate of cooling down.

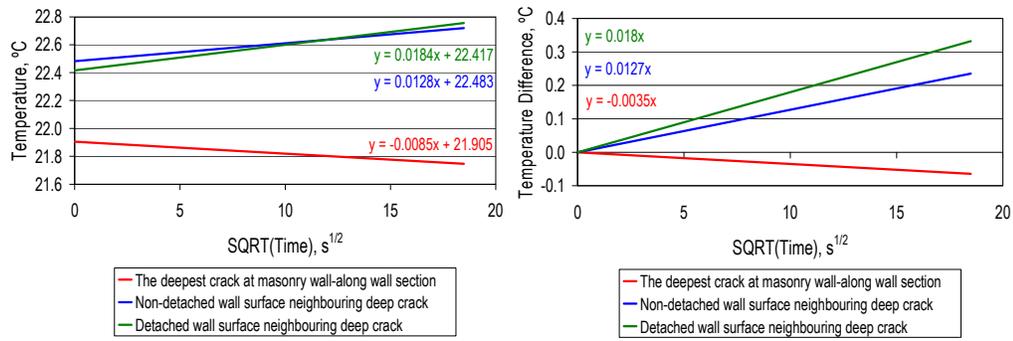
Figure 4.17 The linear fitting of surface temperatures and temperature difference versus square root of time during the heating period for the case defined in Figure 4.14: The thermal behaviour of the deepest crack at the masonry neighbouring detachments was in contrast to the superficial cracks neighbouring detachments (compare with Figure 4.12). The deepest crack had the coldest surface temperature and slightly cooled down under the exposure of heating.

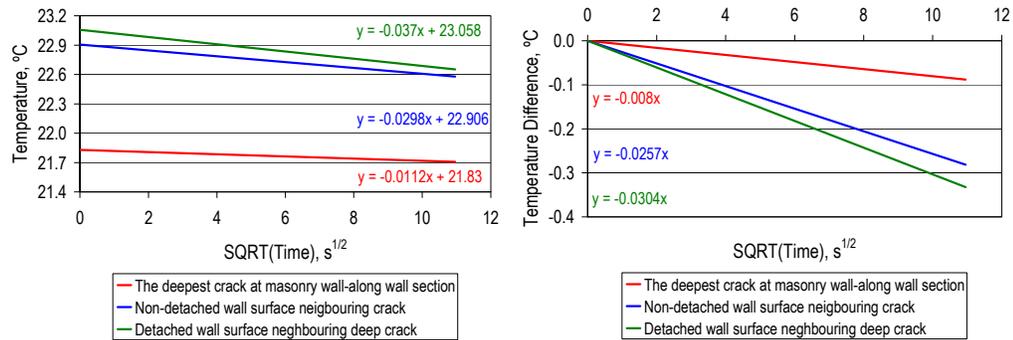
Figure 4.18 The linear fitting of surface temperatures and temperature difference versus square root of time during the cooling period for the case defined in Figure 4.14: The thermal behaviour of the deepest crack at the masonry neighbouring detachments was in contrast to the superficial cracks neighbouring detachments (compare with Figure 4.12). The deepest crack had the coldest surface temperature with the slowest rate of cooling down among neighbouring all wall surfaces.

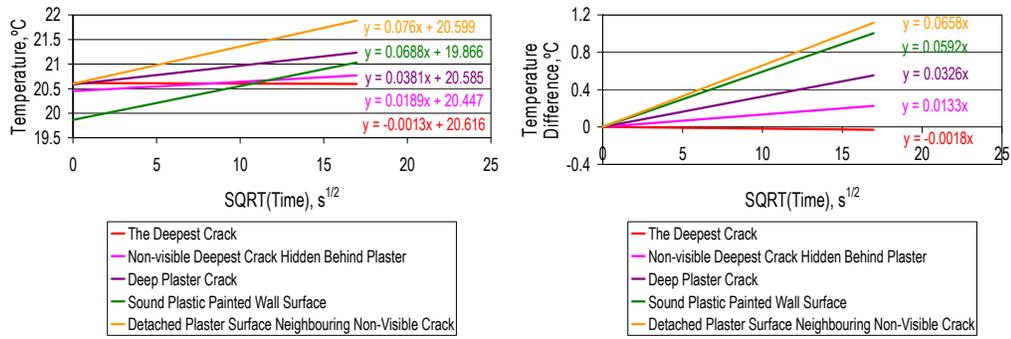
The area between the arch of first layer window and the decoratively painted wall surface above the first layer window was seen visually-sound although thermal analysis signalled the crack on the examined surface due to the similar thermal behaviours of the deepest crack and this examined surface under the exposure of warming up and cooling down conditions. This non-visible deepest crack behind plaster had slightly faster warming up and cooling down rates than those of the deepest crack. Non-visible deepest crack had the warming up and cooling down rates of 0.0133 and -0.0149, respectively (Figures 4.20 and 4.21).

Figure 4.20 The linear fitting of surface temperatures and temperature difference versus square root of time during the heating period for the case defined in Figure 4.19: The detached surfaces warmed up the fastest while the warming rates of cracks were slower than the visually-sound surface. Deep plaster crack warmed up faster than the deepest cracks and the deepest crack slightly-cooled down under the exposure of heating up process.

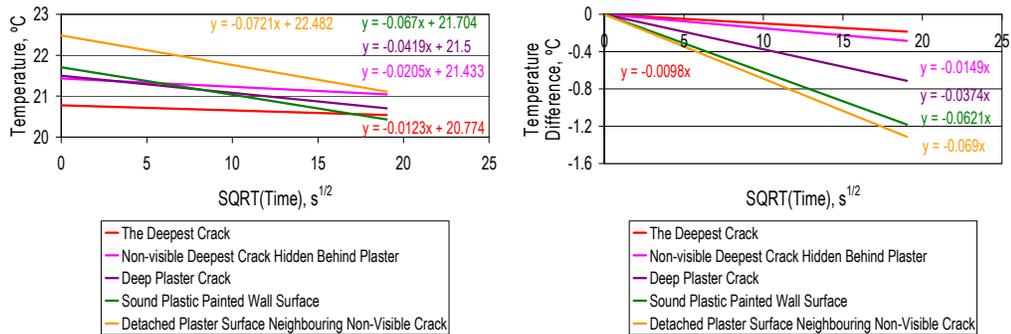
Figure 4.21 The linear fitting of surface temperatures and temperature difference versus square root of time during the cooling period for the case defined in Figure 4.19: The detached surfaces cooled down the fastest while the cooling down rates of cracks were slower than the visually-sound surface. Deep plaster crack cooled down faster than the deepest cracks while the deepest crack had the slowest cooled down rate.

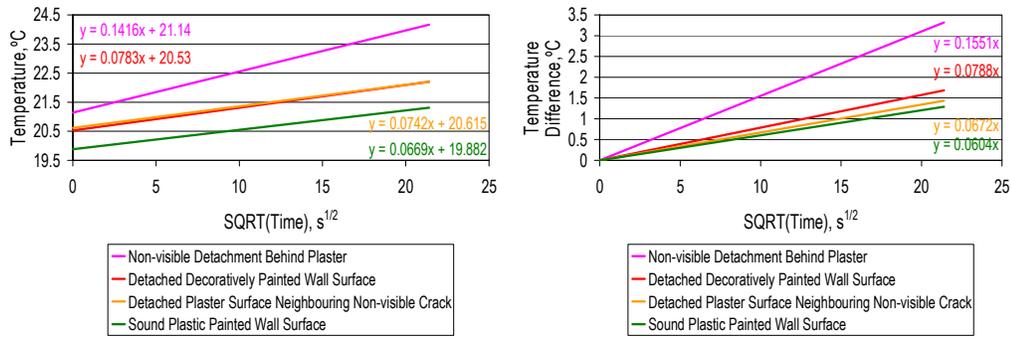
The detached surfaces could be differentiated from each other as well (Figures 4.22 and 4.23). All detachments were warmer than the visually-sound plastic painted wall surface and had the faster warming up and cooling down rates than the visually-sound surface. Detached decoratively painted wall surface and detached plaster surface neighbouring non-visible crack exhibited similar thermal response to the warming up conditions with the rates of 0.0788 and 0.0672, respectively. They also exhibited similar thermal response to the cooling down

Figure 4.22 The linear fitting of surface temperatures and temperature difference versus square root of time during the heating period for the case defined in Figure 4.19: The initial temperatures and warming up rates of detached surfaces were higher than the visually-sound plastic painted wall surface. Non-visible detachment was the warmest surface with the fastest warming up rate.

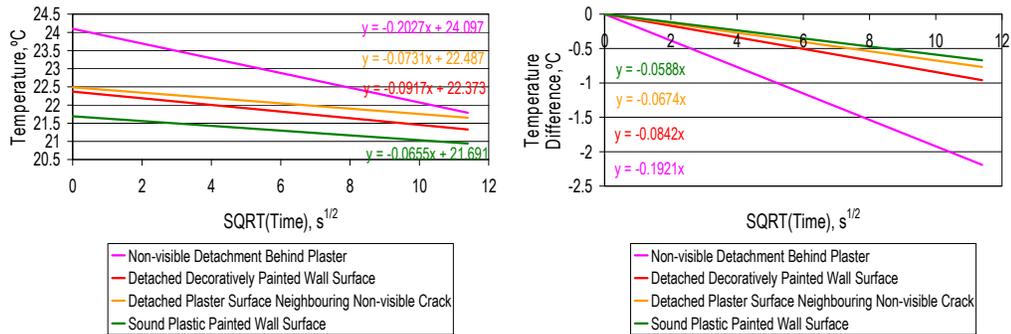
conditions with the rates of  $-0.0842$  and  $-0.0674$ , respectively. Non-visible detachment behind the plaster, on the other hand, was the warmest surface with the fastest rates of warming up and cooling down. This non-visible detachment was warmer than the visually-sound plastic painted wall surface with a temperature difference of  $1.26^{\circ}\text{C}$  and had the warming up and cooling down rates of  $0.1551$  and  $-0.1921$ , respectively.

Figure 4.23 The linear fitting of surface temperatures and temperature difference versus square root of time during the cooling period for the case defined in Figure 4.19: The initial temperatures and cooling down rates of detached surfaces were higher than the visually-sound plastic painted wall surface. Non-visible detachment was the warmest surface with the fastest cooling down rate.

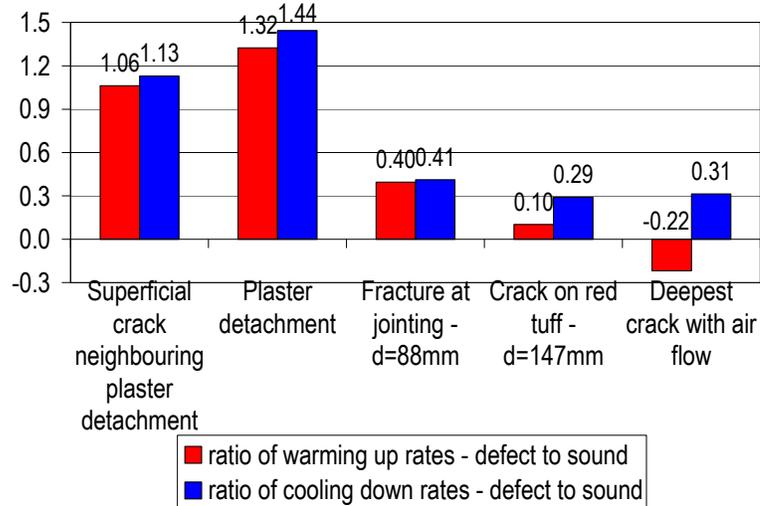
- The data on the warming up ( $R_W$ ) and cooling down rates ( $R_C$ ) for each crack/defect were summarized in Table 4.1, Figure 4.24 and 4.25. When the rates of defects were compared with the rates of visually-sound surfaces, it was found that plaster detachment had the highest ratio for warming up and cooling down conditions. The cracks, on the other hand, had the slowest ratios (Figure 4.24). Non-visible deepest crack hidden behind the plaster layer and the deepest crack presented exactly the same thermal responses under the exposure of cooling

Figure 4.24 The ratios between the  $R_w$  (or  $R_c$ ) of crack/defect to the  $R_w$  (or  $R_c$ ) of sound surface: Superficial and deep cracks had different thermal responses to exposed conditions which made them distinguishable by QIRT analyses.

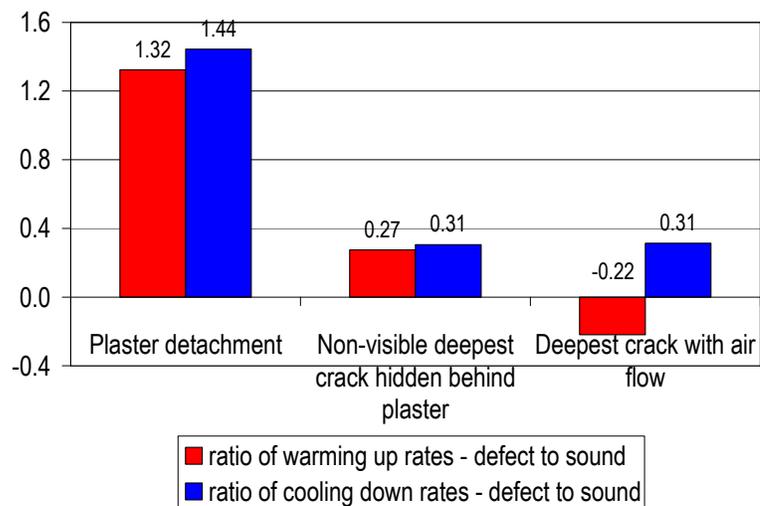
condition and the ratio between the  $R_W$  of non-visible deepest crack hidden behind the plaster layer and the deepest crack to the  $R_W$  of sound surface were similar while the ratio between the  $R_W$  (or  $R_C$ ) of plaster detachment to the  $R_W$  (or  $R_C$ ) of sound surface was noticeably higher (Figure 4.25).

Figure 4.25 The ratios between the  $R_w$  (or  $R_c$ ) of crack/defect to the  $R_w$  (or  $R_c$ ) of sound surface: Non-visible deepest crack had similar thermal responses with the deepest one especially in cooling period, while thermal behaviour of superficial crack and deepest cracks were totally different.

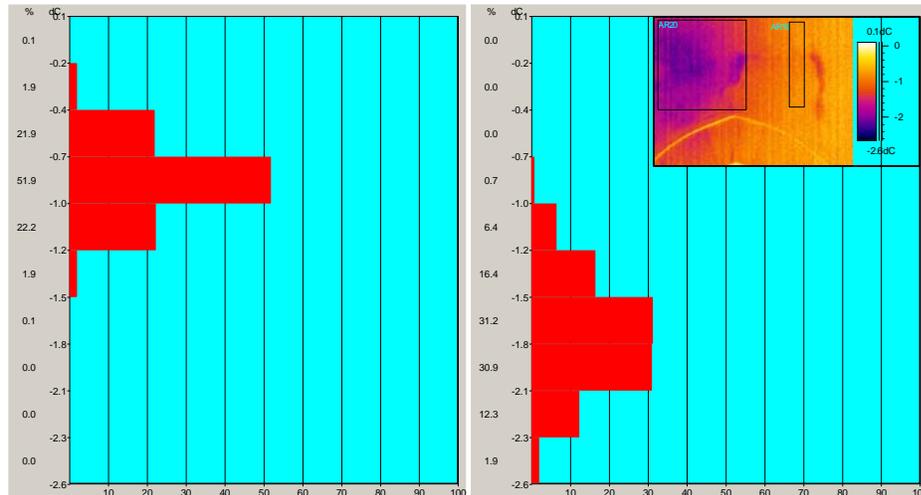
- The wall surface of second floor at the north side painted with recent plaster repairs was analysed during the heating and cooling conditions (Figure 4.27). IR sequences were taken at the ambient conditions of 20.6°C and 55%RH during the heating period of 735s when the wall surface was uniformly heated with halogen lamp and then during the cooling period of 456s after the halogen lamp was turned off. The results showed that heterogeneous temperature distribution of wall surfaces coated with plastic painting was noticed easily in IR images. That signalled the incompatibility of recent repairs. Superficial cracks and the detached plaster surfaces were detected easily in IR image as warmer patches while it was not possible to notice all detaching parts clearly by eye. Temperature distributions of visually-sound and deteriorated wall surfaces coated with plastic paint were presented with the histograms which were taken from the differential IR image taken at 456. second of the cooling period (Figure 4.28). Histograms showed that deteriorated surfaces cooled down faster than the visually-sound wall surfaces.

Figure 4.28 Histogram views of visually-sound wall surface (at the left) and deteriorated surface (at the right) taken from the differential IR image of cooling period for the case defined in Figure 4.27: Heterogeneous temperature distribution of deteriorated surface was easily observed in IR images. Deteriorated wall surfaces cooled down faster than the visually-sound wall surfaces.

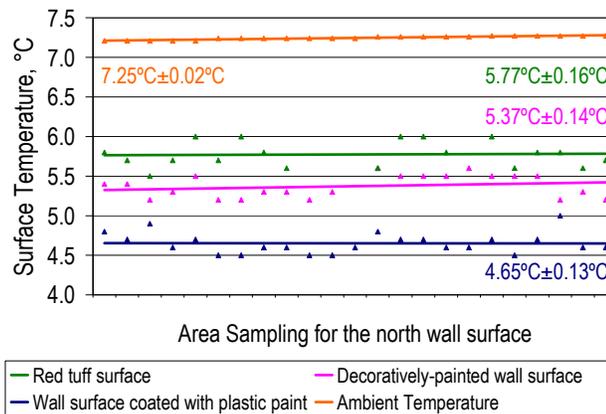
- Single IR images were taken from the decoratively painted wall surfaces above the first layer windows at north wall at the interior climatic conditions of 7.2°C and 51%RH and outside climatic conditions of 2.5°C and 62.5%RH (Figures 4.29 and 4.30). It was found that decoratively painted wall surfaces were warmer than the surfaces coated with plastic paint with +0.6°C temperature difference. In Figure 4.30, the surface temperature data for the fair-faced red tuff, decoratively-painted and plastic paint wall surfaces together with the inside air temperature close to the surface were extracted from several IR images scanning the north wall entirely. According to the results of that scanning, all north wall was colder than the ambient temperature. Wall surfaces coated with plastic paint were the coldest surfaces, having -2.6°C temperature difference with the ambient temperature close to wall surface. Red tuff surfaces, on the other hand, were the warmest areas, with a temperature difference of -1.5°C.

Figure 4.30 The surface temperature plot of north wall showing that the overall wall surfaces were colder than the inside ambient temperature while the ones coated with plastic paint were the coldest areas while the red tuff surfaces were the warmest areas.

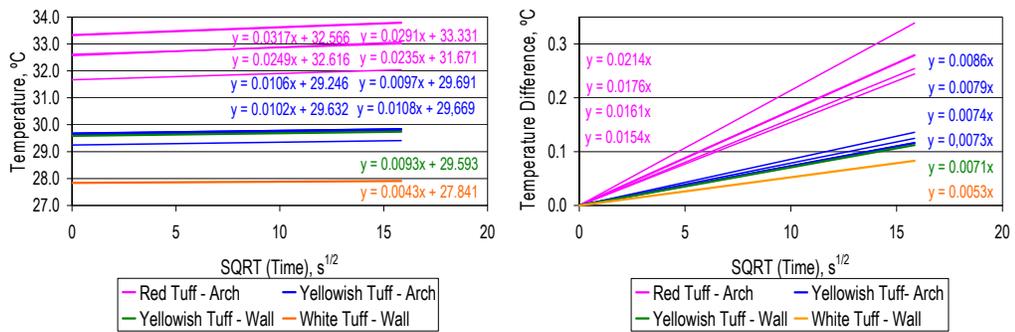
- Thermal behaviours of yellowish, white and red tuff blocks used at exterior wall and arch surfaces were determined by the sequential IR imaging under exposure of solar radiation in damp condition (Figures 4.32 and 4.34). Sequential IR images were taken at the ambient conditions of 28.6 °C and 28%RH during the heating period of 271s when the wall surface was uniformly heated by solar radiation for the case defined in Figure 4.32. Sequential IR images for the case defined in Figure 4.34, on the other hand, were taken at the ambient conditions of 29.4 °C and 27%RH during the heating period of 291s when the wall surface was uniformly heated by solar radiation. The results exhibited that the red tuff blocks at arches had the warmest surface temperatures and they were determined to warm up faster than the yellowish and white tuffs. The yellowish tuff of masonry wall had similar warming up rates with the ones on arches (Figures 4.33 and 4.35). White tuffs, on the other hand, had the coldest surface temperatures. They

Figure 4.33 The linear fitting of surface temperatures and temperature differences versus square root of time during the heating period for the case defined in Figure 4.32: The red tuffs had the warmest surfaces with the fastest warming up rates. The white tuff had coldest surface with the slowest heating up rate. Yellowish tuffs used on wall surfaces and on arches exhibited similar warming up rates.

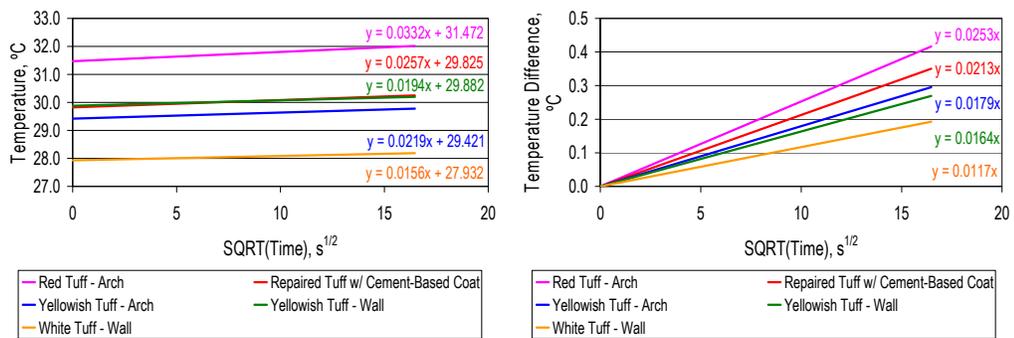
were colder than the ambient temperature with the warming up rate being slower than those of yellowish and red tuffs. That might be due to the presence of moisture in tuffs in different ranges. The repaired tuff with cement-based coat presented different thermal response to the warming up condition than the tuffs. Although the initial real surface temperatures of repaired tuff and yellowish one were similar, the repaired tuff with cement-based coat warmed up faster than the yellowish tuff (Figure 4.35).

Figure 4.35 The linear fitting of surface temperatures and temperature differences versus square root of time during the heating period for the case defined in Figure 4.32: The red tuff had the warmest surface with the fastest warming up rate. The white tuff had coldest surface with the slowest heating up rate. Repaired tuff with cement-based coat had faster warming up rate than the yellowish and white tuffs.

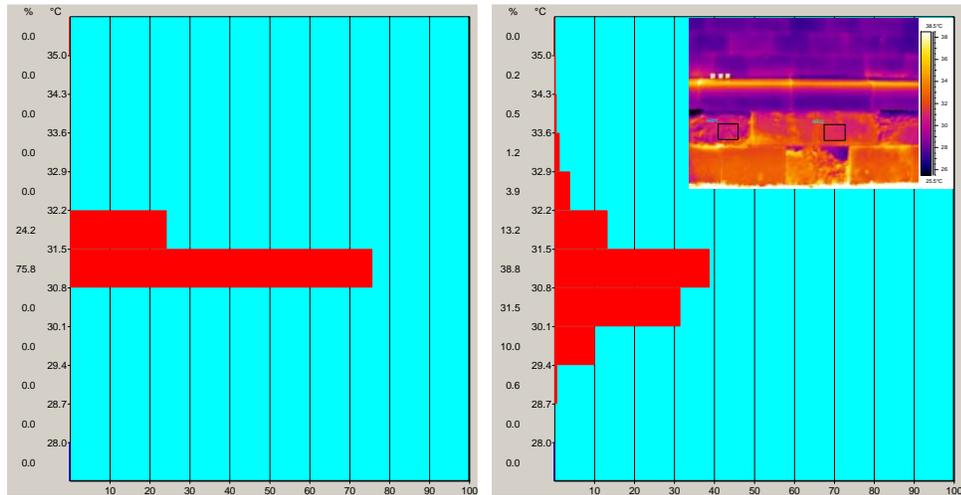
- Visually sound and deteriorated andesite stones at the basement of structure were examined under exposure of solar radiation when the ambient conditions were 28.9 °C and 28%RH. The results were given in the form of histogram views, showing the visually sound and deteriorated andesite stones in the first and second courses above ground level (Figure 4.36 and 4.37). For the first course above the ground level, an even distribution of surface temperatures was observed on the visually-sound andesite, having the surface temperature in the range of 30.9°C and 32.0°C with an average of 31.3°C±0.2°C. On the other hand, andesite which was deteriorated in the forms of material loss and detachments in the first course above ground level showed heterogeneous temperature distribution with the surface temperature in the range of 29.0°C and 34.7°C with an average of 30.9°C±0.7°C (Figure 4.36). For the second course above the ground level, an even distribution of surface temperatures was observed on the visually-sound andesite, having the surface temperature in the range of 31.8°C and 33.4°C with an average of 32.6°C±0.2°C. On the other hand, andesite which was deteriorated in the forms of material loss and detachments in the second course above ground level showed heterogeneous temperature distribution with the surface temperature in the range of 30.5°C and 38.5°C with an average of 33.5°C±1.3°C (Figure 4.37). the results showed that andesite stone which was deteriorated in the form of material loss and detachment had heterogeneous temperature distribution. Additionally, visually-sound and deteriorated andesites in the second course were warmer than the andesite stones in the first course above ground level.

Figure 4.36 Histogram views of visually-sound andesite masonry located in the first course above ground level (at the left) and deteriorated surface in the first course (at the right): Deteriorated surface had heterogeneous temperature distribution.

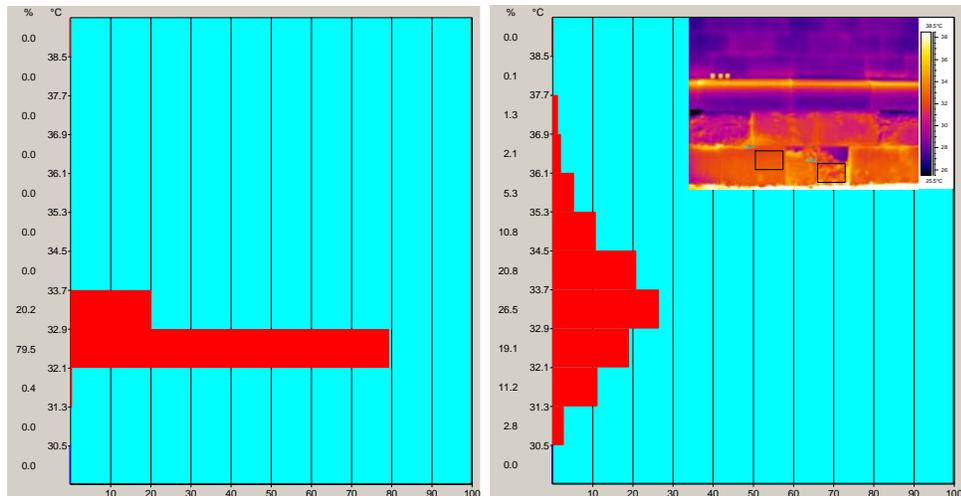
Figure 4.37 Histogram views of visually-sound andesite masonry located in the second course above ground level (at the left) and deteriorated surface in the second course (at the right): Deteriorated surface had heterogeneous temperature distribution.

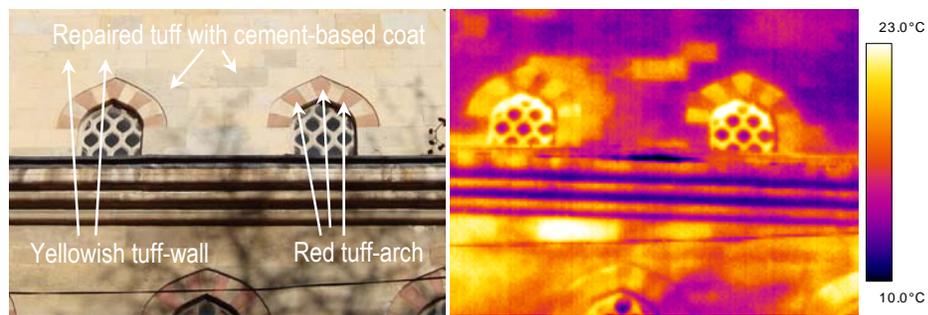
- Surface temperatures of yellowish tuff on wall, red tuff at the arch and repaired tuff with cement-based coat were examined in individual IR images taken during the warming period of daytime at the ambient conditions of 12.4 °C and 48%RH (Figure 4.38). It was found that repaired tuffs with cement-based coat were

warmer than the ambient temperature and visually-sound yellowish tuff wall surfaces with temperature differences of  $+6.65^{\circ}\text{C}$  and  $+2.5^{\circ}\text{C}$ , respectively, that made the detached surfaces clearly visible in IR images although it was not easy to differentiate the repaired tuff surfaces visually by eye. Yellowish and red tuffs could also be distinguished easily due to their different thermal behaviours. Red tuff surface was warmer than ambient temperature with  $+7.6^{\circ}\text{C}$  temperature difference while yellowish tuff on wall was  $+4.15^{\circ}\text{C}$  warmer than the ambient temperature.

Figure 4.38 Partial view of exterior wall surfaces at west side (at the left) and its IR image (at left bottom): Different stone types were easily detected in IR images. Red tuff at the arch and repaired tuff with cement-based coat were warmer than the yellowish tuff used on wall surfaces when all surface temperatures were above the ambient temperature.

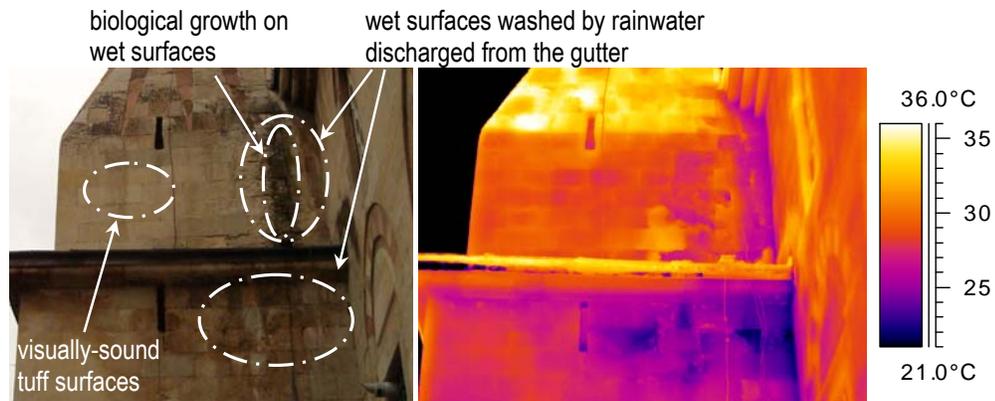
- Thermal responses of minaret wall surface on south façade were detected in IR image after the preliminary wetting by light summer rainfall (Figure 4.39). IR image was taken at the exterior boundary conditions of  $30^{\circ}\text{C}$  and 21%RH. It was found that the visually sound yellowish tuff wall surfaces were  $-1.18^{\circ}\text{C}\pm 0.34^{\circ}\text{C}$  colder than the ambient temperature due to the slightly damp tuff surfaces. The wall surfaces washed by the rainwater discharged directly from the gutters were the coldest surfaces in the IR images, being colder than the ambient temperature with a temperature difference of  $-6.75^{\circ}\text{C}\pm 2.04^{\circ}\text{C}$  while these damp surfaces covered with biological growth were observed to be warmer than visually-sound tuff surfaces with a temperature difference of  $+0.7^{\circ}\text{C}$  while being still colder than the ambient temperature.

Figure 4.39 Partial view of exterior wall surface at the south facade of minaret (at the left) and its IR image (at the right): The visually-sound tuff surfaces were colder than the ambient temperature. The damp surfaces washed by rainwater were the coldest areas while biological growths on these damp zones were warmer than visually-sound tuff surfaces.

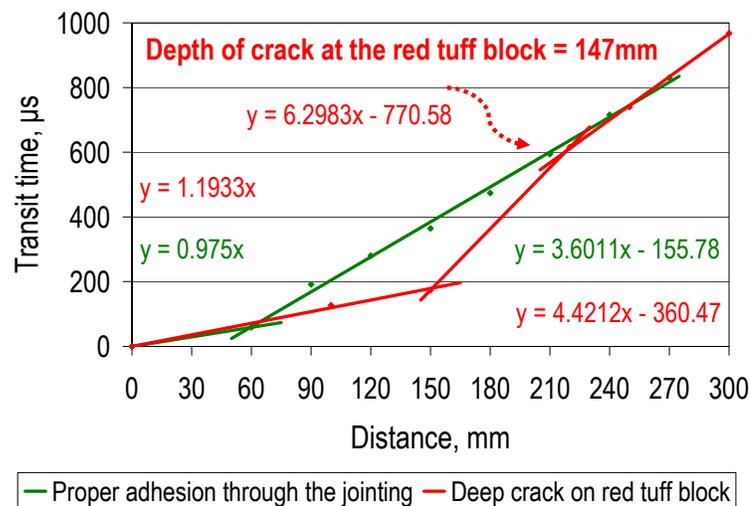
The transit time readings taken on the route of deeper crack and vertical jointing between the red tuff blocks were presented in Figure 4.41. For the case of deeper crack on red tuff block, cavity depth was found 147mm with the correlation coefficients ( $R^2$ ) in the range of 0.995-1.00. 147mm depth meant that it extended along the cross section of red tuff block, having the dimensions of 15cmx94cmx20cm (width x length x height). The crack having almost 15cm depth showed that the block was separated entirely into two. It was not expected to achieve transit time readings in such a case when transmitter and receiver were placed at both sides of the crack. However, a reliable UPV data was obtained when the transducers placed at the opposite sides of crack, presenting a constant slope of 4.42 and indirect UPV value of 335m/s±24m/s (Figure 4.41). It meant that broken tuff block was still well-fastened on the backing masonry with a proper adhesion.

Figure 4.41 The slope of regression lines for the tuff followed by proper jointing (line in green) and the change in the regression slope corresponding to the depth of crack which had separated the red tuff block into two (line in red).

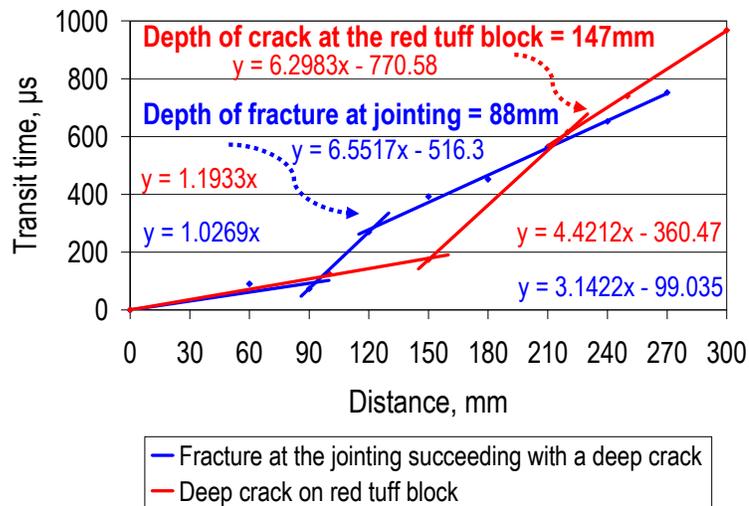
The results of indirect transit time readings taken on the route where there were two succeeding cracks being close to each other were summarized in Figure 4.42. Those cracks were “the fracture at jointing” followed by “the deep crack” on the red tuff

blocks surrounding the left bottom of window niche, as shown in Figure 4.40. The line in blue presented the UPV data taken on left-to-right direction when the fracture at jointing was the first crack on the route of measurement. The line in red presented the data taken at the opposite direction when the deep crack was the first crack on the route of measurement. When there were two successive cracks on the route of receiver, the displacement of regression line belonging to the first crack (fracture at jointing) seemed to dominate and conceal the signals for the following crack. The blue line in Figure 4.42 showed the sharp displacement of regression line for the fracture at jointing with the correlation coefficients ( $R^2$ ) in the range of 0.75-1.00. (being the first crack on the route of transit time readings) while the red line in Figure 4.42 presented the displacement of regression line for the deep crack with the  $R^2$  of 1.00 (being the first crack on the route of transit time readings).

Figure 4.42 The changes in the slope of regression lines for the tuff corresponding to the depth of crack (line in red) and the depth of fracture at jointing (line in blue).

When there were succeeding cracks/vertical discontinuities being close to each other on the same route of indirect UPV measurements, a special care should be given to the location of transmitter and the arrangement of the route for indirect UPV measurements, especially in the presence of successive defects. This meant that the direction of transit time readings became important for such cases. The sharp displacement of regression line, belonging to the first crack/discontinuity, seemed to hide the signs for the second/following crack(s), as shown in Figure 4.42. In order to improve the accuracy of the UPV analyses, the transit time readings should be taken by starting from both sides of cracks and repeating the measurements for several times.

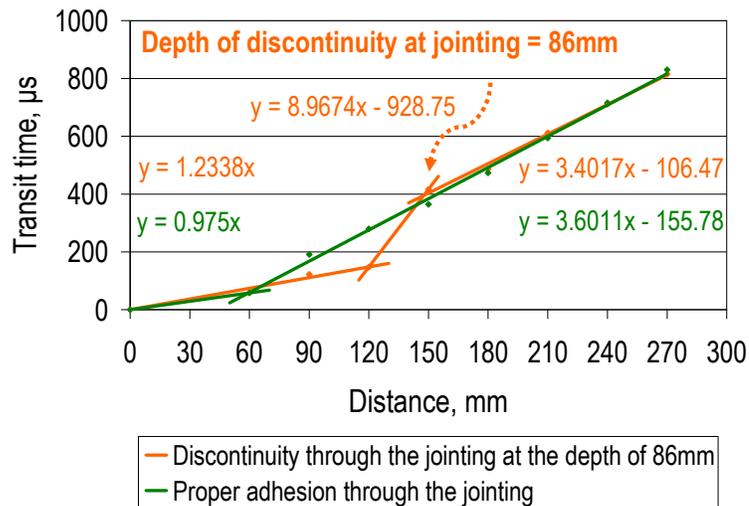
The results obtained from the transit time readings taken for the analyses of vertical and horizontal jointings between the red tuff blocks surrounding the right bottom of window niche were presented in the graph, as shown in Figure 4.43. Here, the red tuff presented a constant slope of regression line while the increase in the slope of

following regression line was due to the presence of jointing detail between neighbouring red tuff blocks (follow the line in green in Figure 4.43). The constant slope of 3.60 with the UPV value of 387m/s without any displacement in transit time readings demonstrated the sound/proper adhesion between the mortar and red tuff at the vertical jointing. On the other hand, the displacement in transit time measured immediately after the jointing with the correlation coefficients ( $R^2$ ) in the range of 0.97-1.00 signalled the presence of a discontinuity/detachment which could not be observed visually (follow the line in orange in Figure 4.43). Here, the horizontal jointing at the right bottom of red tuff blocks was calculated to have a discontinuity at the depth of 86mm.

Figure 4.43 The slope of regression lines for the tuff followed by proper jointing (line in green) and the change in the regression slope corresponding to the depth of discontinuity at jointing (line in orange).

The ultrasonic testing method in indirect transmission mode were found to be promising to examine the soundness of adhesion between mortar and stone surfaces at jointing details as well as the non-visible defects/discontinuities at deeper parts. For instance, a sound/proper adhesion between mortar and red tuff blocks was determined at the vertical jointing (Figure 4.40) with the constant slope of 3.60 with

the UPV value of 387m/s without any displacement in transit time readings (follow the line in green in Figure 4.43). On the other hand, the displacement in transit time measured immediately after the horizontal jointing signalled the presence of a discontinuity at the depth of 86mm which could not be observed visually (follow the line in orange in Figure 4.43). Those jointings, both vertical and horizontal ones, where no visual defect/failure noticed on their surfaces, were found to be sound as well up to a certain depth according to the QIRT analyses. Similar thermal inertia characteristics were determined for the visually-sound jointing mortar and red tuff blocks according to their similar thermal response during the heating period of 15 minutes by halogen lamp (Table 4.1). Considering all, the defect at horizontal jointing should be a local detachment at depth about 86mm, behind which proper adhesion was again achieved.

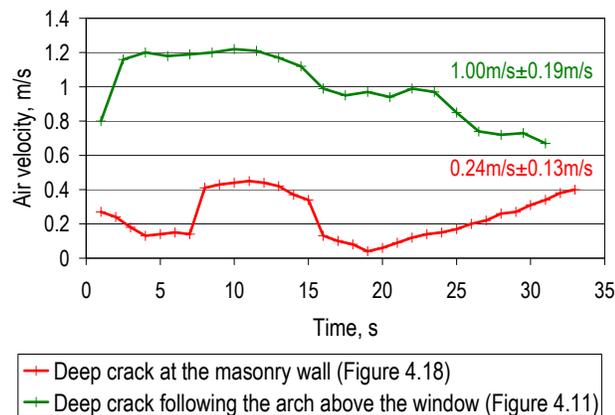
The presence of air flow through the cavity of cracks was measured by using anemometer “VELOCICALC 8364”. Recorded  $V_{AIR}$  values for a period of 30seconds were given in Figure B.1. The  $V_{AIR}$  values were found to be in the range of 0.04m/s and 0.45m/s for the crack at the masonry wall located at the left bottom of window niche. Air flow passing through the cavity of the same crack was measured to be  $0.04l/s \pm 0.04l/s$  for a period of 30 seconds when the sizes of airflow were accepted to be 1cmx6.5cm in width and length. The  $V_{AIR}$  values for the crack following the arch above the window were found varying in the range of 0.67m/s and 1.22m/s. Air flow passing through the cavity of the same crack was measured to be  $0.41l/s \pm 0.17l/s$  for a period of 30 seconds when the sizes of airflow were accepted to be 1cmx5cm in width and length. No airflow was measured for the other cracks.

Figure B.1 The  $V_{AIR}$  values measured at the cavities of deep cracks at the east side of the structure for a period of 30 seconds, proving the presence of air flow between outside and inside through the cracks.
