VERNACULAR TIMBER HOUSES OF UZUNGÖL:
EXAMINING / ANALYZING THEM IN THEIR RE-FUNCTIONING PROCESS

A THESIS SUBMITTED TO
THE GRADUATE SCHOOL OF NATURAL AND APPLIED SCIENCES
OF
MIDDLE EAST TECHNICAL UNIVERSITY

IN PARTIAL FULFILLMENT OF THE REQUIREMENTS
FOR
THE DEGREE OF MASTER OF SCIENCE
IN
RESTORATION IN ARCHITECTURE

FEBRUARY 2012

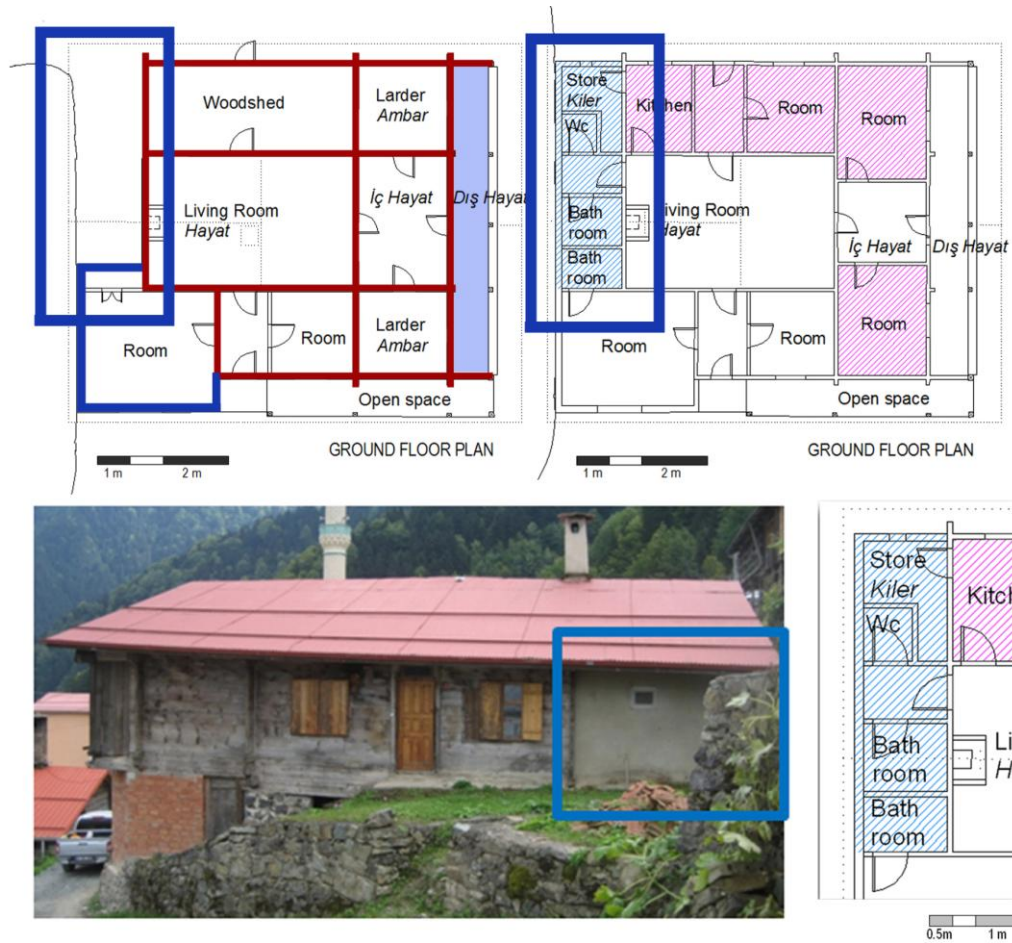
Figure 47, Addition of Wet Spaces Behind the Building

Among space additions, at the 6 of all, the gap has been functioned as wet spaces (see Figure 47). The gap defines a space, which is able to connect with the living space (*hayat*), the main room (*mabeyin oda*) and the woodshed at the same time. So the empty space has been functioned in order to serve all those spaces. Among added spaces, one of them serves to the main room (*mabeyin oda*) that is connecting with a door. Other added wet space, as bath room and wc at the backside, serves to the whole household providing a connection with a door to the living space (*hayat*) or indirectly with inner hall. Also the other wet space, which is at the back side of the kitchen, has been used as storage. It serves to kitchen. Access to the added spaces is from inside. The structural system of the added part is reinforced concrete. The added part has been applied on the same line with the original boundaries of the original building. Concrete framed construction is applied with brick infill and cement plastered. The size of the added window openings are in the range of 40x40 – 50x50 cm and considering no façade order. The roof of the added space is the extension of the original roof of the building and so that intervention seems like more space addition than mass addition.

According to the analyze of the space additions that have been functioned as wet spaces in the study area after the evaluation of materials used, structural system and taken information from the occupants, it is considered that type of additions have been applied in the last 5-10 years.

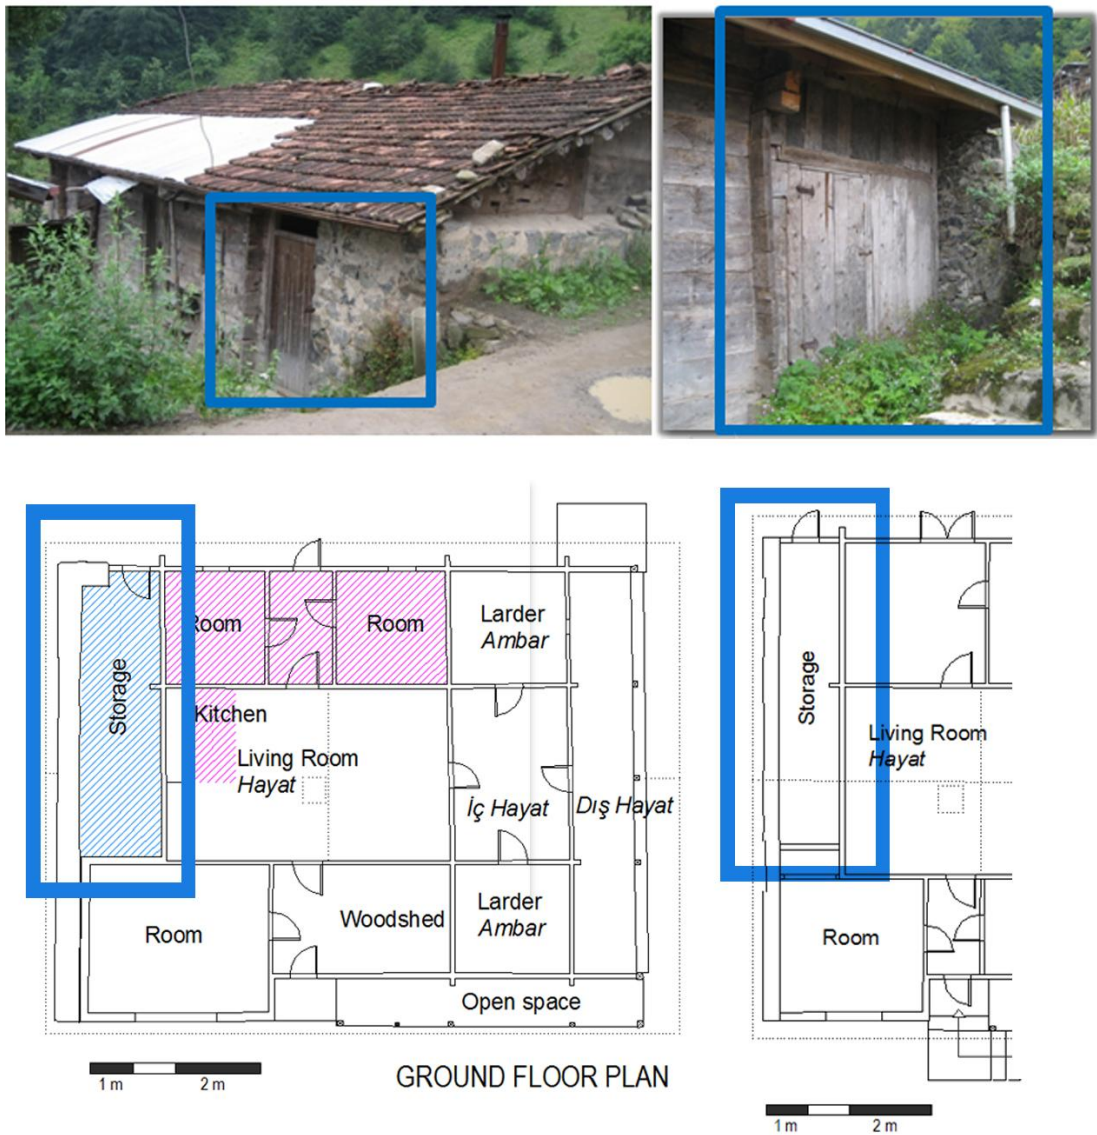
Figure 48, Addition of Storage Behind the Building

extension of the original roof of the building and so that the intervention seems like more a space addition than a mass addition (see Figure 48).

According to the analyze of the space additions that have been functioned as storage or an extra woodshed in the study area after the evaluation of materials used, structural system and taken information from the occupants, it is considered that type of additions have been applied in the last 20 years.

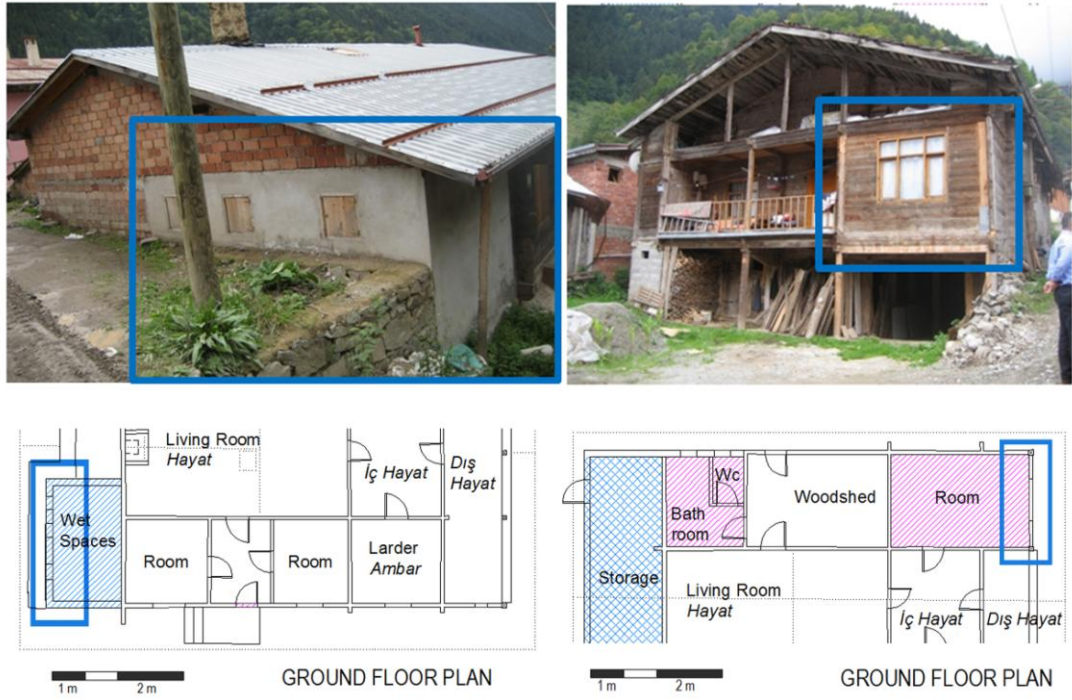
Figure 49, Addition of New Openings with the Organization of New Spaces

Among the architectural element additions, at the 14 of all, original spaces have been reorganized by various arrangements in some of the houses in the study area. After this reorganization, the dimensions of the original spaces could be changed and the original spaces could be reused for new purposes. The reorganized spaces need windows for illumination and doors for connection if access to outside is desired. That brings the addition of new window and door opening at the altered spaces (see Figure 49). The material of the added windows and doors can be new timber, pvc based material or sectional iron. The dimensions of the windows vary according to the space, where the openings are added to, such as: the bigger windows at the living rooms and smaller windows at wet spaces. The windows, which are applied in the rooms, are placed in the middle of the wall surface, being compatible with the façade order; but at the added windows in the wet spaces, no façade order is considered.

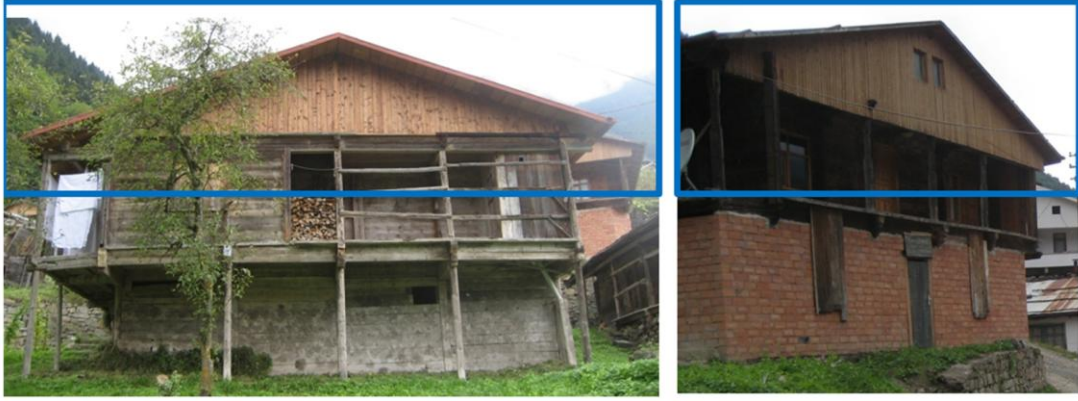
Figure 51, Addition of New Timber Covering to the Triangular Facing of the Roof

Among the architectural element additions, at the 10 of all, it is seen that that space, which is used originally as *kurutmalık*, the triangular facing of it has been covered with new timber at some of the houses. According to the analyze of the coverings at the triangular facing of the space *kurutmalık* in the study area after the evaluation of materials used, structural system and taken information from the occupants, it is considered that type of additions have been applied in the last 15 years (see Figure 51).

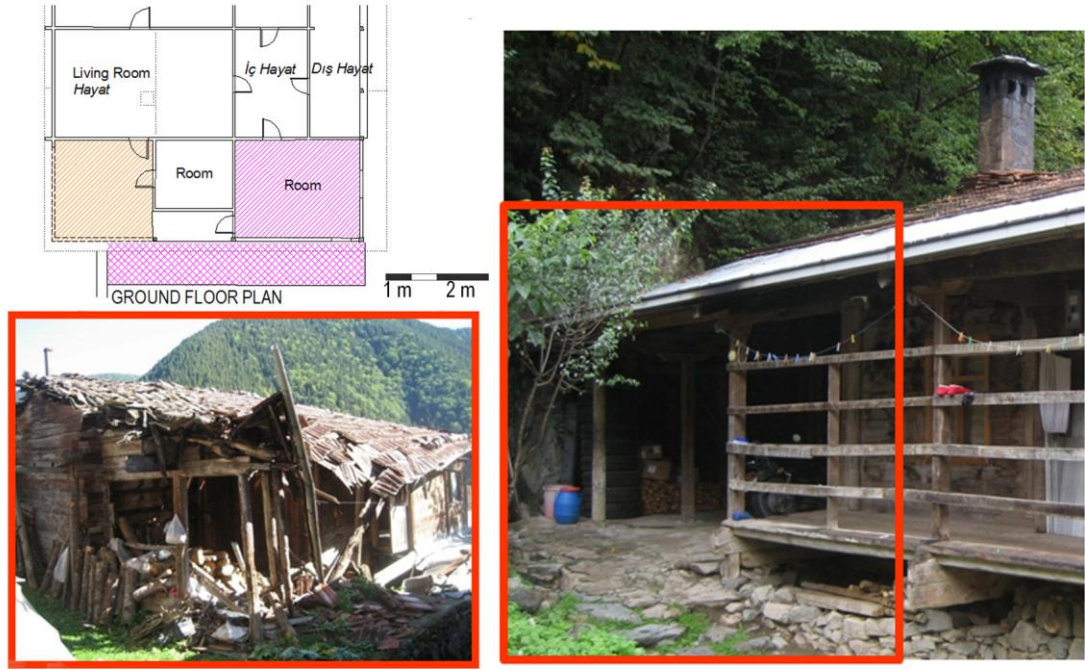
Figure 52, Removal of Mass that is Composed by the Spaces Entrance and *Mabeyin Oda*

Among the mass removals, at the 2 of all, it is seen that the entrance space, including the entrance door, and the main room (*mabeyin oda*) have been removed from the structure at some of the houses in the study area. The type of removal of these two spaces is defined both as mass removal and space removal⁶⁰. At the two of the removals, it is seen that the usage of the houses continues even after the removal of these two spaces. The access to the house is provided directly from the living space (*hayat*). As totally removed, there are no remains of the spaces. The reason why the interventions are accepted as removal is for that the areas of removed spaces remain under the original roof boundaries (see Figure 52).

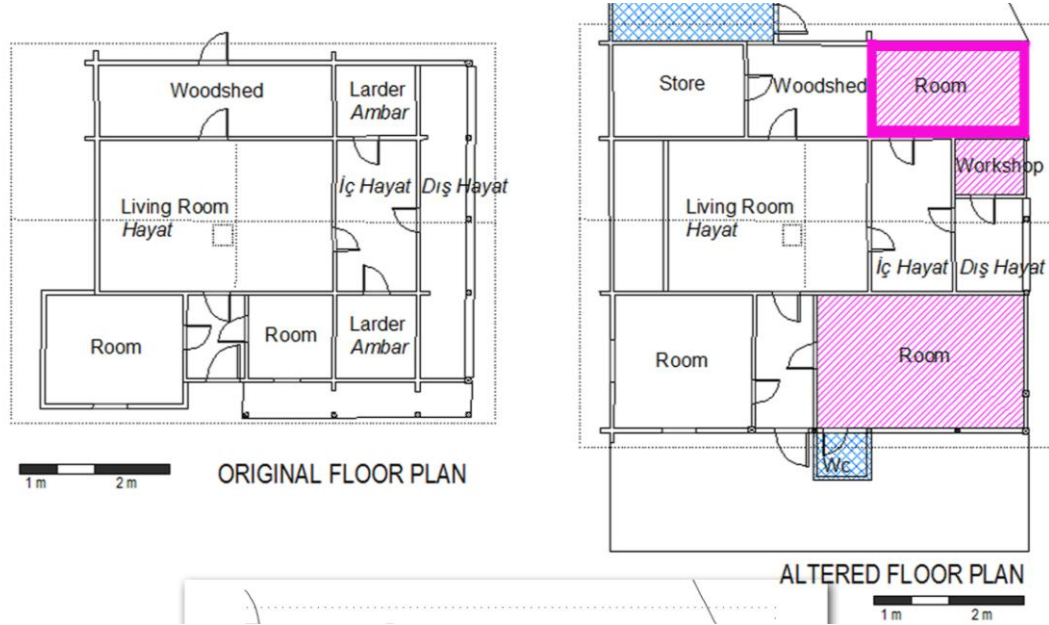
Figure 56, Alteration of the Spaces that Larder and a Part of *Dış Hayat* have been Unified and Turned to a Room

In the 8 of space alterations applied to the houses in the study area, it is seen that the space, which functioned originally as a larder, has been enlarged to *dış hayat*. This new space is arranged as a room (see Figure 56). In this type of alteration, the width of the new space is kept, while the length is increased. Originally located along the whole façade length of the front façade before, after the alteration *dış hayat* is

shortened in one dimension. Many of the altered spaces have window additions at the outer facade walls in order to benefit from daylight. No façade order is considered in positioning of the windows. According to the analysis of the space alterations after the evaluation of materials used and the structural system of the altered spaces and information taken from the occupants, it is considered that these types of alterations have been applied in the last 30 years.

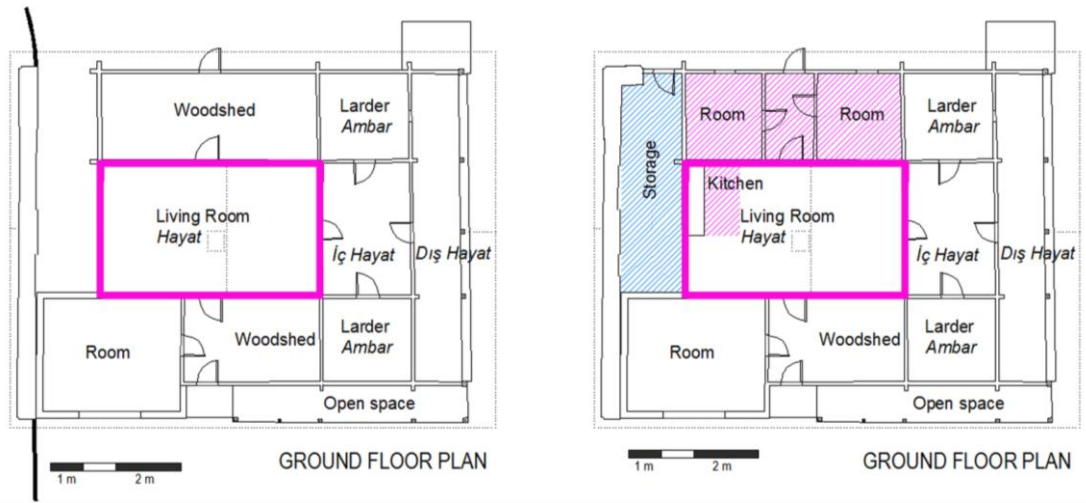
Figure 57, Alteration of the Living Space that *Hayat* has been Re-arranged and Kitchen is Added

In the 6 of the space alterations applied to the houses in the study area, it is seen that the space, which functioned originally as a living space (*hayat*), has been re-arranged and kitchenette has been added in a part of the space (see Figure 57). The open space, functioned as a kitchenette in the living space (*hayat*), is located at the whole length or one part of the backside wall of *hayat*. The kitchen has no physical separation with *hayat*. In the arrangement of the kitchen, the floor of the space is covered with cement screed. Having a kitchen in the living space (*hayat*) makes it easy to cook and eat at the same space. It is also easy to establish the piping system

of the kitchen through the empty space behind the wall, on which the kitchen sink is located.

According to the analysis of the alteration of the living spaces (*hayat*) have been rearranged and a kitchen addition in a part of the space in the study area, after the evaluation of materials used, structural system and information taken from the occupants, it is considered that type of alterations have been applied in the last 25 years.

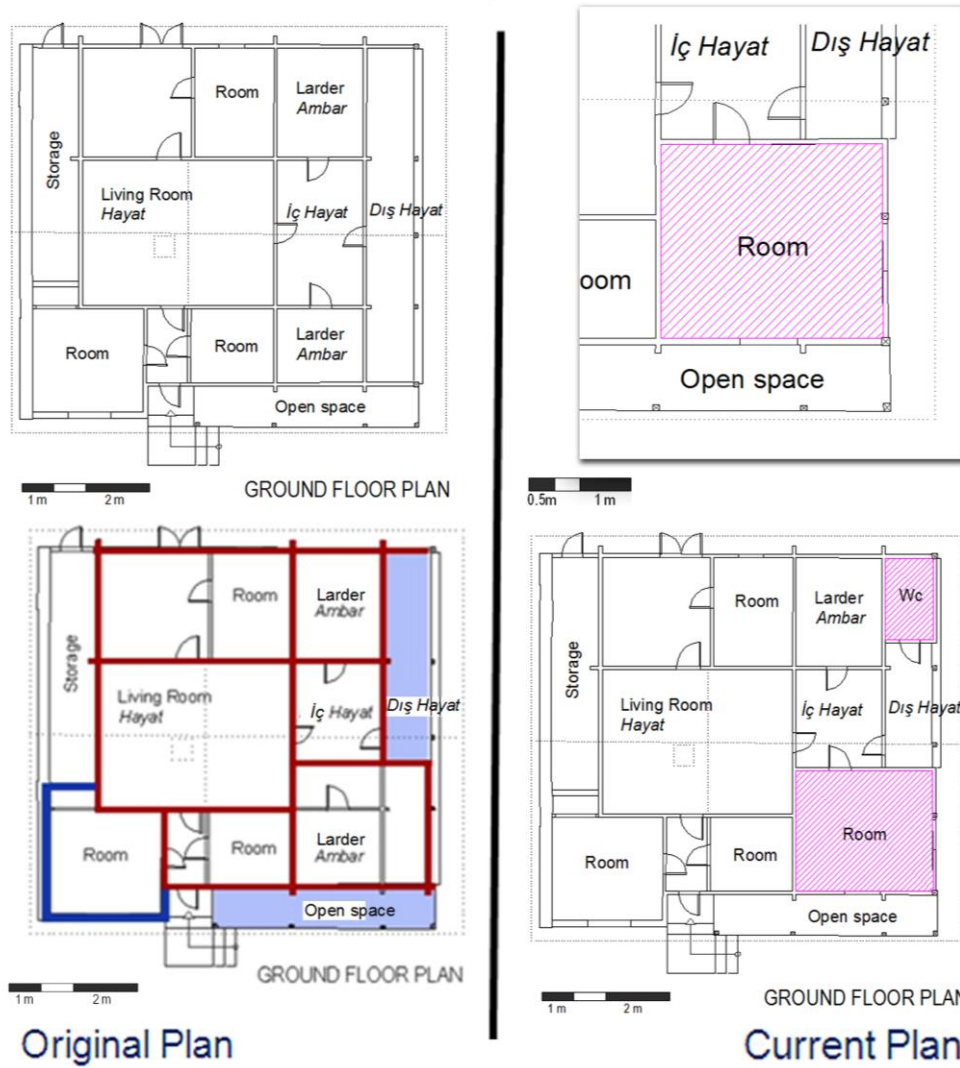
Figure 58, Alteration of the Spaces that Larder, İç Hayat and Dış Hayat have been Unified and Turned to a Room

In the 4 of the space alterations applied to the houses in the study area, it is seen that the space, which functioned originally as larder, has been enlarged and unified with the parts of the adjoining spaces *iç hayat* and *dış hayat* and arranged as a room. At the alteration, larder is enlarged to two directions such as to the space *dış hayat* at the front and *iç hayat* beside, which are the adjoining spaces of the larder (see Figure 58).

Originally located along the whole façade length of the front façade before, after the alteration *dış hayat* is shortened in one dimension. The altered spaces have window additions at the outer facade walls in order to benefit from daylight. No façade order is considered in positioning of the windows.

According to the analyze of the alteration of the space larder to be enlarged to the direction of the adjoining spaces *iç hayat* and *dış hayat* and to be unified and arranged as one room in the study area; after the evaluation of materials used, structural system and taken information from the occupants, it is considered that type of alterations have been applied in the last 30 years.

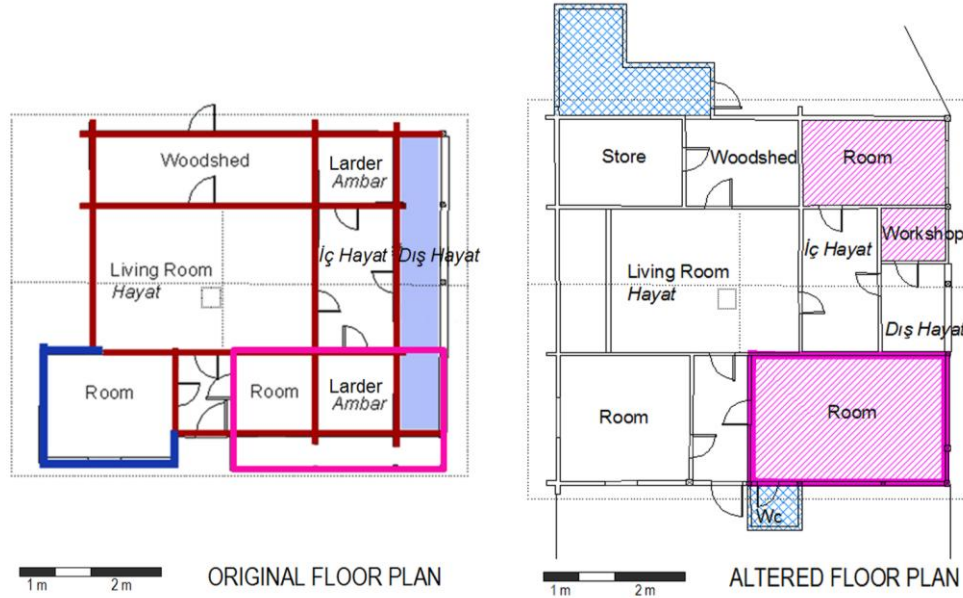
Figure 59, Alteration of the Spaces that Woodshed, Larder, *Dış Hayat* and Side Open Space have been Unified and Turned to a Room.

In the 3 of the space alterations applied to the houses in the study area, it is seen that the space, which functioned originally as larder, has been enlarged and unified with the adjoining spaces and arranged as a room (see Figure 59). Two spaces have been unified by original space dimensions kept. The unified single space has been functioned as a bed room. No change is at the outer boundaries of the building. The altered spaces have window additions at the outer facade walls in order to benefit from daylight. No façade order is considered in positioning the windows.

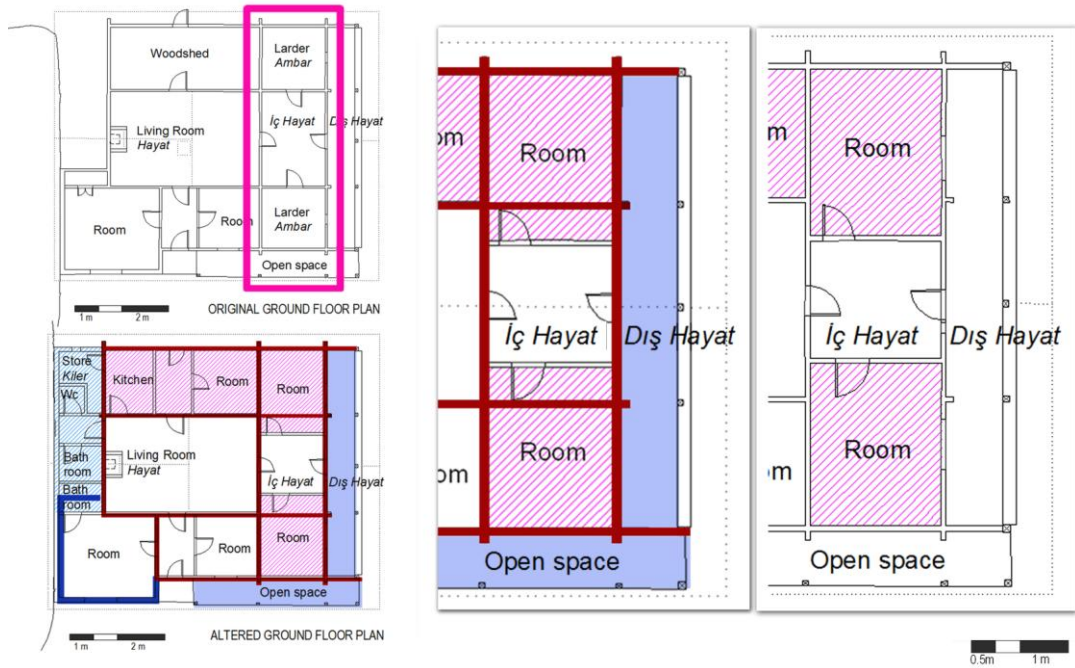
Figure 60, Alteration of the Spaces that Larder and *İç Hayat* have been Unified and Turned to a Room

In the 3 of the space alterations applied to the houses in the study area, it is seen that the space, which functioned originally as larder, has been enlarged by unifying with a part of the adjoining space *iç hayat* (see Figure 60). This new space is arranged as a room. The application is on the transverse axis of the larder to *iç hayat*. In this type of alteration, the length of the new space is kept, while the width is increased.

No change at the space *diş hayat* that is located through the whole front facade length. The altered spaces have window additions at the outer facade walls in order to benefit from daylight. No façade order is considered in positioning the windows.

According to the analysis of these space alterations in the study area; after the evaluation of materials used, structural system and taken information from the occupants, it is considered that type of alterations have been applied in the last 30 years.

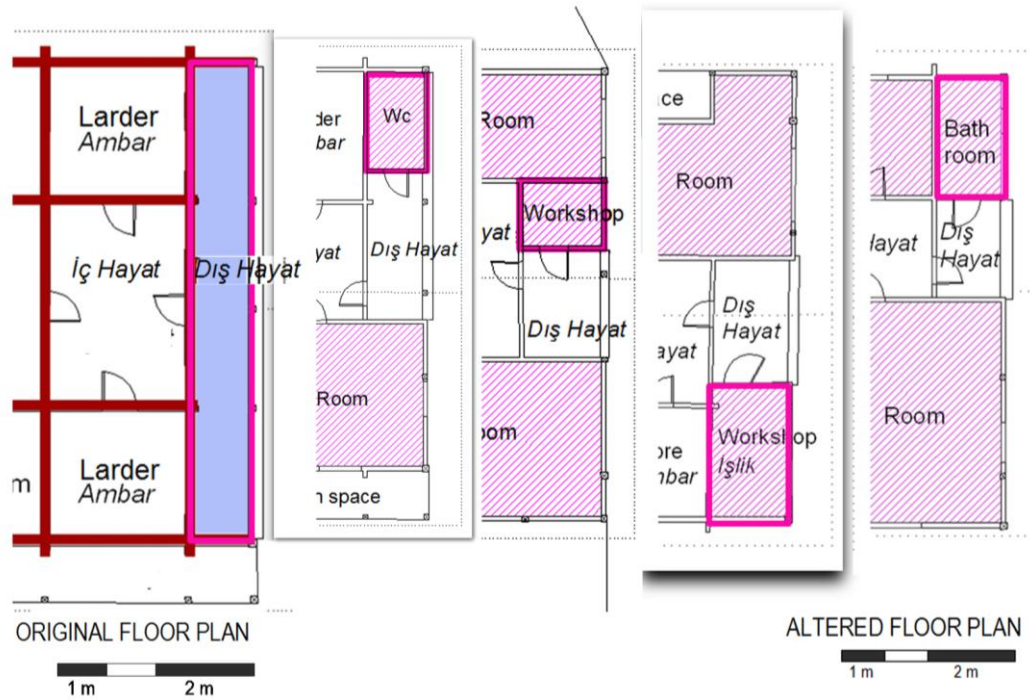
Figure 61, Alteration of the Space that *Dış Hayat* has been Divided and a Small Space has been Added.

In the 5 of the space alterations applied to the houses in the study area, it is seen that the space *dış hayat* has been partially separated in order to get a new closed space. That new space has been functioned for different purposes. Located at one side of *dış hayat*, the length of the new space is 2-2.5 meters. This small space is generally functioned as a workshop for woodwork or a wet space serving to the house (see Figure 61). The construction material of the added space is timber as it is used in the house.

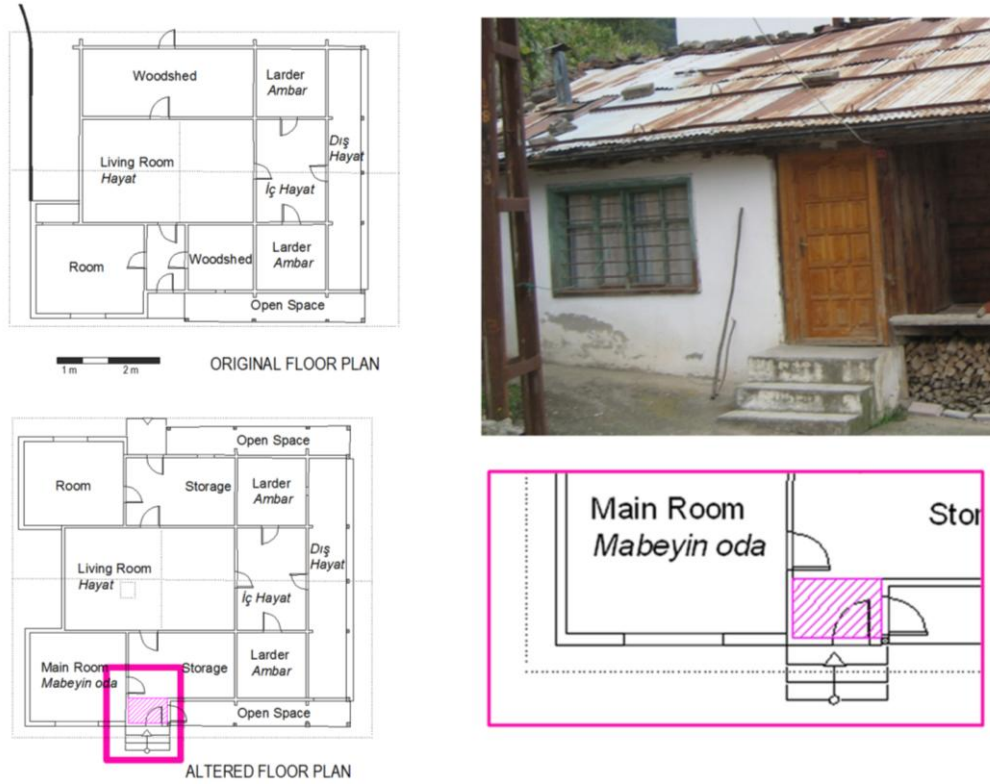
Figure 64, Alteration of the Space that Entrance Space has been Expanded by Moving the Wall Outwards.

In the 3 of the space alterations applied to the houses in the study area, it is seen that the outer wall of the main entrance space has been moved outwards, to the level of the side open space, in order to get bigger entrance hall. Because of the expansion of the entrance hall, the access to the side open space has been provided from the inside (see Figure 64). In this type of alteration, it is seen that a door has been added between the altered entrance hall and the side open space.

According to the analysis of these space alterations, after the evaluation of materials used, structural system and taken information from the occupants, it is considered that type of alterations have been applied in the last 15-20 years.

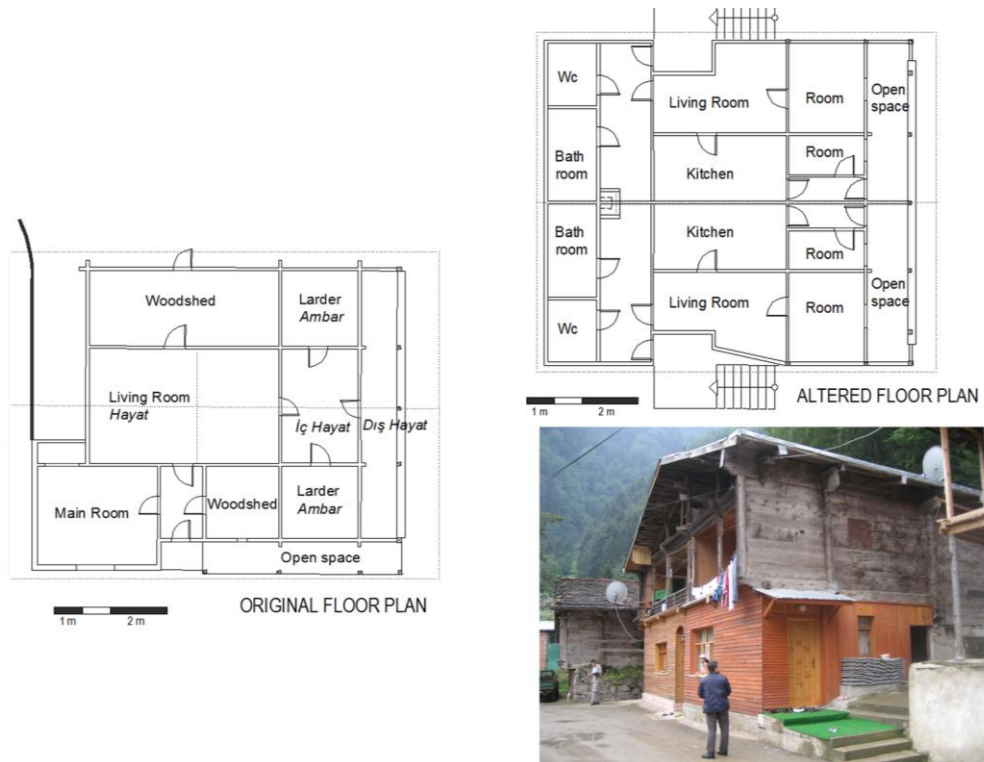
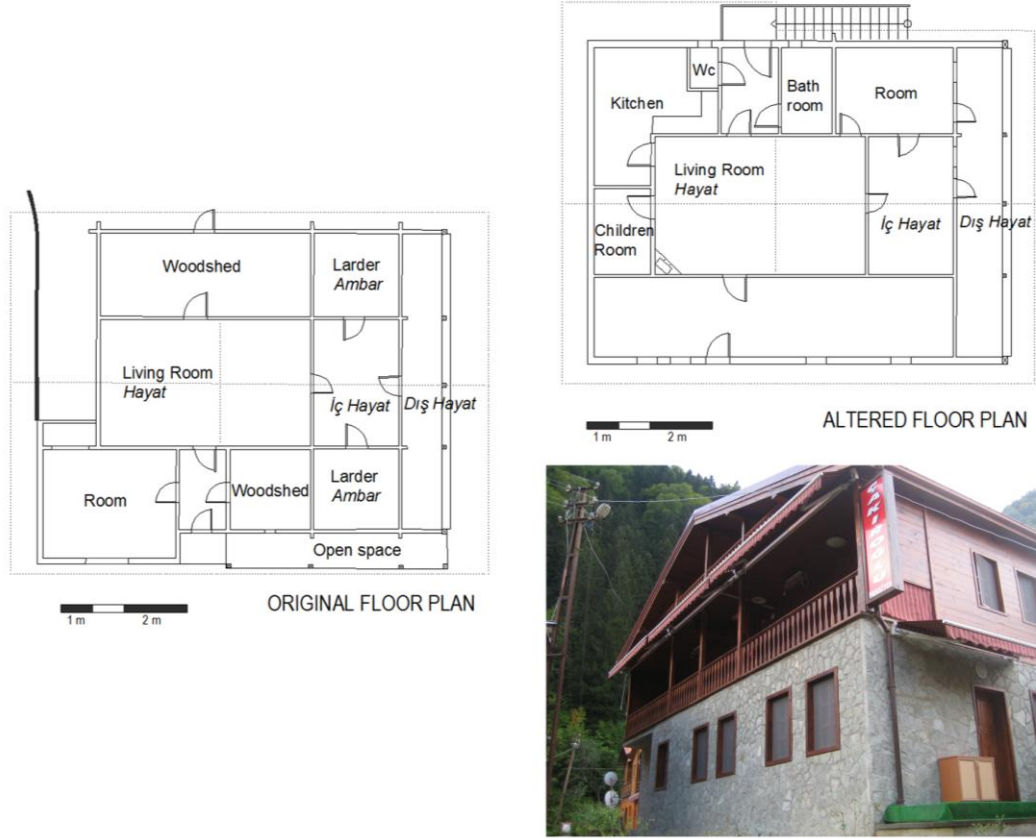
Figure 66, Alteration of Space that Whole Plan Organization has been Altered.

In the 2 of the space alterations applied to the houses in the study area, it is seen that the whole plan layout of the ground floor has been rearranged (see Figures 66, 67). The outer boundaries of the ground floor have been preserved, but the original plan layout can not be distinguished. In the houses that reflects this type of intervention, the inner spaces have been refunctioned as living space, bedrooms, kitchen and bathroom. The spaces have been divided with separation walls. New doors and windows have been added. The inner walls have been covered with new timber. The altered spaces have window additions at the outer facade walls in order to benefit from daylight. No façade order is considered in positioning the doors and windows.

According to the analysis of the space alterations in the study area, after the evaluation of materials used, structural system and taken information from the occupants, it is considered that type of alterations have been applied in the last 15 years.

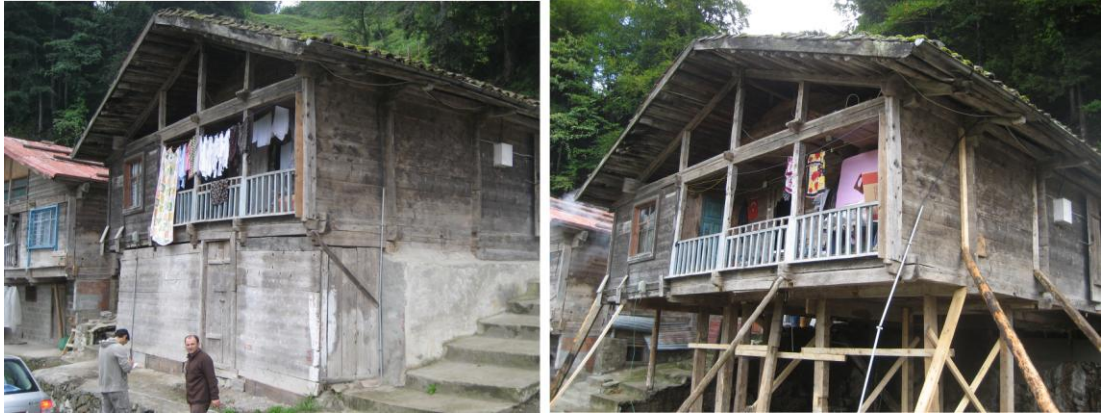
Figure 70, Original View of the House and View During Basement Floor Alteration

In the 10 of the architectural element alterations applied to the houses in the study area, it is seen that the structural system and the construction material of the basement floor have been renewed with alternative materials (see Figures 69, 70). The outer boundaries of the renewed basement floors have been preserved. In some of the houses, the rubble stone masonry basement floor as the original structural system has been replaced with the reinforced concrete frame system. The concrete framed walls are brick infilled and cement plastered. The altered spaces have window additions at the outer facade walls in order to benefit from daylight. No façade order is considered in positioning the doors and windows.

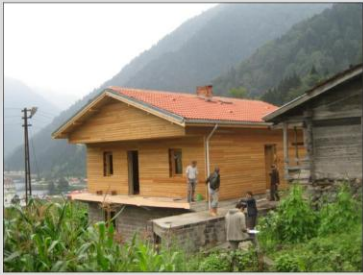
<p>MIDDLE EAST TECHNICAL UNIVERSITY - GRADUATE PROGRAM IN RESTORATION "VERNACULAR TIMBER HOUSES OF UZUNGÖL: EXAMINING / ANALYZING THEM IN THEIR RE-FUNCTIONING PROCESS" prepared by: UMIT GÖKHAN ÇİÇEK / supervisor: Inst. Dr. FUAT GÖKÇE</p>	NAME OF THE HOUSE / ID NO UH - 42	
IDENTIFICATION		INTERVENTIONS	
BUILDING LOT CADASTRAL NO: 137 / 62 REGISTERED <input type="checkbox"/> NOT REGISTERED <input type="checkbox"/> IN USE <input type="checkbox"/> NOT IN USE <input type="checkbox"/> NUMBER OF STOREY: 2 MASS DIMENSIONS (Width / Length) x m TOTAL AREA OF LANDING m ² CURRENT FUNCTION: House CONS. TECH.: Reinforced Concrete ORIGINAL FUNCTION: House MATERIAL: Concrete, brick		<h1 style="margin: 0;">BUILDING IS RENEWED COMPLETELY</h1>	
FAÇADE ELEMENTS

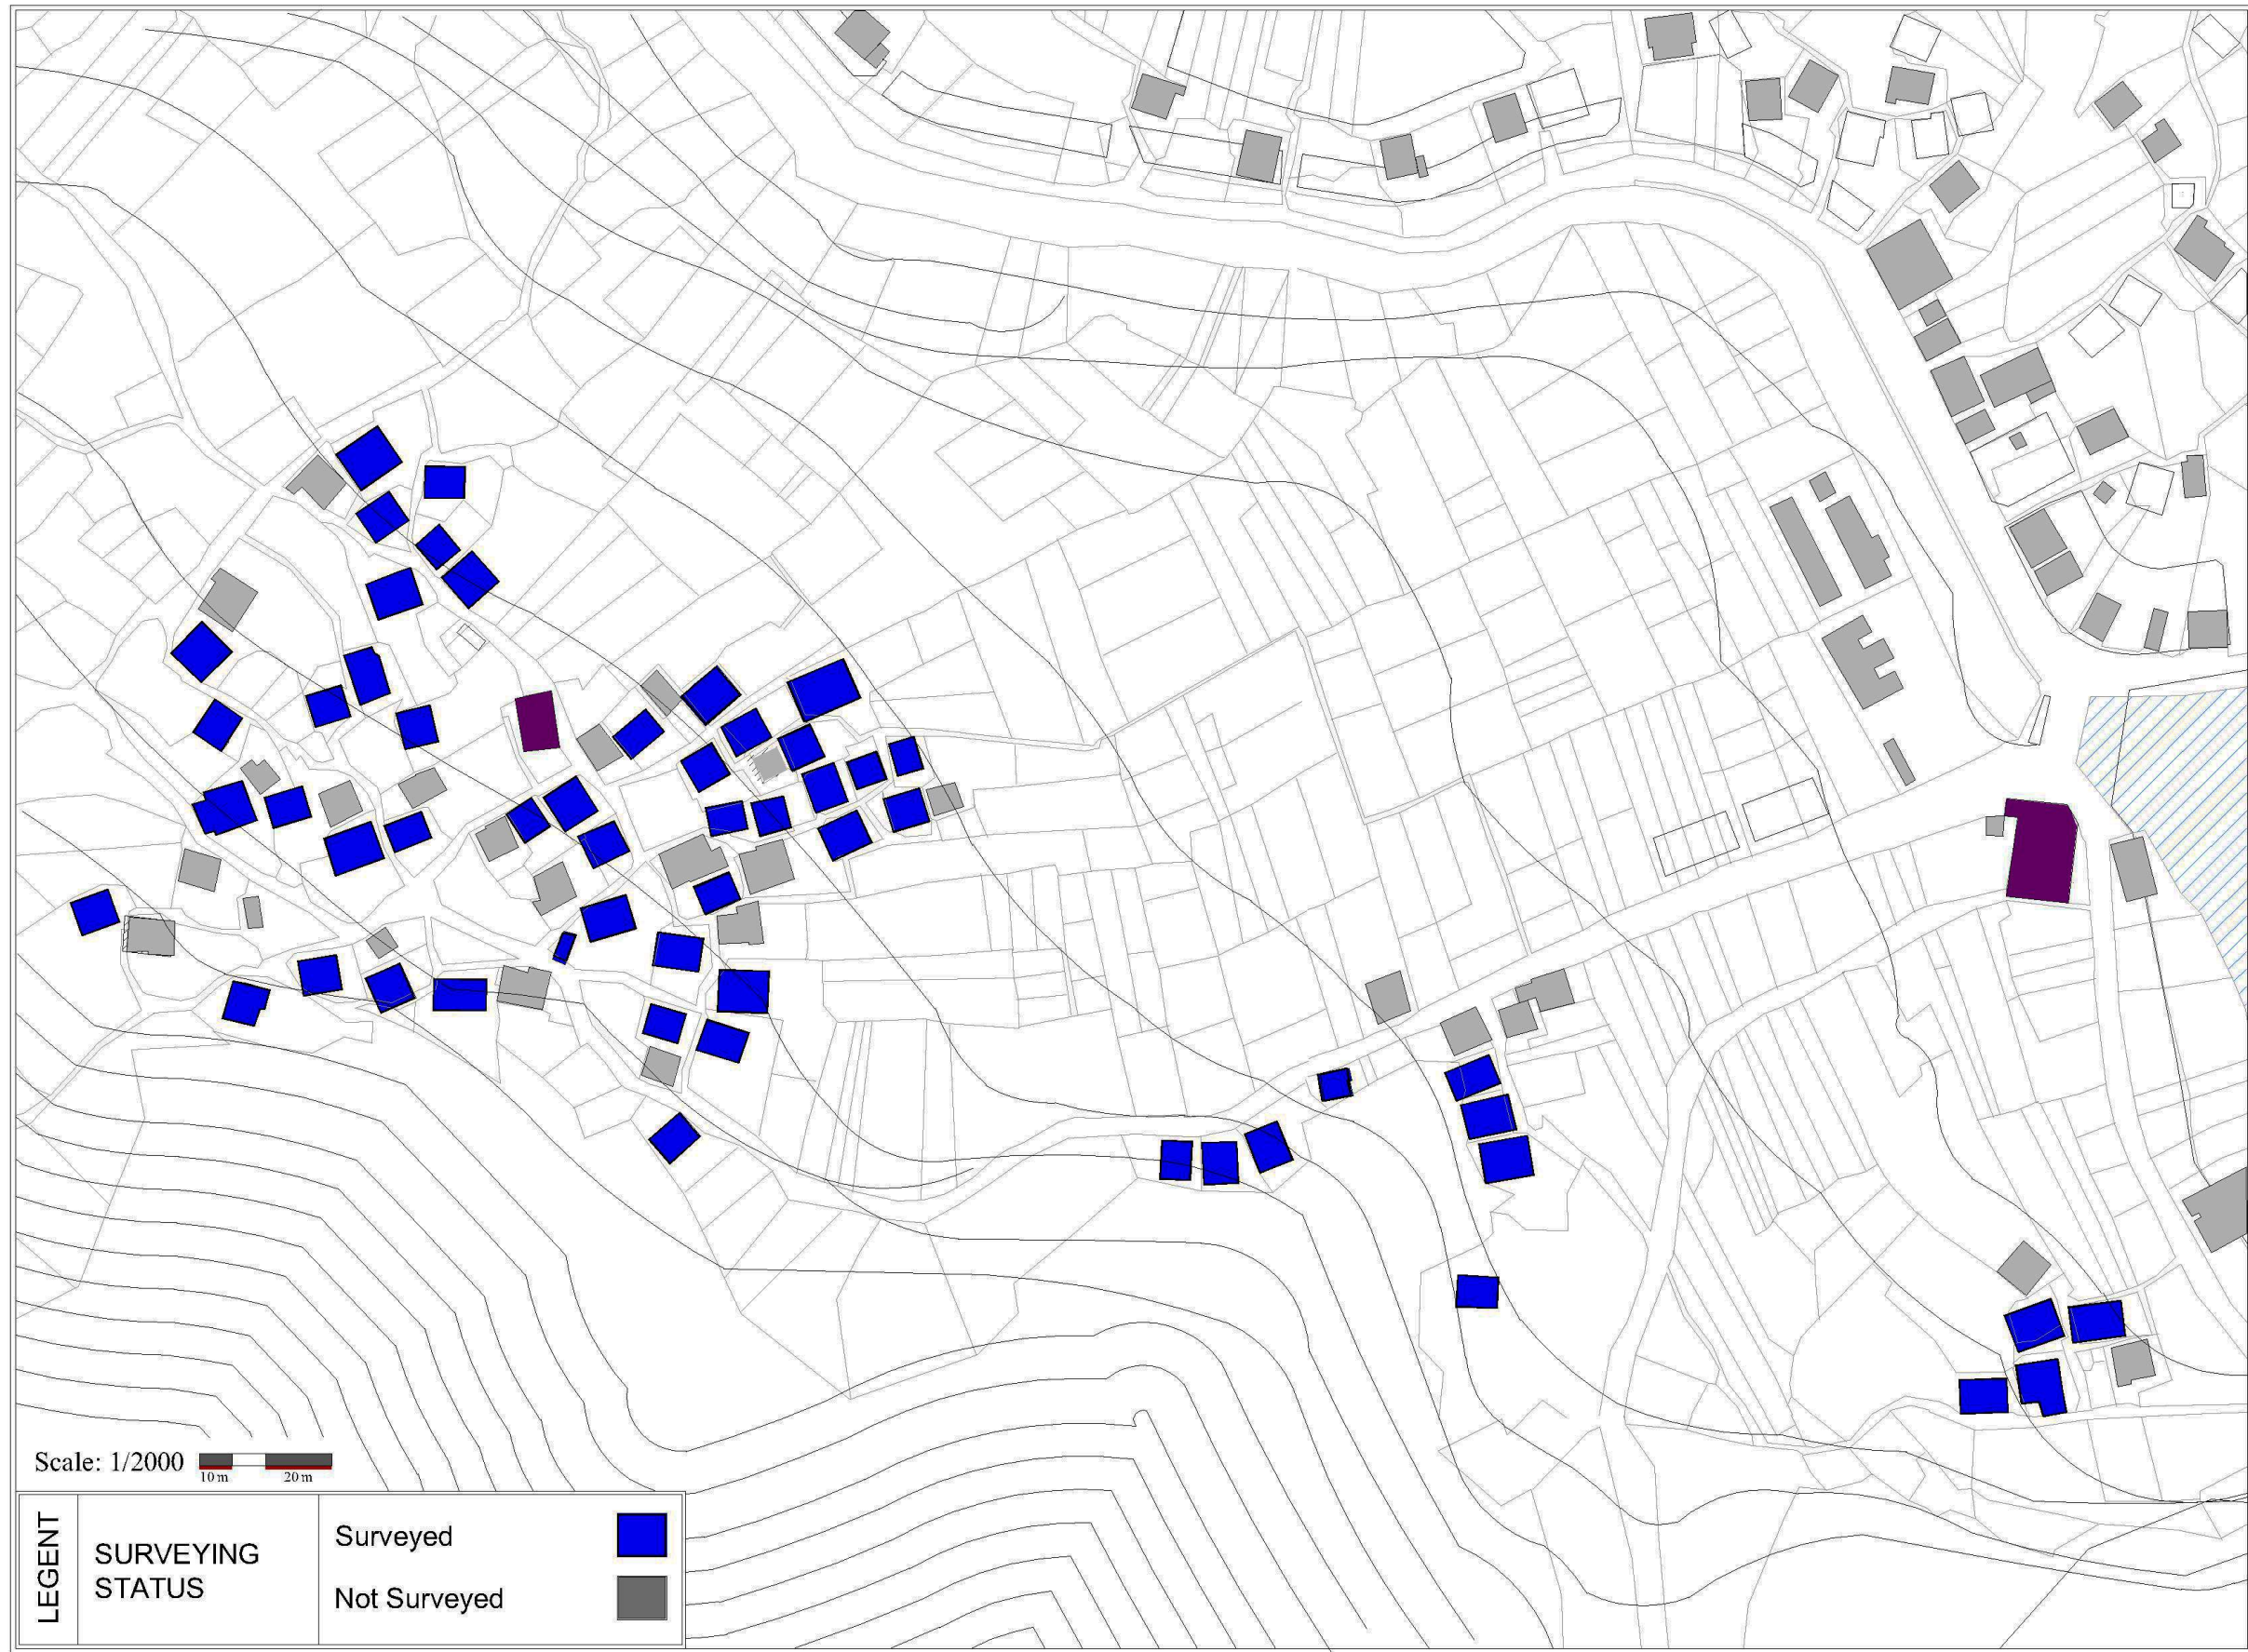
Figure 136, Surveying Status of the Buildings in the Study Area

Vernacular houses of *Uzungöl* have rural settlement characteristics and architectural / physical features that are indigenous. It is aimed to conduct a study first to determine those features, then to analyse and examine the intervention character at vernacular houses in the district. To be able to take reliable results, a limited study area, which has a representative character of the district, was selected. And all registered vernacular houses in that study area were studied (see Appendix B- Figure 135). As the study area *Büyükköy* quarter was selected. 55 registered and 1 unregistered¹² building has been studied of all nearly 90 buildings in the study area (see Figures 2, 10, 136).
