VERNACULAR TIMBER HOUSES OF UZUNGÖL:
EXAMINING / ANALYZING THEM IN THEIR RE-FUNCTIONING PROCESS

A THESIS SUBMITTED TO
THE GRADUATE SCHOOL OF NATURAL AND APPLIED SCIENCES
OF
MIDDLE EAST TECHNICAL UNIVERSITY

IN PARTIAL FULFILLMENT OF THE REQUIREMENTS
FOR
THE DEGREE OF MASTER OF SCIENCE
IN
RESTORATION IN ARCHITECTURE

FEBRUARY 2012

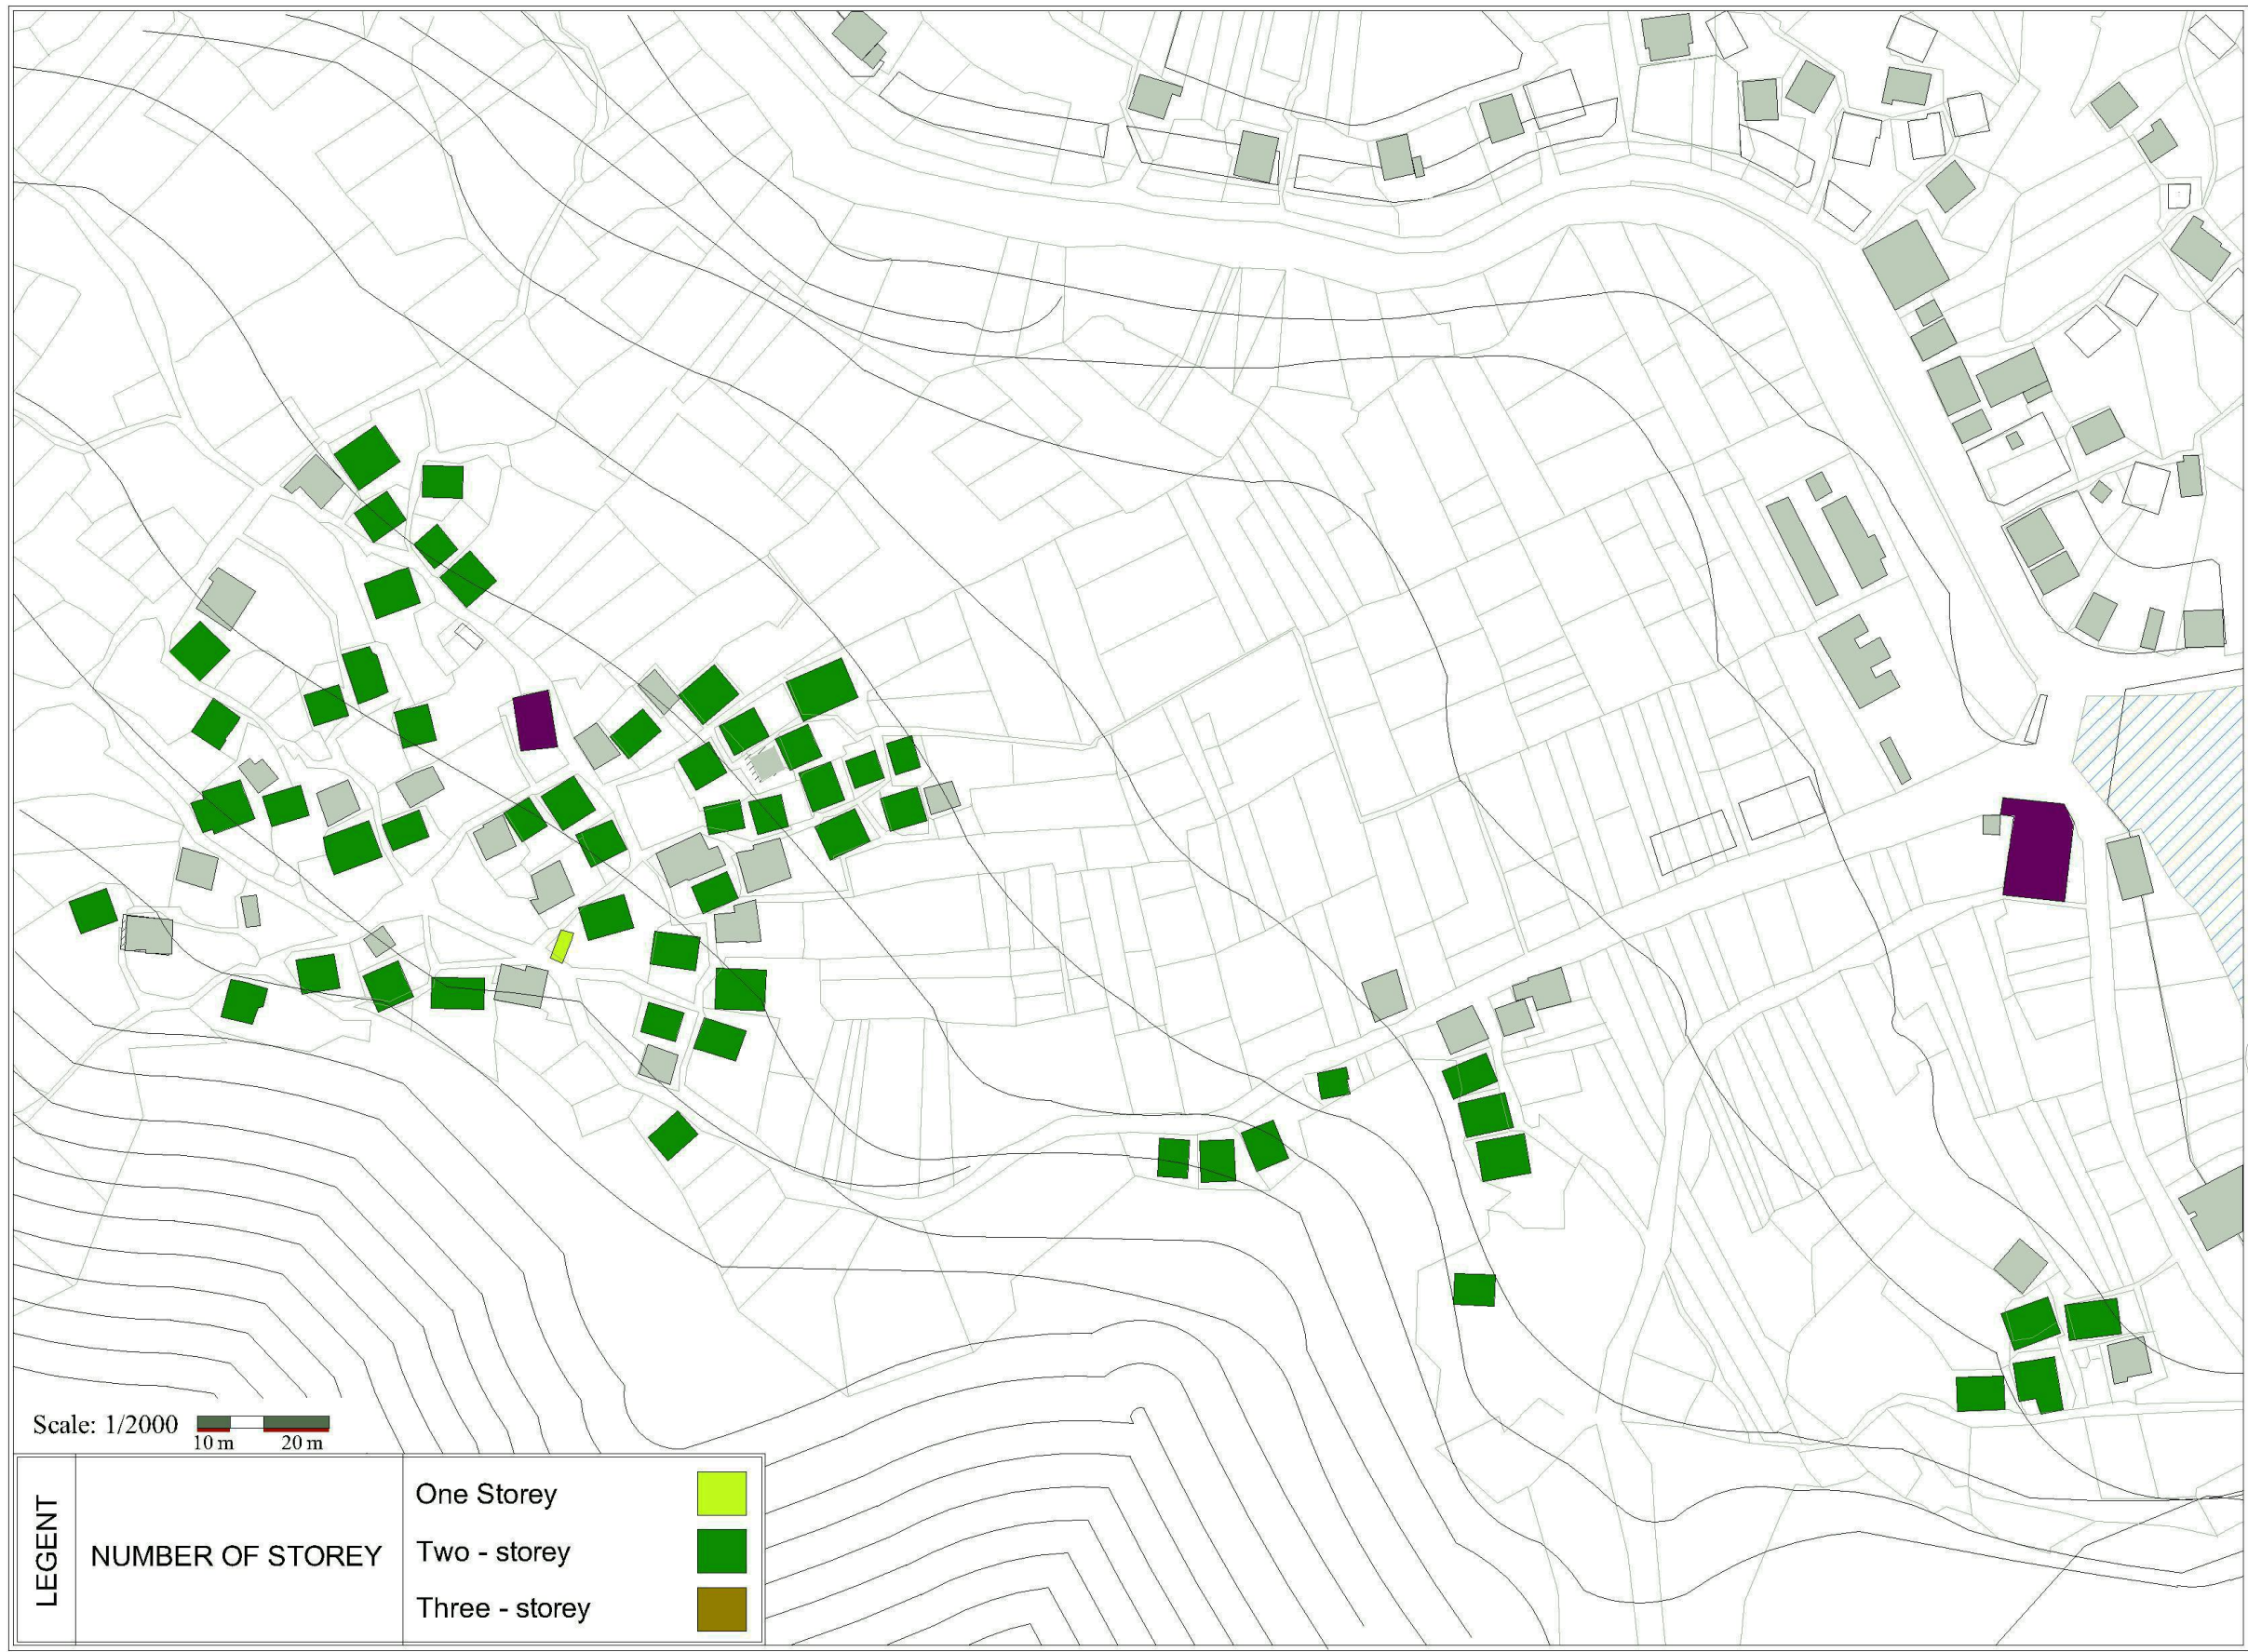
Figure 138, Storey Number of the Buildings in the Study Area

Vernacular *Uzungöl* houses are two storey houses consisting of a basement and a ground floor (see Appendix B- Figure 138). They oriented towards lower points of land. In the inclined topography, houses seem two storeys from the lower point and half of the storey from the higher points. Having nearly the same height with the soil at the back facade, the height of the building reaches to 6.5 meters on the front facade³⁰ (see Figure 16). As a settlement character, each house is located on the ground leaving a 1.5-2 meter gap with the retaining wall (see Figure 18).

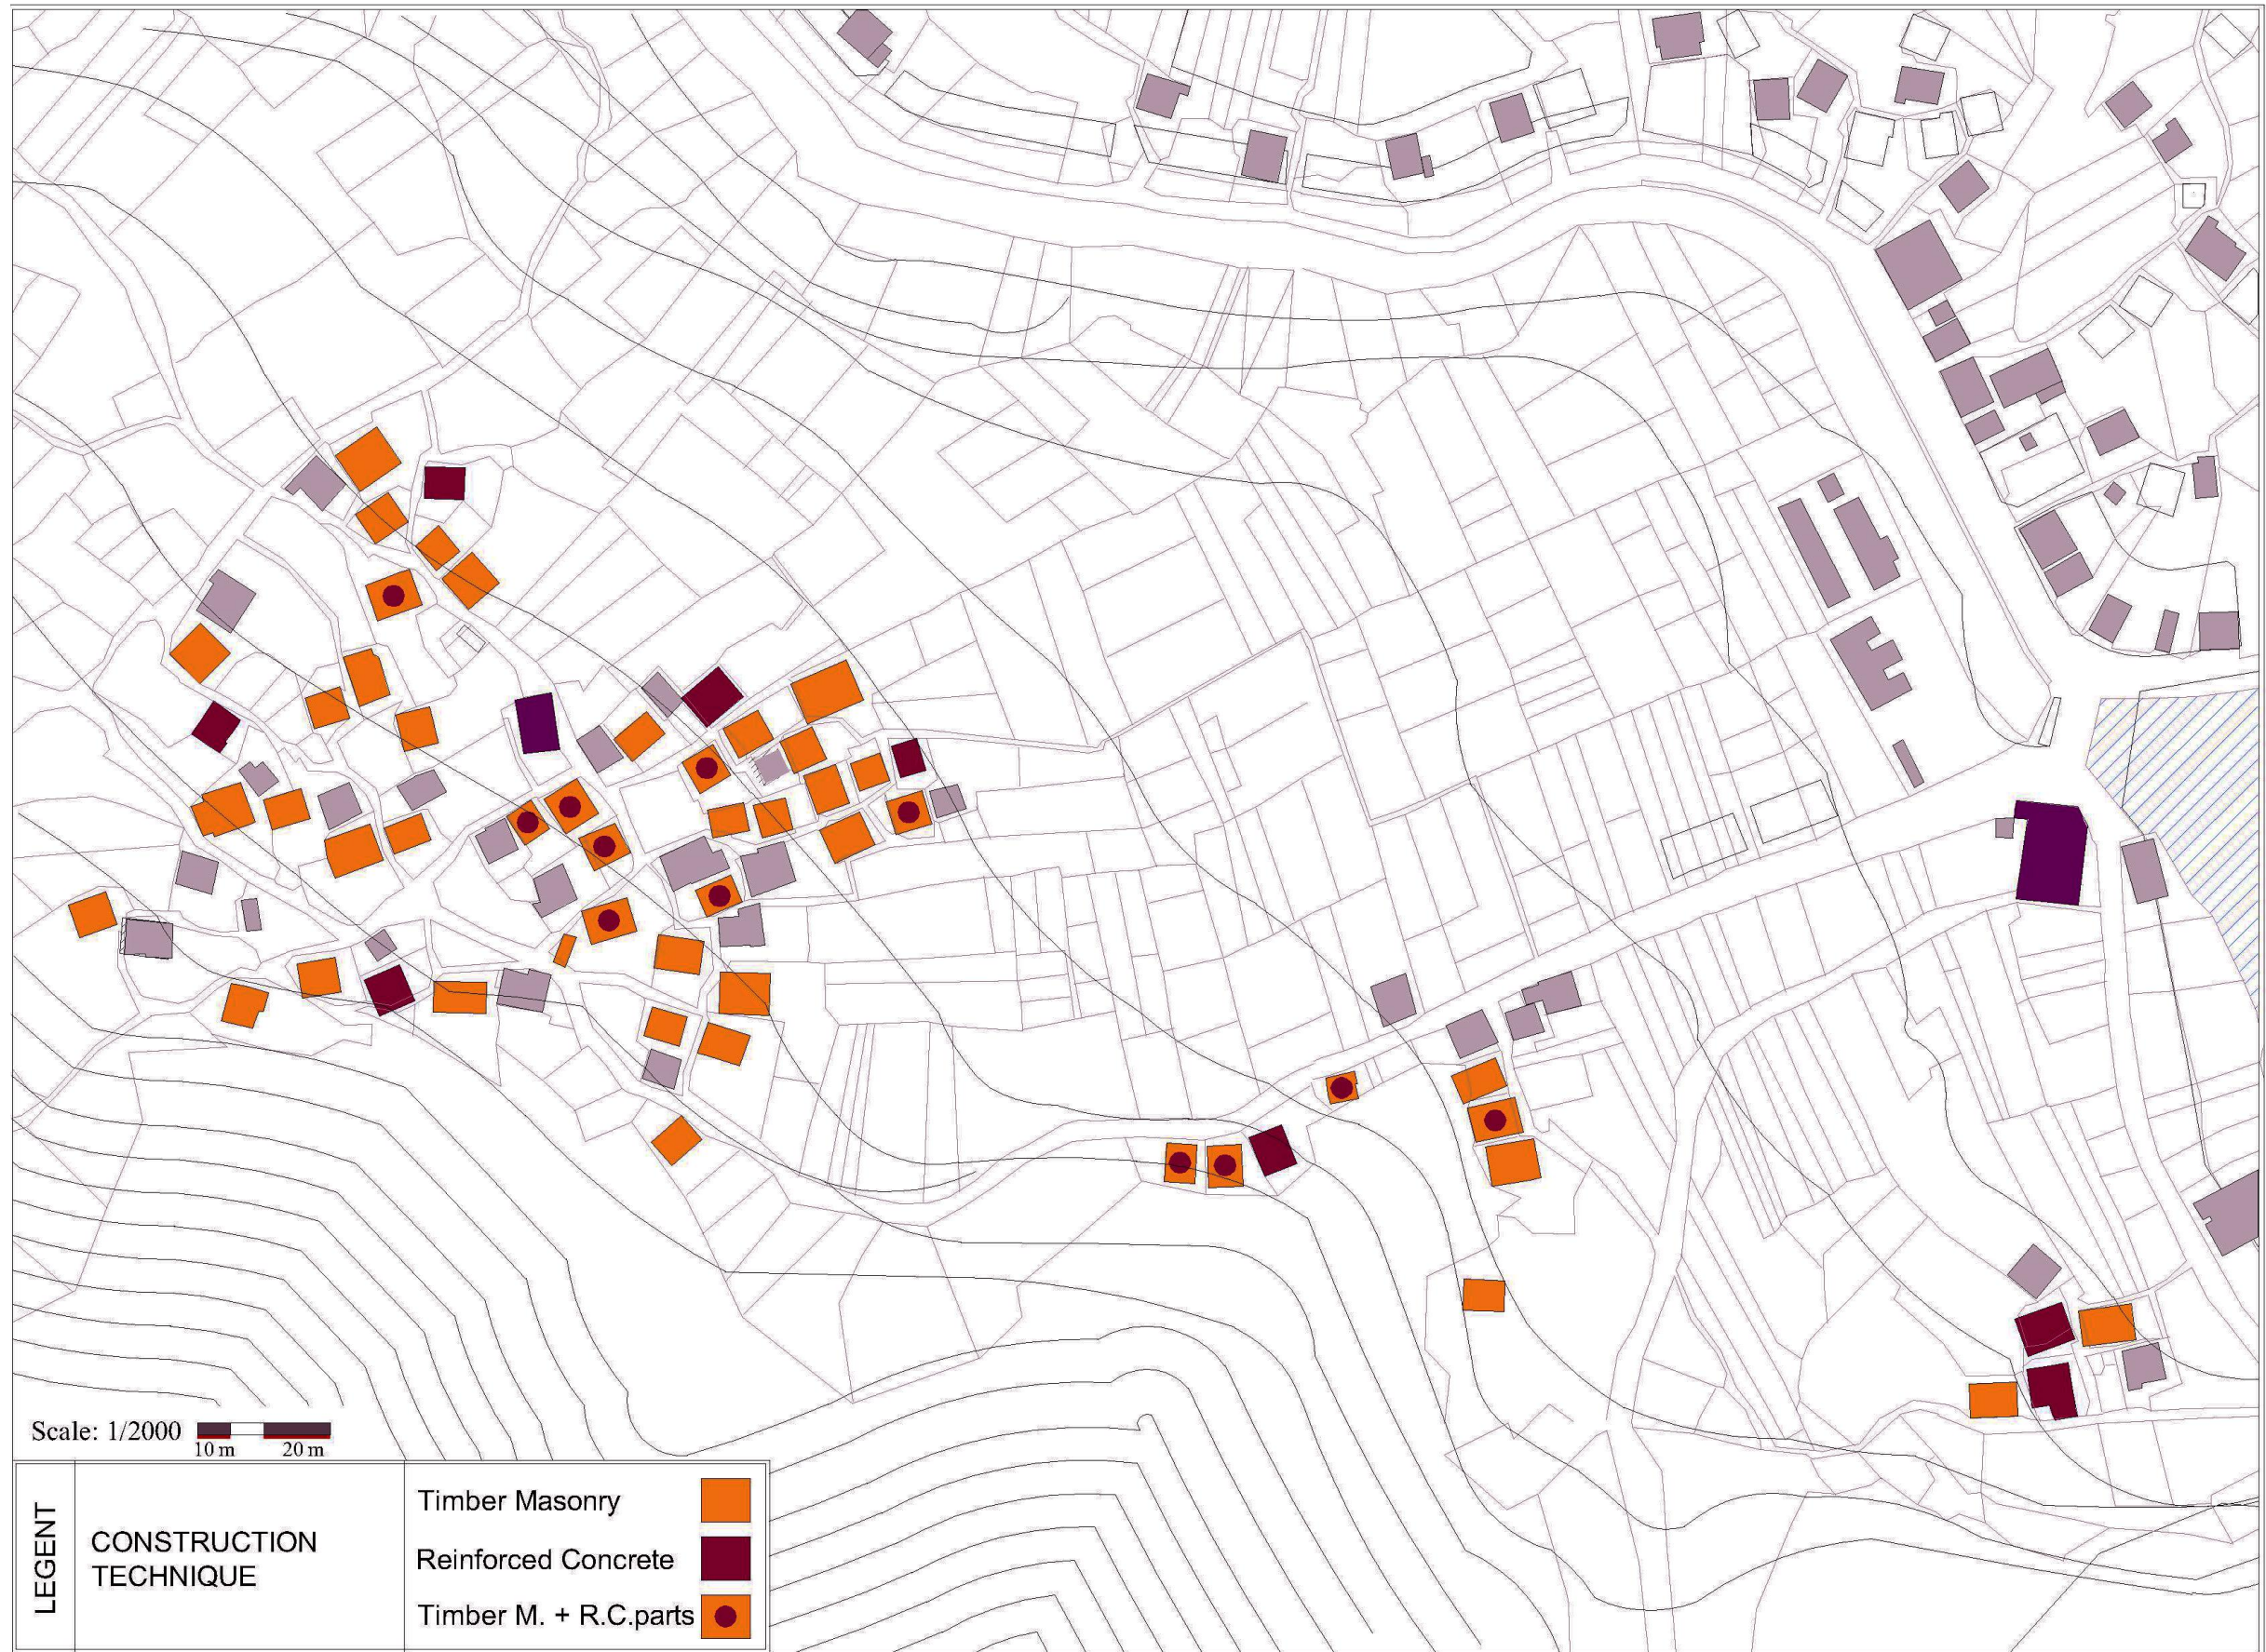
Figure 139, Construction Technique of the Buildings in the Study Area

The houses are built with composite structural system such as rubble stone masonry on the basement floor; timber masonry system on the ground floor(see Appendix B- Figure 139)³¹. Timber masonry system is used as *kurboğazi geçme*³² construction technique at houses. The houses in the study area originally show similar architectural and structural features (see Figure 15).

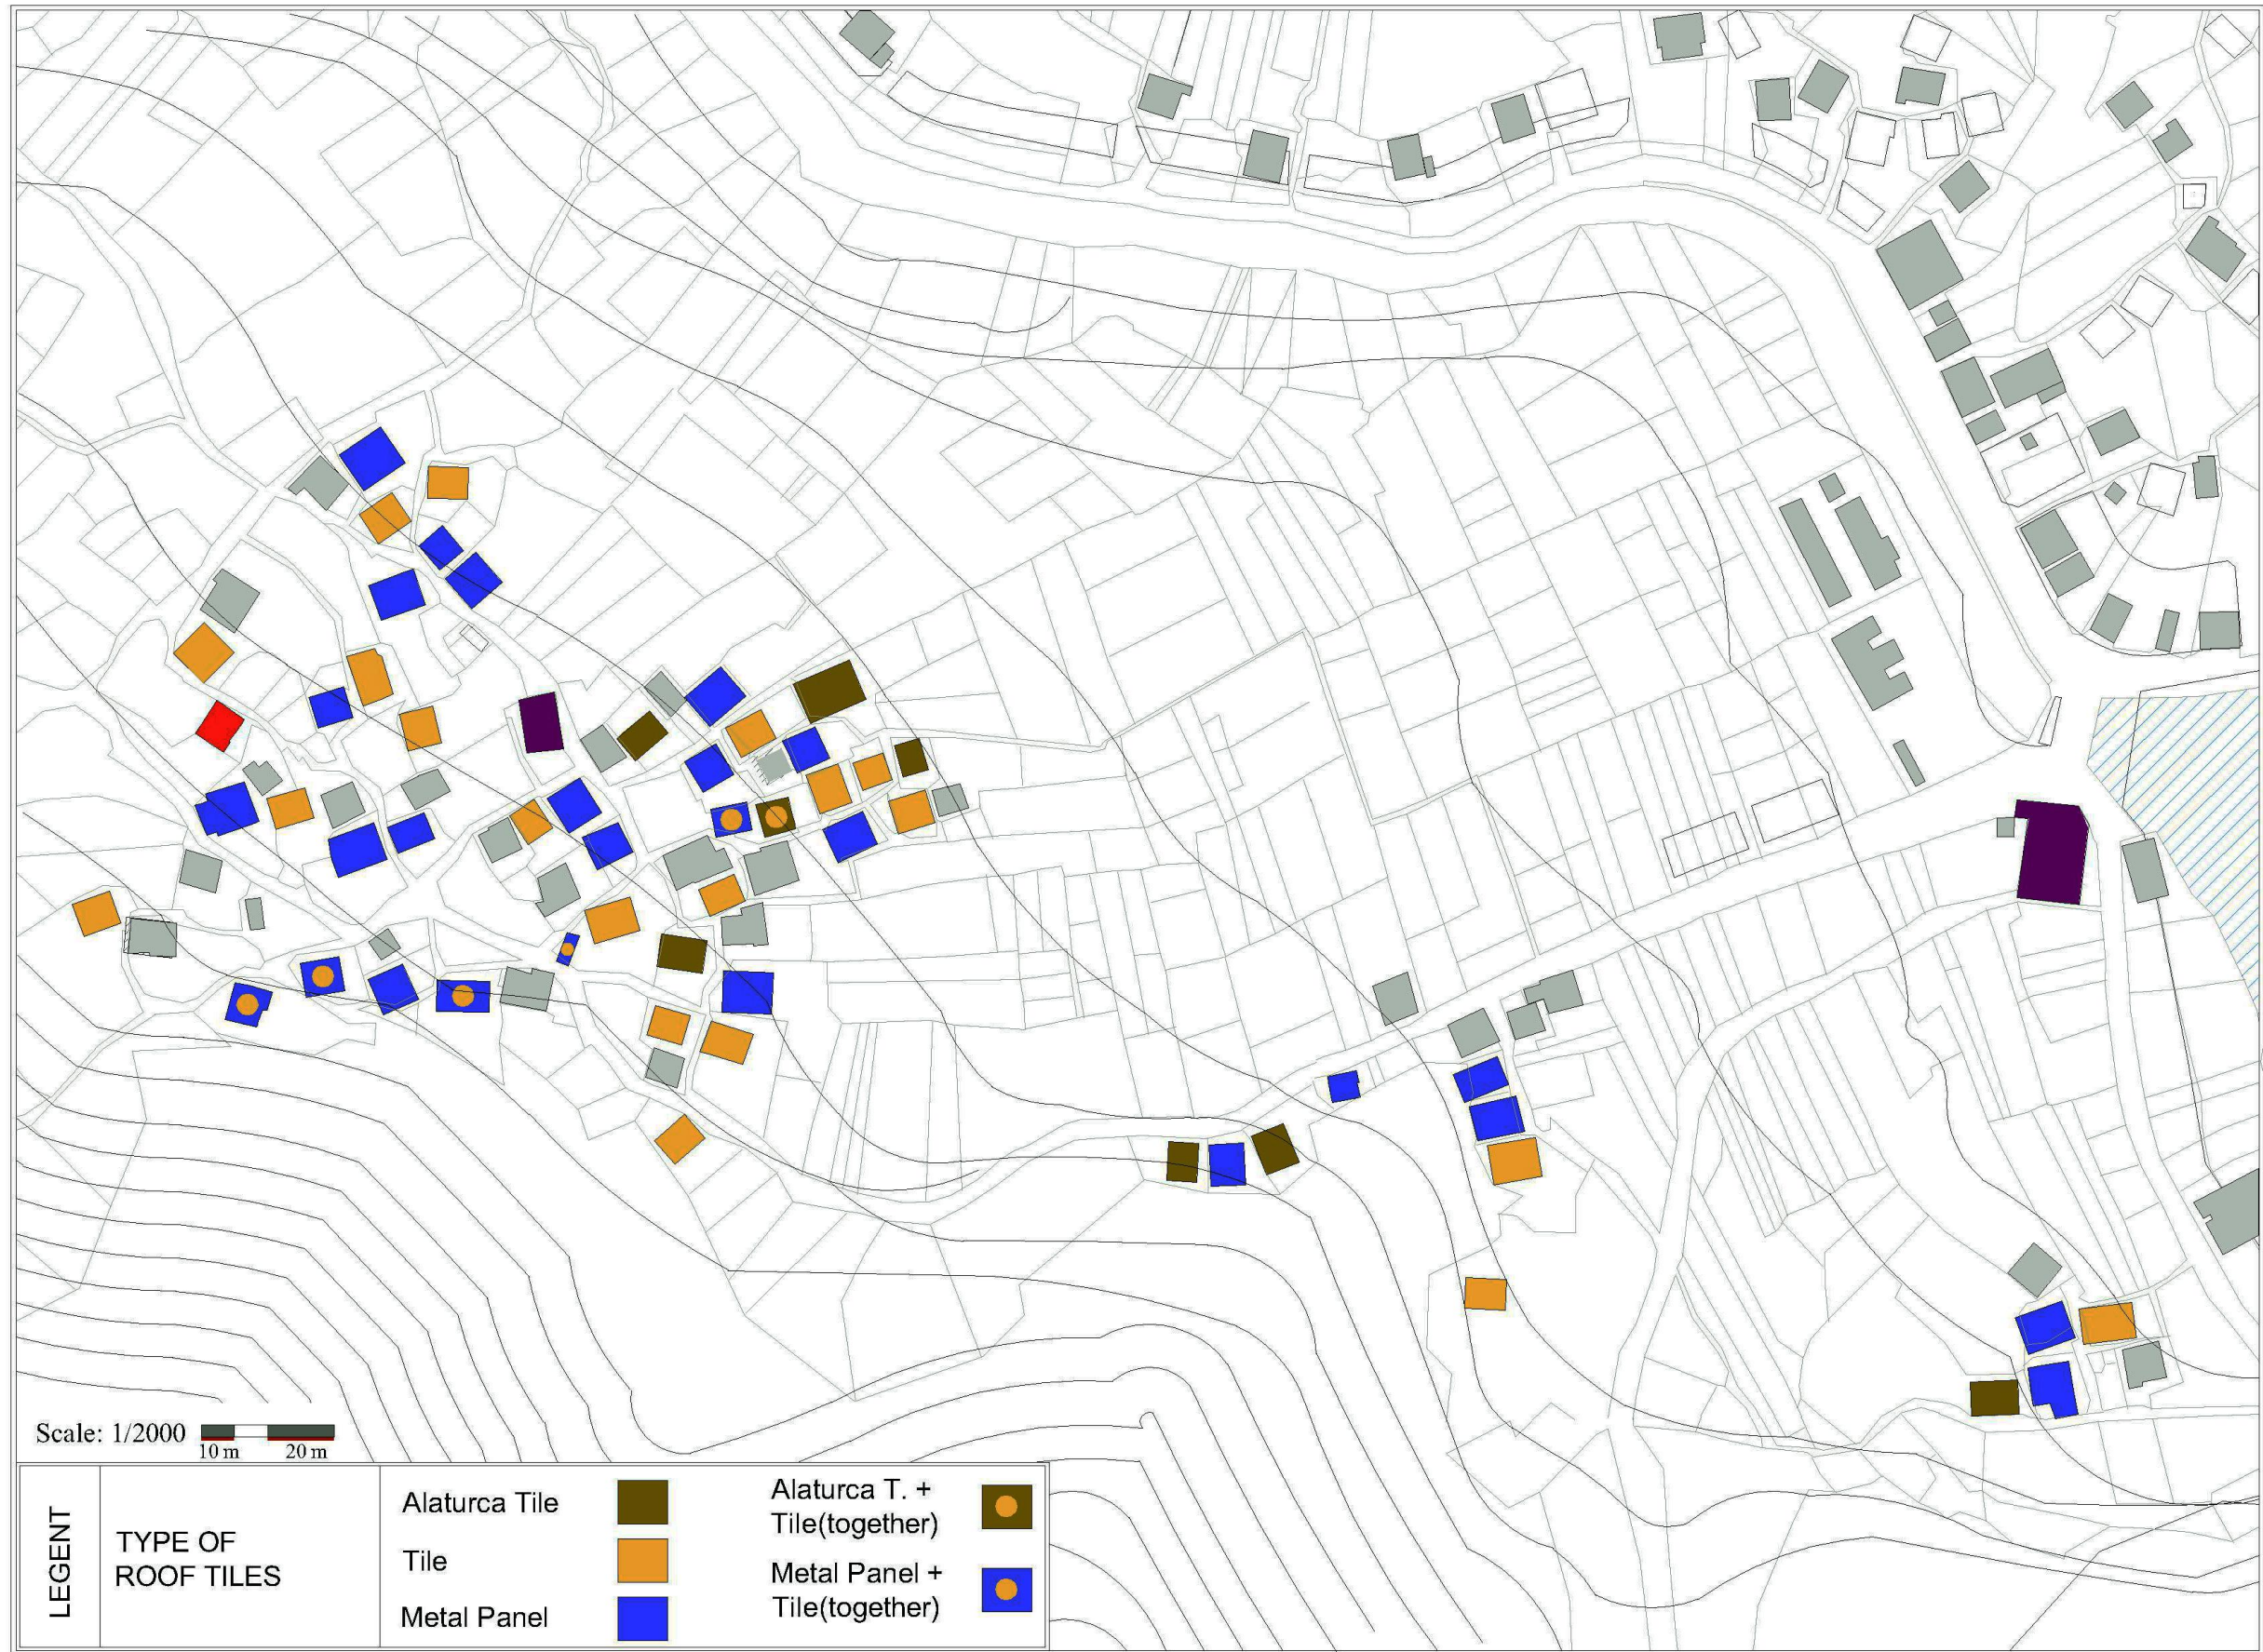
Figure 140, Roof Type of the Buildings in the Study Area

In the buildings, roof type is gable roof in the study area (see Appendix B- Figure 140). Directions of the ridge lines on roofs are generally perpendicular to the lines of slope³⁷.

Gable roofs of the buildings have eaves, which have the extension of 90 cm at the front façade and 50 cm at the side facades. Originally there is no roof gutter at the buildings. Covering materials used in the roofs are over&under tile (alaturca tile), tile, corrugated iron sheet and metal panel⁵² (see Figure 34) (see Appendix B – Figure 140).

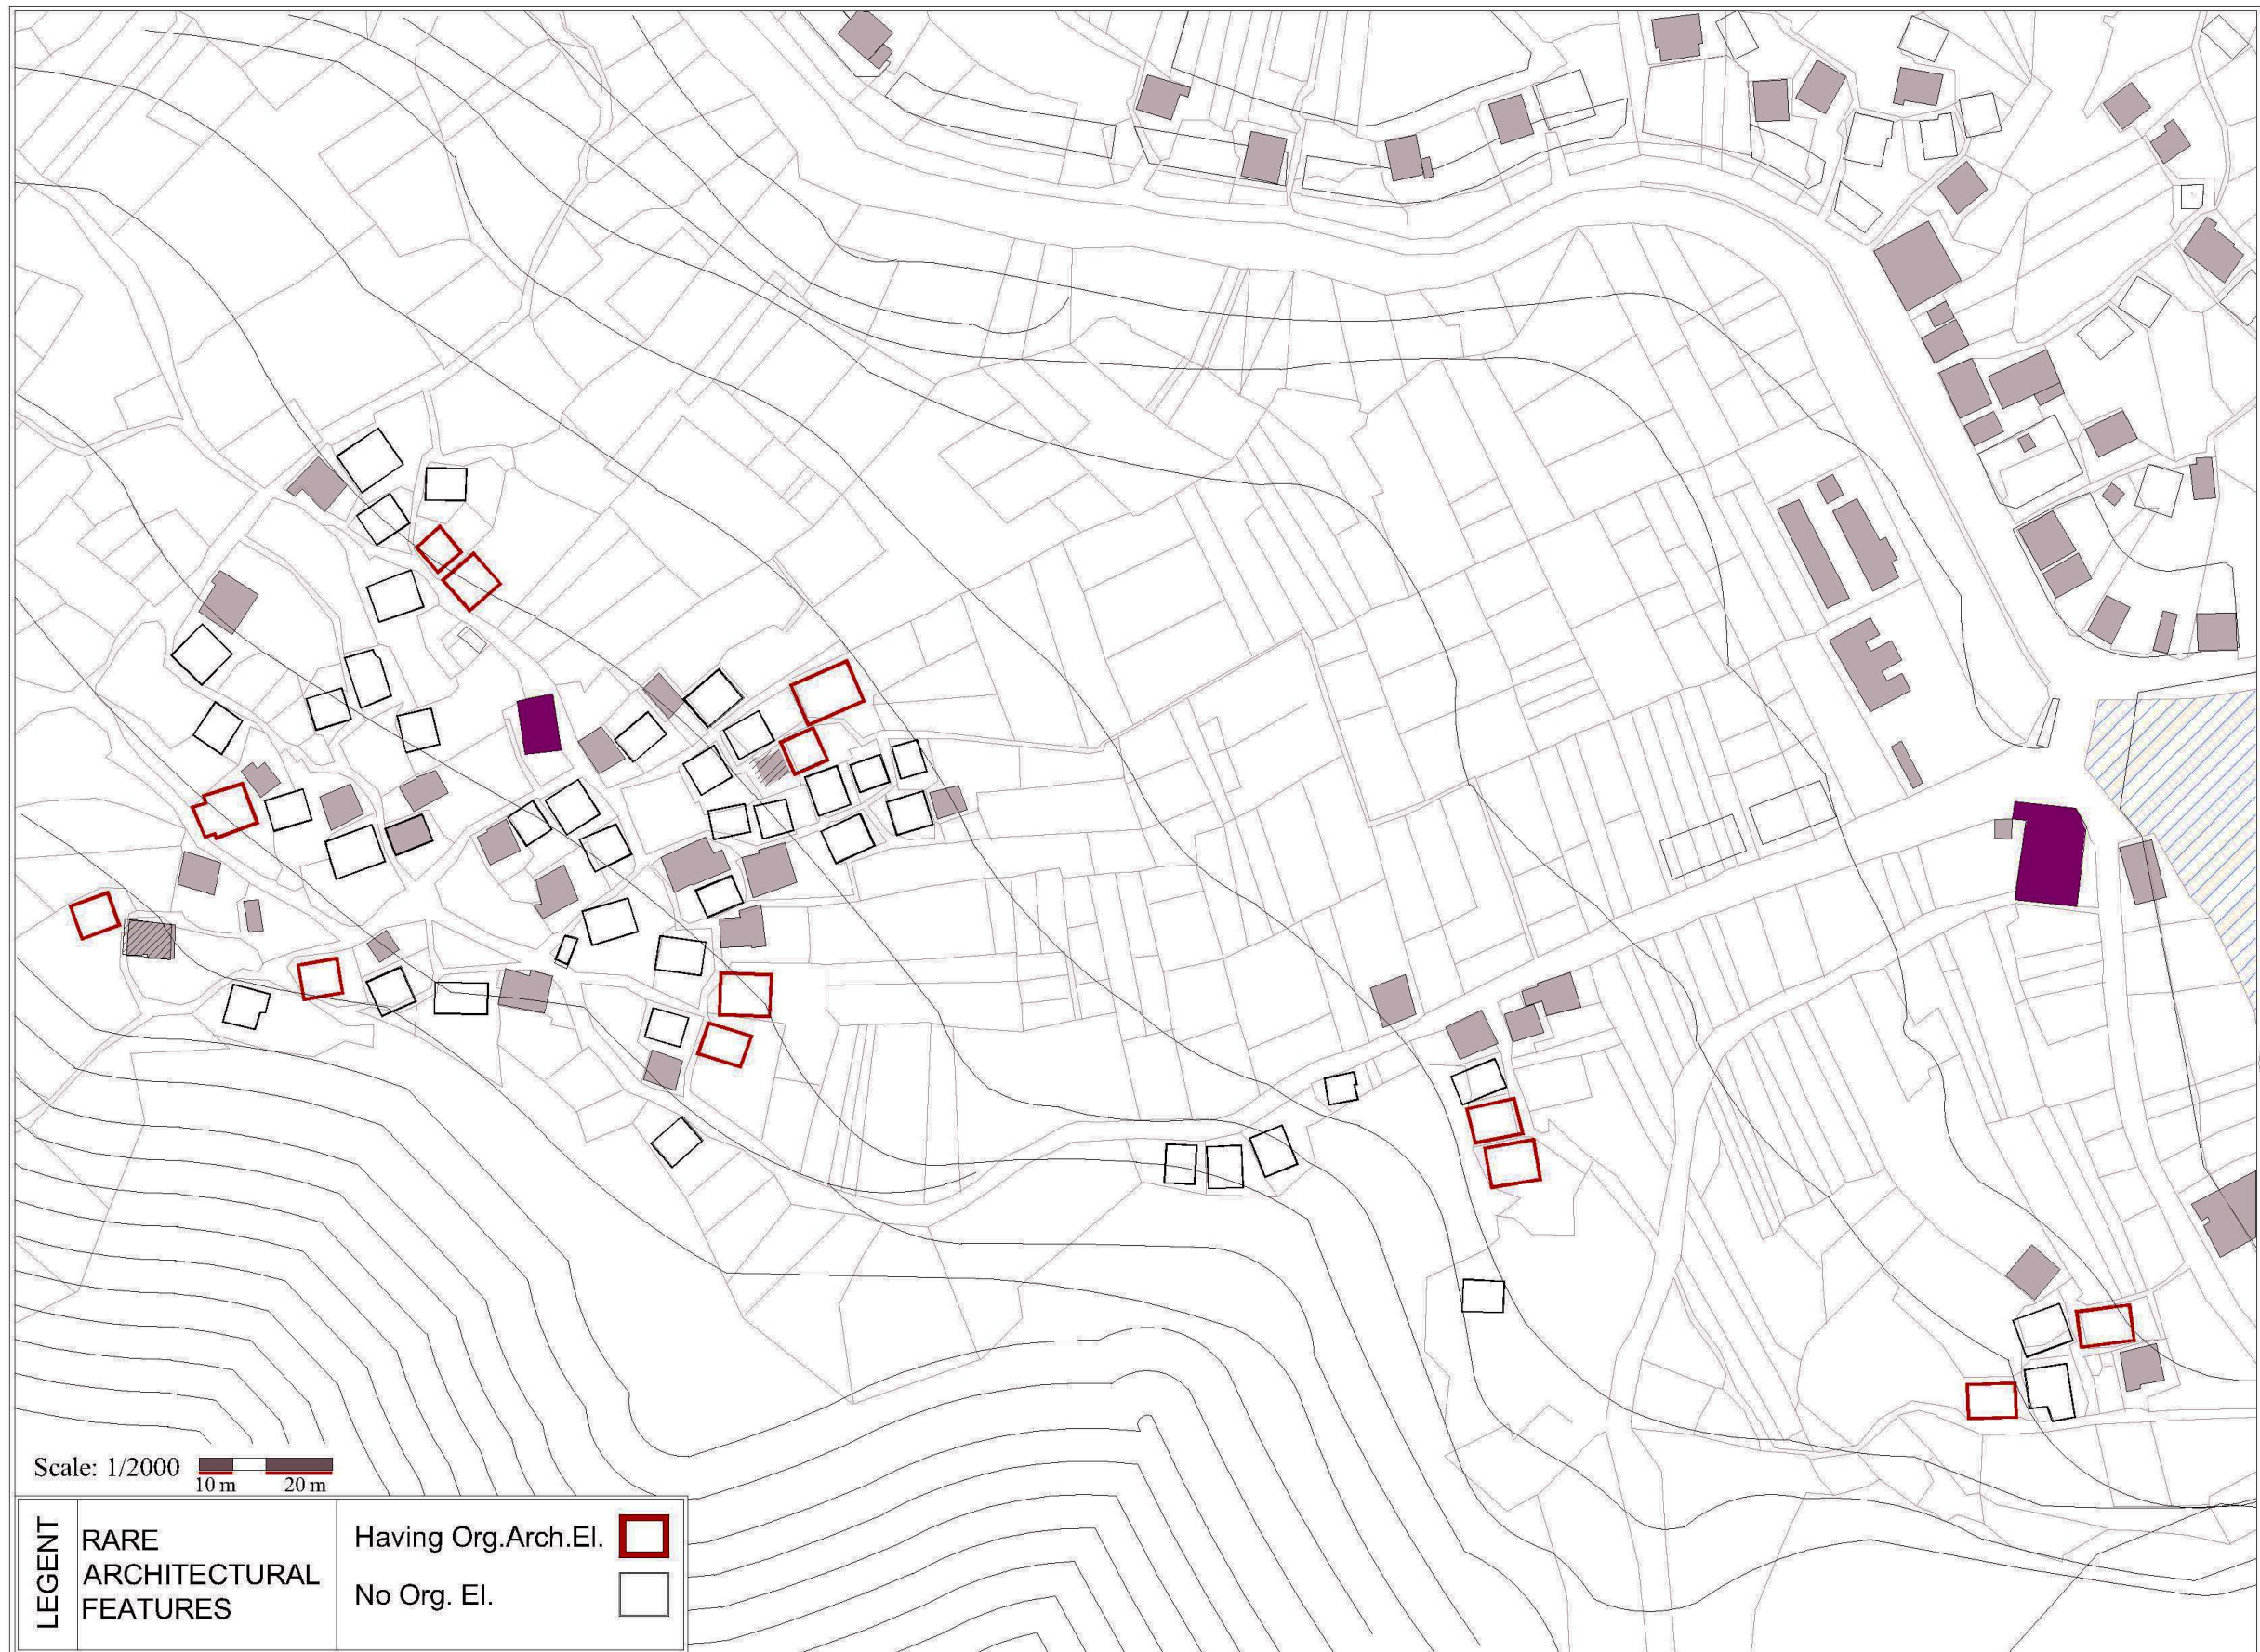
Figure 142, Buildings in the Study Area Having Rare Architectural Elements

Vernacular houses in the study area have rare architectural features (see Appendix B-Figure 142).
