CONSERVATION PROPOSAL OF AN EARLY REPUBLIC PERIOD BUILDING:
ATATÜRK ORMAN ÇİFTLİĞİ HAMAMI

A THESIS SUBMITTED TO
THE GRADUATE SCHOOL OF NATURAL AND APPLIED SCIENCES
OF
MIDDLE EAST TECHNICAL UNIVERSITY

BÜŞRA KUL

FEBRUARY 2012

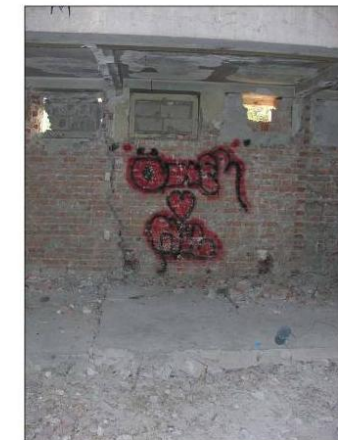
Figure 6

Today there isn't any finishing material on the ground but traces of marble coverings can be observed. In the space, traces of partitions which were probably used as dressing cabinets can be seen. Also remains of walls that are destructed can be seen around the sides of the toilet at north-west corner of the space. (Figure 8) Traces of water system, electricity installation can also be observed on walls and ceiling. There are holes in wall section in east and west at +0.70 m level. (Figure 6)

There is a structural crack that continues on floor, east and west walls due to different settlement of basement. Micro cracks and structural cracks can also be seen on south wall. (Figure 2, 6)

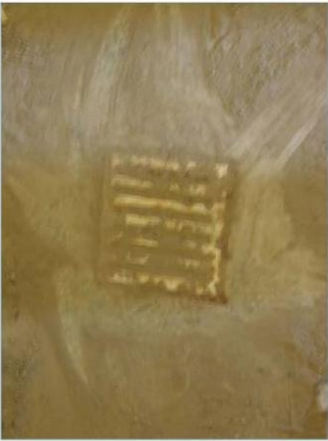
Figure 5

There are traces of demolished walls at corners of the space, are thought to be “halvet” walls . (Figure 6, 8) There are metal water drains on ground. (Figure 5) There are also traces of floor finishing at size of approximately 45x45cm.(Figure 9) Also traces of water system can be seen on east and west walls. (Figure2, 6, 9)There is a hole connected with the chimney at the north - east corner. For the heating system it may reflect existence of a stove. (Figure 4) On east and west wall traces of two line pipe shows that hot and cold water has been brought this space and this space has a bathing function.

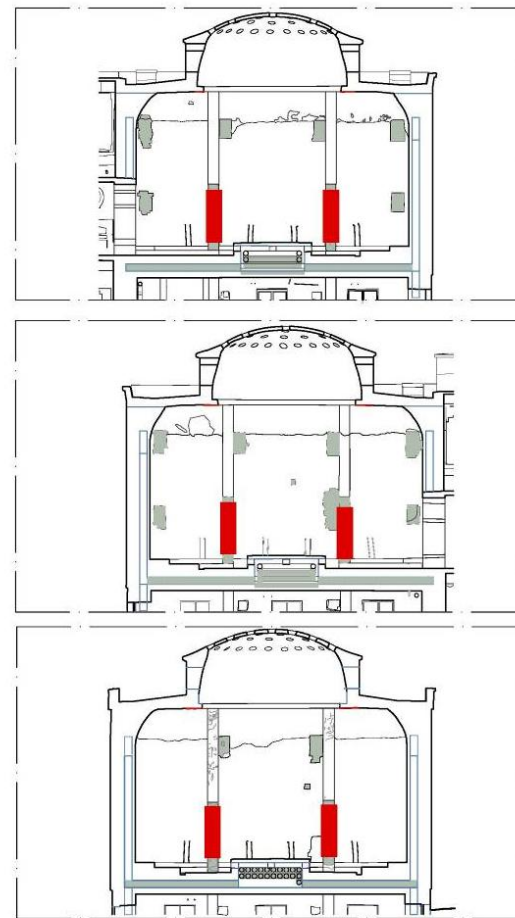
Figure 2- Section Views

Space G- 03 take place at the north side of the building. Space has almost square scheme with of sizes of 8,50 m at north,8,52m at west, 8,53m at east, 8,52m at south. (Figure 1) The space is covered with a dome(inner D:4,68, Outer D: 5,45m) that are carried by four columns(34x34cm) in the middle.(Figure 3) The space has a height of 5,12 m and dome has a top level of +7,50m. The single opening is the door (2,21m x 1,03m)connecting this space to G-02 in south.(Figure 4) There isn't any window, but there are 44 oculus on dome to sustain light. In east, west and north walls there are niches. These niches(approximate height 65cm, width: 40cm) are placed at two different levels.(Figure 5,6) The upper niches has a top level of +4,25m while the lower ones has a +2,24 m level. The upper niches are connected to chimney and basement floor to sustain air ventilation and vapour transfusion. In the middle of the space “göbektaşı” take place(R: 4,31m). The top slab of “göbektaşı” is made up concrete and has openings (height:18cm, width: 22cm) on four sides. (Figure 8) In the ground, floor tile traces can be seen. The seki surrounding the space is arranged in two level. The first level has a height of 14 cm and the second level has a height of 16 cm. The water canals surrounds the space and has a slope through north south direction. In walls , traces of water system and “kurma” can be seen. Also there are traces of covering elements. It is thought that there is a heating system of pipes passing through a canal, like the system in the “göbektaşı”, as the space has a slab height of 67cm. (Figure 9) There are canals going through in wall section. (Figure 7) Fragmentation of the columns and metal corrosion and loss of protection concrete over them are the structural problems observed in Space G-03.(Figure 2)

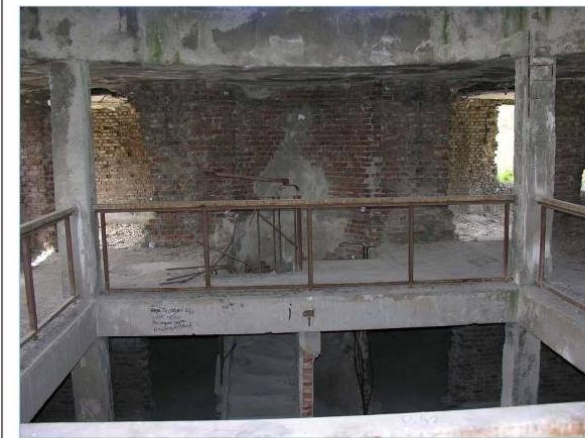
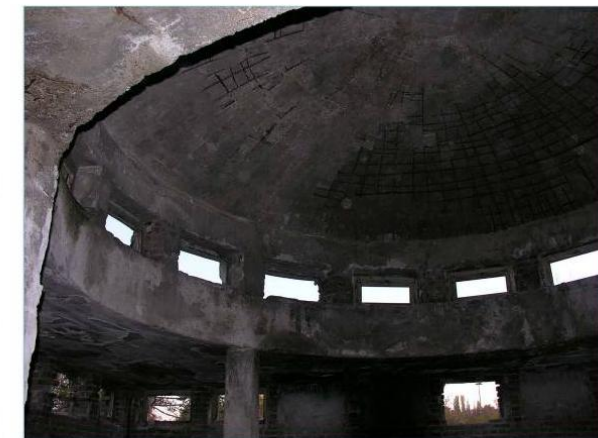
Main problem of the space is fragmentation of concrete. The dome's iron structure has revealed out due to fragmentation of concrete. The same problem can be observed on columns. (Figure 5,6)

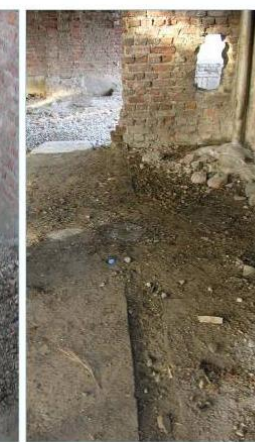
Figure 8

There are also traces of 15 cm width canals on the floor, which are remains of the division walls of the cabinets.(Figure 8) Also there are traces of illumination system on North side walls. (Figure 2) There are also holes on east and west wall, close to the ground level at + 3,12-3,22 m level. A water pipe can be seen on south -east side adjacent to L shape openings at corner. This water pipe may be a trace for heating system in this space. (Figure 2,9)

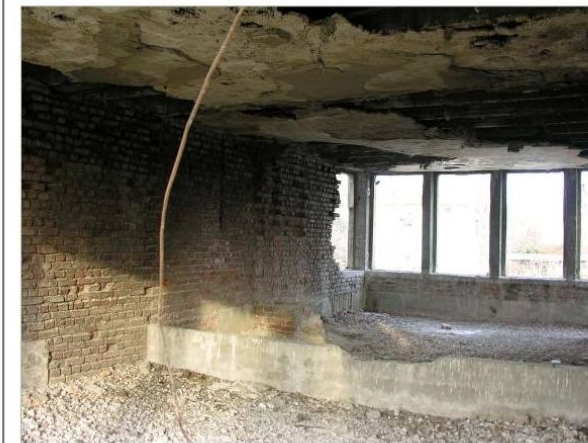
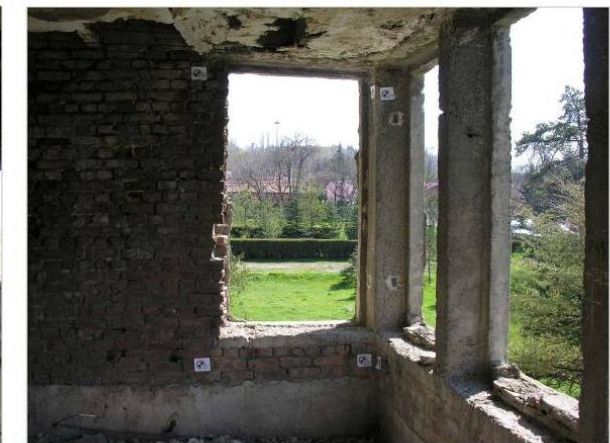
Metal hooks can be observed at + 2,68 level beneath the window openings. The remains of the chimney take place at the north-east corner of the space. (Figure 3-4)

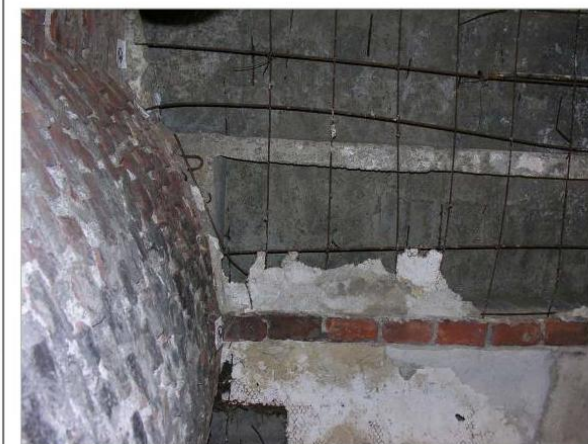
Figure 5

Space F-02 take place in the first floor at the projected part of the building. There are four window openings at the east and west walls while two windows take place at north and south side. (Figure 3-4) At the middle of the space there is a concrete division at a height of 38-40 cm. (Figure 3, 5) There are also remains of brick wall division at the middle of space.

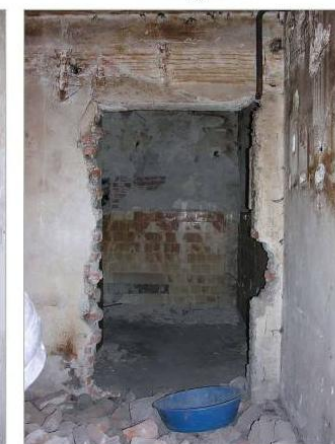
Figure 7

The space floor is covered with terracotta floor finishing and the plastered wall surfaces are painted with straw yellow colour.(Figure 5) 11cm height baseboard surrounds the wall edges. Traces of an electric panel can be seen on the south wall. (Figure 8) A 6 cm diameter pipe sink into south wall. (Figure 7,8)

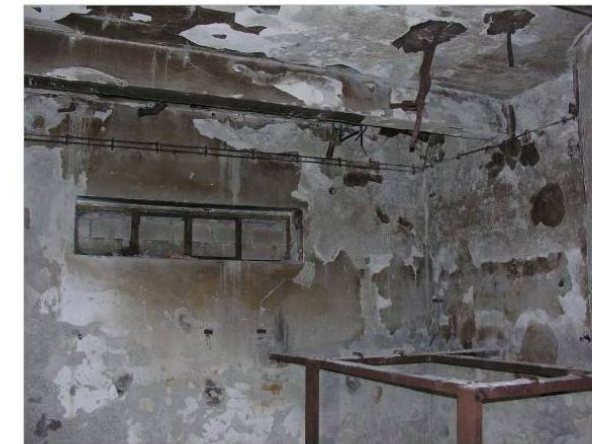
Figure 4

There are metal bracelets that holded water pipes.(Figure 4,8) Also traces of water pipes can be seen spreading to spaces in Hamam. There is a metal frame where the water tank was placed.(Figure 4)

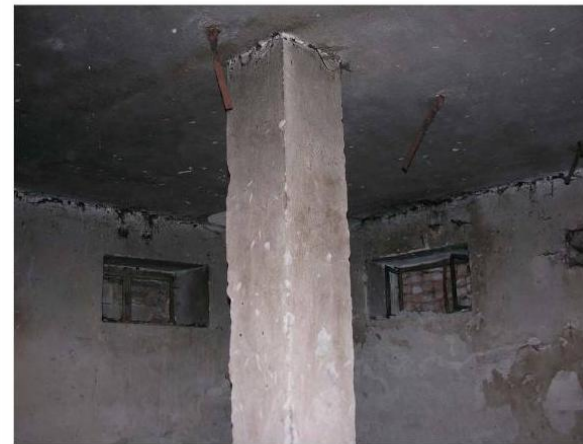
Figure 3

There are four column (approximate 33x33cm)in the middle of the space. (Figure 3) Metal bracelets that holded water pipes can be observed on ceiling and column surfaces . (Figure 4) The remained water pipes in the space continue in space G-03. (Figure 5,6)

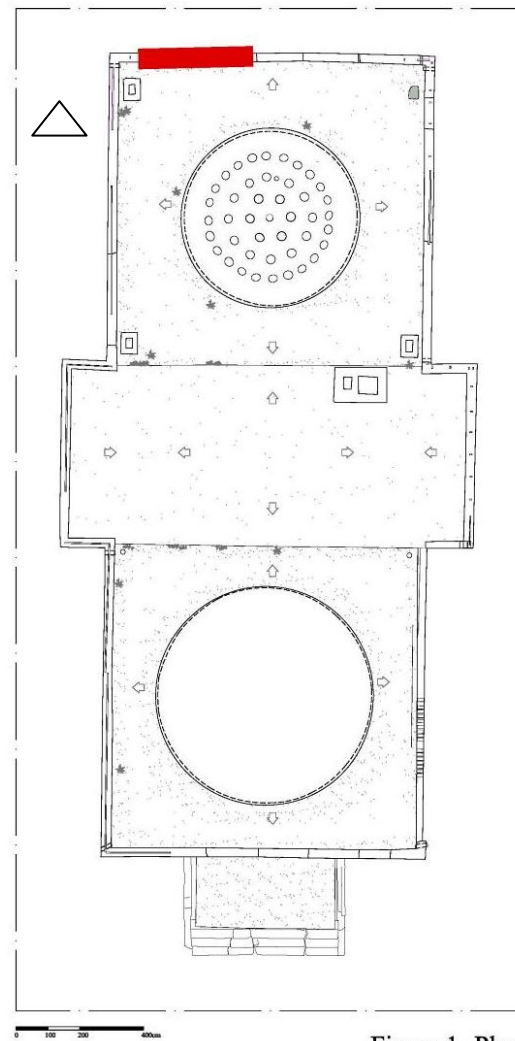
Figure 1- Plan

The roof is composed of three parts. At the middle flat roof take place while at the north and south part dome and flat surfaces take place.

30 cm width parapet surrounds the roof. The parapet is made of brick and a concrete top, slope is given with the plaster over this concrete top. At some parts the parapet courses are demolishes and top cover is lost. There is a structural deformation at the north parapet.

Gutter traces, water drain pipes an can be observed. Eight zinc spout takes at the corners of the north and south part of the roof.

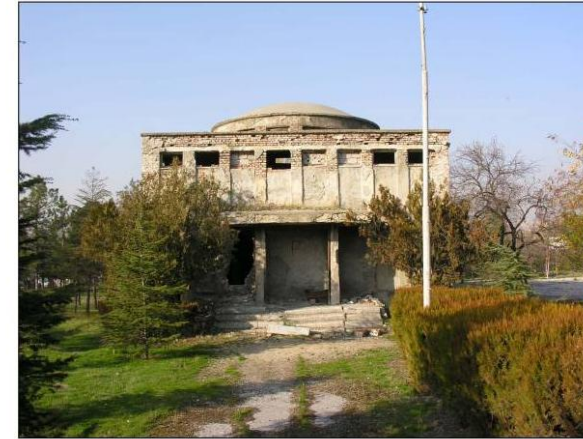
Figure 4

Facades are plastered but the brick courses can be seen where there are plaster lost. (Figure 4,5,6 and 7) Different from general characteristic of facade, the projected part at the middle is made of reinforced concrete and brick . It is possible to see two layers of plaster, of which the layer at the below is thought to be original , and the layer above is a later application. It can be said that the building had a straw yellow colour, from the remains of paint observed on surface . (Figure 5,6).

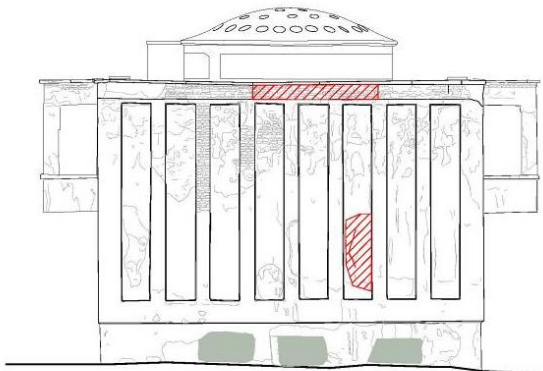
<p data-bbox="2000 720 2083 747">Figure 4</p>	<p data-bbox="2122 344 2561 541">Today the north facade wall is blind. The north facade has a bare design with eight recess. (Figure 4) The observed facade height is 7,40 and the facade has a width of 10m. The parapet take place above recesses and the dome above space G-02 has a pick point at +7.60 m.</p>

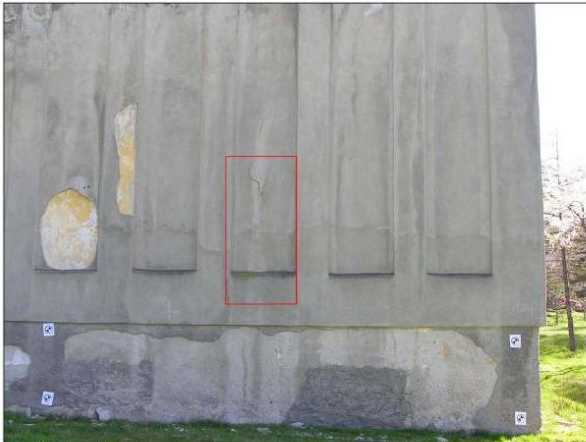
<p data-bbox="1952 1188 2041 1215">Figure 5</p>	<p data-bbox="2122 569 2561 795">Basement floor is intruded inside from -0,06m level. (Figure 4) Three window openings at basement floor are infilled and plastered.(Figure 4-5) Main structural problem determined in space is brick course deformation on parapet at west side and deformation on G-03 wall on the third recession from west side.</p>

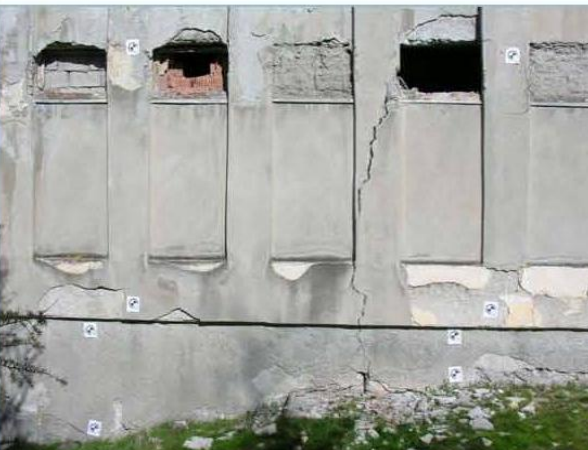
<p>Figure 7</p> <p> ■ Structural Problems ■ Traces & Remains </p>	<p>West facade has a width of 25m. Basically facade is composed of three parts. The blind surface at the north side, projected part at the middle and the surface with windows in ground and first floor. Like the other facades, recesses bring a movement to surfaces and the projected space brings a dynamism.</p> <p>Both first floor and ground floor, there are 8 windows (height: 0,56 m ; width : 0,70 m) that are placed inside the recessed surfaces. Two windows opening can be observed in basement level, at a top level of -0,82 m. In the middle part there are four circular window (R: 58cm). 2,5 m projection from G-02 space and 1,45 m from side walls is made. There are four window opening (height: 1,82m, width:1,01 m). The parapet above the openings is demolished. The side walls of Space G-02 is intruded inside and there is a door opening(height:1,42m ; width:1,04m) at a top level of -1,09 m. There is also a projected part that has a connection with space B-06 with a window at the north side. The north side part of the east facade has a barrel design with recessed surfaces.</p> <p>The structural crack that can be observed in Space G-01 continues in east facade starting from +2.20 level and continues through the basement. Loss of window frames and brick course and concrete losses are observed around openings. Loss of plaster and detachment of plaster are the problems that are expanded on whole surface. At the north side of the projection, concrete window sills are deformed and broken at some parts. Also a brick course of parapet is lost above projection.</p>

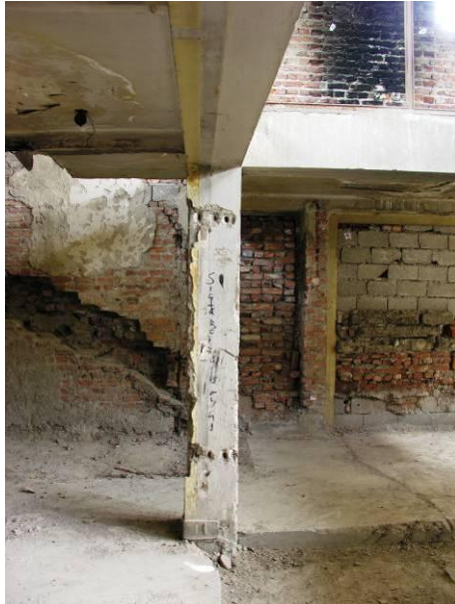
Figure 51 - Columns and beams relation

Main problem of the columns today is fragmentation and as a result corrosion of reinforcing bars. (Figure 51,52)

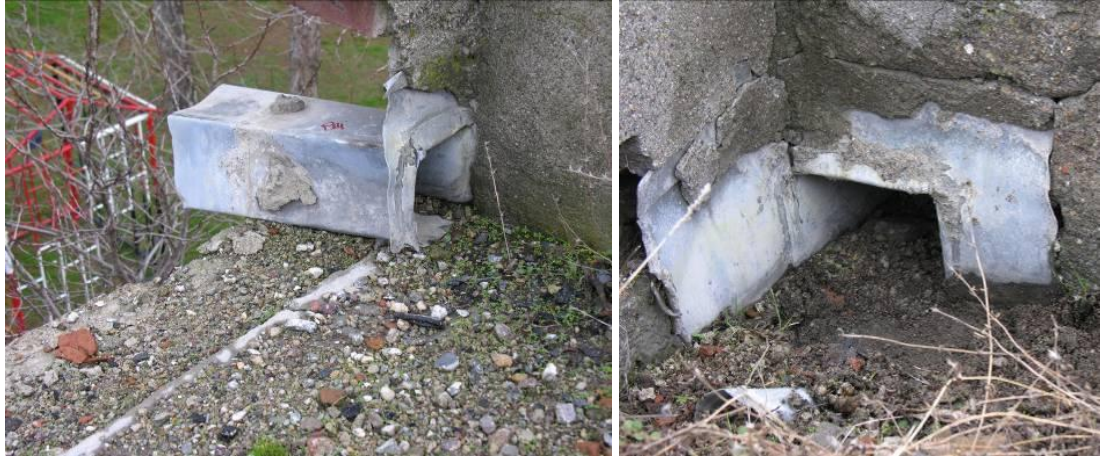
Figure 71 - Gutter(author,2010)

The gutters are used in Hamam to get the rain water away.(Figure 71) They are placed at four corners of the lower roof mass that take place at south and north side. There are 8 gutter in roof which are made of zinc plate. The water is directed through gutter with a slope. The gutter canal's sizes are 11x11 cm.

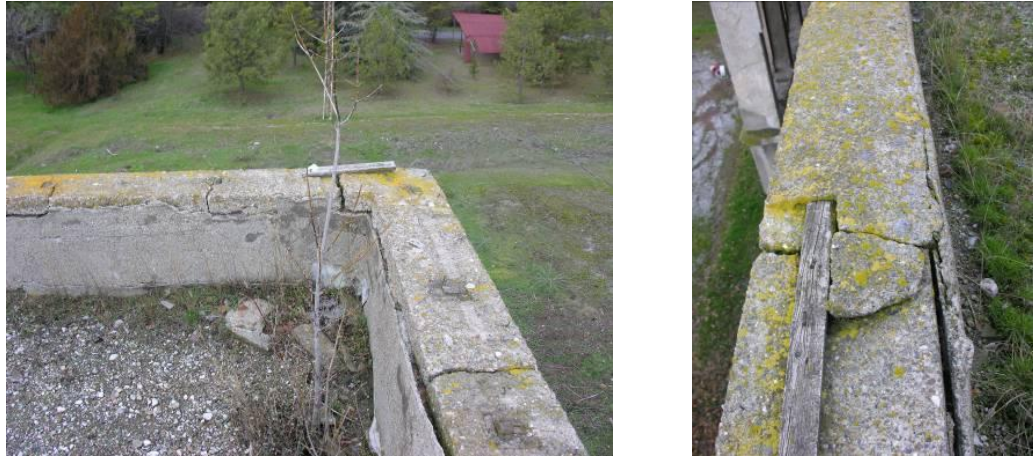
Figure 72 - Parapet(author,2010)

Parapet continuous through roof (Figure 72). It is made of brick and there is a concrete block at top. Above these blocks there are 3,5x6,5 cm sized moulding where wood pieces are placed. Above these wood piece, there is a timber lath and a slope is given with-plaster in two direction. Zinc plates are observed above concrete. The parapet has a width of 25-30 cm with plaster and height of 36-40 cm in south, 41 cm at north and 7 cm above projected part. The parapet has collapsed in several places and structural deformation is observed in north side. Concrete eaves can be seen around dome and parapets. (Figure 73)

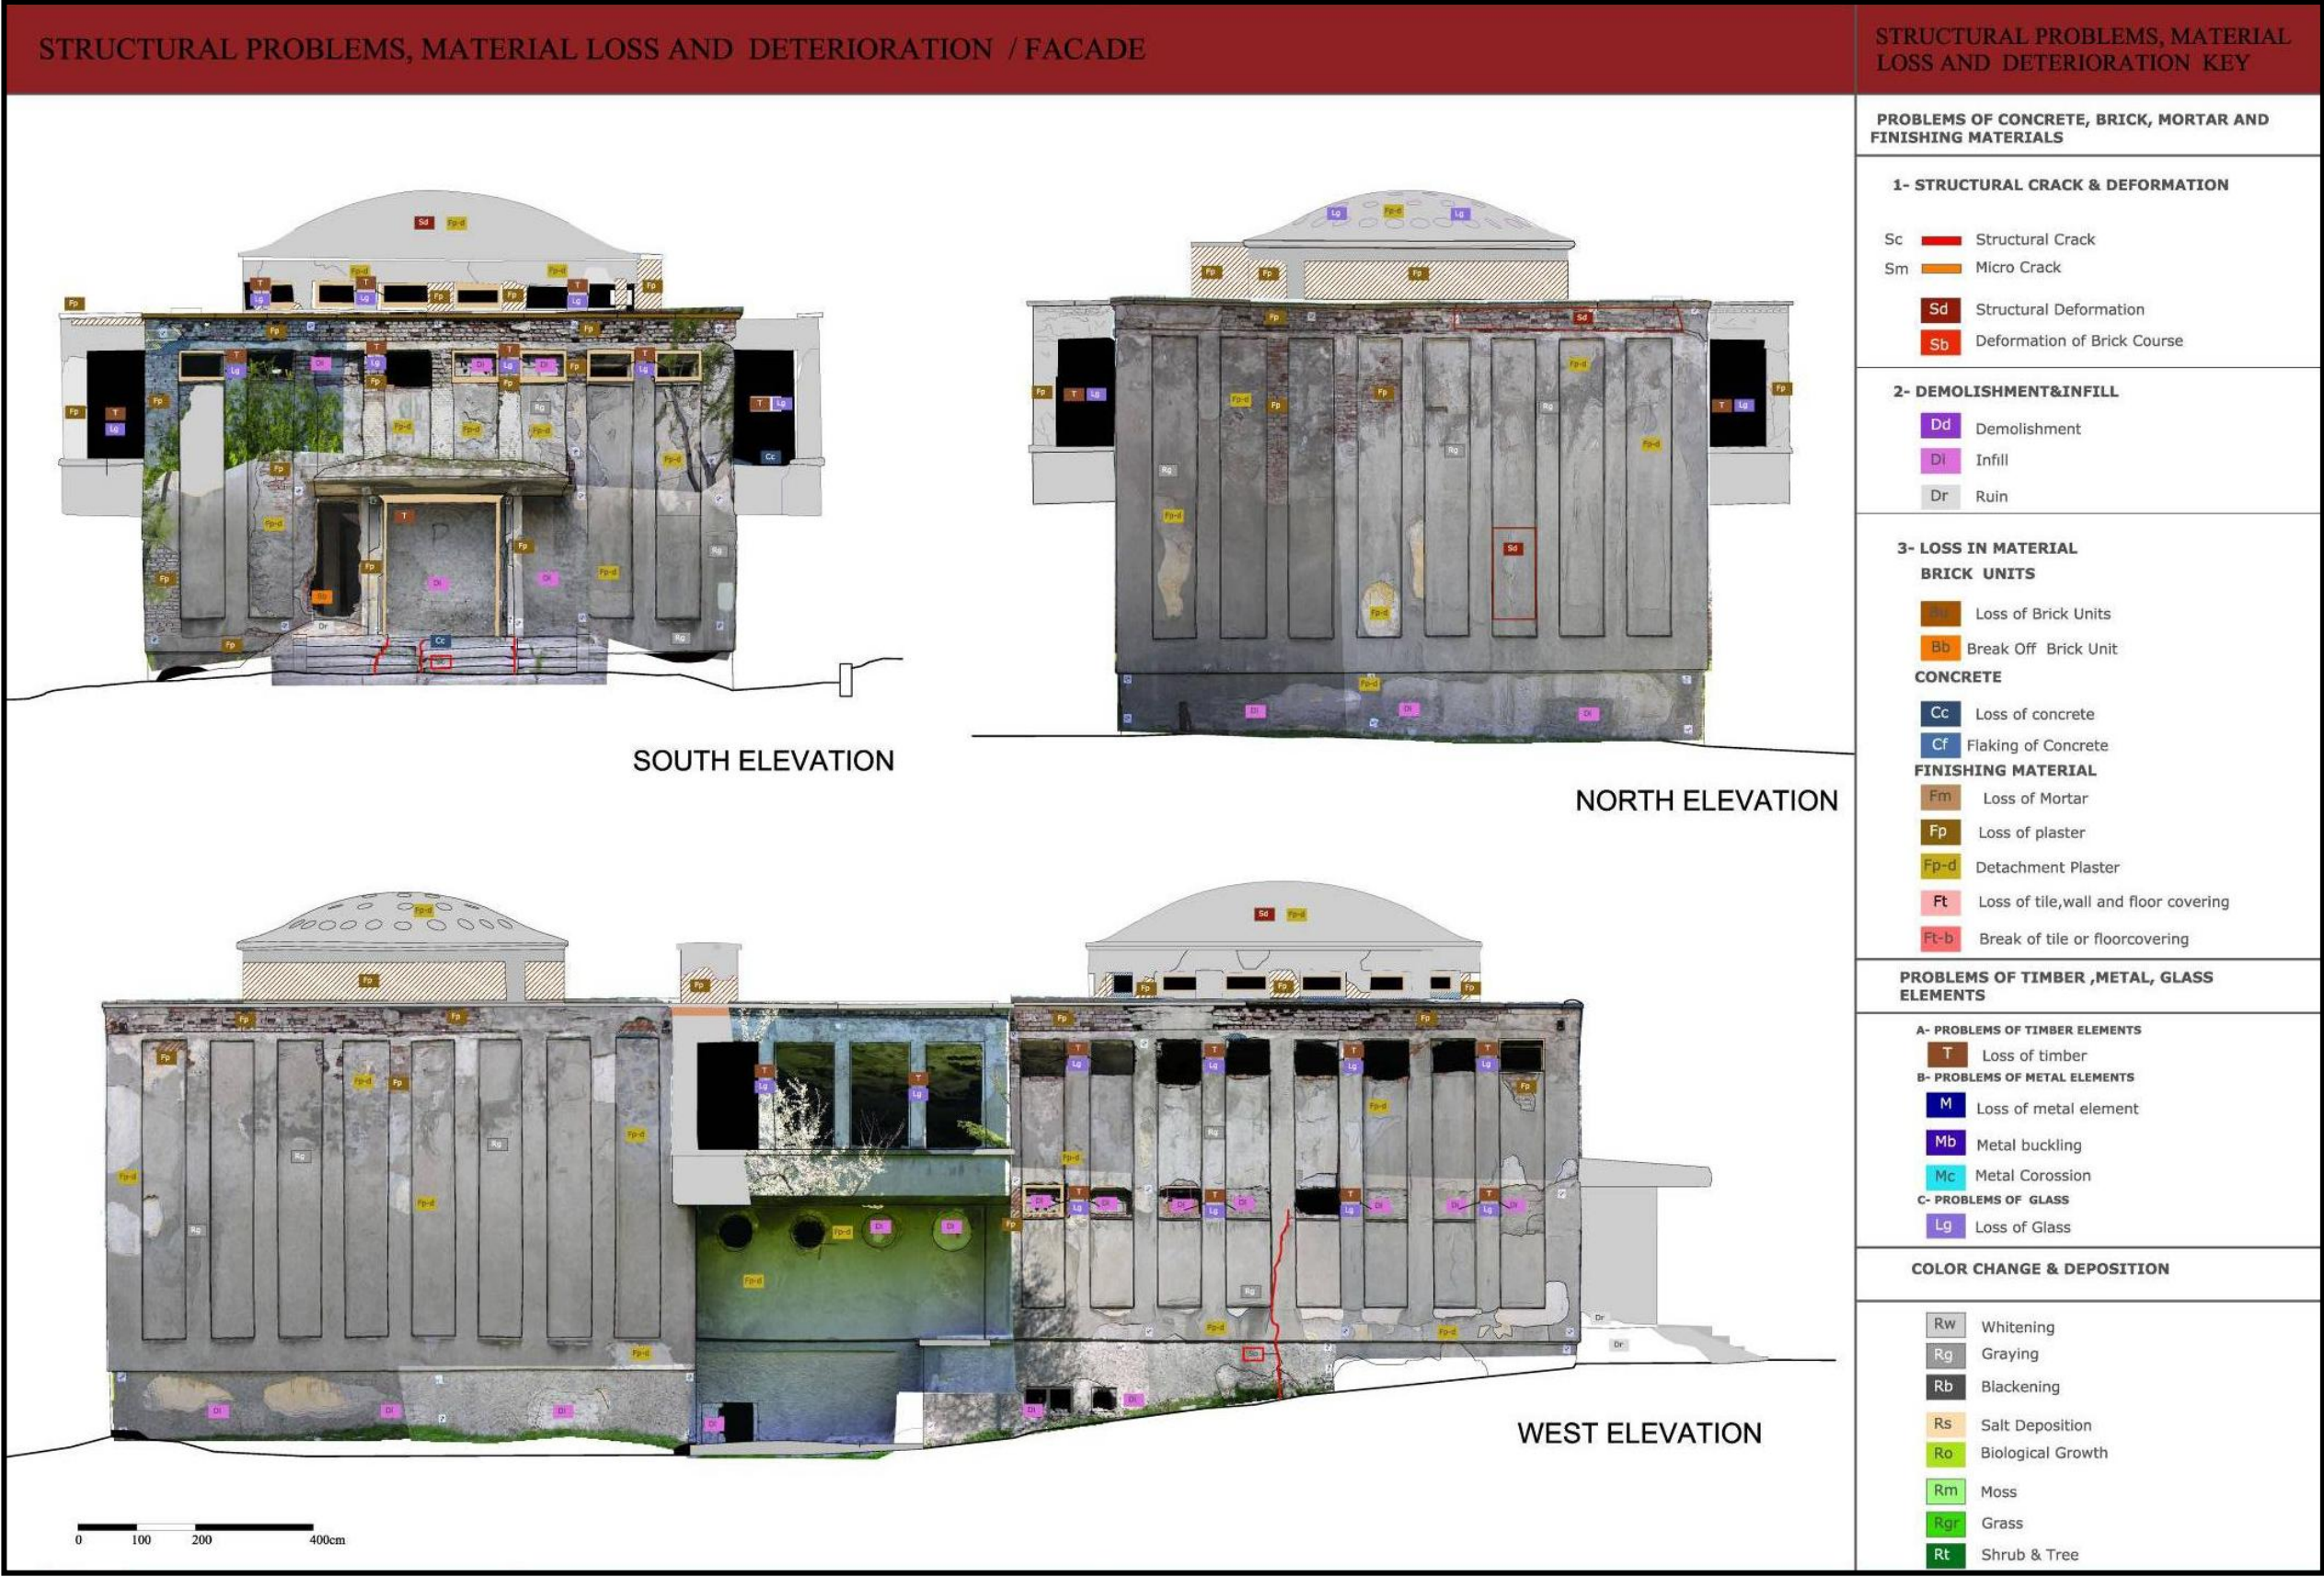
Figure 84- Structural Problems, Material Loss and Deterioration; Sections

The problems determined in building can be categorized under four topics - structural crack and deformation; demolishment and infill; loss in material; colour change and deposition. The main titles branch out into sub-titles according to deterioration and problem types.

Most serious problem of the Hamam is the structural problems. There are structural cracks in space G-01 starting from basement and continues through +2.00 m level at east and west walls. (Figure 76)The crack also continues on ground, through axis of the cracks on walls. It is probably caused by different settlement due to ground level differences in basement floor. The building also forced in South side and structural crack and micro cracks can be seen in South wall of space G-01. Deformation of brick courses can be seen in parapet at the North side and upper niches in space G-03.

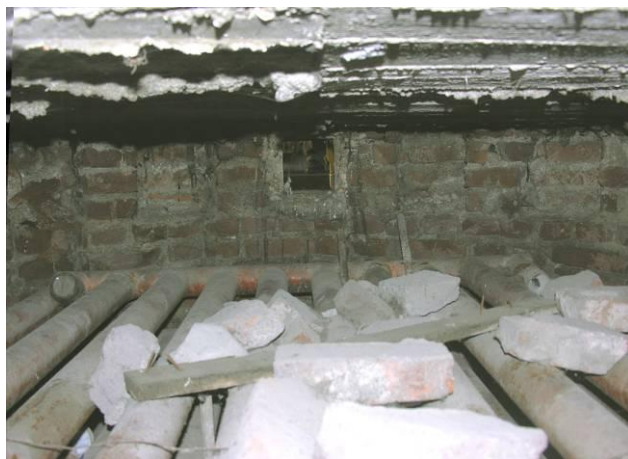
Figure 85– The heating system inside “göbektaşı” (author, 2010)

For heating system the remains give clues about the lost elements and in this study an assumption could be made about how the system had worked. In the AOÇ Hamam a modern technology had been used, and it can be said that the building had a central heating system. The most important clues about heating system are obtained from the pipes inside the “Göbektaşı” at Space-G03. (Figure 85) The system inside “göbektaşı” is made of three level of pipes in which there are ten pipes of each level and openings on four side of “göbektaşı” that enable hot air passage to space. Due to the slab thickness of 69 cm height and the continuous pipe through slab section, it is thought that a similar heating system is embedded in concrete slab and the space is heated by this way. (Figure 86)

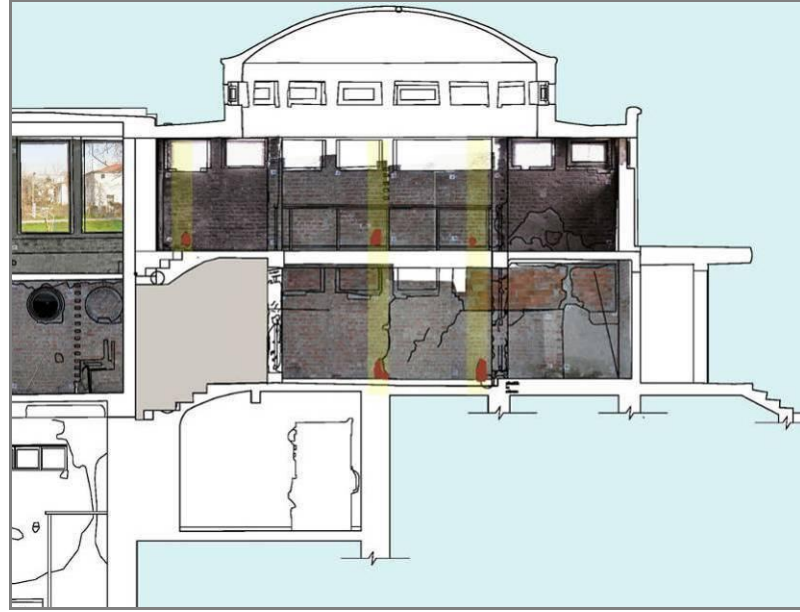
Figure 87 Hallows at the east side in Space G-01 and F-01 at same vertical axis

Since the slab thicknesses are inappropriate, for other spaces its hard to say that they are heated with the heating units installation inside concrete slabs. On the other hand in consideration of space functions and the temperature required for functions, there is no need to arrange a special heating system as in space G-03. However it can be said from the remains, other spaces were heated with a system related with the central heating. Most important clue of this assumptions are the pipes in Space G-01 and F-01 and regular hallows at east, west and south sides at the same vertical and horizontal axes. (Figure 87) The space G-01 and F-01 are the entrance spaces and used as “soğukluk,” space. The spaces don’t have a water related function. These remains of pipes and hallows in that respect can be seen as traces of a heating either with radiator or convectors.

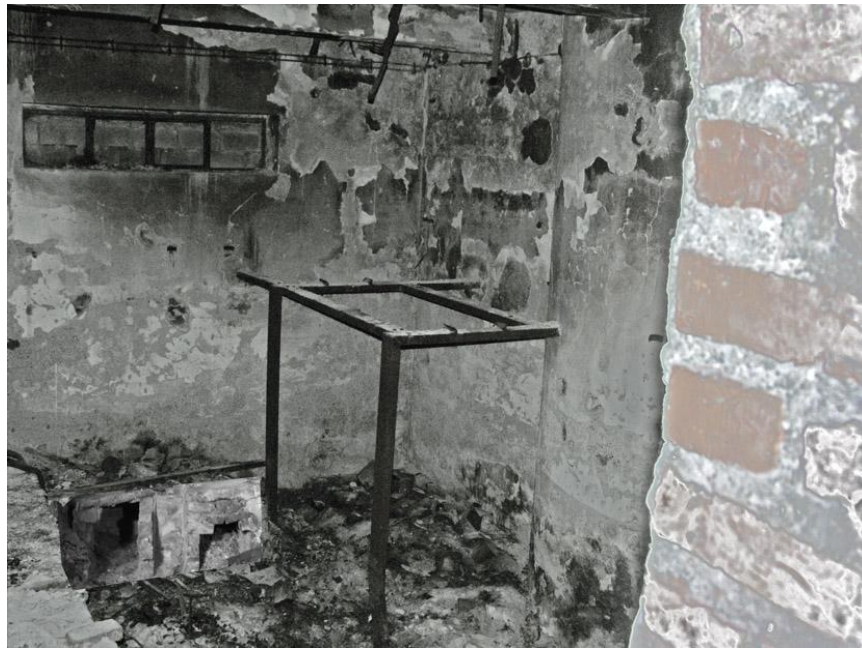
Figure 88 - Space B-06, fireplace and metal frame work(author, 2010)

It is not clear either steam heating systems or hot water heating type was preferred in Hamam but its obvious that there should be a heater mechanism which was probably placed over the fireplace and a water tank over the metal frame work in space B-06. (Figure 88) There should be also a pump near that mechanism to distribute water to up floors. Electric usage in Hamam supports the idea of such kind of mechanisms could be used. Another subject is the type of combustible used. Use of coal is the most preponderant possibility considering the fire place at ground,

chimney opening at below and the projection , like an unloading space, that is connecting space B-06 to outside with a window. On the other hand it could differentiate to preferred heating machine. A schematic system of heating can be seen on 3D Model in Figure 94.

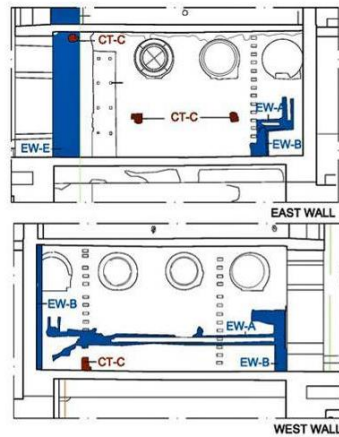
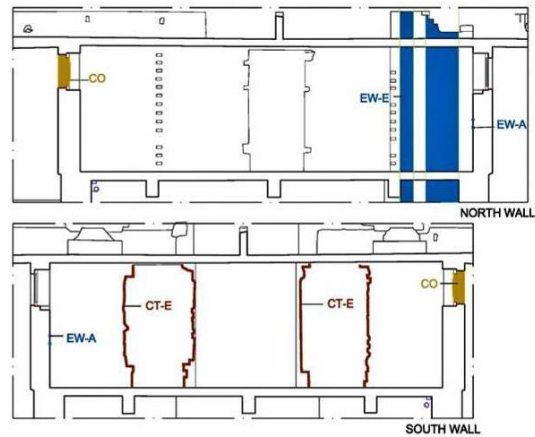
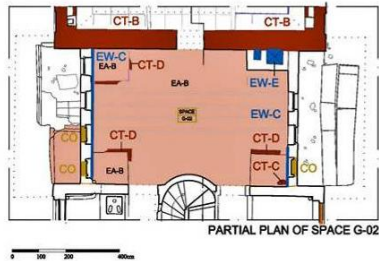
EVALUATION OF REMAIN AND TRACES IN AOÇ HAMAM /SPACE G-02

In space G-02 at south east, west and north west corner we see wall remains of halvet like units. The pipes, water drains on ground and water canals on east and west walls also shows that space had a bathing function. From traces on ground it can be said that marble was used as finishing material. There is also a hole connected with chimney which may be related with heating system.

In east wall there are traces of brick that can be partially observed from plaster.

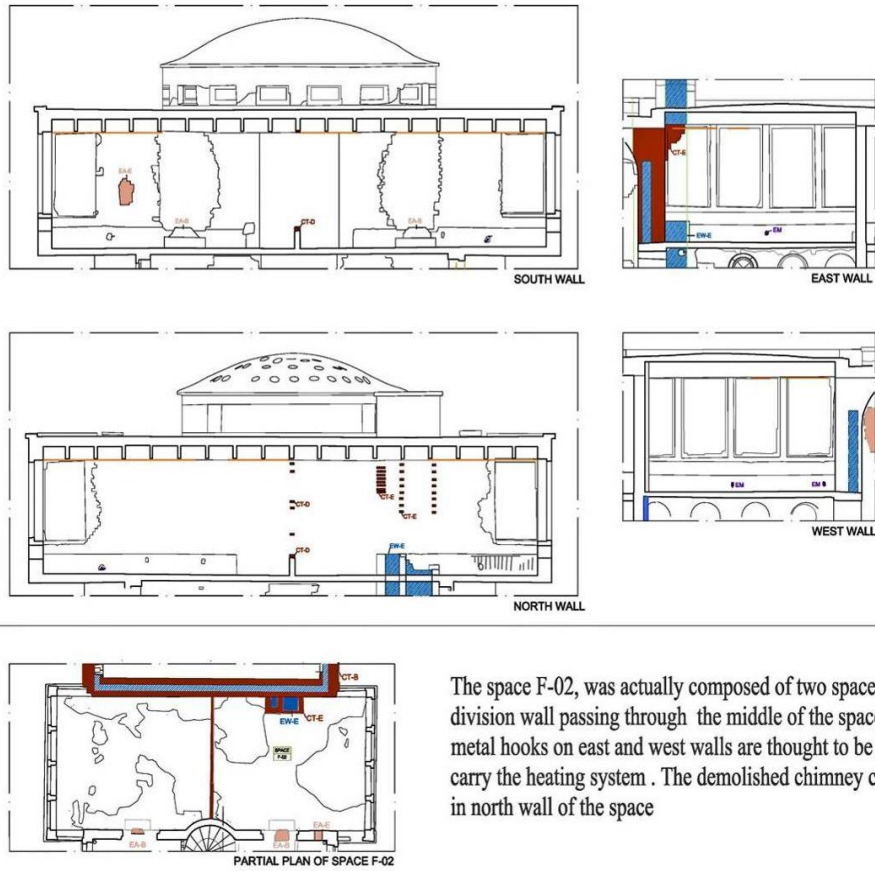
EVALUATION OF REMAIN AND TRACES IN AOÇ HAMAM /SPACE F-02

The space F-02, was actually composed of two space with the division wall passing through the middle of the space. The metal hooks on east and west walls are thought to be used to carry the heating system . The demolished chimney can be seen in north wall of the space

In south wall of the space there is an opening.

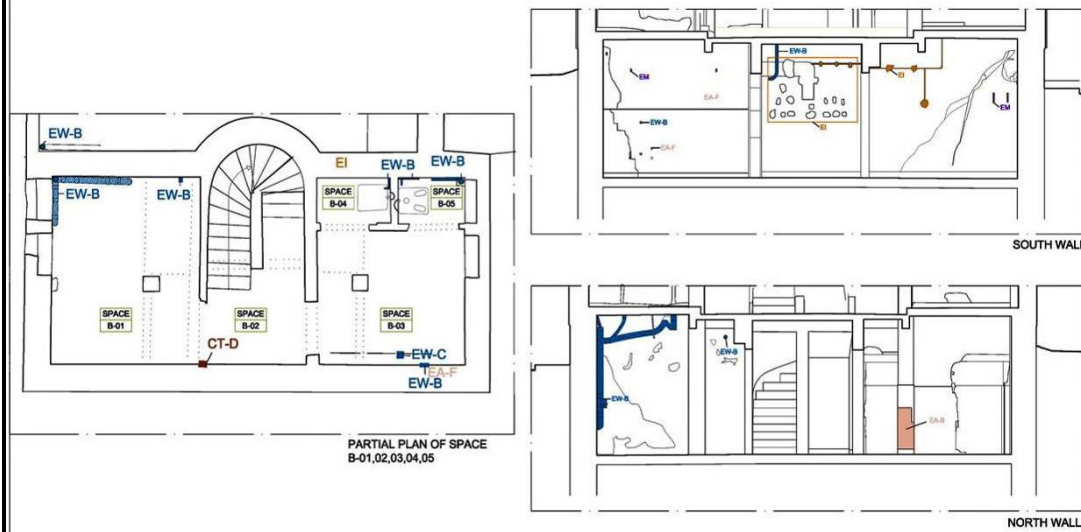
Figure 100- Evaluation of Remain and Traces in AOÇ Hamam

In spaces B 03, B04 and B05 there are toilets. The traces of water pipes and wash basin and mirrors can be observed on south wall of space B-03. From traces it can be said that in space B-02 there was a control panel on south wall. Metal elements which was probably used to hang items can be observed in south wall of space B-01.

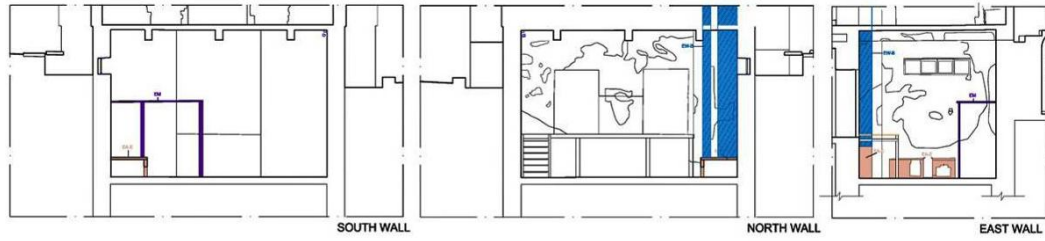
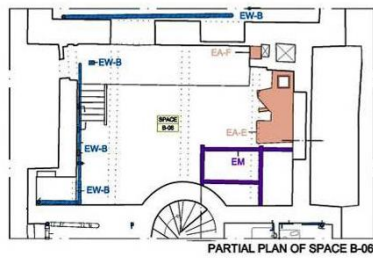
Figure 101- Evaluation of Remain and Traces in AOÇ Hamam

The space B-06 is thought to be centre space for heating as the remains of pipes, metal swivel rings, fireplace take place there. There is also a metal frame work at south east corner which was probably used to place water tank. On the south west side there is a space like used for unloading combustible.

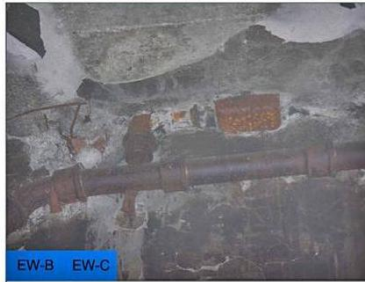
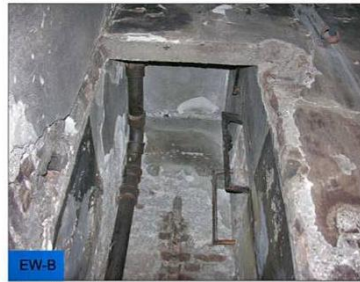
In west wall of the space there is a small space where a window is opening. In south wall of this opening there is a trace which might belong to a door.

In north east corner of the space there is chimney and an opening below.

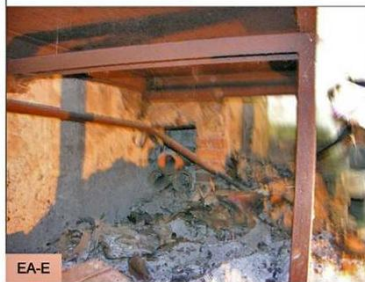
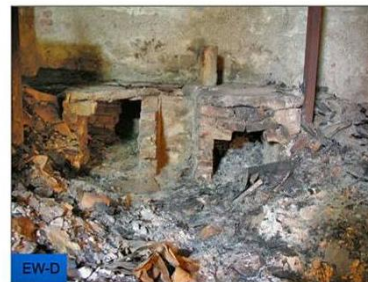
In south part of the space there is a metal framework.

In east part of the space there is an architectural element looks like fireplace.

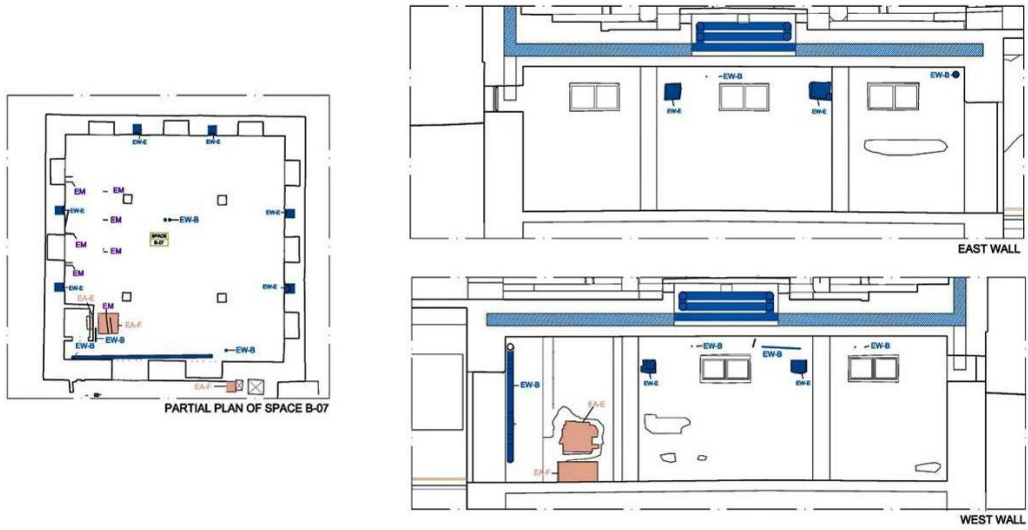
Figure 102- Evaluation of Remain and Traces in AOÇ Hamam

In space B-07 there are metal swivel rings hang on ceiling. There are also water pipes going through space G-03. From remains it can be said that the pipes are hanged on ceiling with metal rings. Also there are little openings connected with the vertical canals going through the wall section in Space G-03. It shows that with the 9 windows in space B-07 there was a special ventilation system arrangement. It is also possible to see illumination system remains on ceiling as well as on south wall.

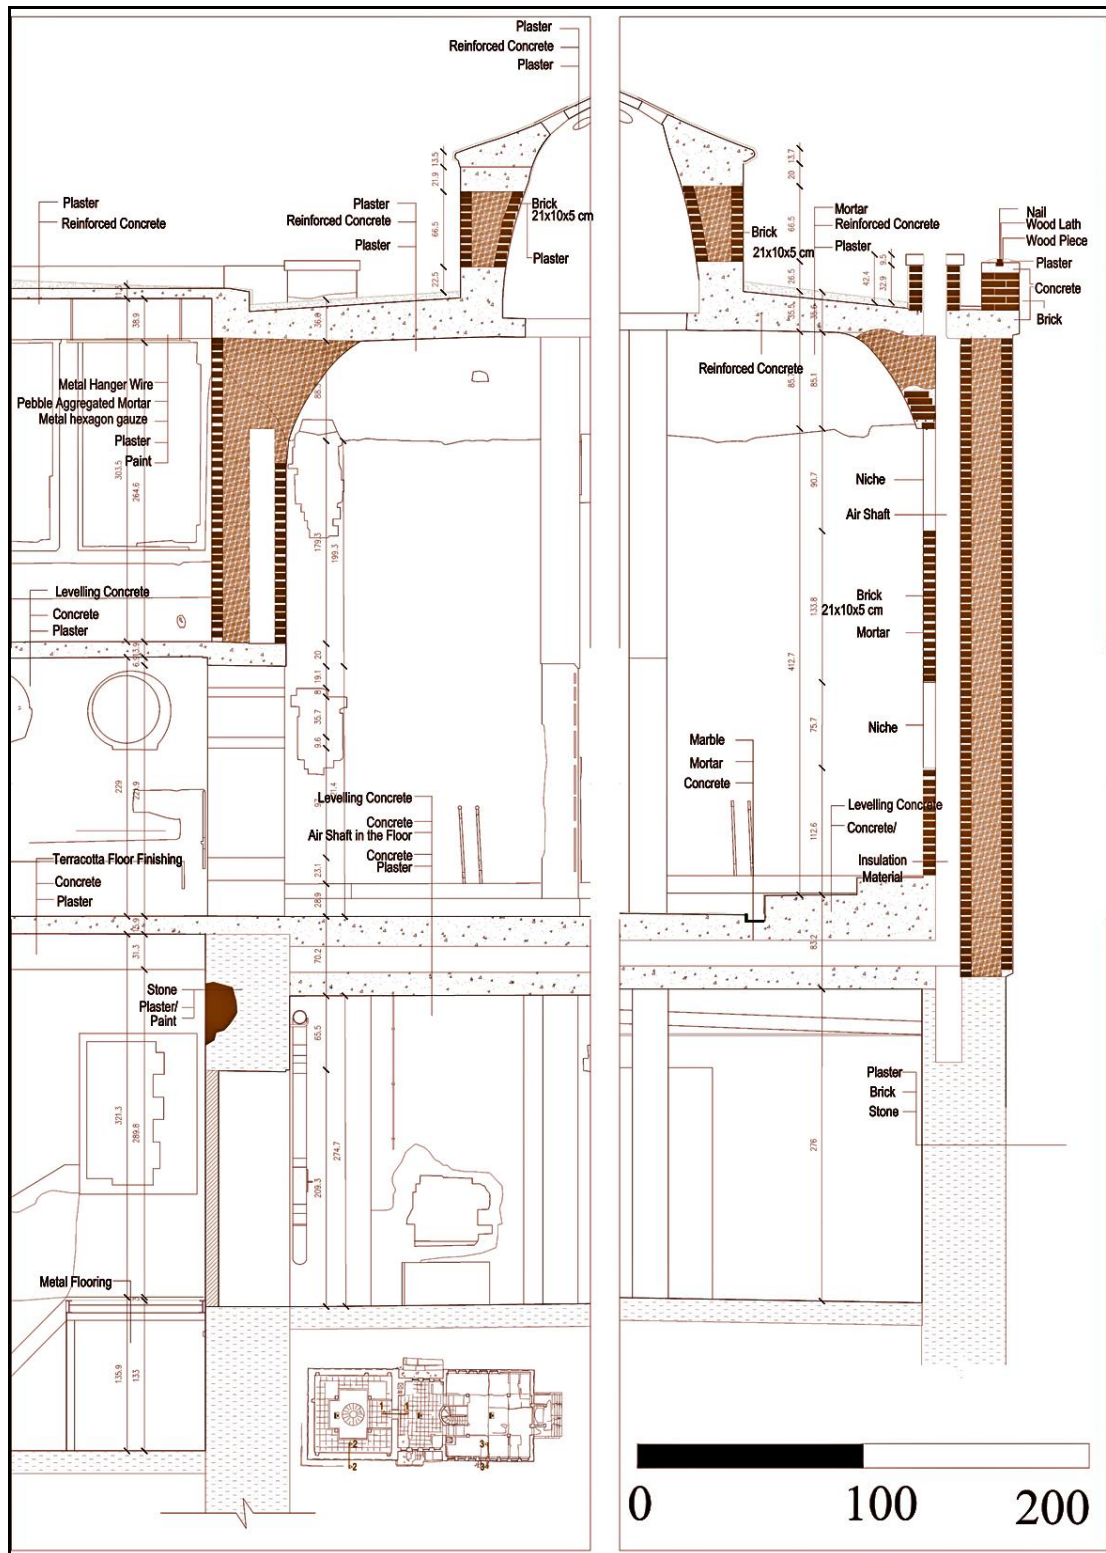
Figure 126 - Construction Technique- Detail Drawing 1-1, 2-2

AOÇ Hamam building was constructed in 1937-1939. Like the other buildings constructed in the same period reinforce concrete system is used. To basically explain, a combined system of reinforced concrete system and masonry system used together in the building. (Figure 126, Figure 127) The columns, slabs and superstructure are constructed with reinforced concrete system, while masonry system is used as complementary of the system and used in outer load bearing walls and main division walls at inner space.(Figure 46) Main construction materials of masonry system are brick and mortar above -0.50 m level, while stone and brick used together below that level at outer walls.
