DEFINING CONSERVATION PRINCIPLES FOR  
THE BREWERY OF ATATURK FOREST FARM

A THESIS SUBMITTED TO  
THE GRADUATE SCHOOL OF NATURAL AND APPLIED SCIENCES  
OF  
MIDDLE EAST TECHNICAL UNIVERSITY

IN PARTIAL FULFILLMENT OF THE REQUIREMENTS  
FOR  
THE DEGREE OF MASTER OF SCIENCE IN RESTORATION  
IN  
ARCHITECTURE

FEBRUARY 2013

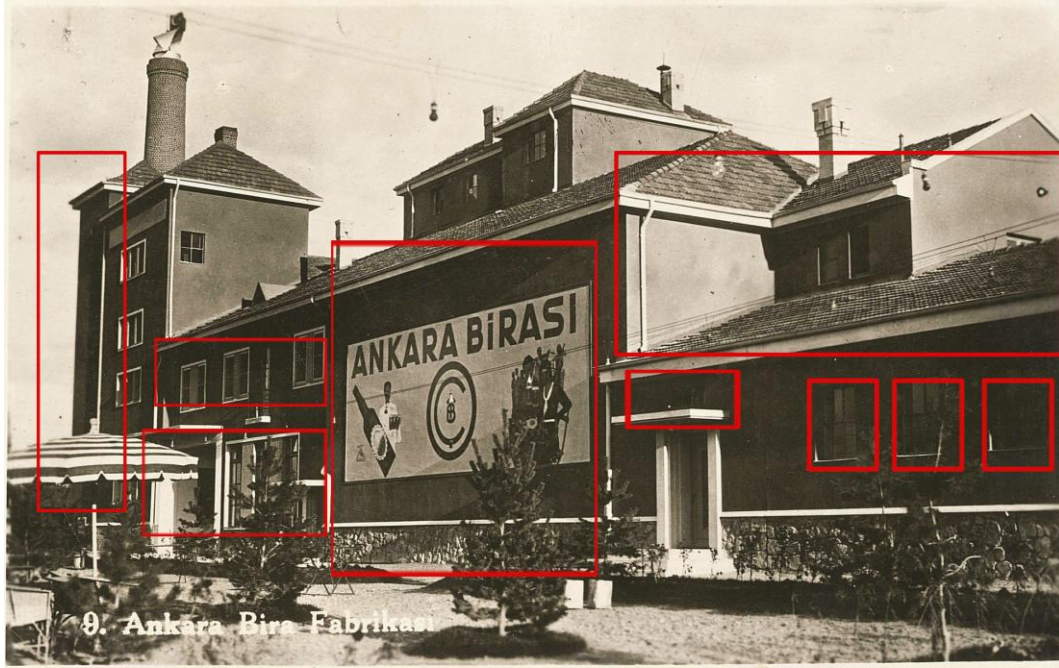
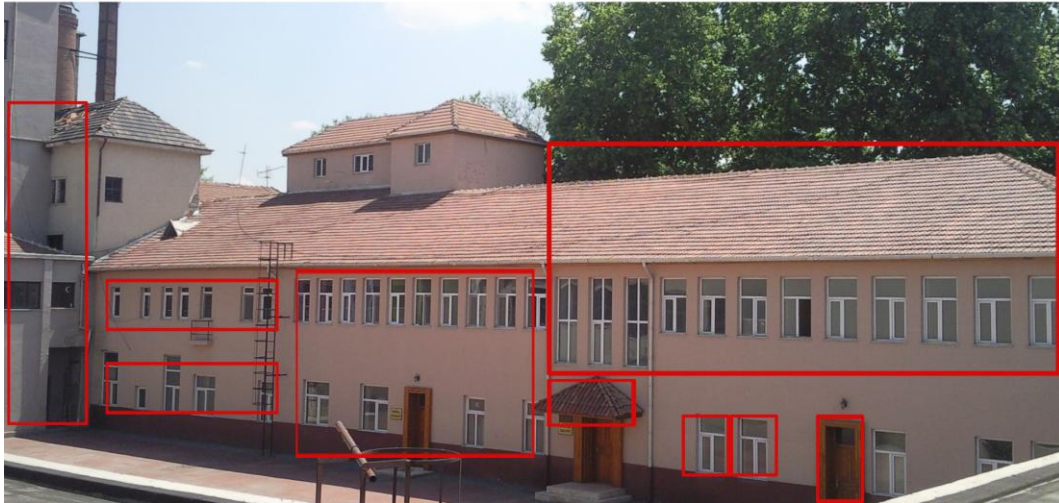
**Figure 44.** The old (before 1937) and new (2012) photographs indicating the alterations on the north (courtyard) facade of the old factory building (Sources: Koleksiyoncular Derneği and Author)

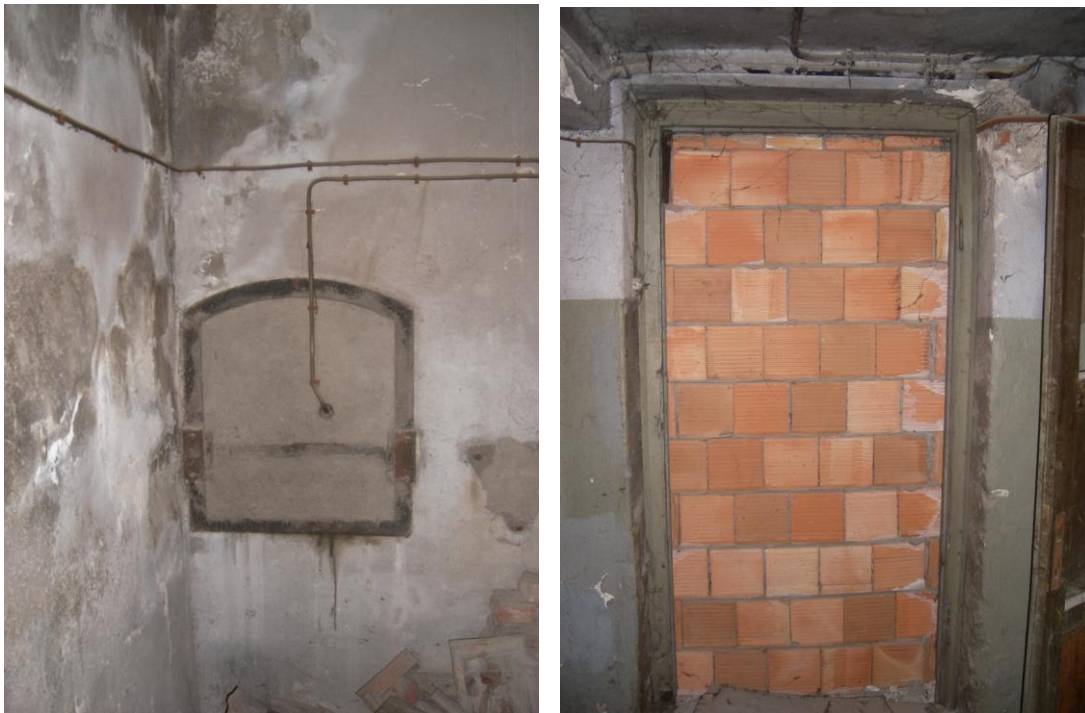
**Figure 46.** The closed openings in the production part of the old factory buildings (Source: Author, 2012)

There are implementations only on exterior in the five storey dwelling part and the interior parts mostly conserve their original conditions. The facades of the building have been painted and the windows have been altered with the PVC ones. There are dampness problems and material deteriorations on the interior walls of this part. The production part has not been exposed to interventions in the recent times and it is the most conserved part in the old factory building. Though, it is the part having the most structural problems and material deteriorations. There are dampness problems and shedding of plasters in most of the interior walls. In addition to that, there are problems on the gable roof especially on timber elements and waterproofing. The windows adjacent to the malt building were closed with gas concrete blocks like the interior ones closed with concrete and brickwork.

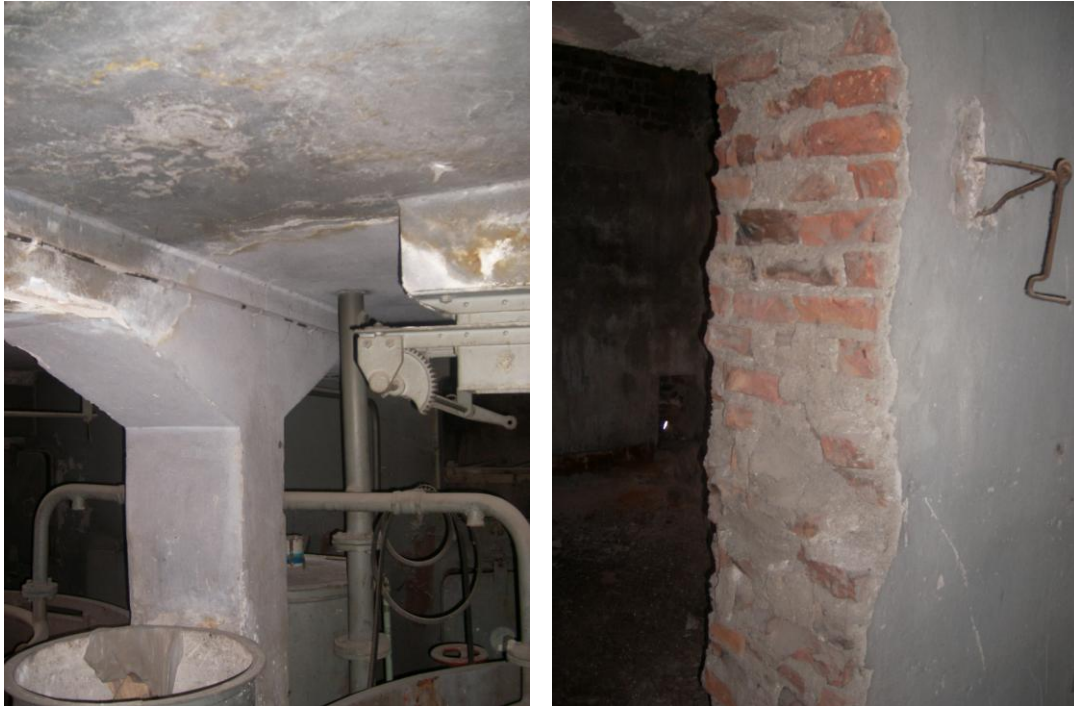
The old factory building was constructed with the combination of brick masonry and reinforced concrete system with brick infill. The brick masonry walls are seen on the ground floor of double storey rectangular part and in the production unit. It is understood from the width of the walls and partially demolished walls. The building has no serious structural problems although the production unit has slight problems especially on slabs. The bureaus

**Figure 47.** The column, beam and brick masonry structure of the production part in the old factory building (Source: Author, 2012)

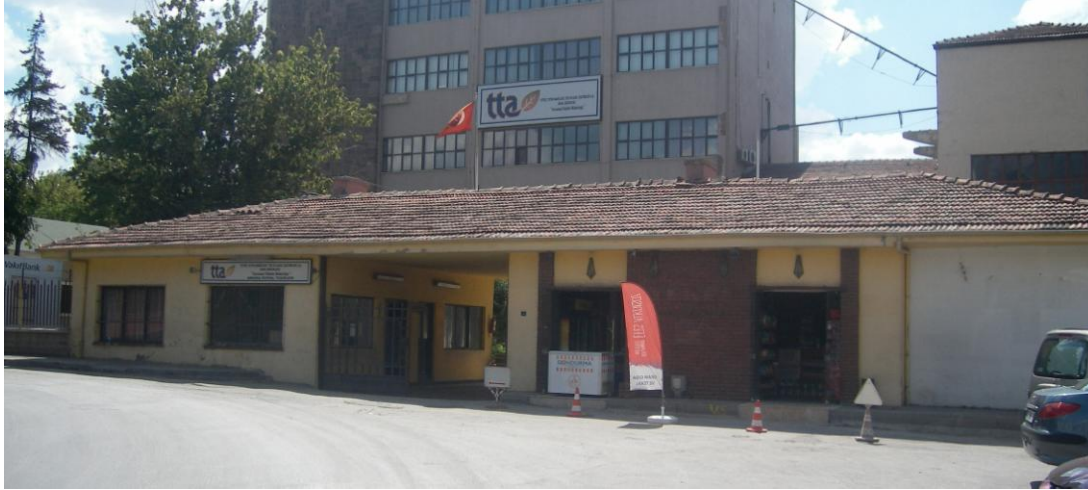
**Figure 49.** Exterior photograph of the entrance building (Source: Author, 2012)

The 1937 dated drawing, which was named as “Antre ve İkametgah” (Entrance and Dwelling) and consists of one plan, three elevations and one section, has a plan number of 471. There are differences between the drawing and today’s condition in terms of mass, plan scheme and elevations. For instance, the original symmetric mass was altered with an additional part which is located on north façade and used as storage today. Moreover, Egli did not place any openings looking to passage on the dwellings to provide privacy but there are windows in these parts today. The kitchen and the space, which is situated adjacent to it and near the passage, were joined by removing the wall between these spaces. In addition to that; the alcove, which is found on the south façade today, is not seen on the original drawings. The iron entrance door is found on the Çiftlik Street however in original drawing the door was located in the middle of the passage.

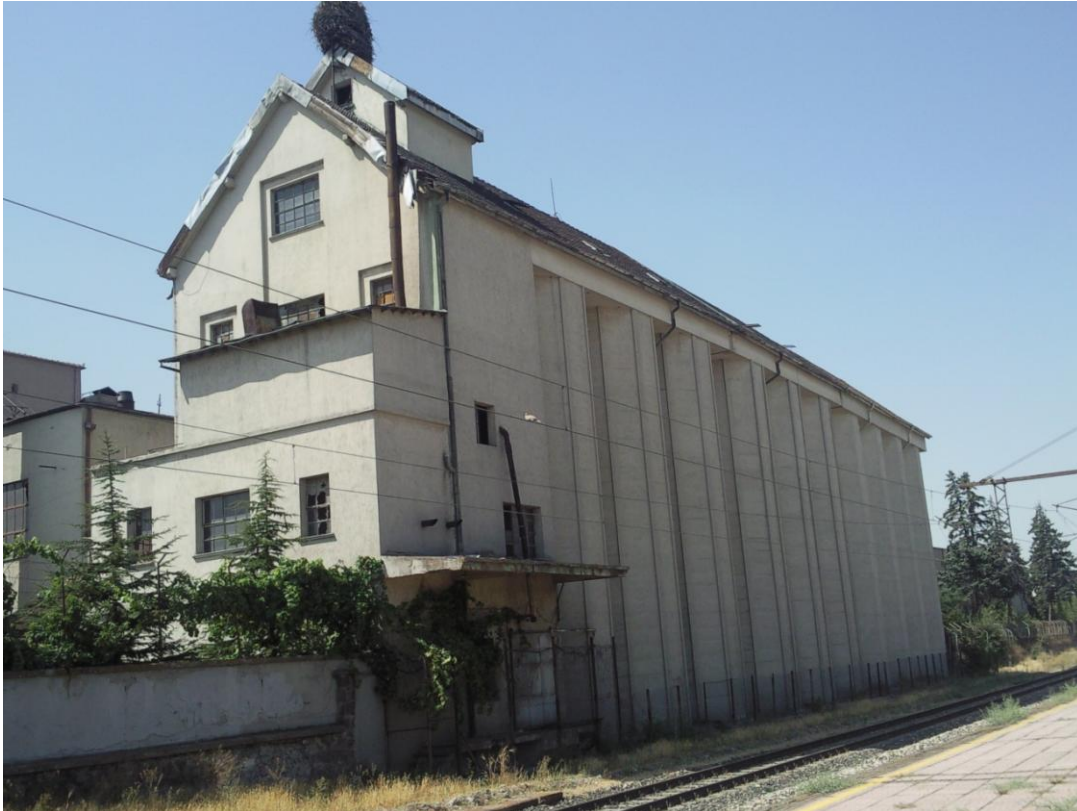
**Figure 52.** Exterior photograph of the silo building (Source: Author, 2012)

In interior walls, cracks and deteriorations are seen on plastered surfaces, while bulking and spalling is seen on paint coated surfaces. Cracking is seen on timber and corrosion seen on iron elements especially in windows and balusters. A backwater having 30-40 cm of height is accumulated on basement floor due to the serious drainage problems of ground water. Therefore, the water and dampness occurred due to this drainage problems caused weakening on the walls of basement and ground floor.

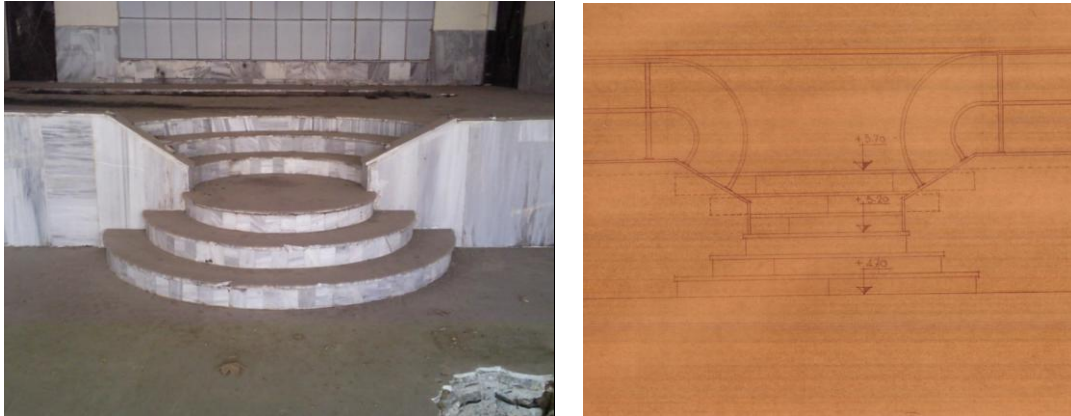
**Figure 84.** Photograph of the circular formed stair in the boiling and fermentation building (left) and the original detail drawing of Ernst Egli in 1937 (right). (Sources: Author and TTA Archive)

The repair in 2001, which was implemented on the exterior of the building and interior of the fermentation part, caused the loss of original materials. The exterior walls are plastered and paint coated apart from the part on east façade which is covered with stone. The original frames and joineries of the exterior doors and windows were altered with the ones made of aluminum. In addition to that, the floors of the fermentation part covered with vitrified ceramic tiles. The floors are covered with leveling concrete and marble tiles apart from the repaired fermentation part. The ceilings and the interior walls are coated with plaster and plastic dyes apart from the some parts of the walls of the fermentation part covered with vitrified ceramic tiles. In addition to that, the interior doors are made of timber and iron differently from the exterior aluminum ones. There are material deteriorations on most of the building although it was repaired in 2001. There are rising damp problems on the walls of the ground floor like the ones on the third and fourth floors having dampness problems due to the drainage problems on the roofs. Moreover, the dyes of some of the exterior walls were flaked away. To sum up, there are some material deteriorations in the building and the implementations made in 2001 caused alterations and disappearances on the original architectural elements, materials and details.

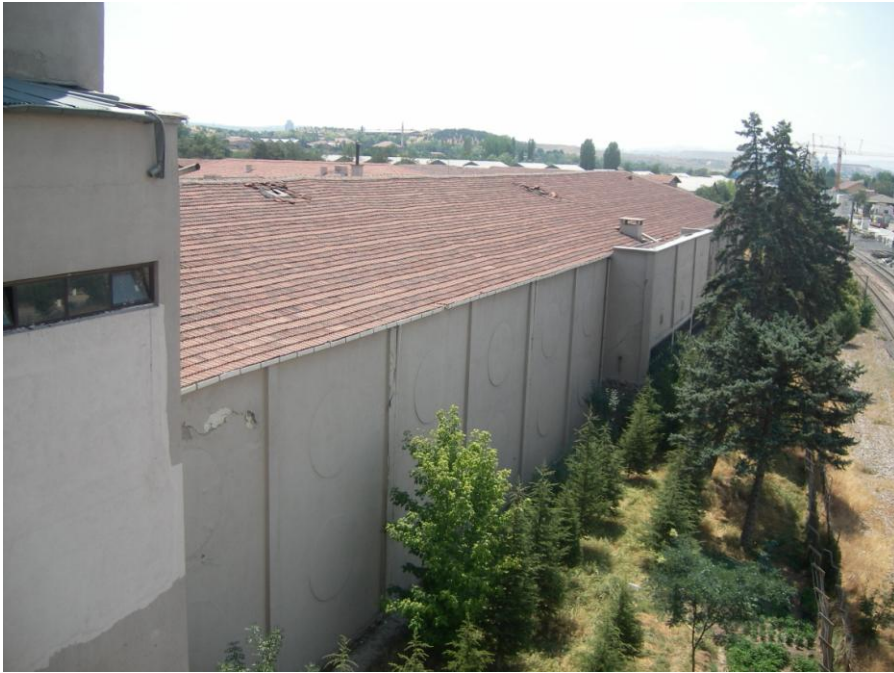
**Figure 86.** The exterior photograph of the beer settling building (Source: Author)

Today, the building, constructed with reinforced concrete system with brick infill, has a hipped roof covered with interlocking tile, although it was constructed with %5 sloped flat reinforced concrete roof. There is no serious structural problem in the building due to the comprehensive repair implemented to building in 2001. Though, this repair totally changed the plan scheme of the building because most of the interior walls were removed. Iron stands were placed for storing the beer barrels inside the building although they do not exist today. Furthermore, the walls were cladded with ceramic tiles as an additional material which was not used in the original building. The floors were covered with surface hardeners containing quartz and the exterior walls were plastered and painted. The iron doors and windows were altered with the aluminum ones. The bronze writings on the north wall also do not exist today however it is not known when these writings were removed from the building. To summarize, the repairs made in 2001 caused the loss of original plan scheme, architectural elements and materials although the original mass was conserved with its period addition constructed in 1939.

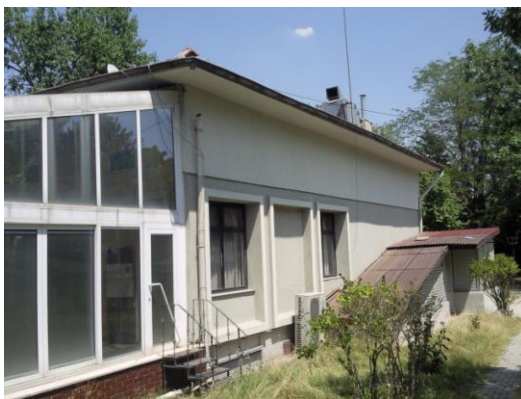
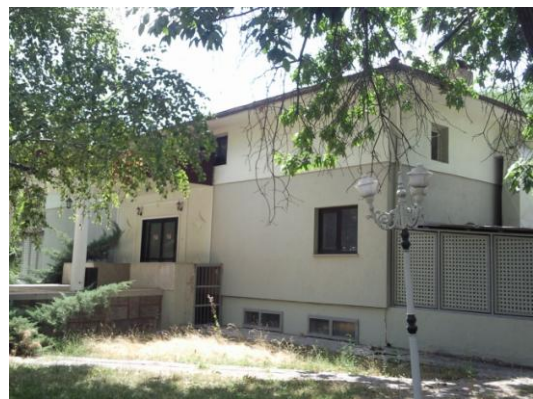
**Figure 96.** The exterior photograph from the south and east facades of the workers club

There are alterations on the exterior walls and the facades of the building. For instance, the terrace on the west of the building was converted to a space by closing with PVC material. Moreover, a single storey mass, used as toilets accessed from outside, has been added on the north wall of the building. In addition to that, the windows on the ground floor level of the east wall have been removed apart from the right one. The middle window on the south wall has also been closed and gypsum jambs have been added around the two remaining windows. Most of the windows of the basement floor have been removed and the existing ones have no iron baluster differently from the original ones. Furthermore, the rectangular formed ornamentalations on the first floor level have been removed like the stone claddings below the sub-basement level. Additional windows are seen on the first floor level of the north and east exterior walls in the places of rectangular formed ornamentalations. To summarize, the repairs implemented in recent times caused the loss of original mass, plan scheme, architectural elements and materials of the building.

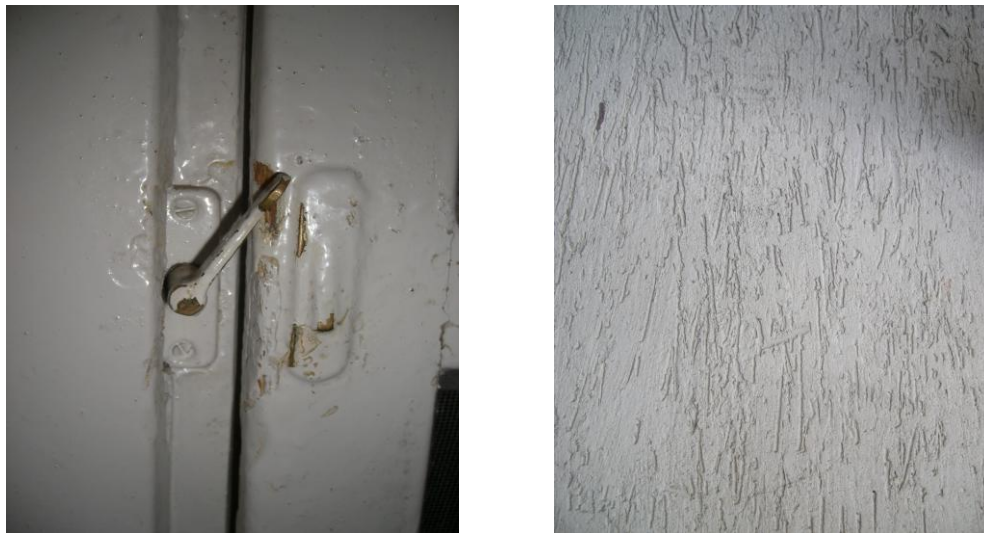
Although, there are no serious structural problems, material deteriorations are seen inside and outside the building. For instance, breakings and sheddings are seen on the exterior artificial stone plasters. Moreover, rising damp problems are seen on the sub-basement level of the exterior walls. Furthermore, the dampness problems are also seen on the walls of the wet spaces in the dwellings. There are fractures and cracks on the plasters of the walls of the rooms. The timber elements on the doors, windows and floors have been deteriorated and they are lacking in varnishes.

**Figure 102.** The original locking detail in the double storey dwellings of officers (left) and the texture of the artificial stone plaster, seen on the exterior walls (right) (Source: Author)

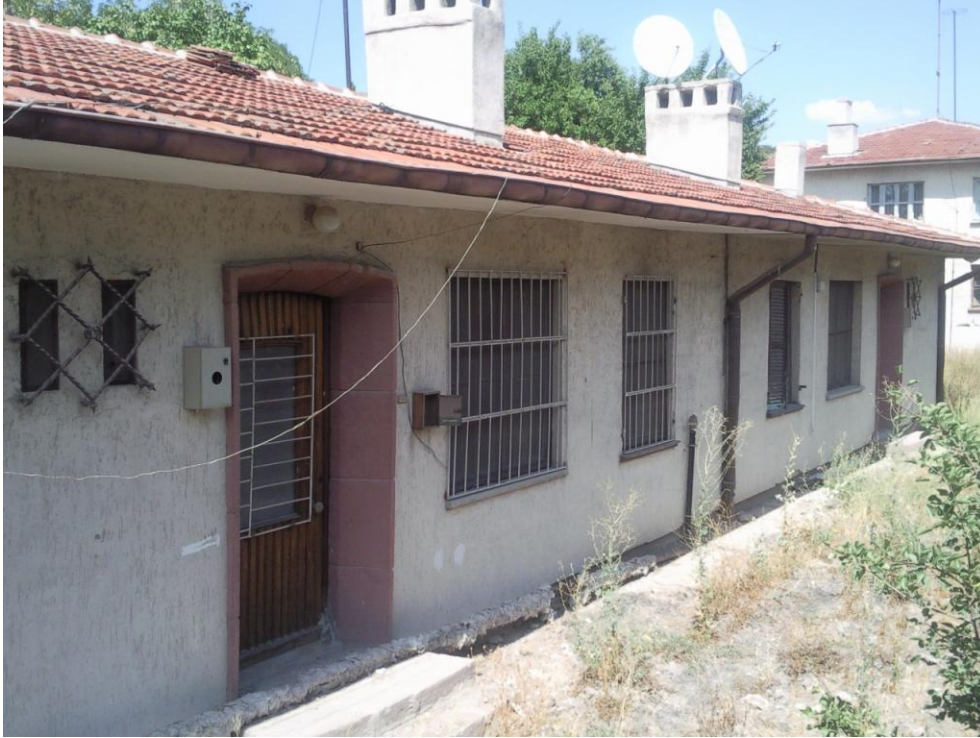
**Figure 104.** The exterior photograph from the south facade of the double dwellings of officers (Source: Author)

Today, the building has a hipped roof covered with interlocking tiles. The exterior walls are covered with artificial stone plaster while the interior ones are covered with lime plaster and ceramic tiles. Moreover, the ceilings are also covered with lime plaster. The frames and joineries of the doors and windows are made of timber while the balusters are made of iron. The slabs of the floors are covered with ceramic tiles in circulation zones and wet spaces while they are covered with carpets in the living rooms and bedrooms. Although, there are no serious structural problems due to being single storey, material deteriorations are seen especially on the plasters of interior walls. Moreover, deformations and deteriorations are seen on timber elements such as the doors, windows and louvers.

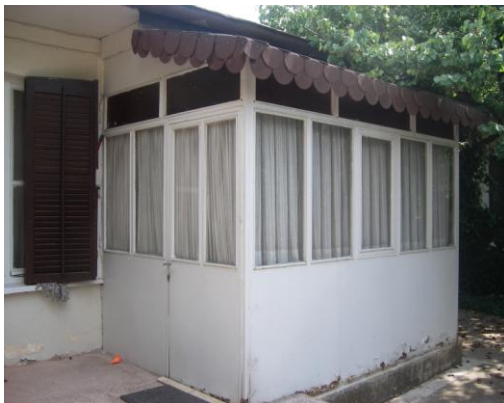
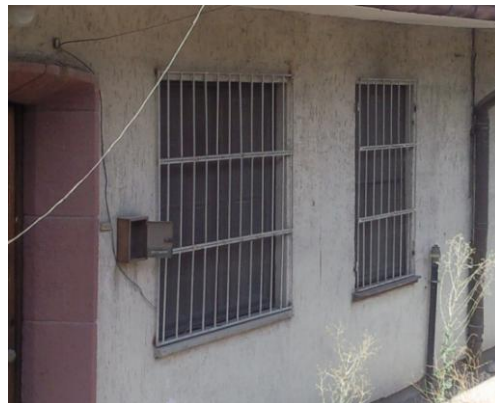
**Figure 109.** The additional timber construction which is not seen on the original drawings (left), the altered and enlarged window with altered iron balusters added in recent times (right) (Source: Author)

Several alterations are seen in the building when they are compared with the original drawings. For instance, the spaces on the north façade below the porches have been converted to spaces by closing with timber structures. In addition to that, the stone coverings below the sub-basement level have been removed. The small windows having iron balusters and the windows near them have been removed and larger windows are located in the places of them. Furthermore, the two louvers on the windows of the south façade have been removed and iron balusters have been placed in the places of them. To summarize, the molar features and the plan schemes are generally conserved while the façade organizations have been changed due to the alterations in the places and the dimensions of the openings.

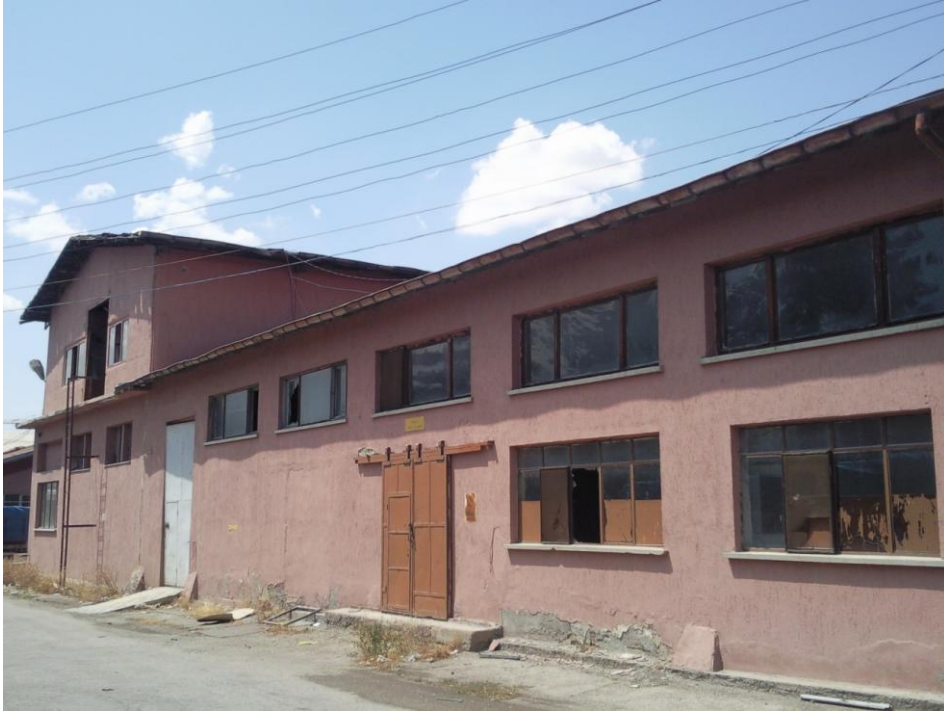
**Figure 111.** The exterior photograph from the south facade of the wine and whiskey production officers (Source: Author)

Although, there are no serious structural problems, material deteriorations are seen inside and outside the building. For instance, rising damp problems are seen on the sub-basement level of the exterior walls. Moreover breakings and sheddings are seen on the plastic dyes of the exterior walls especially below the sub-basement level. The water accumulation due to the drainage problems is seen on the basement floor. Furthermore, the dampness problems, occurred due to the drainage problems, are also seen especially on the ceilings below the roof. There are fractures, cracks and sheddings on the plasters and dyes of the interior walls. The iron architectural elements such as doors and windows have corrosion problems while timber elements have been deteriorated and lacking in varnishes. In addition to that, some of the ceramic tiles on the interior walls have partially broken off.

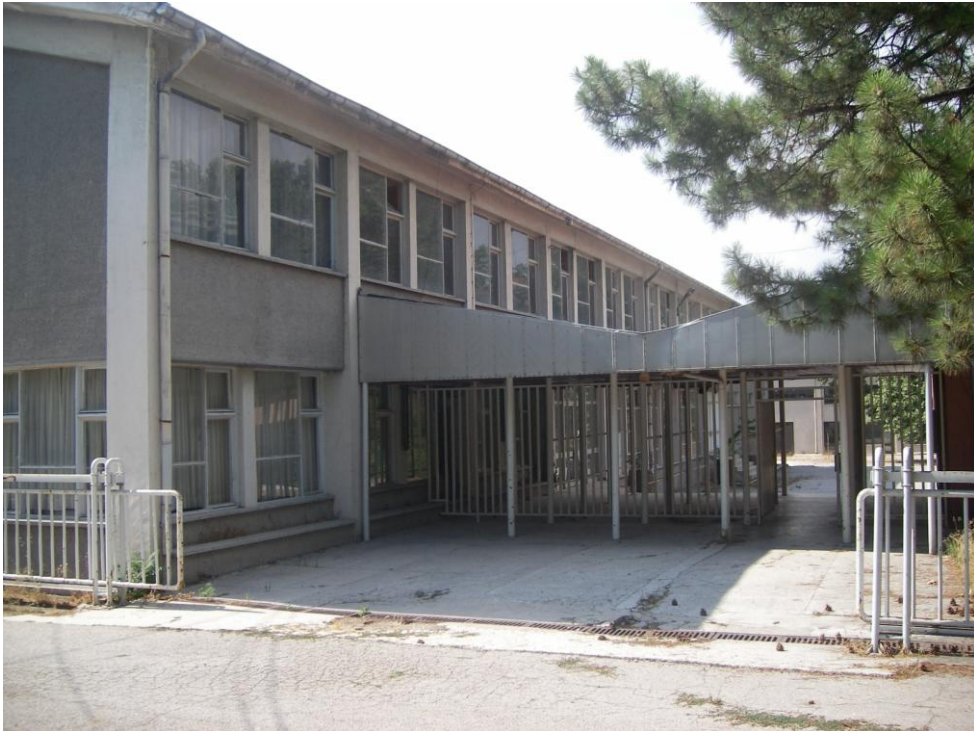
**Figure 116.** The exterior photograph from the east facade of the dining hall (Source: Author)

The building, constructed with reinforced concrete frame system with brick infill, has a gable roof cladded with interlocking tiles. The white marble plasters and artificial stone plasters were used on the facades. All of the slabs on the ground and first floors were cladded with mosaics. Moreover, the walls and ceilings inside the building were covered with lime plasters. The frames and joineries of the doors and windows are made of timber and iron. The reinforced concrete porch between the ground and first floors on the south façade is an additional architectural element. Furthermore, the entrance door and the staircase providing access to it are the additions not seen on the original drawings. Apart from these additions, the mass, plan scheme, architectural elements and the materials are conserved.

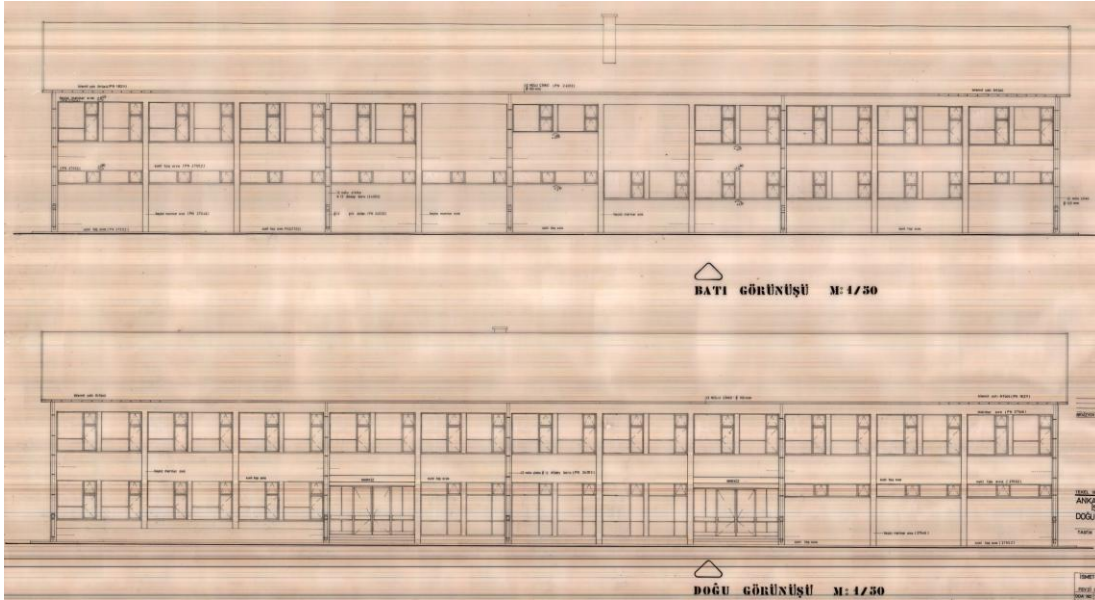
The east façade, including the main entrance doors, has the most openings with respect to other facades. The ribbon windows on the right of the ground floor level symmetrical façade organization. The structural axes can be observed due to the protrusive columns. The service door is located on the south façade and the ribbon windows are located over this door. The south façade visually divided into three parts and there is no window on the left one. There are windows only in the middle part on the first floor level. The pediment composed due to the form of the gable roof is situated over these windows. The west façade resembles the east façade however there is no entrance door on this façade and there are more ribbon windows than the east façade. The north façade resembles the south façade however it has a symmetrical façade organization differently from the south façade.

**Figure 117.** Construction drawing of the dining hall, the west and east elevations, İsmet Şen Construction Company, 22.10.1976 (Source: TTA Archive)

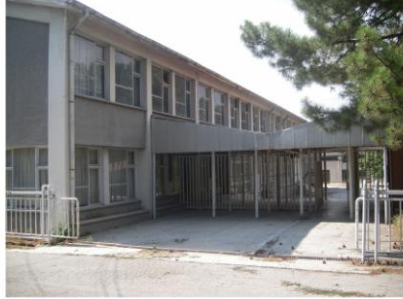
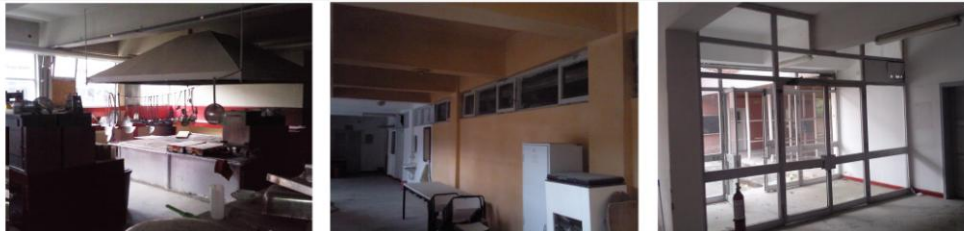
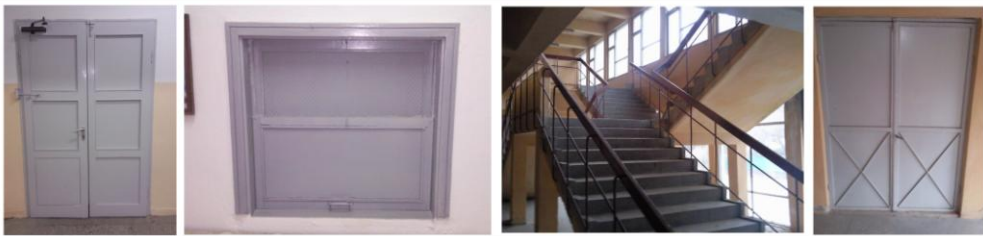
**Figure 118.** Inventory number 13: The dining hall

CONSTRUCTION DATE: 1976		
NUMBER OF STOREY: 2		
ORIGINAL FUNCTION: THE DINING HALL		
CURRENT FUNCTION: NOT USED		
STRUCTURAL SYSTEM: REINFORCED CONCRETE FRAME SYSTEM WITH BRICK INFILL		
ROOF TYPE: GABLE ROOF WITH INTERLOCKING TILES	KEY PLAN

FINISHINGS OF THE FLOORS: MOSAIC		
FINISHINGS OF THE WALLS: LIME PLASTER		
DATES OF PERIOD ADDITIONS: -		
STRUCTURAL CONDITION: THERE ARE NO SEVERE STRUCTURAL PROBLEMS AND MATERIAL DETERIORATIONS		
CONDITION OF CHANGE: ORIGINAL MASS, PLAN SCHEME, MATERIALS AND FACADE ORGANIZATIONS ARE CONSERVED		
EXTERIOR PHOTOGRAPHS
