INTEGRATING THE RUM CHURCHES IN SAMSUN INTO DAILY LIFE

A THESIS SUBMITTED TO THE GRADUATE SCHOOL OF NATURAL AND APPLIED SCIENCES OF MIDDLE EAST TECHNICAL UNIVERSITY

MELDA AYDAN

JANUARY 2016

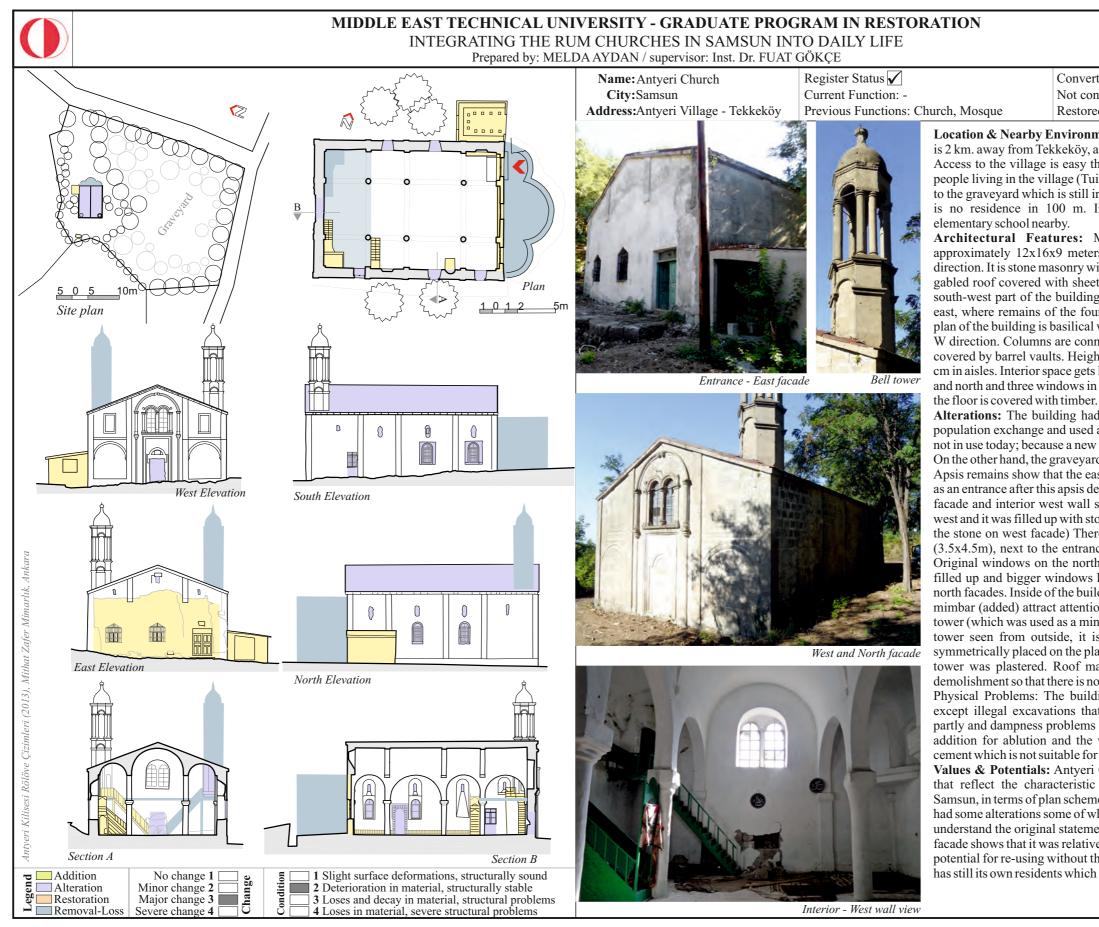
Figure 175: Building Information Sheet S-01 Antyeri Church

Physical Problems: The building does not have many problems except illegal excavations that damaged the floor and the walls partly and dampness problems from the ground and roof. Also the addition for ablution and the windows that are filled up contain cement which is not suitable for this stone building.

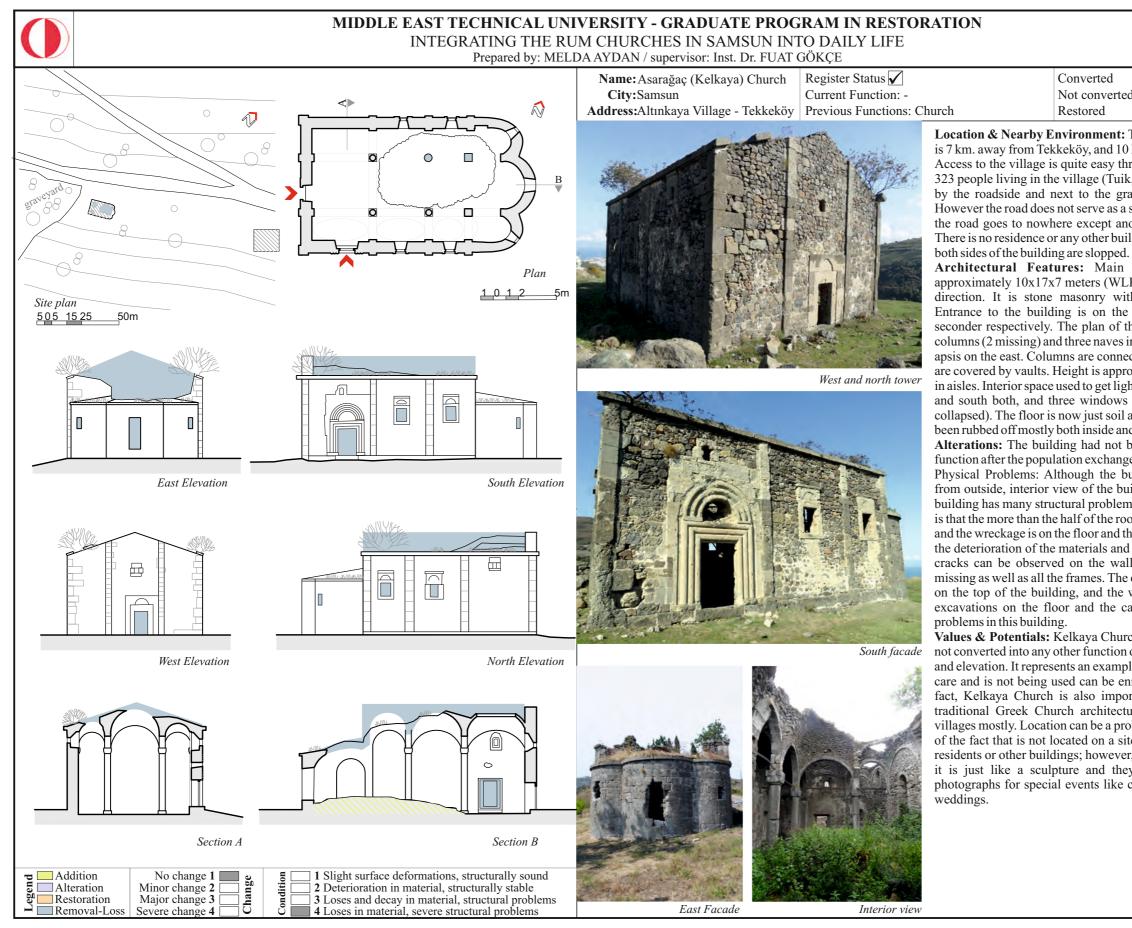
Figure 176: Building Information Sheet S-02 Asarağaç (Kelkaya) Church

Physical Problems: Although the building seems to be healthier from outside, interior view of the building reveals the fact that the building has many structural problems. The most problematic issue is that the more than the half of the roof of the building has collapsed and the wreckage is on the floor and the rest it is also in danger due to the deterioration of the materials and the loss of mortar. Dangerous cracks can be observed on the walls. The floor material is also missing as well as all the frames. The other problem is efflorescence on the top of the building, and the wreckage on the floor. Illegal excavations on the floor and the carvings on the walls are also

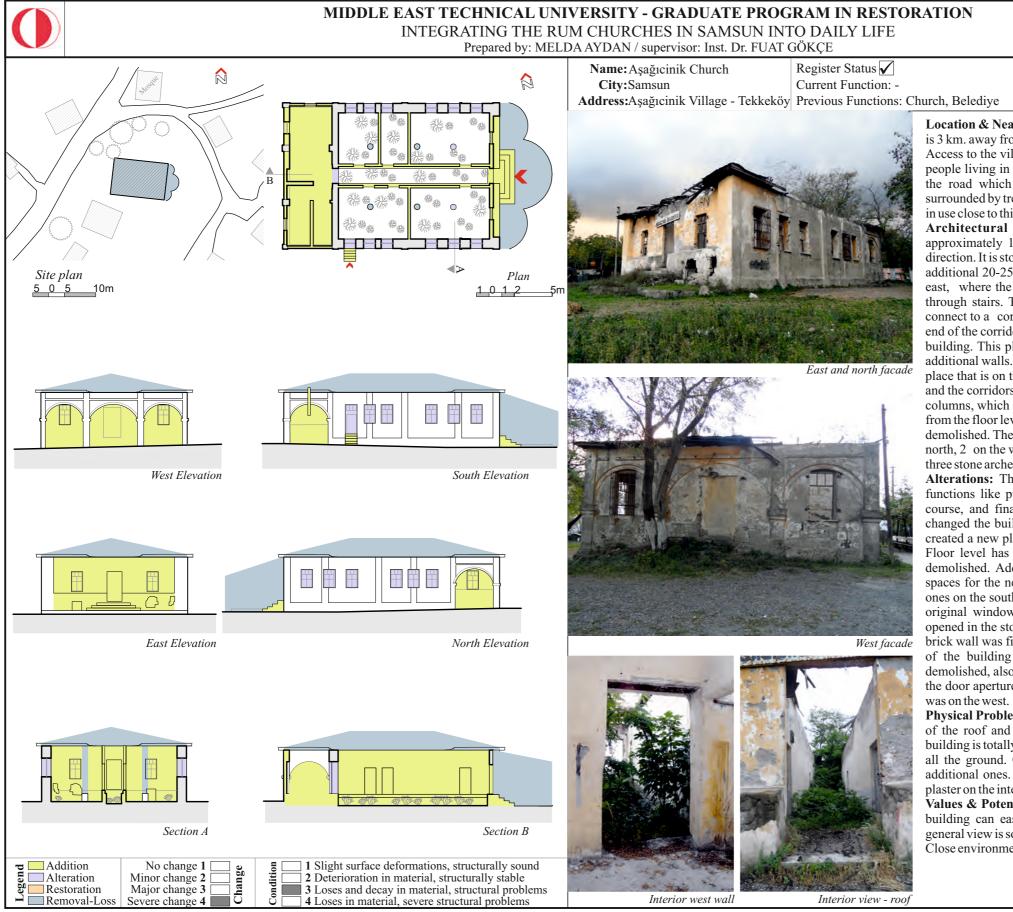
Figure 177: Building Information Sheet S-03 Aşağıçinik Church

building is totally dilapidated and abandoned. There is vegetation on all the ground. Original stone walls are steady compared to the additional ones. Plaster on the facades were rubbed off while the

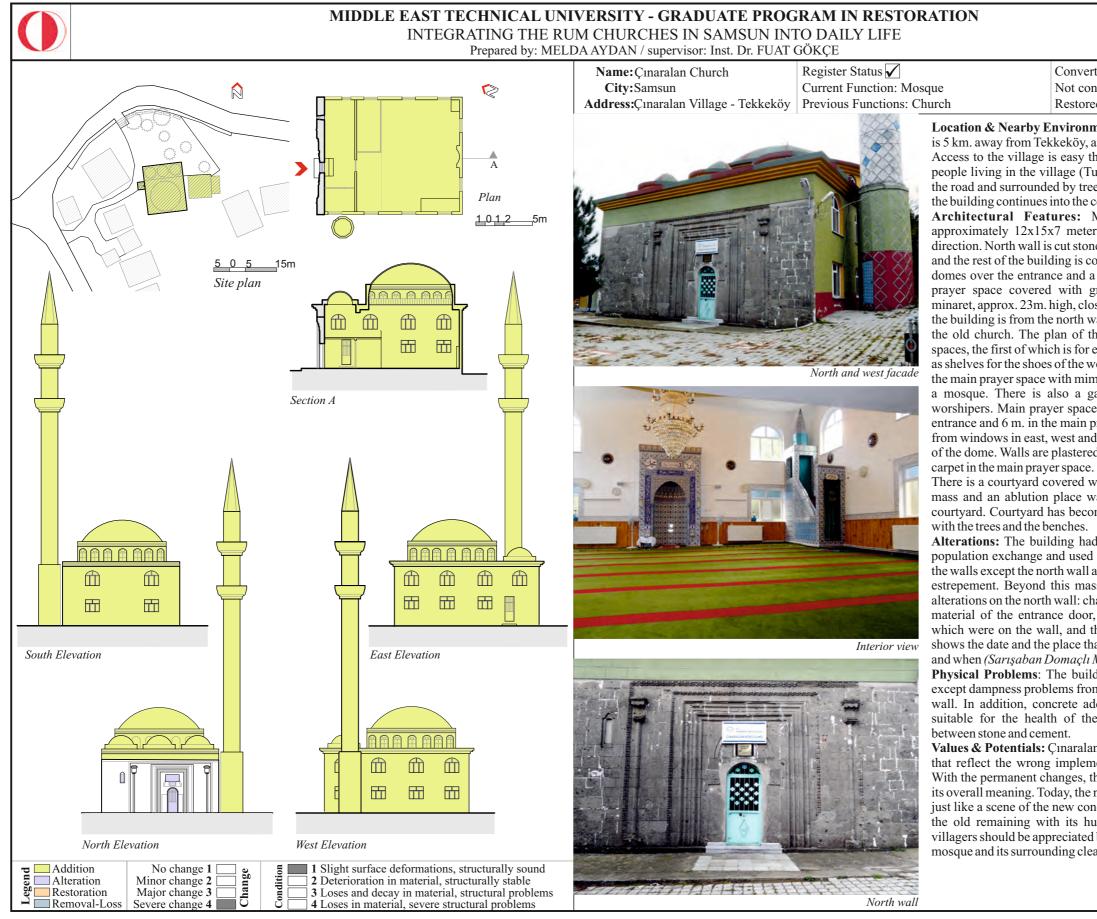
Figure 178: Building Information Sheet S-04 Çınaralan Church

Physical Problems: The building does not have many problems except dampness problems from the ground, especially on the north wall. In addition, concrete addition to the old stone wall is not suitable for the health of the stone due to the incompatibility between stone and cement.

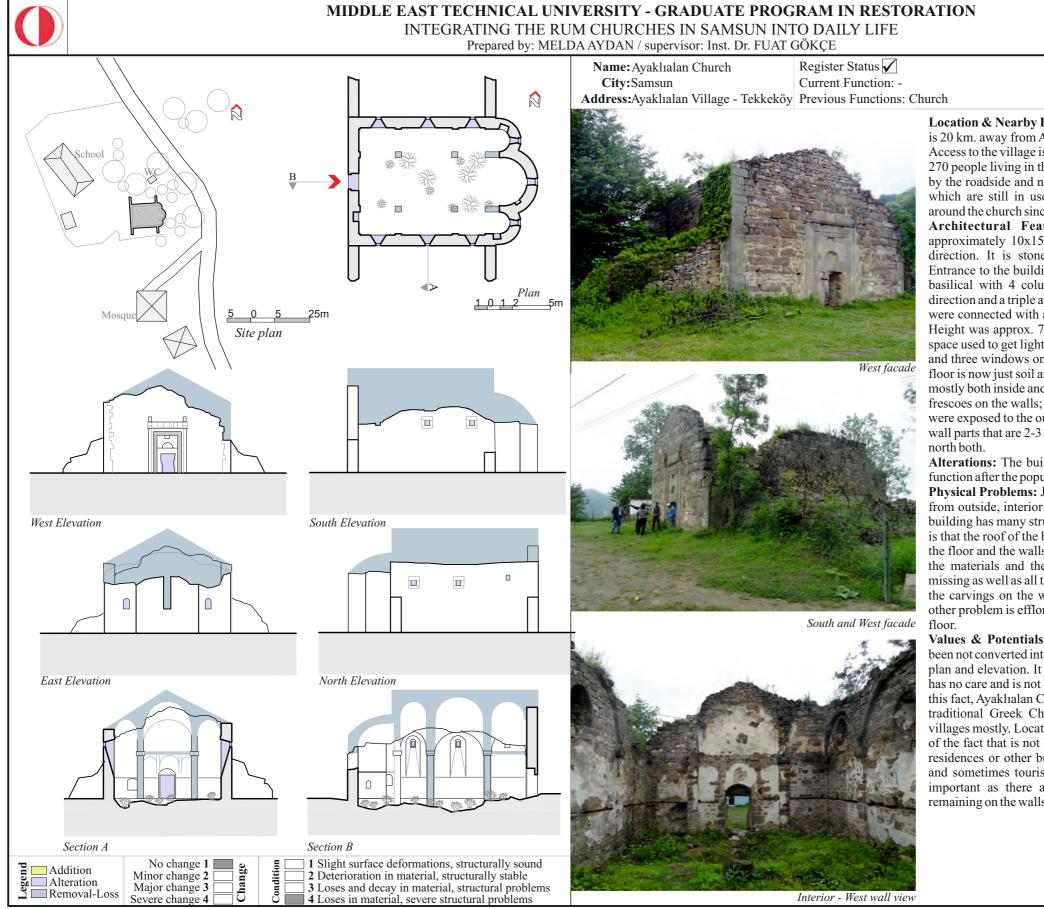
Figure 179: Building Information Sheet S-05 Ayaklıalan Church

Physical Problems: Just like the building seems to be problematic from outside, interior view of the building reveals the fact that the building has many structural problems. The most problematic issue is that the roof of the building has collapsed and the wreckage is on the floor and the walls are also in danger due to the deterioration of the materials and the loss of mortar. The floor material is also missing as well as all the frames. Illegal excavations on the floor and the walls are also problems in this building. The other problem is efflorescence on the walls and the wreckage on the

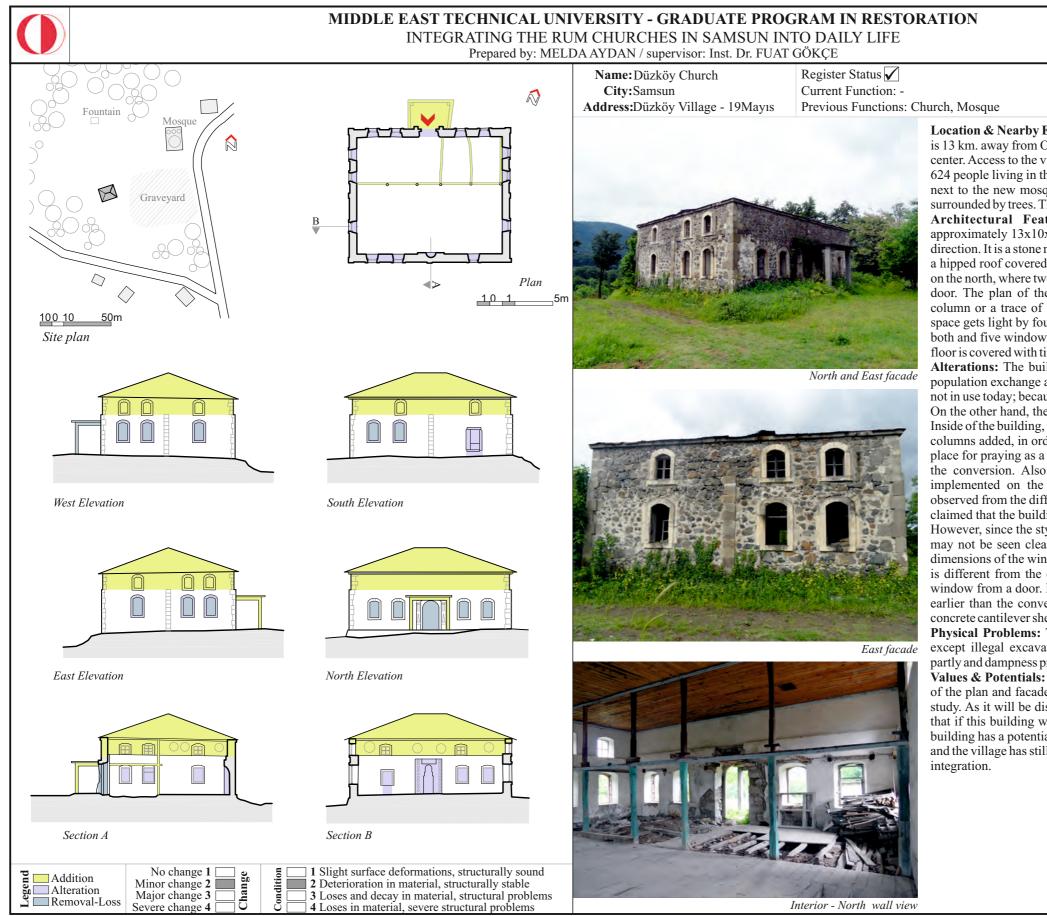
Figure 180: Building Information Sheet S-06 Düzköy Church

Physical Problems: The building does not have many problems except illegal excavations that damaged the floor and the walls partly and dampness problems from the ground and roof.
