CONSERVATION AND REVITALIZATION PROPOSALS FOR
ESKİŐEHİR SUGAR FACTORY SOCIAL FACILITIES AREA

A THESIS SUBMITTED TO
THE GRADUATE SCHOOL OF NATURAL AND APPLIED SCIENCES
OF
MIDDLE EAST TECHNICAL UNIVERSITY

MERVE YILDIZ

FEBRUARY 2016

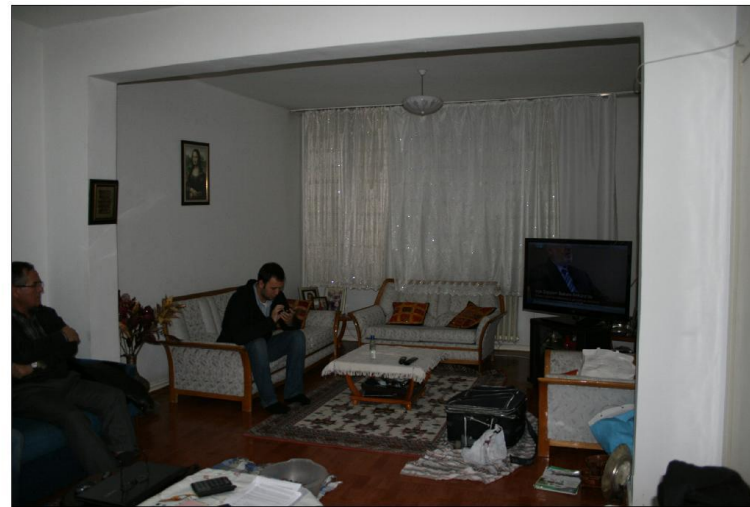
removal of wall

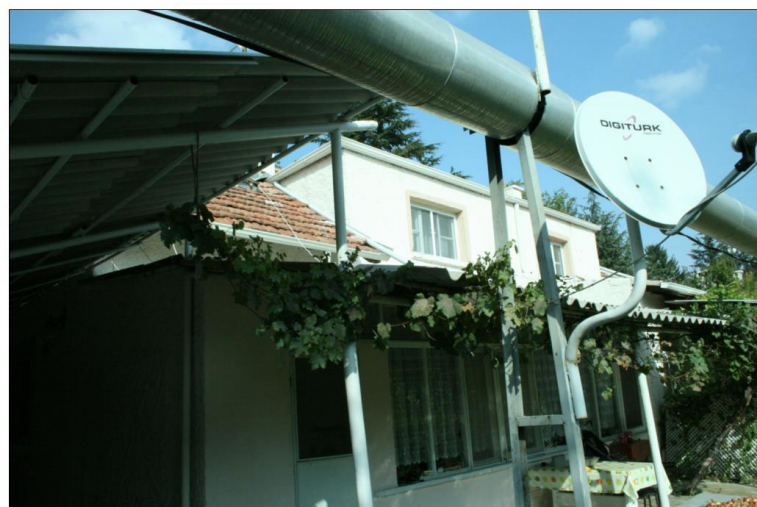
exterior view from south-west- additional mass

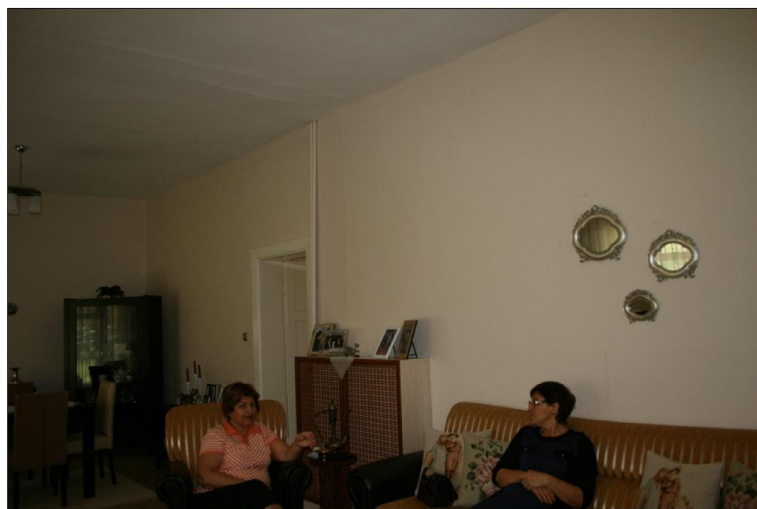
living room and trace of removed wall

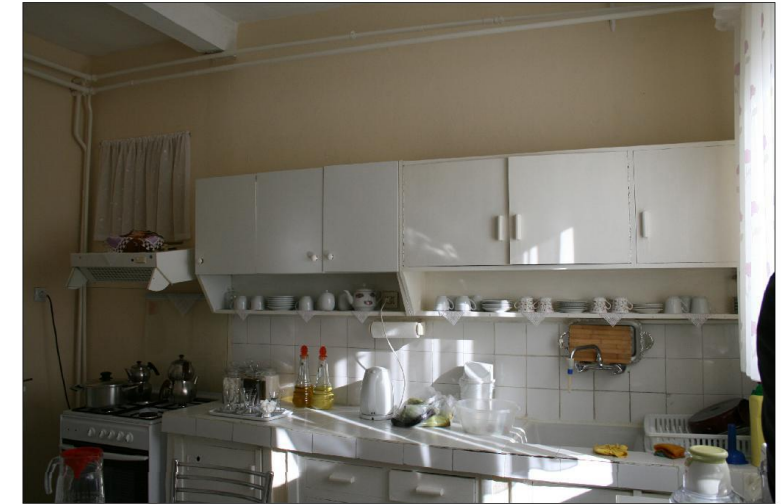
kitchen and beam of removed cellar

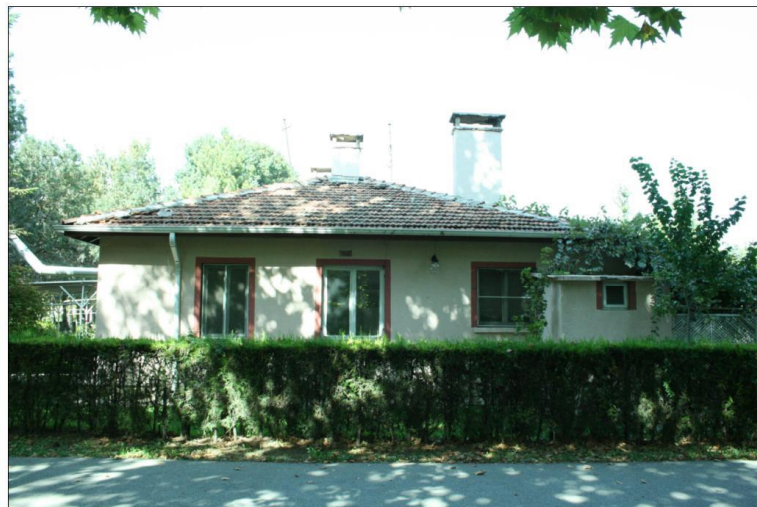
exterior view from north and wet space addition

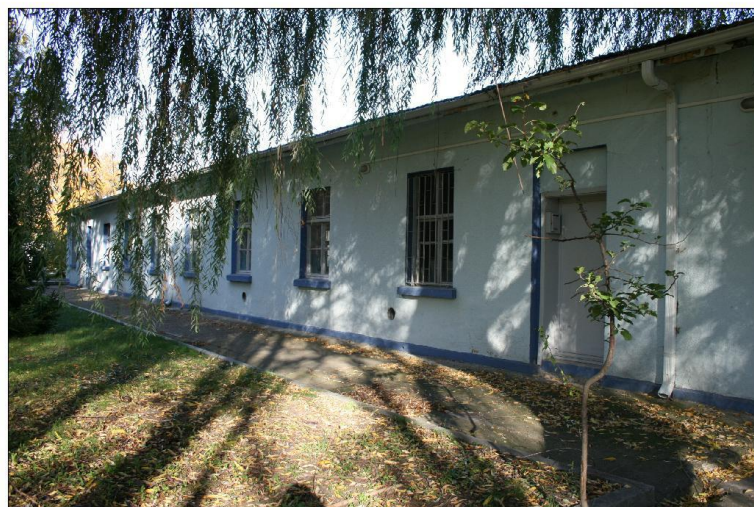
exterior view from south-west and altered opening

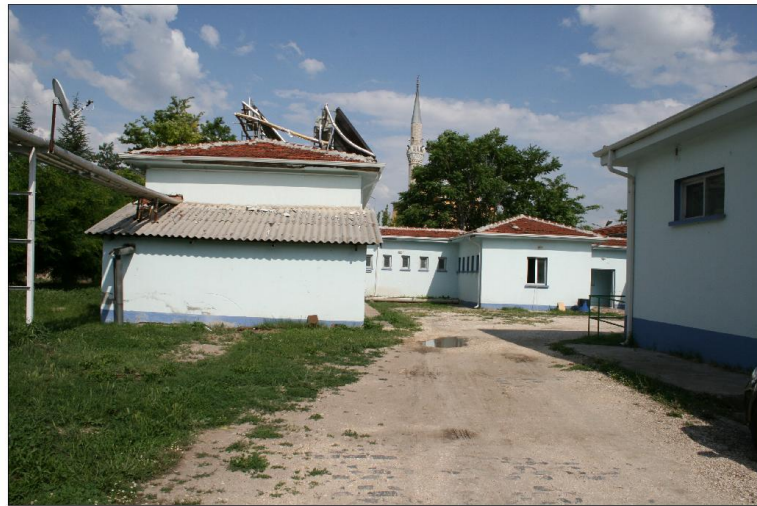
exterior view from west and mass addition
