# CONSERVATION OF LIGHTHOUSES AS A PART OF MARITIME HERITAGE: THE CASE OF LIGHTHOUSES IN AEGEAN COAST, TURKEY

## A THESIS SUBMITTED TO THE GRADUATE SCHOOL OF NATURAL AND APPLIED SCIENCES OF MIDDLE EAST TECHNICAL UNIVERSITY

SEPTEMBER 2019

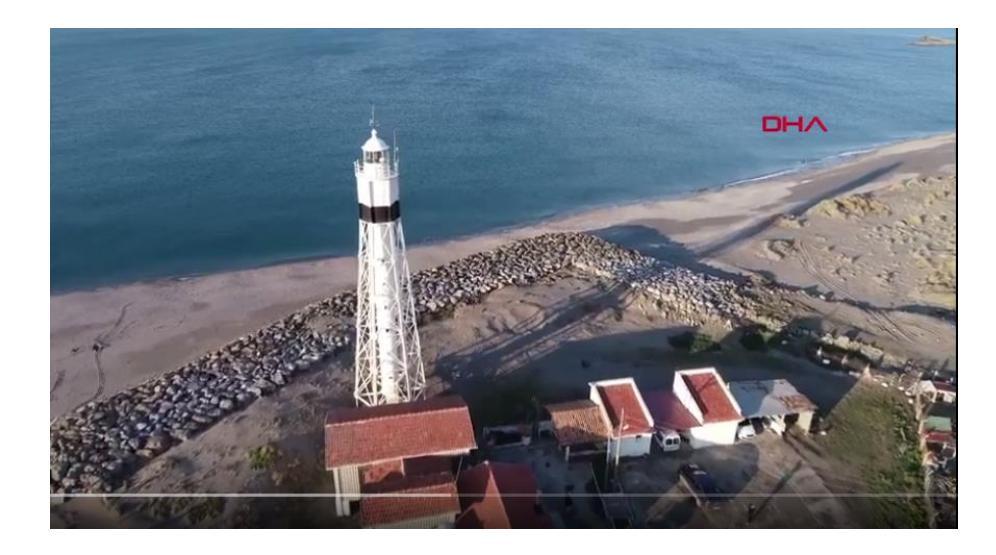
If all conservation measures had failed, then a lighthouse had to be moved. This was the intervention Bafra Lighthouse had to go through. It was built in 1880.<sup>224</sup> The different parts of the lighthouse were manufactured entirely of cast iron in France, shipped to the Ottoman Empire and assembled in situ. Only 2 more replicas of this certain lighthouse type had survived around the world. The first Bafra Lighthouse was located on the intersection of Kızılırmak delta with the Black Sea. As the Kızılırmak delta was slowly filled, the lighthouse had to be moved 750m away from the sea in 1919.<sup>225</sup>

The lighthouse was supported by 7 pilons set 4.5m deep into the delta soil. Today the structure is again under the threat of the sea, which has crept up as close as 25m. An embankment was built around the light station recently to fight against the filling of the coast. But it is still a matter of time to be swollen by the Black Sea, if it is not moved back again.

*Figure 2.33.* Built in 1880, Bafra Lighthouse was moved into its current location back in 1919 (Özkan D.-Y., 2019)

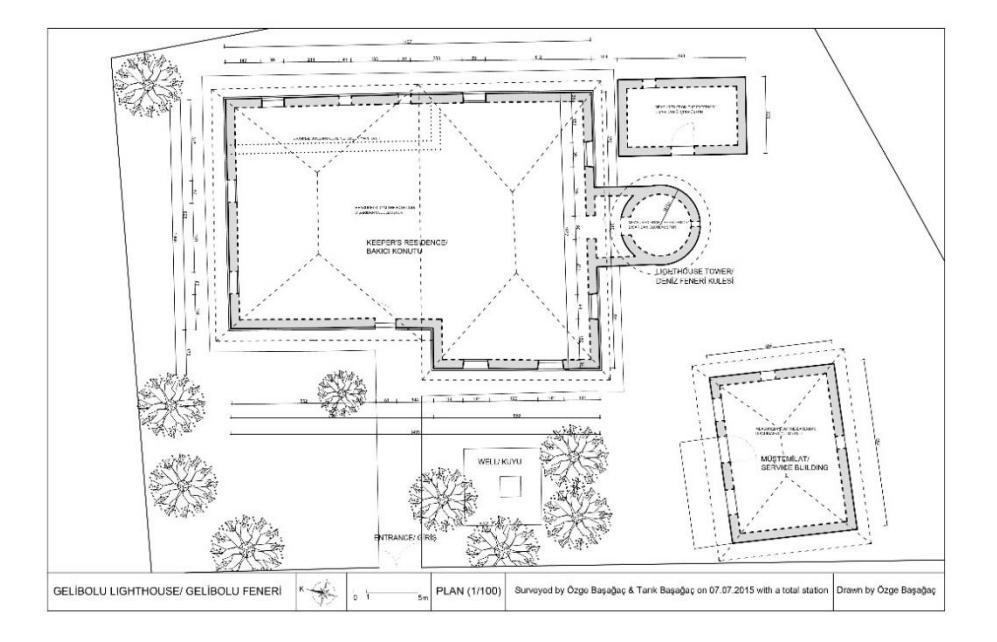
Figure 3.11. Plan of Gelibolu Lighthouse, service building and storage (Author, 2015)

The lighthouse has a T shaped plan.<sup>310</sup> Formerly, it was a courtyard with keeper's residence with an attached tower on one side and wet spaces on the other side. In time, the courtyard was closed, and the service spaces on the side of the courtyard were enlarged. Former fuel depot was enlarged and a new storage, next to the tower, was constructed, too. There is a well and several trees in the well-maintained garden.

All of the buildings located within the lot of the Gelibolu Lighthouse are in good condition without any material or structural problems.

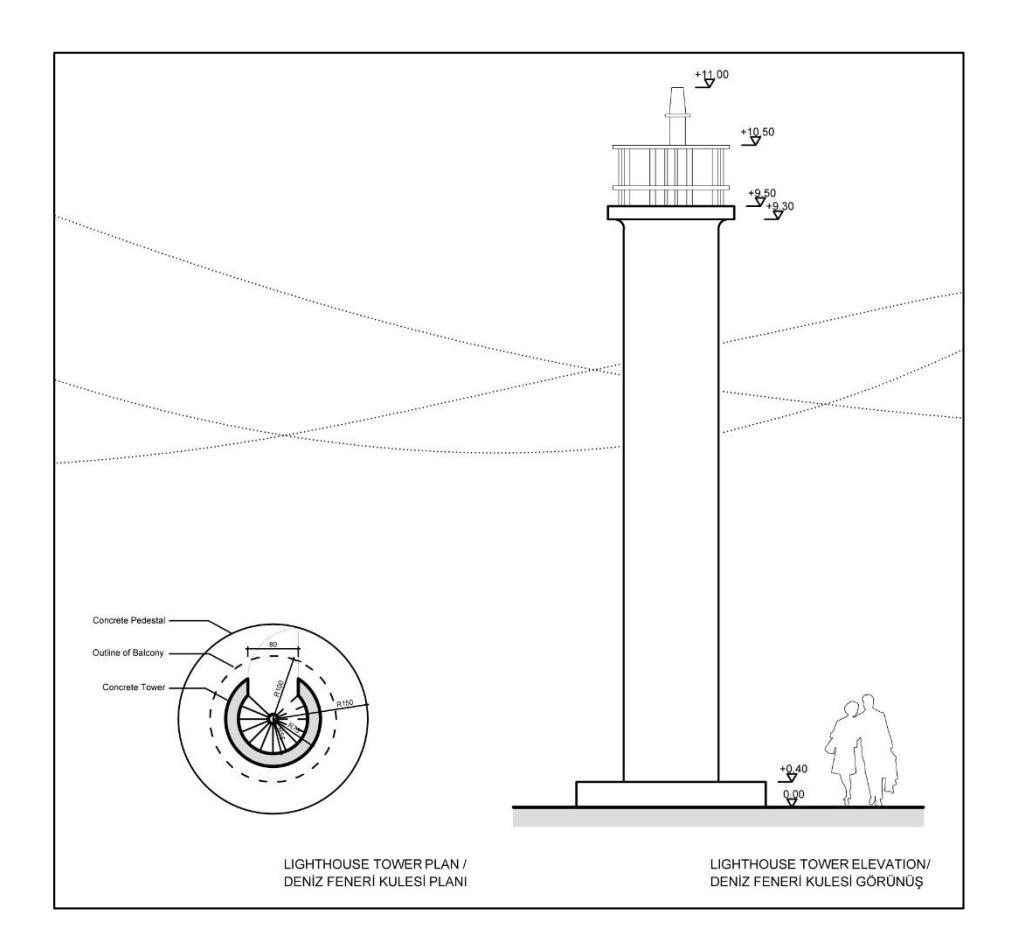
Figure 3.16. Plan and elevation of Çardak Lighthouse (Author, 2015)

The lighthouse is a circular, reinforced concrete tower. The radius is 0.75m and the height is 11m. The light is accessible through a balcony on top, which is reached by a stair inside. The light operates on electricity provided by solar power panels on the balcony.

The lighthouse is vandalized with graffiti frequently. There is a structural crack on the tower, starting from the foundation and going up. The cycle of wetting with sea water and drying under harsh sun is a strong weathering process for the lighthouse. The ground of the lighthouse is also prone to erosion/ decay due to rising sea water and frequent flooding.

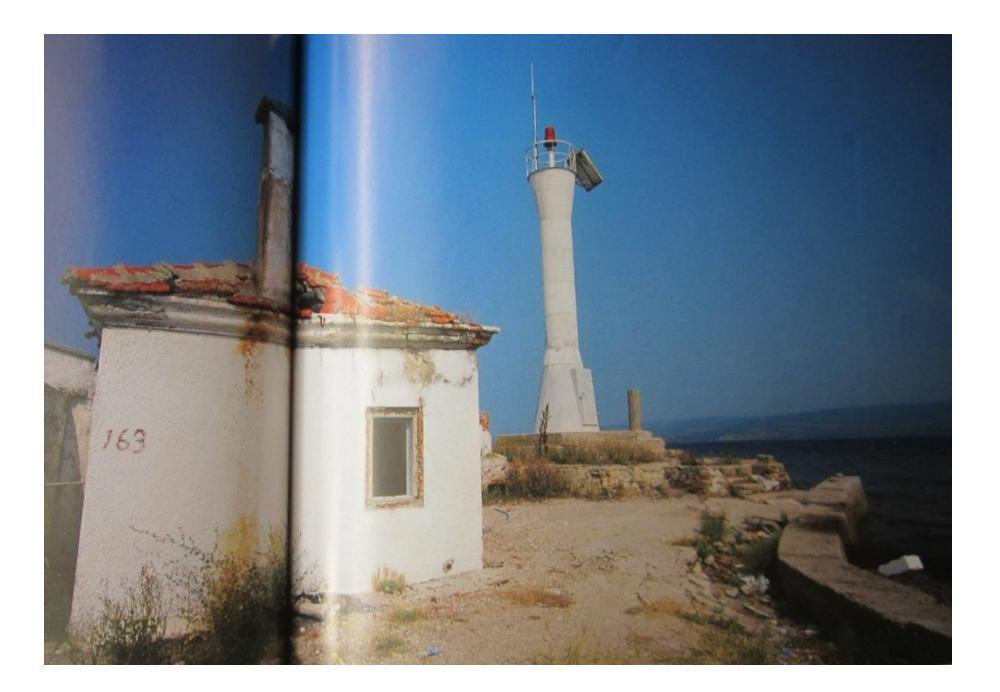
Figure 3.21. Close up of Karakova Lighthouse (Demirel, 2011)

The light keeper's house is abandoned now. The roof had partially collapsed yet the eave line is visible, and the full height of the roof is seen at certain points. It has a T shaped plan. The entrance is through the courtyard which has the rooms on one side and service spaces on the other. The keeper's residence is plastered and painted white. The timber window frames are also seen. The remains of the masonry pedestal of the original metal light pole is observed on the roof.

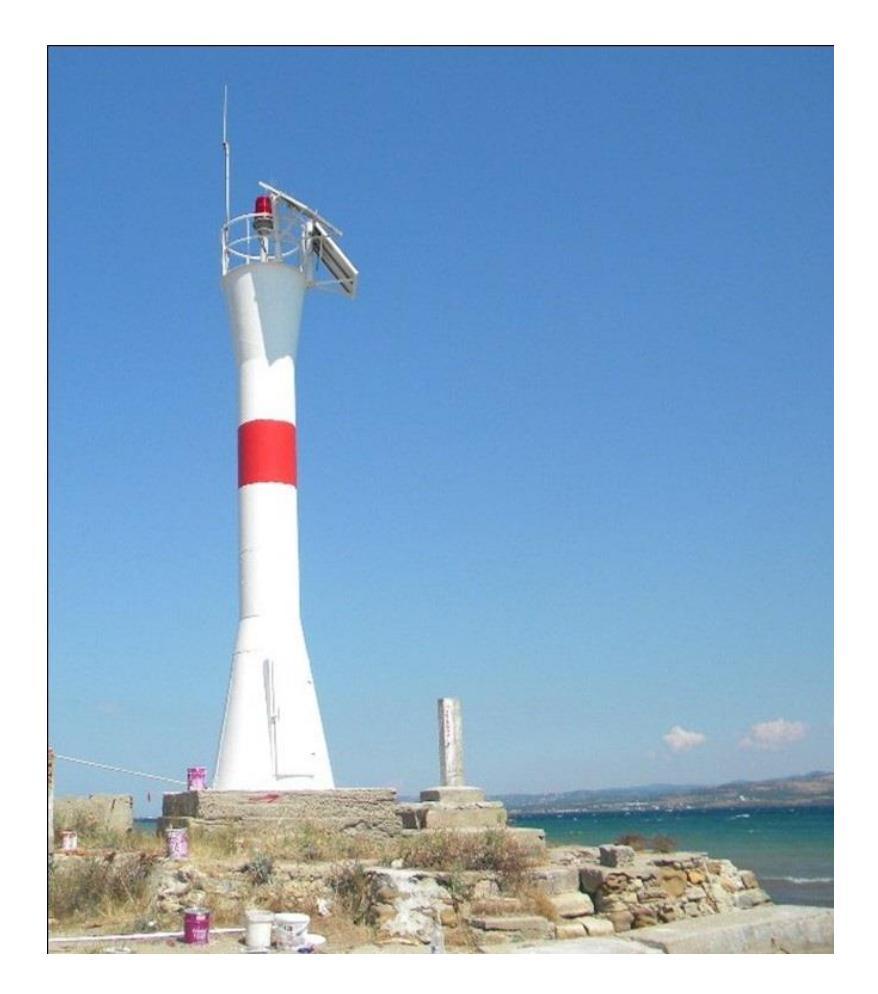
Currently, only the cast iron assembled pylon light tower is maintained. This means the tower had been renewed again recently. The white tower has a red stripe as a significant mark. The light runs on electricity via solar energy.

Figure 3.23. The cast iron light tower of Karakova Lighthouse (KEGM, Kıyı Emniyeti Genel Müdürlüğü, 2012)

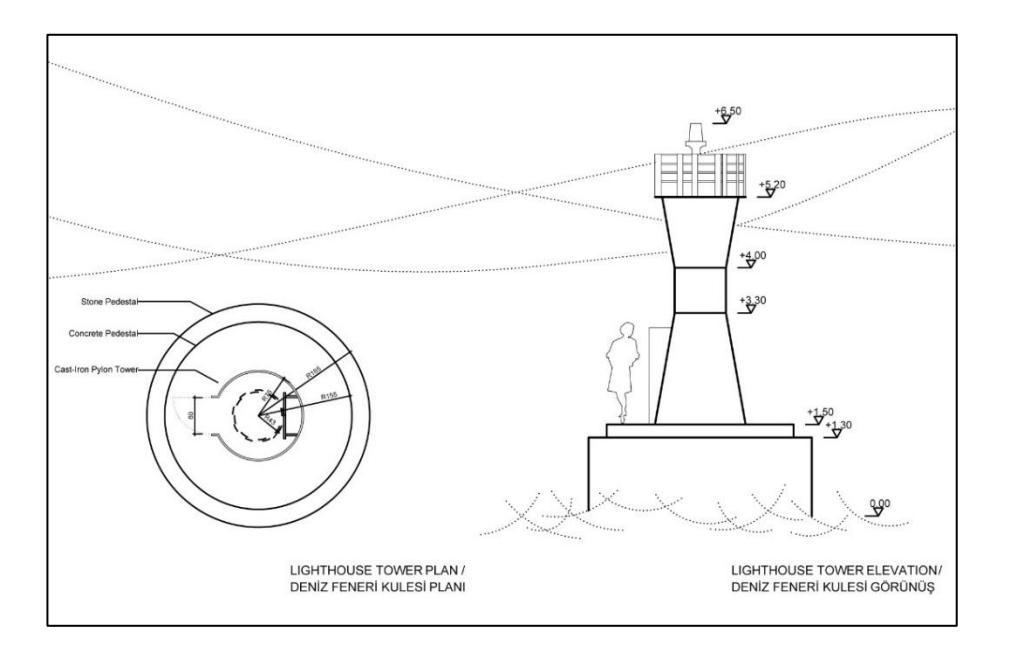
Figure 3.29. Plan and elevation of Akbaş Cape Lighthouse (Author, 2015)

Today there is a cast iron assembled pylon lighthouse on a concrete/ masonry pedestal inside the sea, in front of the Sestos city. The lighthouse is 5m high. It is well maintained and does not have any structural or material problems. As the scale of the lighthouse is quite small it blends with the coastal silhouette.

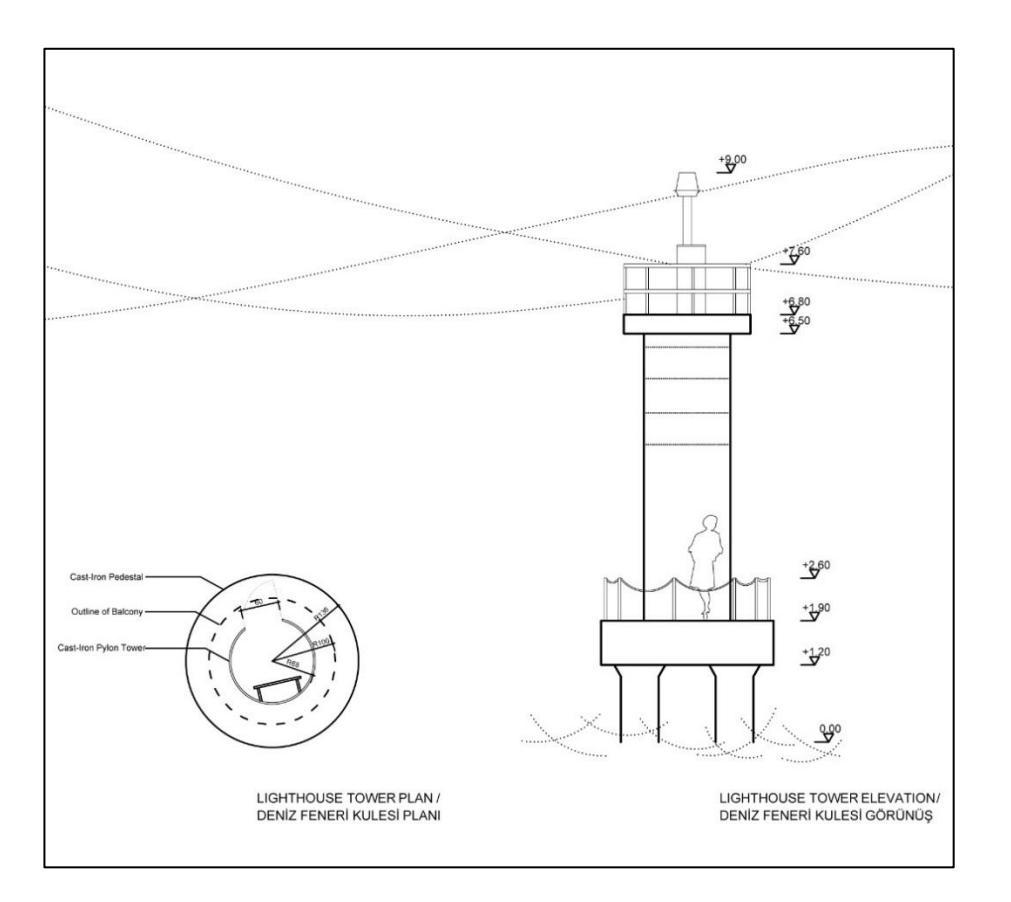
Today, the cast iron, cylindirical lighthouse is located inside the sea, on a small cast-iron galvanized platform close to the shore, which is supported by posts set into the seabed. It is painted white with green distinguishing stripes. The height of the lighthouse is 9m. The structural condition of the lighthouse is good. But there are moderate material problems as oxidation on exterior surfaces.

Figure 3.36. Plan and elevation of Nara Cape Lighthouse (Author, 07.07.2015)

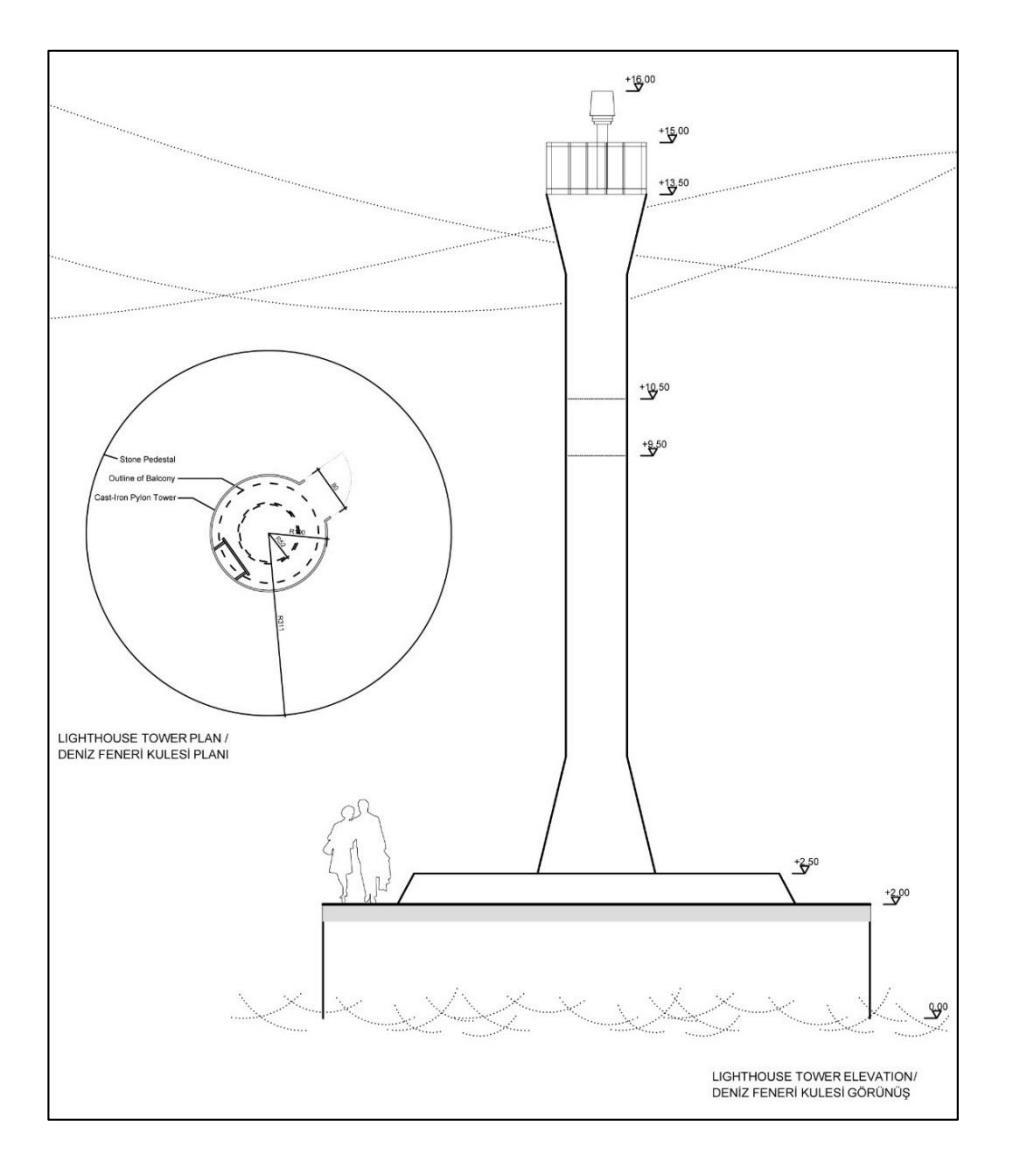
*Figure 3.42.* Plan and elevation of Çimenlik Cape Lighthouse (*Author, 06.07.2015*)

The lighthouse was first set up on 23 July 1856 on the northwest corner of the fortress, on a low wall, as a 13.5m high metal pole. In 1913, it was renewed as a 17m high steel frame light structure.<sup>336</sup> It was repaired in 1946, rebuilt in 2002.<sup>337</sup> It was in the first list of lighthouses to be built along Dardanelles Strait. Today, Çimenlik Cape Lighthouse is a 14m high cast iron assembled pylon tower. The structural and material condition of the lighthouse is very good.

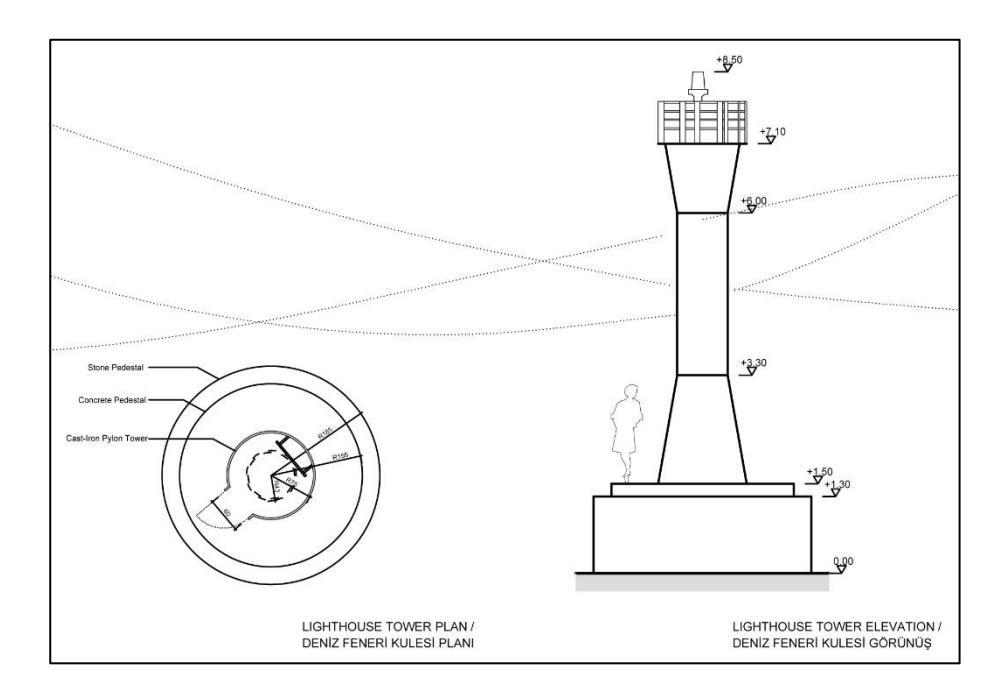
Figure 3.47. Plan and elevation of Kilitbahir Lighthouse (Author, 07.07.2015)

Today, it is a 8.5m high, cast iron assembled pylon lighthouse on the same location. As the structure is small, no light keeper lives here. It is controlled centrally and monitored by the Gelibolu Lighthouse keeper and Kepez Technical Headquarters. The structural and material condition of the lighthouse is very good.

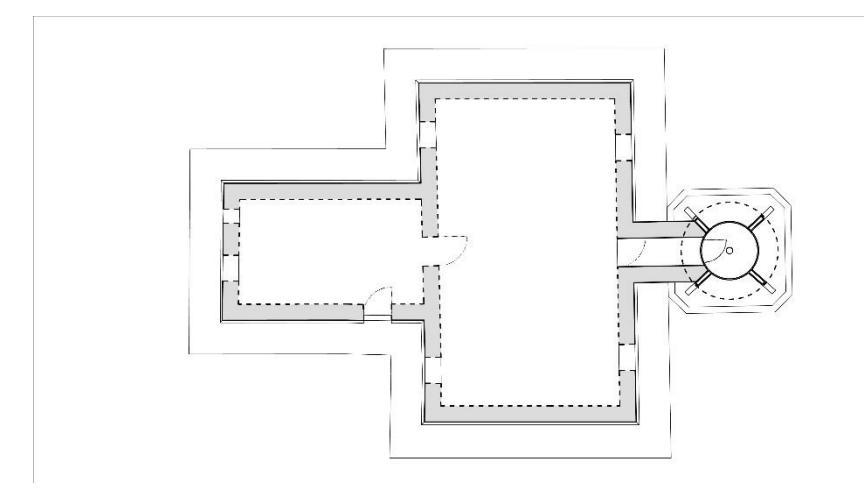
Figure 3.52. Plan of Kepez Lighthouse (Author, 2015)

The structural condition of the buildings is good. But there are material problems as scaling of plaster and paint due to rising damp.

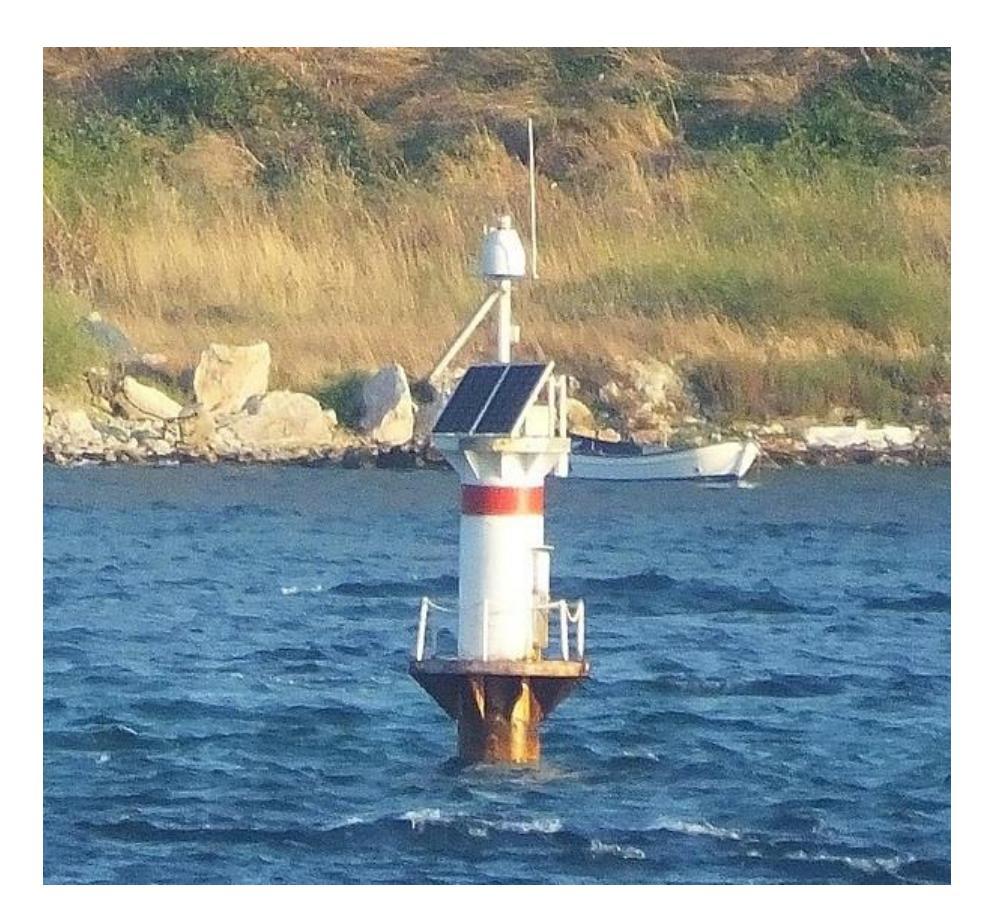
*Figure 3.57*. Seddülbahir lighthouse in the sea, in front of Seddülbahir Fortress and fishing shelter. Sea lighthouses align with the pier lights (*KEGM*, *Ktyt Emniyeti Genel Müdürlüğü*, 2012)

All lighthouses are structurally in good conditions. But they have material problems as surface corrosion, especially the sea lighthouses.

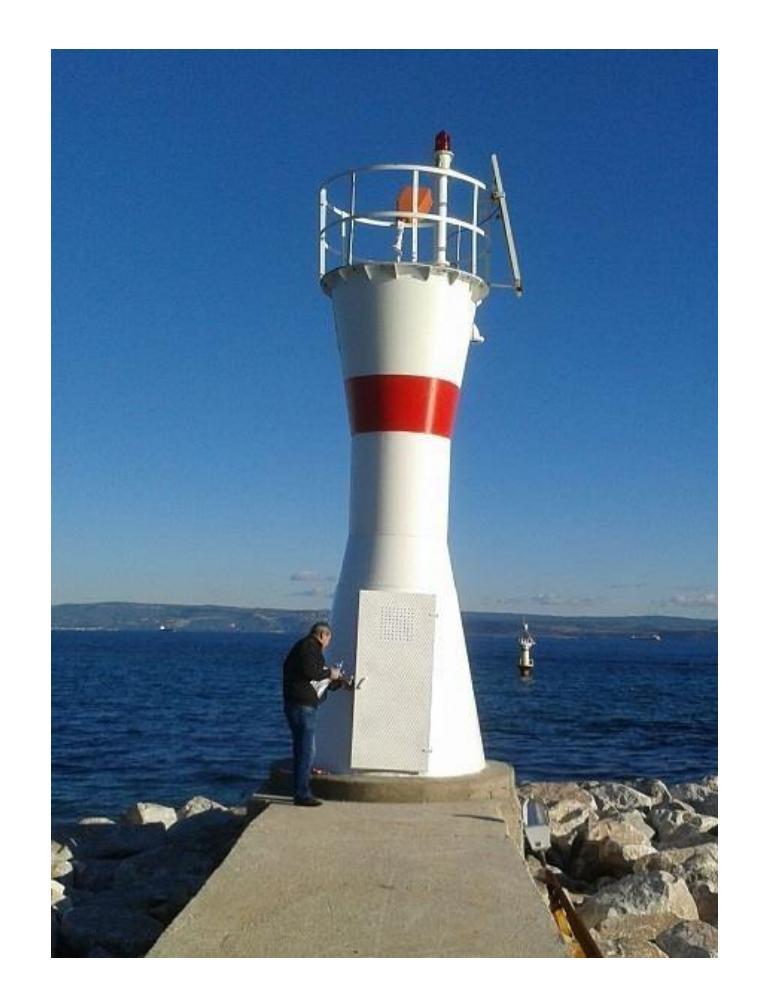
*Figure 3.58.* Seddülbahir lighthouse on the fishing shelter pier, in front of Seddülbahir Fortress. Pier lights align with sea lights (in the background) (*KEGM, Kıyı Emniyeti Genel Müdürlüğü, 2012*)

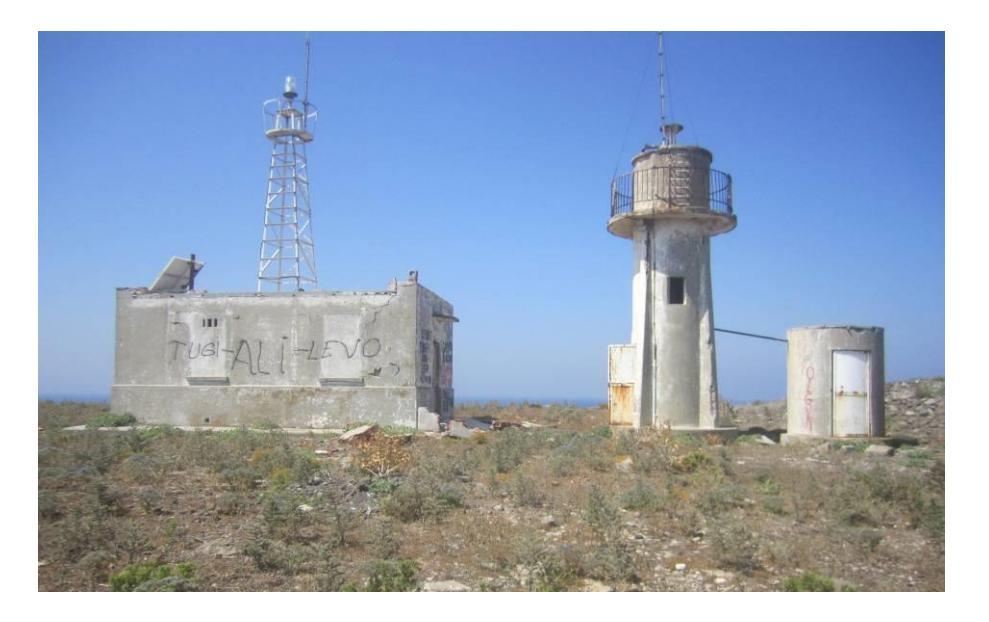
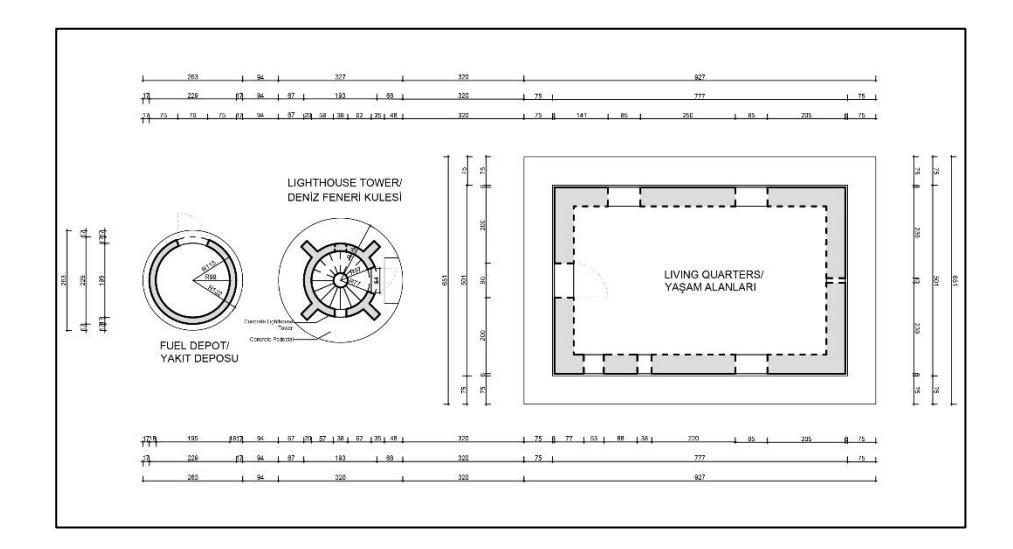
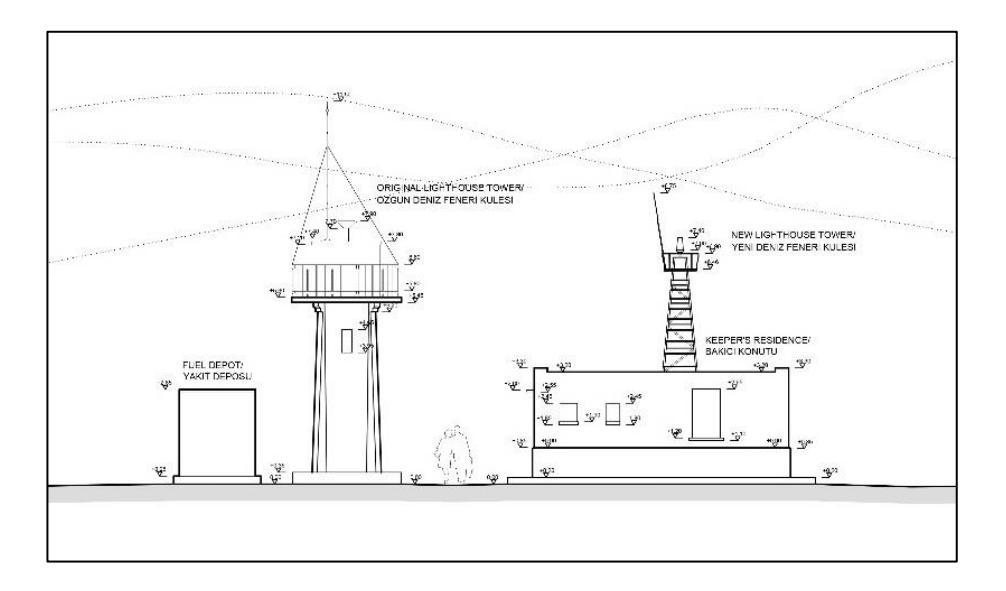
There is a conical, buttressed light tower, a rectangular prismatic light keeper's residence and a cylindirical fuel depot/ auxiliary building. The original buildings are all constructed with reinforced concrete. Currently, the actual light tower is not used. A steel frame light structure is erected next to the original keeper's residence. The light is controlled remotely, operating on solar energy. The windows of the keeper's residence are closed and plastered. The roof of the residence had collapsed. The buildings are covered with graffitis.

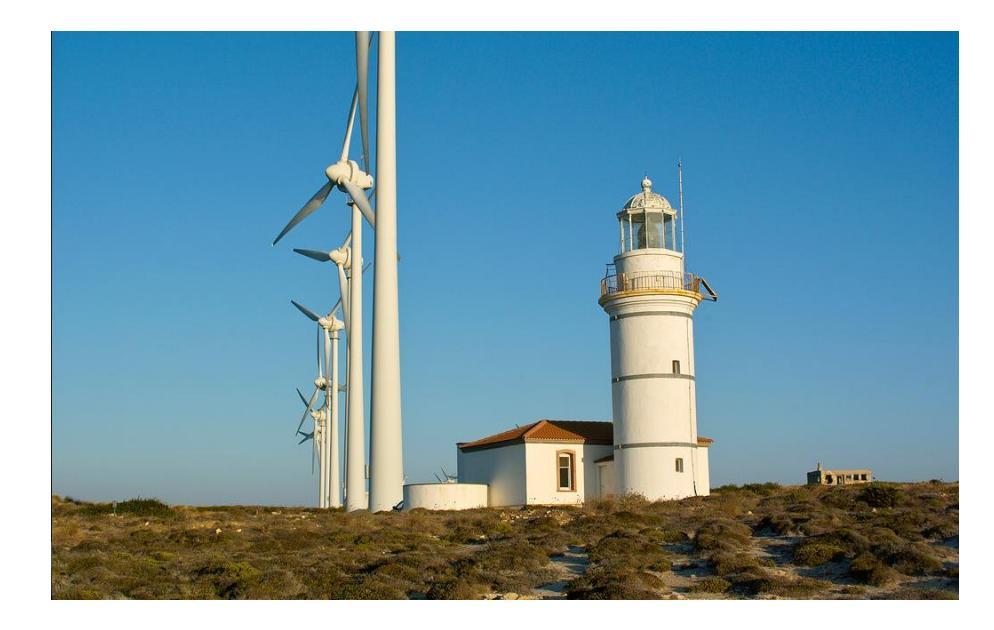
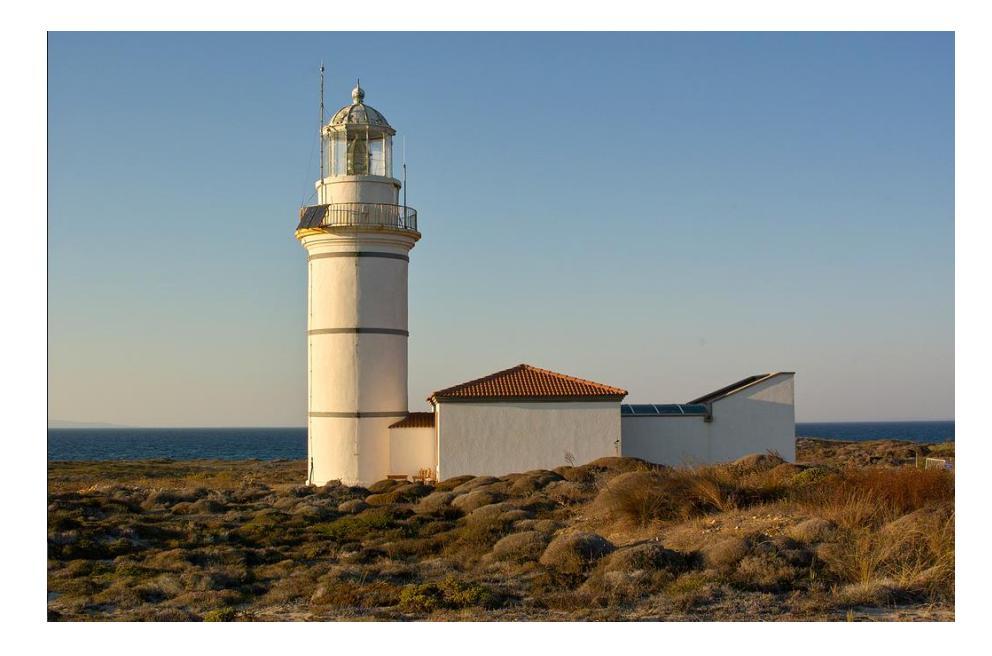
Figure 3.103. Bozcaada West Cape/ Polente Lighthouse after restoration (KEGM, Kıyı Emniyeti Genel Müdürlüğü, 2012)

The light tower is 20m high with stone masonry. As a newly restored building there are no structural or material problems.

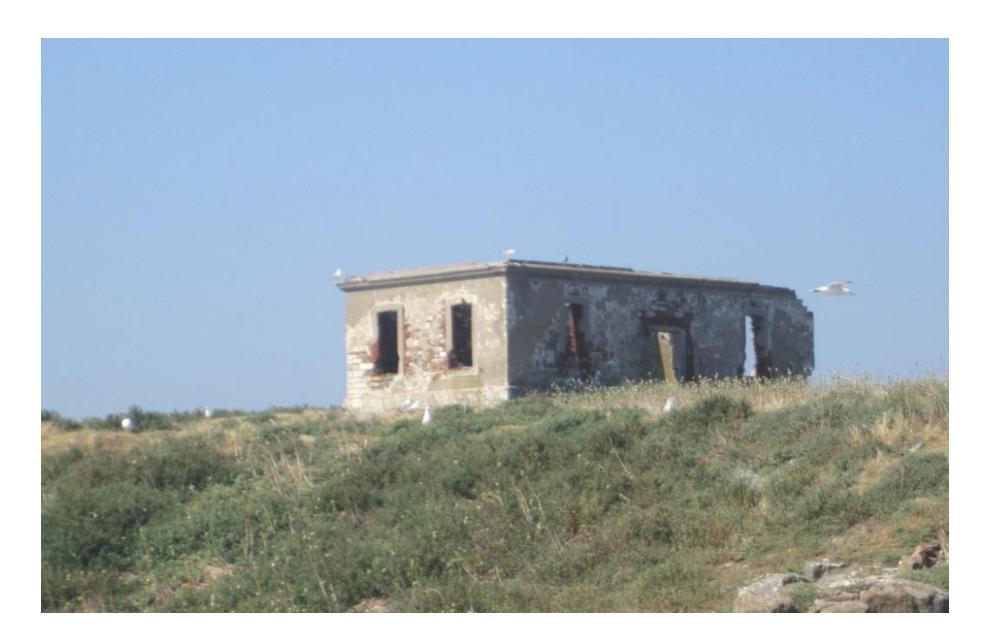
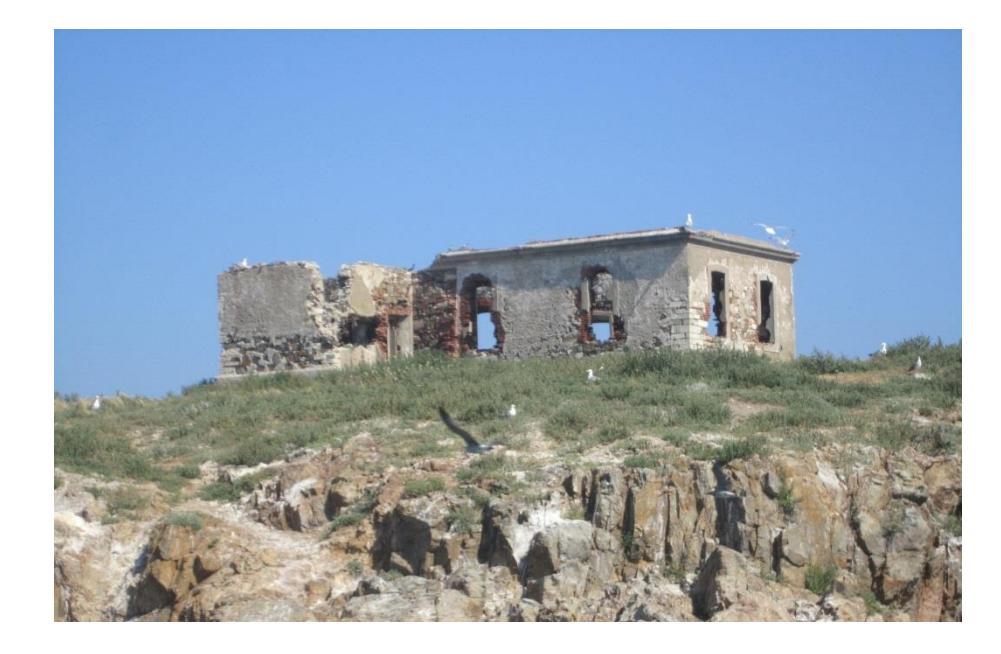
The original Damlacık Lighthouse on the island is stone masonry with brick trims and arches for the openings. The roof had collapsed long ago. But the full height of the walls until the brick eaves are preserved at most parts. Thus, it is possible to understand the general layout of the light station.

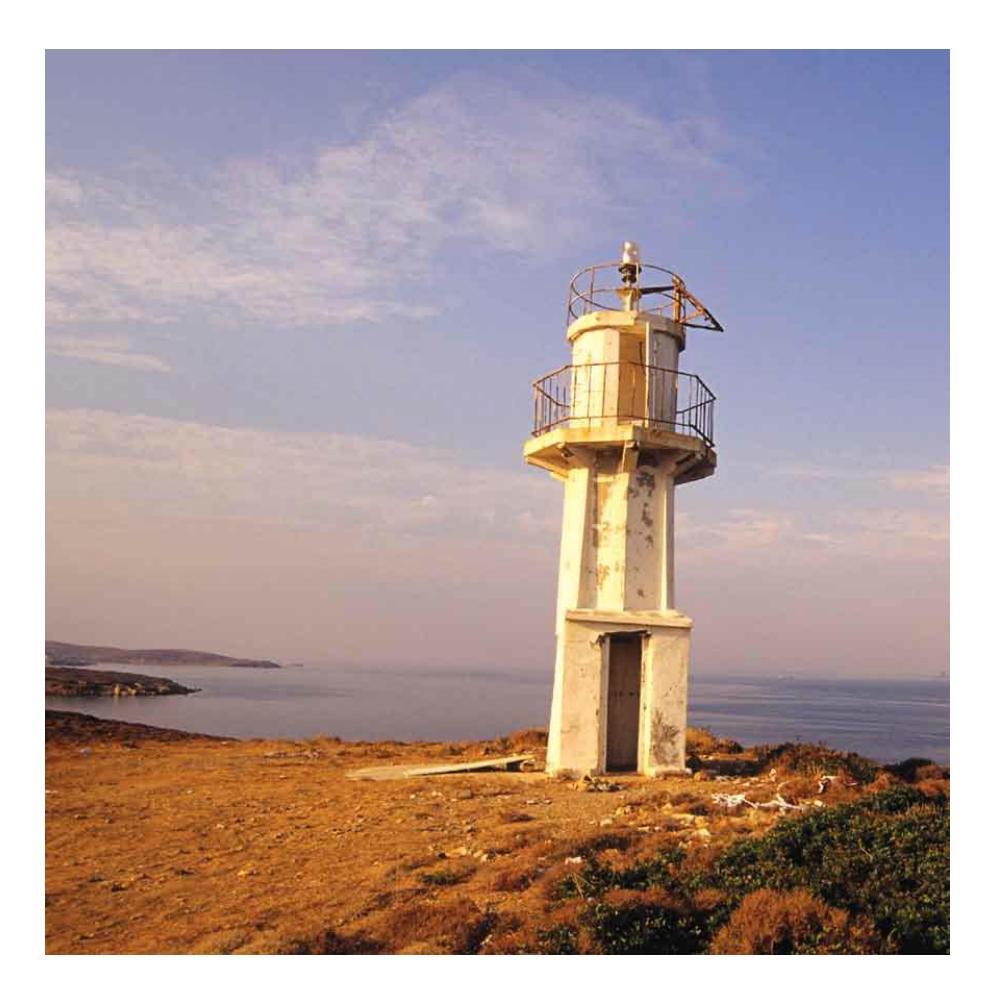
Figure 3.117. Former concrete lighthouse of Mermer/ Oinus Cape (Toroslu, 2008)

However, the Coastal Safety preferred to demolish the concrete lighthouse instead of repairing or maintaining it. Today, Mermer Cape Lighthouse is constructed of cast iron with solar panels on its balcony. The lighthouse is white with black stripes as distinguishing marks in brand new condition.

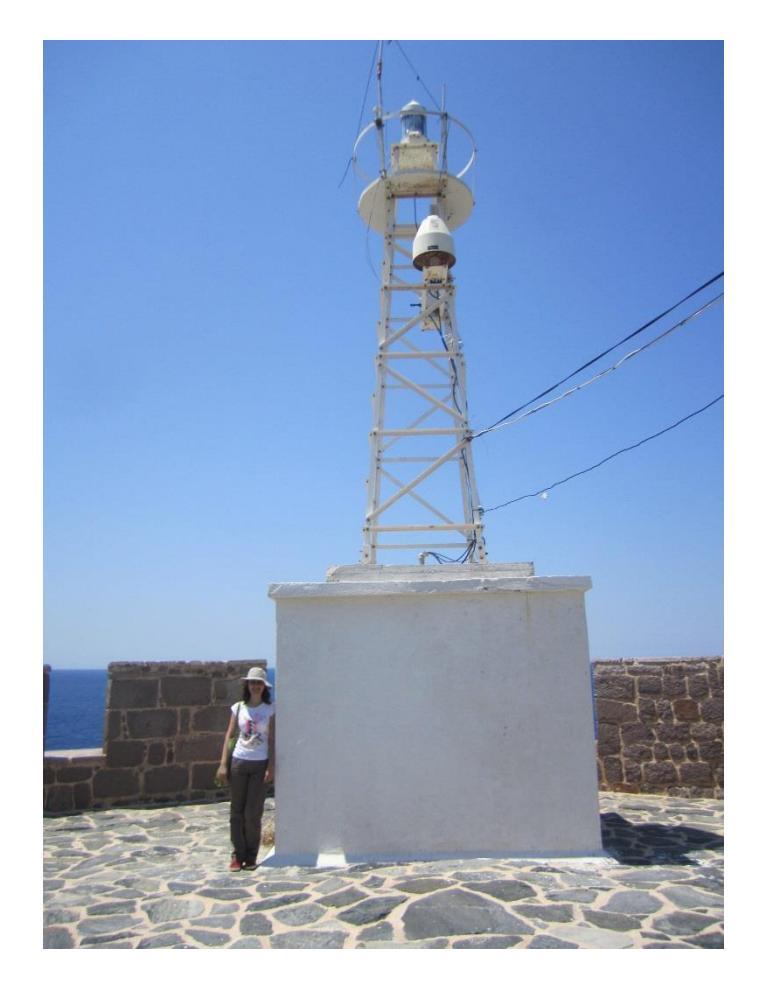
Today, the lighthouse is a 10m high steel frame structure, rising 32m above sea level. It sits on a masonry/ concrete pedestal set on top of the Babakale Fortress. It does not have any structural problems. But there are slight material problems as corrosion on the steel frame.

Figure 3.123. Baba Cape Light Structure on Babakale (Author, 06.07.2015)

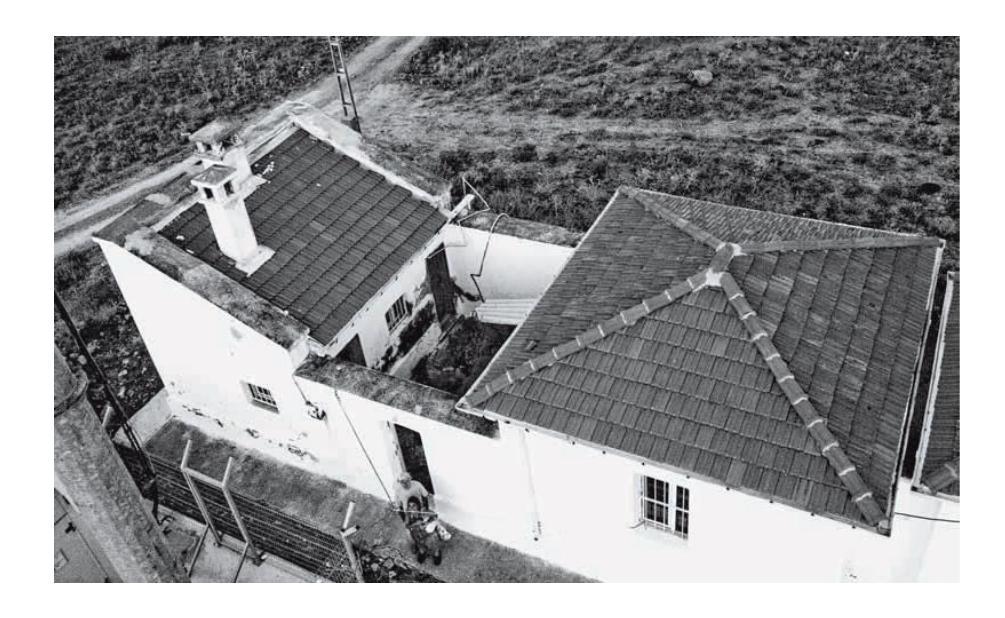
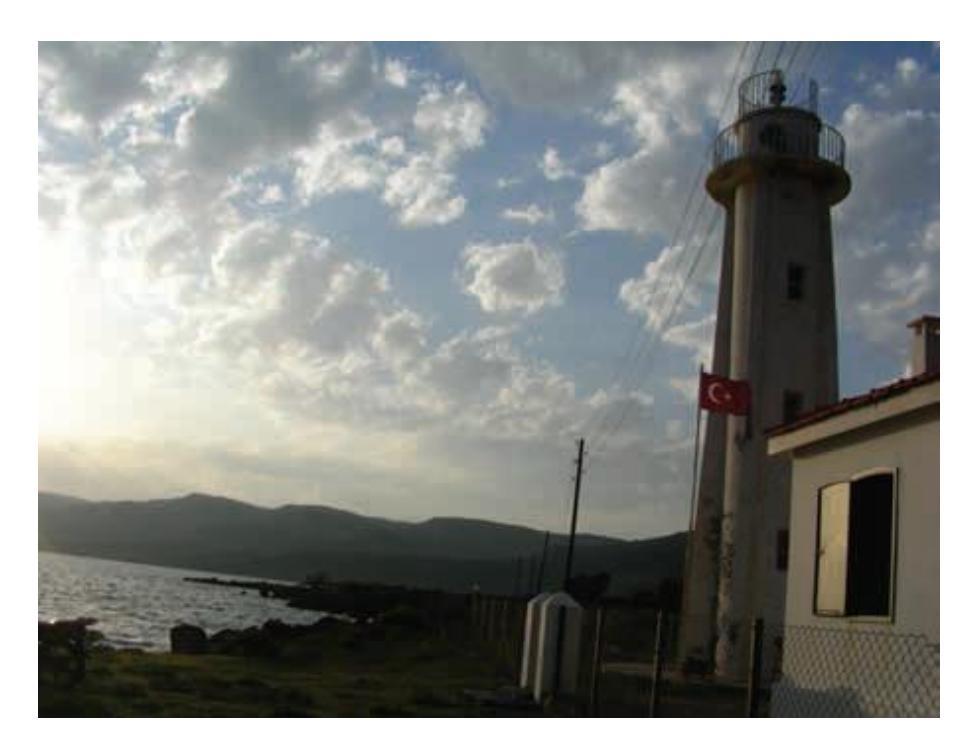
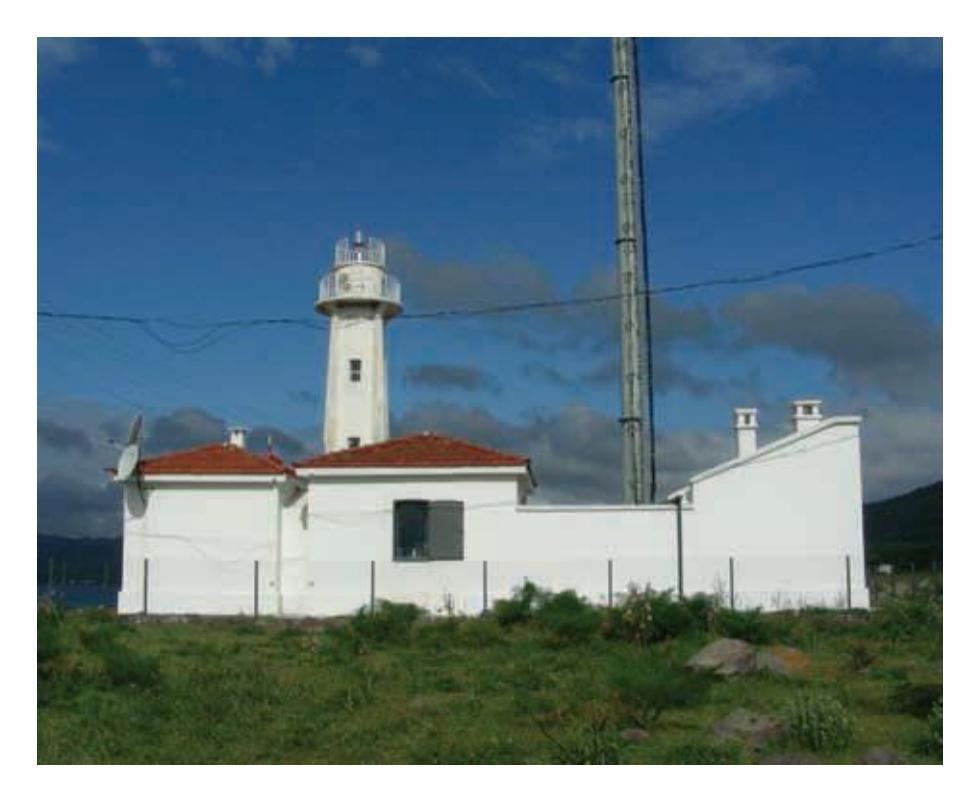
Figure 3.130. Sivrice Lighthouse Keeper's Residence in 2008, before restoration (Sayman, Ağustos 2009)

Figure 3.131. Sivrice Lighthouse Keeper's Residence in 2009, before restoration (Sayman, Ağustos 2009)

Figure 3.132. Sivrice Lighthouse Keeper's Residence in 2009, before restoration (Sayman, Ağustos 2009)

With the restoration the courtyard was closed and turned into a room.<sup>394</sup> The sea room became the library. The exterior plaster and paint were renewed. The openings were kept the same with original iron shutters.

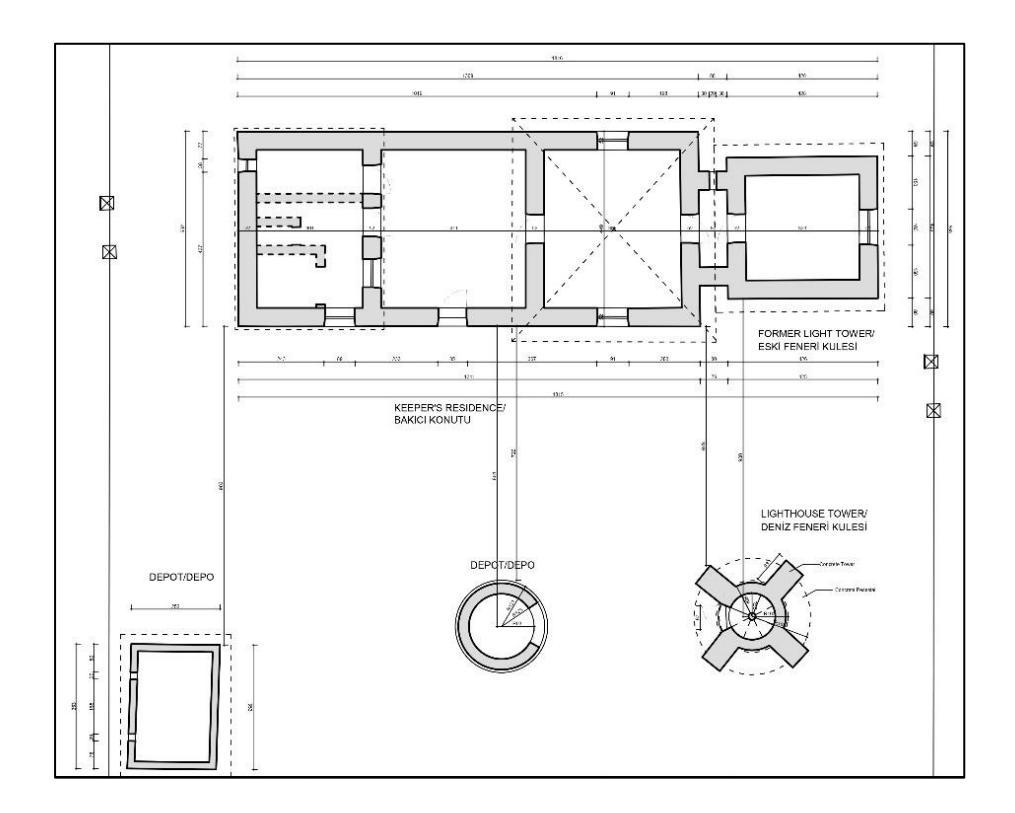
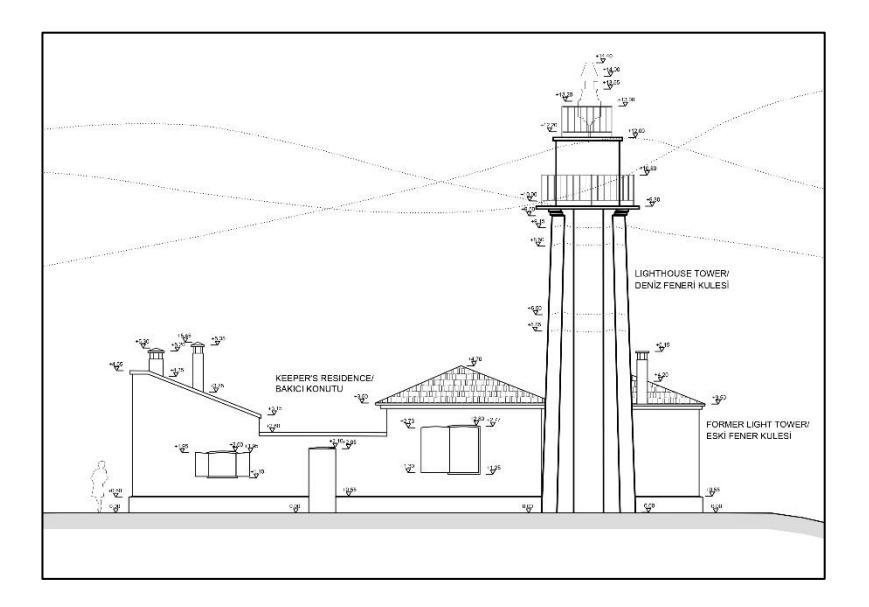
Today, Sivrice Lighthouse is in good condition with minor material problems.

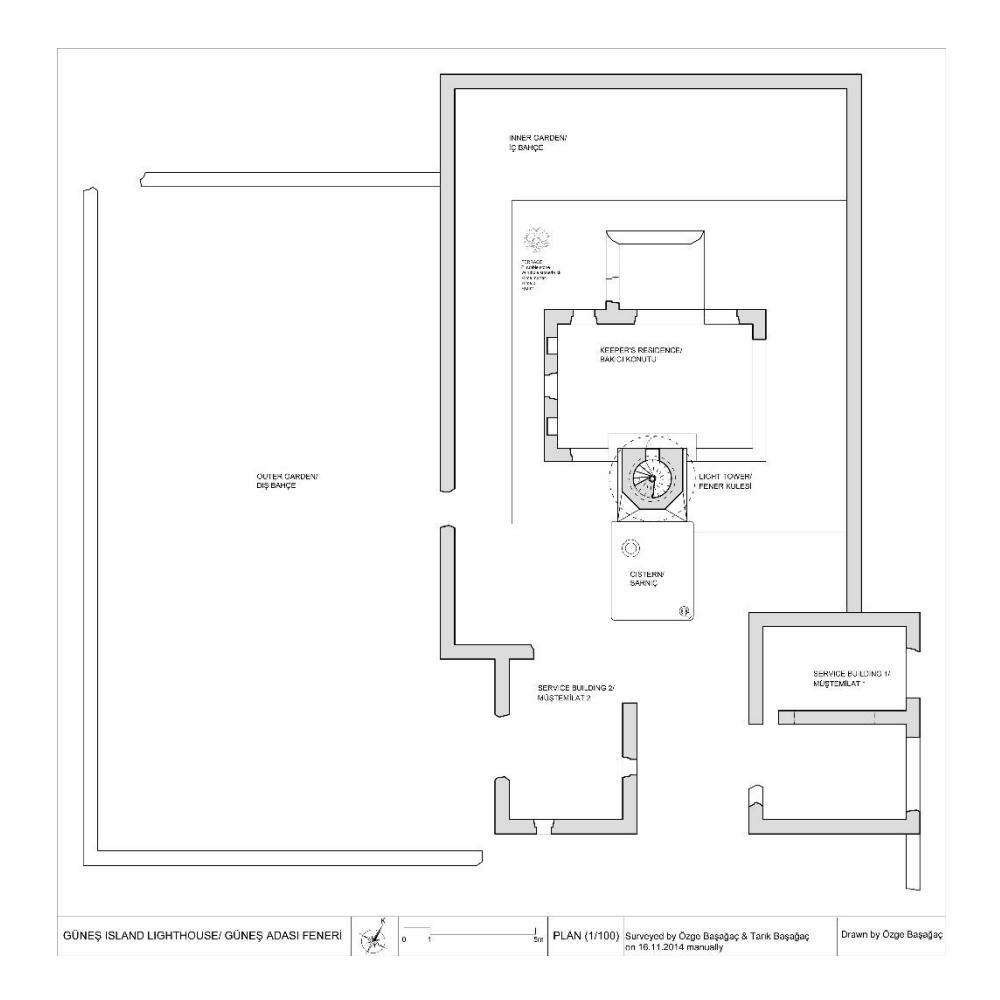
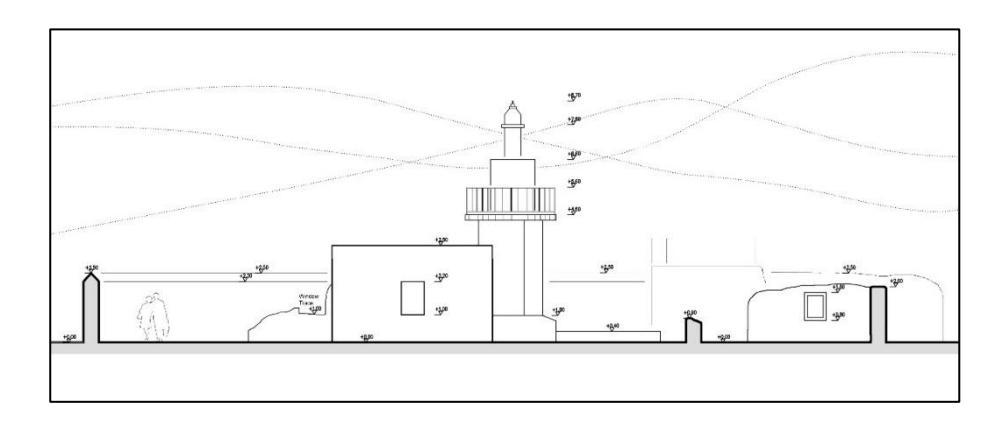
Figure 3.147. Plan of all the structures of Güneş/ Elyas Island Lighthouse surveyed (Author, 2014)

The western parts of the light keeper's residence are preserved to its full height. The eastern parts are ruined, only shallow walls or foundations are visible. The northern spaces are also highly damaged. Yet, it is possible to understand the general arrangement of the spaces. The light tower is plastered and painted. But it has structural cracks and material problems.
