# CONSERVATION OF LIGHTHOUSES AS A PART OF MARITIME HERITAGE: THE CASE OF LIGHTHOUSES IN AEGEAN COAST, TURKEY

## A THESIS SUBMITTED TO THE GRADUATE SCHOOL OF NATURAL AND APPLIED SCIENCES OF MIDDLE EAST TECHNICAL UNIVERSITY

SEPTEMBER 2019

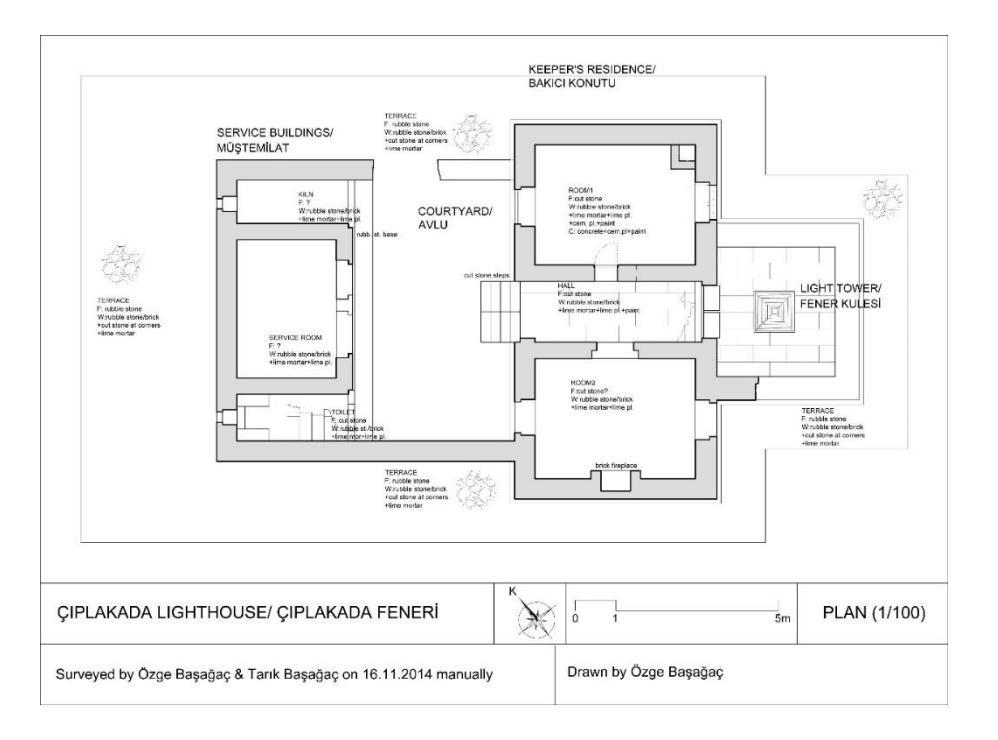
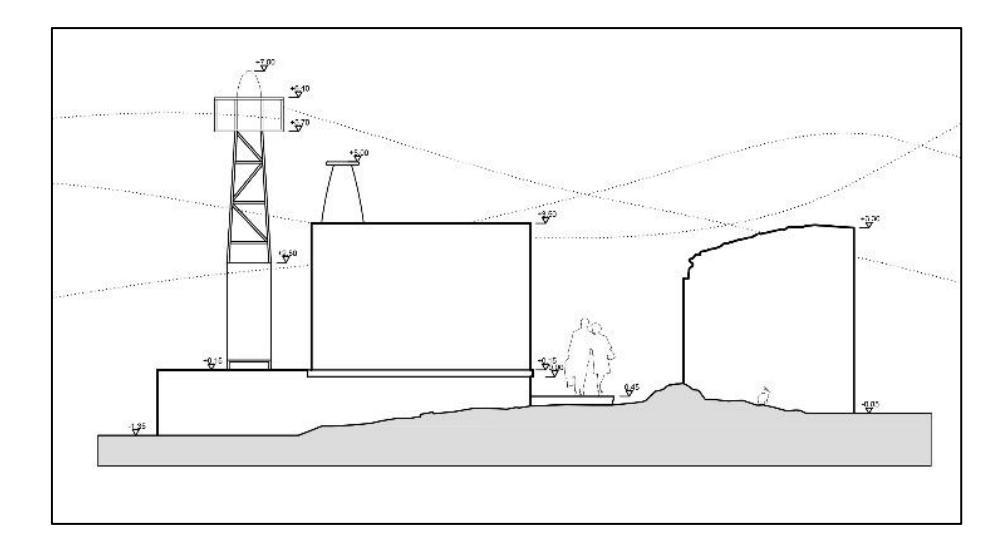
Figure 3.153. Plan of Çıplak Island Lighthouse, surveyed and drawn by the author. (Author, 16.11.2014)

The roof of the lighthouse is all gone except one of the rooms. Some gaps in the stone masonry walls are repaired with bricks. The plaster and paint on the interior are damaged as well as most of the architectural elements. But traces can be observed to understand the overall design of the spaces.

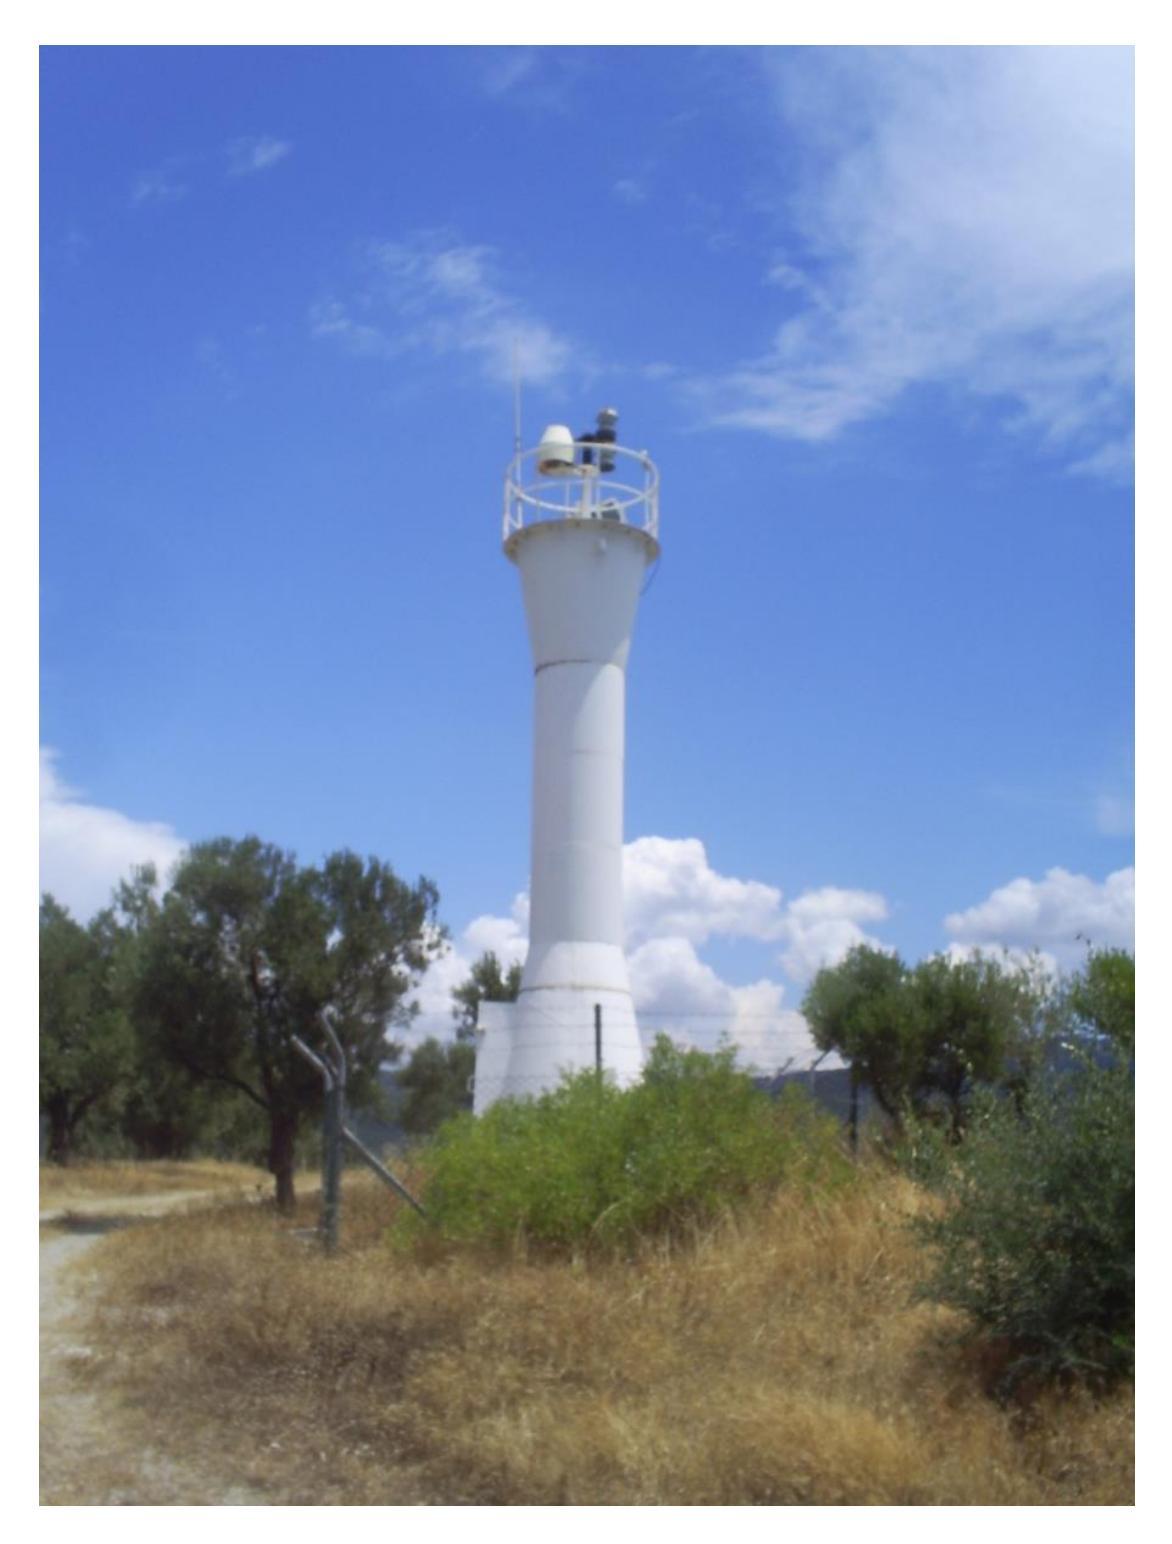
Figure 3.157. Bademli Lighthouse, (KEGM, Kıyı Emniyeti Genel Müdürlüğü, 2012)

Bademli Cape Lighthouse is a small, compact, cast iron assembled pylon type preferred for challenging locations where prefabrication is necessary. As it is relatively new, the condition is good.

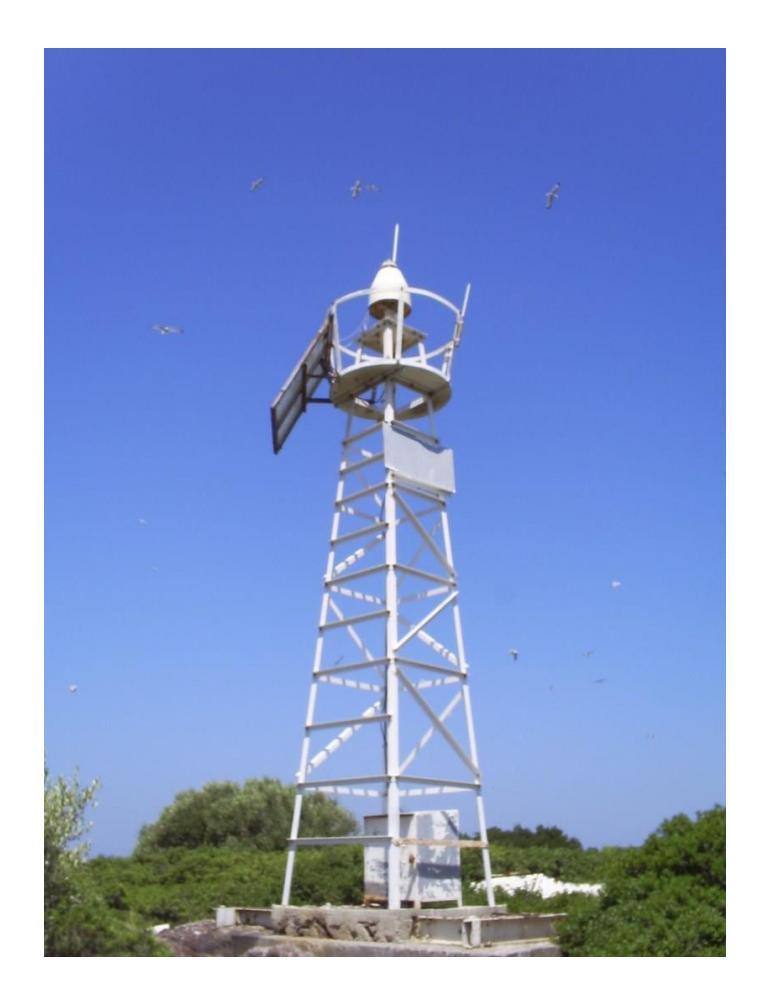
Figure 3.163. The light structure of Tavşan Island near Aliağa (KEGM, Kıyı Emniyeti Genel Müdürlüğü, 2012)

The steel frame light structure is situated at the highest point of the island, visible 360 degrees. The optics system is controlled centrally. The maintenance is done by Serkan Güdem from Dikili, son of a light keeper, responsible for all the lighthouses in/ around Foça, Aliağa, Dikili and Altınova. The light structure is in good condition.

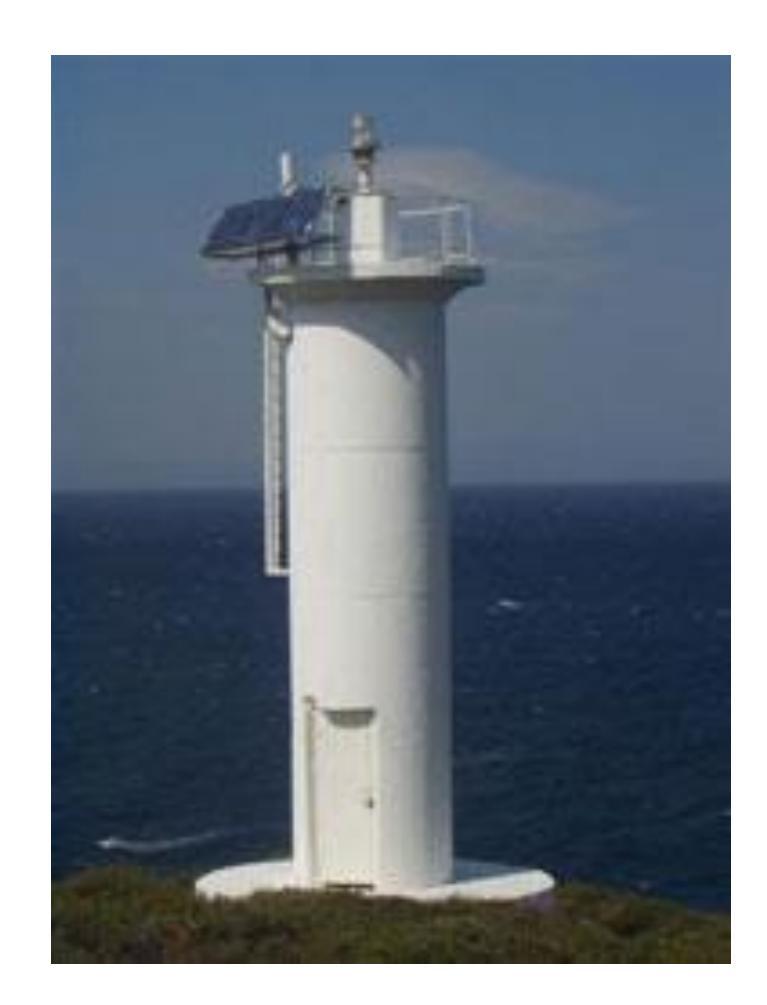
Figure 3.166. Ilıca Cape Lighthouse in Aliağa (KEGM, Kıyı Emniyeti Genel Müdürlüğü, 2012)

The lighthouse is made of concrete, painted white and in good condition, operating on solar panels. It stands out on the cape, marking the industrial nature of the region, too. After all, lighthouses are markers of technological advancement, too.

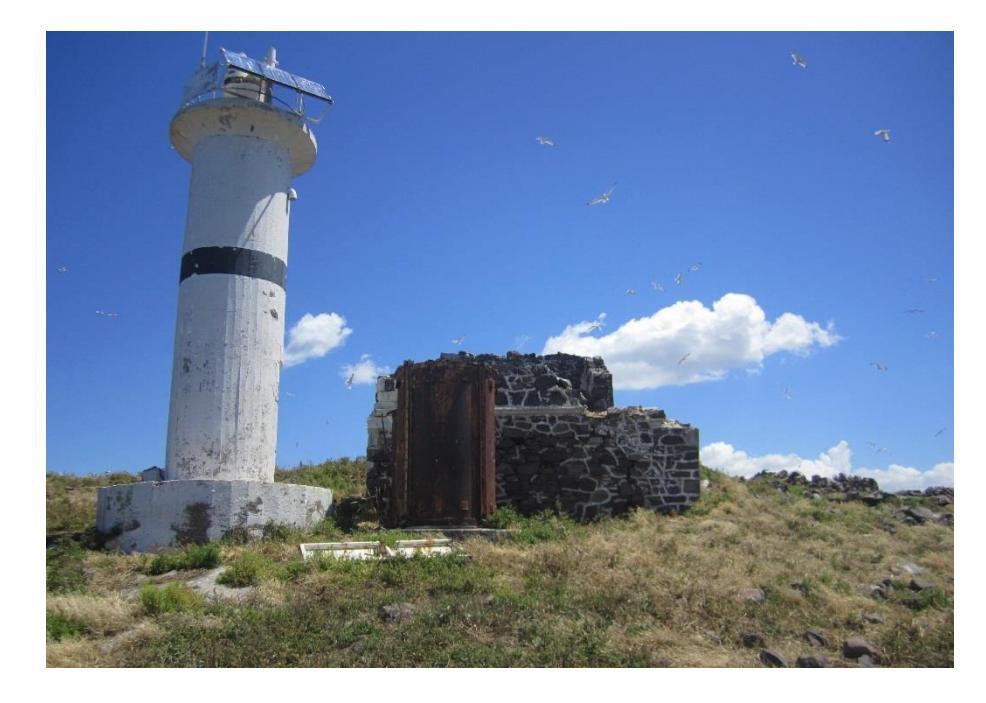
Figure 3.170. Oğlak Island Lighthouse viewed from the sea direction (Author, 20.05.2014)

The lighthouse here was built on 15 July 1887. It was repaired in 1920.<sup>423</sup> Today, the masonry structures are ruined. But looking at the remains, it is possible to understand the general layout of this light station.

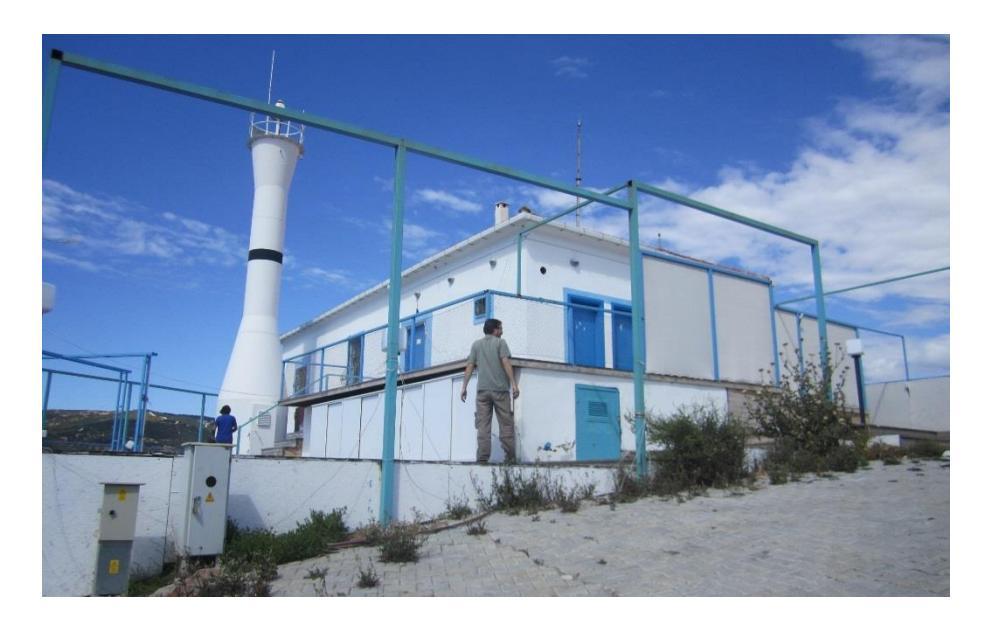
Figure 3.179. Değirmen Cape Lighthouse. (Author, 20.05.2014)

The light tower was formerly steel frame but today it is cast iron assembled pylon type. It is in good condition and well maintained.

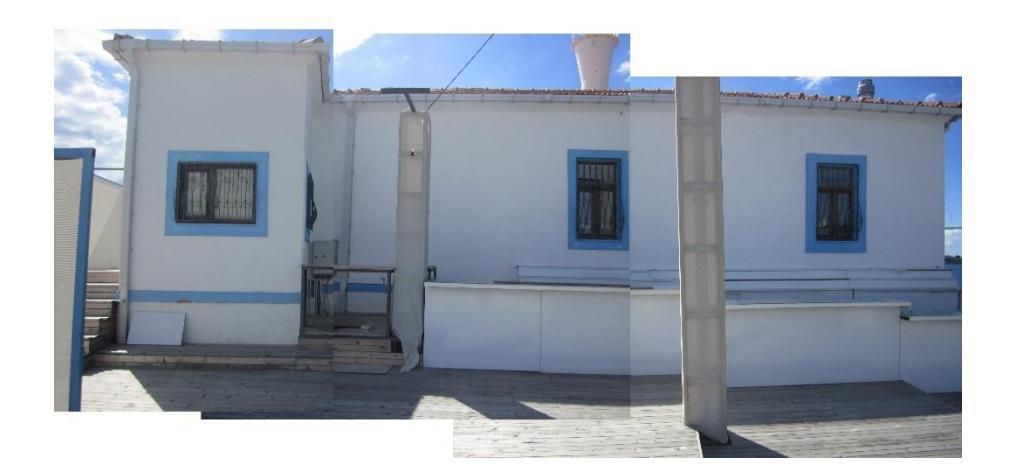
Figure 3.182. Değirmen Cape Lighthouse rear facade (Author, 20.05.2014)

Regarding the new function of the lighthouse as a café/ bar, the new lessee had done interventions on the exterior of the lighthouse and the building lot. The large terrace surrounding the structure is covered with timber flooring and the perimeter is enclosed with high glass panels to prevent wind. Half of the open areas are covered with a roof, including the base of the light tower. The roof rests against the keeper's residence.

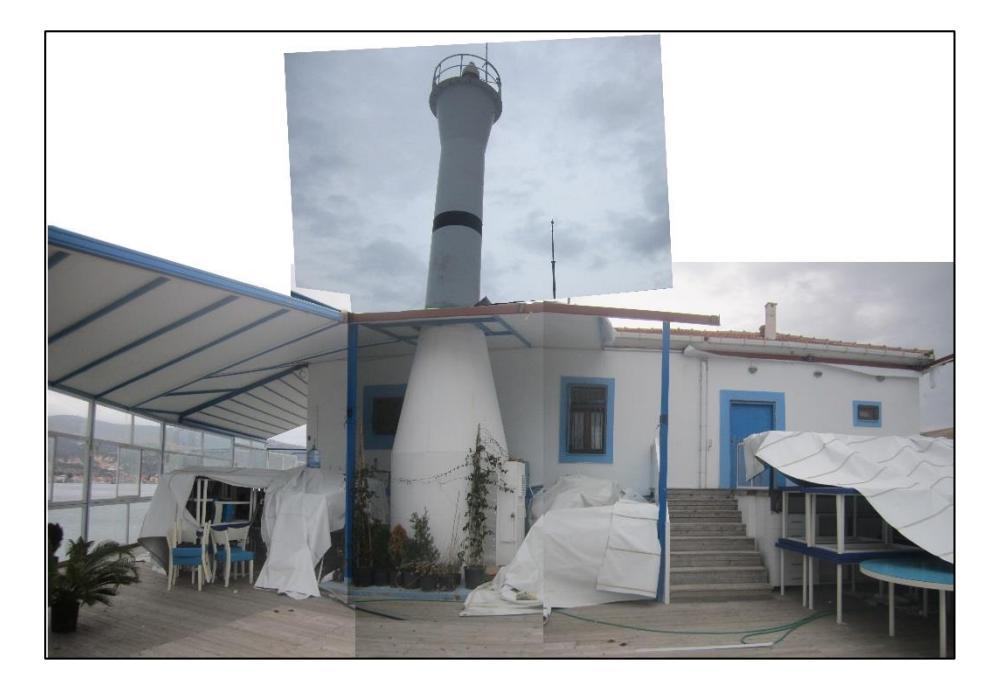
*Figure 3.185.* Değirmen Cape Lighthouse with the new roof attached to the keeper's residence, covering formerly open terraces around the building (*Author, 10.02.2016*)

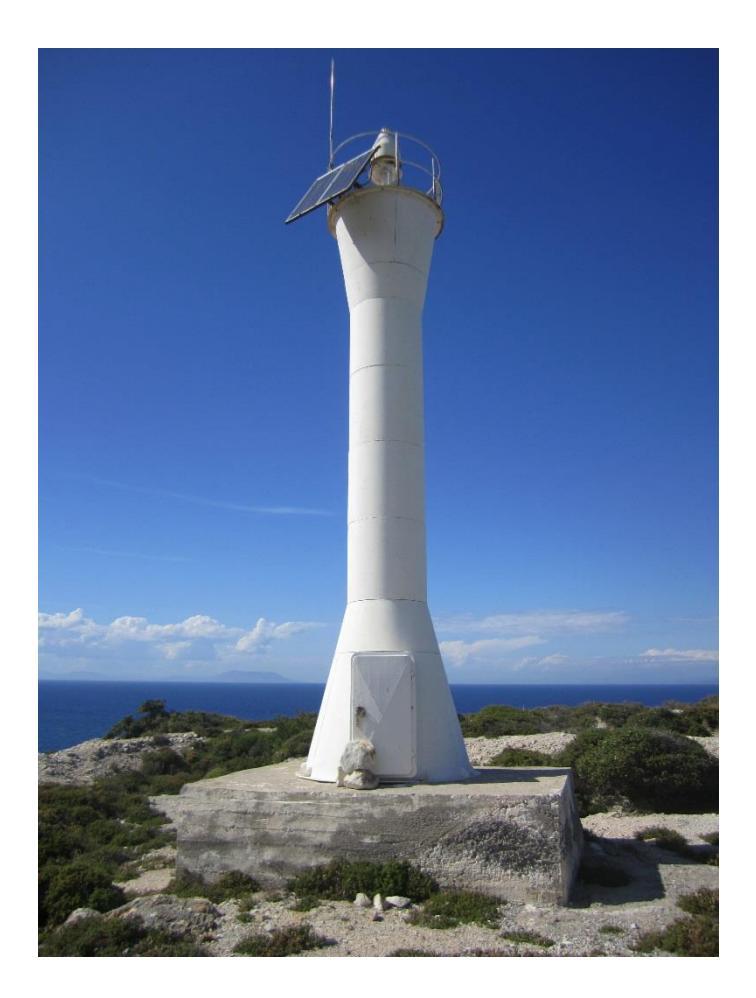
Figure 3.188. Aslan Cape Lighthouse (Author, 20.05.2014)

Aslan Cape Lighthouse is just at the boundary of the urban area and right by the road towards Yeni Foça, easily accessible. But there is no light keeper residing here. This is why the lighthouse is robbed of its accumulator/ battery frequently. The thieves damage the lock and door system. Apart from this, the structure is well maintained with minor issues of corrosion.

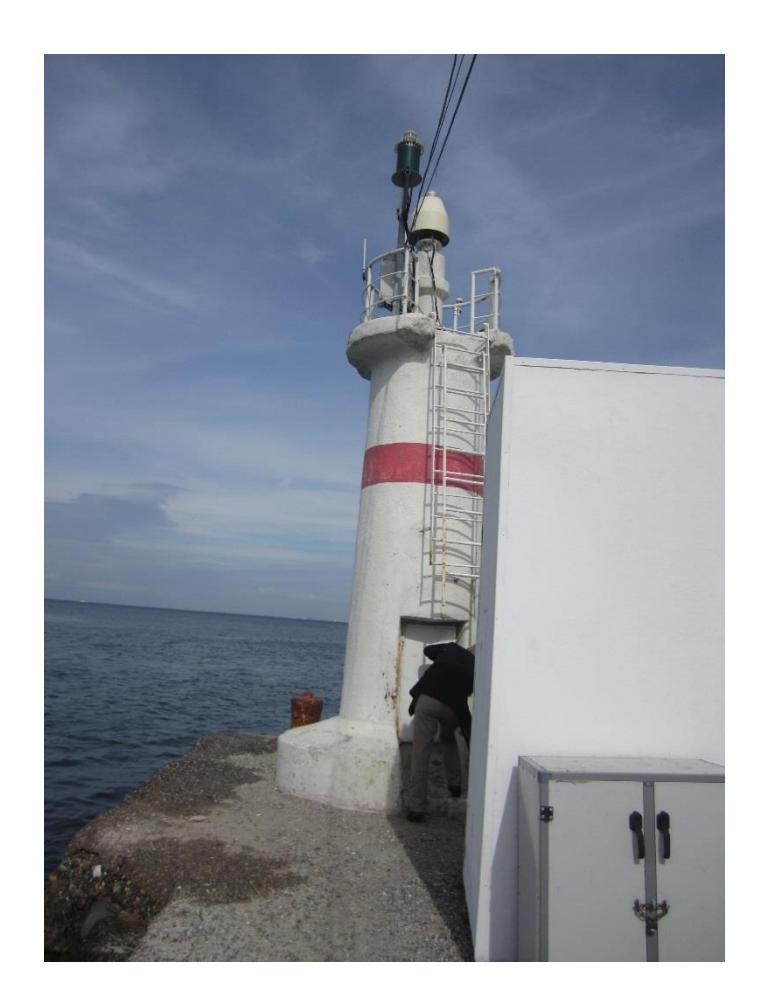
Figure 3.196. Pasaport Lighthouse (Author, 17.04.2014)

The lighthouse or the keeper's residence do not have any structural problems. The material problems are usually related to the dampness due to the sea water.

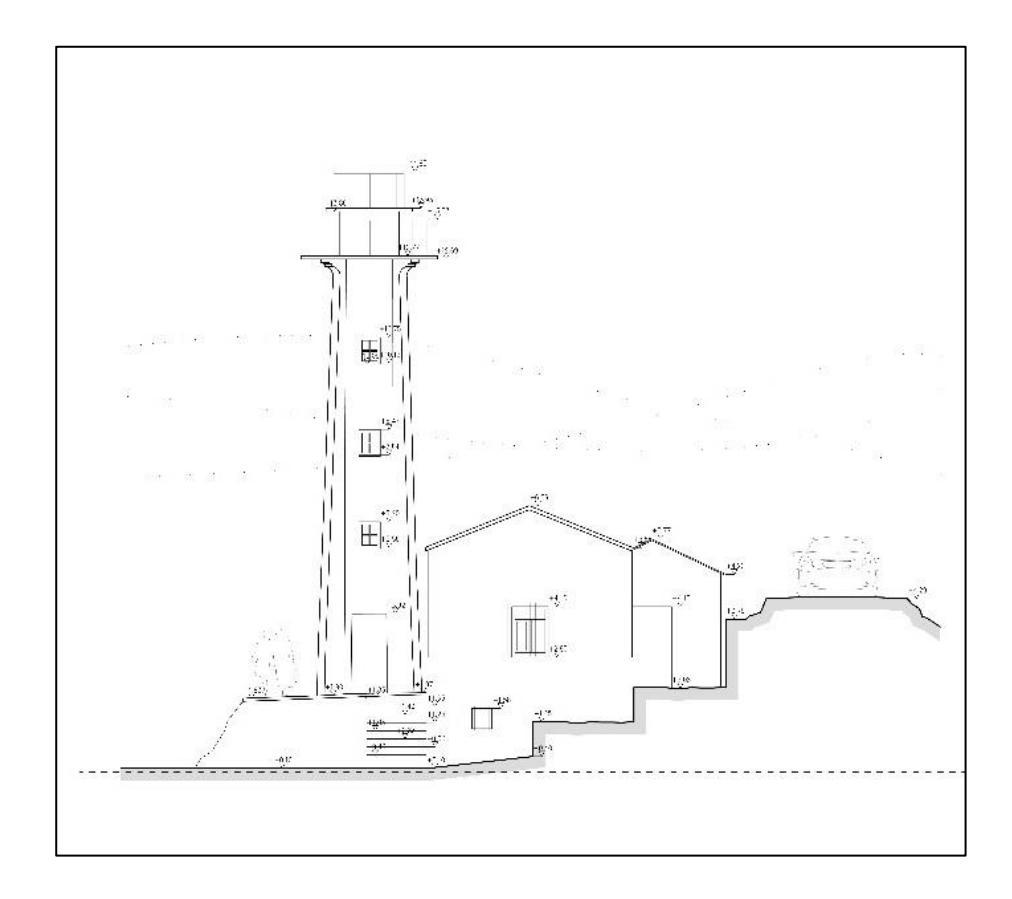
Figure 3.209. South elevation of Sarpıncık Lighthouse (Author, 2014)

Although the structures were restored in 2007, the exterior plasters have dense cracks. All buildings have rising dampness, condensation and rain penetration problems. As there is no light keeper residing here the buildings have deteriorated rapidly.

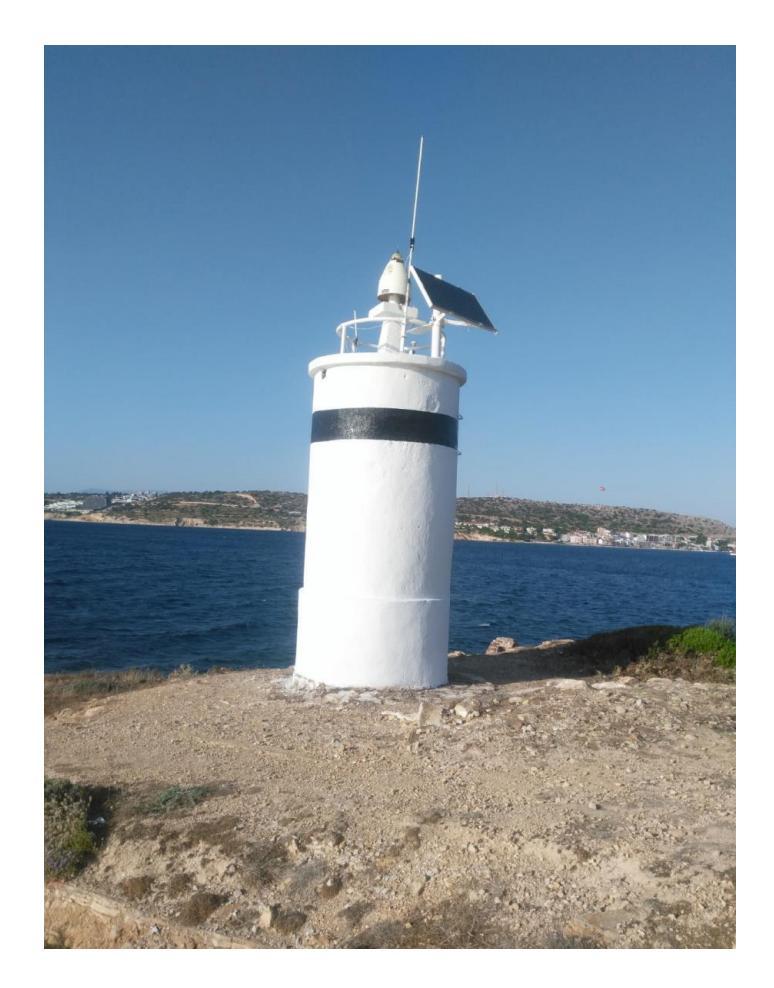
Figure 3.213. Çeşme Fener Cape Lighthouse (KEGM, Kıyı Emniyeti Genel Müdürlüğü, 2012)

The lighthouse is well maintained and does not have any structural or material problems.

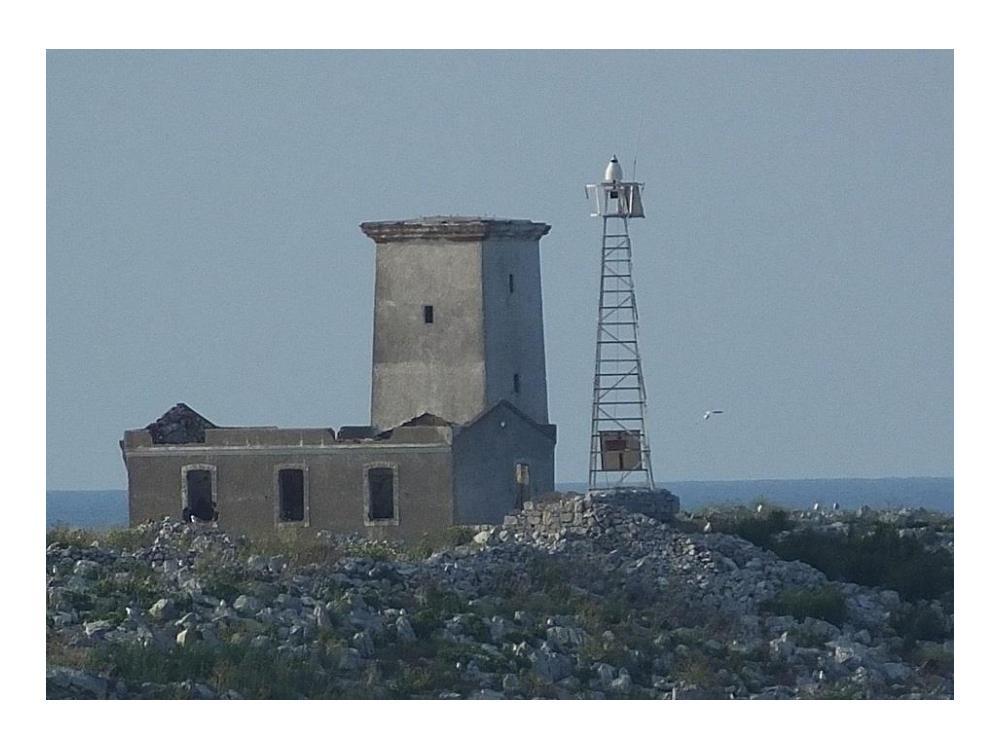
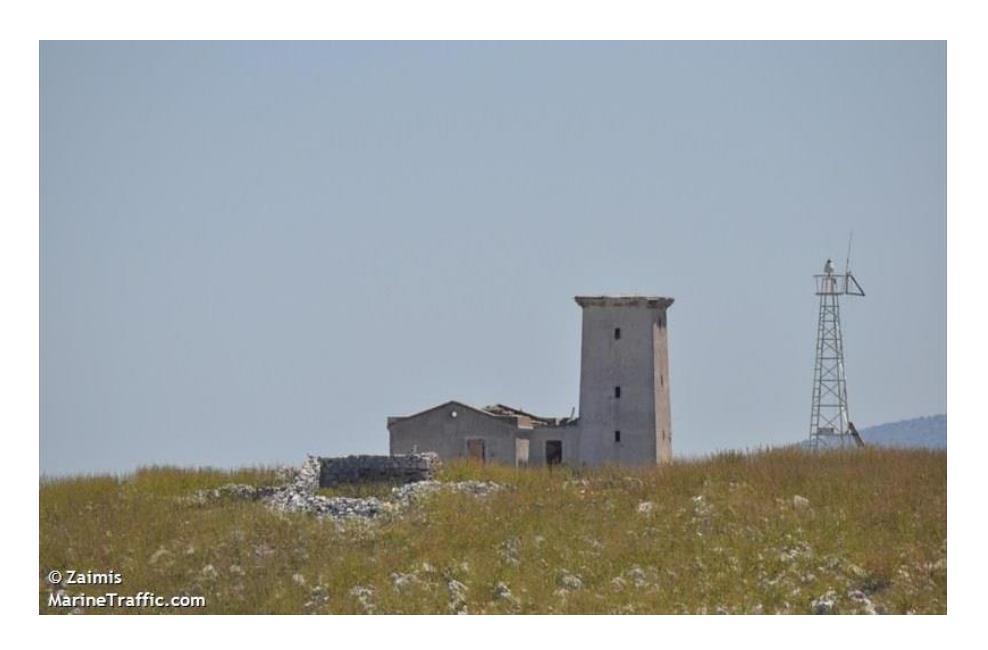
Figure 3.216. Süngükaya/Paspariko Lighthouse on the island (LighthousesRus, 2018)

Figure 3.217. Süngükaya/ Paspariko Lighthouse on the island (Zaimis, 2017)

The roof of the keeper's residence and the light tower had collapsed. But the walls are intact, and the full height may be observed. The service building which is as big as the residence is ruined. But the layout of all structures is recognizable. There are two stone paved paths linking the structures on the island. One of them leads to the coast of the island marking an access to the lighthouse.

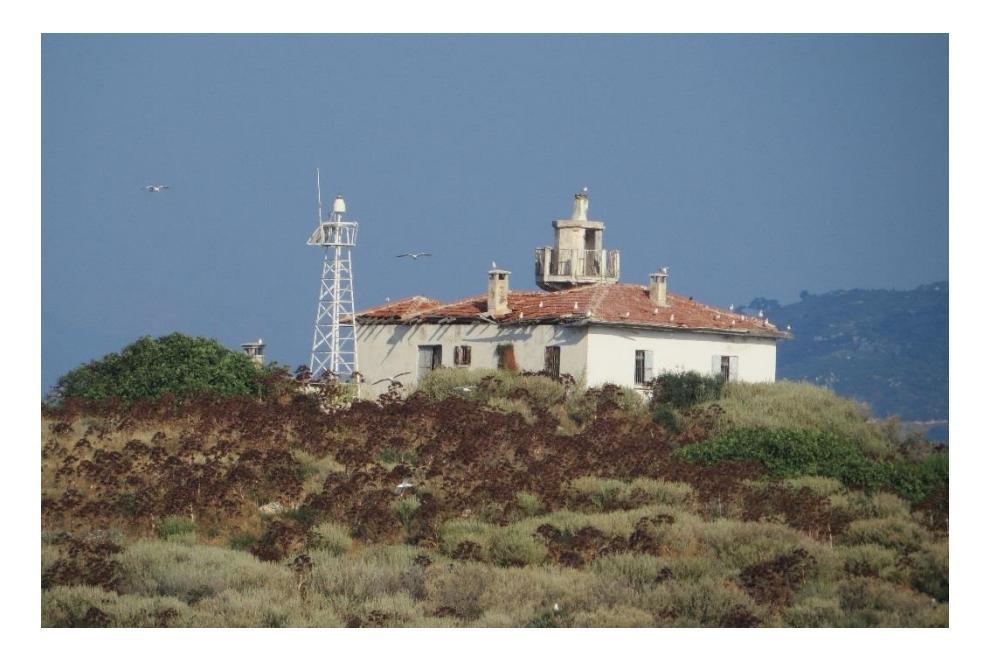
Figure 3.228. Bayrak Island Lighthouse. (Author, 10.06.2014).

The light tower is structurally in a critical condition. There are deep cracks along the vertical axis. The roof of the keeper's residence is damaged at some points, though the general outline is clearly visible. The keeper's residence timber floors are heavily damaged. The exterior and interior plaster is peeling. The light station needs urgent conservation interventions.
