**THE RESTORATION PROJECT OF
THE OLD AGRICULTURAL BANK BUILDING
IN MERSIN**

**A THESIS SUBMITTED TO
THE GRADUATE SCHOOL OF NATURAL AND APPLIED SCIENCES
OF
MIDDLE EAST TECHNICAL UNIVERSITY**

NİDA NAYCI

JANUARY 2005

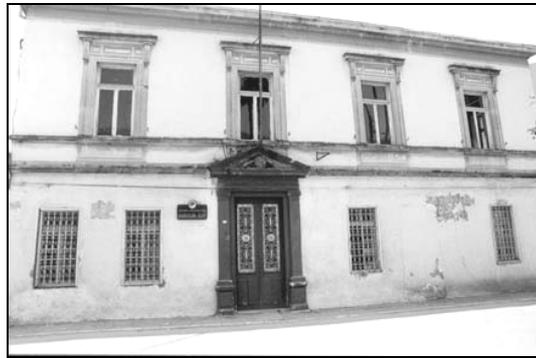
Figure 2.3 The north façade

The whole north facade of the main building is out of cut stone masonry wall. It is plastered and painted in white color except from the window sills, which are left unpainted and the entrance door, which is painted in dark brown. The main problem observed in the north façade of the main building is rising damp problem which rises until 1.50 m above the ground level. Around the openings there are detachments in plaster finishing in flaking forms. On the cut stone window and door sills and horizontal jails, there is black crust deposition due to the atmospheric pollution.

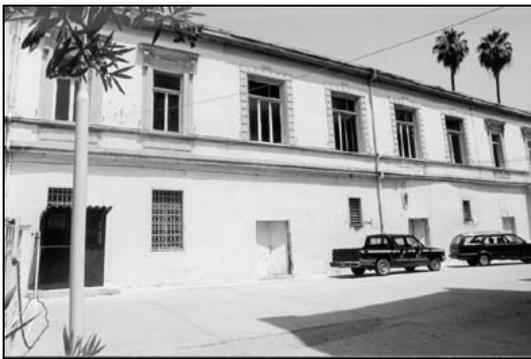
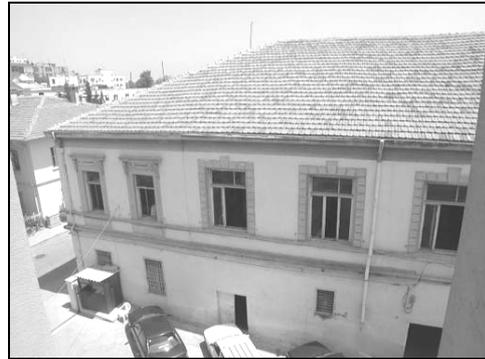
Figure 2.4 West Façade of the building

The main problem observed in the west façade is blind detachment of the cement plaster from the stone masonry walls especially in mid portion of the building. There is black deposition on the cut stone surfaces of the window sills and roof cornice. There are material loss as contour flaking and structural cracks in RC elements of the terrace.

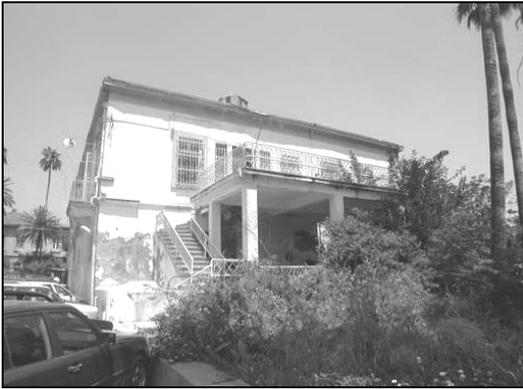
Figure 2.6 South façade of main building Figure 2.7 South façade of the depot building

The main problem observed in the south façade of the building is contour scaling in plaster material especially on the east portion of the ground floor. On the rest of the plaster finishing there is granular to crumbly disintegration of plaster material. The rising damp problem can be visualized on the ground floor level. There is oxidation problem observed in the metal grills and balustrades. The timber door and window elements have been suffering from tiny cracks occurred due to the exposure to UV lights and swelling and shrinkage cycles

of the timber material. On the east portion of the terrace, there is a local destruction of the stone masonry wall in order to install the clean water pipes, which has resulted with material loss in structural scale. In the RC beams and columns of the terrace there are structural cracks and flaking problem in the concrete material.

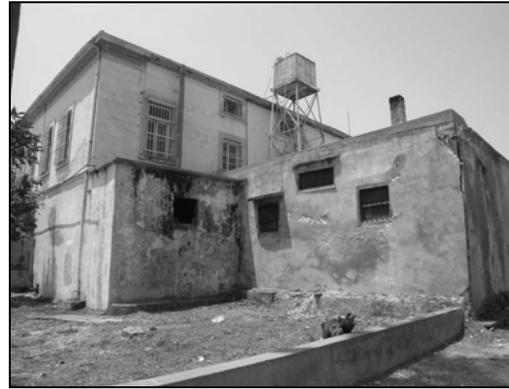
The south facade of the depot building is out of cut stone masonry wall plastered with cement plaster and painted into yellow. From the depot building there is a chimney out of brick masonry with 0.86 m width projecting adjacent to the east wall of the main building and rising approximately 9.00 m height from the depot building. In front of the chimney, there is a metal water tank of the central heating system of the bank that is located on the terrace of the depot building. As in the main building, the main problem observed on the east facade of the depot building is detachment of cement plaster from the stone masonry wall. The salination and dampness areas can be visualized on the surface. On wet portions there are local micro biological colonization areas with greenish color. On the east corner, there is structural crack in stone masonry wall which has caused by macro vegetation growth.

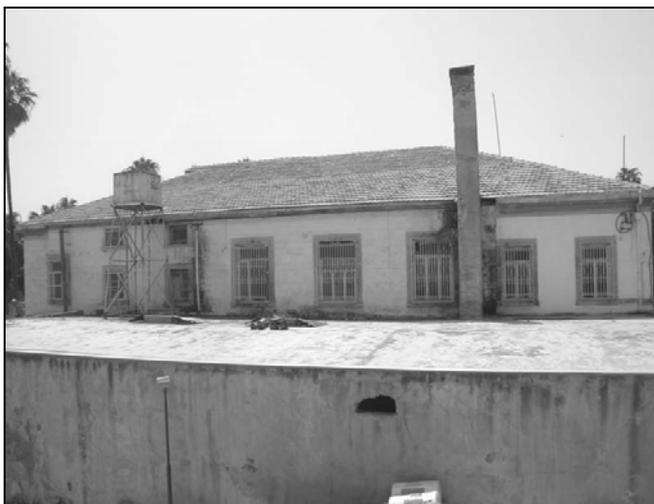
Figure 2.8 East façade

The main problem observed on the east façade of the depot building is detachment of cement plaster from the stone masonry wall. The sallination and dampness areas can be visualized on the surface. On the south portion of the stone masonry wall there is a serious structural crack, which has caused by a macro vegetation growth.

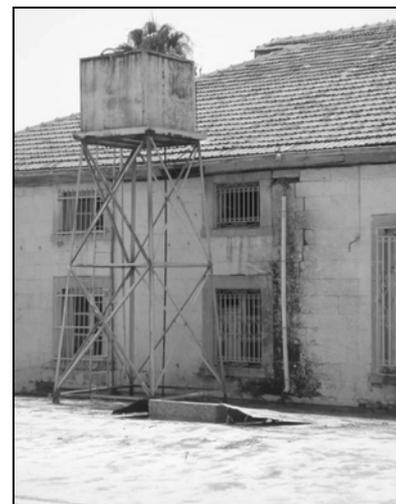
Figure 2.9 Detail from east facade

The east façade is the most decayed façade of the building (Figure 2.9). There is granular to crumbly disintegration of stone material which is has paint finishing. The water on the terraced superstructure of the depot buildings collects on the meeting point of the east façade of the main building since there isn't appropriate drainage system of the terrace. This causes serious material loss on the stone and plaster materials of the east façade. There is macro vegetation observed on the east façade due to damp problem. One of these macro vegetations has caused saw type structural crack on the stone masonry wall. On the cut stone surfaces of the roof cornice and window sills, there is black deposition problem due to atmospheric pollution.

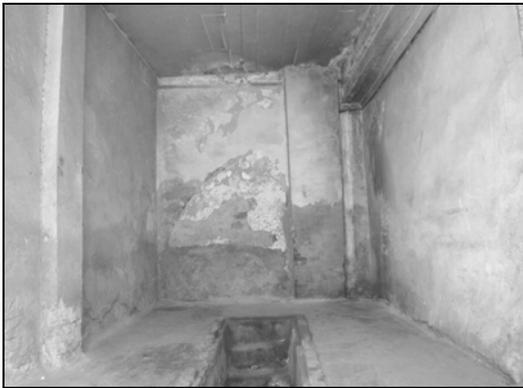
Figure 2.14 Space G09

The main weathering problems observed in space G09 is detachment of plasters on the surfaces due to the rising damp problem. The detachment is seen seriously especially on the south wall of the space. Under the scraped portions the traces of closed arch is observed. The RC slab flooring superstructure has structural decay problem due to the oxidation of the metal rods in the infrastructure of the flooring. The oxidation has caused flaking of the concrete cover over the metal rods.

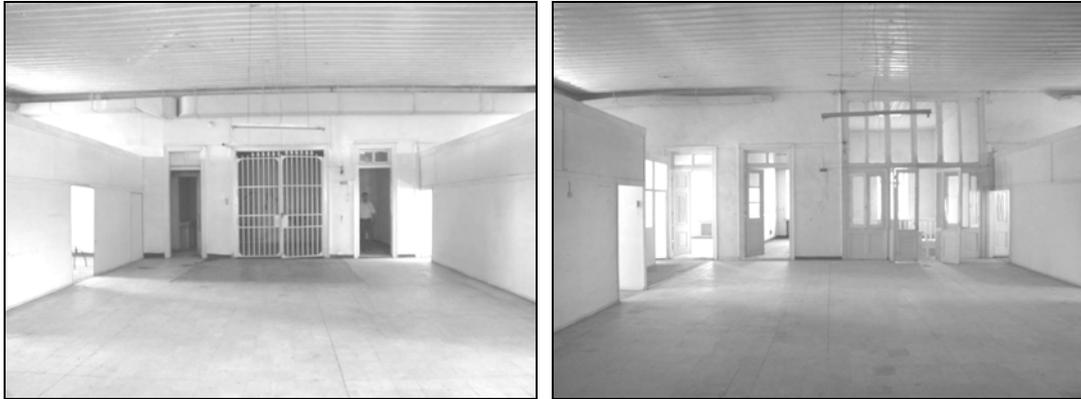
Figures 3.16-3.17 Space 101

All the walls of the space are out of cut stone masonry walls with plaster finishing. The main problem observed in the space 101 is loss of material and detachments in plaster materials. The flaking of plasters is seriously observed especially on the east wall of the space due to the water drainage problem of the superstructure of the depot building. One of the factors that have caused decays is the water coming from the roof resulting with the decays on the corners of the spaces. There is sagging problem in the vaulted flooring, in which the brick vaults have lost their horizontality.

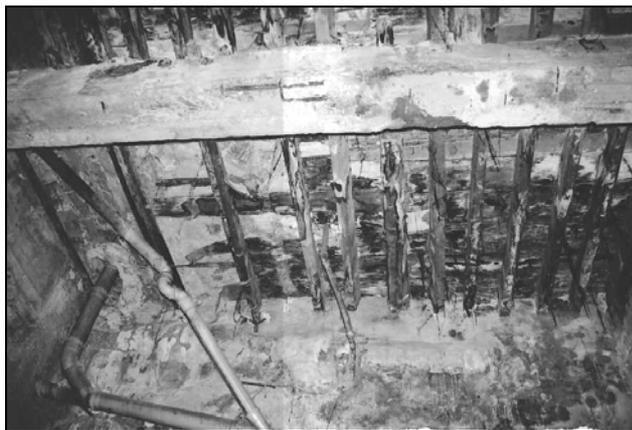
Figure 2.30 Weatherings in timber flooring

In some portions of timber flooring due to water problem, the timber elements have been seriously decayed. (Figure 2.30) The reinforced concrete elements especially the RC slabs and beams have serious structural problems due to the chemical reactions in the infrastructure. (Figure 2.31) There is material loss as flaking in the concrete portion of the elements due to the oxidation occurred in the steel rods. This problem is observed especially in the RC slab of south terrace and the space G10.

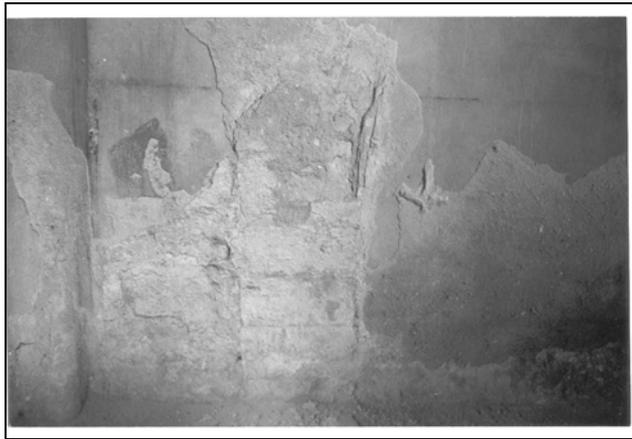
Figure 2.32 Closed arch in space G04

In spaces G02 and G03 the cement window sills and mosaic skirting are later additions. According to the construction technique of the mosaic skirting the mosaic tiling of these spaces are later applications. The north wall of the space G04, have arches which are closed later with masonry walls. (Figure 2.32) As far as observed from the scraped portions of the plasters, three piers supporting the arches are found out. The row of arches which are closed lately, consist of a half arch and two arches starting from west corner of the wall. (Figure 2.33) The pointed arch which is located at the south wall of the space is closed later with rubble stone masonry wall. (Figure 2.34)

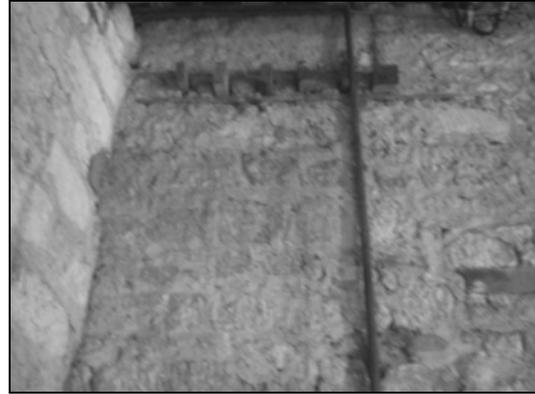
Figure 2.35 Timber beams in space G06

In space G06, the east wall of the space is latterly constructed as a partition wall with different construction materials than the rest of the walls cutting the third arch inadequately from the middle. On the south masonry wall, there are some traces observed under the scraped portions, showing existence of a previous opening which has been closed after. Above the third arch and on the south wall there are timber remains which belong to flooring beams. On the south wall of the space there are remains of timber beams. (Figure 2.35)

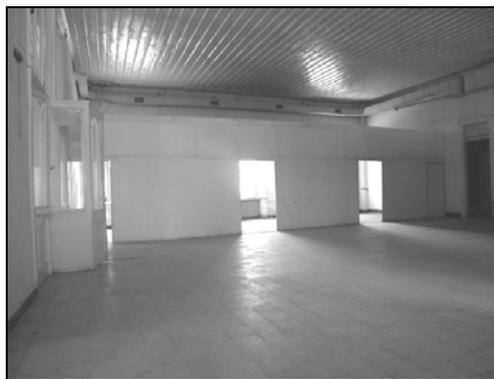
Figure 2.36 Plywood walls in space 101

The plywood partition walls and ceilings that are constructed in the main hall, are later addition (Figure 2.36). From the traces on the flooring it can be evaluated the previous use of space with banking hall function. There must have been desks on each side of the east and west portions of the space located on the intersection of timber and vaulted flooring portions. In addition to this, similarly there must have been a cash point in front of the safe room. The locations of the previous furniture can be concluded by evaluating the flooring. The heating system equipments including vertical, horizontal pipes and radiators as well as metal air ducts are later additions.

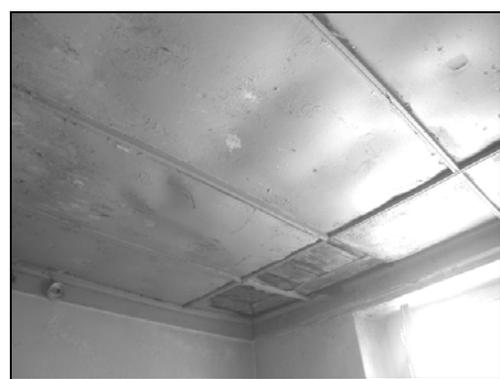
Figure 2.37 Plywood ceilings in space 101

The original timber ceilings of mezzanine floor are covered with plywood sheets as precautions against the water penetrating from the roof. (Figure 2.37)
