**RESTORATION PROJECT OF İBRAHİM ŞAHİN HOUSE IN
SOĞUKPINAR DISTRICT, BEYHAMAM STREET, NO 41, TOKAT**

**A THESIS SUBMITTED TO
THE GRADUATE SCHOLL OF NATURAL AND APPLIED SCIENCES
OF
MIDDLE EAST TECHNICAL UNIVERSITY**

**IN PARTIAL FULFILLMENT OF THE REQUIREMENTS
FOR
THE DEGREE OF MASTER OF SCIENCE
IN
RESTORATION
IN
ARCHITECTURE**

The subject of thesis is to prepare the restoration project of a traditional Anatolian dwelling in Tokat.

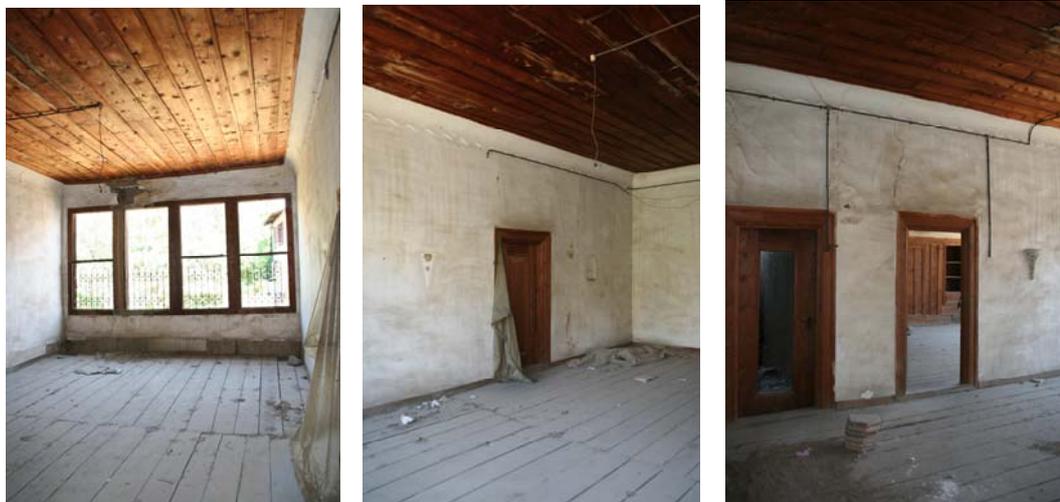
Figure 21: Space 102

doors (DSW-f-fp) at west of this unit. The closer one is connecting the sofa to 106. The one 63 cm away from the west wall is connecting to 105. There is 71 cm between the frames of these doors. The baseboard with a width of 9 cm is continuing up to 83 cm west of the east wall.

The west wall of the space is 4.61 m in length and 3.47 m in height in average. There is a double winged door (DDW-f-fp) at the middle part of the wall. It is higher than the others of this space. At both sides there placed baseboards with a width of 9 cm.

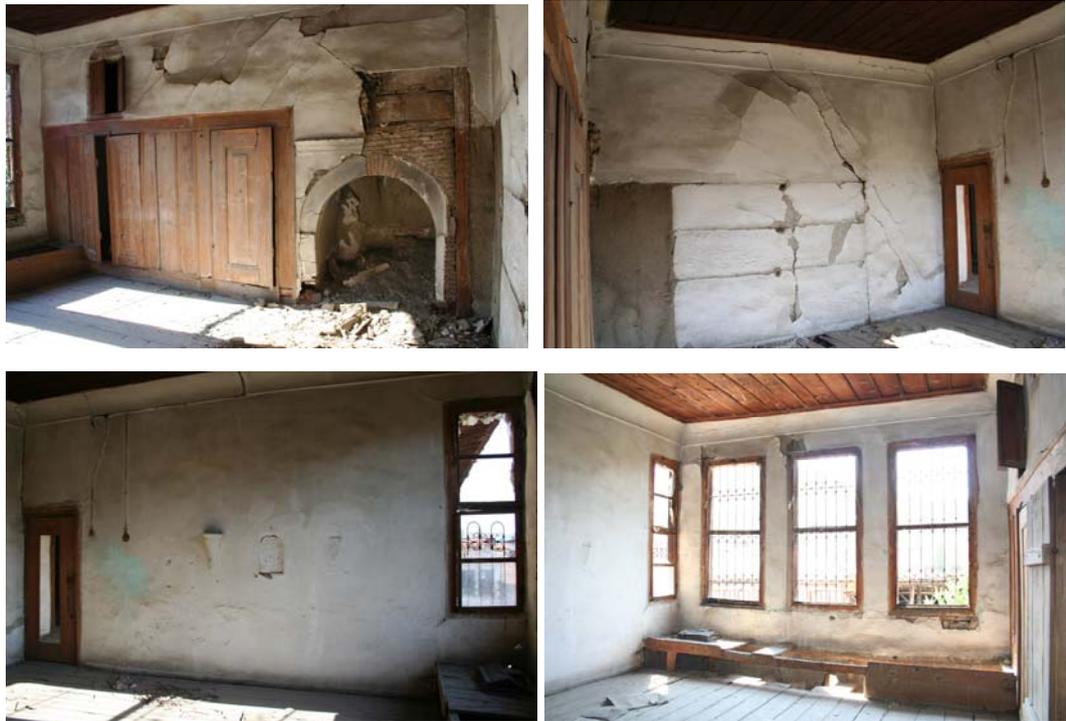
Figure 22: Space 103

The north wall of the space is 5.97 m in length and 3.45 m in height in average. The wall is arranged with two architectural elements. Fireplace (FP1-A1b) at east side has a pointed arch profile. The springing line of it is approximately 0.75 m high from the ground level. The arch profile is emphasized by a brick work as shifting the related surface from that of wall with 4 cm in average. Inside of the unit is covered with 'harman' bricks at a height of 0.76 m from the ground level. All surfaces of fireplace are lime plastered and washed in white. Chimney of it is collapsed; therefore related area is full of rubbles. There is a remaining half of a profiled gypsum veil above the arch profile. The fireplace seems to be framed by posts from each side. The one at east is appeared due to the plaster lost. The part at east of it is mud plastered and not washed up to the lime plastered and washed level which is at about the same line of lateral trace at east wall. The post at west side of the fireplace is covered by the east frame of the built-in cupboard unit. Cupboard has 2.15m*4.12m dimensions (BC-N- 01b). It has an upper cabinet above the double winged part. The west part of it has a lathed frame above the 'sedir'. The east unit of the cupboard is single winged. Space behind the framed face of the cupboard is empty; it has no partitions inside except a chimney hole next to the north wall and a chimney that is adjacent to the cupboard's face between the single winged part and double winged part. The floor of this space is covered with timber boards where the walls behind are lime plastered and lime washed in white color. The upper part of the cupboard' frontal face is again lime plastered and washed in white on laterally placed timber boards.

The west wall of the space is facing the courtyard. It is 4.60 m in length and 3.55 m in height in average. There are three windows (WLSc-2wf-L0) placed in a symmetrical arrangement with intervals of 31 cm. the bottom level of windows is 90 cm high from the ground level and 44 cm high for the 'sedir' placed under them.

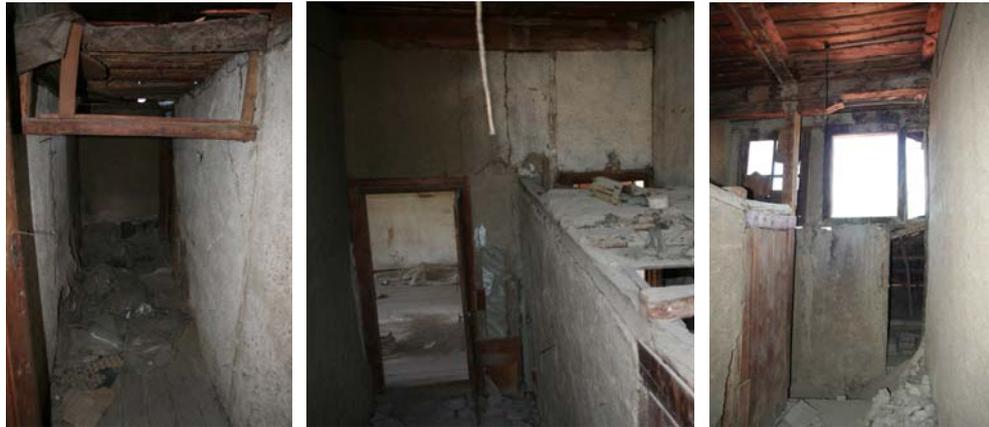
Figure 23: Spaces 104-105

SC02 is separated from 104 and 105 by the half-storey north wall of 104 and a wall plate that is carried by a bracket and a post. 104-105 take light from two adjacent windows (WSSb-ff) placed on north wall of SC02. The wall under the window at east side is partially collapsed. From this opening the attic space of the neighboring building (lot 10) can be seen.

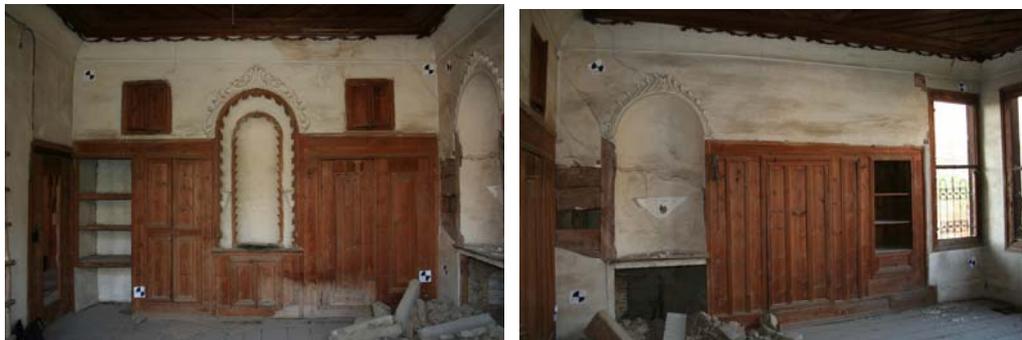
Figure 24: Spaces 106

The west wall of the space is 4.68 m in length and 3.48 m in height in average. This wall has a built-in cupboard (BC-W-E1). The south edge is an opened shelved unit with 4 partitions. There are two cabinet placed symmetrically at the upper wall of the cupboard.

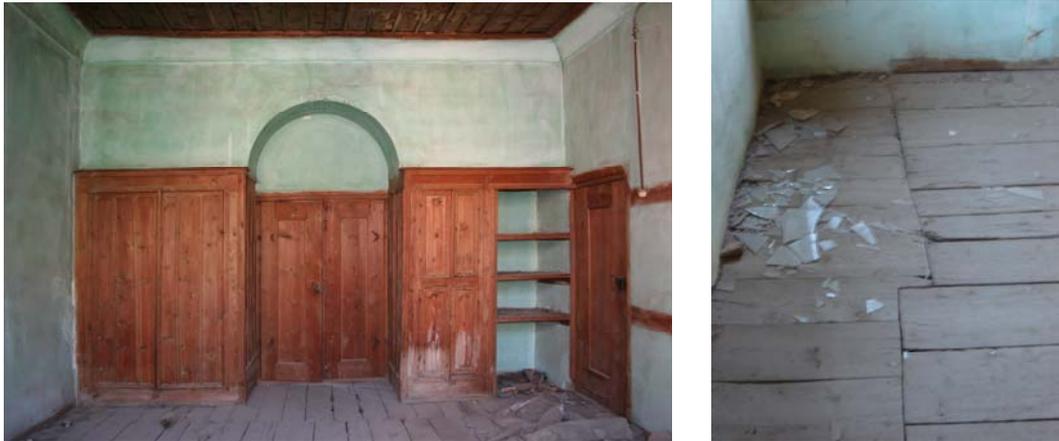
Figure 25: Spaces 107

The north wall of the space is 5.54 m in length (if including the open shelved unit at west wall related length will be 6.33 m) and 3.55 m in height in average. There is a single winged door (DSW-f-fp) at west edge of the wall. There are two timber boards placed adjacent to the east frame of the door with a distance of 0.90 m between each other. The upper one is 25 cm under the top level of door. Both elements have 18 cm widths. The upper one has a length of 2.14 m whereas the lower one is in full-length. The baseboard of the related wall is continuing up to 0.63 m west of east wall. It has a width of 8 cm.

The west wall of the space is 4.71 m in length and 3.59 m in height in average. The wall is arranged symmetrically according to a double winged door (DDW-f-fp) placed at middle. It connects the space to 108. Entrance zone is emphasized with a vault on top. The top level of the arch profile of the vault is 2.95 m above from the ground level. The springing line level is at about the top levels of the cupboards (BCR-W-E2a) at each side of the entrance, which is 2.29 m above the ground level.

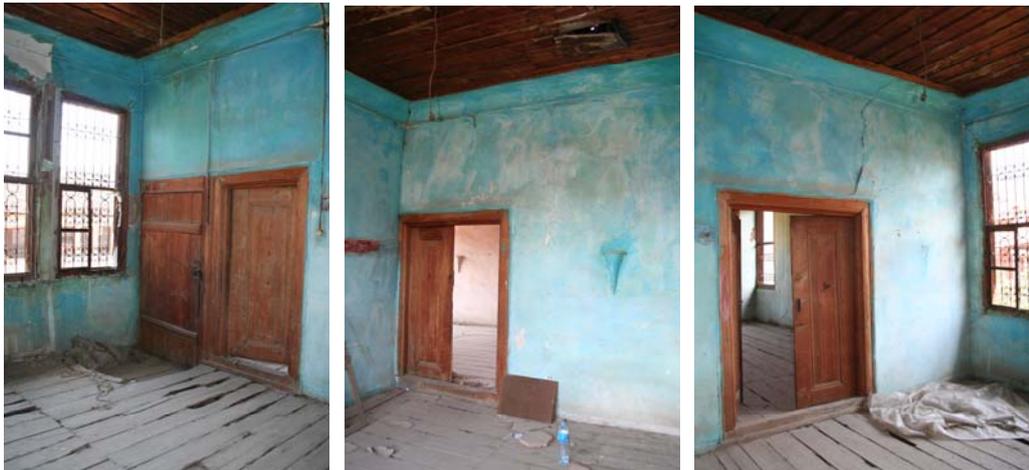
Figure 26: Spaces 108

The east wall of the space is 4.69 m in length and 3.62 m in height in average. There is a double winged door (DDW-f-fp) at middle which gives entrance to 107. A timber board is placed in between this door and the north wall of the space. Its top level is 1.86 m from the ground level. Its width is 16 cm. there is a triangular trace is noticed between the door and the south edge. The timber baseboards of the wall are in 8 cm width and elongated through opposite edges from the bottom of the door.

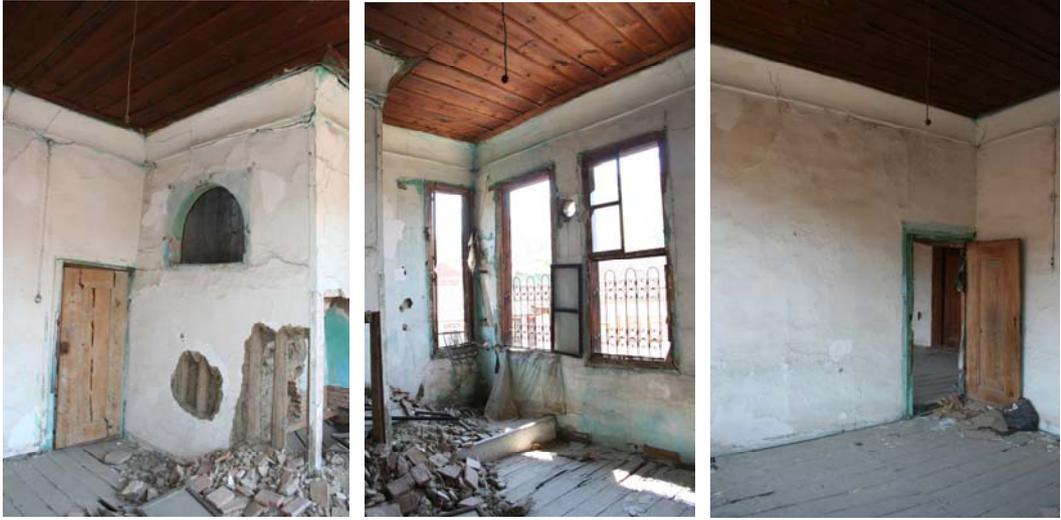
Figure 27: Spaces 109

The north wall of the space is 4.27 m in length and 3.50 m in height. There is a single winged door (DSW-f-fp) at most east which is connecting the space to sofa 101. Timber baseboard of this wall has 10 cm width and has a joint at about the west frame of the door. In fact it is at the same line with the jointing line of flooring boards of the circulation part. It is also cut at 71 cm away from the west wall.

The west wall of the space is 4.77 m in length and 3.57 m in height. There are three windows (WLSc-2wf-L0) at this façade. The frames and glasses of them are almost totally lost. The bottom level of the windows is at about 0.74 m above the ground level. All of them have iron railings (R-1-B-a).

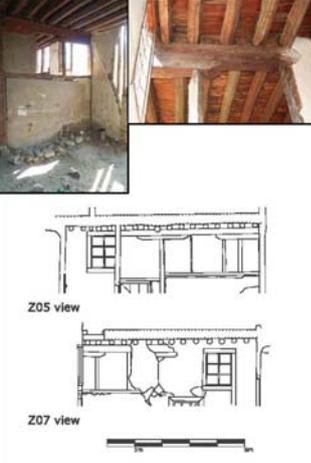
<p>22- Z05: 22a: the upper level openings and the southern wall of the space</p>	<p>1- possible appropriate opening could be provided at the opened part of the upper section. 2- the opening divided into two via a post carrying bracket; the one at western side is again divided into two by the wall coming perpendicular to the related opening. The western side of the second partition looks outside. 3- the stud at the middle of the opening is notched at its bottom and seems to be not relevant in location 4- the infill material and the plaster of the wall under the opening is disjointed 5- there are lateral linear traces on the eastern side of the related wall -possible remaining of a removed wet space unit</p>

<p>OPENED PART OF THE Z05-Z07 WALL UNIDENTIFIED</p>	<p>CASE11</p>
<p>22b: elevated part at the ground at southern west part of the space</p>	<p>1- the elevated platform has clear lines -rubble stone cladding in row- 2- dark deposit on the walls of southern west corner of the space -this might show a kind of specialized function; namely a wet space use- 3- there is a hole at the bottom corner of the same wall-possibly opened for a kind of inlet or outlet water-</p>

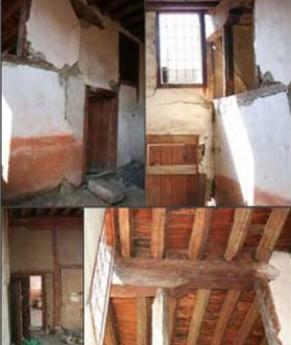
NORTH WALL OF Z07 UNIDENTIFIED	CASE11

UPPER PART OF DOOR Z03-Z07 MISSING/REMOVAL	NA
24f: north wall of the space	1- faults of jointing details of structural timber of the related wall 2- a bracket properly notched found in space on ground 3- bracket at west edge and related post relation 4- z05 door lintel 5- relation with west wall of z07 6- upper lightening window placed at east side of the space 7- exposed stone footing near z05 door is the single sample inside the building

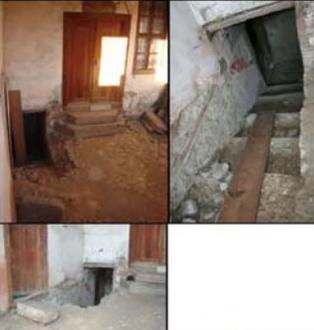
<p>24g: entrance of basement floor</p>	<p>1- closing of north window of east wall 2- jerry built finishing lines of void 3- in order to provideing necessary hight the timber wall plate seems to be cut; north edge is nothed where south one is hidden by timber boards 3-there is no finishing detail above structural timber elements 4- 13 numbered trace: void is possibly closed after this application 5- jerry built door of basement floor</p>

<p>ENTRANCE OF BASEMENT FLOOR RELATED ARTICULATIONS AND STONE STEPS</p> <p>ADDITION</p>	<p>CASE9</p>
<p>25- Z08: 25a: the northern part of the elevated platform</p>	<p>1- the northern half of the platform seems to be demolished due to a possible intervention for installation; rubble is heaped up on the other half 2- the timber flooring elements projected through the space</p>

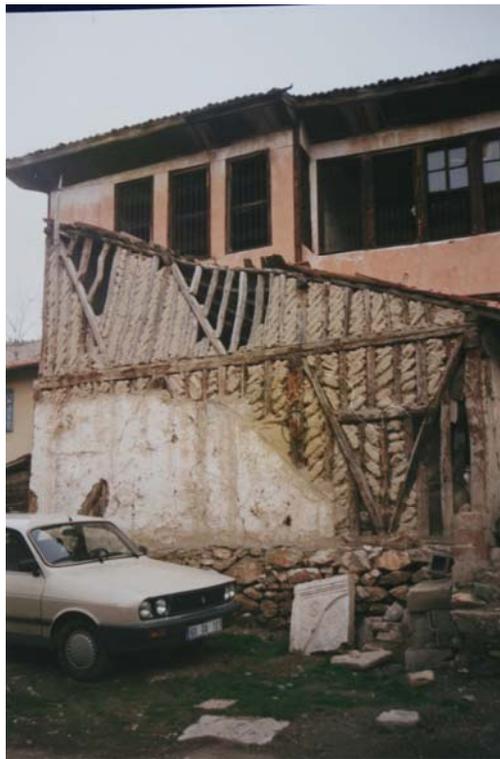
Figure 127: A Structure in front of at Courtyard (1980's) (Ref: İbrahim Şahin, Owner)

related to this unit is the photograph taken at late 1980's⁶ (see Figure 43). The stone element seen inside the structure may refer to the function of the space (see Figure 44). This architectural element seems to be a water well or a 'tandır'. On the other hand, having a fireplace unit inside seems to be not much possible due to the lack of a chimney. The construction technique of the roof is also not convenient to that of the ground floor. The height of the structure also refers to a possible use of the space with a mezzanine floor. The courtyard units seen at other samples are generally used as either a workshop space having a fireplace unit inside; or a storage space for grain, straw or else. All data when thought together within the similar samples, shows that this space was probably used both for storage and for washing.

carried inside Z07. The fireplace unit at courtyard on the middle zigzagged formed wall seems to be collapsed in 1980's as it is seen from the Figures 43 and 44 (p. 249).
