A PROPOSED MODEL FOR UNDERSTANDING THE IMPACTS OF CLIMATE  
CHANGE ON TANGIBLE CULTURAL HERITAGE

A THESIS SUBMITTED TO  
THE GRADUATE SCHOOL OF NATURAL AND APPLIED SCIENCES  
OF  
MIDDLE EAST TECHNICAL UNIVERSITY

EMİNE GİZEM BAŞKAN

JANUARY 2016

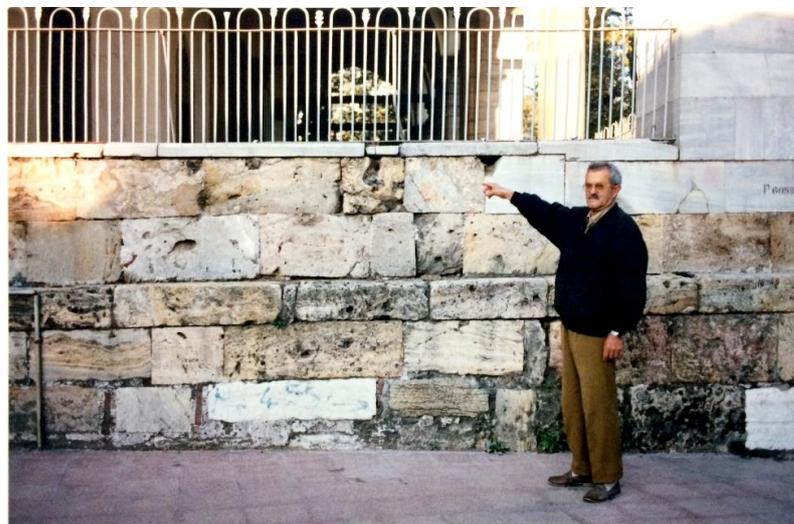
On the northeast corner, upper portion of the minaret's shaft was plastered and its hood is covered with lead sheets while on the northwest corner, upper portion of the shaft and the hood of the minaret are made of stone (Figures 5.2). Glazed tile courses and mortar joints under the balcony of both minarets fell down in patches. Repointing of mortar joints at the minaret on the northeast corner was suggested after scraping plaster on the upper portion of the shaft to check the condition of bricks. Besides, stones of the portico for latecomers were also deteriorated (Figure 5.3). To conclude, the expert suggested basic repair activities to solve the issues mentioned above.

**Figure 5.3.** The photo from the wall of the portico for late comers shows damaged mortar joints, surface erosion, cavities, and detachments.

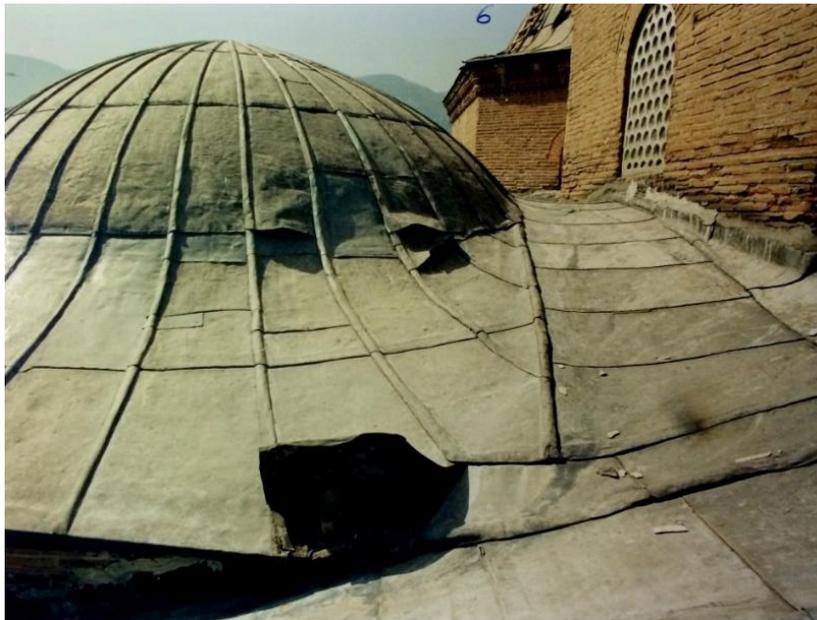
**Figure 5.4.** Damaged lead sheets covered the dome  
(Source. Bursa - CNHPRB, 2000)

- Changing or repairing damaged lead sheets covered the roof and the dome (Figures 5.4 and 5.5);
- Changing the doors at the east and west facades, which were deteriorated due to weathering, in compliance with the original ones (Figures 5.6 and 5.7);
- Removing canopies above the doors at the east and the west facades (Figures 5.6 and 5.7a);
- Repairing wooden doors under the control of Bursa Regional Directorate of Foundations (Figures 5.6 and 5.7).

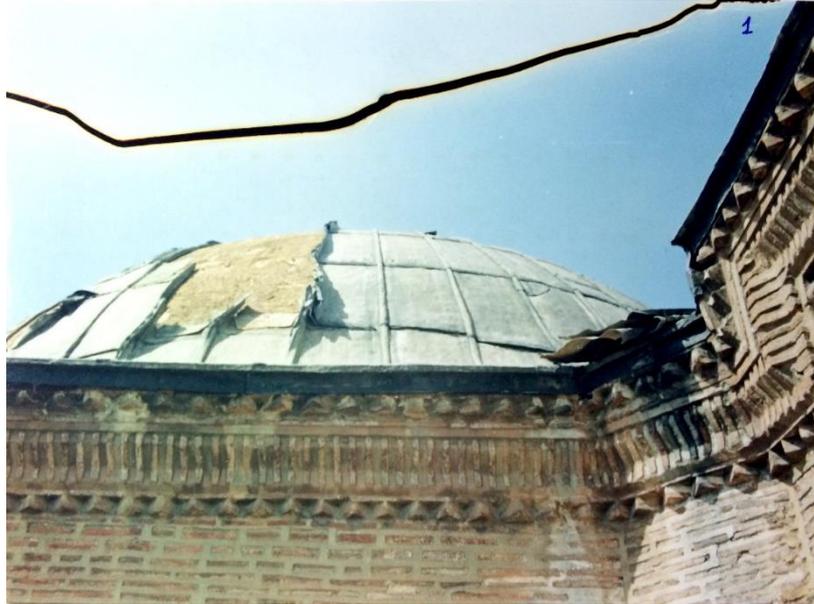
**Figure 5.5.** Missing and damaged lead sheets covered the dome.  
(Source. Bursa - CNHPRB, 2000)

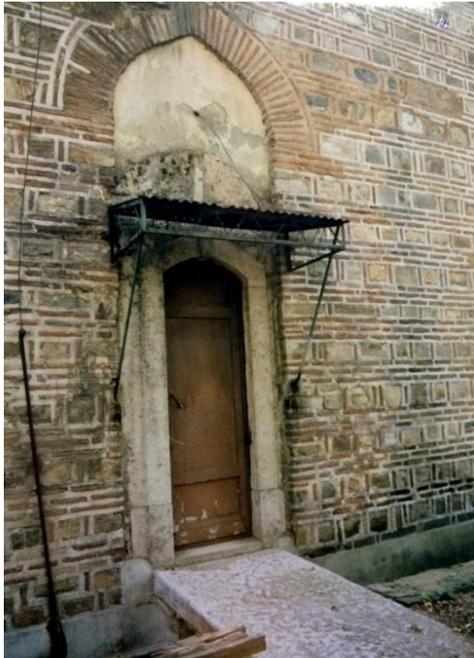
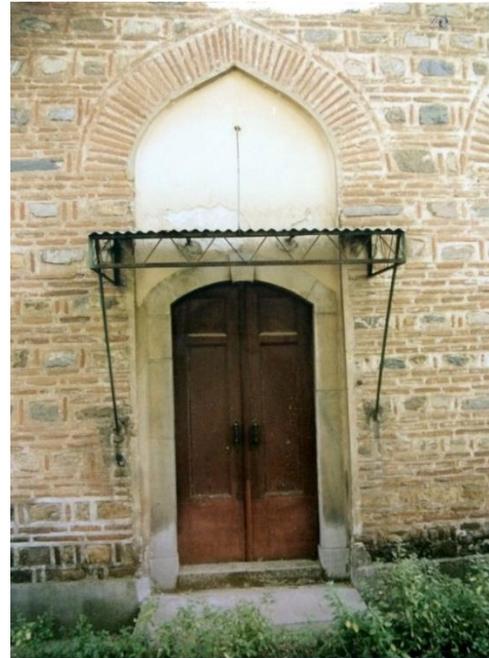
**Figure 5.6.** Both photos from the west facade showing (a) the door of a room and (b) the door of the west entrance.  
(Source. Bursa - CNHPRB, 2000)

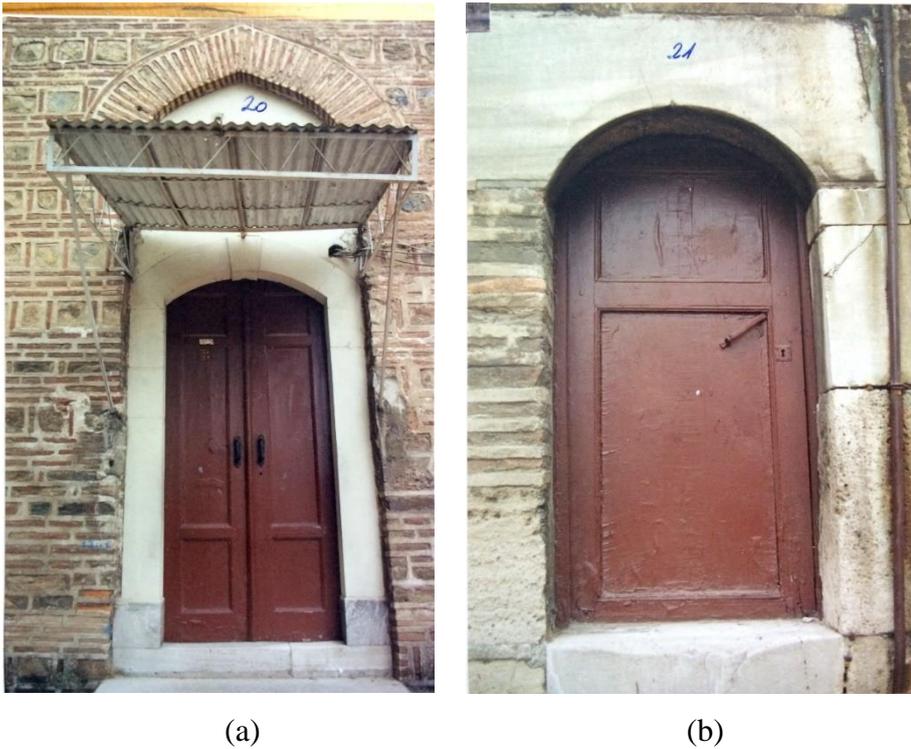
(a) (b)  
**Figure 5.7.** Both photos from the east facade showing (a) the door of the east entrance of the mosque and (b) the door of the minaret.  
 (Source. Bursa – CNHPRB, 2000)

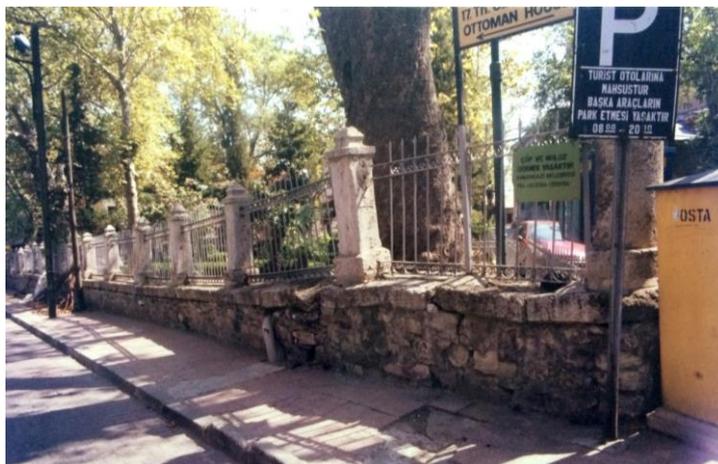
**Figure 5.8.** Damaged garden wall due to the roots of the plane tree.  
(Source. Bursa – CNHPRB, 2001)

- Repointing mortar joints of the garden wall built of rough stones (Figure 5.8);
- Repairing the parts of the garden wall, which was physically damaged by a plane tree (Figure 5.8);
- Repointing mortar joints in the walls of the portico in compliance with the original ones as it is necessary to restore the visual and physical integrity of the masonry (Figure 5.9);

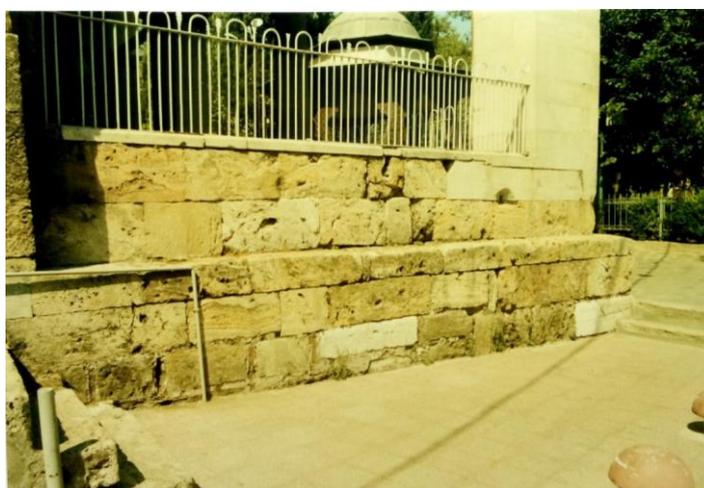
**Figure 5.9.** Eroded mortar joints in the walls of the portico for late comers.  
(Source. Bursa – CNHPRB, 2001)

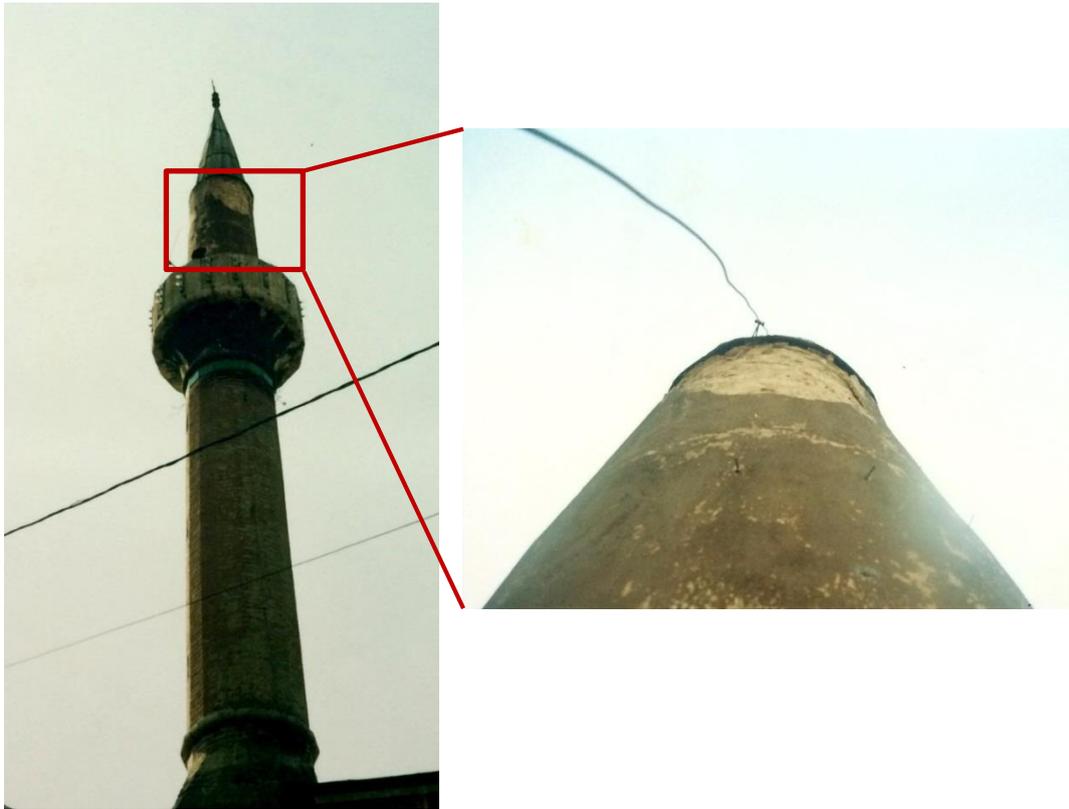
**Figure 5.10.** (a) The minaret on the northeast corner, and (b) spalling plaster on the upper portion of the shaft.

- Repairing plaster on the shaft's upper portion of the northeast minaret as it was impossible to repoint mortar joints in bricks (Figure 5.10);

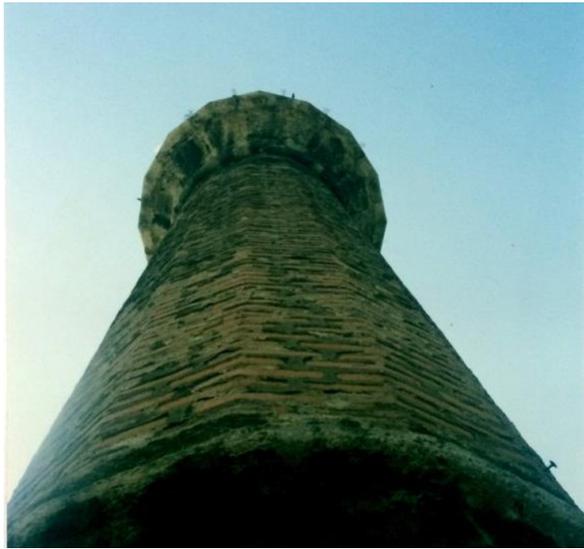
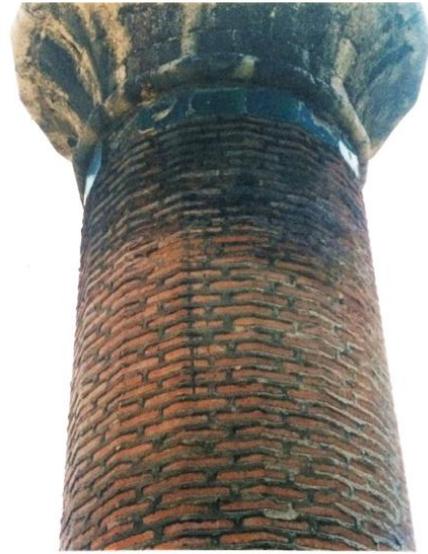
**Figure 5.11.** Both (a) and (b) show damaged mortar joints of the minaret on the northwest corner.

- Changing the hood covered by lead sheets and horizontal wood sheating under the hood of the northeast minaret;
- Repointing swollen and spalling mortar joints in the shaft of the northwest minaret made of brick without giving harm to glazed tiles under the balcony (Figure 5.11);
- Repointing mortar joints in the saw-tooth and common brick courses, and the main walls of the mosque (Figures 5.12 and 5.13);

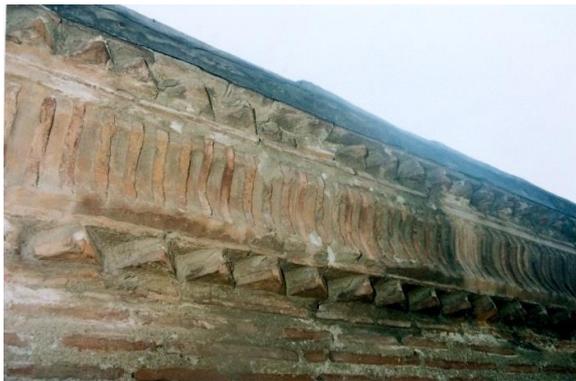
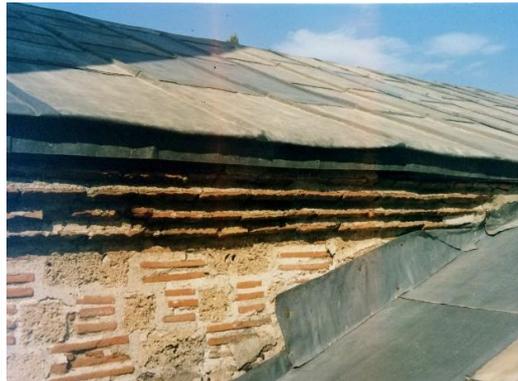
**Figure 5.12.** Both (a) and (b) show eroded mortar joints in the saw-tooth and common brick courses.

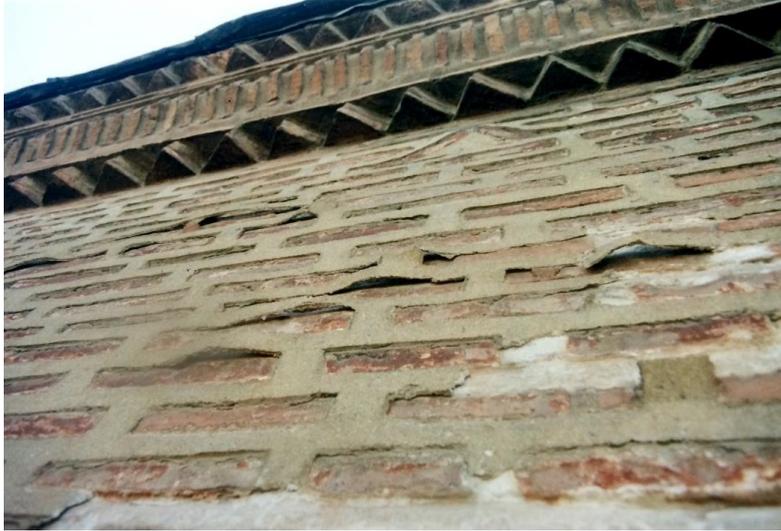
**Figure 5.13.** Swollen mortar joints in the wall, which was filled too full, showing changes in the actual joint thickness and the character of the original brickwork.  
(Source. Bursa – CNHPRB, 2001)

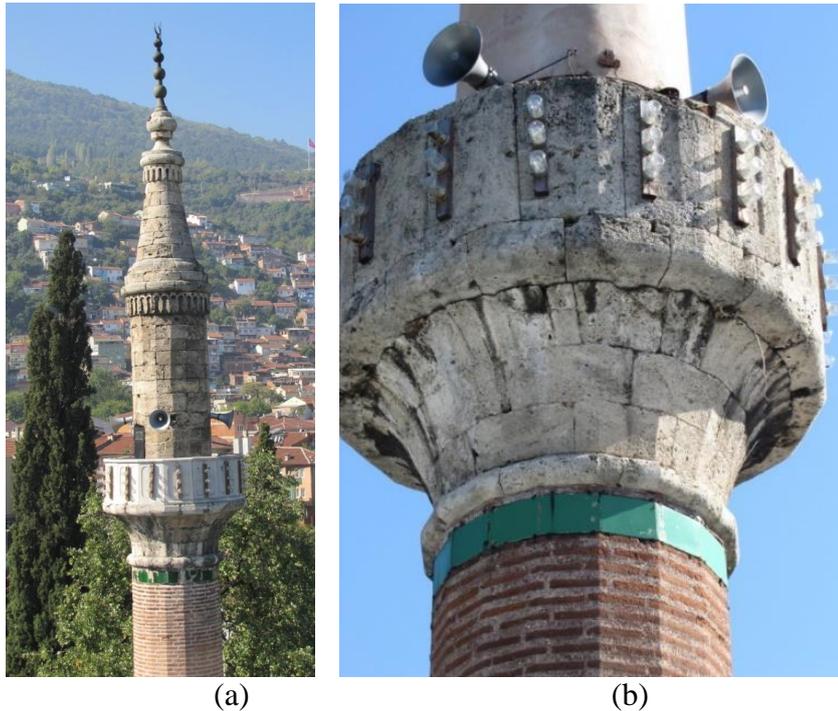
**Figure 5.14.** The photos showing (a) the minaret on the northwest corner and (b) the minaret on the northeast corner before the restoration work.  
(Source. Bursa – CNHPRB, 2011)

\* Minaret on the northwest corner: Marble rail, and stones under the balcony and of the hood were cleaned. Missing parts were completed with the same kind of stones. Cracks were repaired (Figure 5.14).

\* Minaret on the northeast corner: Stones under the balcony were cleaned. Missing parts were completed with same kind of stones. Lead sheets covered the hood were changed. Plaster on upper portion of the shaft was cleaned and mortar joints were repointed with *horasan* mortar (Figure 5.14).

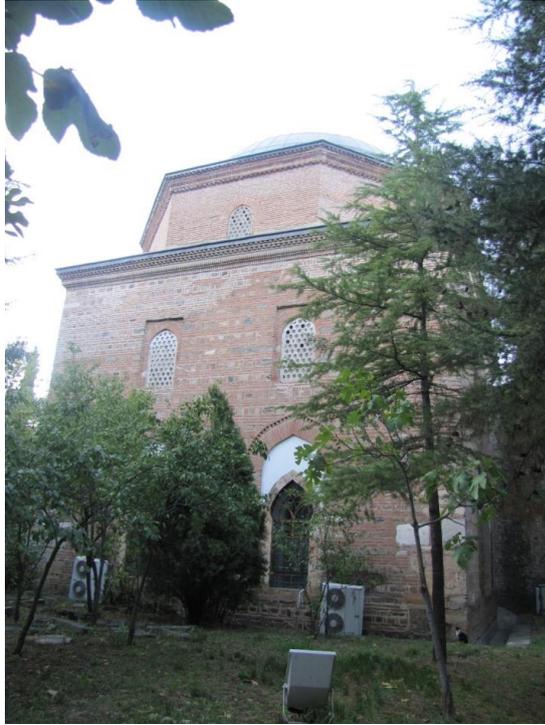
**Figure 5.15.** The photo showing the places of the exterior mechanical units and related fixtures of the air conditioning system, such as air conditioning condenser unit, which impact the mosque's historic character. They were removed during the restoration, and placed after restoration.  
(Source. Bursa – CNHPRB, 2011)

- *Facades:* cement-based mortar and plaster was cleaned especially on stones. Mortar joints were repointed with *horasan* mortar. Sheet iron, nails, pipes, clamps and air conditioner etc., were removed from the facades (Figure 5.15). Saw-tooth brick courses and stone moulding were completed or changed. Blackening, which formed due to dampness and carbon accumulation (blackening) on facades, and biological growth were cleaned (Figures 5.16 and 5.17). Composite patching was carried out where the surface erosion was greater than 10 cm. Bricks which had damaged parts were changed with bricks which were of the same type and had the same dimensions as the old ones. Irregularity of the alternate walls' courses was left as they are.

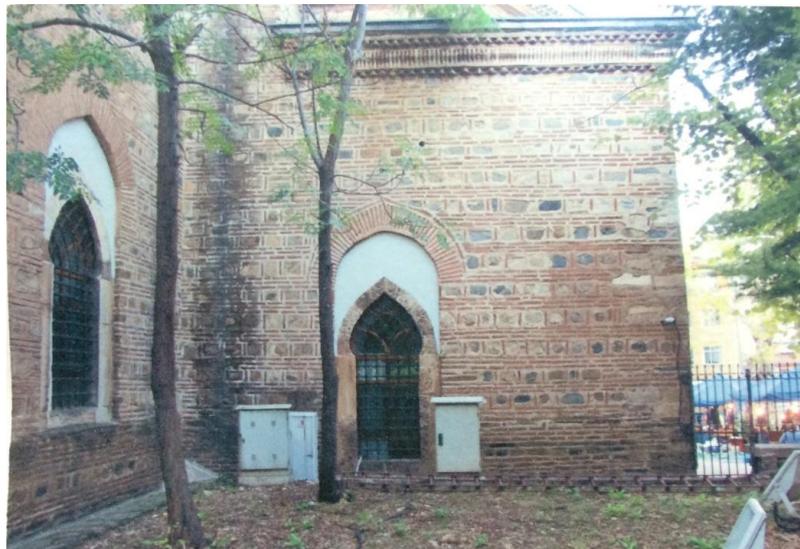
**Figure 5.16.** Blackening and biological growth on the facades before the restoration project  
(Source. Bursa – CNHPRB, 2011)

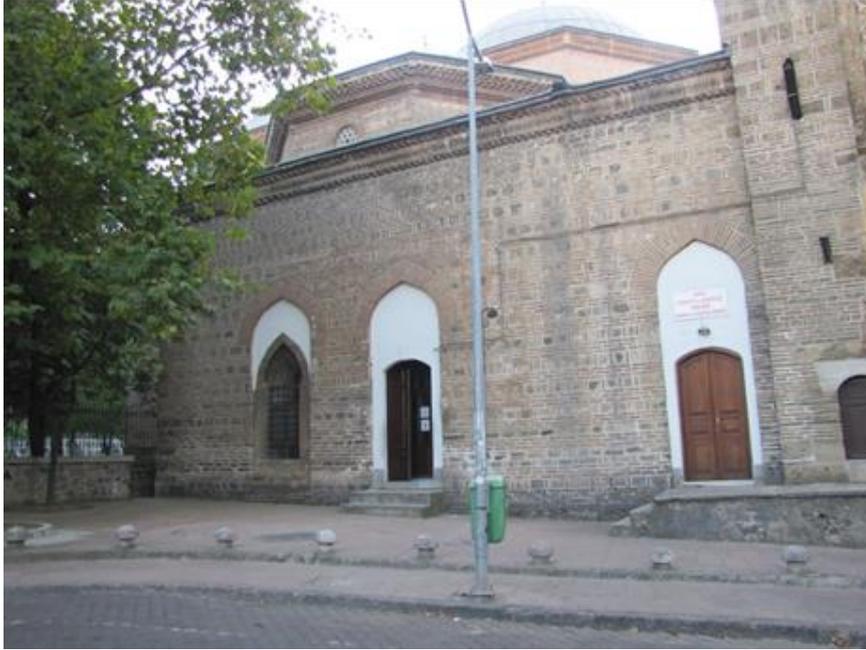
**Figure 5.17.** Blackening and soiled surfaces were seen before restoration on the east facade.

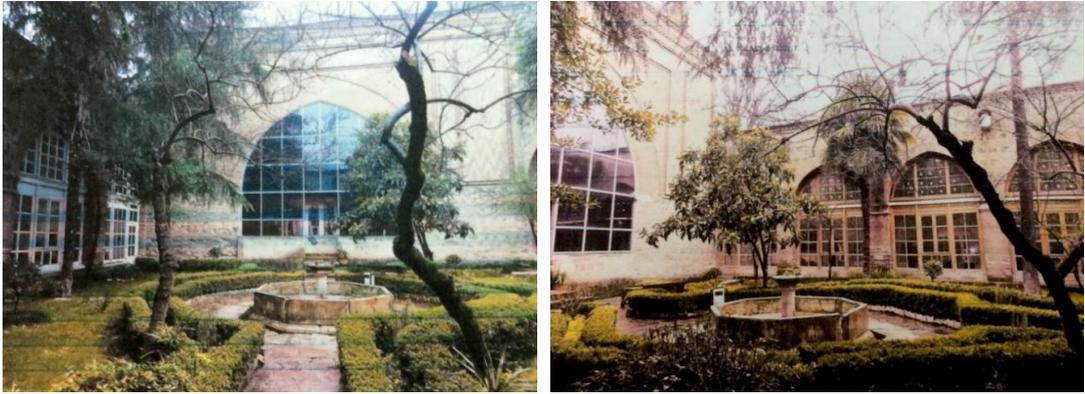
- Dampness problem was observed from both inside and outside of the building. One of the reasons of dampness problem was derived from an intervention to the portico. The openings of the portico were closed with glass panes (Figure 5.18). The other reason is the missing parts of lead sheets of the roof.
- Biological growth was also observed on the surfaces (Figure 5.19).

**Figure 5.18.** Both the photos (a) and (b) display the transformation of the portico to a corridor by closing its openings.

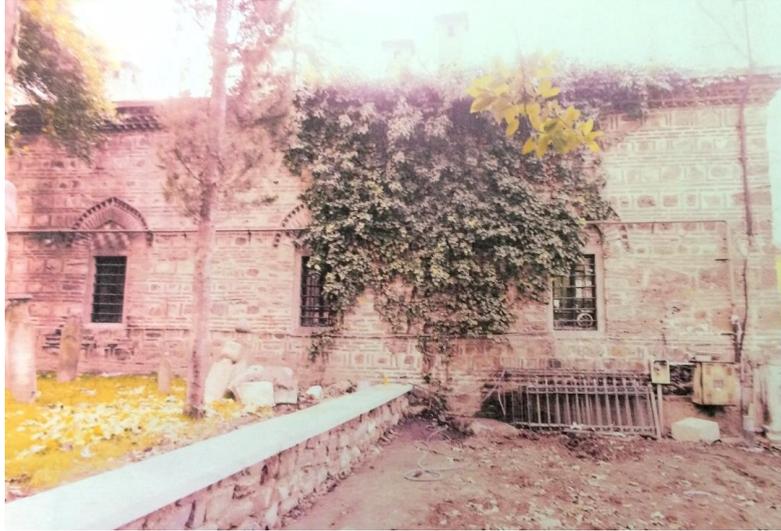
**Figure 5.19.** Biological growth started on the roof and covered the facade.  
(Source. Bursa – CNHPRB, 2013)

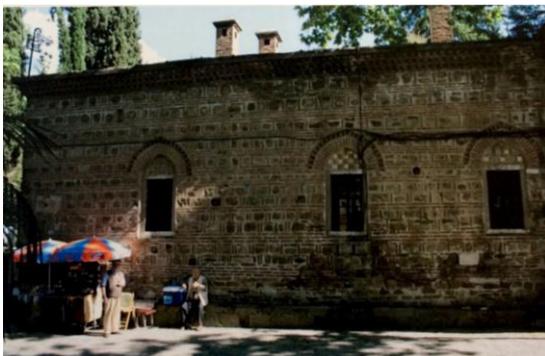
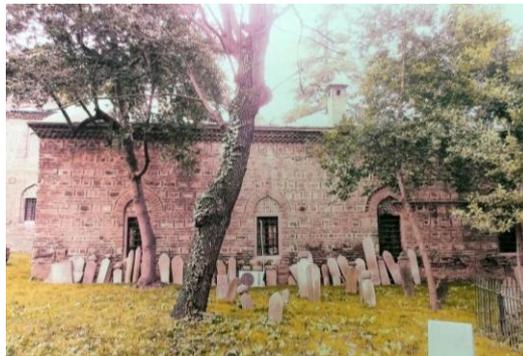
- Blackening, soiling, and water stains due to dampness were observed on all facades of the madrasah (Figures 5.20 and 5.21).

**Figure 5.20.** The north (a) and the east facades (b) of the madrasah suffering from dampness problems.

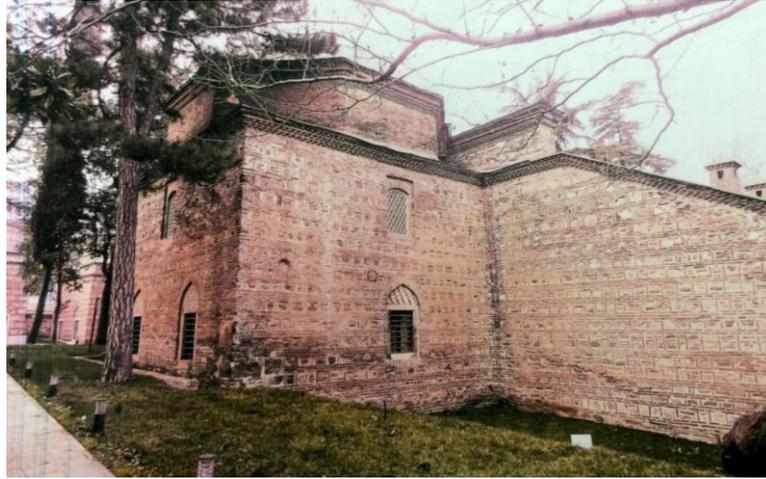
**Figure 5.21.** The southern and southeastern facades having serious problems, such as blackening, soiling, and water stains, due to dampness.  
(Source. Bursa – CNHPRB, 2013)

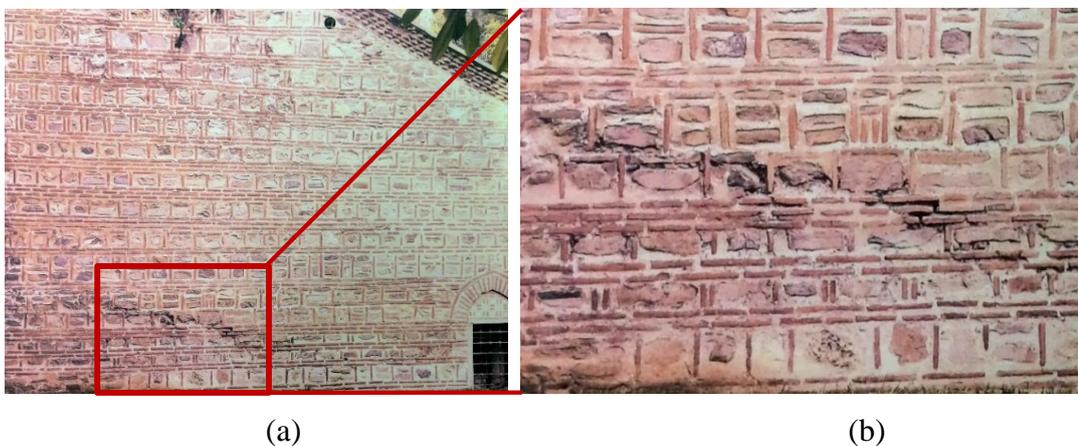
- Poor repointing work raised the level of the mortar joint above the face of the masonry unit, which was aesthetically undesirable and caused performance problems as a thin layer of mortar eroded quickly. In addition, filling joints too completely hid the actual joint thickness and changed the character of the original wall bonding (Figure 5.22).
- Soiling was observed on the marble parts of the facades (Figure 5.23).

**Figure 5.22.** Both (a) and (b) showing the poor repointing work, which caused the eroded mortar joints and detachments of stones.  
(Source. Bursa – CNHPRB, 2013)

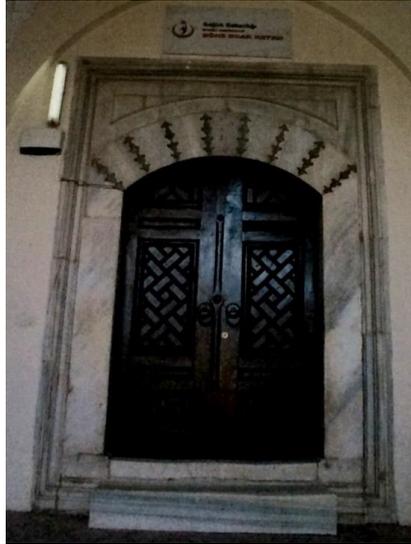
**Figure 5.23.** Soiled marble sections of the main gate  
(Source. Bursa – CNHPRB, 2013)

- **Entrance iwan:** After scraping the plaster from the walls, the dome and the drum, they were replastered with *horasan* plaster, and then painted. The marble parts of the entrance portal on which soiling and discoloration were observed due to weathering processes, were cleaned. The paint on the wooden door was scraped off and given a coat of vapor-permeable finish that allows for movement and the release of moisture. The terrazzo flooring was cleaned and preserved.
- **Portico:** After removing the layer of paint, tie-rods were inserted between the arches, deteriorated ones were replaced with new ones, which were compatible with the original ones.
- **Rooms:** Wooden window sashes and wooden doors were cleaned from paint and given a coat of flexible vapor-permeable finishes. Iron grills of the windows were cleaned and re-painted with anti-rust paint.

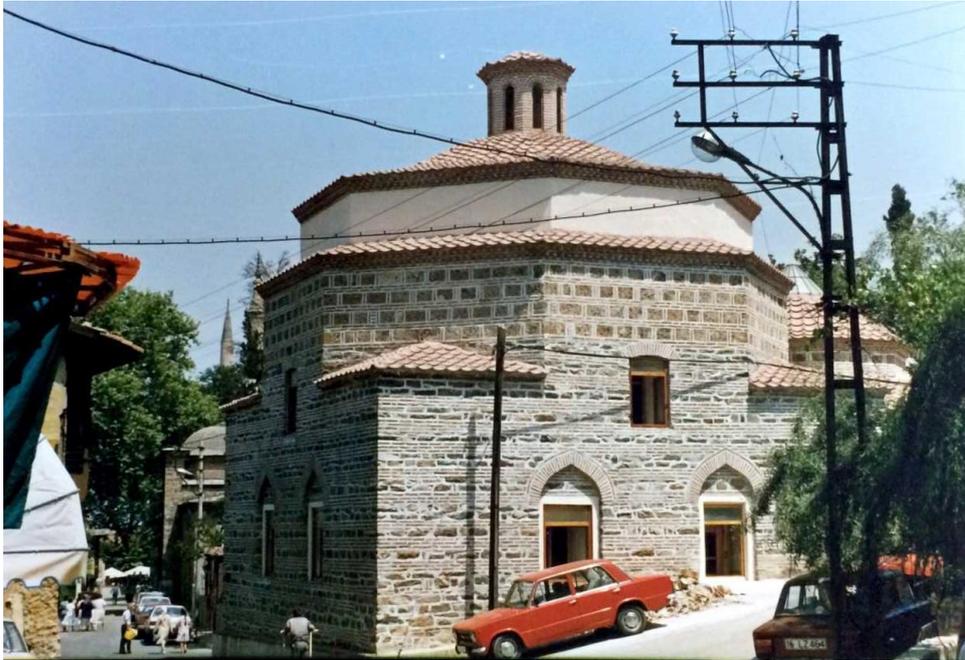
**Figure 5.26.** The photo showing the solved issues, such as biologic growth, blackening, soiling, decayed pantiles and material loss on the northern and the western facades of the building.  
(Source. Bursa – CNHPRB, 1987)

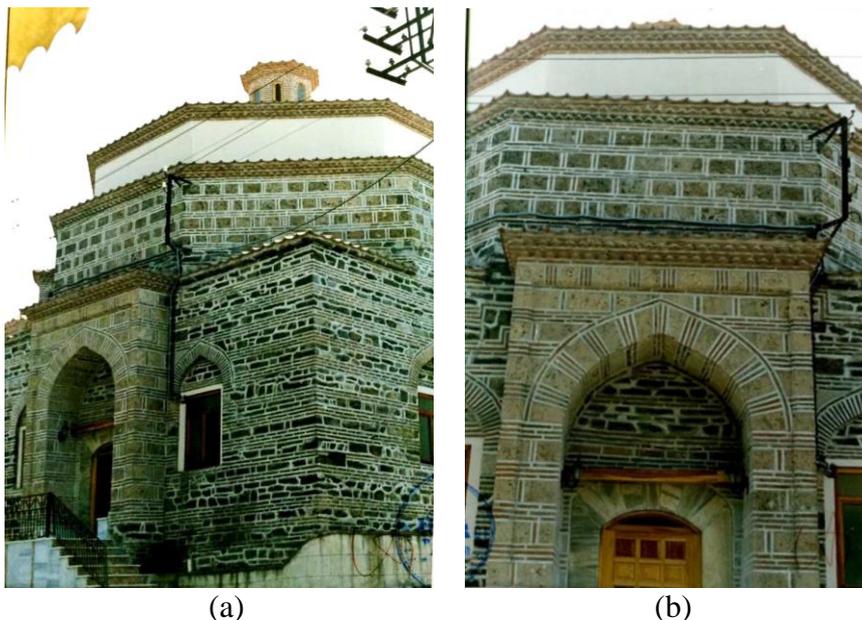
**Figure 5.27.** The both (a) and (b) showing the altered wooden parts of the building, the repaired entrance stairs, the plinth with cut stone finishing, and the places of power cables and utility pole on the facade.  
(Source. Bursa – CNHPRB, 1987)

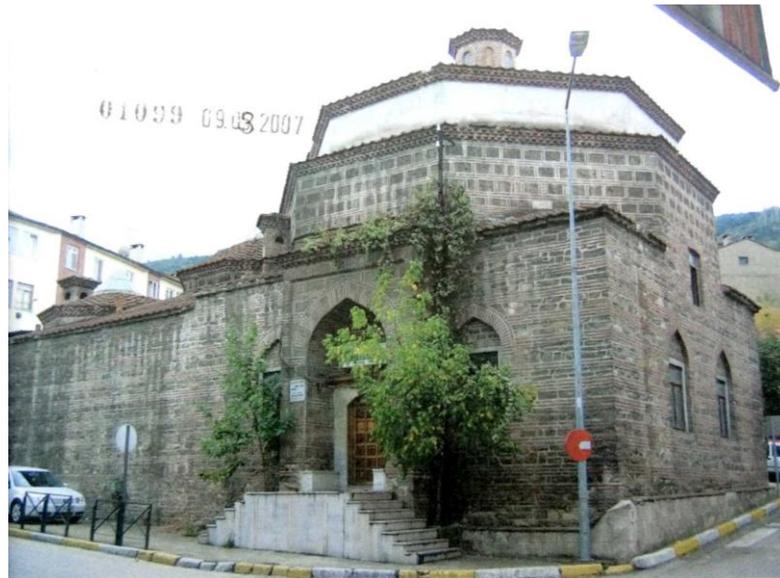
**Figure 5.28.** A view from the entrance of the building showing biologic growth, black streaks, and soiling, which dominated on the facade.  
(Source. Bursa – CNHPRB, 2007)

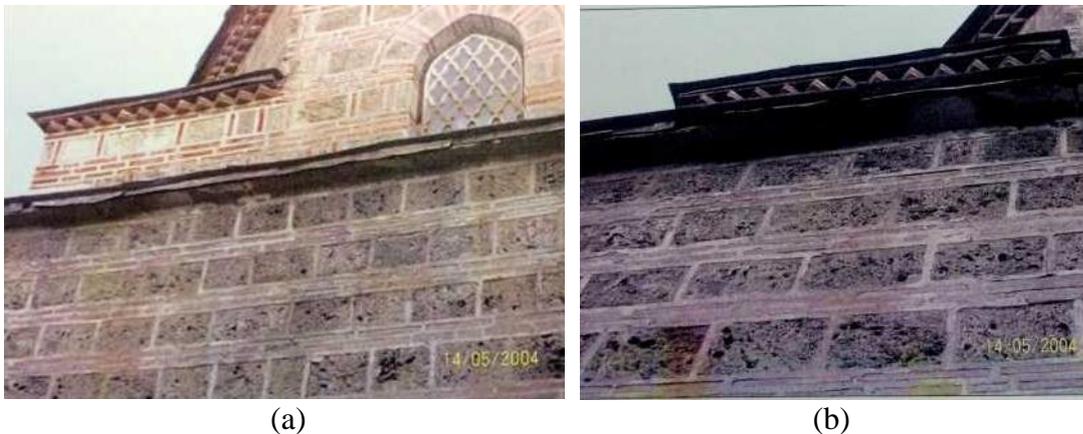
The roof and coping were covered with lead sheets but they had deformed and the seams had speared up. Therefore, water had seeped through and caused deterioration on the surface. Damp stains were observed on the fascia (Figure 5.29). Construction of drip-edge flashing was suggested. Moreover, inside of dome there were also the effects of degradation due to damp, which penetrated from deformed lead sheets.

(a) (b)  
**Figure 5.29.** The both photos (a) and (b) showing the deformed eaves and lead boards.

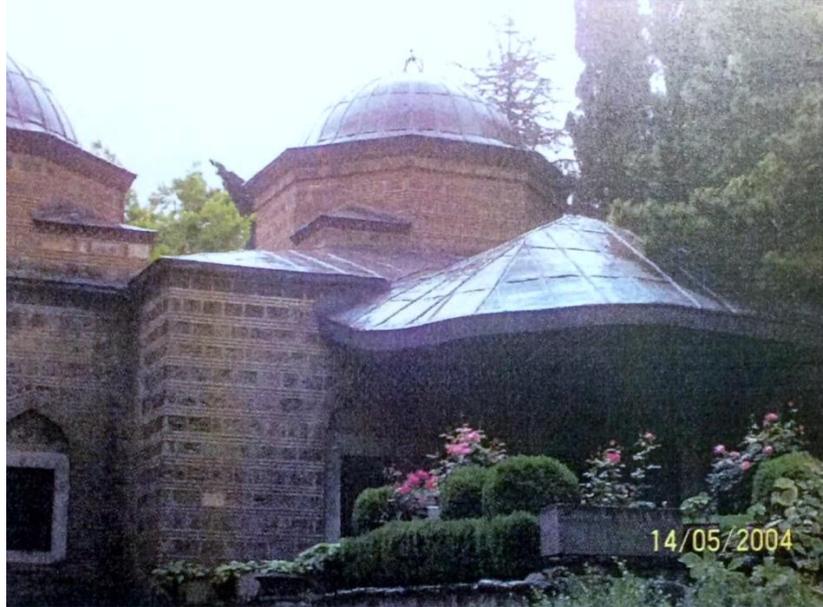
It was stated that the deterioration of lower parts of main walls indicates the problems of rising damp from ground and of soluble salts. Besides, occurrence of the biological growth due to rising damp was also observed (Figure 5.30). Construction of a drainage system was suggested to solve this problem.

**Figure 5.30.** The photo showing the entrance facade on which there were black streaks due to rising damp and dirt.  
(Source. Bursa – CNHPRB, 2004)

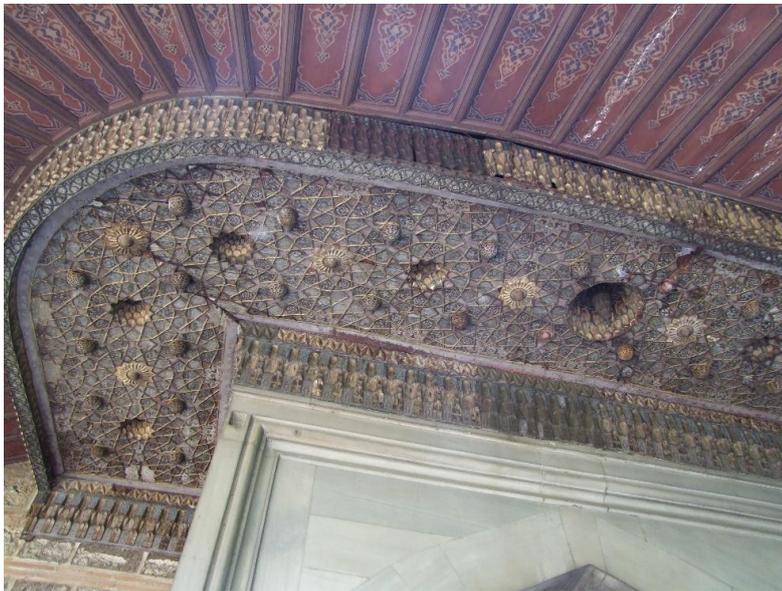
*(iii) Survey Report of 2010:* Blackening and biological growth (algae) due to dampness were determined on the marble parts of entrance portal (Figure 5.31). The canopy made of wood and covered with lead showed signs of decay of in patches (Figures 5.32). Besides, lead sheets of the canopy deformed and damaged (Figure 5.33).

**Figure 5.32.** The photo shows the ceiling of the entrance canopy whose wooden parts embellished with hand-carvings and gilded were deteriorated.  
(Source. D2 Tasarım Mimarlık, 2010)

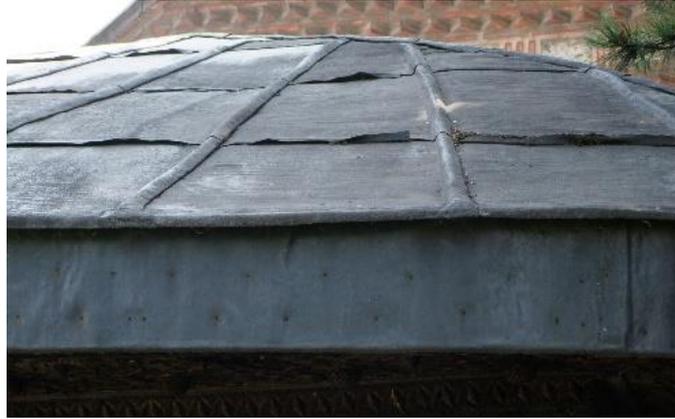
**Figure 5.33.** The photo showing deformed and torn lead boards of the entrance canopy.

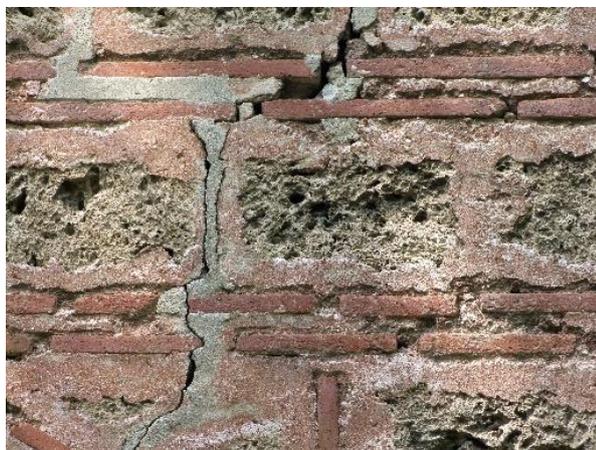
Cracked masonry, eroded mortar joints (Figure 5.34), and dirt stains and blackening due to water leakage from underneath the eaves were determined (Figure 5.35 and Figure 5.36).

**Figure 5.34.** The photo displays poor repointing work raises the level of the mortar joint above the face of the masonry unit. This is aesthetically undesirable and can cause performance problems as a thin layer of mortar will quickly erode.

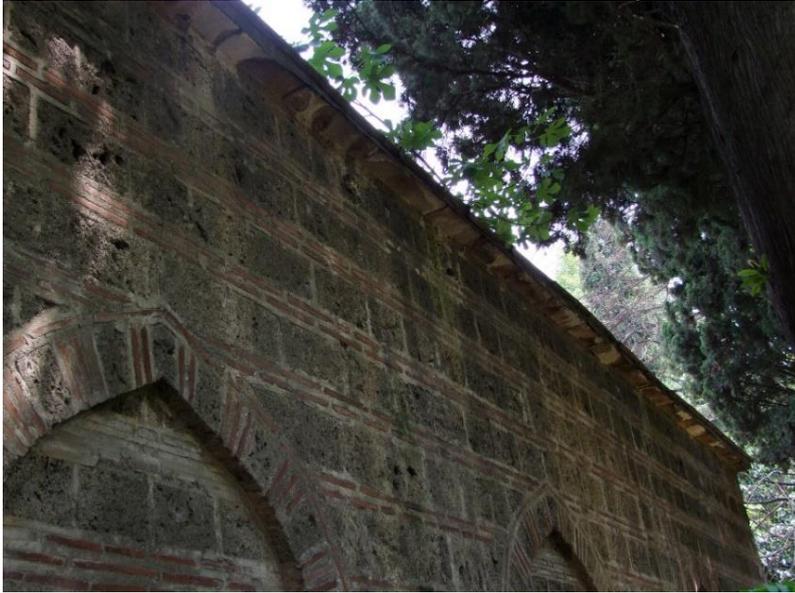
**Figure 5.35.** The view from south facade of the tomb shows dirt stains and blackening due to water leakage from underneath the eaves.  
(Source. D2 Tasarım Mimarlık, 2010)

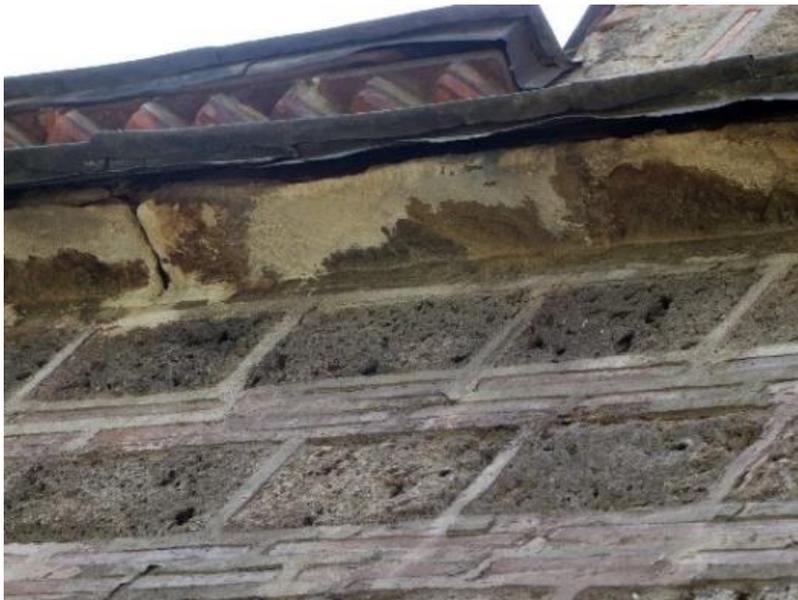
**Figure 5.36.** The photo zooms the detail from the deteriorated eaves, which cause water leakage.  
(Source. D2 Tasarım Mimarlık, 2010)

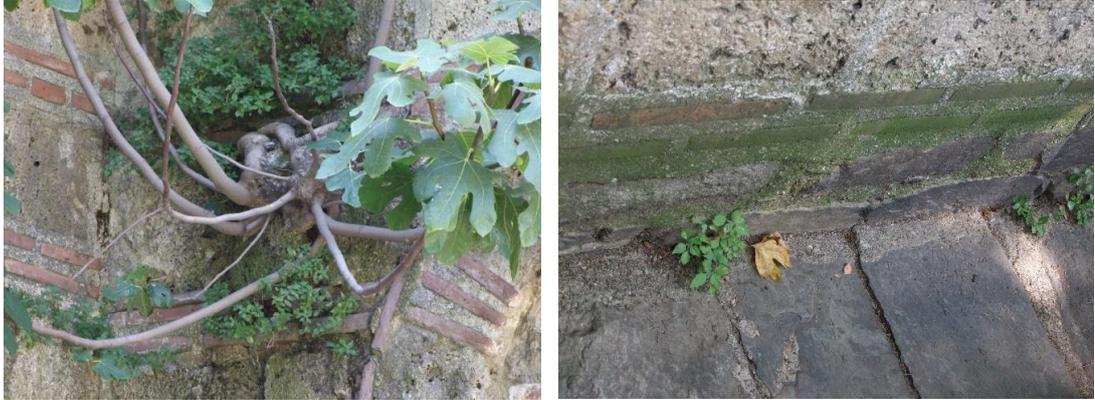
Excessive blackening and biological growth, such as algae, plants, grasses, ivy and climbers, was found on both the plinth and the upper parts of walls (Figure 5.37a). Formation of algae was also noticed on the floors (Figure 5.37b).

**Figure 5.37.** Both (a) and (b) display biological growth (plants and algae) at the intersection of walls and the plinth, respectively.  
(Source. D2 Tasarım Mimarlık, 2010)

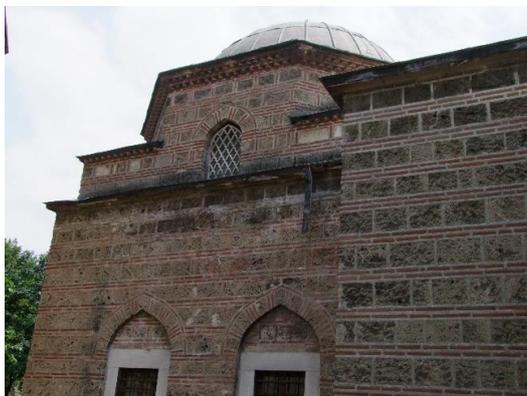
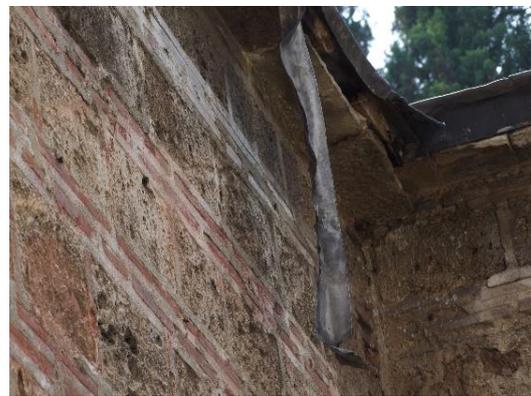
*Tomb of Şehzade Alaaddin:* Deformed and damaged lead sheets over the eaves caused formation of black streaks on walls, damp penetration through the walls, and blackening and watermarks on a saw-tooth course of brick and the moulding on the eaves (Figure 5.39 and Figure 5.40).

Deterioration of brick, stone and marble; accumulation of dirt; and cracks on stones were observed. Although facades were maintained during the previous interventions, formation of black streaks and eroded mortar joints were noticed because of advance level of dirt and degradation (Figures 5.40 and 5.41).

**Figure 5.40.** (a) and (b) zoom to damaged lead sheets and blackening on a saw-tooth course of brick and the moulding, and deteriorated stones.  
(Source. D2 Tasarım Mimarlık, 2010)

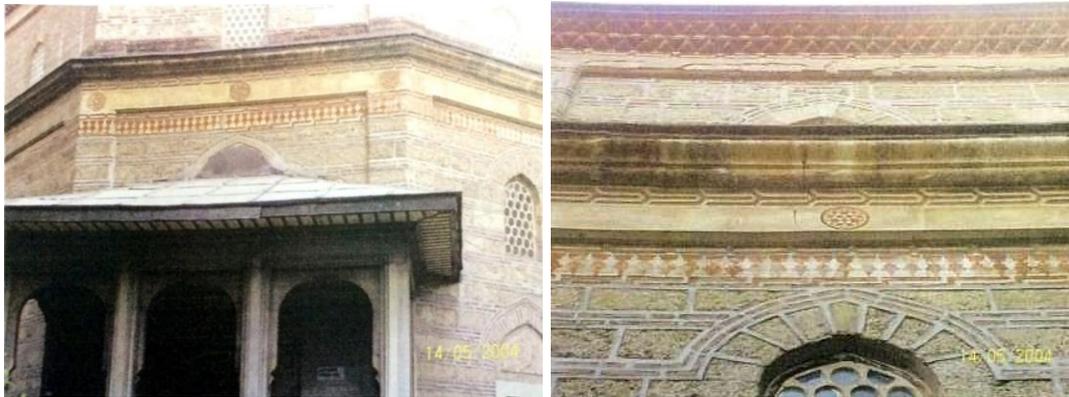
- The dome and copings were covered with lead sheets but they had deformed and the seams had speared up. Therefore, water had seeped through and caused deterioration on the surface. Damp stains, soiling and blackening were observed on the fascia (Figure 5.42).
- Cement-based mortars were swollen.
- Excessive biological growth was especially observed on both the plinth and the mortar joints (Figure 5.43).
- The windows decayed due to wood beetles / termites attack. The paint peeled off from the window frames.

**Figure 5.42.** Both (a) and (b) showing damp stain, soiling and blackening on the moulding and the facade due to deformed lead sheets covering copings; and damaged saw-tooth course of bricks and plaster.

drainage system and waterproofing for the foundation were suggested to solve this problem.

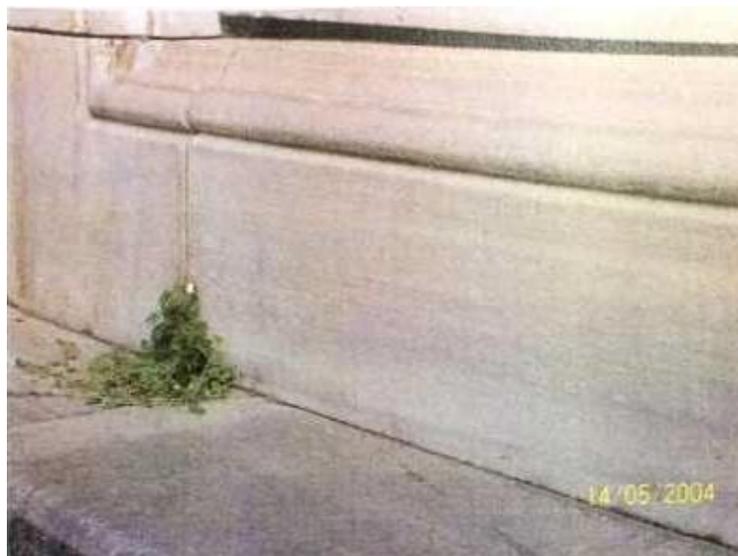
**Figure 5.43.** Biological growth was observed on the mortar joints.

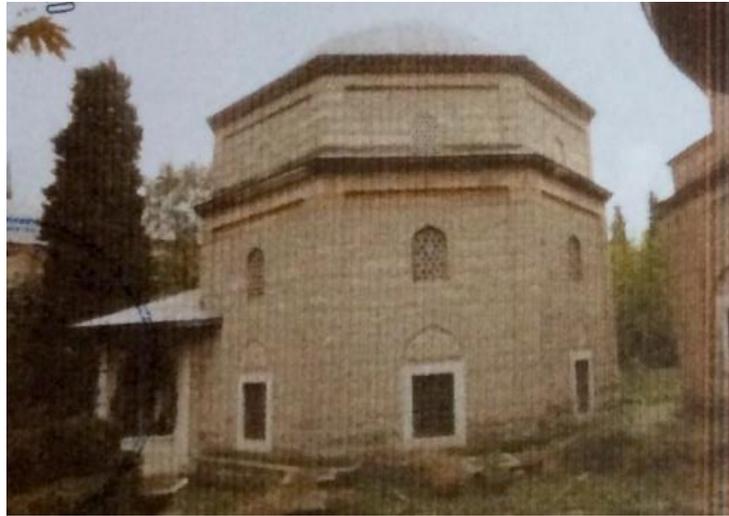
**Figure 5.44.** Blackening and biological growth were observed due to dampness problem on the plinth and around the copings.  
(Source. Bursa – CNHPRB, 2010)

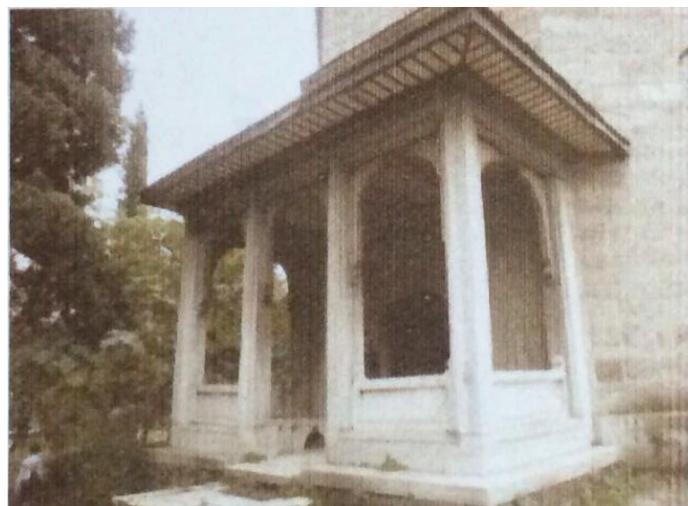
**Figure 5.45.** Blackening, soiling and biological growth were seen on the marble portal  
(Source. Bursa – CNHPRB, 2010)

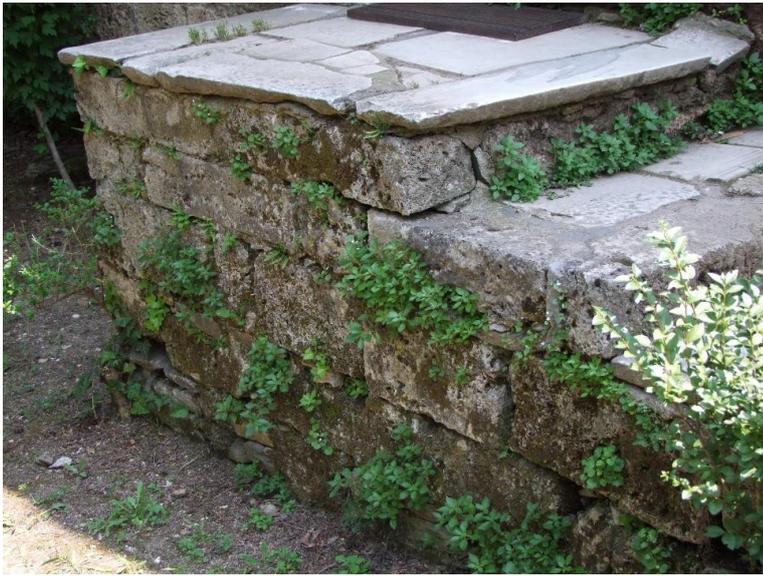
- *Küfeki* stones and facing stones of the stairs in front of the portico eroded and were detached. Several stones displaced while some of them were missing. Soiling and biological growth due to excessive dampness problem were observed (Figure 5.46).

**Figure 5.46.** Biological growth and soiling were observed due to excessive dampness problem.

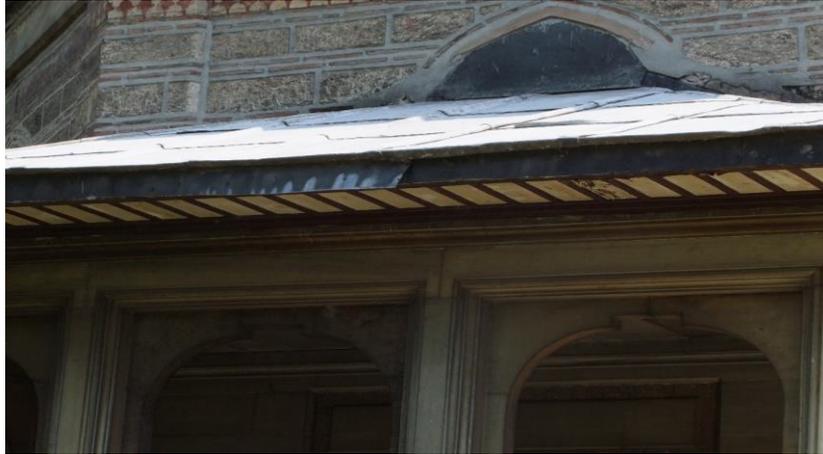
- Lead sheets, which covered the roof of the portico, had deformed and the seams had speared up. Therefore, water had seeped through and caused deterioration on the wooden parts of the roof (Figure 5.47).
- Surface erosion was observed in the saw-tooth brick courses.

**Figure 5.47.** Deformed lead sheets of the portico's roof caused deterioration of wooden parts of the roof.  
(Source. D2 Tasarım Mimarlık, 2010)

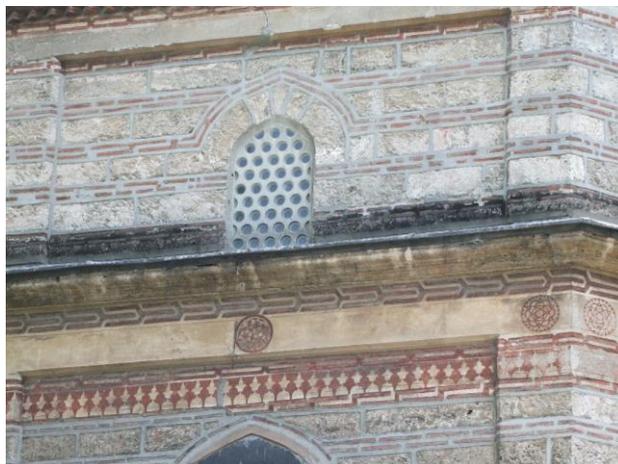
- Water had seeped through the deformed lead sheets, which covered the coping. Therefore, blackening was observed on materials such as stone, marble and bricks. Motifs below the moulding were wiped away due to blackening (Figure 5.48).

**Figure 5.48.** Deformed lead sheets on moulding caused deterioration on motifs and blackening on the facade.  
(Source. D2 Tasarım Mimarlık, 2010)

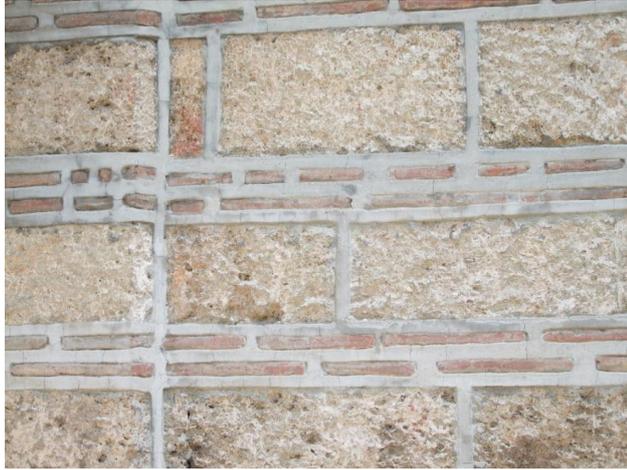
- Cement-based mortar was extensively used during the previous repairs (Figure 5.50).
- Surface erosion and soiling were identified on the facades. Although facades were maintained several times, blackening and eroded mortar joints were observed (Figure 5.51).

**Figure 5.50.** Mortar joints were repointed by cement-based mortar in the previous interventions.
