A PROPOSED MODEL FOR UNDERSTANDING THE IMPACTS OF CLIMATE  
CHANGE ON TANGIBLE CULTURAL HERITAGE

A THESIS SUBMITTED TO  
THE GRADUATE SCHOOL OF NATURAL AND APPLIED SCIENCES  
OF  
MIDDLE EAST TECHNICAL UNIVERSITY

EMİNE GİZEM BAŞKAN

JANUARY 2016

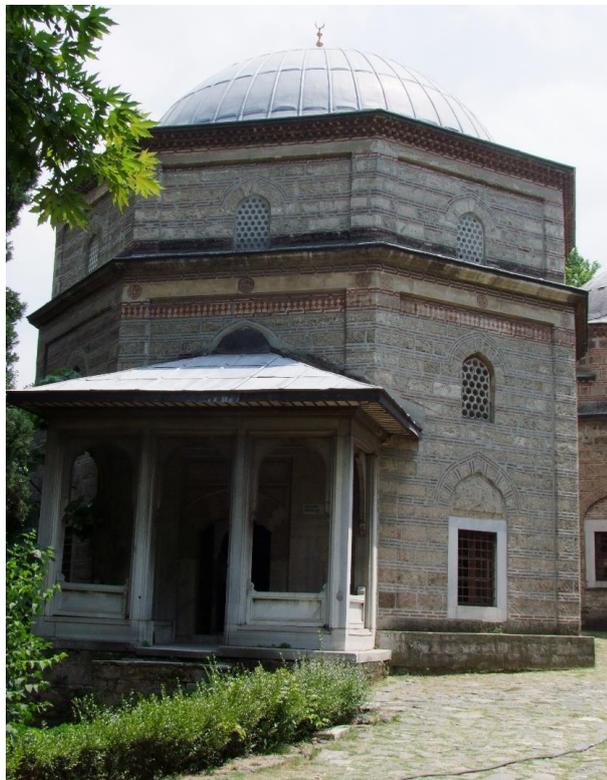
**Figure 5.51.** A view from northern facade of the tomb showing different problems, such as blackening, damp stains, biological growth and misapplication of repointing.

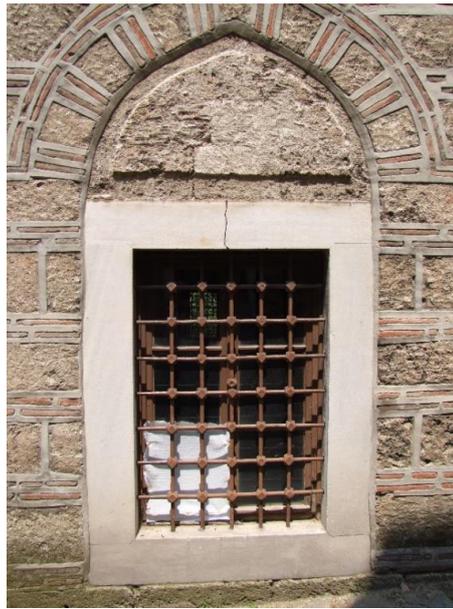
- Detached parts and pitting were observed on *küfeki* stone.
- Due to rising damp, biological growth was found on both the plinth and the upper parts of walls.
- Cracks in the marble window casings and surface erosion on arch pediment of the windows made of *küfeki* stone were identified. Wooden frames decayed and window glazing was broken (Figure 5.52).

**Figure 5.52.** The arch pediment of the window eroded; and marble casing cracked.  
(Source. D2 Tasarım Mimarlık, 2010)

- Cracks in marble and stone window casings were repaired and composite patching was carried out for missing sections.
- Iron grills of the windows were cleared from paint and re-painted with anti-rust paint.
- Wooden window sashes and shutters were reinstated and preserved. Fumigation method was employed. Missing shutters were produced in compliance with the original ones. A coat of flexible vapor-permeable finishes was applied. Broken glasses were replaced.

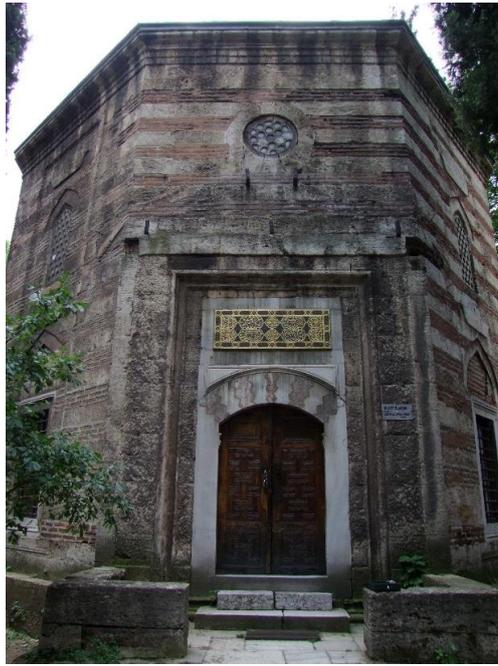
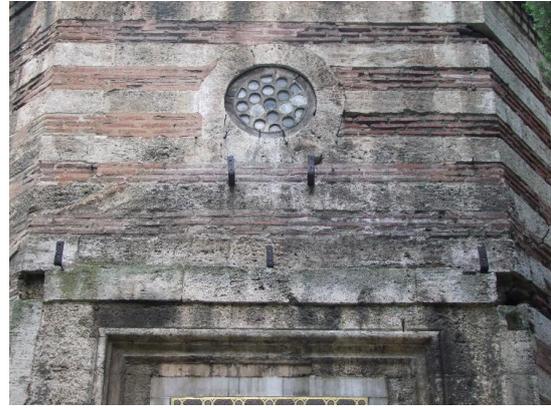
**Figure 5.55.** The photos showing (a) the entrance facade and traces of the missing canopy; and (b) blackening, soiling, and greening due to algae growth on the facade. (Source. D2 Tasarım Mimarlık, 2010)

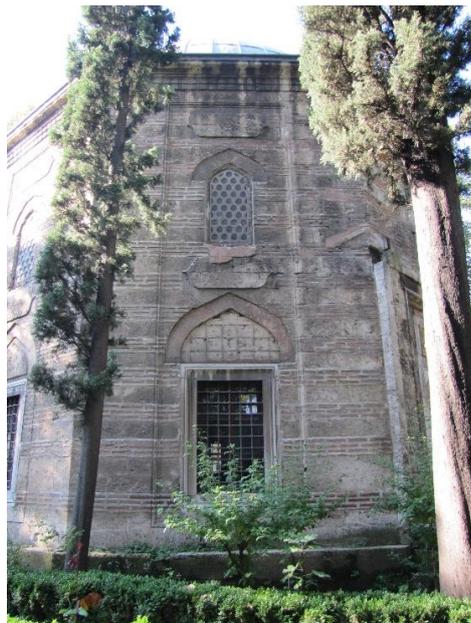
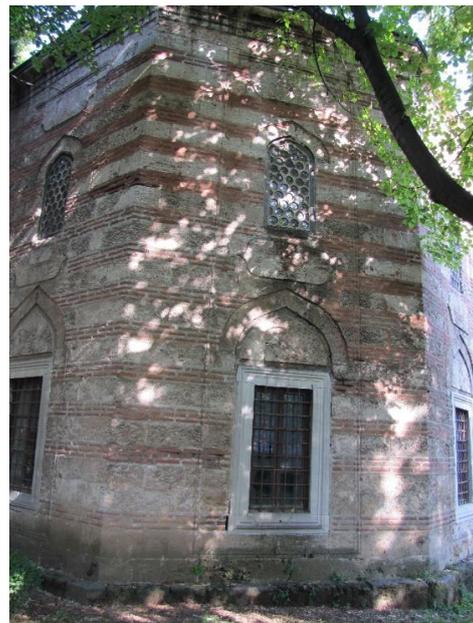
**Figure 5.56.** The photos showing the facades on which there were black streaks and biologic growth due to rising damp and dirt; and material loss. (Source. D2 Tasarım Mimarlık, 2010)

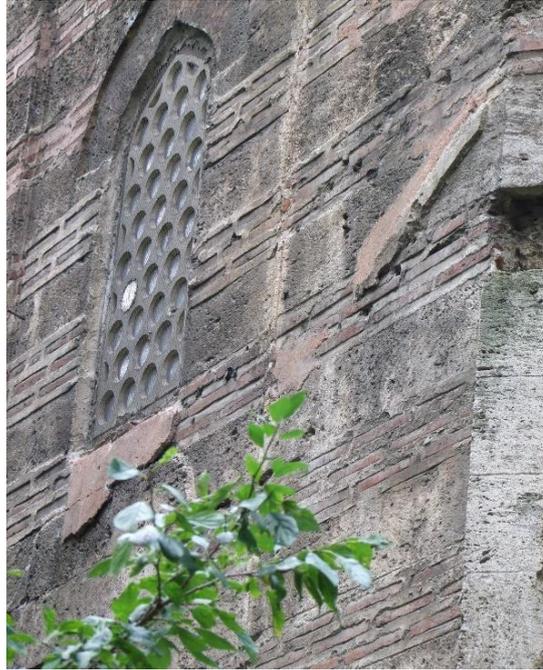
- The improperly done repointing, which not only affected negatively the overall appearance of the facade but also caused physical damage to the masonry, was seen in Figure 5.57.

**Figure 5.57.** The photos displaying the improperly done repointing.  
(Source. D2 Tasarım Mimarlık, 2010)

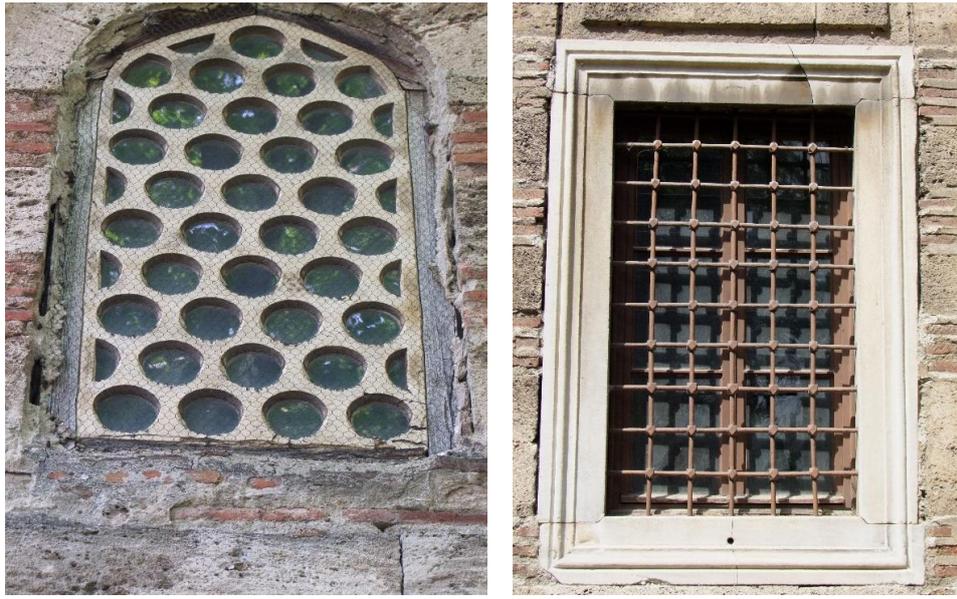
- The gypsum frames of the exterior windows (*dışlık*), which secured the glass pieces, had gradually been deteriorated due to weathering and / or the lack of regular maintenance. Blackening and soiling were also observed on the frames (Figure 5.58).
- Cracks in the marble casings of windows; and blackening and soiling on them were seen. Wooden window frames had damaged due to weathering and /or the lack of regular maintenance.

**Figure 5.58.** The photos displaying (a) the deteriorated window frame made of plaster; and (b) the problems, such as cracks, blackening and soiling.  
(Source. D2 Tasarım Mimarlık, 2010)

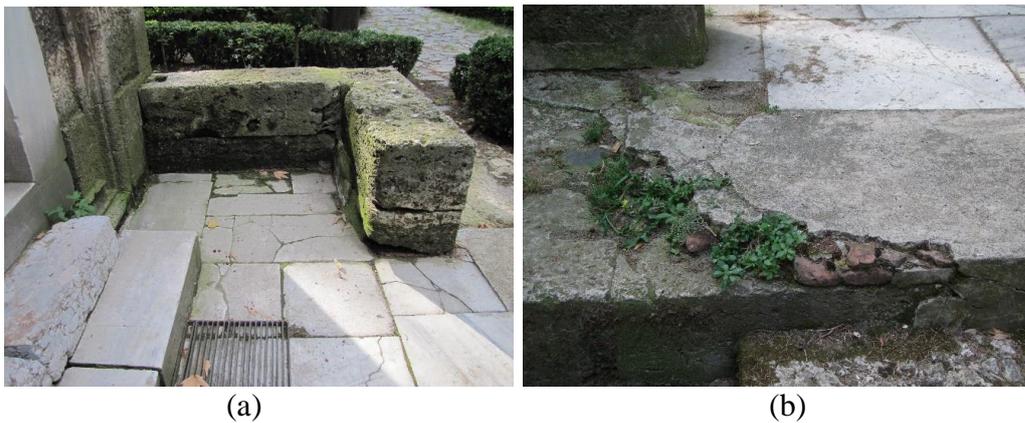
- The wooden entrance door, which was constructed by *kündekari* technique. It had deteriorated due to weathering and / or the lack of regular maintenance. Greening and darkening were seen on the marble parts of the portal (Figure 5.59).
- Biologic growth, such as algae and different kinds of plants, was easily observed on the base of the missing entrance portico. It had a significant contribution to the stone damage through various deterioration mechanisms (Figure 5.60).

**Figure 5.60.** Both (a) and (b) showing the biologic growth and deteriorated stone.  
(Source. D2 Tasarım Mimarlık, 2010)

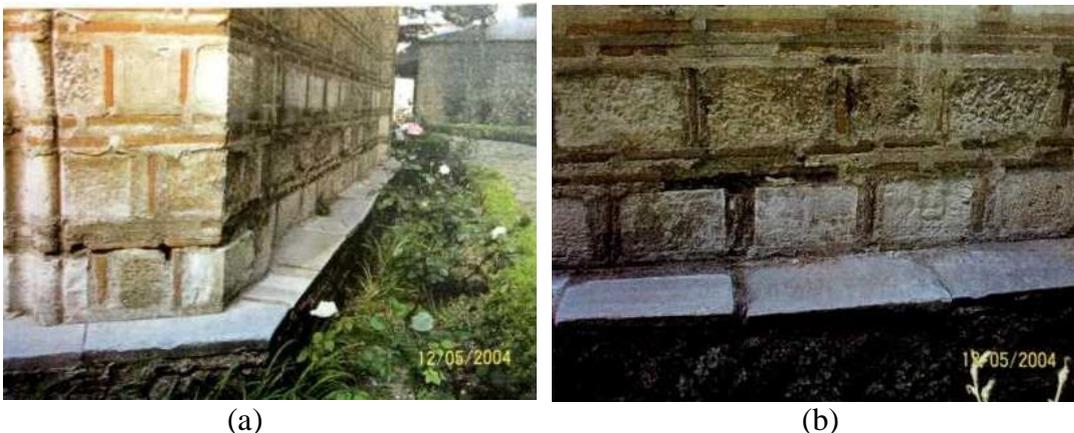
- Damp stains were observed on the eaves fascia.
- Lead sheets had deformed and the seams had speared up.
- Bricks were placed vertically between the stones in the main walls (*almaşık*), which are composed of alternating one course of stone and two courses of brick. The cement-based plaster covered all mortars and calcareous stones. The cement-based plaster disintegrated in patches. The deterioration in physical properties of the stone was observed.
- Eroded brick and stonework was determined especially in the lowest two rows of *almaşık* wall of the south facade (Figure 5.61).
- The effects of deterioration due to damp inside of the dome indicated the water penetration problem due to deformed lead sheets covering the dome.

**Figure 5.61.** Both (a) and (b) showing the deteriorated stone and brick courses.  
(Source. Bursa – CNHPRB, 2004)

It was stated that the deterioration of lower parts of the main walls indicates the problems of rising damp from ground and of soluble salts. Construction of a drainage system and waterproofing for the foundation were suggested to solve this problem.

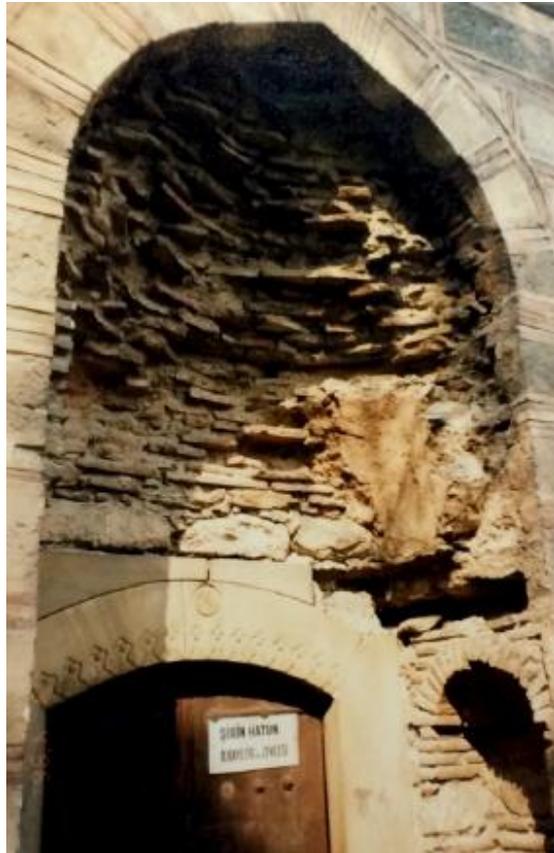
**Figure 5.64.** Excessive deterioration of the brick-built muqarnas hood on the portal of the tomb.

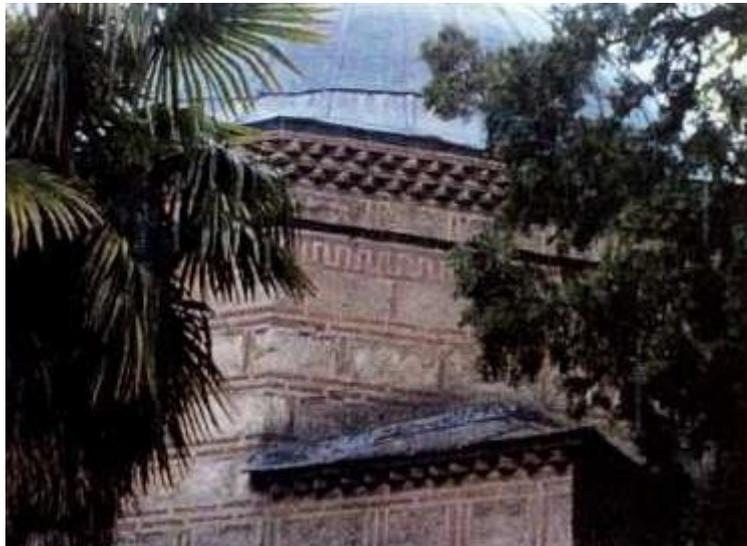
- Saw-tooth courses of brick were in good state (Figure 5.65).
- Lead sheets, especially on the eaves, were deformed (Figure 5.65). The seams speared up.
- Cracks were observed in the marble window casings.
- Deterioration on wooden window frames was determined.
- Poor repointing work raised the level of the mortar joint above the face of the masonry unit. Therefore, lime plaster was swollen, and spalled in patches (Figure 5.66).
- Window shutters were excessively deteriorated due to fungal decay and infestation.

**Figure 5.65.** The photo showing the deformed lead sheets and saw-tooth courses of brickwork which were sound.  
(Source. Bursa – CNHPRB, 2004)

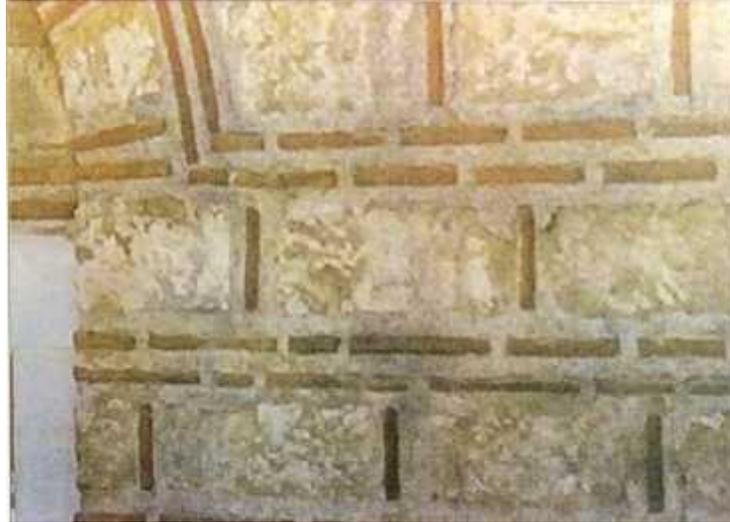
**Figure 5.66.** The photo showing the poor repointing and spalling of the plaster.  
(Source. Bursa – CNHPRB, 2004)

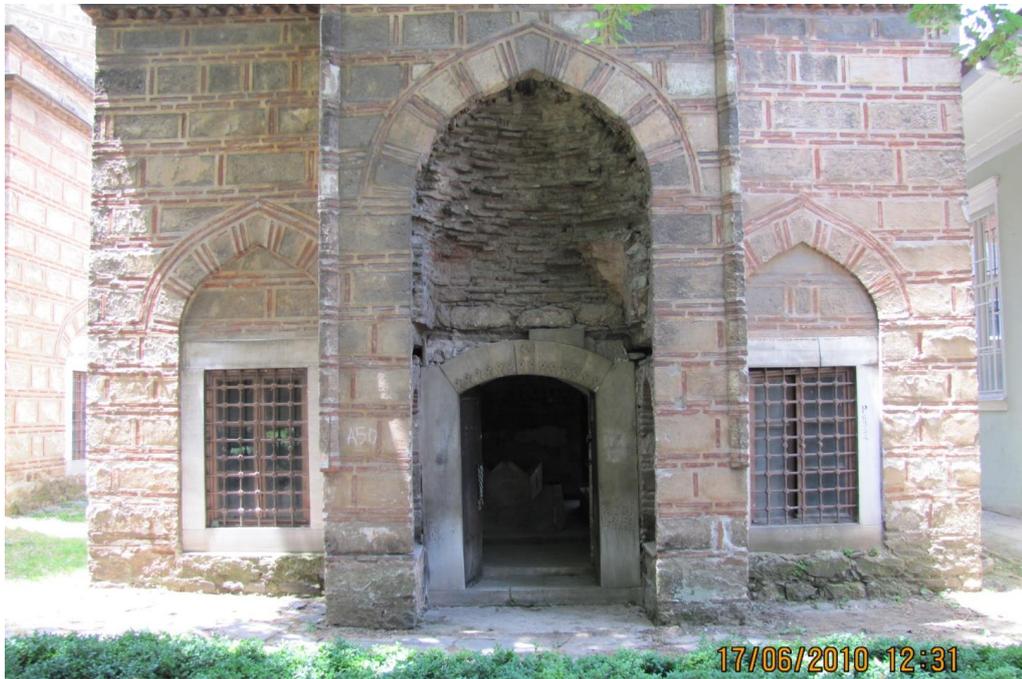
**Figure 5.67.** The photo showing the eroded or detached brickwork of the portal, the cement-based mortar joints and the flaking plaster over the cut-stone, and dampness problem.

- Cement-based mortars and plaster were removed (Figure 5.67). Repointing was conducted according to results of the mortar analysis.
- After removing the detached portions of the saw-tooth courses of brick, the ones, which were same type and same dimensions, were placed.
- Irregularity of the alternate walls' courses was left as they are.
- Blackening due to dampness and carbon accumulation was cleaned (Figure 5.67).

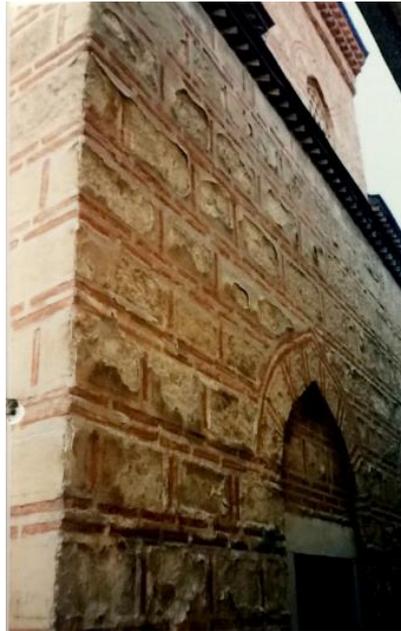
**Figure 5.68.** The flaking plaster over the facades  
(Source. Directorate of Bursa Museum, 1996)

*i) Expert Report of 1996:* According to a report of an expert from the Directorate of Bursa Museum, basic maintenance and repairs were recommended, such as removing plaster over the cut-stone (Figure 5.68), cutting out and repointing of mortar joints in alternating brick and stone rows, and repairing the wooden door and window frames. Besides, the activities, such as repairing the brick-built muqarnas hood on the portal of the tomb, and scraping off plaster on the brick courses of two niches on both sides of the portico were included in the extensive remedial activities conducted by preparing survey and restoration projects.

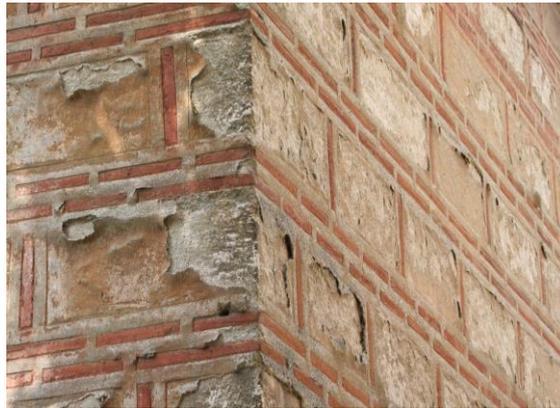
- All facades were covered with cement-based plaster in the previous interventions. The plaster on the surfaces of the stonework and the mortar joints swelled and spalled in patches (Figure 5.70).

**Figure 5.70.** The photo showing the plaster spalling on the surfaces of masonry.  
(Source. D2 Tasarım Mimarlık, 2010)

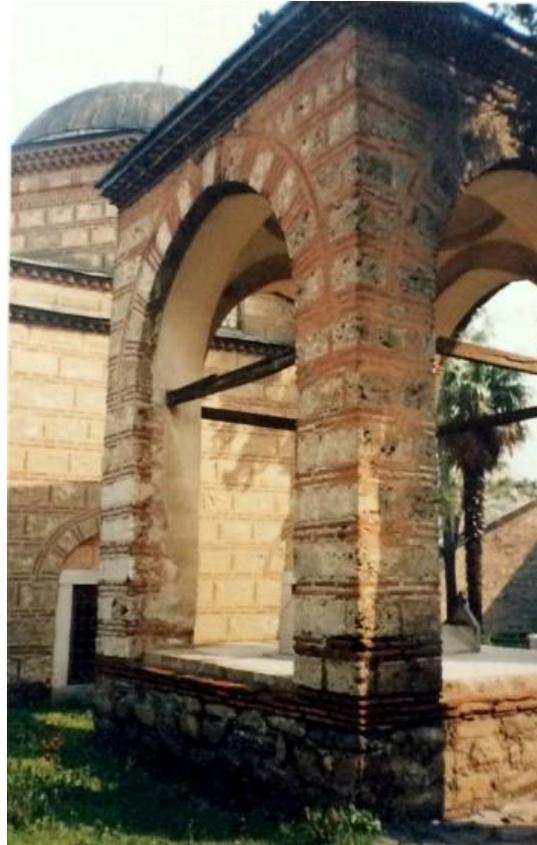
**Figure 5.72.** The photo showing the stains of the dampness problem and deteriorated brickworks and mortar joints.  
(Source. Directorate of Bursa Museum, 1996)

*i) Expert Report of 1996:* According to a report of experts from the Directorate of Bursa Museum, basic maintenance and repairs were recommended, such as re-plastering and painting the inside, removing plaster over the cut-stone courses, and

cutting out and repointing of mortar joints in alternating brick and stone courses  
(Figure 5.72)

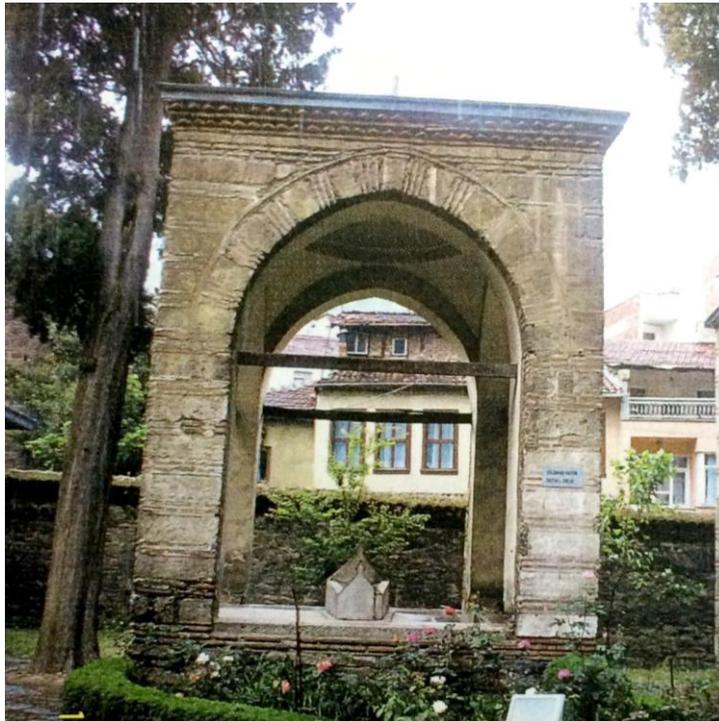
- The deflection of the bonding timber and material loss were observed at the west and south facades.
- Brick courses above the plinth deteriorated and detached seriously.
- Mortar joints deteriorated especially in between bricks constituting of the lower parts of the piers (Figure 5.73).

**Figure 5.73.** The photo showing the deteriorated mortar joints, the spalled plaster covering the surfaces of stone courses, and blackening.  
(Source. Bursa – CNHPRB, 2004)

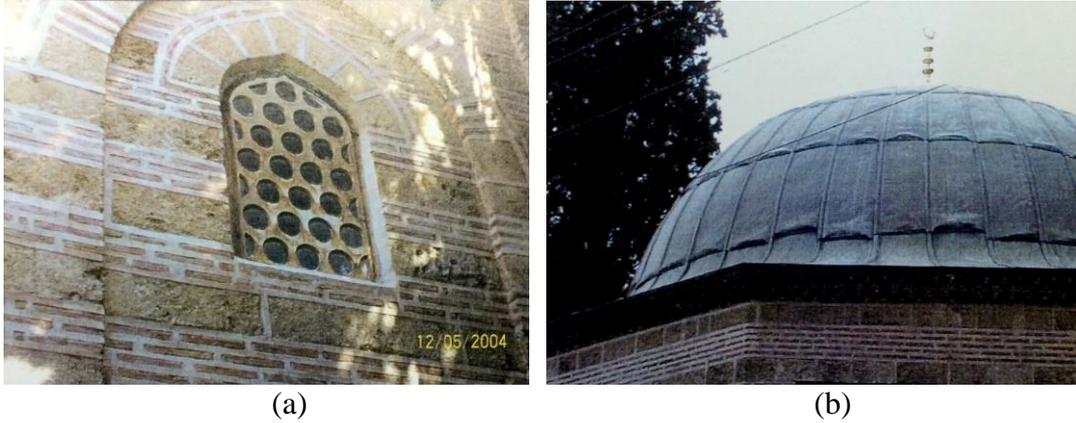
- Eroded sections of the plinth were repaired by using mortar.
- The cement framed exterior window (*dışlık*), which is on the south facade, split from the facade (Figure 5.75a).
- Saw-tooth brick courses were in good state.
- Lead sheets covering the dome, the eaves and the roof of the canopy were deformed. Unrepaired lead sheets caused water seep through the deformed seams, and then led to interior wall damage (Figure 5.75b).

**Figure 5.75.** The photos showing (a) the deteriorated cement framed exterior window and improper repointing, and (b) unrepaired lead sheets covering the dome. (Source. Bursa – CNHPRB, 2004)

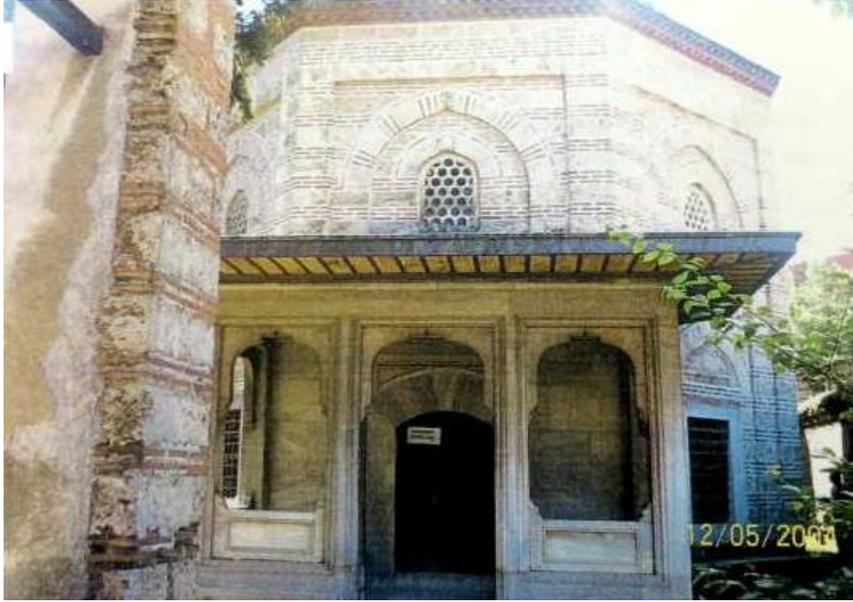
- Material loss was observed in the marble parts of the portal and the portico (Figure 5.76).
- Swelling, formation of the crystalline deposit (efflorescence), and spalling in patches on the surface of the plaster were observed due to the dampness problem derived from capillary rise.
- The deteriorated gypsum framed interior windows (*içlik*) split from the facade. The bell jars (*fil gözü*) were broken.
- The window frames were in good state while the window shutters and the wooden door, which was produced with *kündekari* technique, decayed due to wood beetles / termites attack. Besides, material loss was also observed.

**Figure 5.76.** The photo showing material losses, blackening, soiling and greening on the marble portions of the portico and the portal.  
(Source. Bursa – CNHPRB, 2004)

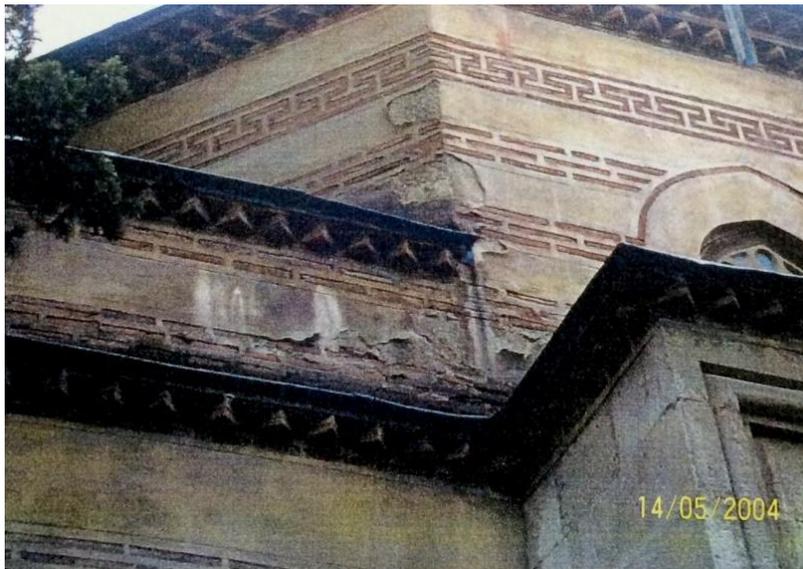
- It was visually observed that cut-stone courses were covered with lime plaster (sand+lime), which was swollen and spalled in patches (Figure 5.79).
- Saw-tooth brick courses were in good state.
- Lead sheets covering the dome were deformed, and so unrepaired lead sheets did not performed their duties.

**Figure 5.79.** The photo showing the spalled plaster, blackening and improper repointing.

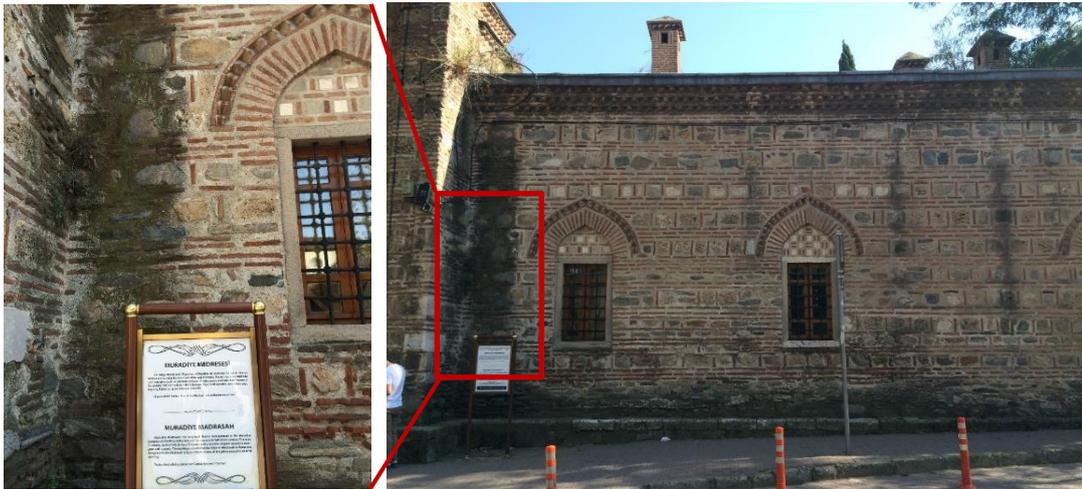
One of the possible reasons of the observed greening of stone surfaces, which indicates an increase in moisture availability and associated time of wetness, is the flow of water over the surface (Figure 6.30).

Black streaks, i.e. accumulated dirt and pollutants, were also observed on the facades that may be linked to changes in pollution regime in urban locations. Automotive emissions generating atmospheric particles and corrosive gases in contact with climate parameters may also be effective in formation of black streaks (Figure 6.30).

**Figure 6.30.** The greening of stone and black streaks were dominant on the facade (taken by the author in August 2014).

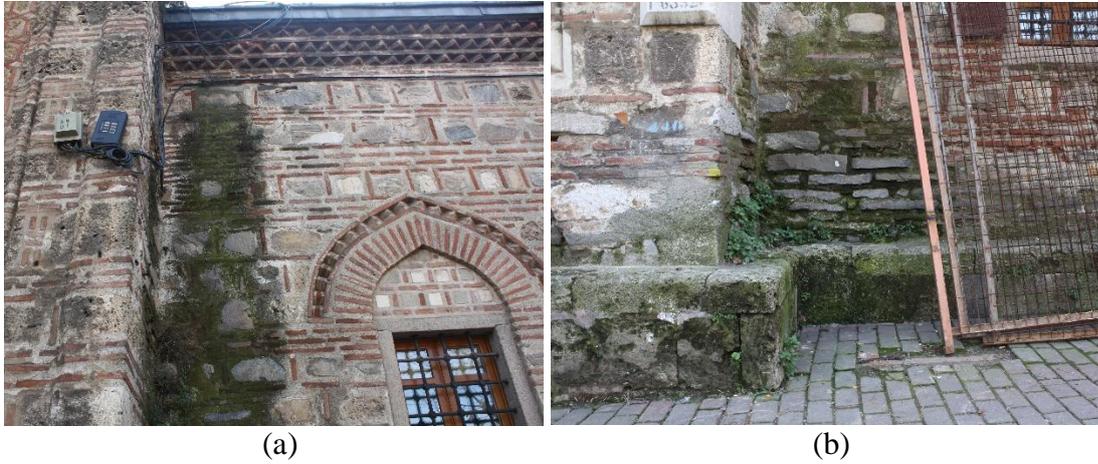
Biological growth is unavoidable at varying locations of building exteriors. Many types of biological colonization are harmless, and the presence of them may indicate other problems that affect a structure whereas some growths can damage underlying building materials like stone and mortar. In Figure 6.31, in the wet season rapid growing of algae on the surface may lead to damage during the wetting-drying cycles with producing excessive amounts of slime that may expand and contract. Therefore, it may cause flaking or spalling of stone surfaces. Moreover, the algal layer creates a medium within the mortar joints between the stones and bricks that promotes the

development of small plants bushes and grasses and/or woody plants, which may also damage to the masonry.

**Figure 6.31.** Both (a) and (b) showing different kinds of biological matters, which were more dominant than dry season, on wet areas in November 2014 (taken by the author).

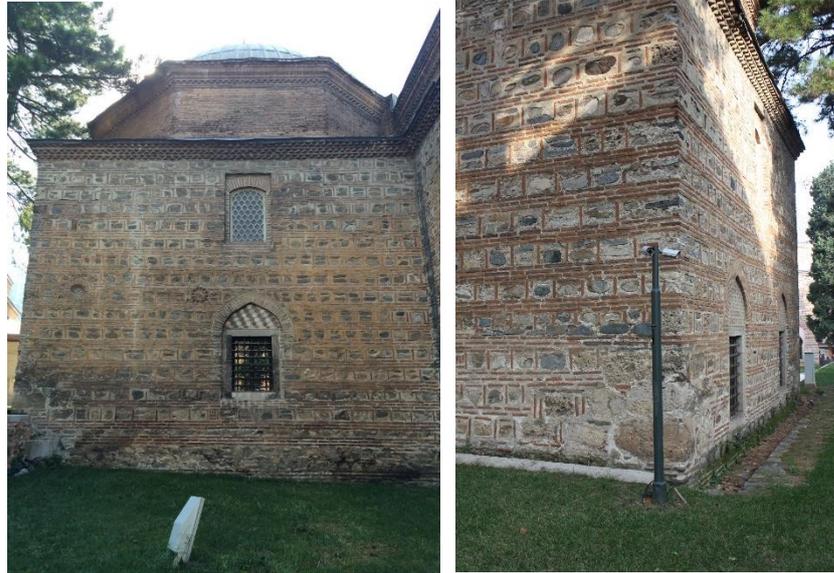
Another reason of wetness is rising damp whose signs were observed in both August and November (Figure 6.32).

**Figure 6.32.** The photos taken in August (a) and November (b) showing the signs of rising damp on facades (taken by the author).

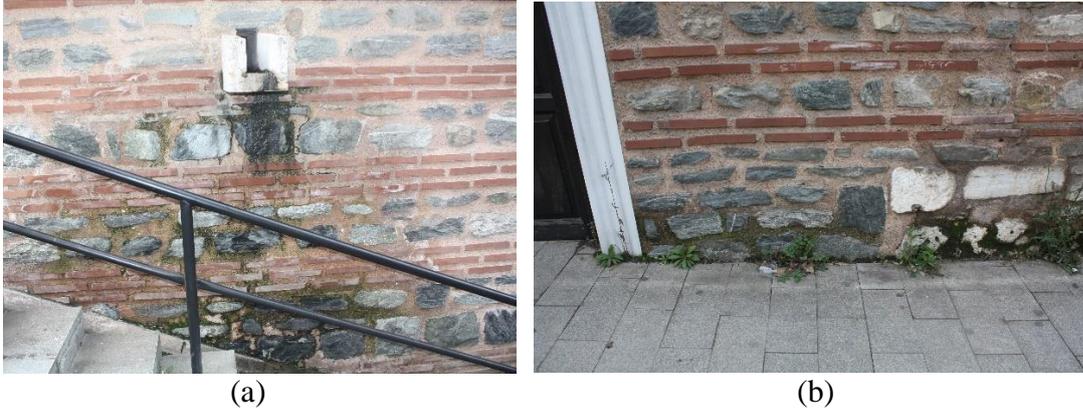
Other hot spots where excessive moisture and biological growth have been observed in the hammam are around of the gutter with a spout and on the base of the walls. The gutter designed to convey water away from the facade causes saturating the wall, which paves the way for biological growth. The defective sidewalks, which normally slope downward from the building and direct water to drains on the roads, and rainwater splashing back on the walls may lead to dampness and biological growth on the base of the walls (Figure 6.35).

**Figure 6.35.** (a) The gutter with a spout and (b) the defective sidewalk may lead to biological growth and dampness (taken by the author).

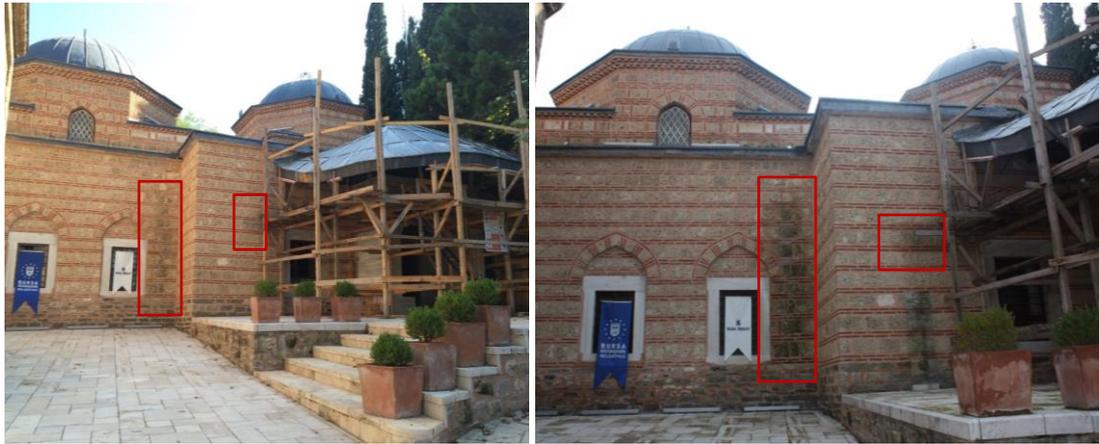
*Tomb of Murad the Second [and Şehzade (Prince) Alaaddin]:* The specific areas on the front facade of the tomb have suffered from biological growth due to excessive moisture (Figure 6.36). Before the remedial activities, same problems were observed on these areas.

**Figure 6.36.** The photos taken in (a) August and (b) November showing the damp areas and the formation of algae, which have increased on the walls within three months (taken by the author).

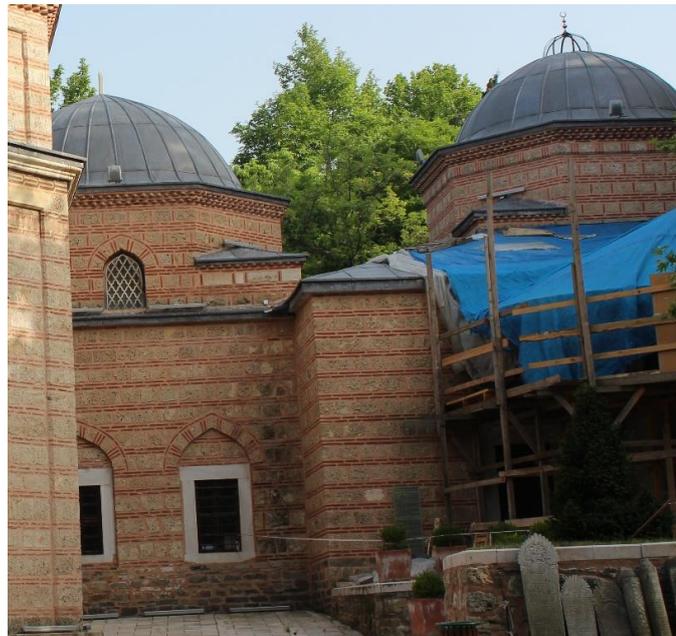
Apart from the photos taken by the author, the following photo taken in May 2015 displays the areas mentioned above. The darker color of these areas indicates the possibility of dirt and/or carbon accumulation on them over the months (Figure 6.37).

**Figure 6.37.** The problematic areas are darker in May 2015 (taken by Şeyma İpekci).

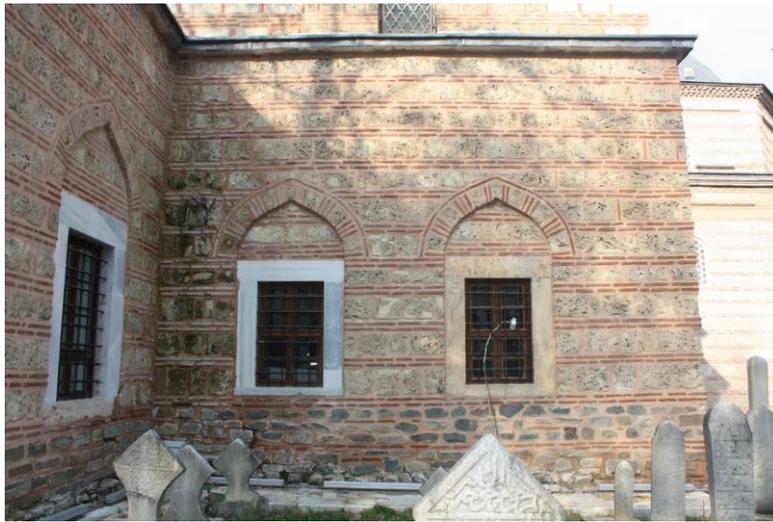
The greening indicating excess moisture has also been observed on the back facade (south) of the tomb (Figure 6.38). Since biological growth attract moisture to the masonry and hold it there, investigation of the source and extent of growth can point detects. The low levels of sun exposure and low evaporation rates in combination with the prevailing winds contribute to damp problems as well as defects or failures of roofing materials or of water shedding.

**Figure 6.38.** The biological growth has found on the back facade of the tomb after removal of plant material during the remedial activities (taken by the author).

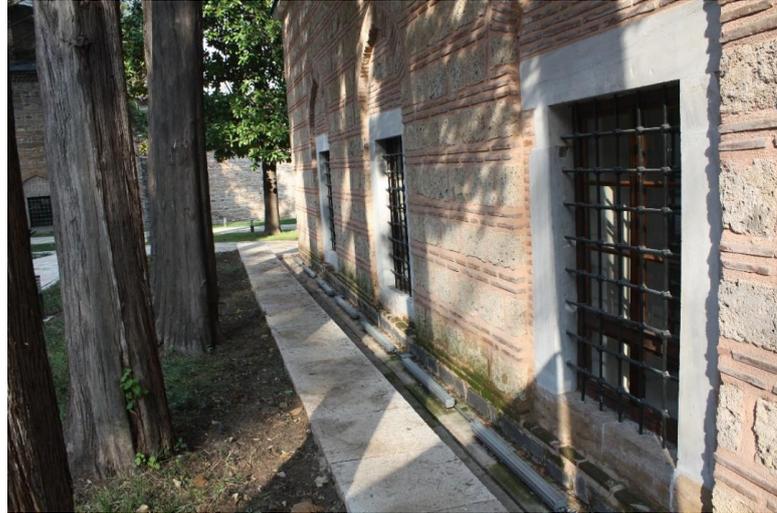
Since the building had had a rising damp problem, open and closed subsurface drainage systems were constructed during the remedial activities. The greening has been found on the base of the walls after the restoration (Figure 6.39).

**Figure 6.39.** Biological growth has been obvious on the plinth in November (taken by the author).

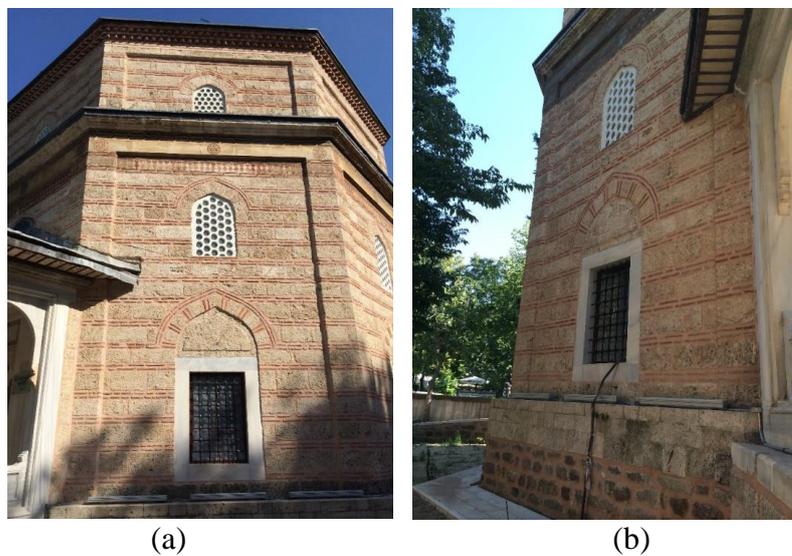
*Tomb of Şehzade (Prince) Ahmet:* In August 2014, although the work program about outside of the tomb was completed, it was observed that there were some problems about lead sheets of the portico's roof. Additionally, biological growth has prolonged (Figure 6.40).

**Figure 6.40.** The photos showing (a) the deformed lead sheets covering the roof; and (b) biological growth on the plinth in August 2014 (taken by the author).

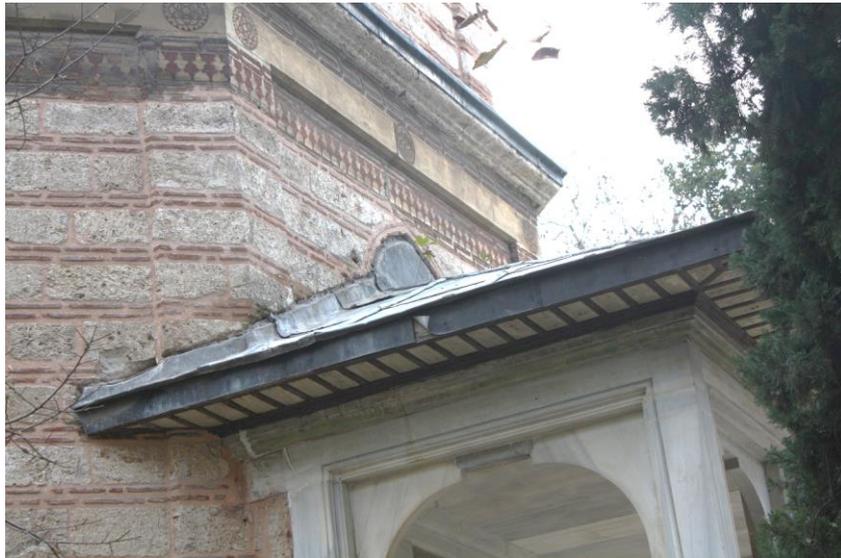
The deformed lead sheets, discoloration and blackening were also observed in November (Figures 6.42 and 6.43).

**Figure 6.42.** The photo displaying the deformed lead sheets, especially from seams; greening on the marble parts of the portico; and the woody roots plant penetrating the materials (taken by the author).

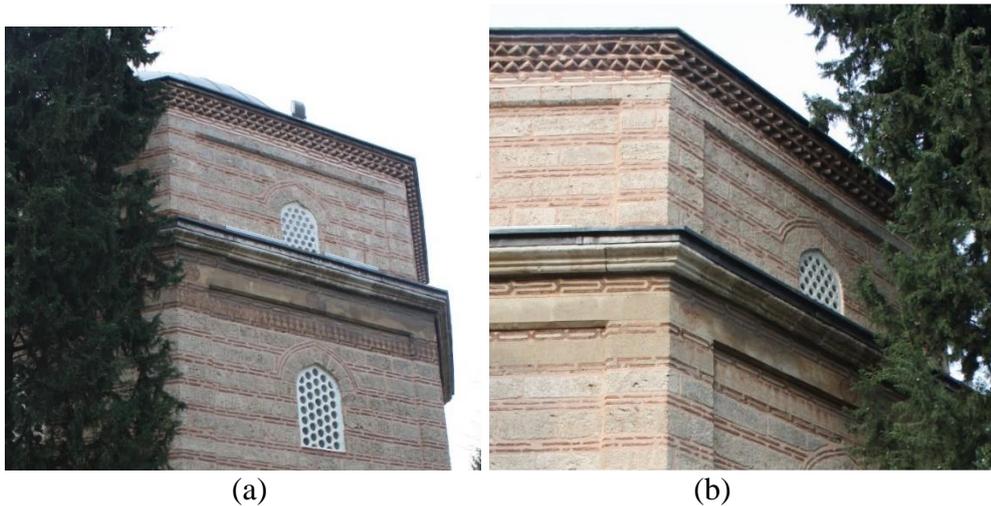
**Figure 6.43.** The photos showing blackening and soiling on the moldings and the decorated parts of the facades below the moldings. Discoloration has been seen in patches (taken by the author).

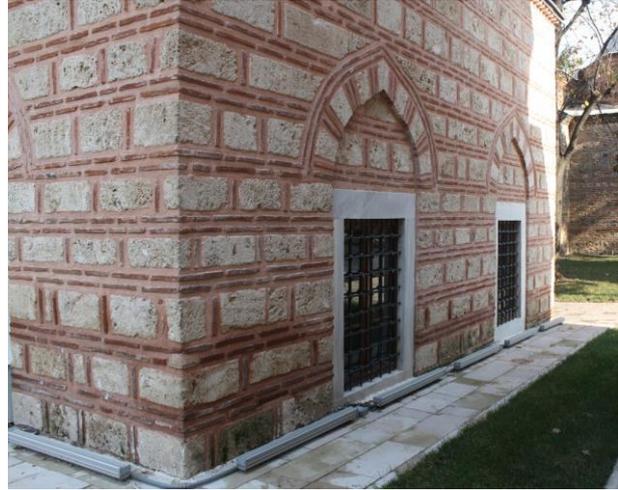
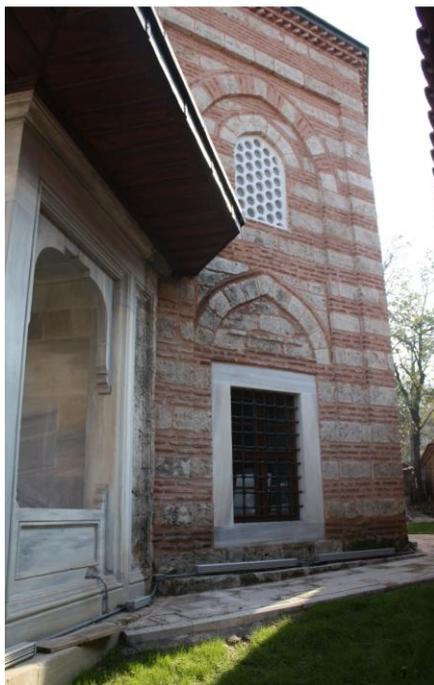
**Figure 6.45.** (a) The level of dampness in the Tomb of Gülbahar *Hatun* (Ebe - Obstetrician Lady), and (b) Greening on the stone surfaces and darker patches in the Tomb of Şirin *Hatun* indicating the presence of dampness (taken by the author).

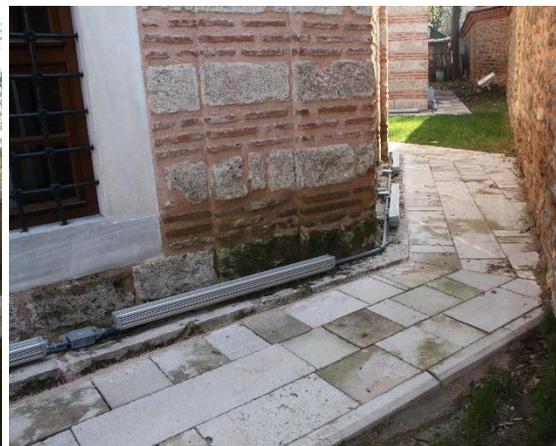
**Figure 6.46.** The photos displaying the level of damp and greening on the surfaces of the Tomb of Şehzade (Prince) Mahmut (taken by the author).

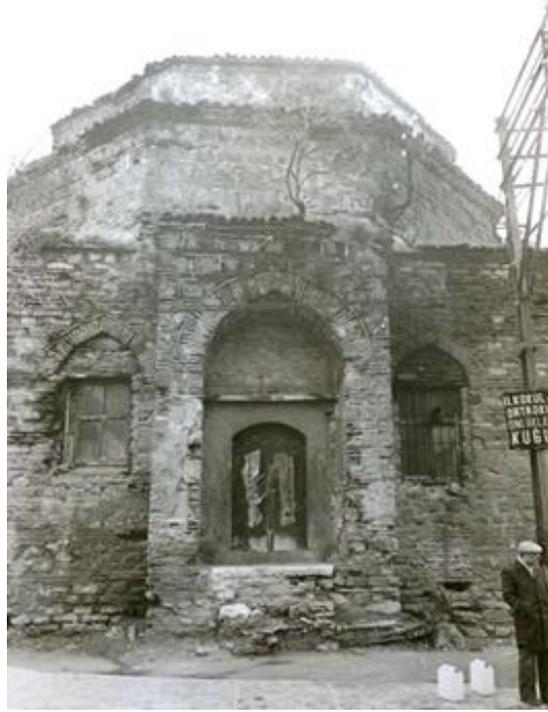
**Figure D.5.** The wooden entrance door severely decayed. The stairs reached to the entrance door were completely demolished (unknown date).  
(Source. Inventory of General Directorate for Foundations)

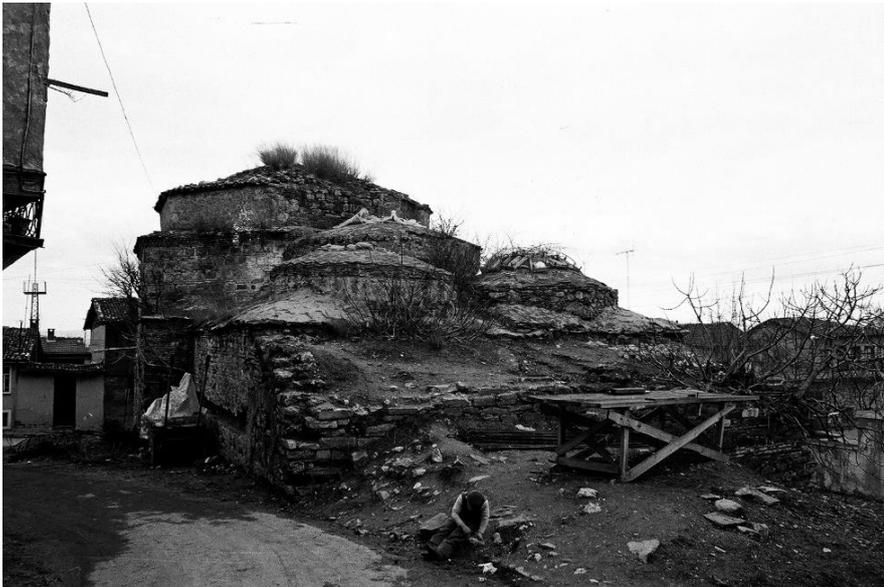
**Figure D.8.** The demolished boiler room of the Muradiye Hammam in 1975.  
(Source. Inventory of General Directorate for Foundations, 1975)

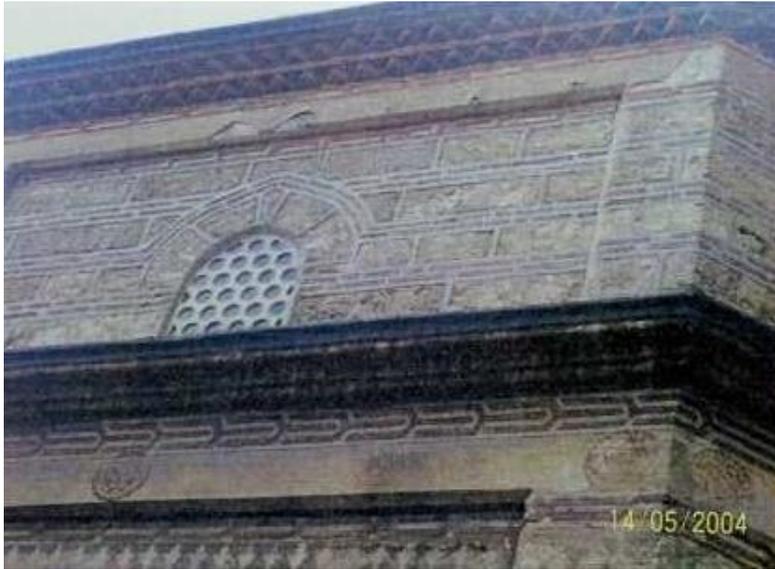
**Figure D.15.** The photo showing damp stain, soiling and blackening on the moulding and the facade  
(Source. Bursa-CNHPRB, 2004)

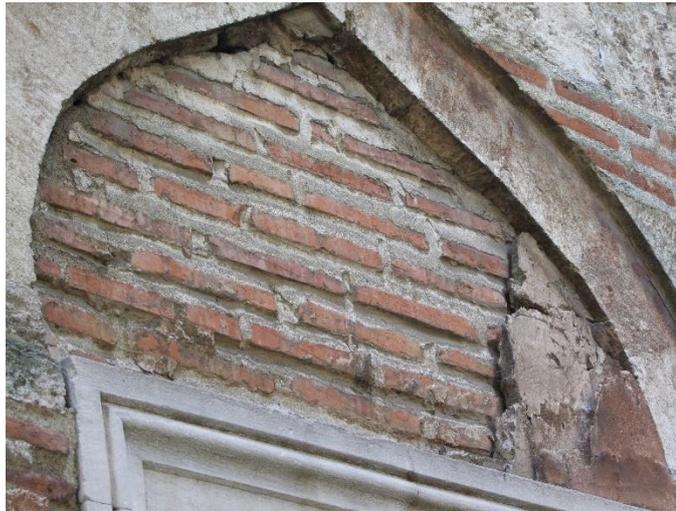
**Figure D.18.** Material loss was seen in the arch pediment of the window.  
(Source. D2 Tasarım Mimarlık, 2010)

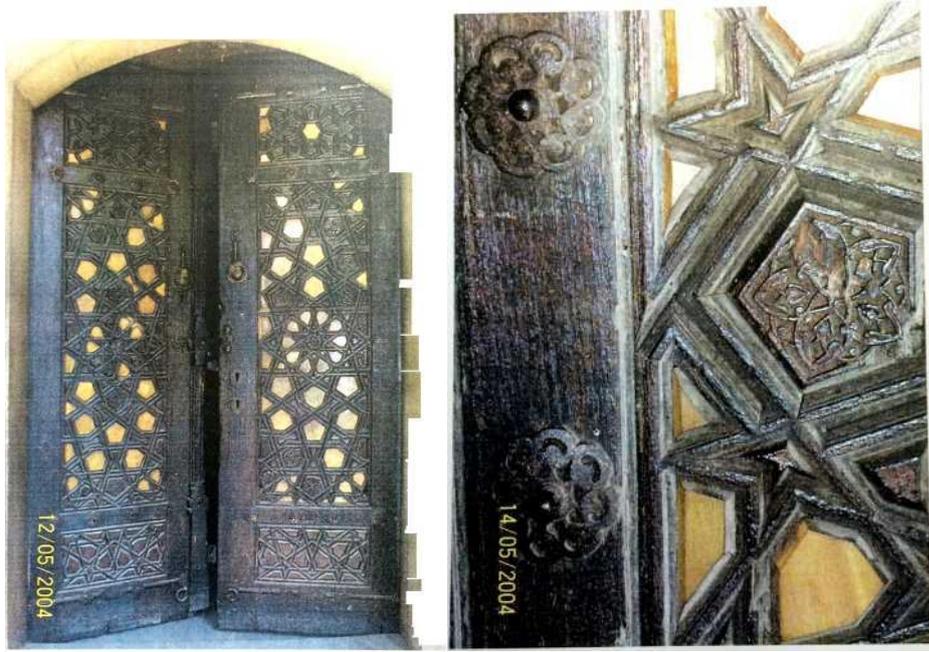
**Figure D.21.** Material loss and installation of substitute materials leading to visual change in the wooden door.  
(Source. Bursa-CNHPRB, 2004)

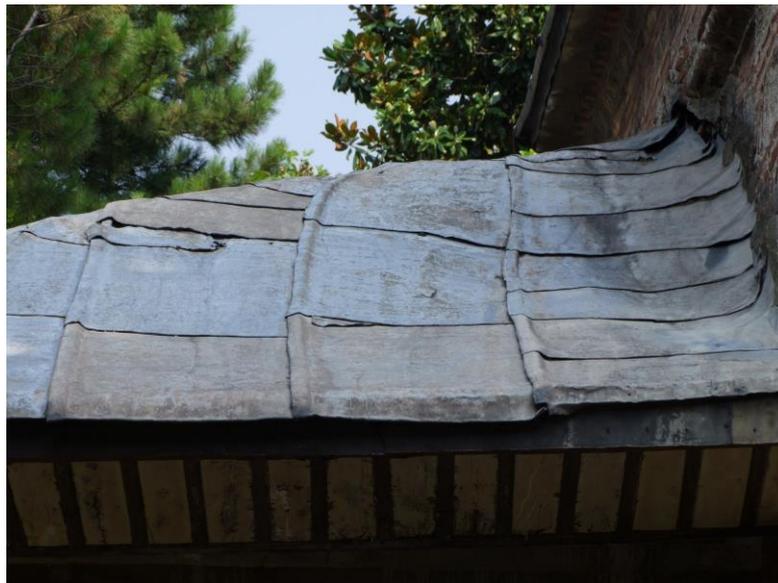
**Figure D.22.** Deformed lead sheets covering the entrance canopy.  
(Source. D2 Tasarım Mimarlık, 2010)

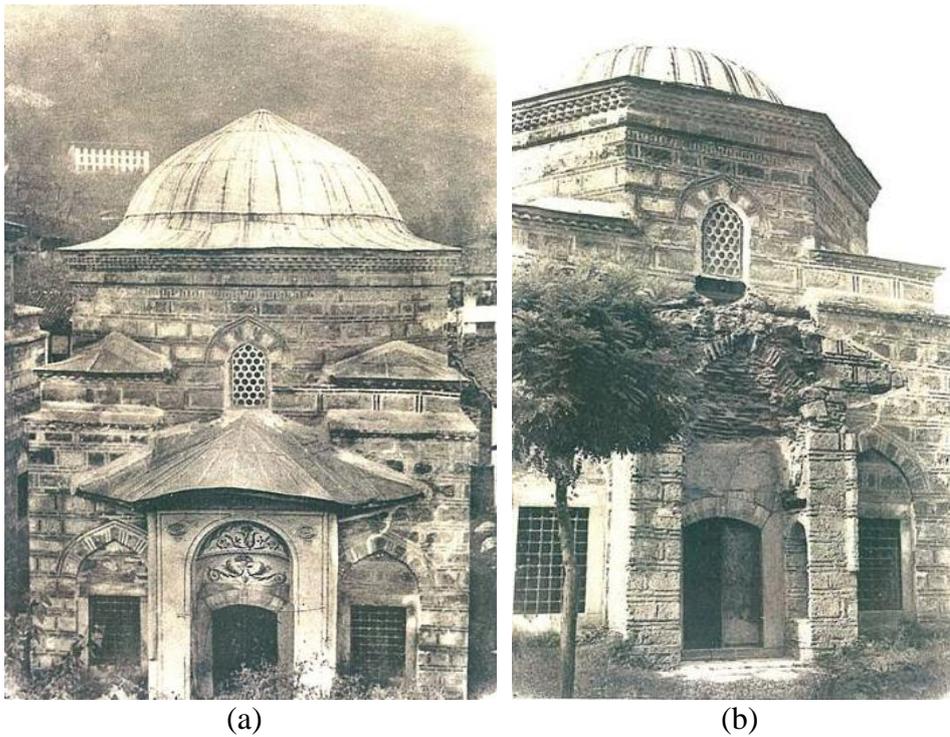
**Figure D.23.** (a) The state of the facade and the canopy, which was built in the Baroque style in the third quarter of the nineteenth century. (b) The canopy was removed and *iwans* were repaired (unknown date - before 1958)  
(Source. D2 Tasarım Mimarlık - Restitution Report, 2010)
