A PROPOSED MODEL FOR UNDERSTANDING THE IMPACTS OF CLIMATE  
CHANGE ON TANGIBLE CULTURAL HERITAGE

A THESIS SUBMITTED TO  
THE GRADUATE SCHOOL OF NATURAL AND APPLIED SCIENCES  
OF  
MIDDLE EAST TECHNICAL UNIVERSITY

EMİNE GİZEM BAŞKAN

JANUARY 2016

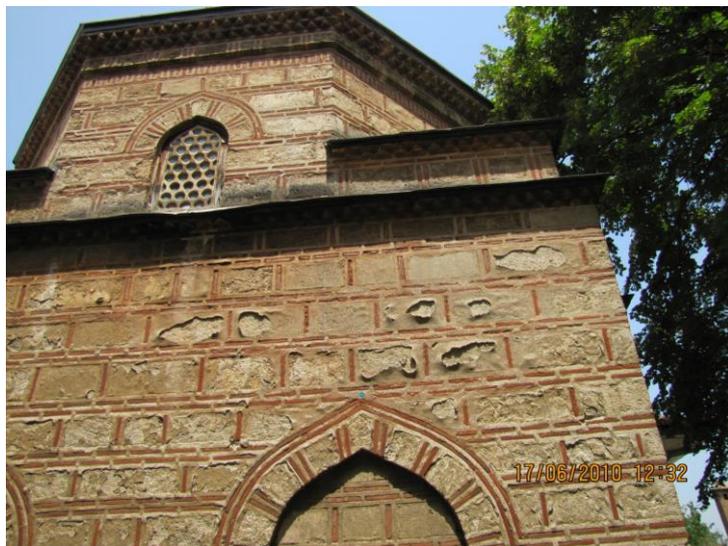
**Figure D.24.** The photo showing spalled plaster, blackening and deformed lead sheets over the eaves.  
(Source. D2 Tasarım Mimarlık, 2010)

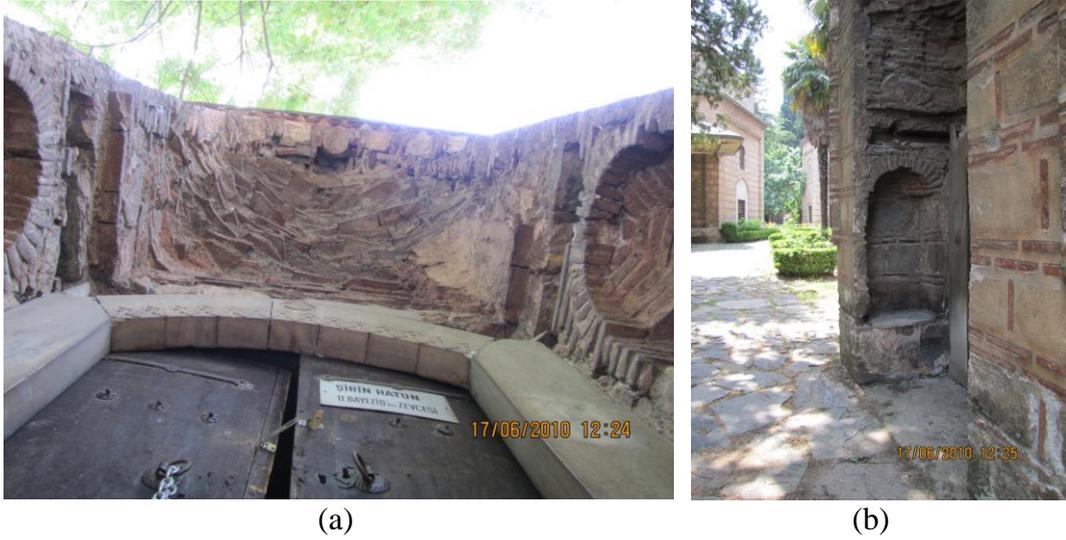
**Figure D.25.** The photos showing the state of (a) the half-dome muqarnas hood (*kavsara*) and (b) the niche of the entrance portal.  
(Source. D2 Tasarım Mimarlık, 2010)

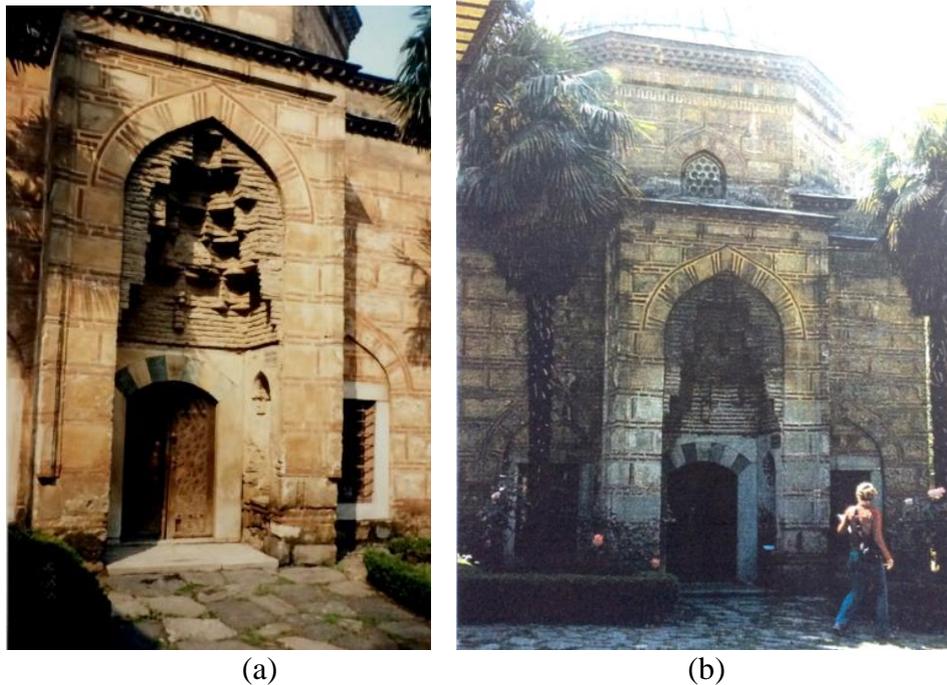
**Figure D.26.** The photos showing the state of the entrance iwan in (a) 1996 and (b) 2004.

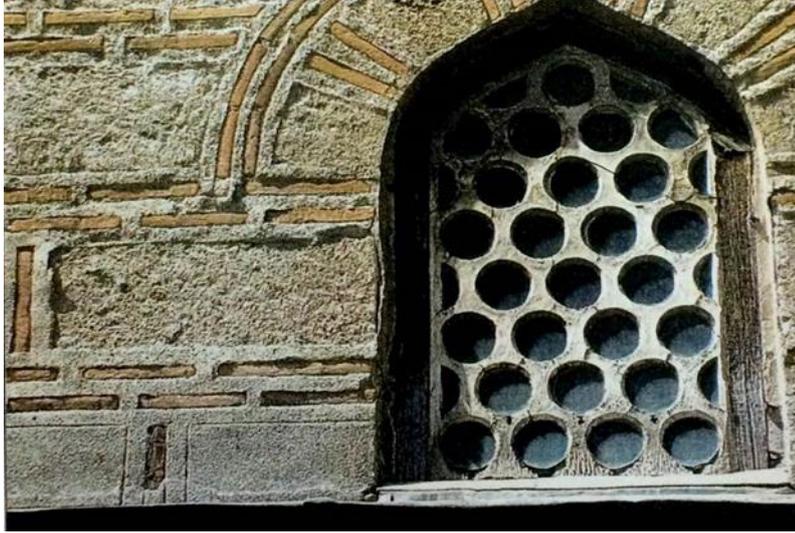
**Figure D.27.** The photo showing the poor repointing and the deformed gypsum-framed window (*dışlık*).  
(Source. Bursa-CNHPRB, 2004)

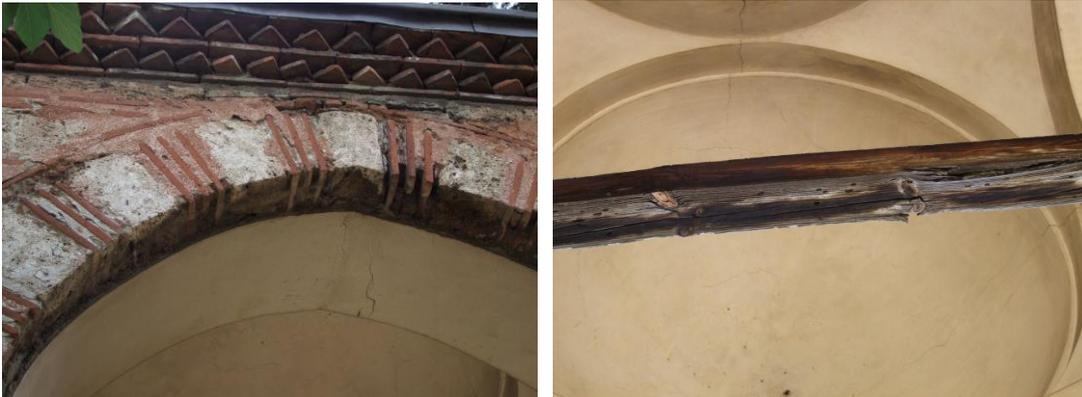
**Figure D.28.** The photos showing (a) material losses in the arches and (b) deformed bonding timber in between arches.  
(Source. D2 Tasarım Mimarlık - Survey Report, 2010)

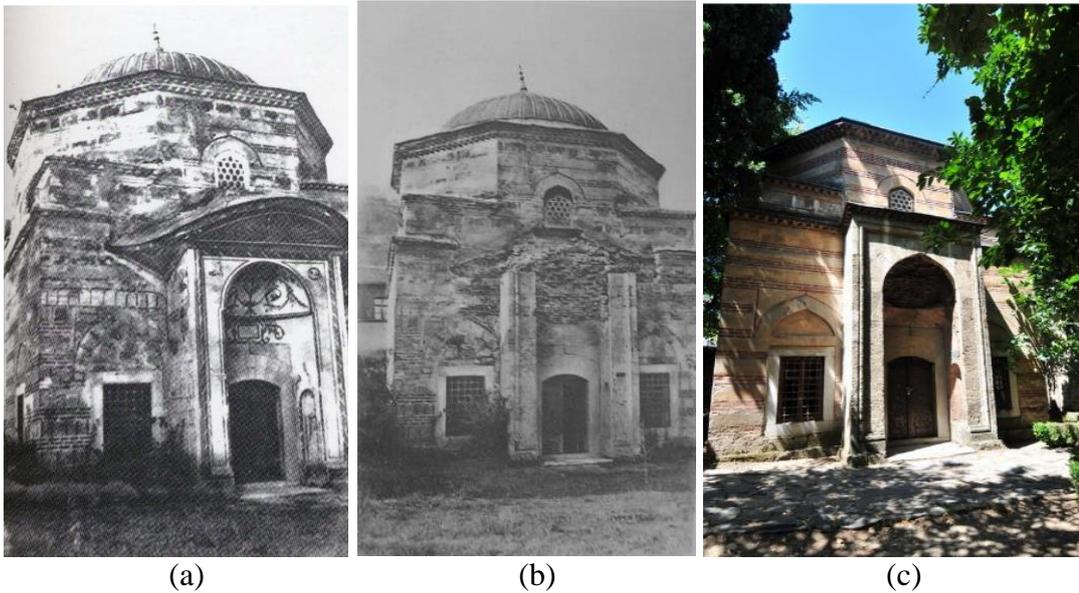
**Figure D.30.** (a) The state of the facade and the canopy, which was built in the Baroque style in the third quarter of the nineteenth century. (b) The canopy was removed (unknown date - before 1958). (c) The portal was repaired (unknown date- before 2012).

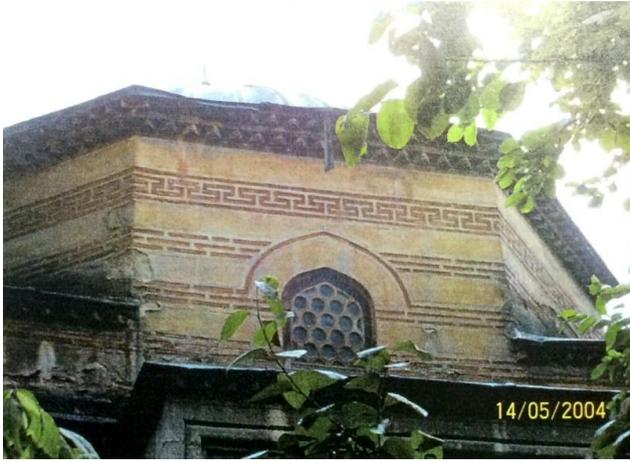
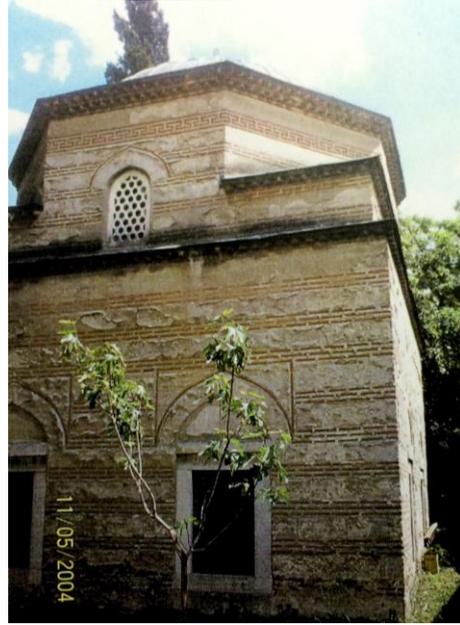
**Figure D.31.** The both photos showing the state of the facades: spalled plaster, blackening and deformed lead sheets.  
(Source. Bursa-CNHPRB, 2004)

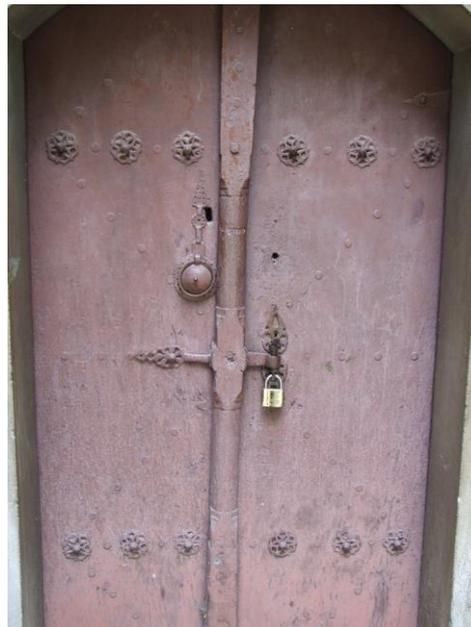
**Figure D.32.** The wooden door, which was embellished with rosettes, lost its original state due to being painted several times.  
(Source. D2 Tasarım Mimarlık, 2010)

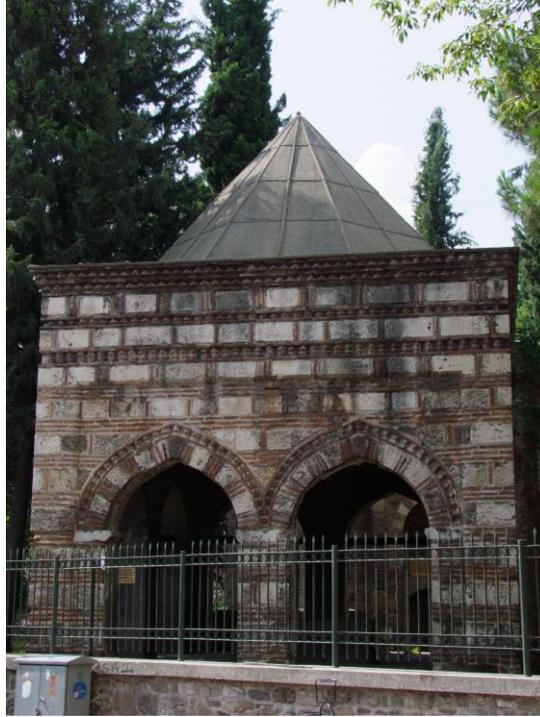
**Figure D.33.** The north facade of tomb showing the blackening (unknown date-before 2012)  
(Source. Governorship of Bursa)

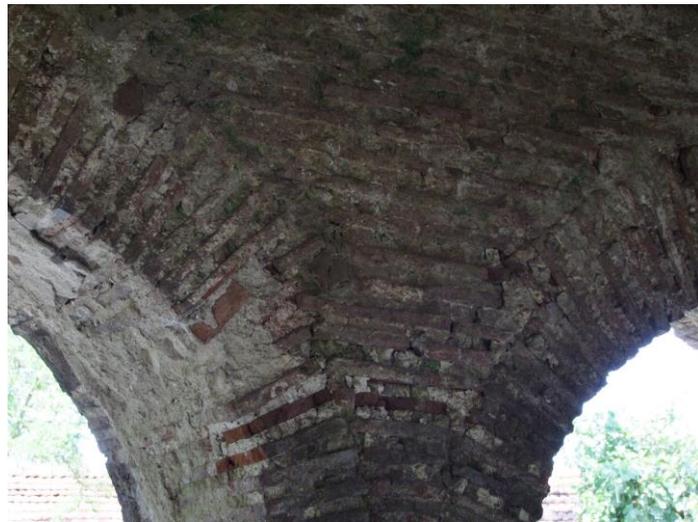
**Figure D.34.** The photo showing the eroded brick and stone courses due to cement-based mortar and plaster, and the formation of fungi from bottom to the top of the piers due to dampness.  
(Source. D2 Tasarım Mimarlık, 2010)

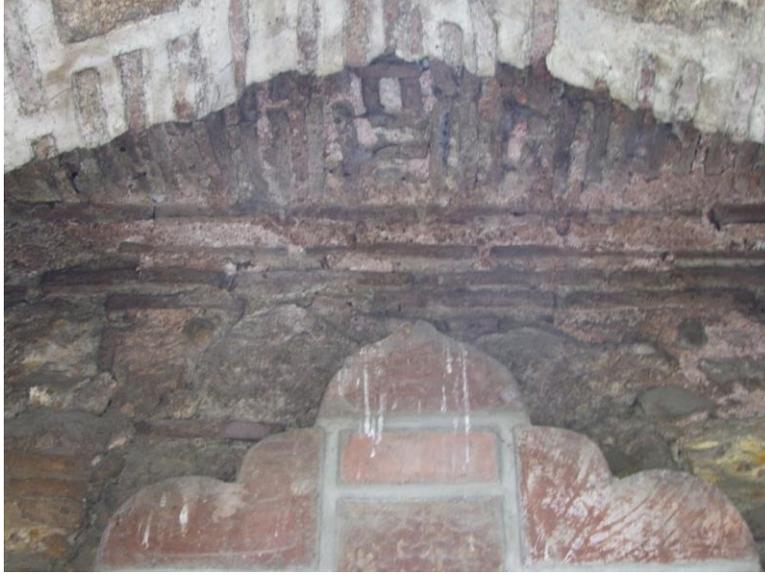
**Figure D.35.** The photo showing the eroded brick and stone courses in the half-dome muqarnas hood (*kavsara*) of the portal.  
(Source. D2 TasarıM Mimarlık, 2010)

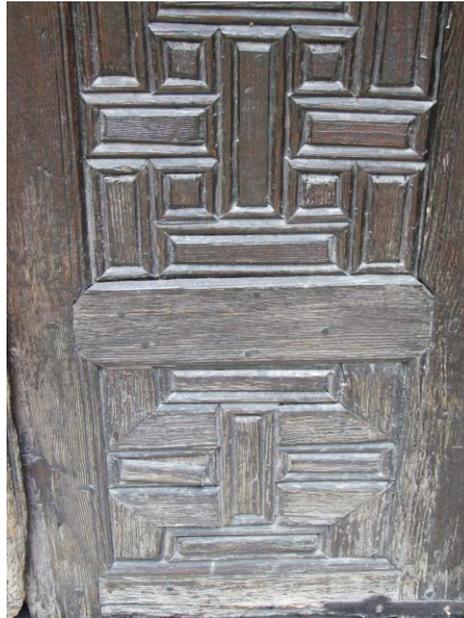
**Figure D.35.** The wooden door, which was produced with *künde-kari* technique, decayed excessively. Its lock / hinge rails and stiles were destroyed. Metal parts were lost.
