**PRECAST CONCRETE PANEL REINFORCED INFILL WALLS
FOR SEISMIC STRENGTHENING OF
REINFORCED CONCRETE FRAMED STRUCTURES**

**A THESIS SUBMITTED TO
THE GRADUATE SCHOOL OF NATURAL AND APPLIED SCIENCES
OF
MIDDLE EAST TECHNICAL UNIVERSITY**

**BY
MEHMET BARAN**

**IN PARTIAL FULFILLMENT OF THE REQUIREMENTS
FOR
THE DEGREE OF PHILOSOPHY OF DOCTORATE
IN
CIVIL ENGINEERING**

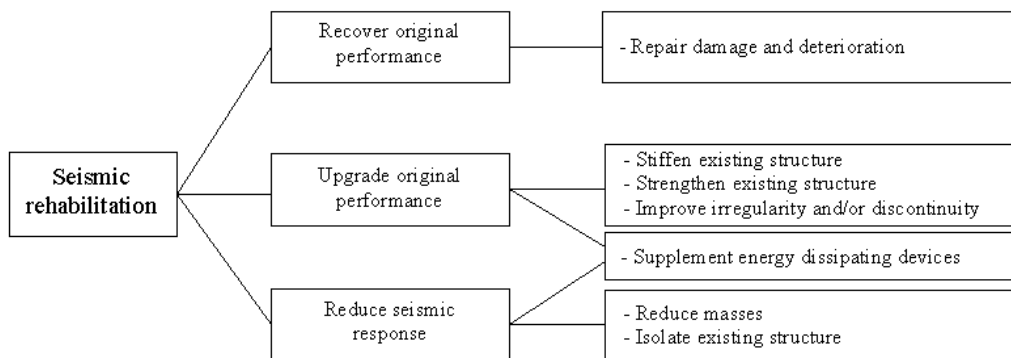
Figure 1.1. Seismic rehabilitation strategy and measures (Sugano [3])

There are various methods to rehabilitate structures. A method appropriate for one building can be inappropriate for another building. A detailed investigation should be made and the performance of the building should be established before making any rehabilitation. If there is a damage, causes of it should be correctly determined. The selected rehabilitation methods should be consistent with the function of the building and should aim to correct the deficiencies in the building. The newly added strengthening elements should be able to work with the existing ones and should not interfere with the function of the building. Basic strategies and operations for seismic rehabilitation has been summarized in Figure 1.1. [3].

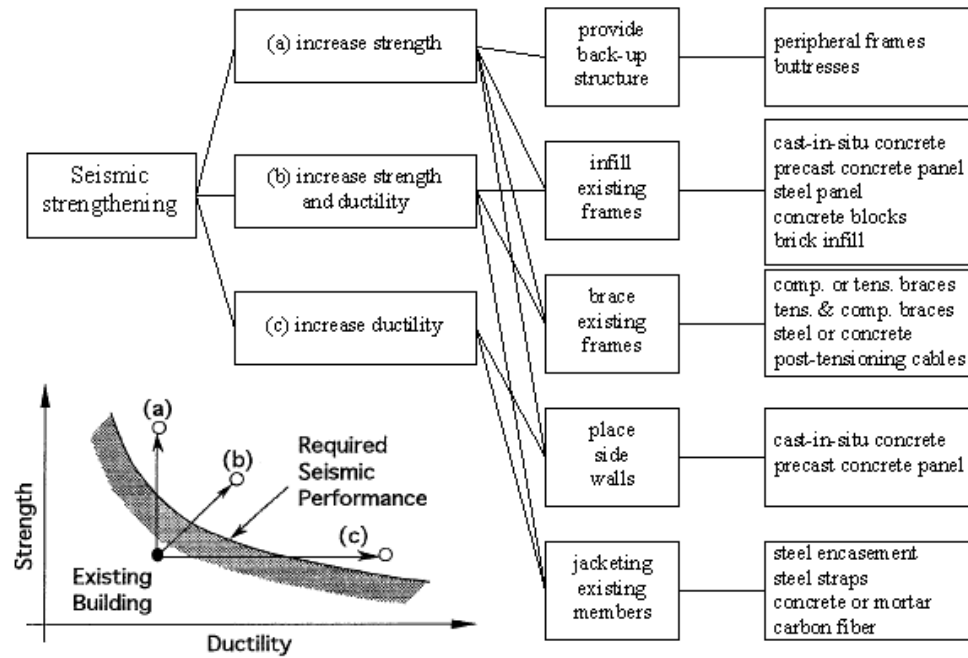
Figure 1.2. Typical strengthening methods (Sugano [3])

To summarize, the existing frames in buildings are mostly not suitable to resist lateral loads in Turkey. Therefore, a new lateral load resisting system composed of structural walls is formed in “System Improvement”. According to Sugano [3], using cast-in-situ concrete, precast concrete panels, steel panels, concrete blocks and brick infill are used for system improvement with various connection techniques as shown in Figure 1.2. Careful attention must be given to the connections so that they will strongly affect the overall behavior of the strengthened structure.

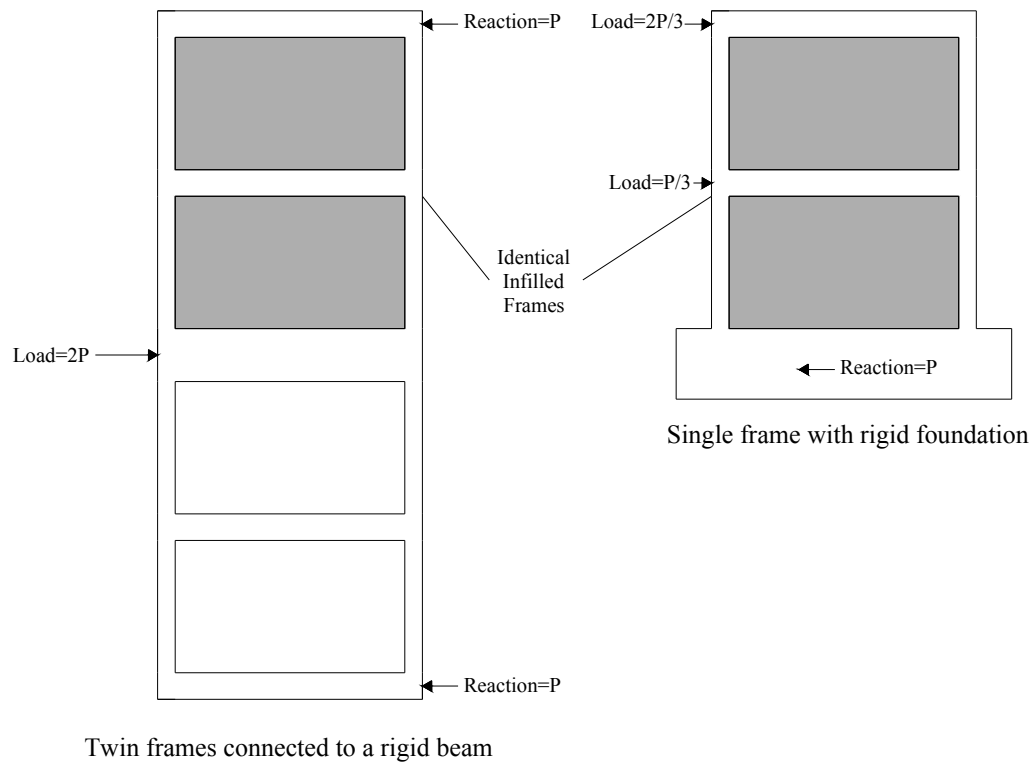
Figure 3.1. The general view of the old and new test specimens

Since one of the aims of the present study is to modify the test set-up for one-bay, two-story frames, a new test set-up was developed to be used for the future studies beginning with the study conducted by Duvarci [6]. In the new test set-up, specimens are tested vertically. Since experimental study is time consuming and expensive, test specimens were designed and detailed carefully, construction of the test specimens were planned considering all the details and the instrumentation were designed considering the main objectives for this experimental research. The general view of the old and new test specimens are given in Figure 3.1.

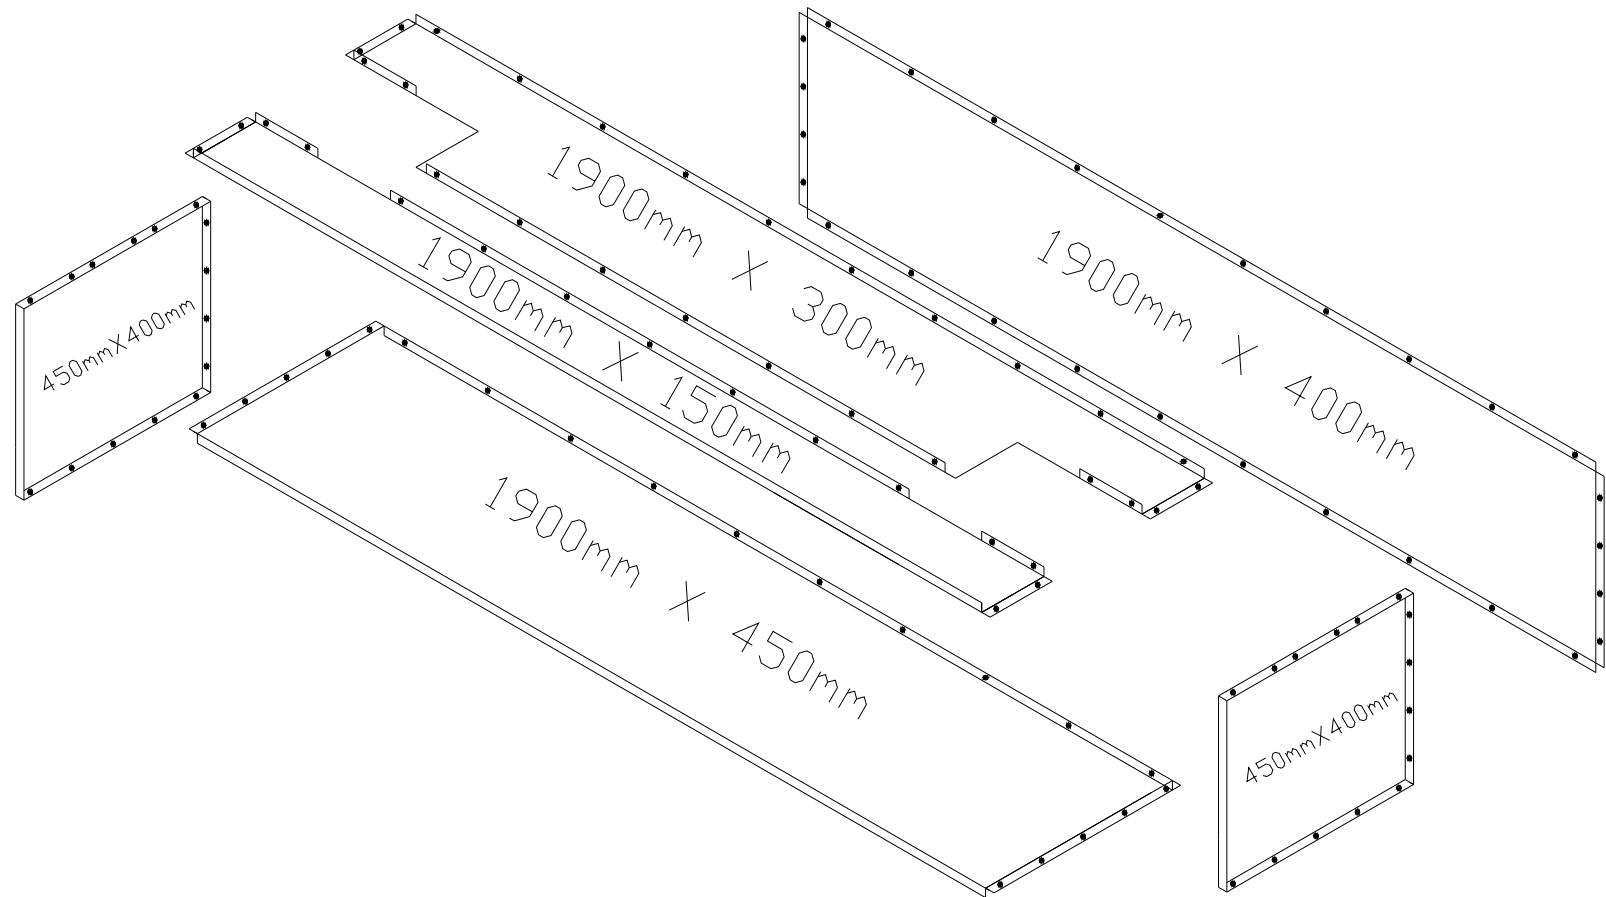
Figure 3.2. Details of the formwork for the rigid foundation beam

All specimens were cast horizontally by using steel formworks. The steel formwork was manufactured from 2.0 mm thick steel plates which were assembled with bolts. The steel forms were accurately manufactured with an error of one-tenth of a millimeter. The steel plates, forming the parts of the formwork, were stiff enough to avoid any unexpected deformations during casting of the specimens. The stiffness of the steel plates was gained by bending both edges. The width and the length of the bent edges were 20 mm and 50 mm, respectively. The details of the formwork for the rigid foundation beam and for the columns and beams are given in Figure 3.2. and Figure 3.3., respectively.

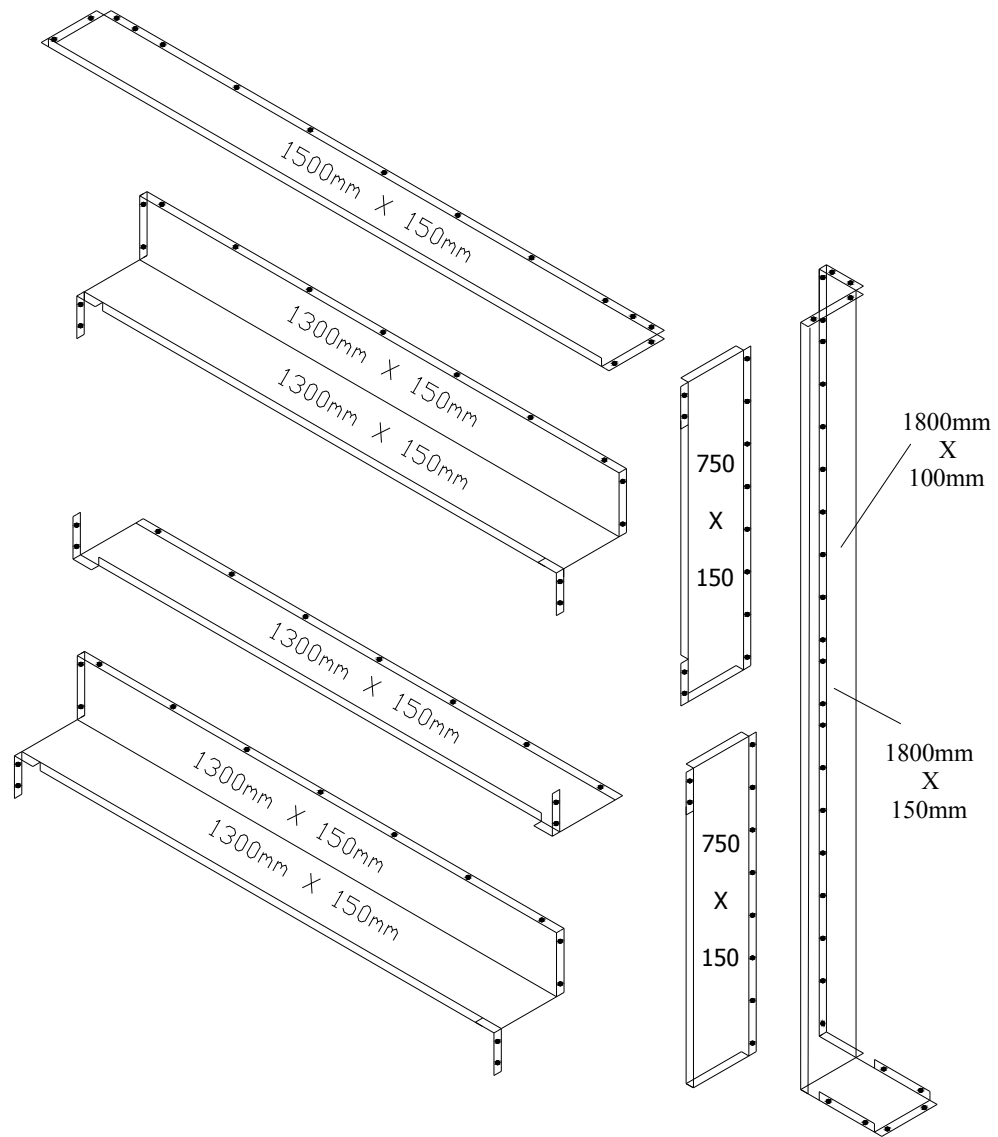
Figure 3.3. Details of the formwork for the columns and beams

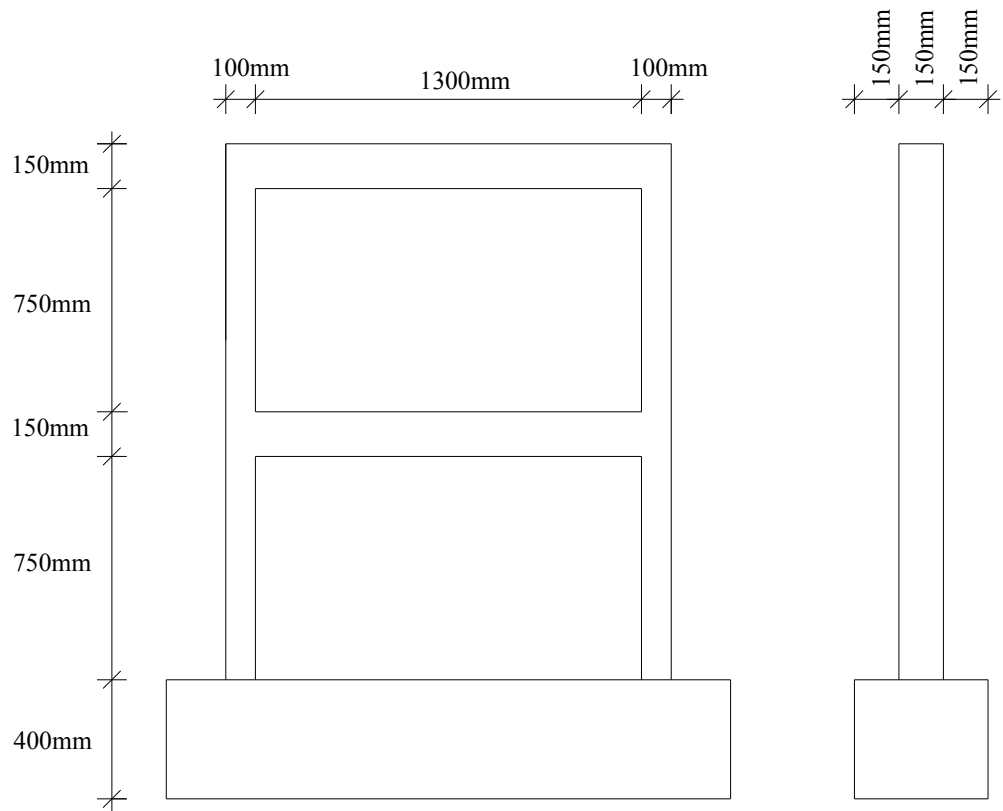
Figure 3.4. Dimensions of the test specimen

In the new test set-up, the specimens had a clear span of 1300 mm, and a net story height of 750 mm. The columns were 100 mm x 150 mm and the beams were 150 mm x 150 mm. The rigid foundation beam has a height of 400 mm, width of 450 mm and a length of 1900 mm. The details of the test specimens are shown in Figure 3.4. The assembled view of the steel formwork is given in Figure 3.5.

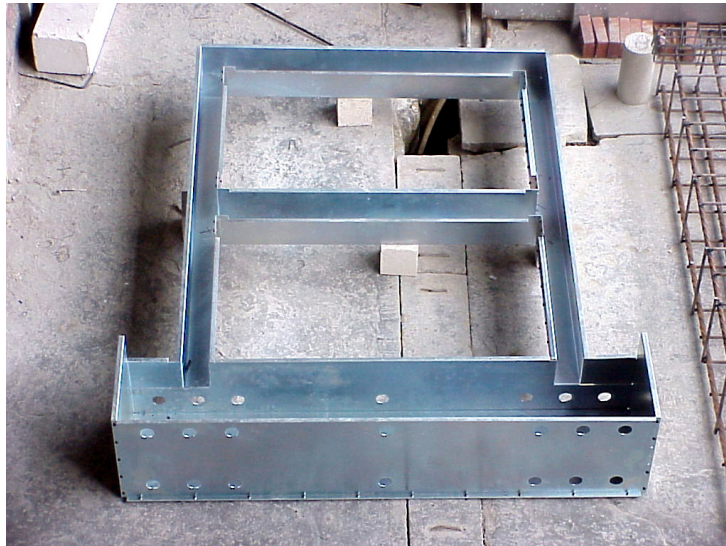
Figure 3.5. The assembled view of the steel formwork

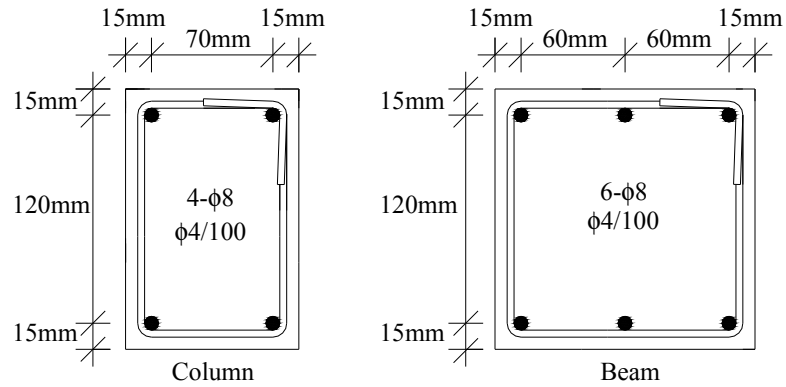
Figure 3.6. Reinforcement details of the column and beam

In beams, 6 ϕ 8 plain bars were used as longitudinal reinforcement. The beam top reinforcement was extended into the column and bent 90° downward and the ends were hooked. The beam bottom reinforcement was extended into the column and its ends were bent 90° upwards only. In columns, 4 ϕ 8 plain bars were used as longitudinal reinforcement. In three of the specimens, column reinforcement was spliced at both foundation and floor levels with a splice length of 20 ϕ (160 mm). In the remaining specimens, column reinforcement was not spliced at either level. Column outer longitudinal reinforcement was bent 90° inwards and hooked 135°, column inner longitudinal reinforcement was bent 90° outwards and hooked 135° at the bottom of the rigid foundation beam. The reinforcement details of the column and beam is shown in Figure 3.6. Same reinforcement details were used for all the test specimens.

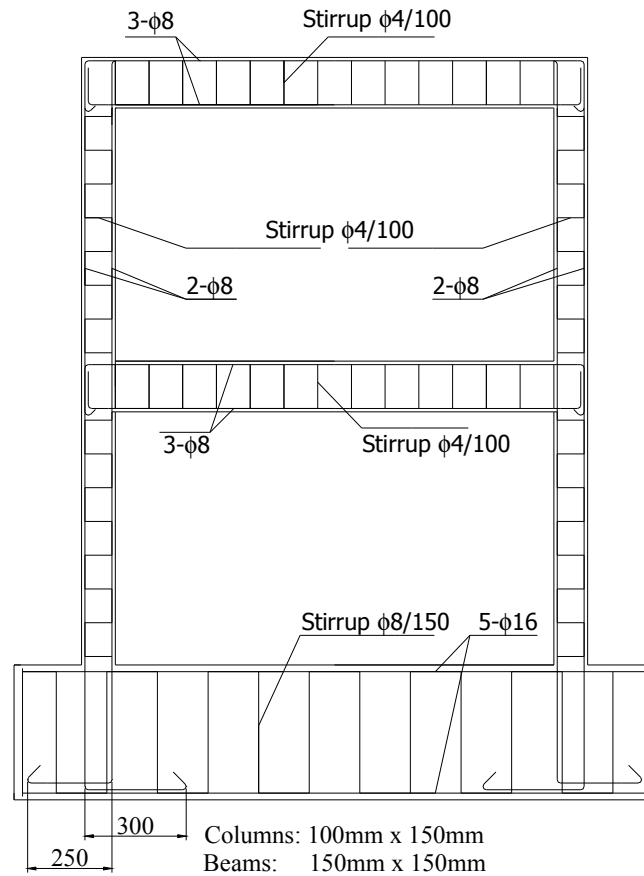
All Dimensions are in mm

Figure 3.7. Reinforcement pattern with continuous longitudinal reinforcement

In beams and columns, ϕ 4 plain bars were used as stirrups at a spacing of 100 mm. The ends of the stirrups had 90° hooks. The straight portion of the hook was extended fifteen bar diameters (60 mm). The reinforcement pattern of the specimens are shown in Figure 3.7. and Figure 3.8., respectively for specimens with continuous longitudinal reinforcement, and with lapped splice longitudinal reinforcement.

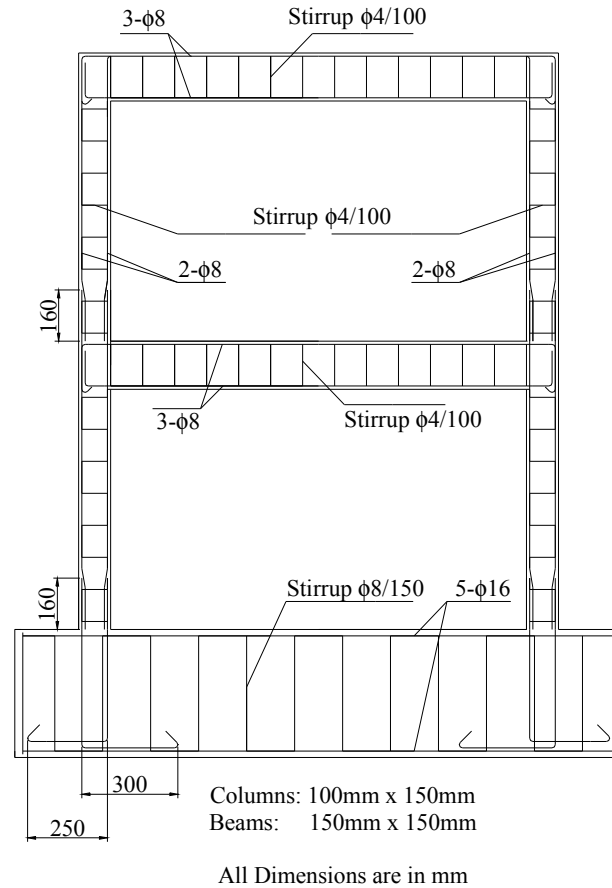
Figure 3.8. Reinforcement pattern with lapped-splice longitudinal reinforcement

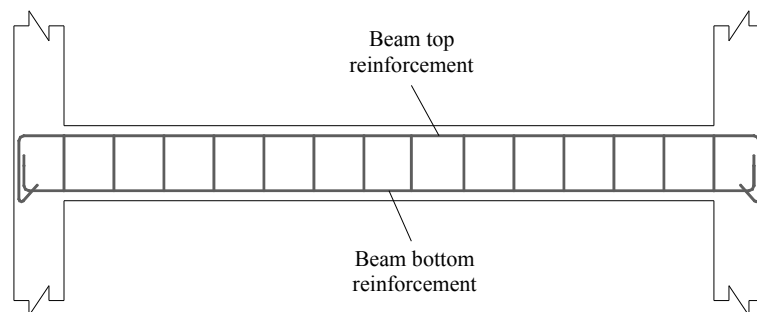
Figure 3.9. Detailing of beam longitudinal reinforcement

The side view of the beam and detailing of the beam longitudinal reinforcement is shown in Figure 3.9. Beam and column detailing were the same for all the test specimens.

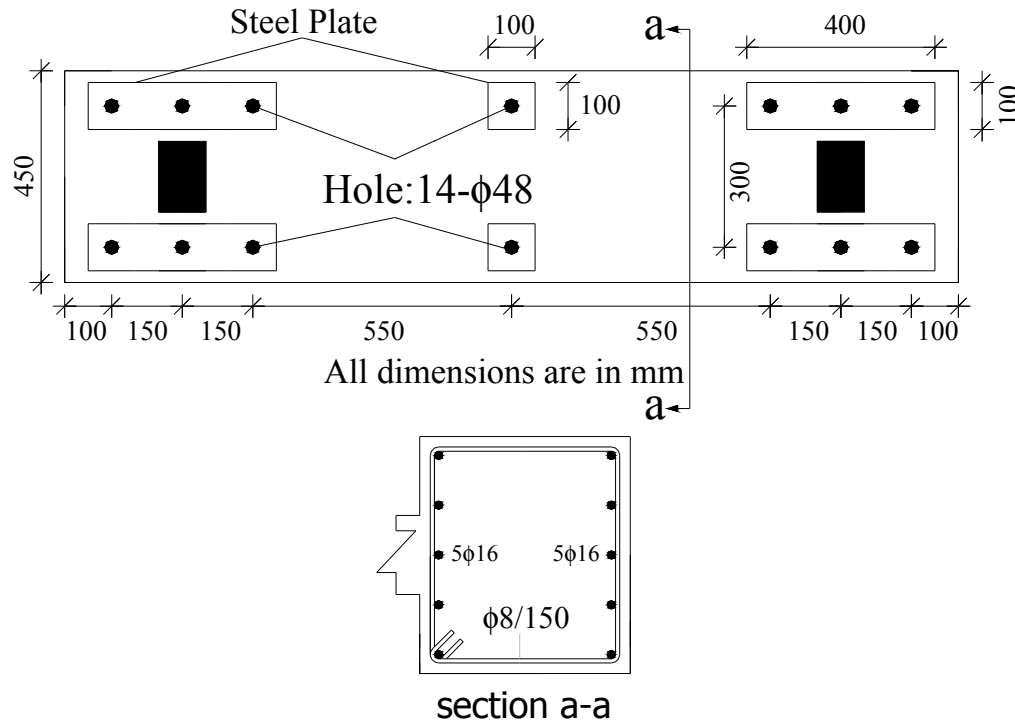
Figure 3.10. Plan and cross-sectional view of the foundation beam

Since the test specimens were tested vertically in the new test set-up, a rigid foundation beam was constructed and cast together with the frame, which will fix the frame to the universal base. Every specimen has its own foundation with dimensions 1900 mm in length, 450 mm in width and 400 mm in height. The foundation beam was designed according to the code [5] in order not to have any problem in foundation beam during the test. In foundation beam, 10 ϕ 16 deformed bars, 5 at the top and 5 at the bottom of the beam cross-section, were used as longitudinal reinforcement. This much reinforcement corresponds to 1.1% of the concrete area. As stirrups, 8 mm diameter deformed bars were used at a spacing of 150 mm and the ends had 135° hooks. The straight portion of the hook was extended fifteen bar diameters (120 mm). The bottom and top longitudinal reinforcements of the foundation beam were welded to each other by using the same type of reinforcement, 16 mm diameter deformed bars. The plan and cross-sectional view of the foundation beam is given in Figure 3.10.

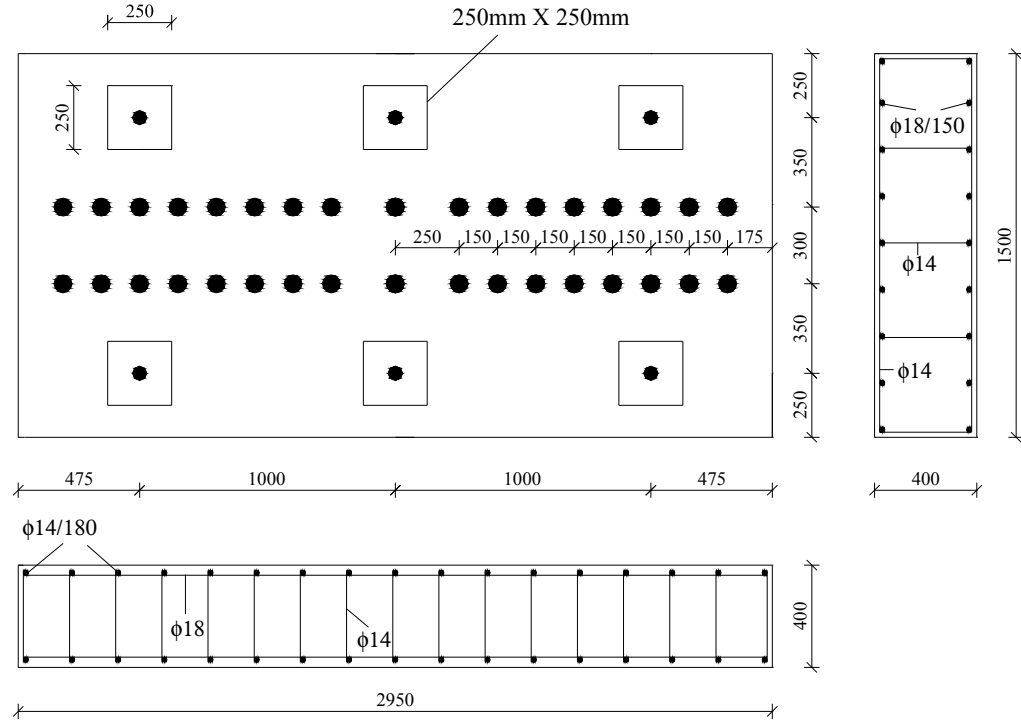
Figure 3.11. Detailed drawing of the universal base (All dimensions are in mm)

As mentioned before, the foundation was designed to be convenient for testing specimens having different aspect ratios. For this purpose, thirtyfour M38 nuts were produced from 67 mm hexagonal steel and were embedded into the foundation. However, only fourteen of them were used in the present study to connect the bolts passing through the frame foundation.

In the universal base, $\phi 18$ deformed bars were used as longitudinal reinforcement at both layers (top and bottom) in the longer direction where $\phi 14$ deformed bars were used at both layers (top and bottom) in the longer direction. The longitudinal reinforcement distribution is uniform for both directions. The reinforcements in top and bottom layers were welded to each other by using $\phi 14$ deformed bars. Detailed drawing of the foundation is given in Figure 3.11.

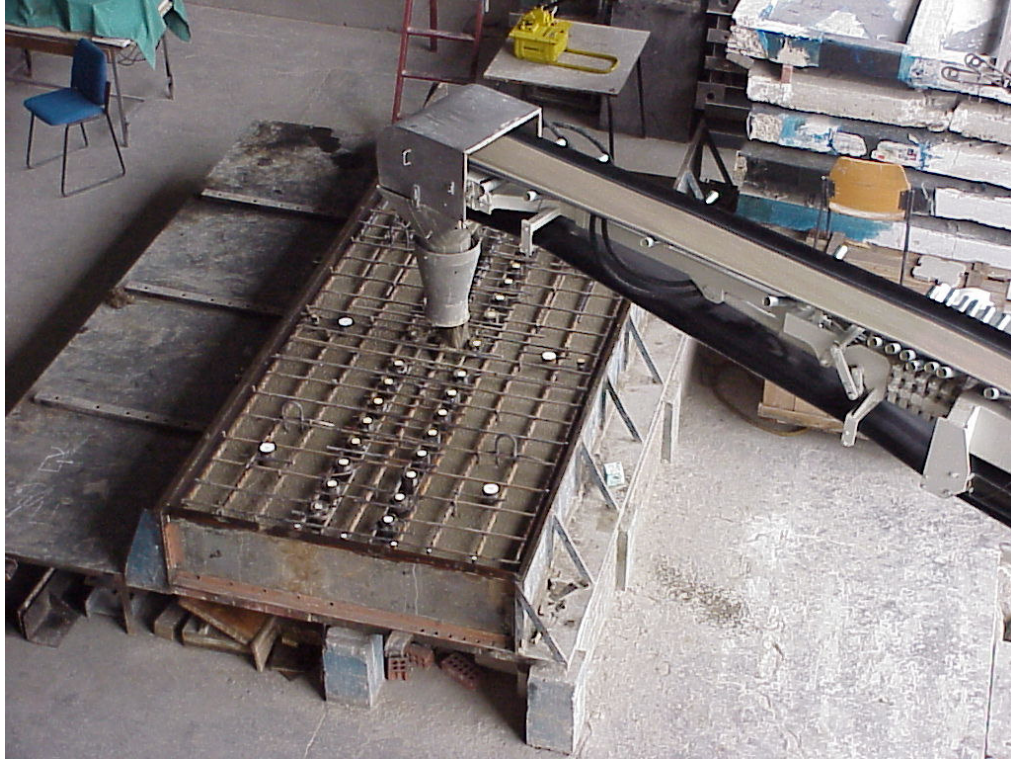
Figure 3.12. Moulding ready mixed concrete of the universal base

The steel forms available in the Structural Mechanics Laboratory of METU were used for casting of the foundation concrete. Approximately 2m^3 of concrete was required for the production of the universal base. It was impossible to produce this amount of concrete at one or two batches in the laboratory. Therefore, ready mixed concrete was ordered from a ready mixed concrete company. Before placing the concrete, the inside of the forms were cleaned and greased to facilitate the forms' removal after concrete was set. Moulding of ready mixed concrete is shown in Figure 3.12.

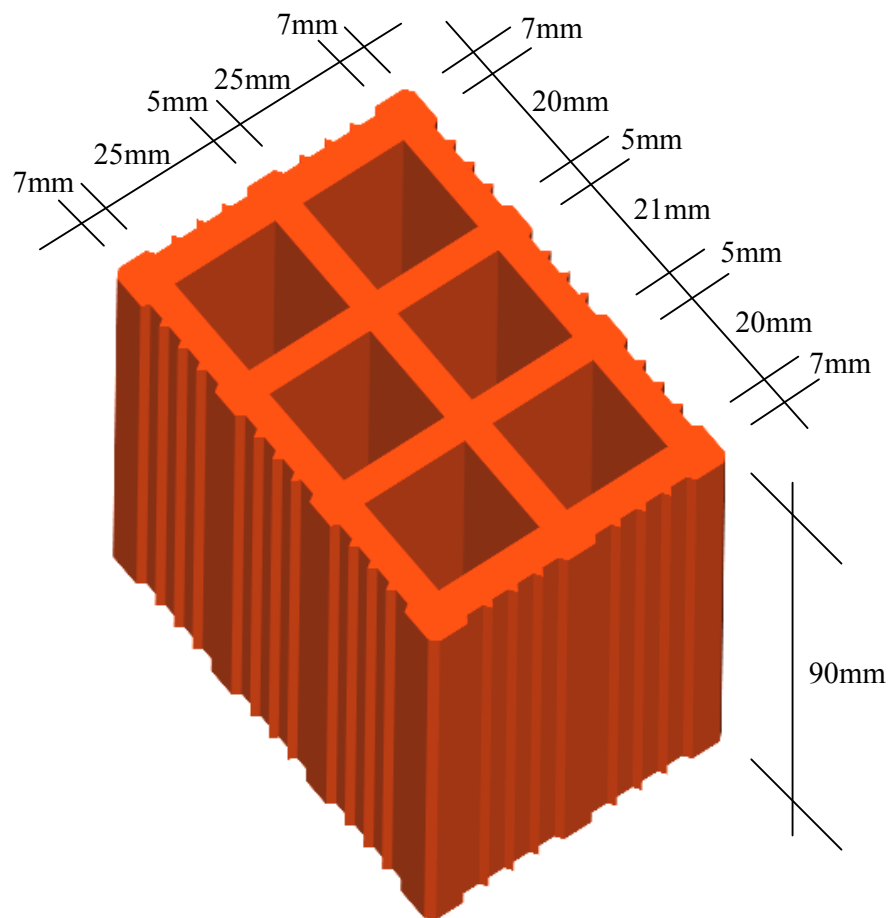
Figure 3.13. Dimensions of hollow brick used as infill material

In all specimens, only the face of the brick wall was plastered at the interior side whereas brick wall together with the beams and columns were plastered at the exterior side. The plaster thickness on each face was about 10 mm. Mortar used in plastering was also used in joining the bricks to each other. The compressive strength of the mortar was determined by testing the cylinders having 75 mm diameter and 150 mm height. The mix proportions for mortar are given in Table 3.5. It was seen that mortar compressive strength was directly proportional to curing of mortar. Mortar strengths of the specimens are given in Table 3.6. Mortar compressive strength, as in practice, varied between 3 MPa to 7 MPa in specimens. General view of hollow brick used as infill material and plastering of the specimen is shown in Figure 3.13. to Figure 3.15.

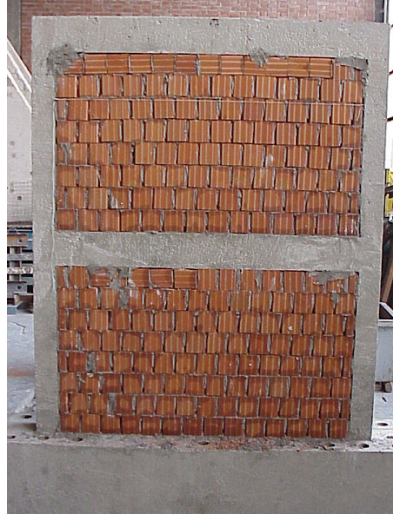
Figure 3.14. Hollow brick used as infill material

Hollow brick were used as infill in all specimens. Brick used in specimens were especially produced for the present experimental study in Turgutlu, Manisa and were scaled down (one-third scale) to simulate the real brick as shown in Figure 3.14. Bricks were tested by loading in the direction parallel to holes and results of compression tests on tiles are given in Table 3.4.

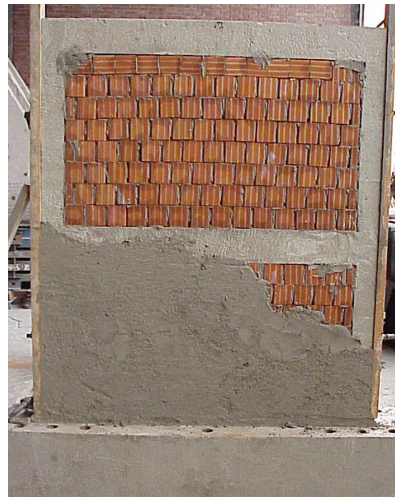
Figure 3.15. Plastering of the specimen

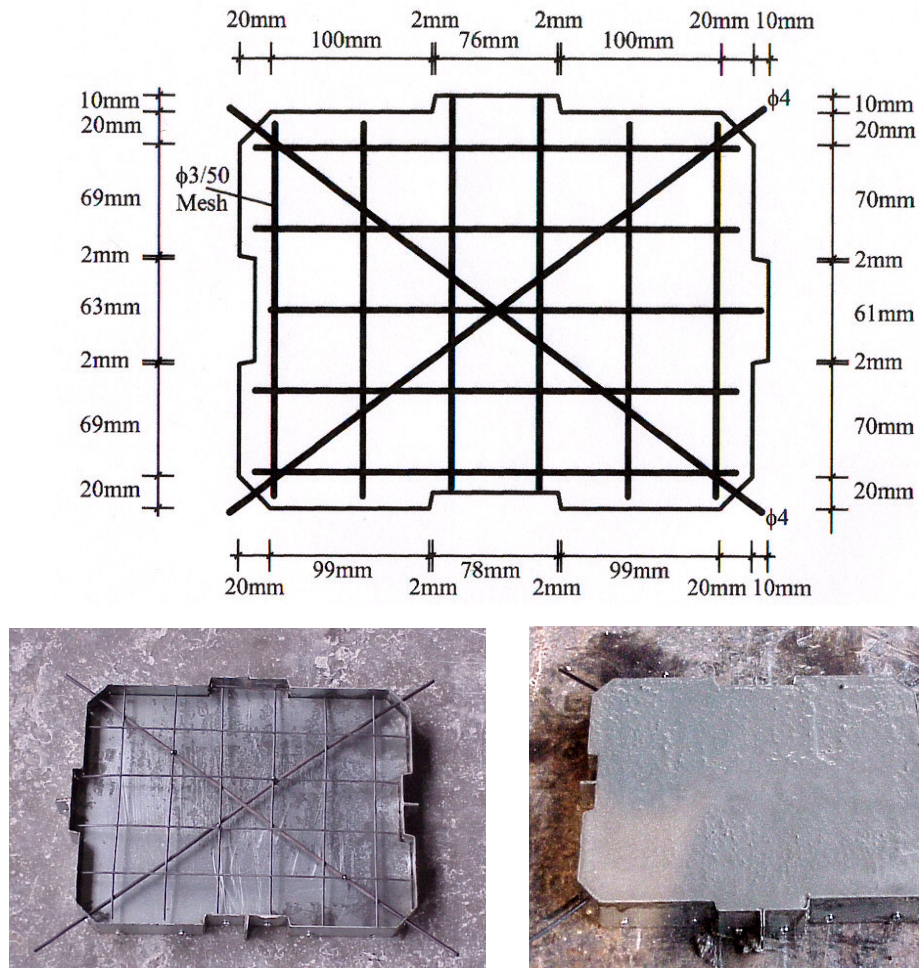
Figure 3.16. Dimension, reinforcement and moulding of Type A panels

At the initial stage of the work, every possible measure was taken to ensure monolithic behaviour of the infill. To this end, shear keys were provided at each side of the individual panels; reinforcing steel bars extending out at the corners and edges of the panels were welded together; and panels were epoxy connected to each other. With these considerations, Type A panel was designed to have dimensions of 320 mm in vertical direction whereas it was 245 mm in horizontal direction. Twelve Type A panels were used to strengthen each story. Type B reflects a different design approach, since it is a narrow and tall panel to cover the full floor height having dimensions of 745 mm by 105 mm. The basic idea under this approach was to keep the number of panels to strengthen one story constant. Both panels had a thickness of 20mm. In each type of panels, $\phi 3$ mesh steel and $\phi 4$ steel were used as reinforcement. The details and moulding of the Type A and Type B panels are shown in Figure 3.16. and Figure 3.17.

Shear keys at the edge of the panel types A and B were used to provide shear transfer and connection between panels.

Shear keys to provide shear transfer were placed along opposite sides of the panels leaving small gaps and these gaps were filled with epoxy mortar. Different key arrangements were used for both types of panels. Also, male and female shear key arrangement was used in order to engage the panels to each other with small gaps. In spite of using epoxy mortar, $\phi 4$ type embedded reinforcements were also used for welding the panels to each other for proper connection.

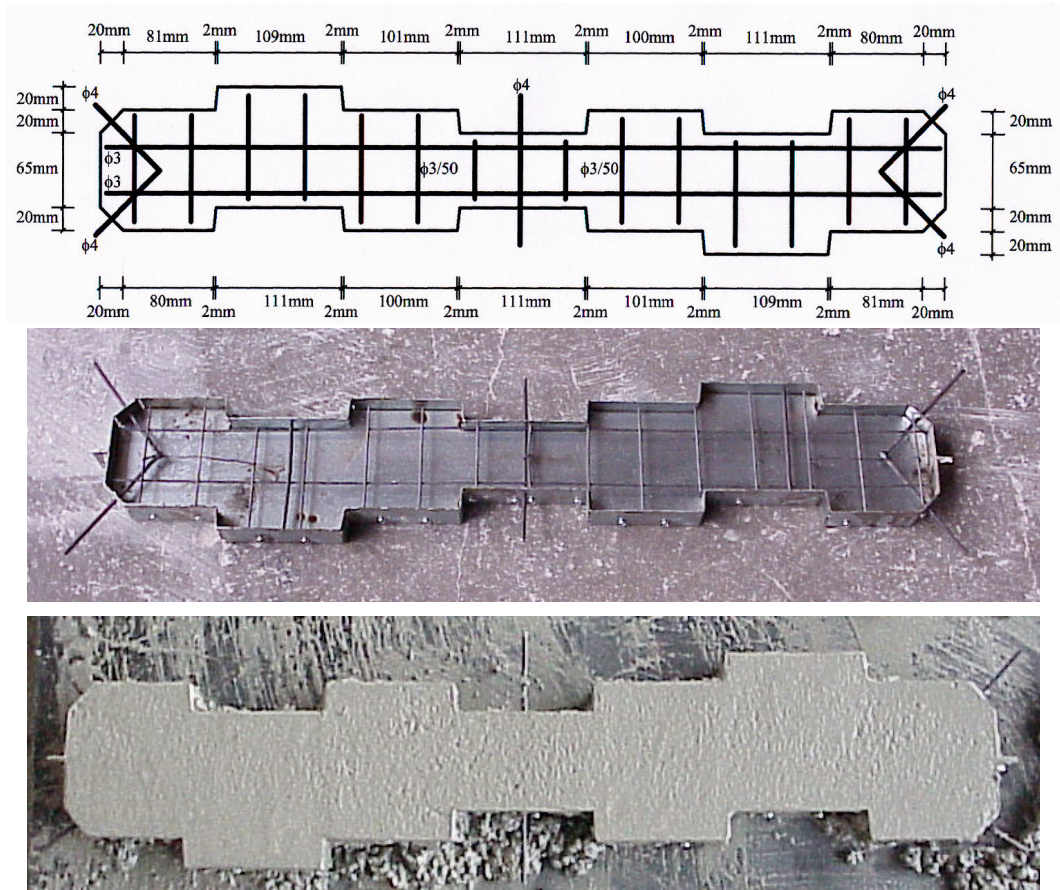
Figure 3.17. Dimension, reinforcement and moulding of Type B panels

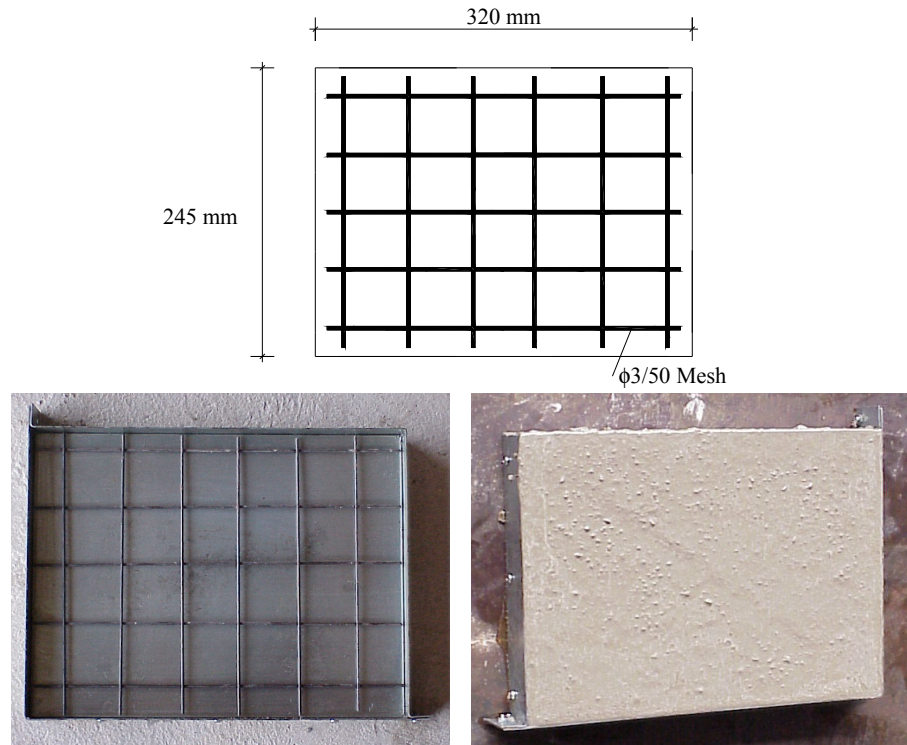
Figure 3.18. Dimension, reinforcement and moulding of Type C panels

With the considerations mentioned in Section 3.5.1., Type C panels were designed to have dimensions of 320 mm in vertical direction whereas it is 245 mm in horizontal direction. Twelve Type C panels were used to strengthen each story. Type D is a narrow and tall panel to cover the full floor height having dimensions of 740 mm by 105 mm. Type D panels were designed to be 5mm shorter than Type B panels in order to make filling of the gap between the frame element and panels more easy. In each type of panels, $\phi 3$ mesh steel were used as reinforcement. The details and moulding of the Type C and Type D panels are shown in Figure 3.18. and Figure 3.19.

The panels were connected to one another only through the use of epoxy mortar.

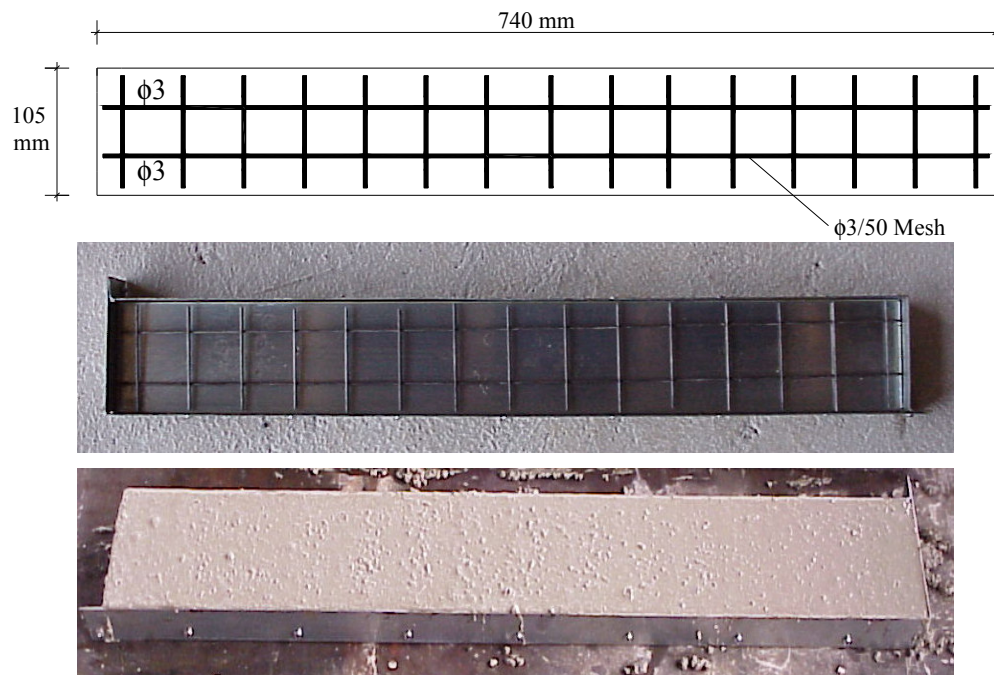
Figure 3.19. Dimension, reinforcement and moulding of Type D panels

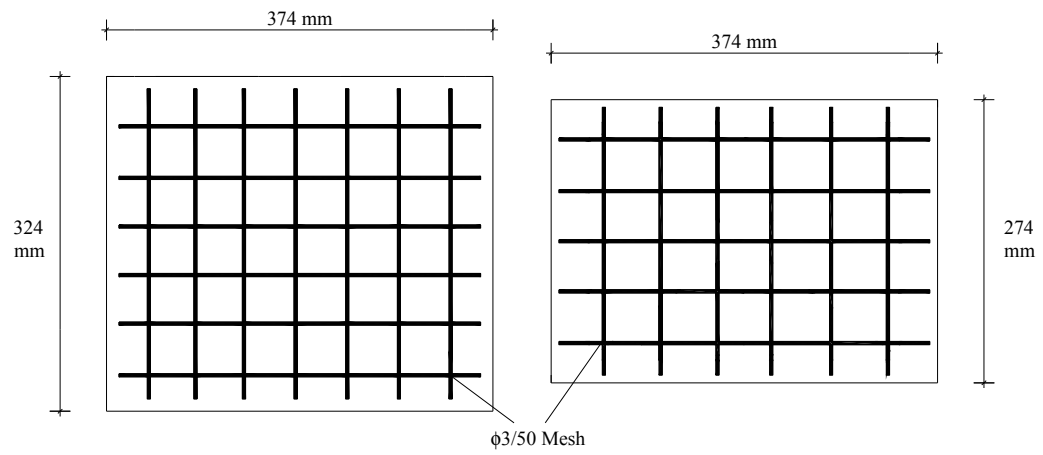
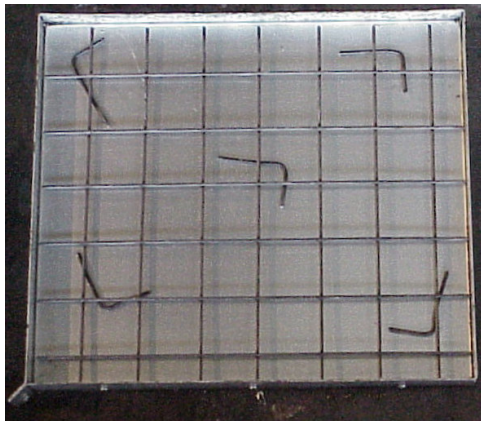
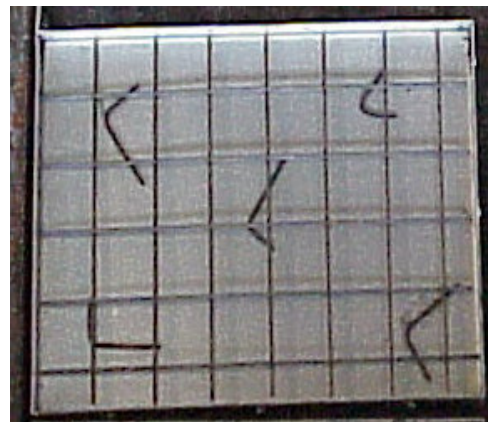
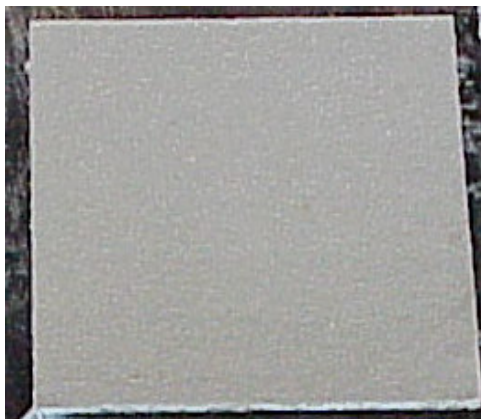
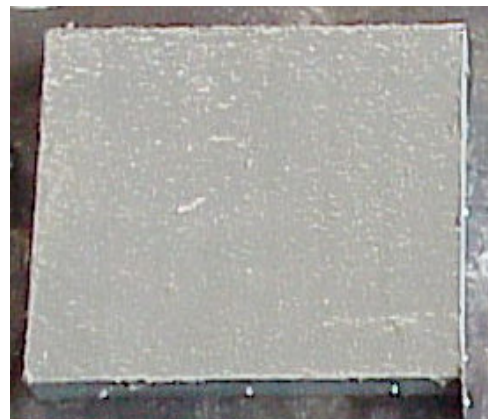
Figure 3.20. Dimension, reinforcement and moulding of Type E panels

As the length from the foundation level to the middle of the first story beam and the length from the middle of the first story beam to the top of the specimen are different from each other, two different panels having the same dimension in vertical direction but different dimensions in horizontal direction were designed for both Type E and Type F panels. In each type of panels, $\phi 3$ mesh steel were used as reinforcement. Conical steels were fixed to the forms by means of 3/16" screws in order to leave holes on the Type E and Type F panels during casting. Holes having 10 mm diameter and 100 mm depth were drilled on the frame by using the holes on the panels. After cleaning the holes by compressed air and wet cloth, epoxy was injected into the holes and 8 mm diameter bolts were drilled into these holes. Type E and Type F panels were fixed to the columns and beams of the specimen by using nuts and pre-drilled bolts. The panels were connected to one another only through the use of epoxy mortar. Out of plane resistance of the wall system was achieved by connecting the panels to plaster which covers the wall previously infilled hollow brick with epoxy mortar. The details and moulding of the Type E and Type F panels are shown in Figure 3.20. and Figure 3.21.

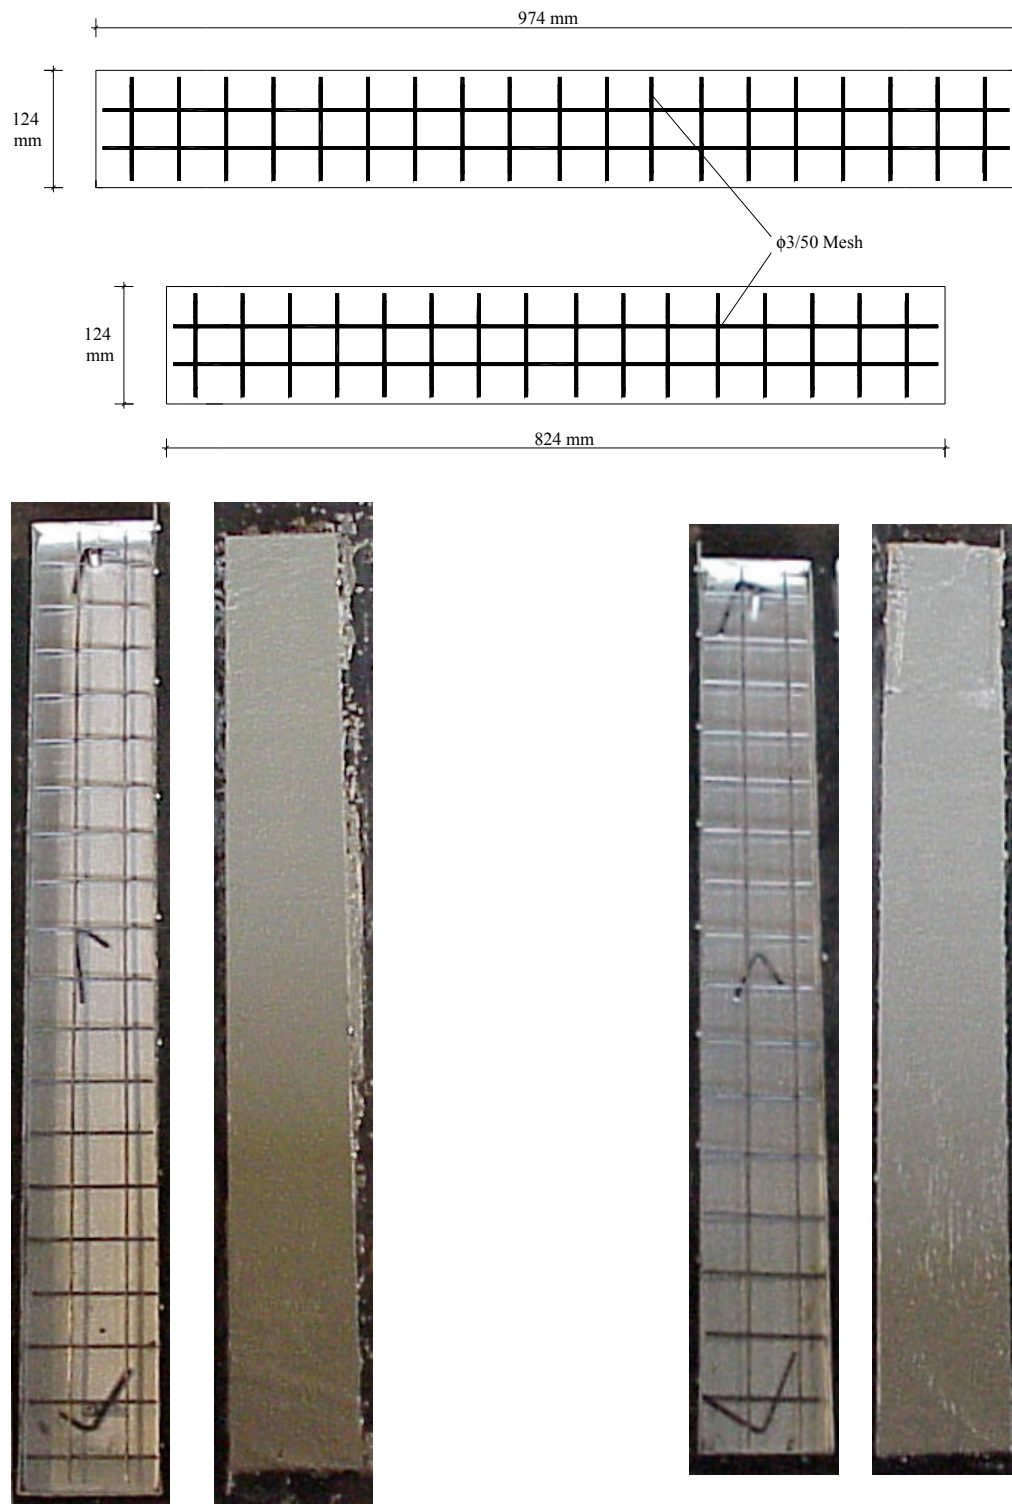
Figure 3.21. Dimension, reinforcement and moulding of Type F panels

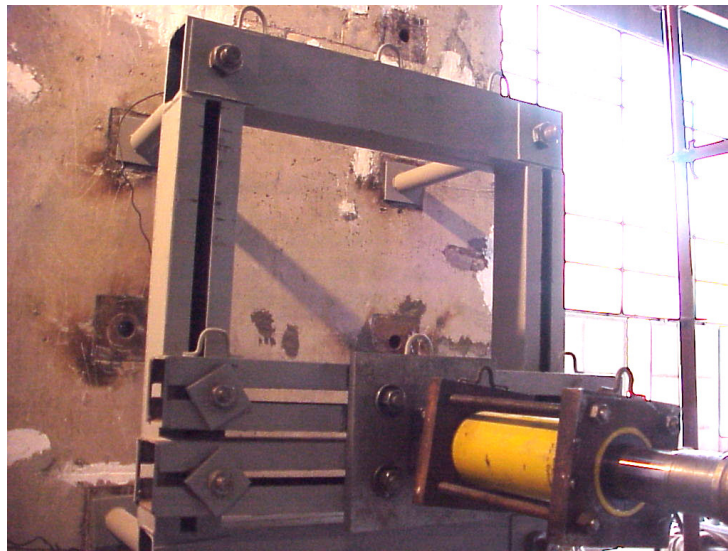
Figure 3.22. A general view of the sliding mechanism between the reaction wall and lateral loading system

The lateral loading system was attached to the strong wall and in line with the beams of the test specimen. The loading system consisted of a hydraulic jack, a load cell, adaptors for connecting the load cell and the hydraulic jack and hinges at both ends. The loading system had to move freely on the strong wall allowing accurate positioning since different specimens having variable story numbers and heights would be tested by using the same lateral loading system. For this reason, a rail system was designed using steel sections. The top and bottom sections of the system consisted of built-up box sections consisting of two U200 steel sections welded together. The side sections consisted of two U140 sections with a space of 40 mm between them to provide sliding. U140 sections were strengthened by welding 1mm thick steel plates to the flanges. The side sections were welded to the

top and bottom sections to form the columns. These vertical members enabled sliding in the vertical directions. The same sliding mechanism formed from two U140 sections was placed on the vertical members to allow the movement in the horizontal direction. A 400x400x30 mm steel plate was attached on the mechanism to allow fixing the hinge of the lateral loading system to the strong wall. The sliding mechanism was fixed to the reaction wall by means 4 steel pipes. A general view of the sliding mechanism between the reaction wall and lateral loading system is shown in Figure 3.22.

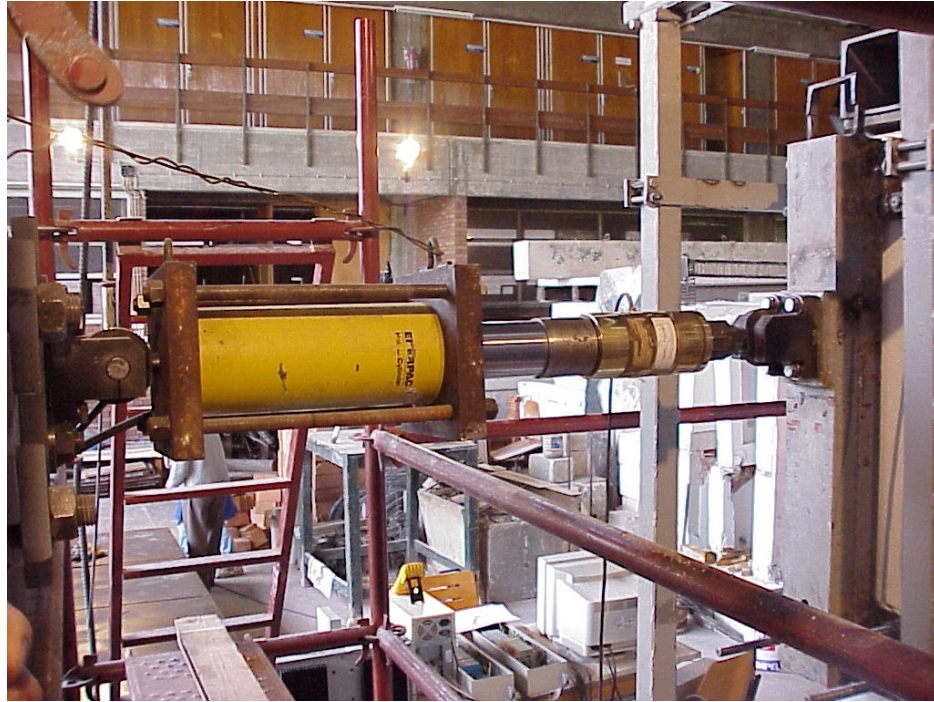
Figure 3.23. A general view of the lateral loading system

Reversed cyclic lateral loading was applied by using a double acting hydraulic jack which was capable of applying 600 kN in compression and 420 kN in tension. A load cell was connected between the hydraulic jack and the test frame to measure the magnitude of the applied lateral load. The capacity of the load cell was 600 kN in compression and 300 kN in tension. An adapter made from strong steel was used to connect the hydraulic jack and load cell. The lateral loading system had pin connections at both ends to eliminate any accidental eccentricity mainly in the vertical direction and tolerating a small rotation in the horizontal direction normal

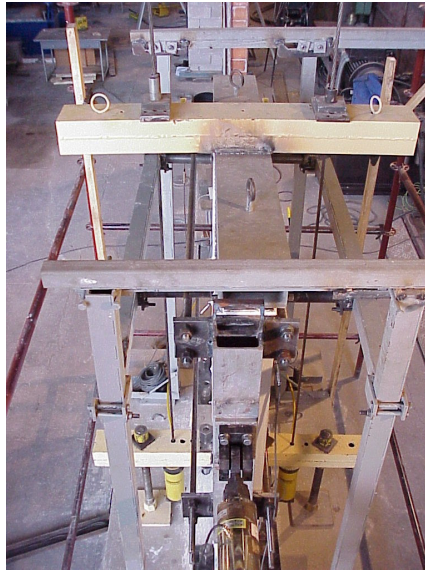
Figure 3.24. Guide frame preventing out-of-plane deformations

A rather rigid external steel 'guide frame' attached to the universal base, was constructed around the test specimen in order to prevent out-of-plane deformations. The frame consisted of four steel columns, each made by welding of two L sections to make a box section, post-tensioned to the universal base by using the bolts for fixing the universal base to the strong floor. Another two box sections each made from two L sections, were used to connect the columns in the long direction. These two box sections could move in the vertical direction. Four rollers, two on each side, were attached to the box sections, and they gently touched the test frame beam, smoothly allowing in-plane displacement. In the short direction, columns were connected by using two L sections (later strengthened by using box sections by means of welding for the application of panels on the exterior face of the specimen) and these L sections were fixed to the laboratory wall. For rollers, ball bearings were used satisfactorily since the test frame had to make vertical as well as horizontal displacement. The ball bearings used in the interior panel experiments had an axial load capacity of 2.5 kN where the capacity of these units were increased by using different types for panel application on the exterior face of the specimen. Guide frame is shown in Figure 3.24. and ball bearings are shown in Figure 3.25.
