**PRECAST CONCRETE PANEL REINFORCED INFILL WALLS
FOR SEISMIC STRENGTHENING OF
REINFORCED CONCRETE FRAMED STRUCTURES**

**A THESIS SUBMITTED TO
THE GRADUATE SCHOOL OF NATURAL AND APPLIED SCIENCES
OF
MIDDLE EAST TECHNICAL UNIVERSITY**

**BY
MEHMET BARAN**

**IN PARTIAL FULFILLMENT OF THE REQUIREMENTS
FOR
THE DEGREE OF PHILOSOPHY OF DOCTORATE
IN
CIVIL ENGINEERING**

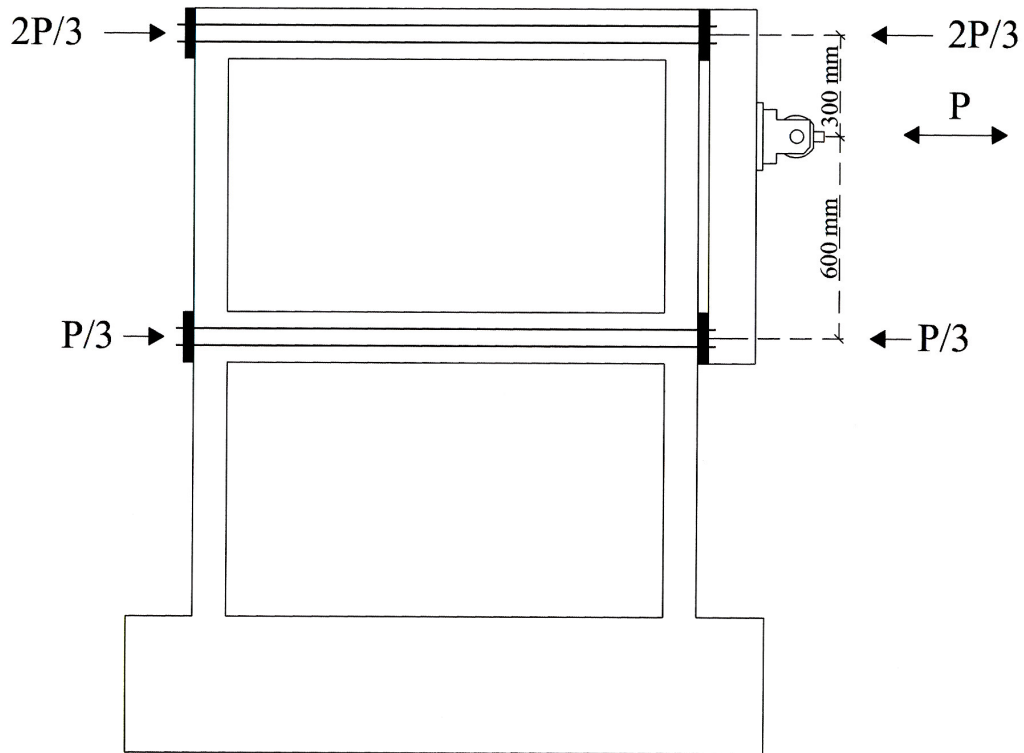
Figure 3.26. Load sharing between the floor levels

To solve the load distribution problem, the lateral load was applied on a spreader beam at one-third of its span to ensure that the lateral load at the second floor level always remains twice as the lateral load at the first floor level. At floor levels, clamps made of four steel bars connected to two loading plates at both ends were loosely attached to the test frame. At the spreader beam side, loading plates at both

floor levels were welded to the spreader beam. Before every test, the clamps were carefully controlled to be loose not to make any external prestressing on the beams. By this way, a horizontal push was applied to the test unit through steel loading pads without inducing any undesirable tension in the beam in case of pulling the frame from a loading point anchored into the beam end. Lateral load sharing between the floor levels is given in Figure 3.26.

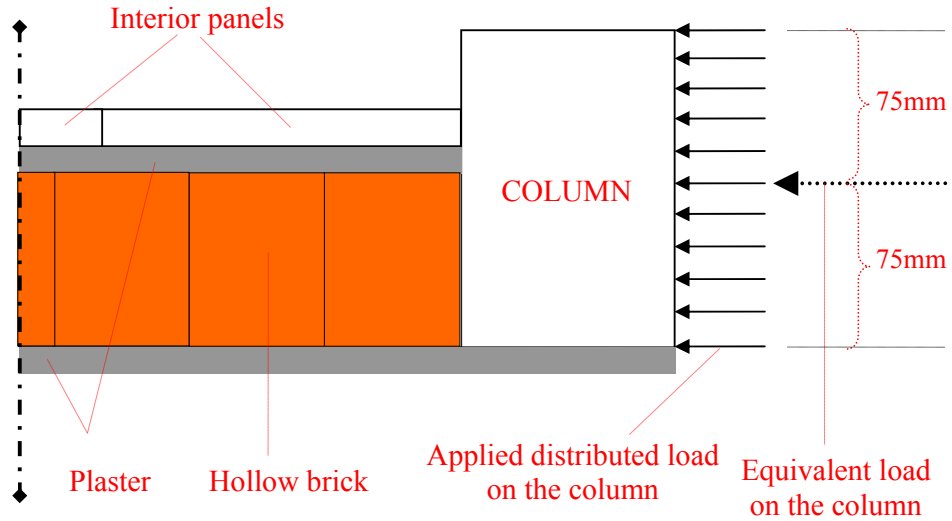
Figure 3.27. Load application on to the specimen (interior type panels)

As mentioned before, the infill wall was placed eccentrically on the exterior side of the beam to reflect the common practice, in all the specimens. Thus, the contribution of the infill made the frame behaviour somewhat unsymmetrical but the placement of the interior panels (Type A, Type B, Type C and Type D panels) on the infill wall turned the scene to be more symmetrical. Therefore, the lateral load was applied on to the specimen in the plane of symmetry of the column. In the

experiments of the reference and interior panel strengthened specimens, it was observed that the ball bearings gently touched the specimens meaning that there was no remarkable eccentricity introduced to the specimen. The application of lateral load on to the specimen in the experiments when interior type panels were used is shown in Figure 3.27.

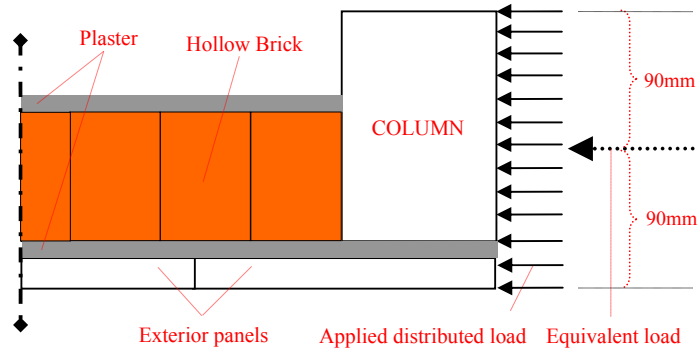
Figure 3.28. Load application method on to the Specimen CEE4

The application of the lateral load on to the specimen in the plane of symmetry of the column did not create any problems in the experiments until Type E panels were used at the exterior face of the specimen CEE4. It was the first experiment where exterior type panels were used to strengthen the specimen and the lateral load was applied on to the specimen in the plane of symmetry of the cross-section, not the column's plane of symmetry. The application of load on to this specimen is shown in Figure 3.28. In this experiment, the contribution of the exterior type panels made the frame behaviour unsymmetrical, and the load applied in the plane of symmetry created warping, which led to significant undesirable out-of-plane deformations resulting with buckling in one of the L sections of the guide frame, which was fixed to the laboratory wall, towards the end of the test. Actually, the test of Specimen CEE4 had to be terminated due to this progress. Therefore, precautions were taken for the sake of safety in the future tests. Firstly, L sections,

which were fixing the guide frame to the laboratory wall, had to be strengthened. First precaution was taken by welding new ones on the existing L sections. By this way, L sections become closed box sections. Second and more important precaution was to apply the lateral loading on the specimen eccentrically. The last three specimens (CEF4, CEE1, and CEER) were tested under lateral loads applied eccentrically and the application of load method on these specimens is shown in Figure 3.29.

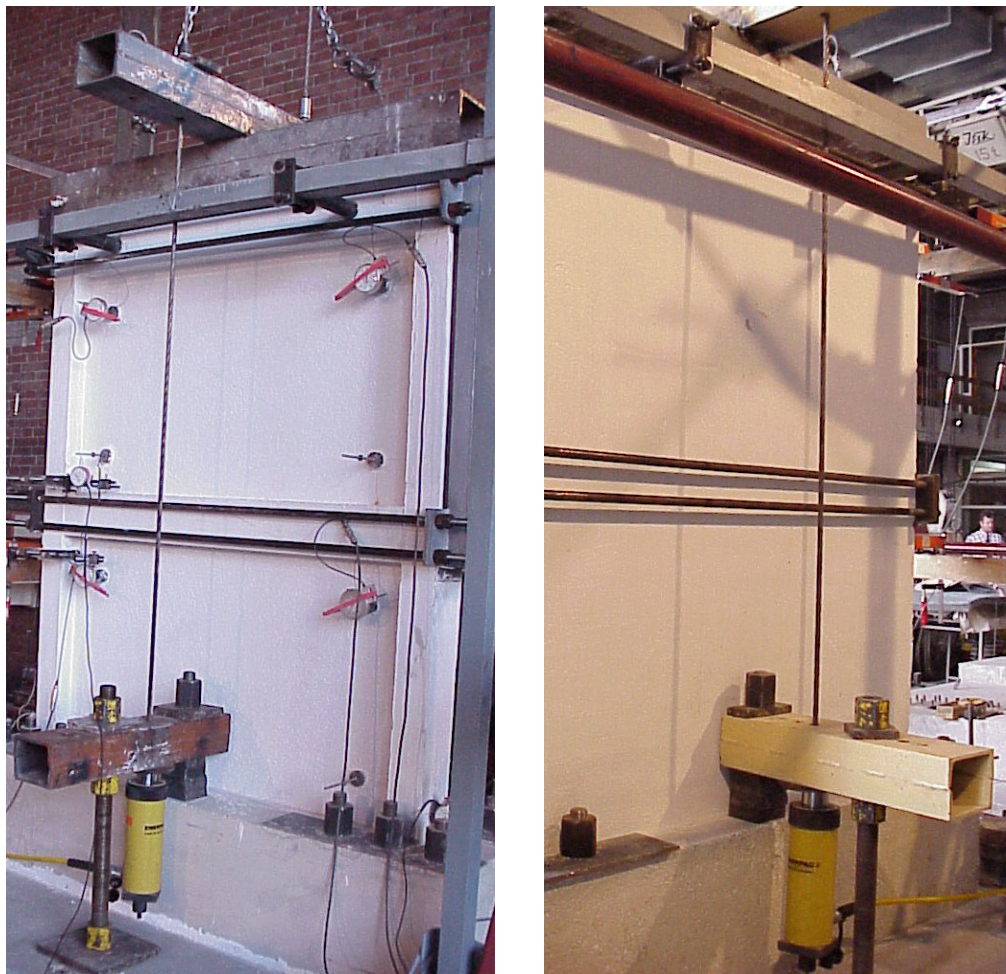
Figure 3.30. The axial load apparatus

The axial load on columns was provided by steel cables post-tensioned by hydraulic jacks. On both sides of the test specimen, built up steel sections were fixed by using the bolts on the universal base and bolts on the foundation of the test frame. Steel cables, passing through the holes on the hydraulic jacks and built up

steel sections, were fixed to the cross beam by using jacks. The cross beam was welded perpendicular to the spreader beam which was supported as a simple beam with supports at the column heads. When the load was applied, the spreader beam divided the load developing in the hydraulic jacks and the steel cables into two equal components and transferred it to the two columns. The load was continuously monitored and readjusted during the test. However, a significant readjustment was not needed, since the variation caused by displacement of the frame was not high. The axial load apparatus is shown in Figure 3.30. General view of the test set-up is given in Figure 3.31. and Figure 3.32.

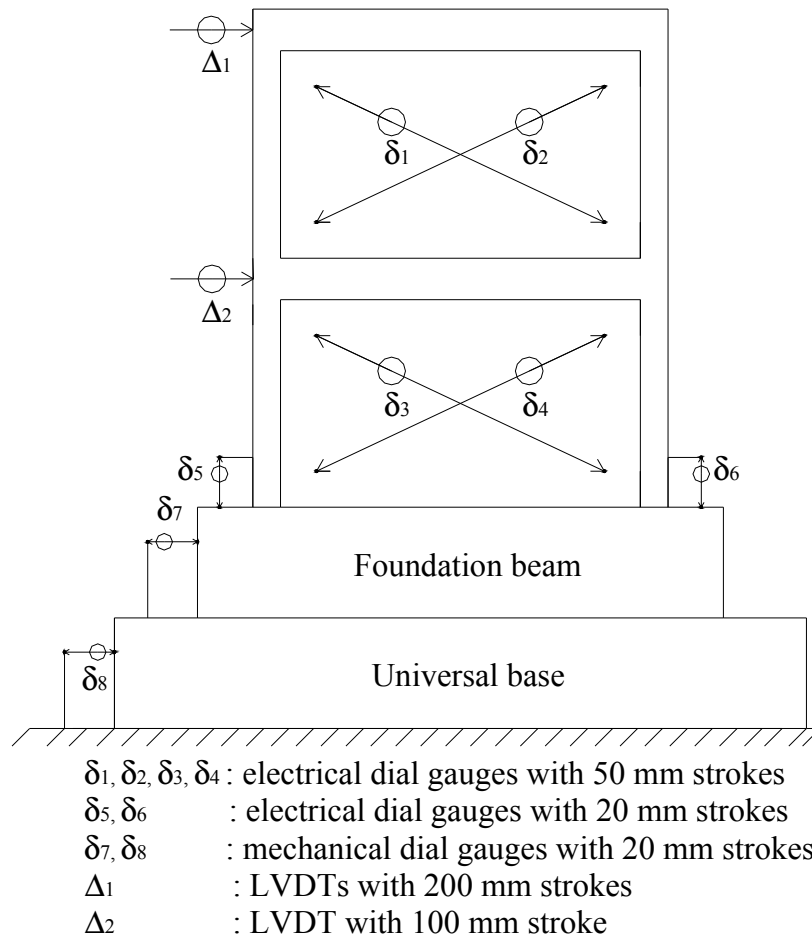
Figure 3.33. Instrumentation

Shear deformations were measured on both first and second story infill walls by means of two diagonally placed dial gauges, having 50 mm strokes, mounted on infill as shown in Figure 3.33. Transducers were located 130 mm away from the corner of the infill walls. The reason for choosing this location was to avoid localized effects like crushing of concrete during experiment. Transducers were mounted on the hollow brick infill wall or on the panels by means of epoxy mortar Sikadur 31. Drilling holes on the infill wall and on the panels and mounting the transducers by means of bolts and nuts was not preferred since localized effects like crushing of concrete due to the holes would not be tolerable during the experiments.

Dial gauges were mounted at the bottom of the both columns in vertical position in order to measure the displacement values at the bottom of the both columns. These readings would be used to have an idea about the rotations when the infill wall remains intact and the whole test specimen resembles cantilever behaviour, vertical deformations at the column bases during the application of the axial load on columns and the deformations at the column-foundation connections, steel yielding in the tension side column and concrete crushing in the compression side.

The rigid body displacements of the frame and universal base were measured by means of mechanical dial gauges. A dial gauge was mounted on the universal base in horizontal position in order to measure the displacement with respect to the ground and another was mounted on the frame foundation in horizontal position in order to measure the displacements with respect to the universal base. These gauges were monitored manually at the peak of each cycle to observe any possible rigid body displacement occurred at the universal base and foundation beam. If any movement was observed, these displacement values were used to make corrections in the story displacements.

Displacement transducers, either LVDTs (Linear Variable Displacement Transducer) or electrical dial gauges were used for deformation measurements and load cells were used for load measurement. Deformations were measured by LVDT's with 200 mm and 100 mm strokes and dial gauges with 50 mm and 20 mm strokes. The details of the instrumentation is given in Figure 3.33. Voltage outputs from the instruments were fed into a data acquisition system, from which all signals were directed to a personal computer. Data were stored as force and displacement by a computer program developed at METU. By the help of this program, load-displacement diagram was continuously displayed on the screen of the computer during the experiments.

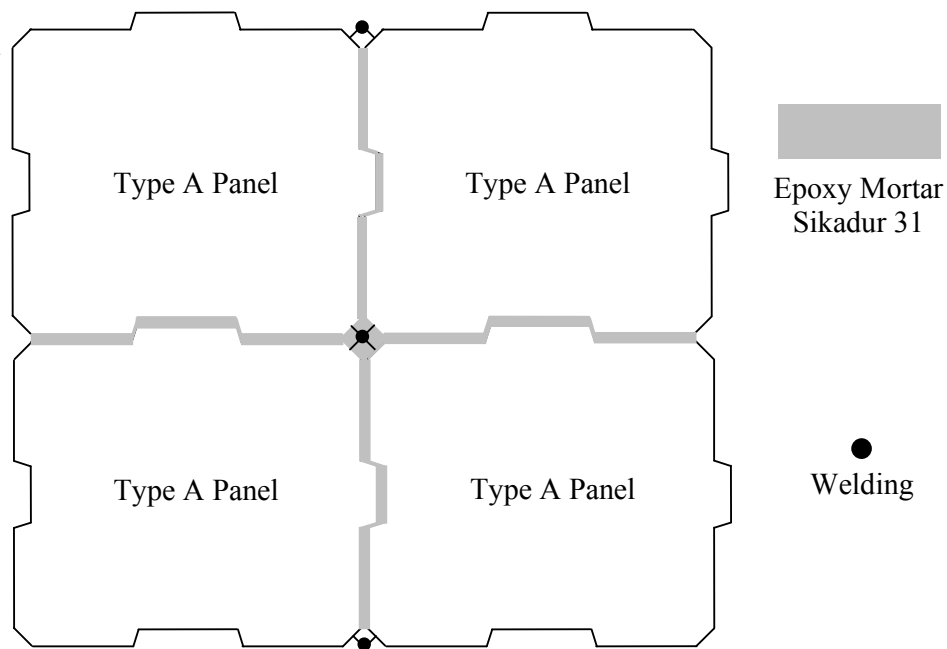
Figure 4.1. Panel-to-panel connection details for Type A panels

Type A precast concrete panels were placed on the interior faces of the infill walls of Specimen CIA4 [6]. The necessary frame-to-panel connections were provided by using dowels. Before placing the panels, holes were drilled into the inner faces of the columns and beams. After cleaning the holes by compressed air and wet cloth, epoxy was injected into the holes and $\phi 6$ dowels were placed into these holes. The depth and diameter of the dowel holes were 80 mm and 8 mm, respectively. The panels were epoxy connected to the plaster which covers the hollow brick infill wall. Epoxy mortar Sikadur 31, presented in Section 3.4.4., was used to connect the panels to the plaster. After connecting the panels to the plaster, the reinforcement at the connection joints of the adjacent panels were welded to the dowels at the columns and beams. The shear capacity of the panel-to-panel joints must be high enough to develop full shear capacity of the wall in order to ensure solid wall behaviour. Therefore, male and female shear key arrangement was used at panel sides in order to provide shear transfer and also panels were connected to one another through the use of epoxy mortar Sikadur 31. In spite of using epoxy mortar, embedded reinforcements at the corner of the panels were welded to each

other for proper connection of the panels. Gaps between the panels and between the panels and the frame members were filled with epoxy mortar after welding process. Panel-to-panel connection details for Type A panels is shown in Figure 4.1. Panel arrangement and configuration of the dowels for Specimen CIA4 is shown in Figure 4.2. The photograph of type A panels before and after filling the gaps with epoxy mortar are given in Figure 4.3. and Figure 4.4., respectively. Detailed arrangement of Type A panels in vertical section is shown in Figure 4.5.

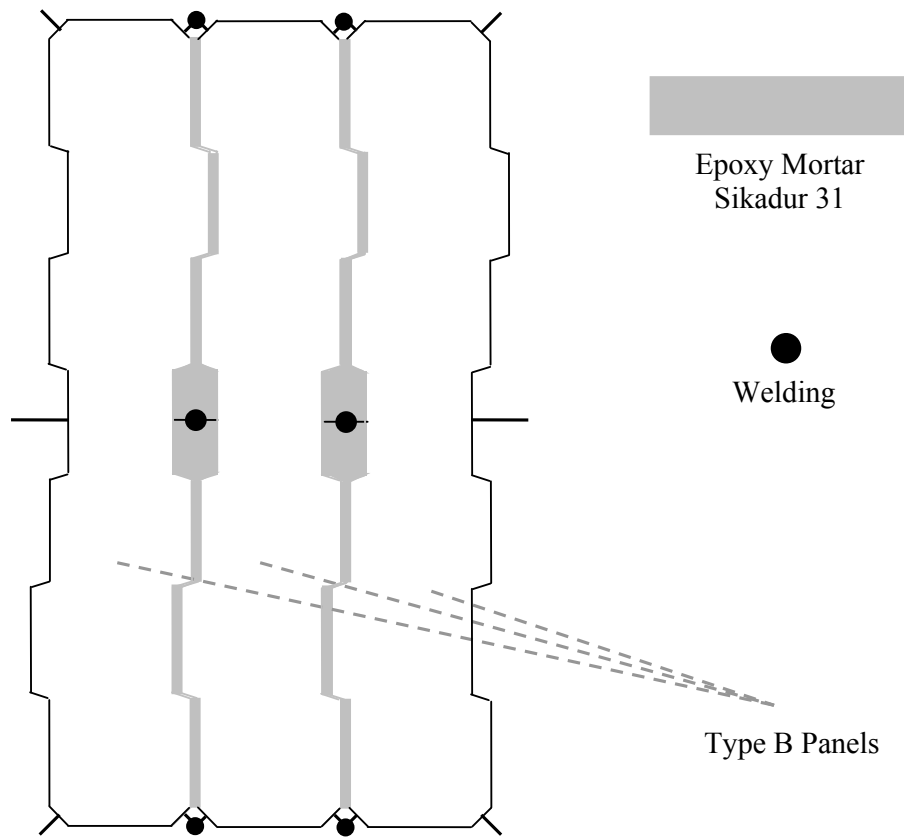
Figure 4.6. Panel-to-panel connection details for Type B panels

Type B precast concrete panels were placed on the interior faces of the infill walls of Specimen CIB4 [6]. Frame-to-panel and panel-to-panel connection details were as in the case of Specimen CIA4 given in Section 4.3. For specimen CIB4, panel-to-panel connection detail is shown in Figure 4.6., panel arrangement and configuration of the dowels is shown in Figure 4.7. The photograph of type B panels before and after filling the gaps with epoxy mortar are given in Figure 4.8. and Figure 4.9., respectively. Detailed arrangement of Type B panels in vertical section is shown in Figure 4.5.

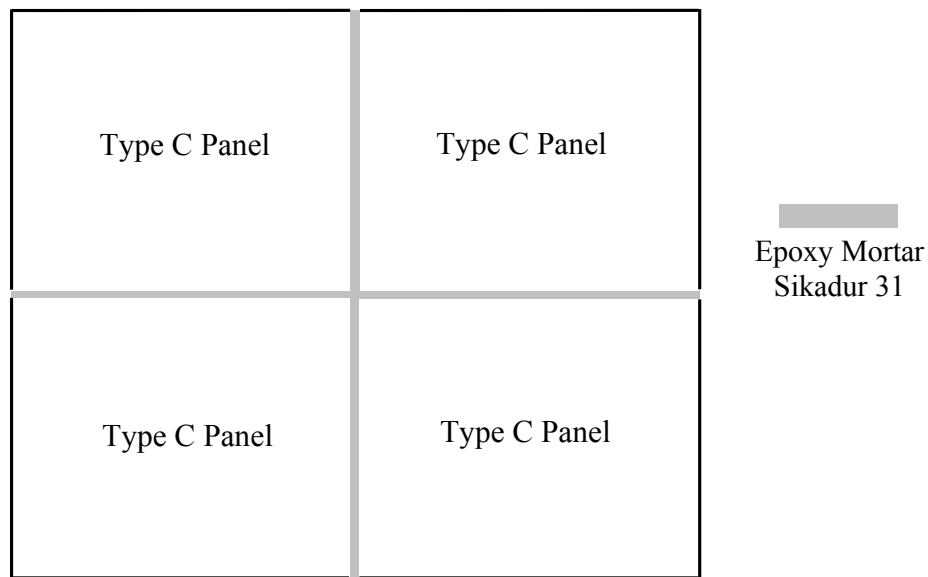
Figure 4.10. Panel-to-panel connection details for Type C panels

Type C precast concrete panels were placed on the interior faces of the infill walls of Specimen CIC1 and LIC1. The necessary frame-to-panel connections were provided by the use of epoxy mortar. However, epoxy anchored dowels (anchorage bars) at the foundation level, where the most critical load effects take place, were considered essential. Therefore frame-to-panel connections were provided by both epoxy mortar and epoxy anchored dowels at the foundation level. Dowels were drilled to the foundation beam in-between the adjacent panels. The depth and diameter of the dowel holes were 100 mm and 10 mm, respectively and $\phi 8$ deformed bars were epoxy anchored to these holes. After connecting the panels to plaster and to each other by using epoxy mortar, gaps between the panels and between the panels and the frame members were filled with epoxy mortar. Panel-to-panel connection detail for Specimens CIC1 and LIC1 is shown in Figure 4.10. Panel arrangement and configuration of the dowels is shown in Figure 4.11. The photograph of type C panels before and after filling the gaps with epoxy mortar are given in Figure 4.12. and Figure 4.13., respectively. Detailed arrangement of Type C panels in vertical section is shown in Figure 4.5.

The anchorage bars on both columns of the first story was the only difference between Specimens CIC1 and CIC3. For specimen CIC3, panel-to-panel connection detail is shown in Figure 4.10., anchorage bar arrangement is shown in Figure 4.18., and panel arrangement and configuration of the dowels is shown in Figure 4.19. The photographs of Specimen CIC3 during connection of panels to plaster and before filling the gaps with epoxy mortar are given in Figure 4.20. and Figure 4.21., respectively. Detailed arrangement of Type C panels in vertical section is shown in Figure 4.5.

The anchorage bars on both first story beam and columns was the only difference between Specimens CIC1 and CIC4. For Specimen CIC4, panel-to-panel connection detail is shown in Figure 4.10., anchorage bar arrangement is shown in Figure 4.22., and panel arrangement and configuration of the dowels is shown in Figure 4.23. The photographs of Specimen CIC4 before and after filling the gaps with epoxy mortar are given in Figure 4.24. and Figure 4.25., respectively. Detailed arrangement of Type C panels in vertical section is shown in Figure 4.5.

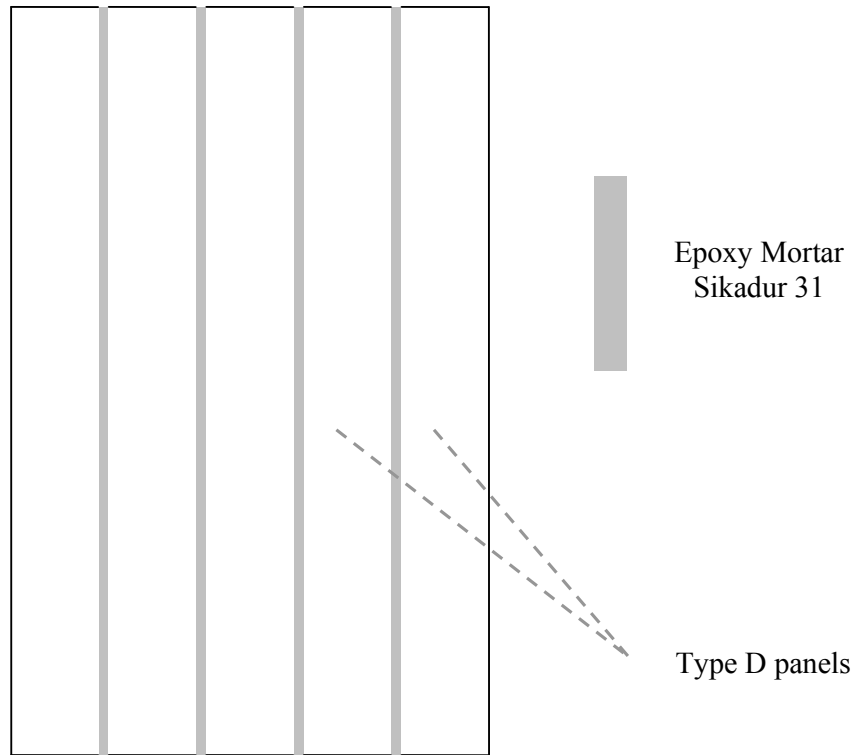
Figure 4.14. Panel-to-panel connection details for Type D panels

Type D precast concrete panels were placed on the interior faces of the infill walls of Specimens CID1 and LID1. Frame-to-panel and panel-to-panel connection details were as in the case of Specimens CIC1 and LIC1 given in Section 4.5. For Specimens CID1 and LID1, panel-to-panel connection details is shown in Figure 4.14., panel arrangement and configuration of the dowels is shown in Figure 4.15., anchorage bar arrangement and the photograph of type D panels before filling the gaps with epoxy mortar are given in Figure 4.16. and Figure 4.17., respectively. Detailed arrangement of Type D panels in vertical section is shown in Figure 4.5.

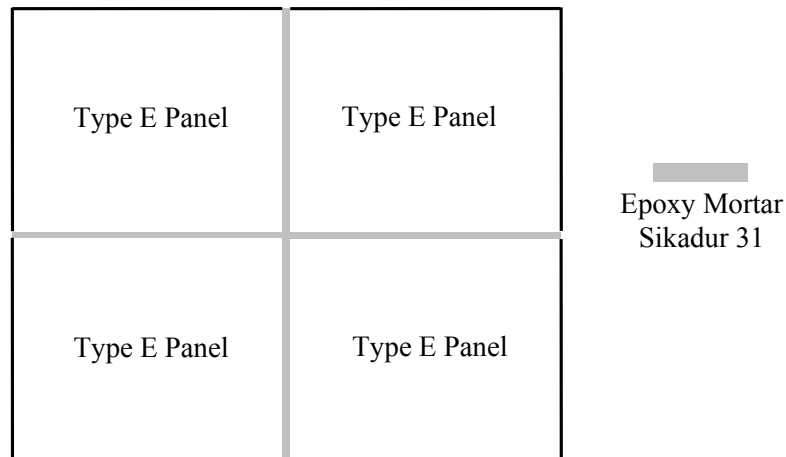
Figure 4.26. Panel-to-panel connection details, Specimen CEE4

Type E precast concrete panels were placed on the exterior face of Specimen CEE4. Epoxy anchored dowels (anchorage bars) at the foundation level were considered essential for the exterior type panels also. Therefore, epoxy anchored dowels were used in-between the panels at the foundation level. Panel-to-frame (exterior face of the specimen is plastered) and panel-to-panel connections were provided only by the use of epoxy mortar Sikadur 31. After connecting the panels to each other and to the plaster, gaps between the adjacent panels around the anchorage bars were filled with epoxy mortar. Also, $\phi 8$ bolts were used to fix the panels to the plaster. Holes were drilled into the frame on the selected points. The depth into the frame and diameter of the dowel holes were 100 mm and 10 mm, respectively. The holes passed through the panel, plaster and the frame, respectively. After cleaning the holes by compressed air and wet cloth, epoxy, presented in Section 3.4.4., was injected into the holes and $\phi 8$ bolts were placed into these holes. Panel-to-panel connection details for Specimen CEE4 are shown in Figure 4.26. Panel arrangement and configuration of the dowels for Specimen CEE4 is shown in Figure 4.27. The photograph of Specimen CEE4 before and after filling the gaps with epoxy mortar and placing $\phi 8$ bolts are given in Figure 4.28. and Figure 4.29., respectively. Detailed arrangement of Type E panels in vertical section is shown in Figure 4.30.

Type E precast concrete panels were placed on the exterior face of Specimen CEE1. The only difference between Specimens CEE4 and CEE1 was that no $\phi 8$ bolts were used to fix the panels to the plaster in Specimen CEE1. Panel-to-panel connection details for Specimen CEE1 are shown in Figure 4.26. Specimen CEE1 before the test is shown in Figure 4.35. Panel arrangement and configuration of the dowels for Specimen CEE1 is shown in Figure 4.36. Detailed arrangement of Type E panels in vertical section is shown in Figure 4.30.

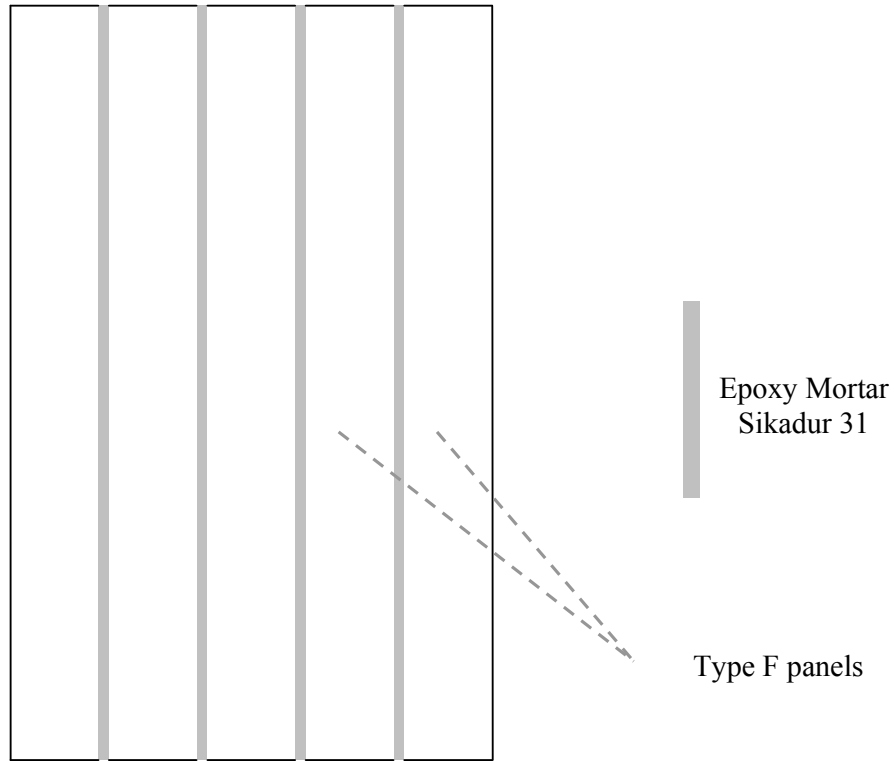
Figure 4.31. Panel-to-panel connection details, Specimen CEF4

Type F precast concrete panels were placed on the exterior face of Specimen CEF4. Panel-to-panel and panel-to-frame connection details were as in the case of Specimen CEE4 given in Section 4.10. For Specimen CEF4, panel-to-panel connection details is shown in Figure 4.31., panel arrangement and configuration of the dowels is shown in Figure 4.32. The photograph of Specimen CEF4 before and after filling the surround space of the anchorage bars with epoxy mortar and placing $\phi 8$ bolts are given in Figure 4.33. and Figure 4.34., respectively. Detailed arrangement of Type F panels in vertical section is shown in Figure 4.30.

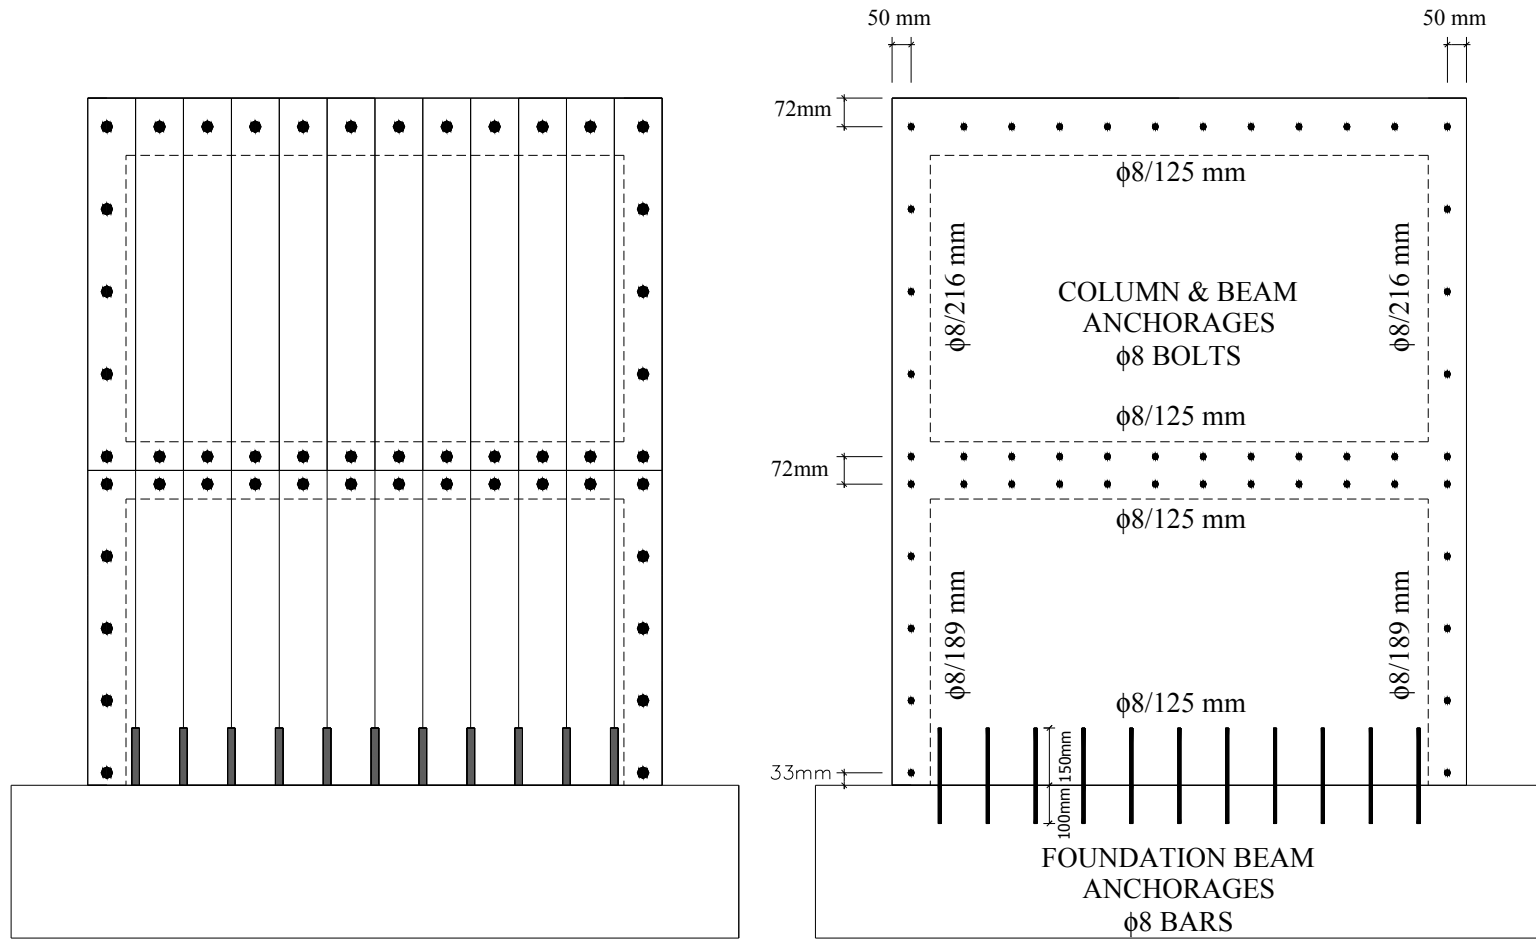
Figure 4.32. Panel arrangement and configuration of the dowels for Specimen CEF4

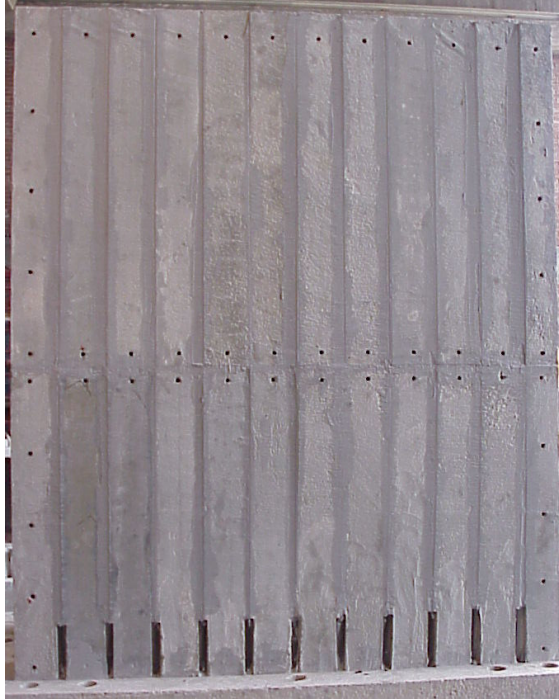
Figure 4.33. Specimen CEF4 before filling the gaps between the adjacent panels around the anchorage bars with epoxy mortar and placing $\phi 8$ bolts

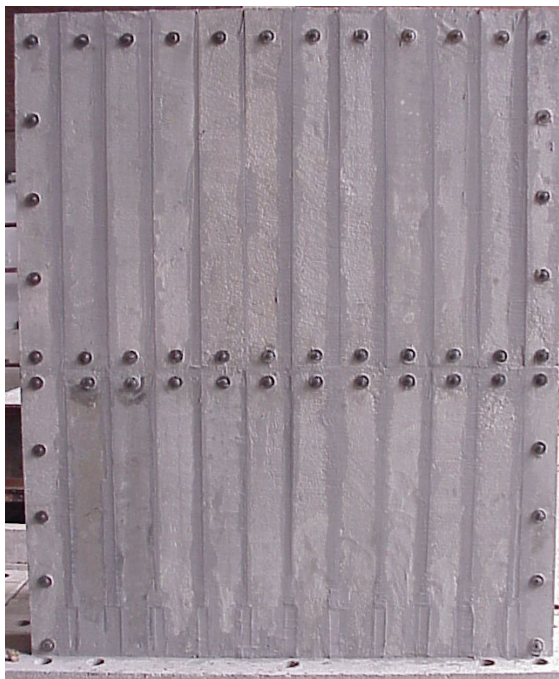
Figure 4.34. Specimen CEF4 with $\phi 8$ bolts

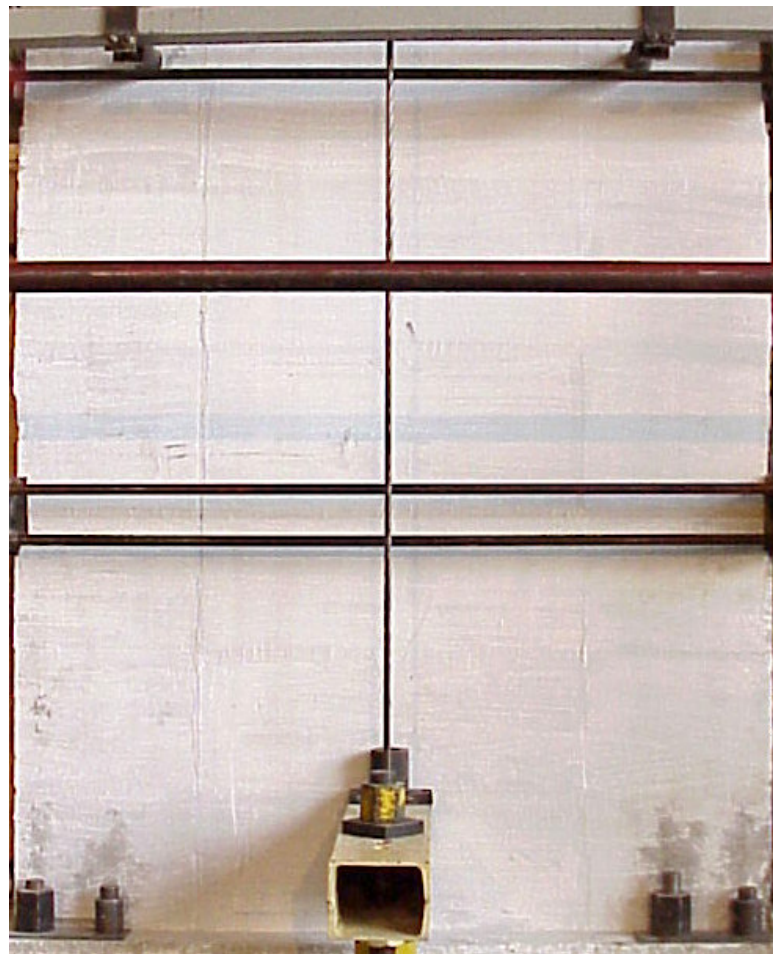
Figure 4.35. Specimen CEE1 before the test

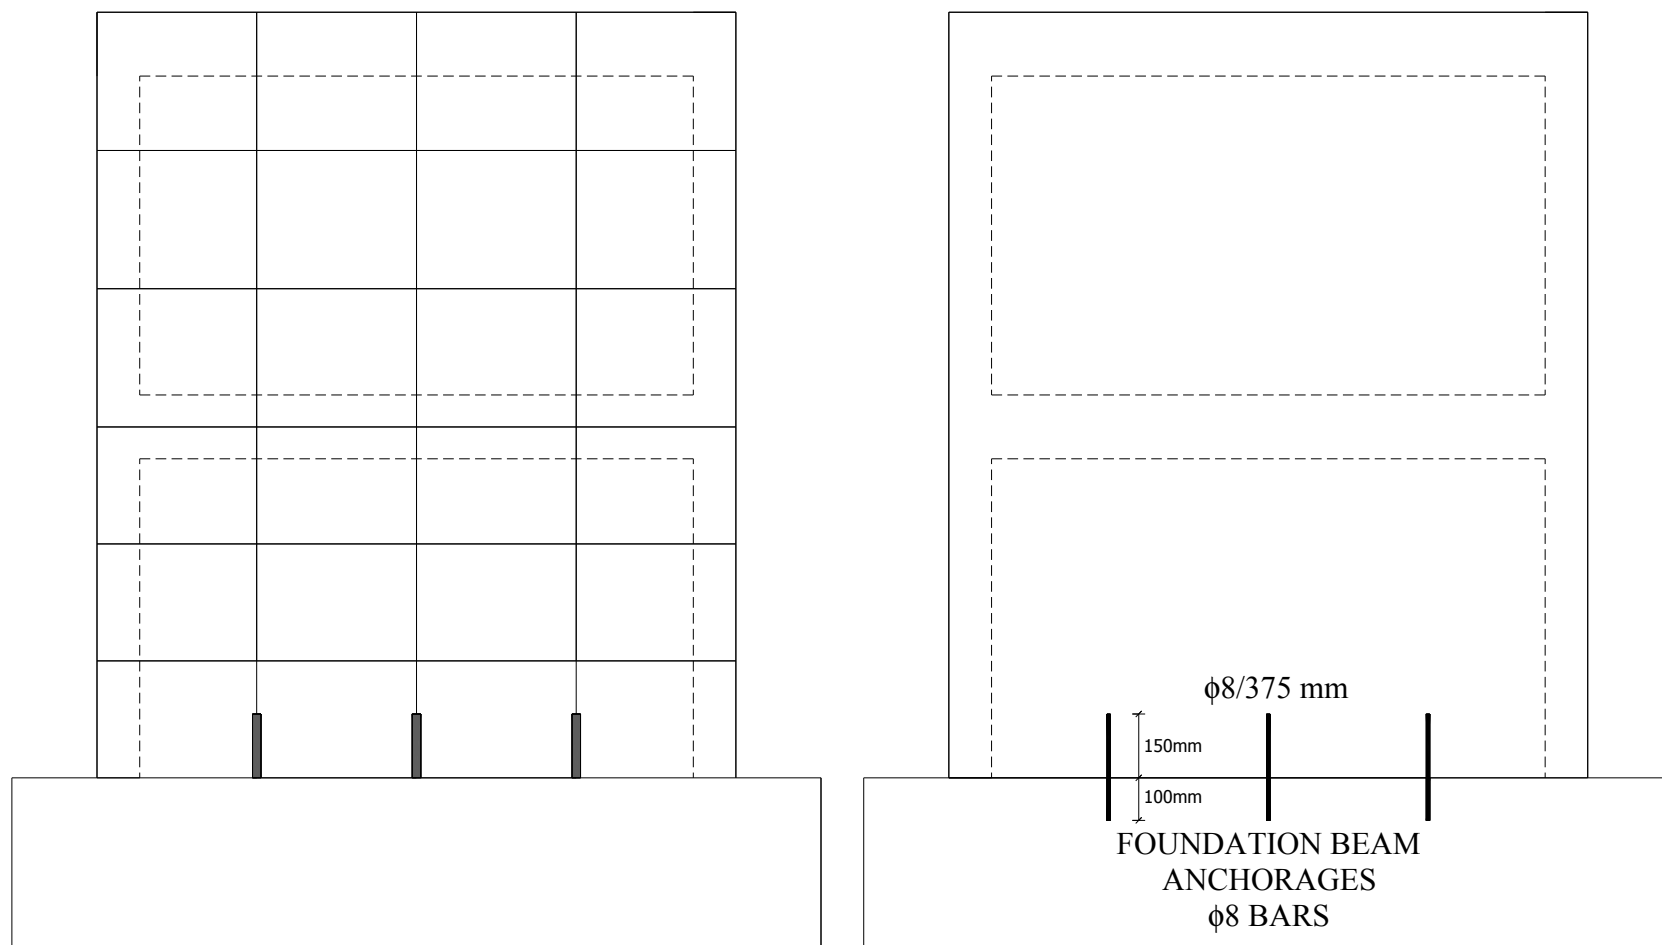
Figure 4.36. Panel arrangement and configuration of the dowels for Specimen CEE1

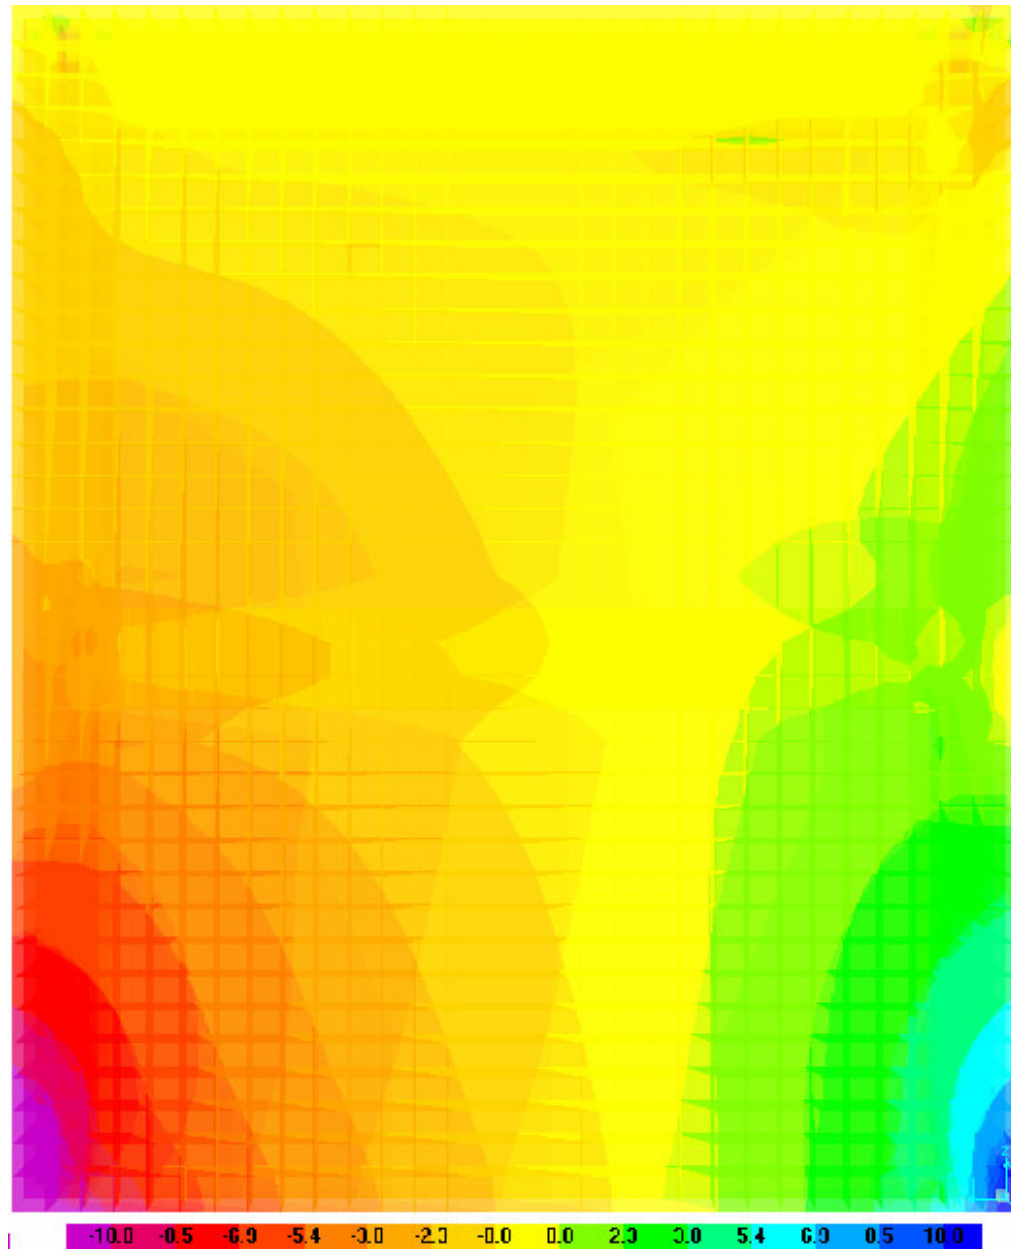
The stresses shown are in MPa (N/mm^2)

Figure 4.37. Analysis Results

Before strengthening Specimen CEER with type E precast concrete panels, an elastic analysis of Specimen CEE1 was performed by using the program SAP 2000^(*). Apart from Specimen CEE4, Specimen CEE1 also showed a superior behavior although it was strengthened without $\phi 8$ bolts. The aim in making the analytical study was to minimize the number of $\phi 8$ bolts in strengthening Specimen CEER. By this way, the construction mass of placing the bolts will be minimized whereas the strengthened building will hopefully show a satisfactory behavior in practice. Decreasing construction mass means decreasing construction expense and construction period. In the elastic analysis, the plastered infill wall strengthened by using precast concrete panels were idealised as monolithic since there were no separations observed on the panel-to-panel connections of Specimen CEE4 and Specimen CEE1 during the tests. At the end of the analysis, the internal Von Mises stress was drawn and it was seen that the most critical regions were the first story panels, especially the corner panels where the rate of change of principal stress was maximum. The panels of these regions should be fixed to the frame with a sufficient number of $\phi 8$ bolts to make sure that the shear stress between the frame and the plaster at the critical region could reach its maximum value. The internal Von Mises stress for Specimen CEE1 is shown in Figure 4.37. After the analysis, the points where $\phi 8$ bolts would be used were determined. The placement of $\phi 8$ bolts were as in the case of Specimen CEE4. The only difference between Specimens CEE4 and CEER was that reduced number of $\phi 8$ bolts were used to fix the panels to the plaster in Specimen CEER. For specimen CEER, panel-to-panel connection details are shown in Figure 4.26., panel arrangement and configuration of the dowels is shown in Figure 4.38. The photograph of Specimen CEER before and after placing $\phi 8$ bolts are given in Figure 4.39. and Figure 4.40., respectively. Detailed arrangement of panels in vertical section is shown in Figure 4.30.

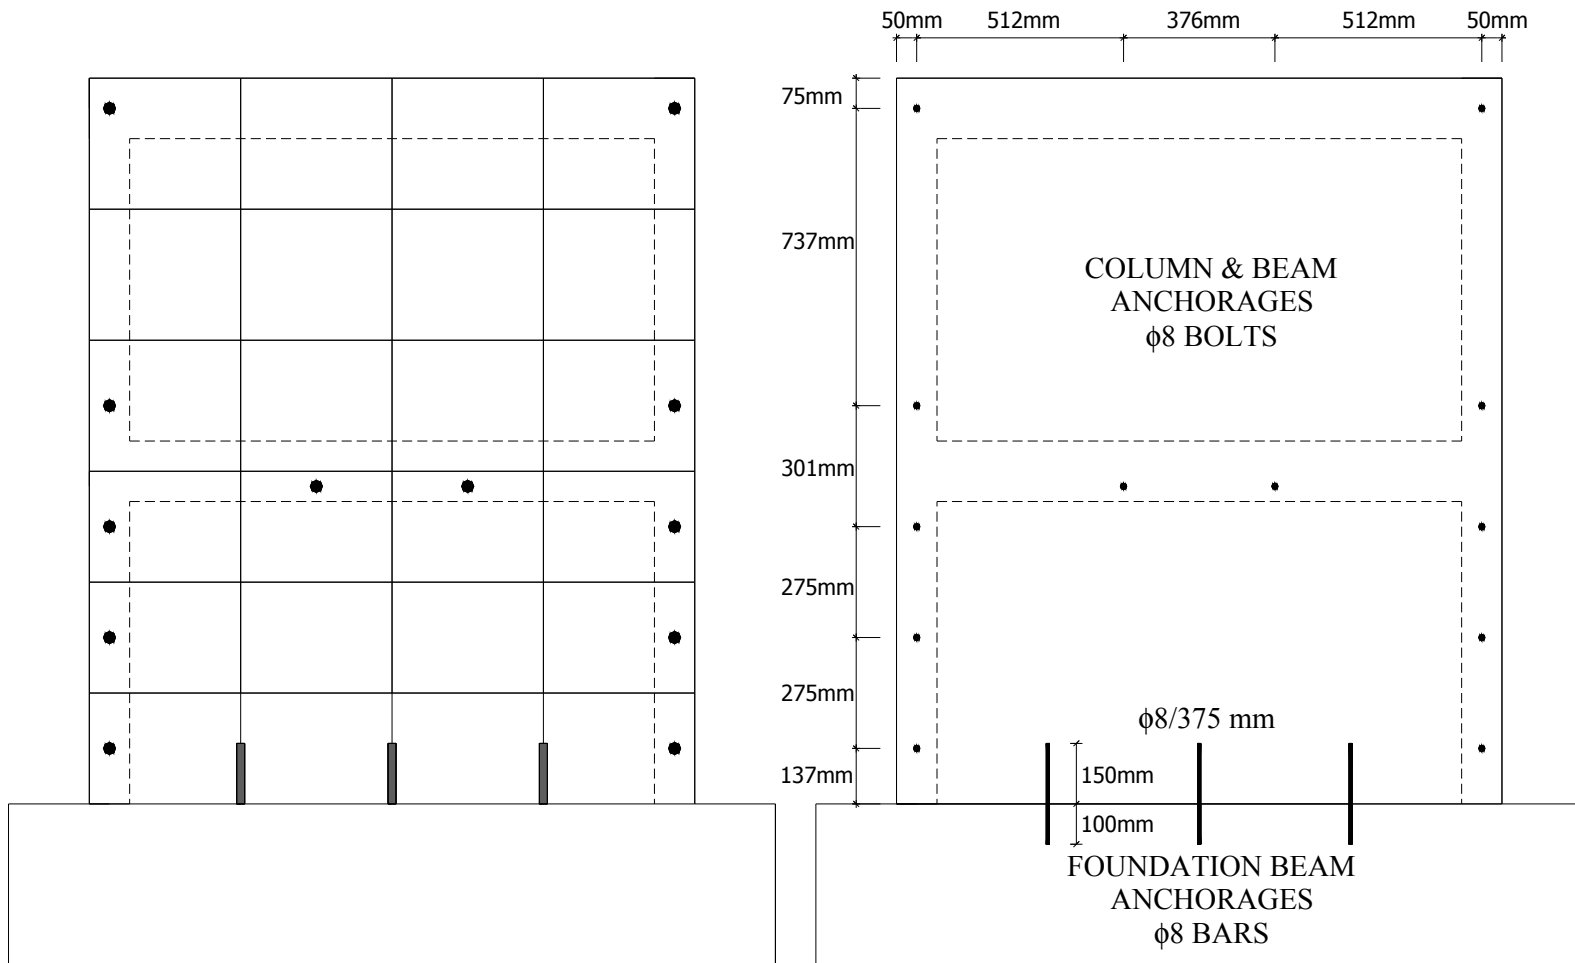
Figure 4.38. Panel arrangement and configuration of the dowels for Specimen CEER

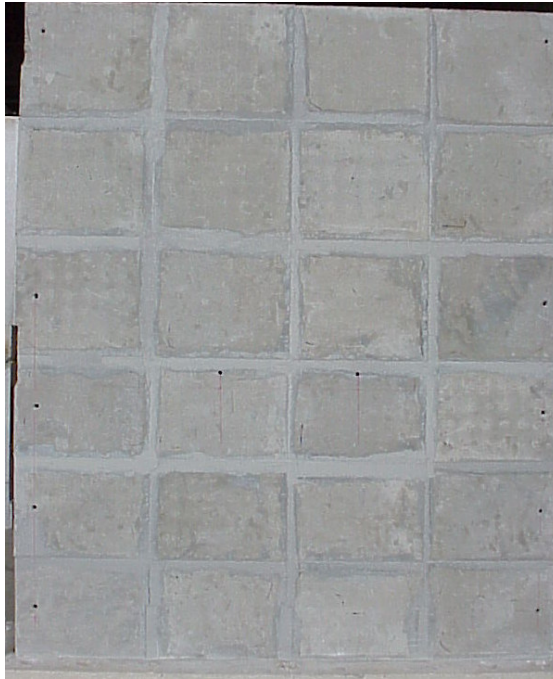
Figure 4.39. Specimen CEER before fixing $\phi 8$ bolts

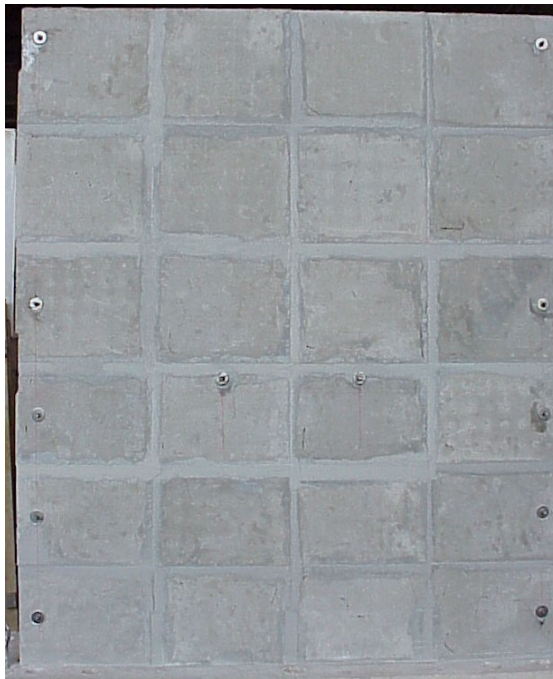
Figure 4.40. Specimen CEER after fixing $\phi 8$ bolts

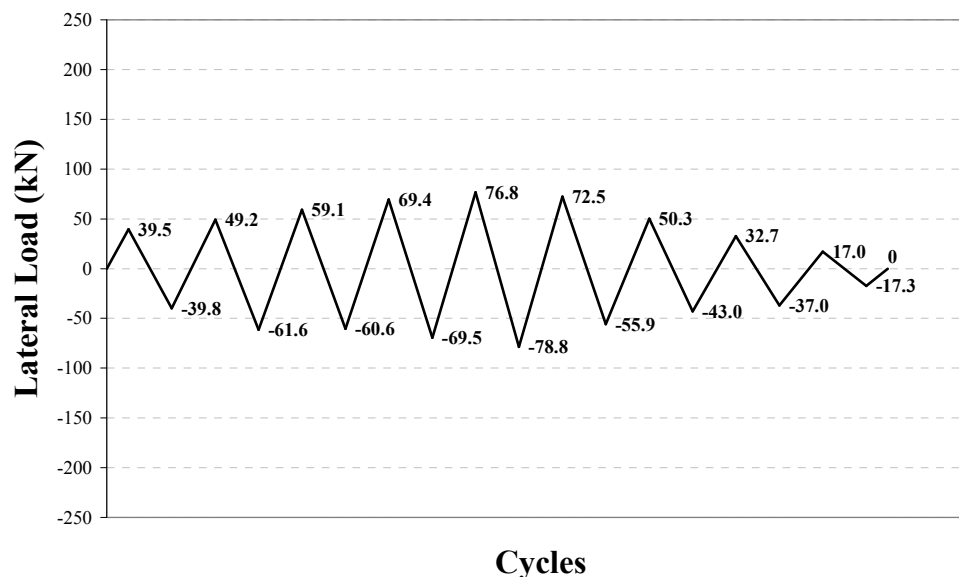
Figure 5.1. Loading history of Specimen CR

Specimen CR was subjected to lateral loading history presented in Figure 5.1. For this specimen, maximum forward and backward loads were 76.8 kN and 78.8 kN, respectively. In Figure 5.2. and Figure 5.3., lateral load-displacement curves are presented for second story and first story, respectively. Lateral load-shear deformation curves are presented for the top story and bottom story infill walls are presented in Figure 5.4. and Figure 5.5. As can be seen from Figure 5.4., the shear displacement in the second story infill wall was almost elastic and significantly smaller than the first story infill wall shear displacement, due to high base shear relative to the second story shear. Lateral load-column base vertical displacements are given in Figure 5.6. and Figure 5.7.

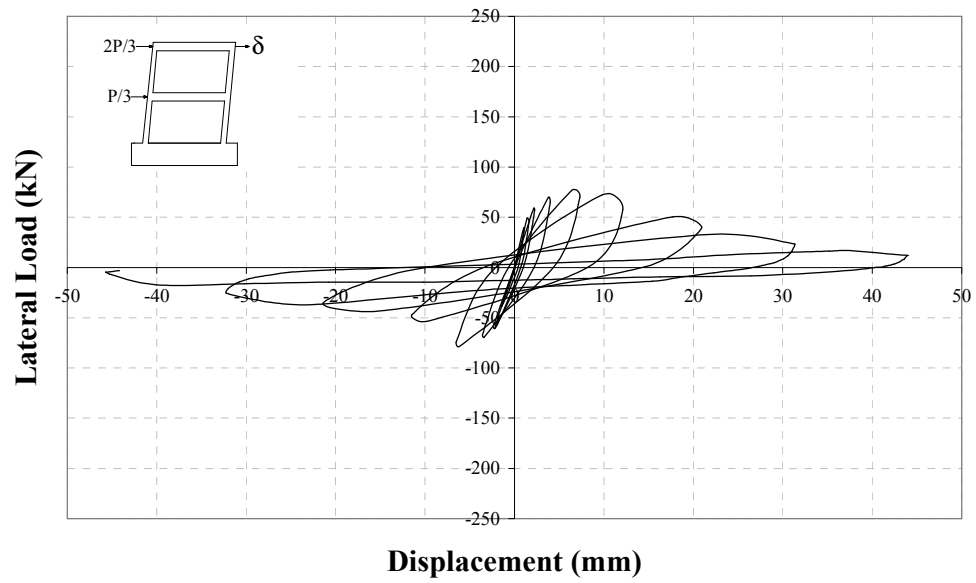
Figure 5.2. Load – second story level displacement curve, Specimen CR

The conclusions drawn from the lateral load-displacement curves presented are as follows; the initial stiffness of the specimen was 43.5 kN/mm. The initial stiffness of the specimen was defined as the initial slope of the lateral load-second story level displacement curve in the first forward half cycle. At the instant of forward maximum loading, the interstory drift ratios for the first and second stories were 0.0042 and 0.0033, respectively whereas these values were 0.0030 and 0.0041 at the instant of backward maximum loading, respectively.

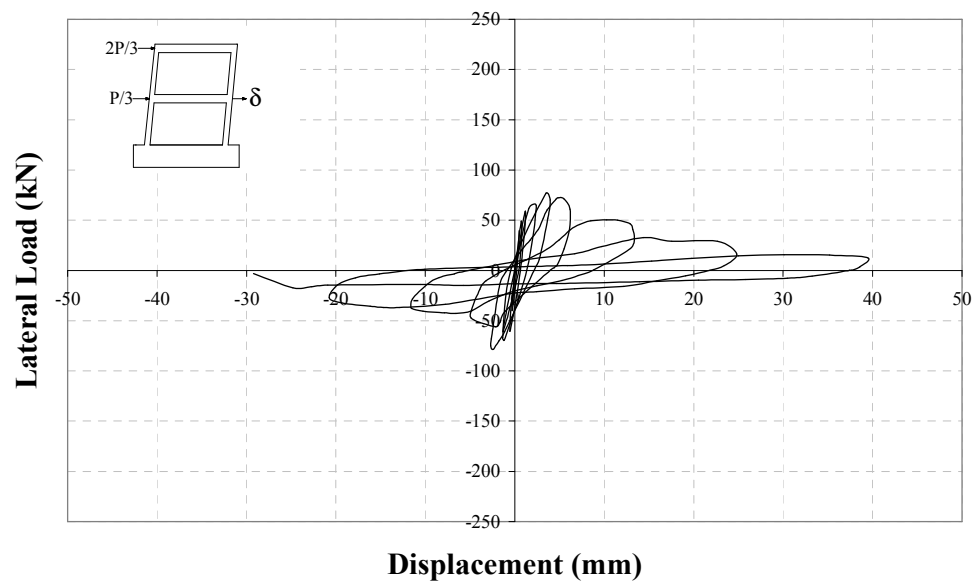
Figure 5.3. Load – first story level displacement curve, Specimen CR
