**PRECAST CONCRETE PANEL REINFORCED INFILL WALLS
FOR SEISMIC STRENGTHENING OF
REINFORCED CONCRETE FRAMED STRUCTURES**

**A THESIS SUBMITTED TO
THE GRADUATE SCHOOL OF NATURAL AND APPLIED SCIENCES
OF
MIDDLE EAST TECHNICAL UNIVERSITY**

**BY
MEHMET BARAN**

**IN PARTIAL FULFILLMENT OF THE REQUIREMENTS
FOR
THE DEGREE OF PHILOSOPHY OF DOCTORATE
IN
CIVIL ENGINEERING**

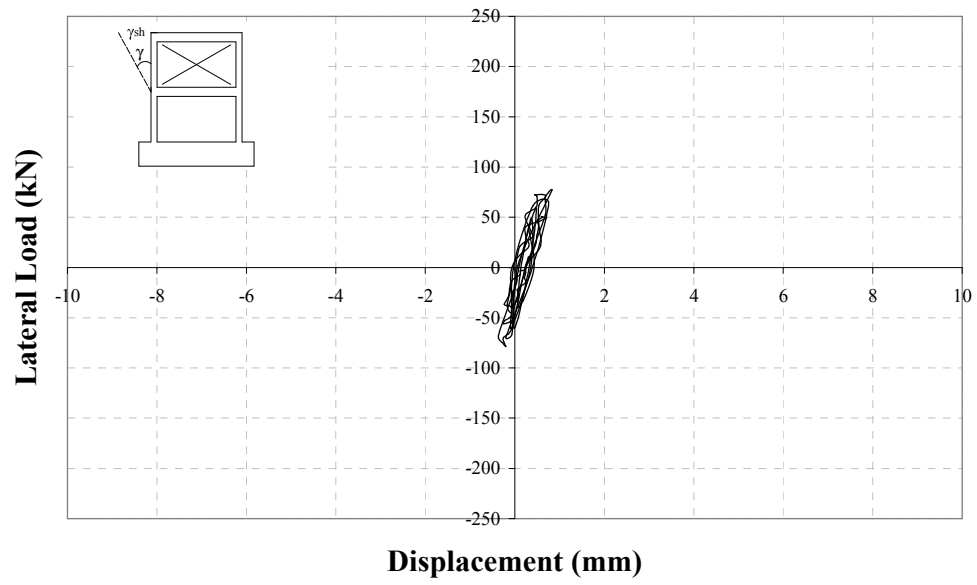
Figure 5.4. Load – second story shear displacement curve, Specimen CR

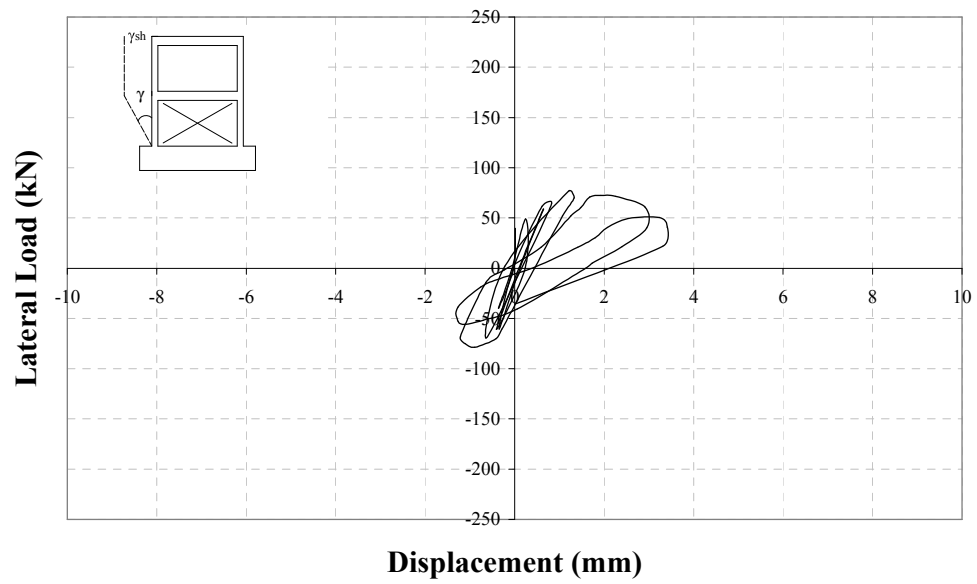
Figure 5.5. Load – first story shear displacement curve, Specimen CR

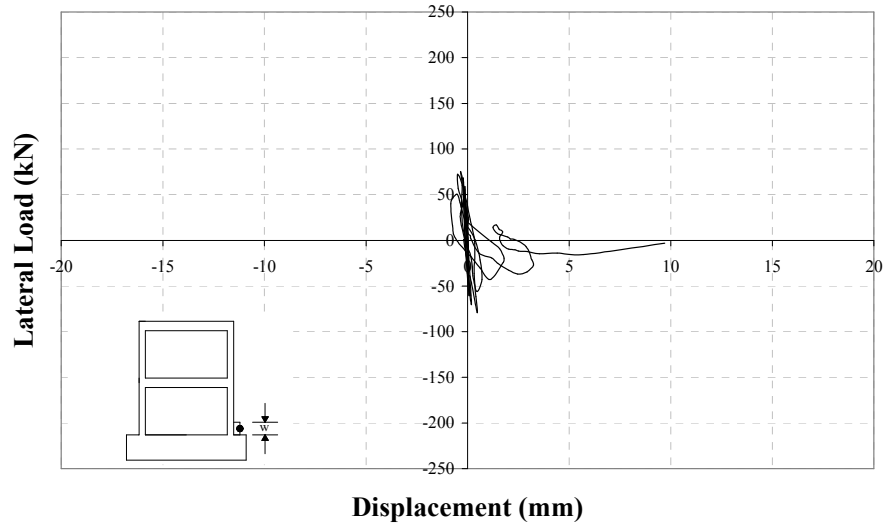
Figure 5.6. Load –north column base vertical displacement, Specimen CR

Specimen CR was subjected to lateral loading history presented in Figure 5.1. For this specimen, maximum forward and backward loads were 76.8 kN and 78.8 kN, respectively. In Figure 5.2. and Figure 5.3., lateral load-displacement curves are presented for second story and first story, respectively. Lateral load-shear deformation curves are presented for the top story and bottom story infill walls are presented in Figure 5.4. and Figure 5.5. As can be seen from Figure 5.4., the shear displacement in the second story infill wall was almost elastic and significantly smaller than the first story infill wall shear displacement, due to high base shear relative to the second story shear. Lateral load-column base vertical displacements are given in Figure 5.6. and Figure 5.7.

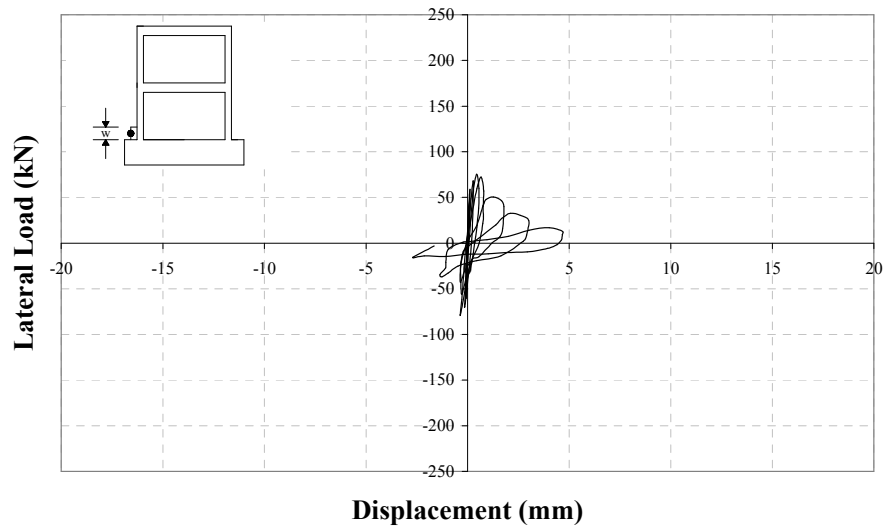
Figure 5.7. Load –south column base vertical displacement, Specimen CR

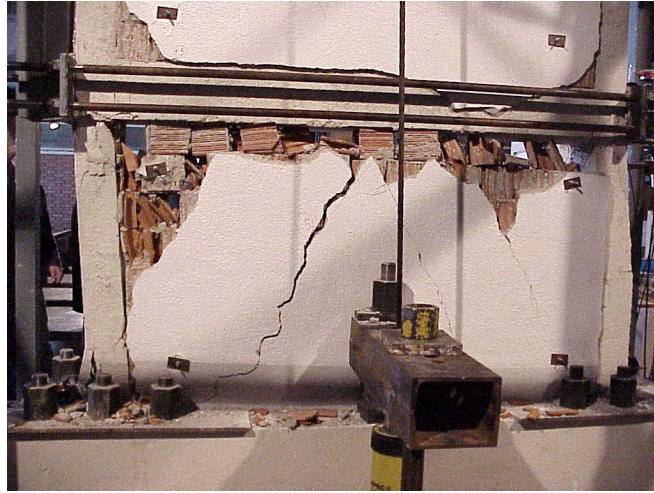
Figure 5.8. Rear view of Specimen CR at the end of the test

- In the ninth forward cycle, the specimen was loaded to a second story level of 43.9mm. In the backward half cycle, the specimen could not carry any load due to crushing and grinding of the columns. Hence, the test was terminated. The rear and front views of Specimen CR at the end of the test are given in Figure 5.8. and Figure 5.9.

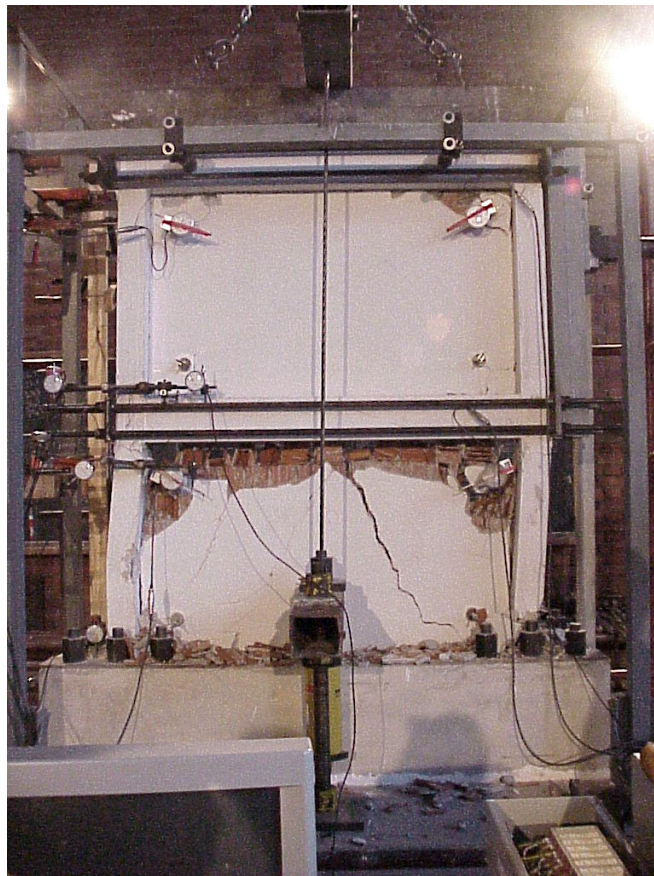
Figure 5.9. Specimen CR at the end of the test

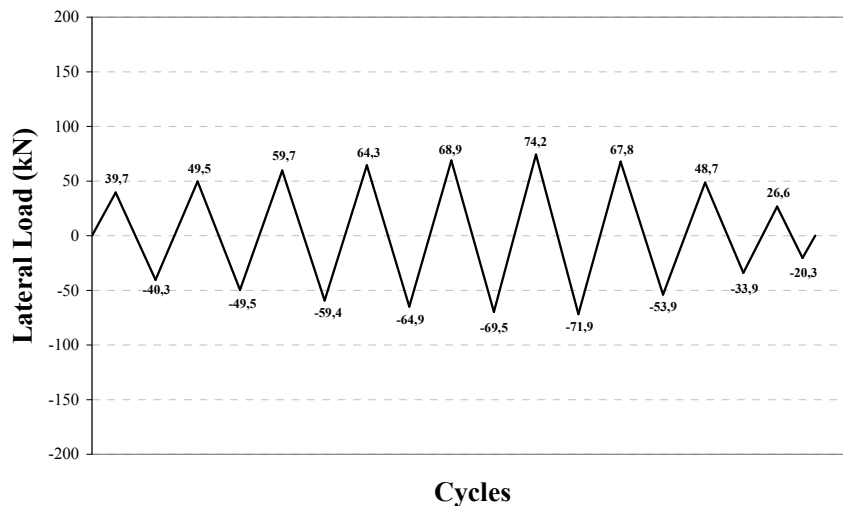
Figure 5.10. Loading History of Specimen LR

Specimen LR was subjected to lateral loading history presented in Figure 5.10. For this specimen, maximum forward and backward loads were 74.2 kN and 71.9 kN, respectively. In Figure 5.11. and Figure 5.12., lateral load-displacement curves are presented for second story and first story, respectively. Lateral load-shear deformation curves are presented for the top story and bottom story infill walls are presented in Figure 5.13. and Figure 5.14. As can be seen from Figure 5.13., the shear displacement in the second story infill wall was almost elastic and significantly smaller than the first story. Lateral load-column base vertical displacements are given in Figure 5.15. and Figure 5.16.

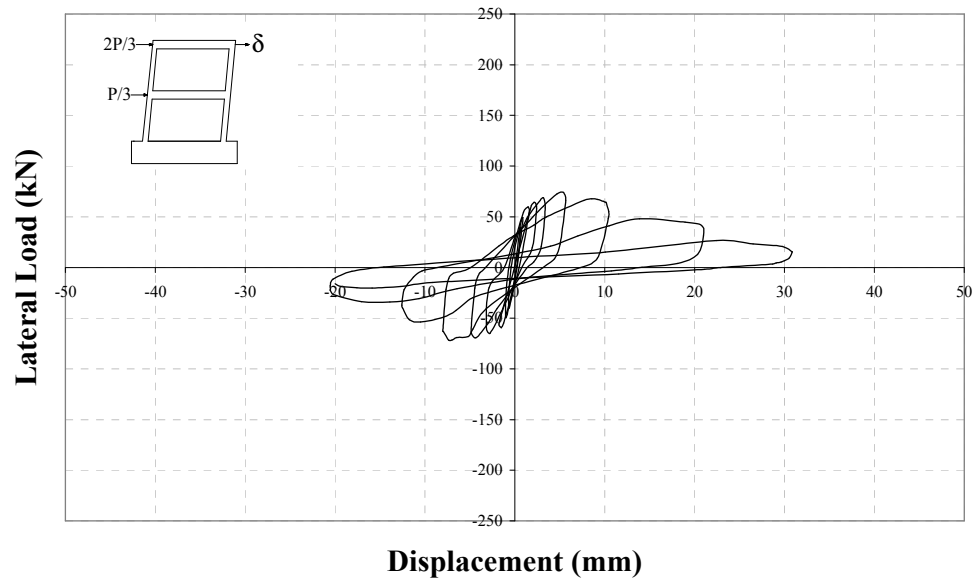
Figure 5.11. Load – second story level displacement curve, Specimen LR

The initial stiffness of the specimen was 59.1 kN/mm. At the instant of forward maximum loading, the interstory drift ratios for the first and second stories were 0.0035 and 0.0021, respectively whereas these values were 0.0033 and 0.0057 at the instant of backward maximum loading, respectively.

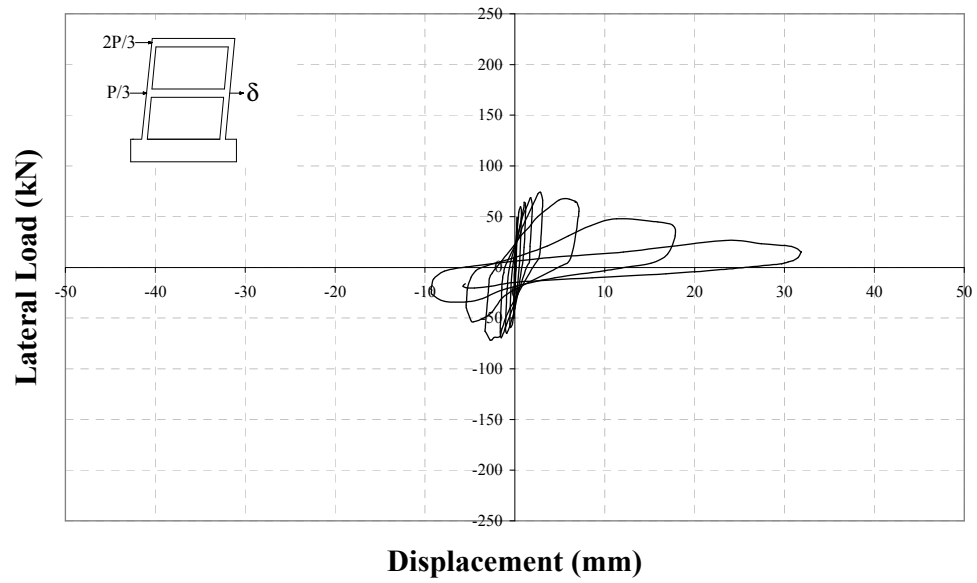
Figure 5.12. Load – first story level displacement curve, Specimen LR

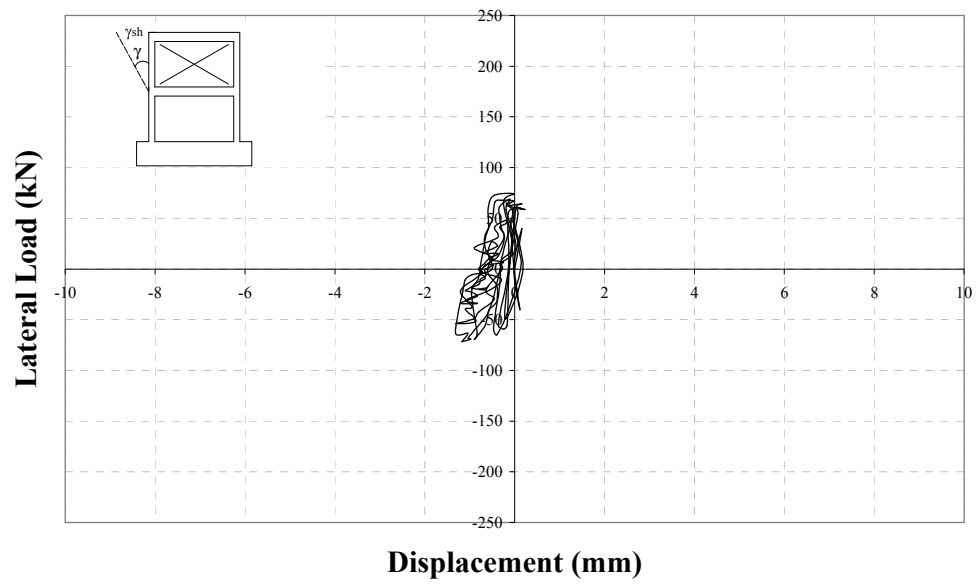
Figure 5.13. Load – second story shear displacement curve, Specimen LR

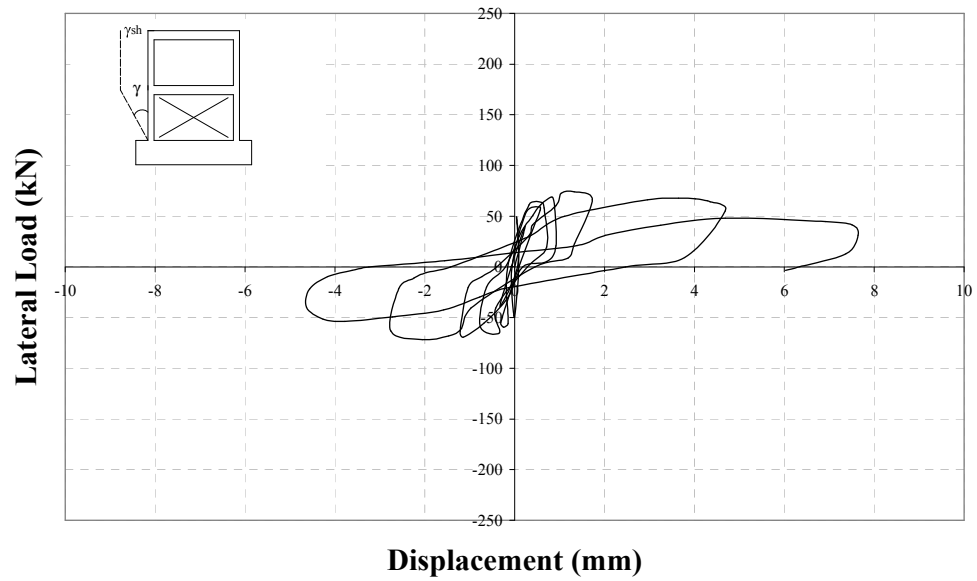
Figure 5.14. Load – first story shear displacement curve, Specimen LR

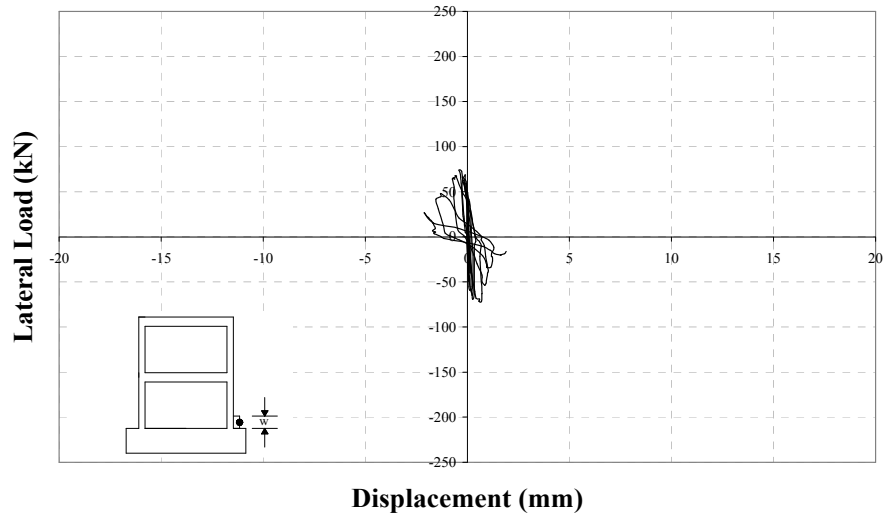
Figure 5.15. Load –north column base vertical displacement, Specimen LR

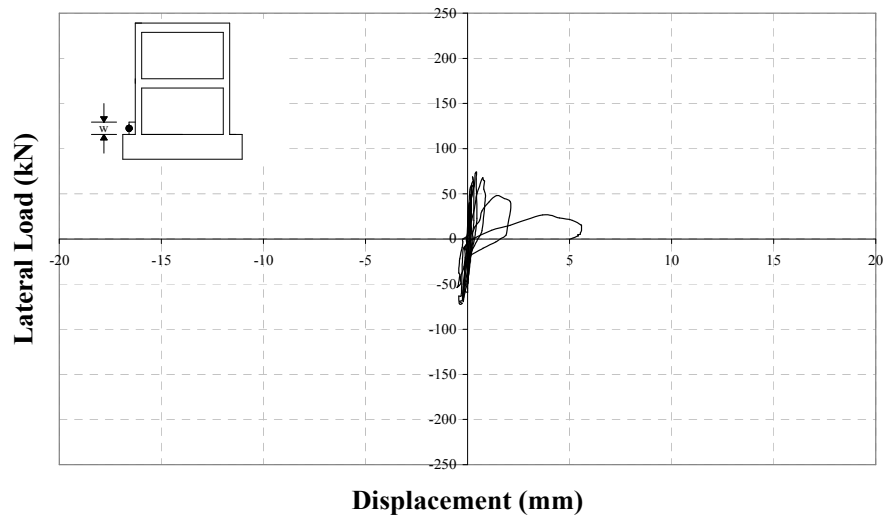
Figure 5.16. Load –south column base vertical displacement, Specimen LR

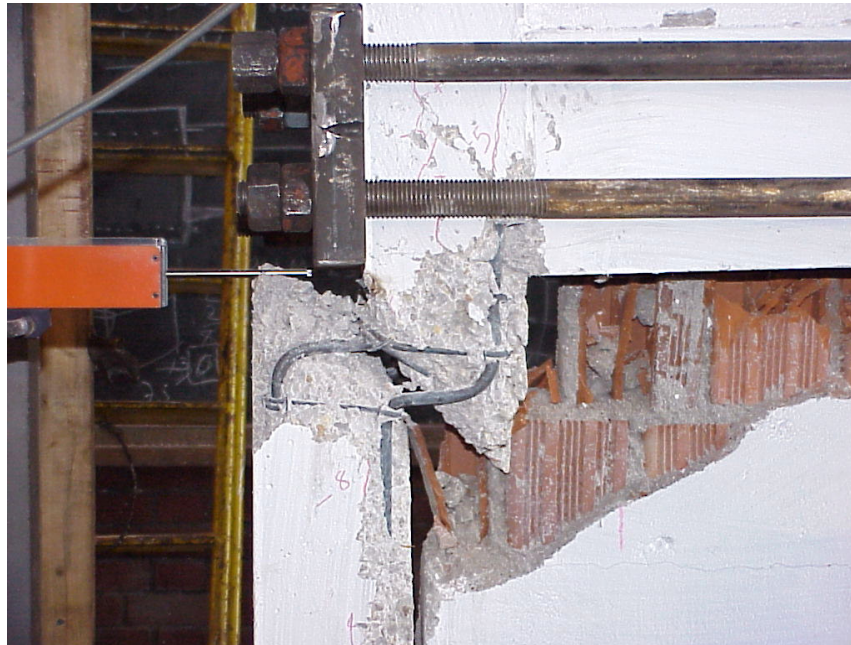
Figure 5.17. South column after the test, Specimen LR

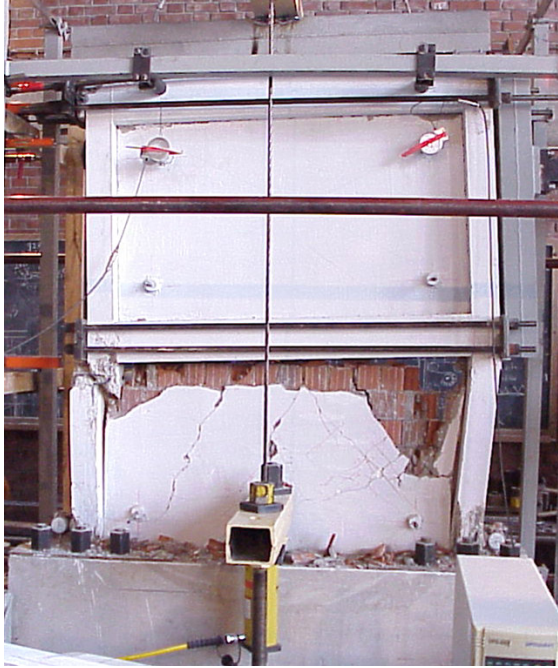
Figure 5.18. Specimen LR after the test

- In the ninth forward cycle, first story infill wall lost its load carrying capacity and the frame began to carry the load itself after their separation. In this cycle, second story level displacement reached 30mm. In the backward cycle, diagonal crack just below the first story beam- south column joint turned out to be a shear failure and the column broke-off due to the low concrete strength of the frame. Hence, the test was terminated. The south column after the test is shown in Figure 5.17. The front and rear view photographs of Specimen LR after the test are given in Figure 5.18. and Figure 5.19.

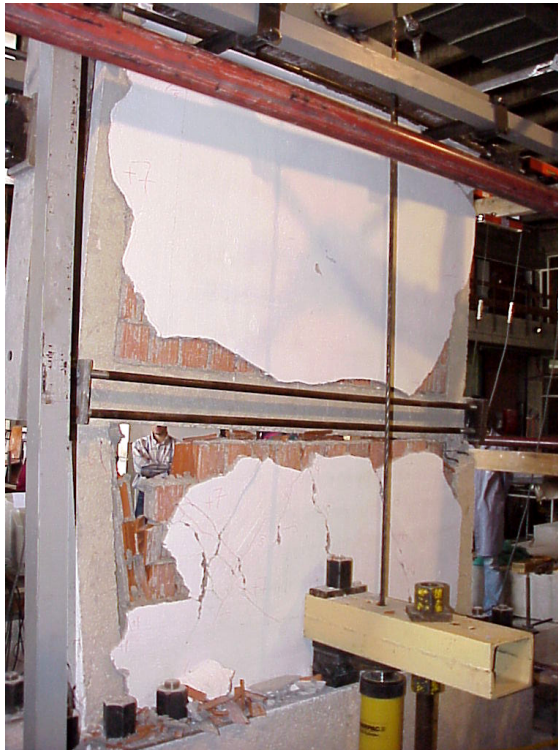
Figure 5.19. Rear view of Specimen LR at the end of the test

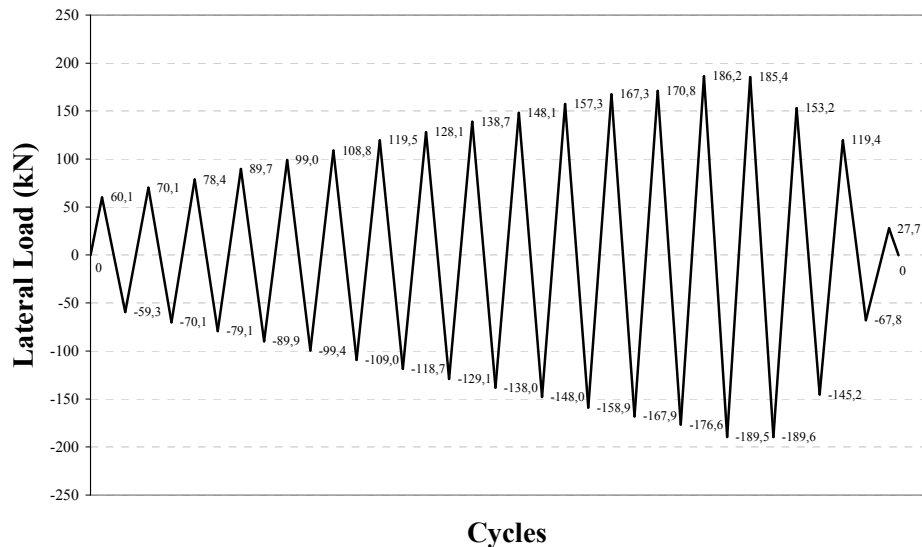
Figure 5.20. Loading history of Specimen CIA4

Specimen CIA4 [6] was strengthened by using Type A precast concrete panels and subjected to lateral loading history presented in Figure 5.20. For this specimen, maximum forward and backward loads were 186.2 kN and 192.5 kN, respectively. In Figure 5.21. and Figure 5.22., lateral load-displacement curves are presented for second story and first story, respectively. Lateral load-shear deformation curves are presented for the top story and bottom story infill walls are presented in Figure 5.23. and Figure 5.24. As can be seen from both figures, both story shear displacements were almost the same. Both story infill panels behaved linearly. Lateral load-column base vertical displacements are given in Figure 5.25. and Figure 5.26.

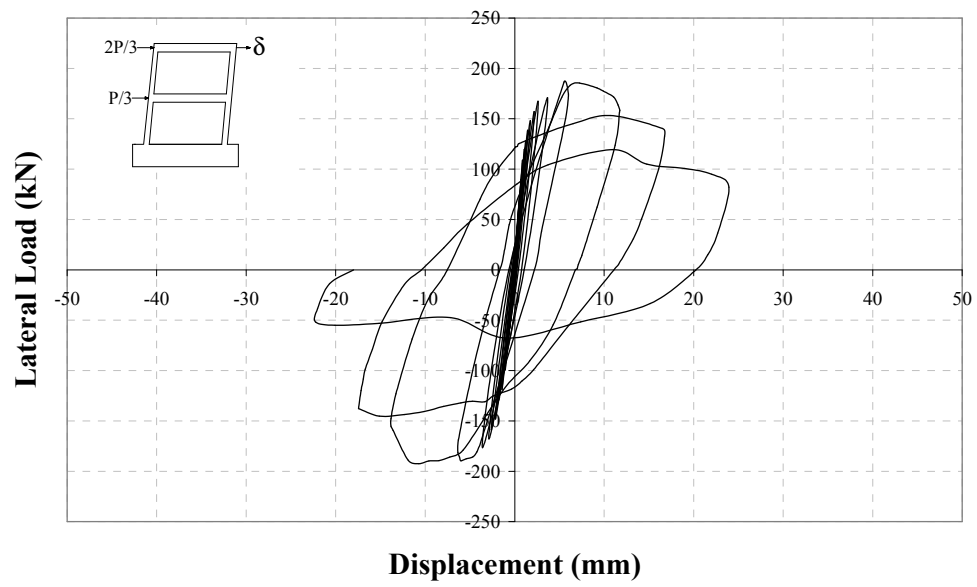
Figure 5.21. Load – second story level displacement curve, Specimen CIA4

The conclusions drawn from the lateral load-displacement curves presented are as follows; the initial stiffness of the specimen was 123.5 kN/mm. At the instant of forward maximum loading, the interstory drift ratios for the first and second stories were calculated as 0.0038 and 0.0026, respectively whereas these values were calculated as 0.0069 and 0.0056 at the instant of backward maximum loading, respectively.

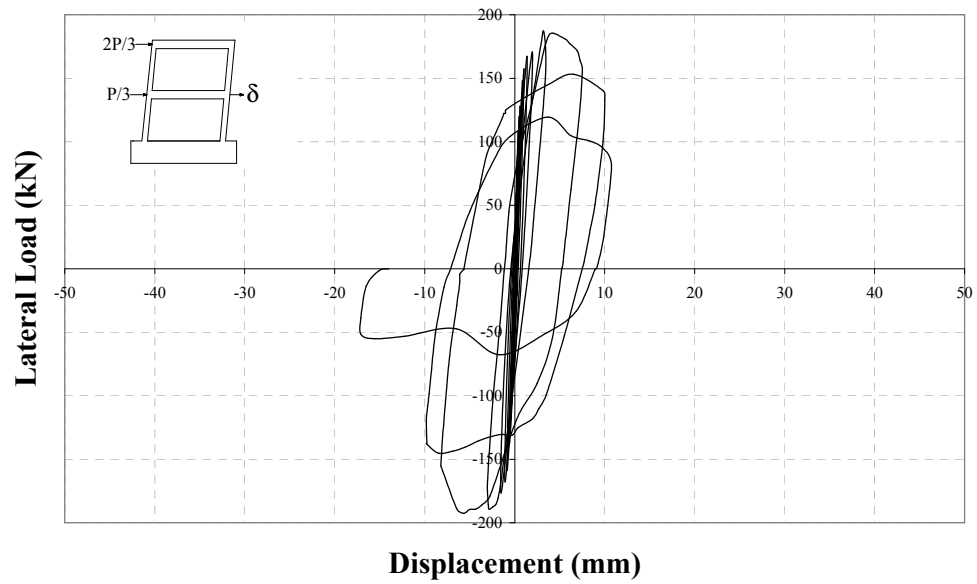
Figure 5.22. Load – first story level displacement curve, Specimen CIA4

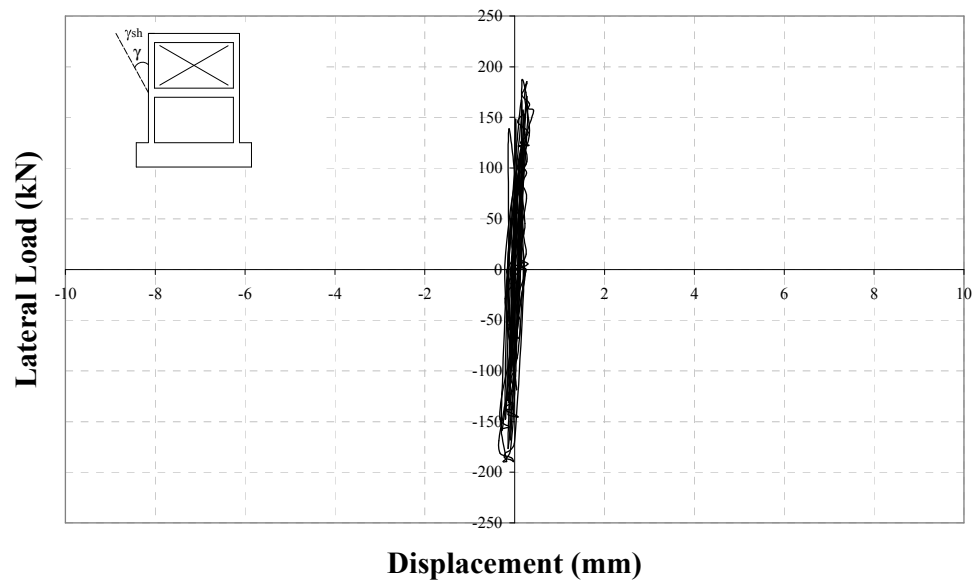
Figure 5.23. Load – second story shear displacement curve, Specimen CIA4

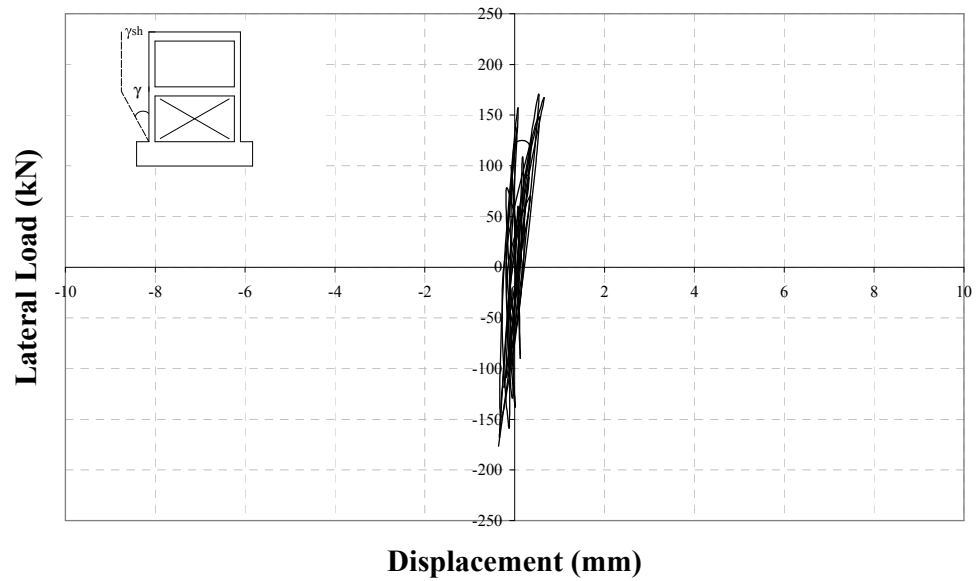
Figure 5.24. Load – first story shear displacement curve, Specimen CIA4

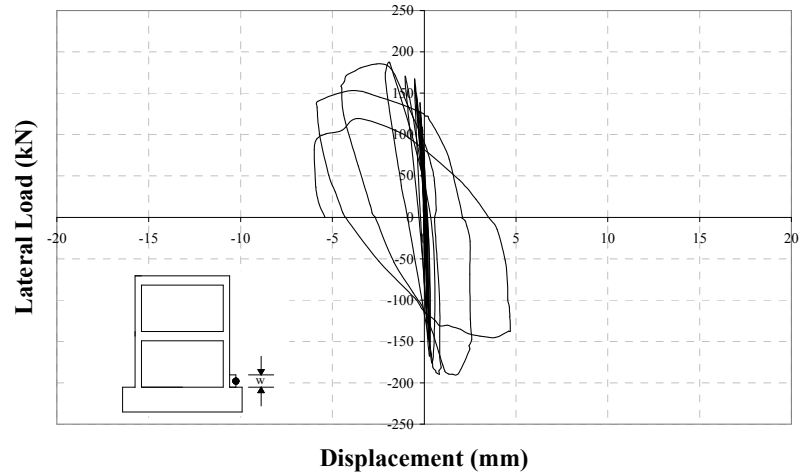
Figure 5.25. Load –north column base vertical displacement, Specimen CIA4

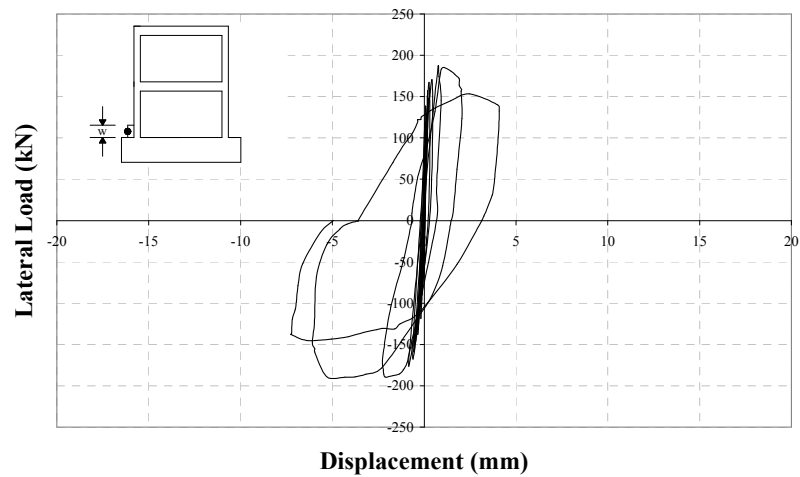
Figure 5.26. Load –south column base vertical displacement, Specimen CIA4

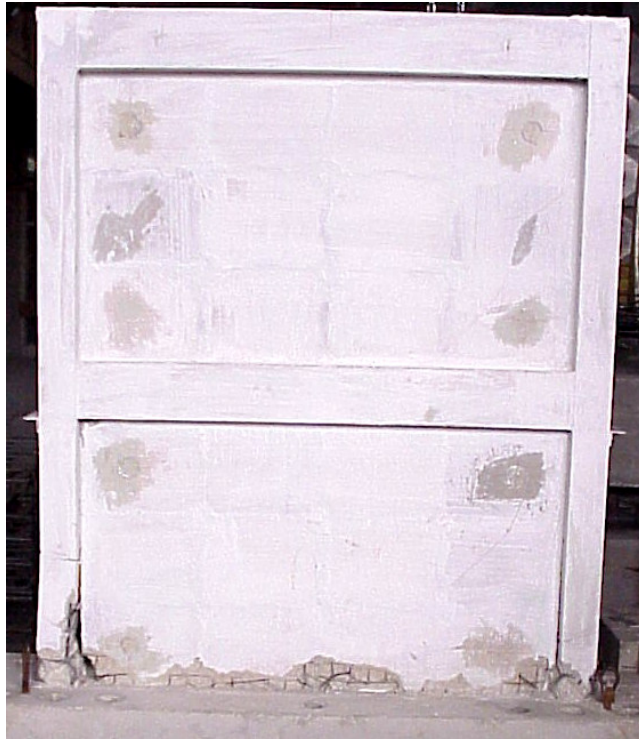
Figure 5.27. Front view after the test, Specimen CIA4

test was terminated. Front and rear views of Specimen CIA4 after the test are given in Figure 5.27. and Figure 5.28.

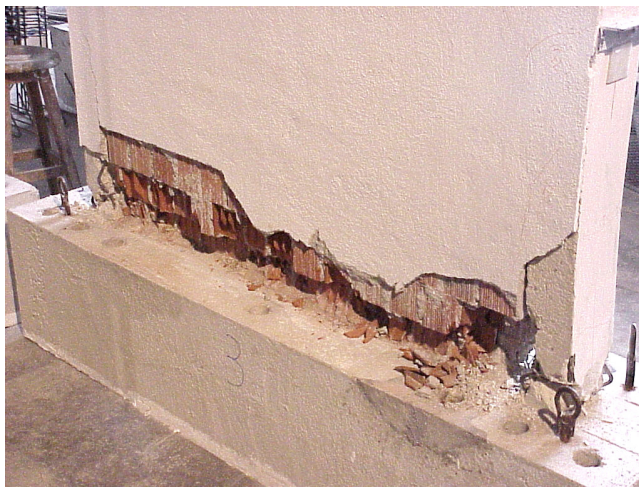
Figure 5.28. Rear view after the test, Specimen CIA4

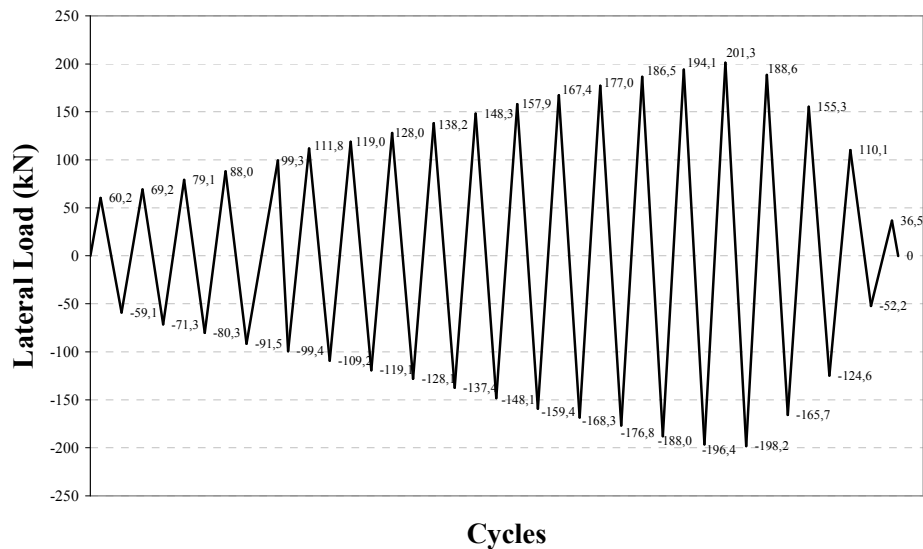
Figure 5.29. Loading history of Specimen CIB4

CIB4 [6] was strengthened by using Type B and subjected to lateral loading history presented in Figure 5.29. For this specimen, maximum forward and backward loads were 201.3 kN and 198.2 kN, respectively. In Figure 5.30. and Figure 5.31., lateral load-displacement curves are presented for second story and first story, respectively. Lateral load-shear deformation curves are presented for the top story and bottom story infill walls are presented in Figure 5.32. and Figure 5.33. As can be seen from both figures, both story shear displacements were almost the same. Both story infill panels behaved linearly. Lateral load-column base vertical displacements are given in Figure 5.34. and Figure 5.35.

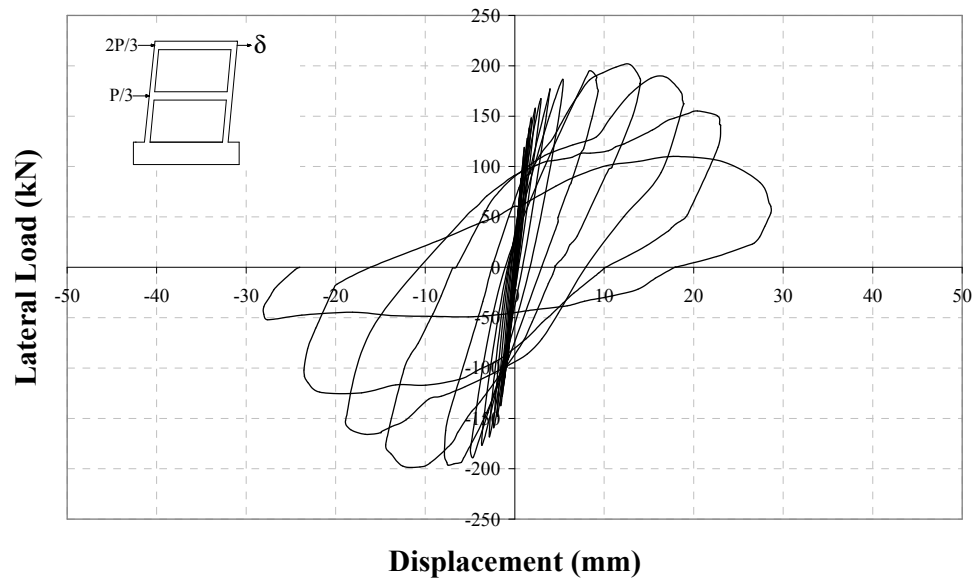
Figure 5.30. Load – second story level displacement curve, Specimen CIB4

The conclusions drawn from the lateral load-displacement curves presented are as follows; the initial stiffness of the specimen was 123.4 kN/mm. At the instant of forward maximum loading, the interstory drift ratios for the first and second stories were calculated as 0.0089 and 0.0062, respectively whereas these values were calculated as 0.0070 and 0.0053 at the instant of backward maximum loading, respectively.

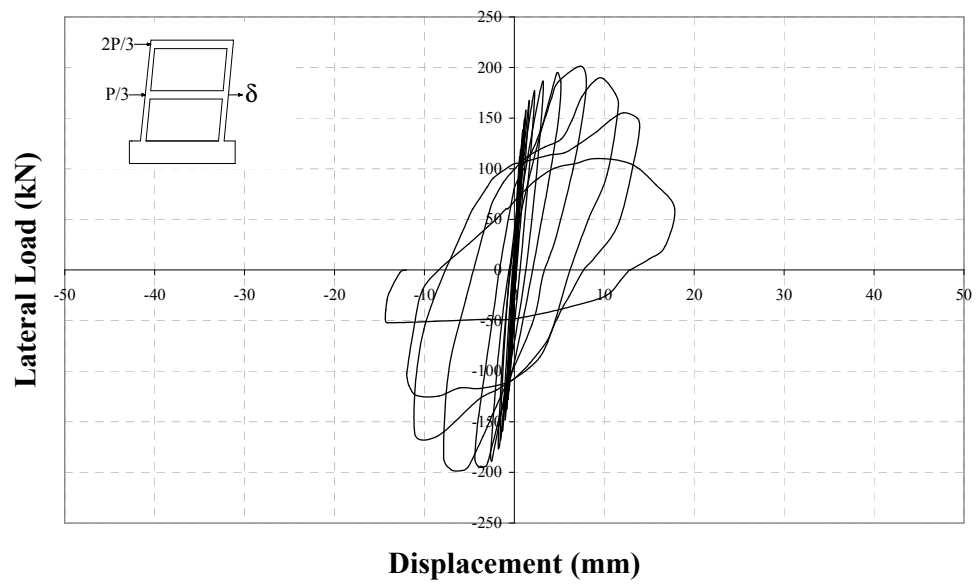
Figure 5.31. Load – first story level displacement curve, Specimen CIB4

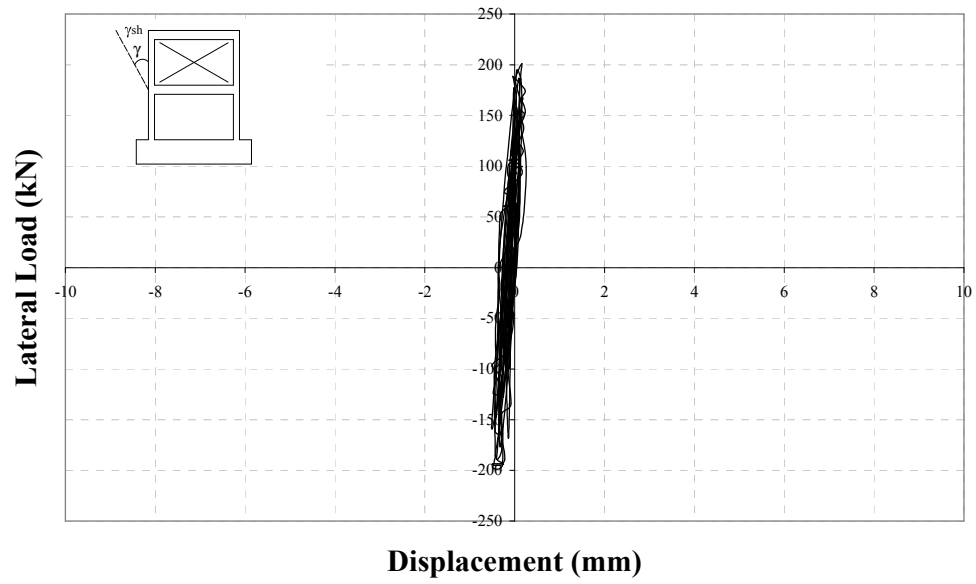
Figure 5.32. Load – second story shear displacement curve, Specimen CIB4

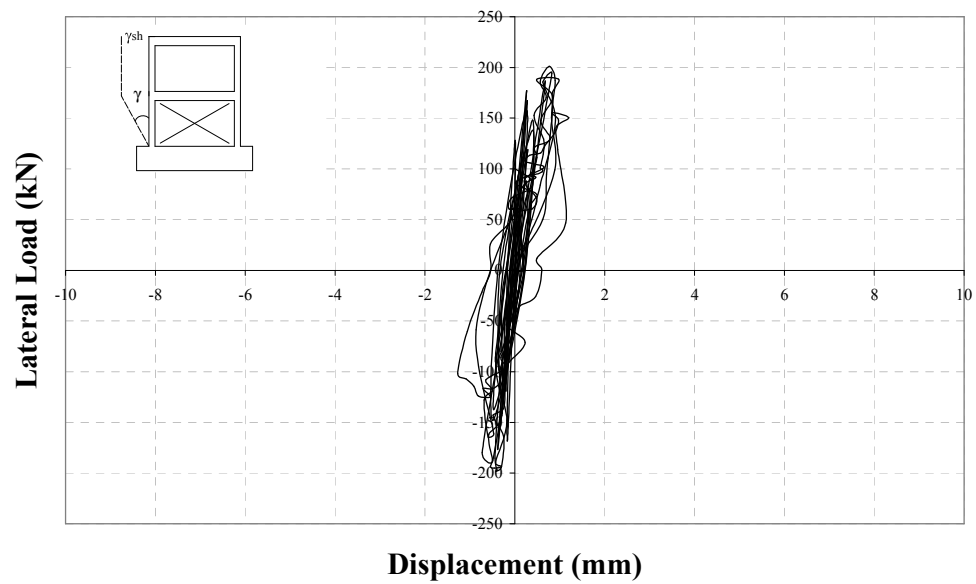
Figure 5.33. Load – first story shear displacement curve, Specimen CIB4

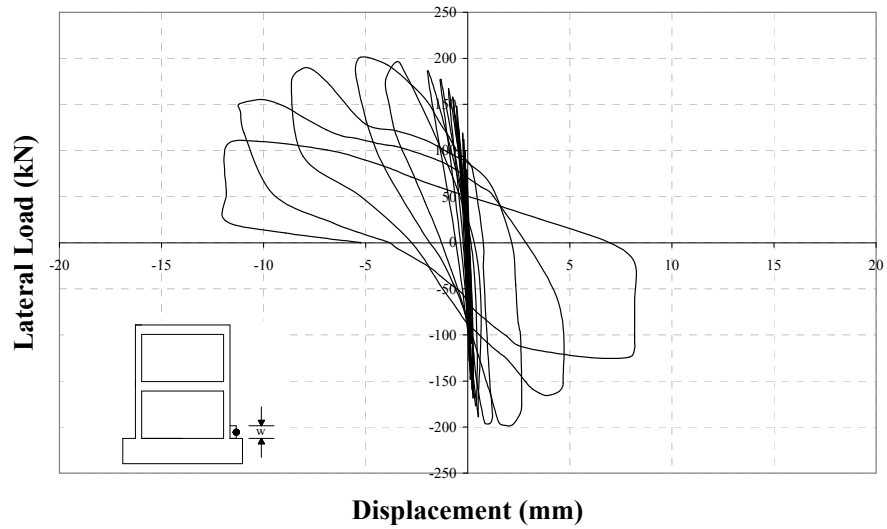
Figure 5.34. Load –north column base vertical displacement, Specimen CIB4

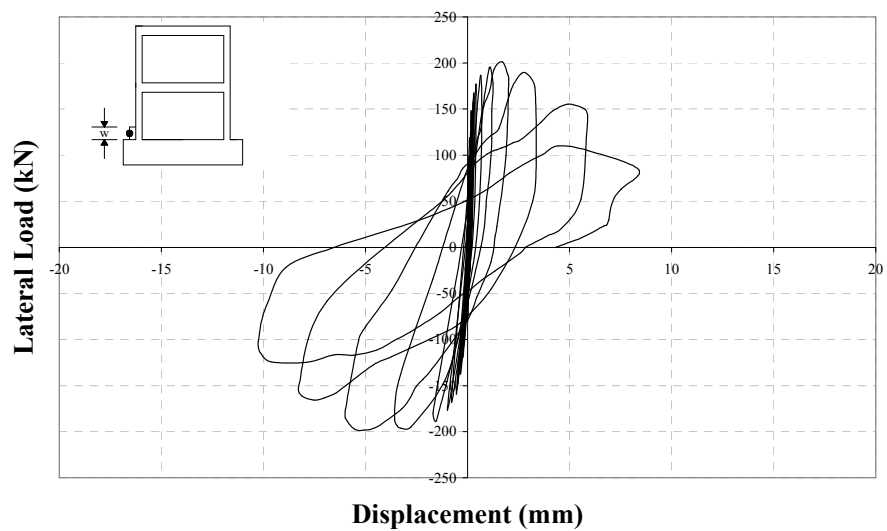
Figure 5.35. Load –south column base vertical displacement, Specimen CIB4

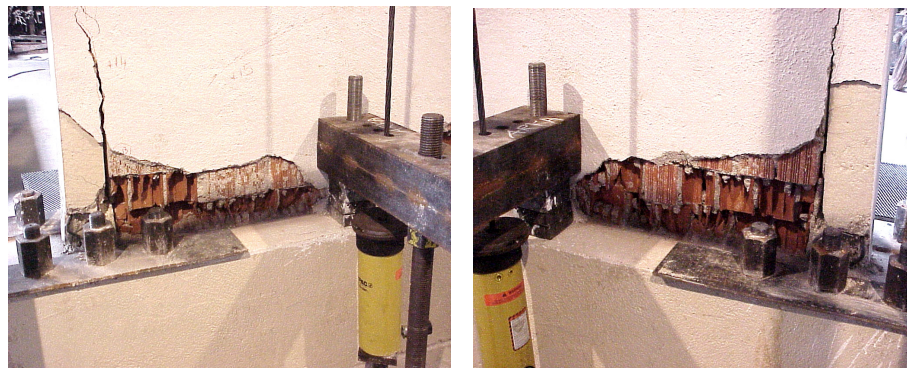
Figure 5.36. Rear view after the test, Specimen CIB4

- In the last cycle, the frame could not take any further load due to crushing and grinding of the columns. Hence, the test was terminated. The rear and front view photographs of Specimen CIB4 after the test are given in Figure 5.36. and Figure 5.37., respectively.

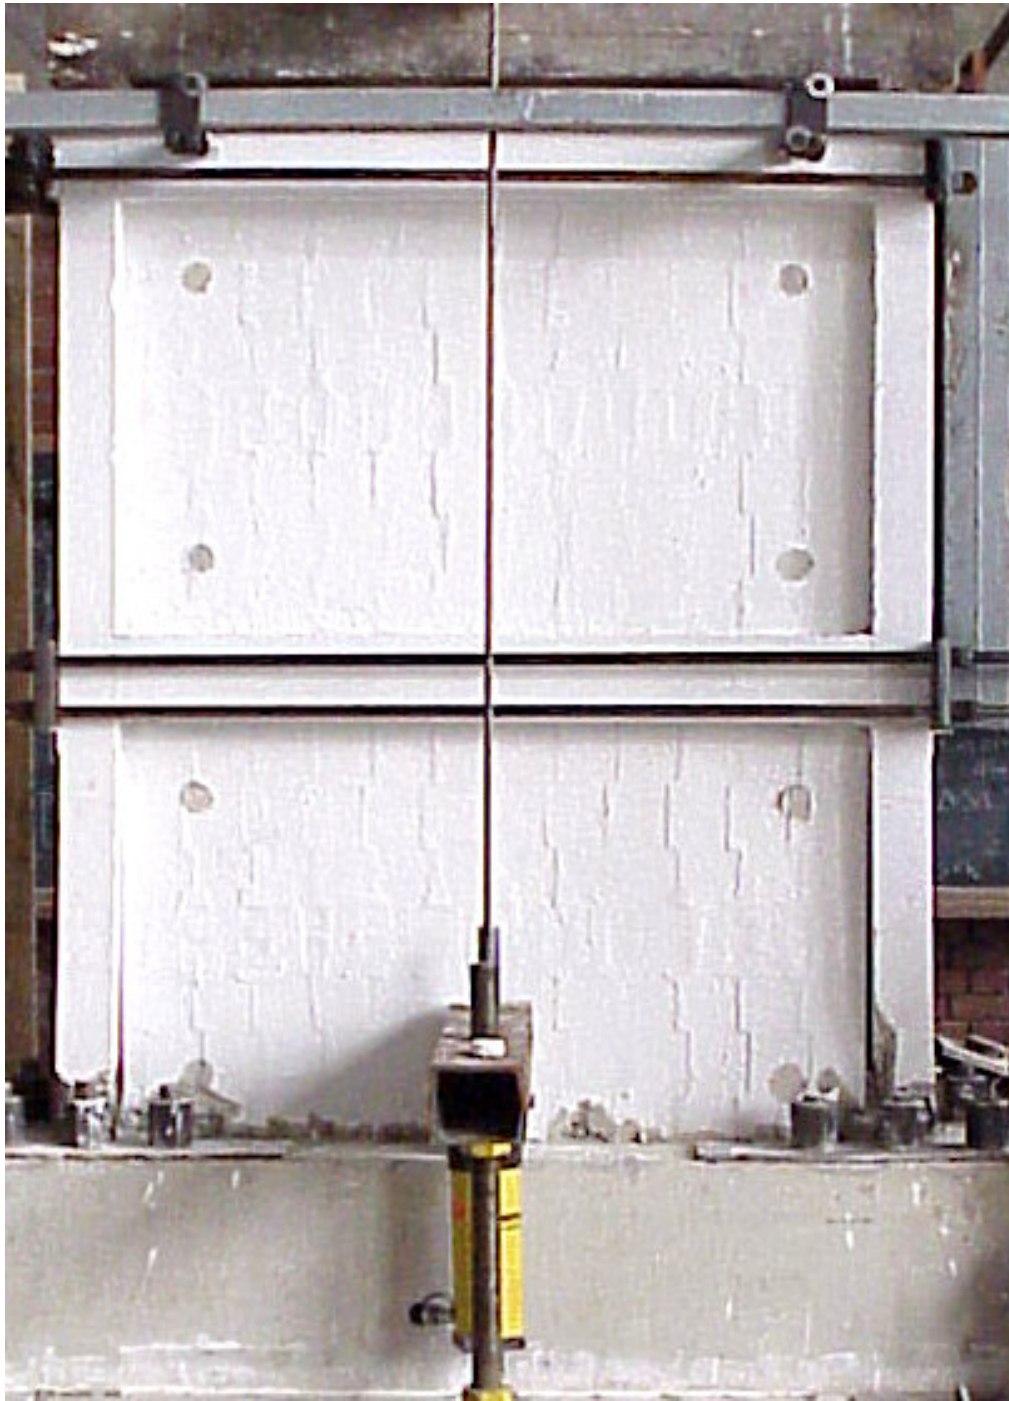
Figure 5.37. Front view after the test, Specimen CIB4

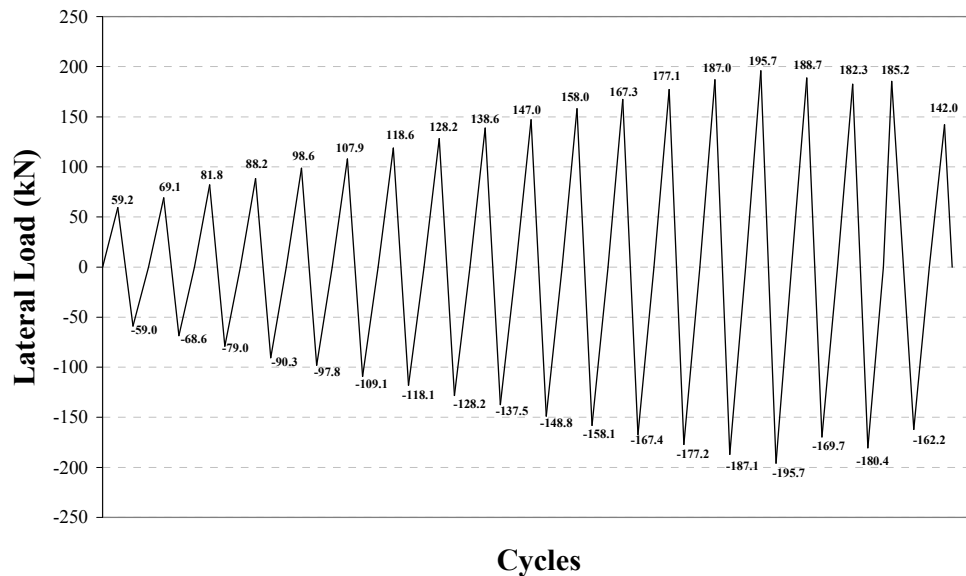
Figure 5.38. Loading history of Specimen CIC1

CIC1 was strengthened by using Type C Panels and subjected to lateral loading history presented in Figure 5.38. For this specimen, maximum forward and backward loads were 195.7 kN for both cycles. In Figure 5.39. and Figure 5.40., lateral load-displacement curves are presented for second story and first story, respectively. Lateral load-shear deformation curves are presented for the top story and bottom story infill walls are presented in Figure 5.41. and Figure 5.42. As can be seen from the graphs, both story shear displacements were almost the same. Lateral load-column base vertical displacements are given in Figure 5.43. and Figure 5.44.

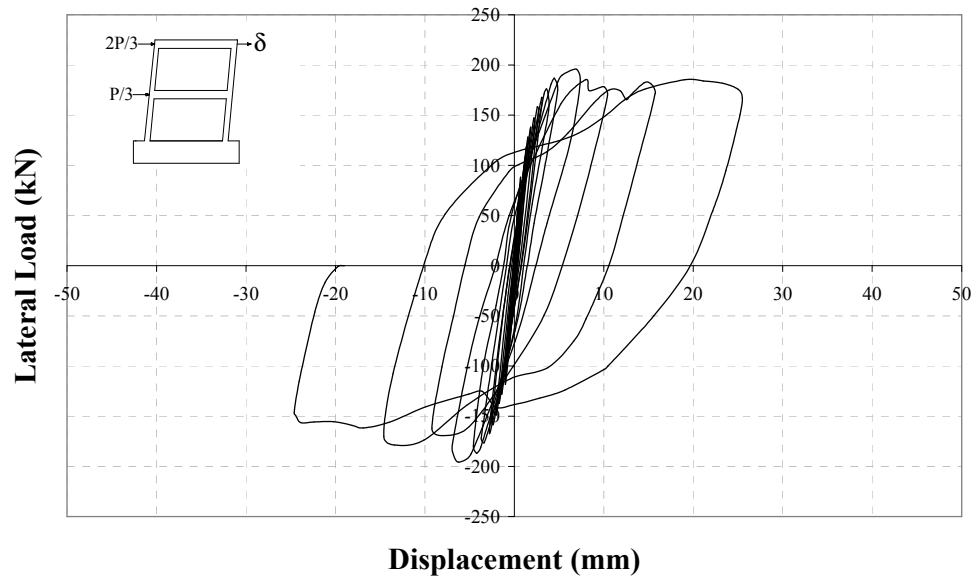
Figure 5.39. Load – second story level displacement curve, Specimen CIC1

The conclusions drawn from the lateral load-displacement curves presented are as follows; the initial stiffness of the specimen was 118.7 kN/mm. At the instant of forward maximum loading, the interstory drift ratios for the first and second stories were calculated as 0.0053 and 0.0029, respectively whereas these values were calculated as 0.0038 and 0.0034 at the instant of backward maximum loading, respectively.

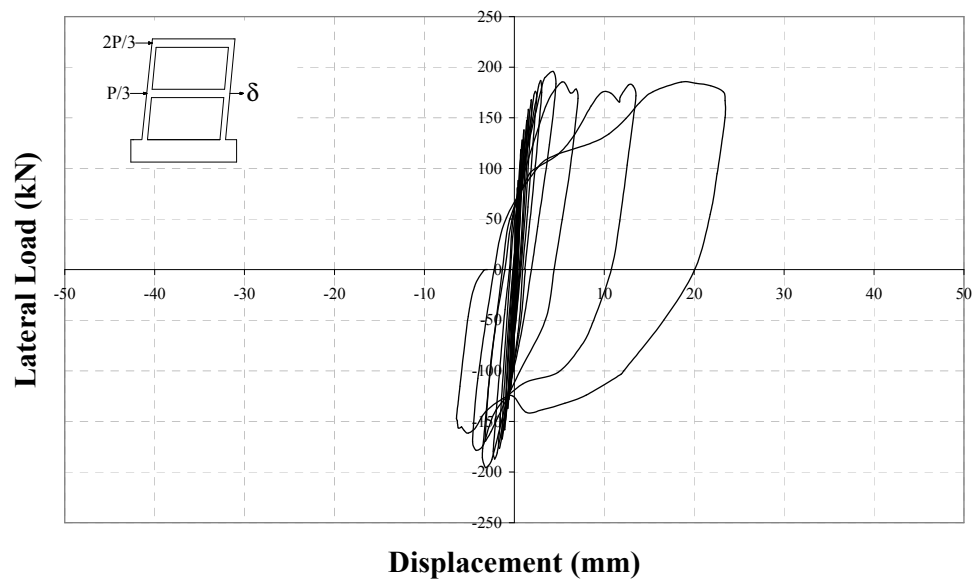
Figure 5.40. Load – first story level displacement curve, Specimen CIC1

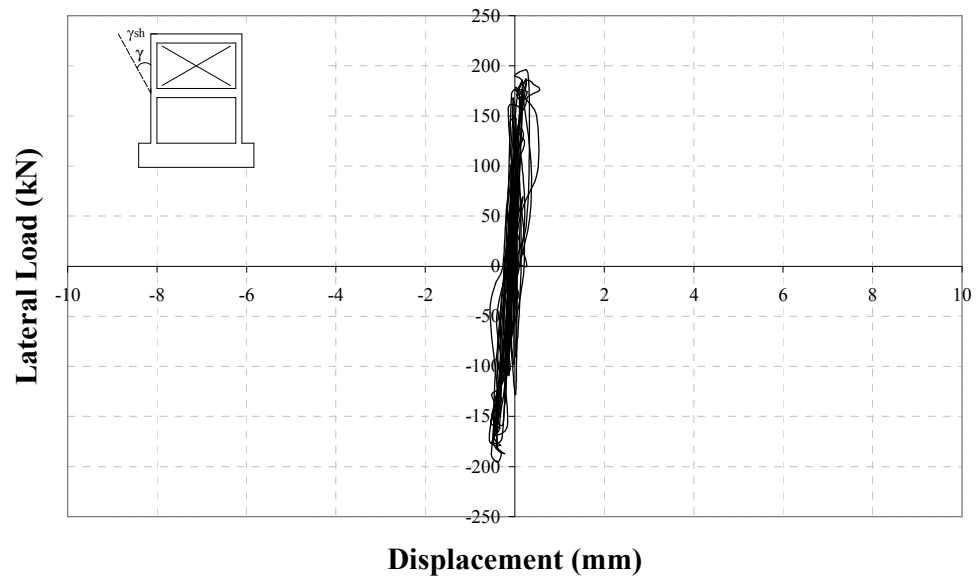
Figure 5.41. Load – second story shear displacement curve, Specimen CIC1
