**PRECAST CONCRETE PANEL REINFORCED INFILL WALLS
FOR SEISMIC STRENGTHENING OF
REINFORCED CONCRETE FRAMED STRUCTURES**

**A THESIS SUBMITTED TO
THE GRADUATE SCHOOL OF NATURAL AND APPLIED SCIENCES
OF
MIDDLE EAST TECHNICAL UNIVERSITY**

**BY
MEHMET BARAN**

**IN PARTIAL FULFILLMENT OF THE REQUIREMENTS
FOR
THE DEGREE OF PHILOSOPHY OF DOCTORATE
IN
CIVIL ENGINEERING**

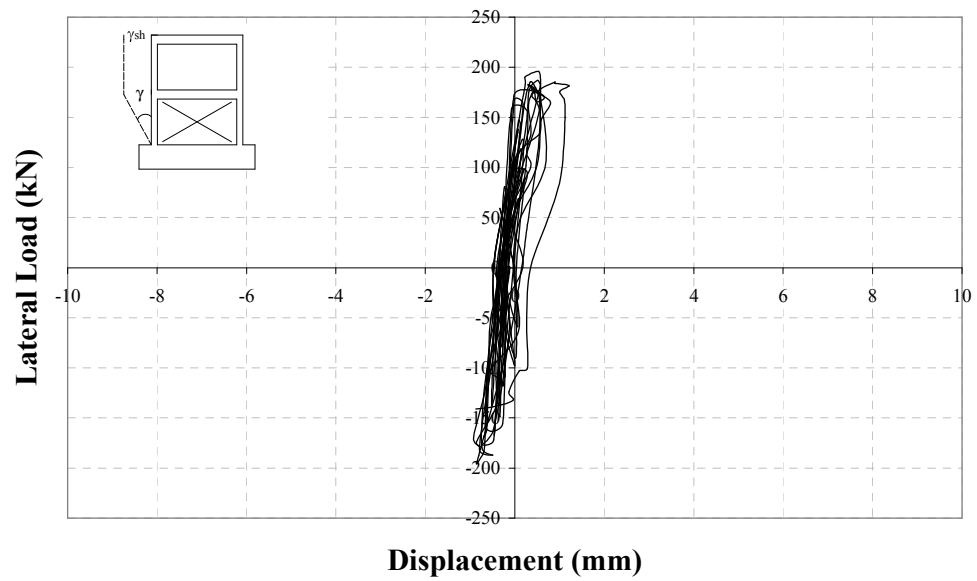
Figure 5.42. Load – first story shear displacement curve, Specimen CIC1

CIC1 was strengthened by using Type C Panels and subjected to lateral loading history presented in Figure 5.38. For this specimen, maximum forward and backward loads were 195.7 kN for both cycles. In Figure 5.39. and Figure 5.40., lateral load-displacement curves are presented for second story and first story, respectively. Lateral load-shear deformation curves are presented for the top story and bottom story infill walls are presented in Figure 5.41. and Figure 5.42. As can be seen from the graphs, both story shear displacements were almost the same. Lateral load-column base vertical displacements are given in Figure 5.43. and Figure 5.44.

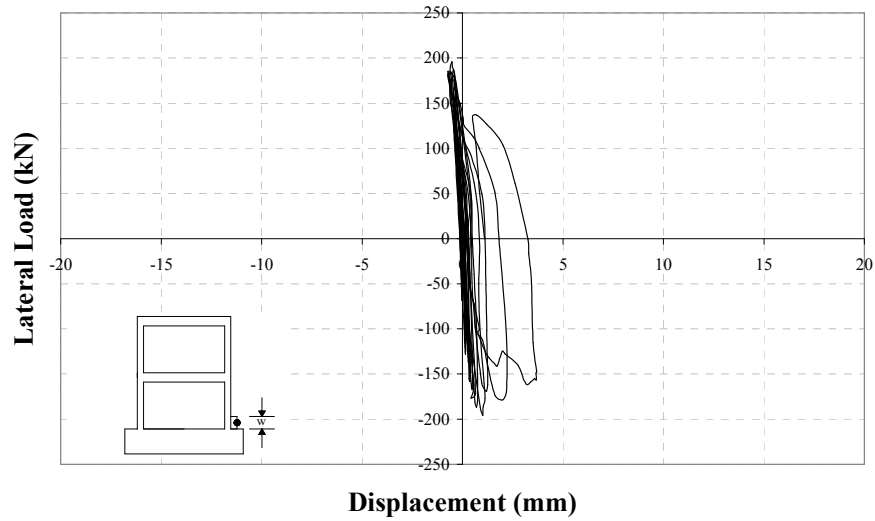
Figure 5.43. Load –north column base vertical displacement, Specimen CIC1

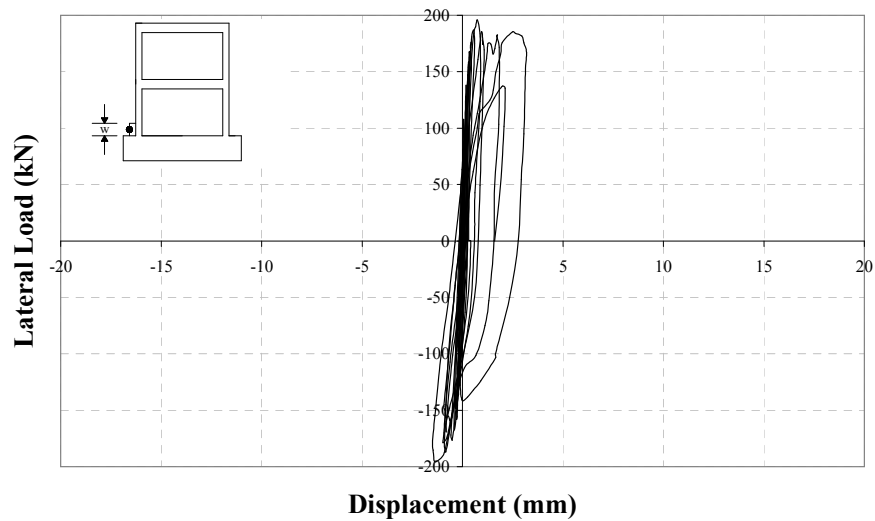
Figure 5.44. Load –south column base vertical displacement, Specimen CIC1

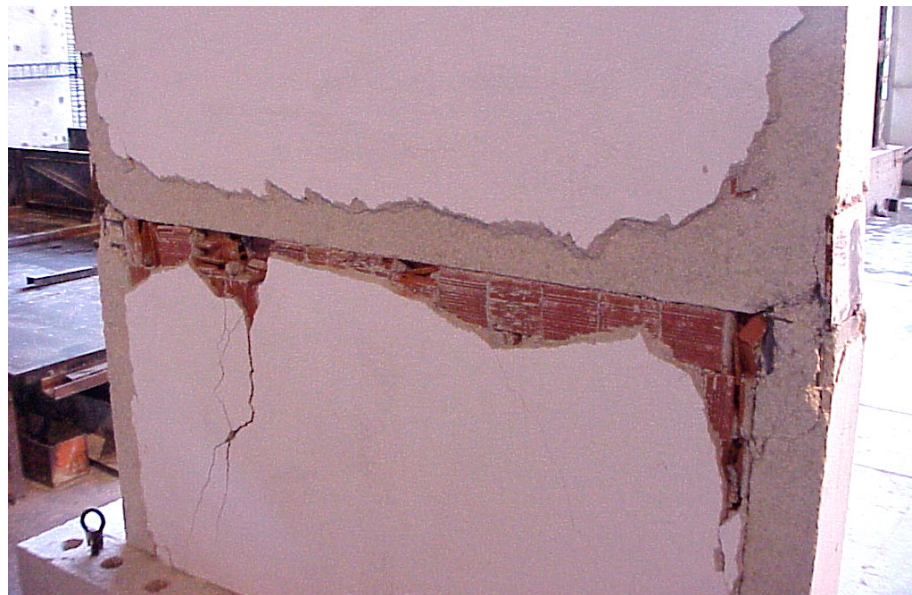
Figure 5.45. Rear view after the test, Specimen CIC1

- In the last cycle, the test was terminated since the specimen could not take any load. Rear and front views of Specimen CIC1 after the test is given in Figure 5.45. and Figure 5.46., respectively.

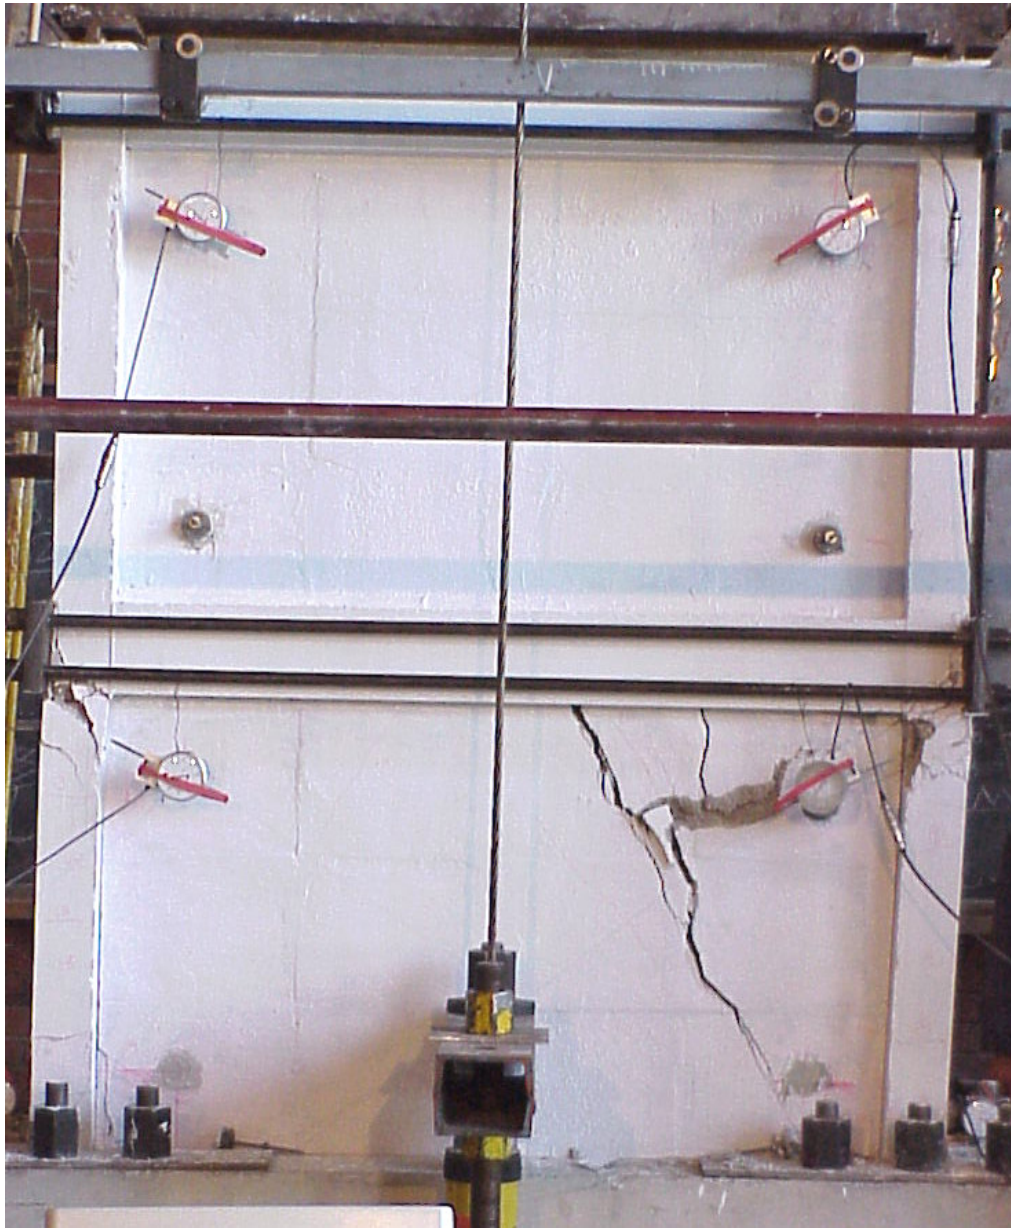
Figure 5.46. Front view after the test, Specimen CIC1

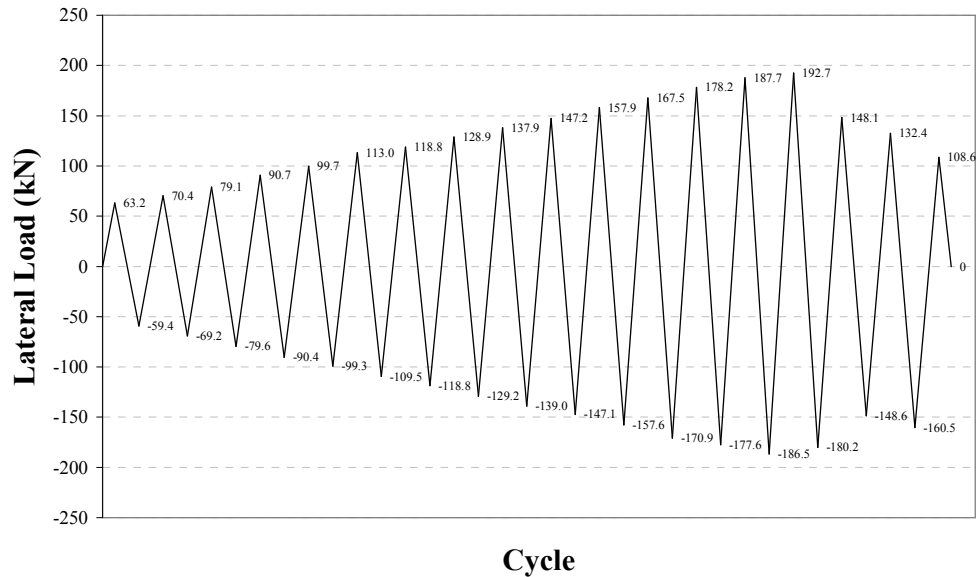
Figure 5.47. Loading history of Specimen CID1

CID1 was strengthened by using Type D Panels and subjected to lateral loading history presented in Figure 5.47. Maximum forward and backward loads were 192.7 kN. and 186.5 kN, respectively. In Figure 5.48. and Figure 5.49., lateral load-displacement curves are presented for second story and first story, respectively. Lateral load-shear deformation curves are presented for the top story and bottom story infill walls are presented in Figure 5.50. and Figure 5.51. As can be seen from the graphs, the shear displacement in the second story infill wall was almost elastic and significantly smaller than the first story infill wall shear displacement. Lateral load-column base vertical displacements are given in Figure 5.52. and Figure 5.53.

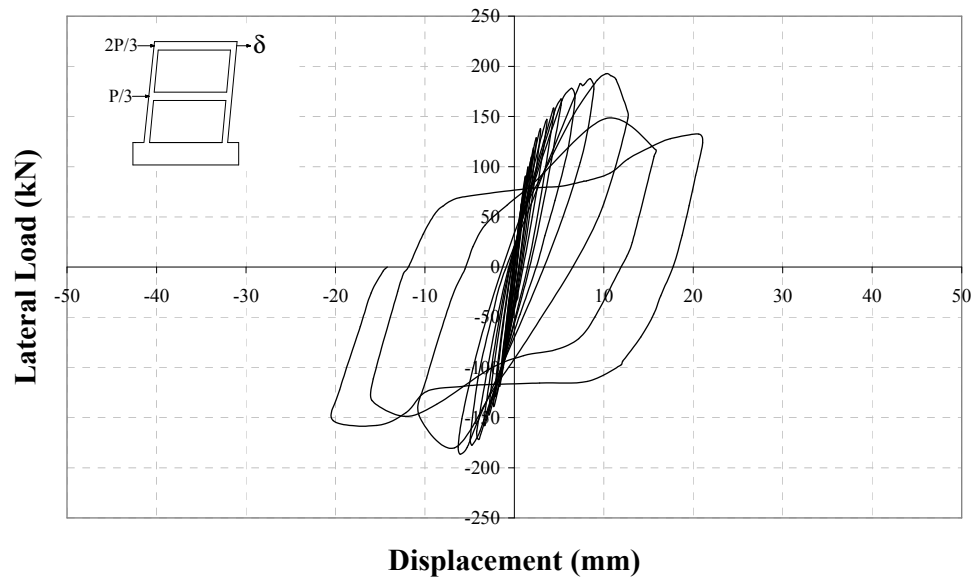
Figure 5.48. Load – second story level displacement curve, Specimen CID1

The conclusions drawn from the lateral load-displacement curves presented are as follows; the initial stiffness of the specimen was 109.8 kN/mm. At the instant of forward maximum loading, the interstory drift ratios for the first and second stories were calculated as 0.0066 and 0.0053, respectively whereas these values were calculated as 0.0035 and 0.0035 at the instant of backward maximum loading, respectively.

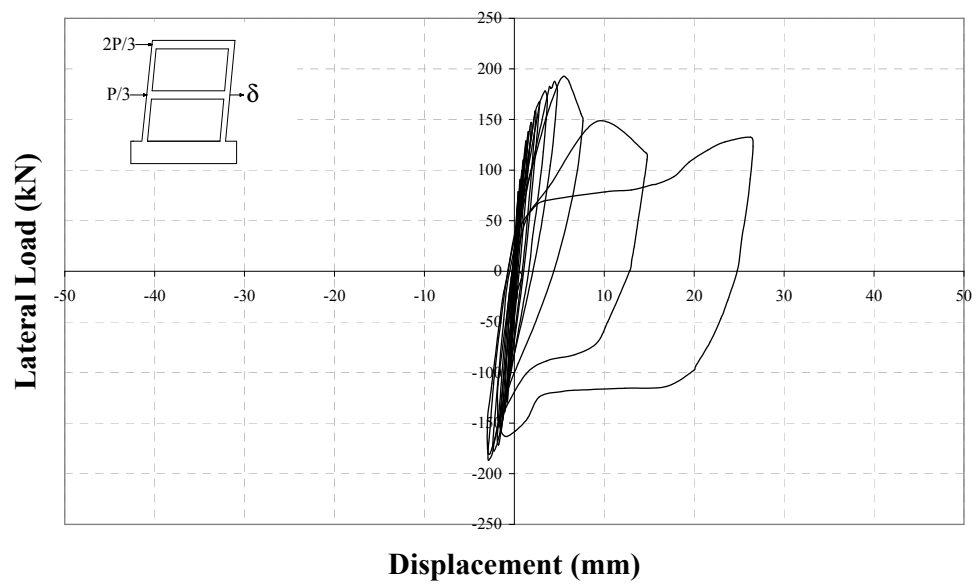
Figure 5.49. Load – first story level displacement curve, Specimen CID1

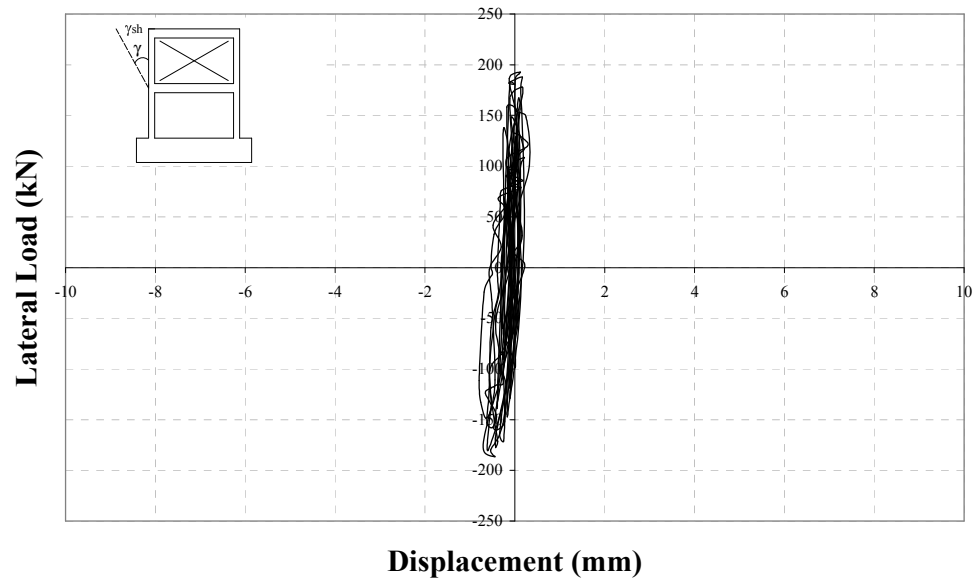
Figure 5.50. Load – second story shear displacement curve, Specimen CID1

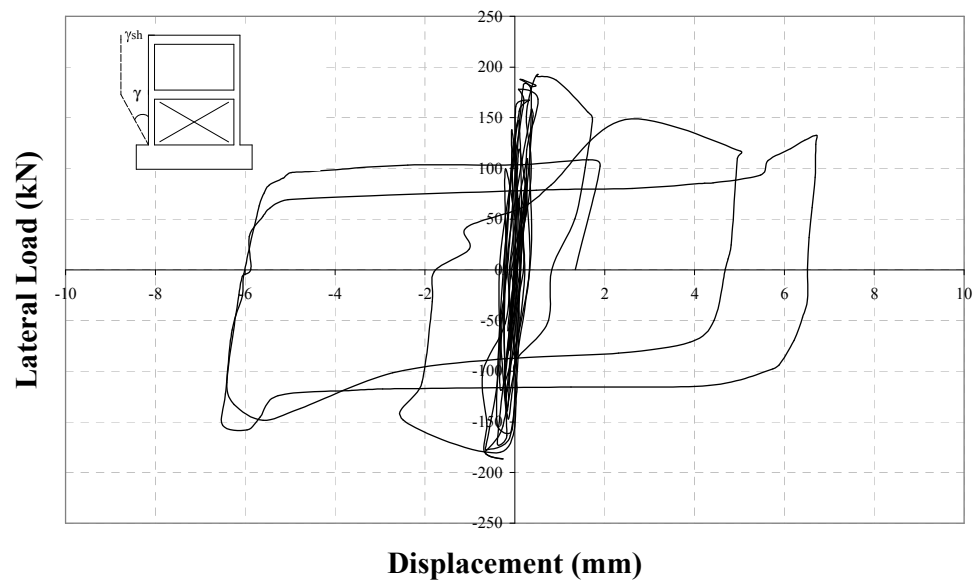
Figure 5.51. Load – first story shear displacement curve, Specimen CID1

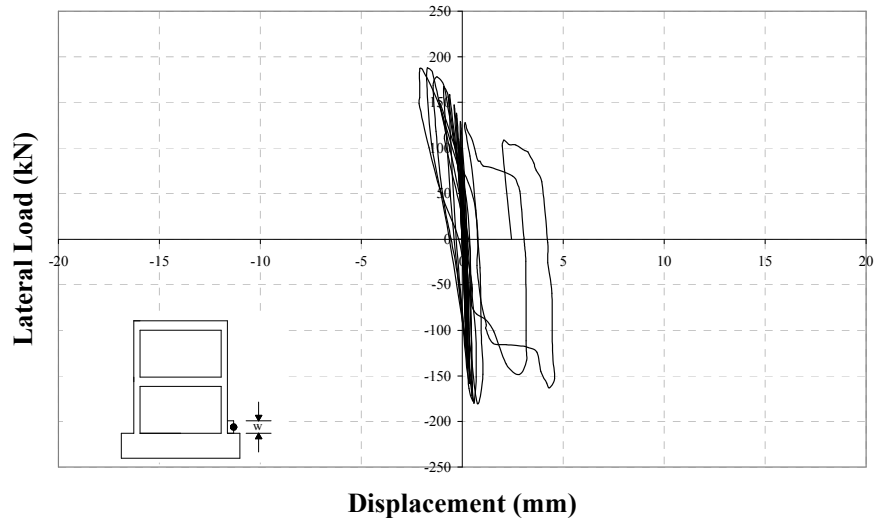
Figure 5.52. Load –north column base vertical displacement, Specimen CID1

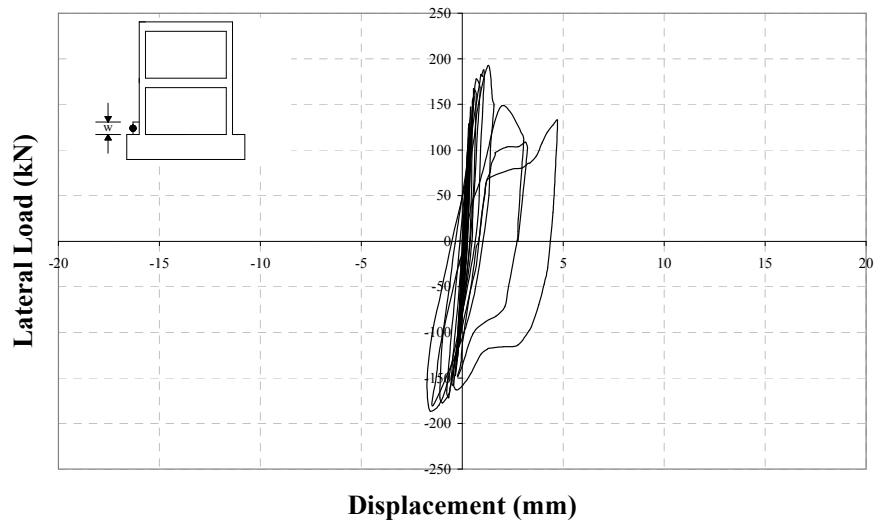
Figure 5.53. Load –south column base vertical displacement, Specimen CID1

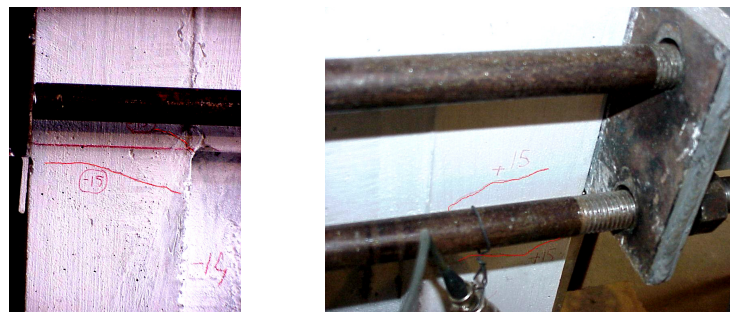
Figure 5.54. Cracks at first story beam-column joints in the tenth cycle

- In the tenth forward cycle, two new cracks were observed on north column, which one of them was at first story beam-north column joint and the other was 50mm below the joint. In the backward cycle, same type of cracks were observed at first story beam-south column joint. The joint cracks are shown in Figure 5.54.

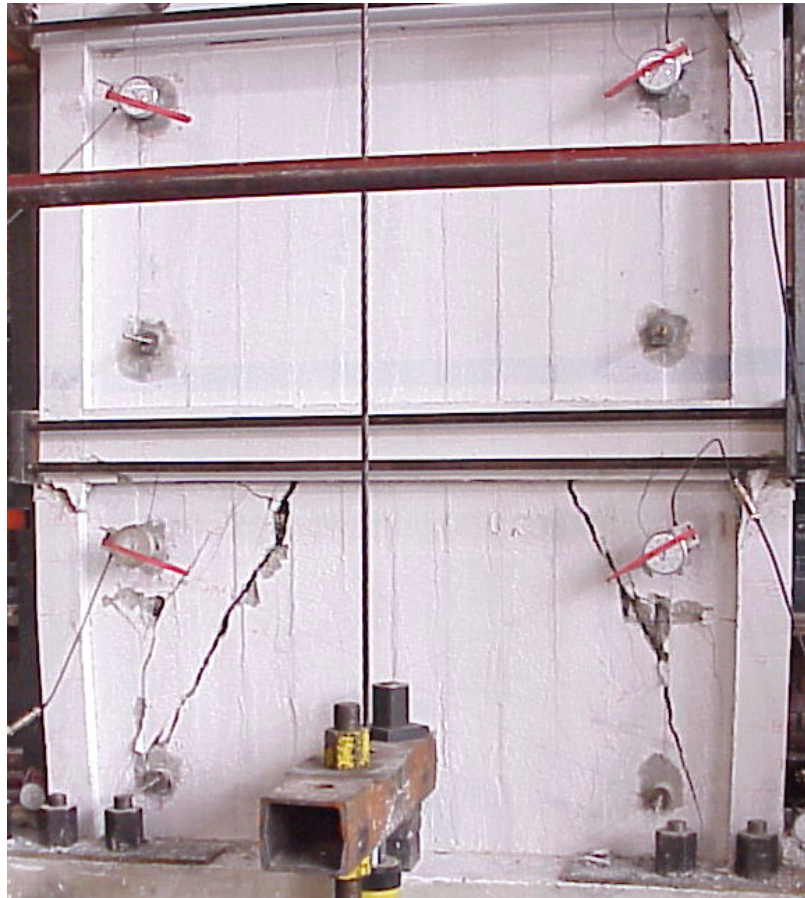
Figure 5.55. The front view after the test, Specimen CID1

- The front and rear views after the test is shown in Figure 5.55. and Figure 5.56., respectively.

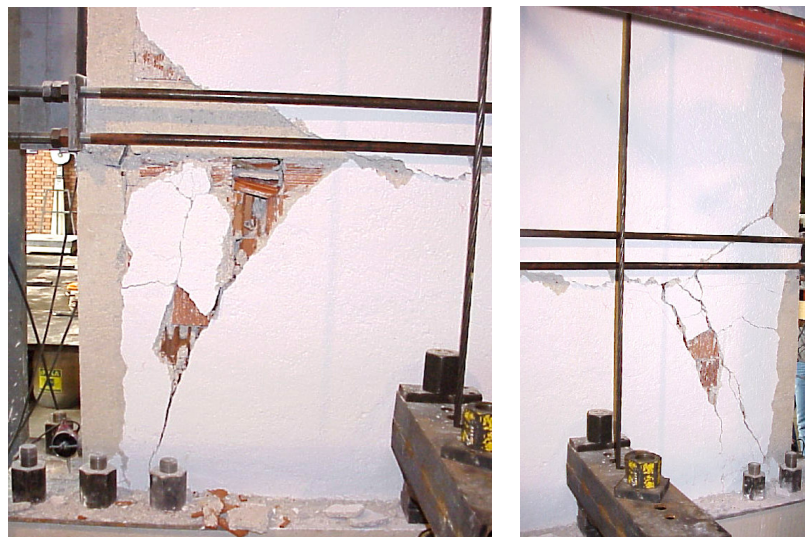
Figure 5.56. The rear view after the test, Specimen CID1

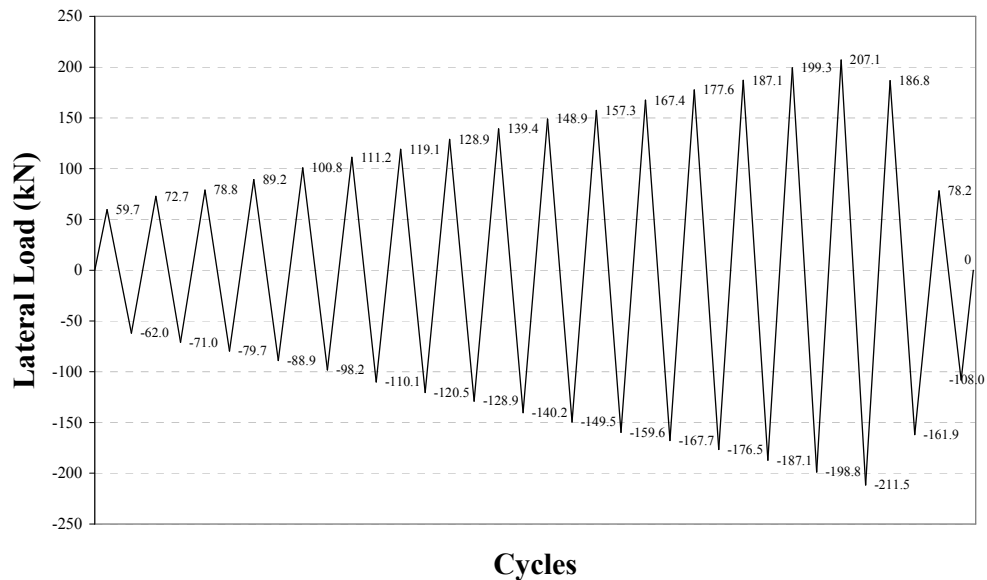
Figure 5.57. Loading history of Specimen CIC3

Specimen CIC3 was strengthened by using Type C panels and subjected to lateral loading history presented in Figure 5.57. For this specimen, maximum forward and backward loads were 207.1 kN and 210.6 kN, respectively. In Figure 5.58. and Figure 5.59., lateral load-displacement curves are presented for second story and first story, respectively. Lateral load-shear deformation curves are presented for the top story and bottom story infill walls are presented in Figure 5.60. and Figure 5.61. As can be seen from the graphs, both story shear displacements were almost the same. Lateral load-column base vertical displacements are given in Figure 5.62. and Figure 5.63.

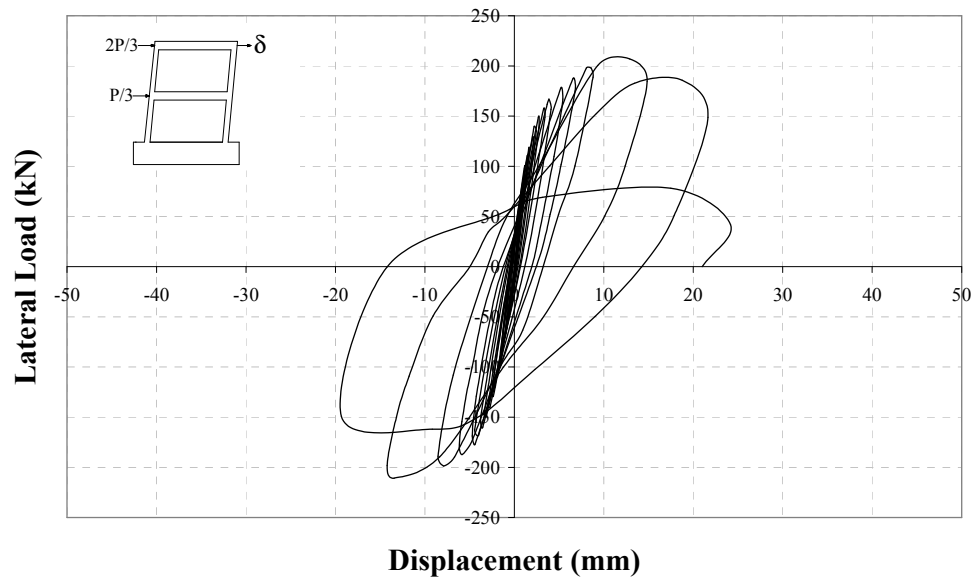
Figure 5.58. Load – second story level displacement curve, Specimen CIC3

The conclusions drawn from the lateral load-displacement curves presented are as follows; the initial stiffness of the specimen was 112.7 kN/mm. At the instant of forward maximum loading, the interstory drift ratios for the first and second stories were calculated as 0.0092 and 0.0059, respectively whereas these values were calculated as 0.0056 and 0.0097 at the instant of backward maximum loading, respectively.

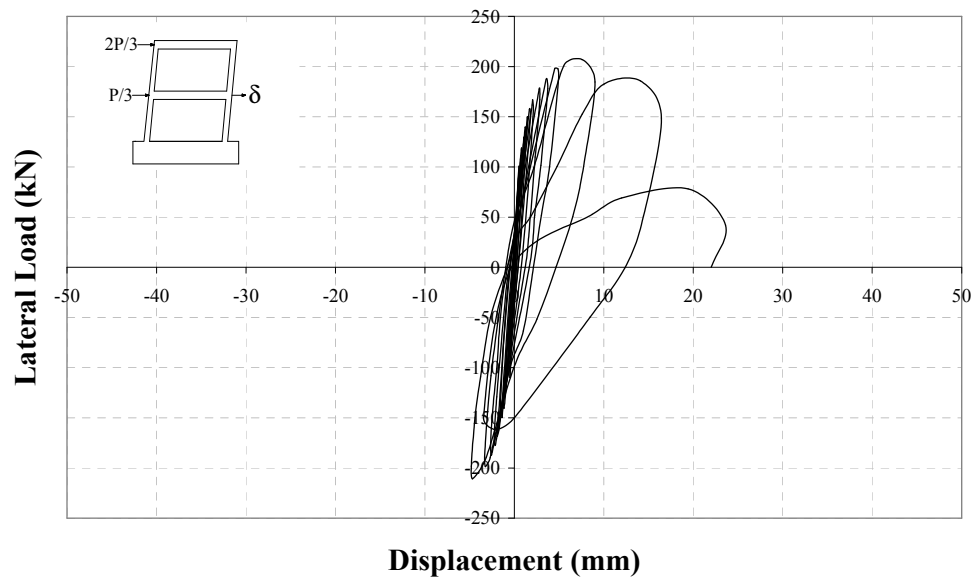
Figure 5.59. Load – first story level displacement curve, Specimen CIC3

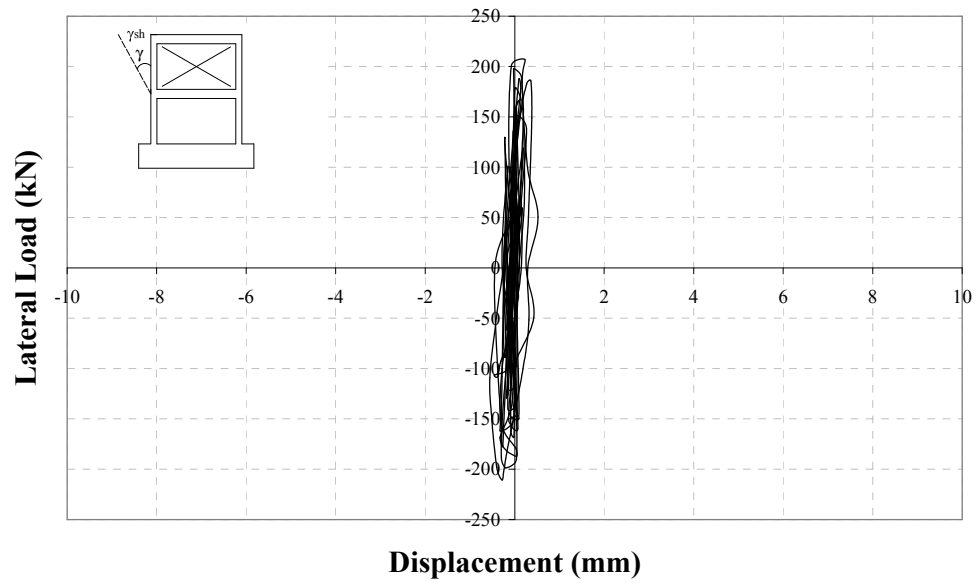
Figure 5.60. Load – second story shear displacement curve, Specimen CIC3

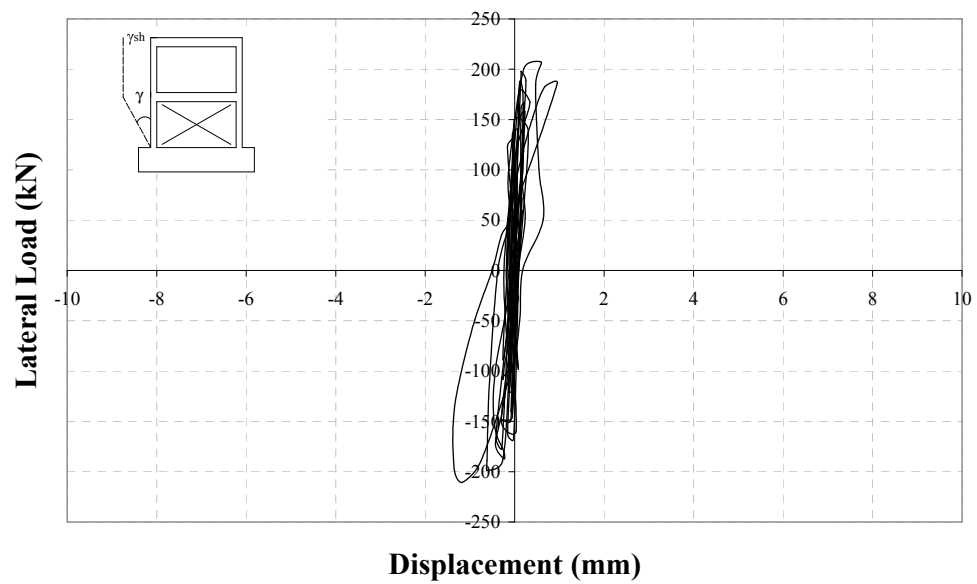
Figure 5.61. Load – first story shear displacement curve, Specimen CIC3

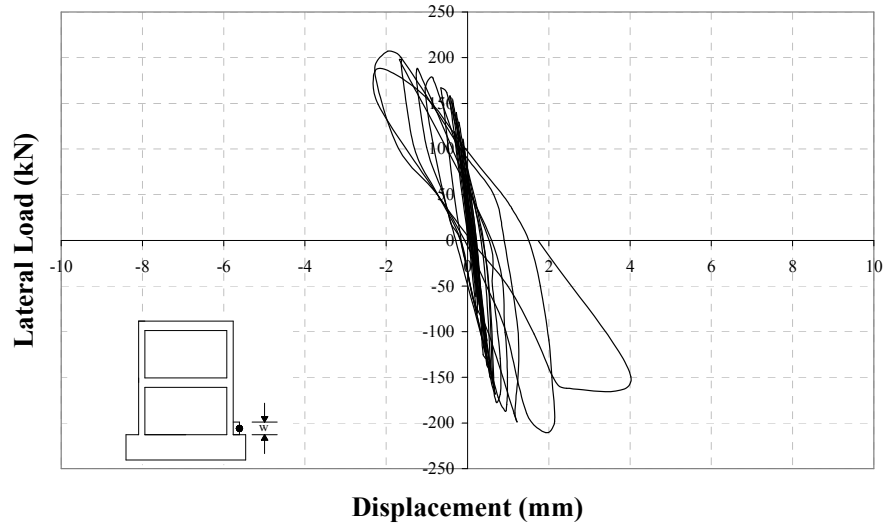
Figure 5.62. Load –north column base vertical displacement, Specimen CIC3

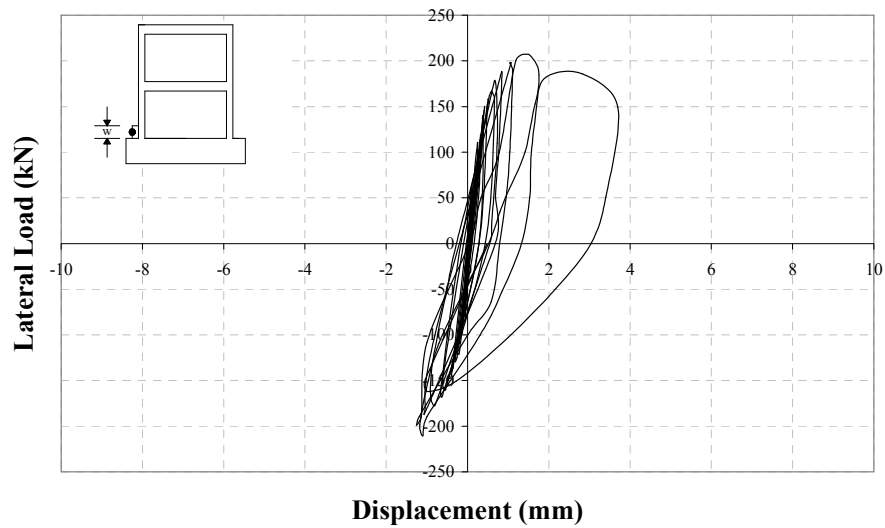
Figure 5.63. Load –south column base vertical displacement, Specimen CIC3

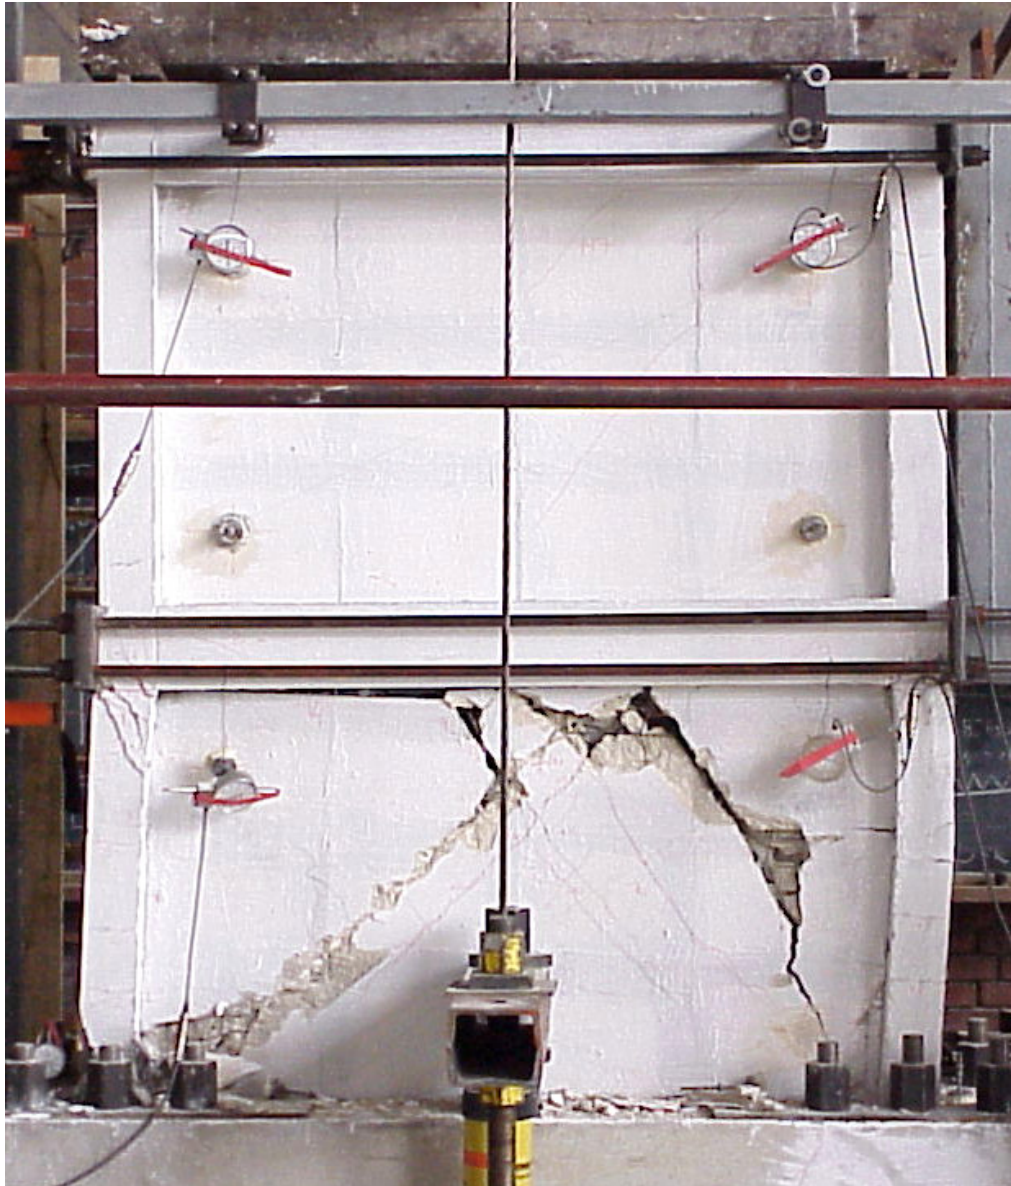
Figure 5.64. Front view after the test, Specimen CIC3

the specimen could not carry any further load and a sudden release of the axial load occurred due to the crushing and grinding at the bottom of the south column together with the breaking off the reinforcement of the first story panels. The front view of Specimen CIC3 after the test is given in Figure 5.64.

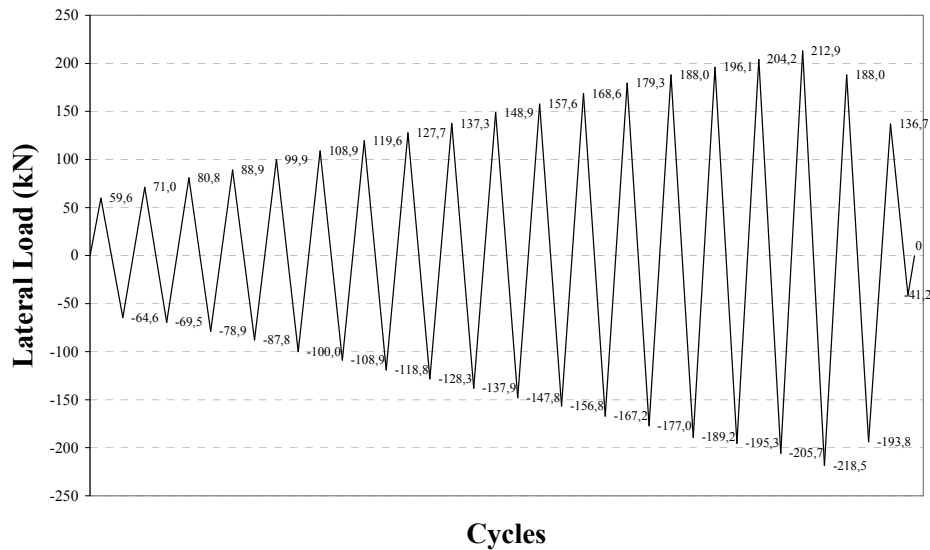
Figure 5.65. Loading history of Specimen CIC4

Specimen CIC4 was strengthened by using Type C panels and subjected to lateral loading history presented in Figure 5.65. For this specimen, maximum forward and backward loads were 212.9 kN and 218.5 kN, respectively. In Figure 5.66. and Figure 5.67., lateral load-displacement curves are presented for second story and first story, respectively. Lateral load-shear deformation curves are presented for the top story and bottom story infill walls are presented in Figure 5.68. and Figure 5.69. As can be seen from the graphs, the shear displacement in the second story infill wall was almost elastic and significantly smaller than the first story infill wall shear displacement. Lateral load-column base vertical displacements are given in Figure 5.70. and Figure 5.71.

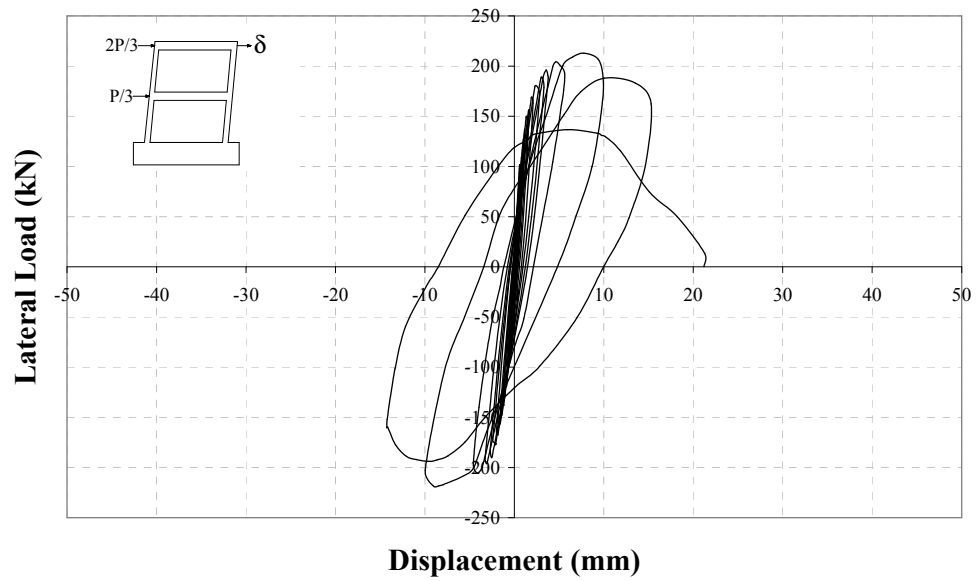
Figure 5.66. Load – second story level displacement curve, Specimen CIC4

The conclusions drawn from the lateral load-displacement curves presented are as follows; the initial stiffness of the specimen was 125.3 kN/mm. At the instant of forward maximum loading, the interstory drift ratios for the first and second stories were calculated as 0.0055 and 0.0036, respectively whereas these values were calculated as 0.0062 and 0.0043 at the instant of backward maximum loading, respectively.

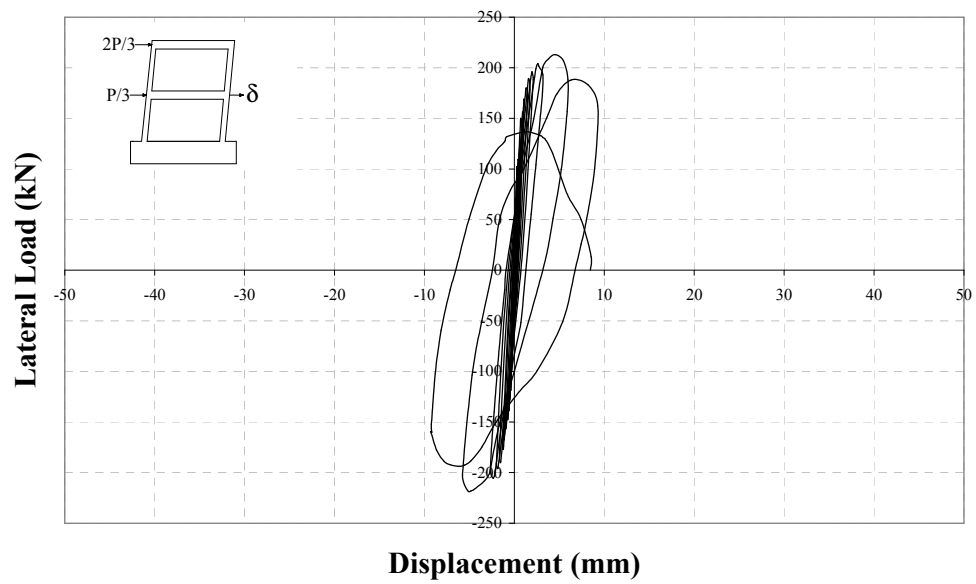
Figure 5.67. Load – first story level displacement curve, Specimen CIC4

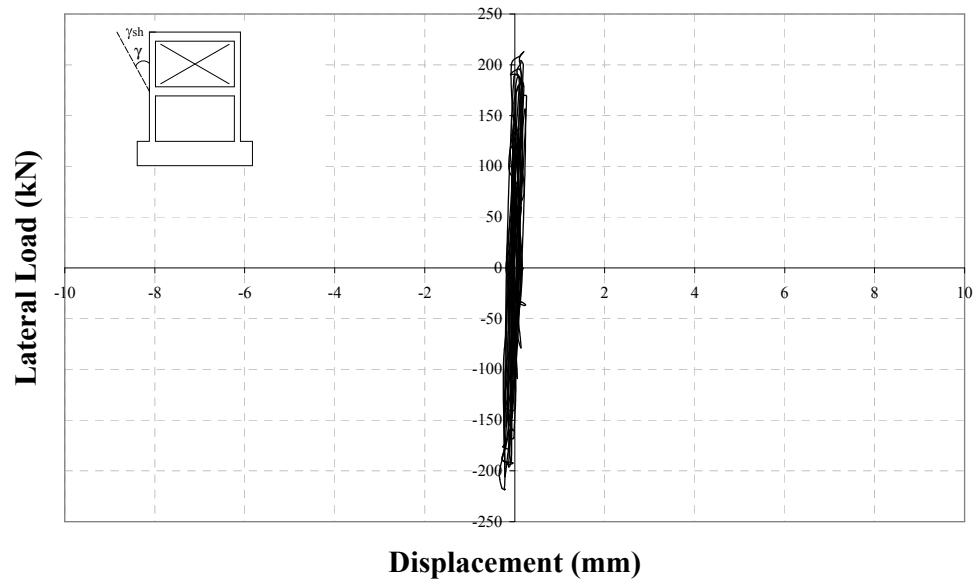
Figure 5.68. Load – second story shear displacement curve, Specimen CIC4

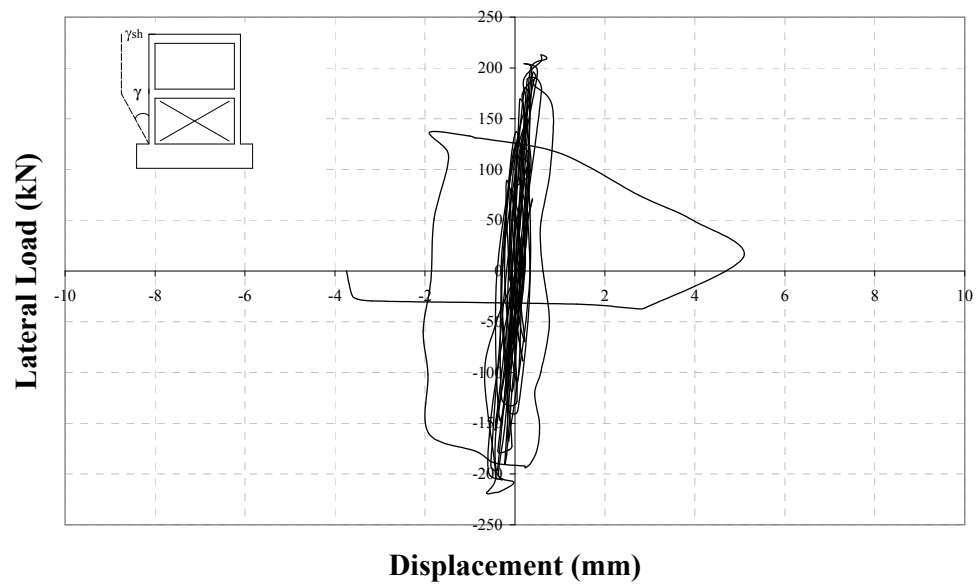
Figure 5.69. Load – first story shear displacement curve, Specimen CIC4

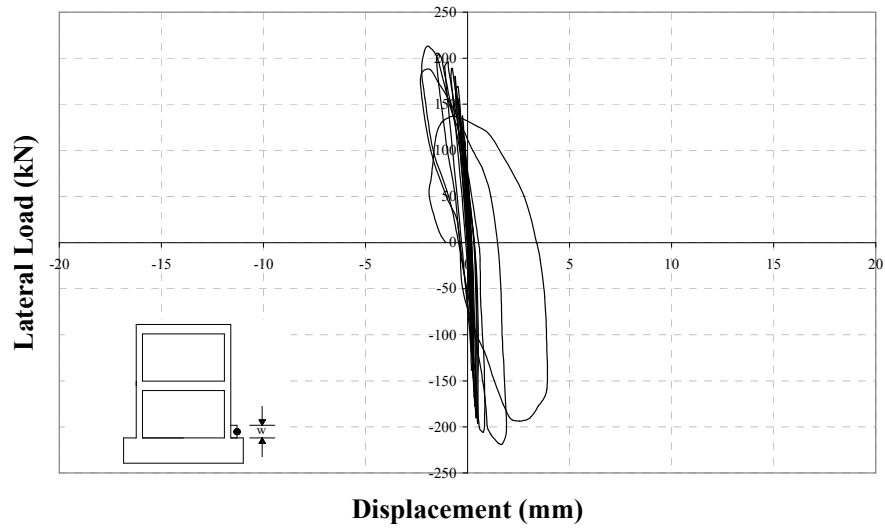
Figure 5.70. Load –north column base vertical displacement, Specimen CIC4

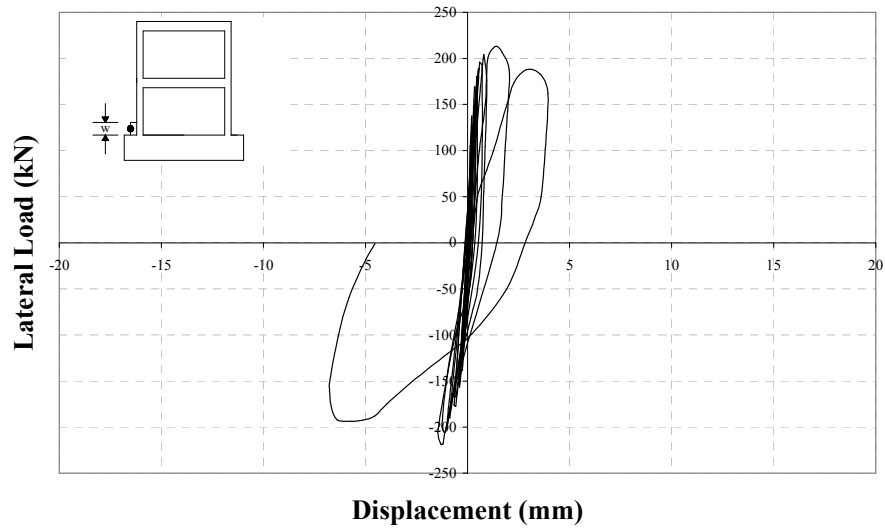
Figure 5.71. Load –south column base vertical displacement, Specimen CIC4

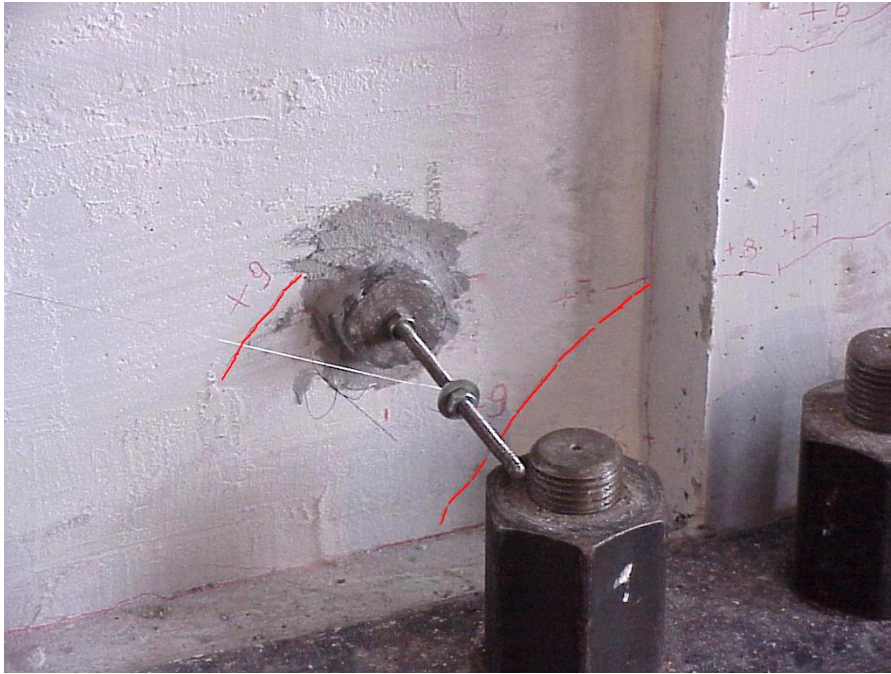
Figure 5.72. Crack occurred on the panel in the ninth forward cycle

- In the eighth backward cycle, crack occurred on the panel in the seventh backward cycle extended to the frame foundation diagonally.
- In the ninth forward cycle, two diagonal cracks were observed on the bottom corner panel near the north column as shown in Figure 5.72. In the backward cycle, a crack occurred on the south column 600mm above bottom.

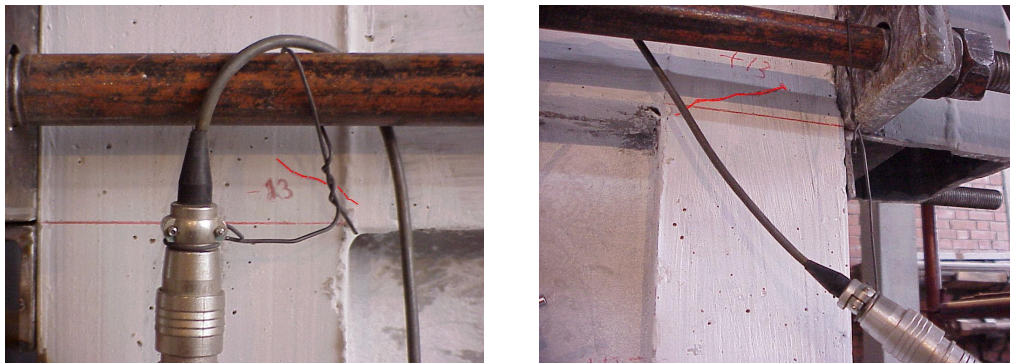
Figure 5.73. First crack at first story beam-column joints in the thirteen cycle

- In the twelfth forward cycle, crack observed in the seventh forward cycle on the front face of the north column extended backwards to the side face.
- In the thirteenth forward cycle, a diagonal crack was observed at the first story beam-north column joint as shown in Figure 5.73. In the backward cycle, a diagonal crack was observed at the first story beam-south column joint this time.

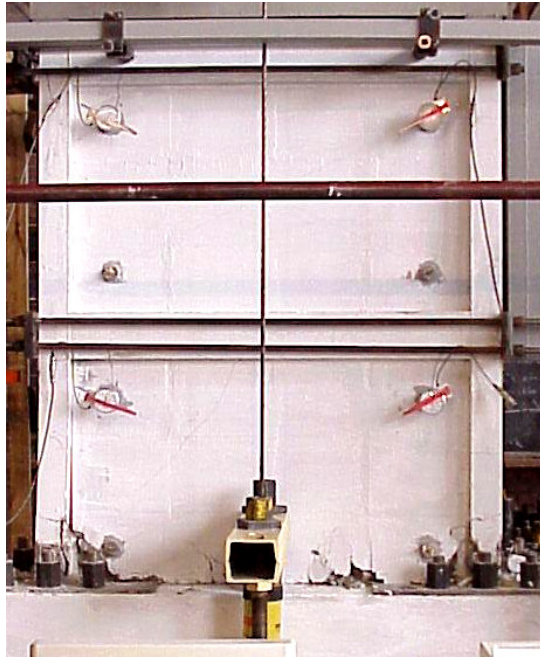
Figure 5.74. The front view of Specimen CIC4 after the test

- In the nineteenth forward cycle, total axial load level decreased to 100 kN level due to the acceleration in the crushing of south column together with the bottom corner panel. The second story level displacement reached 22mm in the forward cycle. In the backward cycle, crushing of the north column with the bottom corner panel accelerated and the axial load level on both columns decreased to 90 kN and 60 kN level immediately after. Hence, the test was terminated. Two layers of hollow clay bricks from bottom crushed. Majority of the damage occurred at the frame foundation level. Apart from the bottom panel cracks, only one crack occurred at the first story panels. The front and rear views of the specimen are given in Figure 5.74. and Figure 5.75.

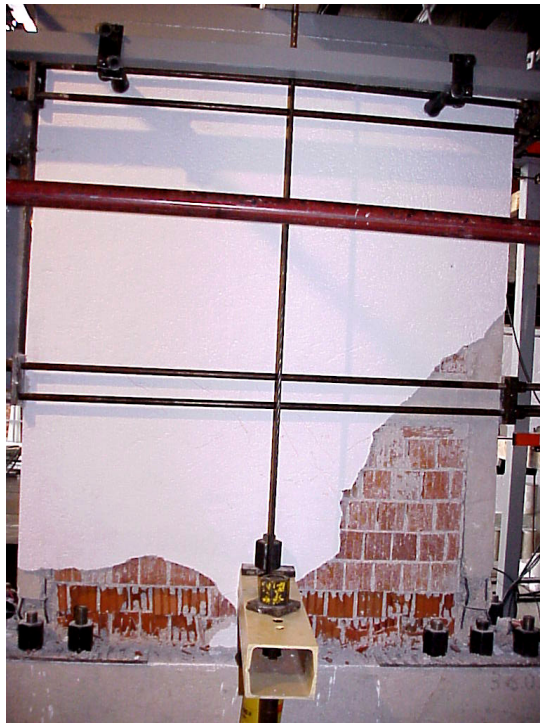
Figure 5.75. The rear view of Specimen CIC4 after the test

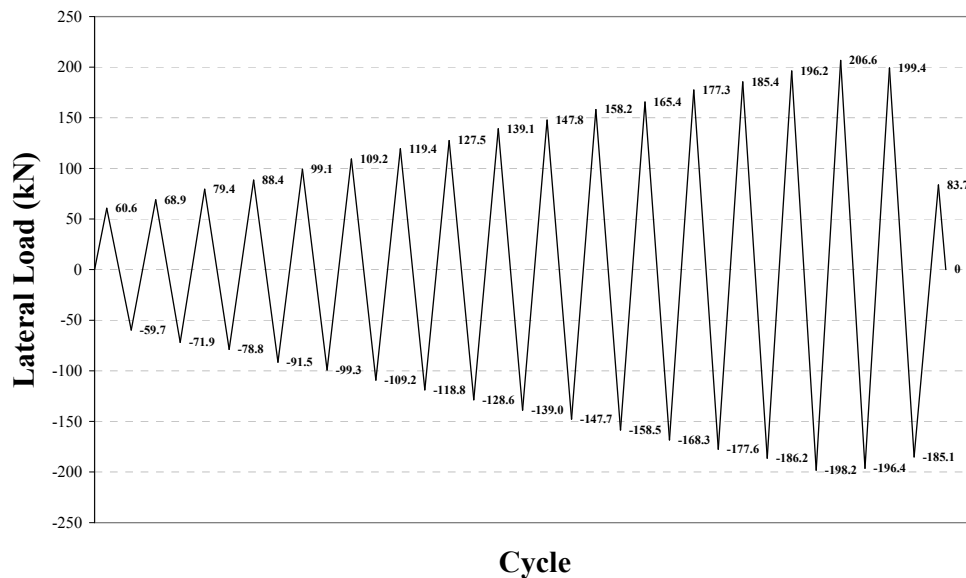
Figure 5.76. Loading History of Specimen CEE4

CEE4 was strengthened by using Type E Panels and subjected to lateral loading history presented in Figure 5.76. For this specimen, maximum forward and backward loads were 206.6 kN and 198.2 kN, respectively. In Figure 5.77. and Figure 5.78., lateral load-displacement curves are presented for second story and first story, respectively. Lateral load-shear deformation curves are presented for the top story and bottom story infill walls are presented in Figure 5.79. and Figure 5.80. As can be seen from the graphs, the shear displacements for both stories were almost the same except from the last few cycles. Lateral load-column base vertical displacements are given in Figure 5.81. and Figure 5.82.

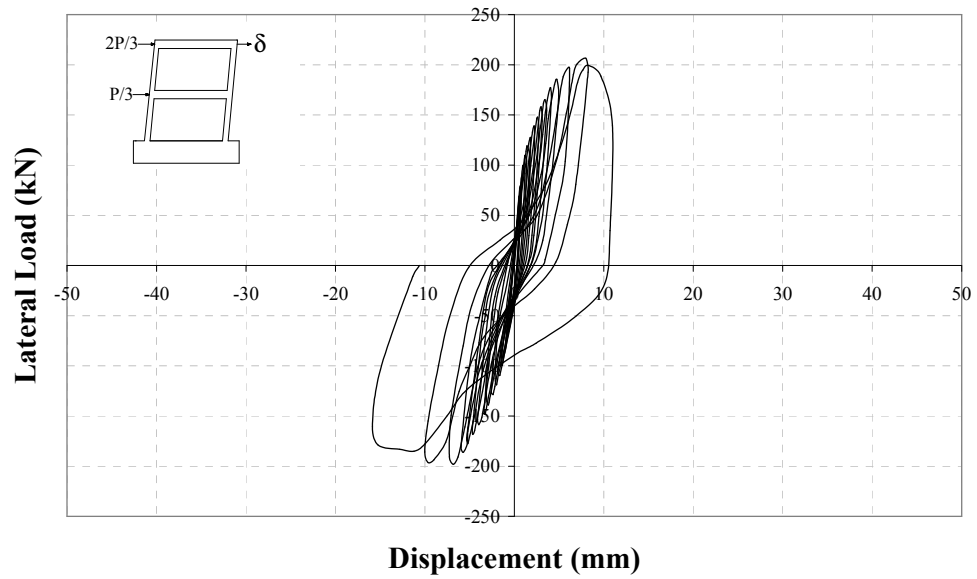
Figure 5.77. Load – second story level displacement curve, Specimen CEE4

The conclusions drawn from the lateral load-displacement curves presented are as follows; the initial stiffness of the specimen was 112.8 kN/mm. At the instant of forward maximum loading, the interstory drift ratios for the first and second stories were calculated as 0.0073 and 0.0022, respectively whereas these values were calculated as 0.0052 and 0.0029 at the instant of backward maximum loading, respectively.
