**PRECAST CONCRETE PANEL REINFORCED INFILL WALLS
FOR SEISMIC STRENGTHENING OF
REINFORCED CONCRETE FRAMED STRUCTURES**

**A THESIS SUBMITTED TO
THE GRADUATE SCHOOL OF NATURAL AND APPLIED SCIENCES
OF
MIDDLE EAST TECHNICAL UNIVERSITY**

**BY
MEHMET BARAN**

**IN PARTIAL FULFILLMENT OF THE REQUIREMENTS
FOR
THE DEGREE OF PHILOSOPHY OF DOCTORATE
IN
CIVIL ENGINEERING**

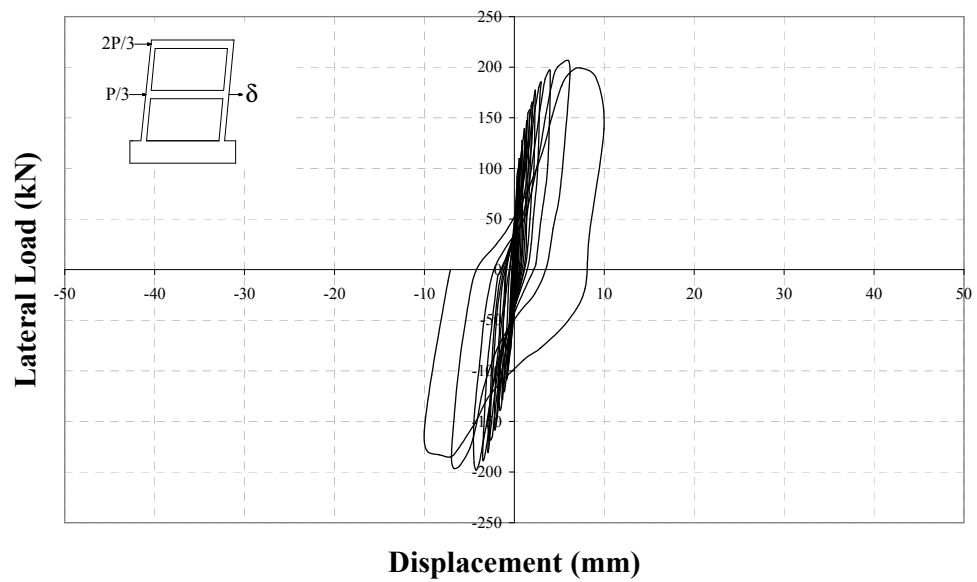
Figure 5.78. Load – first story level displacement curve, Specimen CEE4

CEE4 was strengthened by using Type E Panels and subjected to lateral loading history presented in Figure 5.76. For this specimen, maximum forward and backward loads were 206.6 kN and 198.2 kN, respectively. In Figure 5.77. and Figure 5.78., lateral load-displacement curves are presented for second story and first story, respectively. Lateral load-shear deformation curves are presented for the top story and bottom story infill walls are presented in Figure 5.79. and Figure 5.80. As can be seen from the graphs, the shear displacements for both stories were almost the same except from the last few cycles. Lateral load-column base vertical displacements are given in Figure 5.81. and Figure 5.82.

The conclusions drawn from the lateral load-displacement curves presented are as follows; the initial stiffness of the specimen was 112.8 kN/mm. At the instant of forward maximum loading, the interstory drift ratios for the first and second stories were calculated as 0.0073 and 0.0022, respectively whereas these values were calculated as 0.0052 and 0.0029 at the instant of backward maximum loading, respectively.

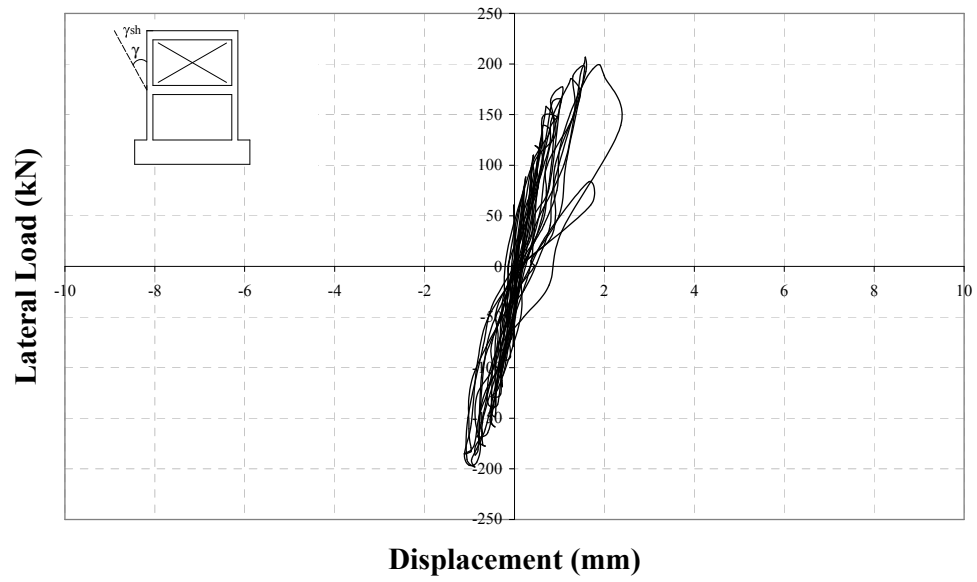
Figure 5.79. Load – second story shear displacement curve, Specimen CEE4

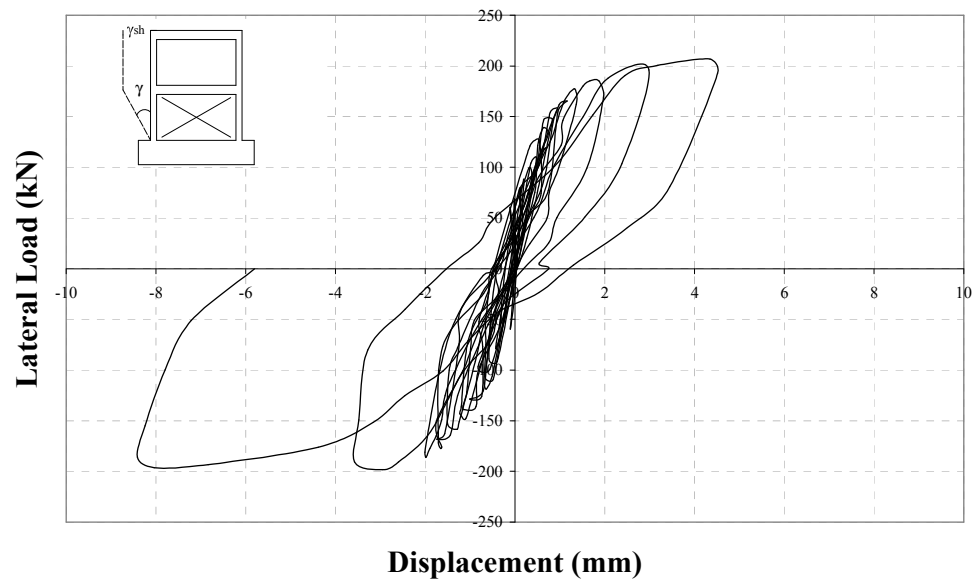
Figure 5.80. Load – first story shear displacement curve, Specimen CEE4

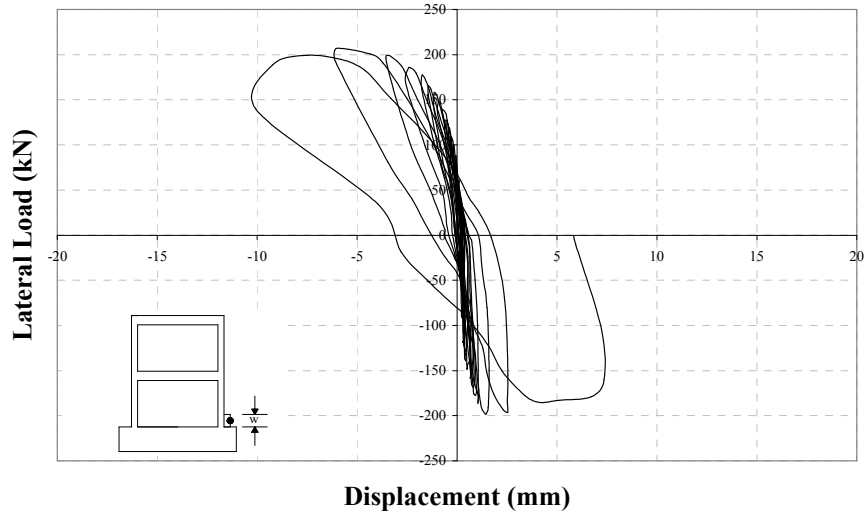
Figure 5.81. Load –north column base vertical displacement, Specimen CEE4

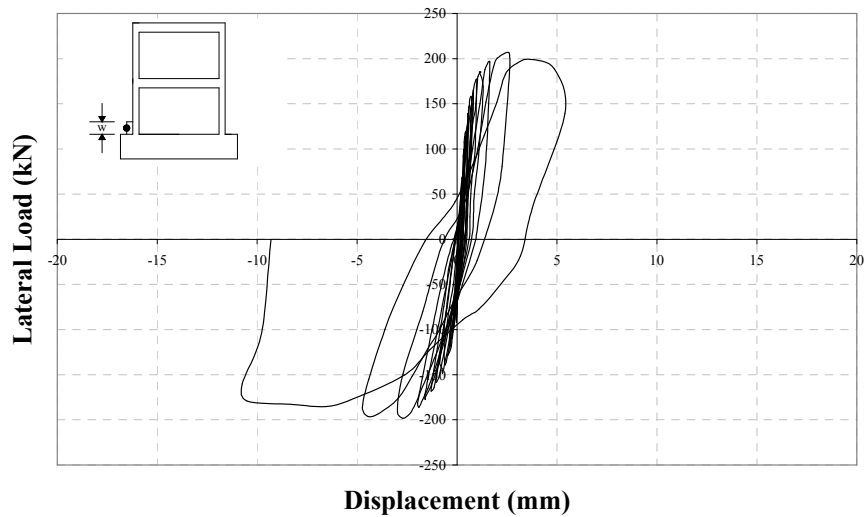
Figure 5.82. Load –south column base vertical displacement, Specimen CEE4

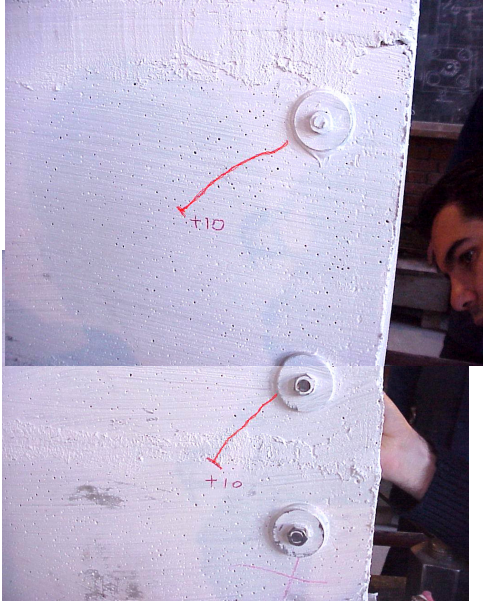
Figure 5.83. First cracks on the first story panels

- In the tenth forward cycle, first cracks were observed on the first story panels as shown in Figure 5.83. In addition, a diagonal crack was observed at the back face of the north column 550mm above bottom. In the backward cycle, three inclined cracks were observed on the side, back, and interior face of the south column on the first story level.

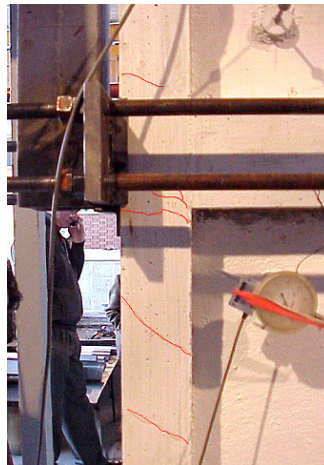
Figure 5.84. Cracks on the back face of the north column in the eleventh cycle

- In the eleventh forward cycle, cracks were observed on the back face of the north column at various levels as shown in Figure 5.84. In the backward cycle, two new cracks were observed on the south column.

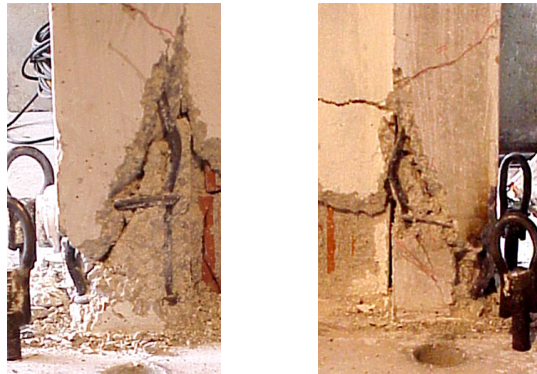
Figure 5.85. Columns after the test, Specimen CEE4

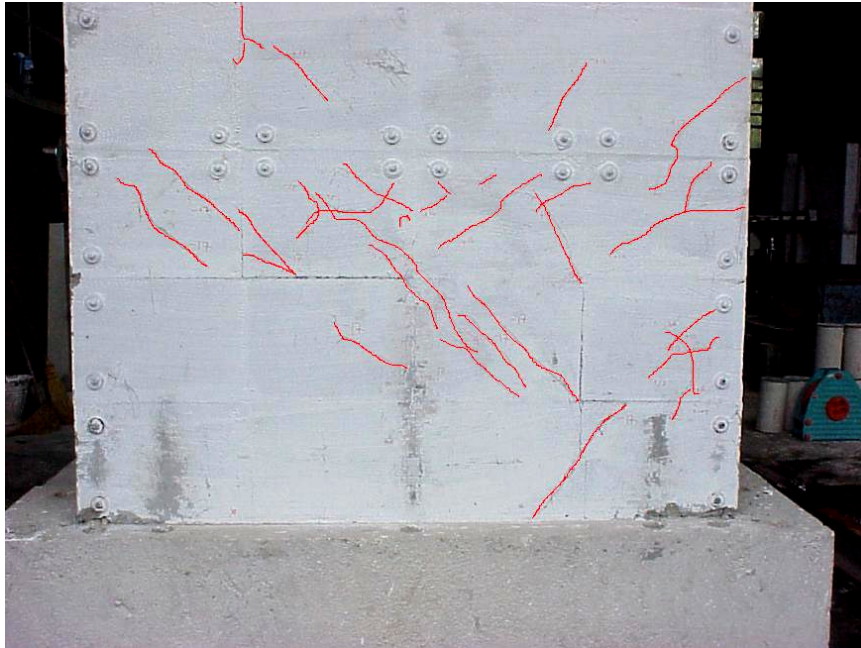
Figure 5.86. Crack pattern on the first story panels, Specimen CEE4

- In the seventeenth forward cycle, bottom of the south column together with the bottom corner panel crushed and L-section connecting the columns of the 'guide frame' to the laboratory wall buckled near a lateral load of 200kN. In the backward cycle, bottom of the north column together with the bottom corner panel crushed. Hence, the test was terminated. In this cycle, buckling occurred at both column longitudinal reinforcements. Columns after the test are given in Figure 5.85. Crack pattern on the first story panels and Specimen CEE4 after the test are given in Figure 5.86. and Figure 5.87.

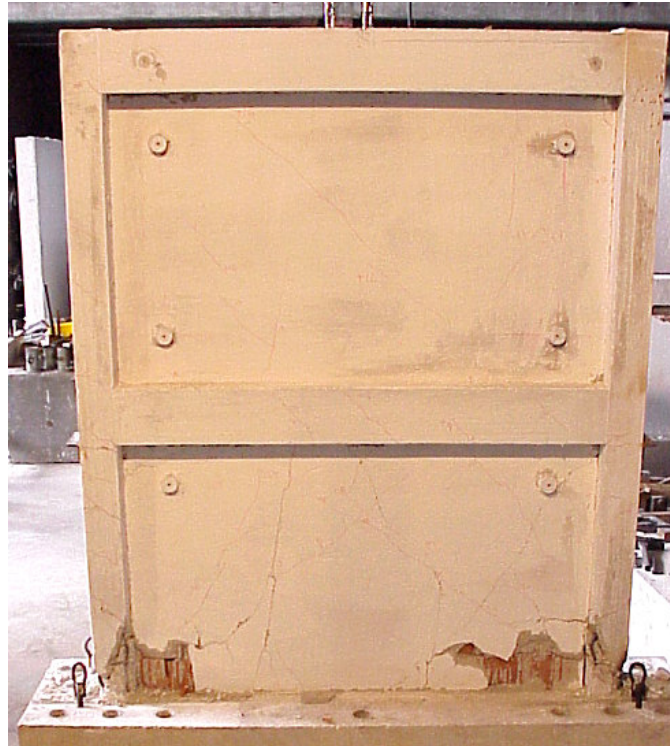
Figure 5.87. Specimen CEE4 after the test

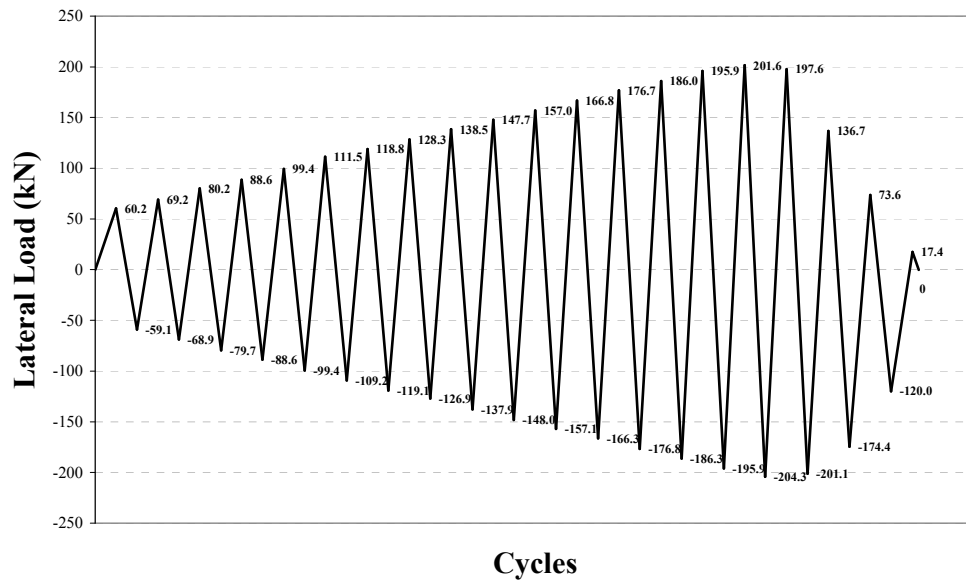
Figure 5.88. Loading History of Specimen CEF4

CEF4 was strengthened by using Type F Panels and subjected to lateral loading history presented in Figure 5.88. For this specimen, maximum forward and backward loads were 201.6 kN. and 204.3 kN, respectively. In Figure 5.89. and Figure 5.90., lateral load-displacement curves are presented for second story and first story, respectively. Lateral load-shear deformation curves are presented for the top story and bottom story infill walls are presented in Figure 5.91. and Figure 5.92. As can be seen from the graphs, the shear displacement in the second story infill wall was smaller than the first story infill wall shear displacement. Lateral load-column base vertical displacements are given in Figure 5.93. and Figure 5.94.

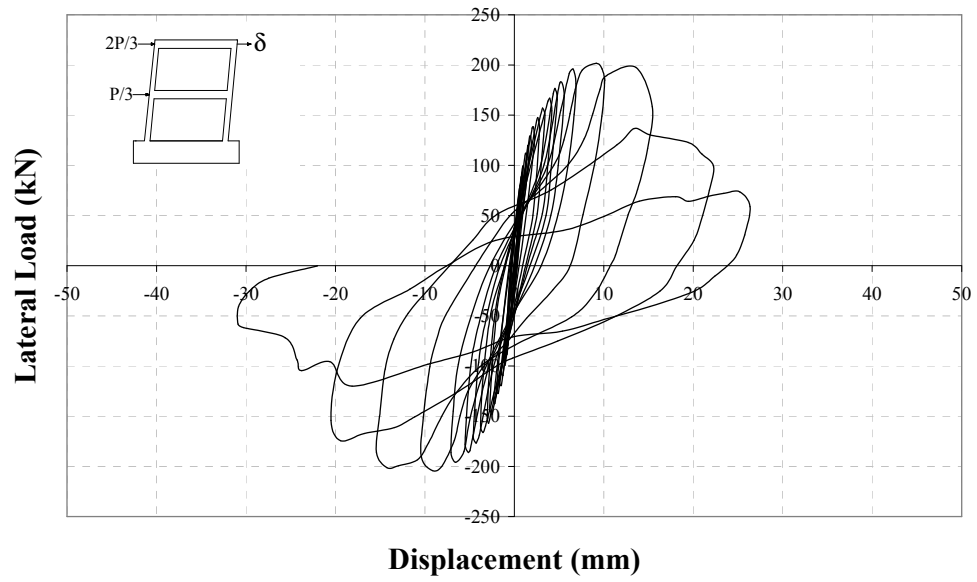
Figure 5.89. Load – second story level displacement curve, Specimen CEF4

The conclusions drawn from the lateral load-displacement curves presented are as follows; the initial stiffness of the specimen was 124.6 kN/mm. At the instant of forward maximum loading, the interstory drift ratios for the first and second stories were calculated as 0.0076 and 0.0032, respectively whereas these values were calculated as 0.0071 and 0.0041 at the instant of backward maximum loading, respectively.

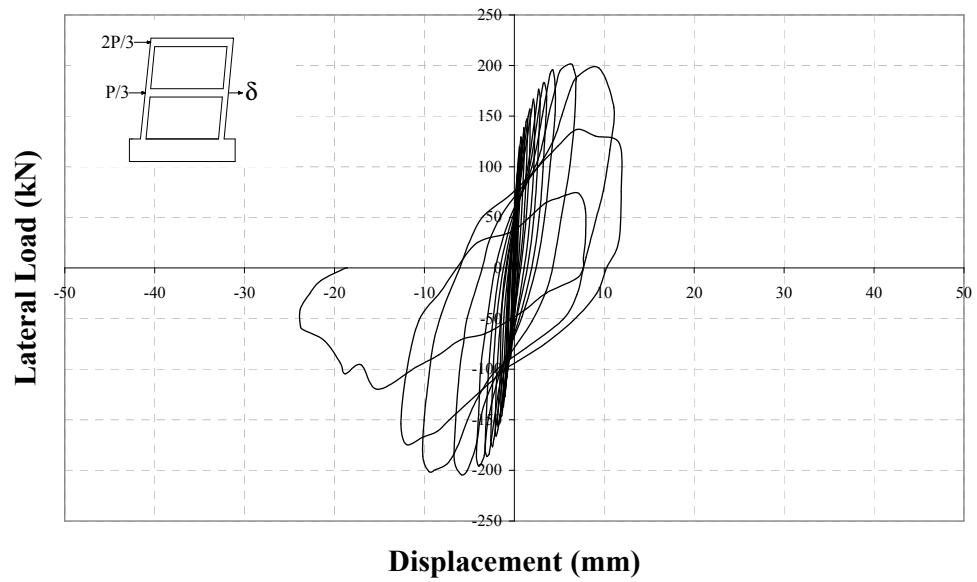
Figure 5.90. Load – first story level displacement curve, Specimen CEF4

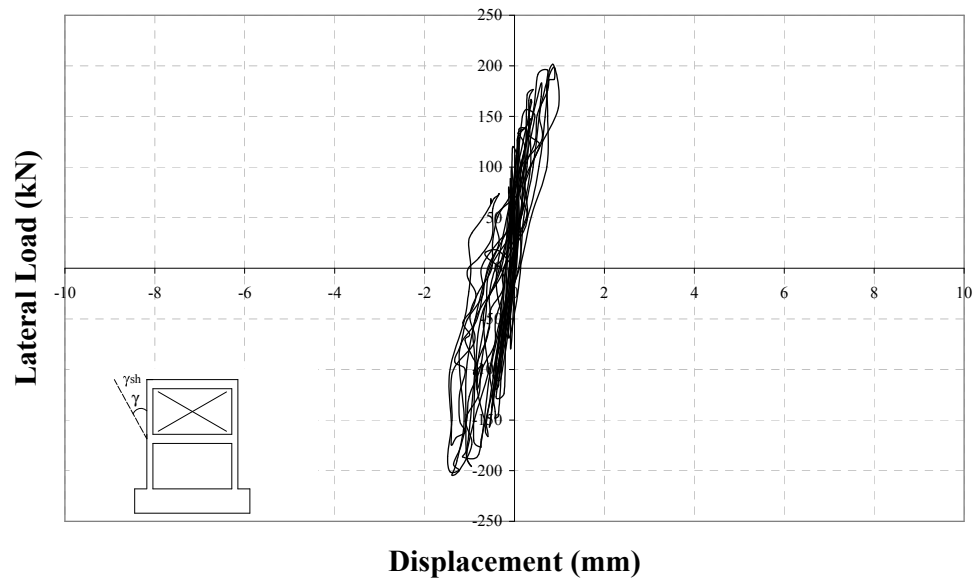
Figure 5.91. Load – second story shear displacement curve, Specimen CEF4

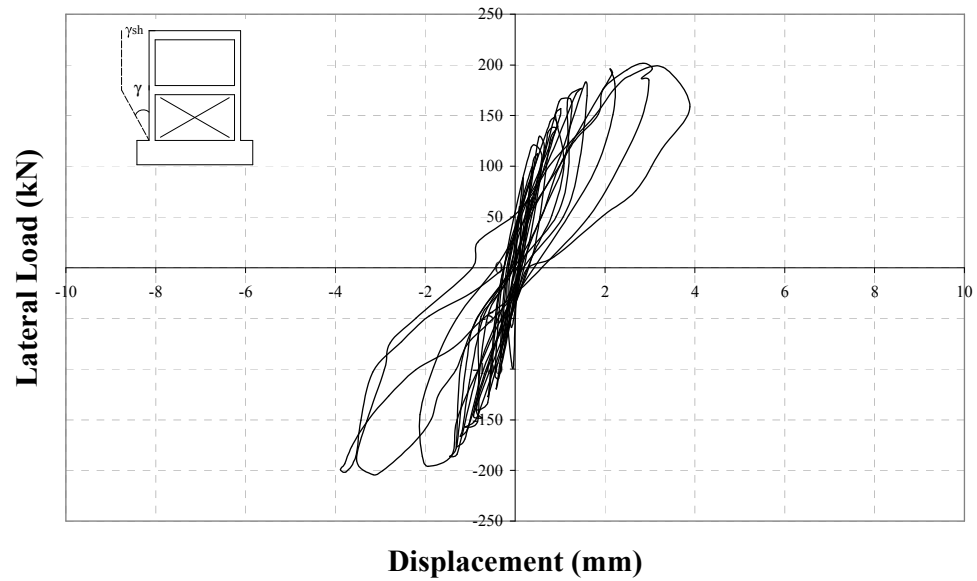
Figure 5.92. Load – first story shear displacement curve, Specimen CEF4

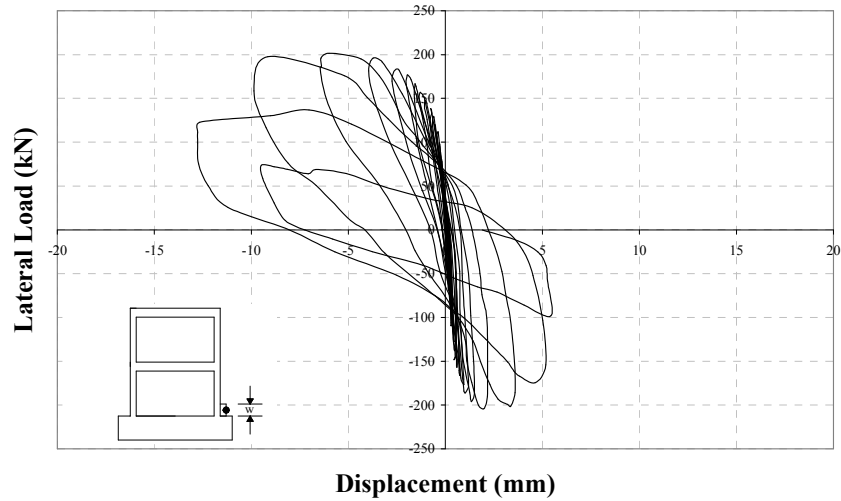
Figure 5.93. Load –north column base vertical displacement, Specimen CEF4

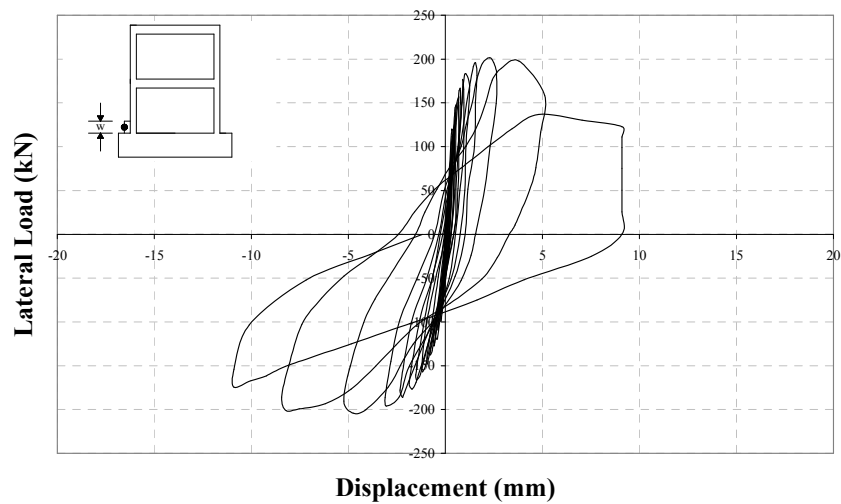
Figure 5.94. Load –south column base vertical displacement, Specimen CEF4

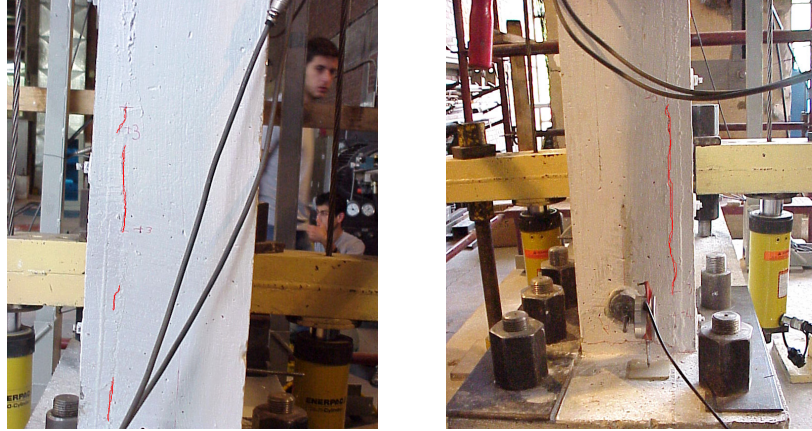
Figure 5.95. Plaster-column connection cracks in the third cycle

- In the first two cycles, separations were observed at both first story infill wall-column connections.
- In the second forward cycle, first crack was observed at the north column. In the backward cycle, similar crack was observed at the south column this time.
- In the third cycle, cracks occurred at both plaster-column connections as shown in Figure 5.95.

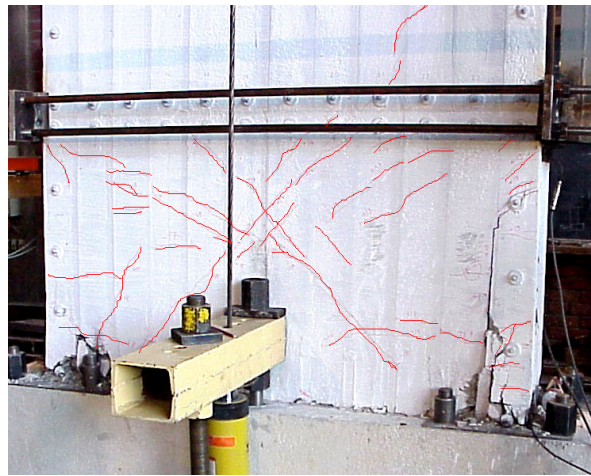
Figure 5.96. The crack pattern on first story panels

- In the nineteenth forward cycle, total axial load level on columns decreased to 75kN and 40kN in the backward cycle due to the accelerated crushing of the columns. Two layers of hollow clay brick from bottom crushed. Bottom of the corner panels also crushed. Hence, the test was terminated. Crack pattern on first story panels, the photographs of the first story infill wall and the Specimen CEF4 after the test are given in Figure 5.96., Figure 5.97., and Figure 5.98., respectively.

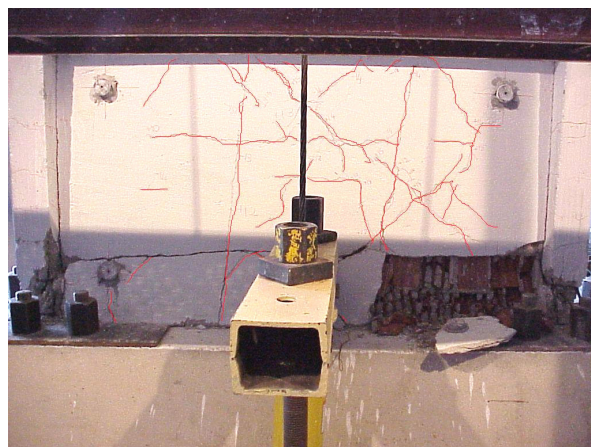
Figure 5.97. First story infill wall after the test

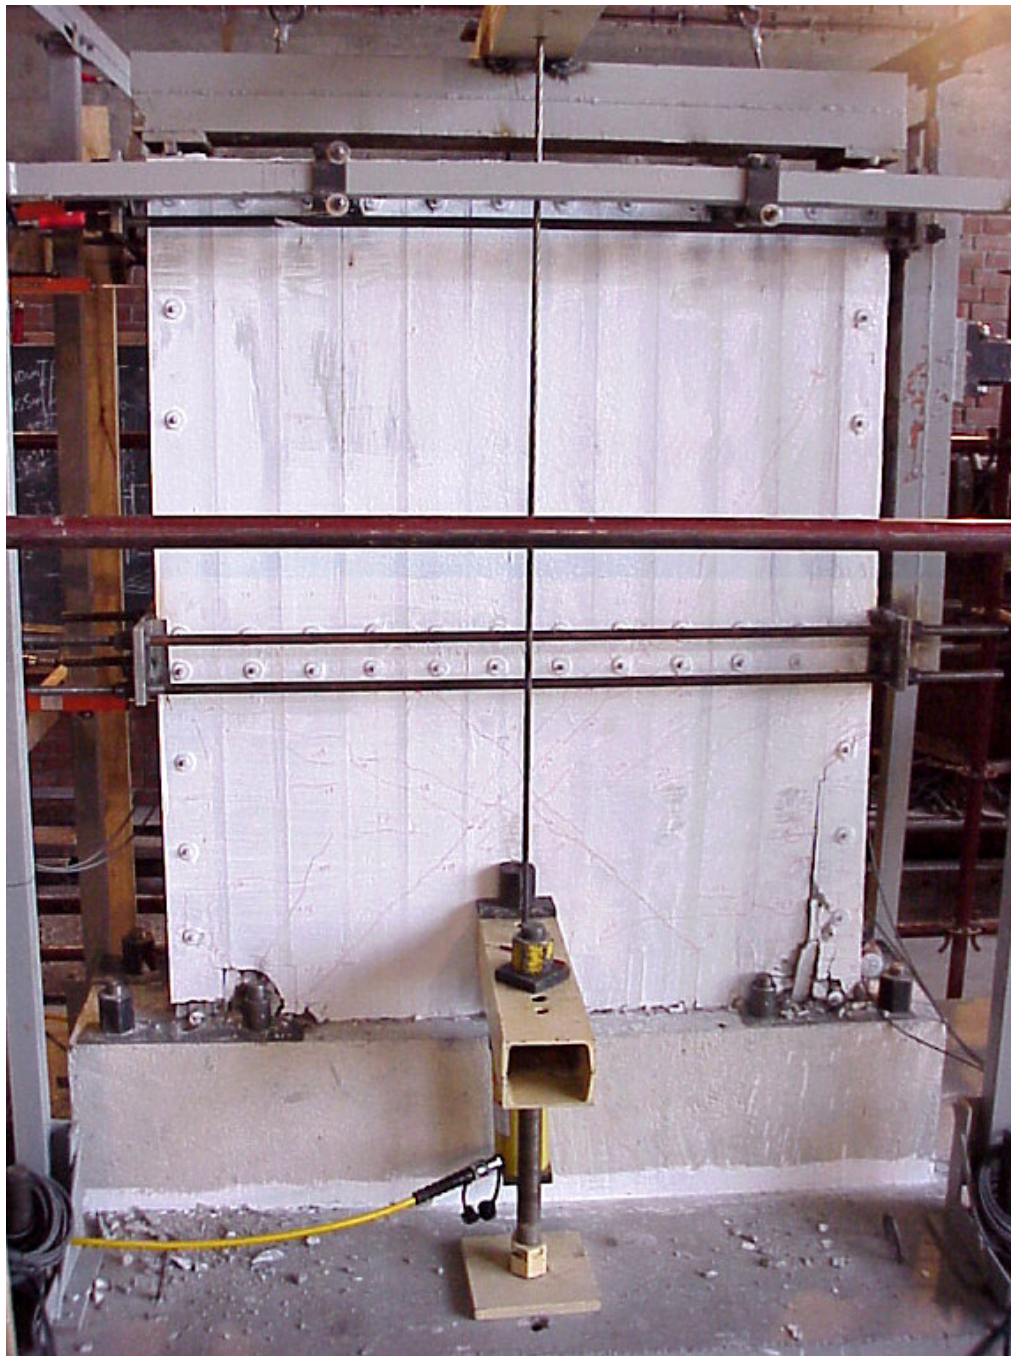
Figure 5.98. Specimen CEF4 after the test

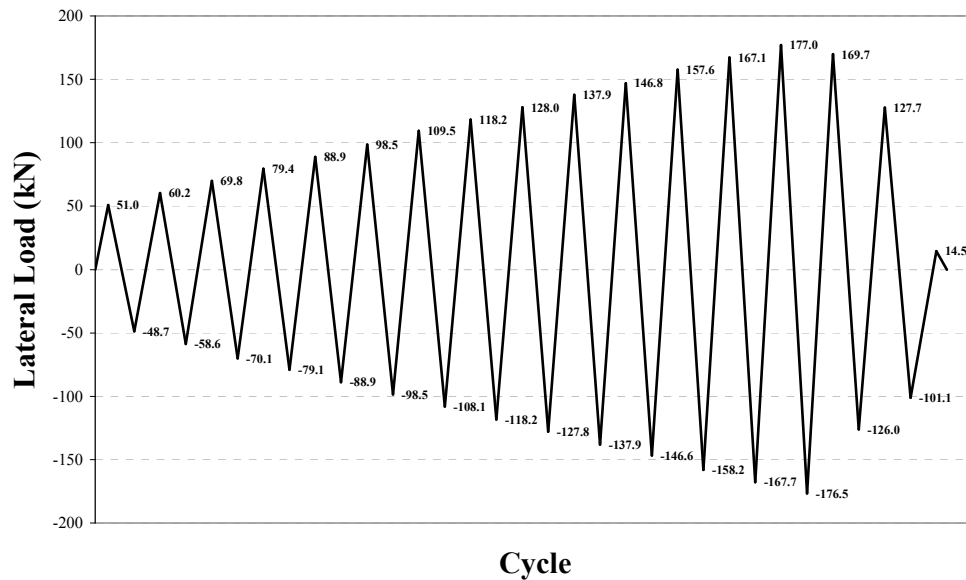
Figure 5.99. Loading History for Specimen CEE1

CEE1 was strengthened by using Type E Panels and subjected to lateral loading history presented in Figure 5.99. For this specimen, maximum forward and backward loads were 177.0 kN and 176.5 kN, respectively. In Figure 5.100. and Figure 5.101., lateral load-displacement curves are presented for second story and first story, respectively. Lateral load-shear deformation curves are presented for the top story and bottom story infill walls are presented in Figure 5.102. and Figure 5.103. As can be seen from the graphs, the shear displacement in the second story infill wall was smaller than the first story infill wall shear displacement. Lateral load-column base vertical displacements are given in Figure 5.104. and Figure 5.105.

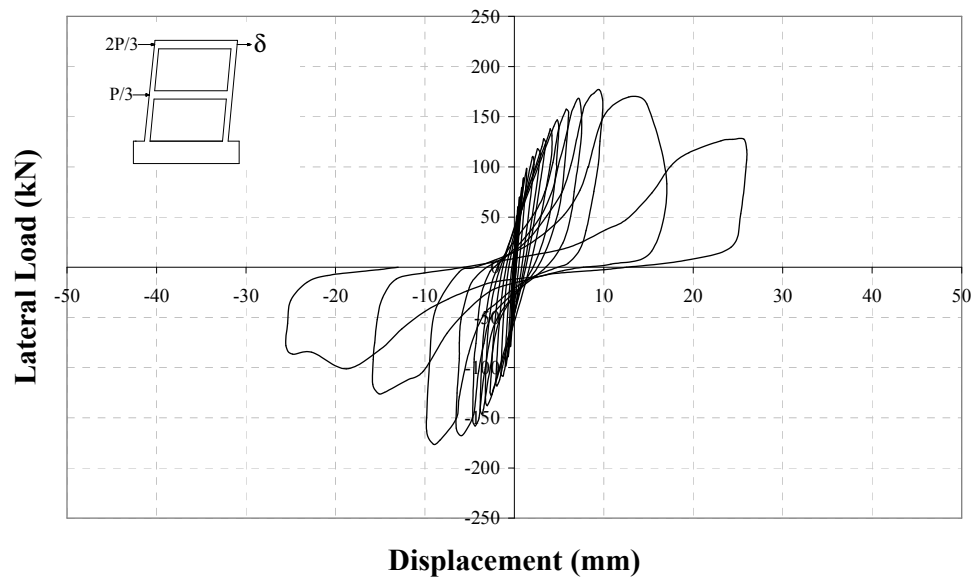
Figure 5.100. Load – second story level displacement curve, Specimen CEE1

The conclusions drawn from the lateral load-displacement curves presented are as follows; the initial stiffness of the specimen was 133.7 kN/mm. At the instant of forward maximum loading, the interstory drift ratios for the first and second stories were calculated as 0.0057 and 0.0053, respectively whereas these values were calculated as 0.0065 and 0.0041 at the instant of backward maximum loading, respectively.

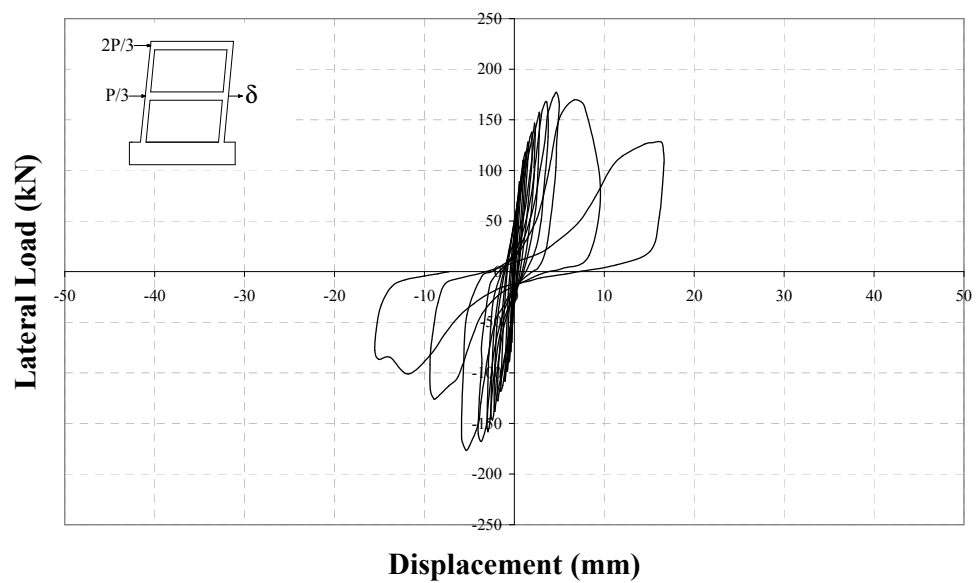
Figure 5.101. Load – first story level displacement curve, Specimen CEE1

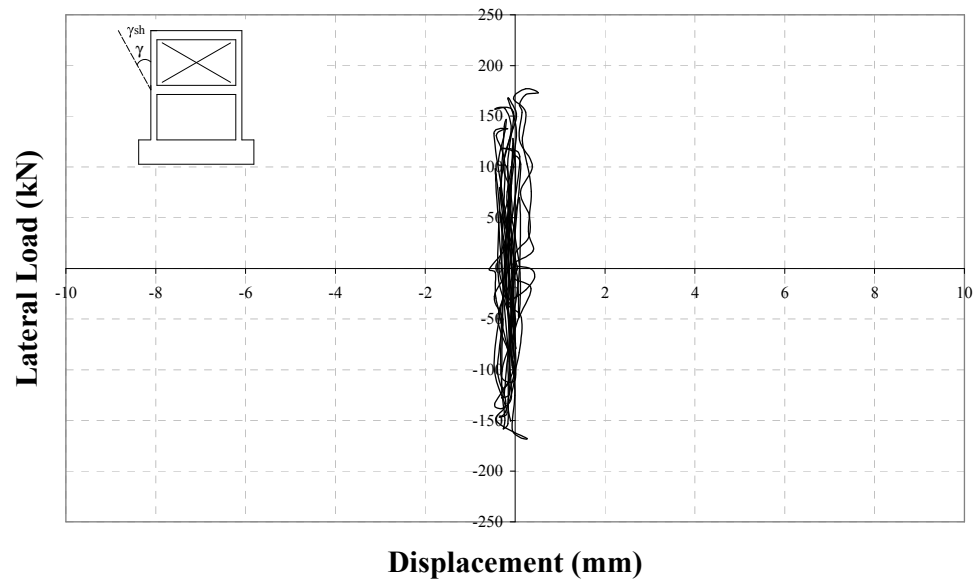
Figure 5.102. Load – second story shear displacement curve, Specimen CEE1

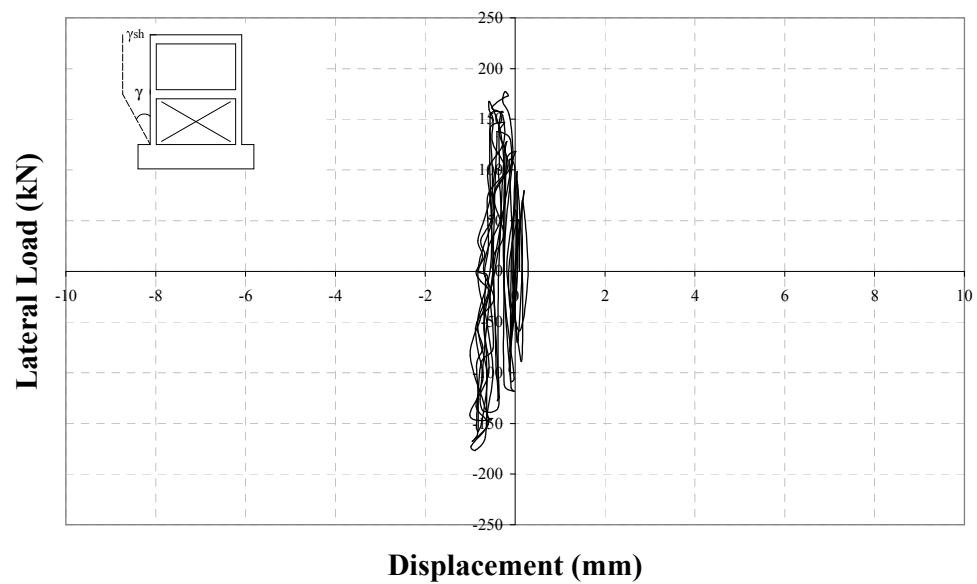
Figure 5.103. Load – first story shear displacement curve, Specimen CEE1

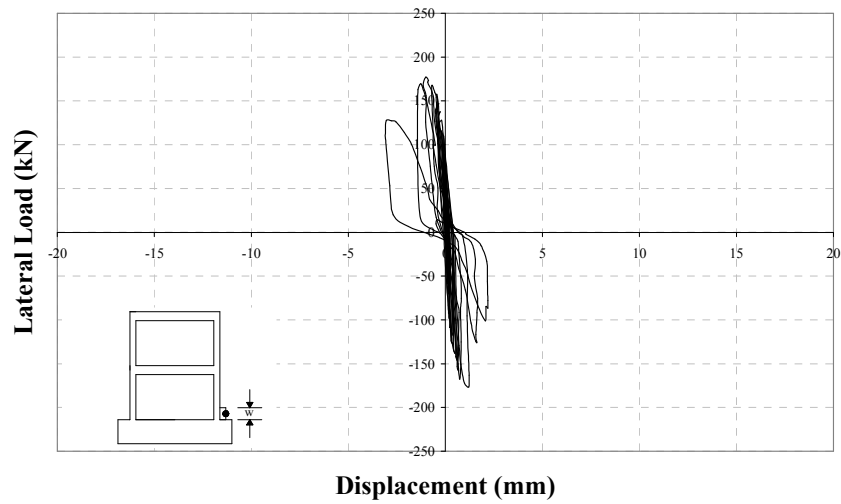
Figure 5.104. Load –north column base vertical displacement, Specimen CEE1

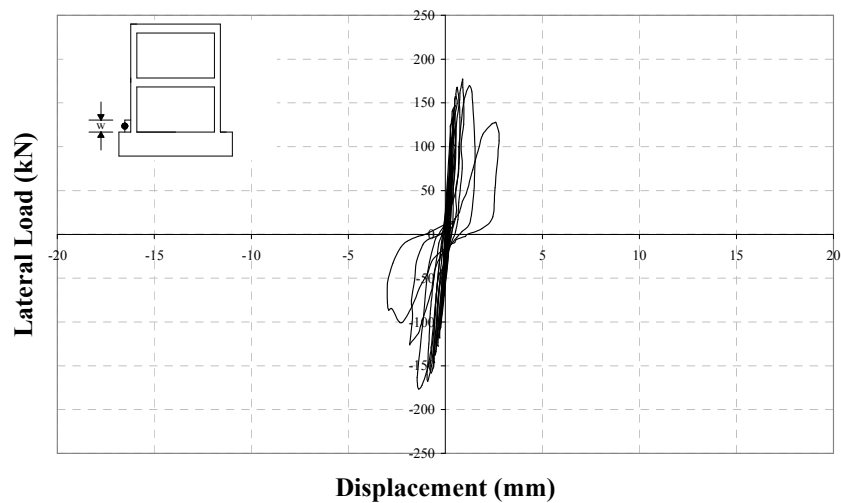
Figure 5.105. Load –south column base vertical displacement, Specimen CEE1

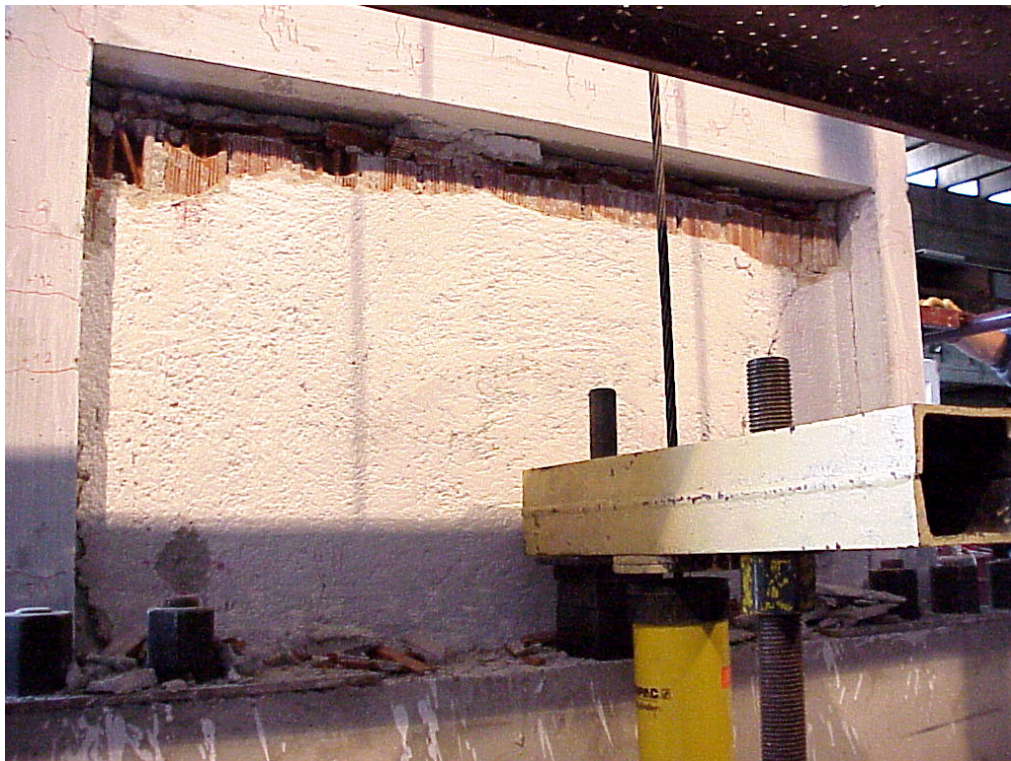
Figure 5.106. The first story infill wall after the test, Specimen CEE1

- In the sixteenth cycle, panels behaved monolithically and as a cantilever beam so that separation at the panel-frame foundation at the north region in the forward loading and at the south region in the backward loading could clearly be observed. In addition, new cracks were observed on the first story panels. Second story level displacements reached 25mm in this cycle.
- Since panels separated from the frame completely, the test was terminated. The photograph of the first story infill wall of Specimen CEE1 and the crack pattern on the panels and after the test is given in Figure 5.106. and Figure 5.107., respectively.

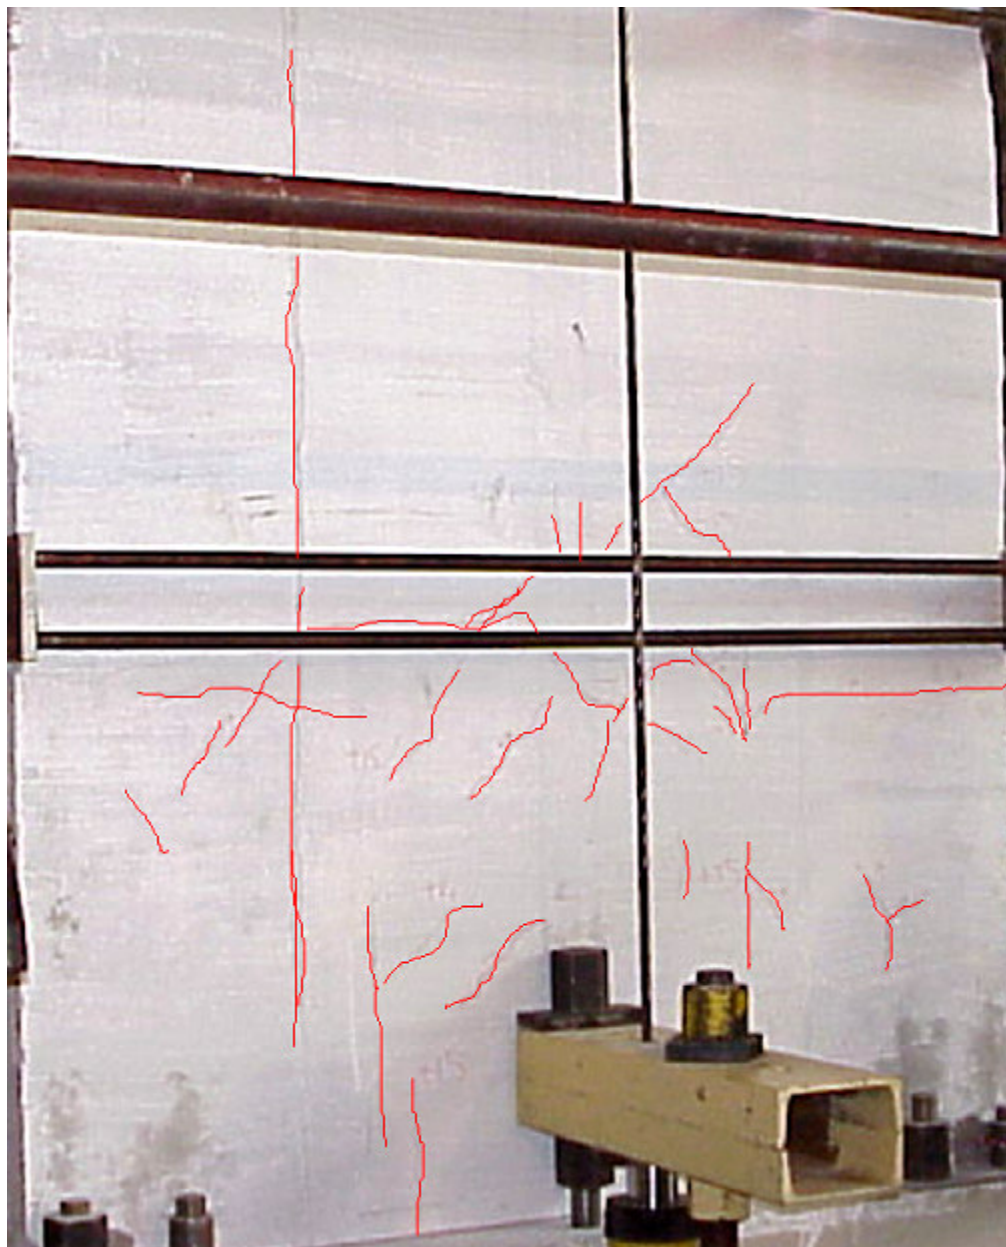
Figure 5.107. The crack pattern on the panels, Specimen CEE1

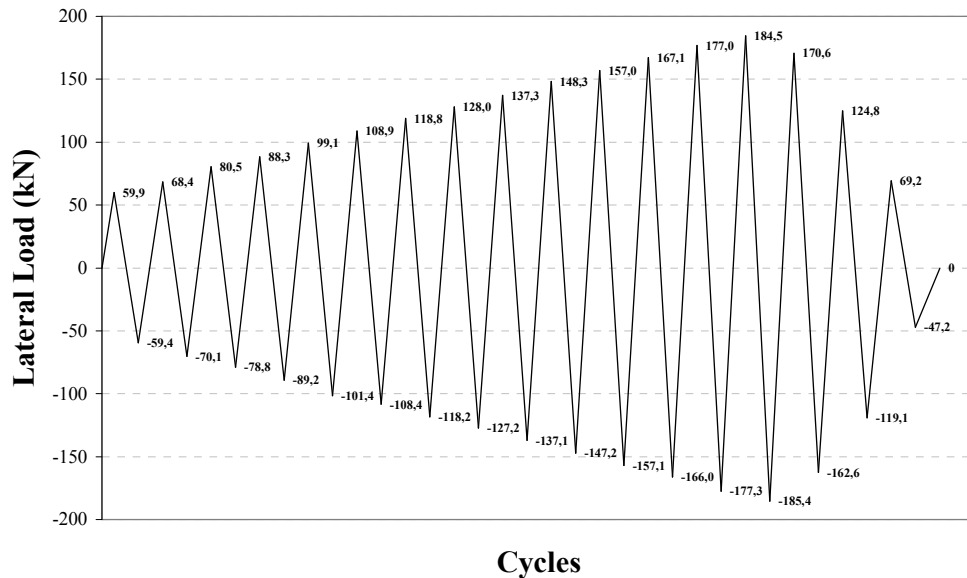
Figure 5.108. Loading History of Specimen CEER

CEER was strengthened by using Type E Panels and subjected to lateral loading history presented in Figure 5.108. Maximum forward and backward loads were 184.5 kN and 185.4 kN, respectively. In Figure 5.109. and Figure 5.110., lateral load-displacement curves are presented for second story and first story, respectively. Lateral load-shear deformation curves are presented for the top story and bottom story infill walls are presented in Figure 5.111. and Figure 5.112. As can be seen from the graphs, the shear displacement in the second story infill wall was smaller than the first story infill wall shear displacement. Lateral load-column base vertical displacements are given in Figure 5.113. and Figure 5.114.

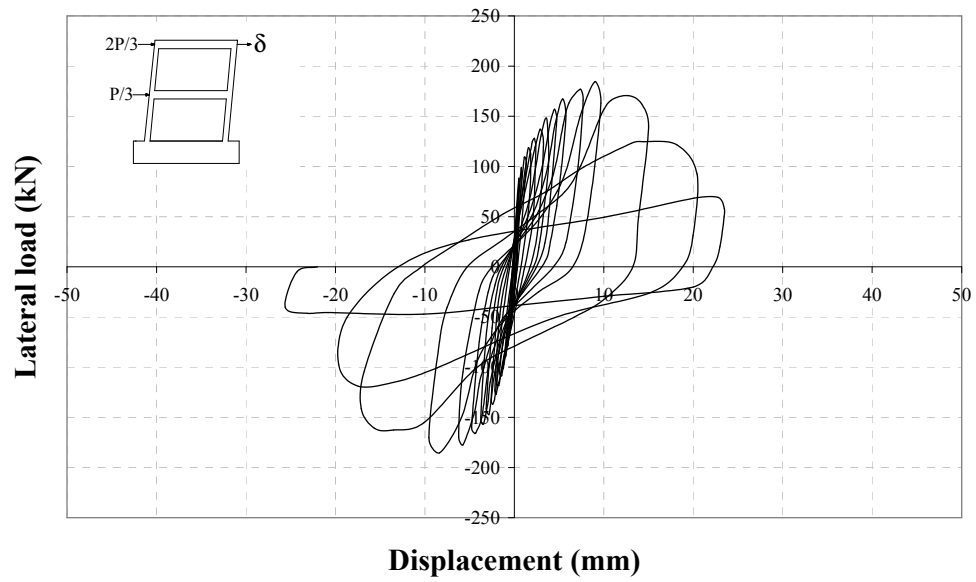
Figure 5.109. Load – second story level displacement curve, Specimen CEER

The conclusions drawn from the lateral load-displacement curves presented are as follows; the initial stiffness of the specimen was 124.7 kN/mm. At the instant of forward maximum loading, the interstory drift ratios for the first and second stories were calculated as 0.0059 and 0.0046, respectively whereas these values were calculated as 0.0063 and 0.0035 at the instant of backward maximum loading, respectively.

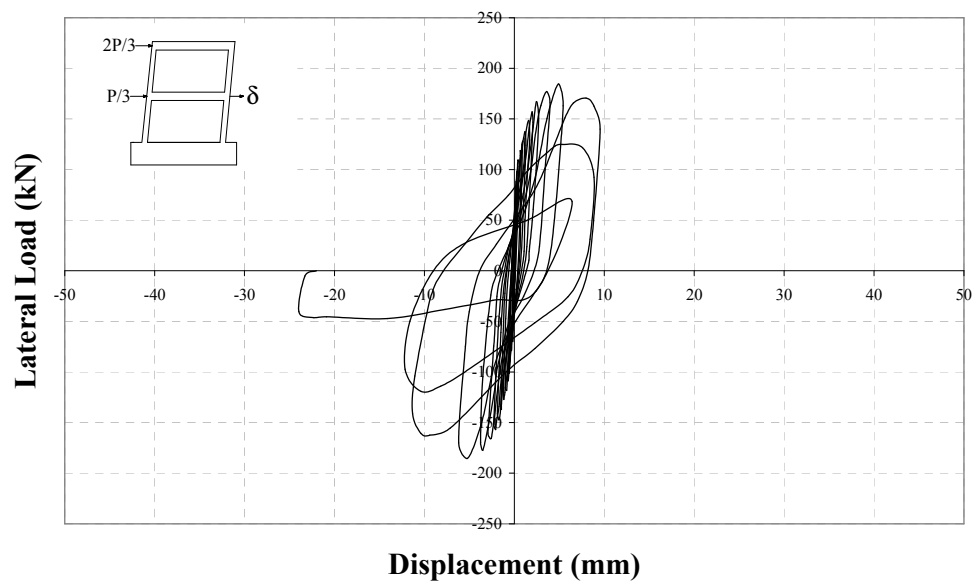
Figure 5.110. Load – first story level displacement curve, Specimen CEER

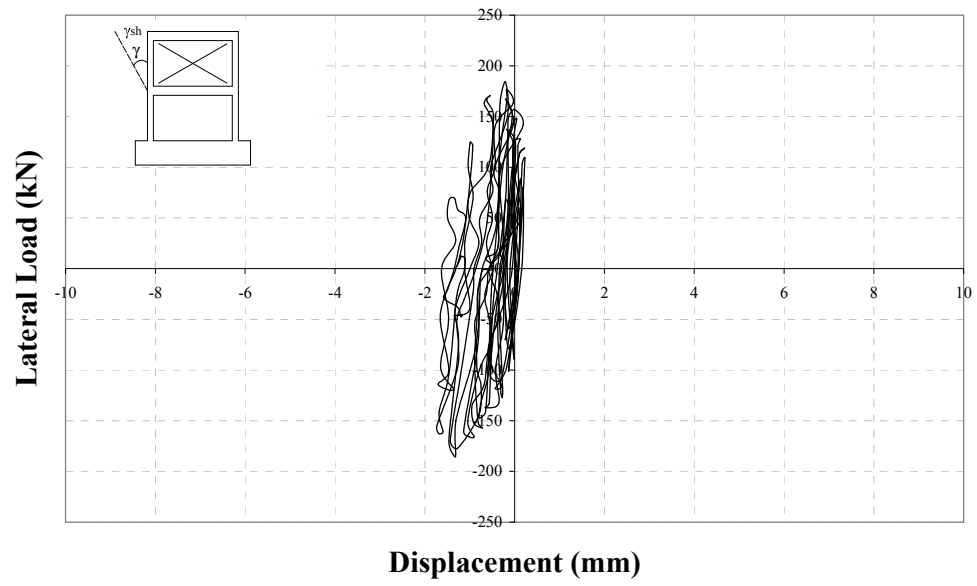
Figure 5.111. Load – second story shear displacement curve, Specimen CEER

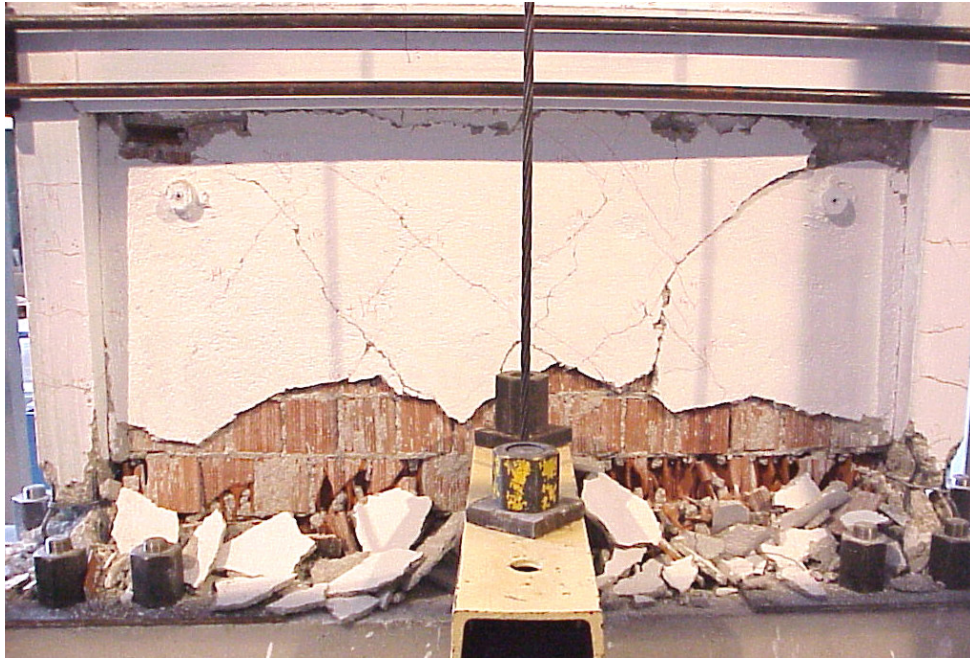
Figure 5.115. First story of Specimen CEER after the test

- In the seventeenth cycle, column longitudinal reinforcements buckled and columns grinded. Therefore, the specimen could not carry any further load and hence, the test was terminated. Photograph of the first story of the specimen and the crack pattern on the panels are given in Figure 5.115. and Figure 5.116.

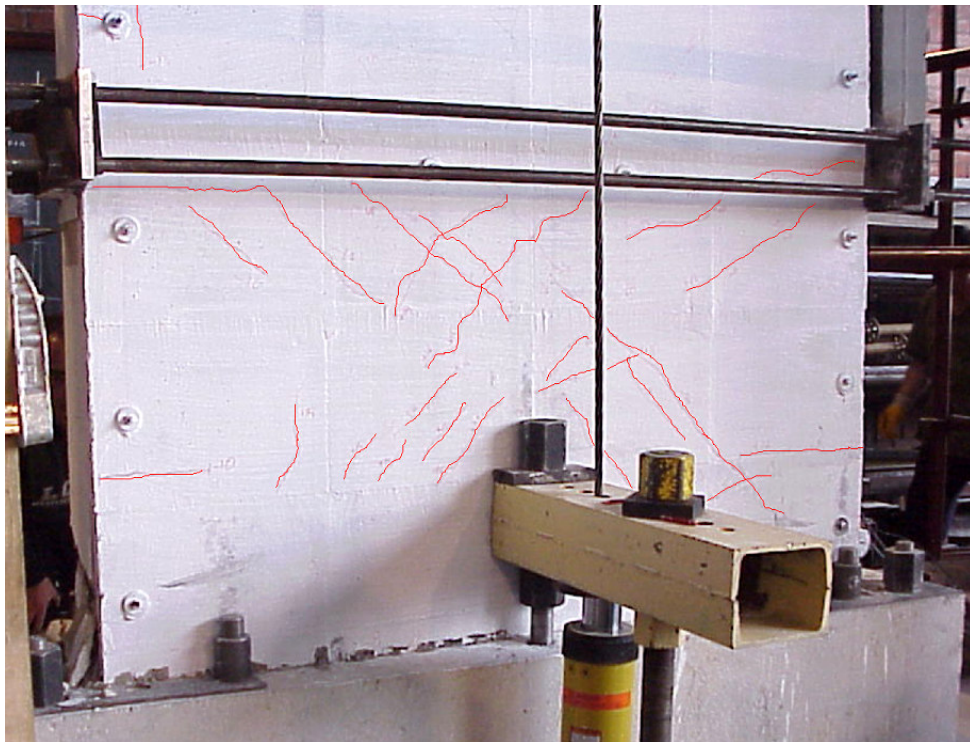
Figure 5.116. The crack pattern on the panels after the test, Specimen CEER
