**PRECAST CONCRETE PANEL REINFORCED INFILL WALLS
FOR SEISMIC STRENGTHENING OF
REINFORCED CONCRETE FRAMED STRUCTURES**

**A THESIS SUBMITTED TO
THE GRADUATE SCHOOL OF NATURAL AND APPLIED SCIENCES
OF
MIDDLE EAST TECHNICAL UNIVERSITY**

**BY
MEHMET BARAN**

**IN PARTIAL FULFILLMENT OF THE REQUIREMENTS
FOR
THE DEGREE OF PHILOSOPHY OF DOCTORATE
IN
CIVIL ENGINEERING**

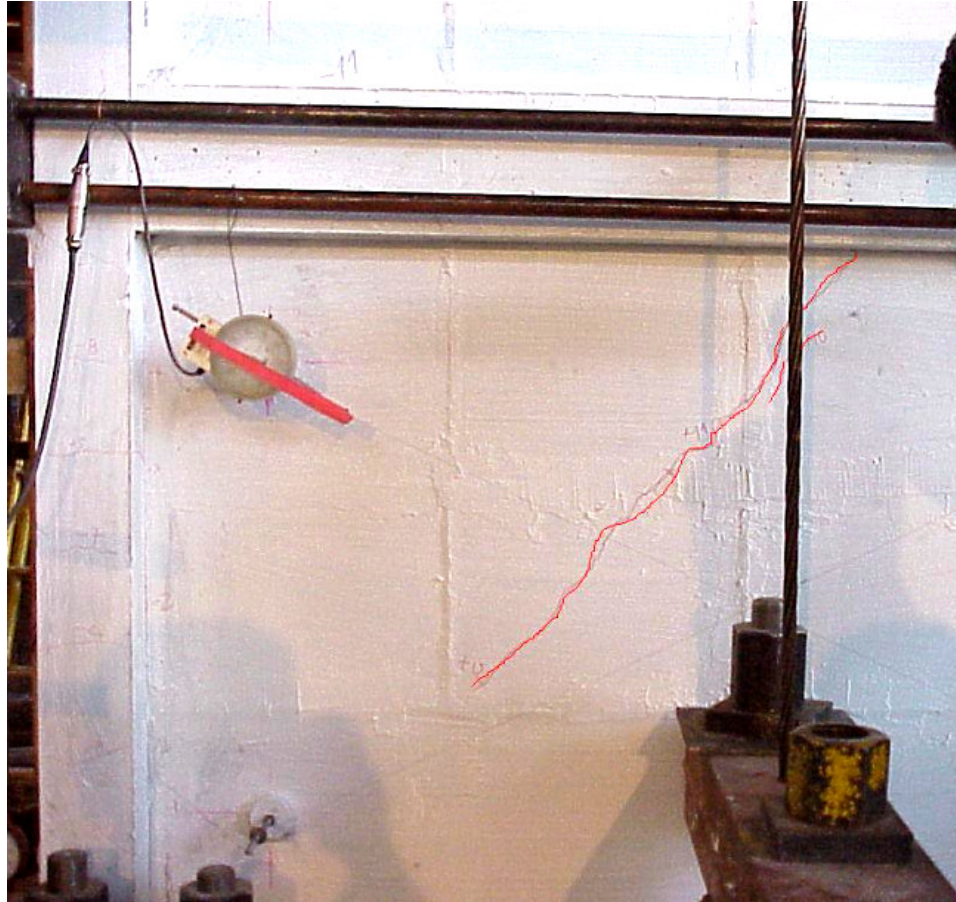
Figure 5.124. Crack in first story panels in the twelfth forward cycle

- In the eleventh forward cycle, second diagonal panel crack was observed near the first.
- In the twelfth forward cycle, crack on the panels extended diagonally towards bottom as shown in Figure 5.124. Two new diagonal cracks were observed at the first story beam level and a diagonal crack was observed in the first story beam-south column joint in the backward cycle. A crack occurred on the south column 600mm above bottom.

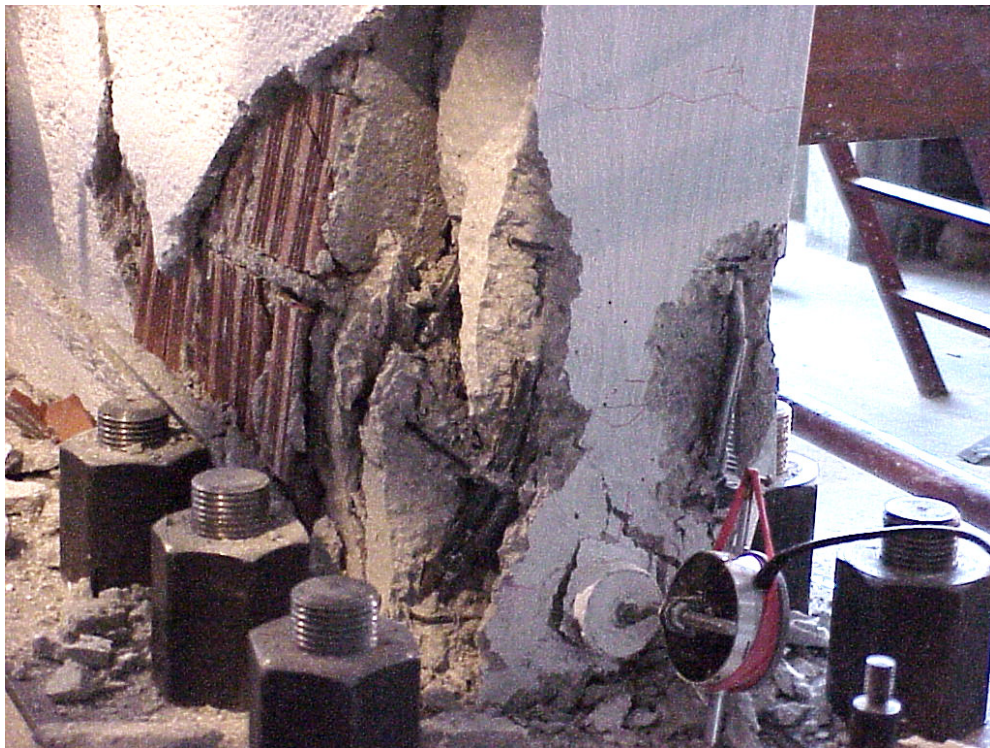
Figure 5.125. South column after the test, Specimen LIC1

- In the fifteenth forward cycle, crushing began at the bottom of the south column and at the corner of the adjacent panel whereas the crack width widened on the north column. Crushing began at the first story beam-south column joint. In addition, diagonal crack on the south column just below this joint widened and reinforcement of the column buckled at this level.
- In the sixteenth forward cycle, longitudinal reinforcement of the south column buckled at the bottom and total axial load level on columns began to decrease. Out of plane deformation was observed in the first story level of the specimen. Hence, the test was terminated. The photograph of the south column after the test is presented in Figure 5.125. The front and rear photographs of Specimen LIC1 after the test are given in Figure 5.126. and Figure 5.127.

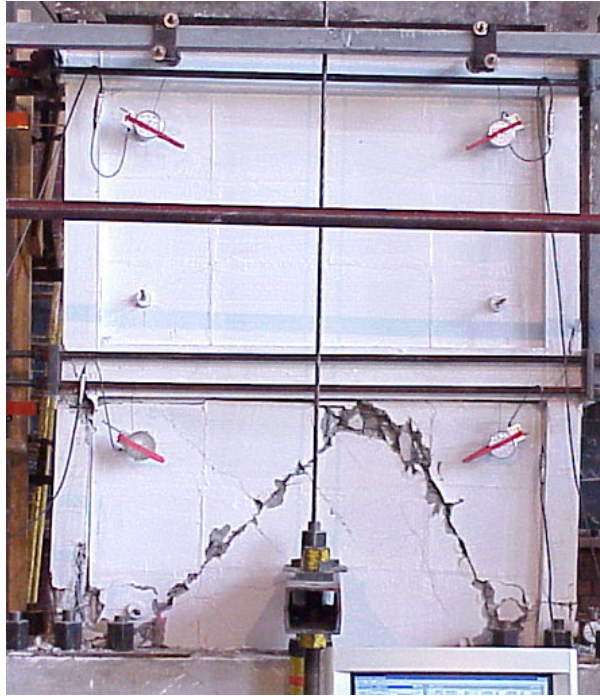
Figure 5.126. The front view after the test, Specimen LIC1

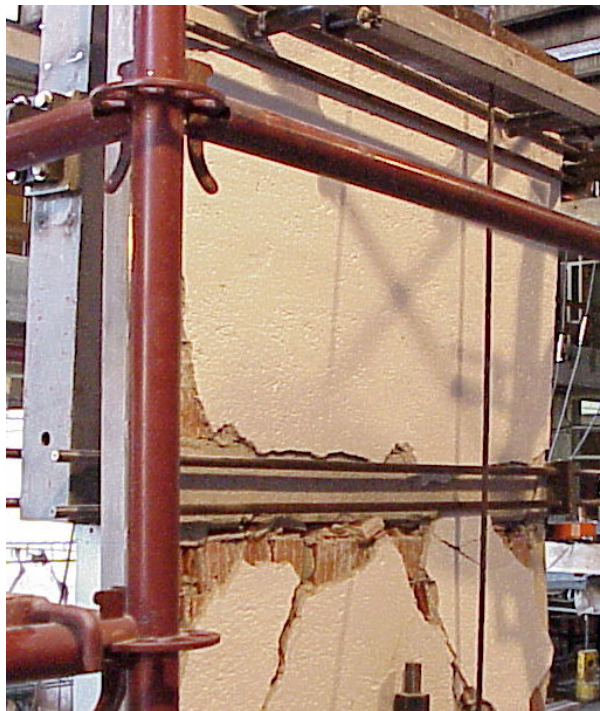
Figure 5.127. The rear view after the test, Specimen LIC1

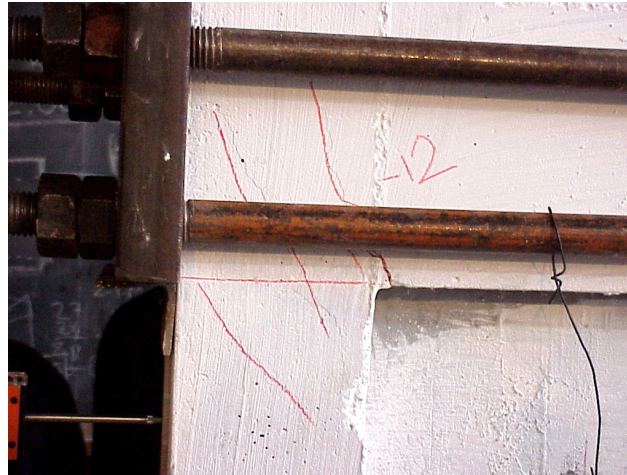
Figure 5.135. First story beam-south column joint in the twelfth forward cycle

- In the twelfth forward cycle, first diagonal crack on the first story panels were observed. In the backward cycle, diagonal cracks were observed at the first story beam-south column joint. In addition, a shear crack was observed just below this joint as shown in Figure 5.135. Maximum forward and backward loads were reached in this cycle. Beginning with the backward cycle, half cycle loadings were controlled by second story level displacement.

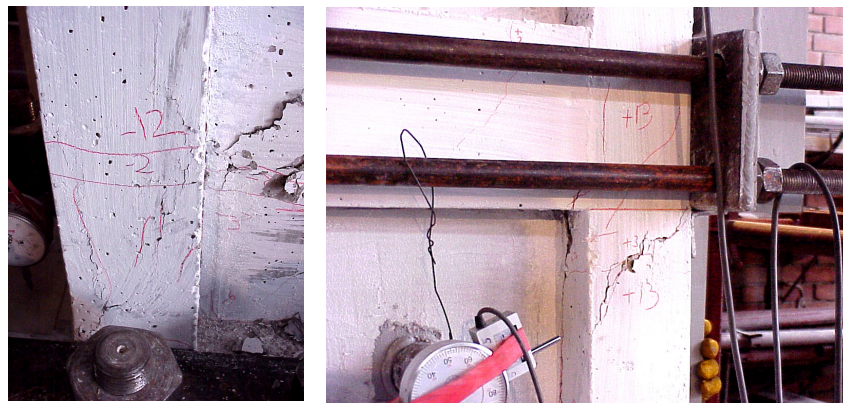
Figure 5.136. Cracks in the thirteenth forward cycle

- In the thirteenth forward cycle, diagonal cracks were observed at the first story beam-north column joint whereas a shear crack appeared just below this joint. Diagonal crack in the first story panel widened and crushing began at the bottom of the south column together with the corner of the bottom panel adjacent to the south column as shown in Figure 5.136. In this cycle, second story level displacements reached 11mm.

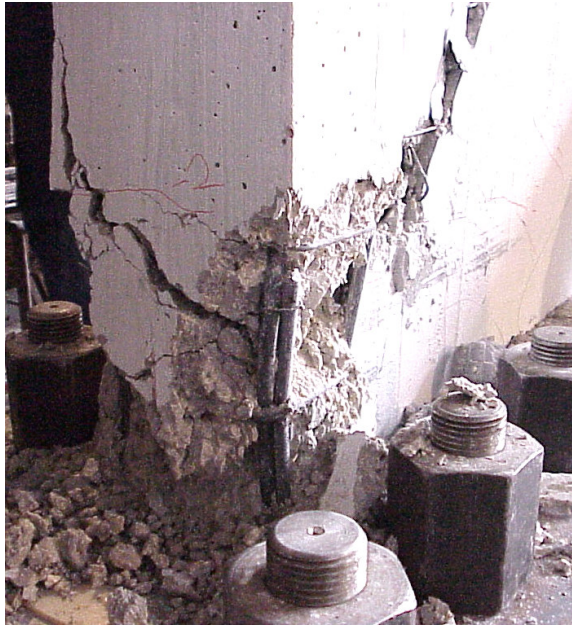
Figure 5.137. South column of Specimen LID1 after the test

- In the fifteenth forward cycle, bottom of the south column crushed and longitudinal reinforcement buckled. Total axial load level on both columns decreased to 100kN and 80kN immediately after. Hence, the test was terminated due to the grinding of the bottom of the south column. The photograph of the south column after the test and the front view of the specimen LID1 were given in Figure 5.137. and Figure 5.138., respectively.

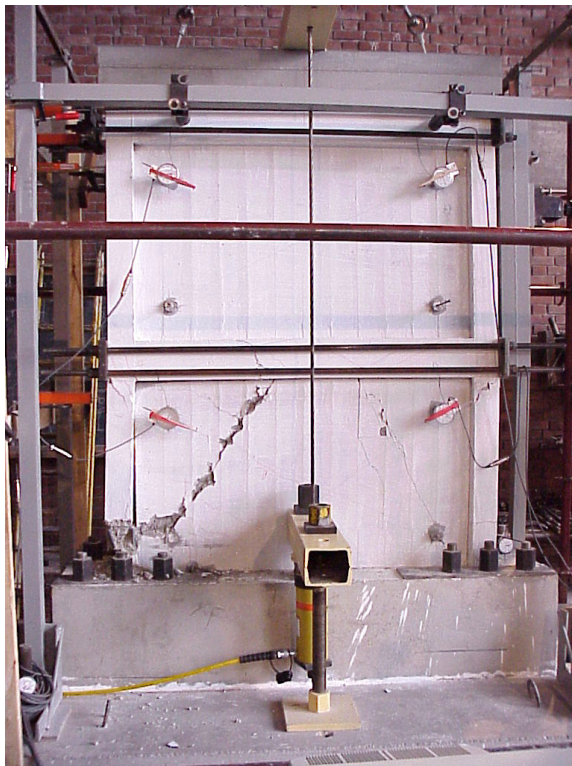
Figure 5.138. The front view after the test, Specimen LID1

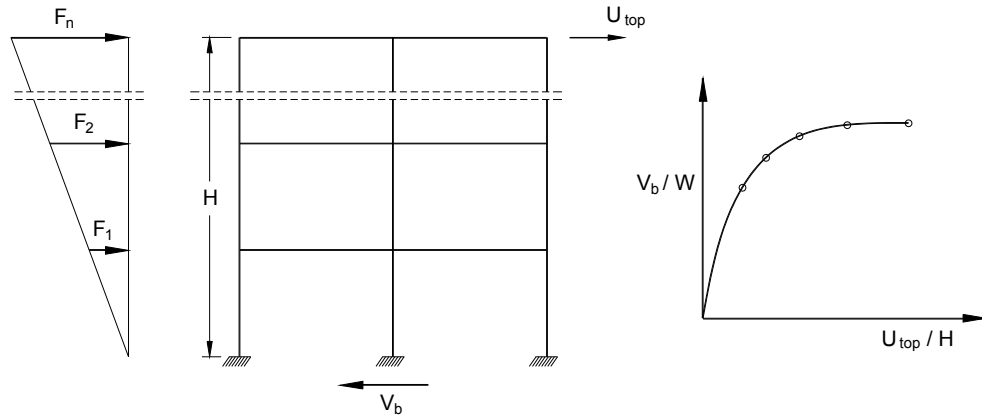
Figure 7.2. Push-over analysis

Push-over analysis is a kind of nonlinear static analysis procedure that is generally used to evaluate the performance of the structures under lateral loads [32]. In the push-over analysis, a load pattern is selected first and applied to the structure in incremental steps. The procedure is illustrated simply in Figure 7.2. For the push-over analysis of the test specimens, inelastic plane frame computer program DRAIN-2Dx was used [49]. Using this computer program, push-over analysis can be made by either force controlled or displacement controlled manner. Displacement controlled type push-over analysis was recommended by Prakash, Powell and Campbell [50] since numerical problems might occur due to reduction of stiffness of the structure in the force controlled loading. In the displacement controlled loading, a lateral displacement pattern is selected and applied to the structure in incremental steps. In each step, member internal forces are calculated and those members with the internal forces exceeding the yield force envelopes are marked as “yielded” and then the stiffness matrix is updated and internal forces are redistributed accordingly. The push-over analysis is completed when the target displacement is exceeded. However, the structure might turn into a mechanism before reaching a target displacement . For this reason, the position and dispersion of the plastic hinges should carefully be observed.

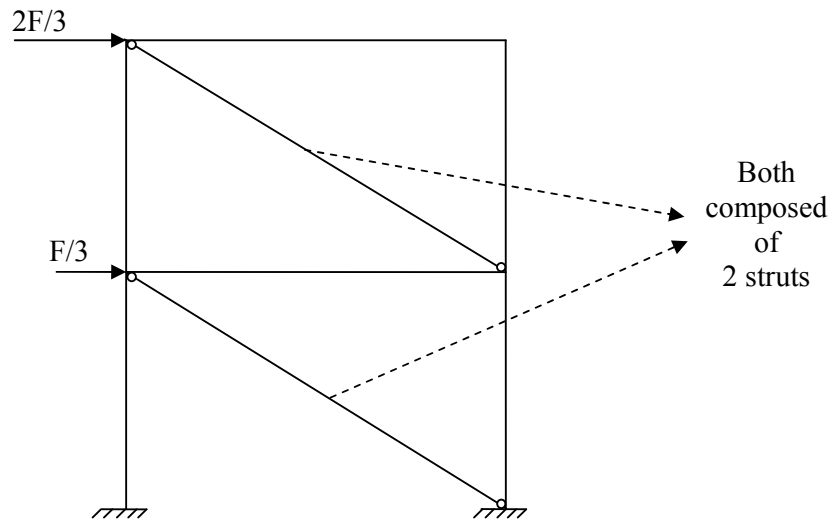
Figure 7.3. Analytical model of the strenghtned test specimens

Following the above-mentioned steps, an analytic model was prepared for the infilled test specimens as presented in Figure 7.3. In the model, hollow brick infill walls strengthened by relatively high strength precast concrete panels were replaced with two equivalent diagonal compressive struts. One of the struts is to model the plastered hollow brick infill wall and the other is to model the whole panel made up of smaller carriable precast concrete panels.

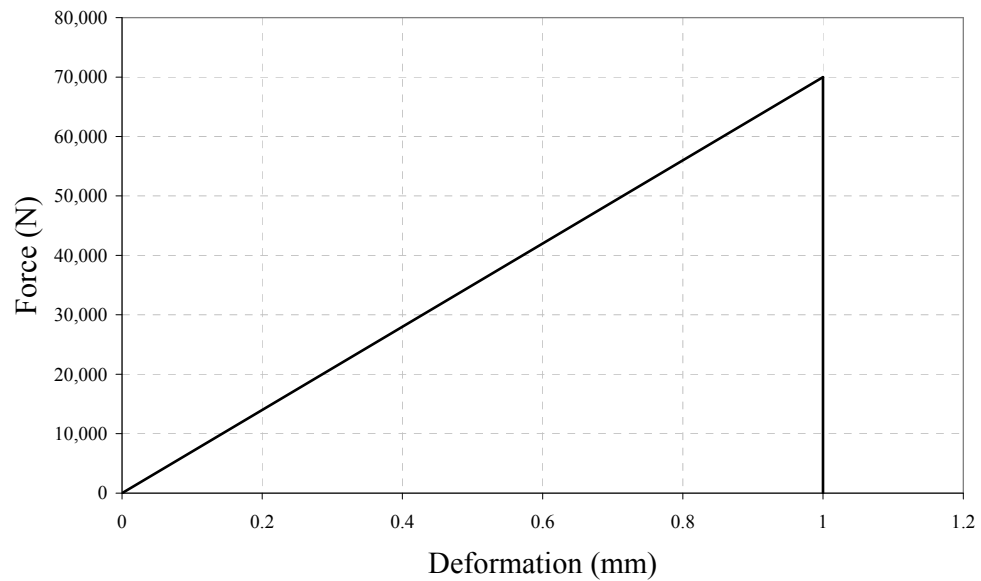
Figure 7.4. Idealized force-deformation diagram of elasto-plastic bar to model the plastered hollow brick infill wall

Equations through 7.4. to 7.7. were used to calculate the equivalent axial stiffness and yielding resistance of elasto-plastic bar in compression to model the plastered hollow brick infill wall for Drain-2Dx. By using these obtained data, force-deformation diagram of elasto-plastic bar to model the plastered hollow brick infill wall to be used in Drain-2Dx can be idealized as shown in Figure 7.4.

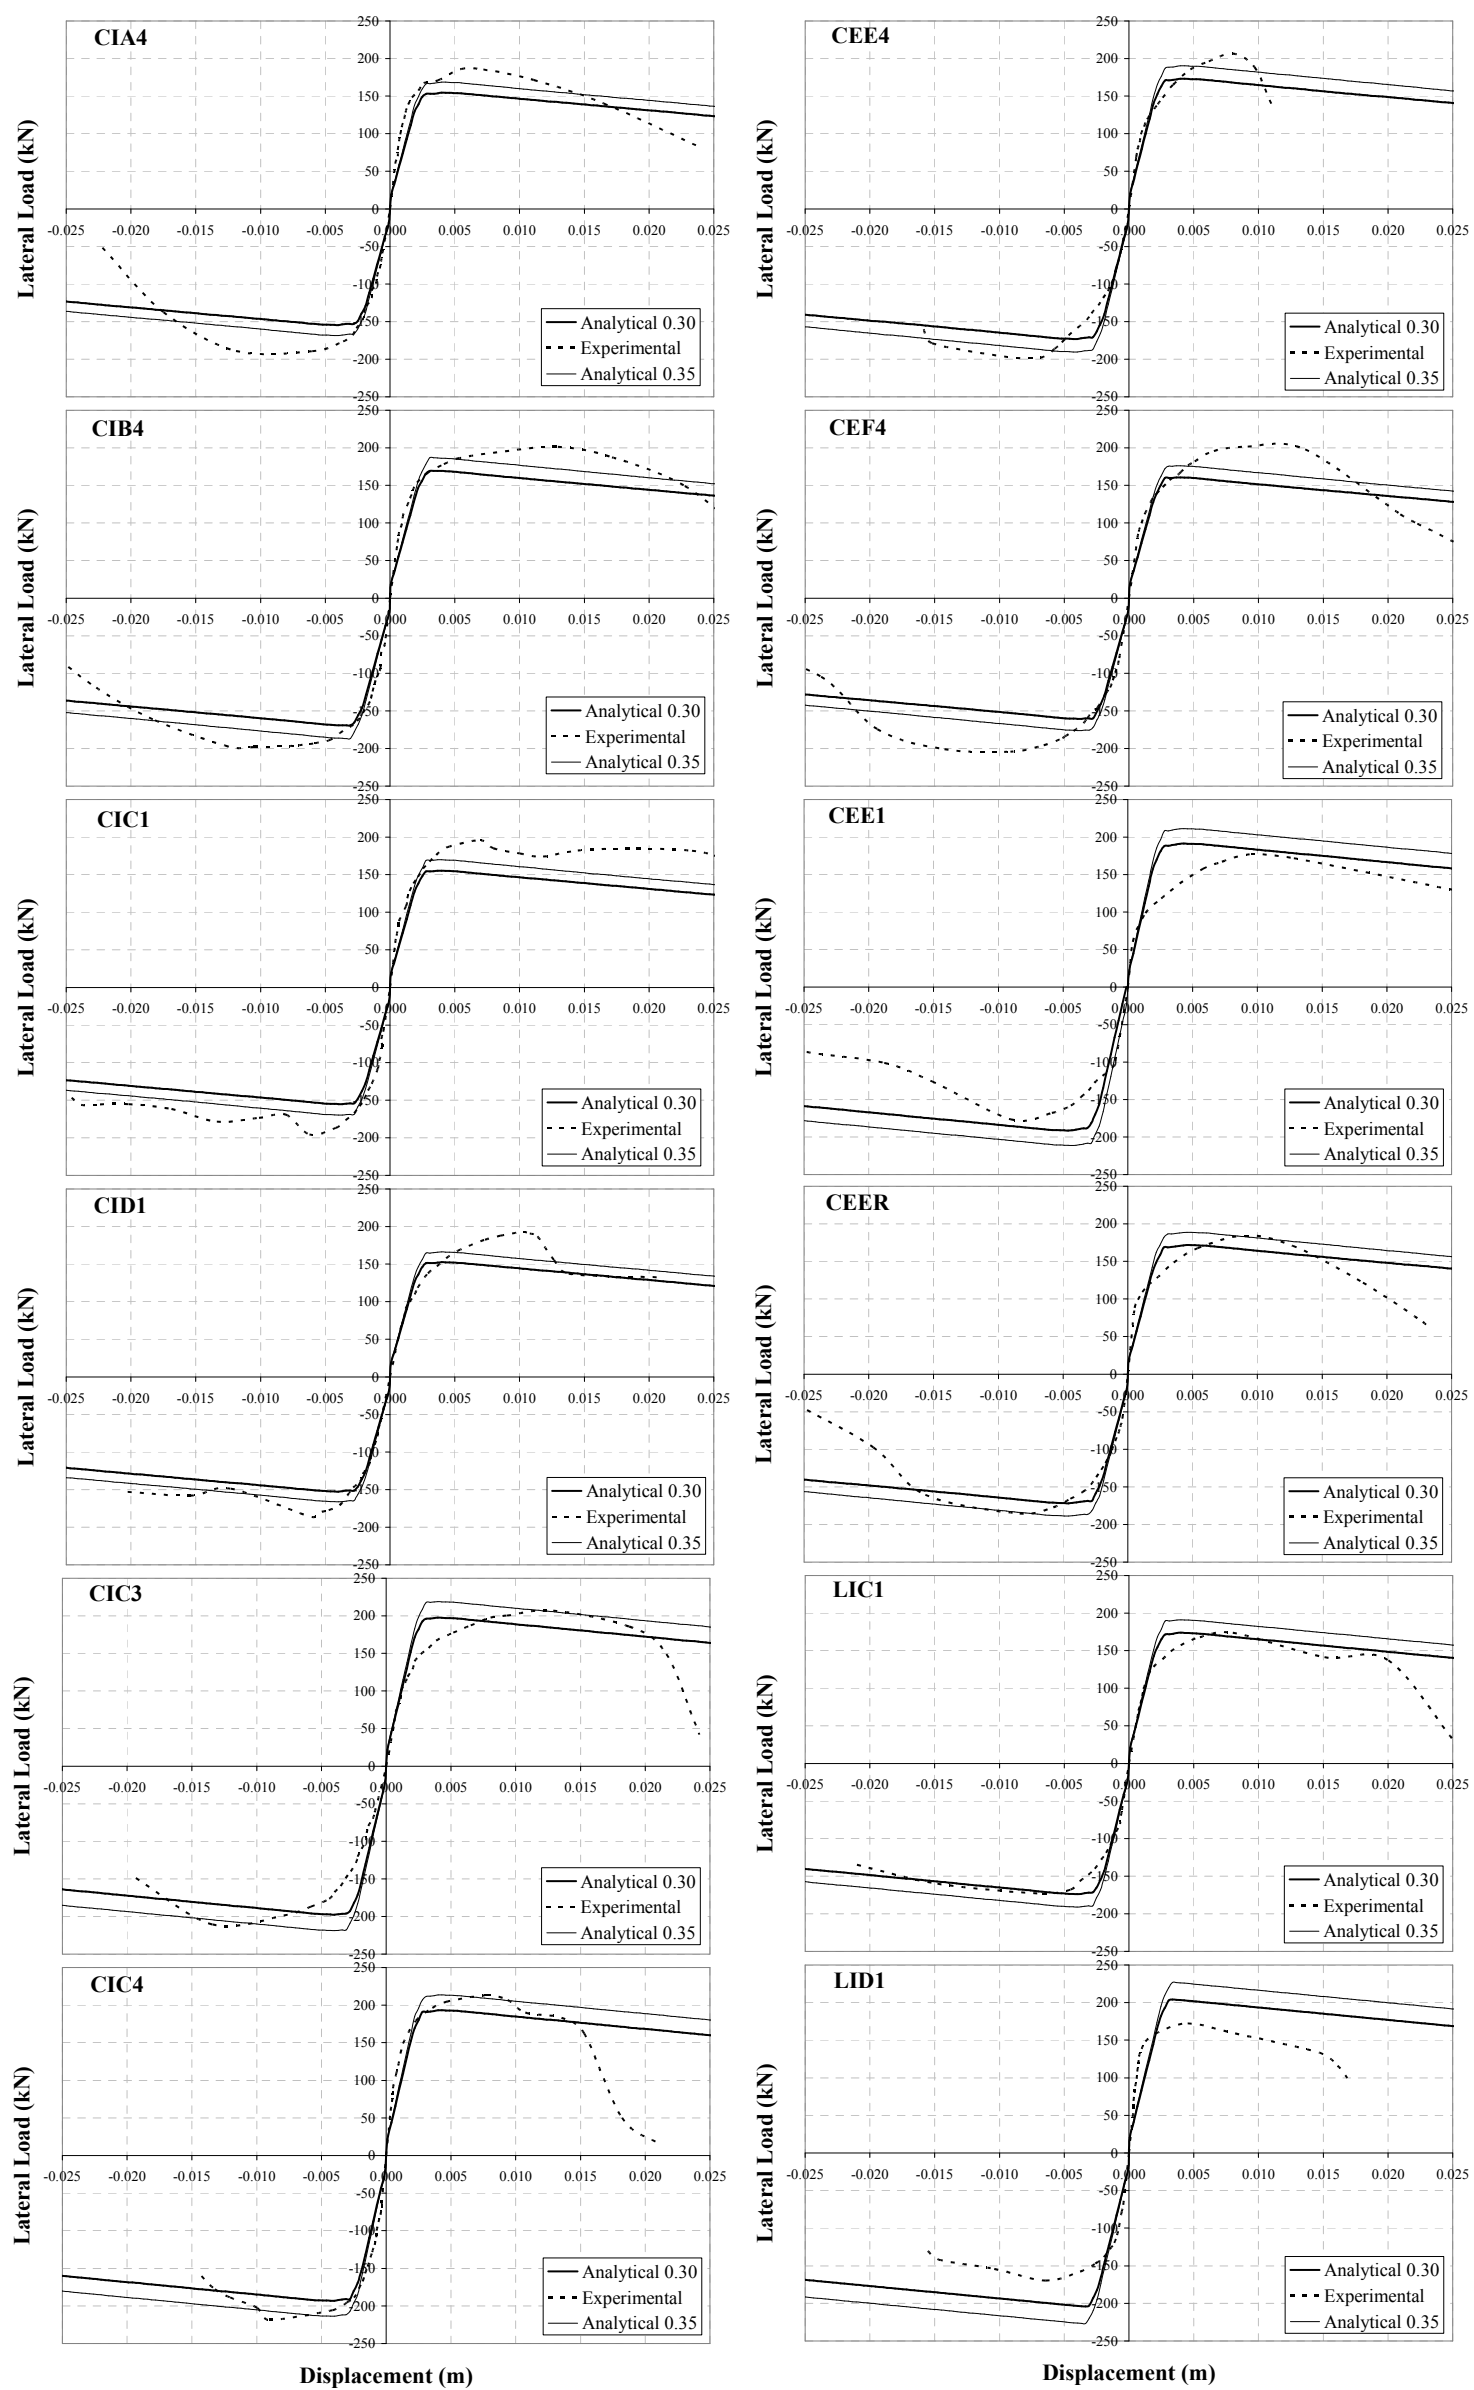
Figure 7.8. Response envelope and push-over curves of the strengthened specimens for two different values of λ_λ

According to the results presented in Figure 7.8., compression strut method estimates the initial stiffnesses satisfactorily, except from Specimen LID1. In addition, the designer would be on the safe side by using a constant value of 0.35 for λ_λ when lateral load carrying capacities of the specimens are concerned.

By using Drain-2Dx, nonlinear push-over analysis (displacement controlled type) was conducted for each strengthened specimen for different values of λ_λ . Next, push-over curves were plotted together with the experimental response envelope curves to best fit the analytical and experimental curves. The characteristic values for the diagonal strut to model the whole panel and the values of λ_λ in best-fitting experimental and analytical curves are presented in Table 7.2. The interaction diagram for the beams and columns of the specimens defined for the program [55] are presented in Figure 7.5. and Figure 7.6. Best-fit push-over curves of the strengthened specimens for different values of λ_λ are presented in Figure 7.7. In drawing analytical curves in Figure 7.7., hollow brick infill walls strengthened by precast concrete panels were modelled as two equivalent diagonal compression struts. Push over curves for two different values of λ_λ (0.30 and 0.35) are presented in Figure 7.8.

When push-over curves presented in Figure 7.8. and λ_λ values presented in Table 7.2. are analysed, it can be concluded that a value of 0.35 can practically and safely be used for λ_λ . Since lateral load carrying capacity of the equivalent compression strut was formulized to be composed of two struts, then, it can be written as

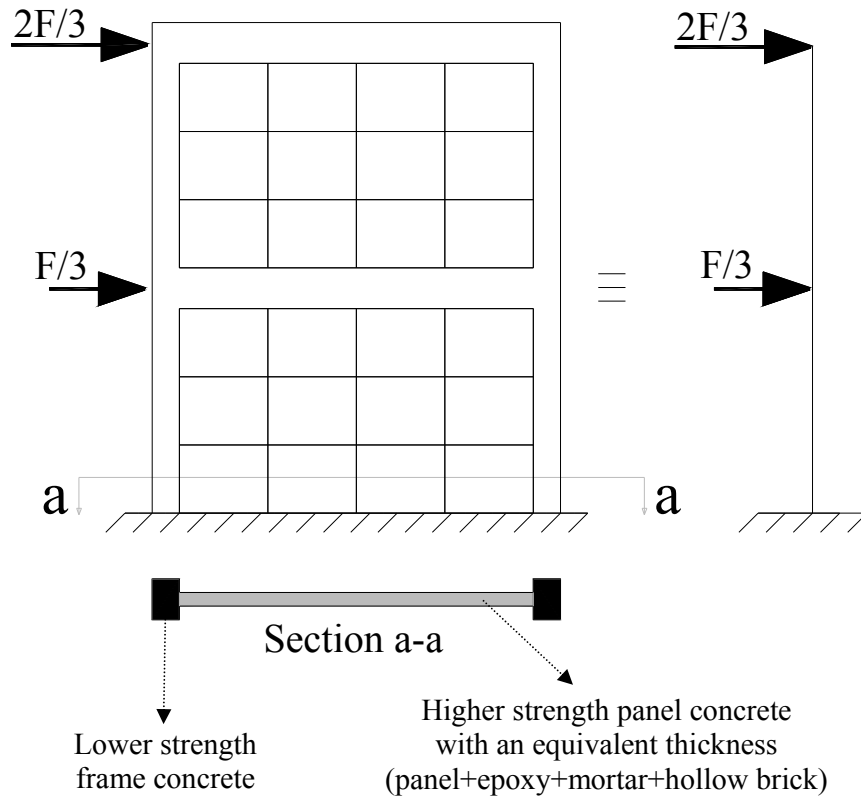
Figure 7.9. Equivalent column model of the strengthened test specimens

In this part of the study, an alternative analytical model was developed besides the equivalent diagonal compression strut. The strengthened infilled frame bays were modelled as equivalent columns. Since the equivalent column model of such structural members are widely used by the designers, it might be beneficial to compare the results of the equivalent compression strut model with the equivalent column model. The description of the equivalent column model is simply presented in Figure 7.9. In the model, the whole strengthened frame section is defined as a single column. An equivalent thickness was taken into account instead of the thickness of the whole panel reinforced hollow brick infill wall for each strengthened specimen to form the interaction curves [55]. For interaction curves, the equivalent thickness was calculated by using Young's Modulus of each layer.

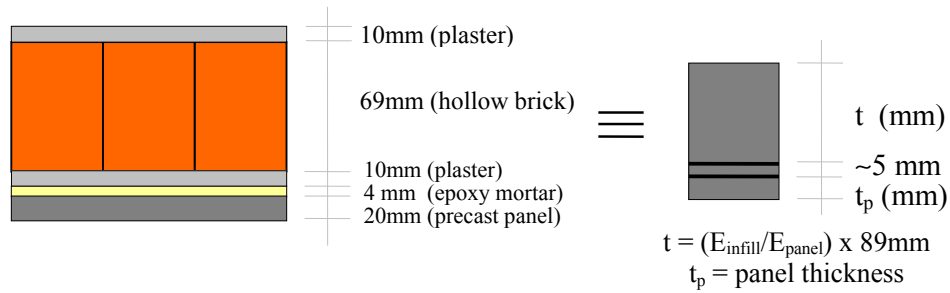
Figure 7.10. Calculation of the equivalent thickness

Calculation of the equivalent thickness of the panel reinforced hollow brick infill is simply shown in Figure 7.10. In the calculations, modulus of elasticity of the plastered hollow brick infill was taken as 7,500 MPa and modulus of the elasticities of the frame and panel concrete were calculated according to the equation 7.8. [54] given before. Data for equivalent thickness calculation to be used in RESPONSE 2000 is tabulated in Table 7.3.

It should be noted here that an adjustment was needed for the exterior type panels in the cases where the panels were not effectively connected to the frame members. The thickness of the precast concrete panels were decreased in calculating the effective thickness in case of exterior type panels if the connection was questionable. In this analytical study, the thickness of the precast concrete panels were taken as 20mm for Specimens CEE4 and CEF4 since an effective connection between panels and frames were established by using adequate number of $\phi 8$ bolts and hence, an effective compression on panels can be established. It was decided to take the panel thickness as 10mm for Specimen CEE1 by using engineering judgement. This was due to the fact that no $\phi 8$ bolts were used in case of Specimen CEE1 to connect the panels to the frame. In case of interior type panels, full thicknesses of the panels can be taken into consideration since the precast concrete panel layer is confined all around by the frame members resulting with an effective compression on the panels.

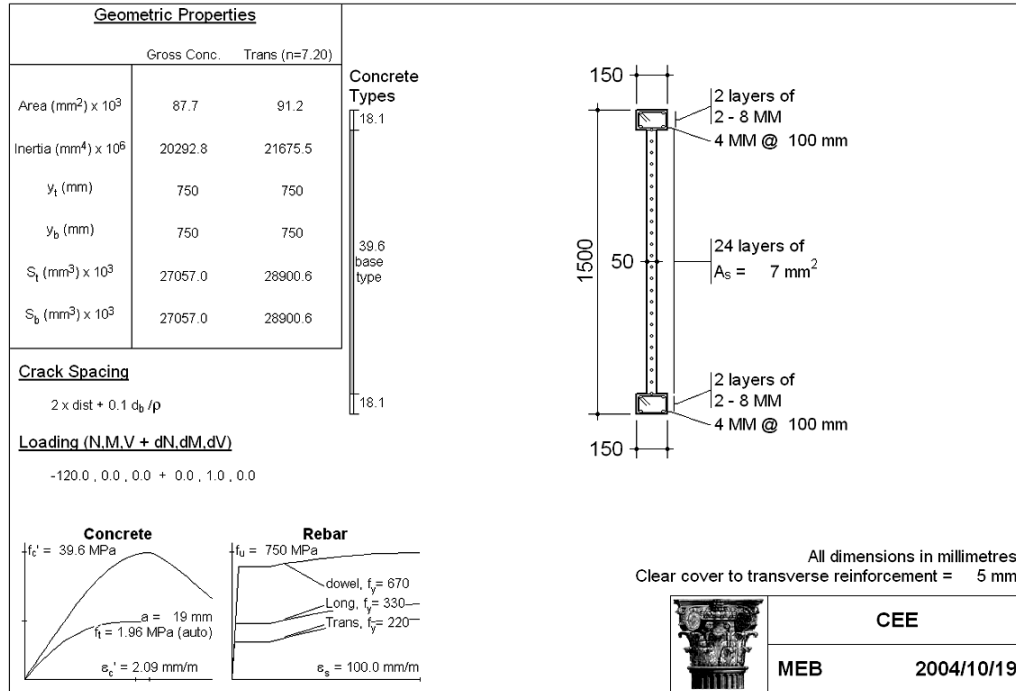
Figure 7.11. Equivalent column analysis by RESPONSE 2000

By using the computer program RESPONSE 2000 [55], the interaction curves, defined for the analysis program Drain-2Dx, were formed. An example of an equivalent column analysis by RESPONSE 2000 [55] program to form the interaction curve of the section is presented in Figure 7.11. As it can be seen in Figure 7.11., the mesh steel used for panel reinforcement was taken into account in the equivalent column analysis. The interaction curves defined are presented in Figure 7.12.

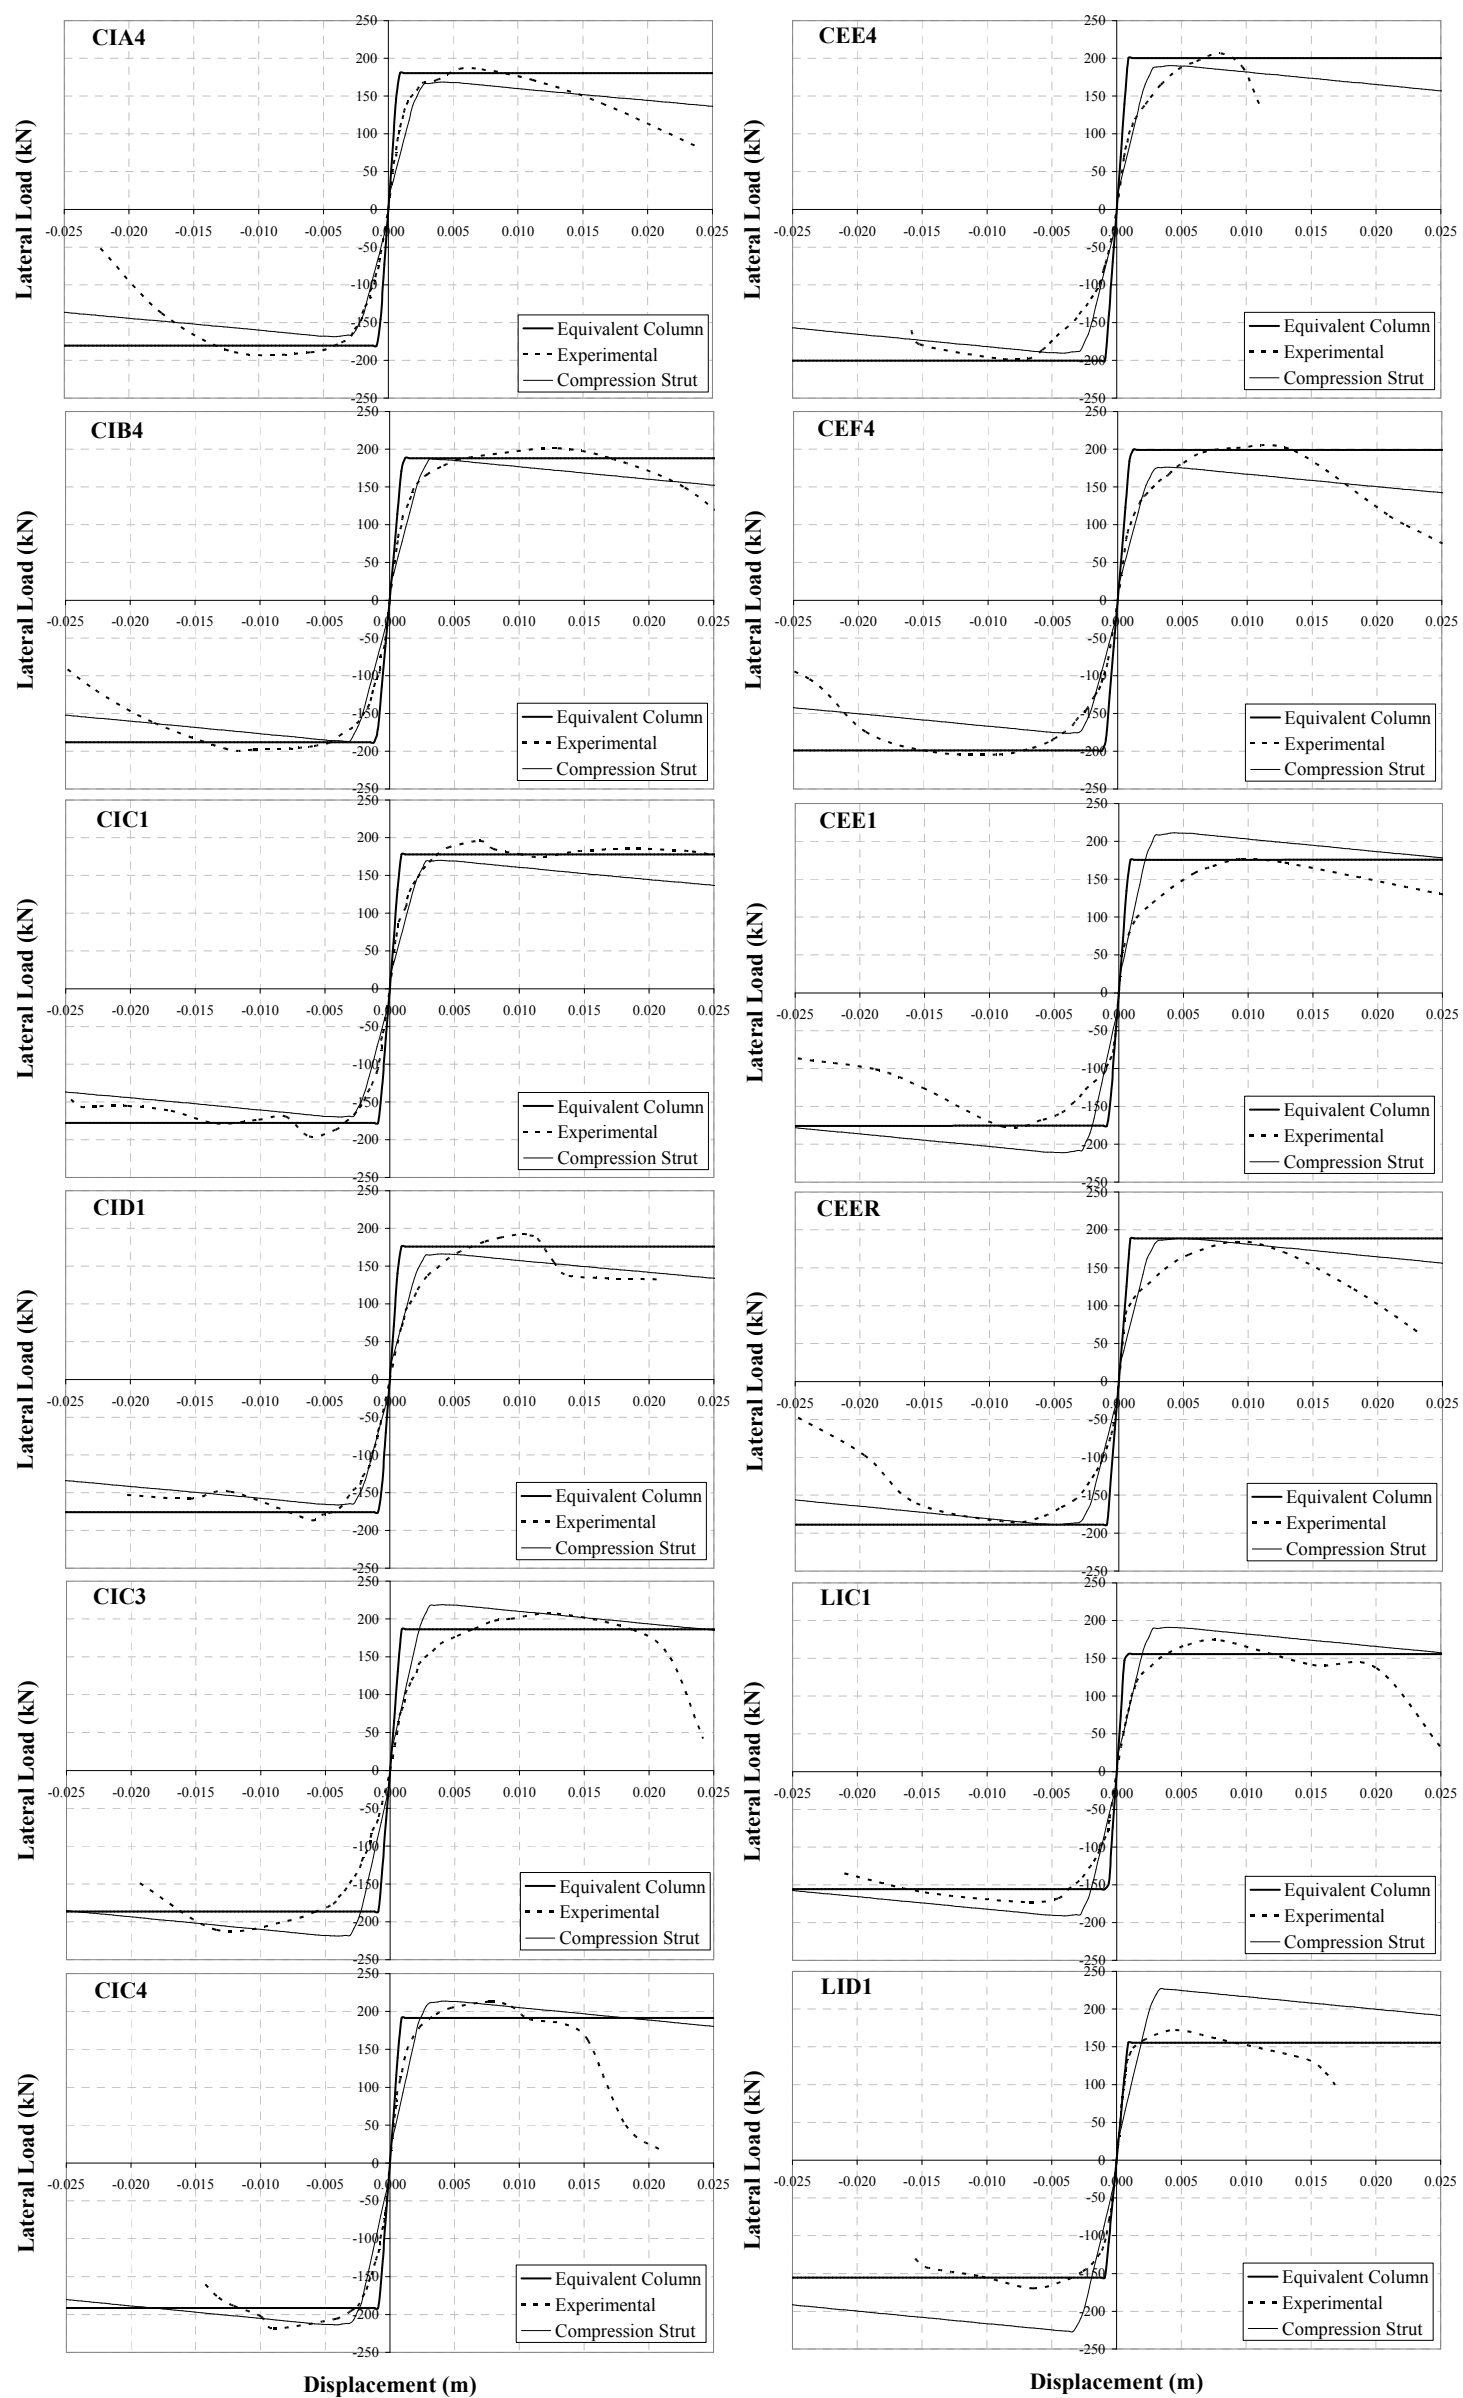
Figure 7.13. Push-over curves of the equivalent strut model and equivalent column model of the strengthened specimens

As it can be seen in Figure 7.13., the equivalent column method overestimates the initial stiffnesses of the specimens as compared to the compression strut method although the Young's modulus was decreased. However, it is more successful in estimating the ultimate load capacities of the specimens. As expected, equivalent column method does not satisfactorily simulate the post-peak portion (descending portion) of the push-over curves. Except Specimens LIC1 and LID1, compression strut method underestimates the ultimate load capacities of the specimens having panel compressive strength less than 40 MPa since load capacity of a compression strut is highly influenced by the panel compressive strength in this method. However, it should be noted that the panel compressive strength is not the only parameter on the ultimate load estimation in this method. In addition, compression strut is more successful in simulating the post-peak portion (descending portion) of the push-over curves. Unfortunately, the decrease in the stiffness due to the reversed cyclic lateral loading could not be well simulated by both methods and the reason for this was that Drain-2Dx could not consider the stiffness degradation due to the reversed cyclic lateral loading.

For Drain-2Dx, the Young's Modulus of the each infilled wall section was decreased by using a factor of 0.70, in order to consider the cracks in the early cycles. Also, reduced yield stresses for longitudinal bars, as calculated by equations 7.3., for Specimens LIC1 and LID1 were used in Drain-2Dx. Push-over curves of the equivalent compression strut model ($\lambda_\lambda=0.35$) and equivalent column model are presented together with response envelope curves of the strengthened specimens in Figure 7.13.

Both methods, the equivalent compression strut method and equivalent column method adequately simulates the behaviour of the test specimens and could be used in the quick determination of the lateral load carrying capacities of the frames strengthened with precast concrete panels. Push-over analyses of the frames with both methods give safe and sound results provided that the precast concrete panels would have a concrete compressive strength not less than 40 MPa, panels would effectively be connected to the frame members in case of exterior type panels, and a constant value of 0.35 is used for λ_λ . Besides, both equivalent diagonal compression struts and equivalent column can easily be added to the existing frame model of the buildings and considerable amount of time and work might be saved by the use of these methods which enable the quick determination of the ultimate load carrying capacities of the frames strengthened with precast concrete panels.

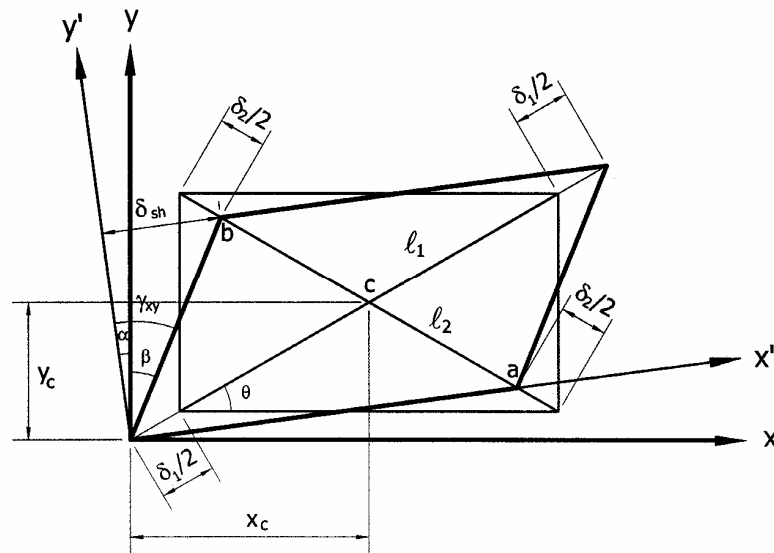
Figure A.1 Rectangular shape distortion

In this appendix, the computation of shear displacement is presented. Shear deformations on the panels were measured by means of diagonally placed dial gauges. Since two displacement readings were taken along the diagonals, it is possible to determine the deformed shape of the wall panel. Approximate deformed shape of the panel is presented in A.1

According to the geometry shown above, shear deformations can be computed approximately as follows:
