PLACE – IDENTITY – CHANGE IN ANKARA UNIVERSITY CEBECİ CAMPUS  
AS AN ISSUE OF MODERN HERITAGE CONSERVATION

A THESIS SUBMITTED TO  
THE GRADUATE SCHOOL OF NATURAL AND APPLIED SCIENCES  
OF  
MIDDLE EAST TECHNICAL UNIVERSITY

FEBRUARY 2018

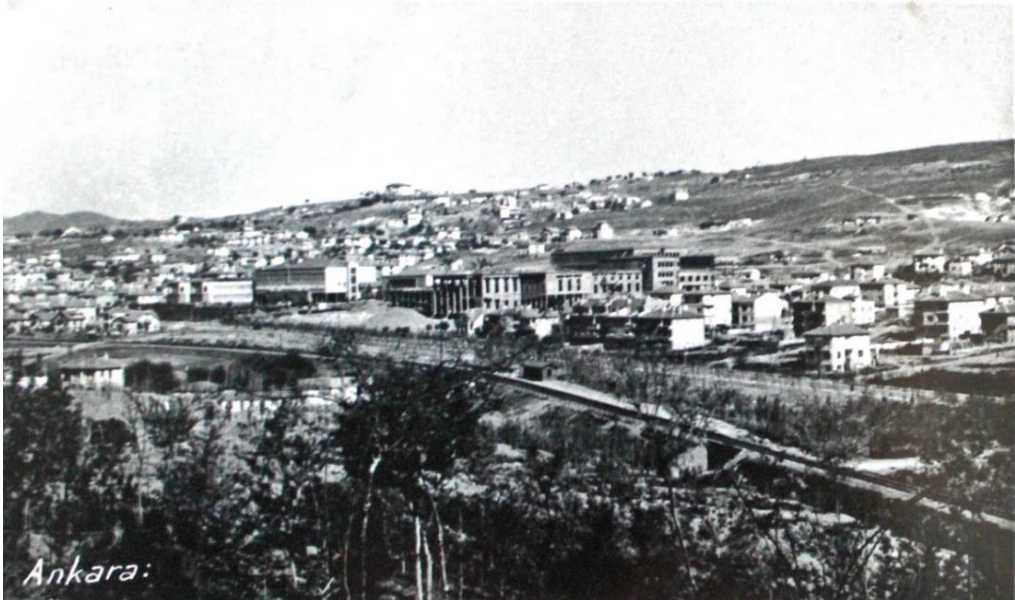
Figure 12. View of Ziya Gökalp Street dated 1938. It is possible to see that the construction of *Mülkiye* was completed but *Hukuk Fakültesi* was still in the construction process (CANGIR, 2008).

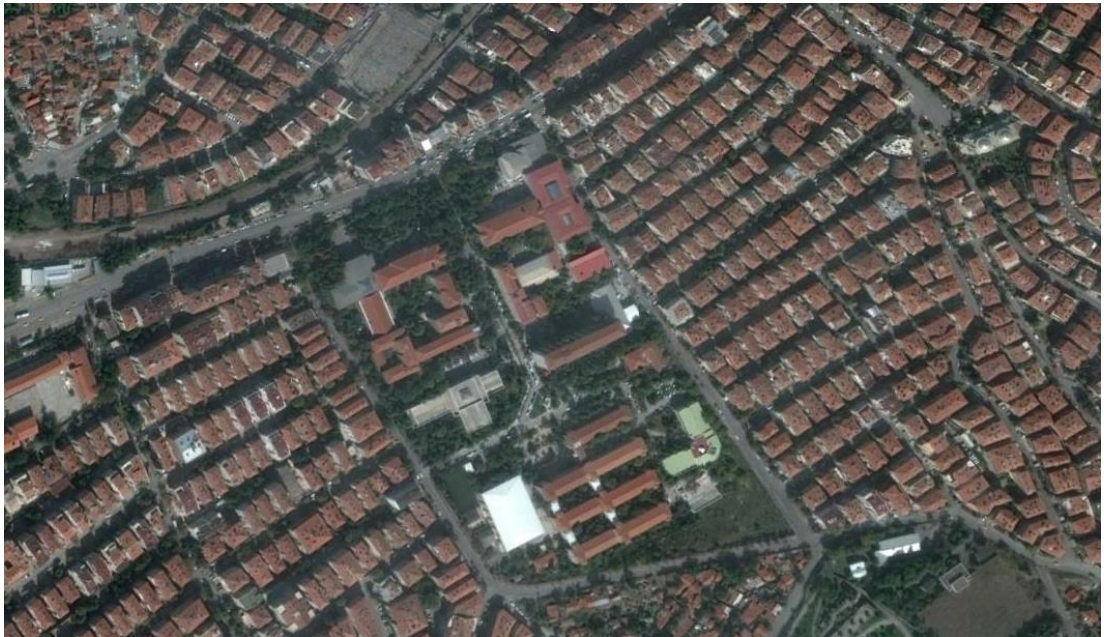
Figure 25. Google Earth view showing the existing situation of Ankara University Cebeci Campus

Ankara University Cebeci Campus is located in the neighborhood named Fakülteler in Cebeci District of Çankaya county; and surrounded by Cemal Gürsel Street on the north, Yeni Acun Street on the east and Erdem Street on the west and south (Figure 25). After the Campus gained its physical unity in 1990s, the separate entrances to the buildings were removed and two controlled entrances were defined to the Campus area; one of which is from Cemal Gürsel Street as the main entrance and other is from the Erdem Street on the west. However, one of the former entrances from Erdem Street to *Hukuk Fakültesi* - in original it was the entrance belong to the lodgings of The Dean- is still in use for the employees of the Faculty.

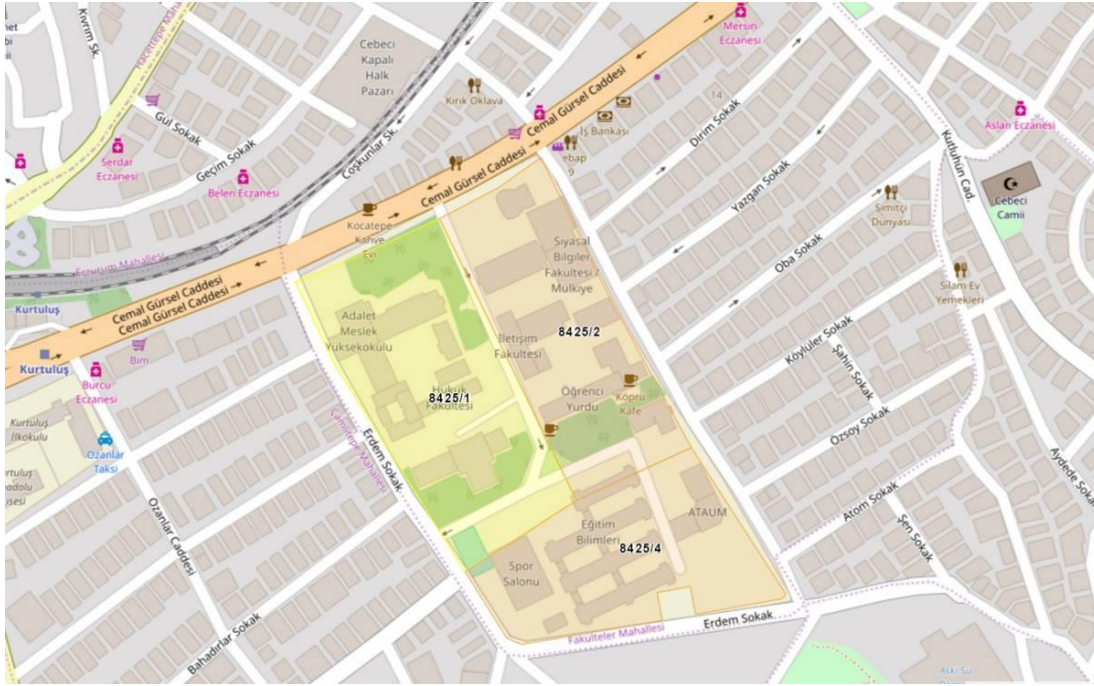
Figure 26. Map showing the parceling in Ankara University Cebeci Campus (<https://parselsorgu.tkgm.gov.tr/>)

The area the Campus covers is composed of three parcels today: 8425-1 *Hukuk Fakültesi*, 8425-2 *Mülkiye* and 8425-4 Faculty of Educational Sciences (Figure 26). It is easy to grasp the division of the total area by looking at the vehicle road connecting

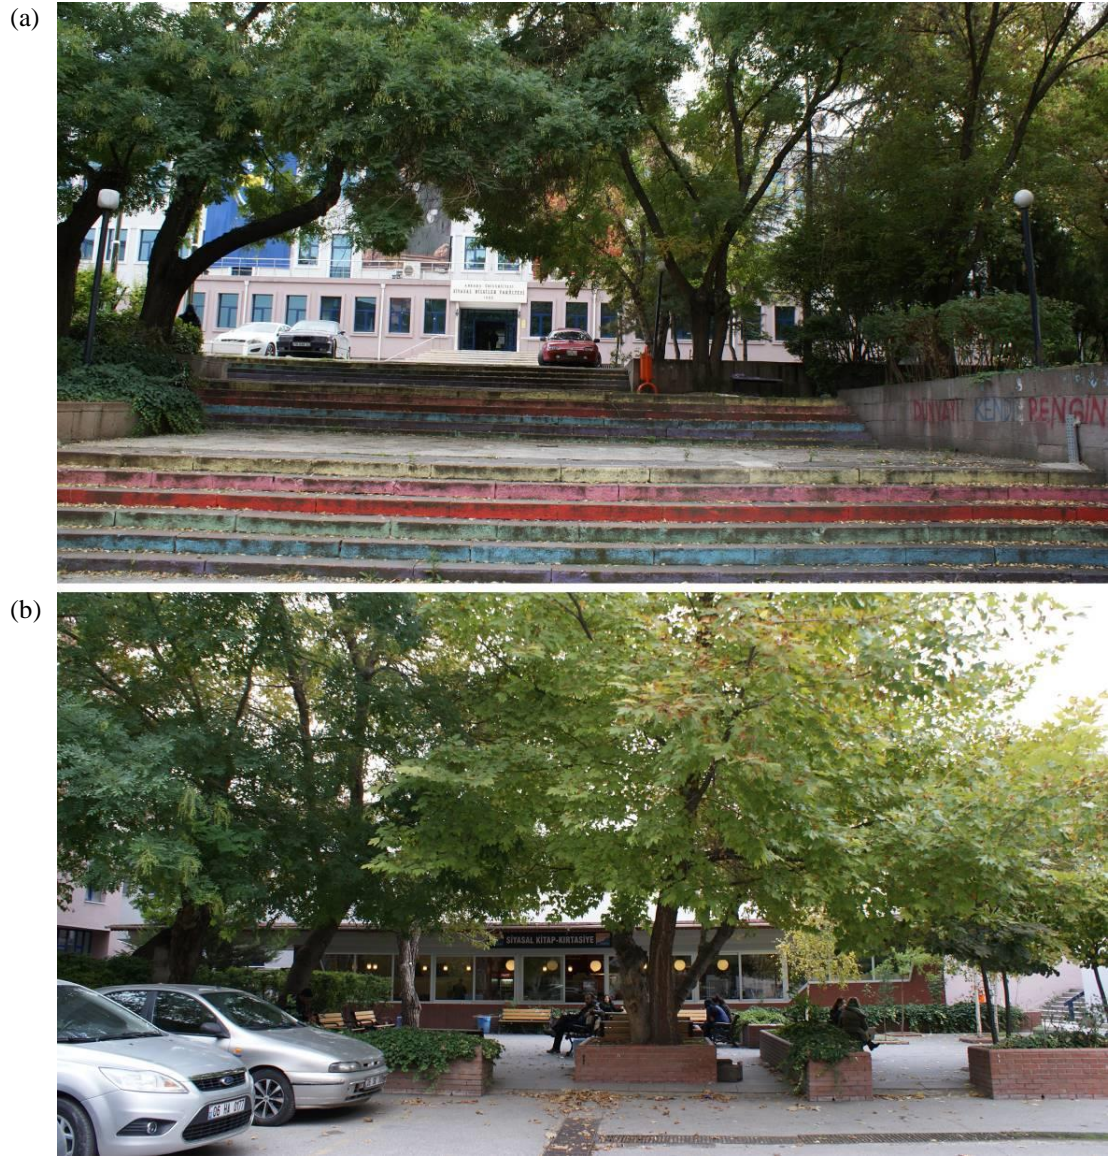
Figure 28. The former entrance stairs in front of *Mülkiye* and the area used as car parking area (a) and the area between *Mülkiye* and Sports Hall used as car parking area in front of the canteen (b) (Azize Elif Yabacı, 2017)

It is unfortunate that most of the open spaces created between the buildings are serving as car parking areas. As mentioned above, before the faculties were gathered within the same campus area, *Mülkiye* had its own separate entrance from Cemal Gürsel Street. After becoming Campus, this entrance was cancelled to have common and controlled entrances to the Campus area. This reorganization led non-use of green area facing the street in front of the faculty building. The use of the firm ground as car-parking area could be one important cause behind this misuse. Besides, the area between *Mülkiye* and Sports Hall also serves as car parking area which is a missed opportunity due to the location of canteen and stationery with a small resting area facing this area (Figure 28). However, the open green area designed between the dormitory building and the Sports Hall the as multi-leveled garden with sitting areas and pool may be the most student-friendly peaceful atmosphere within this parcel.

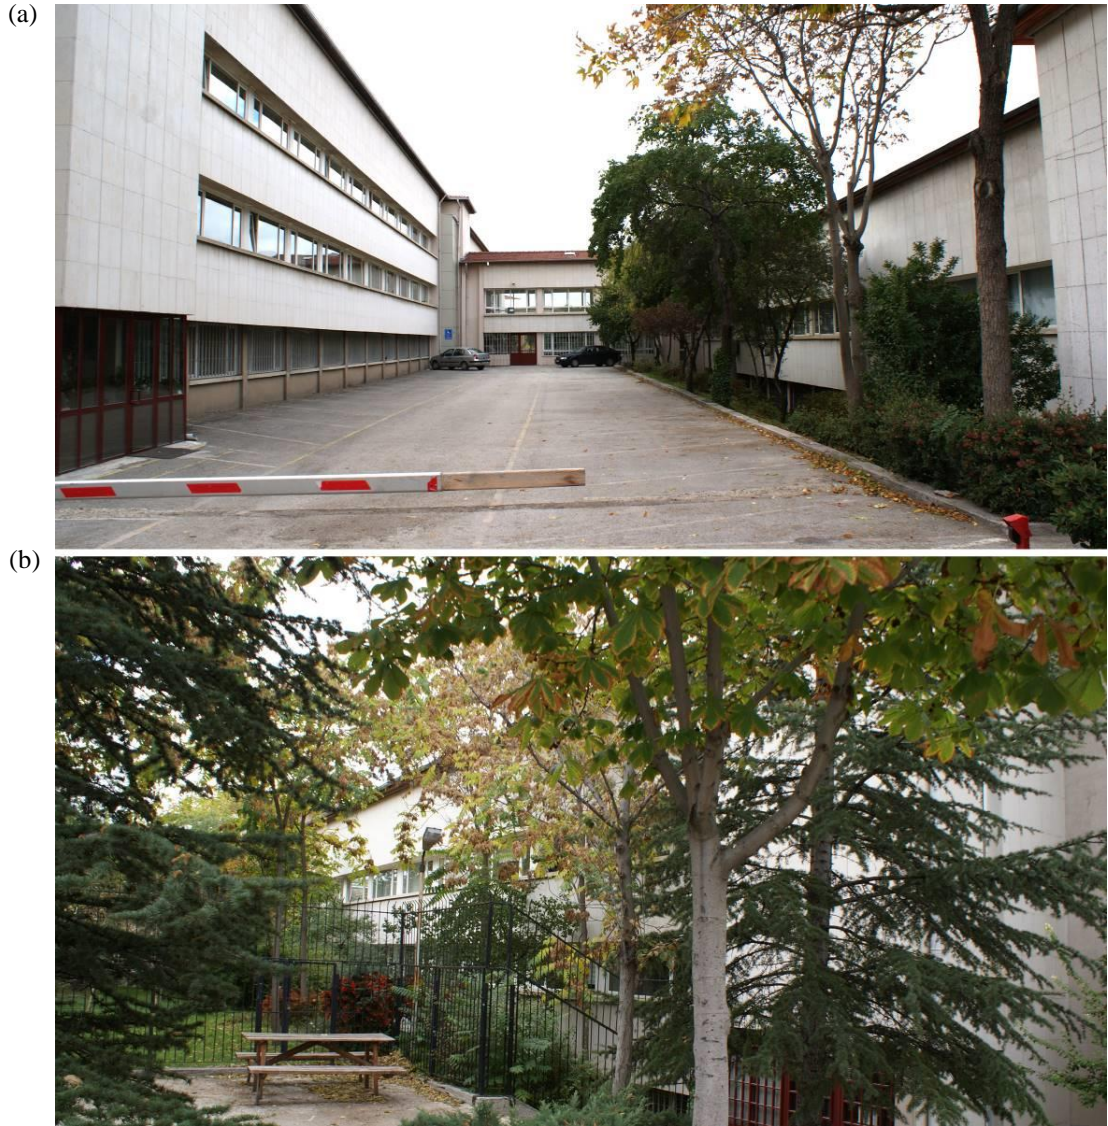
Figure 34. One of the courtyards (a) used as car parking area and the one (b) designed as green area but closed with bars (Azize Elif Yabacı, 2017)

The design of the faculty building mainly depends on the idea of vertically connected linear blocks which is ended up with numerous courtyards in-between. While some of these courtyards are firm ground some are green open spaces. Similar to other two parcels most of the firm ground courts are serving as car parking areas; however, more unfortunate fact is that the courts left as green areas are closed with bars (Figure 34). On the other hand, the wide-open area in front of the entrance of students, on the west wing, is designed and has been kept until today as green areas and firm ground with sitting units (Figure 35). The sensitivity in creating positive outdoor spaces in between the buildings cannot be observed between the faculty building and additional buildings; and these in-between areas are left be except designing entrances to the buildings.

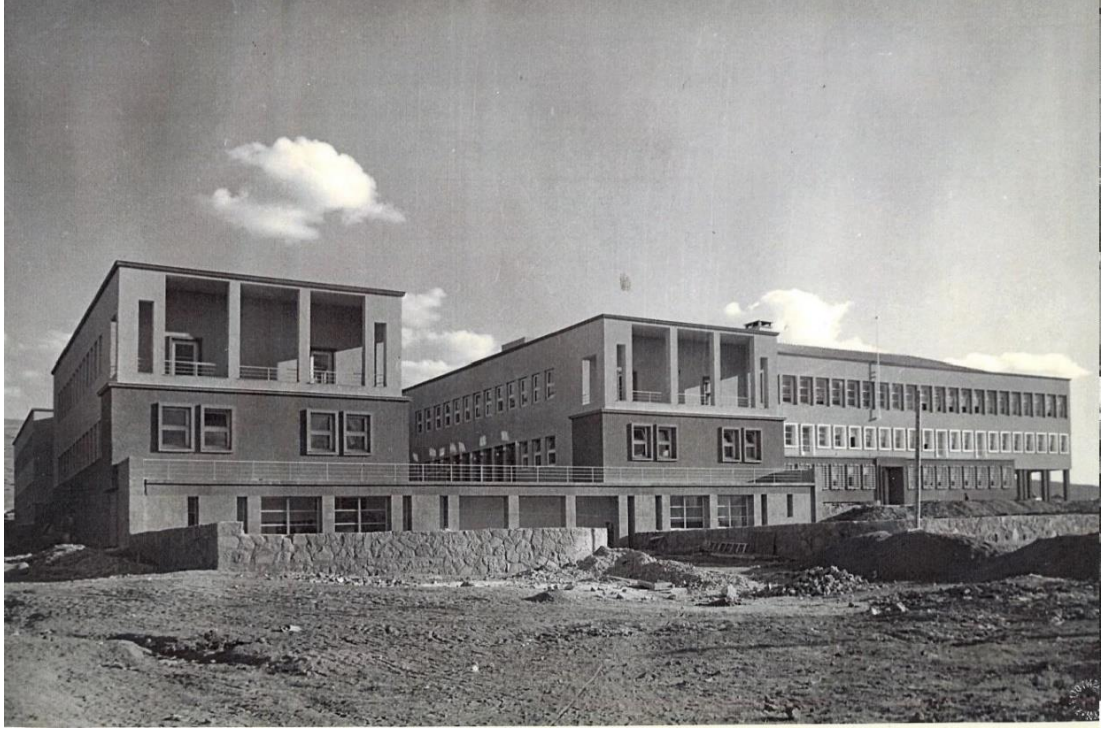
Figure 43. North façade of the faculty building (facing the Street) (ALPAGUT, 2010: 145)

All four facades of the main blocks were designed with different manners. The one facing the street has a simple and horizontally designed façade, covered with Ankara stone till ground floor level and look alike the base of the building. (Alpagut, 2012: 204). There are eight windows on both sides of twelve-stepped main entrance and with the extension of these window parts a balcony for upper floor is obtained. So, the monotony, created by frequently located same-sized windows, is broken with this arrangement. Besides, the windows are framed with stones extended from the façade which prevents the two-dimensional perception of the façade. In addition, the colonnaded parts on the corners were open in original plan (Aslanoğlu, 2010: 182); (Figure 43-44).

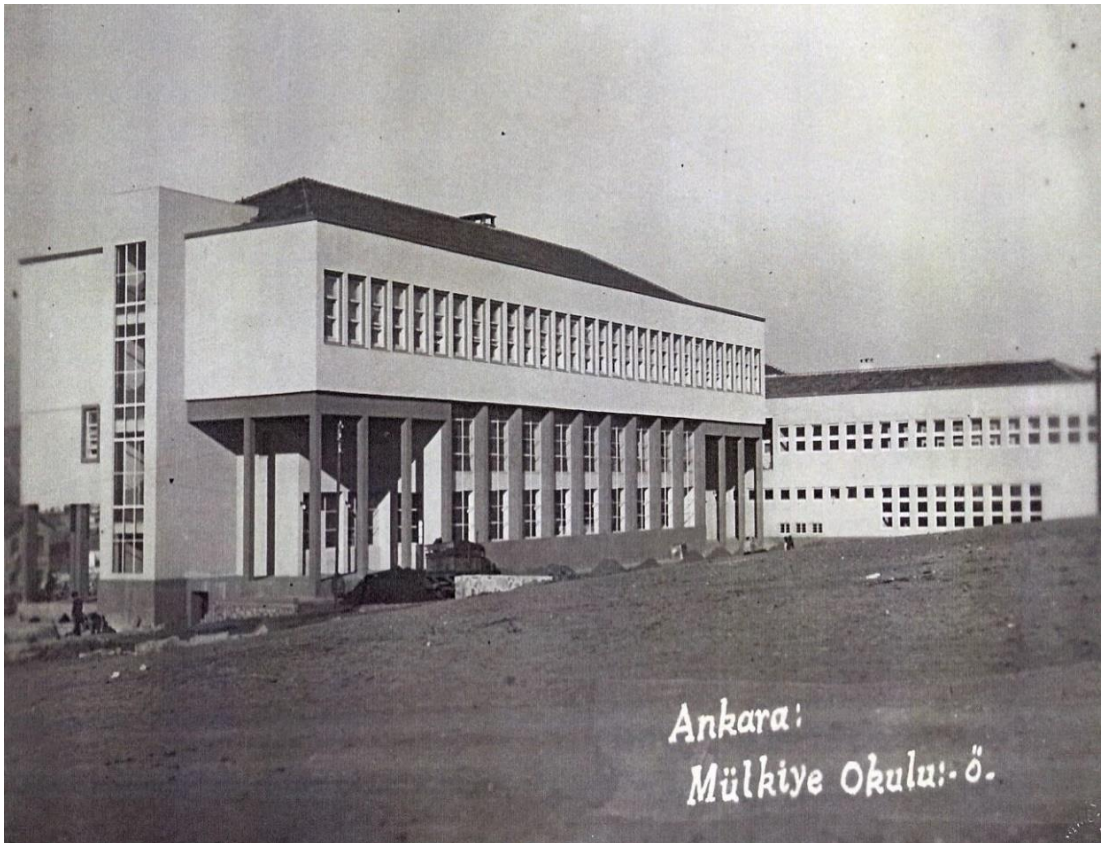
Figure 44. South façade of the faculty building (ALPAGUT, 2010: 141)

The south façade looking at the Sports Hall is reflecting differentiation of two storeys of the building. On the ground floor the colonnades of the former corner openings are continuing through the façade with vertical windows in-between. On the upper floor, there is a monotonous order of same-sized windows with the front façade.

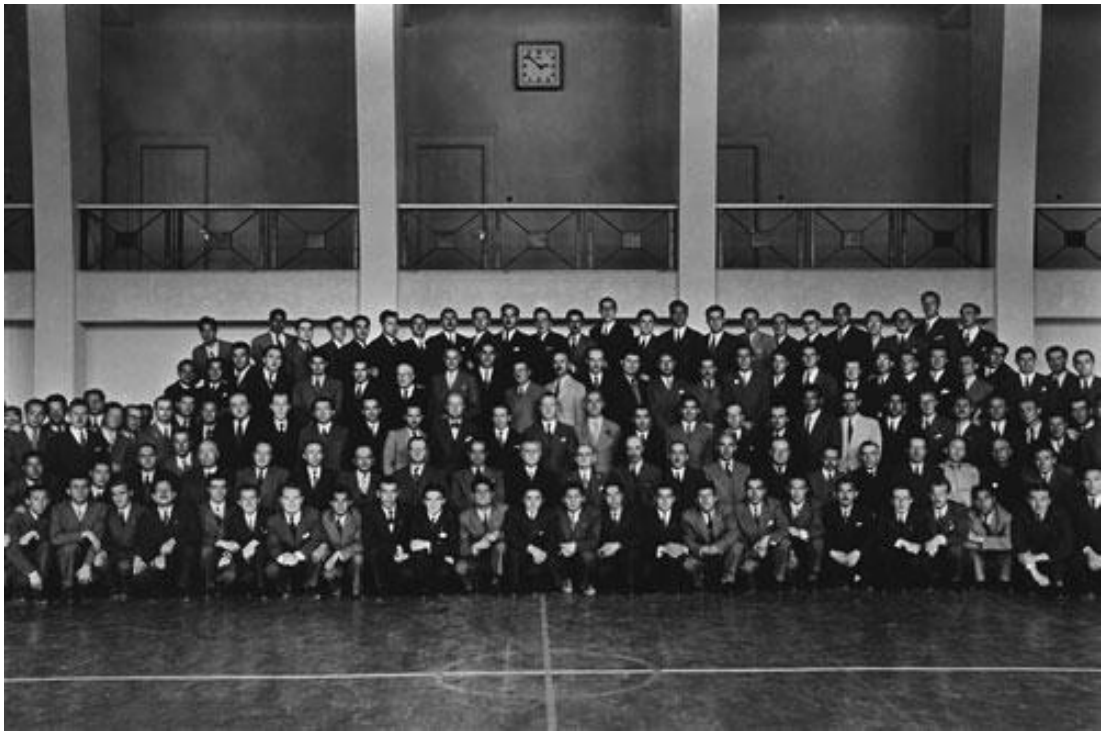
Figure 45. An old photo form the interior of the Sports Hall building (archive of *ilef*)

This Sports Hall building has witnessed many spatial transformations through the time due to needs for more classes<sup>33</sup>. Prof. Dr. Celal Göle remembers the time that the Sports Hall was used as classroom for freshman class in 1963 and mentions that to make the area suitable for this use, huge velvet curtains were hung. Besides, as mentioned above, the roof design and materials were also changed in addition to the removal of the doors belong to lodgings and make them available to reach only from separate entrance from outside. Moreover, the service area also has gone through some transformations. The entrance to the area from outside was cancelled and a new entrance from the main corridor was opened to reach this area. Indeed, there are minor spatial and material changes in this area, also. However, these transformations were temporary and today, the building still serves as sports hall with its original spaces.

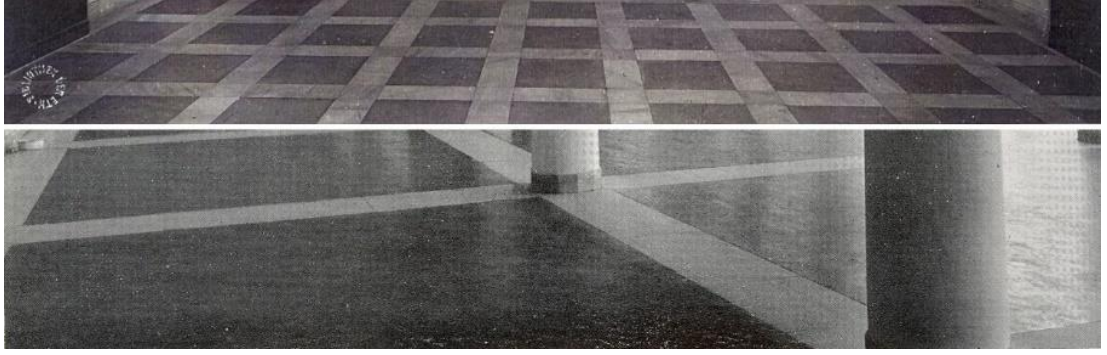
Figure 47. Geometric pattern of floor covering of the entrance hall and the marble-covered multi-purpose hall (ALPAGUT, 2010: 142-143)

The simplicity and no decoration as main concerns can be observed in the entrance and the marble-covered multi-purpose hall where the entrance gave way. The lack of any decorative elements, the use of pure geometric forms in architectural elements, floor coverings, lighting elements etc. and the simple joint details of vertical and horizontal elements prevent user from get lost in details and enable him/her to have spatial experience in its pure form (Figure 47).

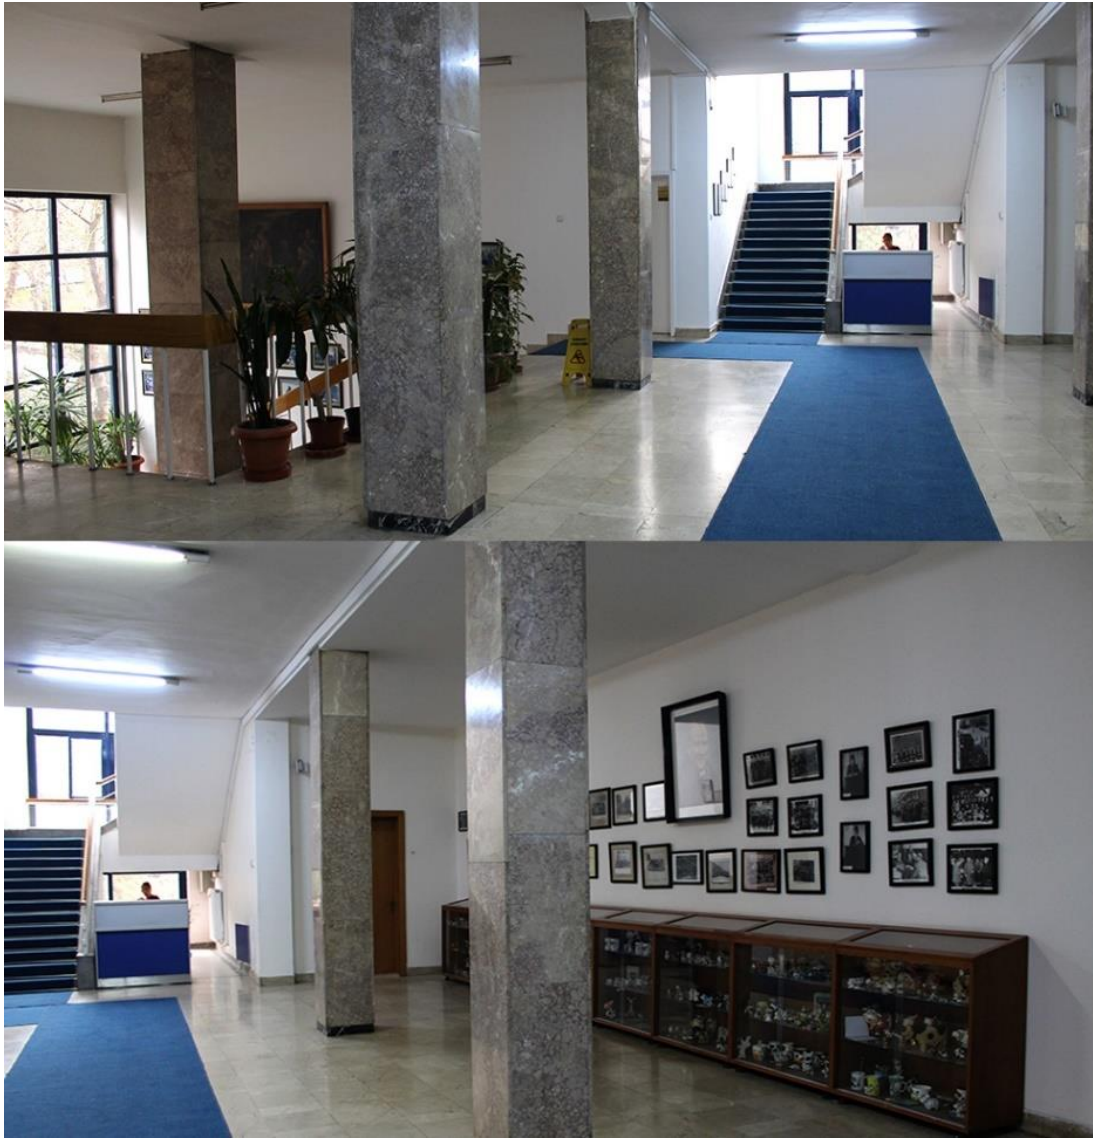
Figure 50. First floor of original library as the dean's Office and new staircase (Azize Elif Yabacı, 2017)

Öztürk (2007: 32) states that there was a room behind the Dean's office used as bathroom in the first stage of the rearrangement of library as office. Although the exact date of the change was not known, related with this spatial change, it is deduced from the comparison of original and current plan that, the open terrace continuing through the south façade of the building was also closed and added into marble-covered multi-purpose hall (Figure 53-54).

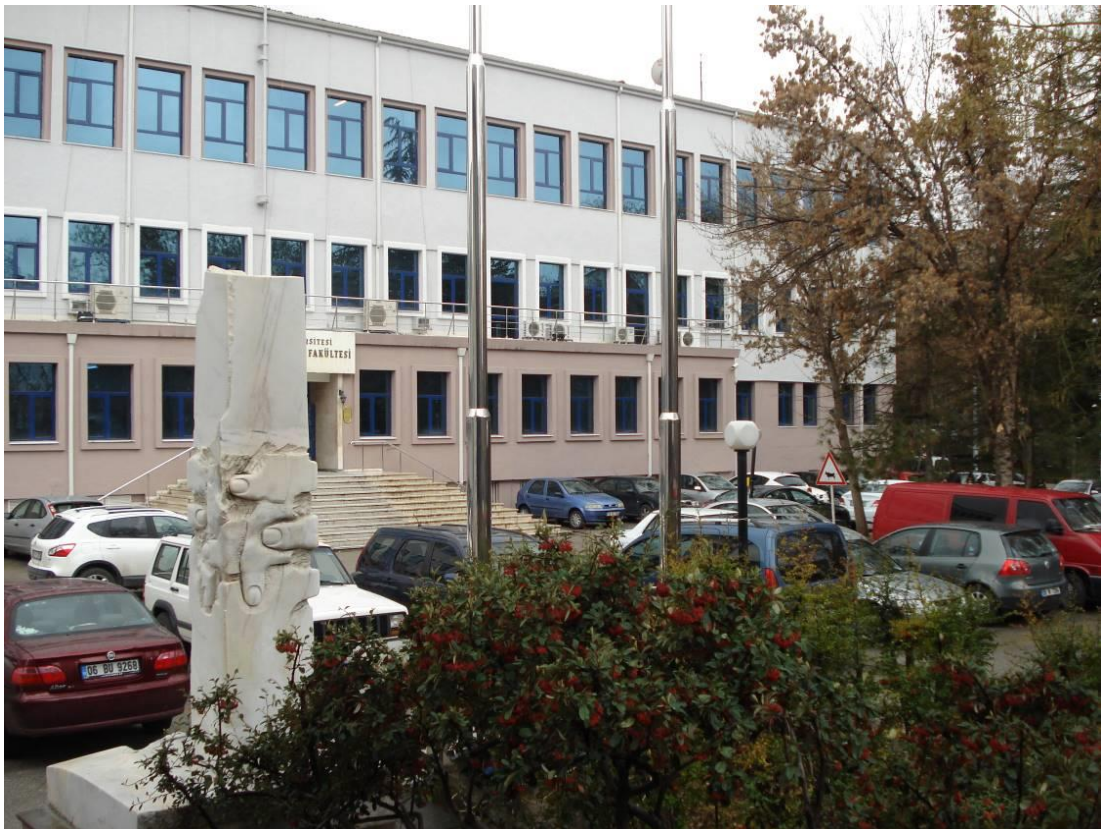
Figure 52. The open terrace as closed and added into inner space (Azize Elif Yabacı, 2016)

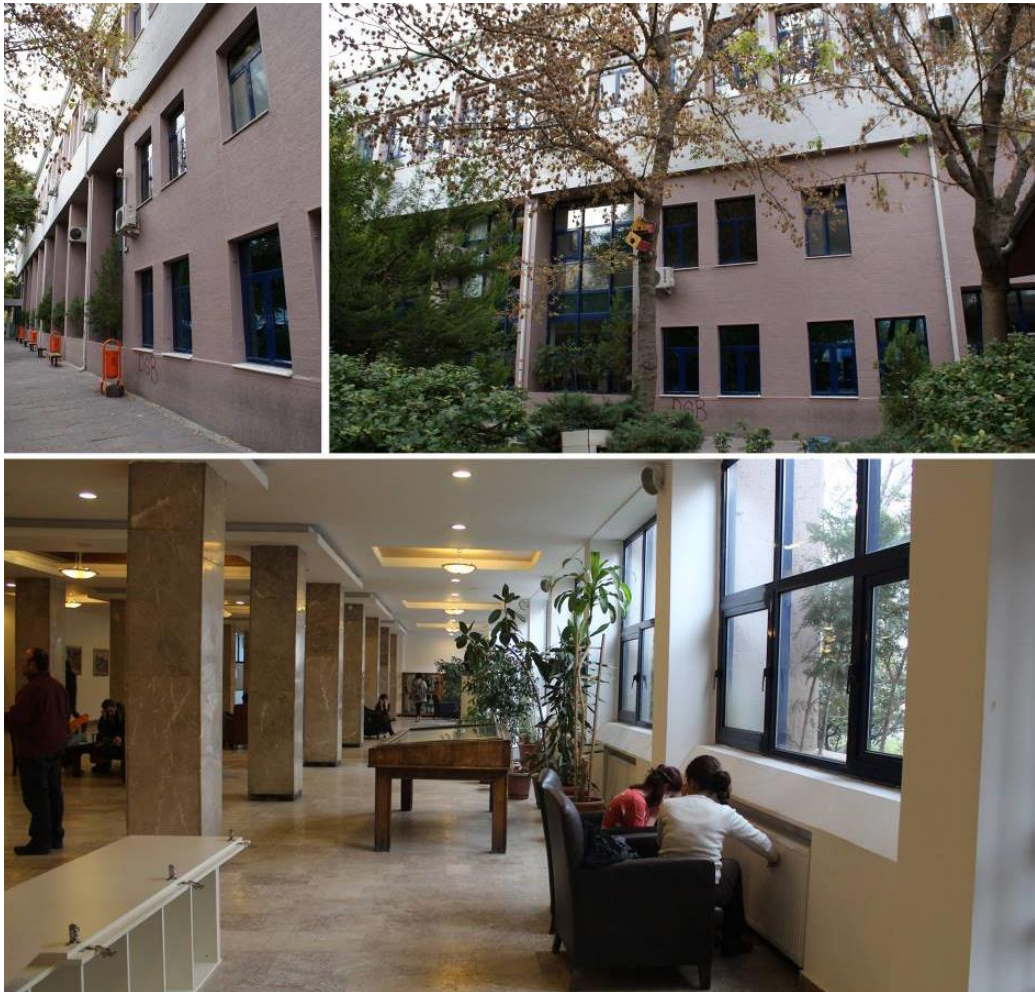
Figure 54. Marble-covered multi-purpose hall including closed open terrace in 2016 (Azize Elif Yabacı, 2017)

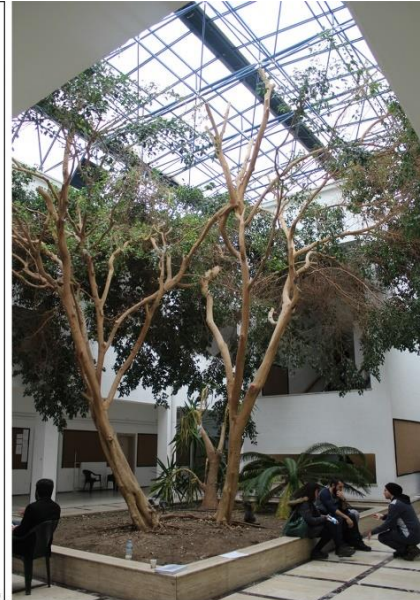
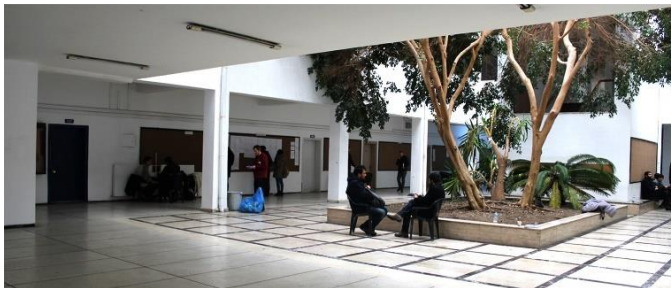
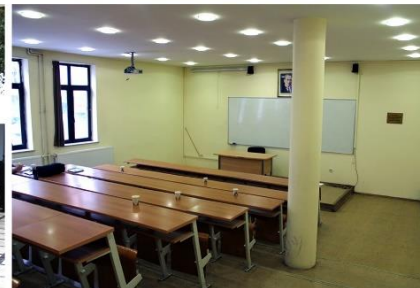
Figure 61. Location of dormitory rooms on the ground floor (a) and views from the ground floor, inner garden and classroom Z18 today (b) transformed from dormitory rooms (Azize Elif Yabacı, 2017)

In the same period, the dormitory rooms across the conference hall on the ground floor were also rearranged as classrooms which were classrooms coded Z01- Z06 and Z13- Z18. While transforming the dormitory rooms, it can be observed from the comparison of original plan with the current plan that the corridor was widened, the location of staircases was changed, and an inner garden was formed. And from the projects taken from the Ankara University Directorate of Construction and Technical Works shows that all these changes and rearrangements were planned within the scope of extension and renovation project of the faculty building prepared by Enver Tokay, Ayhan Tayman and Yılmaz Şanlı (Figure 61). Relatedly, with the use of new classrooms in 1964, sports hall began to serve in its original function again (Baskıcı, 2009: 28).

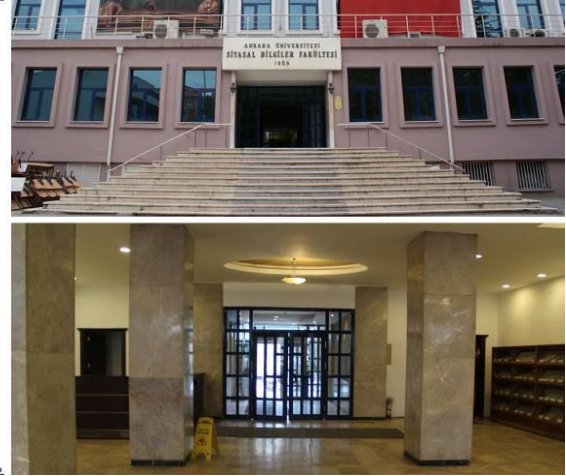
Figure 65. Location of the entrance stairs and the entrance hall of the faculty building (a) and entrance stairs and the entrance hall today (Azize Elif Yabancı, 2017)

Furthermore, in the older photographs of the building, the entrance seemed to have a few steps and there were also a level difference and steps to the marble-covered hall. Relatedly, there were some projects, dated 1969, prepared for the entrance stairs of the building (Figure 64). So, there was also a rearrangement both inside and outside of the entrance of the faculty building in terms of levels differences. The level difference inside building was projected to the outside and the number of steps of entrance stairs increased; and the steps in the entrance hall were removed (Figure 65). In the process of this rearrangement process, the stairs on the both sides of the entrance hall were also removed as deduced from the comparison of old drawings, photos and current situation. After the removal of these stairs, this space was closed and added to the upper floor spaces. Besides, today there were functions as security and document registration located on the entrance hall.

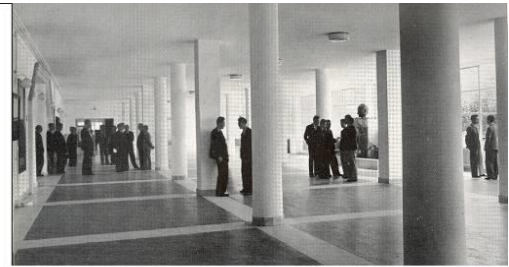
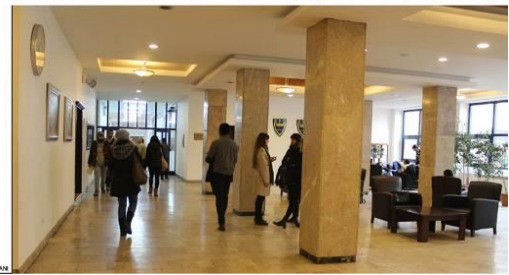
Figure 66. Location of marble-covered multi-purpose hall (a); situation of hall and the columns in original (b) (ALPAGUT, 2010: 143) and the hall today (c) (Azize Elif Yabancı, 2017)

In 1967, the construction of classes and conference hall(amphi) building and in 1968 (Figure 62), the main part of the School of Press and Broadcasting (*Basın Yayın Yüksek Okulu*) was completed and begun to be used (Figure 63). Following year, marble-covered multi-purpose hall was reorganized, the cylindrical columns were covered with marble in rectilinear form (Baskıcı, 2009: 30).

Together with the arrangements in the entrance hall, the marble-covered hall was also reorganized in 1969; and reopened to use in this year, the hundredth anniversaries of the faculty (Baskıcı, 2009: 30-31). Although, the information about the time of change was lack in written documents, it is known that the columns of the hall were in cylindrical and, then these columns were covered with marble and reshaped in cornered form (Öztürk, 2007: 33); (Figure 66). It is highly possible that this change in the material and form of columns was realized in the hundredth anniversary rearrangement of the hall.

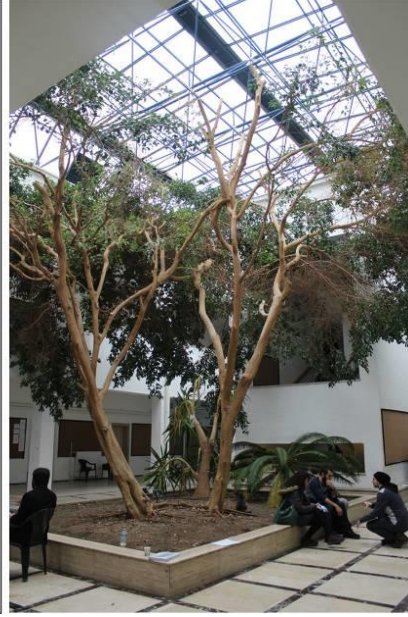
Figure 70. Location of the inner garden on the ground floor (a) and inner garden and space-frame roof (b) today (Azize Elif Yabancı, 2017)

It is known that there was a ventilation area, surrounded with glass up to the ceiling in original. In 1999, this glass structure was removed and reunited with the soil ground. As mentioned above, the borders were lined with stones from Erzincan, different trees were planted, and an inner garden was formed. Left area was covered with marble and the roof of the area was covered with space frame to achieve ventilation (Öztürk, 2007: 45)<sup>51</sup>.

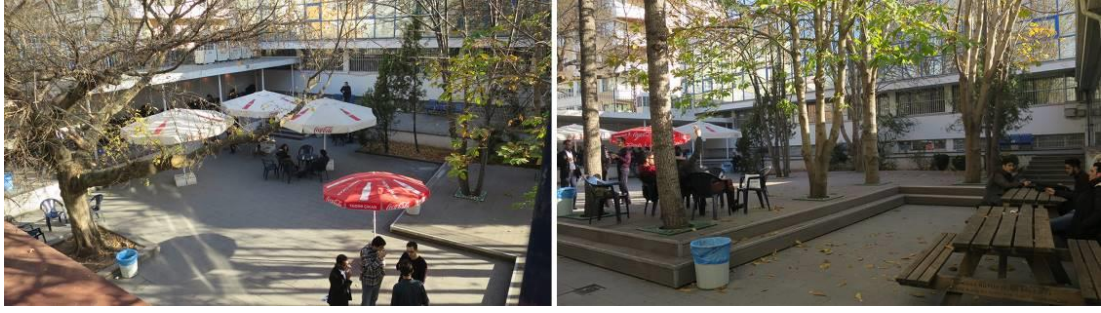
Figure 71. Courtyard between the faculty building and the library building today (Azize Elif Yabacı, 2017)

On the outside of the buildings, the pool between the faculty building and library building was filled with soil and planted. The firm ground around was covered with Ankara stone and began to serve as a nice canteen area and meeting point (Öztürk, 2007: 46); (Figure 71). Emre Demir mentions that due to its physical properties – closed on sides and open from the top – the area was called as aquarium. The area is densely used between April and October and students spend their times mostly in this space. Indeed, Demir remembers that he was spending his all day from 10am to 6pm in aquarium with his friends sometimes.

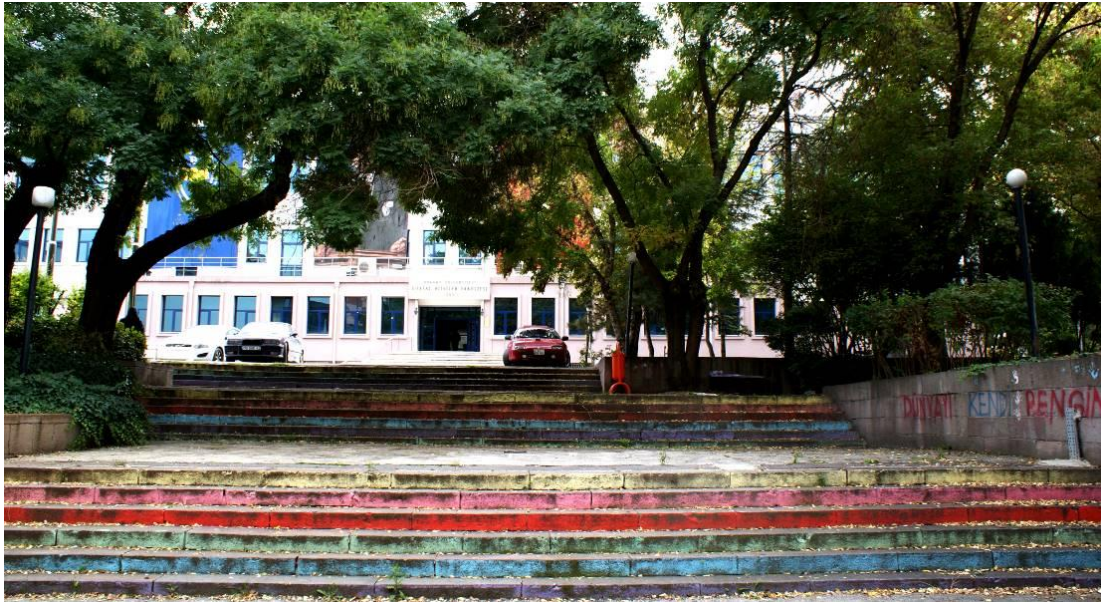
Figure 74. Stairs constructed in front of the faculty building between upper and lower garden (Azize Elif Yabacı, 2017)

In 2001, the front gardens were reorganized and on the edges of the garden, paving stones were placed to compose walking routes. Besides, a stair was constructed from upper garden to lower garden (Figure 74). There were works on sports hall also in this year. The old floor coverings of the hall were renewed, the baskets were changed, and numbers were increased from two to six, the dressing rooms and shower cabins were renewed. In 2003, there was a small repair and reorganization work in boiler room of the faculty (Öztürk, 2007: 47).

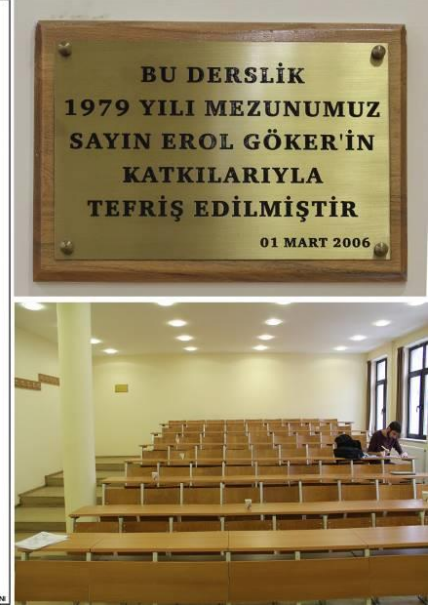
Figure 76. Location of classroom 114 (on top) and classroom 118 (on bottom) on the ground floor (a) and the signboard showing the grantor of the renewal of classroom 118 with the interior view (Azize Elif Yabancı, 2017)

From 1987 to 1991, there were ongoing repairs in the faculty like re-furnishing of classrooms coded 114,118, 221 and 230 with covering floor with carpet and served to use of graduate students and change of ceramics on the ground and floor of ceramic and sinks.

In 2006, classroom coded 118 and 221 was also reorganized as amphi by an old graduate Erol Göker and Bursa branch of *Mülkiyeliler Birliği* (Figure 76). Besides, storage of belongings was moved to the place of publication storage on the basement floor and the room left was reorganized as Faculty Academic Hall. In 2007, classroom coded 218 was reorganized as amphi by *Mülkiyeliler Birliği*. In 2009, the library was reorganized as open-shelf system and re-opened to use (Öztürk, 2007: 49). In addition, Emre Demir remembers that in the 2006-2007 education year, the roof of the building was repaired. He remembers that very clearly because they made this repair in the winter, in December or January.<sup>42</sup>

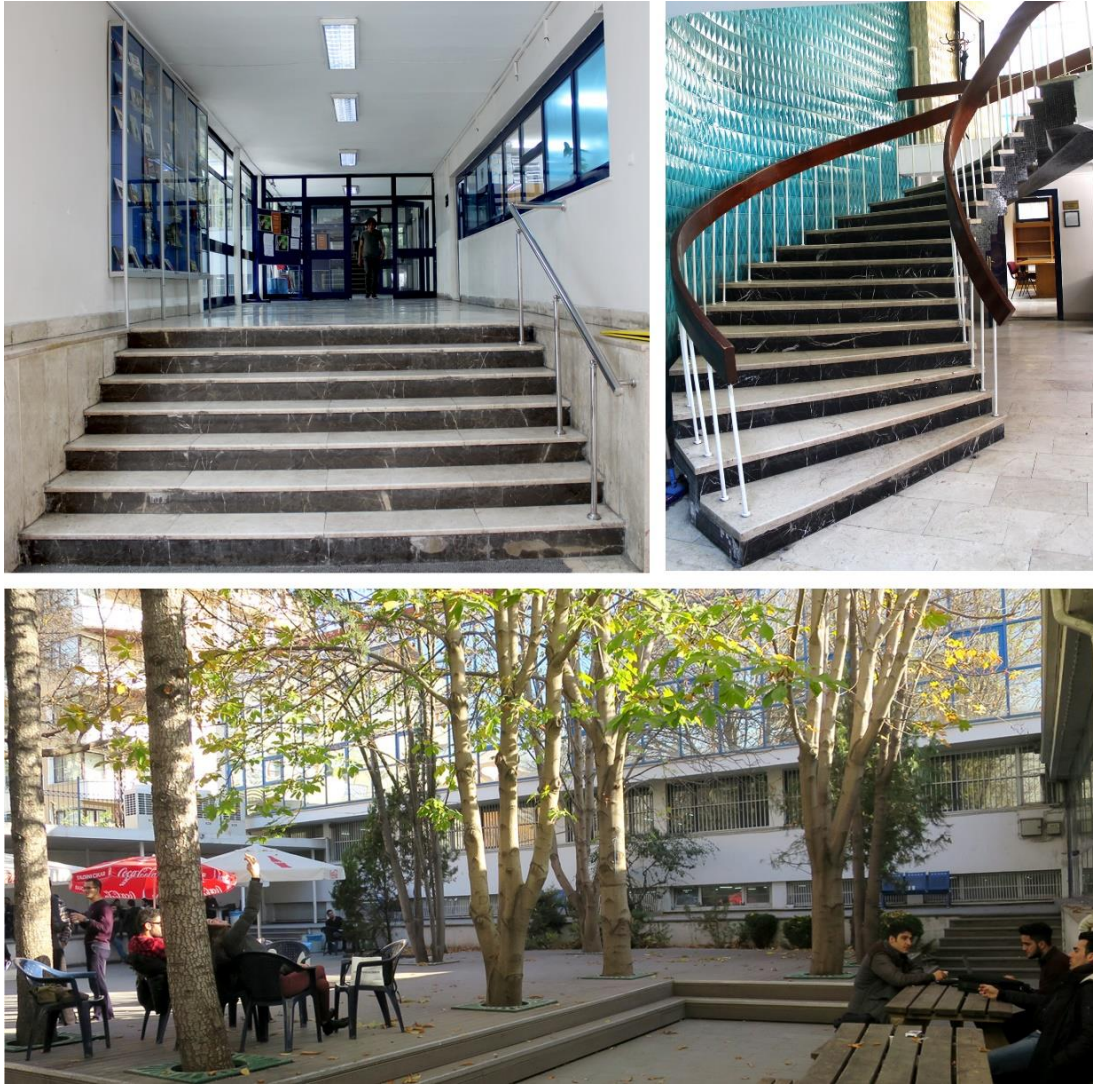
Figure 81. The corridor connecting the library building to *Mülkiye*, the courtyard between the buildings and the spiral staircase in the library building (Azize Elif Yabacı, 2017)

The library building is connected to the main building with a wide corridor attached to the main building behind the conference hall; and forms an inner courtyard between these two buildings serving as the open space of the *Mülkiye Café*<sup>45</sup> (Figure 81). While, the eastern side of the corridor was a transparent surface looking directly to this courtyard, on the opposite site- looking to the Sports Hall there are WCs, administrative spaces, etc. with entrances.

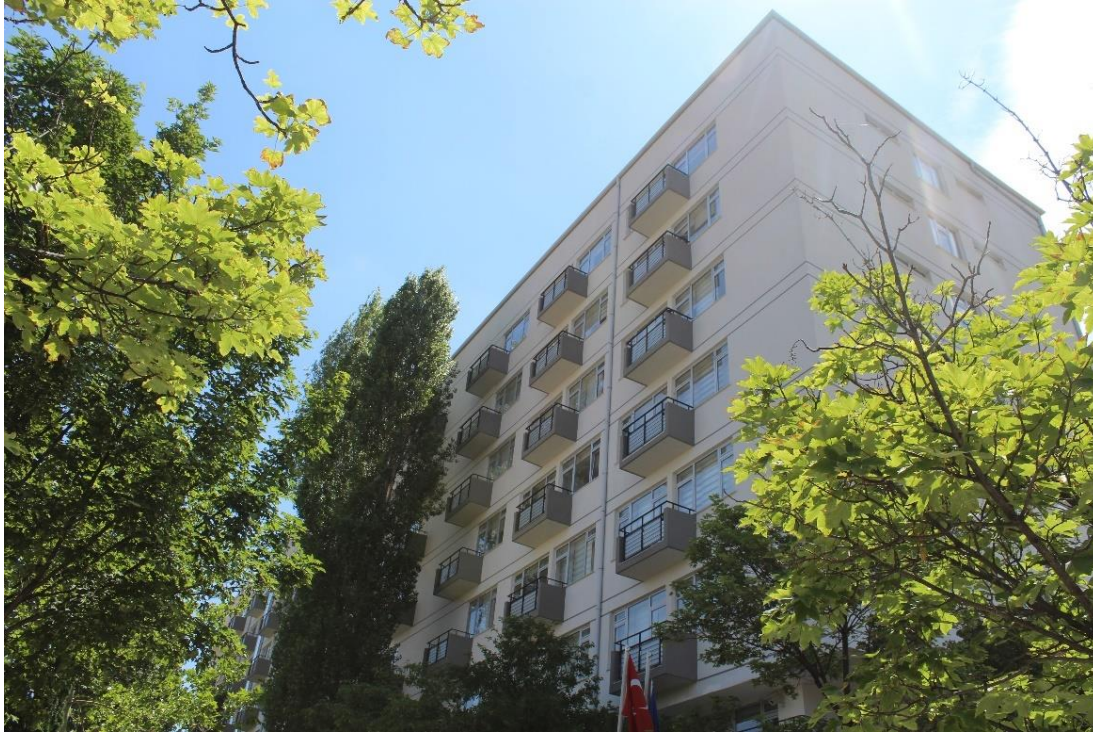
Figure 94. Dormitory building today (Azize Elif Yabancı, 2017)

Lastly, this year, in 2017, the dormitory building has an exterior repair implementation the change of bars on the balconies, whitewash which changes the colors of the building into grey tones (Figure 94).

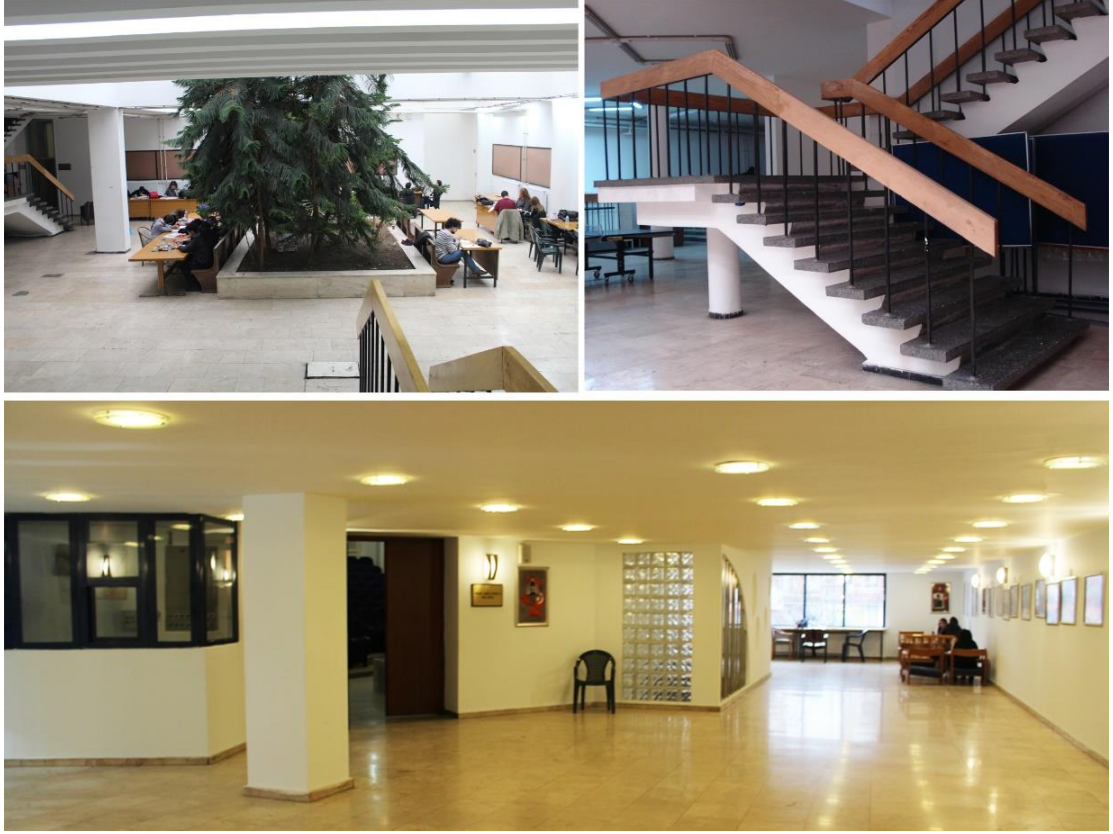
Figure 98. The basement floor of the amphi with inner garden and classrooms around, the stairs connecting bigger and small amphi and the hall in front of the entrance of bigger amphi from the entrance of the building on the ground floor (Azize Elif Yabacı, 2017)

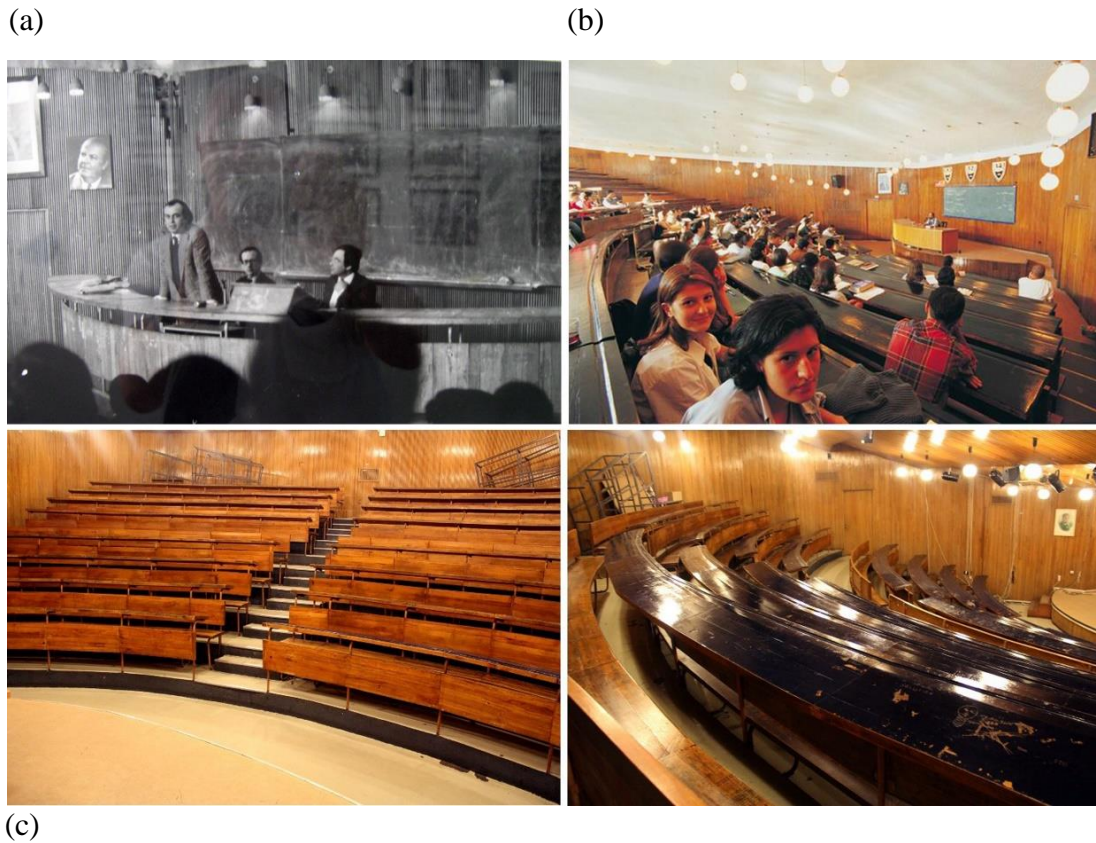
Figure 99. An older photopgraph from the small amphi (a) (archive of Zafer Akay), a view from the small amphi dated between 1999-2006 (b) (archive of *ilef*) and photographs of the small amphi today (c) (Azize Elif Yabacı, 2017)

amphi preserves its original spatial and material features in a very extensive point; and, this space is one of two spaces that the originality and the history of *Mülkiye* building could be observed<sup>52</sup> (Figure 99).

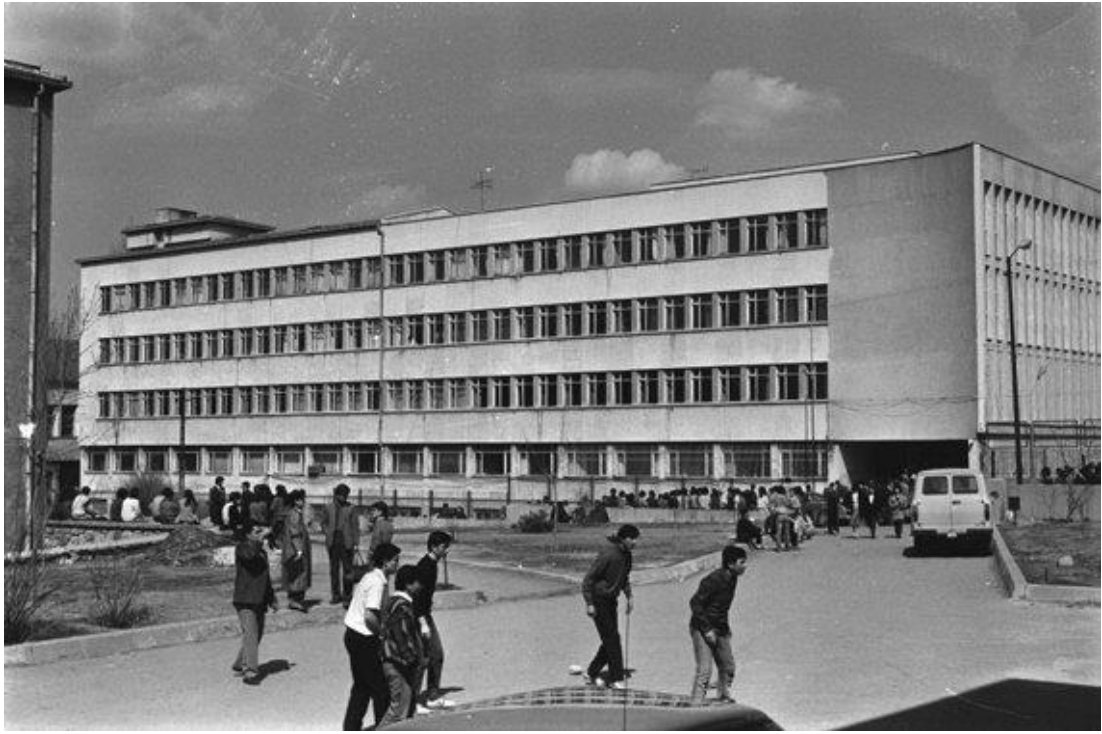
Figure 109. The view from of the Faculty of Communication building from in front of the *Anfiler – D* Block dated 1988 (archive of *ilef*)
