PLACE – IDENTITY – CHANGE IN ANKARA UNIVERSITY CEBECİ CAMPUS  
AS AN ISSUE OF MODERN HERITAGE CONSERVATION

A THESIS SUBMITTED TO  
THE GRADUATE SCHOOL OF NATURAL AND APPLIED SCIENCES  
OF  
MIDDLE EAST TECHNICAL UNIVERSITY

FEBRUARY 2018

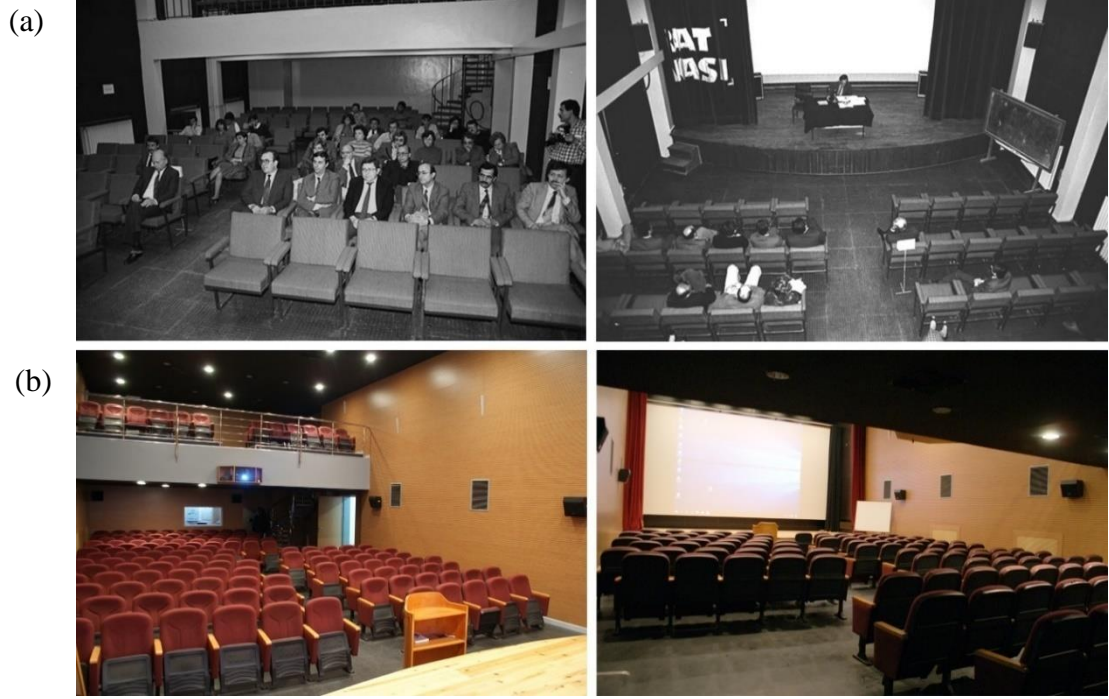
Figure 113. Views from the cinema hall dated 1986 (a) (archive of *ilef*) and from the cinema hall today (b) (Azize Elif Yabacı, 2017)

cancelled before the construction. After that, in 2011, the cinema hall underwent an extensive repair. The acoustic fabrics over the wooden covering over the walls were removed and replaced with low frequency sound-absorbing wall panels with steel frames. Similarly, the vinyl floor coverings of both the ground floor and the mezzanine floor were also replaced with homogeneous acoustic PVC floor coverings. In addition, the wooden platform on the mezzanine floor was also replaced with the metal one. During this process, seats were removed, and new seats were placed with a new arrangement which enabled increase this number. Besides, the cinema screen in 300x500 cm was removed, the wall behind the screen was covered with sound insulation wooden wall paneling and a new screen in 380x700 cm was placed. Moreover, the doors of the hall, except the backstage door, and the metal spiral staircase were renewed; the rear door of the mezzanine floor was removed, and this entrance was cancelled. Relatedly, the ramp in this entrance of the mezzanine floor was also removed and the floor was made even. The control room on the mezzanine floor also underwent a total renewal in this process. The covering material of the walls, floor and the ceiling were renewed; the walls and the floor covering was renewed with sound absorbing materials and a gypsum suspending ceiling was constructed. Lastly, a new rostrum was added to the hall (Figure 112-113).

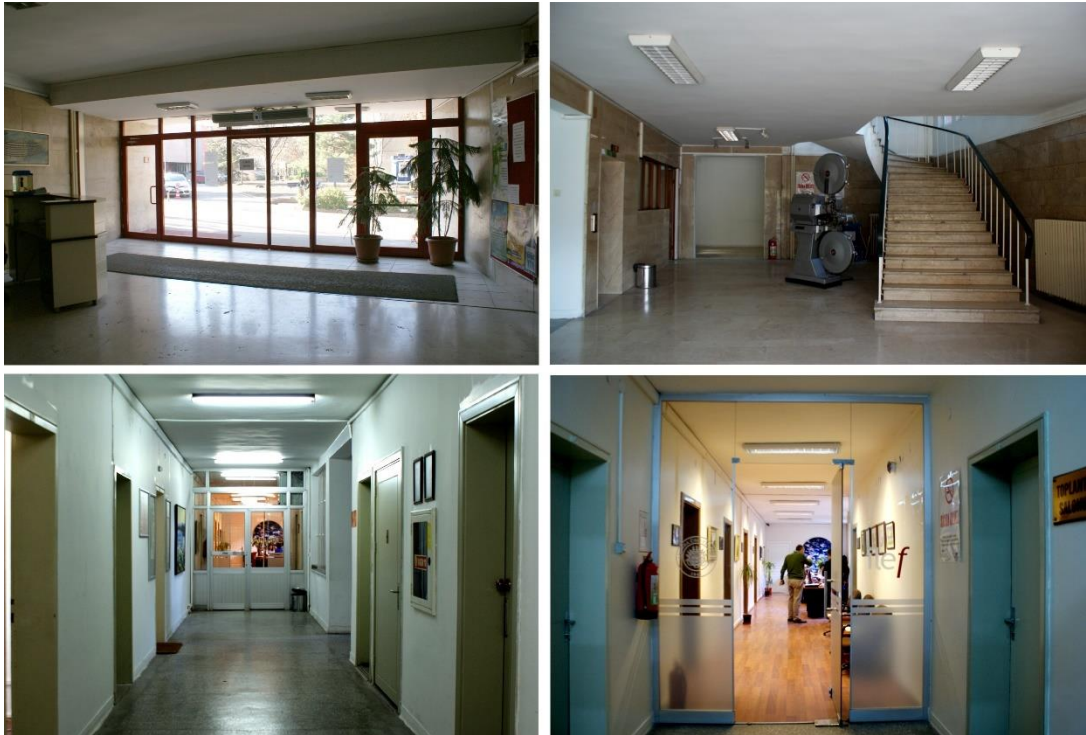
Figure 114. Views from ground floor showing entrance hall and the administrative offices (Azize Elif Yabacı, 2017)

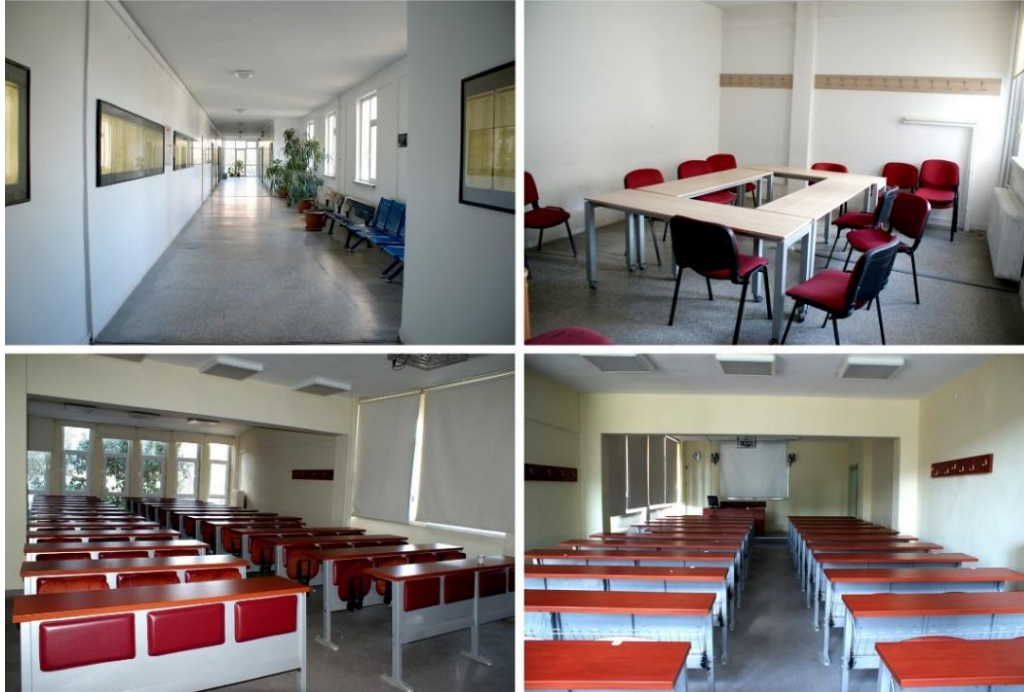
Figure 116. Comparison of the original first floor plan and the measured drawing of the floor dated 2014 (a) (archive of Ankara University Directorate of Construction and Technical Works) and views from first floor showing corridor, examples from seminar room and classrooms (b) (Azize Elif Yabancı, 2017)

The first floor, to continue, included wide spaces serving as classroom and room of academic board, resting room for the academicians and library. Today, it is seen that some of these spaces were divided and refunctioned as seminar hall while the room of academic board and resting room were refunctioned as classrooms. The classroom located behind the stairs in the area the two blocks met still serves as classroom. Additionally, the library spaces were also refunctioned as classroom while the library was moved to another floor. By the way, the WCs at the end of the corridor were cancelled in every floor and transformed into spaces needed. In this floor, they were refunctioned as offices (Figure 116). Similar changes can be observed on the second floor also. However, this time, all the wide spaces all of which were classrooms were

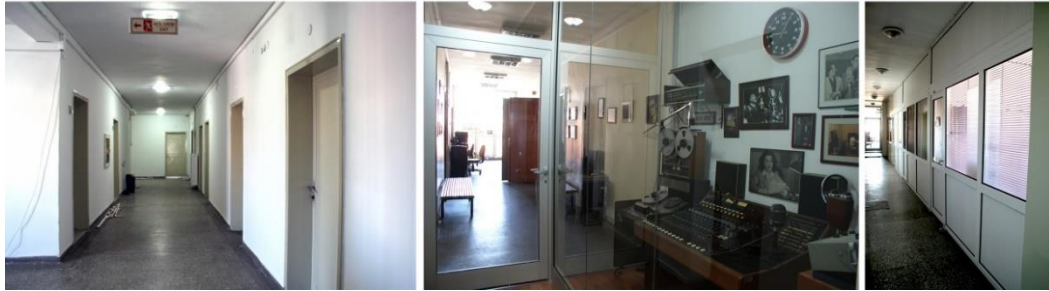
Figure 118. Comparison of the original third floor plan and the measured drawing of the floor dated 2014 (a) (archive of Ankara University Directorate of Construction and Technical Works) and vfrom third floor showing corridor, film recording part and classrooms spaces formed with PVC dividers on the corridor (b) (Azize Elif Yabacı, 2017)

On the third floor, besides cinema hall, some of the wide spaces which were seminar rooms were divided and functioned as the offices of academicians. The lodgings on the north of the floor was cancelled the plan was rearranged and these spaces were also transformed into offices. One of the seminar rooms was also divided and today serves as film recording offices and radio. There are also additional spaces on the corridor formed by dividing the spaces PVC dividers. Additionally, today there is ongoing repair works on the south part of the floor (Figure 118).

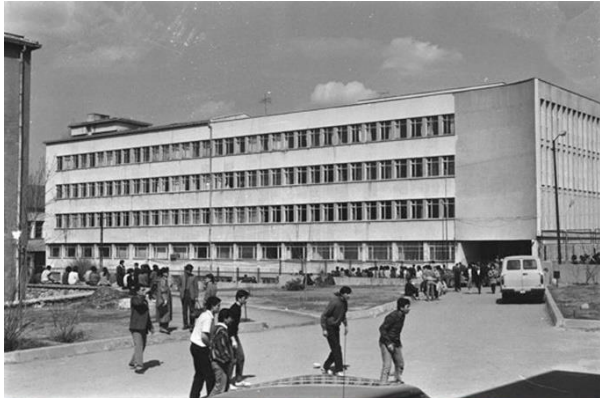
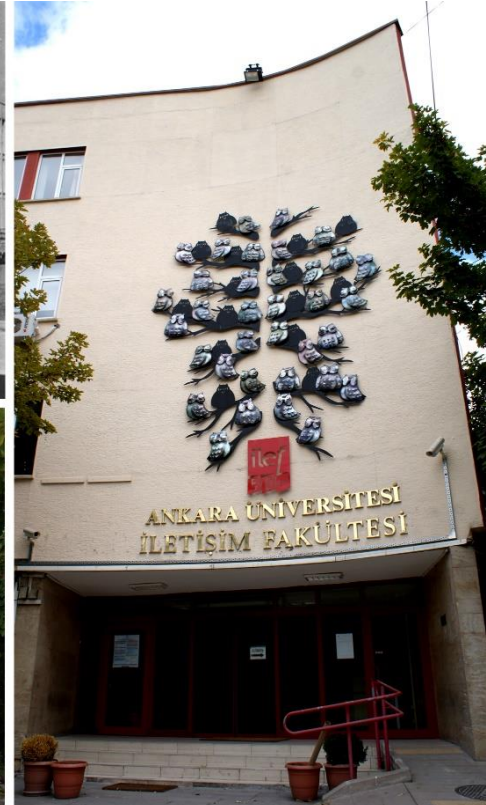
Figure 121. An old photo of the Faculty of Communication dated 1988 (archive of ilef), relief above the main entrance (b) and faculty of Communication today (Azize Elif Yabacı, 2017)

Despite all these major changes and extensive repairs, the building keeps its originality mostly on the façade. In other words, except the change of fenestrations, there is almost no three-dimensional change on the façades of the Faculty of Communication building. However, there is the relief above the main entrance of the building. With no precise knowledge of the date, by referring to the insigne of the ‘fiftieth year of the faculty’, the year of the relief can be estimated as 2015. In the original project drawings of the building, it is seen that the architect planned to put a relief of feather above the main entrance; however, today, there is a relief of owls on the branches of a tree (Figure 121).

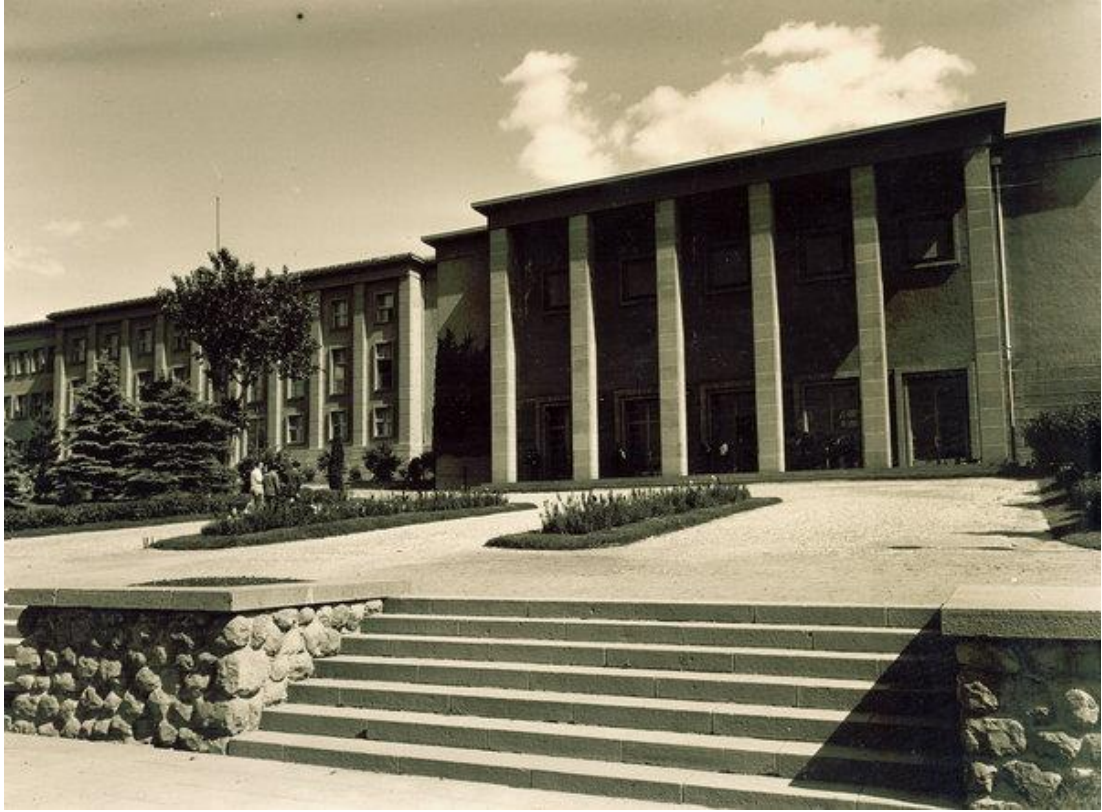
Figure 123. *Hukuk Fakültesi* in 1954 (archive of VEKAM)

entrances with stairs and colonnades, the entrance halls covered with marble and the facade organization reminds the ministry buildings of the period – like Ministry of Justice- and the building of General Directorate of State Railways. With large masses and the facades designed with neo-classical style, the building of *Hukuk Fakültesi* is an example of the last years of the period that German massive architecture gained power (Figure 123).

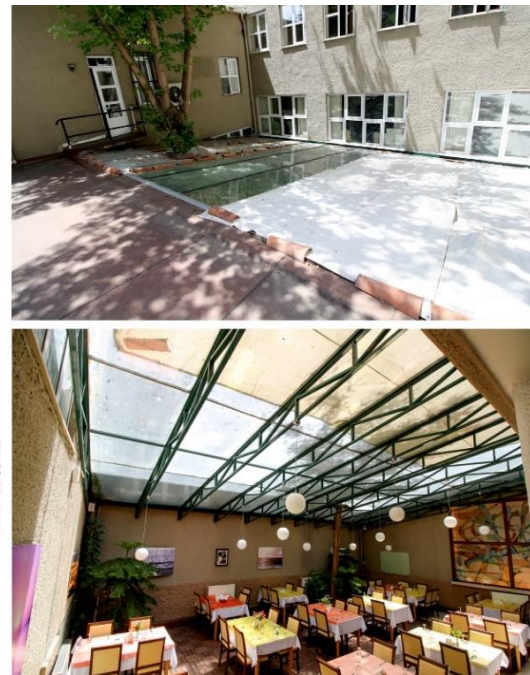
Figure 136. Location of Sera Cafe in the main building (a) Sera Cafe after the rearrangement of the courtyard (b) (archive of Ankara University Directorate of Construction and Technical Works)

There is another major repair, and in fact a reformation of a space in the building implemented by Prof. Dr. Metin Feyzioğlu. The space designed as greenhouse in the inner courtyard of the Vocational School of Justice part of the building by the architect Engin Ünal, who was the architect of Faculty of Educational Sciences at the same time, in 1968 was rearranged as a restaurant serving for the academicians with the name Sera Cafe<sup>74</sup>. Prof. Dr. Figen Çok remembers that rearrangement and thinks that it was the most original innovation in the campus. In the beginning, the top of the restaurant was open but then make it available to be used in cold air also (Figure 135-136).

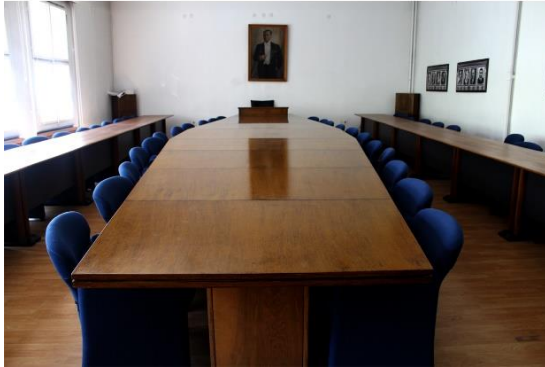
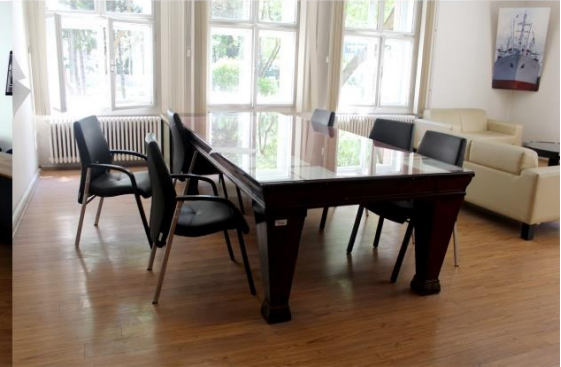
Figure 138. Location the part including *Profesörler Odası Asistanlar Odası* and meeting hall in the main building (a) (archive of Ankara University Directorate of Construction and Technical Works), *Profesörler Odası* and the original mail boxes in the room (b), meeting hall (c) and *Asistanlar Odası* (d) (Azize Elif Yabancı, 2017)

interventions. Assist. Prof. Dr. Başak Şit İmamoğlu also remembers this loss which means that this change must be realized after 2000s. She mentions the room as ‘absolutely a room of professors’ with its heavy – both literally and metaphorically – furniture in it.<sup>75</sup> However, with the loss of these original furniture, the atmosphere of the rooms was also damaged (Figure 138).

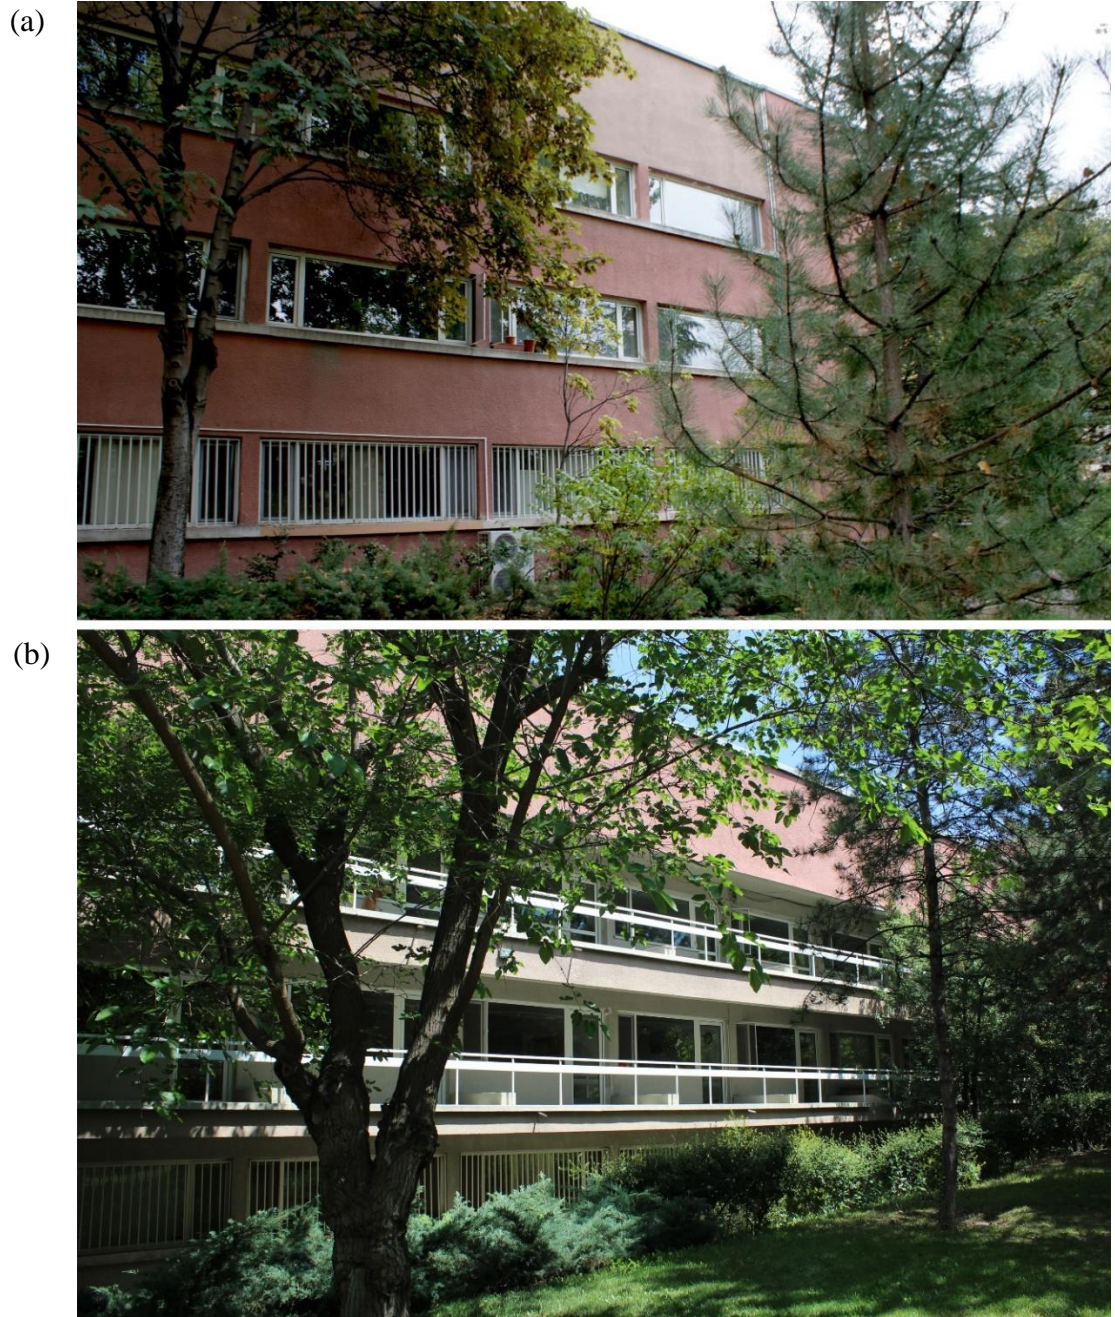
Figure 146. Photo of north façade (a) of the linear block with horizontal windows and south façade of the linear block (b) with balconies and horizontal windows (Azize Elif Yabacı, 2016)

Related with the different width of the blocks, the linear office block stands a step behind the amphi block both on the north and the south which gives the impression of a dynamic façade. Due to the office spaces, it embodies, the linear office block has horizontal band-like windows divided with structural elements which emphasizes the linearity of the mass. This linearity is achieved by the balconies continues through the whole façade in ground and first floor on the south façade. On the basement floor, on the other hand, the same window arrangement with the north façade is seen (Figure 146).

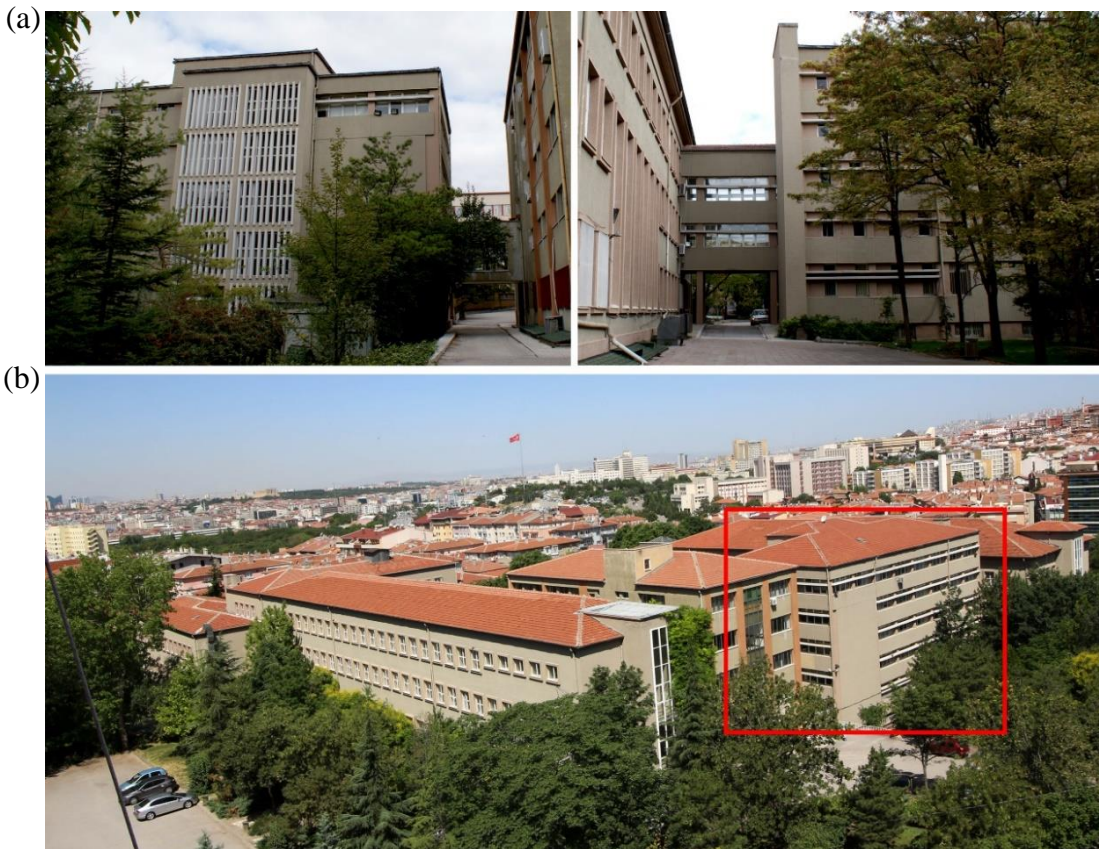
Figure 152. Photo of façades of the building of Research Institute of Banking and Commercial Law looking inner courtyard and the connecting bridges (a) (Azize Elif Yabacı, 2017) and the eastern façade with its relationship with the main building (archive of Ankara University Directorate of Construction and Technical Works)

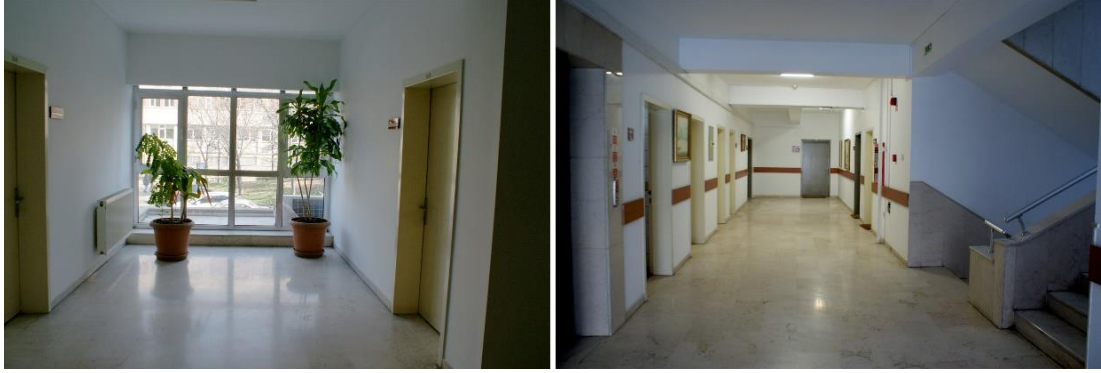
Figure 154. A general view showing the floor plan repeating in each floor of the building of Research Institute of Banking and Commercial Law (new) (Azize Elif Yabacı, 2017)

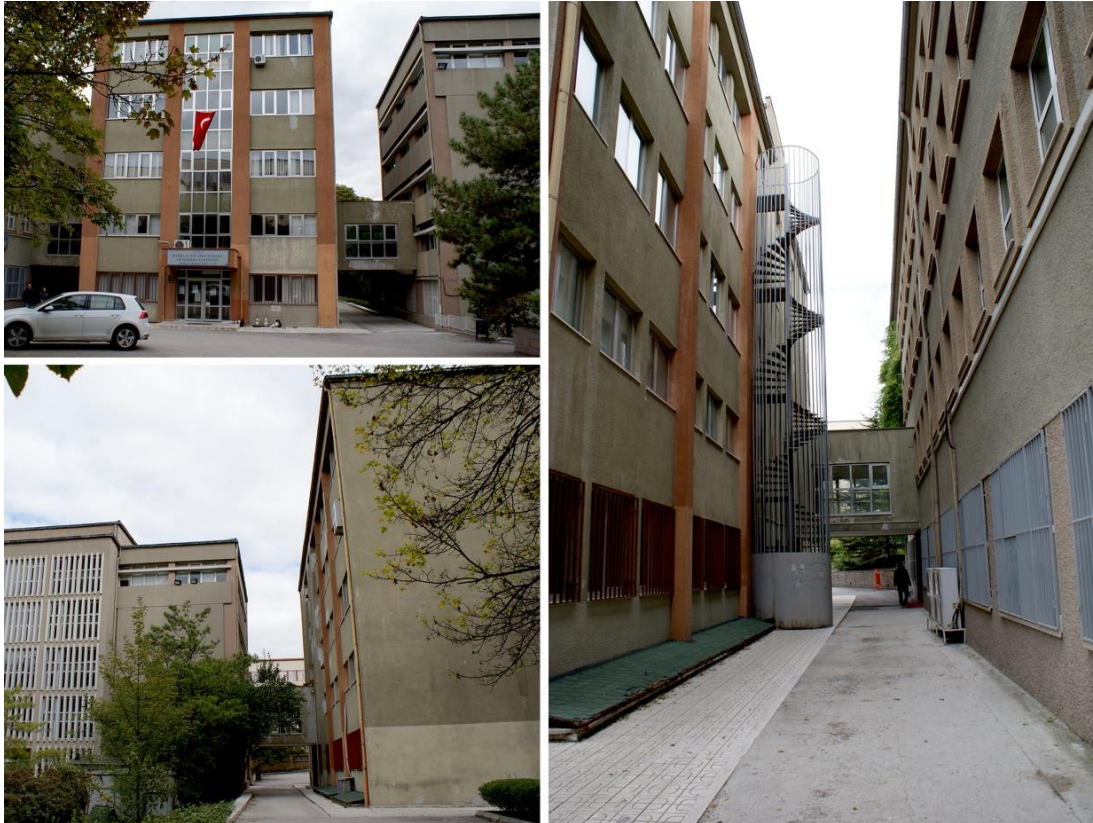
Figure 155. Photos showing the façades of the building of Research Institute of Banking and Commercial Law (new) (Azize Elif Yabacı, 2017)

The northern and southern façades have almost same design with minor differences related with the functions behind. Both façades have regular window series. Between two columns there are three windows located with small intervals in each floor. Both façades are interrupted in the first floor with the bridge-like corridor connecting the building to the neighboring buildings. The only difference between two façades is on the circulation and service areas. While on the northern façade there is a long vertical window in the stair well continuing through the floors like in the main façade. On the other hand, there are small windows on the toilets and one-unit window with same height with the other regular windows on the kitchens in each floor; and, a blank part for the small space behind the elevator. Additionally, there is fire-escape stairs in front of the one-unit regular window which becomes a door on the top floor. Other than that, there are bars on all the windows on the ground floor in each façade (Figure 155).

with the users of the building from different generations that building has not gone through major spatial or functional transformations. Relatedly, the façades of the building keep their originality, as well. There are some air conditioning devices on the façades that were added later related with the changes that the academicians have done in their offices.

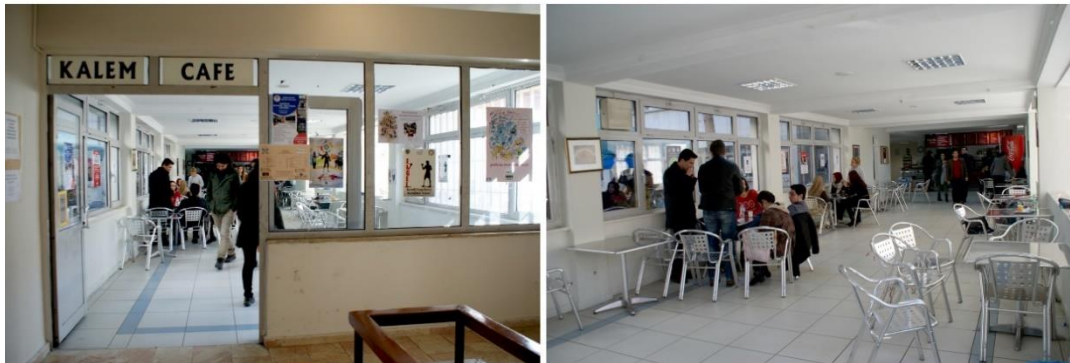
Figure 170. Location of the closed spaces under pass ways in the building of Political Sciences (a) (archive of Ankara University Directorate of Construction and Technical Works) and the closed spaces on the right in the upper figure transformed into canteen (b) (Azize Elif Yabacı, 2017)

Prof. Dr. Figen Çok, joined the faculty in 1985, remembers one of these voids in its opened form. She states that according to the spatial needs they were closed and added to the inner space in time. The one that she remembers was functioned as the cafeteria of academicians the earlier times that she joined the faculty. Because with the increase in the number of students the current cafeteria that academicians and the students had lunch together became inadequate. So, to gain an additional space, the pass ways connecting Blocks 2A and 2B to the ground floor of the Block 3B closed and a cafeteria was formed. Although being not an effectively-used space, it had an aesthetic value before it was closed, as she evaluated this change (Figure 170).

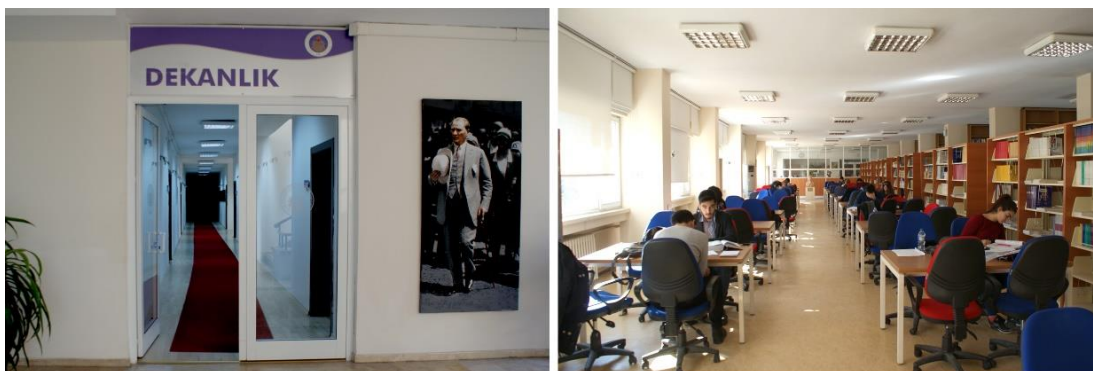
Figure 173. The deanery in the Block 1A and the reading room of the library in the Block 4A today (Azize Elif Yabacı, 2017)

In the library block – 4A -, the single space book storage on the ground floor was divided into spaces surrounding a central corridor; and at the end of the corridor a storage space, four times larger than others, was formed. On the first floor, the niche spaces in hall of the stairs in the pass ways were closed and two more spaces were acquired. On the second floor, lastly, the WCs were cancelled, the hall was narrowed, and a reading room was formed in these gathered spaces (Figure 173).

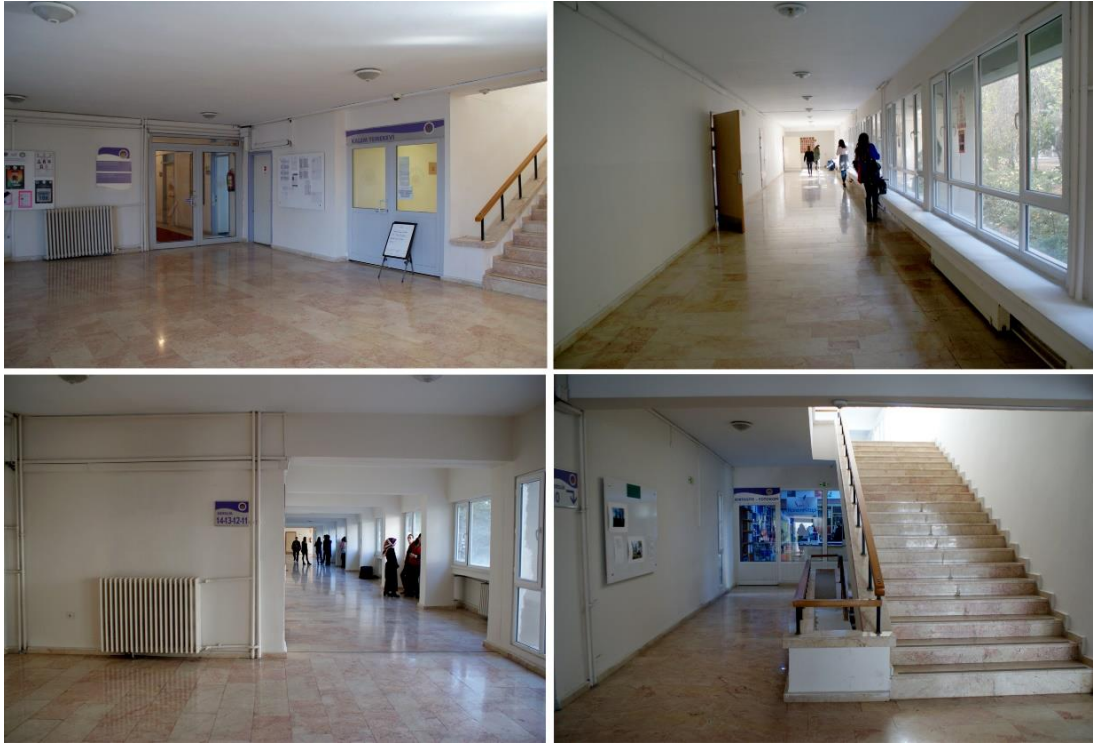
Figure 177. After the extensive repair projects applied in the corridors of the building of the Faculty of Educational Sciences (Azize Elif Yabancı, 2017)

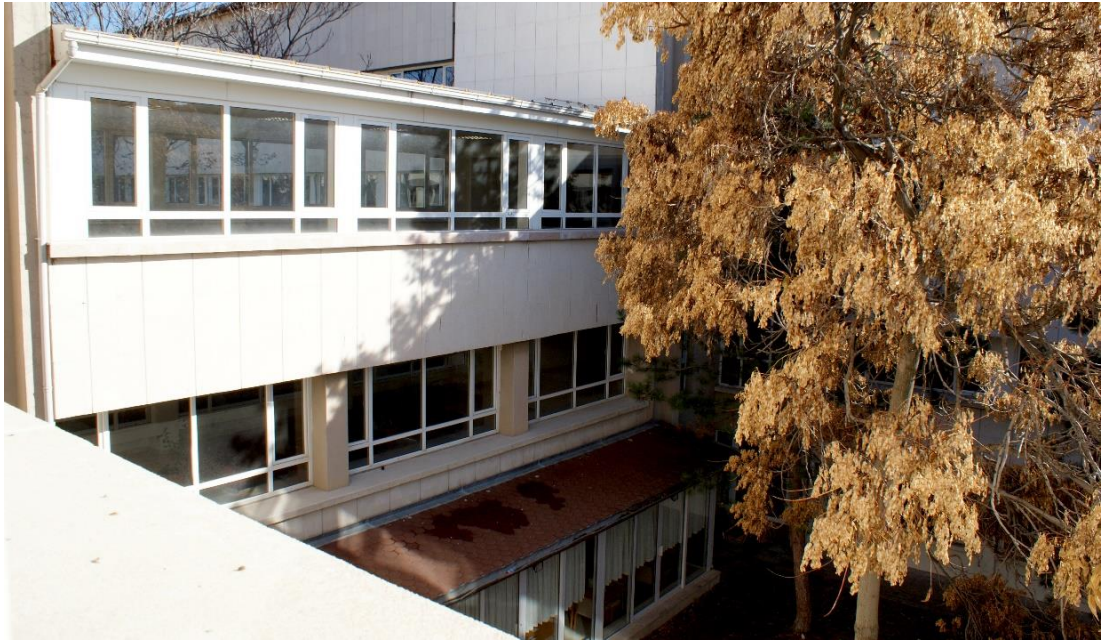
Figure 179. The photo of the archive formed by closing the bridge-terrace (Azize Elif Yabacı, 2017)

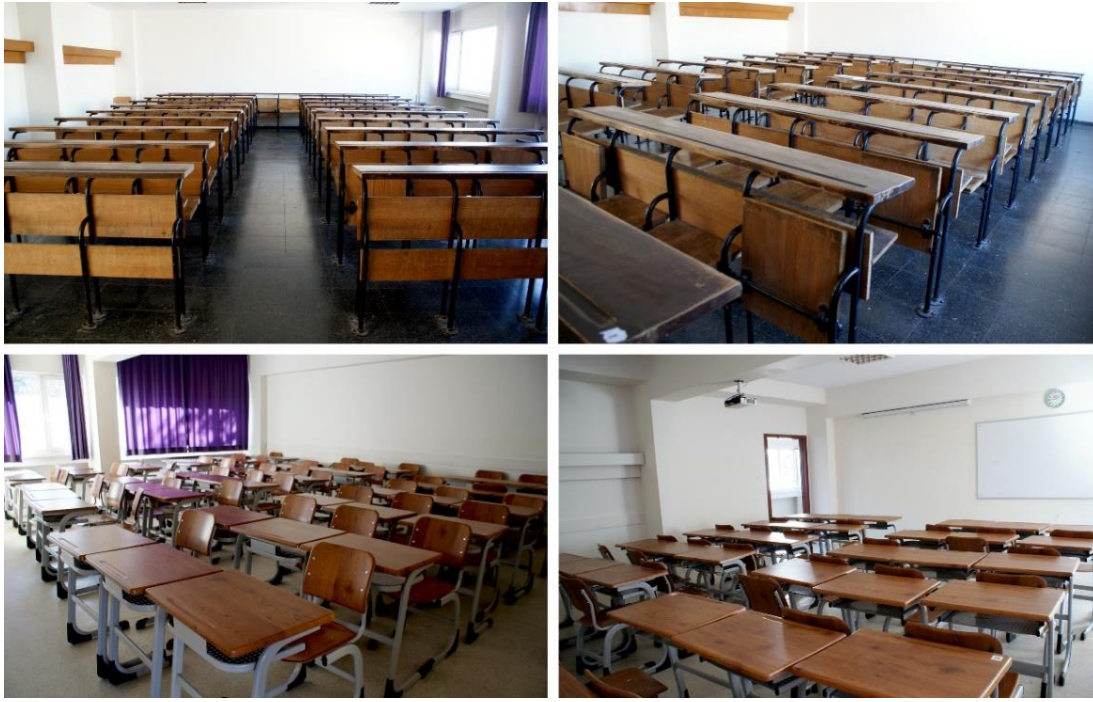
Figure 180. Original classrooms survived today (above) and the newly-formed classrooms in time today (below) (Azize Elif Yabacı, 2017)

The blocks housing the offices of academicians and the classrooms, which are 2A, 2B, 3A and 3B, have also kept their original floor plans. Especially the classrooms in the Blocks 3A and 3B do not have any spatial change compared to the original plans; there are just some spaces added to the halls on two ends of the blocks (Figure 180). The larger offices, twice of the other office, in the Blocks 2A and 2B were divided into two to increase the number of offices. Other than this change there is no spatial change in these parts also. However, there was a very drastic intervention to the ground floor of the Block 3B which included three classrooms as the rest of the floors in the building. Yet, these classrooms were cancelled and a new large classroom, covering around 2/3 of the floor was formed on the east. On the other side, a canteen was designed by adding the hall and the vertical pass way that reaches to the hall to this canteen area. In addition, the vertical pass way on the east was also transformed and functioned as cafeteria by adding a part of the hall to the space, again. Besides, a storage was formed in the hall near the staircase (Figure 181).

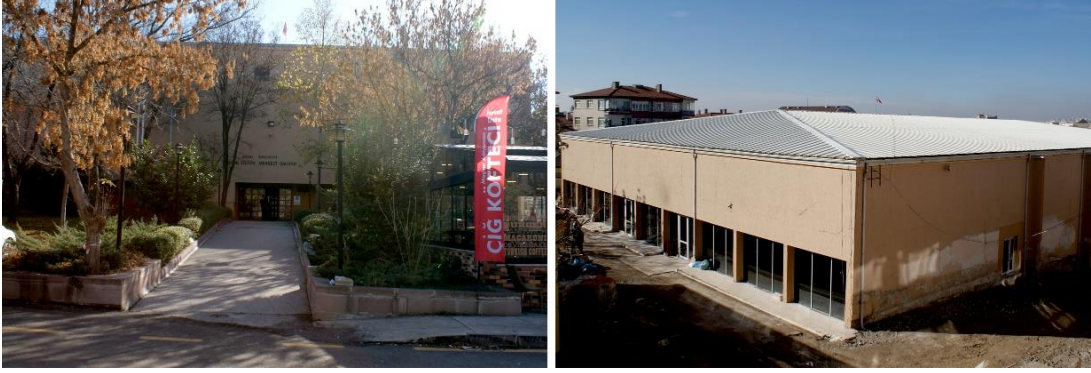
Figure 186. Façades of the Sports Hall building today (Azize Elif Yabancı, 2017)

The building was designed to take the light totally from the top and to sit on the slope. It was planned that the heat load will be thrown by air conditioner; however, the university could not afford it due to the financial difficulties. After that, the roof design was revised; the light taken from the roof was cancelled and, instead, a completely closed roof was constructed.<sup>82</sup> Ünal also mentioned in his interview in 1979 that the new Sports Hall building constructed for the use of three faculties did not put into service for years and abandoned (1979: 41). However, Prof. Dr. Figen Çok remembers that the Sports Hall was being used around 1982 and basketball tournaments were arranged in the hall.<sup>83</sup>

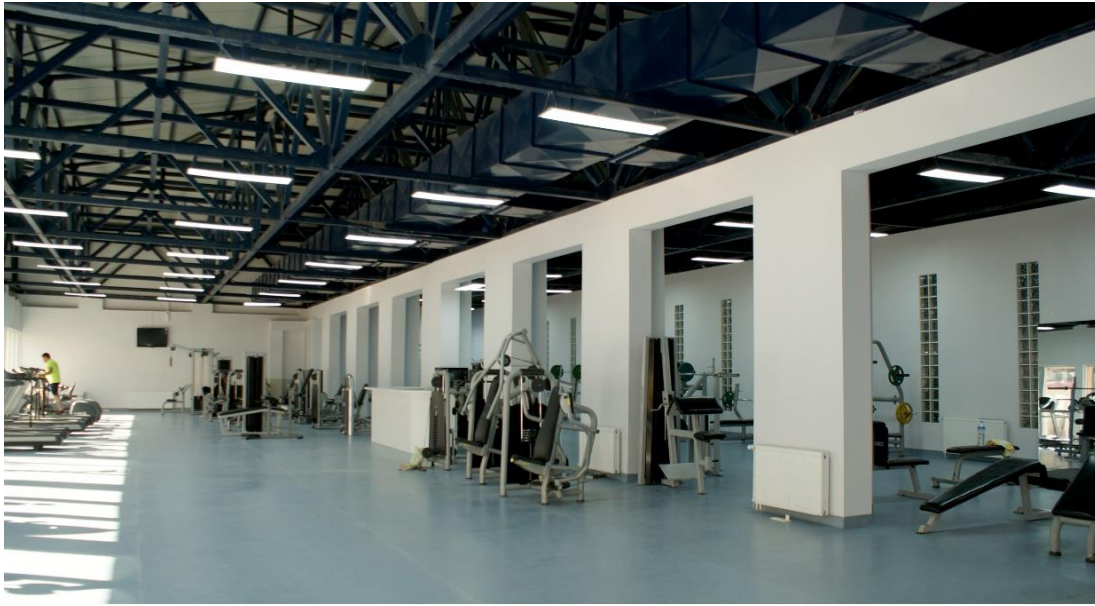
Figure 189. Fitness center formed by rearrangement of the locker rooms area in the Sports Hall building (Azize Elif Yabacı, 2017)

There were also repairs and whitewash in the interior and exterior, especially on the façades of the buildings. Recently, in 2017, the building has gone through another repair and the part of the locker rooms was rearranged. The walls dividing the rooms was removed and only the main wall separating the space from the hall remained; the whole area of the locker rooms was refunctioned as fitness center (Figure 189). However, there was no projects found in the archives related with this kind of interventions. With reference to these minimum changes and interventions in the building, it can be said that they were mostly material changes related with the renewal of doors and windows. There were no severe spatial changes which is related with the function of the building probably. The existing spatial changes, on the other hand, were realized within the boundaries of an existing space which did not end up with spaces affecting the original design of the building (Figure 190).

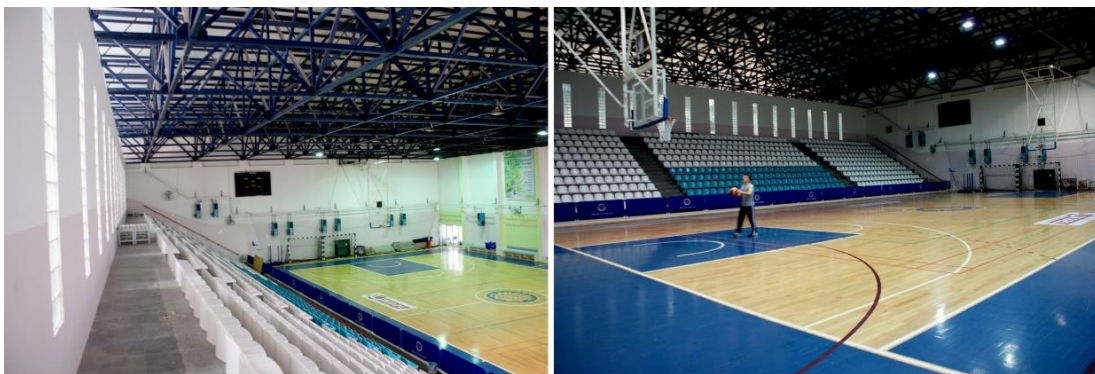
Figure 190. Sports Hall building today (Azize Elif Yabacı, 2017)

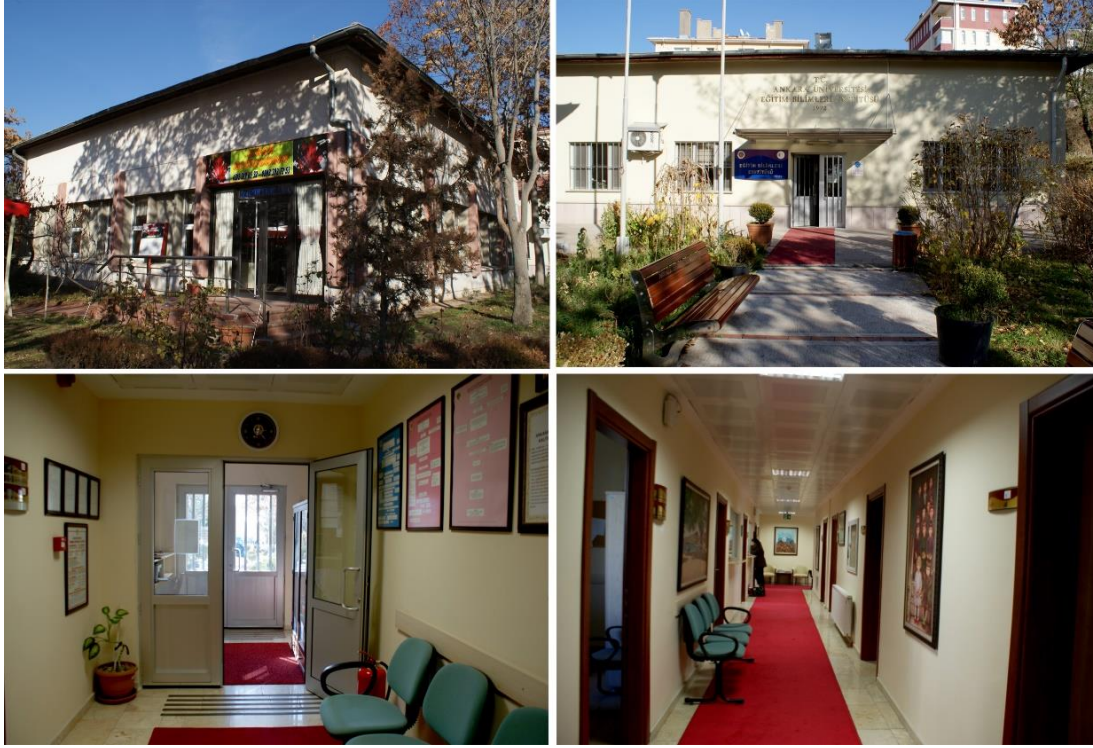
Figure 196. Photos showing the façades and the interior of the Institute of Educational Sciences and Restaurant building (Azize Elif Yabacı, 2017)

Although being a later-constructed building in the campus in comparison to the other and being a small-scaled one, the building has gone through remarkable and extensive changes, especially the rectangular block. The interior design of the blocks has totally changed in time which has effects on the façade of the building. Besides, the cubic mass also had some changes in terms of function, all of which were related with gastronomic activities, space and material. However, when compared with the other block, they were minor interventions mostly necessitated in consequence of the transformation of the connected block. In the end, it is almost impossible to trace the originality of the building in the Institute part while it can be possible to have some clues on the façade and the plan in the restaurant part (Figure 196).

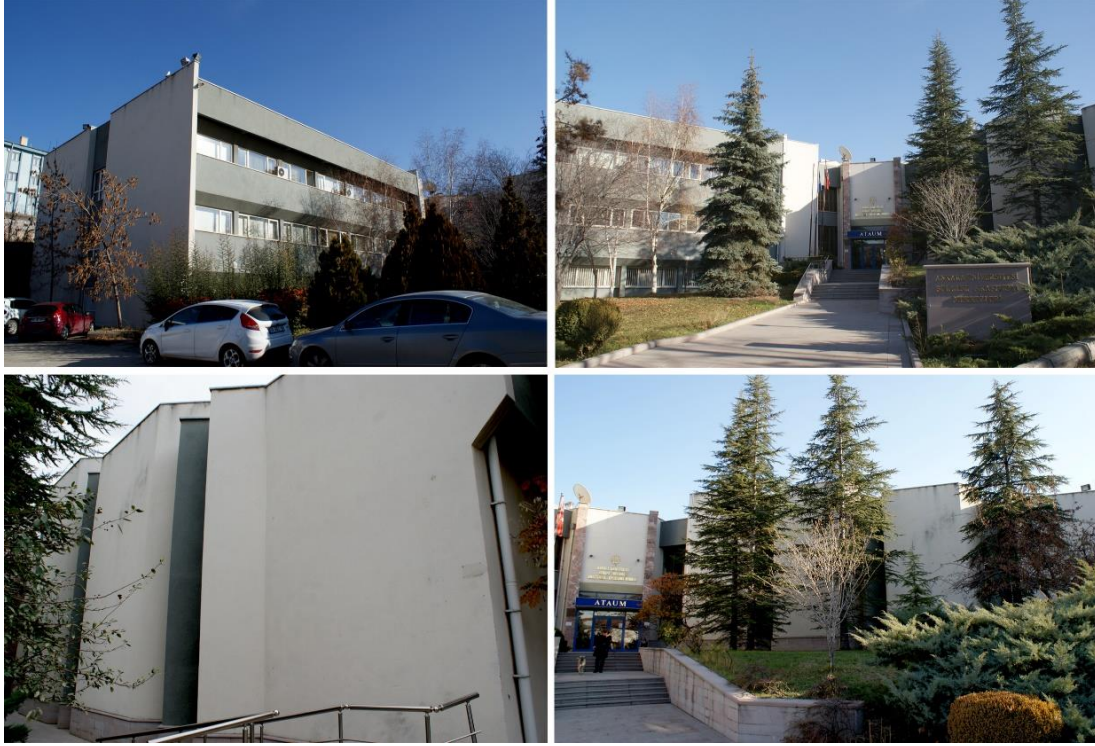
Figure 202. Façades of the ATAUM building today (Azize Elif Yabancı, 2017)
