CONSERVATION AND REVITALIZATION PROPOSALS FOR
ESKİŐEHİR SUGAR FACTORY SOCIAL FACILITIES AREA

A THESIS SUBMITTED TO
THE GRADUATE SCHOOL OF NATURAL AND APPLIED SCIENCES
OF
MIDDLE EAST TECHNICAL UNIVERSITY

MERVE YILDIZ

FEBRUARY 2016

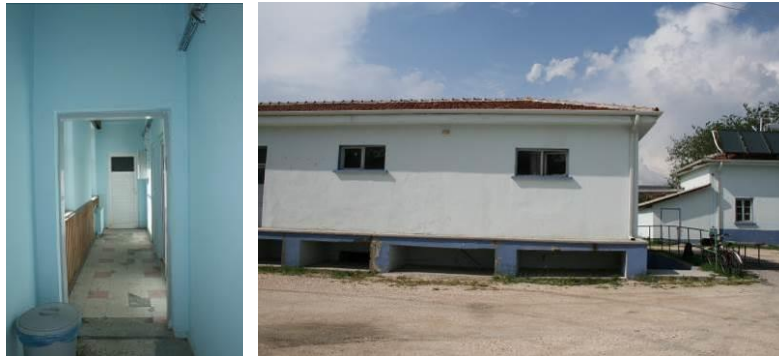
In terms of structural and material condition, the building of Milk House is in bad condition due to the fact that basement floor have material and structural problems and immediately needs an extensive intervention. In addition, ground floor of the building needs maintenance of timber architectural elements and floor coverings.

Plan schema and façade organization of the building is mostly changed. First of all, east part of the building is added to the original one locating on the west lying along the platform at west part at a date in between 1950 and 1975. Original mass is seen in

the aerial photograph belonging to 1950 while in the aerial photograph of 1975 additional mass is attached to the original mass at east side is seen. In addition, alteration is seen in the floor coverings of the original mass. For instance, some parts of terrazzo coverings at corridors are changed with vinyl.

Figure 3.78: Example of alteration and additional mass at the east side of Milk House

Third and last group includes buildings that are in a bad condition due to their structural problems such as material loss in bearing walls and deep cracks. Thus, milk house building (B15) is determined as having a bad condition.

Milk house building was constructed as two storey structure (basement and ground floor) with stone and brick masonry system in which floor slabs were built in reinforced concrete. Today, basement floor is out of use and ground floor is used as worker's pavilion. Apart from the other buildings of the area, milk house building has severe structural problems and in bad condition. Mass addition also can be seen at the building.

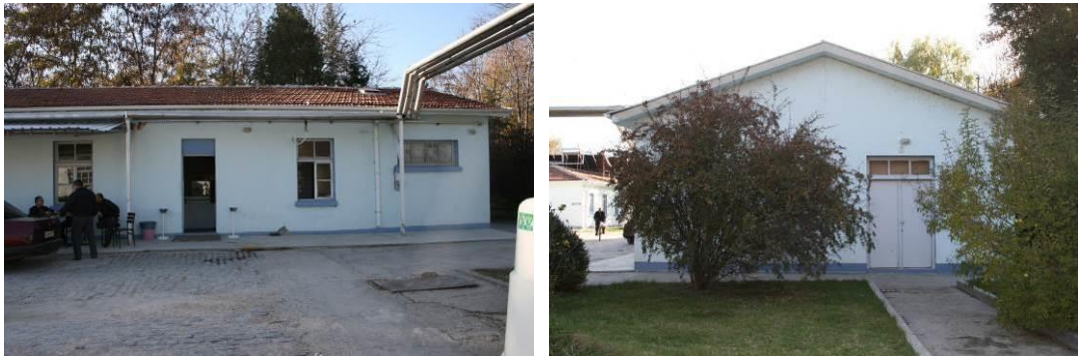
Plan schema and façade organization of the building is mostly changed. Except from the mass addition to the south façade, removal and addition of architectural elements and transformation of windows into doors are seen. On the other hand, alteration is

seen also in finishing materials. For instance, ceramic floor and wall coverings are added to the wet space.

Figure 3.86: Examples of alterations in Club House

In the archive research, interior photos of 1949 and original plan, elevation and section drawings of 1933 was reached.¹⁰² Compared to current situation, it is clearly seen that plan schema and façade organization of the Club house had been significantly changed. First of all, entrance door at south façade was closed due to the mass addition adjacent to the main building. In spite of the fact that two doors are seen in the plan drawing, only one entrance door is seen in the photos taken in 1949. Thus, it is accepted that, during the construction one of the doors was cancelled. Besides, service area composed of kitchen and storage were altered; thus, kitchen transformed into toilet and door opening through storage were closed. Moreover, window and door openings of the service spaces were altered, removed or new ones were added such as; window of kitchen near the north-east corner of the room was removed, instead a window was added at a higher level in a different form. In addition, windows at north façade were removed and instead a wide door was opened near the west corner of the façade. As last, due to the fact that main entrance door at south façade was closed, one of the windows at east façade was transformed into a door in order to provide access to the building.

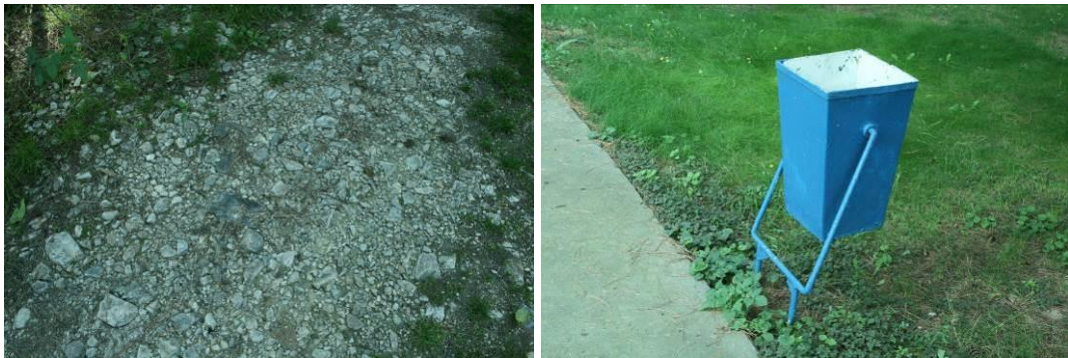
Figure 3.106: Coarse gravel mosaic pavement remains and litter bin of the area at the west part of the park

Today, boundaries of the pathways are not easily seen; hence coarse gravel mosaic pavement is seen partially in some parts of the area. In the project, area is drawn according to the aerial photograph of 1950 in which design is clearly seen.

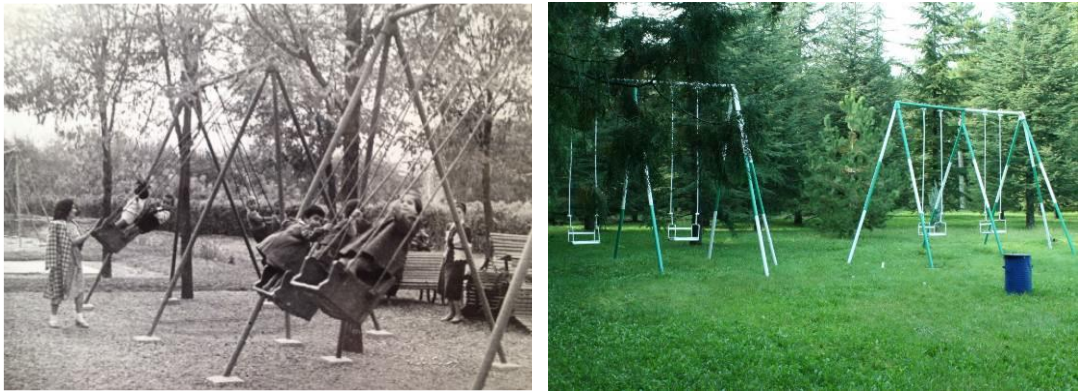
Figure 3.109: Structures of Playground 1 in 1949 and 2014

Playground Type 1 locates in the land locating at south part of the 2nd Street and behind the Employee Dwelling Type 4 (B07). Construction date and designer of the area is unknown; hence playground is seen in the photographs taken in 1949. Area covers a land of 4.000 m². All the types of playground structures in the area were changed except from the swing sets.

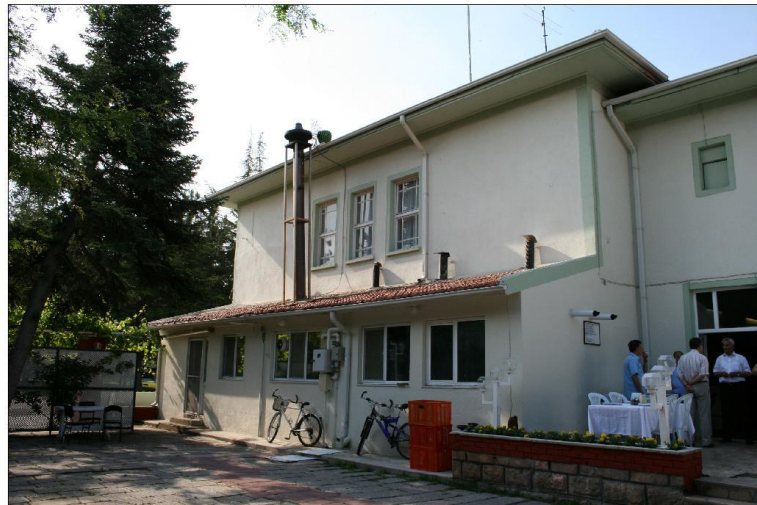
exterior view from south and mass addition

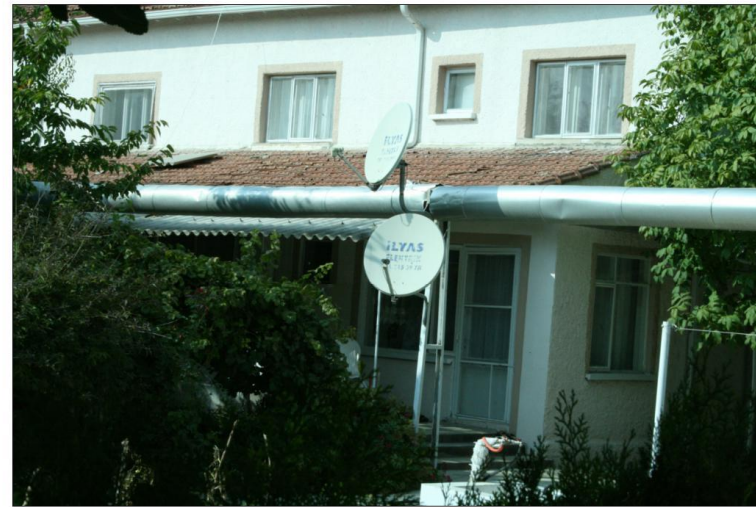
additional mass

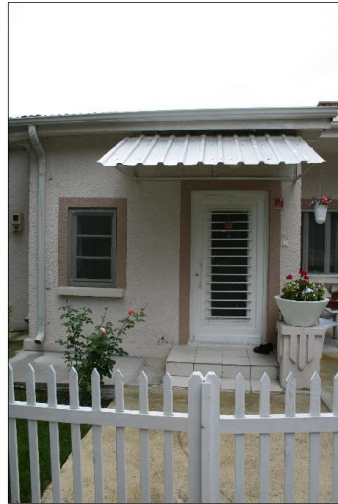
additional entrance

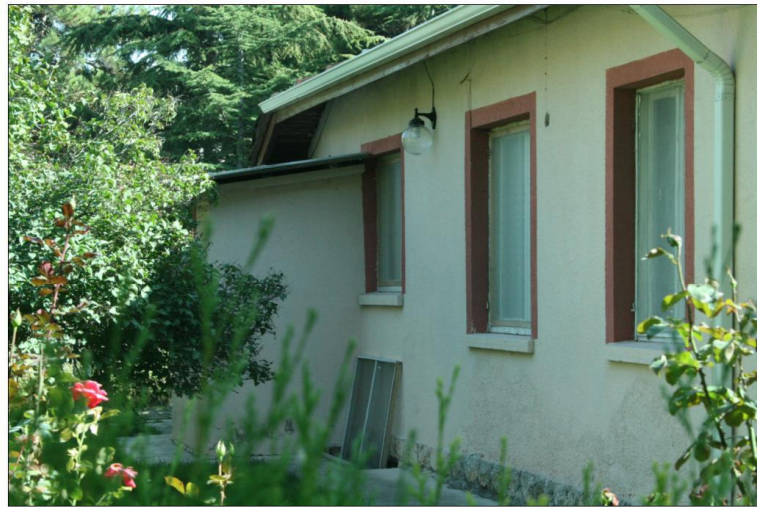
mass addition

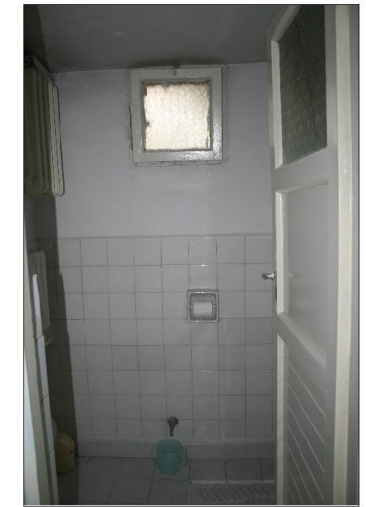
additional wet space
